**2003 Investigation of Rose Creek  
Tailings Facility, Faro Mine  
Report on Coring and Multi-Level Well  
Installation**

**Draft Report**

**Gartner Lee Limited**

**December 2003**

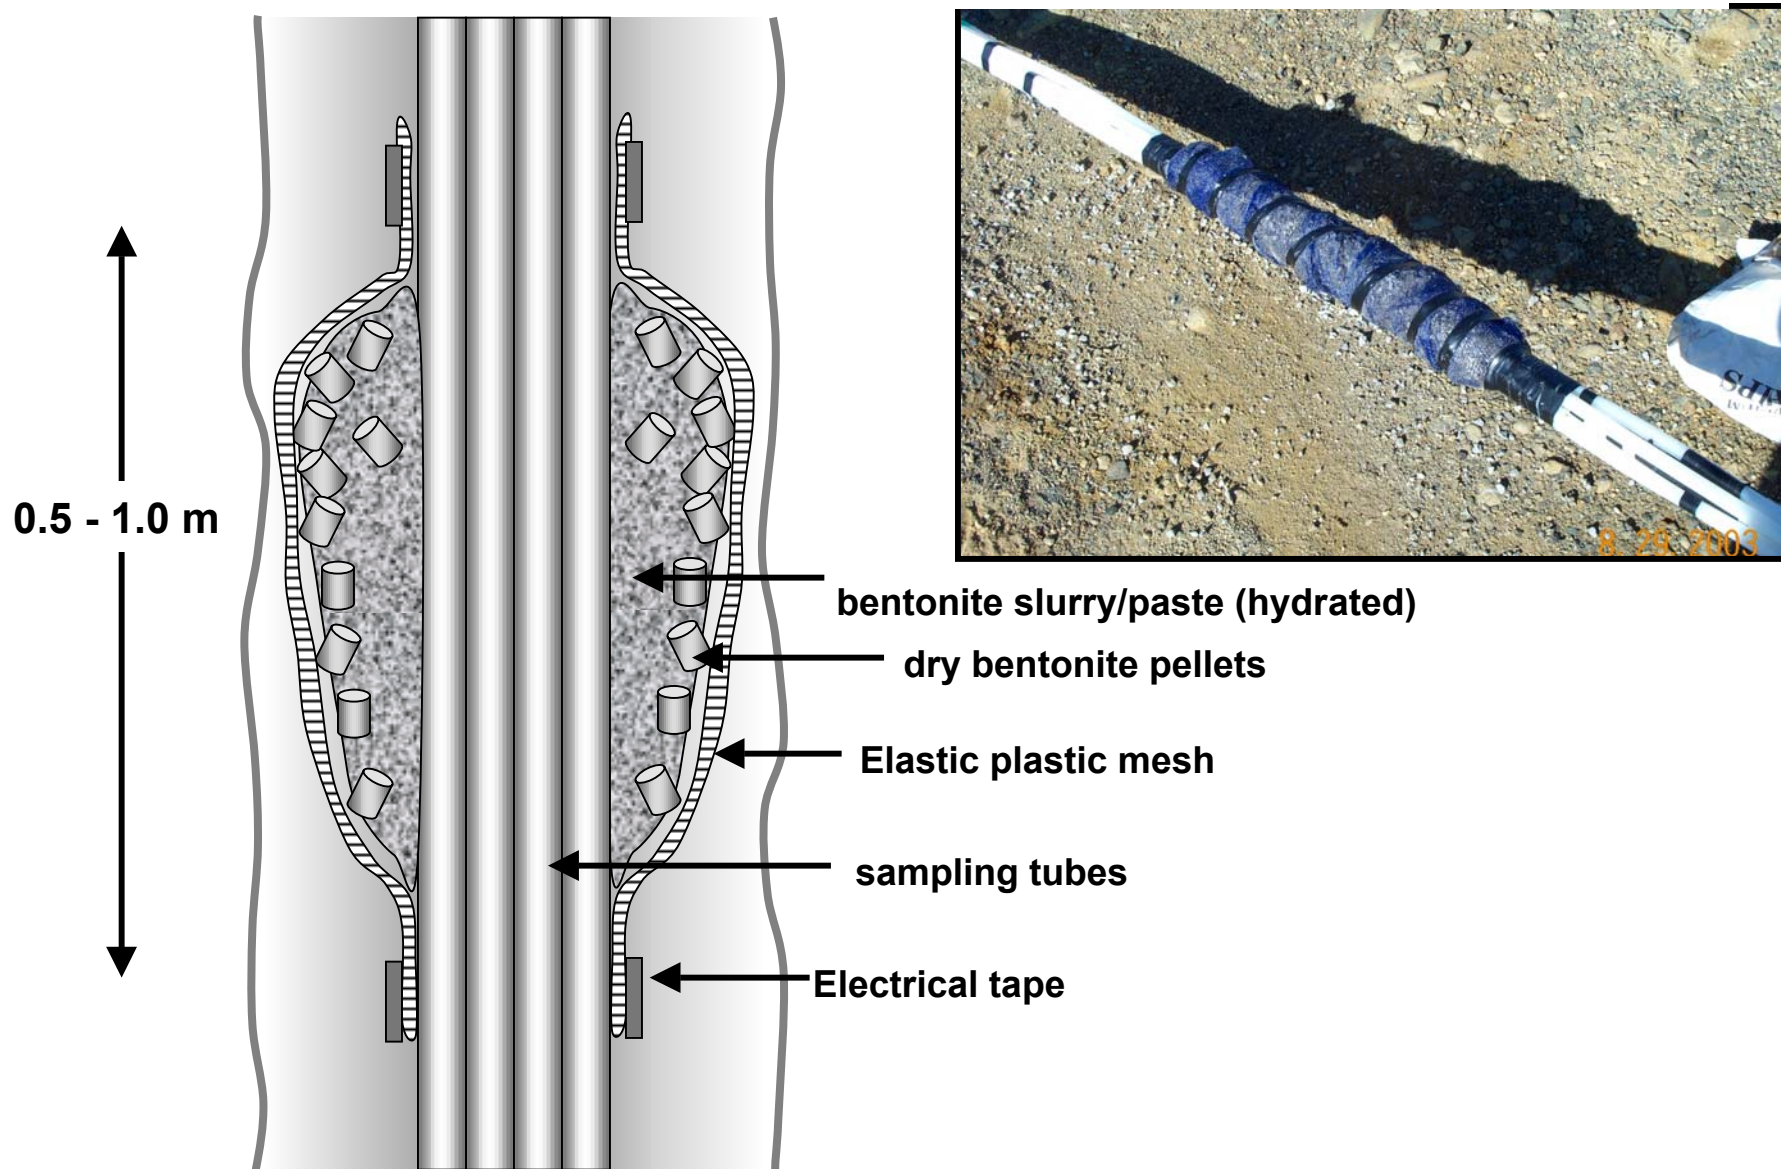
Figure 4. Schematic and photograph of bentonite seal used to ensure proper seal across tailings/native sediments interface

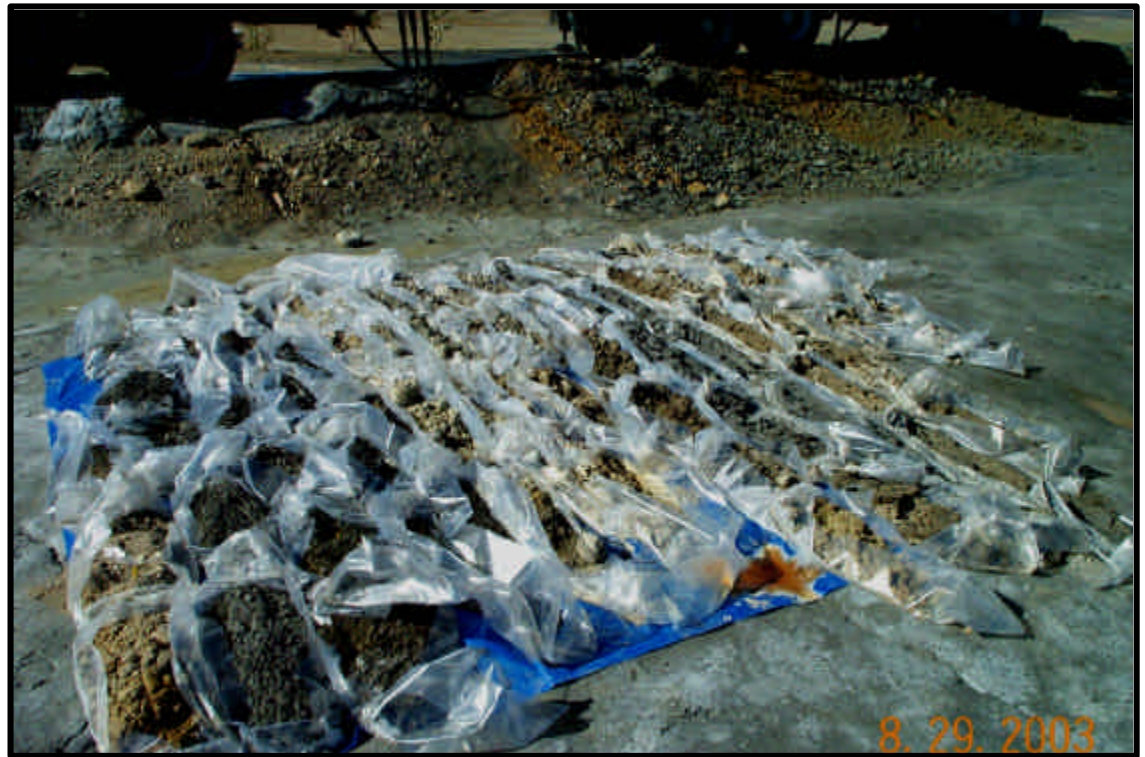
Cores at ground surface showing detailed geology and sharp transition in geological detail

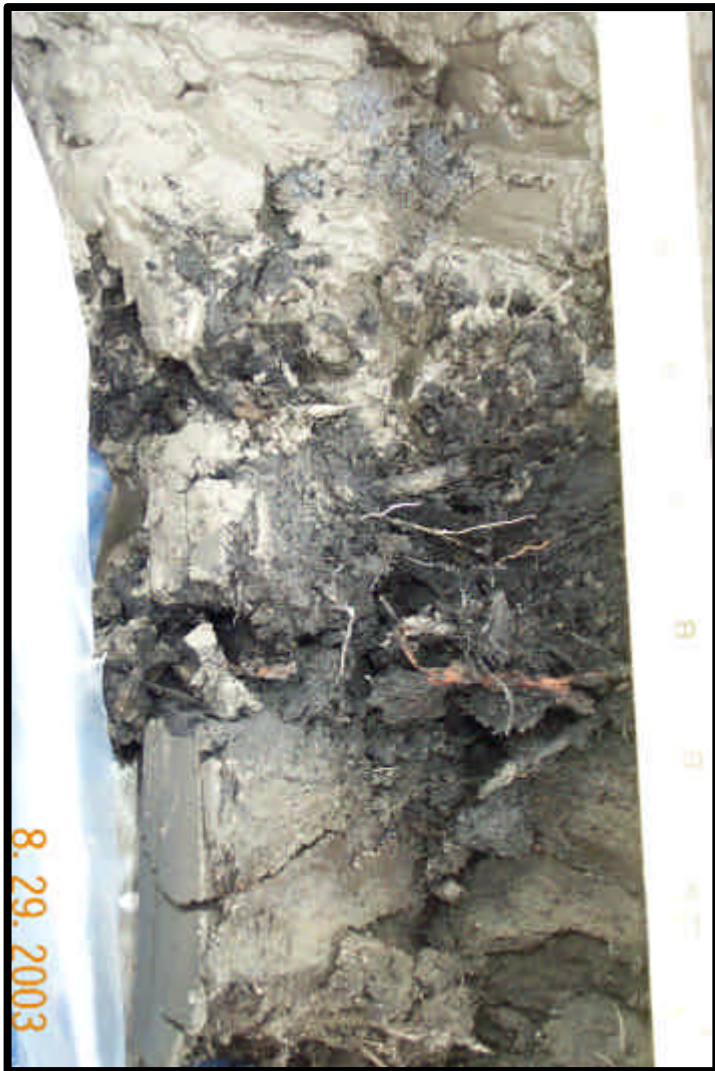
Detailed geology and identification of interface showing organics under the tailings

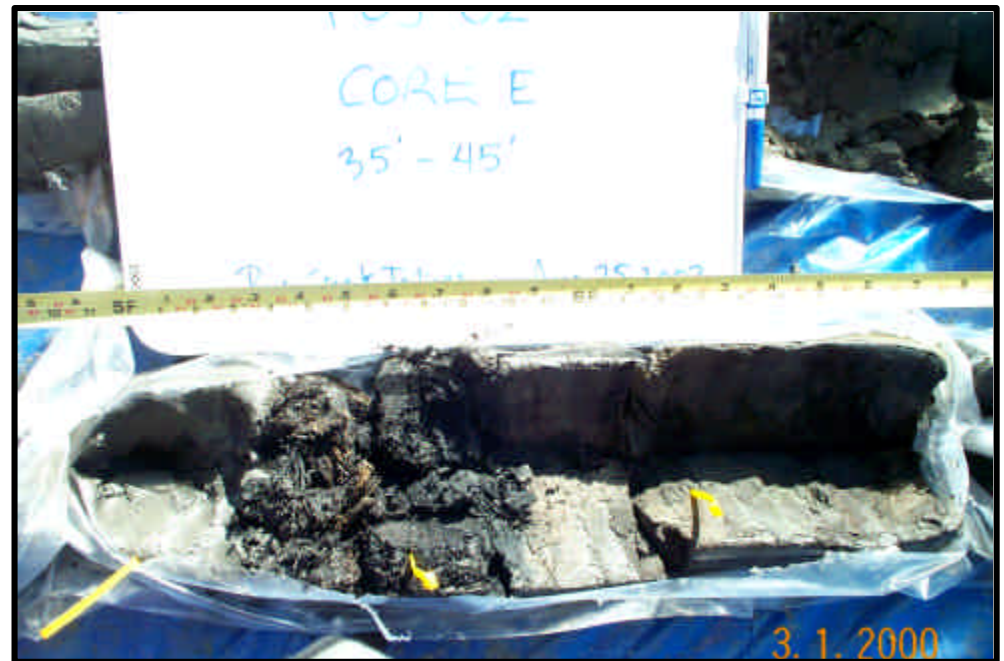
Detailed geology and identification of interface at location P03-02

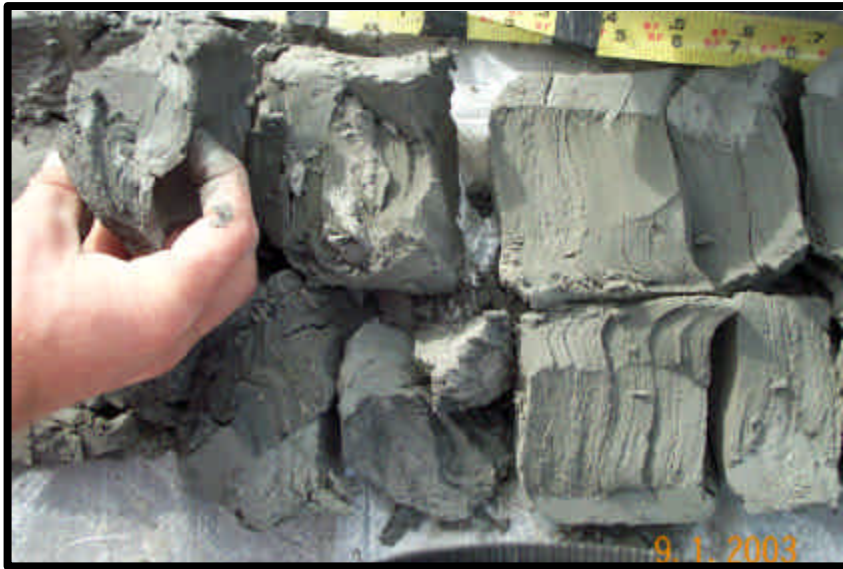
Core sample from P03-07 (155' - 165') showing lacustrine sediments (varved sequence)

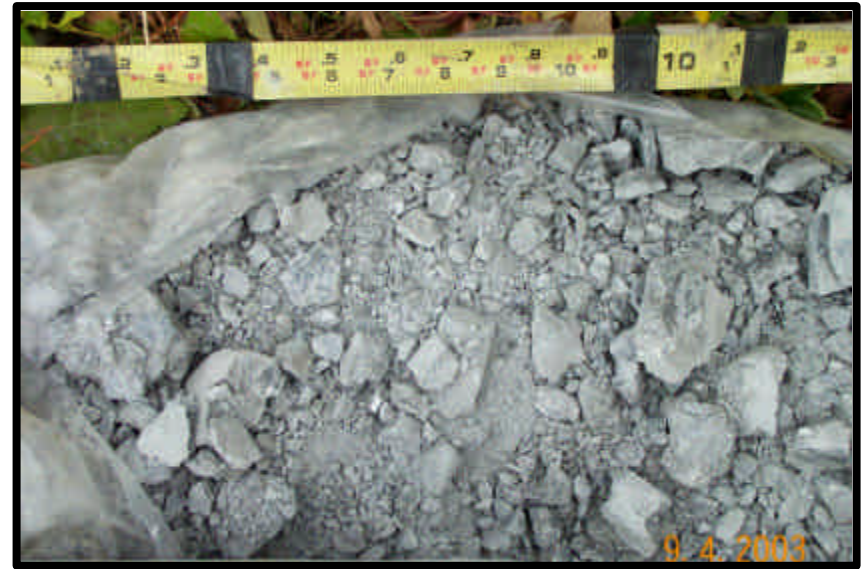
Identification of weathered bedrock
