2004 Leakage Assessment of P01 Series Wells, Faro Mine

**Deloitte and Touche Inc.
Interim Receiver, Faro Mine**

Gartner Lee Limited

June 1, 2004

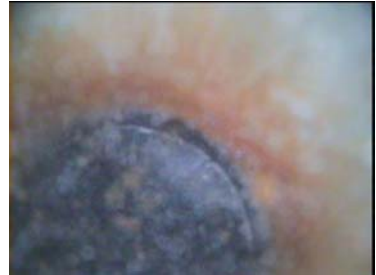
Iron staining above the joint, black staining below the joint. Joint below water table.

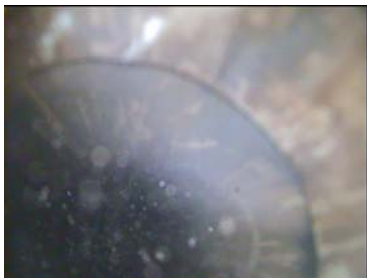
Black staining below joint. Joint below water table.

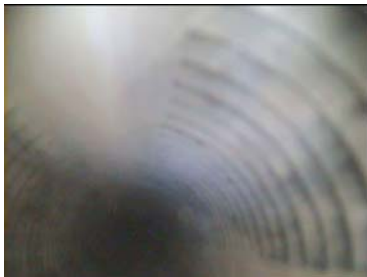
Black staining on screen

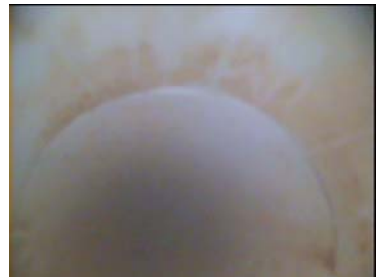
Well Location and Casing Joint Depth: P01-06

Water fairly clear, no other obvious joints, iron staining

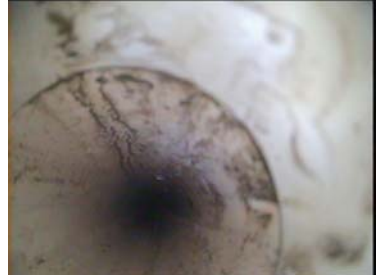
Field Observations:
Leakage apparent

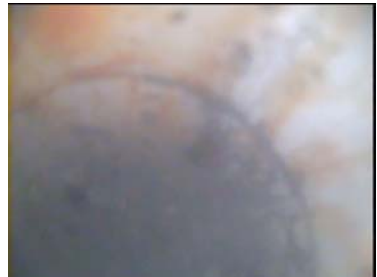
Field Observations:
Black staining below
joint

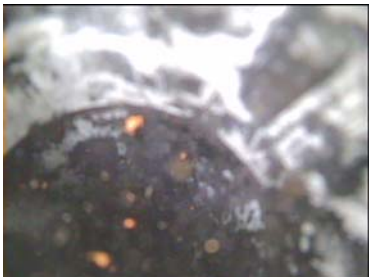
sides of tube very
black, following 3 joints
all resemble this one
with black staining both
above and below joint.
Screen appears white
with patchy black
staining - murky image

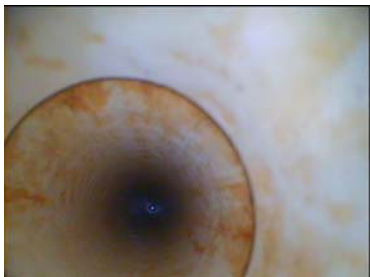
Field Observations:
Spotty iron staining
along walls

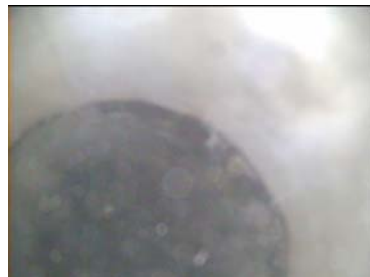
Field Observations:
Black staining on lower
side of joint

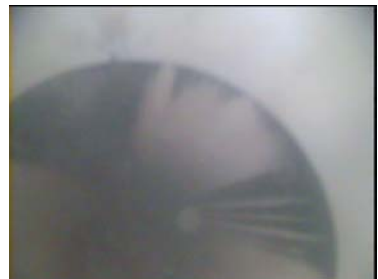
Field Observations:
Black stain - leakage
likely

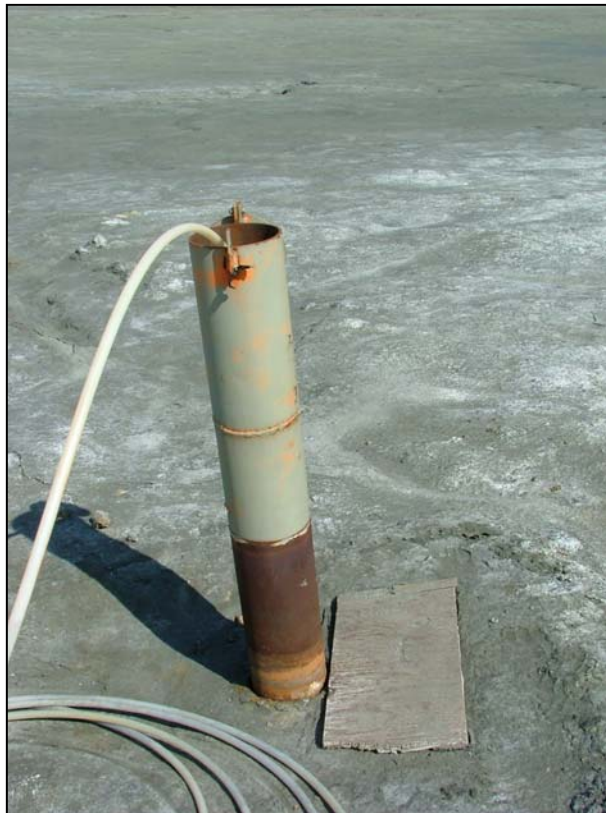
Tailings from well P01-10B

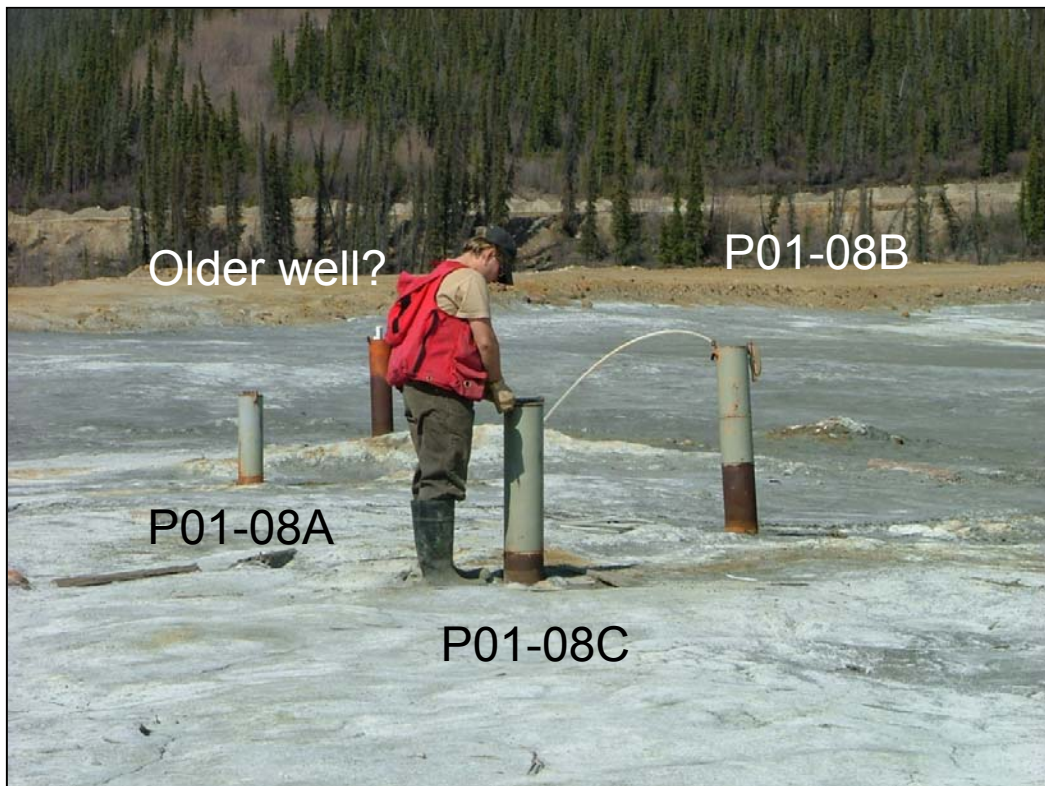
Well P01-08B (well casing appears to have heaved and is loose)

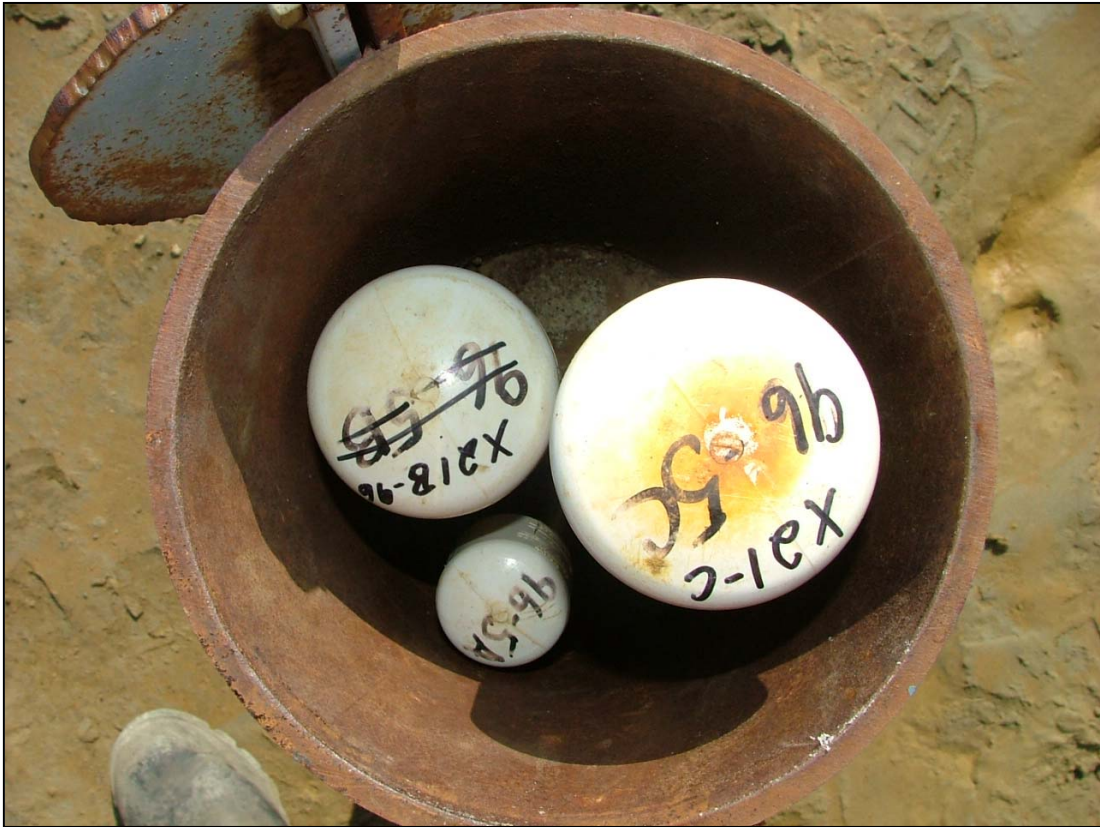
Well Cluster X21. Annular space is filled with sand
