# 2005 Water Balance for the Mount Nansen Mine Tailings Pond, Yukon

Prepared for  
**Yukon Government, Abandoned Mines Project Office**

Submitted by  
**Gartner Lee Limited**

February 2006

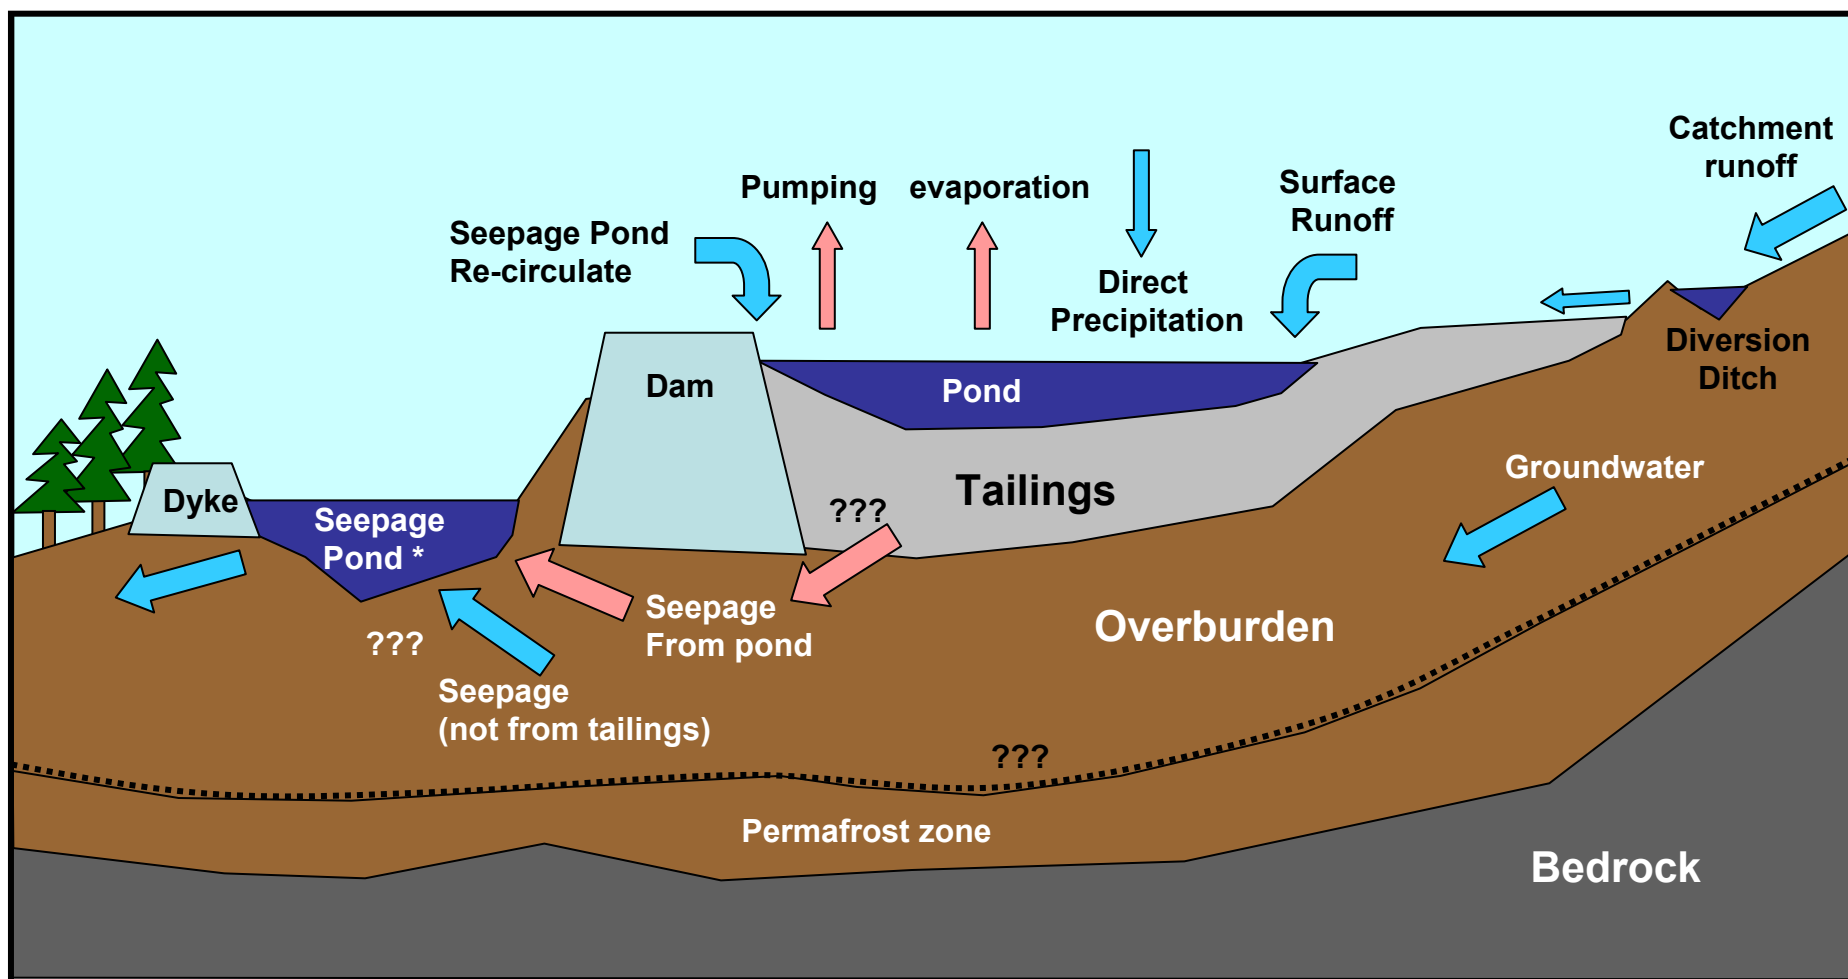
Figure 1. Conceptual Model of Tailings Pond Water Balance, Mt. Nansen Mine, YT *Tailings Pond Water Balance, Mt. Nansen Mine - Gartner Lee Limited*

EBA (2002) and (2004) summarized available records of water pumped from the seepage pond downstream of the main tailings dam. Water from the seepage pond was pumped and re-circulated to the main tailings pond until 2004. In 2005, Yukon Government pumped water from the seepage pond and discharged it to the Dome Creek after water quality monitoring indicated that pond water met discharge requirements. The flow rates available for the seepage re-circulate are summarized in Table 1 and Table 2. As pointed out by EBA (2004) and discussed further in this report, these rates represent only an estimate of the actual groundwater seepage from the tailings pond because the seepage pond does not necessarily capture all seepage, it is not constructed to prevent outflow of seepage and it is subject to surface runoff and direct precipitation (Figure 1).

Seepage from a pond located near the base of the tailings dam is re-circulated to the main tailings pond. As pointed out by EBA (2002), the rates and volumes of seepage re-circulated back into the tailings pond are only estimates of total seepage from tailings impoundment. The seepage pond captures direct rainfall and surface runoff from the tailings dam slope and the north and south abutment slopes. It is also likely that the seepage pond may also not capture all seepage from the dam or retain all the seepage (Figure 1).

\* Seepage pond also subject to surface runoff, precipitation and evaporation

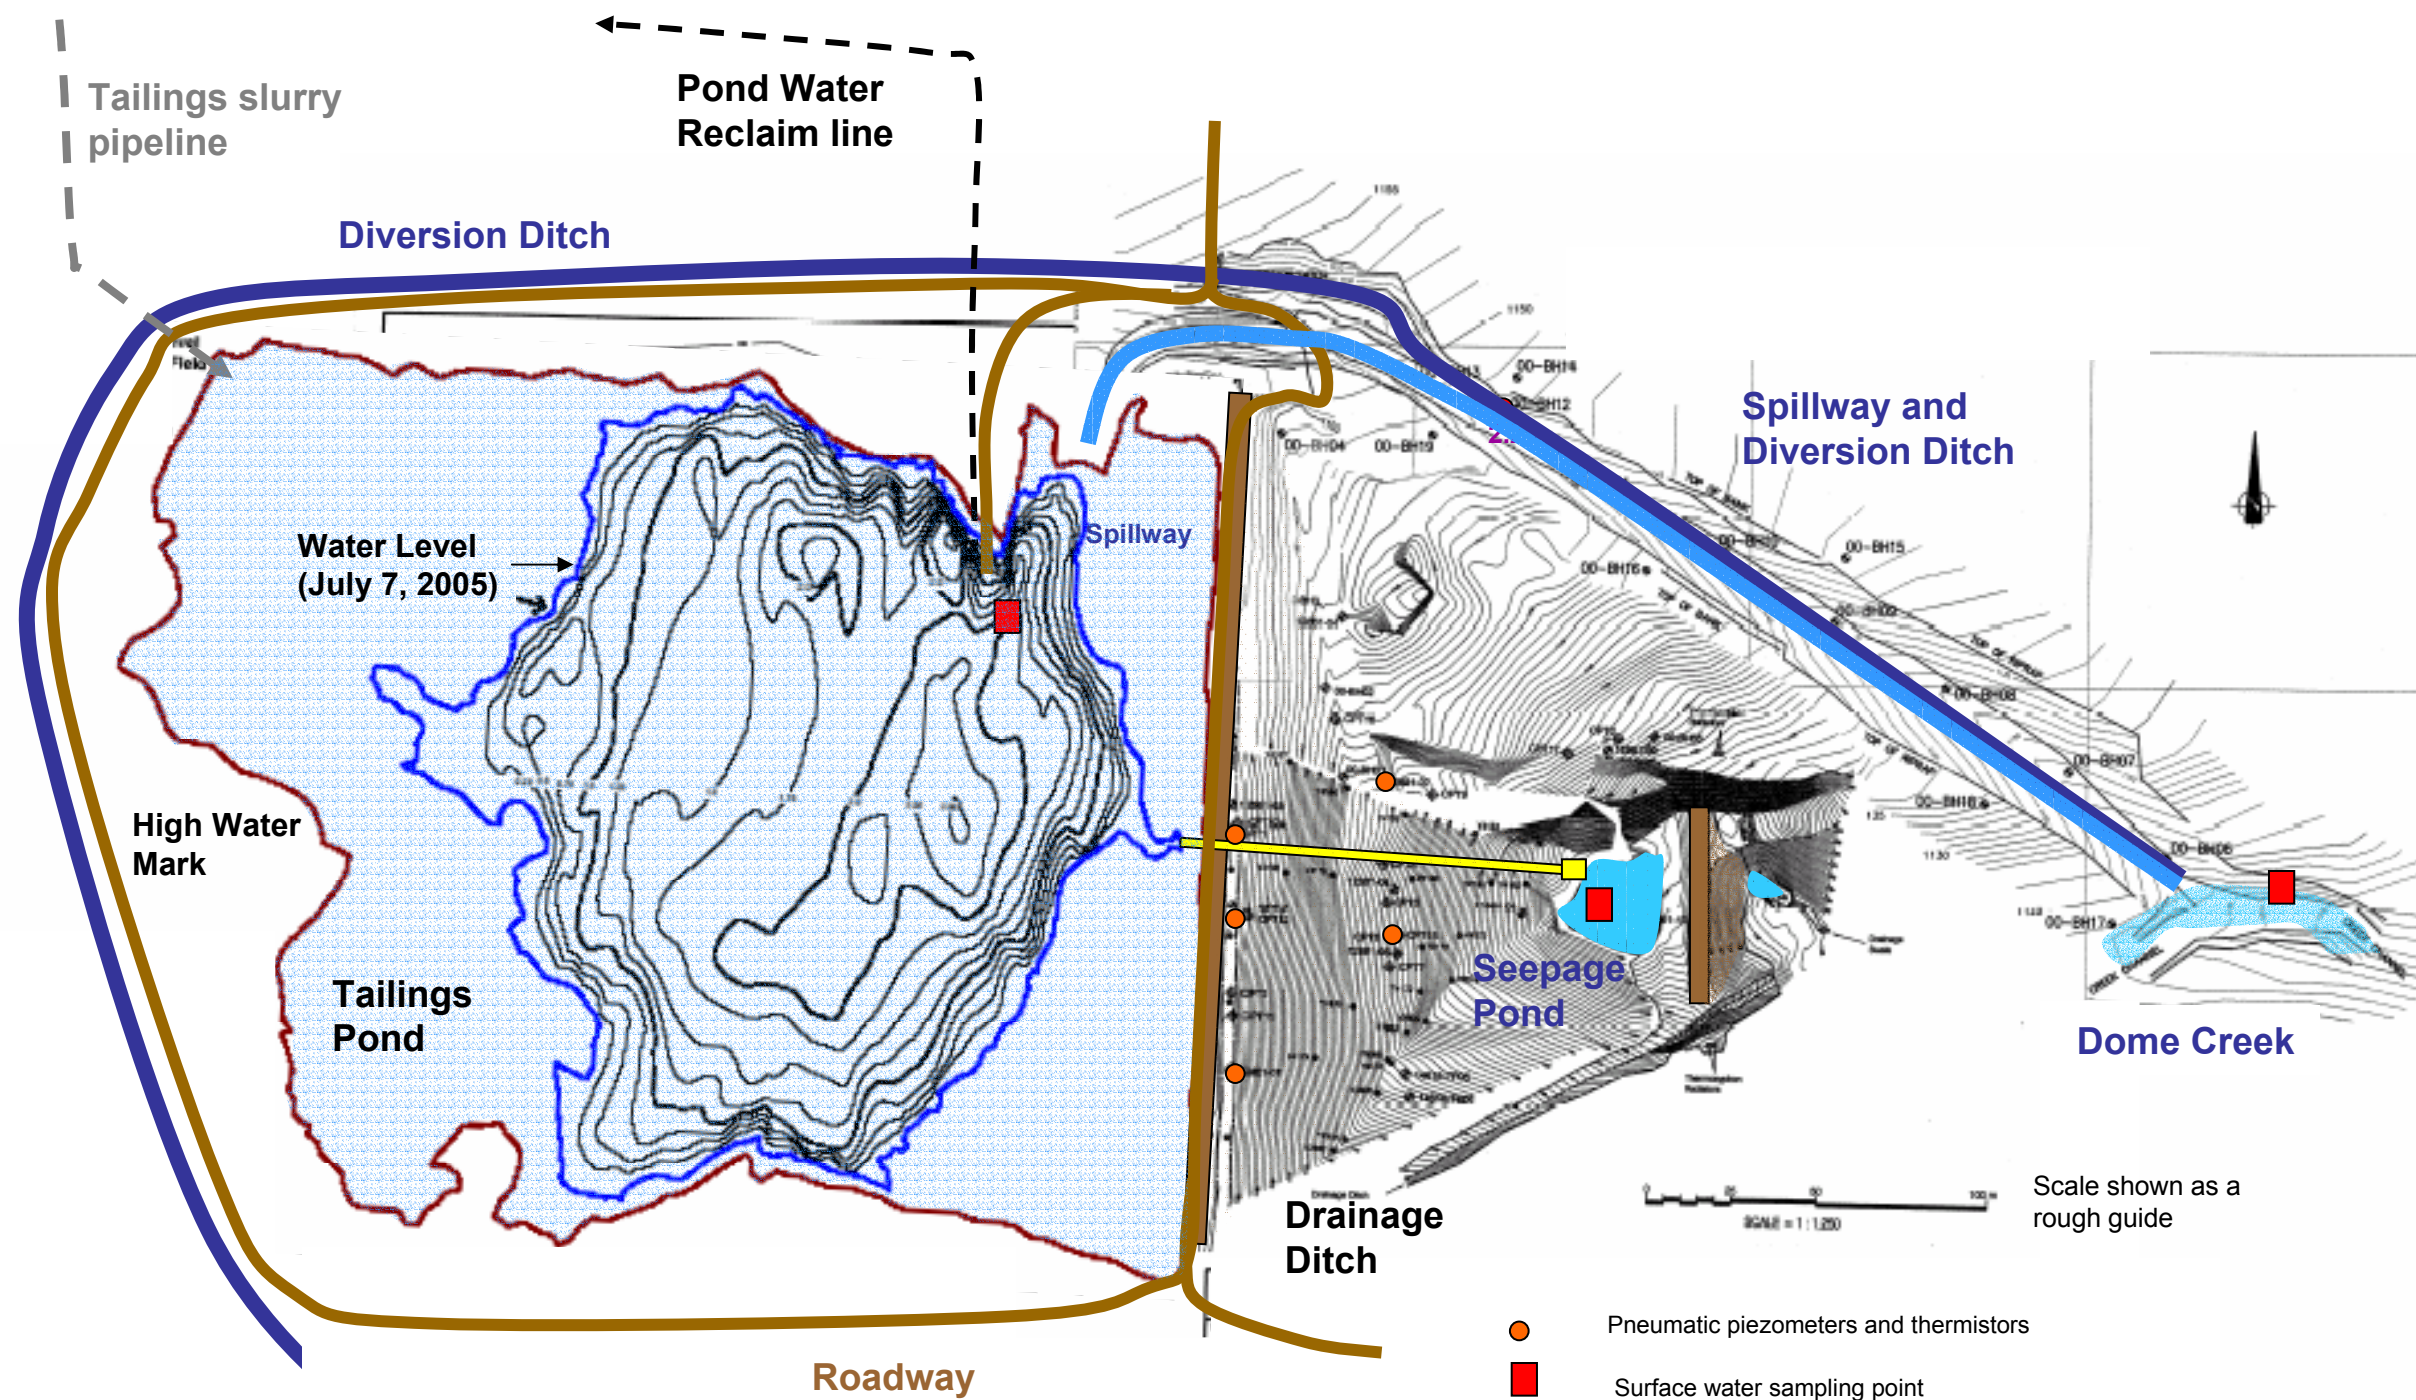
Figure 2. Schematic Layout of the Mt. Nansen Mine Tailings Impoundment Showing Tailings Pond Bathymetry (not to scale)  
Composite diagram incorporating 1) Pond Bathymetry (EDI, 2005), 2) Tailings Dam Survey (EBA, 2004), 3) Spillway Survey

A diversion ditch and spillway were constructed around the tailings impoundment to divert surface water from the upstream catchment area, around the tailings and tailing pond (Figure 2 and Figure 3). This ditch was constructed un-lined with sand and has not been maintained for several years. The ditch was designed to capture most surface runoff from upstream and is reported to not have any breaches in the side berms. However, it is probable that water may leak through the bottom and sides of the ditch, resulting in infiltration to groundwater and perhaps even direct surface flow to the tailings pond. (McAlpine 2006).

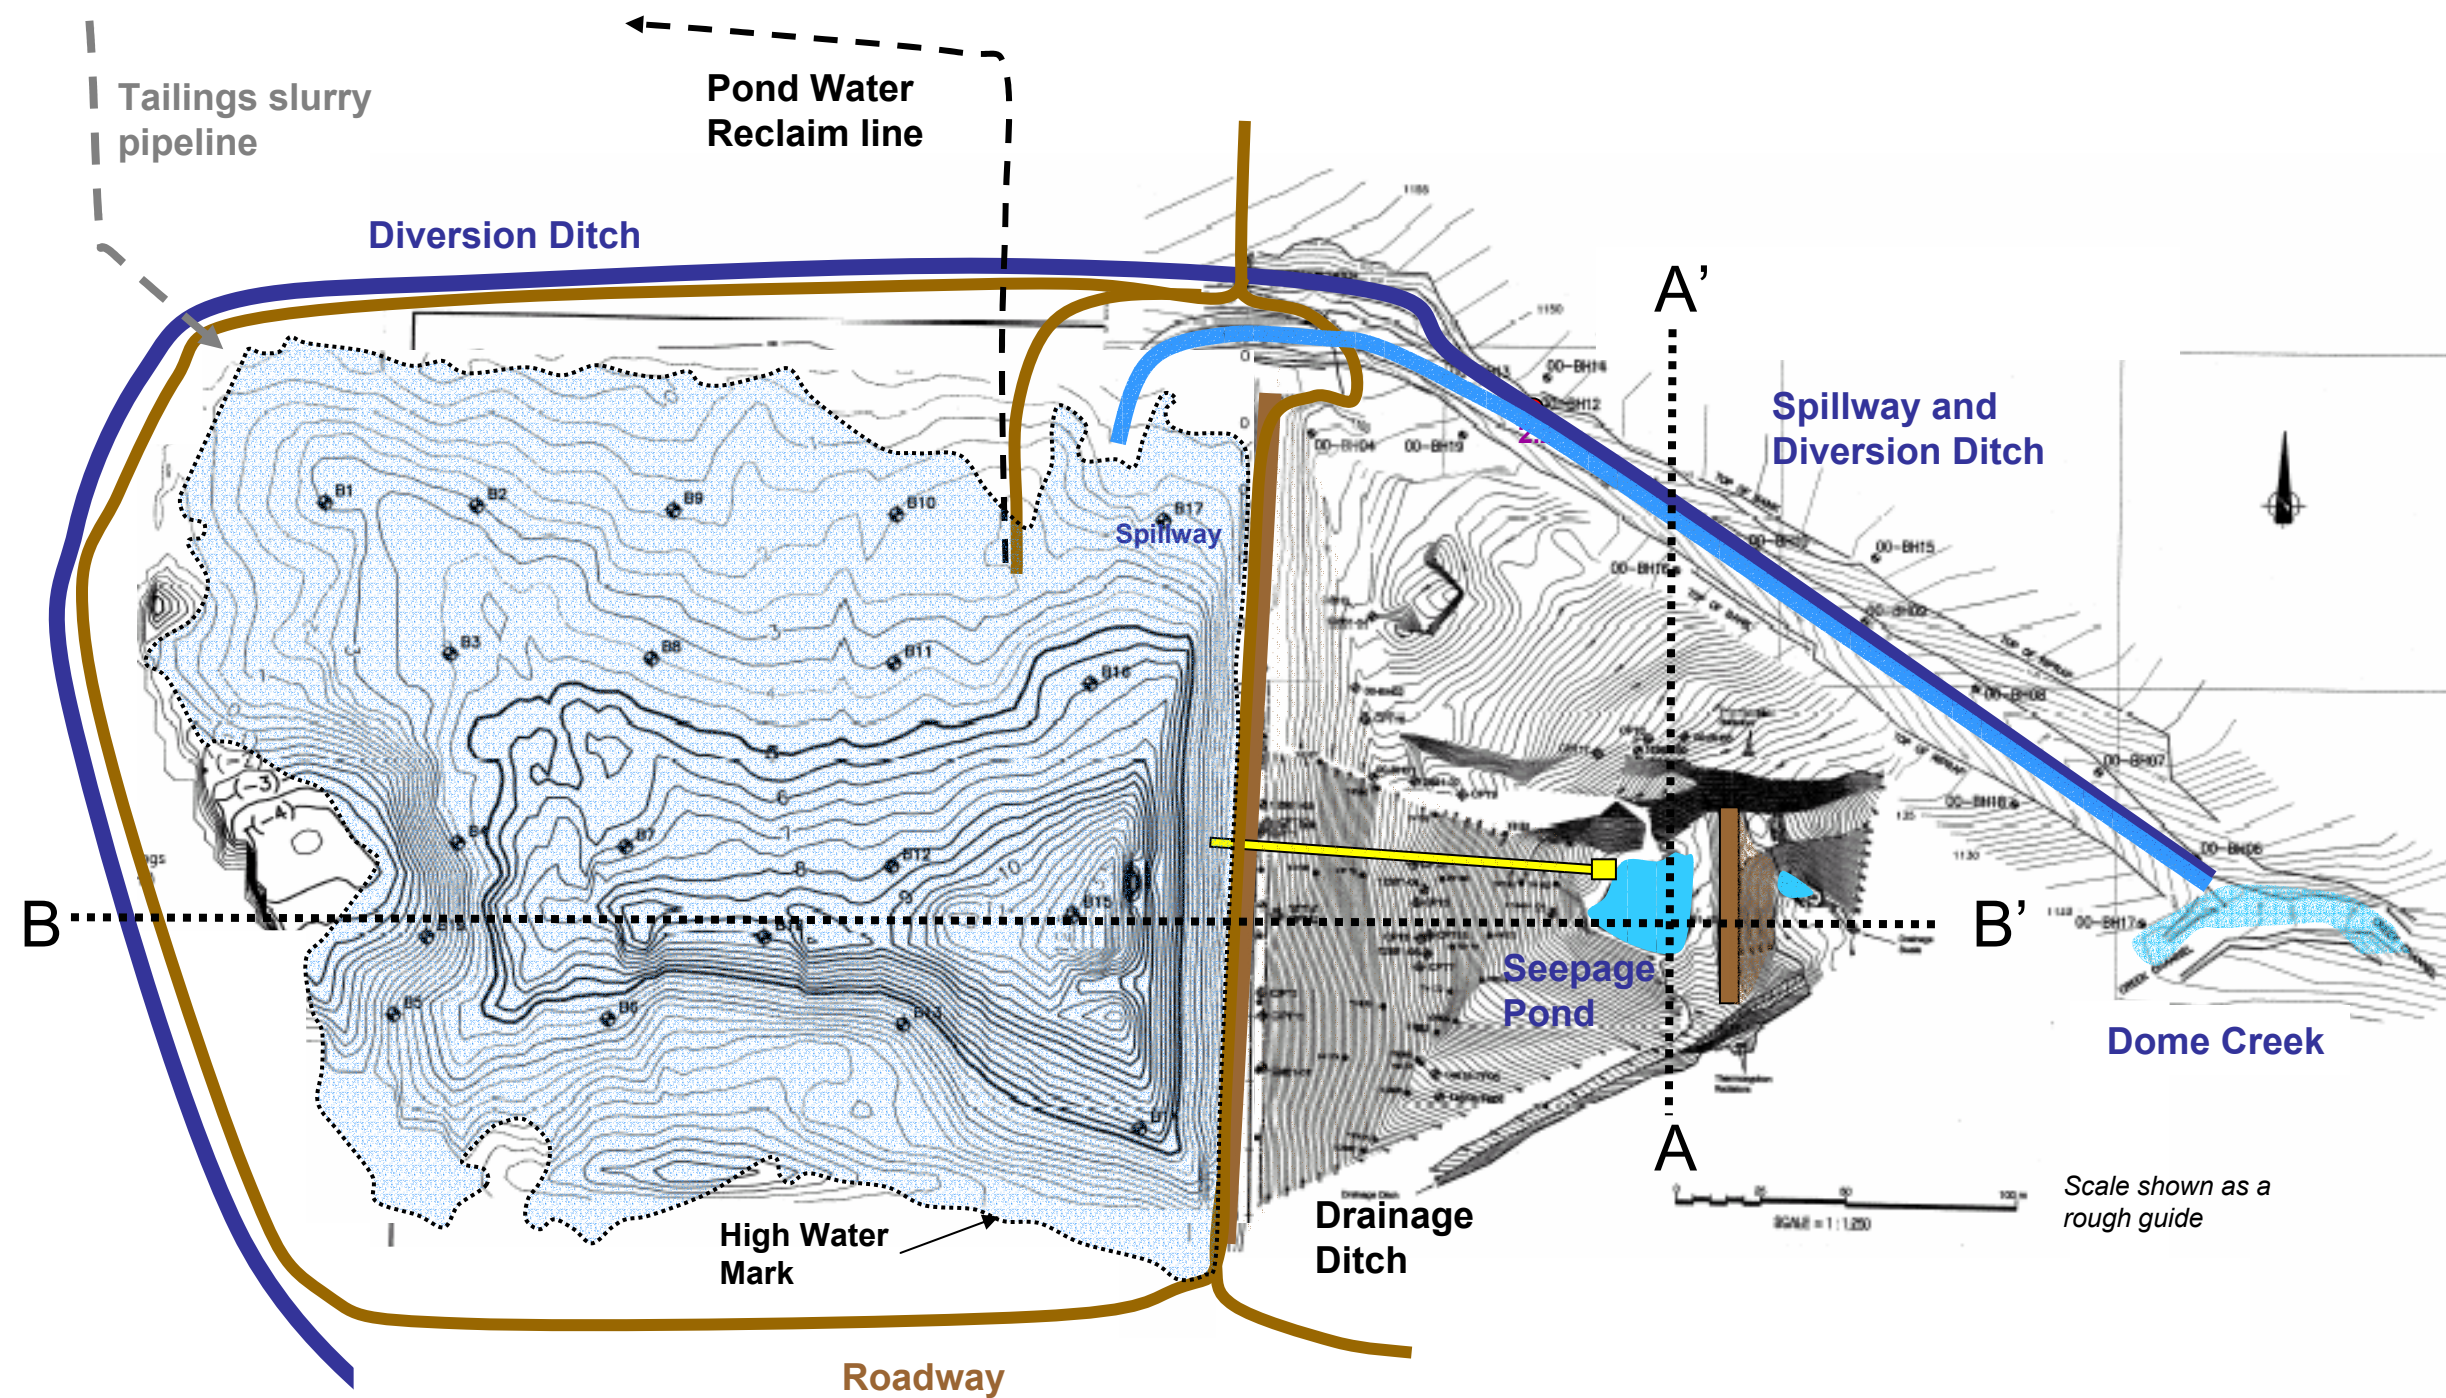
Figure 3. Schematic Layout of the Mt. Nansen Mine Tailings Impoundment Showing Tailings Thickness and Location of Interpretive Cross Sections. (not to scale) Composite diagram incorporating 1) Tailings Thickness (YES, 2002), 2) Tailings Dam Survey (EBA, 2004), 3) Spillway Survey

The distribution of tailings is an important factor controlling groundwater movement within and around the impoundment. The thickness of the tailings and relative distribution can also affect pore water residence times, groundwater quality and seepage rates from the pond. Yukon Engineering Services (YES) prepared an estimate of the volume and distribution of tailings at the site in November 2001. The procedure and approach used is discussed by EBA (2002). The interpreted YES tailings survey has been incorporated into Figure 3. At its maximum thickness near the centre of the original valley bottom, the tailings are estimated to have a thickness of approximately 12.5 m. The volume of tailings in the impoundment is estimated at between 250 000 m<sup>3</sup> and 310 000 m<sup>3</sup> (EBA 2001).

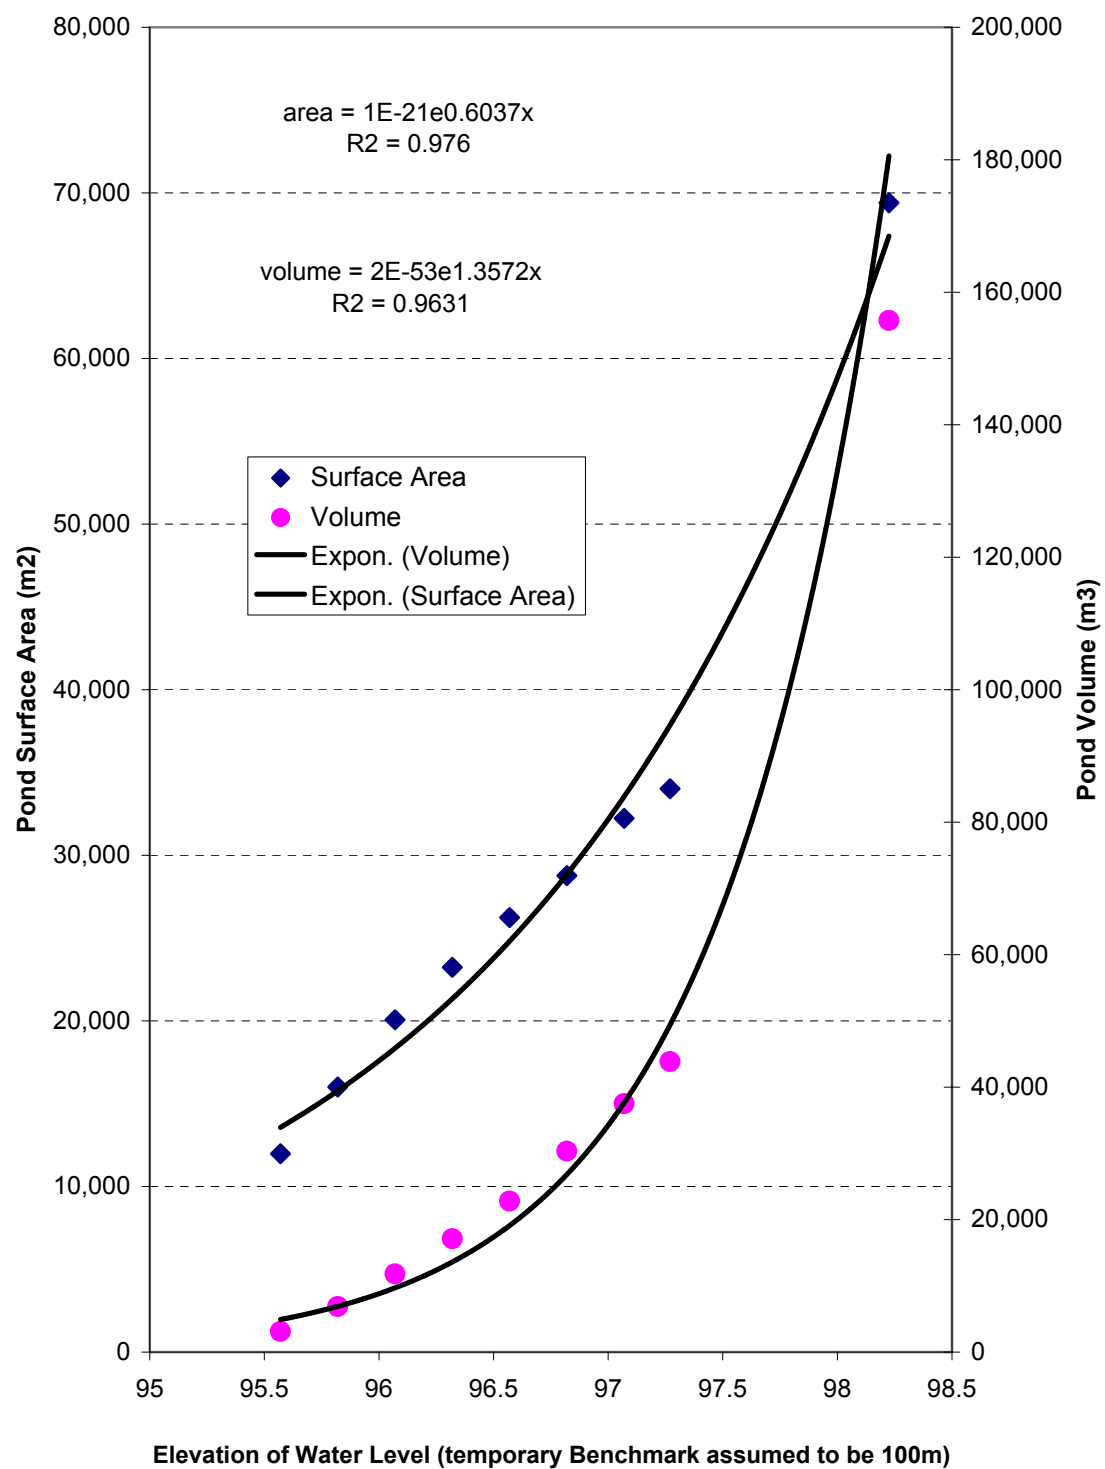
Figure 4. Pond Surface Area, Volume and Water Level Relationships

Pond bathymetry was reportedly surveyed by Laberge Environmental Services in 1999 for calculations of tailings volumes (EBA 2004). A recent bathymetric analysis of the tailings pond was completed by EDI (2005) (Figure 2). EDI provided a number of pond water levels and their corresponding pond water volume and surface areas (Table 3). Based on these data, pond lake water levels and pond volumes estimated as a function of pond elevation (Figure 4) were used in the water balance calculations.

Mathematical functions were developed which relate pond lake elevations to pond lake volumes and pond lake surface areas based on pond bathymetry data (Figure 4). To facilitate calculations, the temporary benchmark used by Yukon Government to measure pond levels was assumed to be at an elevation of 100 m as shown in Figure 4. Monthly time steps consistent with the time increment of available meteorological data (i.e. snowfall, evaporation) were selected for the model. The following sections provide details regarding the various components of the water balance model, including information about input data, calibration procedures and overall results.

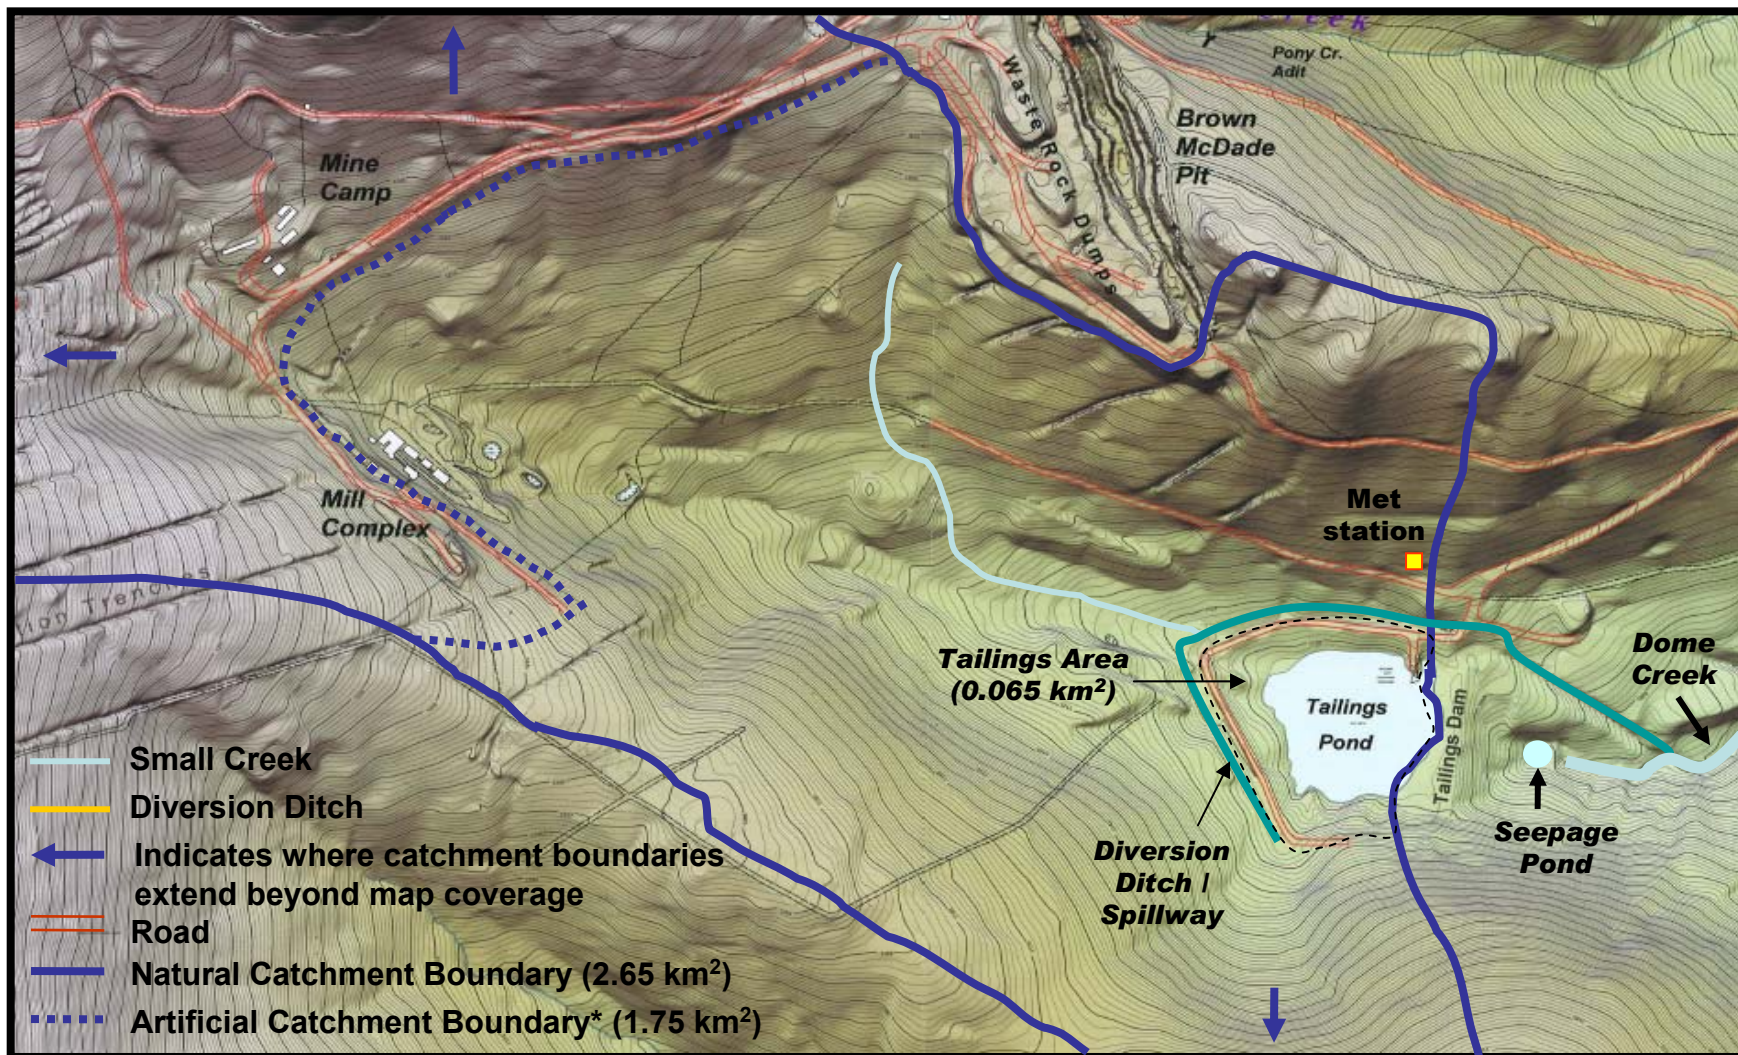
Figure 5. Tailings Pond Catchment Areas and Surficial Drainage (Mt. Nansen Mine, YT)

Figure 5 shows the assumed surficial drainage patterns in the Dome Creek catchment upstream of the pit. The catchment area assumed to contribute overland flow at least in part to the diversion ditch around the tailings impoundment is 1.69 km<sup>2</sup>. The efficiency of the diversion ditch in diverting surface runoff from this area is dependent on its integrity. This issue is addressed in previous sections. For the purposes of this water balance, the diversion ditch was assumed to leak a small percentage of surface water from the catchment, directly as overland flow to the pond.

\* The artificial catchment boundary is due to a diversion ditch that captures all runoff up-valley from entering the Tailings Pond.

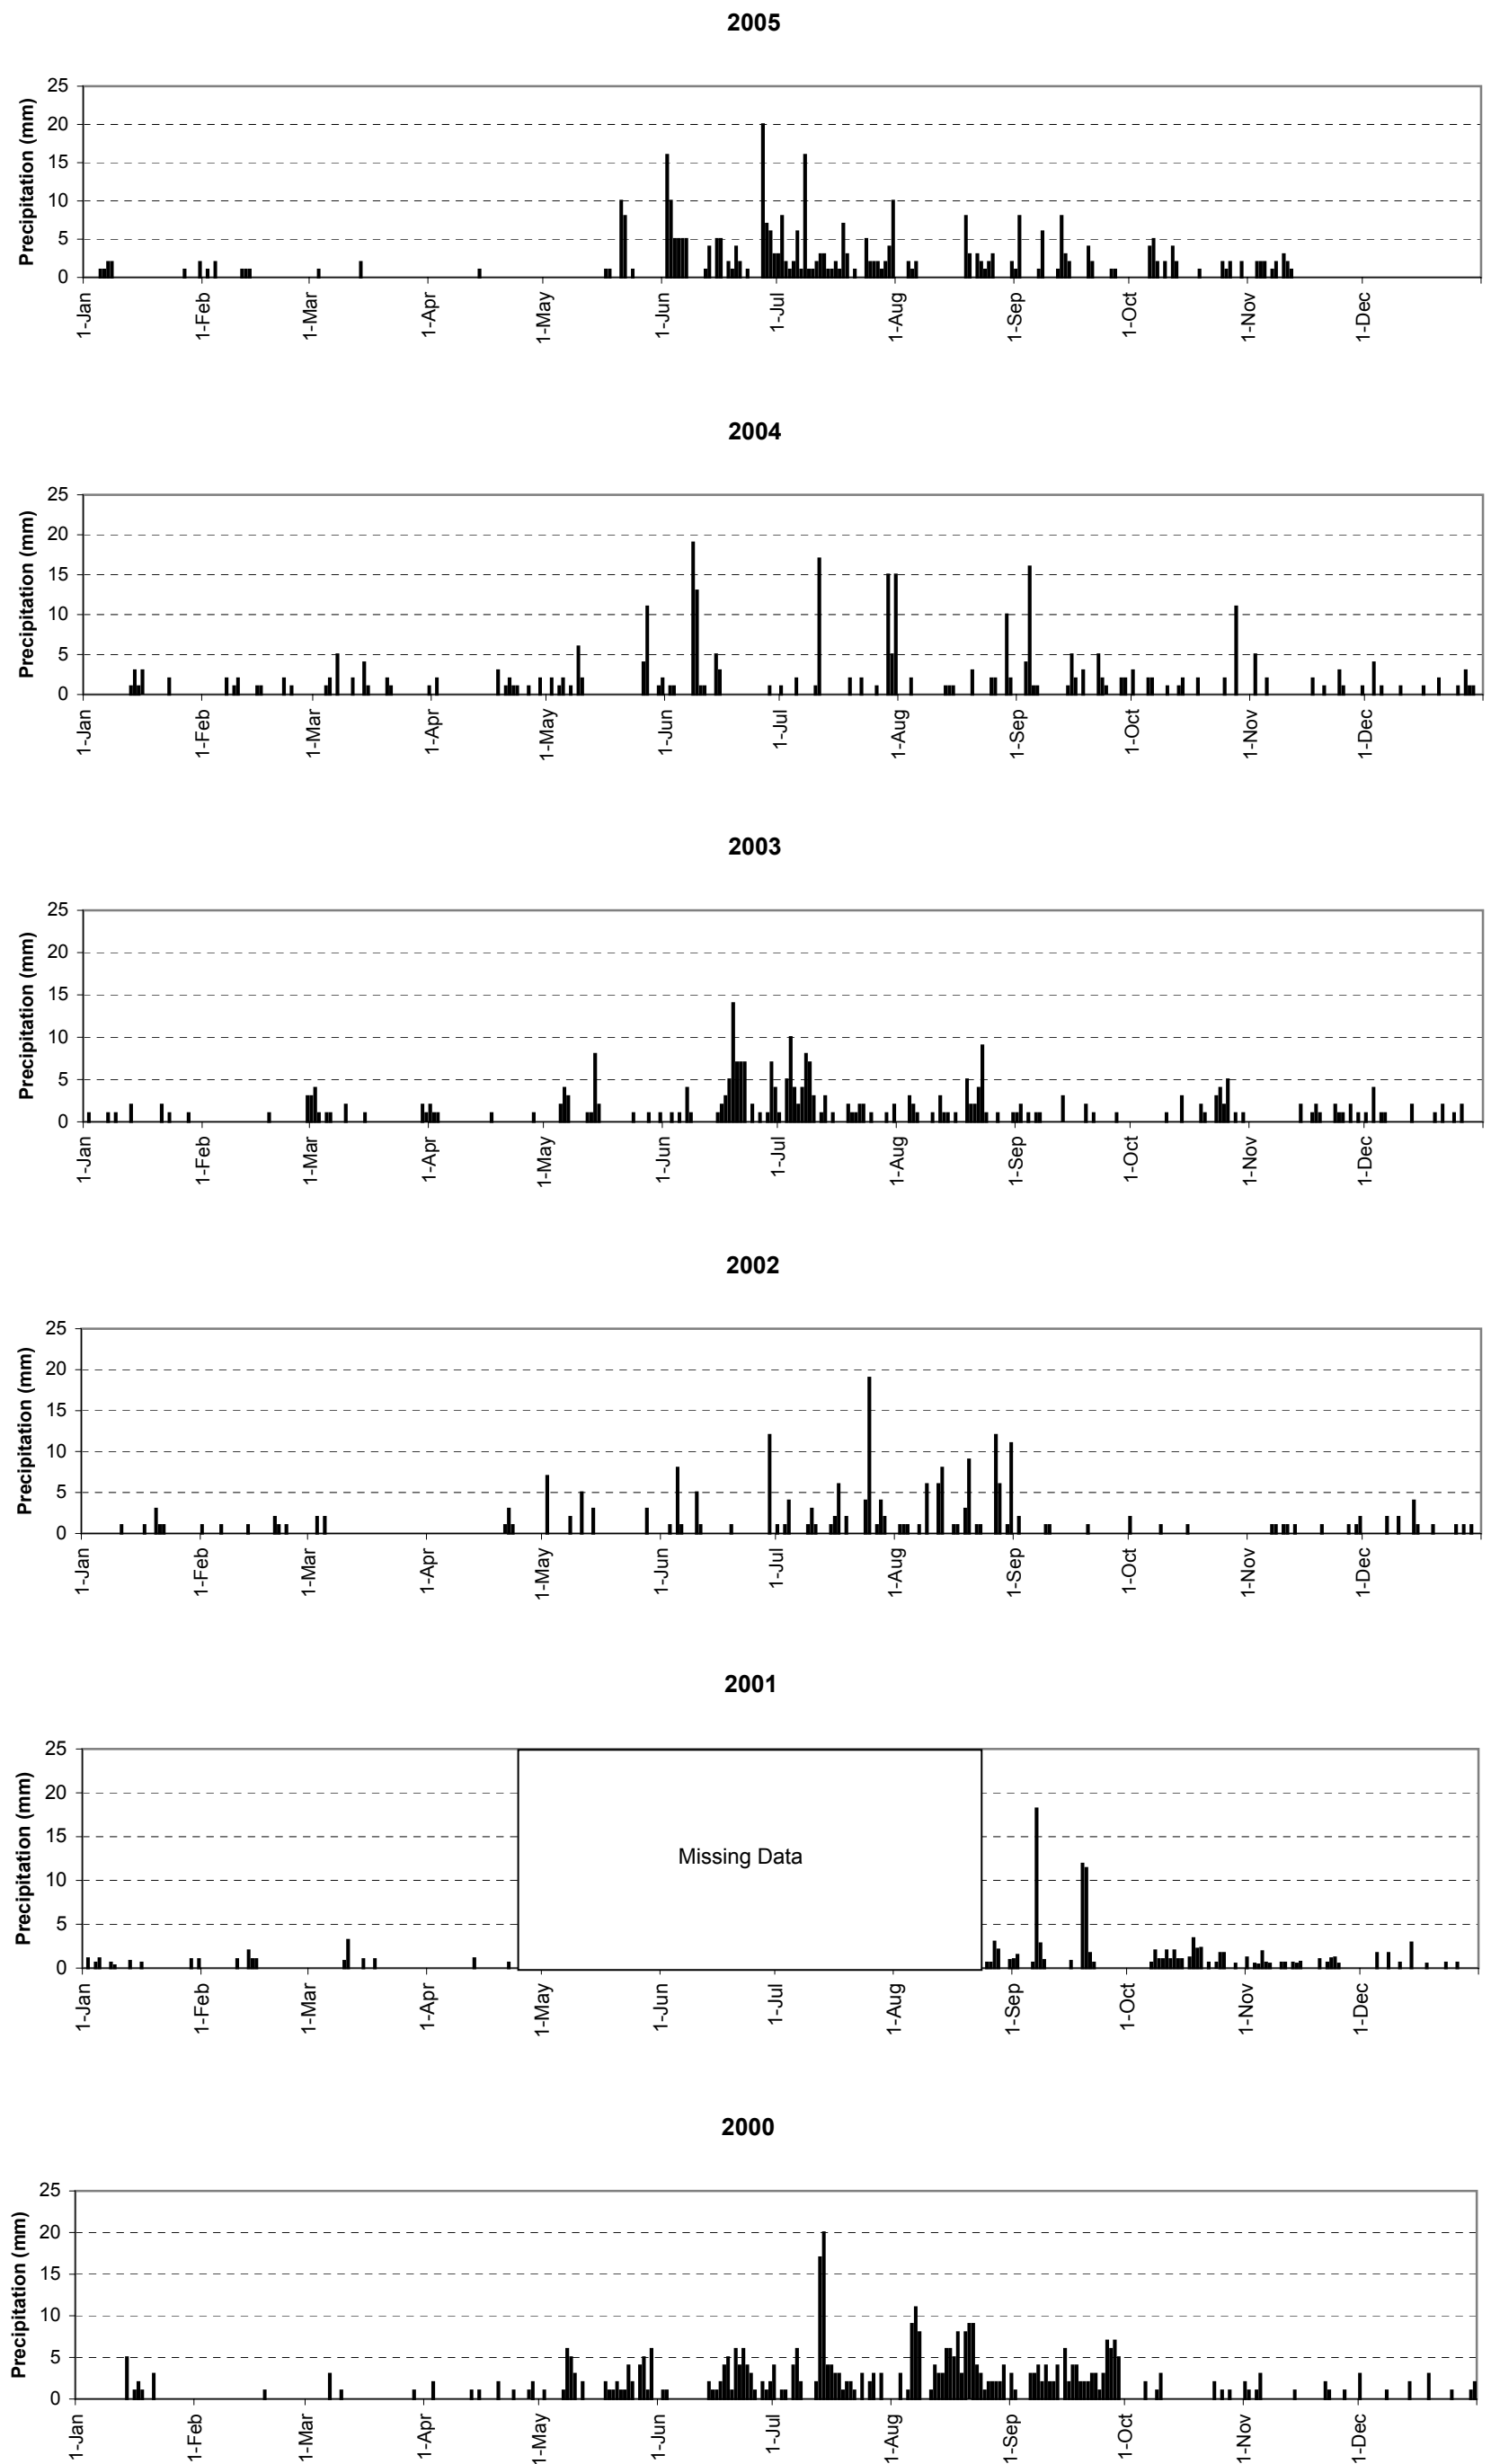
Figure 6. Daily Precipitation at Mt. Nansen Site (2000 - 2005)

Monthly rainfall data for 2000 to 2005 recorded at the site are summarized in Table 4. These site specific 2005 data were used to calibrate the water balance model to the water levels measured in the pond over the corresponding time periods. Daily precipitation values are shown on Figure 6.

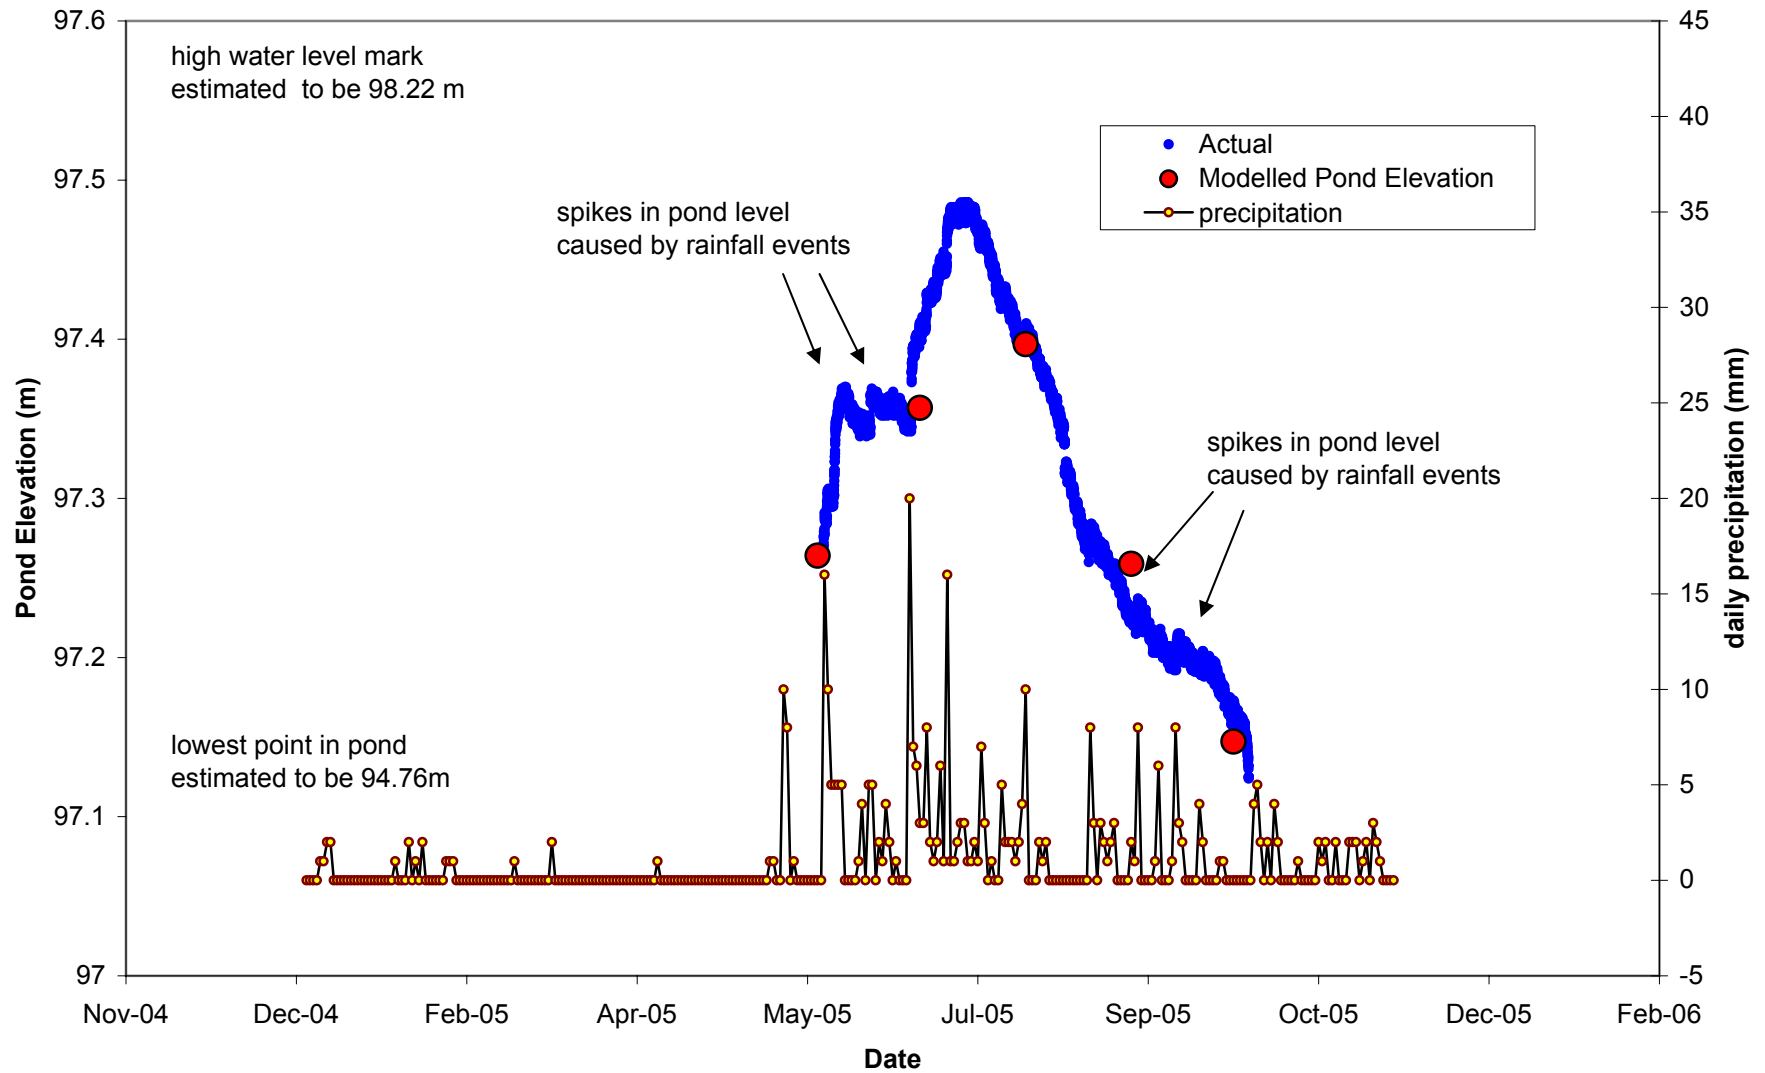
**Figure 7. Calibrated Water Balance Results, Observed Water Levels and Daily Precipitation (2005)**

The tailings pond water balance was calibrated to the available pond water level-elevation data available for June to October 2005 (Figure 7). In combination with the pond volume / pond surface area relationship, and up-valley catchment areas, actual meteorological data collected from the Mount Nansen Mine Site meteorological station was used to calibrate the water balance model. This approach allowed a sensitivity analysis for various water balance components.

Short term rainfall events (often lasting only a few hours or days) caused corresponding responses in the pond level (Figure 7). The monthly time step used water balance did not capture these daily variations and did not capture the maximum level recorded in 2005. In order to capture these changes, a weekly or

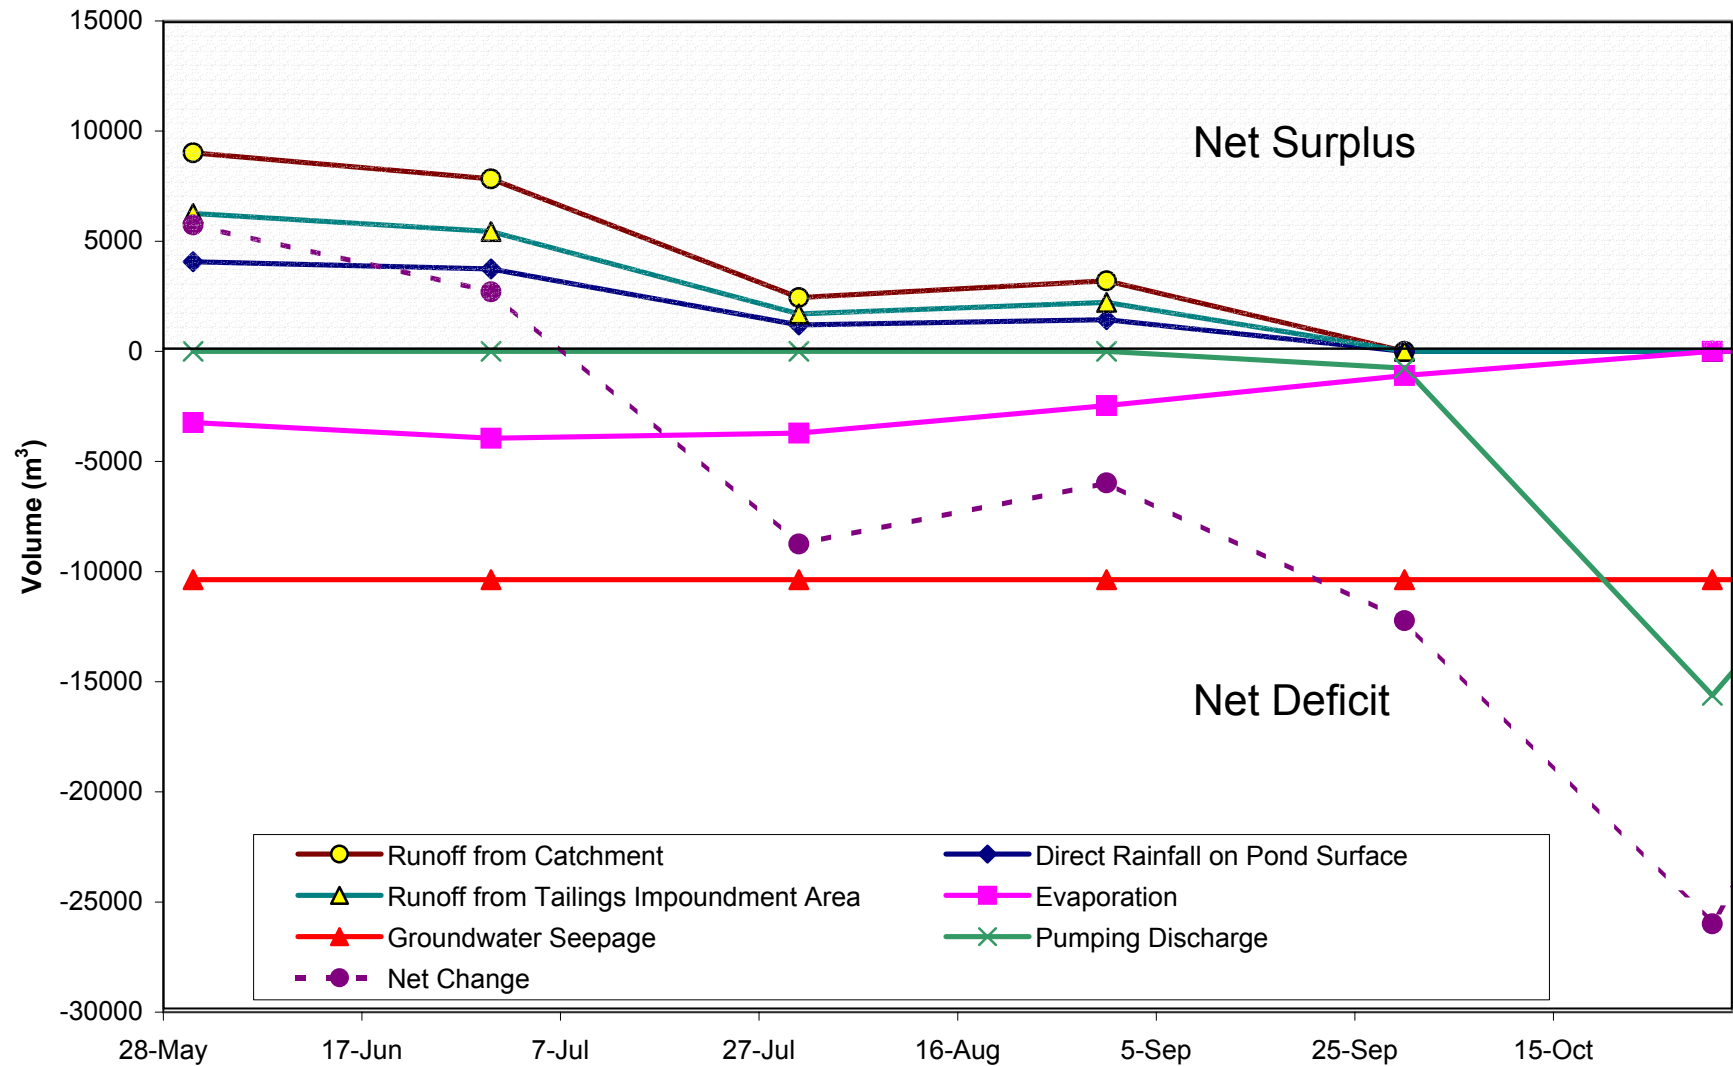
**Figure 8. 2005 Water Balance Components, Mt. Nansen Mine, YT**

The relative contribution of individual components to the overall water balance are shown on Figure 8. The calibrated model suggests that groundwater seepage out of the pond is an important component of the overall tailings pond water balance. Tailings impoundments typically have zones with varying degrees of saturation, porosities and grain size distribution as a result of the deposition process. Beaches of fines and slimes have likely formed against the upper face of the dam. These finer grained materials affect the distribution of hydraulic heads and groundwater velocities within the tailings.

For the water balance, values of groundwater seepage out of the pond between 2 and 6 L/s were most suitable to reproduce the observed water level fluctuations. These rates are within the similar range of observed seepage re-circulate rates.
