# 2005 Water Balance for the Mount Nansen Mine Tailings Pond, Yukon

Prepared for  
**Yukon Government, Abandoned Mines Project Office**

Submitted by  
**Gartner Lee Limited**

February 2006

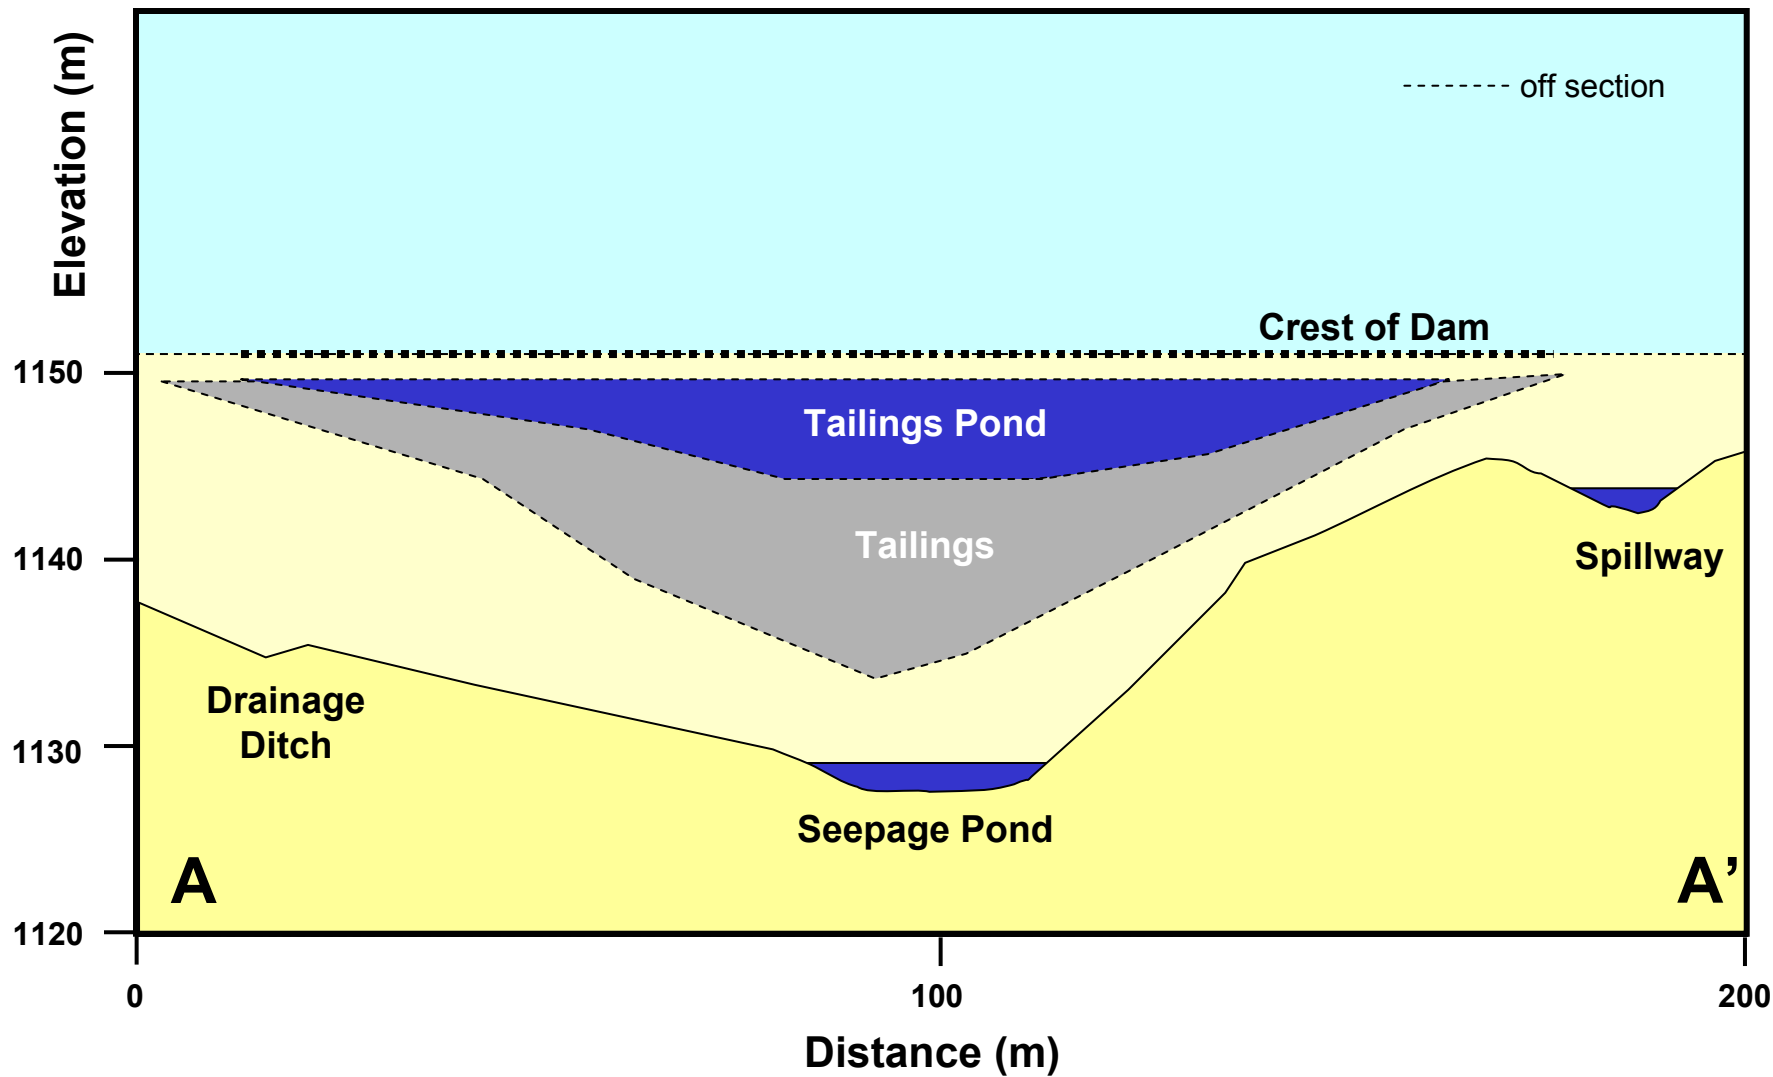
Figure 9. Schematic Interpretation of Longitudinal Section A – A' Profile of Tailings Pond Area.

Figure 9 and Figure 10 show how the tailings pond is located approximately 20 m higher than the seepage pond. The cross sections also show how the diversion ditch/spillway is approximately 10 m above the level of the seepage pond as it flows past it. Figure 9 also shows that sources other than direct tailings pond seepage may contribute to the seepage pond. Tailings pond water that infiltrates to groundwater may also flow past without discharging to the seepage pond. As pond levels decrease, although the seepage rates in the seepage pond might not change significantly, the relative contribution of each component (i.e. regional groundwater, groundwater from the sides of the valley, water from the spillway, tailings pond seepage) may change.

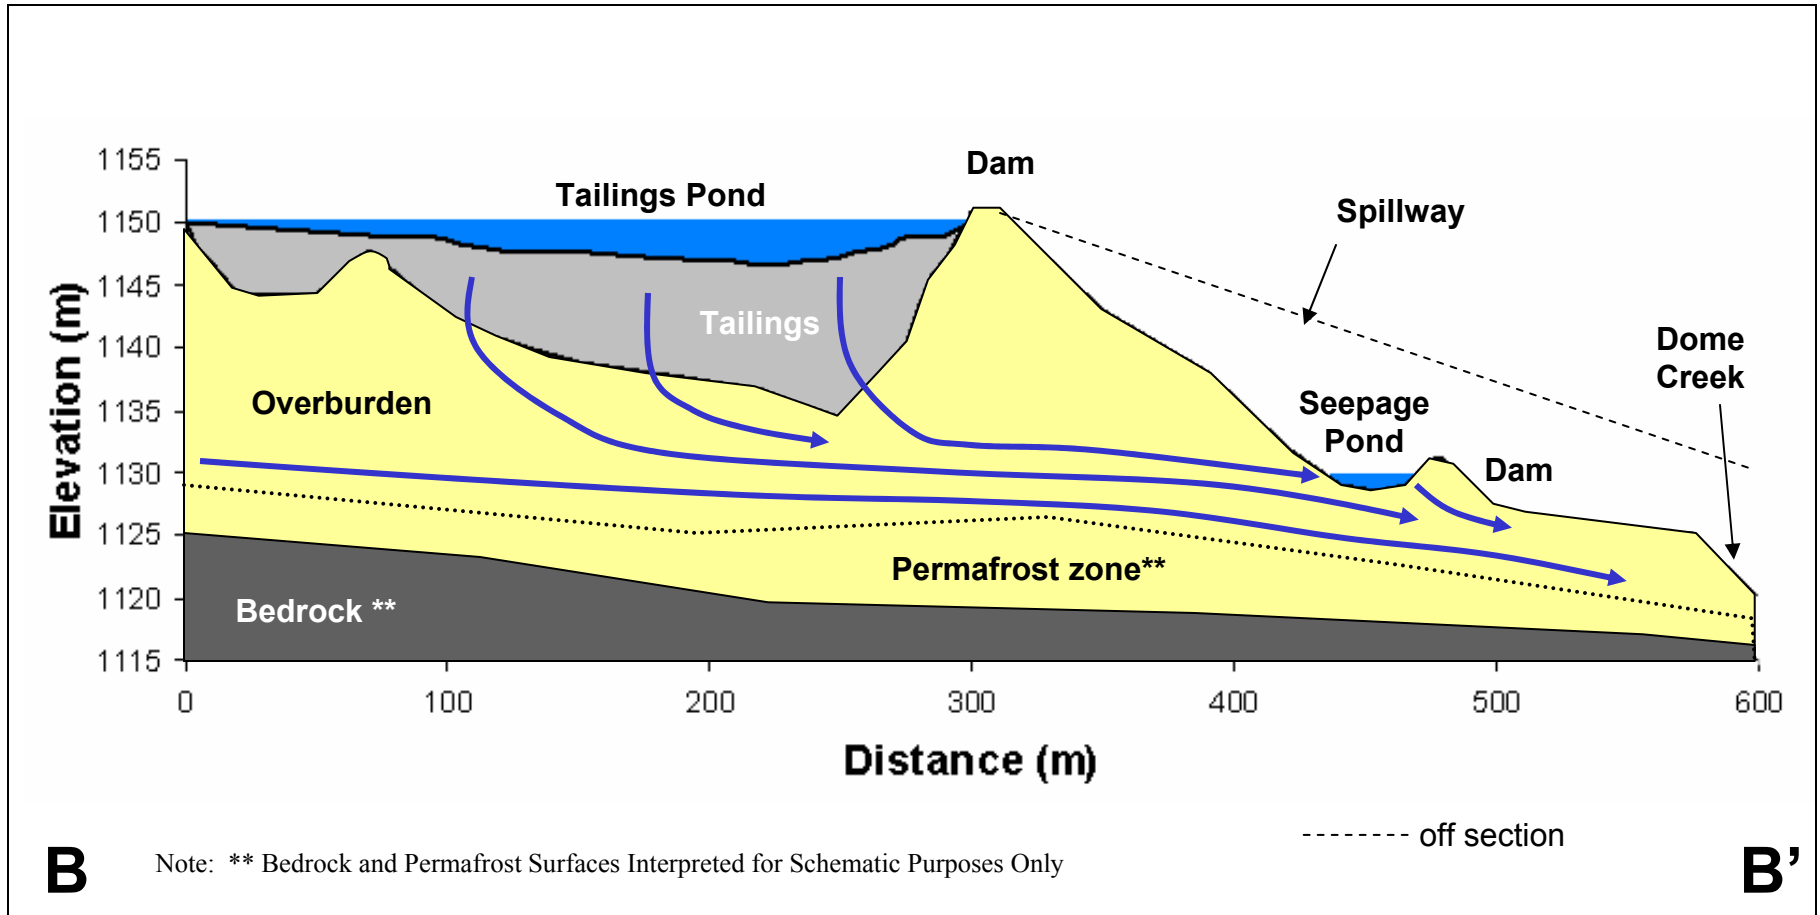
Figure 10. Schematic Interpretation of Longitudinal Section B – B' Showing Elevation of Tailings Pond and Tailings Relative to Seepage Pond. (note vertical exaggeration) and Interpreted Groundwater Flow

- The spillway is approximately 10 m higher than the seepage pond as it passes cross-gradient. Consequently, there is a possibility that leakage from the spillway/diversion ditch contribute to seepage captured by the seepage pond.

- The amount of flow in the diversion ditch both upstream and downstream of the tailings pond should be measured to help quantify the amount of leakage that may be occurring from the ditch to the groundwater system or from the ditch, directly to the tailings impoundment as surface flow.

- Conduct a visual inspection of the diversion ditch to determine its integrity and whether leakage is occurring either to groundwater or to the surface of the tailings impoundment.
