**INDIAN AND NORTHERN AFFAIRS CANADA
ABANDONED CLINTON CREEK
ASBESTOS MINE
*CONDITION ASSESSMENT REPORT***

APRIL, 2000

PREPARED BY
UMA ENGINEERING LTD.
ENGINEERS AND PLANNERS
1479 BUFFALO PLACE
WINNIPEG, MANITOBA
R3T 1L7

**Reference: Abandoned Clinton Creek Asbestos Mine
Condition Assessment Report**

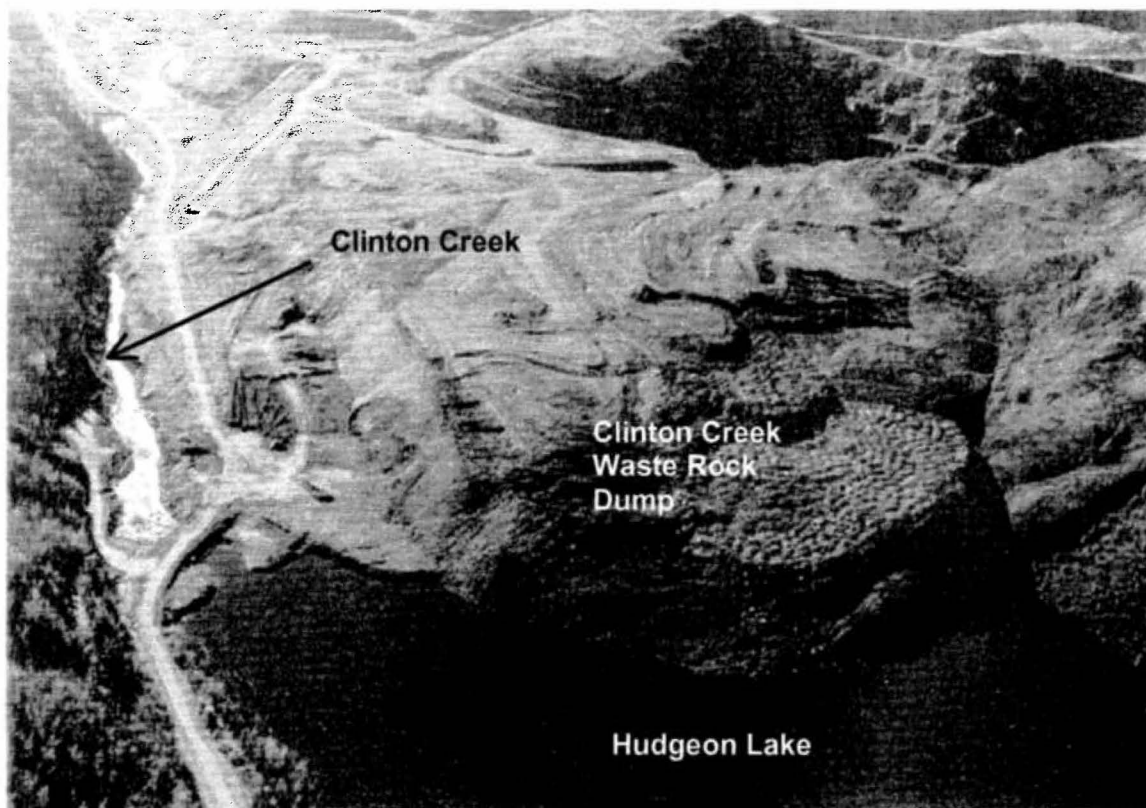
The waste rock from the Porcupine Pit placed along the south slope of the Clinton Creek valley is referred to as the Clinton Creek Waste Rock Dump (Drawing 03). The waste rock dump consists of overburden and argillite waste rock consisting of sand, gravel and cobble sizes containing occasional boulder size material. Significant lateral spreading of the rock fill, in particular at the west end of the dump towards Hudgeon Lake, has occurred as a consequence of instabilities associated with the placement of waste rock during the mining operation. Active movement of the waste rock dump has continued since the mine closure as seen in Photo 1(1986).

Photo 1
Clinton Creek Waste Rock Dump

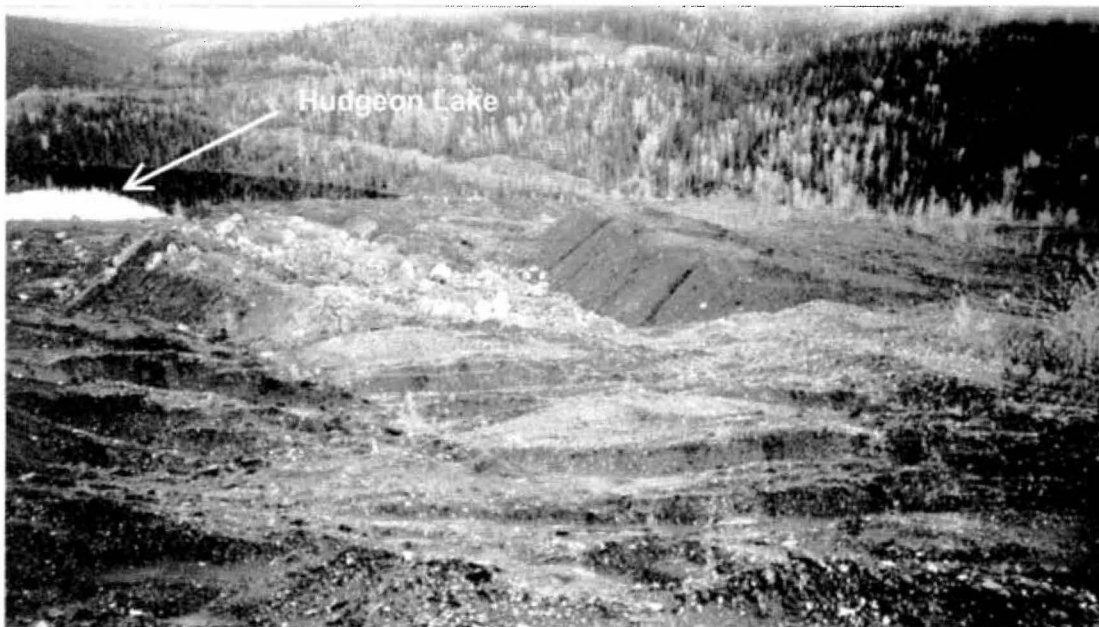
The surface of the waste rock dump is hummocky with a series of benches, slump blocks and tension cracks resulting from the on-going displacements (Photo UMA 9-9 and 9-4). Ground vegetation in the areas of the waste rock dump is extremely scarce and plant diversity very low. Ground vegetation species at the waste rock site was similar to that found at the tailings site. Nevertheless, the re-establishment of trees and vegetation in general has been much greater at the waste rock site than on the tailings lobes.

Photo UMA 9-9
Slumping of Waste Rock Dump (1998)

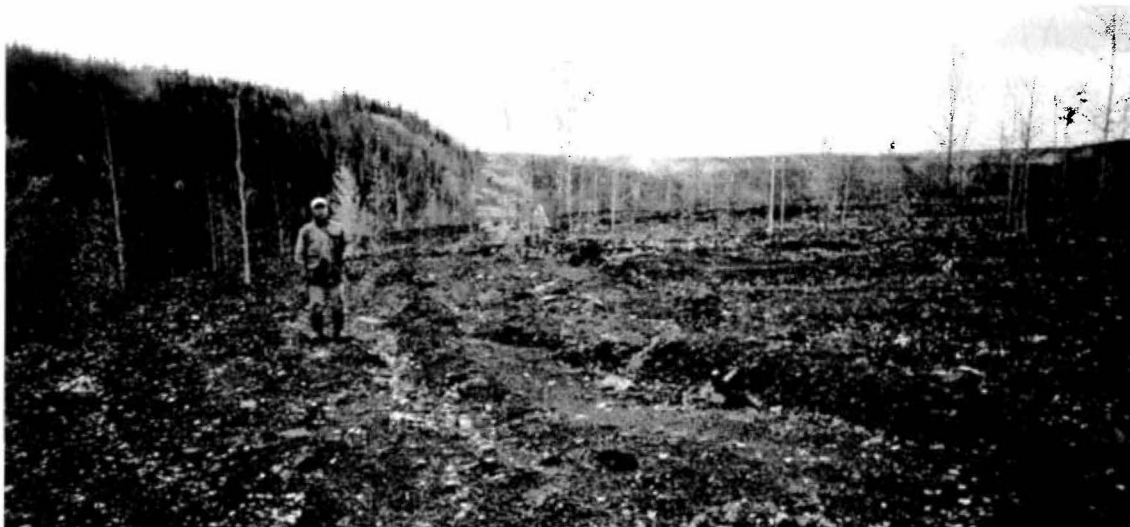
Photo UMA 9-4
Tension Cracks West End of Waste Rock Dump (1998)

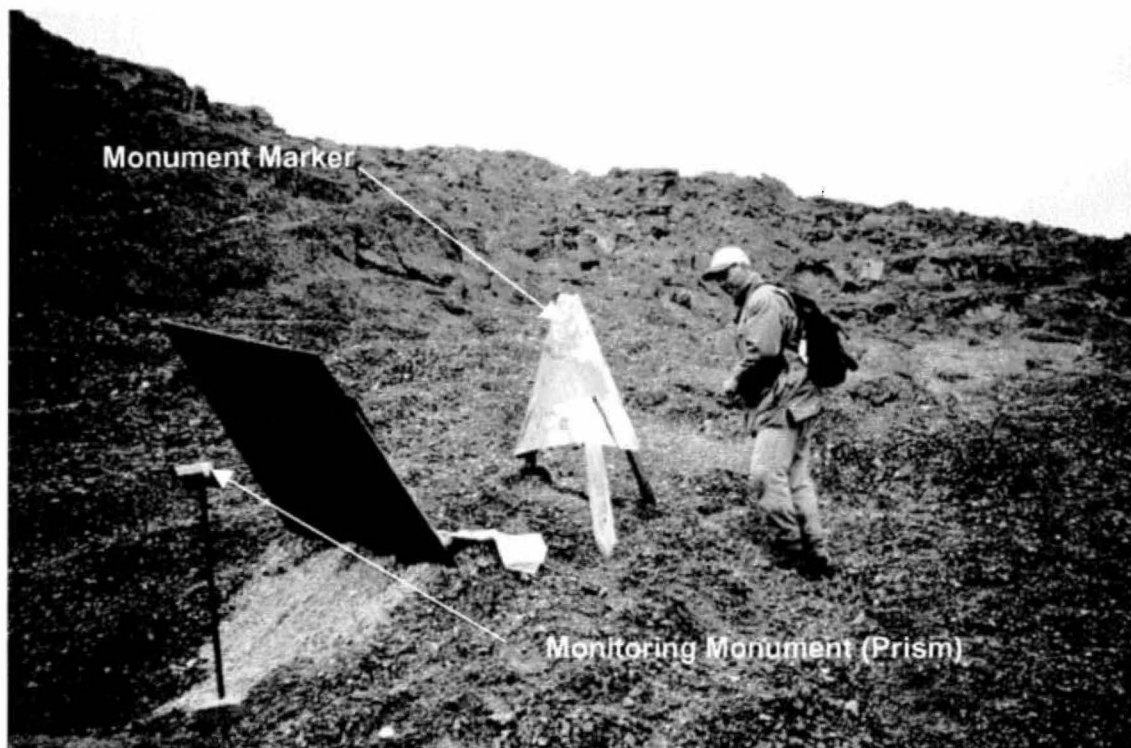
Photo UMA 5-12
Typical Ground Movement Monitoring Monument (1998)

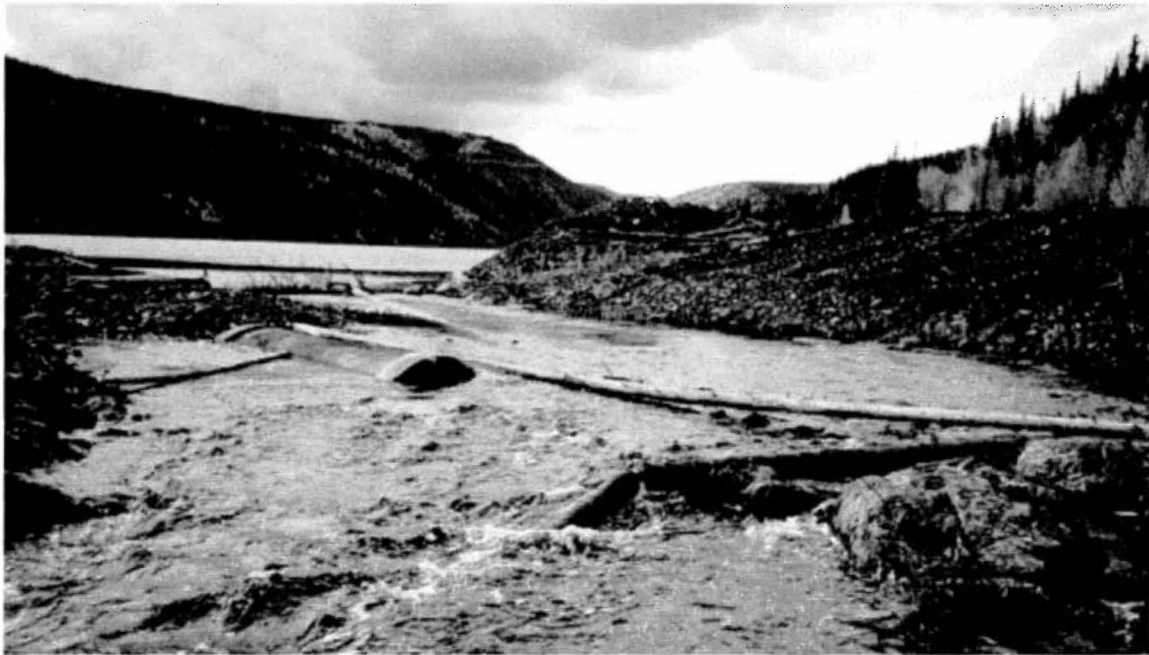
Photo UMA 8-9

The road crossing at the lake outlet has been washed out and only two of the original four-1.8m diameter corrugated metal pipe (CMP) culverts remain, one of which (north) was only partially intact. Outflow from Hudgeon Lake passes through the culverts and between the north culvert and the north bank (Photo UMA 8-9). The inlet of the south culvert is not visible and is blocked by debris, limiting flow. Water depths in the open

Hudgeon Lake Outlet and Access Road Culverts (1998)

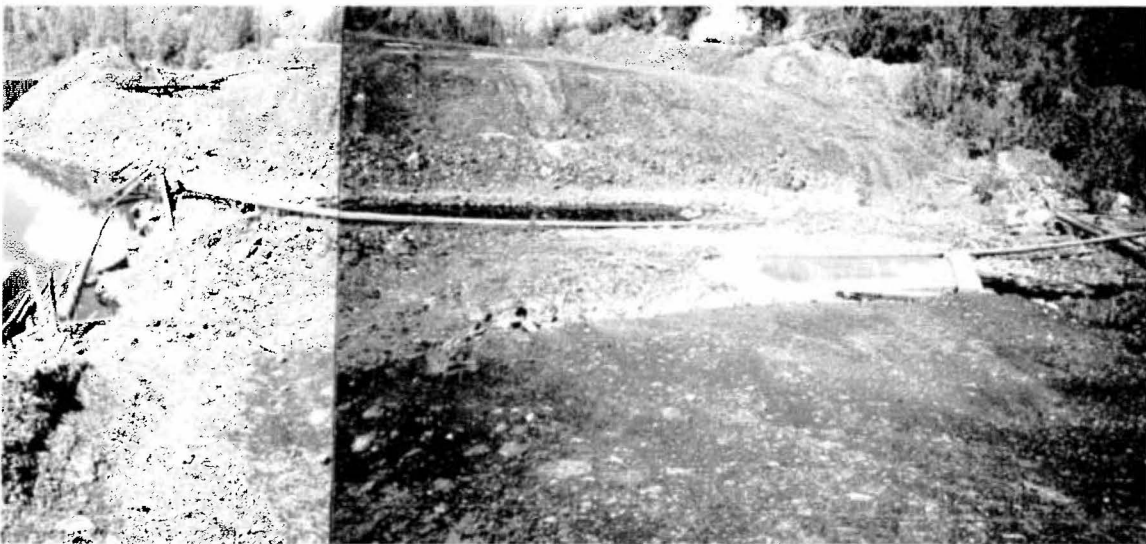
Photo UMA 15-0/1

channel were estimated at 0.5 metres in September 1998 and 0.1 metres in July 1999 (Photo UMA 15-0/1). The north culvert is badly out of round. A CMP section visible in the channel through the waste rock dump a considerable distance downstream is believed to be a missing section of this culvert.

Hudgeon Lake Outlet and Access Road Culverts (1999)

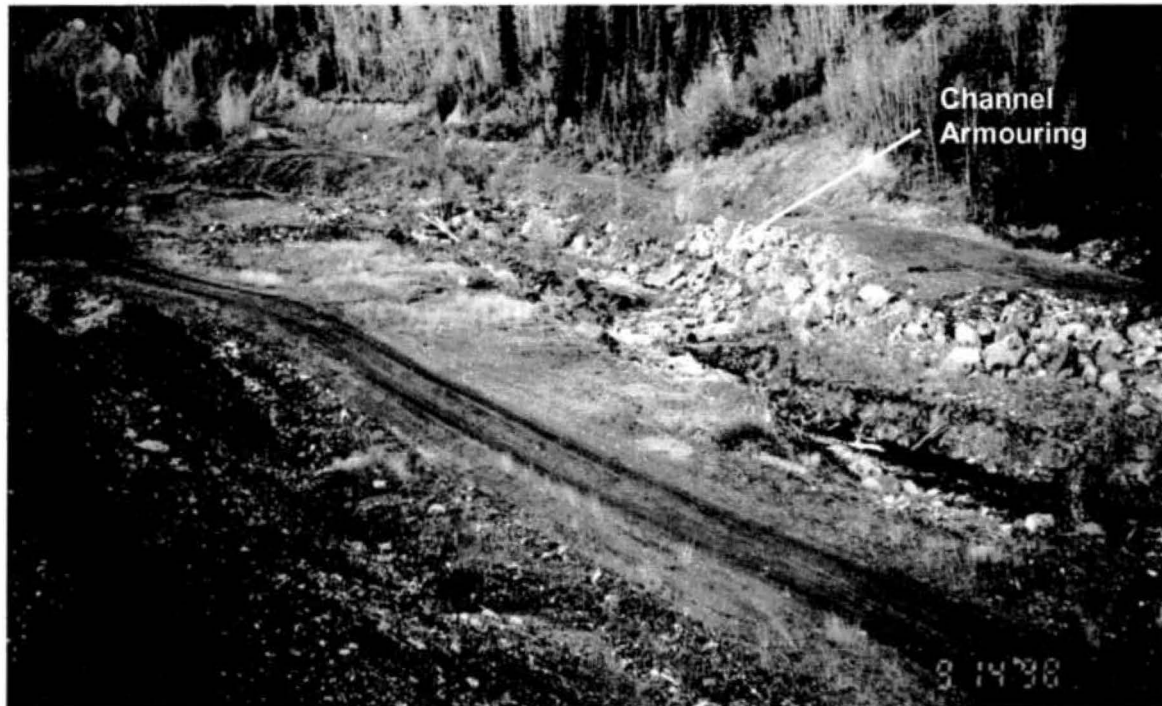
Photo RRU-1

Previous erosion control works (rip rap armouring) constructed in 1979 were almost completely destroyed in the spring of 1997 (Photo RRU-1).

Clinton Creek Channel Immediately Downstream of Outlet (1998)

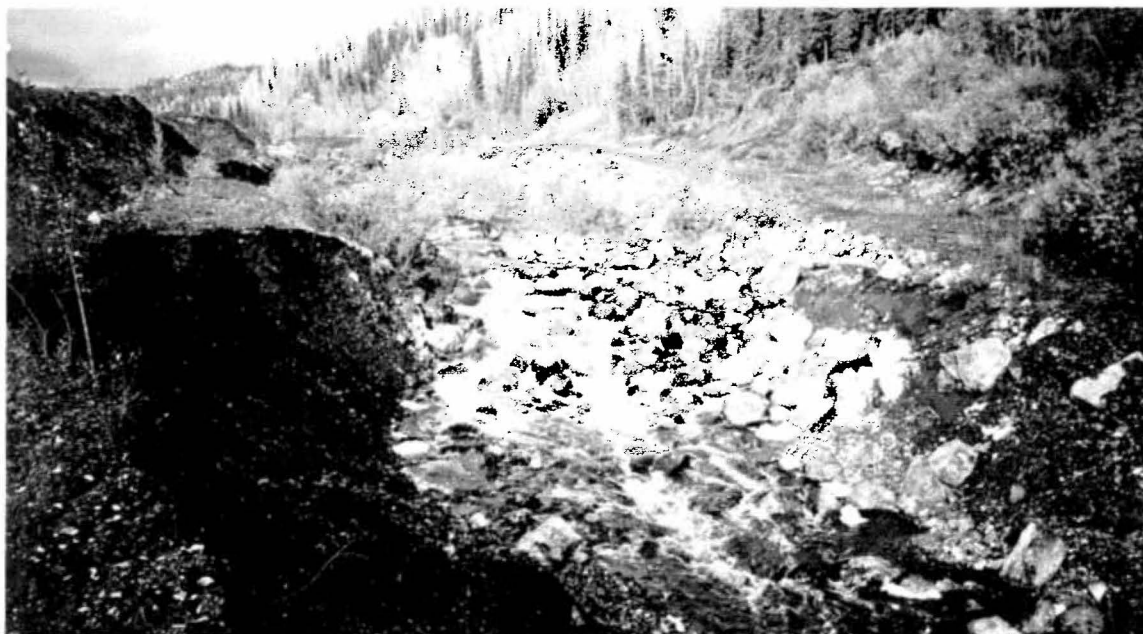
Photo UMA 7-24

Since 1986, down-cutting near the Hudgeon Lake outlet has occurred (Photo UMA 7-24). Up to 2 to 3 metres of incising has occurred immediately downstream of the outlet where the channel bed is bounded to the south by waste rock and to the north by natural colluvial soils overlying bedrock on the valley slope. Two springs discharge from the waste rock just downstream of the lake outlet. Water from both springs is clear with no evidence of fines. Brown slime was growing over the rocks at the downstream spring and the water had a noticeable hydrogen sulphide odour.

Channel Down-cutting Immediately Downstream of Hudgeon Lake Outlet

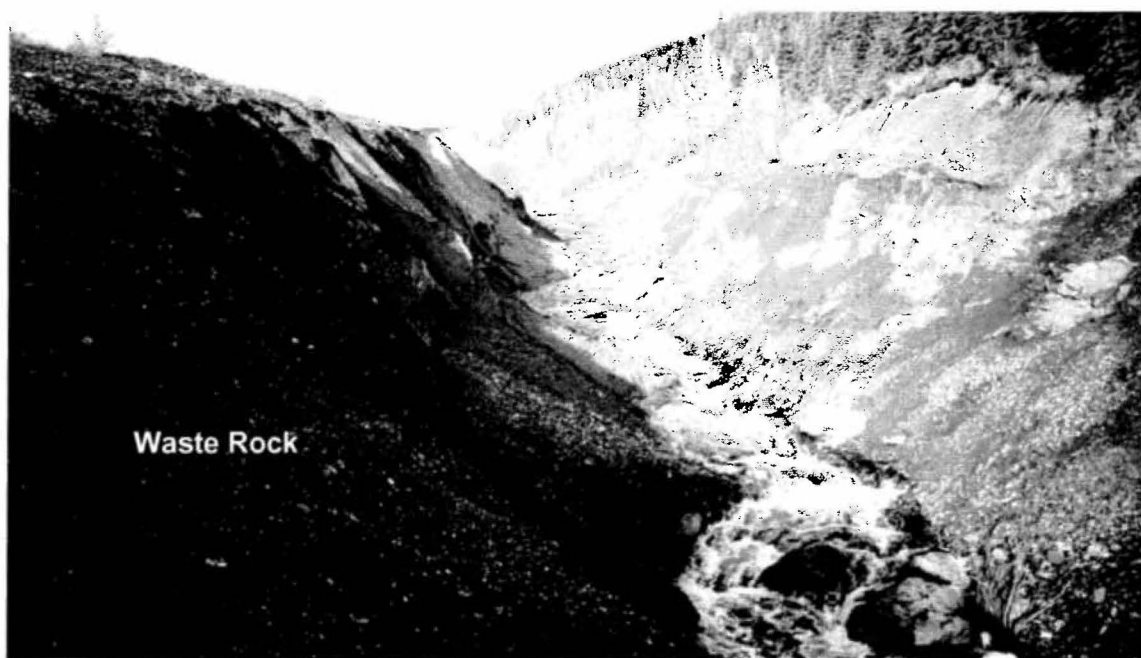
Photo UMA 7-17

Channel widening and incising is evident throughout the waste rock dump where both waste rock and valley material is being actively eroded (Photo UMA 7-17).

Channel Erosion (1998)

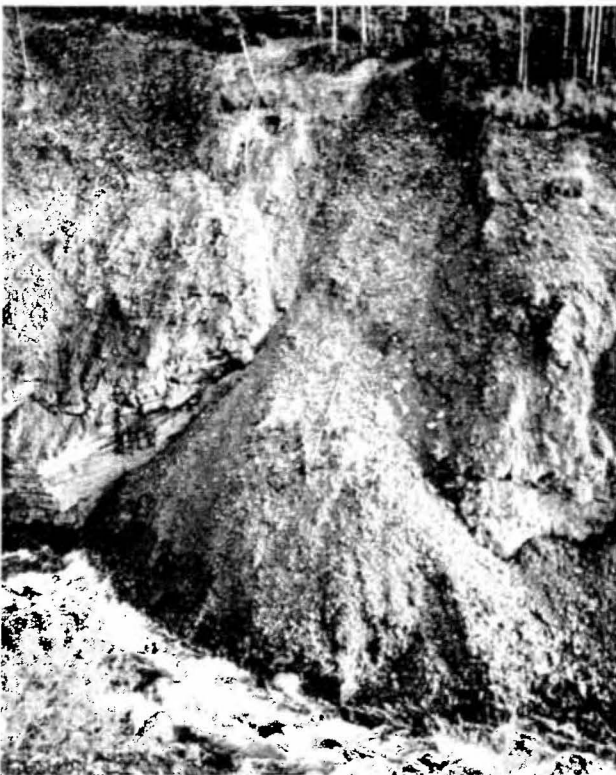
Numerous slumps and localized slope failures are occurring on both the waste rock and valley slopes (Photo UMA 7-6) as a result of channel erosion and incising. These localized instabilities have lead to meandering of the stream bed which has impacted the integrity of the access road along the waste rock dump. Tension cracks are visible along the north shoulder of the access road (Photo UMA 7-14) and narrowing of one section of the access road has occurred as a result of a slope failure into the channel (Photos UMA 14-18/19 and UMA 2-8).

Photo UMA 7-6
Slumping of Valley Slope(1998)

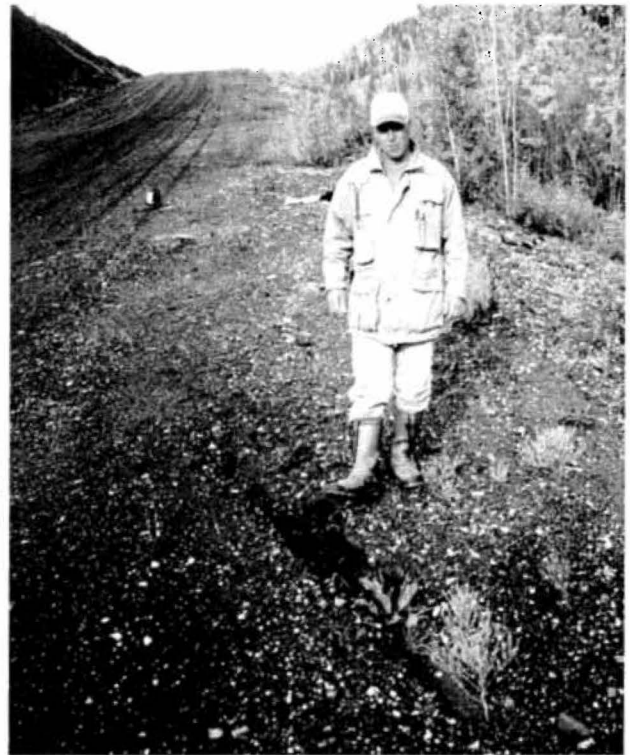
Photo UMA 7-14
*Tension Cracks in Waste Rock
Along Access Road (1998)*

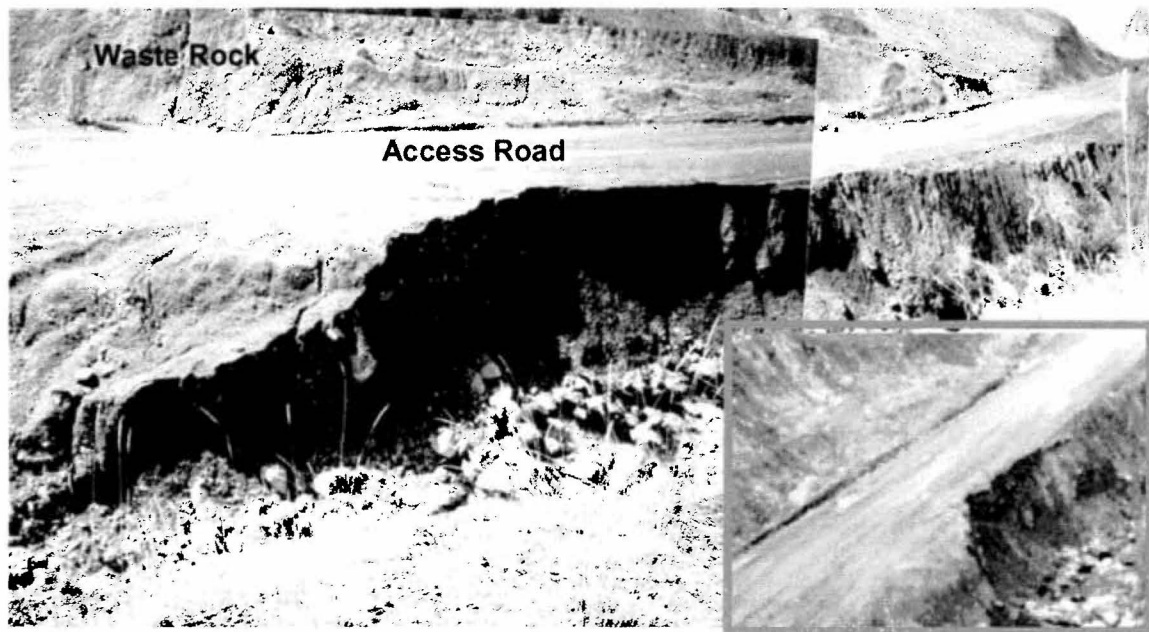
Photos UMA 14-18/19 and UMA 2-8 (Insert)
Slope Failure Along Access Road (1998 & 1999)

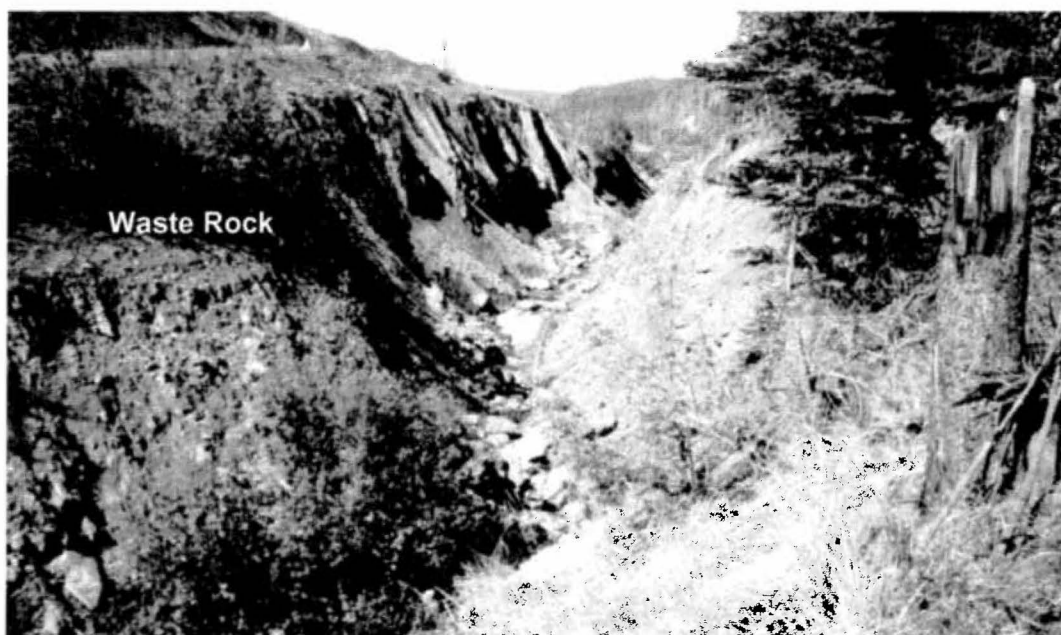
Downstream portions of the creek channel through the waste rock slope have been cut into the weathered argillite bedrock on the valley slope (Photo UMA 14-15). At these locations, the bedrock consists of a weathered weaker bedrock unit overlying a stronger more competent bedrock unit with horizontal to slightly dipping bedding planes.

Photo UMA 14-15
View Upstream Along Creek Channel (1998)

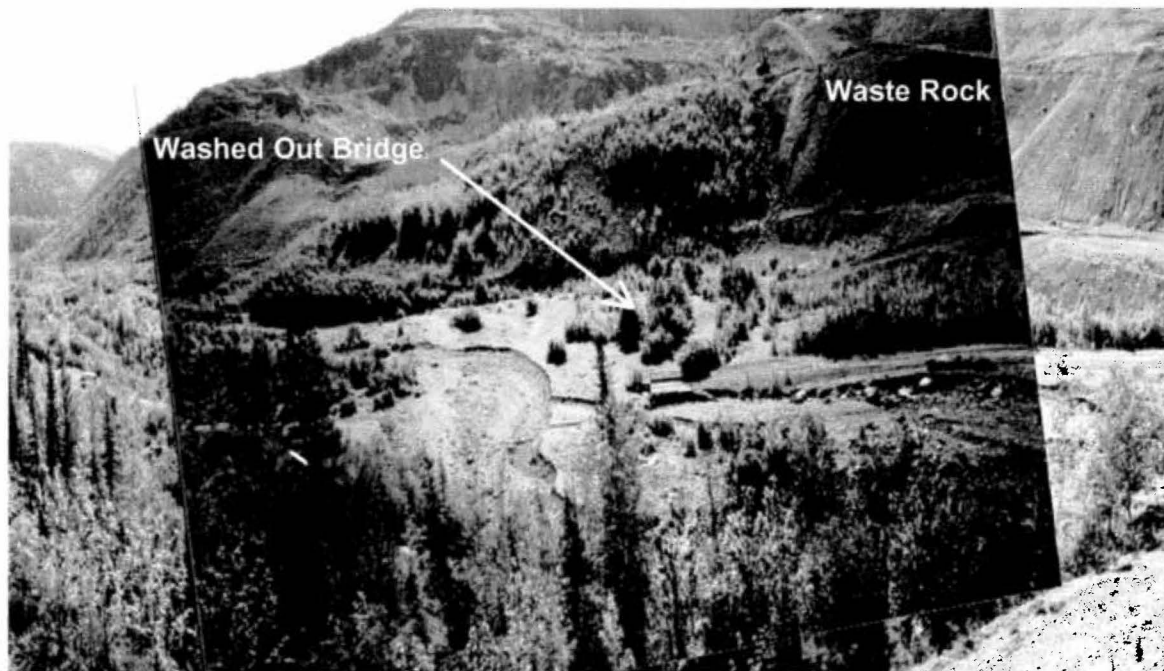
The timber access road bridge at the downstream toe of the waste rock dump was washed out in the spring of 1997 (Drawing 03). The creek valley in the area of the bridge was infilled with out-wash material where a new creek channel was incised (Photo UMA 14-20/21/22). The out-wash (flow debris) material consists of gravel and cobbles up to 200 millimetres in diameter. Several channel remnants and evidence of significantly wider historic channel flow are visible. High water marks on trees immediately downstream of the waste rock dump are about 0.6 metres above the ground surface, or about 1.5 to 2 metres higher than the existing creek channel. At locations as far as 200 metres downstream of the bridge, trees and brush have trapped debris.

Photo UMA 14-20/21/22
Clinton Creek Channel at Washed Out Bridge Location (1998)

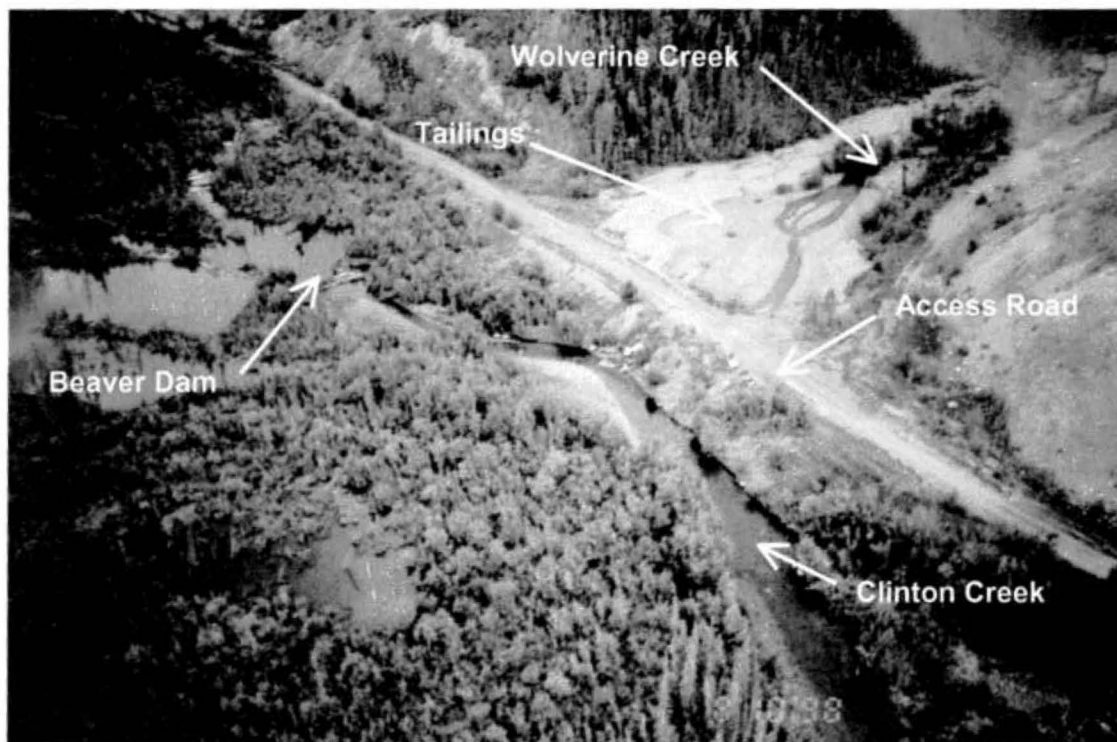
**Photo UMA 2-6**

The confluence of Clinton Creek and Wolverine Creek is approximately 500 metres downstream of the washed out bridge. Under normal flow conditions, Wolverine Creek drops approximately two metres into Clinton Creek through a 1600 millimetre diameter steel plate (19 millimetre thick) culvert under the access road. As seen in Photo UMA 2-6, a significant amount of tailings out-wash material has been deposited within the Wolverine Creek channel just upstream of the culverts. Beaver dams several hundred metres downstream of the bridge have flooded a large area near the junction of Wolverine and Clinton Creek.

Confluence of Wolverine Creek and Clinton Creek (1998)

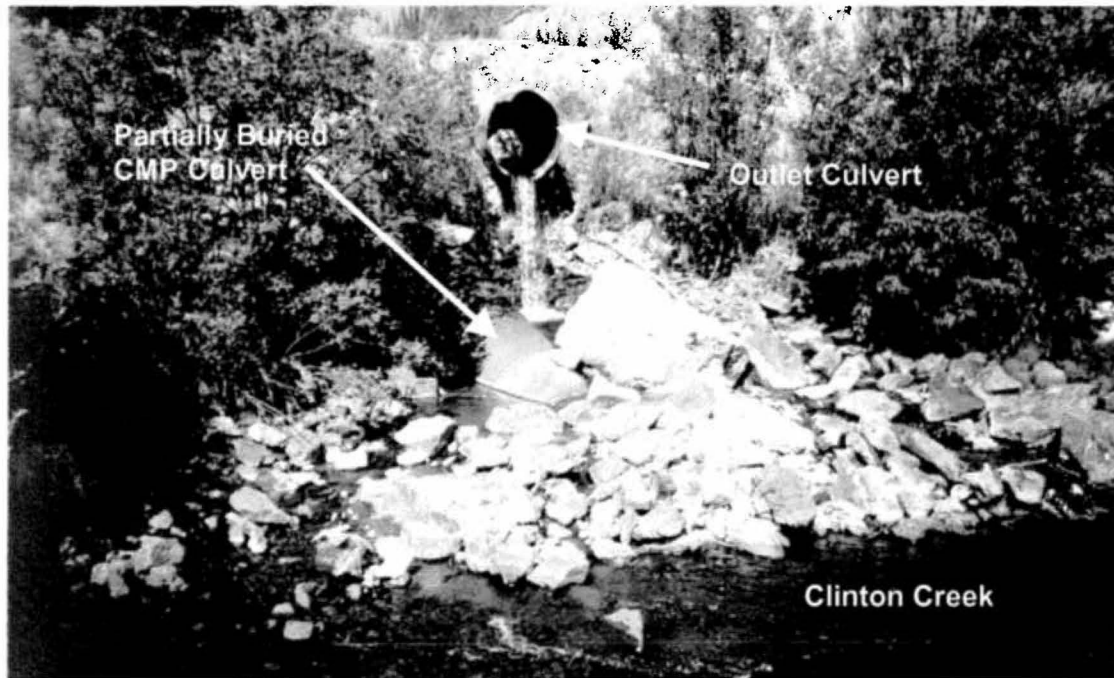
The access road culvert is in good condition. The outlet of a second culvert (corrugated metal pipe) located at a lower elevation was submerged in the Clinton Creek stream bed (Photo UMA 15-10 and 15-8). The invert of a third 1200 millimetre diameter culvert, located immediately south of the Wolverine Creek outlet culvert, is set about 1 metre higher.

Photo UMA 15-10
Wolverine Outlet Culvert at Clinton Creek (1999)

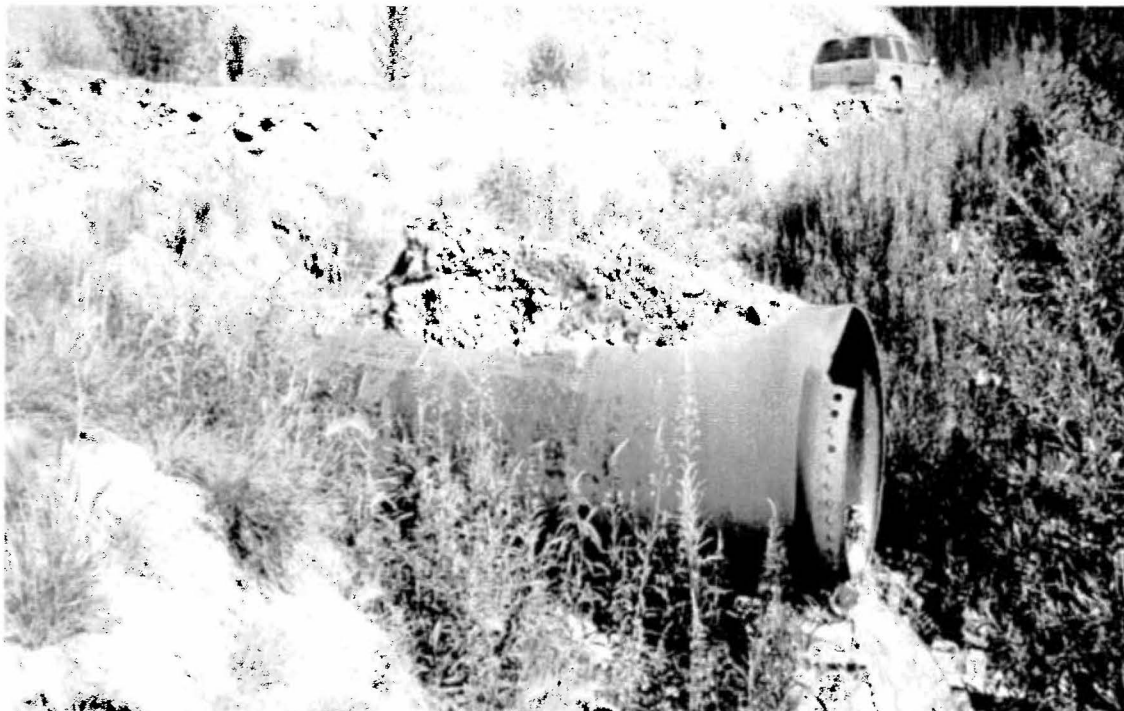
Photo UMA 15-8
Wolverine Creek Outlet Culvert (1999)

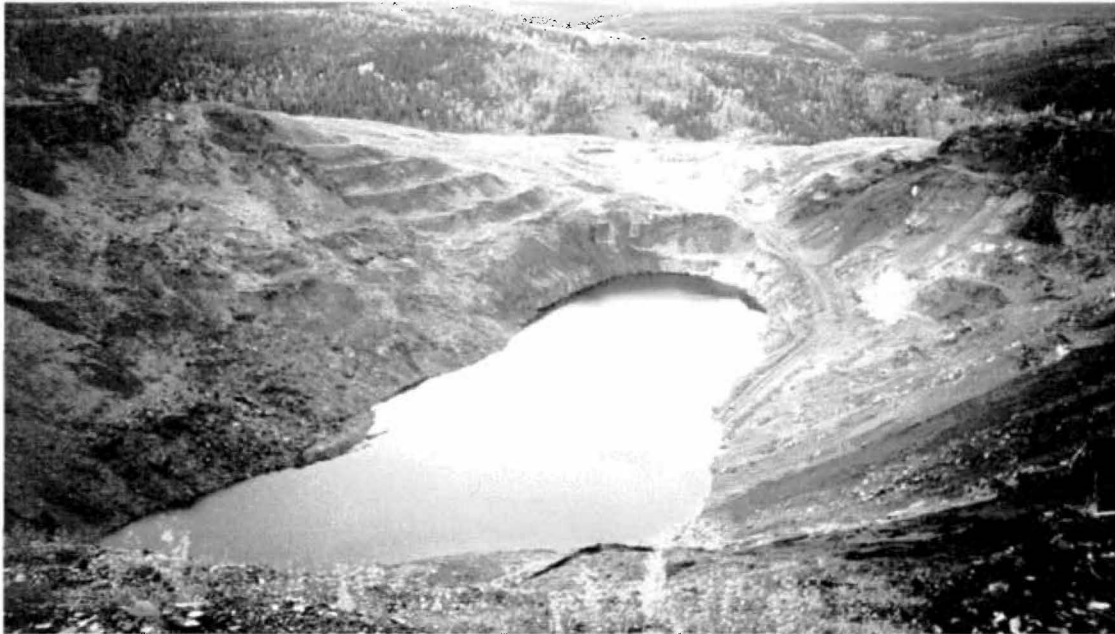
Porcupine pit walls are a maximum height of about 200 metres inclined at approximately 45 to 50 degrees (Photo UMA 11-1). Water is currently ponded in the bottom of the pit at approximately elevation 385 metres. Instabilities of the pit walls are evident, in particular along the north and west sides. The instabilities range from ravelling and small wedge failures along the remnants of the pit benches to deep seated movements along the west side where back scarps and tension cracks well back from the edge of the pit wall are visible. Sloughing of the pit walls is clearly evident and debris could be heard falling into the water during the reconnaissance in the area.

**Photo UMA 11-1***View East at Porcupine Pit (1998)*

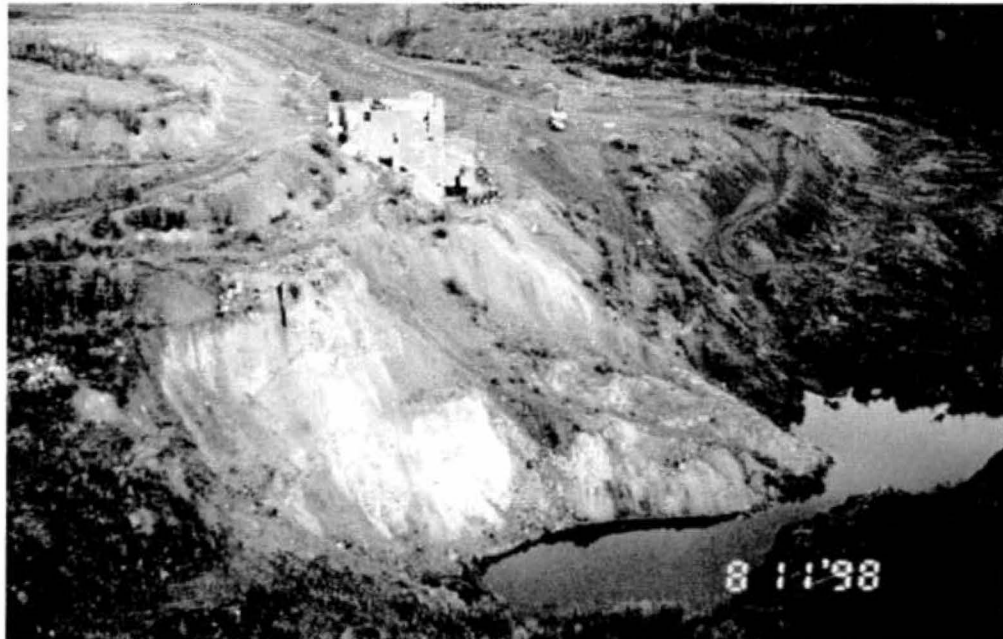
The former Crusher Building is situated near the crest between Porcupine Pit and Creek Pit, across the valley from the mill site (Drawing 04, Photo RRU-3 and Photo RRU-4). Large sections of the metal roofing and metal siding are missing and there is scattered debris in the general area. Remnants of what may have been the hydro sub-station are located at the base of the Creek Pit Road.

**Photo RRU-3***Crusher Building (1998)*

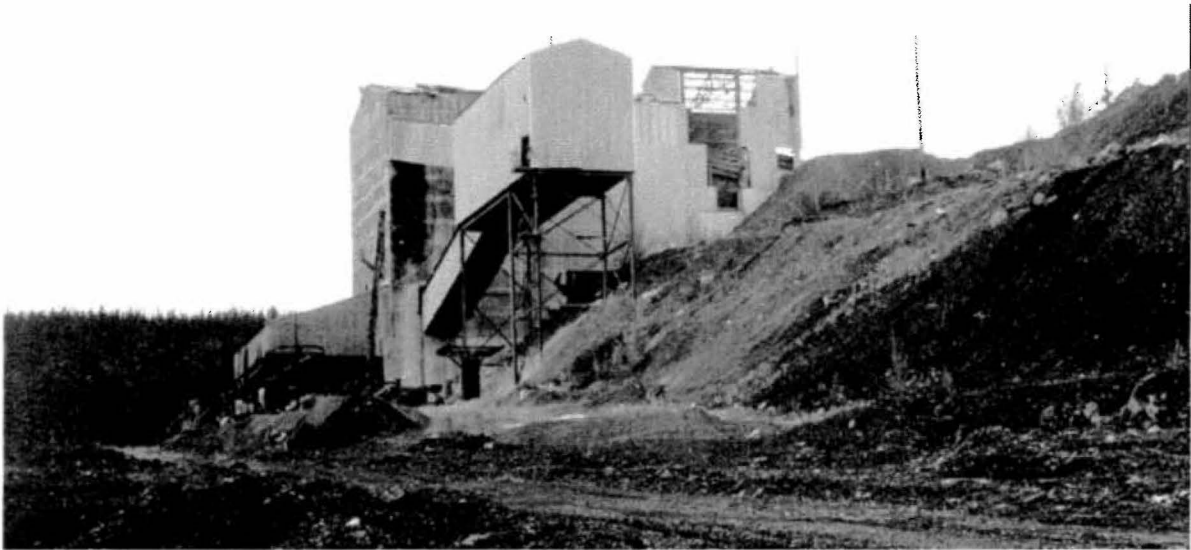
Photo RRU-4
Crusher Building (1998)

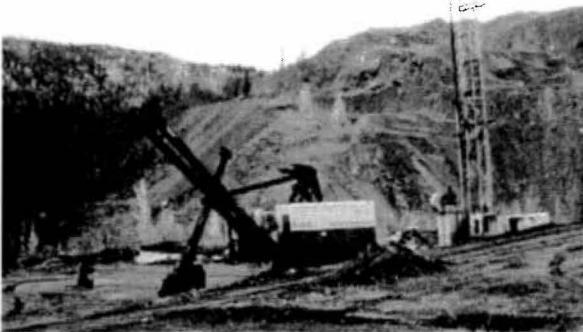
Abandoned equipment, including a drag line excavator and a drill rig, are located down slope, north of the Crusher Building (Photo RRU-5 and Photo RRU-6).

Photo RRU-5
Abandoned Equipment (1998)

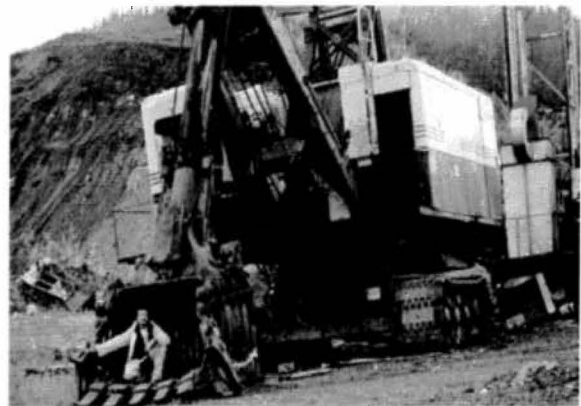
Photo RRU-6
Excavator (1998)

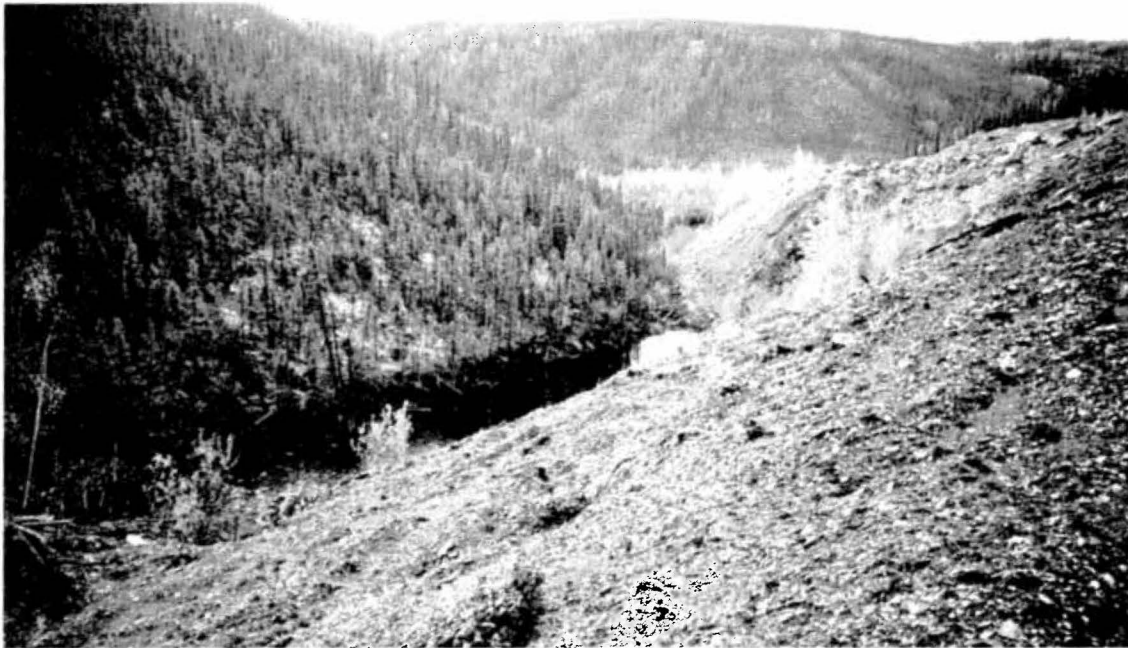
Photo UMA 10-2

Waste rock material placed on the north east side of Porcupine Pit has resulted in blockages of natural drainage along Porcupine Creek (Drawing 04 and Photo UMA 10-2) and the formation of a small unnamed reservoir. The two northeasterly blockages are relatively stable with no signs of active movement. The southwestern section of the

Porcupine Creek Northern Waste Rock Blockage (1998)

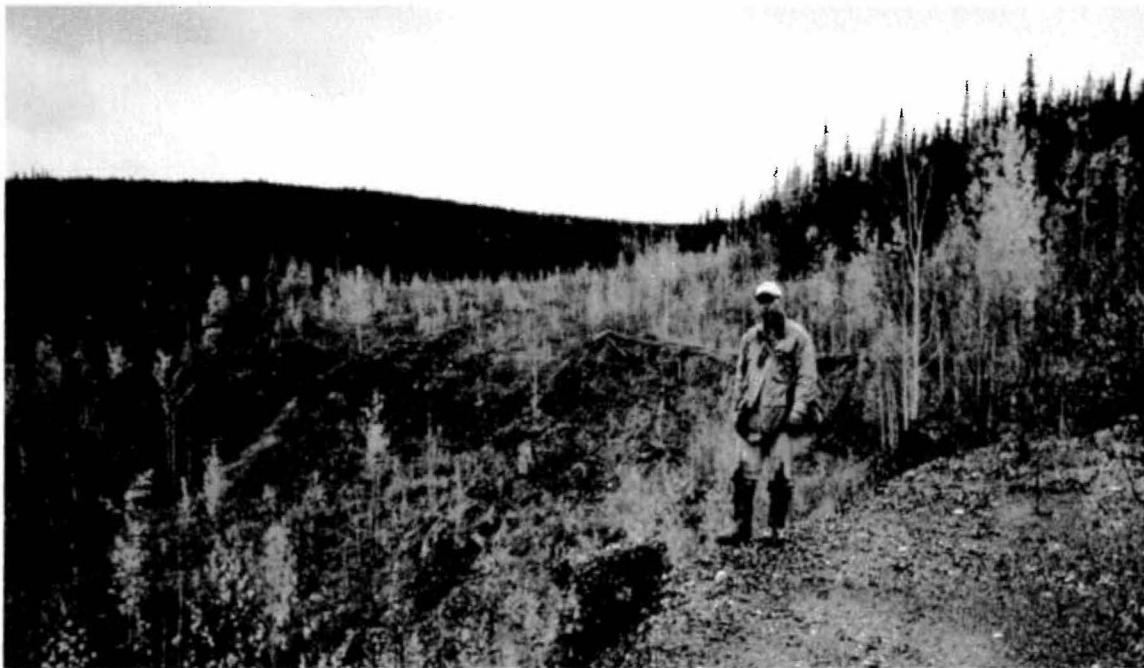
Photo UMA 11-0

waste rock dump has undergone extensive movement, however, resulting in numerous tension cracks and back scarps as shown in Photo UMA 11-0.

Porcupine Creek Waste Rock Failure Backscarp (1998)

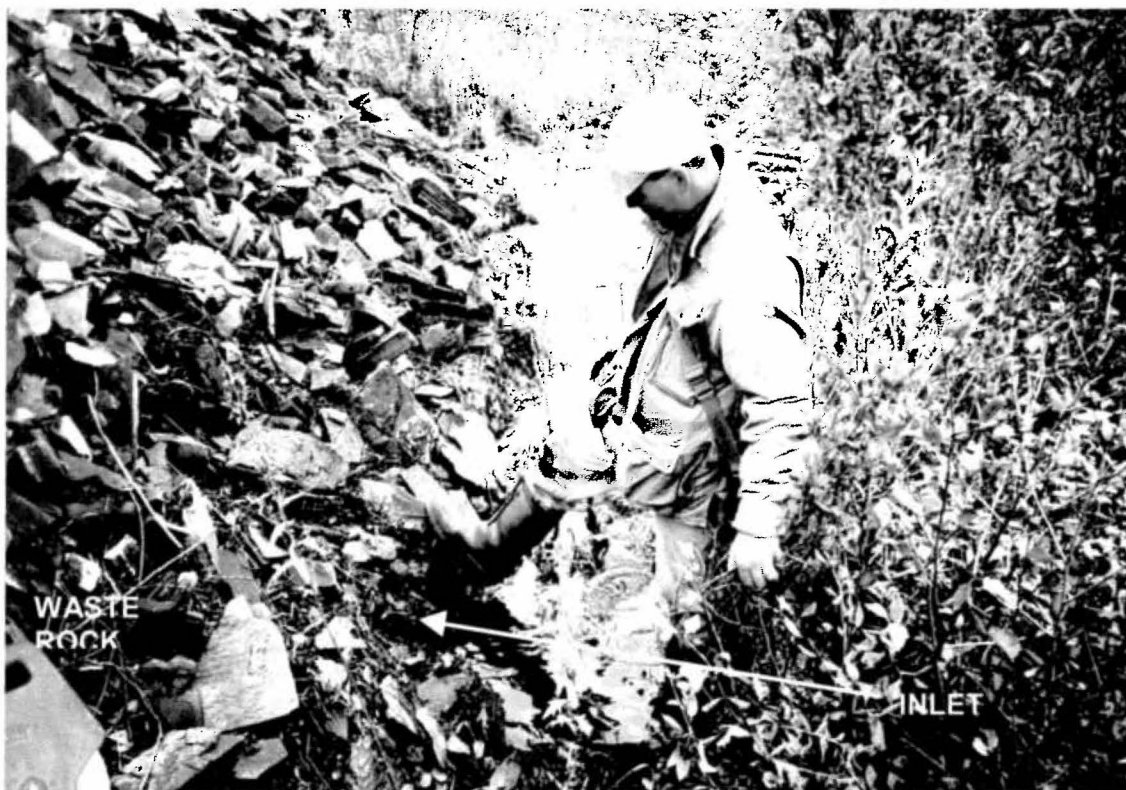
Impounded water upstream of the waste rock dump continues to flow either below or through the waste rock or along the east valley slope in subterranean channels. The majority of flow occurs via a drainage channel incised through the slide debris from the unstable southern portion of the waste rock where it enters the waste rock pile (Drawing 04 and Photo UMA 10-9).

Photo UMA 10-9
Inlet into Waste Rock (1998)

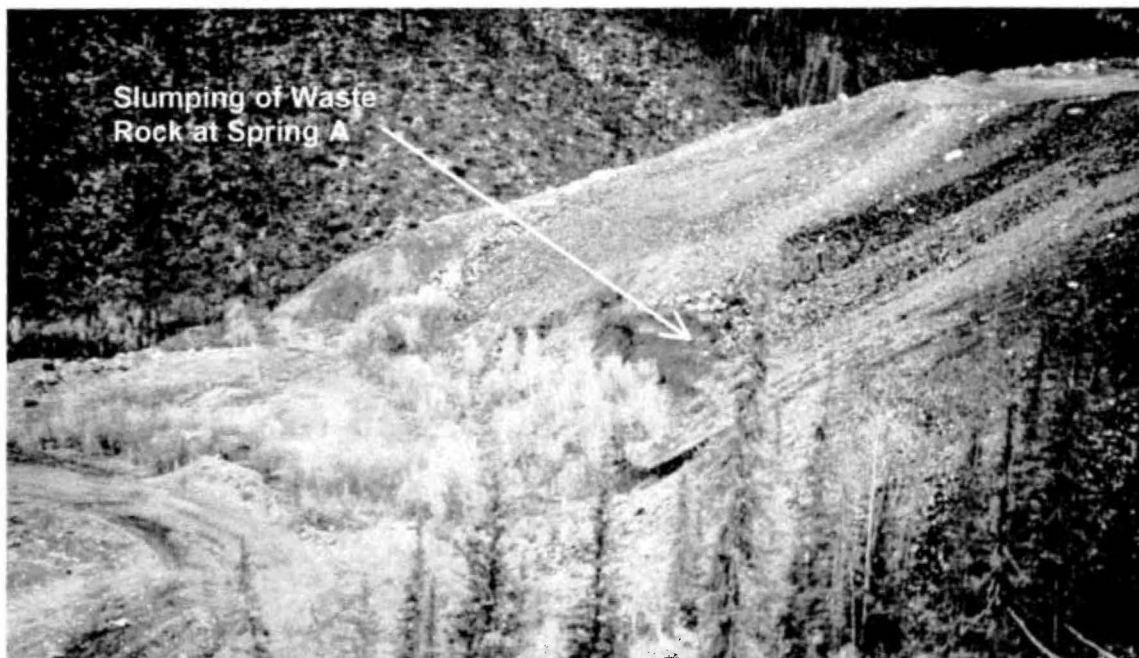
**Photo UMA 11-3**

Water draining internally through the waste rock discharges through the waste rock about 5 metres above the toe of the north slope, approximately 550 metres to the north of the inlet (Spring A). In September 1998, discharge at Spring A was estimated to be in the order of 10 l/s approximately 5 m above ground surface. Localized slumping of the waste rock is evident at the discharge point as illustrated in Photo UMA 11-3. Water is subsequently conveyed along a drainage channel incised along the south edge of the road where it eventually spills into the Creek Pit.

Spring A at Porcupine Creek Waste Rock Dump (1998)

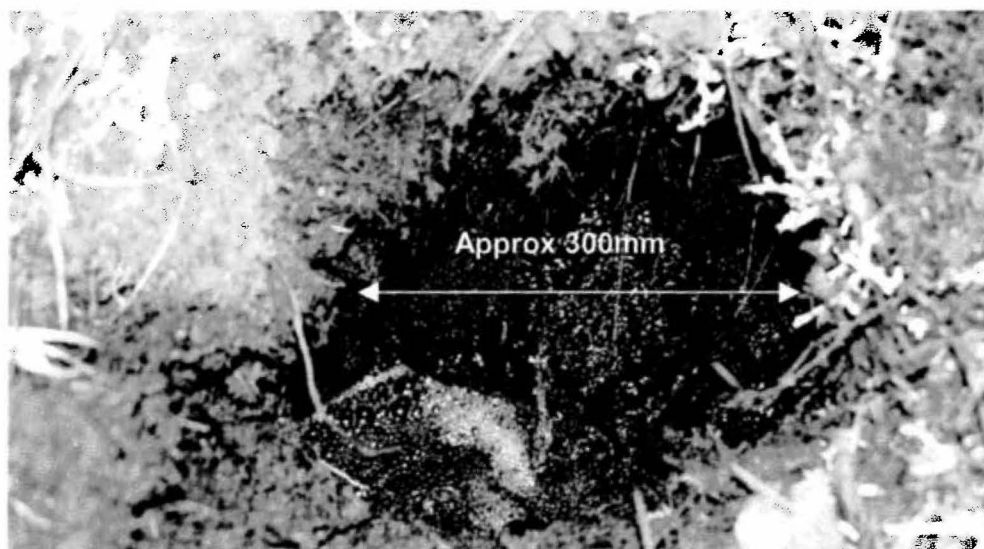
**Photo UMA 9-24**

Discharge is also occurring via subterranean flow along the toe of the waste rock and east valley slope where flowing water is visible below the organic mat on the valley slope (Photo UMA 9-24, Drawing 04). Discharge from the subterranean flow system occurs as a spring (Spring B) near the northwest corner of the waste rock dump (Drawing 04). Some fine grained material has been deposited at the discharge point.

Subterranean Flow at SE Edge of Waste Rock (1998)

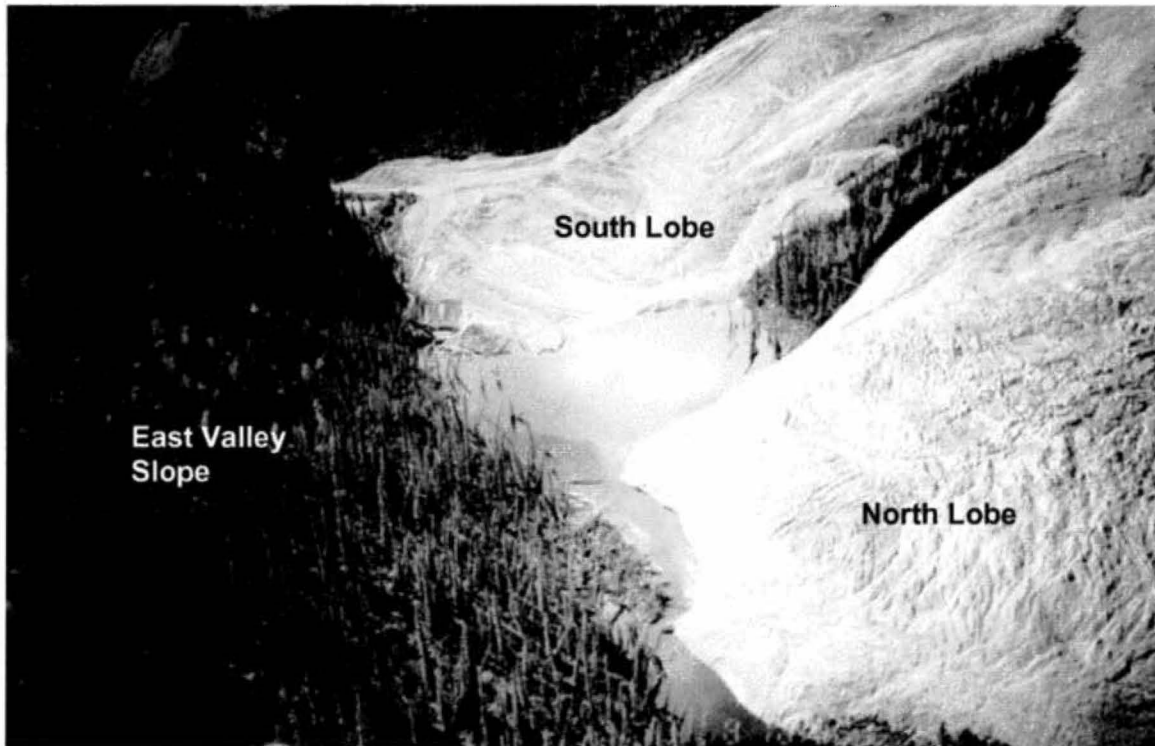
The tailings from the milling process were originally deposited with a stacker conveyor over the valley crest on the west slope of Wolverine Creek (Drawing 05). The mill tailings generally consist of well graded 25 millimetre down crushed serpentine rock with some asbestos fibre not removed during milling. In 1974, a sudden failure of the tailings pile (referred to as the south lobe) lead to a complete blockage of Wolverine Creek. Following the failure of the south lobe, tailings were deposited further north along the west slope of Wolverine Creek. This area is referred to as the north lobe. Gradually, failure of the north lobe lead to another blockage of the creek channel just upstream of the south lobe (Photo UMA 1-3).

Photo UMA 1-3
North and South Tailing Lobes (1998)
