**INDIAN AND NORTHERN AFFAIRS CANADA
ABANDONED CLINTON CREEK
ASBESTOS MINE
*CONDITION ASSESSMENT REPORT***

APRIL, 2000

PREPARED BY
UMA ENGINEERING LTD.
ENGINEERS AND PLANNERS
1479 BUFFALO PLACE
WINNIPEG, MANITOBA
R3T 1L7

**Reference: Abandoned Clinton Creek Asbestos Mine
Condition Assessment Report**

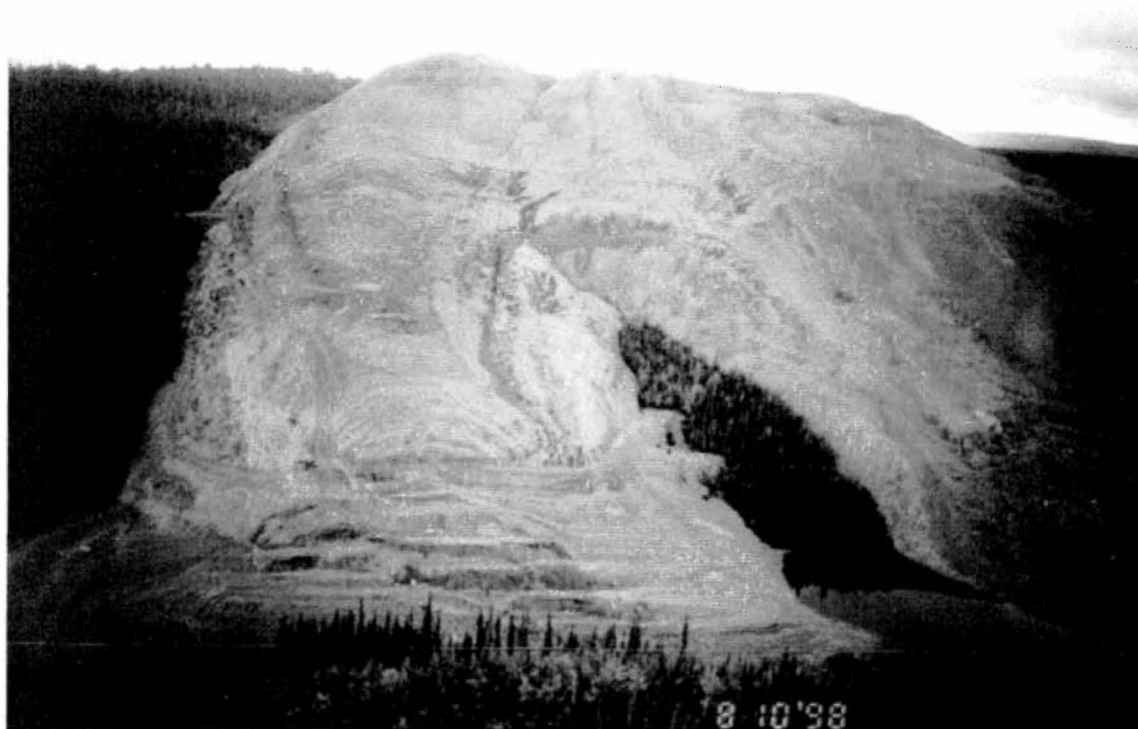
Continued instabilities of the south and north lobes are evident with numerous tension cracks and slump blocks between the crest and toe (Photo UMA 3-6 and 1-6). As a result of the on-going instabilities, the leading edge of the lobes gradually advance into the Wolverine Creek channel where the tailings are eroded and transported downstream (Photo UMA 5-20).

Photo UMA 3-6
View West at Failed Tailings Pile(1998)

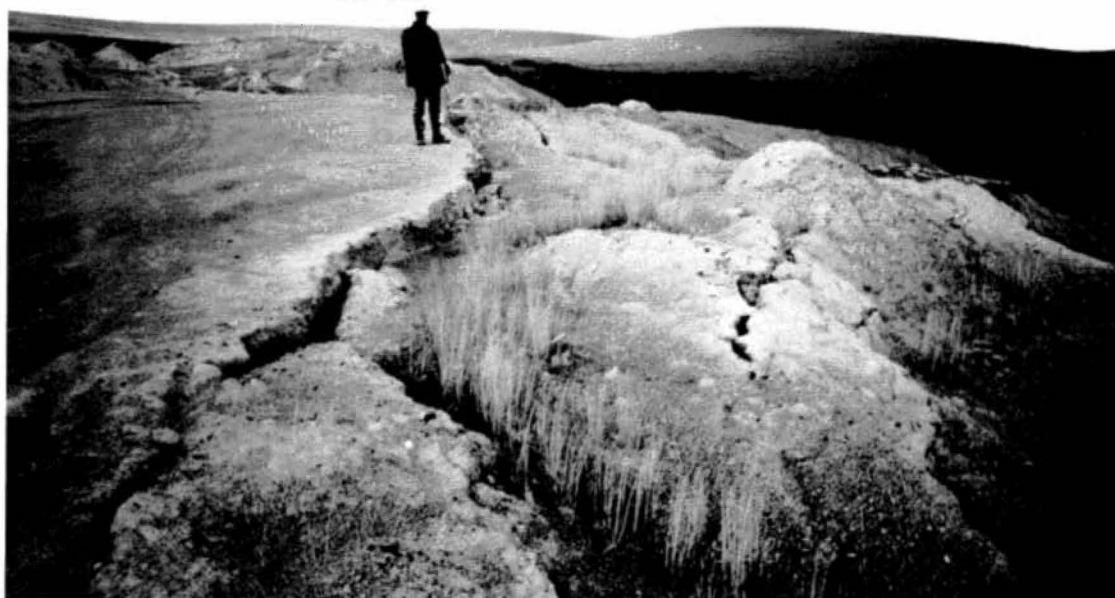
Photo UMA 1-6
Tension Cracks and Slumping at Top of Tailings Pile (1998)

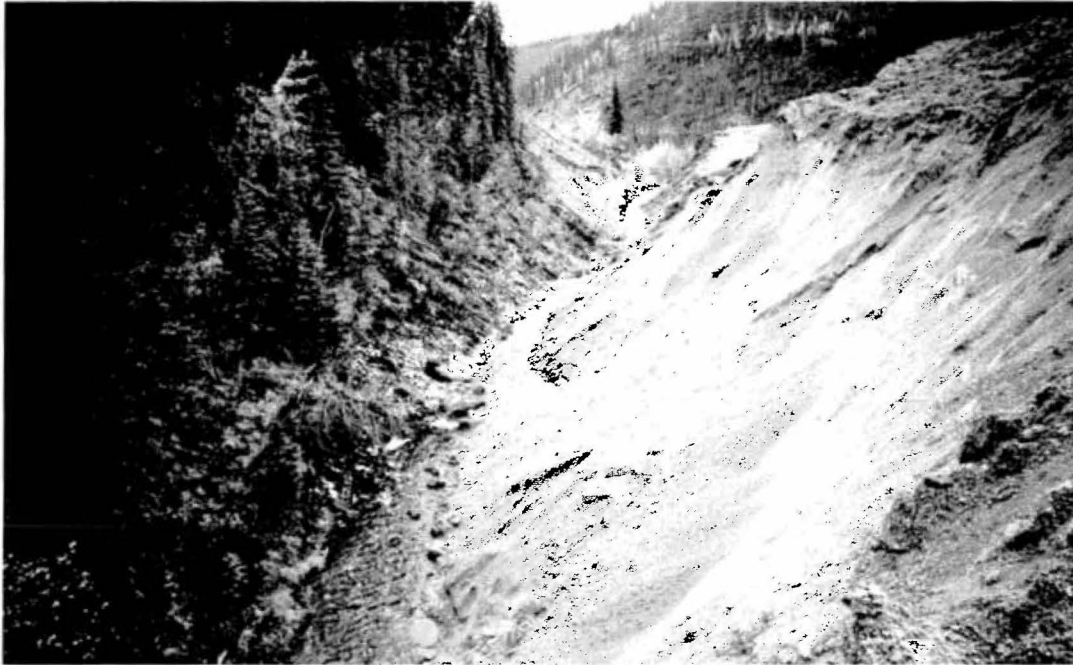
**Photo UMA 5-20**

Erosion at Toe of Advancing Tailings (1998)

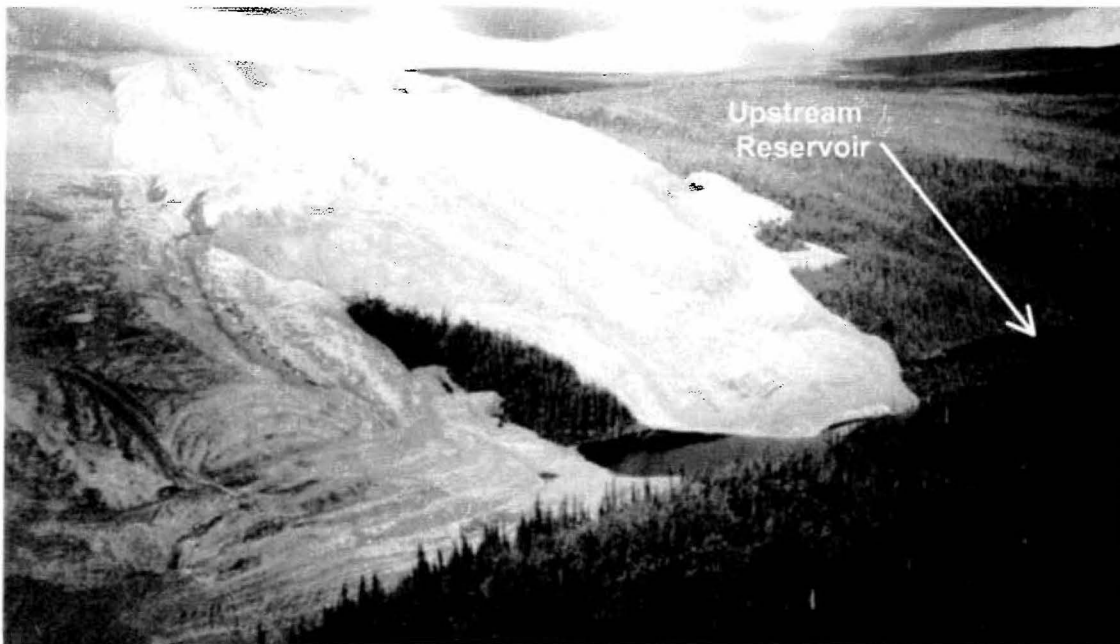
**Photo RRU-10**

In addition to the channel obstruction created by the advancing tailings, heaving of the valley floor directly in the path of the advancing north lobe is evident (Photo RRU-10). A small reservoir is located upstream of the tailings lobes on Wolverine Creek creating by the blockage of the creek channel as shown on Drawing 05.

View North West at Tailings Pile (1998)

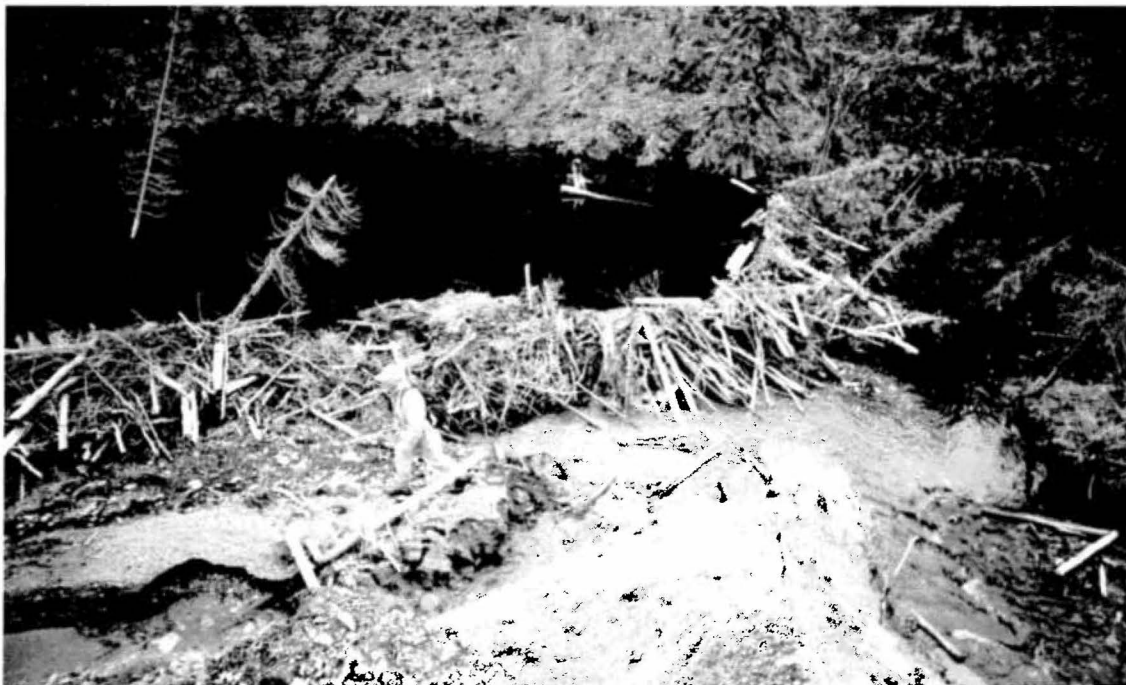
The second beaver dam, located between the upstream side of a small channel island and the toe of the north tailings lobe, does not impound a significant amount of water. The third beaver dam is located at the upstream end of the south lobe as shown in Photo UMA 5-18 and is responsible for raising the water level in the pond between the two tailings lobes by at least one metre. Beaver dam 4 is located immediately downstream of dam 3.

Photo UMA 5-18
Beaver Dam 3, Wolverine Creek (1998)

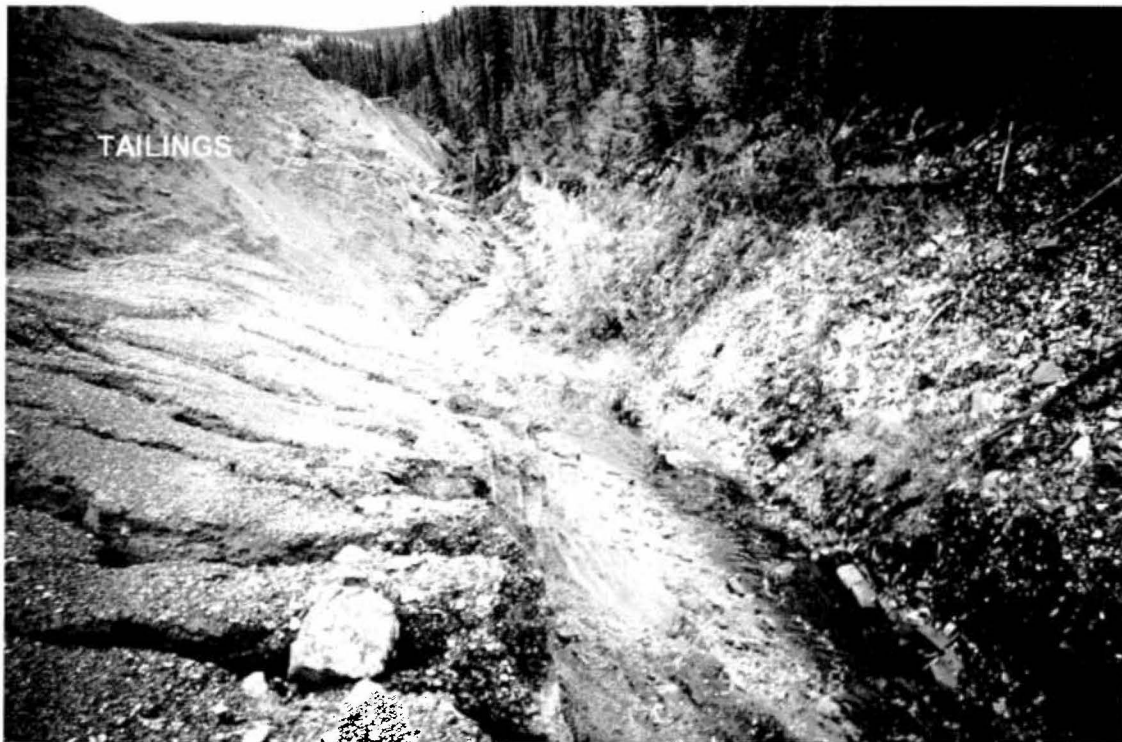
The four beaver dams have reduced channel velocities and erosion of the channel where the tailings piles meet the toe of the valley slope. Downstream of the beaver dams however, velocities increase significantly as the channel narrows and the gradient steepens. Within this stretch, the channel has down-cut into the underlying weathered argillite bedrock resulting in surficial slumping of the overburden soils (Photo UMA 5-23). A series of rock weirs line the channel immediately downstream of the south lobe. Flow is contained within the channel with no significant erosion or down-cutting observed. Ground vegetation in the areas of the tailings lobes is extremely scarce and plant diversity very low. Mats of chrysotile asbestos were observed in the lower branches of trees at a height corresponding to that of the snow pack.

Photo UMA 5-23
View Upstream Along Wolverine Creek (1998)

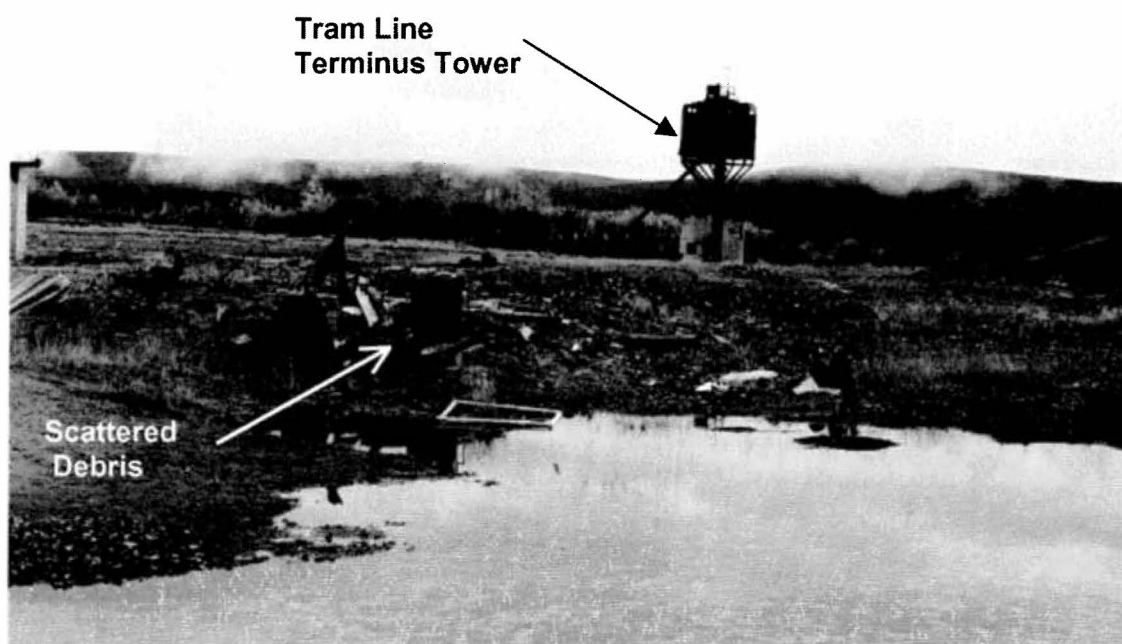
The former aerial tramline terminated at a large steel tower on a suspected concrete footing or piles (Photo RRU-8). Seven intermediate towers are located between the terminus and the Crusher Building as seen in Photo RRU-9 and on Drawing 02. The intermediate towers are steel and are also likely founded on concrete footings or piles.

Photo RRU-8
Mill Site Area(1998)

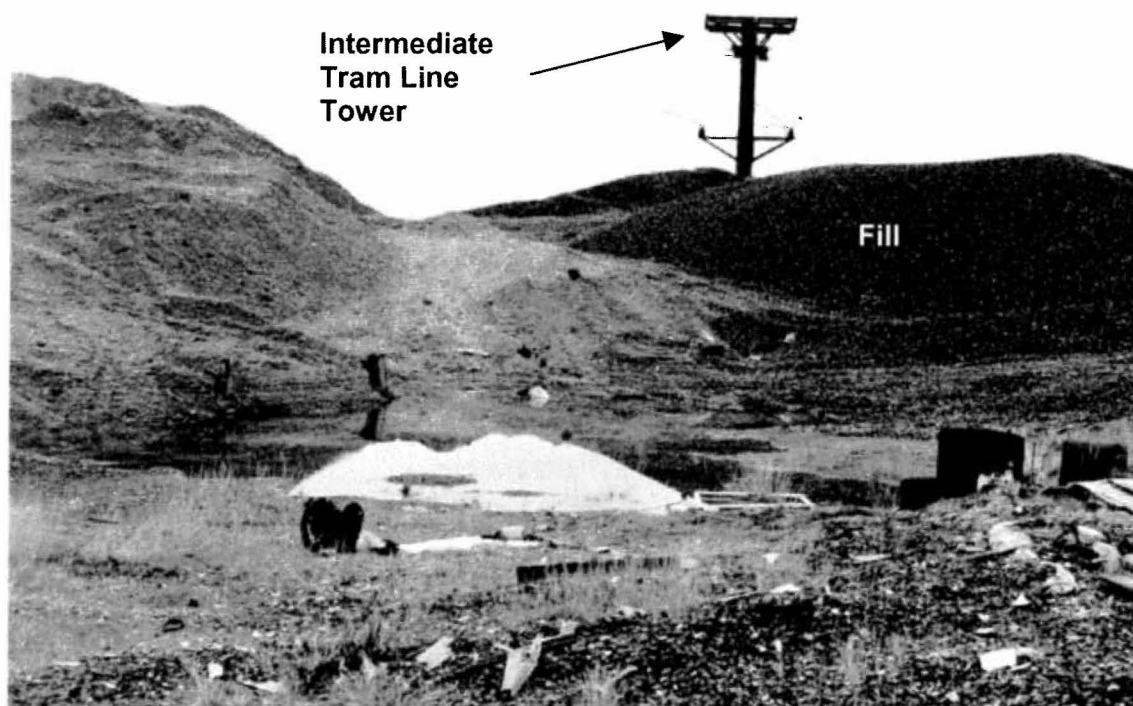
Photo RRU-9
Fill Material Above Fibre Building Foundation (1998)
