INDIAN AND NORTHERN AFFAIRS CANADA

ABANDONED CLINTON CREEK ASBESTOS MINE ENVIRONMENTAL LIABILITY REPORT

**Prepared by
UMA Engineering Ltd.
1479 Buffalo Place
Winnipeg, Manitoba, R3T 1L7**

June 2003

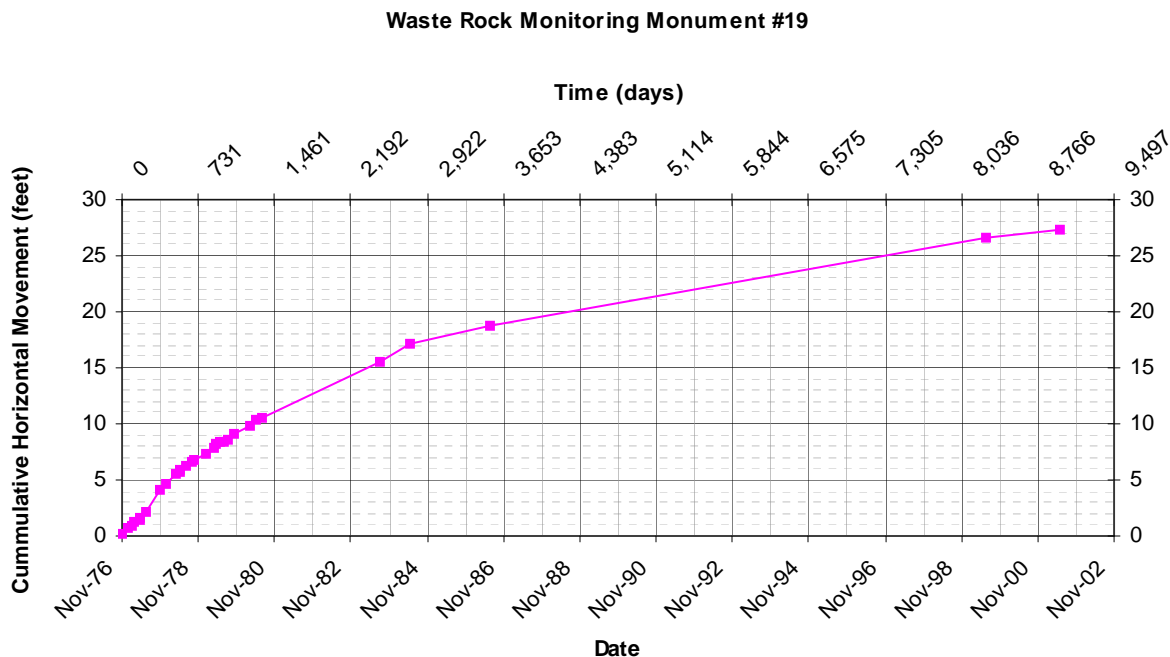
Subsequent to preparation of the Conceptual Design Report, waste rock movement monitoring and a detailed survey of the Hudgeon Lake outlet were carried out in June 2001. Over the two-year period from July 1999 to June 2001, annual horizontal movements ranging from 1 to 11cm were observed, or an average annual rate of 7cm. Over the same time period, the average rate of vertical settlement appears to be in the order of 7 cm. The movements confirm previous observations that waste rock pile movements are small (in comparison to movements prior to 1986) and are perhaps decreasing with time. The horizontal movements for monitoring monument #19 are summarized on Figure 3-1. The movements can either be interpreted as small constant strain rates or strain rates that are decreasing with time, and as such are referred to as creep movements (as compared with the large movements observed prior to 1986). There are no signs to indicate strain rates are increasing, observations that would be expected if large movements of the waste rock were imminent. These creep movements may continue at similar strain rates for many more years, and in particular, the horizontal movements may be susceptible to channel erosion (i.e. down cutting) along the north edge of the waste rock. A location plan of all the monitoring monuments and survey benchmarks, a table of the benchmark co-ordinates and the monitoring results for all the waste rock movement monitors are included in Appendix-A.

Figure 3-1) Waste Rock Dump Movements

Providing that channel stabilization measures can be constructed to accommodate anticipated creep movements, waste rock stabilization is not considered necessary in the short term, in particular given the possibility of further reductions in these movements. With this in mind, the need for waste rock stabilization could be evaluated once the channel stabilization measures are constructed and additional monitoring data is available. Because the channel stabilization works involve partial infilling of the existing channel, it is possible that the observed horizontal creep movements may be reduced or possibly halted as a result of the channel stabilization work.

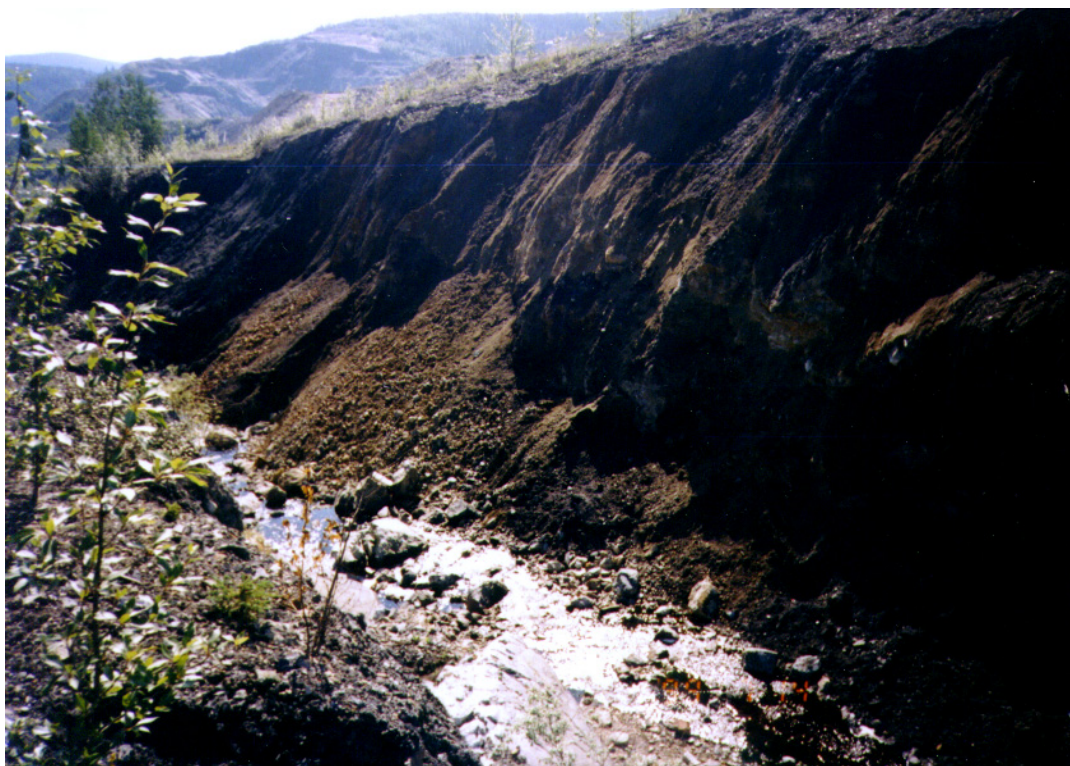
downstream of the mine. As the down-cutting gradually retrogresses towards the outlet however, conditions may quickly develop where normal flow and/or an overtopping event (i.e. breach of a waste rock slump) could trigger a full scale breach of the waste rock at the lake outlet. The consequences of a breach and rapid draining of Hudgeon Lake are discussed in UMA's Risk Assessment report (UMA 2000).

**Figure 3-2) Waste Rock Slumping Into Creek Channel
(View Downstream)**

Given the possibility of conditions worsening at the outlet before the channel can be stabilized, the stabilization work could be staged to allow the most immediate concern (the condition of the outlet) to be addressed before the overall stabilization works are completed. This strategy would allow mitigation of the catastrophic breach potential but would not significantly reduce the chronic erosion that would occur downstream of the stabilized section. The stabilization work at the outlet can likely be designed as a component of the overall channel stabilization measures.

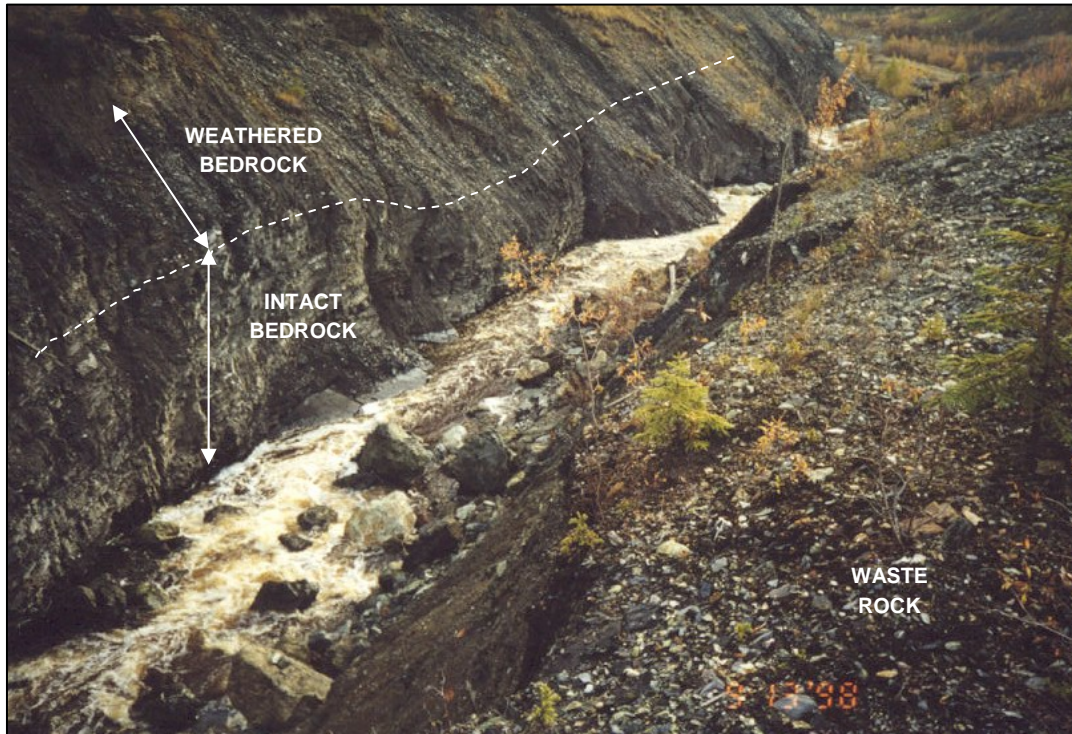
Figure 3-3) Clinton Creek Channel (View Downstream)

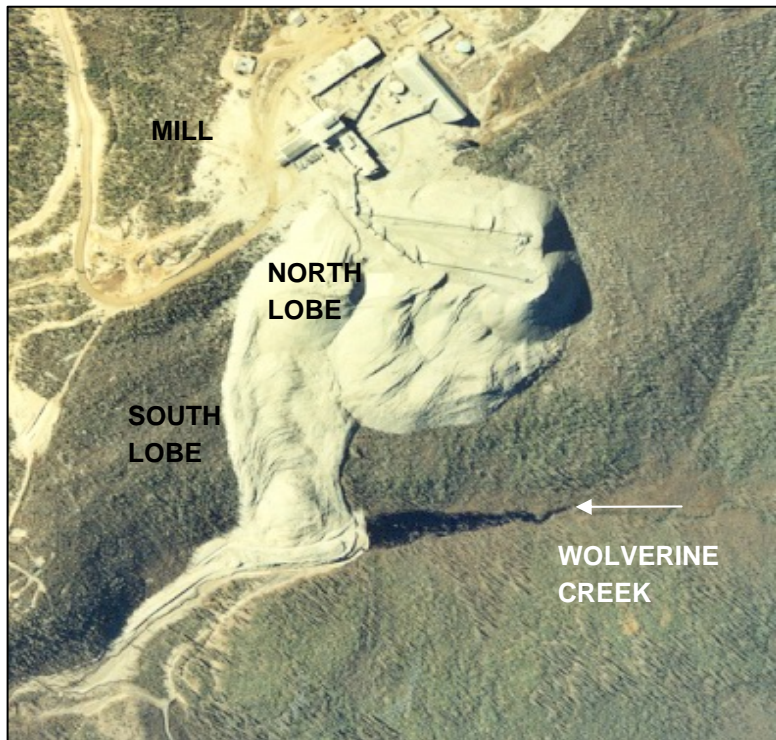
Between 1968 and 1974, tailings were deposited on the upper portion of the west slope of the Wolverine Creek valley (referred to as the south lobe). In 1974, a failure of the south lobe blocked natural flow in Wolverine Creek backing up approximately 9m of water behind the landslide material (Figure 4-1). In the spring of 1974, a sudden breach of the tailings occurred resulting in flash flooding of the Wolverine creek valley to the confluence with Clinton Creek where the flooding is believed to have quickly attenuated. The eroded tailings were deposited several metres deep in the creek valley directly downstream of the south lobe (Figure 4-2). Although the majority of the tailings are believed to have been deposited upstream of the mine access road shown on Drawings 01 and 09, some of the finer material including asbestos fibres entered the Clinton Creek channel where it was deposited possibly as far downstream as the Forty Mile River.

Figure 4-1)
Failed South
Lobe (1976)

- The mechanism of failure for the south lobe is thought to have involved the build-up of excess pore pressures within the active layer of the foundation soils beneath the tailings in the draw. As indicated by the continuous slow downslope movement of the south lobe, a point of incipient failure was reached before the 1974 failure.

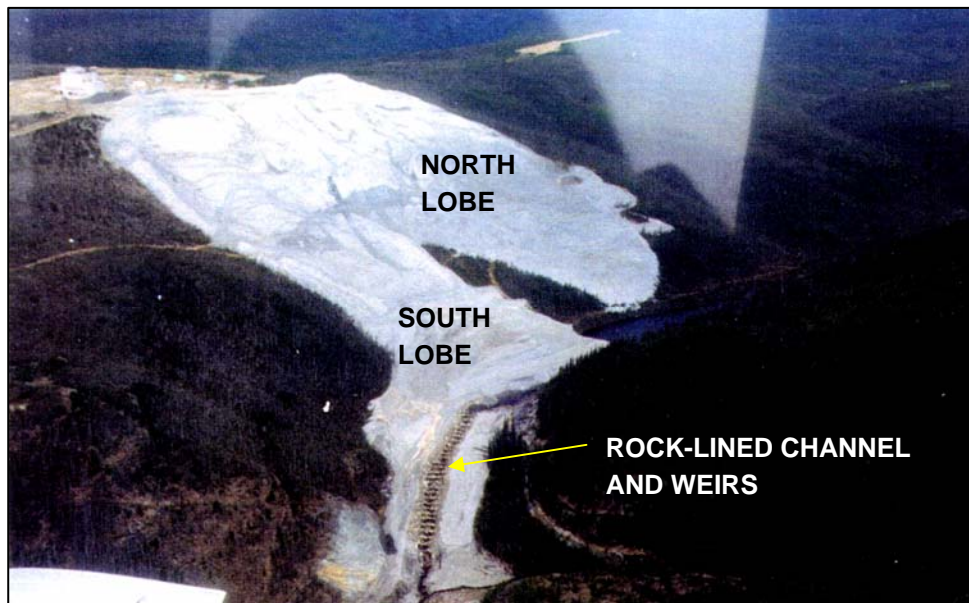
Following the failure of the south lobe, a 9m deep channel was excavated at the toe of the tailings to facilitate creek flow and a new tailings pile was established north of the failed mass, now referred to as the north lobe (Figure 4-1). By 1977, the north lobe was showing signs of instability (Figure 4-2) and during the last months of mine operation, the tailings were placed in the northwest corner of the north lobe. Partial re-grading of the north and south lobes was undertaken in 1978 and 1979 in an unsuccessful attempt at stabilizing the tailings. In 1978, channel stabilization measures were constructed in Wolverine Creek across the tailings immediately downstream of the south lobe. These measures consisted of a rock-lined channel with a series of rock weirs (Figure 4-2). To date, these measures have performed well although some deterioration was noted during the 2001 site visit.

Figure 4-2) Rock-Lined Channel and Weirs (1982)

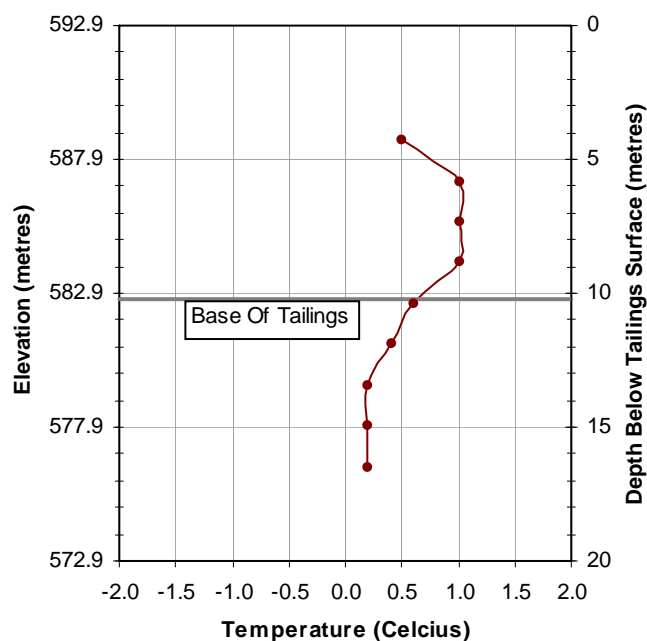
Figure 4-5) Temperature Profile for T5

Thermistor strings T5 (Figure 4-5) and T8 (Figure 4-6) are located on the south lobe of the tailings pile at the crest and at mid-slope, respectively. The tailings forming the south lobe had been in place for approximately 4 to 5 years when the thermistor strings were installed. As shown in Figures 4-5 and 4-6, the midpoints of the thermistor strings were located near the interface between the tailings and overburden soils. Both the tailings and the overburden were observed to be unfrozen. The thermistor plot for T5 shows the uppermost point was about 0.5 degrees C cooler than the three points just below, possibly indicating a cool or frost front is advancing downward from the tailings surface. The points in the overburden were typically between 0.2 and 0.5 degrees C suggesting that

degradation of the permafrost had occurred. The temperature profile from T8 decreases gradually from 0.6 to -0.1 degrees C with depth. The temperature of the overburden material appears to be very close to 0 degrees C. The slightly cooler temperatures in the overburden may be related to the thicker depth of tailings at this location (18m), which is about twice the thickness found at thermistor string T5.

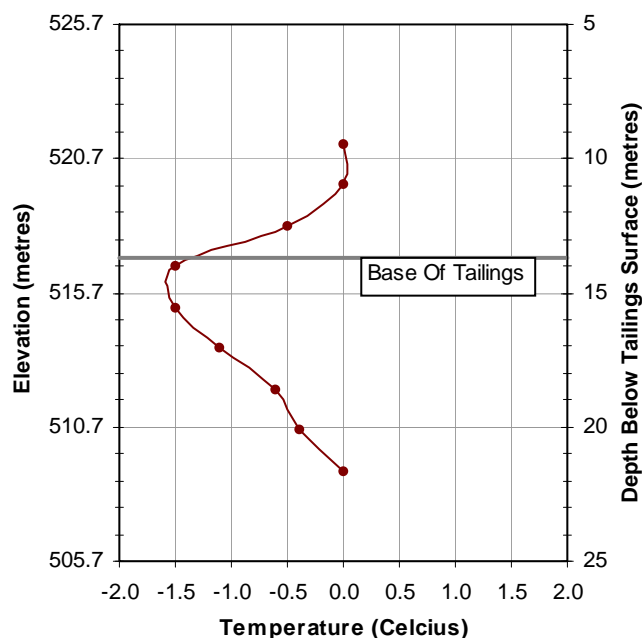
Figure 4-7) Temperature Profile for T7

Thermistor T7 is located near the northern edge of the tailings pile. The tailings at this location had been in place for approximately 1 to 2 years when the thermistor was installed. The data shown in Figure 4-7 indicates that the tailings and foundation soils were frozen with the coldest temperatures (-1.6 degrees C) just below the interface of the tailings and foundation soil. The temperatures of the foundation soils appear to gradually increase from -1.5 degrees C at the interface to nearly 0 degrees approximately 6m below the tailings. It is possible that these tailings were placed during the winter season, which would help to insulate the frozen overburden soils. This also might explain the cooler temperatures of the tailings just above the overburden soils. The warming trend with depth in the overburden may indicate where the bottom of permafrost layer is at this location.

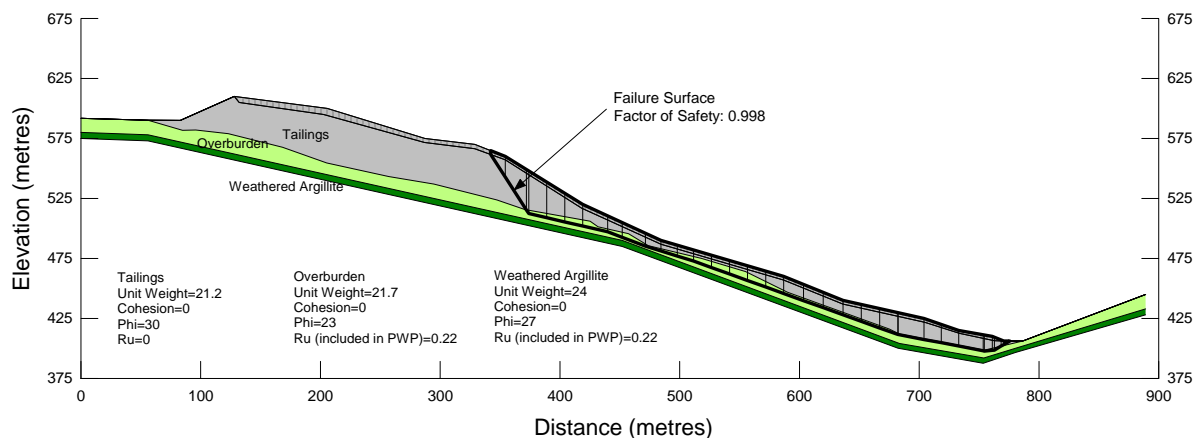
Figure 4-8) North Lobe – Existing Geometry

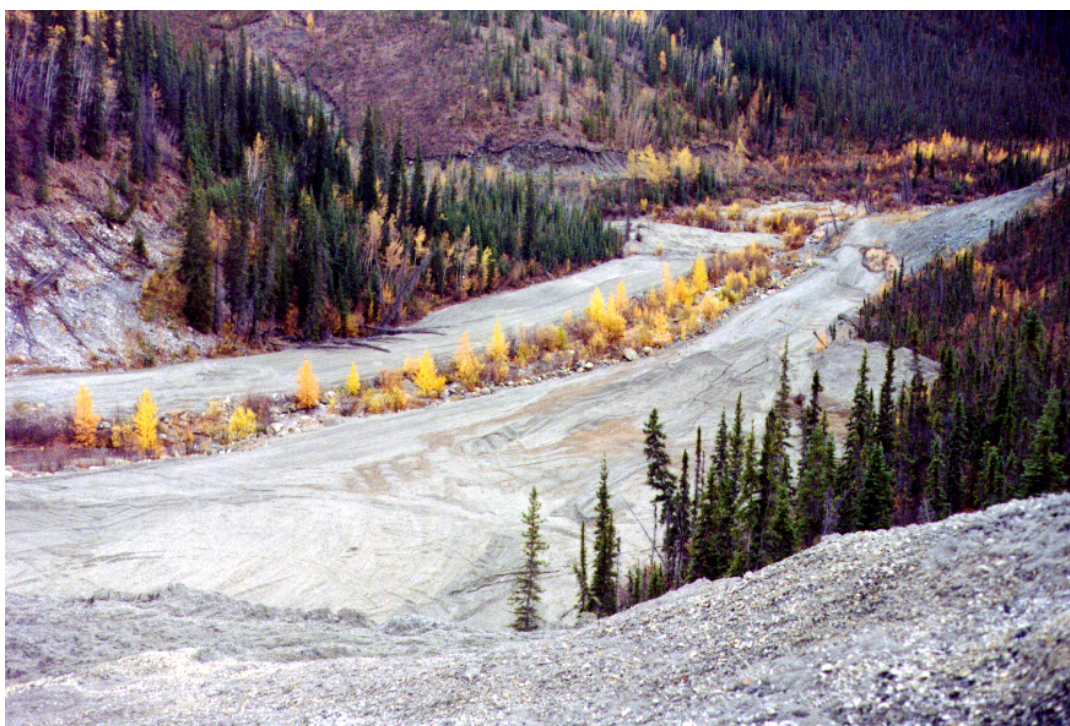
Figure 4-10) Vegetation Along Rock-Lined Channel
