ABANDONED CLINTON CREEK ASBESTOS MINE

Site Visit May 21, 2002

Northern Affairs Program

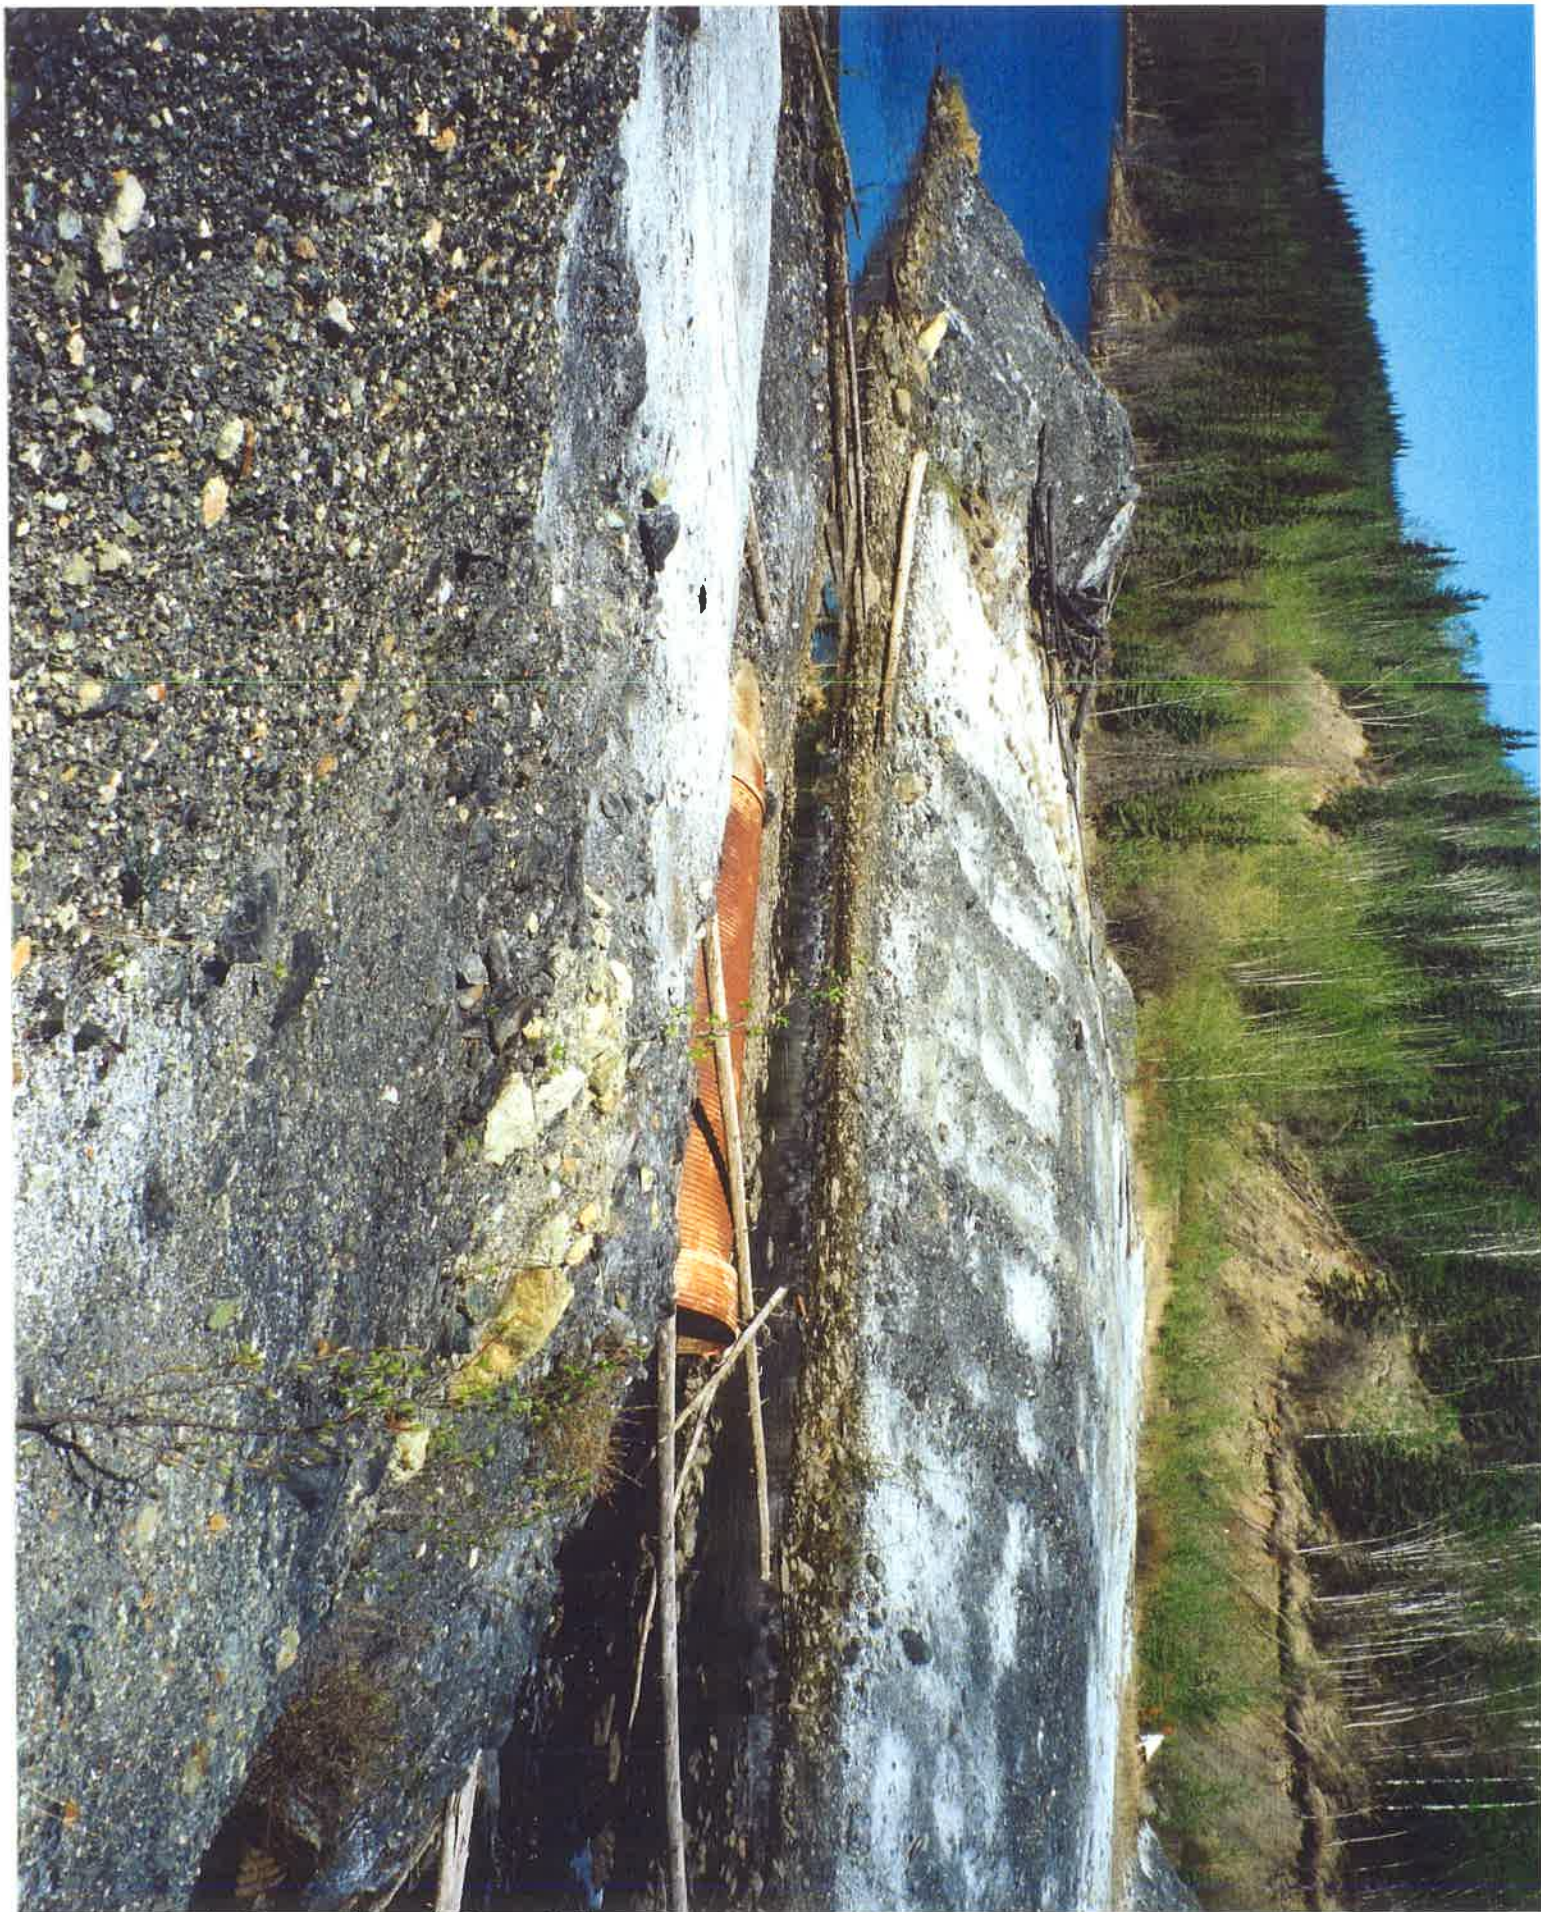
The level of Hudgeon Lake and the decant was as low as it has ever been, in the author's memory (Photo A and B). Personal observations at this site go back to 1991. The elevation of the downstream end of the decant plug appears to be noticeably lower than last year. The end of laminar flow and the start of the riffle area visible in the photo (Photo C), begins at the location of the crossed trees at the culvert end. This appears to be closer to the Lake than in the previous year.

Photo A: Decant from Hudgeon Lake

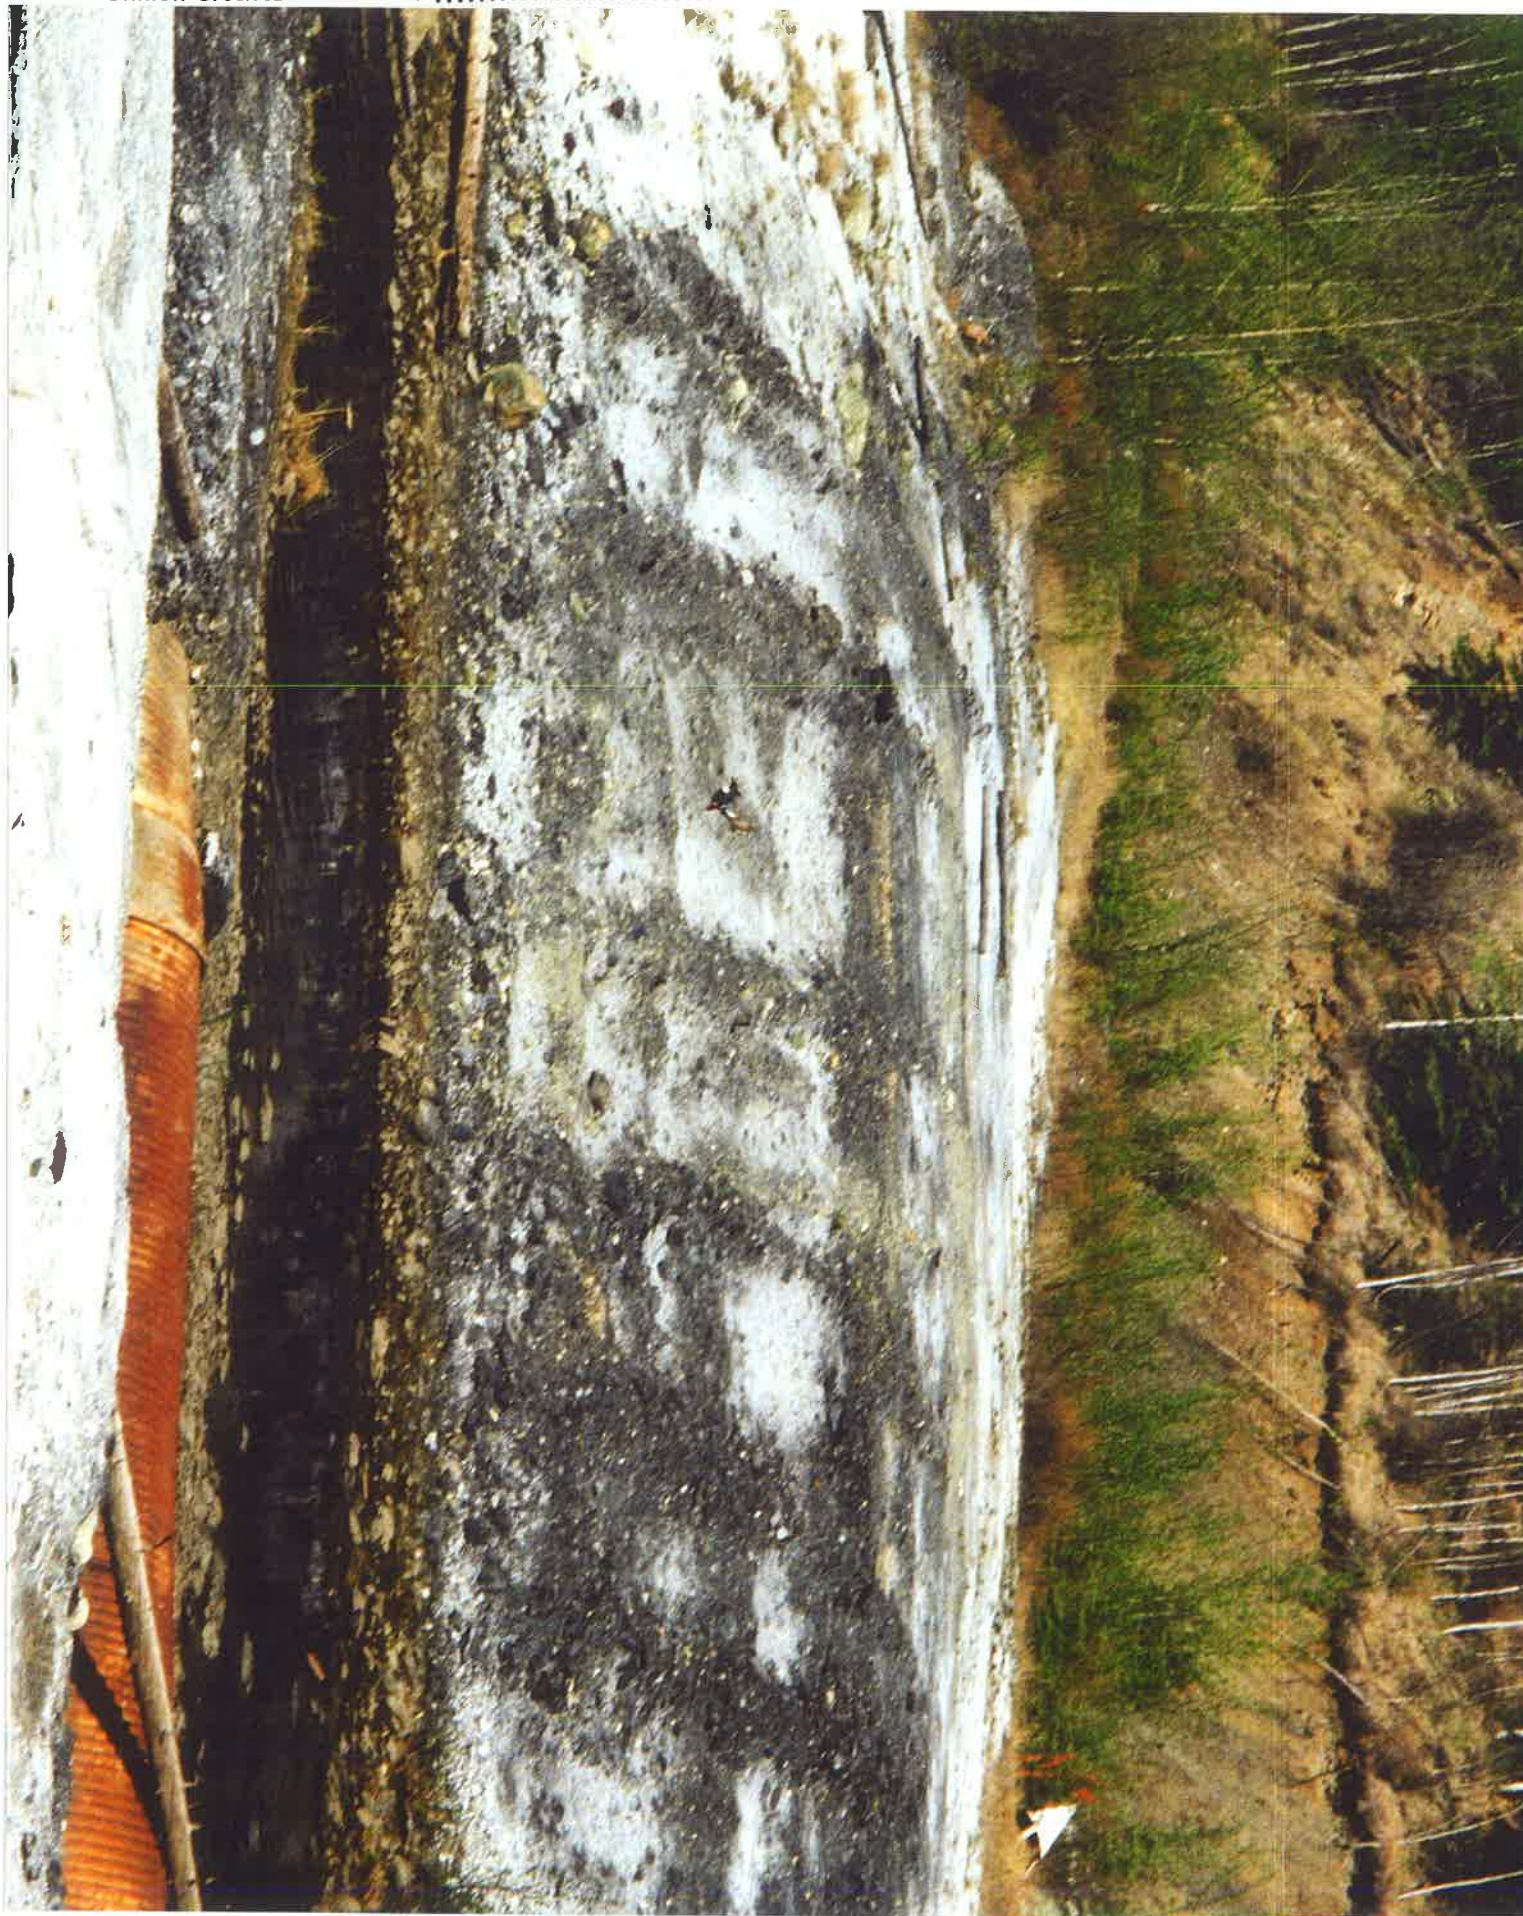
Photo B: Decant crossing

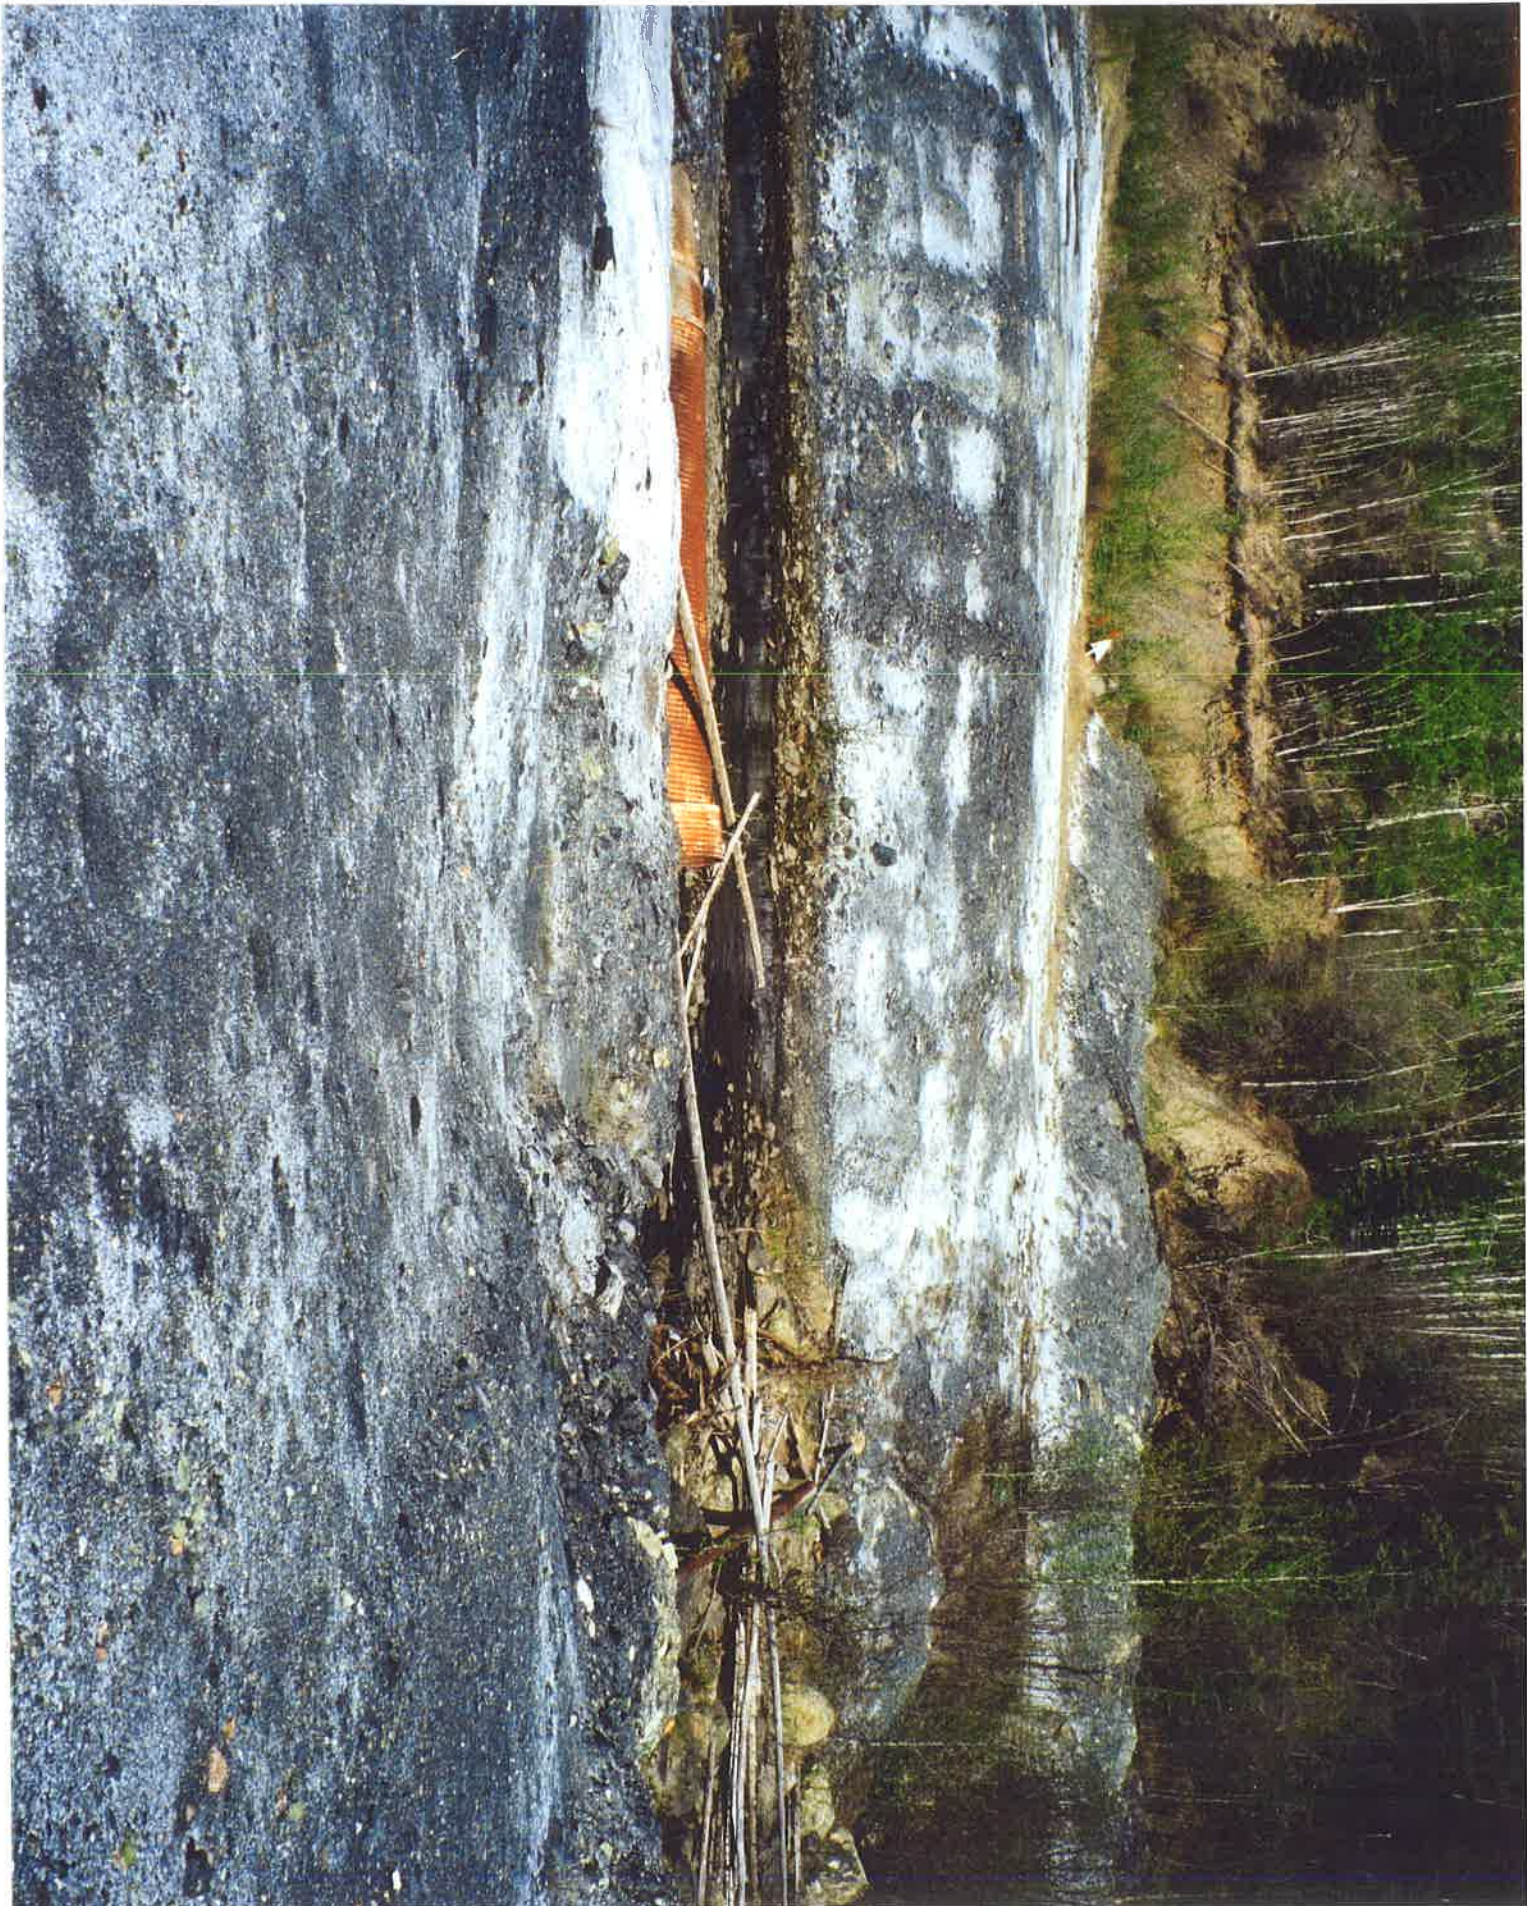
Photo C: Riffle movement

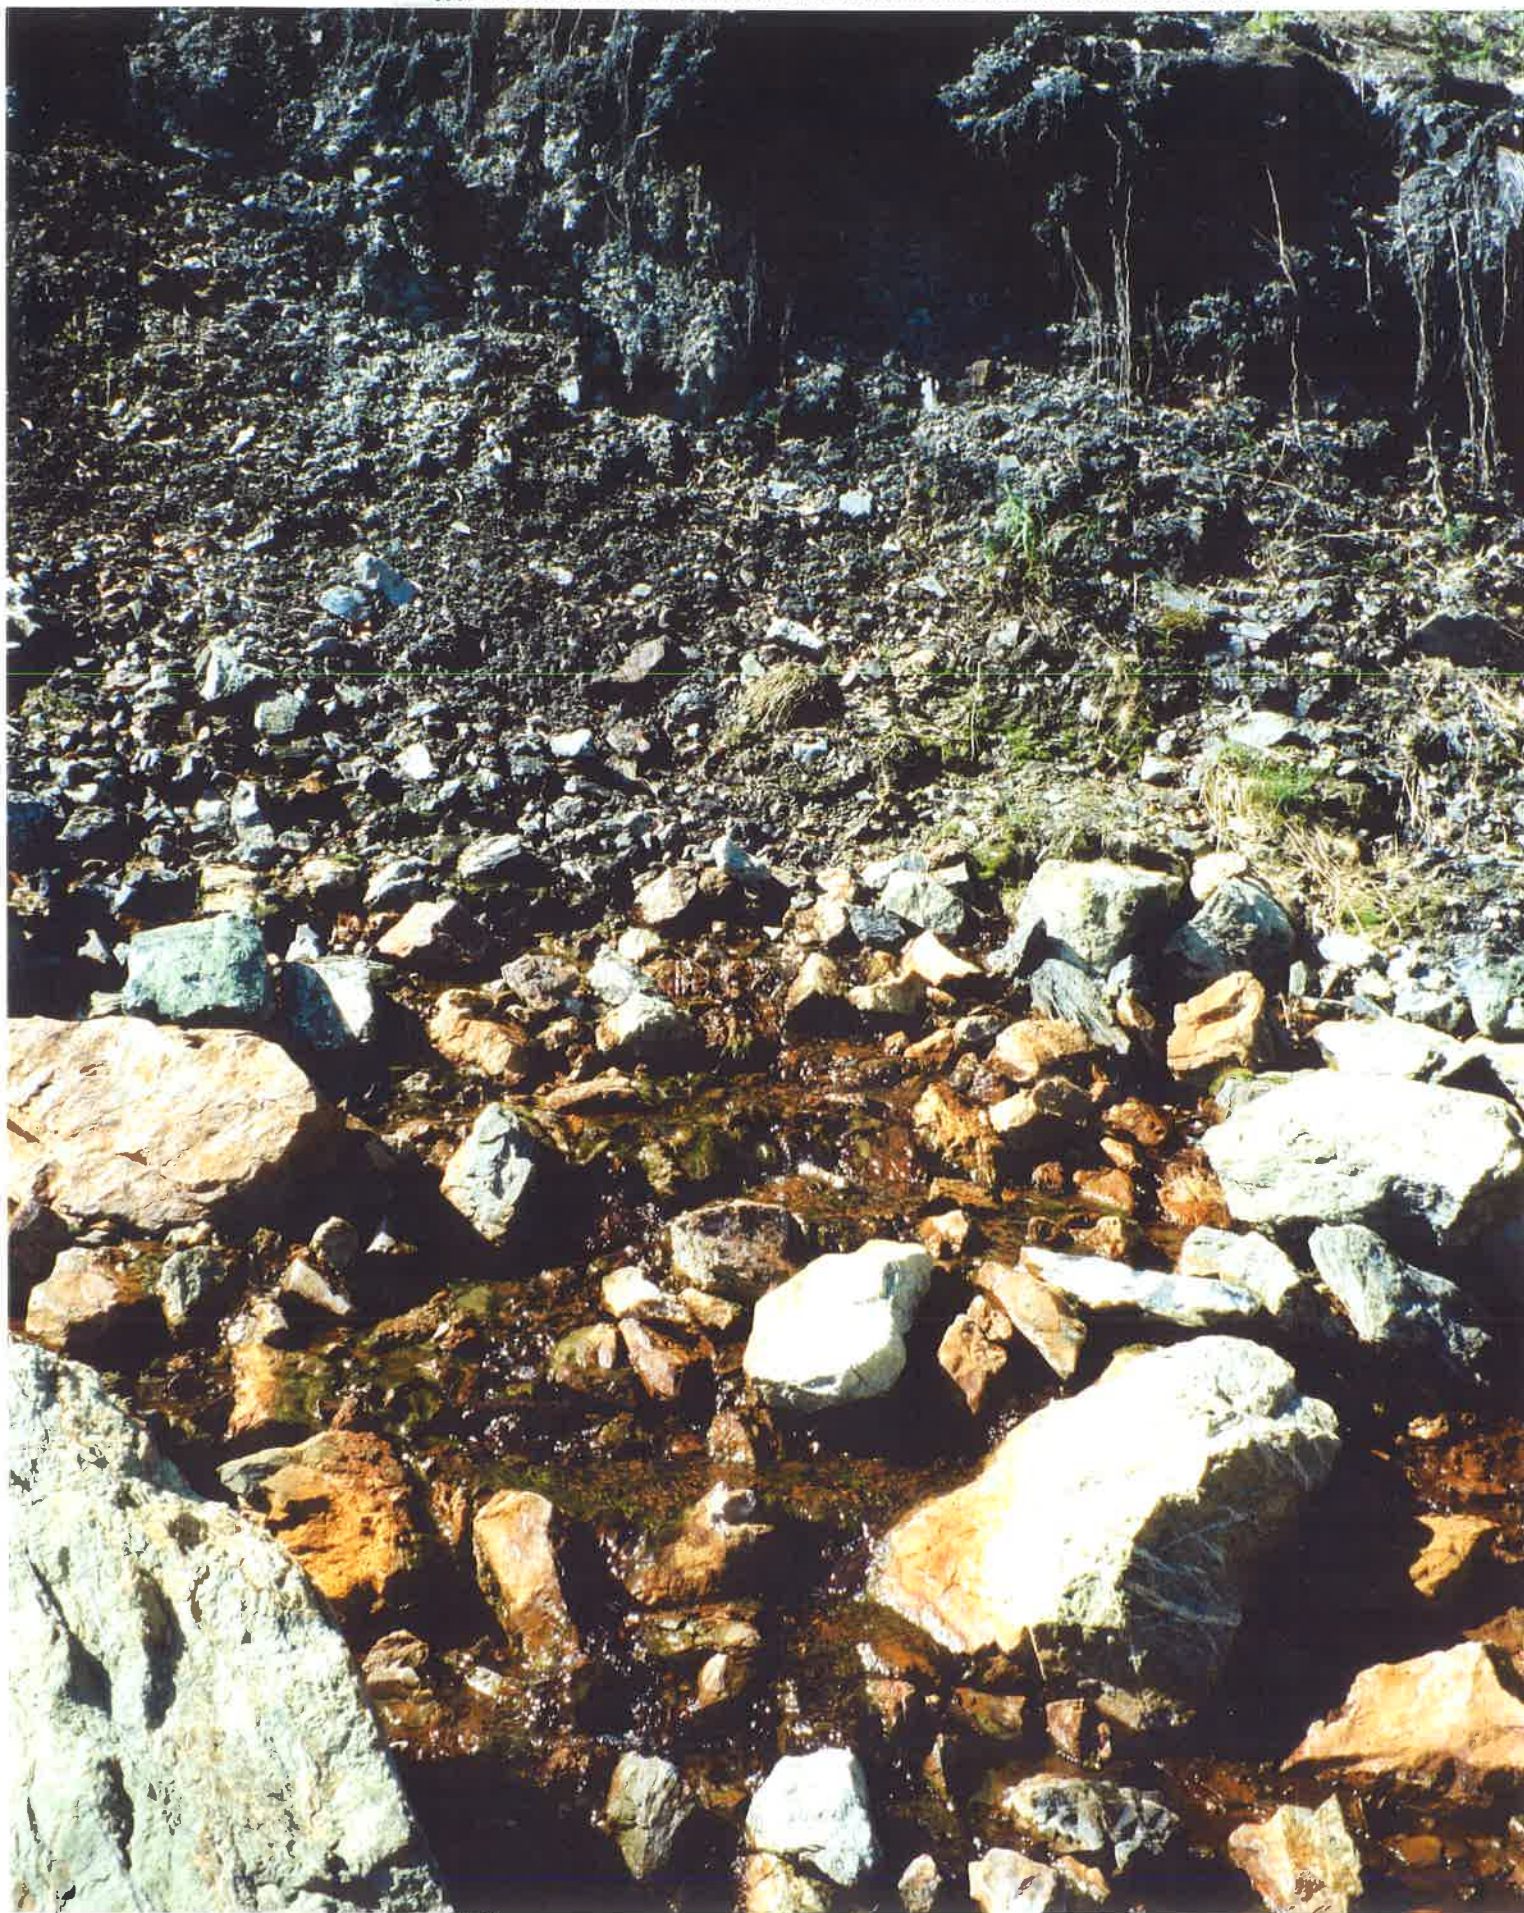
Immediately downstream of the outlet, on the waste rock side of the channel, there is a new slump in the bank material at the site of two springs (Photo D). The flow rate of the lower of the two springs appears to be higher than in previous years (Photo E) and the location of this spring corresponds to cracks in the road bed above.

Photo D: Spring and slump

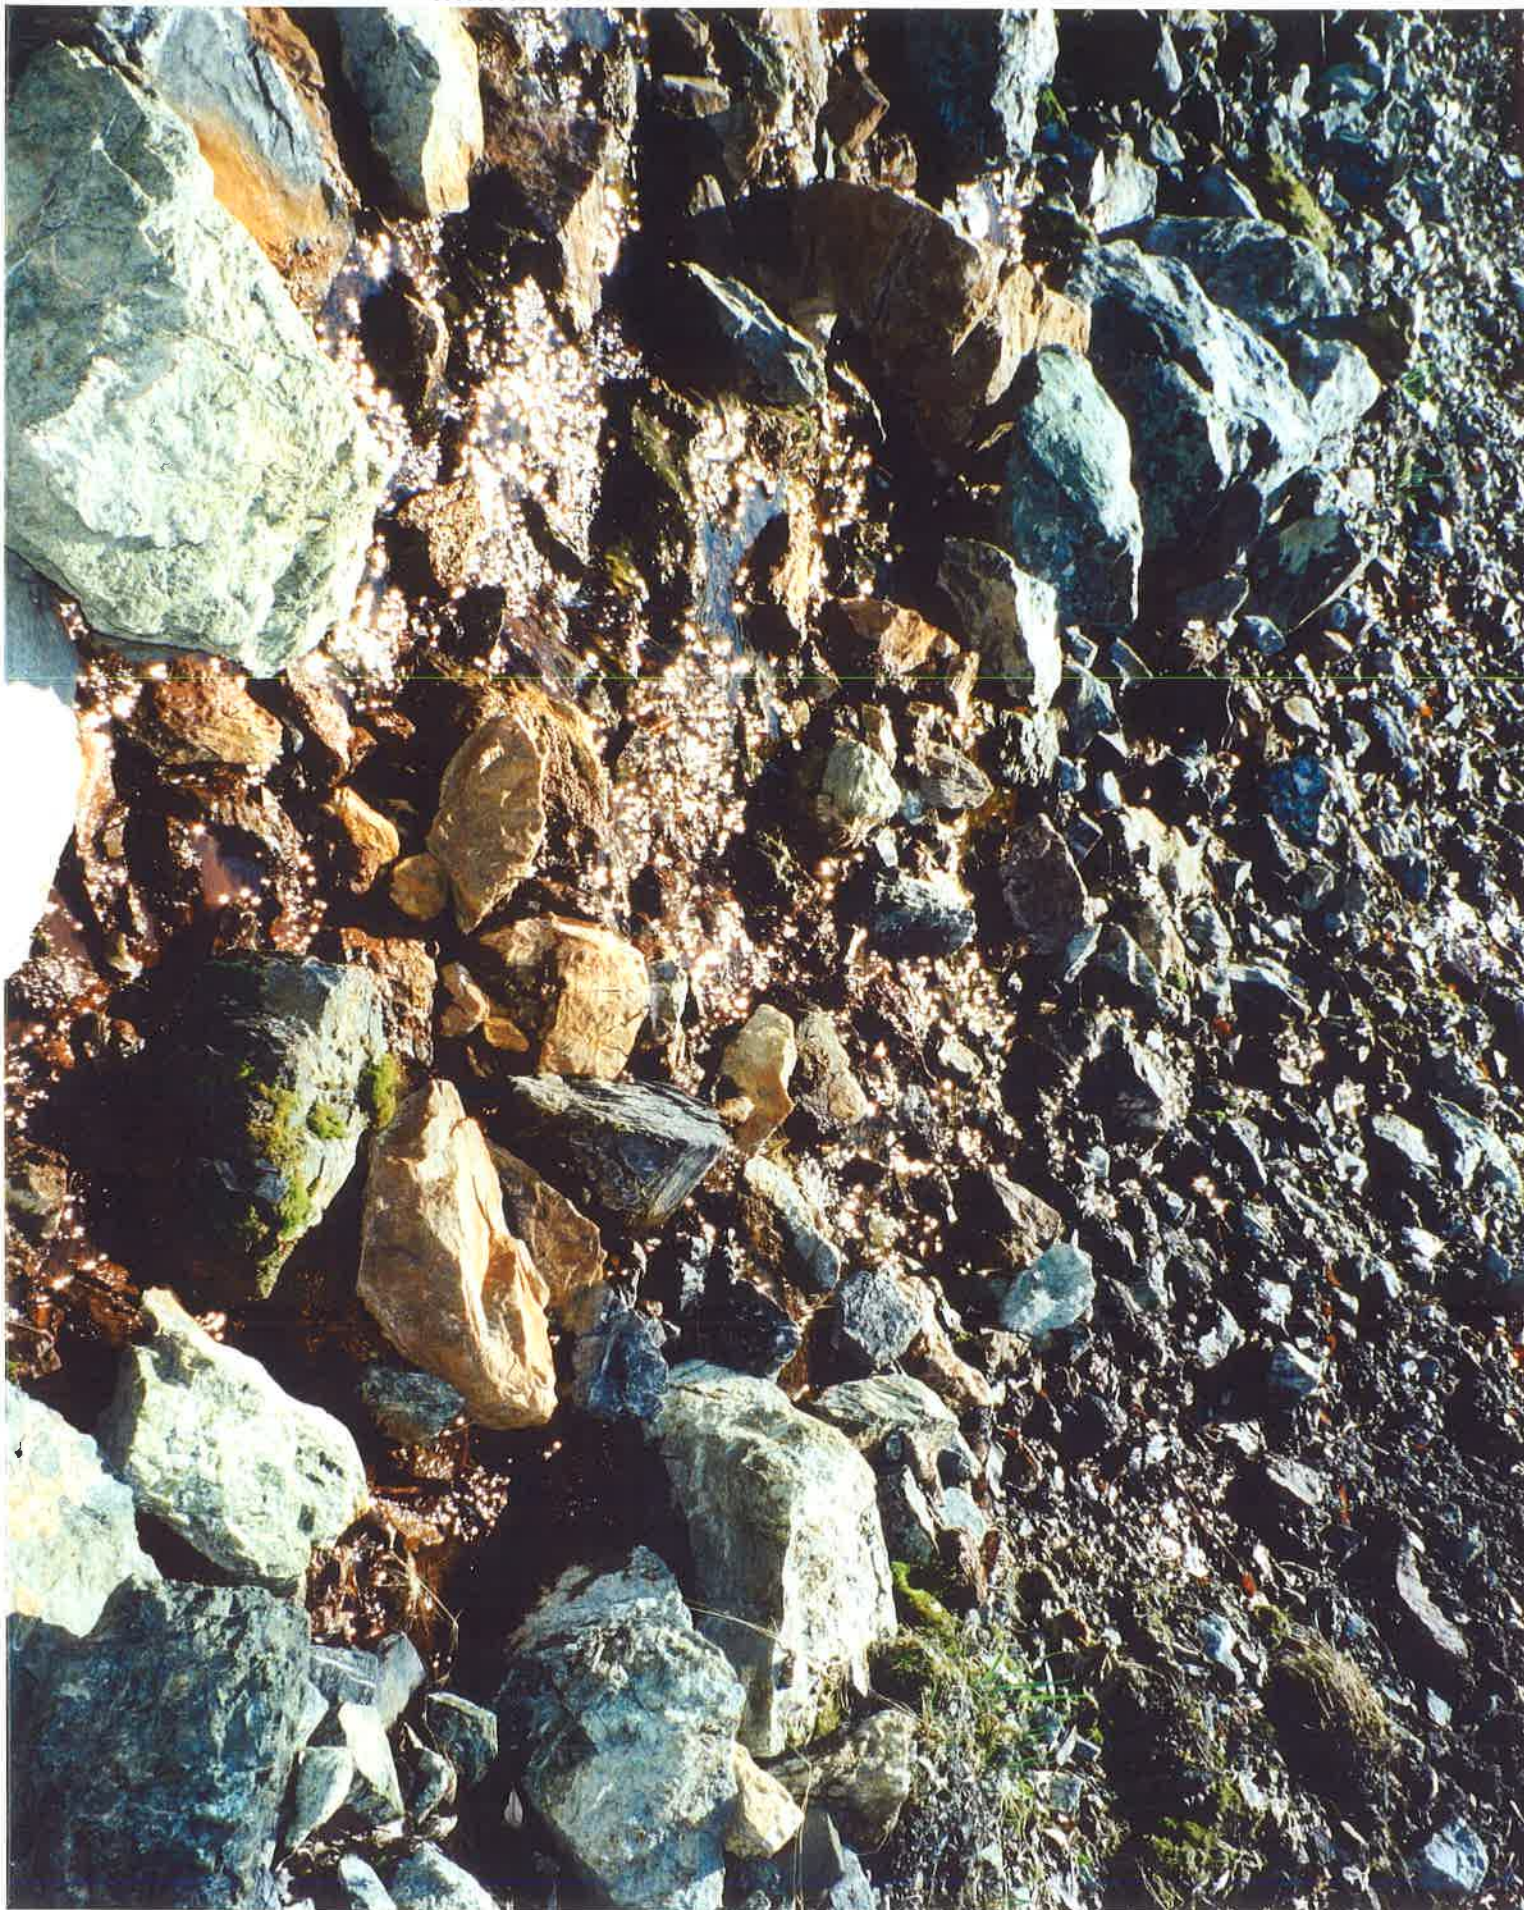
Photo E: Spring flow

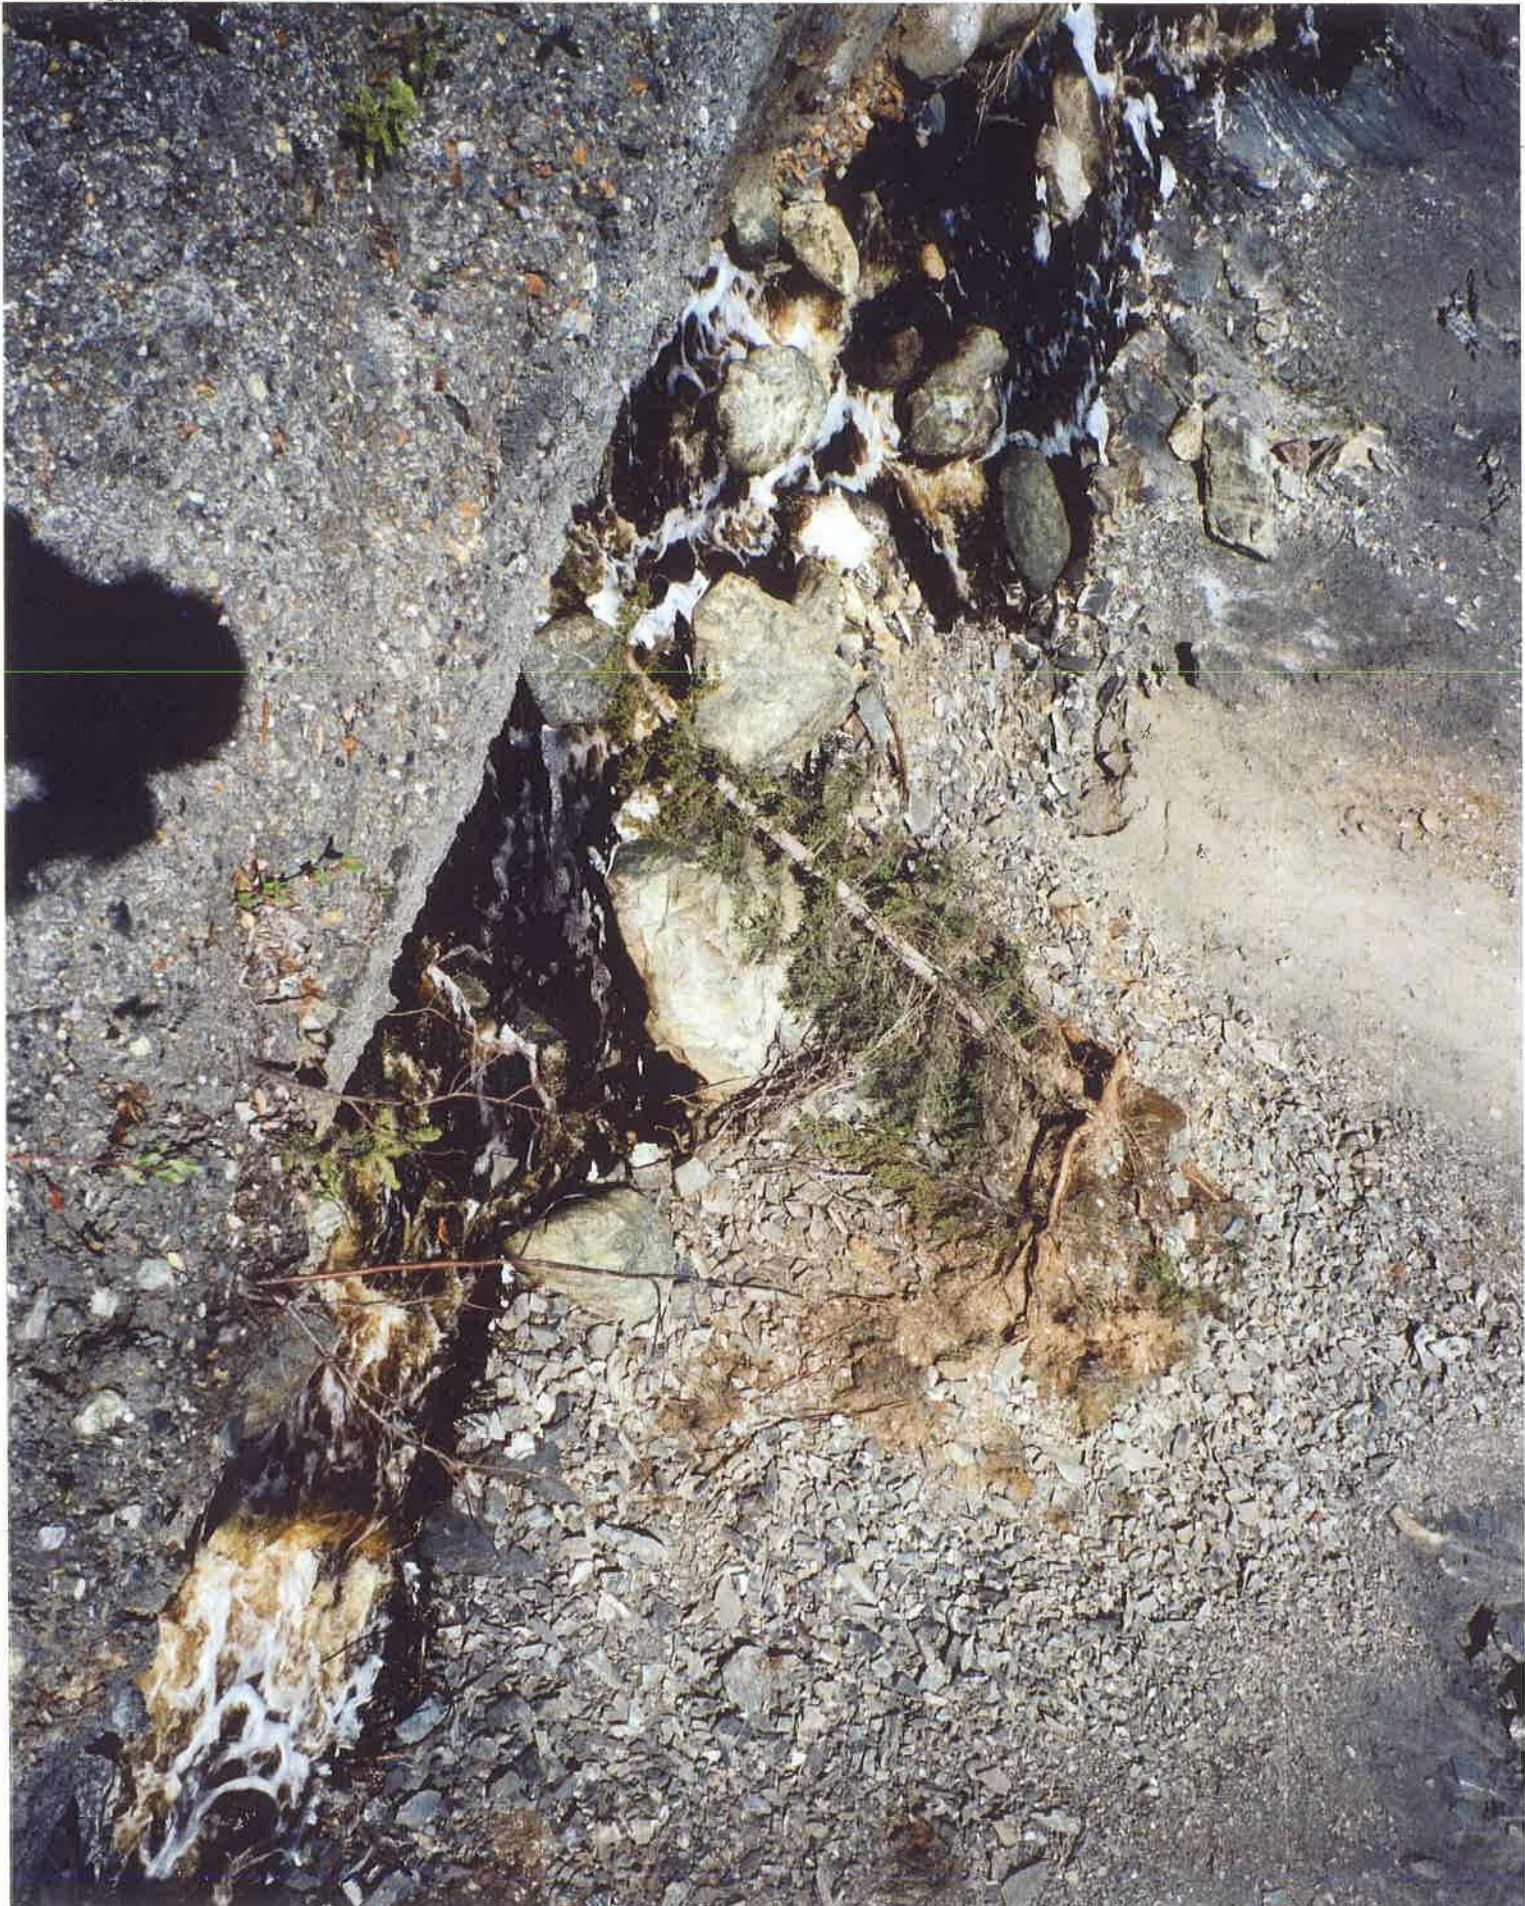
Further downstream in the channel, slumping has occurred on the native rock side of the channel, due to undercutting of the native rock (Photos F and G). Several more areas are in the process of sliding in from this same side, as you move downstream. The road bed has become more noticeably deformed through the movement of waste rock toward the Creek and new active lateral cracking of the material was observed.

Photo F: Clinton Creek channel slump - native rock side of channel

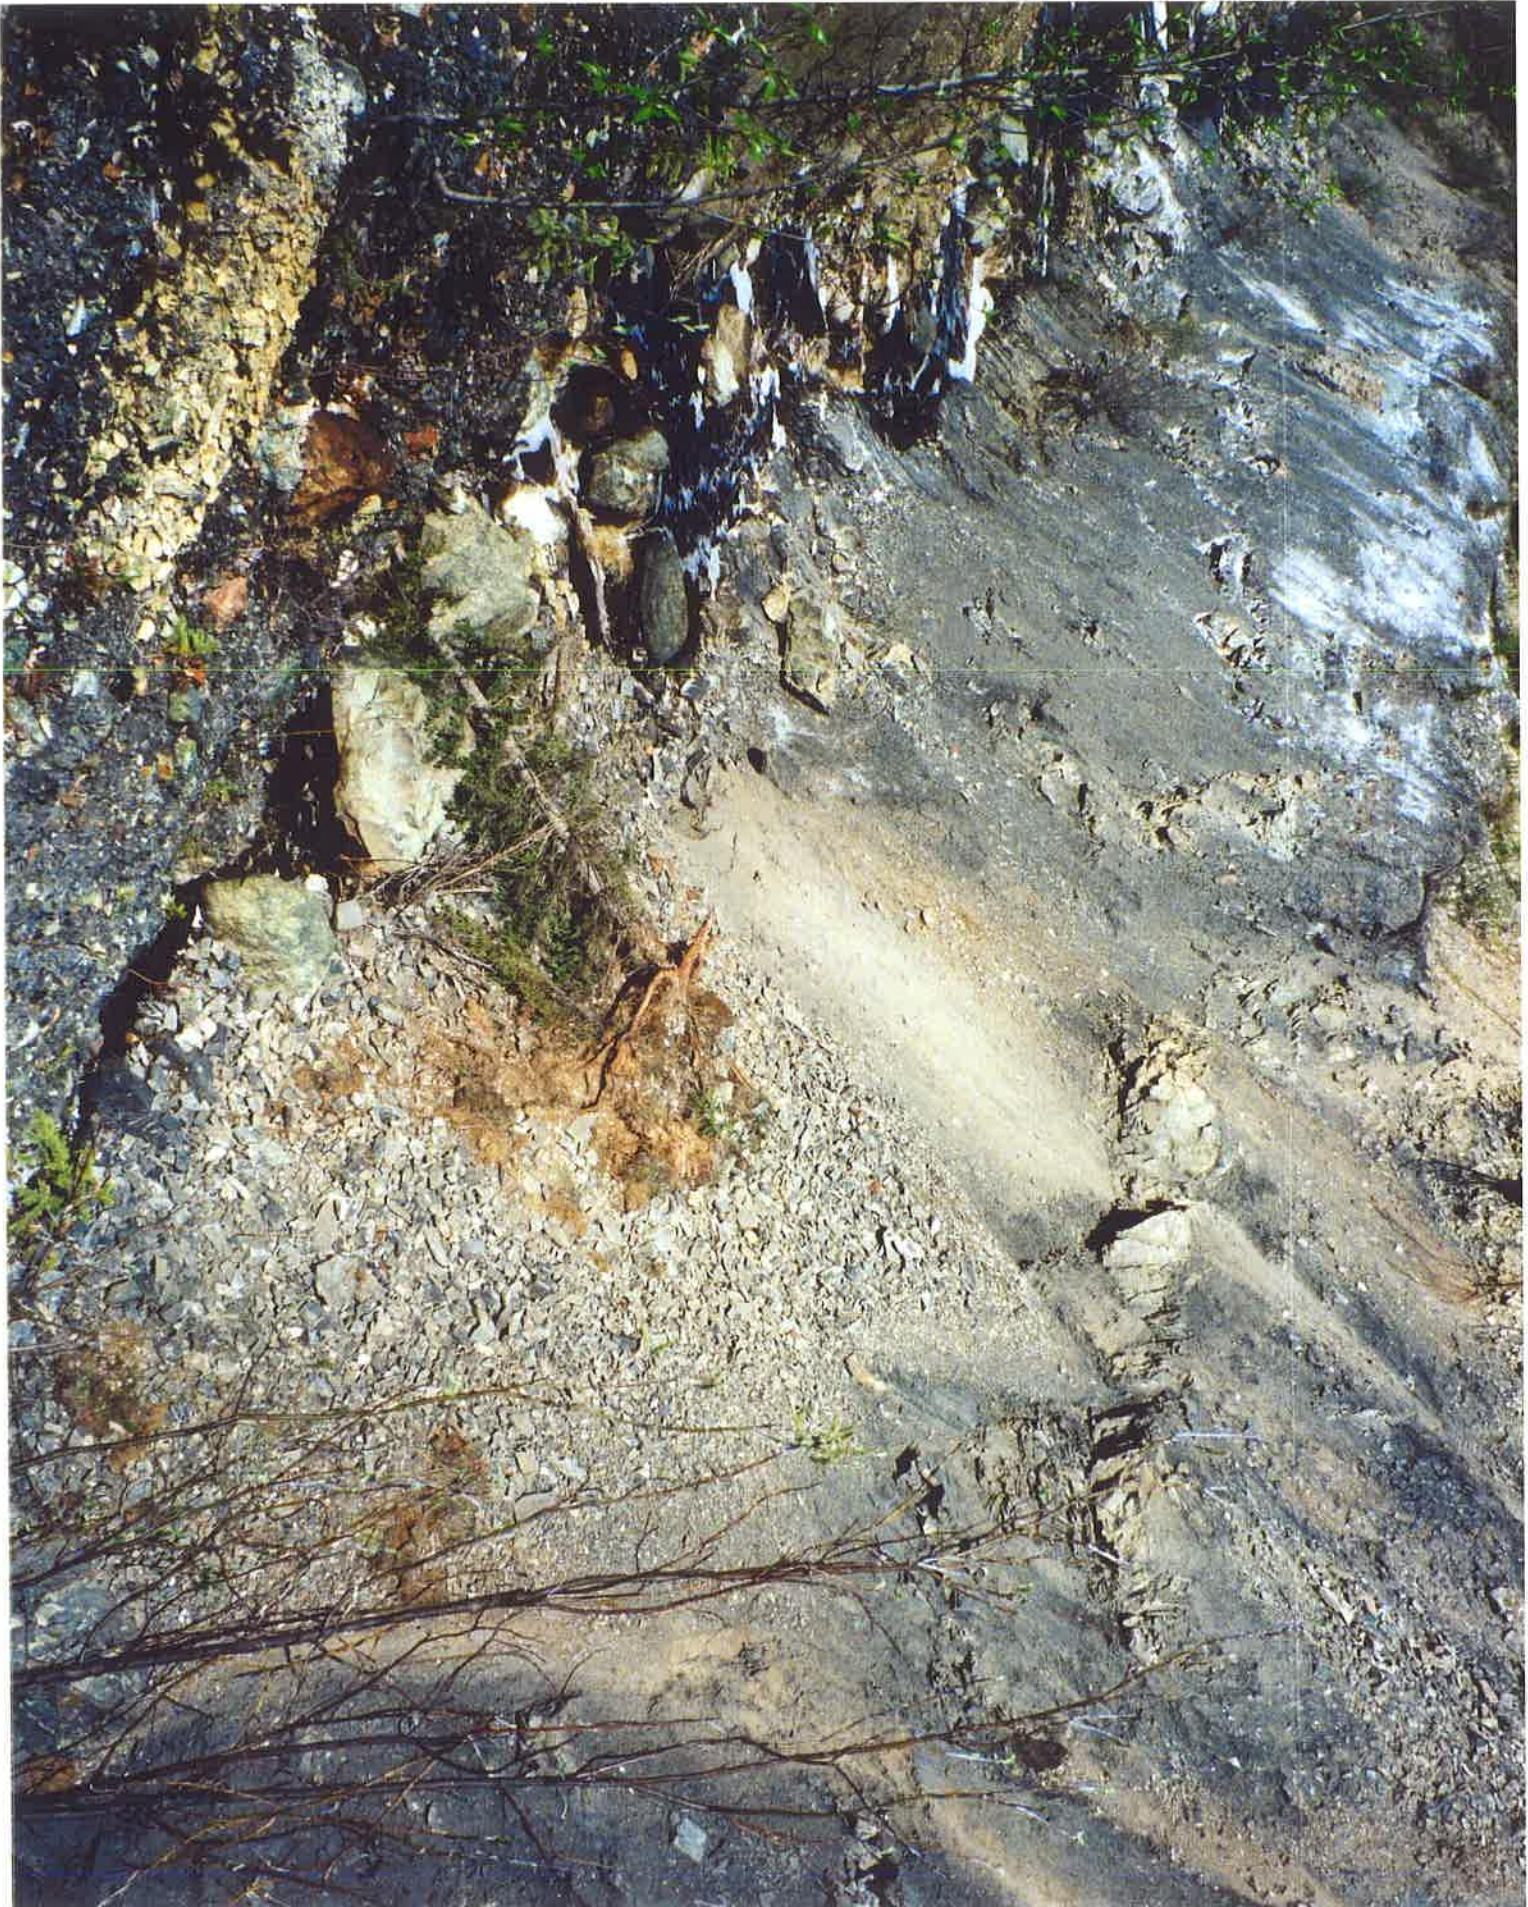
Photo G: Clinton Creek slump - looking upstream
