ABANDONED CLINTON CREEK ASBESTOS MINE

Site Visit May 21, 2002

Northern Affairs Program

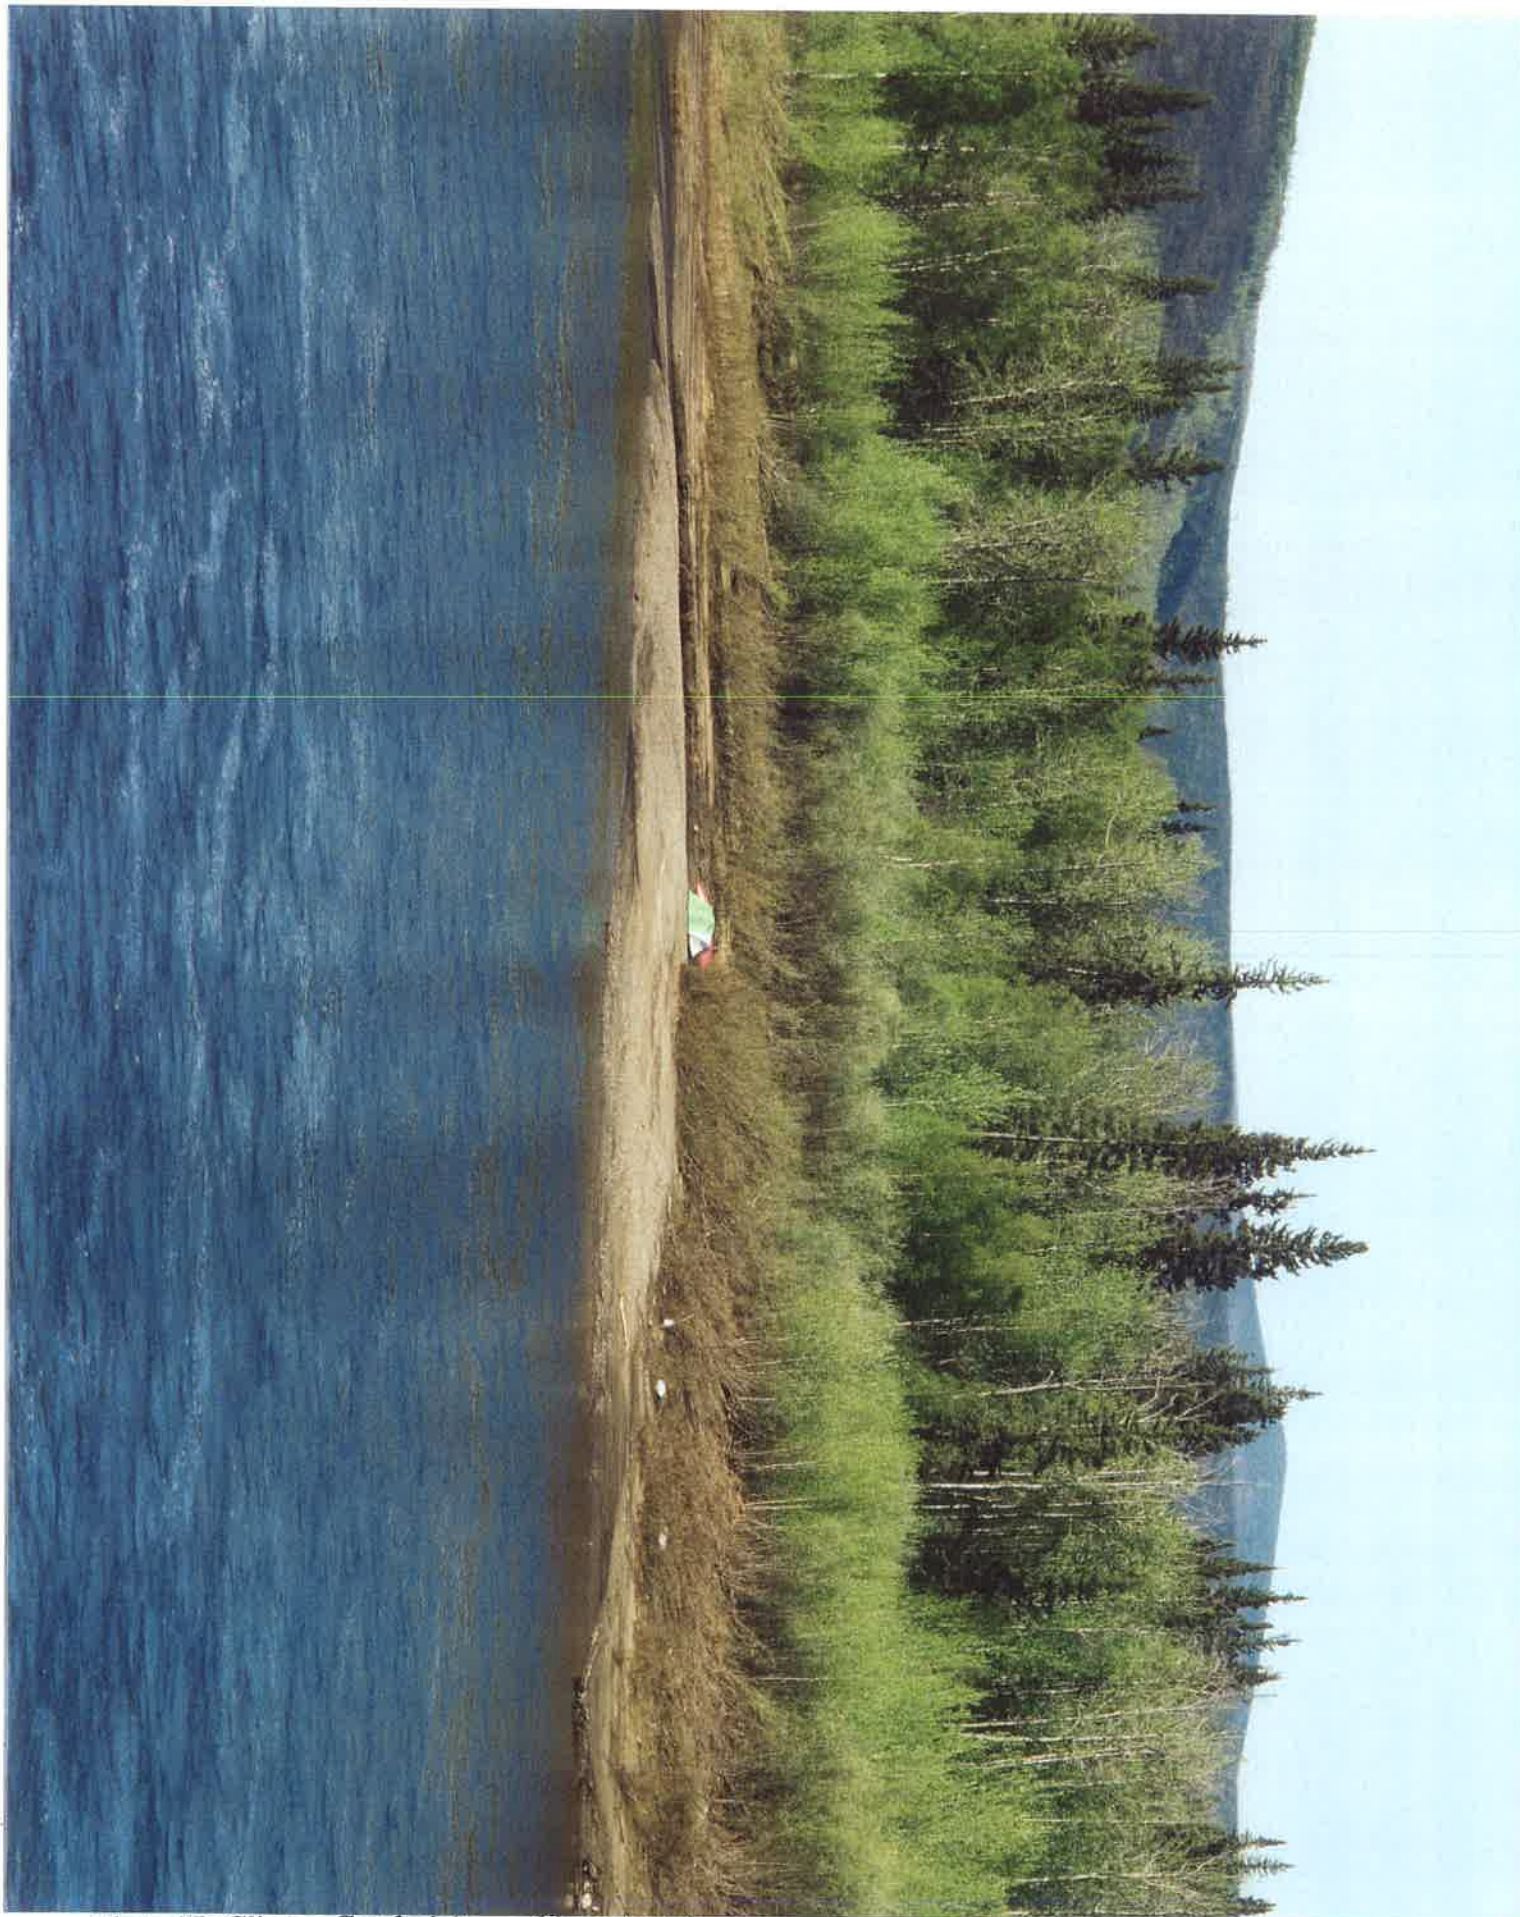
The concern for public safety, due to the instability of the waste rock plug, is the one potential effect of the Clinton Creek site that is not mitigable through post-failure action. Recent use of the Clinton Creek delta as an overnight campsite for canoeists (Photo H) entering the 40 Mile River from the Alaska side has increased the potential for risk to human health.

Photo H: Clinton Creek delta - with tents and canoes
