ANVIL RANGE MINE, YUKON

***WATER STORAGE DAM
INTERNAL PIPE INSPECTION***

SEPTEMBER 2001

DIVING DYNAMICS COMMERCIAL DIVING DIVISION

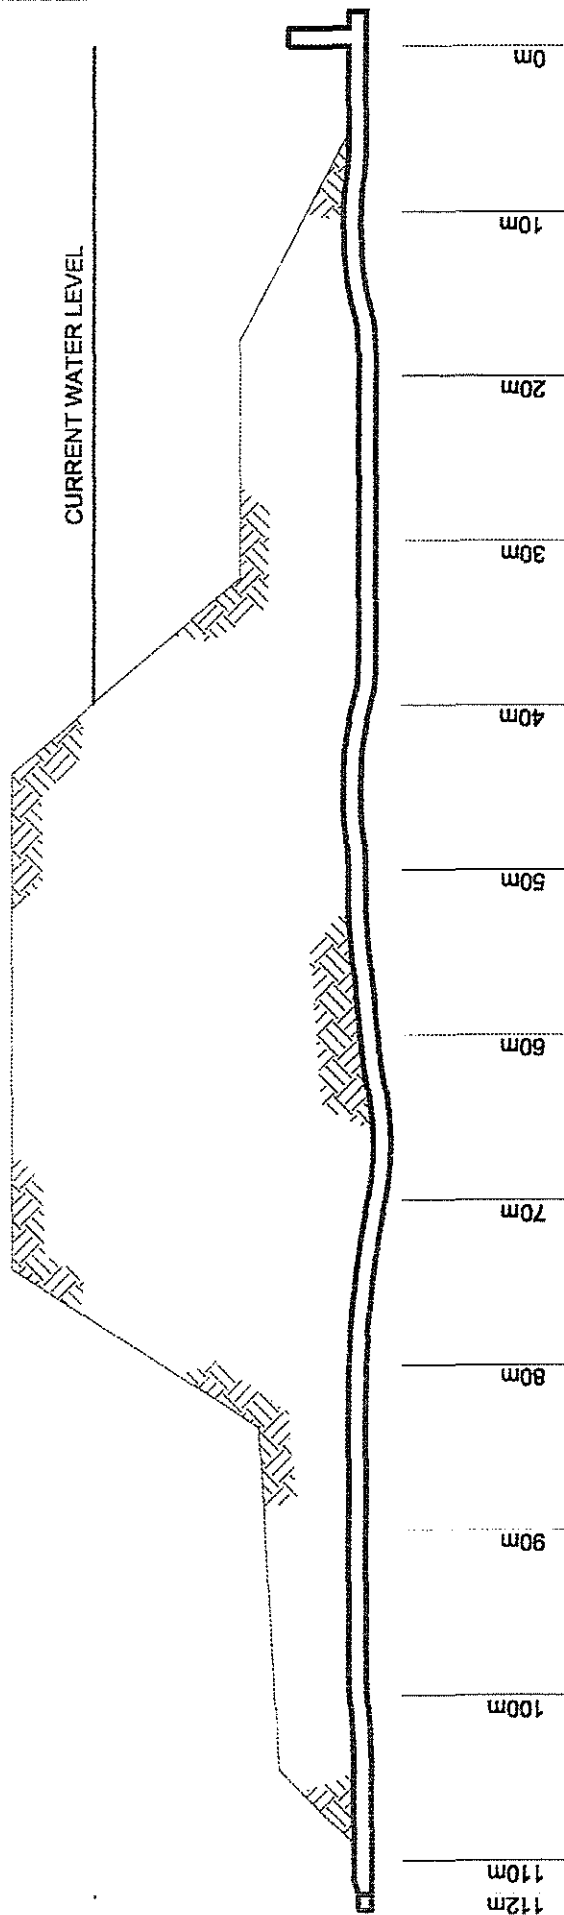
ANVIL RANGE / WATER STORAGE DAM /
PIPE PENETRATION

The area of concern is specifically the 60-meter station to the 70-meter station. Our elevations of the invert show a drop in the pipe as much as 5' over the 10 meters. Past experience has demonstrated that pipe collars force any transient water to pool typically below the pipe as it moves along to the next collar and is then forced to repeat itself again. Thus generating a void or simply water saturated loose material below the pipe. I would suggest that if you look at the dam surface carefully the slight depression that exists over the pipe in the centre of the dam is the beginning of a sinkhole. This slight depression has a diameter of approximately 3 meters and an elevation drop of approximately 7". At no other location on the dam is there a depression of this nature. The fault line that is visible from one end of the dam to the other passes through the edge of this depression.

There is another slight dip in the pipe near the 'T' as well. It should be noted that our divers when being extracted from the pipe noticed the drop in pipe elevations physically. Our outside diver tenders would be assisting our exit by coming up on the umbilical and hence with greater speed we would notice these drops.

It should be noted that we did not feel or find any joint failures during the pipe inspection. The CAD drawing shows the elevations of the pipe.
