As-Built Construction Report Fresh Water Supply Dam, Faro Mine

Project Reference Number:
SRK 1CD003.22

February 2004

**AS-BUILT CONSTRUCTION REPORT
FRESH WATER SUPPLY DAM BREACH, FARO MINE**

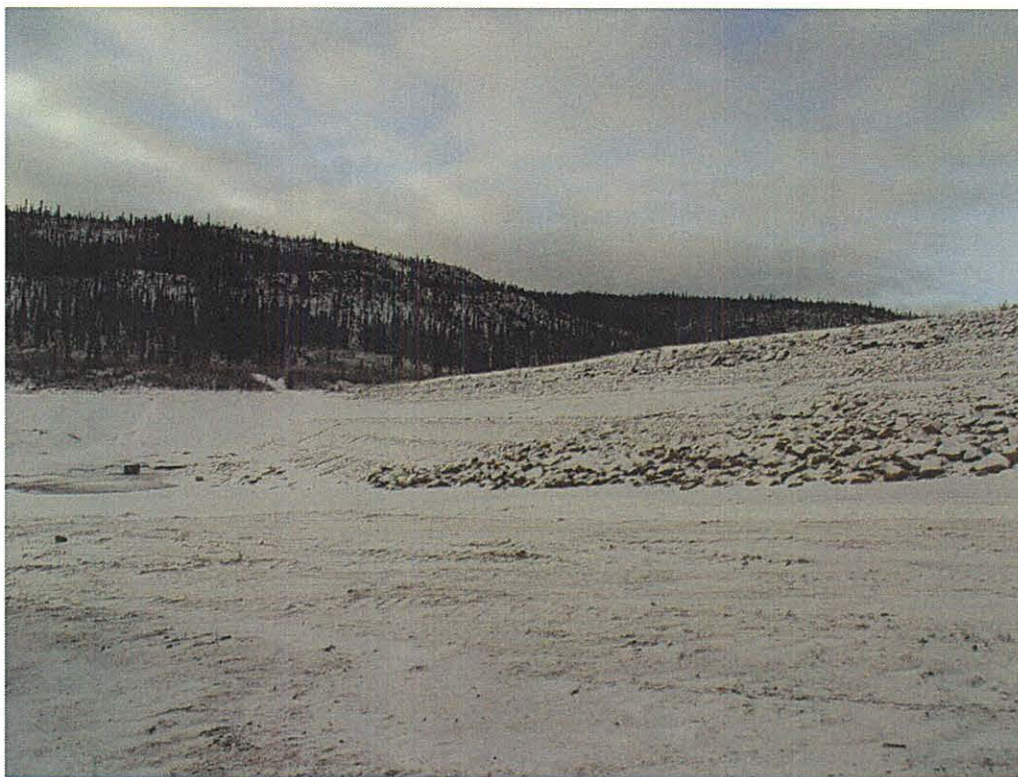
Photo 1 – Upstream face of FWS Dam, prior to breaching, Nov. 9, 2003.

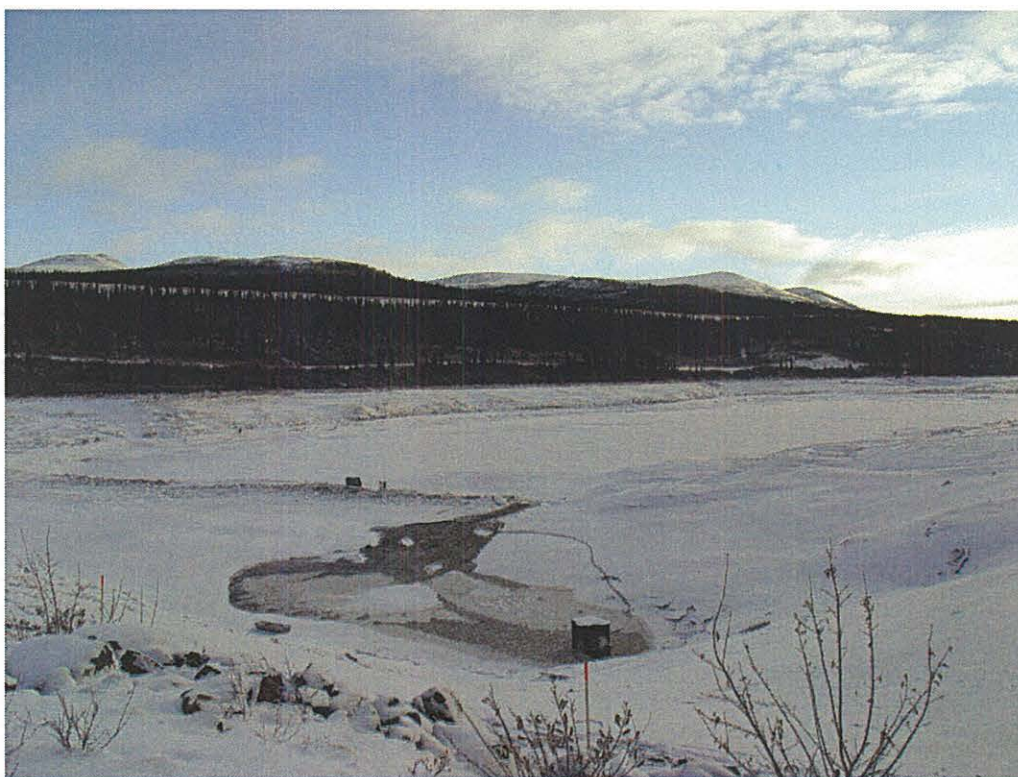
Photo 2 – View from FWS Dam of creek flow over cofferdam prior to pumping. Note position of inlet of low level outlet pipe at lower right, Nov. 9, 2003.

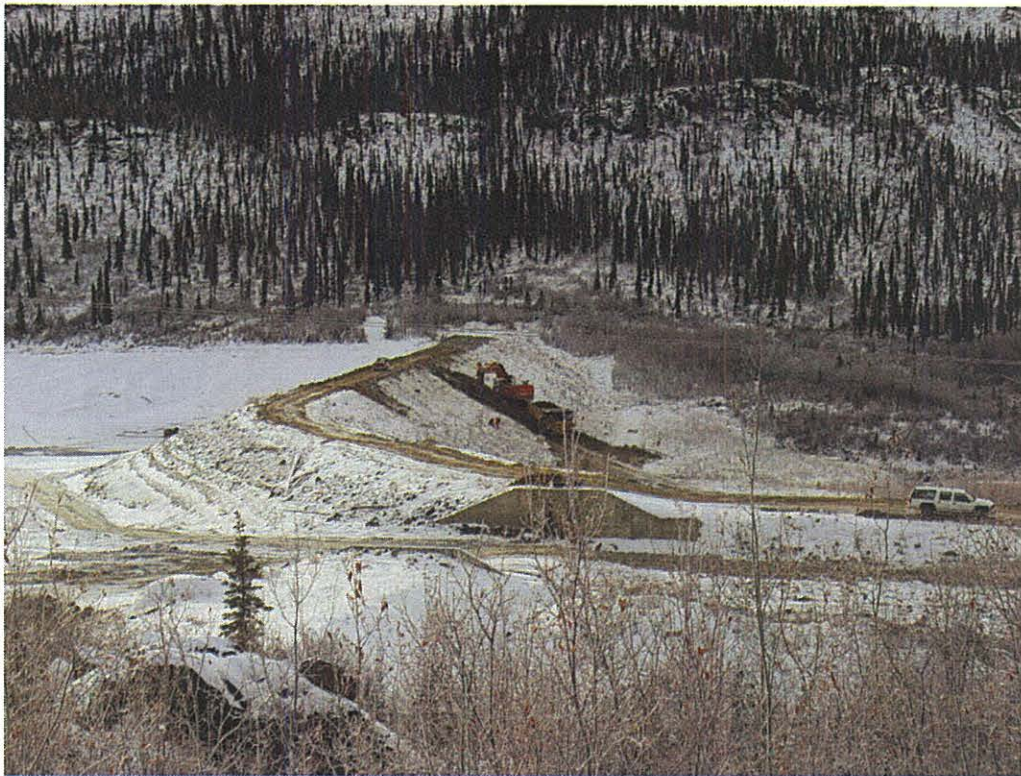
Photo 3 – Southward view of initiation of bulk excavation on downstream face, Nov. 11, 2003.

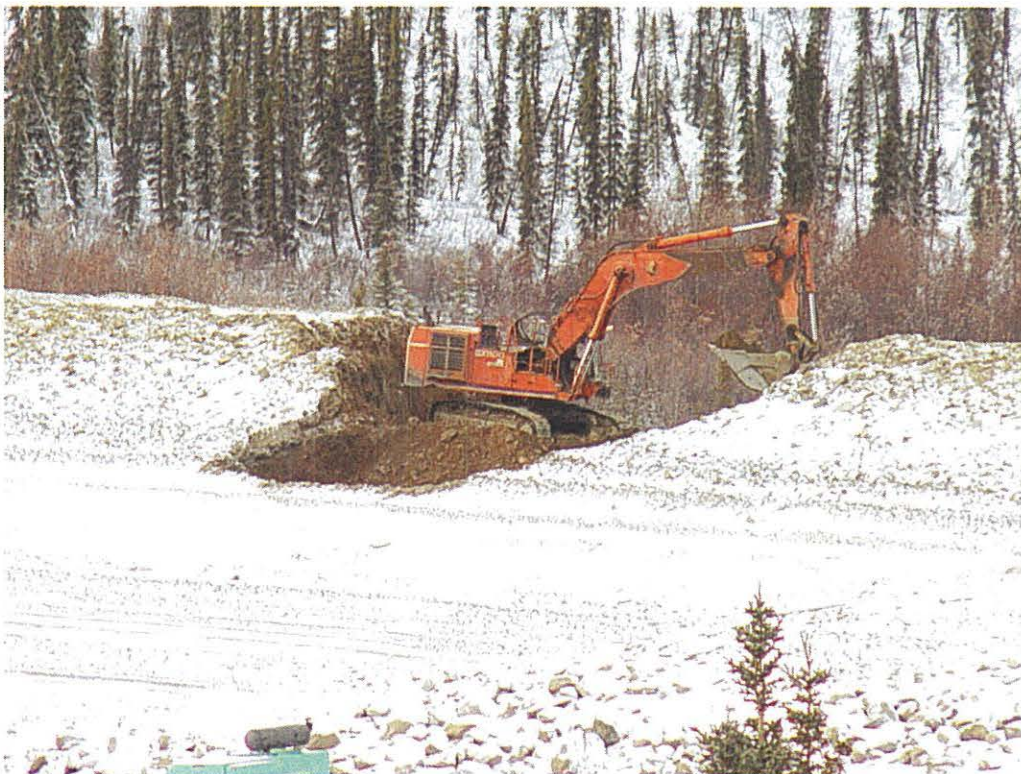
Photo 4 – Excavation of the breach through the upstream face, Nov.11, 2003.

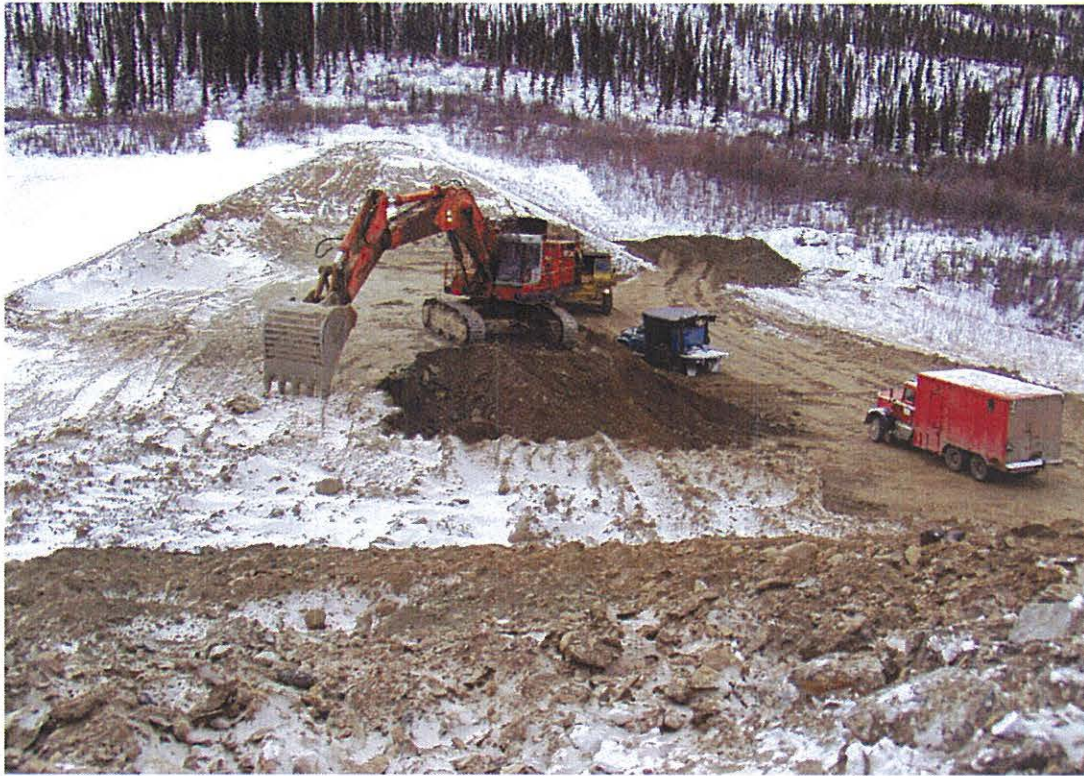
Photo 5 – Southward view of continued bulk excavation, Nov. 15, 2003.

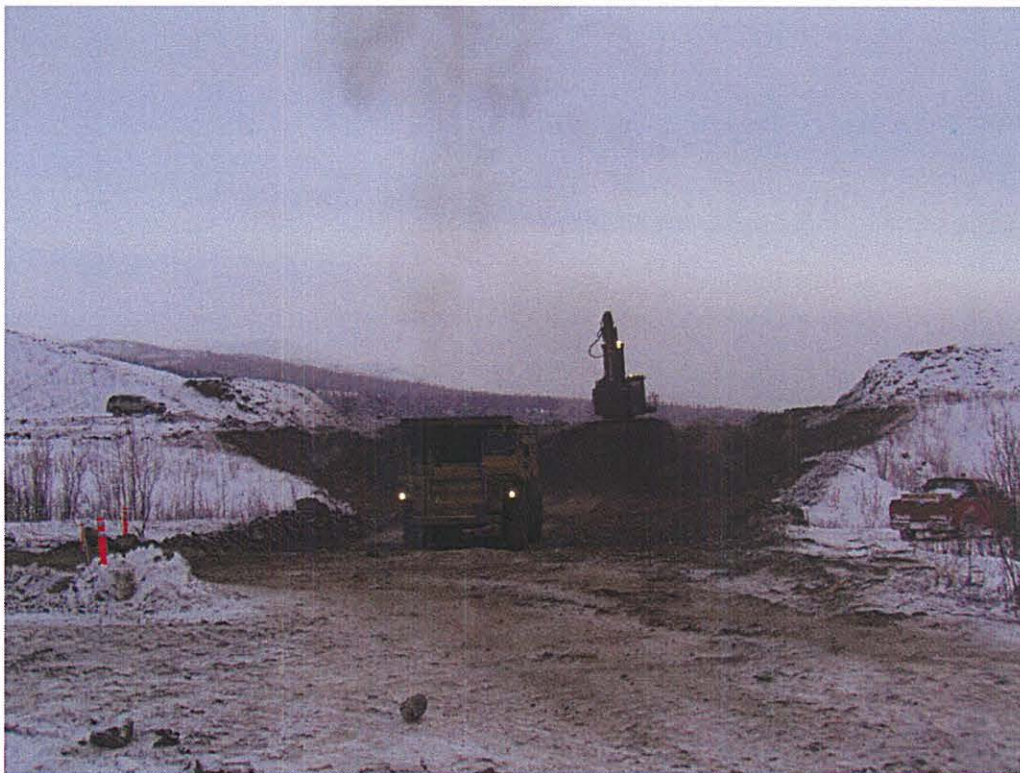
Photo 6 – Bulk excavation nearing the floodplain level, Nov. 18, 2003.

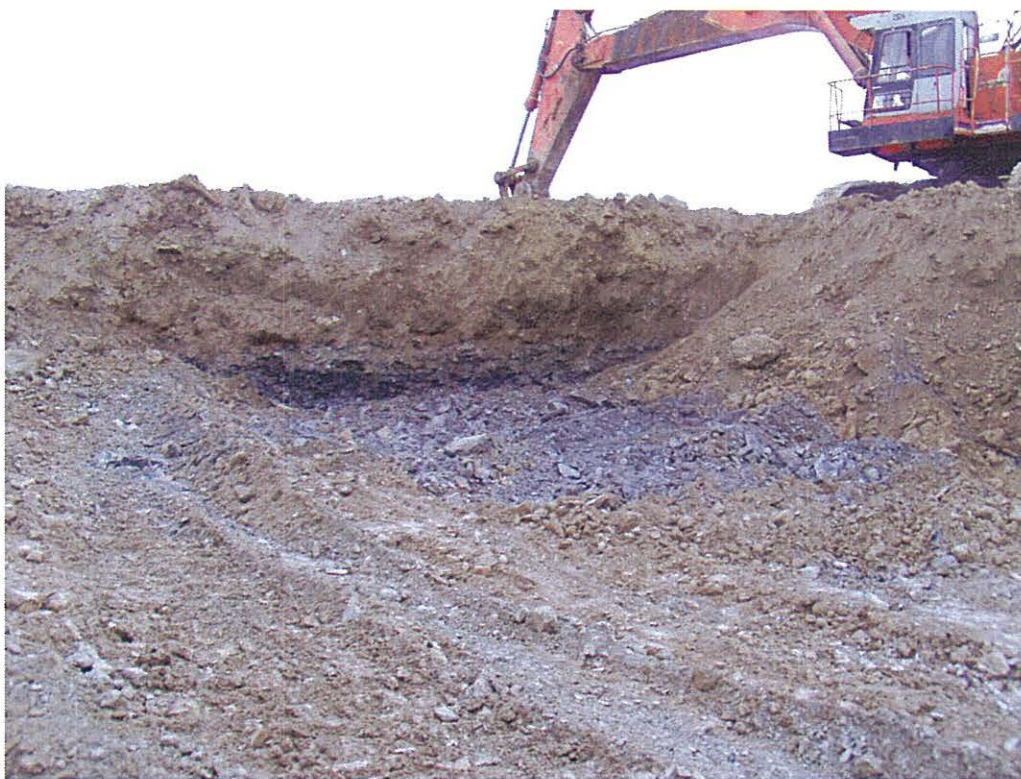
Photo 7 – Exposure of the 1969 berm, at downstream toe. The lighter grey material was taken to the PAG spoil area, Nov. 18, 2003.

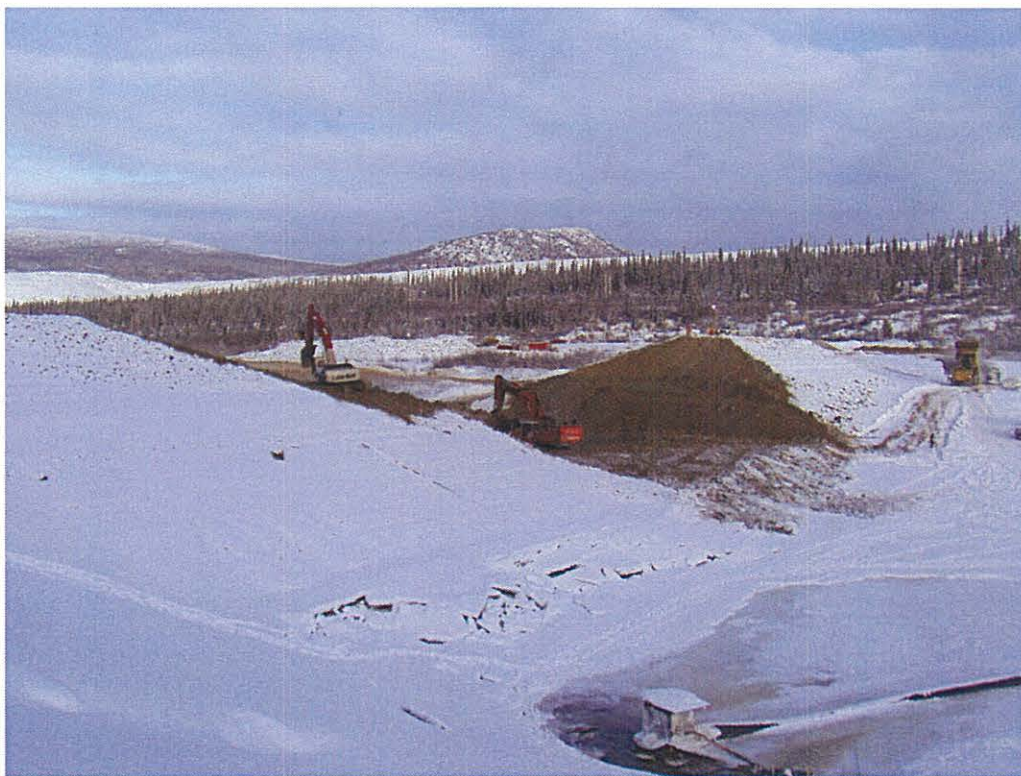
Photo 8 – Northward view of continued bulk excavation and slope trimming, Nov. 20, 2003.

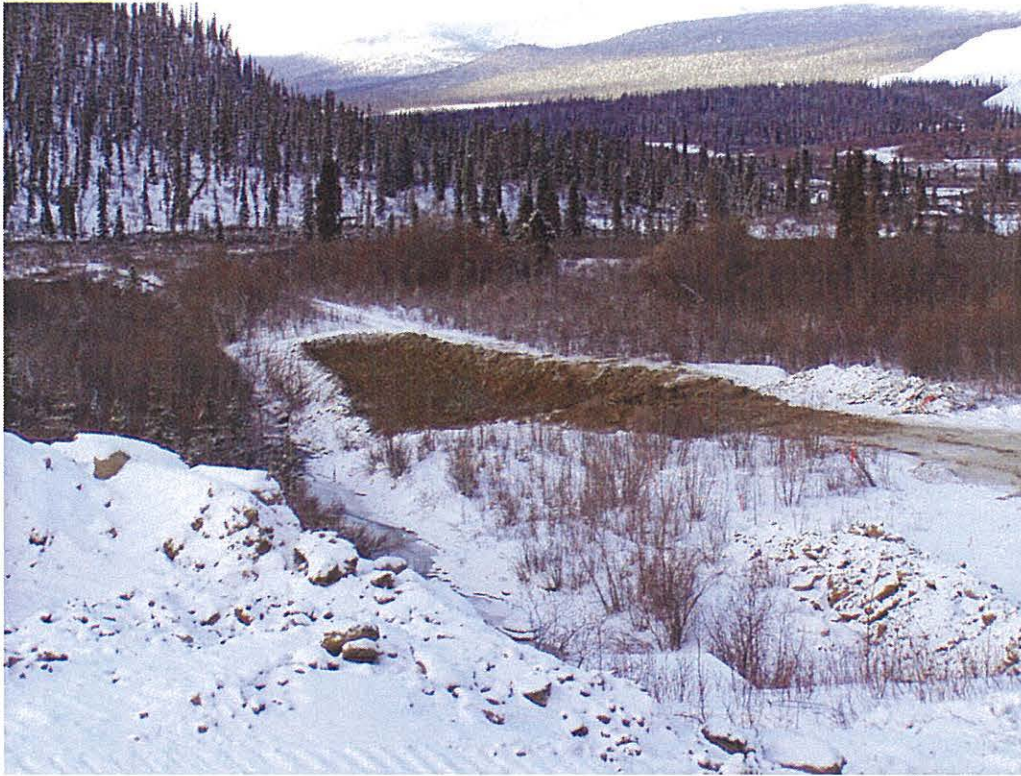
Photo 9 – Bulk excavation at the downstream limit of the breach. Fresh water channel in foreground, Nov. 23, 2003.

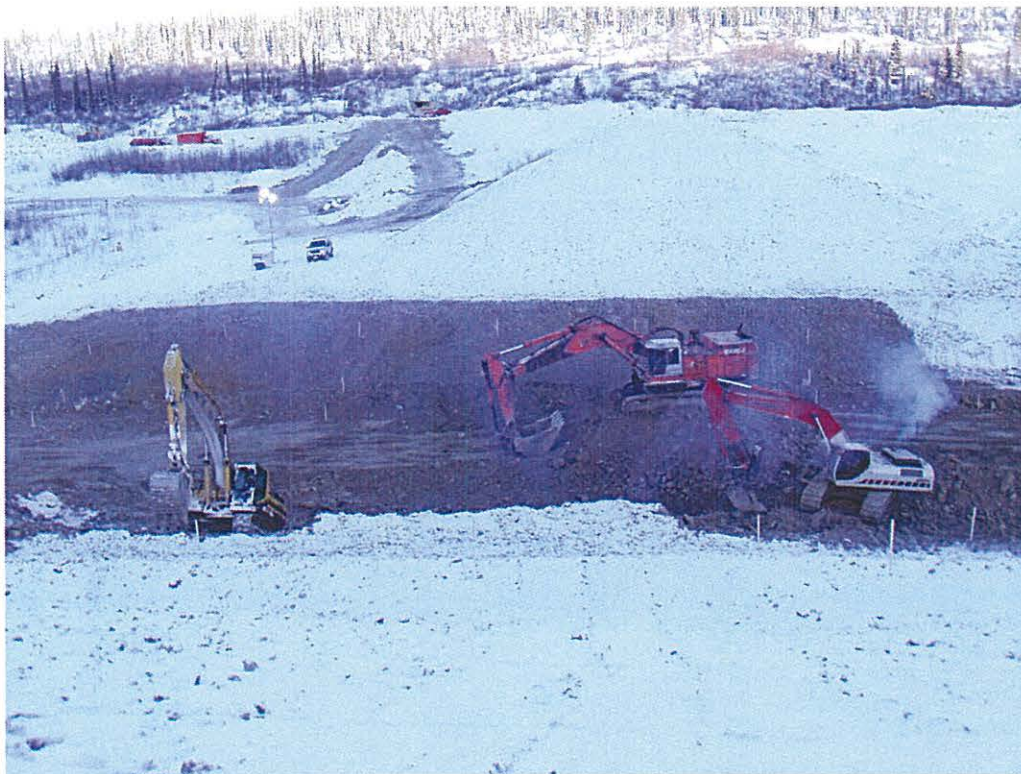
Photo 10 – Northward view of final excavation to floodplain level and slope trimming, Nov. 25, 2003.

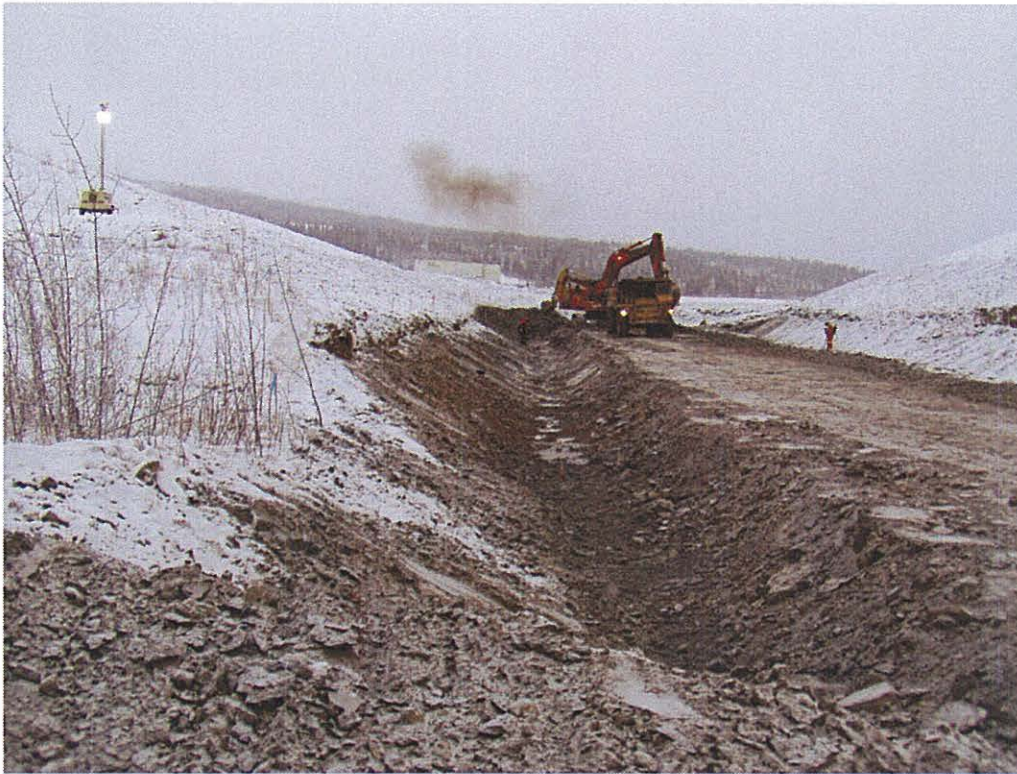
Photo 11 – Excavation for erosion protection, on right side of floodplain,
Nov. 29, 2003.

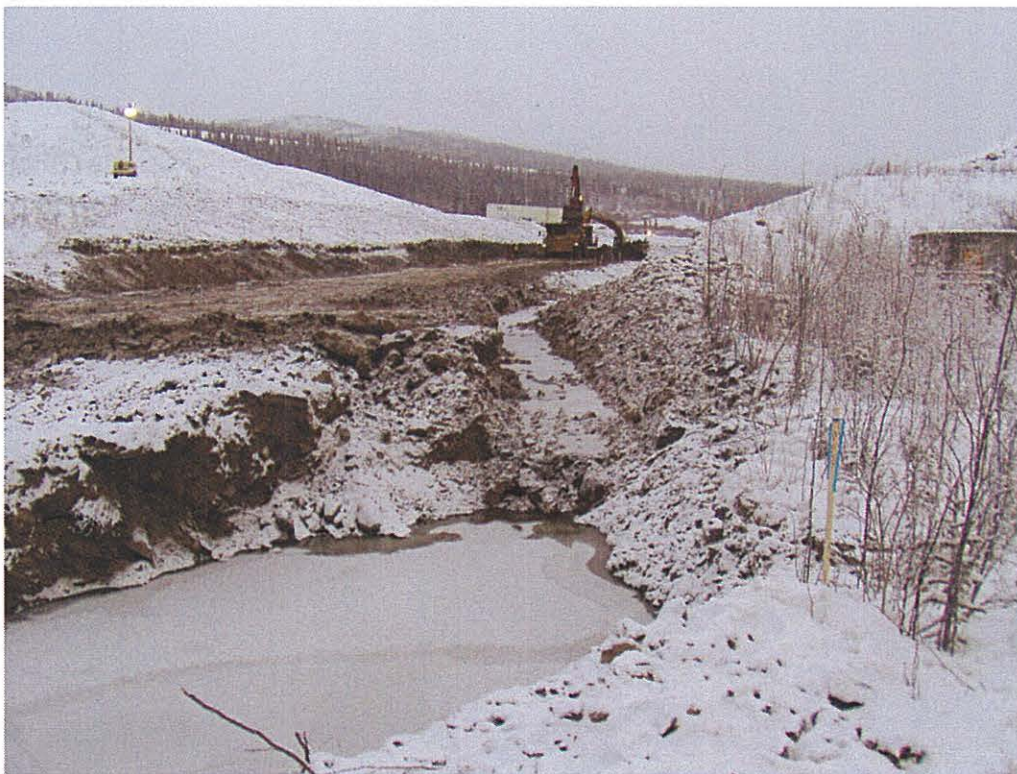
Photo 12 – Excavation for erosion protection, left side of floodplain,
Nov. 29, 2003.

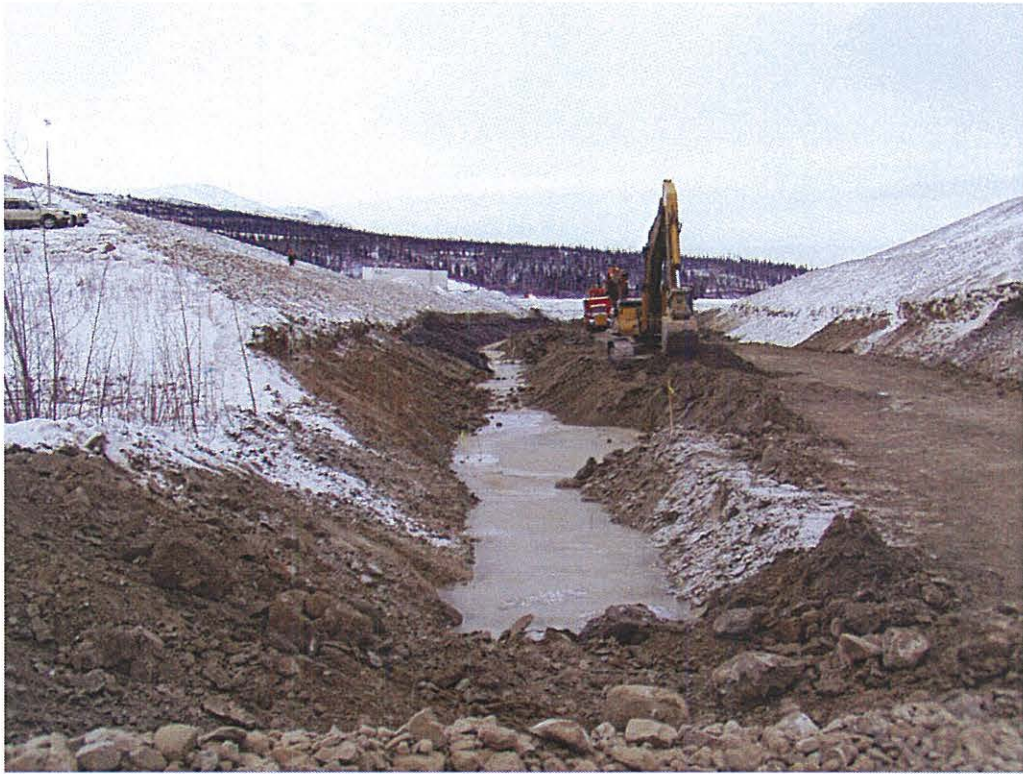
Photo 13 – Installation of geotextile, Dec. 1, 2003.

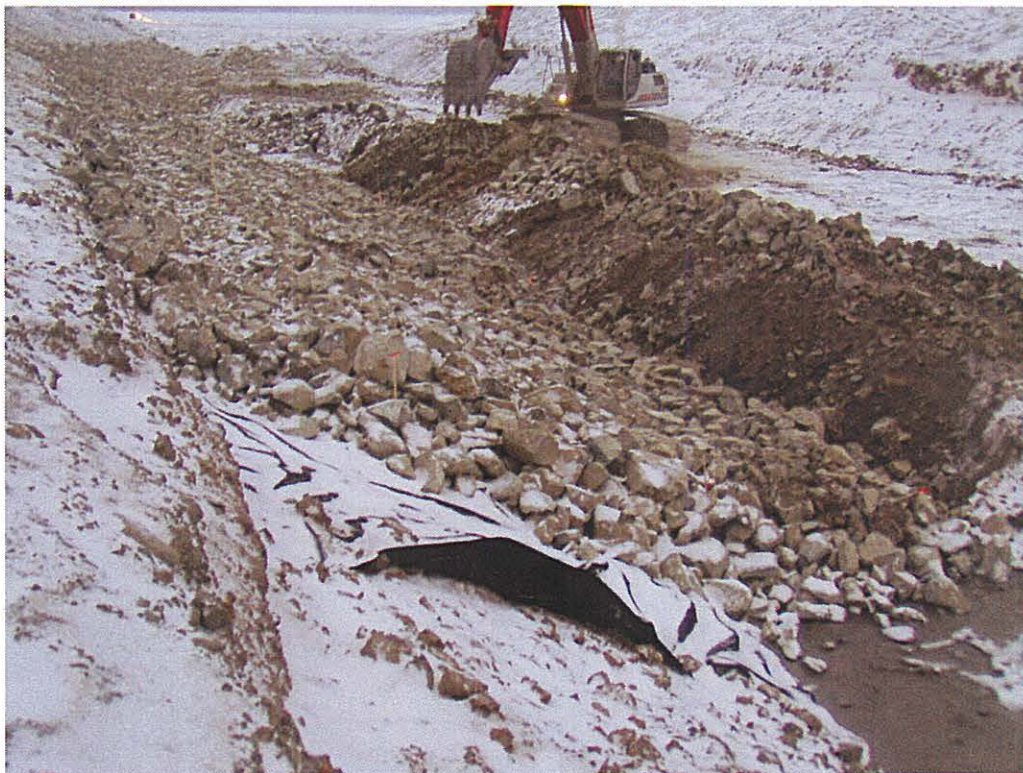
Photo 14 - Installation of rip rap within erosion protection, Dec. 2, 2003.

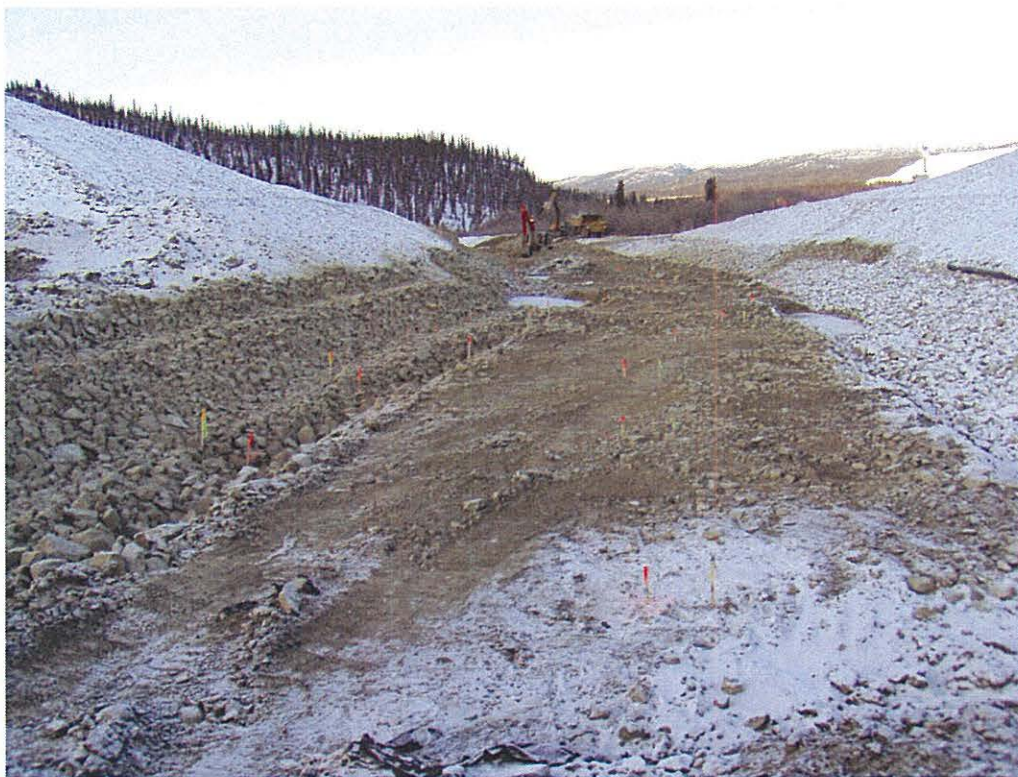
Photo 15 – View of floodplain, erosion protection riprap installed, prior to channel excavation, Dec. 4, 2003.

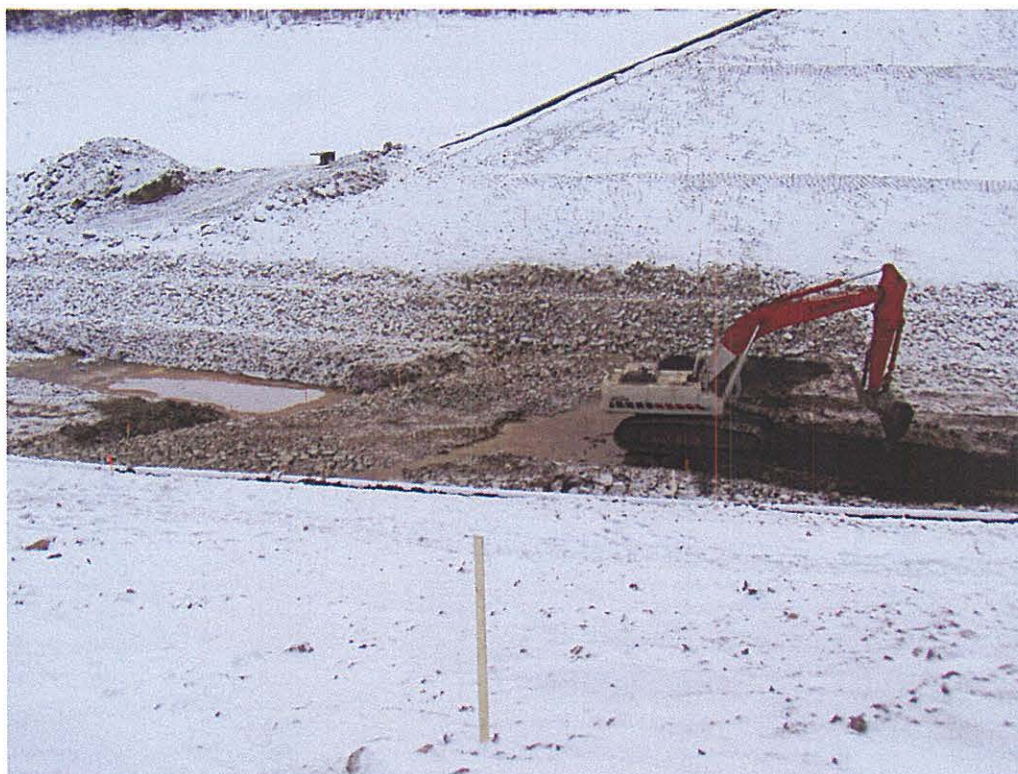
Photo 16 – Completion of the rip rap surface at riffle 1 (southward view), Dec. 7, 2003.

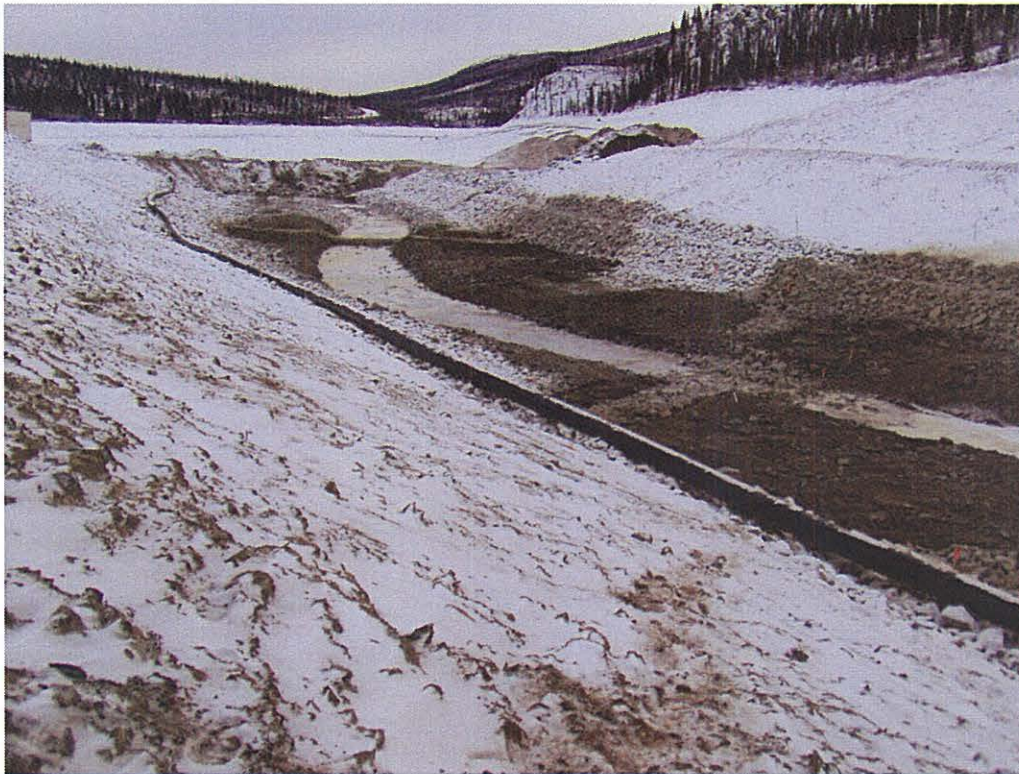
Photo 17 – View of upstream portion of completed channel, erosion protection and riffles 1 & 2, Dec. 9, 2003.

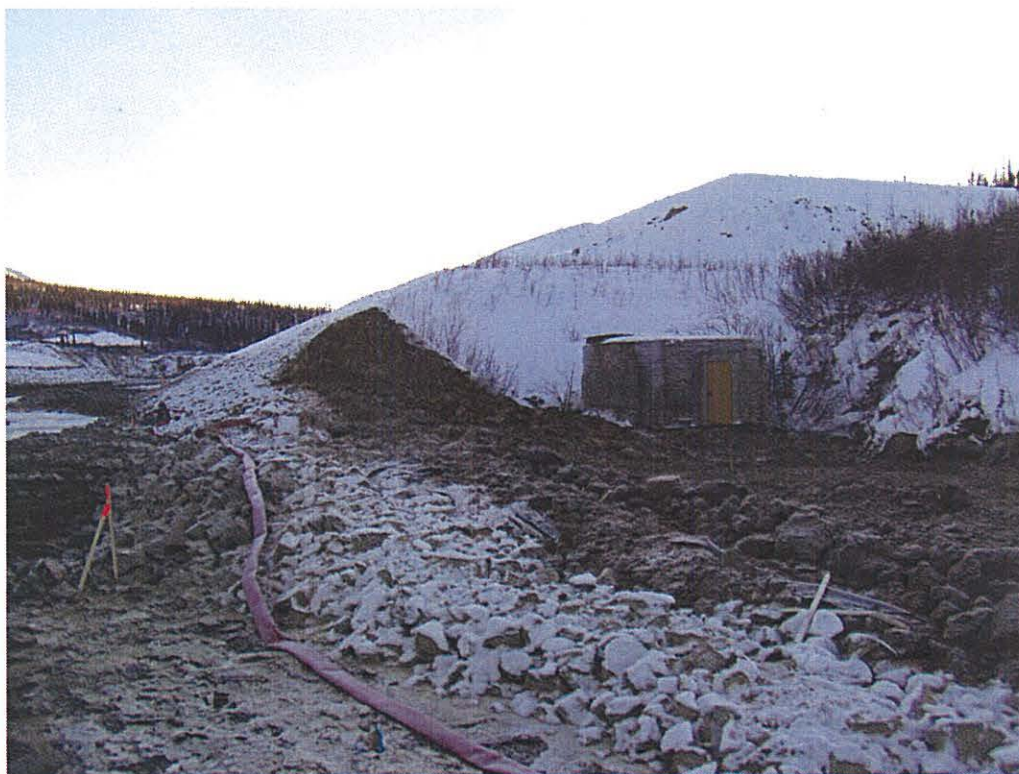
Photo 18 – View of valve house, Dec. 8, 2003.

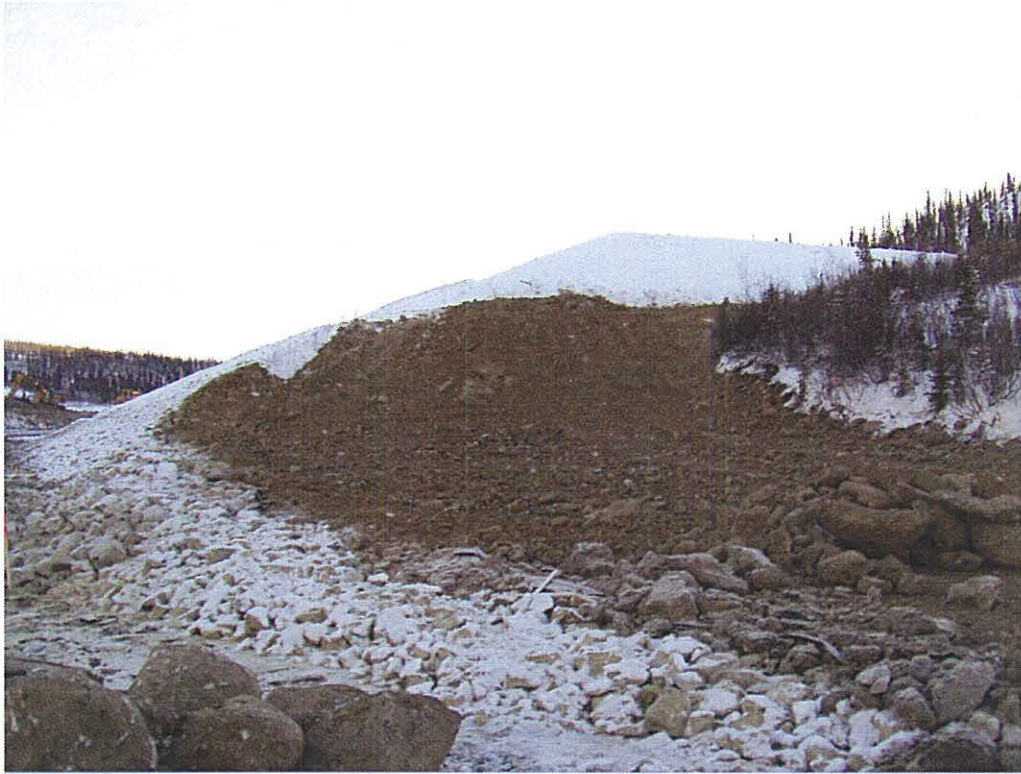
Photo 19 – Valve house removed and fill placed in fresh water channel, Dec. 11, 2003.

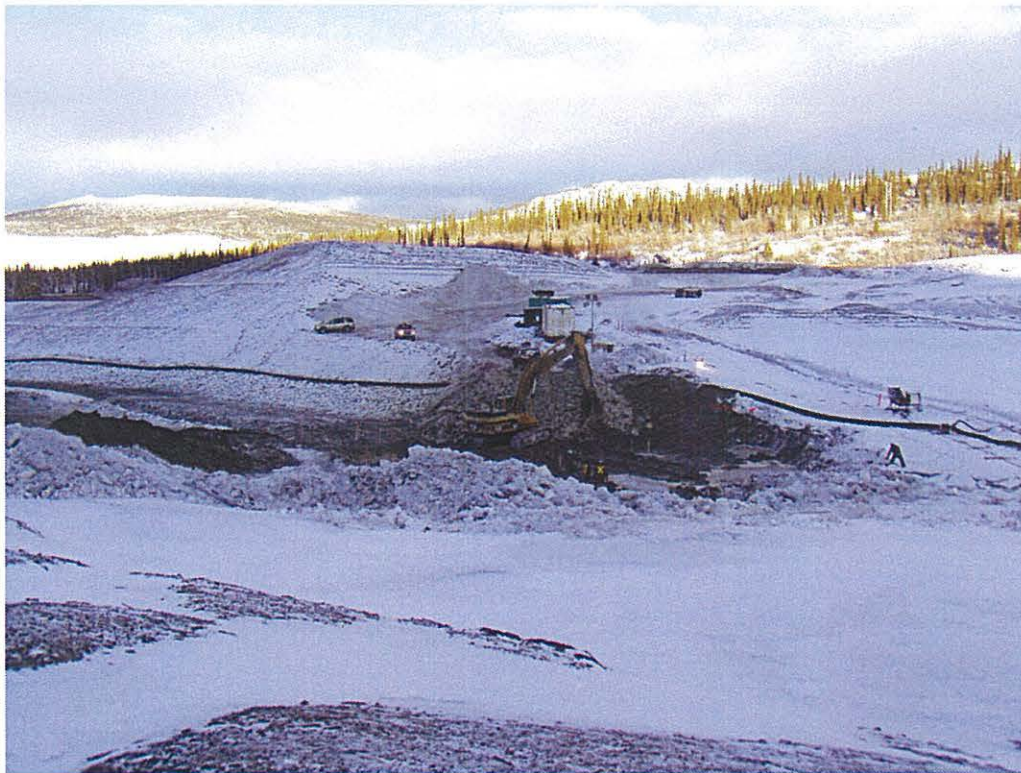
Photo 20 – Excavation of final portion of the channel at the location of the cofferdam, Dec. 13, 2003.

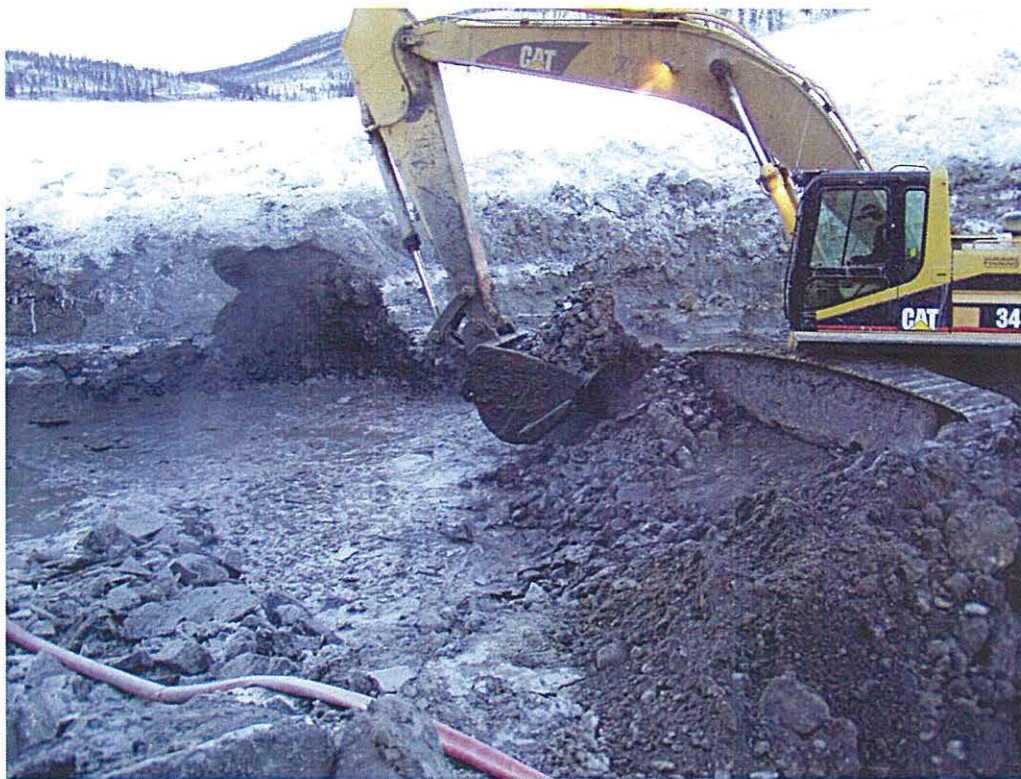
Photo 21 – Excavation for the placement of the inlet structure, Dec. 14, 2003.

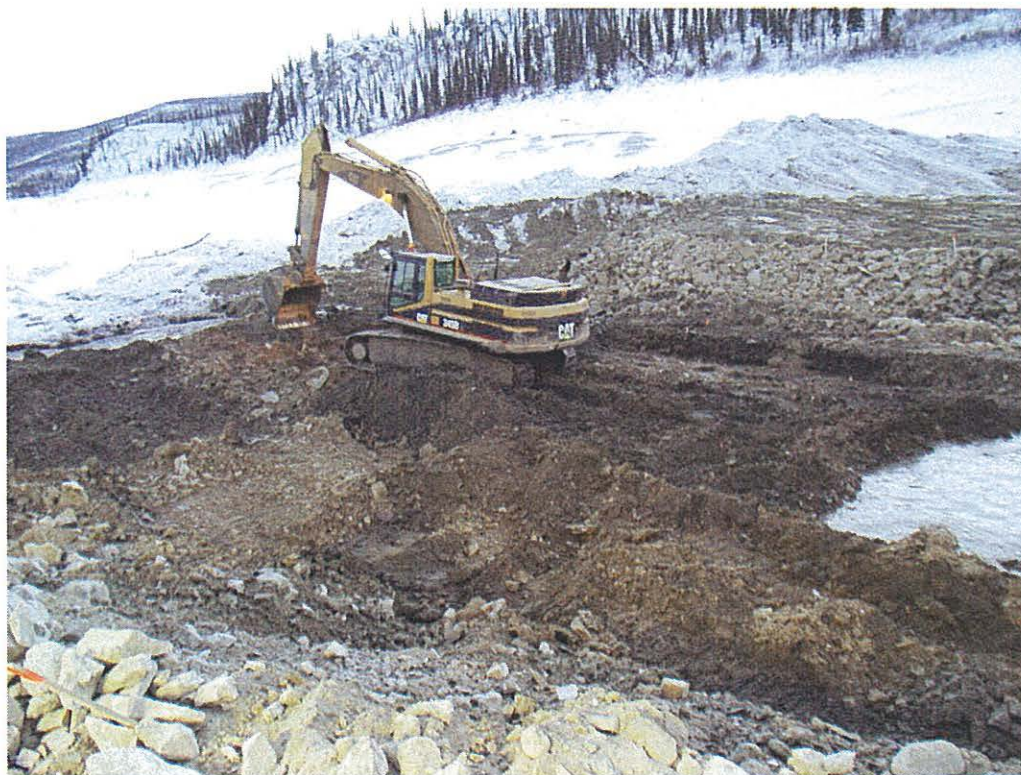
Photo 22 – Excavation for the downstream apron of the inlet structure, Dec 15, 2003.

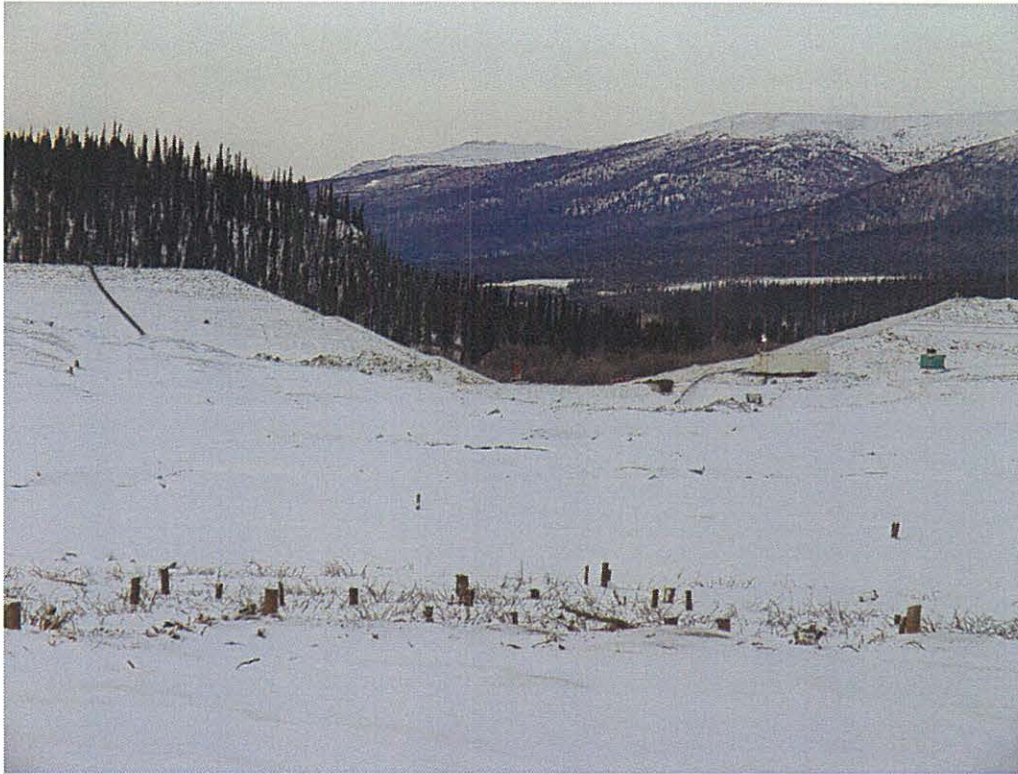
Photo 23 – Overview of completed breach, Dec. 16, 2003.

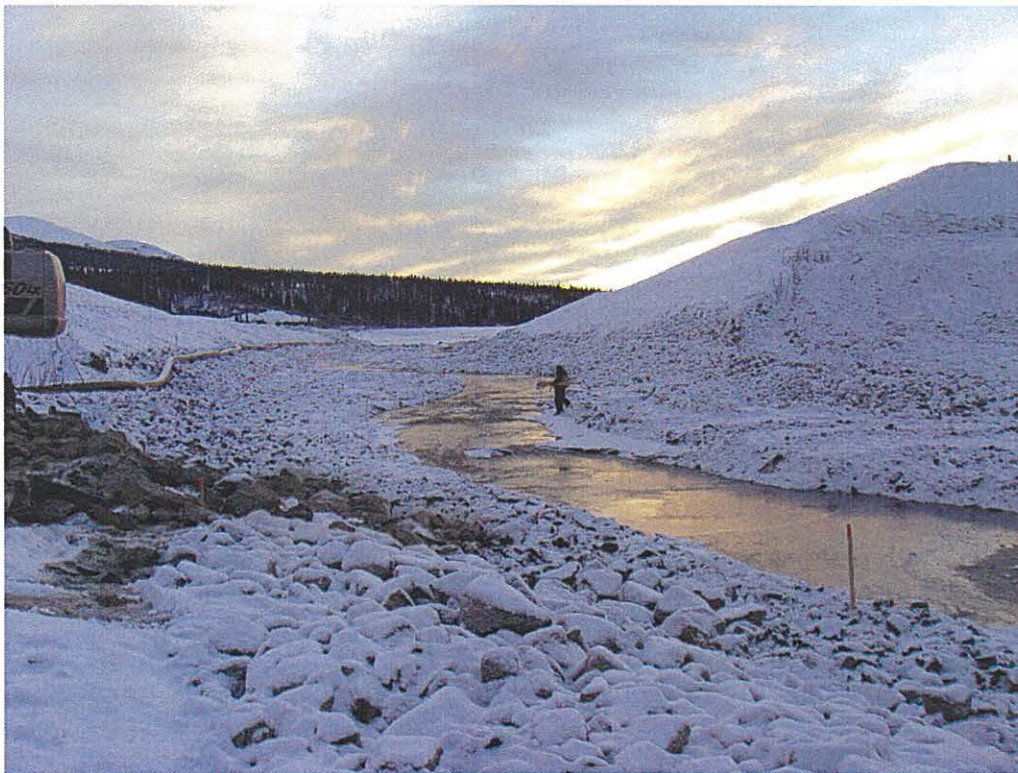
Photo 24 – Completed construction, looking at middle portion of the breach, Dec. 16, 2003.

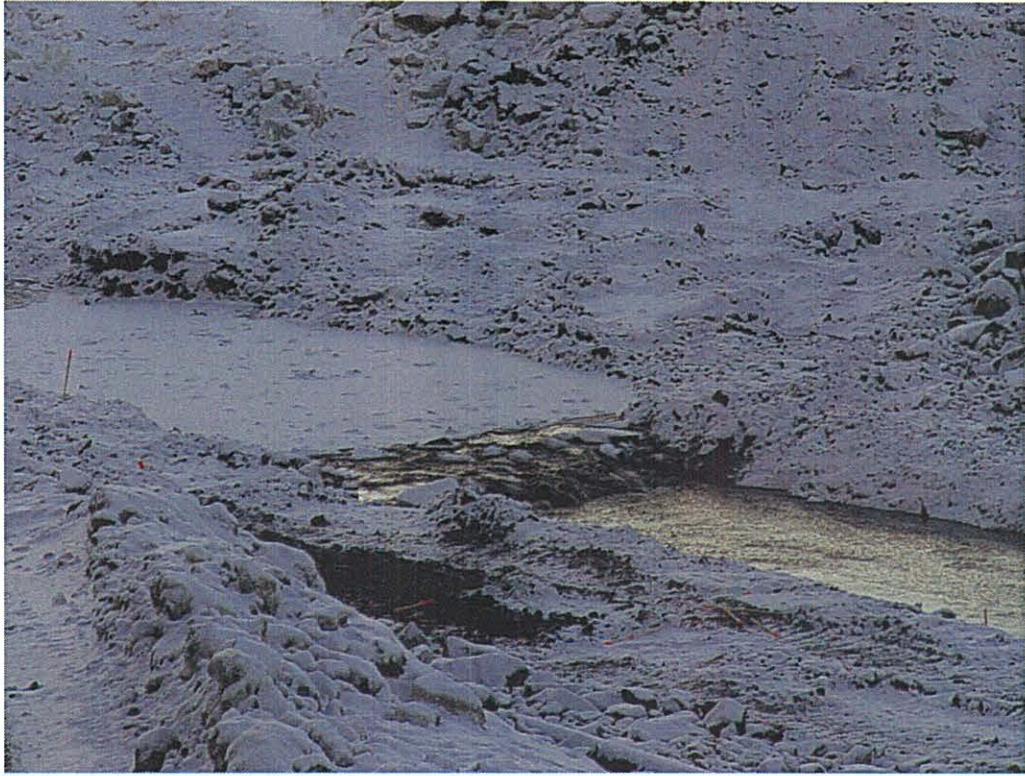
Photo 25 – Crest of the inlet structure, Dec. 16, 2003.

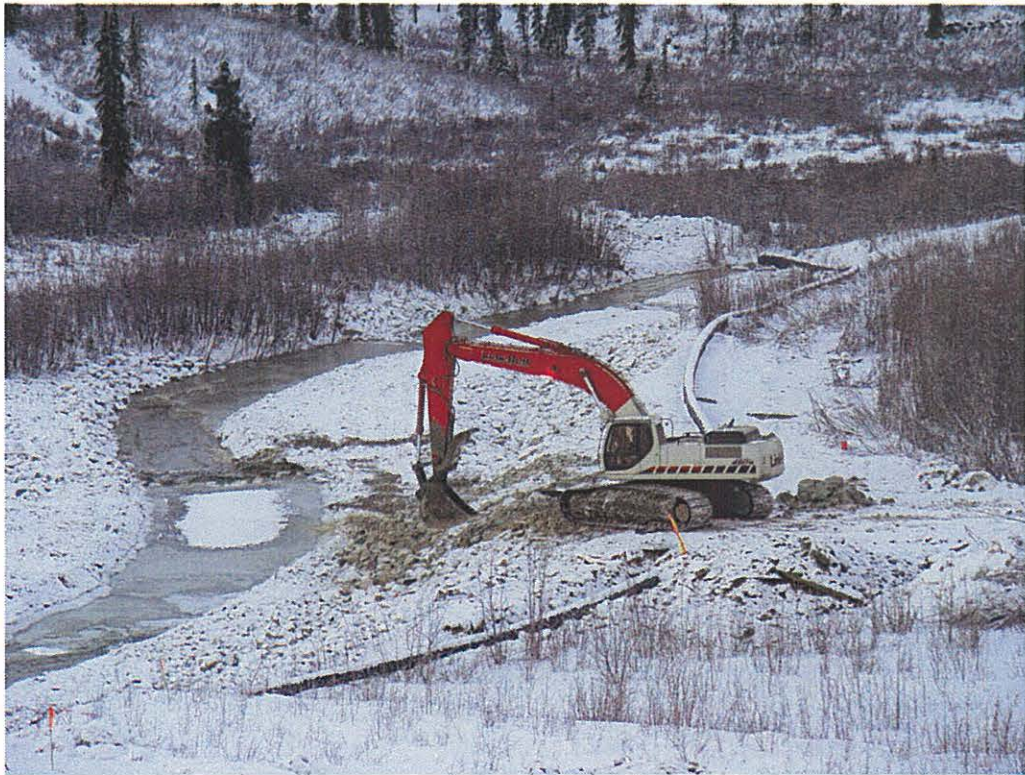
Photo 26 – View of the downstream portion of the completed channel and floodplain, Dec. 16, 2003.

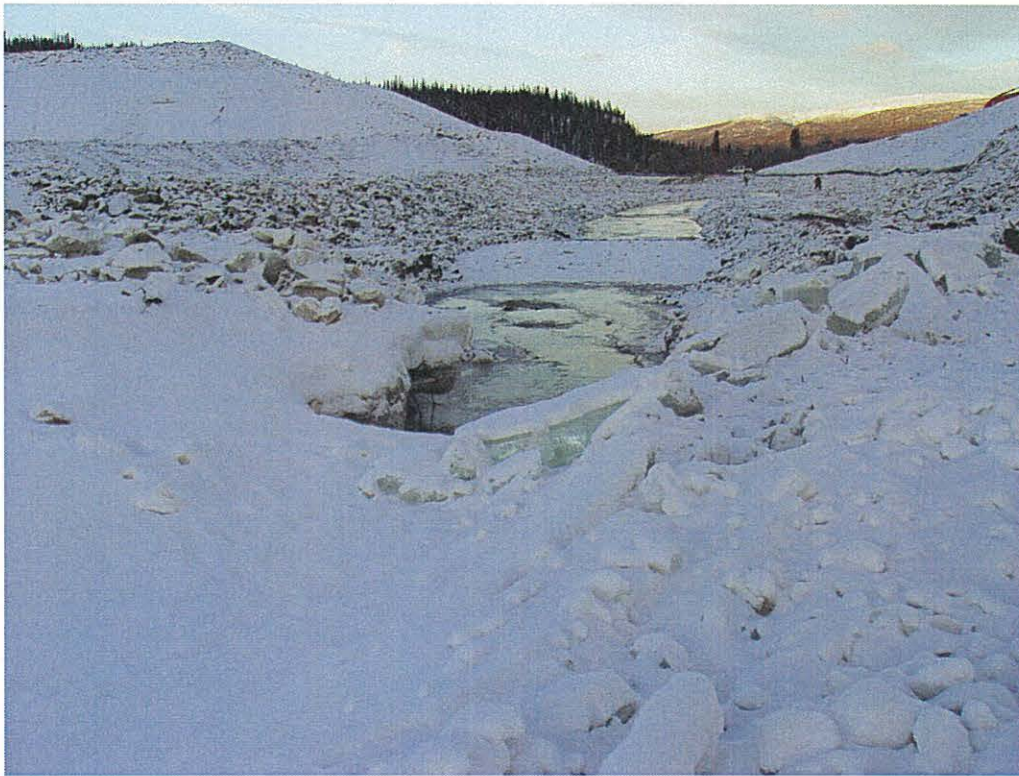
Photo 27 – View looking downstream at the completed breach. Photo taken from upstream of the inlet structure, Dec. 16, 2003.
