As-Built Construction Report Fresh Water Supply Dam, Faro Mine

Project Reference Number:
SRK 1CD003.22

February 2004

**AS-BUILT CONSTRUCTION REPORT
FRESH WATER SUPPLY DAM BREACH, FARO MINE**

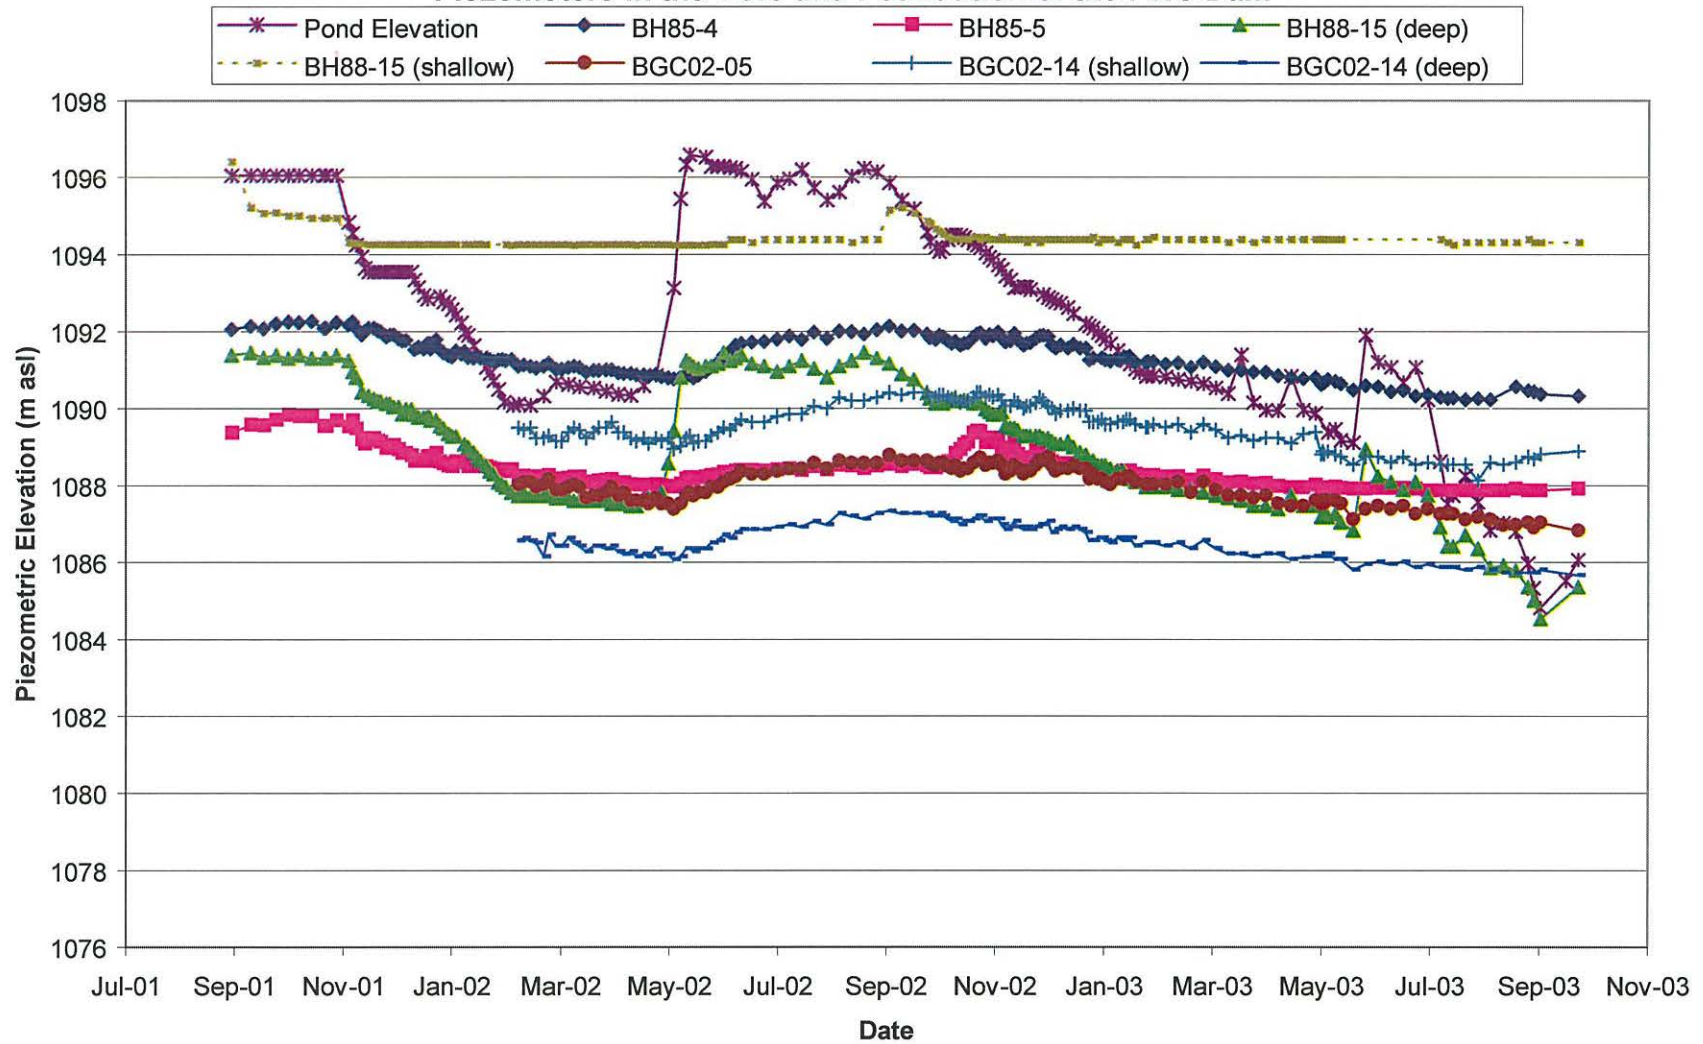
Figure 1

The reservoir level has been lowered and maintained at low levels throughout the spring, summer and fall. The reservoir elevation and the piezometric elevations for 2003 are shown on Figure 1. The piezometric elevations within the core of the FWS dam at the end of October/beginning of November can be used to represent the immediately post-construction piezometric conditions. Given that the reservoir was maintained at very low levels throughout the year, the measured piezometric elevations are almost the same as those assumed for the long term analysis.
