**Re: EBA Engineering Report “Brown-McDade Pit Assessment at the Mount Nansen Site”  
(November 2012)**

## **BROWN - McDADE PIT ASSESSMENT AT THE MOUNT NANSSEN SITE**

NOVEMBER 2012  
ISSUED FOR USE  
EBA FILE: V13401062

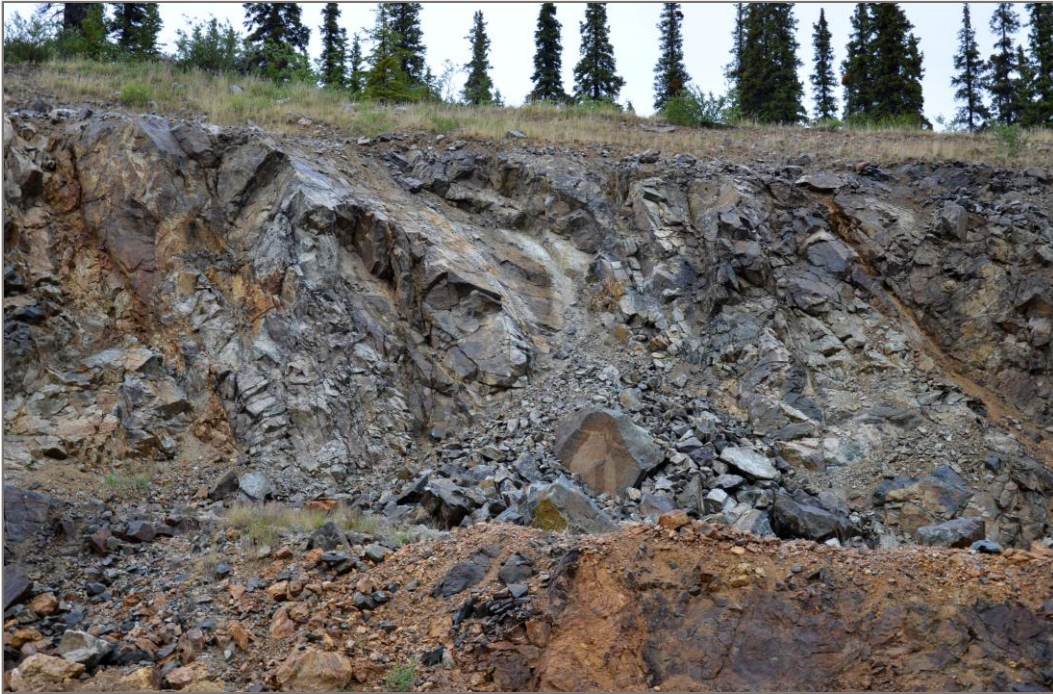
**Photo 11:** Sector 1 requires one day of light machine scaling.

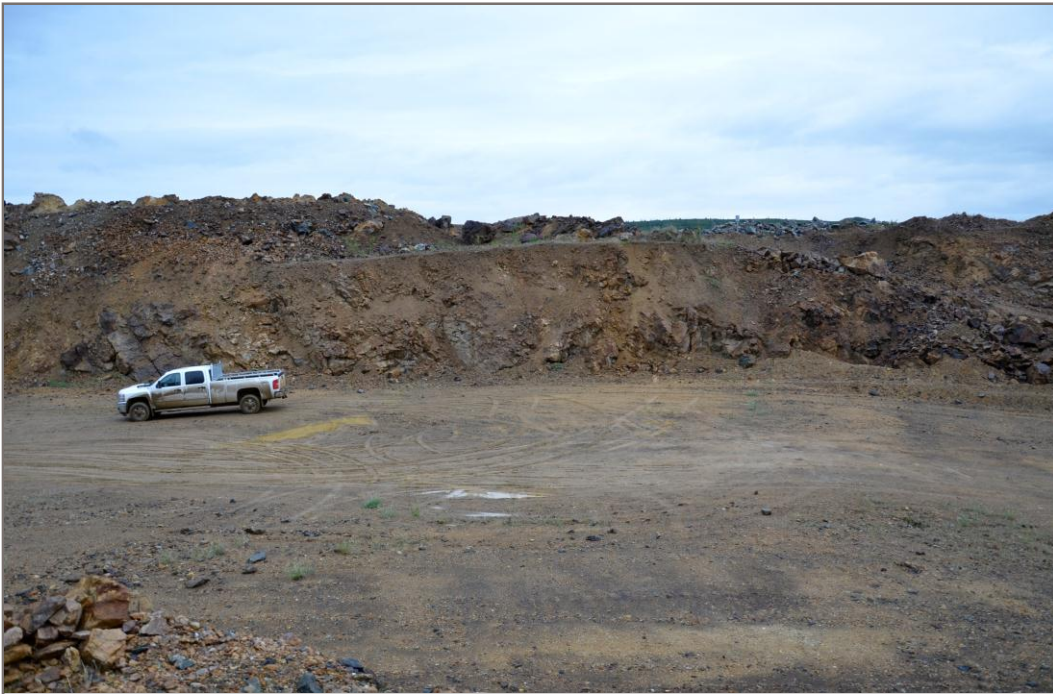
**Photo 12:** Sector 2 requires scaling to pull back crest of slope. This is approximately one day of machine scaling.

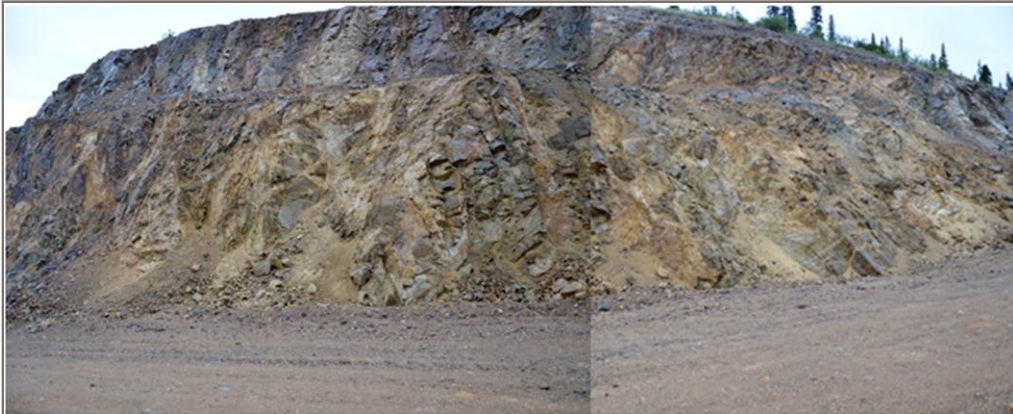
**Photo 13:** Sector 3 requires light scaling at the crest and minor scaling on the slope. 16 hours of hand scaling is expected.

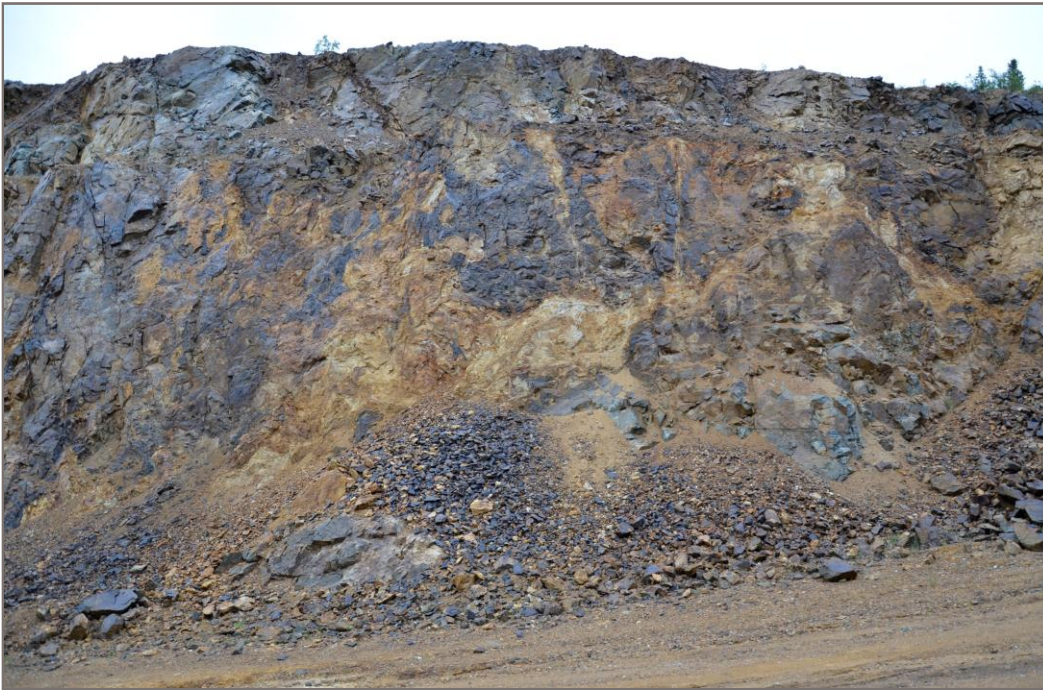
**Photo 14:** Sector 4 requires light scaling of fairly tight rock mass. Eight hours of hand scaling is expected.

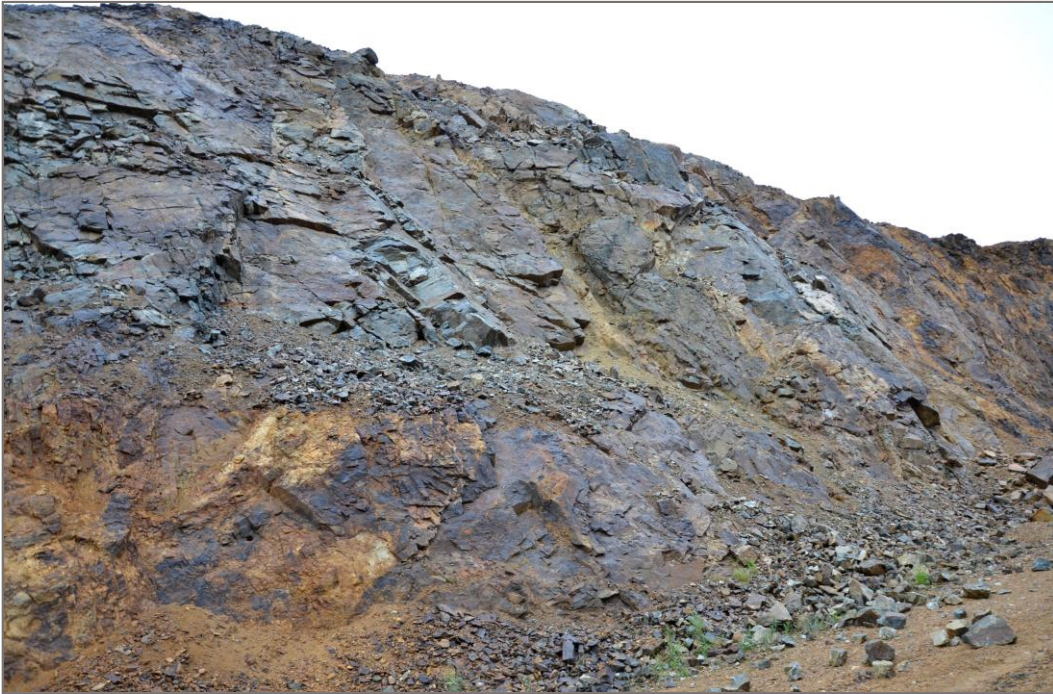
**Photo 15:** Sector 5 requires moderate scaling of blocky rock mass which is expected to take 24 hours.

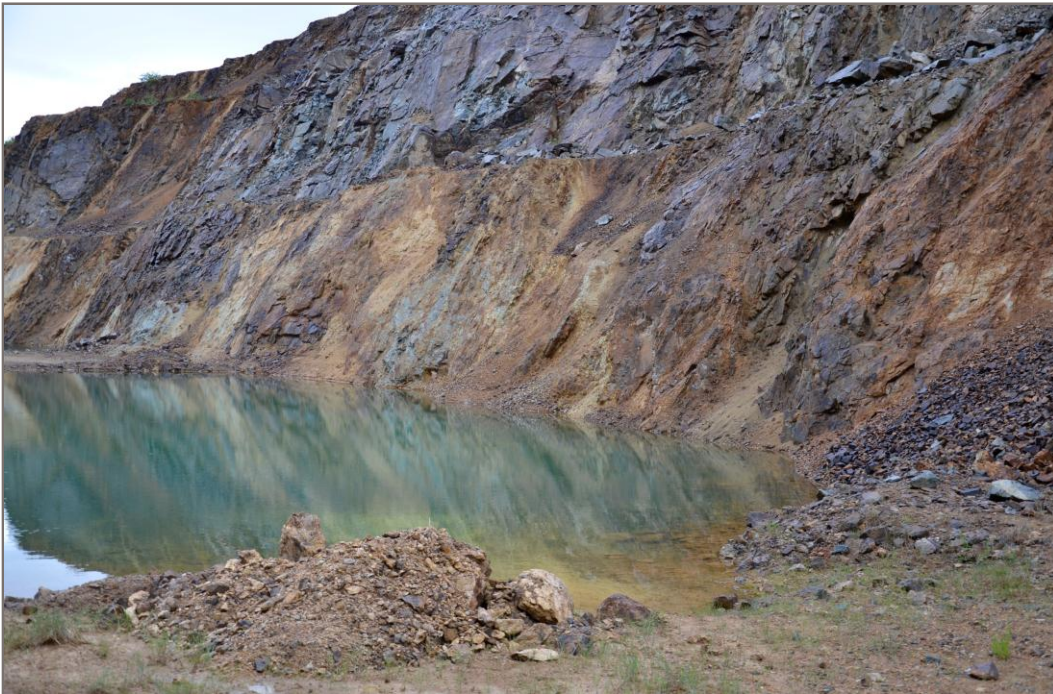
**Photo 16:** Sector 6 requires eight hours of hand scaling of the lower bench.

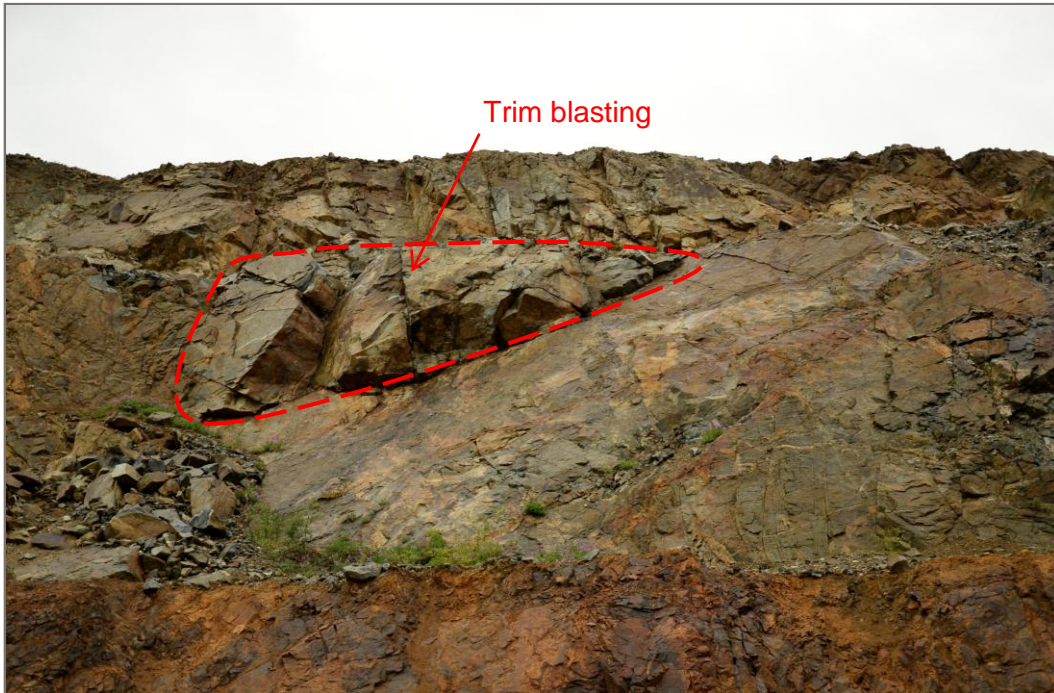
**Photo 17:** Sector 7 requires trim blasting with 14 holes at 2m with 30 kg of explosive totalling 120 m<sup>3</sup>, eight hours of check scaling and rock removal from bench.

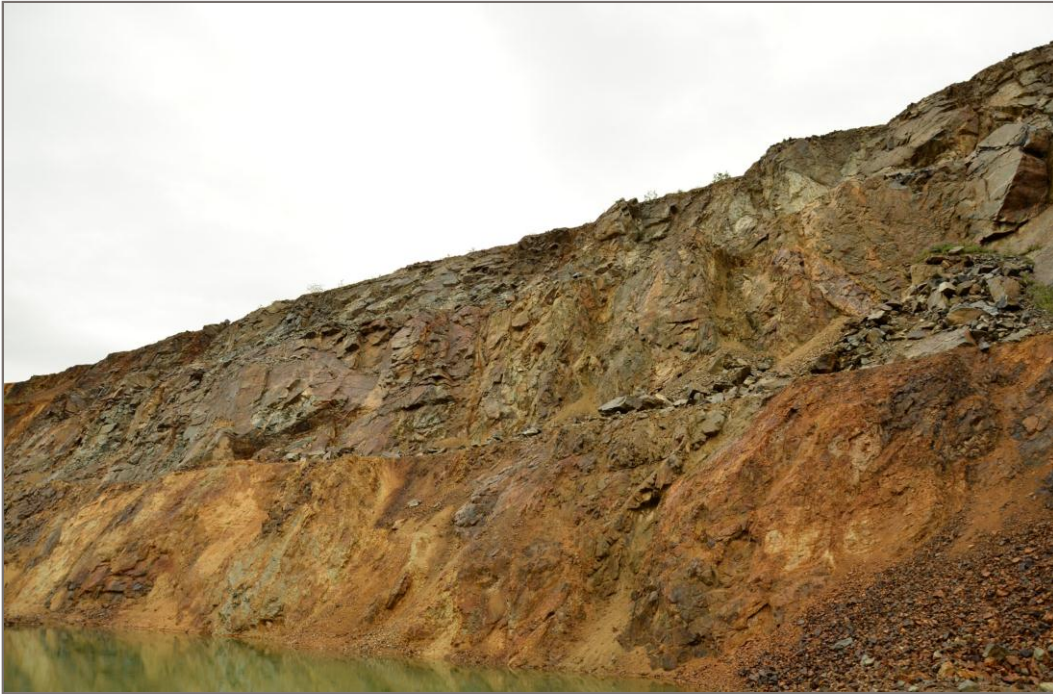
**Photo 19:** Sector 8 requires heavy scaling of numerous blocks in the pit wall. This is expected to require 24 hours of hand scaling.

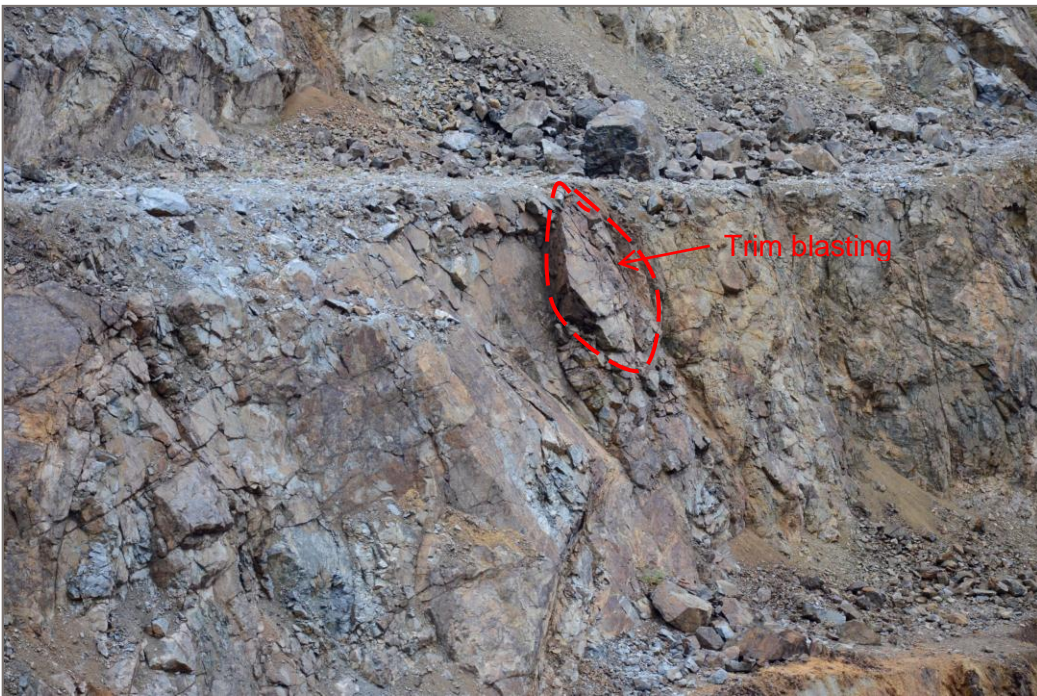
**Photo 20:** Sector 8a - allowance for trim blast.

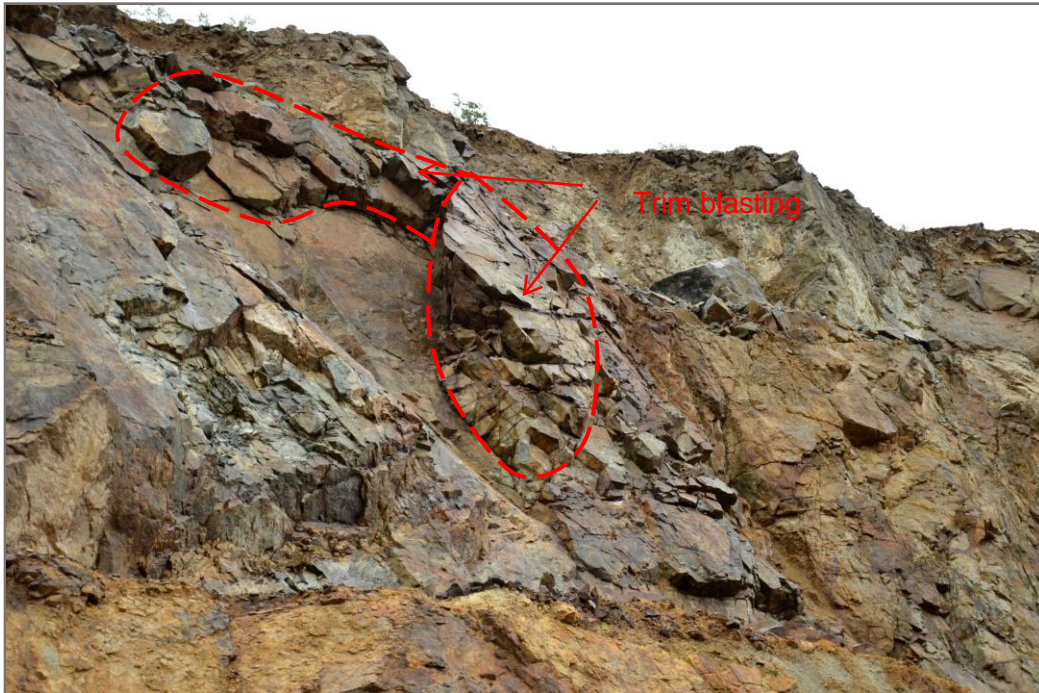
**Photo 21:** Sector 8a requires trim blasting.

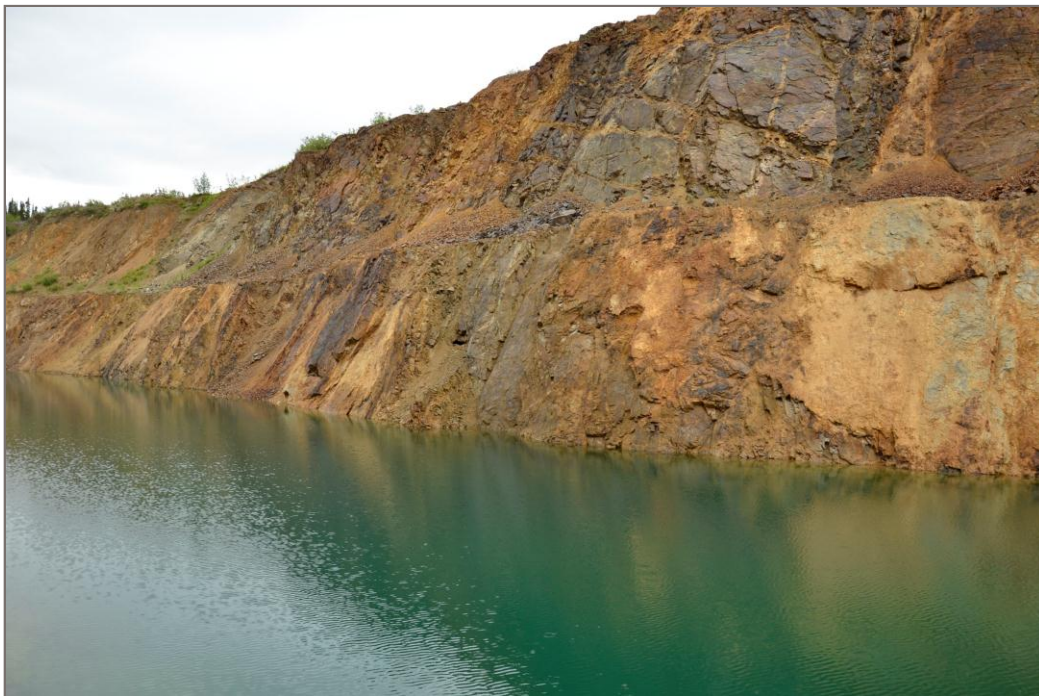
**Photo 22:** Sector 9 requires light scaling which is estimated to take 24 hours of hand scaling.

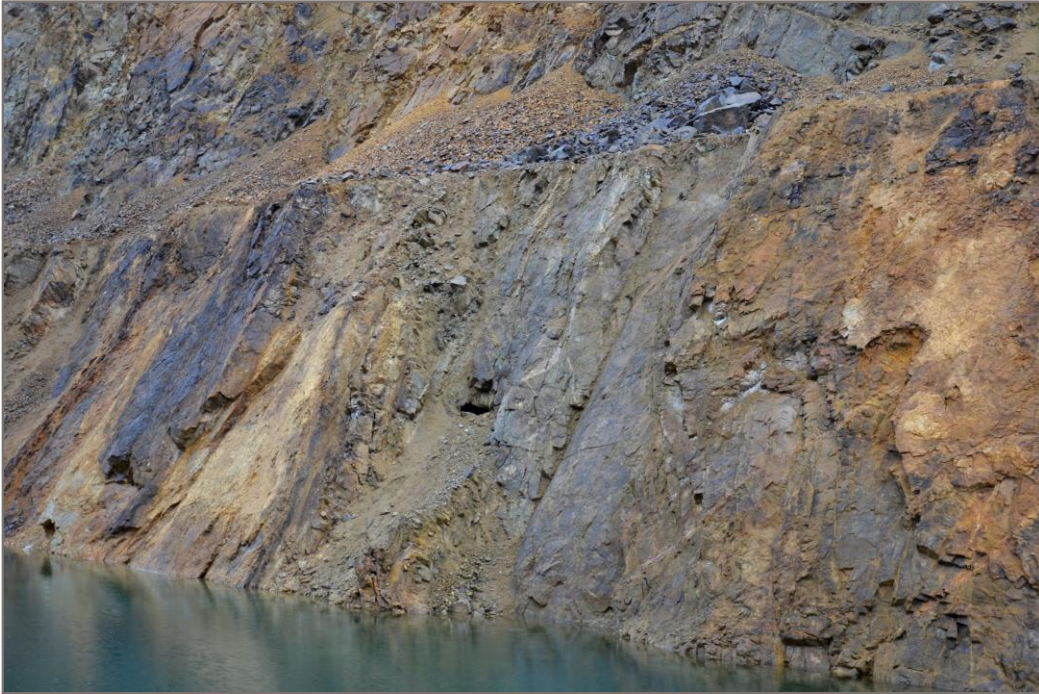
**Photo 23:** Sector 9a requires block removal 1m back from crest. Scaling should also be done on the north side of the adit.

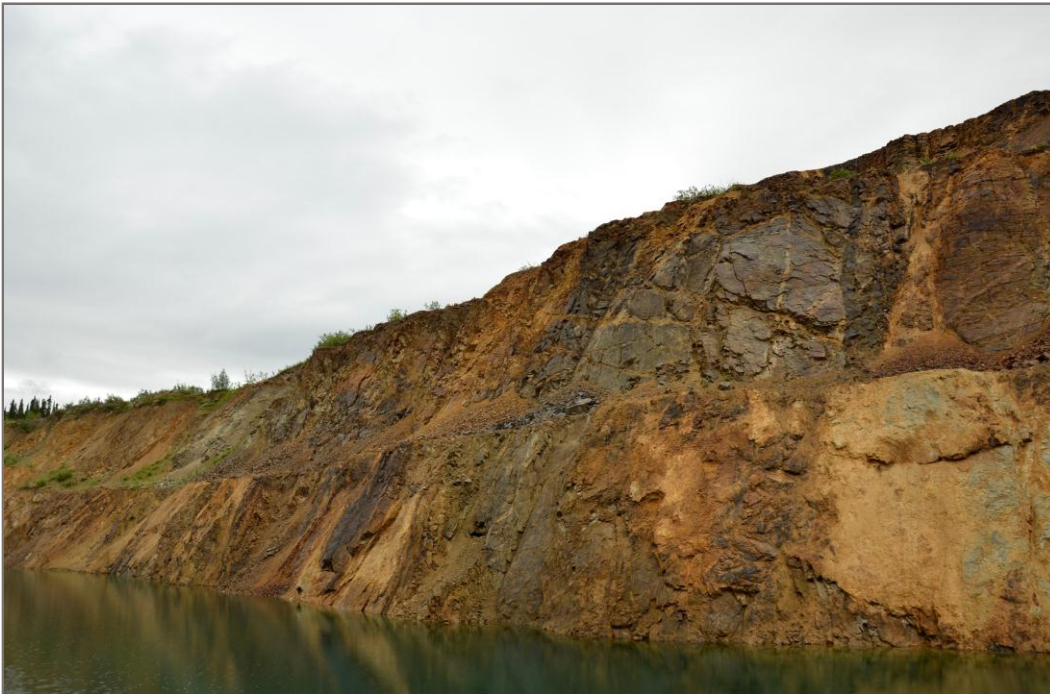
**Photo 24:** Sector 10 requires the brow to be cleaned 1m to 45° as well as light scaling of overburden at northern end. 40 hours of hand scaling is anticipated.

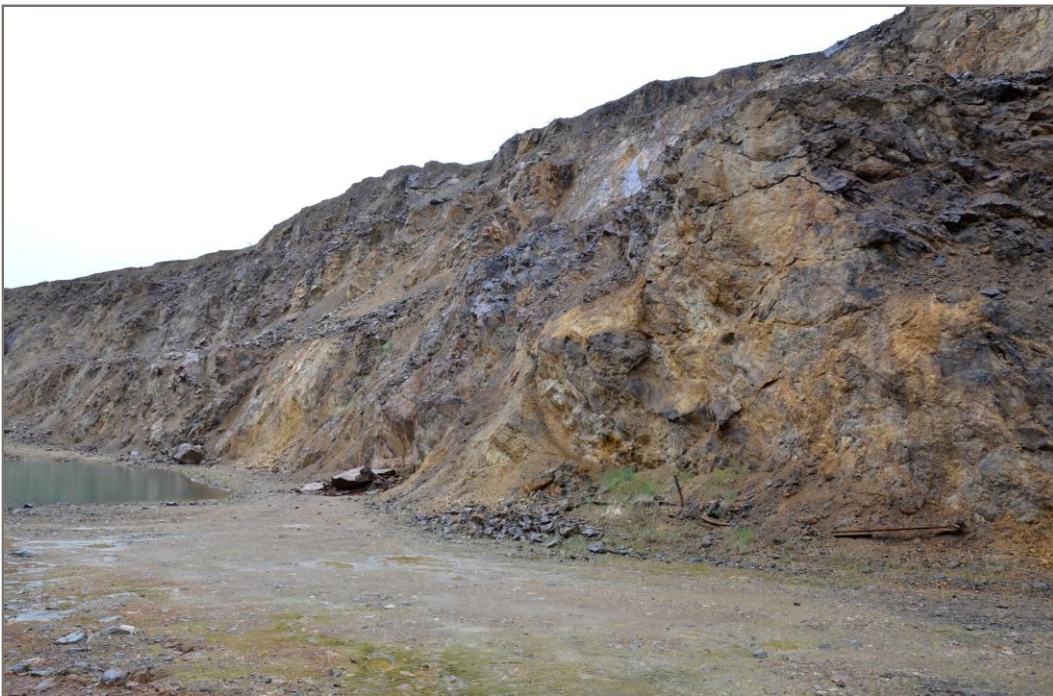
**Photo 26:** Sector 11 requires light scaling. 16 hours of hand scaling and one day of machine scaling is expected.

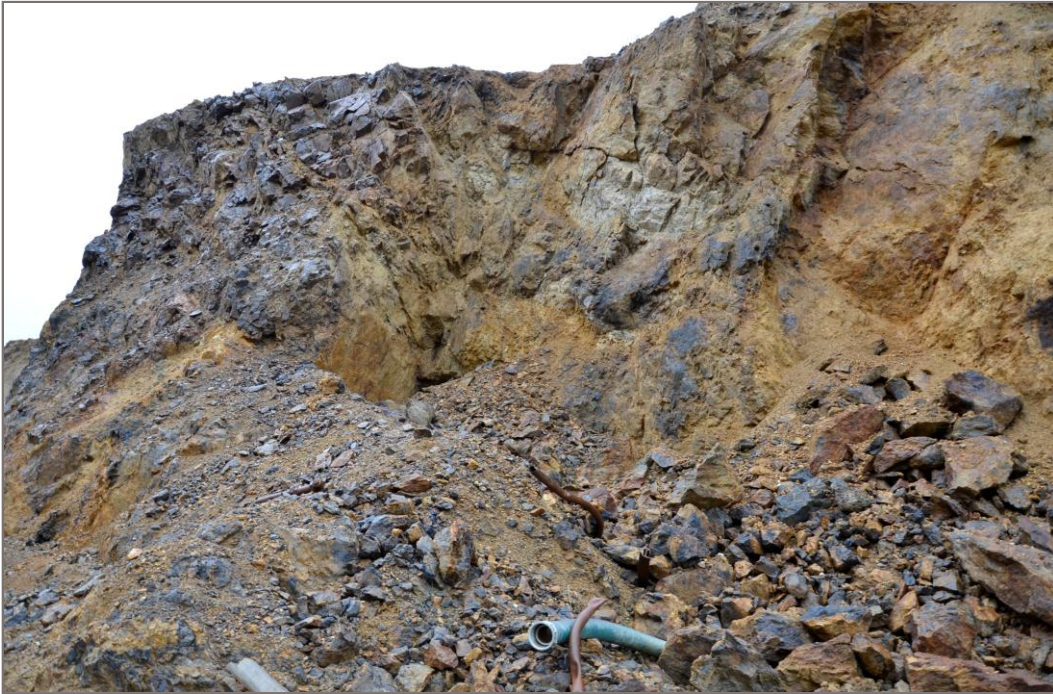
**Photo 27:** Sector 11a requires intense scaling localized to the adit.

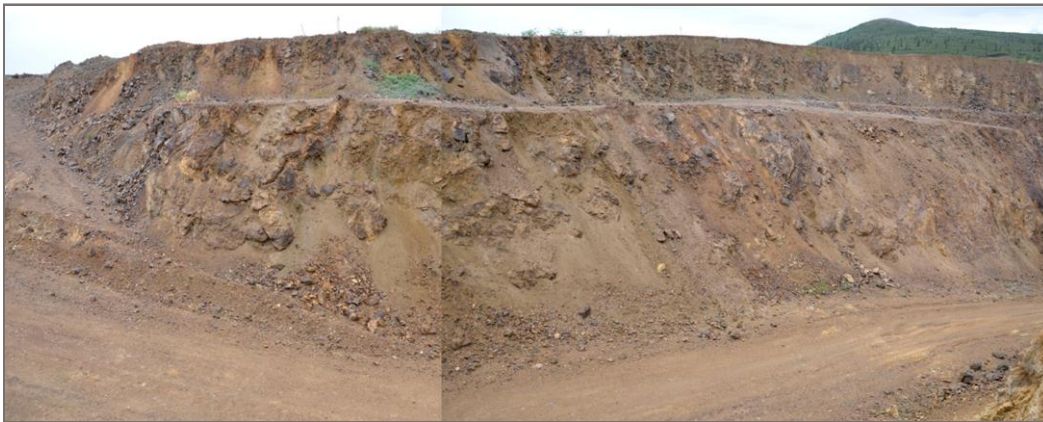
**Photo 28:** Sector 12 requires one day of machine scaling from crest.

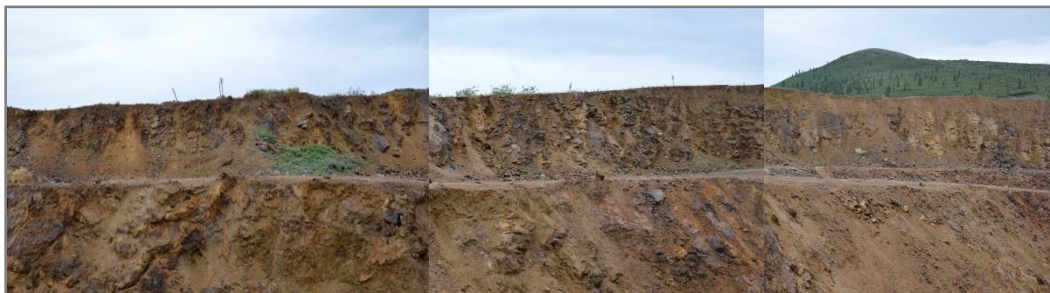
**Photo 29:** Sector 13 requires one day of machine scaling.

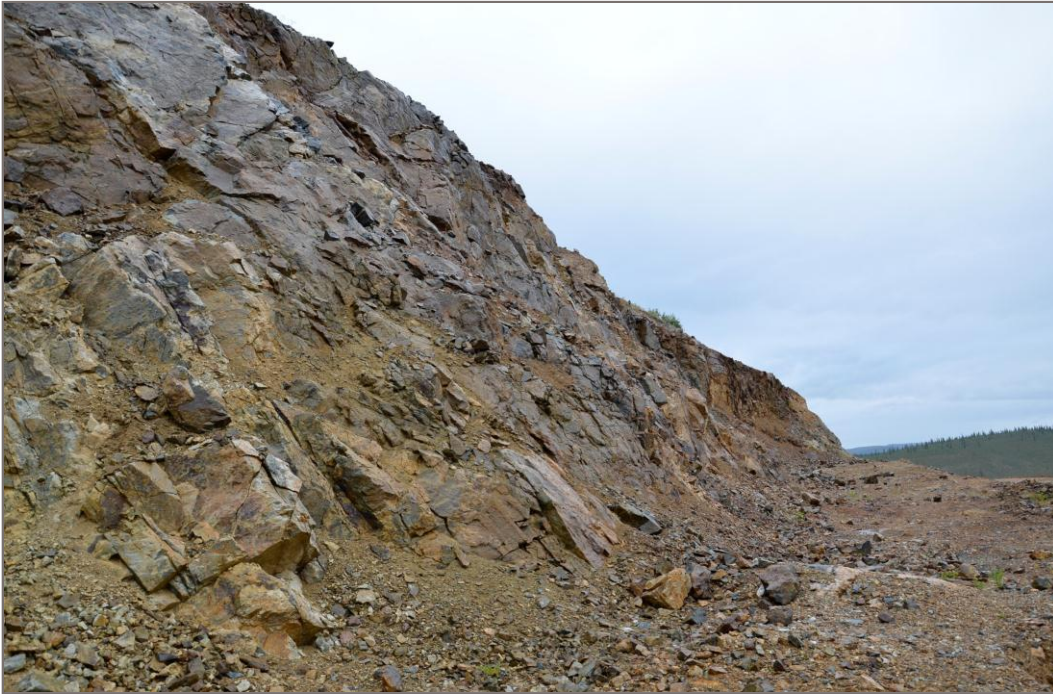
**Photo 30:** Sector 14 requires about 40 hours of light scaling.

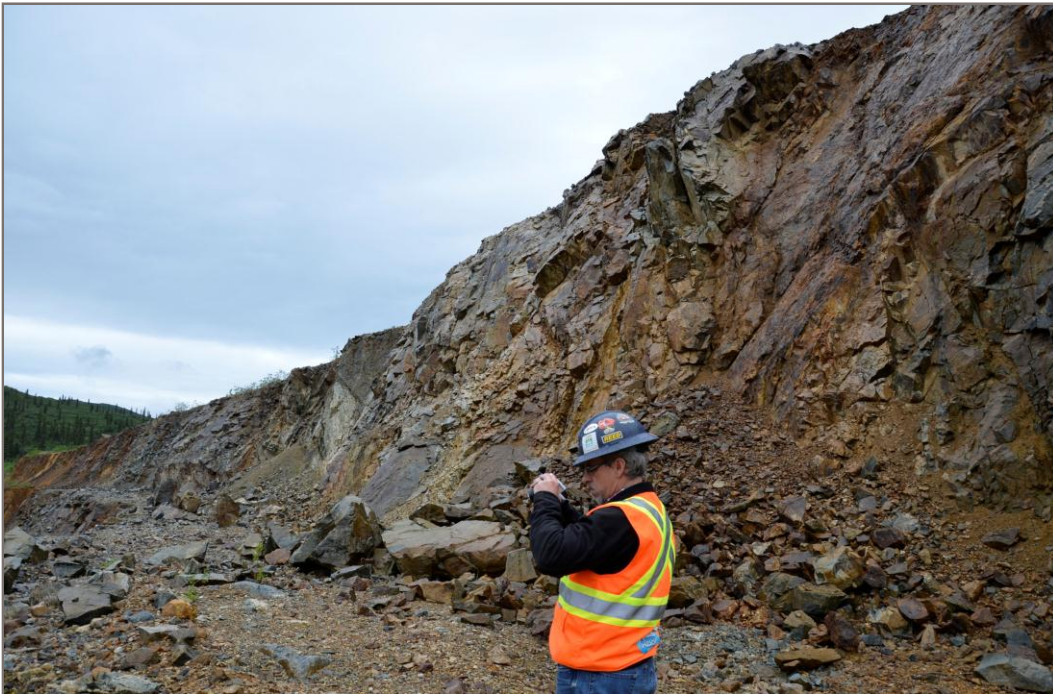
**Photo 31:** Sector 15 requires 40 hours of hand scaling.

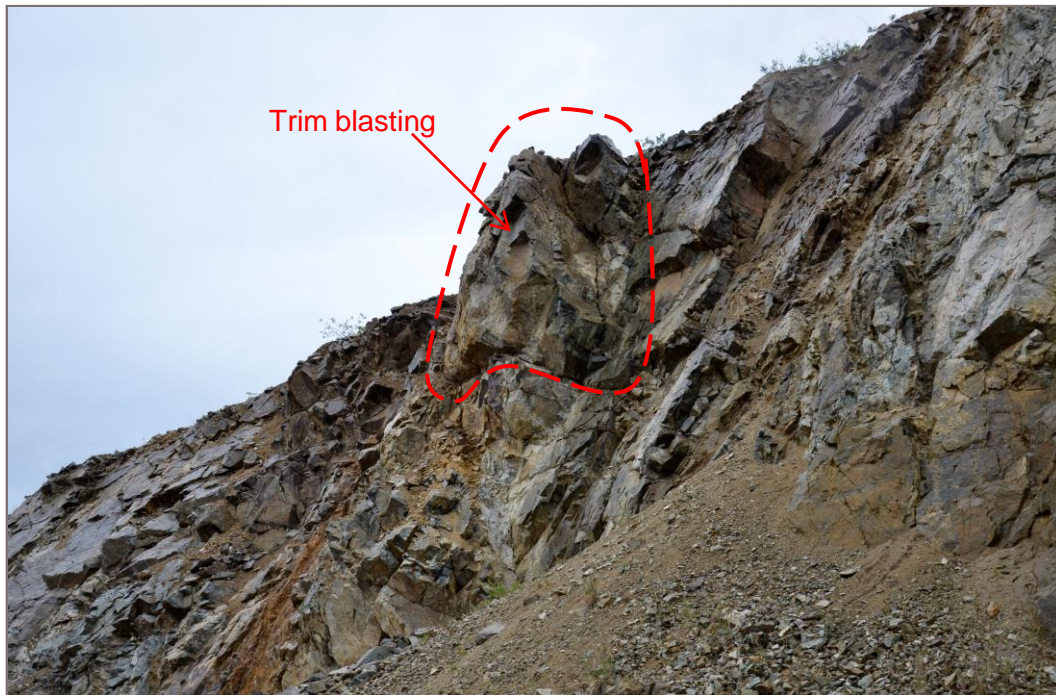
**Photo 32:** Sector 15a requires trim blasting of 3 x 3 x 2 m (12 m<sup>3</sup>).

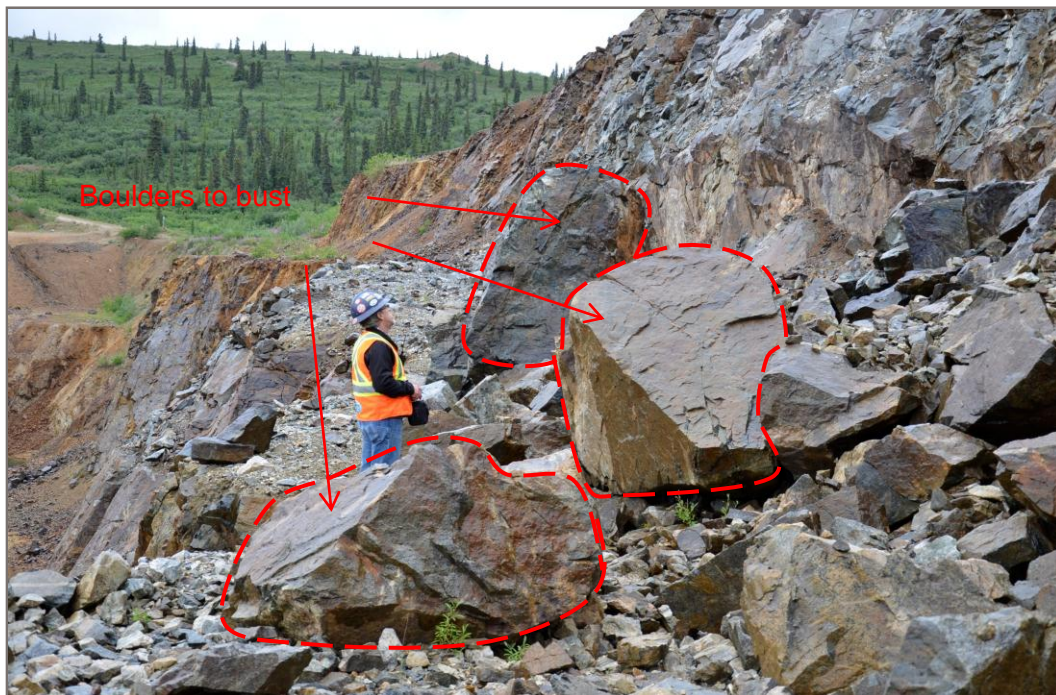
**Photo 33:** Sector 15b contains four boulders (about 10m<sup>3</sup>) for busting.

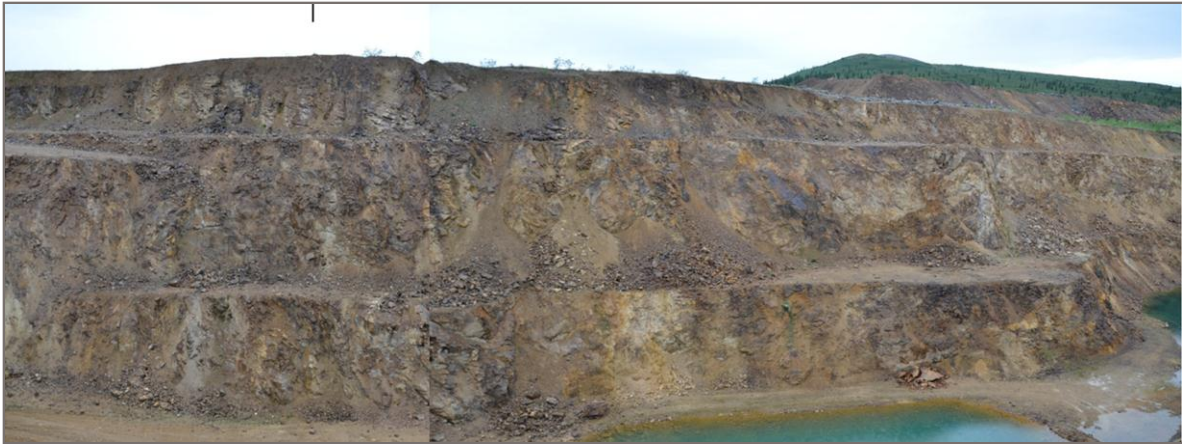
**Photo 34:** Sector 16 requires gullies to be cleaned as well as light scaling. 64 hours of hand scaling is anticipated

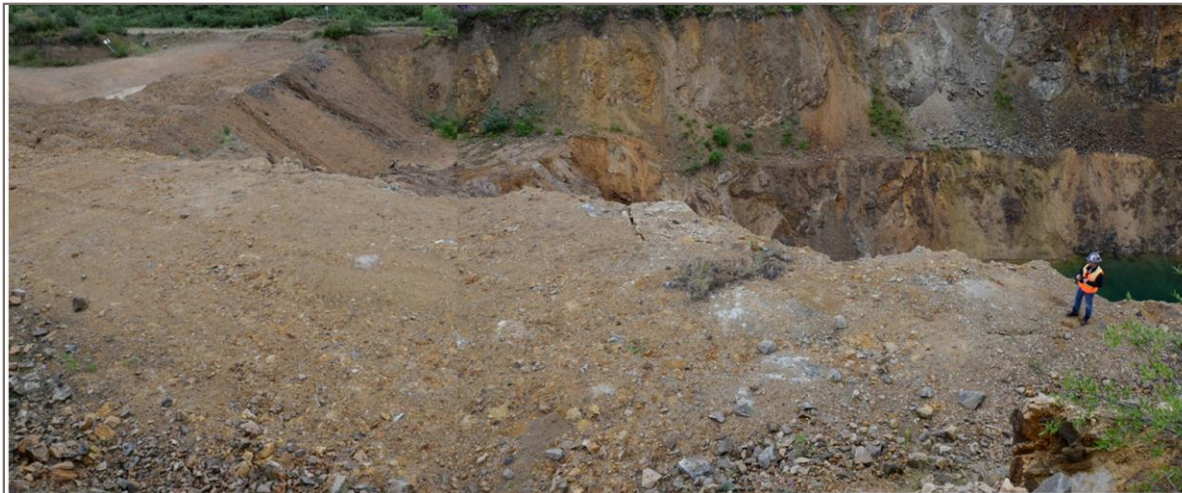
**Photo 35:** Sector 18a shows a series of tension cracks that need 60 m<sup>3</sup> of trim blasting or two days of machine scaling.

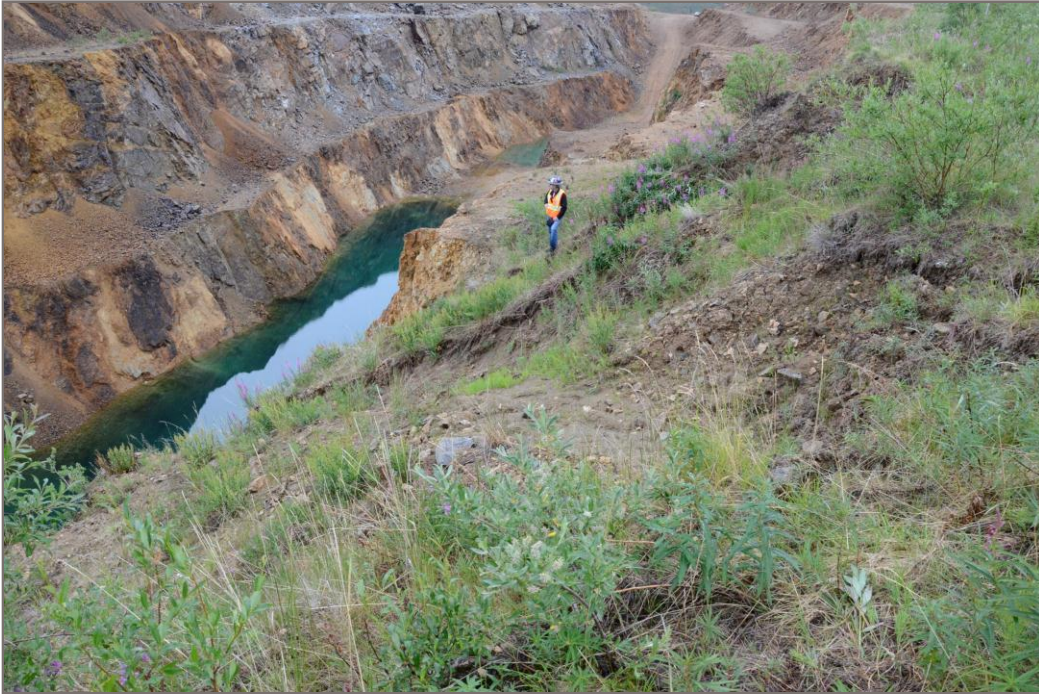
**Photo 36:** Sector 18b requires about eight hours of check scaling and overburden slips.

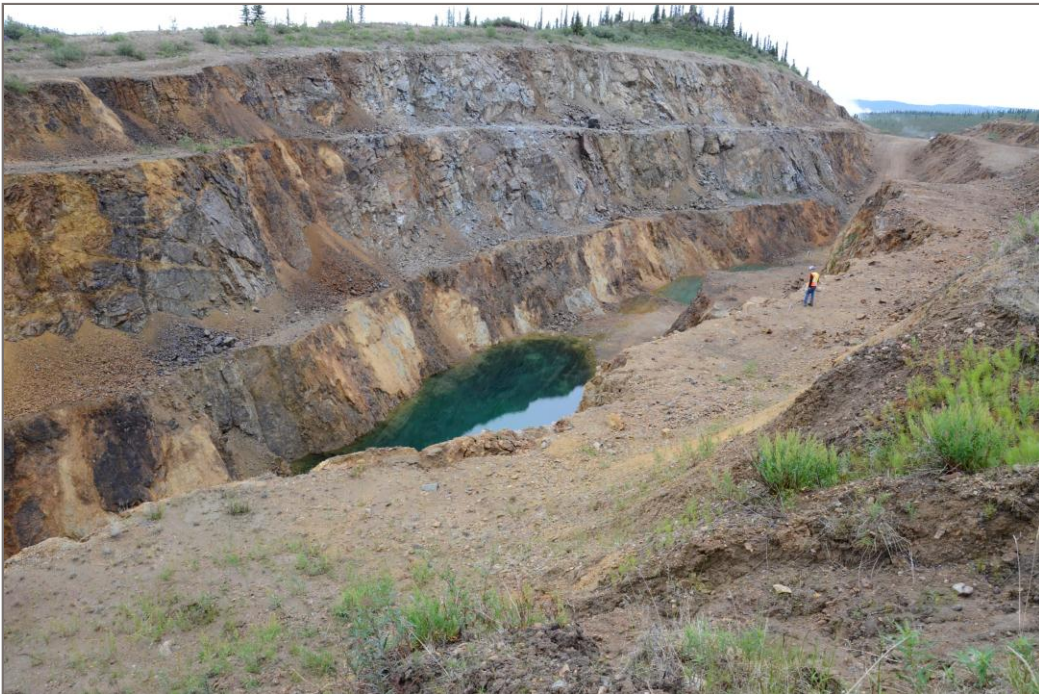
**Photo 37:** Sector 18c requires trim blasting of 20 x 2 x 3 m.

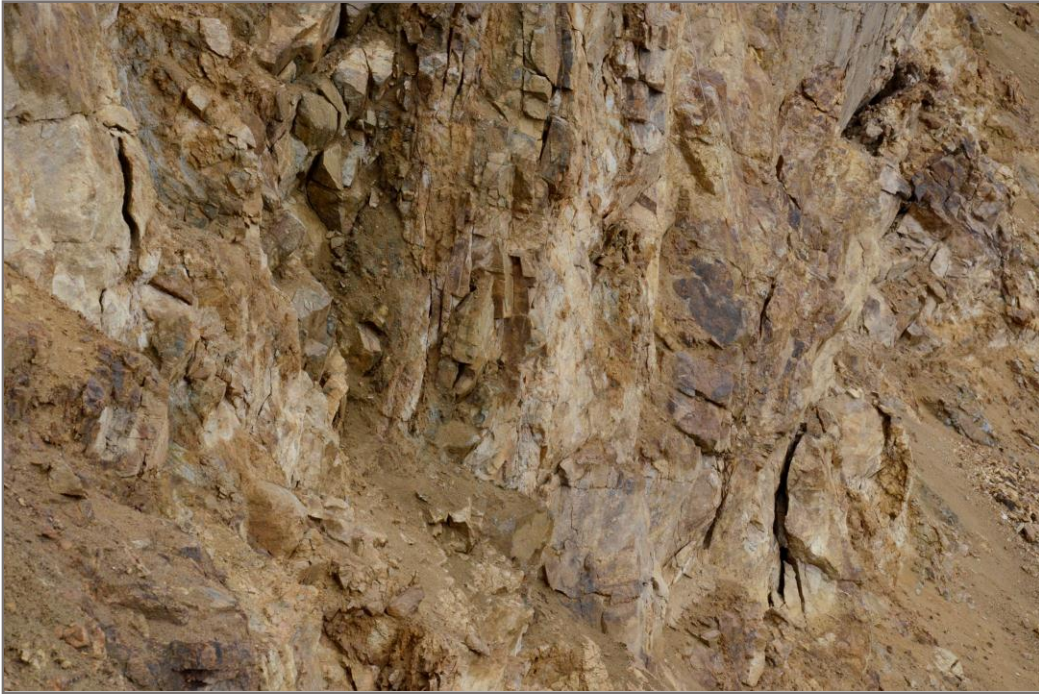
**Photo 38:** Sector 18c requires trim blasting of 20 x 2 x 3 m totalling 220 m<sup>3</sup>.

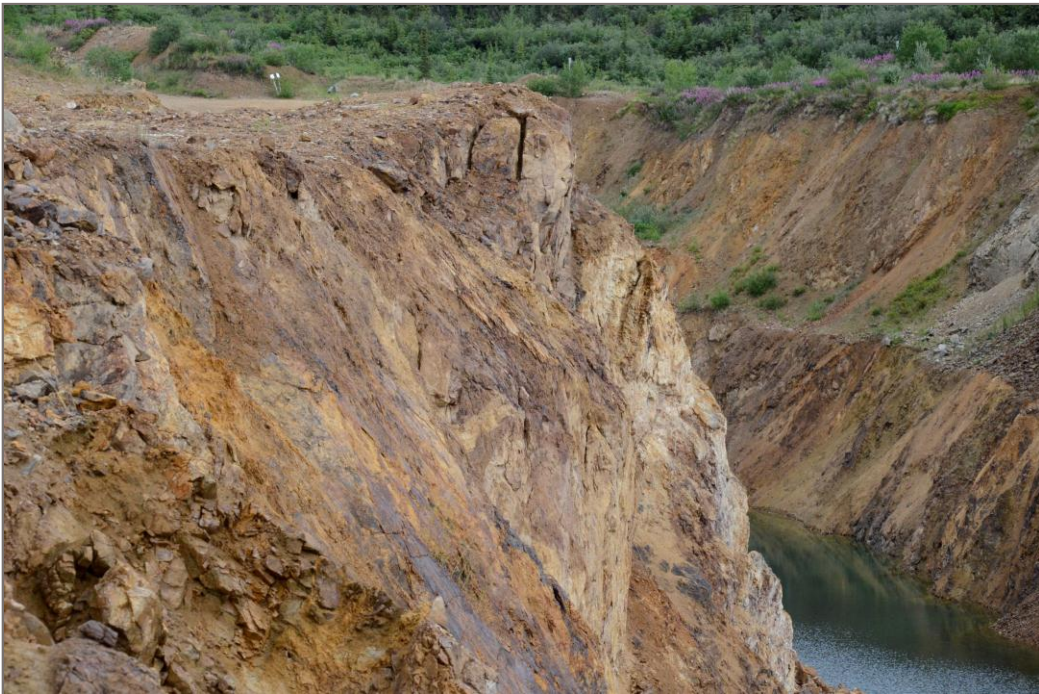
**Photo 39:** Sector 18d requires trim blasting of 40 x 2 x 3 m totalling 240 m<sup>3</sup>.

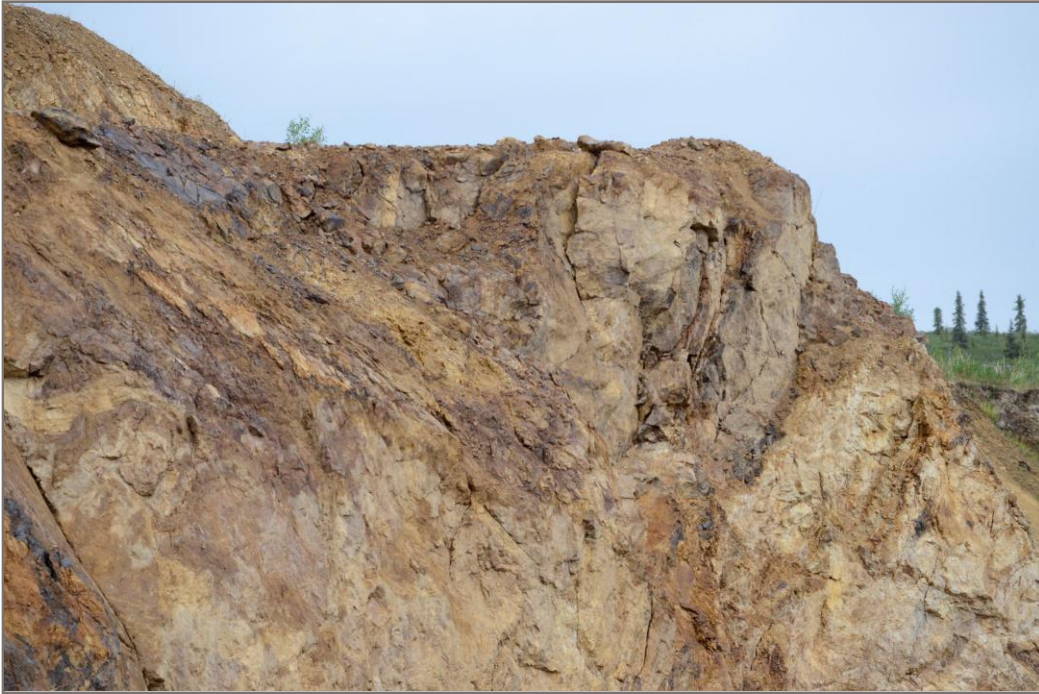
**Photo 40:** Sector 18d requires trim blasting of 40 x 2 x 3 m totalling 240 m<sup>3</sup>.

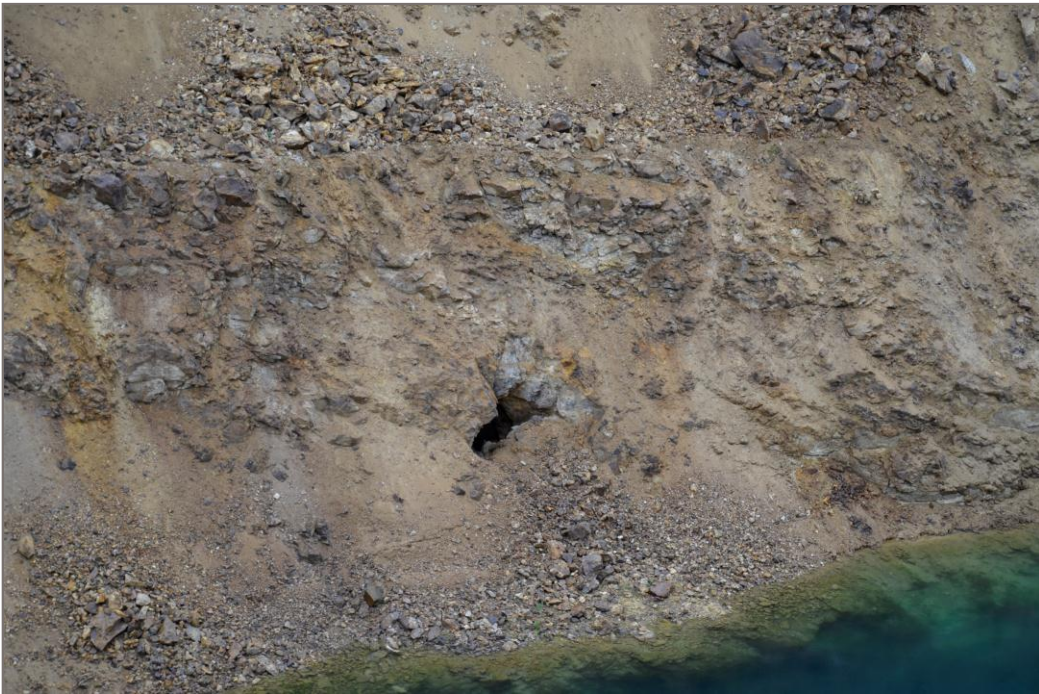
**Photo 41:** Sector 19a shows the adit. Site 19 requires about 40 hours of hand scaling to trim the crest. The talus must also be scaled after trimming

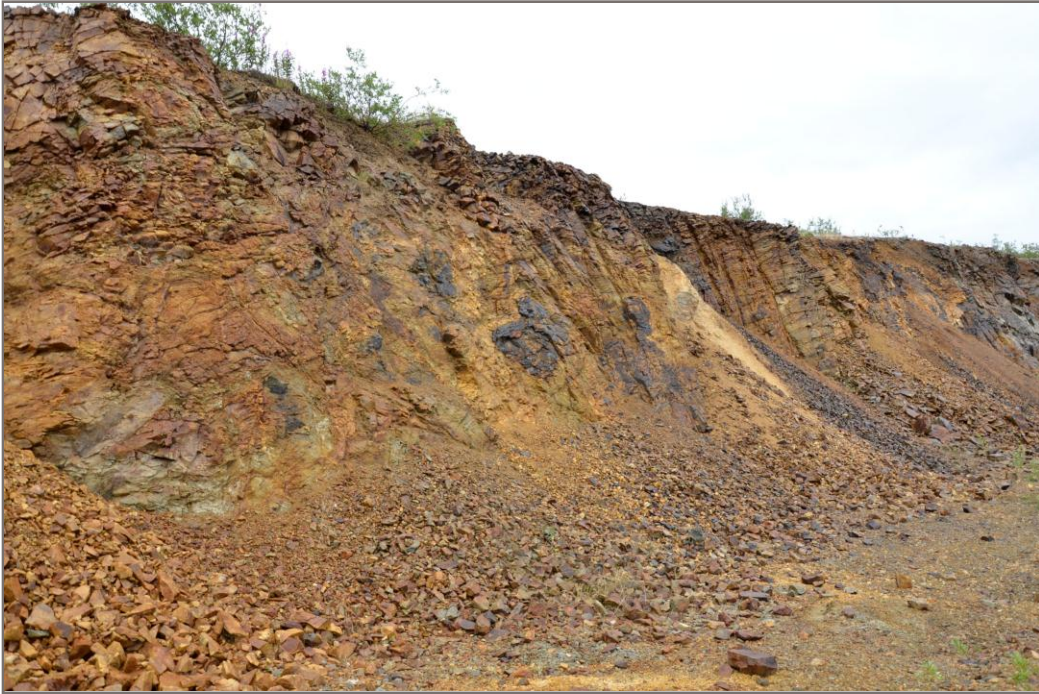
**Photo 42:** Sector 20 requires light scaling that is expected to take eight hours of hand scaling.

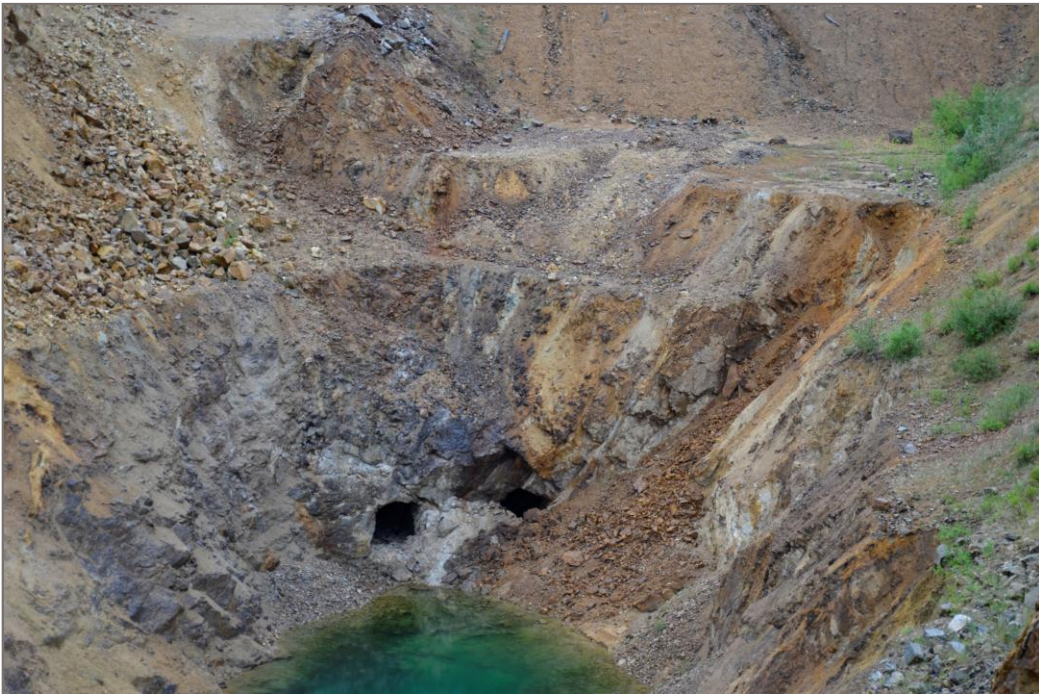
**Photo 43:** Sector 21 will require 16 hours of hand scaling.
