**To:** Distribution- - see below  
**From:** H. F. McAlpine  
**Date:** October 22 1999  
**Subject:** Dam Safety Assessment of the Mt. Nansen Tailings Dam

**BYG Tailings Dam, Mount Nansen, YT - Site Visit Report**

INDIAN AND NORTHERN AFFAIRS  
WATER RESOURCES DIVISION  
BYG Tailings Dam, Mount Nansen, YT - Site Visit Report

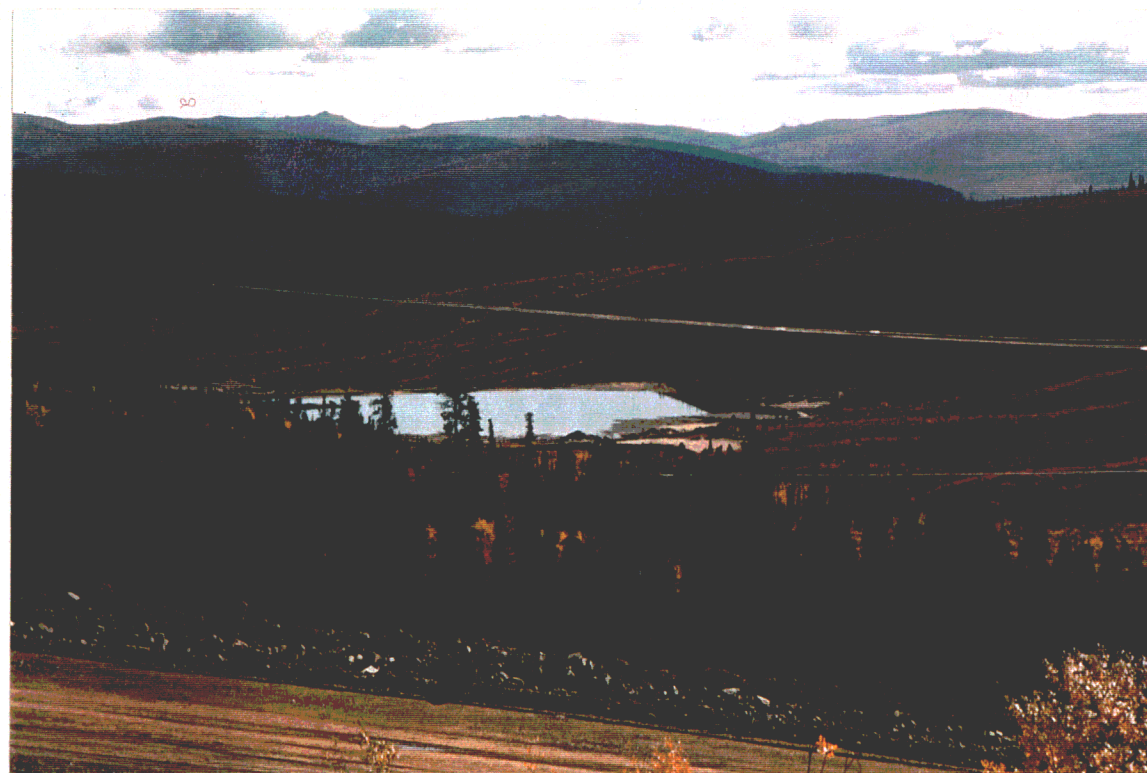
The purpose of this letter is to provide a general impression of the current condition of the BYG Tailings Impoundment (see Photo 1 and Figure 1 for site plan) as well as to identify some issues related to the safety and integrity of the dam that require immediate attention. On September 16, 1999 our Robert Lo visited the site together with yourself, Mr. Cord Hamilton of EBA and Mr. Milos Stepanek of Geo-engineering. This report is based mainly on our observations and discussions on site together with a preliminary review of some recent site monitoring data provided to us through EBA. The letter was prepared in consultation with Mr. Cord Hamilton of EBA. We will carry out a more thorough review as stipulated earlier, but this must not delay initiation of improvement measures given in this letter.

Photograph 1 Bird's eye view of Tailings Impoundment - looking southeast.

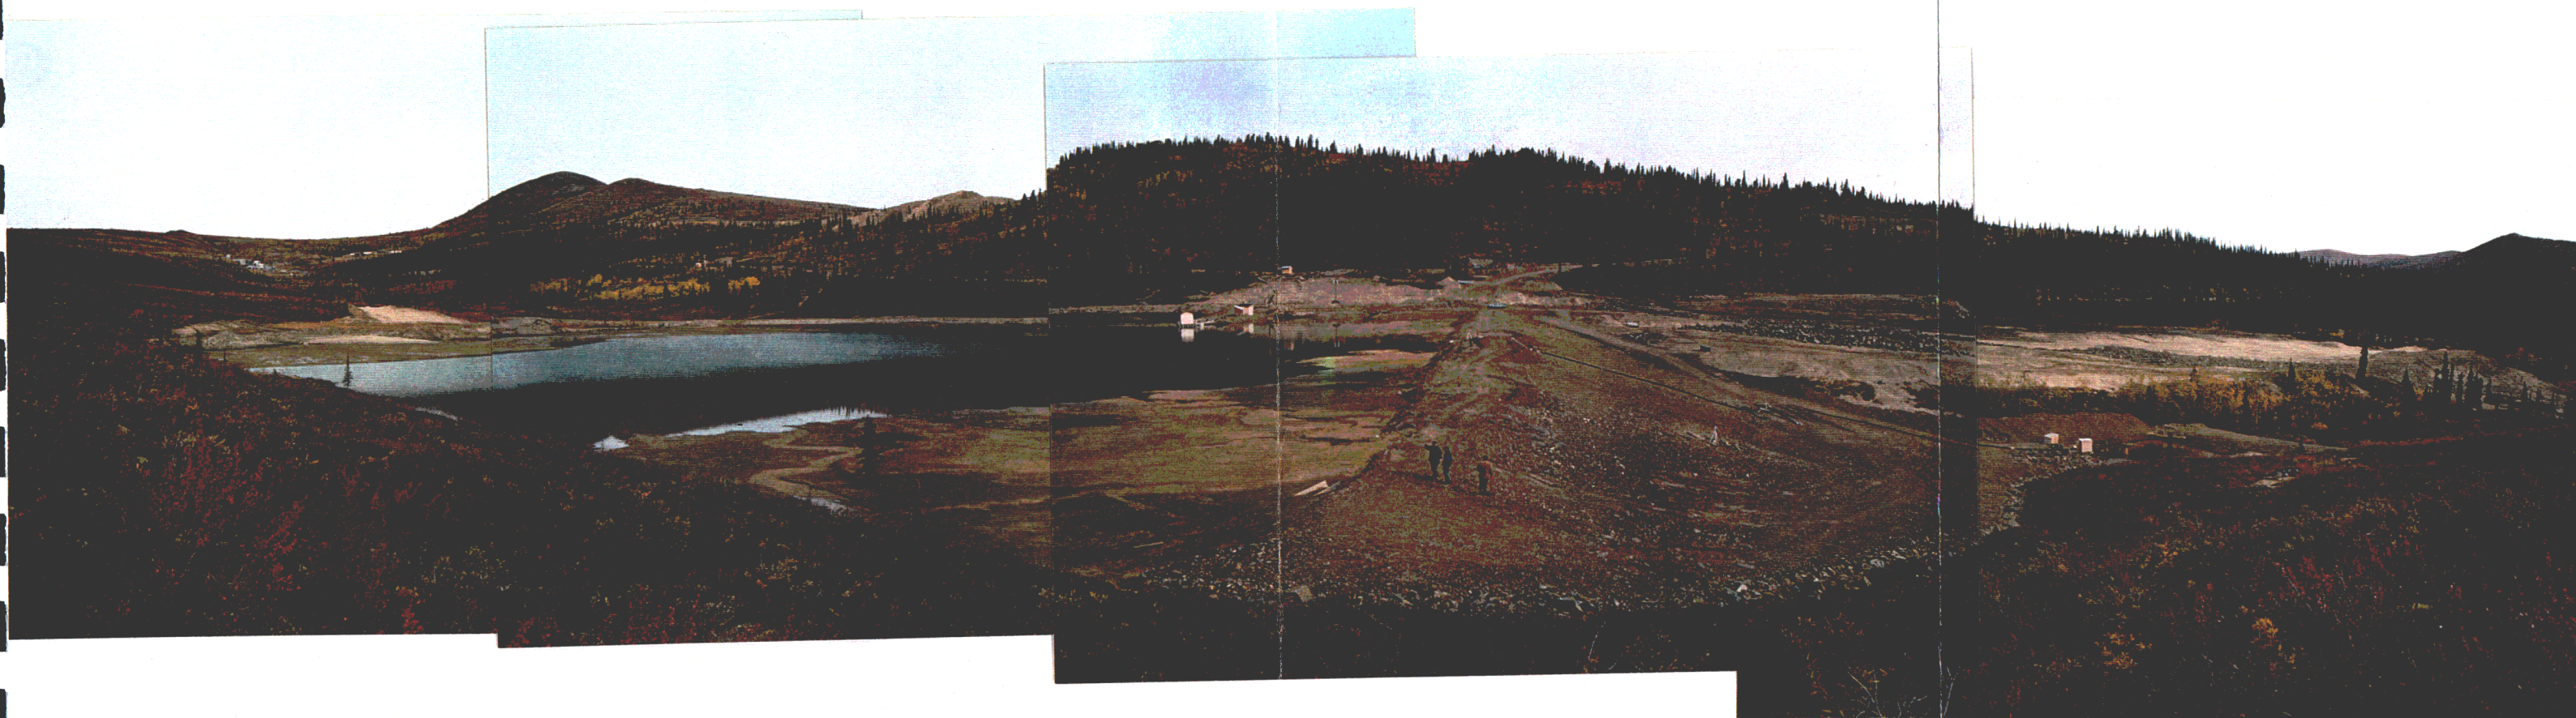
During our site visit, the pond level was very high relative to the crest elevation (design crest at El. 1151.5 m) of the Main Dam, with some tailings beach showing above the pond level at the south end and middle portion of the dam (see Photos 2 and 3). It is worth noting that the original design envisaged a 50-m wide continuous tailings beach, and this criteria was not met at the time of our site visit.

Photograph 2 Panoramic View of Tailings Impoundment - from south abutment of Tailings Dam.

1. Lower the tailings pond level to maintain a tailings beach with a minimum width of about 50 m at all times.
2. Install a flow meter at the pump located at the Seepage Recovery Pond to improve the ongoing seepage monitoring.

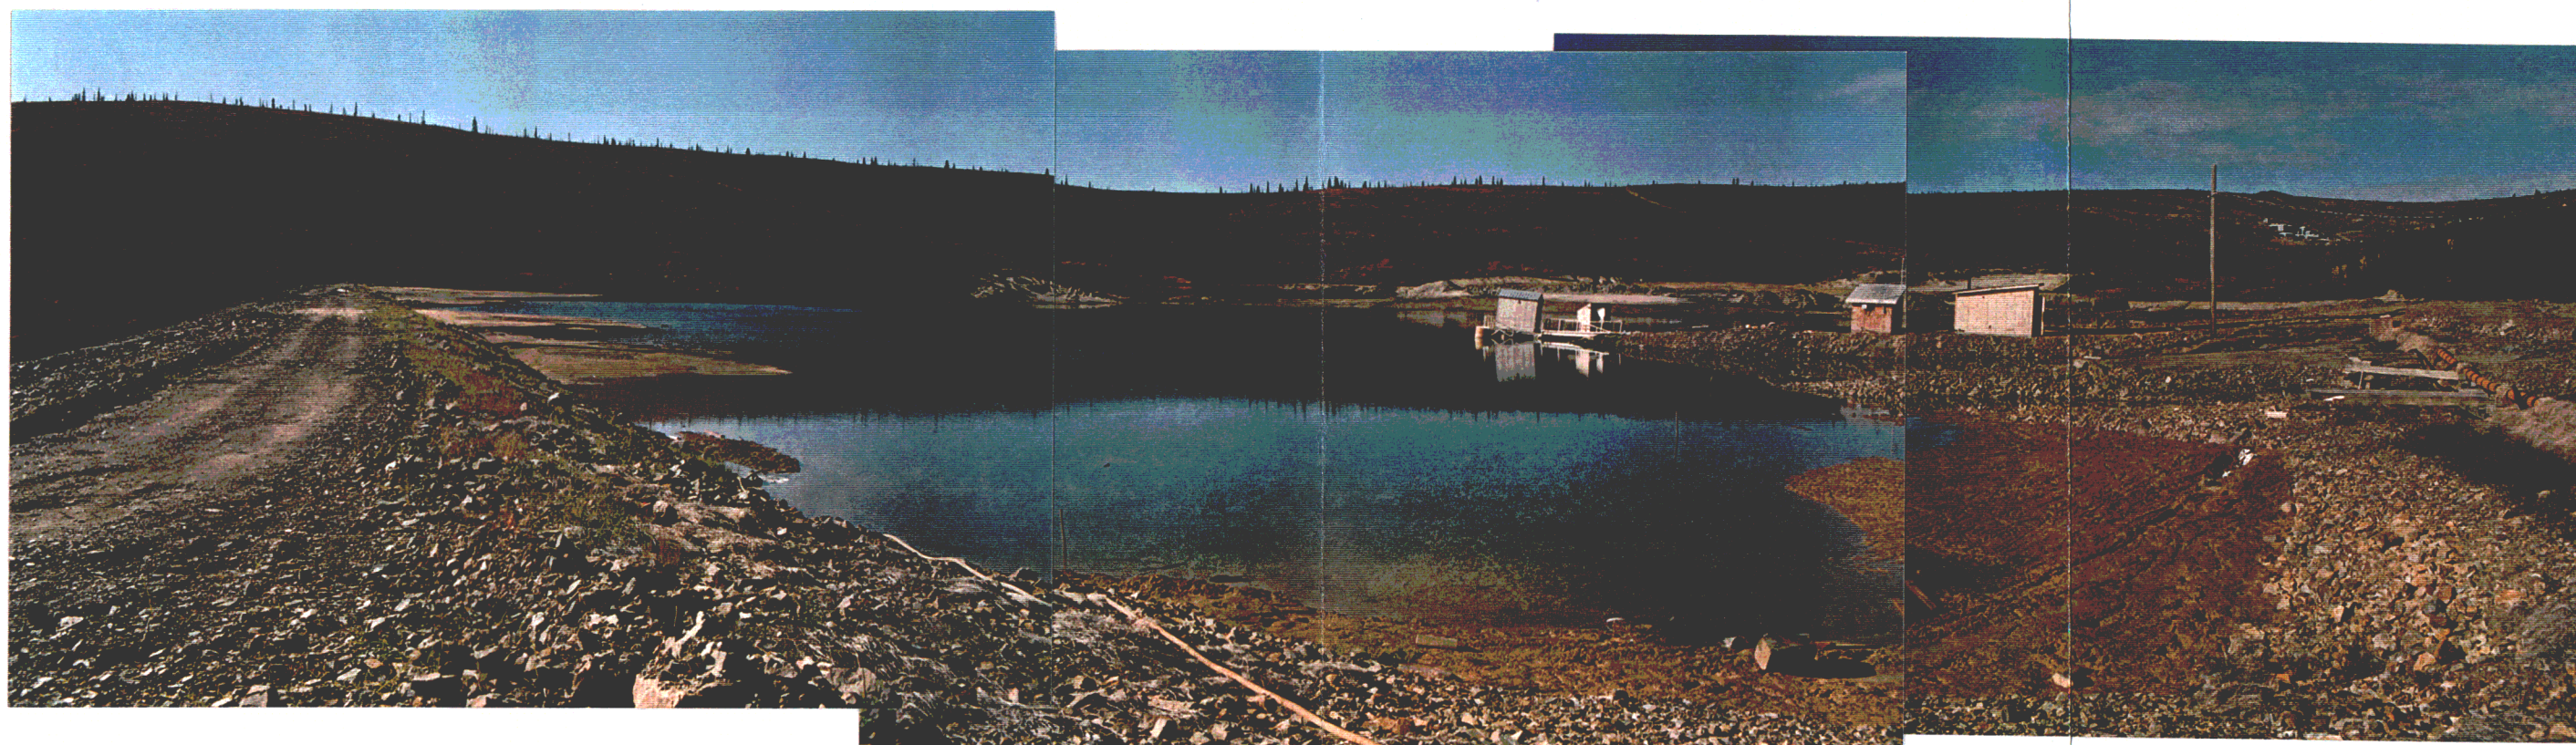
Photograph 3 Panoramic View of Tailings Impoundment - from north end of Tailings Dam crest.

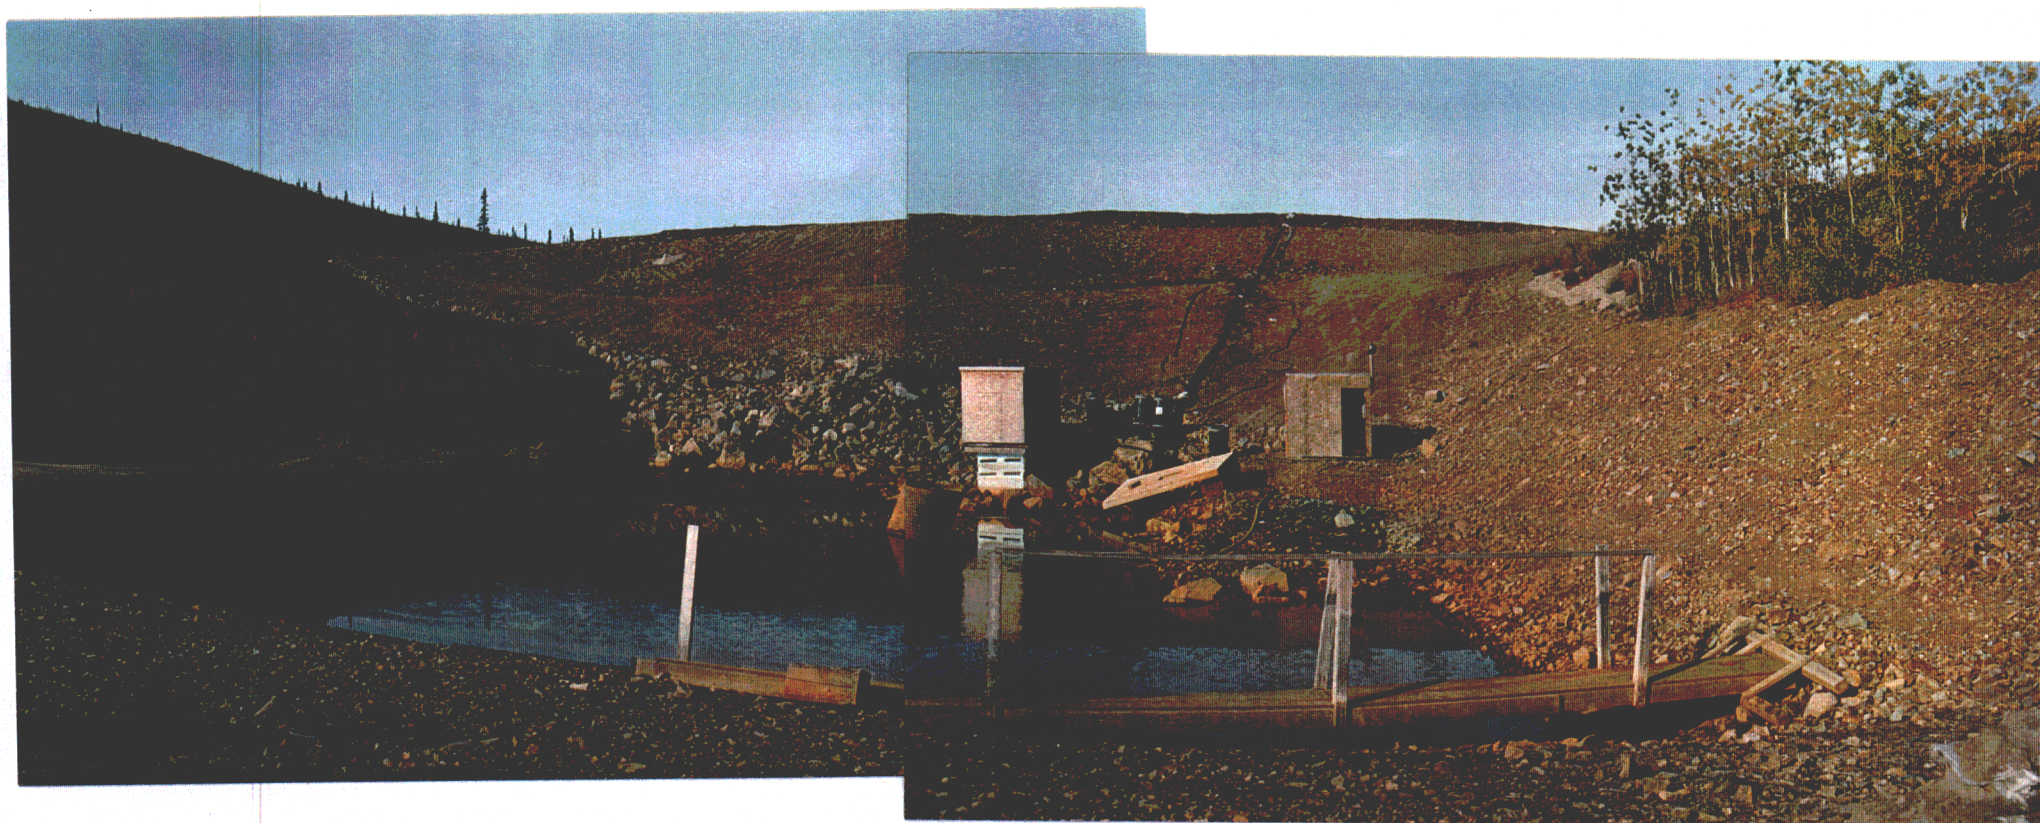
The Main Tailings Dam, in general, appeared to be in good condition (see Photos 2 to 4). Outlined in the following are some observations in specific areas:

The general appearance of the Seepage Control Dam (see Photos 4, 8 and 9) was similar to that of the Main Dam. Some water was impounded in the Seepage Recovery Pond, and reddish stains were visible (see Photo 8). A vertical culvert was also observed leaning (see Photo 4). Downstream of the Seepage Control Dam, seepage was observed to exit from its downstream toe at three locations. At the leftmost seepage exit location near the left (north) abutment, a pump set-up was observed, presumably for returning the seepage to the tailings pond (see Photo 9). We understand that downstream of the Seepage Control Dam heaves of the creek bed were observed in the winter of 1998-1999, possibly due to freezing of seepage under the surficial frozen zone.

Photograph 4 Tailings Dam Downstream Slope and Seepage Recovery Pond.

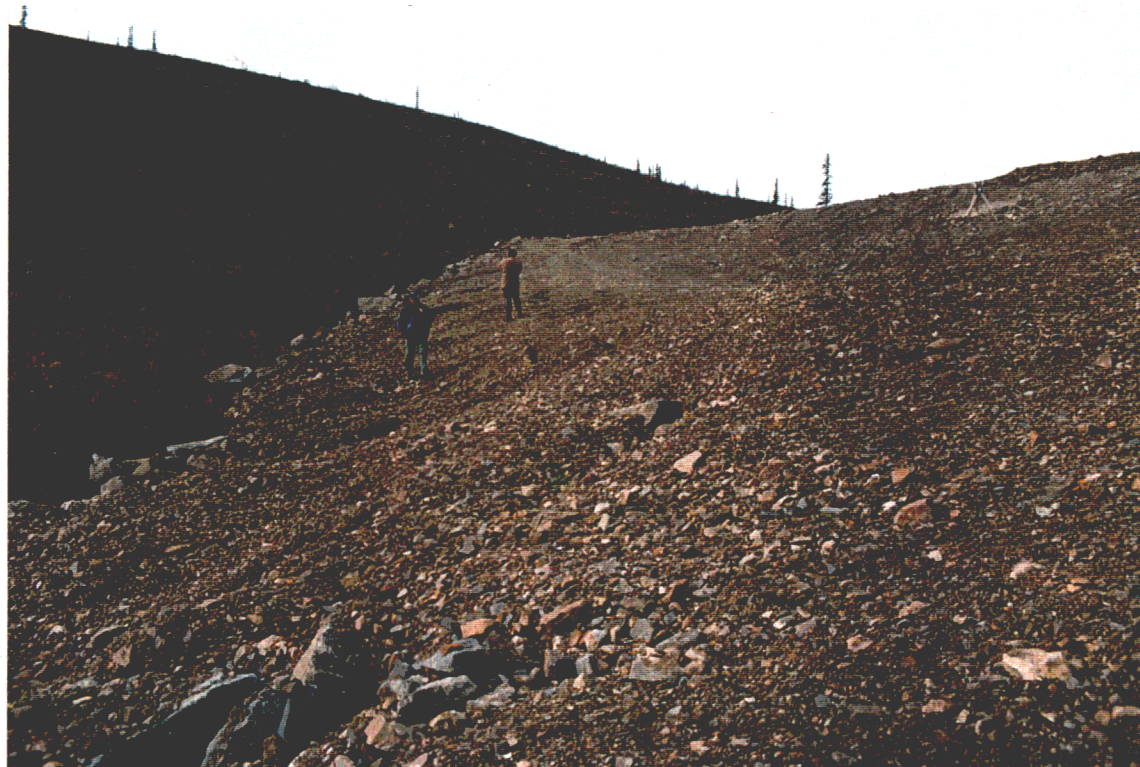
- The downstream slope of the buttress berm near the right (south) abutment has local depressions and extensive cracks (see Photos 5 to 7).
- Ongoing erosion was observed at a downstream diversion trench located at the south abutment, starting from the south end of the Main Dam and continuing beyond the south end of the Seepage Control Dam (see Photo 4). We understand that the trench was originally formed by a bulldozer during dam construction.
- Seepage was observed daylighting along the downstream toe of the Main Dam buttress berm (see Photo 4). The seepage was concentrated on the south abutment side and in the middle of the berm toe. At both points it was flowing clear through the coarse rock fill that forms the toe of the buttress berm. We understand that suspended solids in the seepage recovery pond have been higher than current.

Photograph 5 Downstream Slope of Buttress Berm - looking upward towards south abutment.

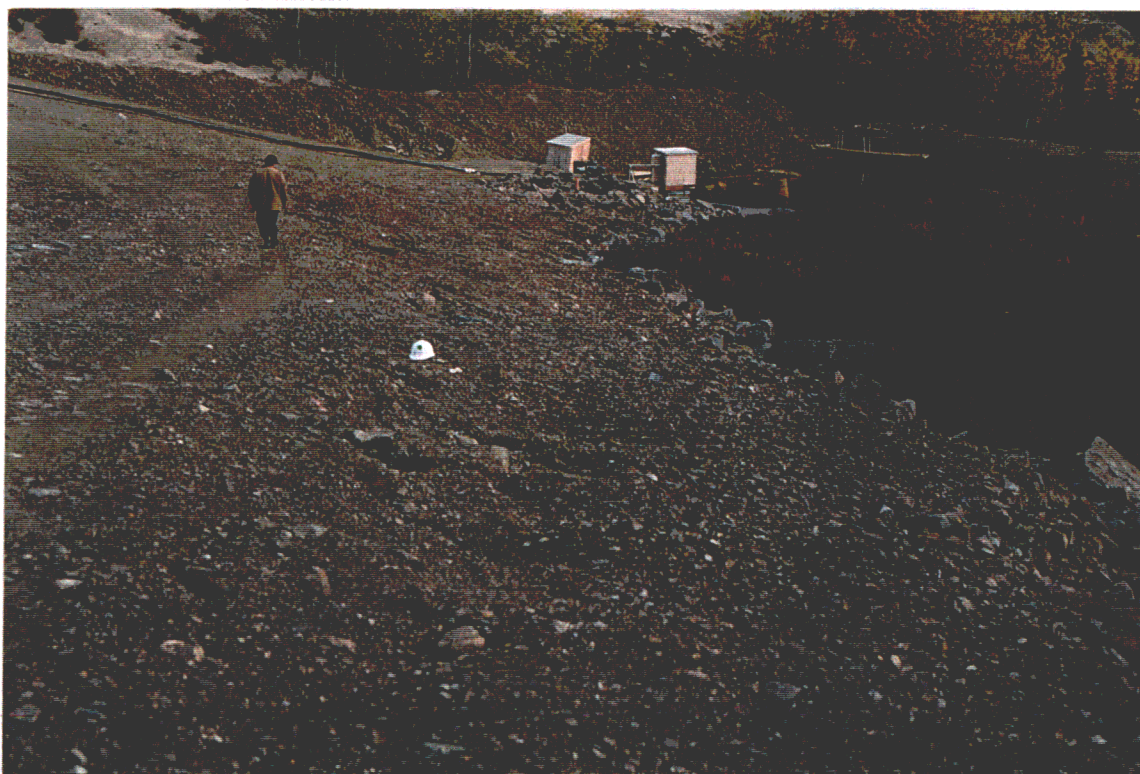
Photograph 6 Downstream Slope of Buttress Berm - looking downward towards Seepage Recovery Pond.

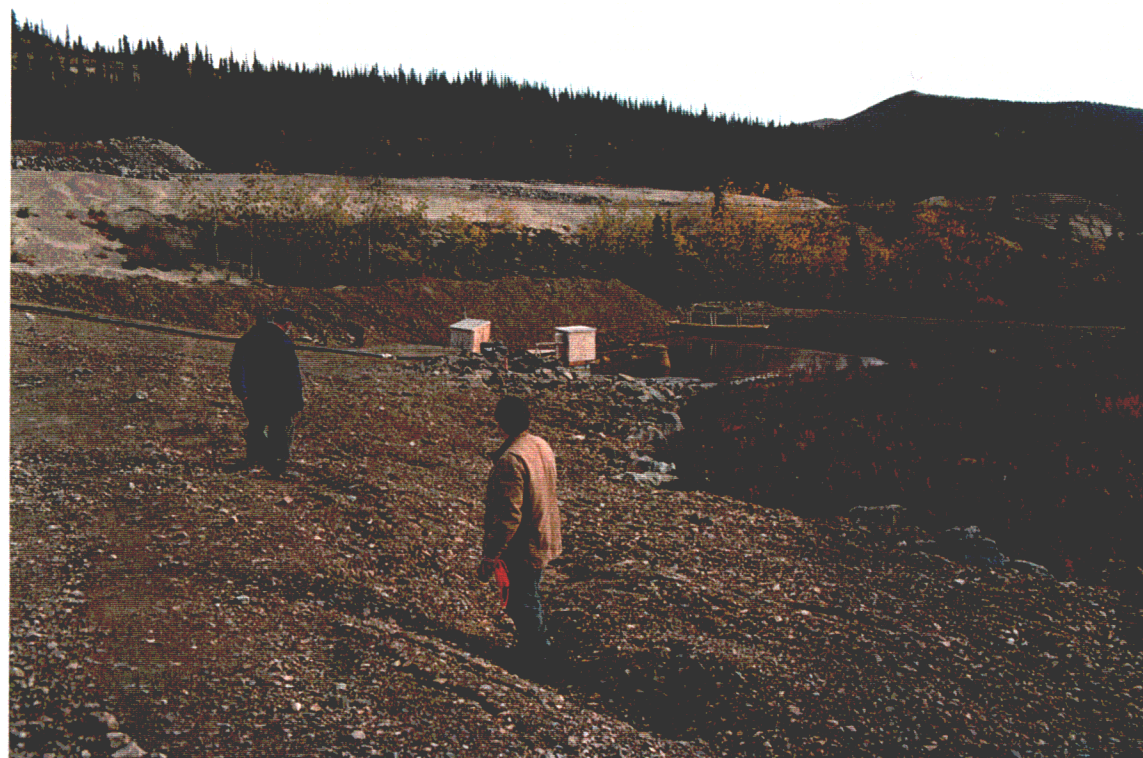
Photograph 7 Close-up of local depressions on buttress berm slope.

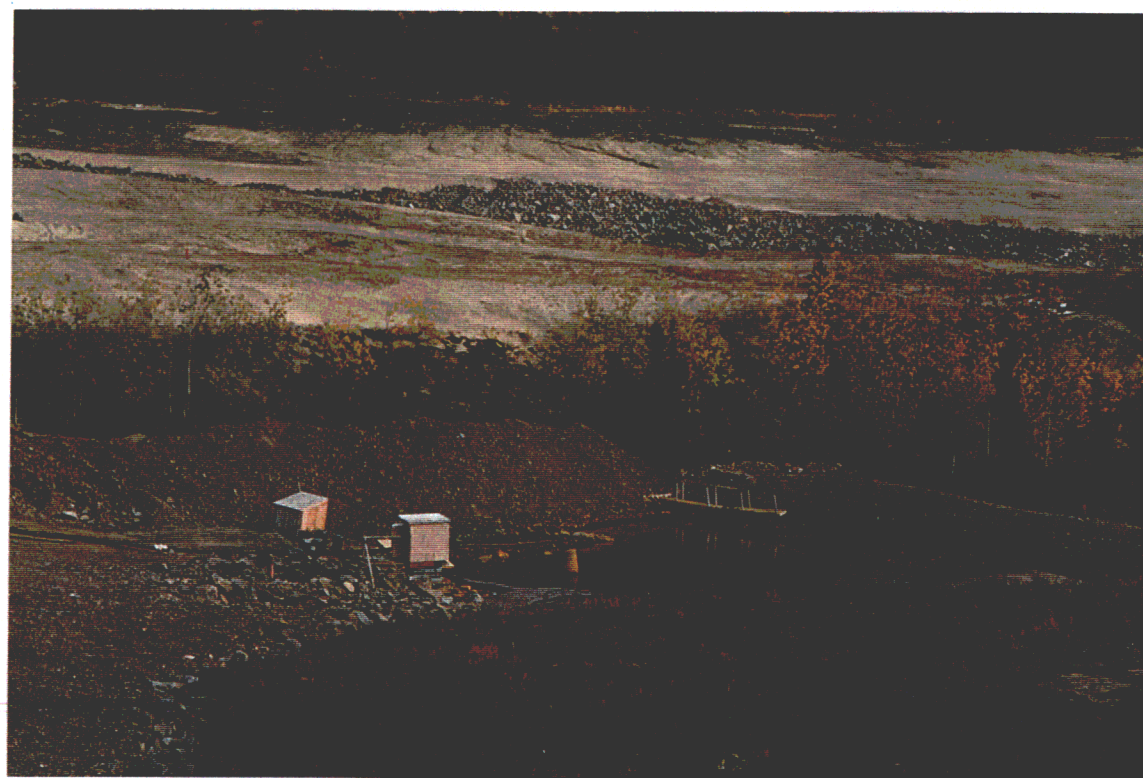
Photograph 8 Seepage Recovery Pond and Seepage Control Dam - looking northeast.

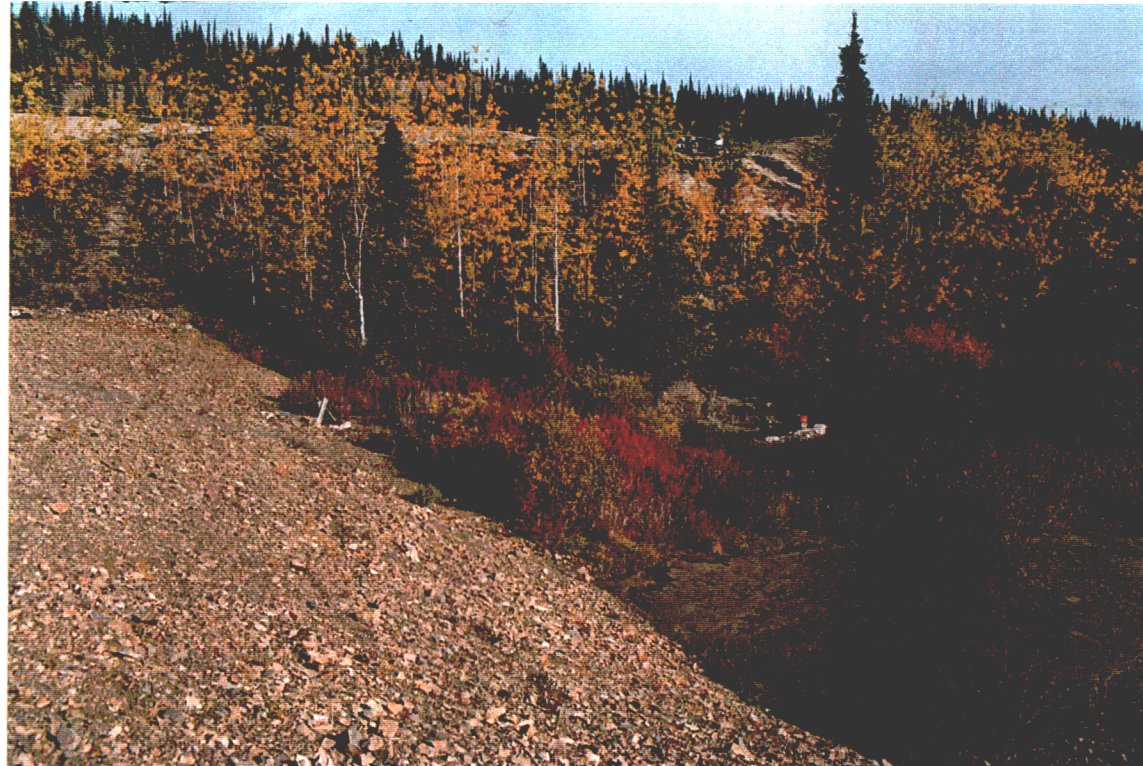
Photograph 9 Seepage Control Dam downstream slope - looking northeast (observable seepages exiting from the toe).

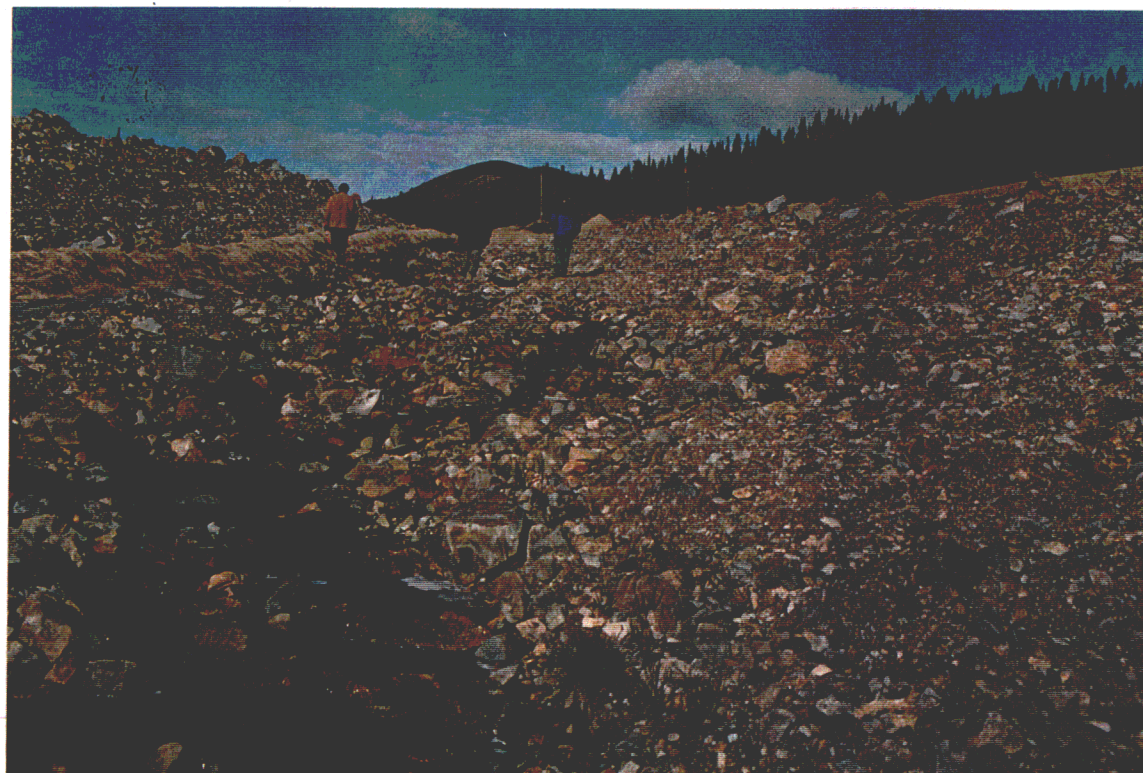
the flow back into Dome Creek downstream of the Seepage Recovery Pond. Its downstream segment shares the channel with the Emergency Spillway outlet channel (see Photos 10 and 11). The extended West Diversion Ditch picks up additional surface runoff along the west perimeter of the tailings impoundment (see Photo 14).

Sand and silt sediments generally covered the channel bottom along the West Diversion Ditch and the upstream segment of the North Diversion Ditch (see Photos 13 and 14). As the gradient increases along the downstream segment of the North Diversion Ditch, the riprap protection reduces the downcutting of the ditch invert. Ongoing erosion and side slope adjustment as well as the maintenance of the slope protection were visible (see Photos 10 and 11).

Photograph 10 Emergency Spillway Channel - lower segment (used also for conveying water from North Diversion Ditch).

3. Investigate the existing condition of the emergency spillway channel to check what improvements to the slope protection of the channel may be required. This investigation should be carried out to a downstream point, where the Main Dam will no longer be threatened if the flow jumps out from the spillway channel. A thorough review of the site record and discussion with personnel familiar with the past mine operation by EBA would be a useful initial step.

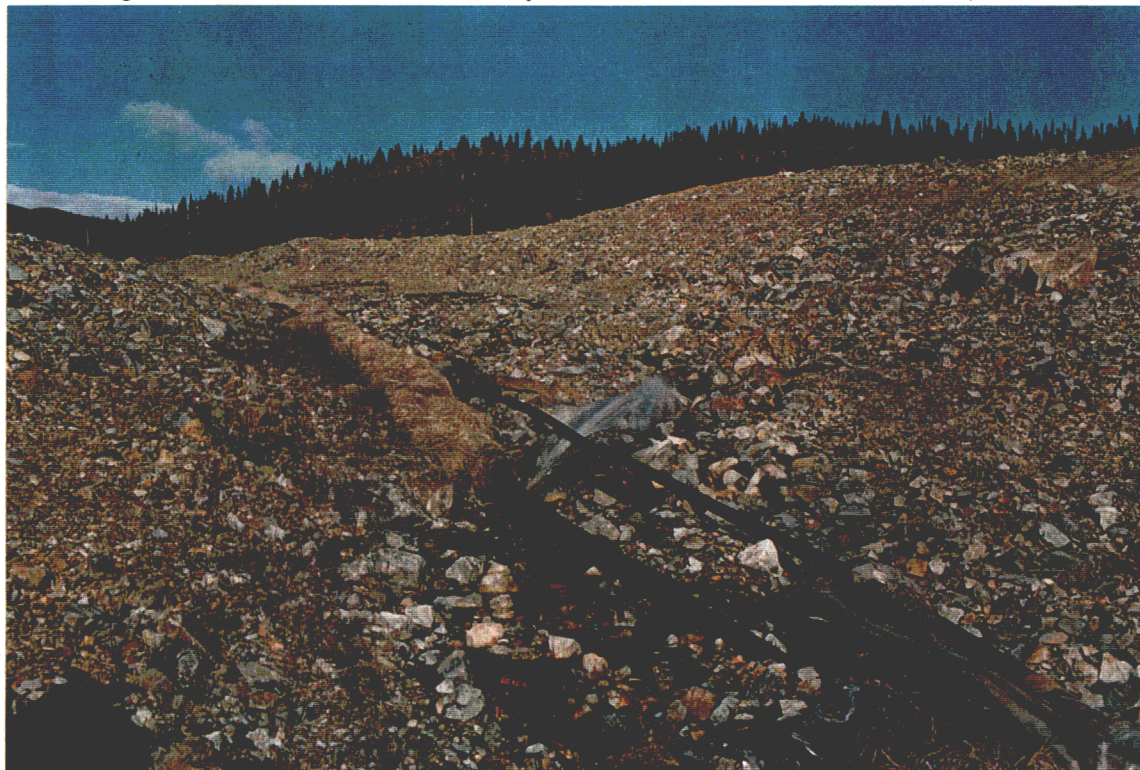
Photograph 11 Emergency Spillway Channel - upper segment (used also for conveying water from North Diversion Ditch).

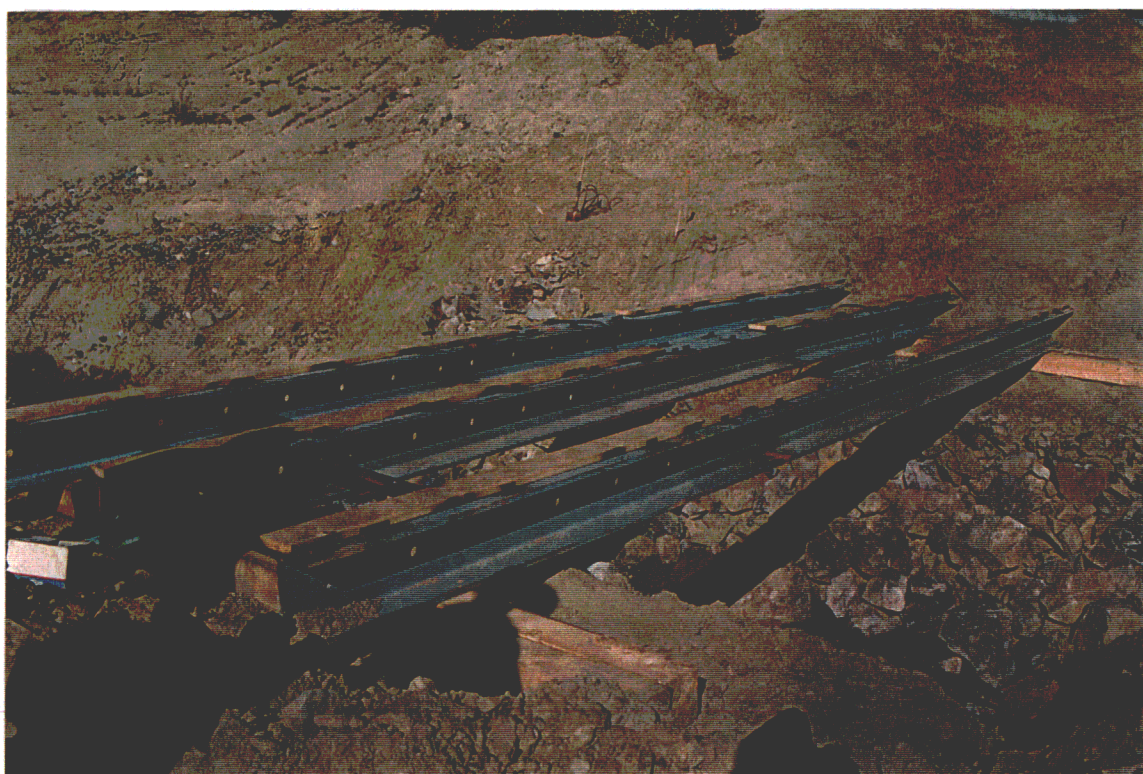
The North Diversion Ditch diverts Dome Creek from the northwest corner of the tailings impoundment (see Photo 14) along its north perimeter (see Photos 13 and 12) and returns

Photograph 12 Bridge construction in progress - across North Diversion Ditch.

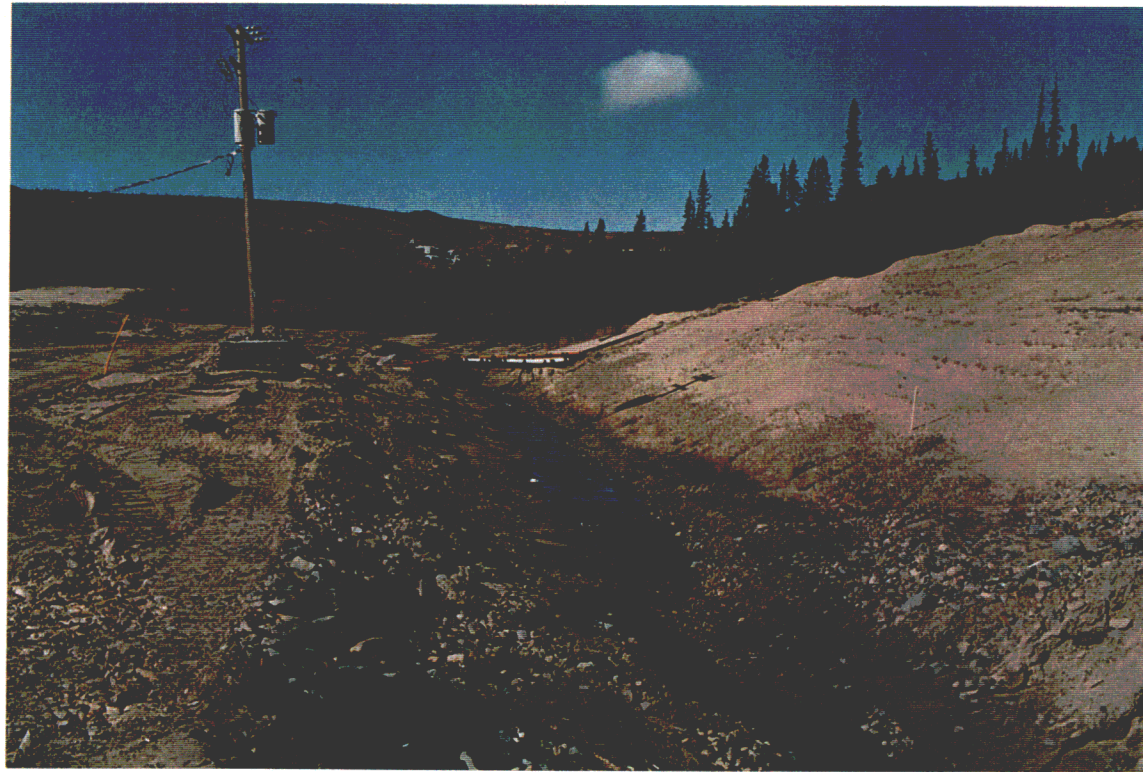
Photograph 13 North Diversion Ditch - looking west (pipelines crossings in background).

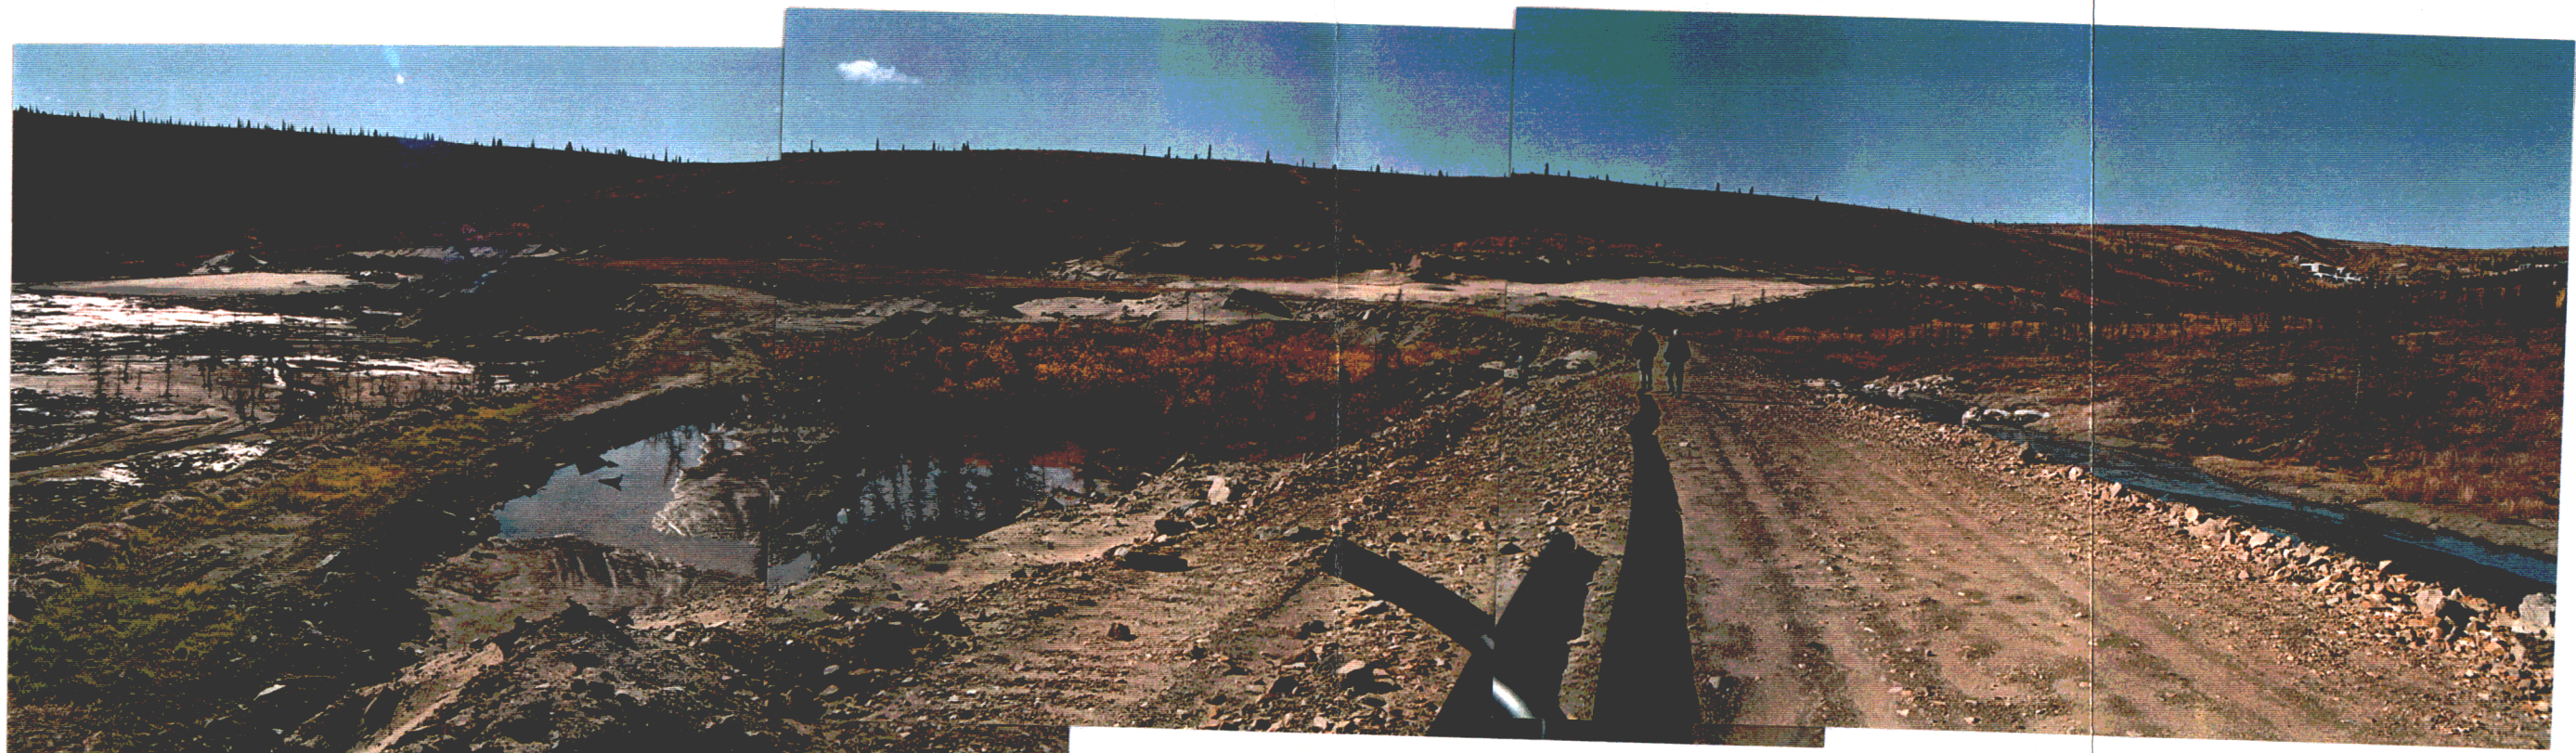
Photograph 14 North and West Diversion Ditches - looking north and northwest.
