HARDY ASSOCIATES (1978) LTD.

File No. K4946

June 22, 1981

RE: Cassiar Asbestos Mine,
Waste Dump and Tailings
Pile Stability

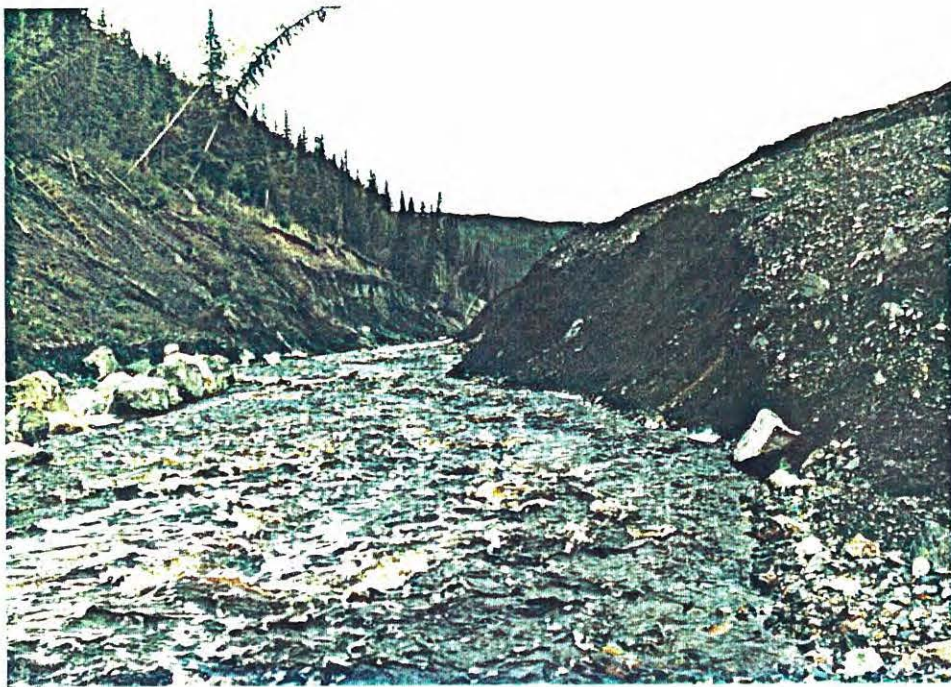
Despite a relatively low spring runoff, the banks of the creek channel show fresh sloughing and erosion scars (Photo 1).

PHOTO 1 - Clinton Creek downstream of closures, note undercutting of both banks.

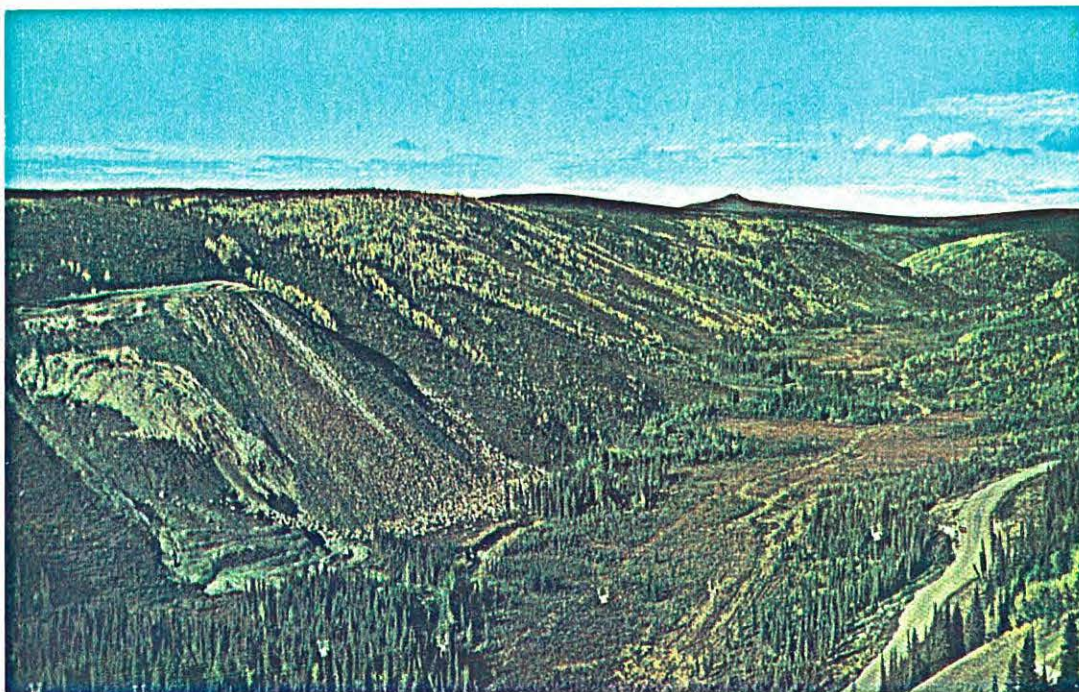
1.3 Initial dump failure. An old post card (Photo 2) obtained during the site visit and showing the initial stage

- angle of repose of the waste material is greater than the shearing resistance of foundation materials,
- the dump failed due to the failure of its foundation, both on the slope and in the valley bottom,
- the movement resulted in a net decrease of shearing resistance (along the slip planes) from its original peak to residual strength value,
- the stabilization of the dump, if left to natural processes, will likely take a very long time while the factor of safety against sloughing would be unlikely to significantly exceed the value of unity,
- the sloughing experienced during the initial stages of the dumping operation provided an early warning of possible problems resulting from uncontrolled dumping of waste material into this area.

PHOTO 2 - Post Card showing an initial dump stage, note the instability of left dump portion.

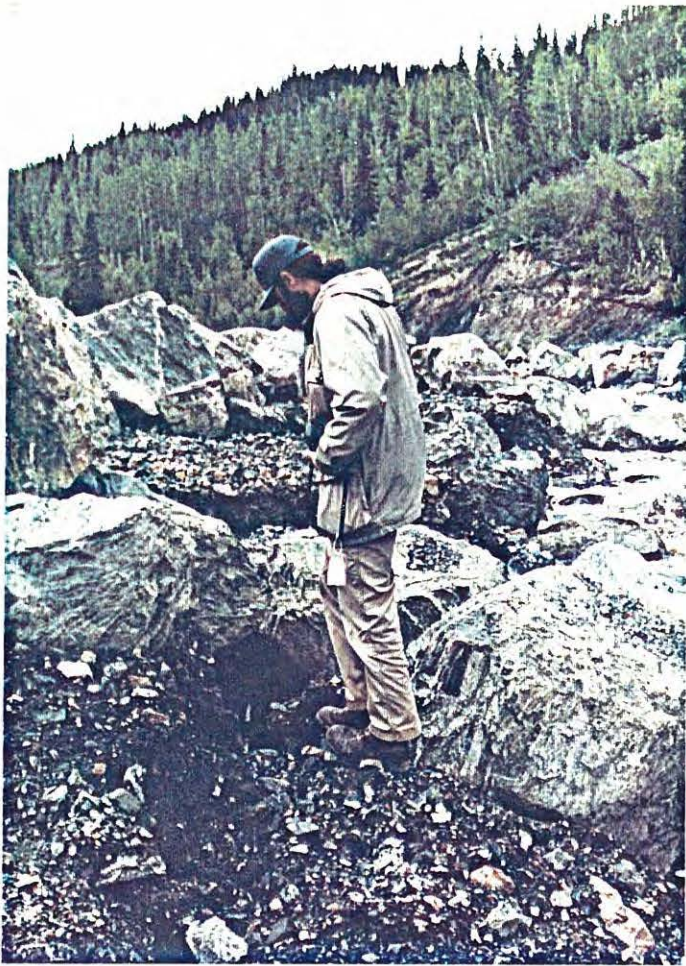
1.5 Structural integrity of weirs controlling the lake outfall is poor. Rock blocks forming the weirs are being undermined (Photo 3) and gradually displaced. This will, eventually, destroy the system.

PHOTO 3 - Undermined and unstable rock blocks forming weir closures.

It has been brought to our attention that Cassiar Asbestos Corporation Ltd. plans to reconstruct the weirs. The plans prepared by Golder Associates are considered adequate insofar as armouring of this creek segment is concerned; however, narrowing of the stream channel to the original design width is also considered. While the design width may be sufficient to convey the flows, I do not favour the proposed channel narrowing. It is my opinion that the channel banks, due to the existing armouring, have achieved a certain degree of stability which could be destroyed by the proposed construction works. Since the flow velocity and erosion potential in the narrower channel will be increased, it appears prudent to maintain the existing channel width and to reconstruct and improve the weir system using additional rip-rap material.

When selecting the rock for rip-rap and weir construction, attention should be paid to the rock durability. Most local rock types exhibit relatively rapid deterioration.

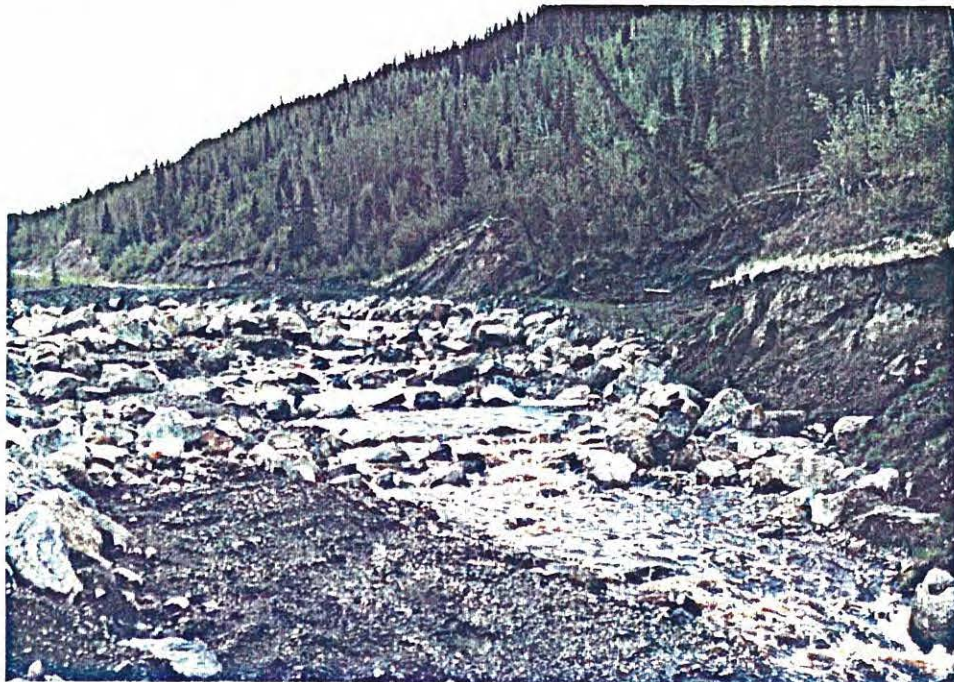
In addition, the channel bottom downstream of the last weir is unprotected and the change in the flow velocity in this area (Photo 4) has already damaged the downstream-most weir. This will, unless mitigated, accelerate retrogressive erosion and adversely affect the stability of upstream weirs.

PHOTO 4 - Continuing deterioration of weirs at the closure outfall.

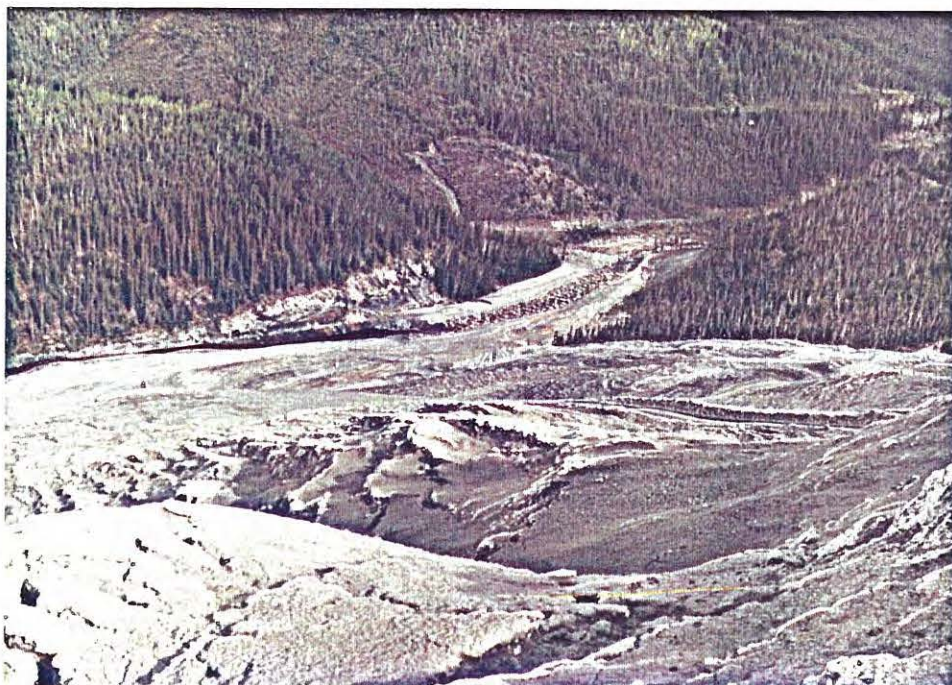
The visual inspection of both south and north tailing pile lobes revealed a number of fresh cracks and scarps, indicative of continuing and possibly accelerating movement of key components of the pile (Photos 5 to 7 inclusive). The toe of the south lobe, forming the bank of the creek channel upstream of the weir system, exhibits extensive deformation, manifested by cracks parallel and perpendicular to the stream (Photos 7 and 8). It is apparent that this area is experiencing both horizontal and vertical movements.

PHOTO 5 - General view of Wolverine Creek south lobe tailings pile.

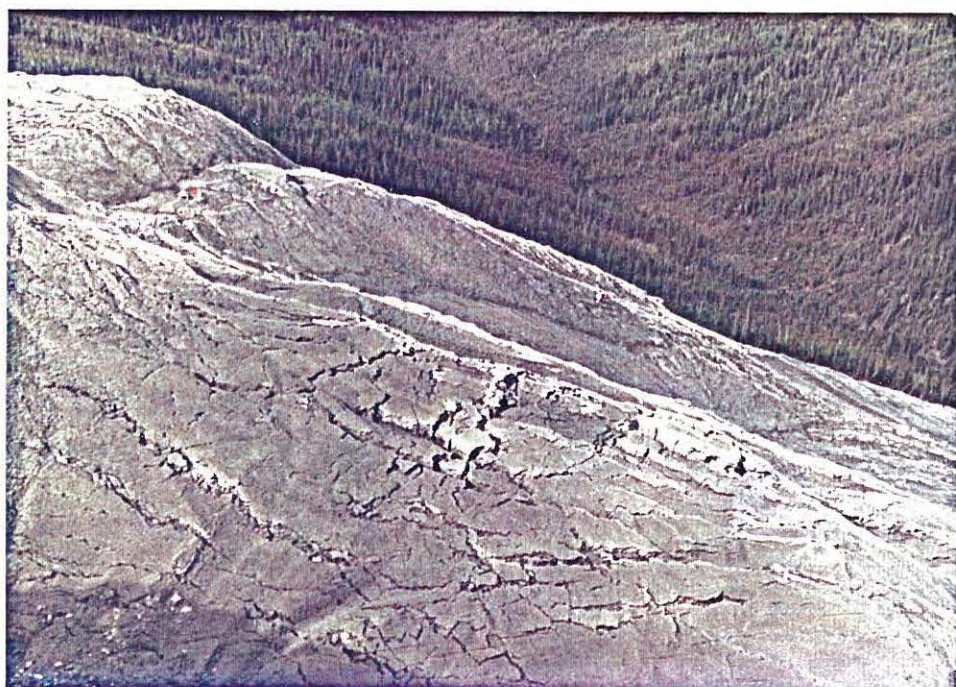
Considerably greater deformations are discernible on the north lobe of the tailings pile. Numerous wide open cracks and almost vertical and relatively high scarps exist throughout the north lobe of the pile. Some of the benches, cut into the pile in 1978 with the intent of arresting the movement, are intersected by numerous cracks and scarps. The toe area of the north slope is bulged and the

PHOTO 6 - North lobe of the tailings pile, note slide cracks and scarps.

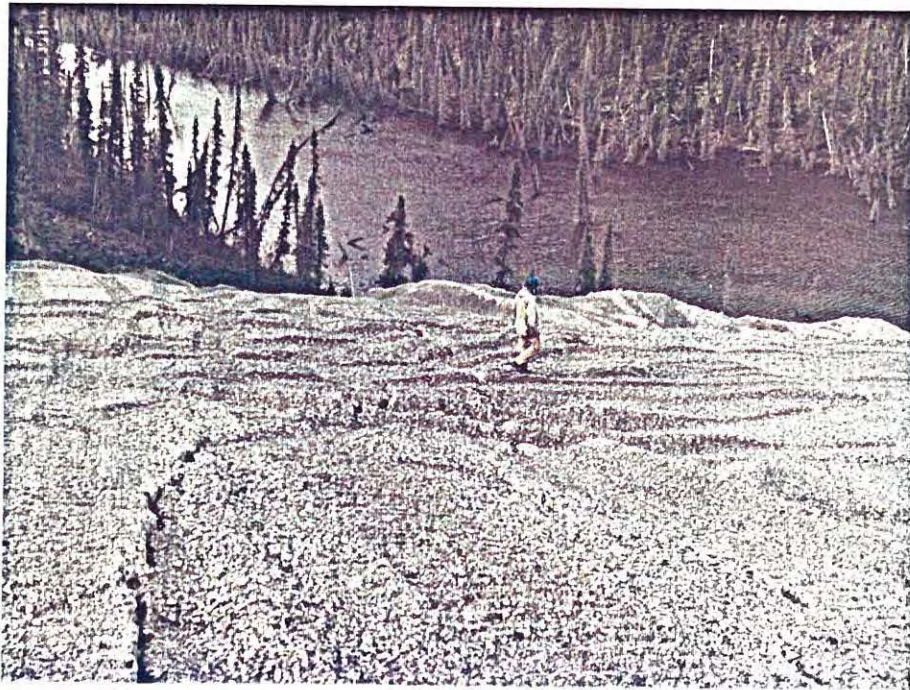
PHOTO 7 - Downslope segment of south lobe exhibiting open slide cracks.

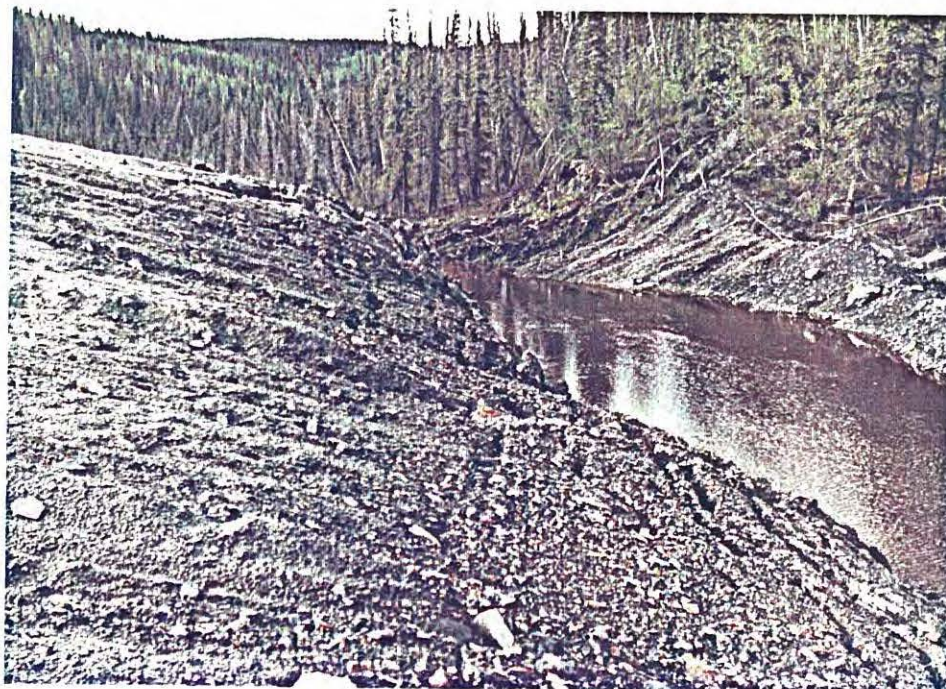
PHOTO 8 - Toe of the south lobe moving upwards and into the creek channel upstream of weir spillway.

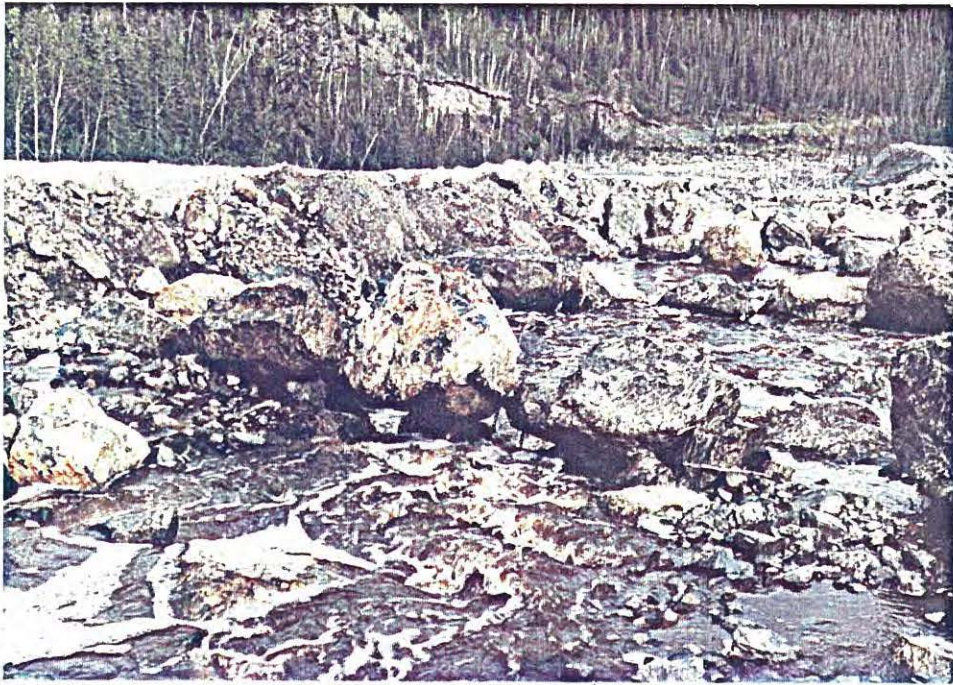
2.3 Visual inspection of the Wolverine Creek spillway system showed that most of the weirs and embankment armouring are performing satisfactorily. However, since the outfall (i.e. the area immediately downstream of the last weir), is unprotected, retrogressive erosion is occurring and the structural integrity of the last three weirs is poor (Photos 9 and 10). It would be prudent to undertake the following repair works:

PHOTO 9 - Undermined rock blocks forming a downstream weir.

- installation of a rip-rap apron downstream of the last weir,
- rehabilitation of the damaged weirs.

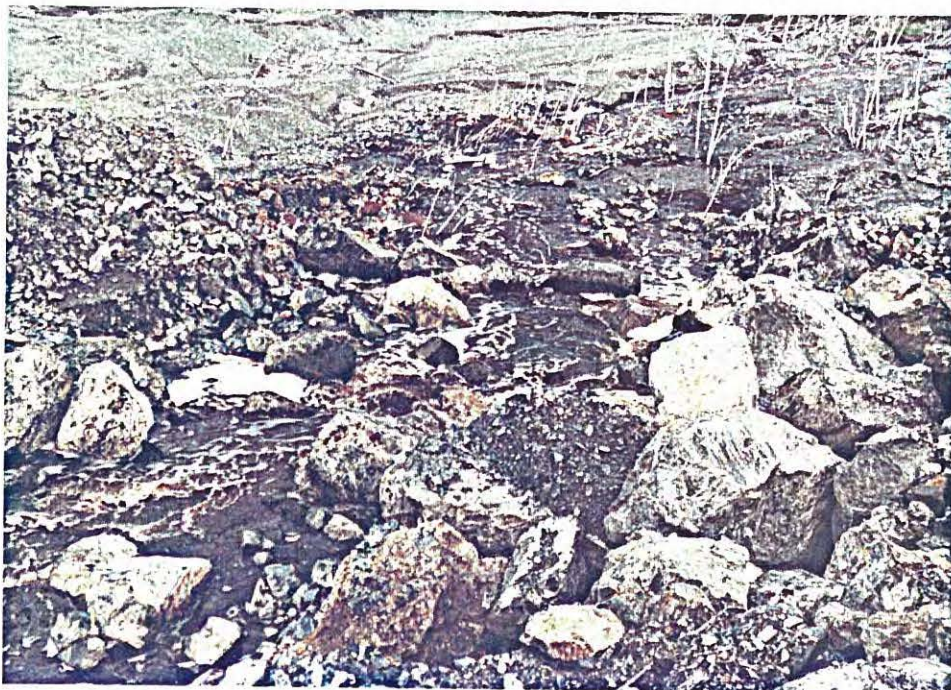
PHOTO 10 - Weir spillway outfall exhibiting distress due to erosion.
