**CLINTON CREEK**

**INDEPENDENT ENGINEER'S CHANNEL  
ASSESSMENT**

PROJECT NO.: 0533-019

DATE: October 31, 2016

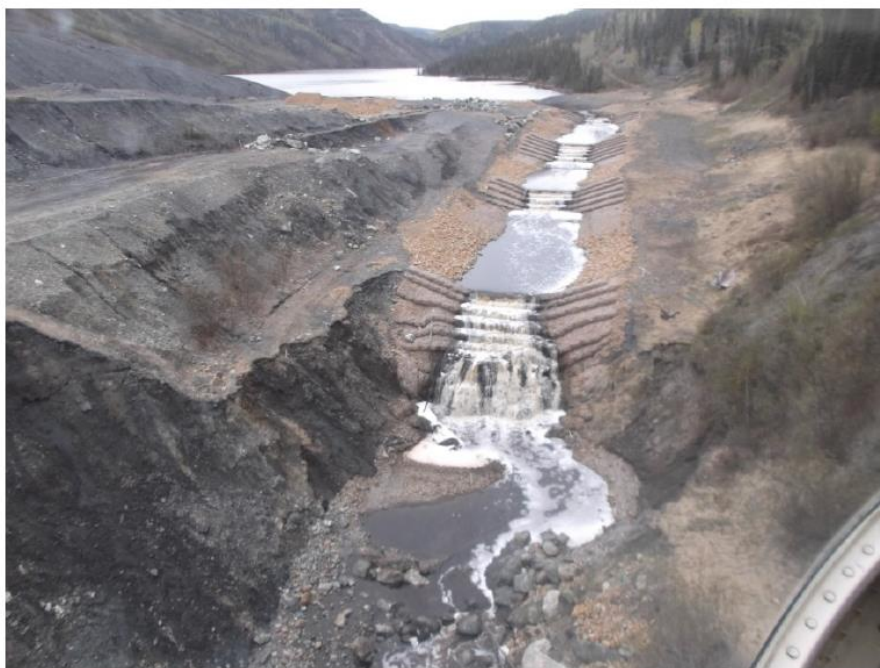
In 1974, failure of the Clinton Creek waste rock dump resulted in the formation of a landslide dam across Clinton Creek and the formation of Hudgeon Lake. Clinton Creek formed a new channel along the interface between the waste dump and the original valley wall over a distance of approximately 700 m at a gradient of 3 to 6% (Robinson 2005). Erosion of the new channel at the lake outlet, prompted concerns of a potential landslide dam outbreak flood and efforts were made starting in 1981 to stabilize the channel from erosion using riprap. Multiple failures and high flow events resulted in damage and subsequent re-building of the erosion protection over the years since 1981. Between 2002 and 2004, a series of 4 temporary gabion drop structures were constructed along the outlet channel (Figure 2-1). In 2010, a high flow event on the order of the 100 to 200-year return period resulted in headcutting of the creek and damage to the most downstream structure, which is known as Drop Structure 4 (DS4) (WP 2015b). This damage is apparent on Figure 2-1.

**Figure 2-1. Site overview prior to 2015 DS4 Repairs. May 21, 2014. Looking upstream (west) with Hudgeon Lake in the background, and the Clinton Creek waste rock dump slide on the left (Advisian 2015).**

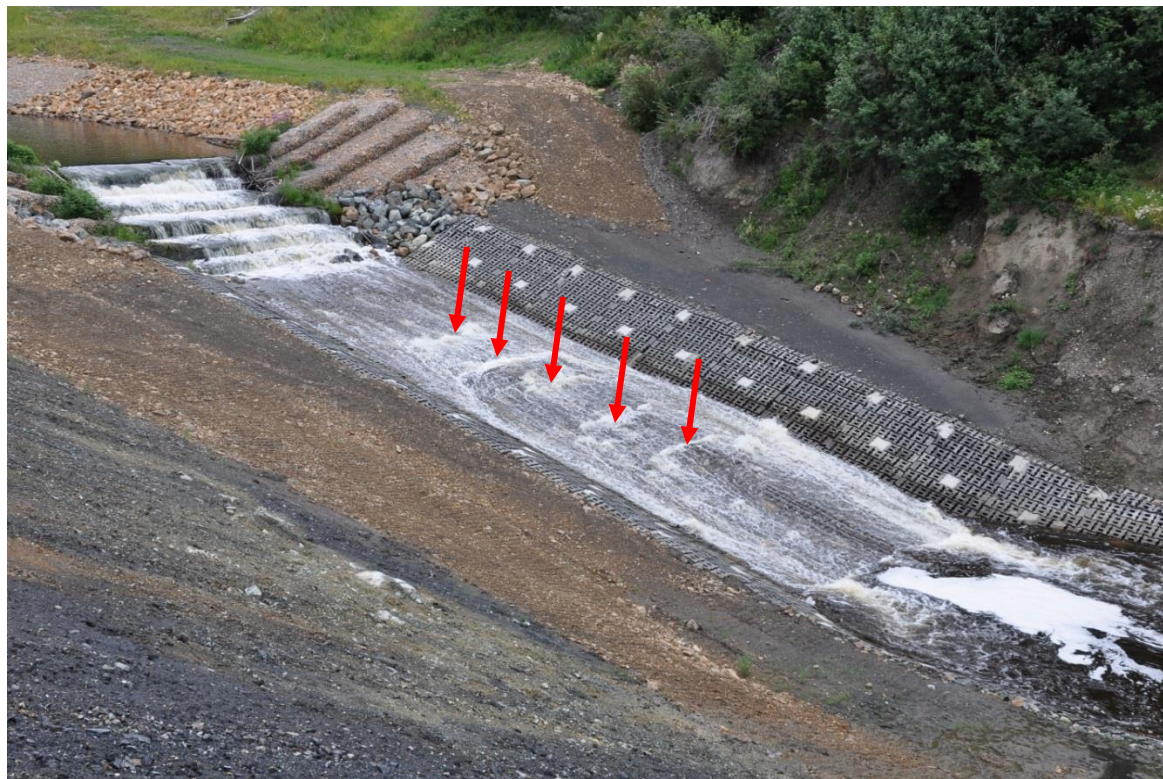
**Figure 2-2. Channel chute with deformities as observed by YG AAM on July 19, 2016.**

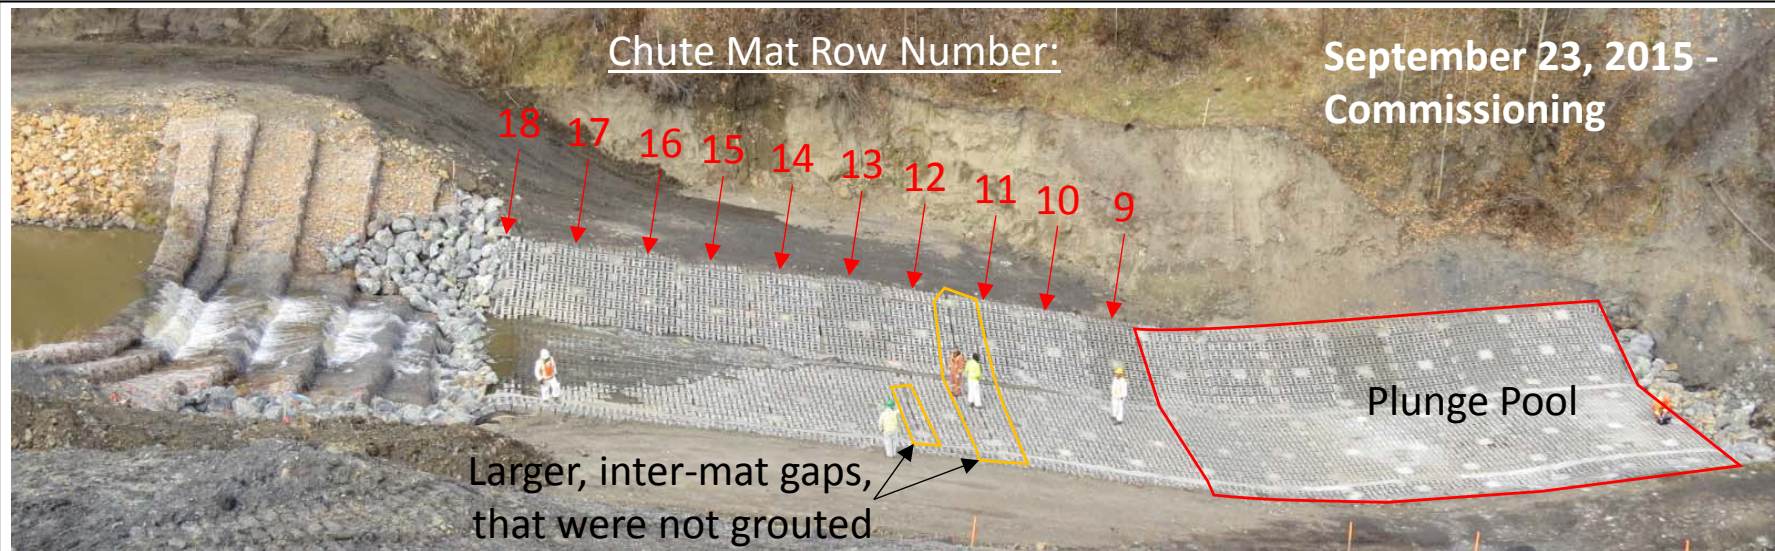
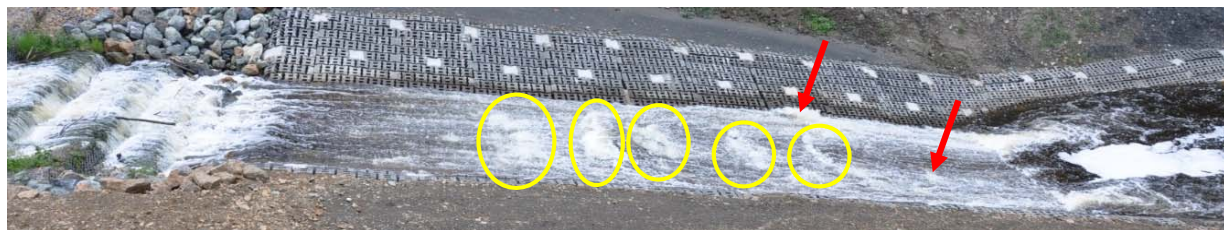
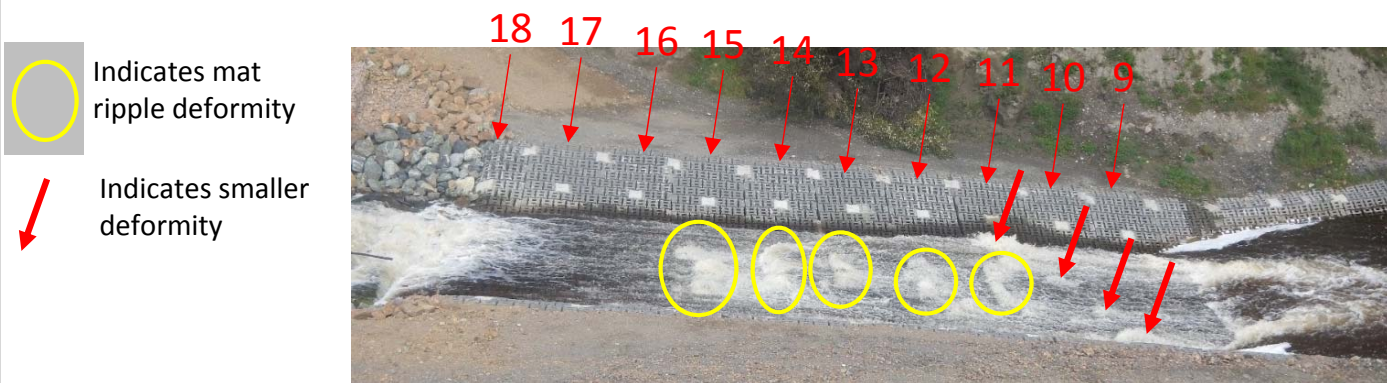
Figure 3-1. Photos of spillway during commissioning, and two site visits. Flow direction is left to right.

- As shown in Figure 3-1, the chute is comprised of 10 rows of mats and five deformation ripples were observed:
  - a. Between mats in row 11 and 12, the downstream mat (row 11) was observed to be protruding above the upstream mat (row 12) in the centre of the channel. Also, adjacent to the left bank and immediately downstream of the lateral mat connection, highly turbulent flow was observed.

- b. Between mats in row 12 and 13, the downstream mat (row 12) was observed to be protruding above the upstream mat (row 13).
  - c. Between mats in row 13 and 14, turbulent water obscured the mat, but indicated a deformity.

- As shown in Figure 3-1, Figure 3-3 and Figure 3-4, there were large gaps between rows 11 and 12, and rows 12 and 13, where the mats did not abut one another at commissioning and the gaps were never grouted. Between rows 11 and 12 on the right bank, the geogrid was observed to be bunched, some of the blocks were cracking, and a 10 cm gap was measured at the surface of the blocks. Between rows 12 and 13 on the right bank, the geogrid was observed to be bunched, the site was associated with a geogrid overlap location, and a 6 to 7 cm gap was measured at the surface of the blocks.

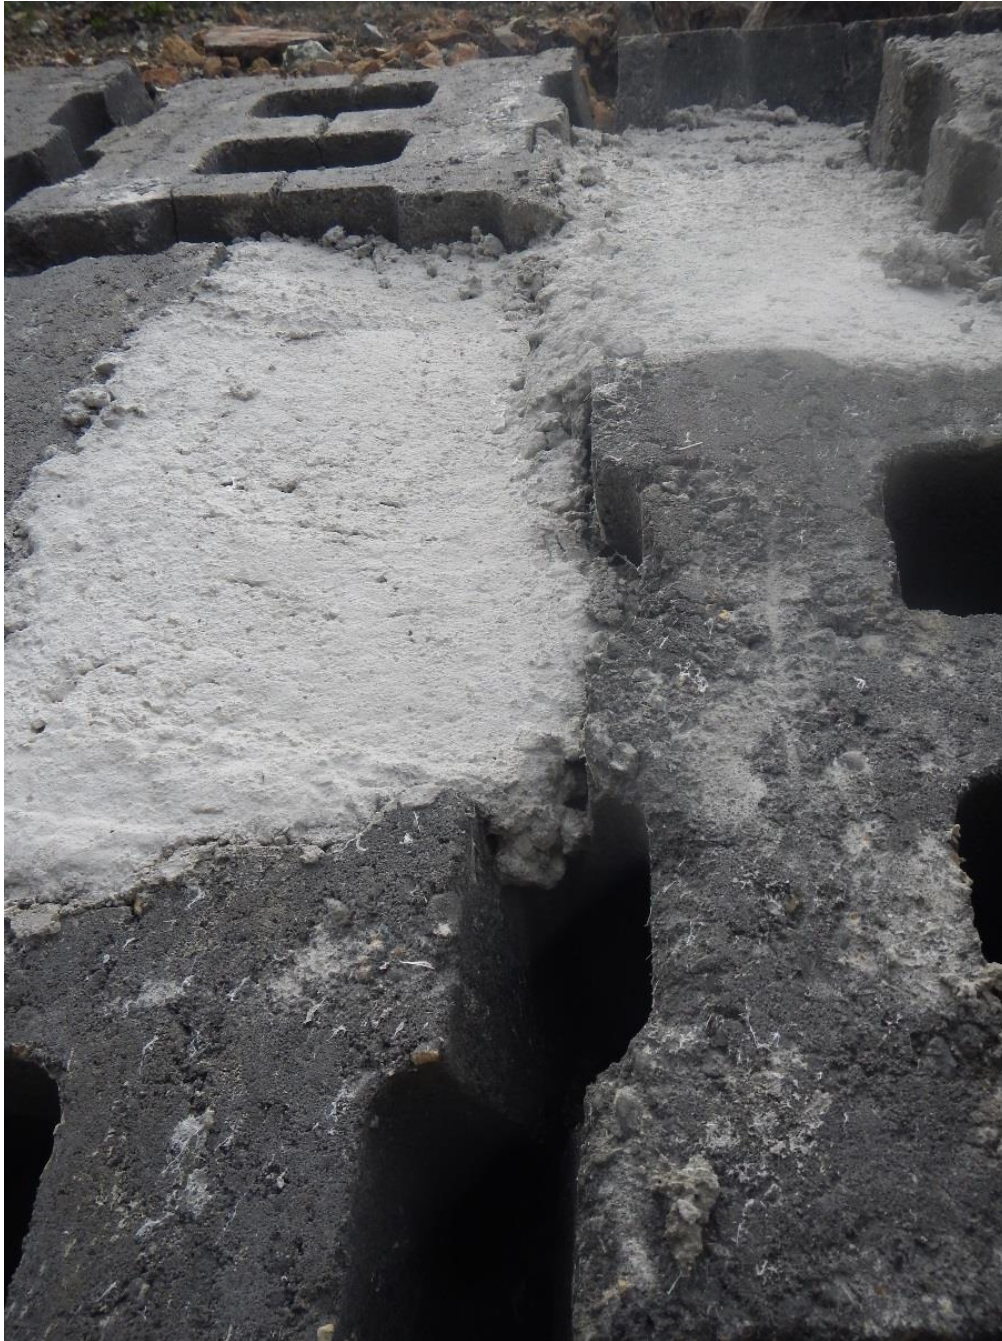
**Figure 3-2. Example of grouting of void blocks not flush with adjacent blocks. Flow direction is from right to left.**

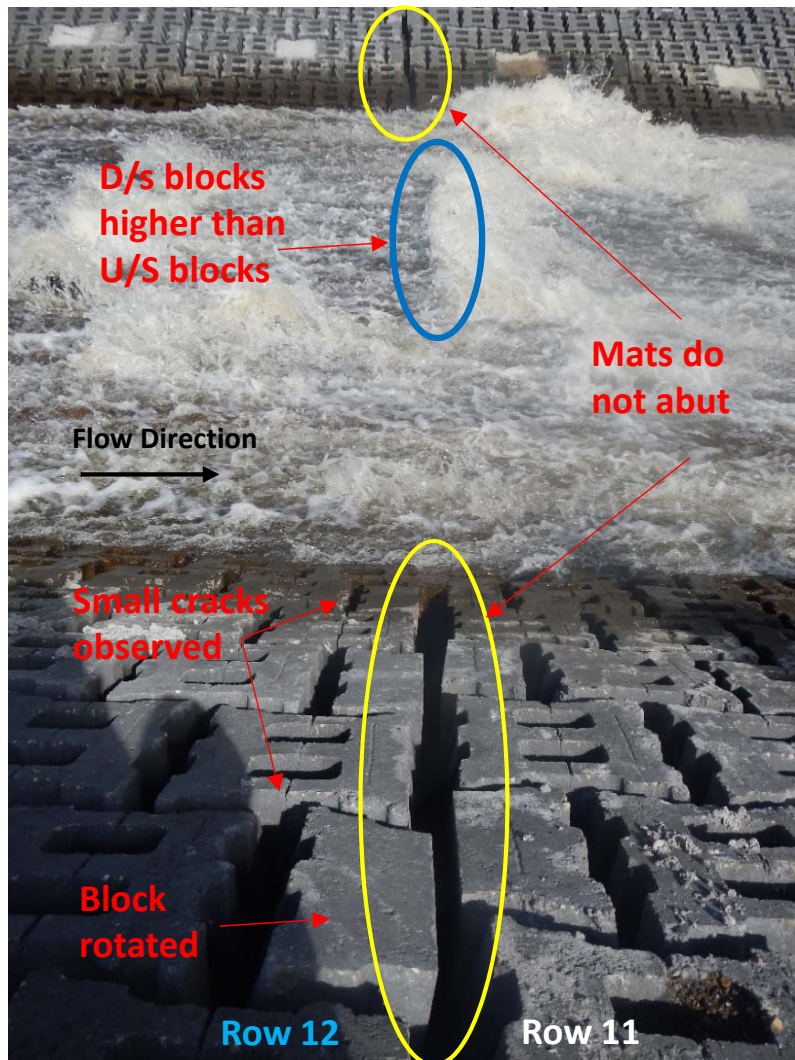
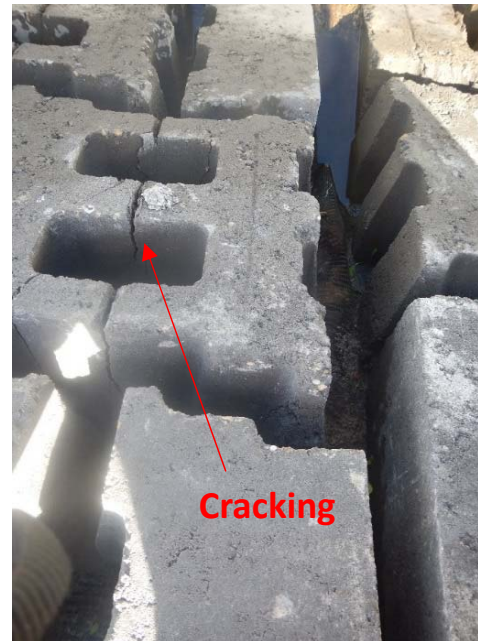
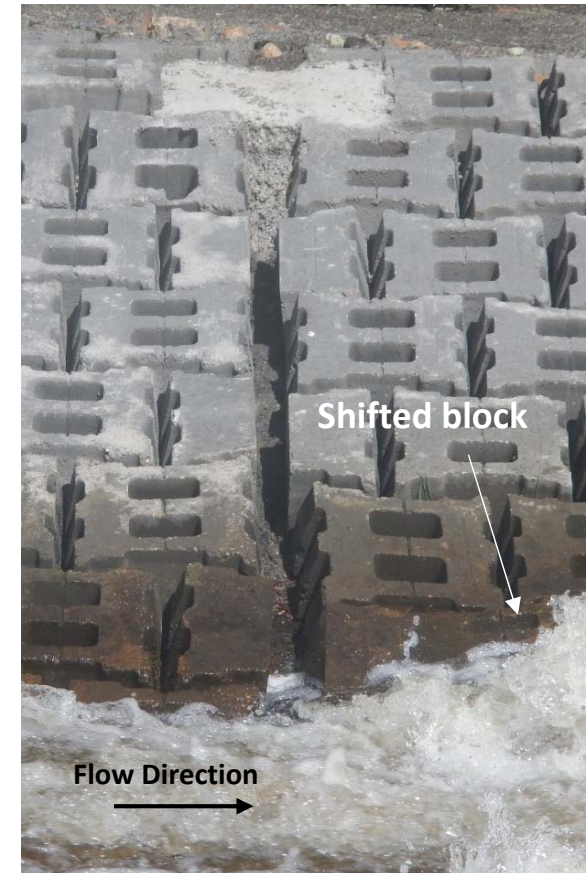
Figure 3-3. Observations of ACB Mats at Row 11/Row 12 Connection (August 23, 2016)

Mats do not abut one another. Approximately a 10 cm gap on mat surface. Half block has partially rotated. Geogrid is bunched the length of the right bank

Enlarged View of Right Bank at Water's Edge

Enlarged View of Left Bank

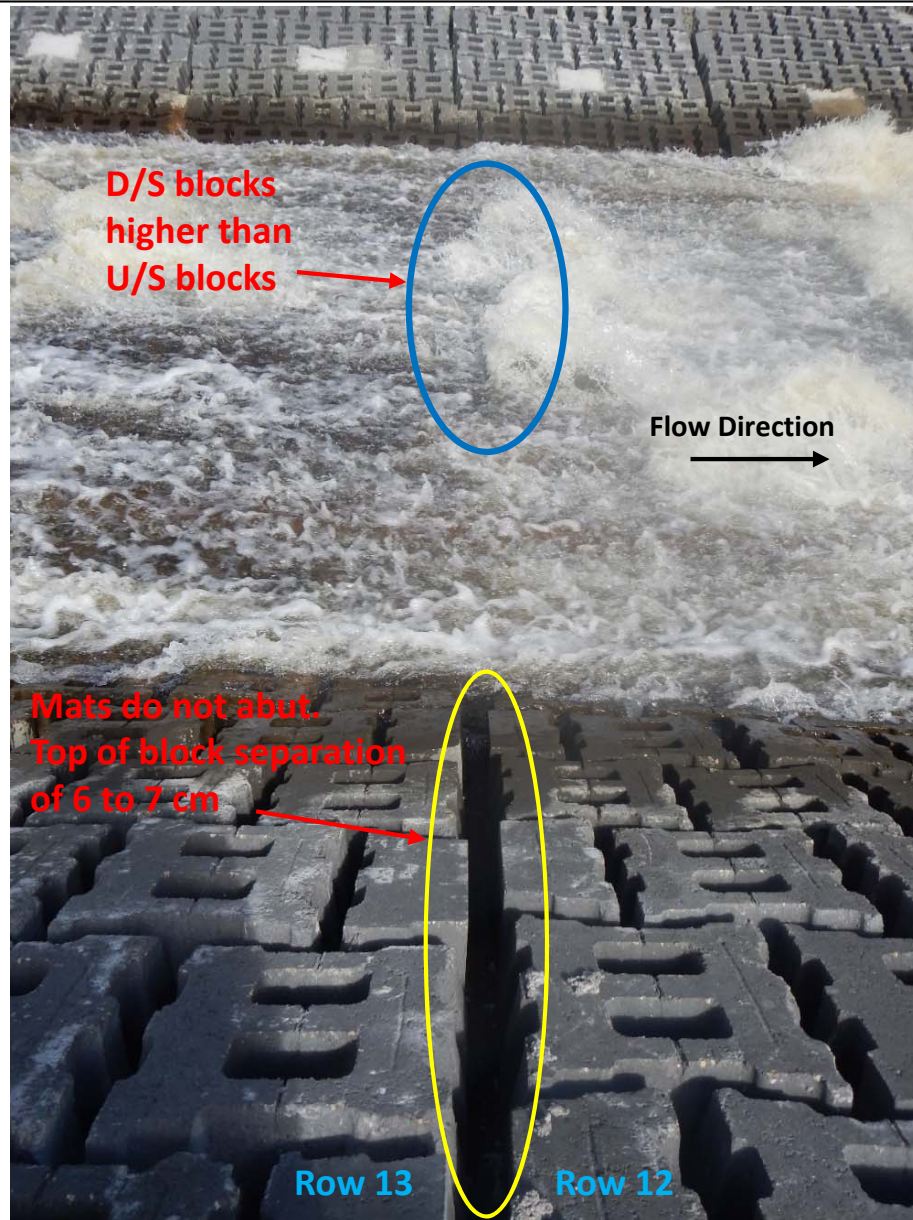
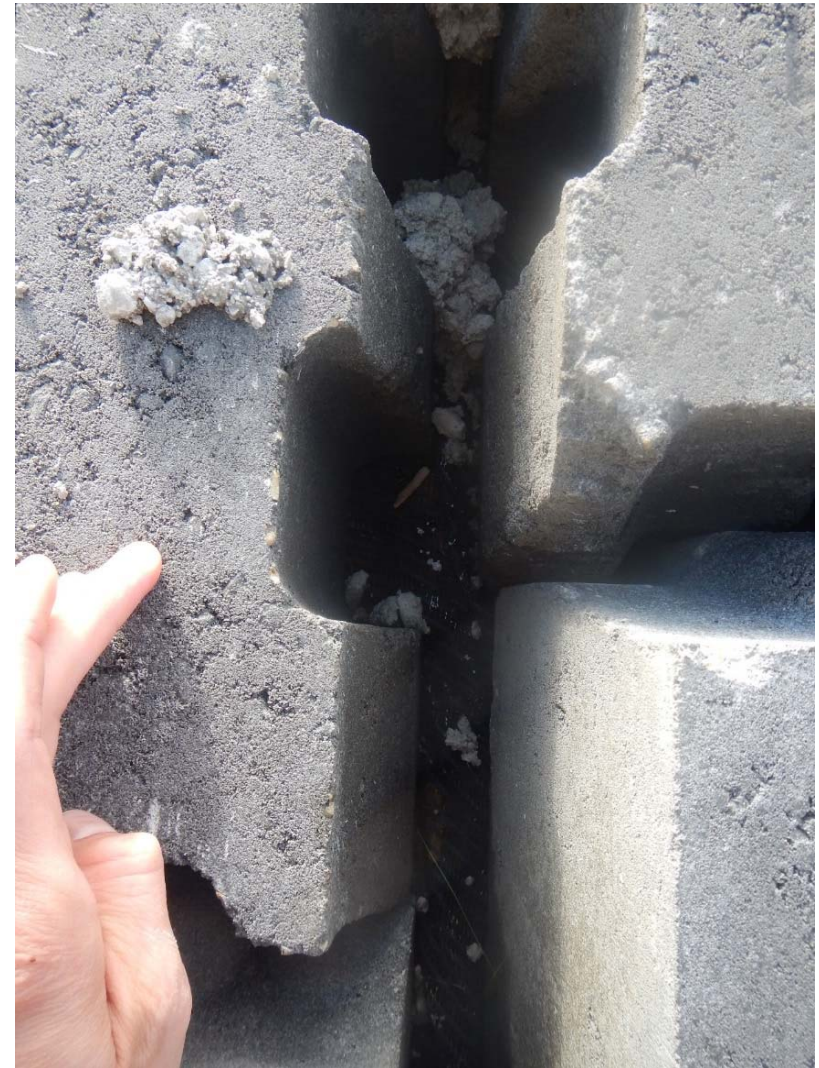
Figure 3-4. Observations of ACB Mats at Row 12/Row 13 Connection (August 23, 2016)

Enlarged View of Left Bank

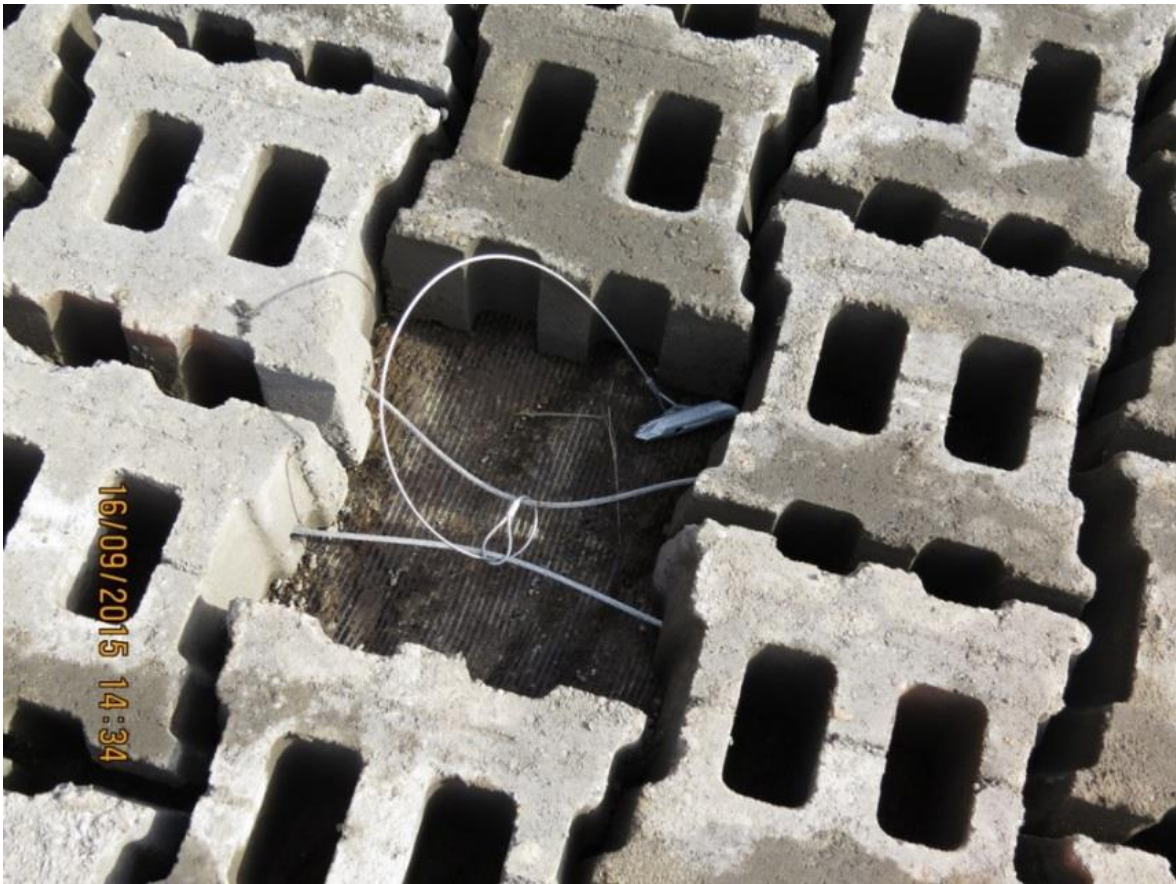
Change in anchor attachment method.	<ul style="list-style-type: none"><li>Anchors not crimped to mat cables as designed. Instead, looped back on itself (Figure 4-2) rather than a fixed ring. Inadequate anchor tension could allow loop to open more than the diameter of the fixed ring.</li><li>If anchor failed, loop could more easily open than crimped ring. If failure point was at a mat to mat transition, this could allow the mats to separate, further weakening the integrity of the mat structure</li><li>Although it appears that one anchor has failed (Figure 4-7), mat deformity locations don't appear to correlate with anchor locations.</li></ul>	<ul style="list-style-type: none"><li>Less Likely</li></ul>
Anchors pulled out of the ground	<ul style="list-style-type: none"><li>The substitution of “orange fill” material for waste rock as a sub-base meant that the rocks made installation of anchors difficult (YG AAM 2015b). YG AAM notes that the orange material was sorted to have the large rocks removed (2015b), but WP notes that due to large rocks in the orange fill, anchor holes were pre-drilled (2015). Lab tests for the orange fill show 30% of the material was larger than 50 mm (Advisian 2015). Both construction reports discuss the difficulty with installing the anchors due to the presence of rocks.</li><li>YG AAM notes that on September 16, it was decided by WP, Sidhu and YG AAM and approved by YG AAM, to change the anchor attachment method and that this would also help reduce the slack in the anchor cable.</li><li>It appears that one anchor has failed (Figure 4-7). The failure is at a location where there is a bulge in the mat that appears to be the result of soil deposition beneath the mat.</li><li>Mat deformity locations such as at the connection between rows 11 and 12 and also between 12 and 13 don't appear to correlate with anchor locations.</li></ul>	<ul style="list-style-type: none"><li>Possible</li></ul>

**Figure 4-2. Example of modified mat-to-anchor attachment method (photo from YG AAM 2015b).**

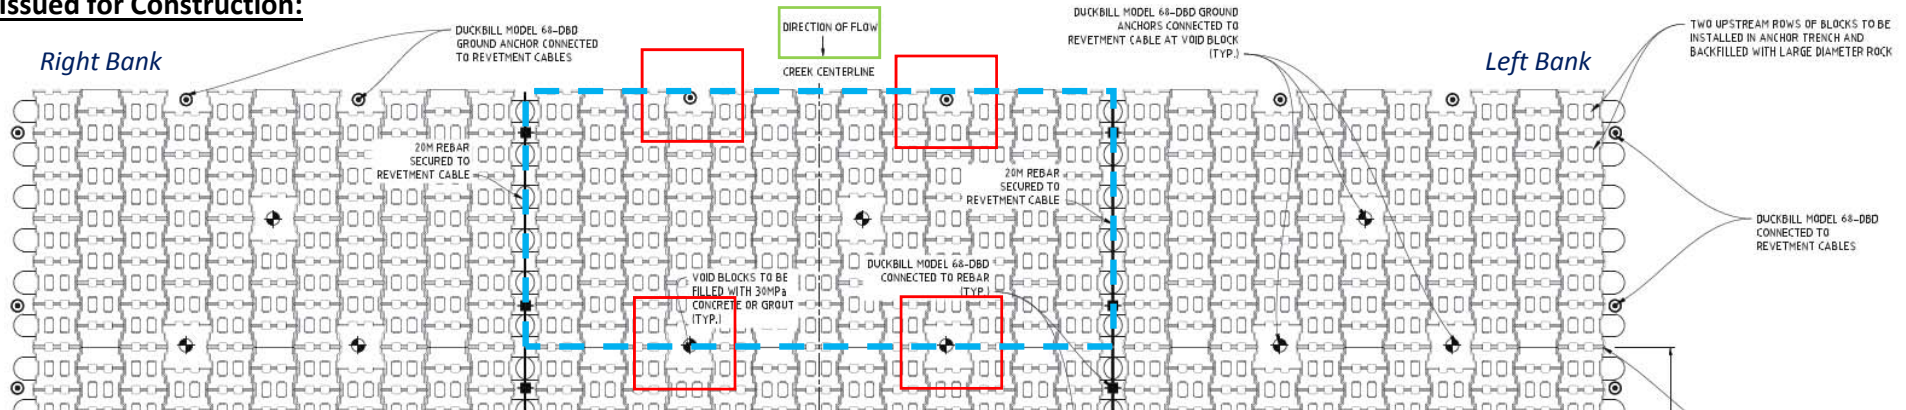
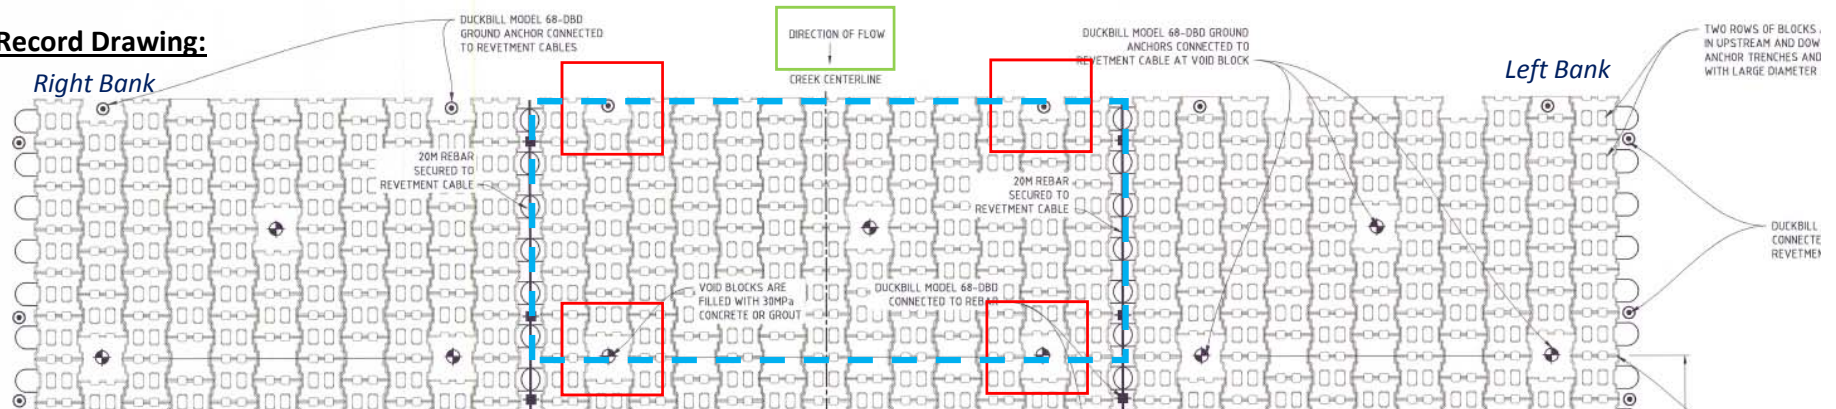
**Anchors as constructed are less centered.**

**Figure 4-3. Changes in anchor pattern between Issued for Construction (YG AAM 2015a) and Record drawings (Advisian 2015).**

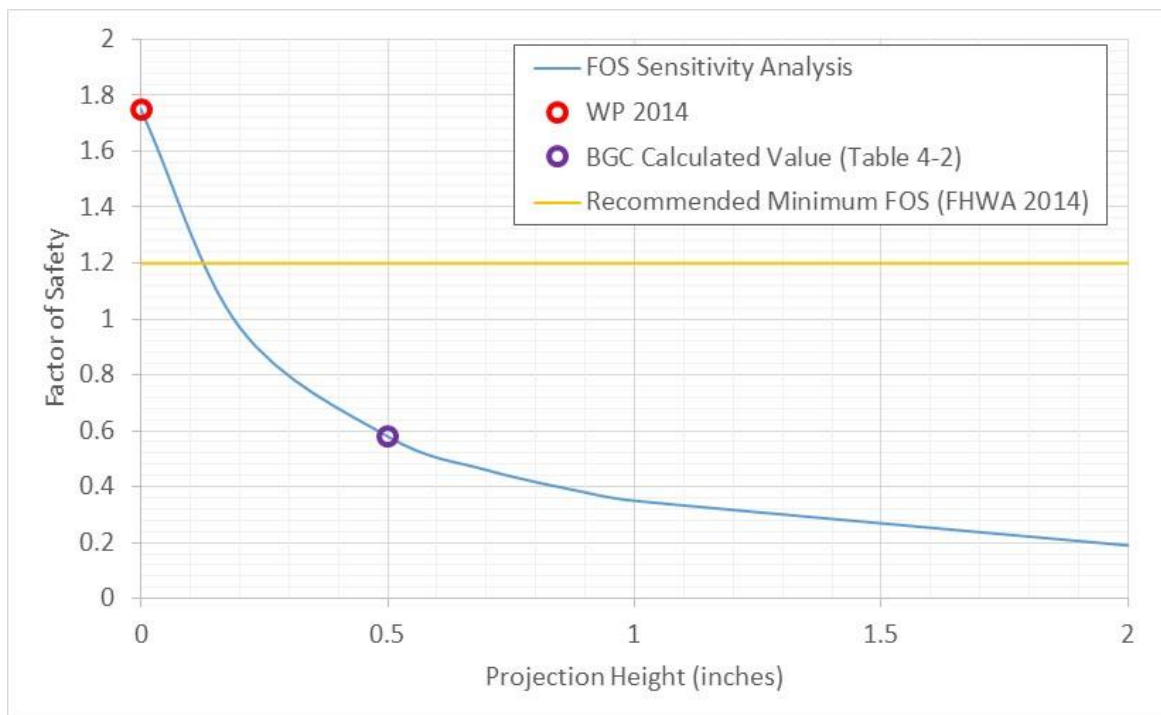
The block stability design software output report shows a Factor of Safety of 1.8. When no projection height is used, BGC obtains similar results. Figure 4-4 shows that the block stability is very sensitive to projection height, particularly between 0 and 0.5 inches. The block stability software output report (WP 2014) suggests to BGC that WP selected the block type using inappropriate input assumptions by selecting no projection height (value of zero).

The hydraulic stability calculations by BGC indicate that the mat design may not be adequate for the design flows, thereby magnifying the impact of changes between the design intent and construction.

**Figure 4-4. Factor of safety sensitivity analysis for block projection height.**

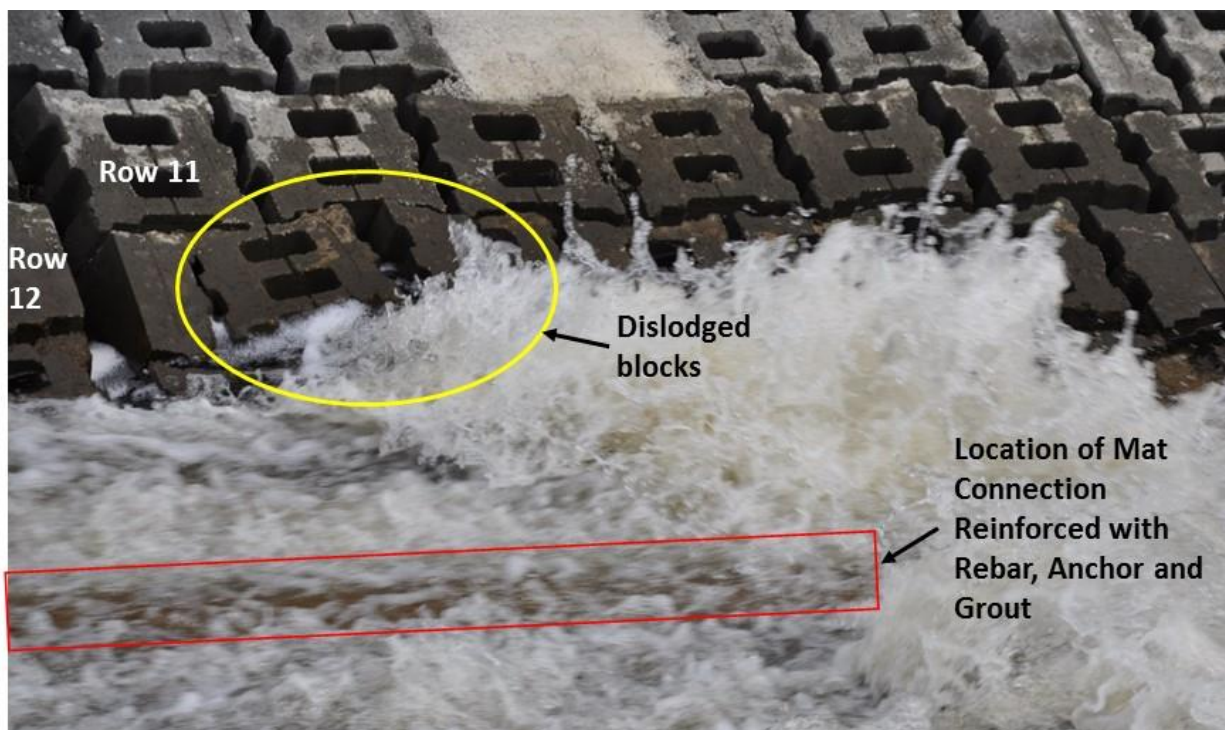
However, the turbulence could be associated with the large mat separation which was observed on both banks and is visible on the chute invert in the construction photos. During commissioning, water flow was directed initially to the left bank, so possibly there is a greater concentration of flow on the left bank than on the right bank. In addition, the upstream mat deformities also help to concentrate flow on the banks.

**Figure 4-6. Close up view of the left bank of mat row 11 and the highly turbulent flow immediately downstream of the lateral mat connection. Photo taken July 19 2016 (YG AAM 2016a).**

The construction specifications required: mat seams with openings larger than 5 cm to be grouted and mat seams with a grade change to be grouted (YG AAM 2015a).

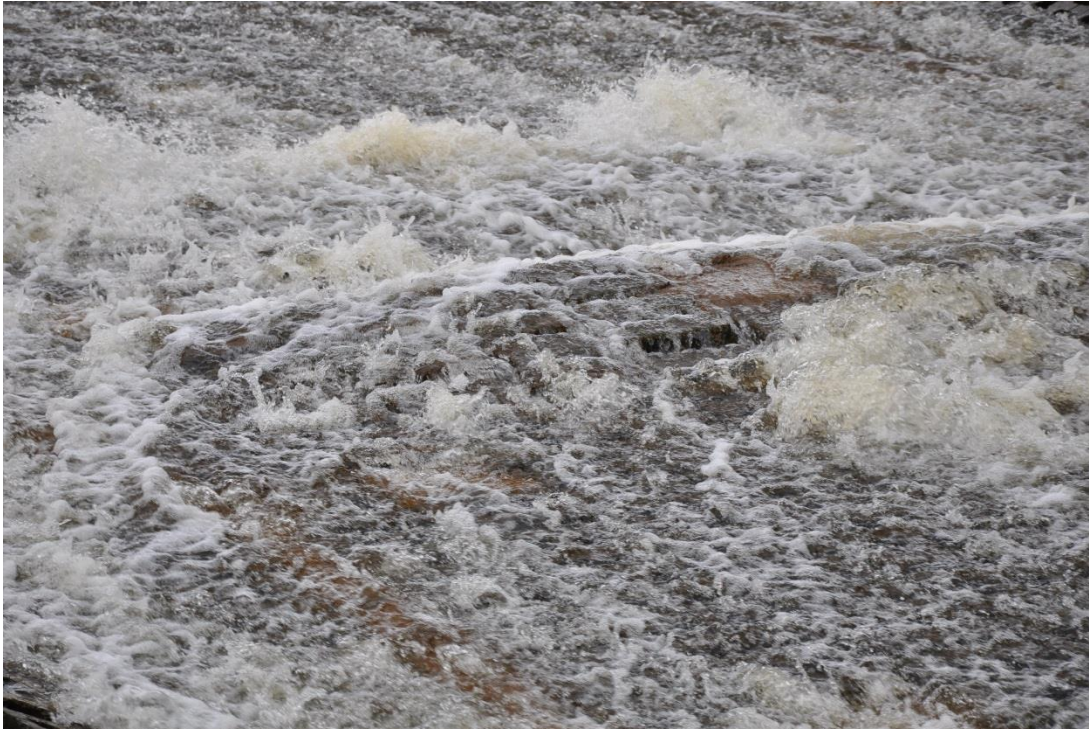
For the three upstream mat deformities (between mats in rows 13 to 16), it is likely that the anchor spacing is greater than design spacing, allowing the mat to move under flow. The wave-like profile of the two upstream locations (mat rows 14 to 16) with a depression followed by a similar-sized bulge suggests that the subgrade was exposed to flow at the mat connection point, and that the subgrade material was eroded and transported downslope to the location of the bulge. Figure 4-7 shows a close up of one of the bulges during lower flow. The bulge includes a grout block, suggesting that the anchor at this location has failed either by pulling out of the ground or because of the anchor connection method (too slack as a result of poor installation or poor connection method).

In addition to the anchor spacing, the deformities between mats in rows 13 to 16 could have also been generated by any of the potential failure modes highlighted as possible contributors in Table 4-1:

**Figure 4-7. Close up view of the bulge downstream of mat connection between rows 14 and 15. Photo taken July 19 2016. (YG AAM 2016a)**

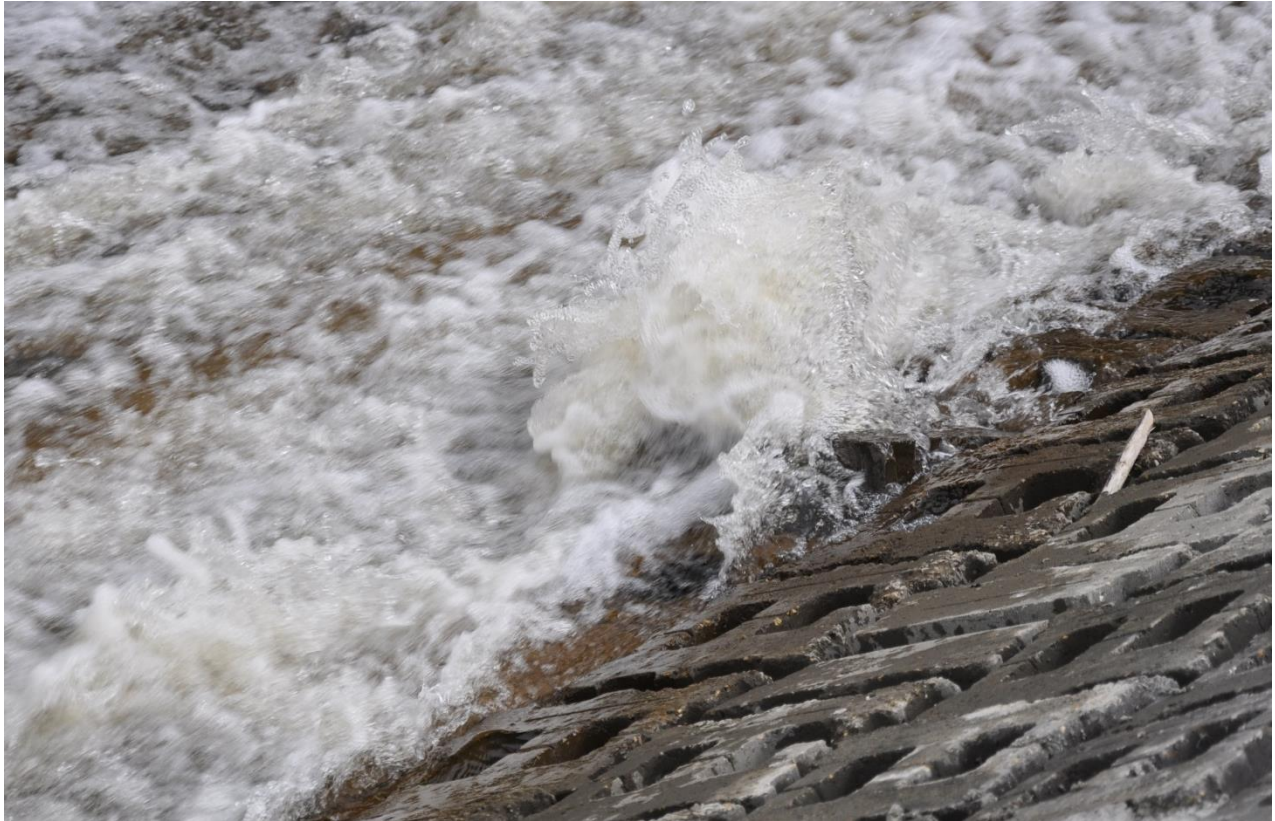
- Problems with block taper
- Problem with individual blocks
- Problem with grout “blocks”
- Subgrade preparation not smooth enough for block placement

In addition, this deformity could be a result of flow being concentrated on the banks due to the upstream mat deformities.

**Figure 4-8. Close up view of a smaller deformity located adjacent to the right bank of mat row 10. Photo taken July 19 2016. (YG AAM 2016a)**
