Clinton Creek Misc Works 2016

The Yukon Government – Assessment and Abandoned Mines branch (YG) is responsible for Care and Maintenance (C&M) of the former Clinton Creek Mine site. Regular site visits are undertaken by YG to ensure the protection of human health, safety, and the environment until such time that the site can be remediated. Most recently, YG Representatives and WorleyParsons Canada Services Ltd. (Advisian) Representatives were on-site to carry out the field portion of the Long Term Performance Monitoring Program (LTPMP). During the site visit, several items that require care and maintenance of the site infrastructure were noted by YG and Advisian. YG retained Boreal Engineering Ltd. (BEL) to provide the services at the Clinton Creek Site. The works consisted of:

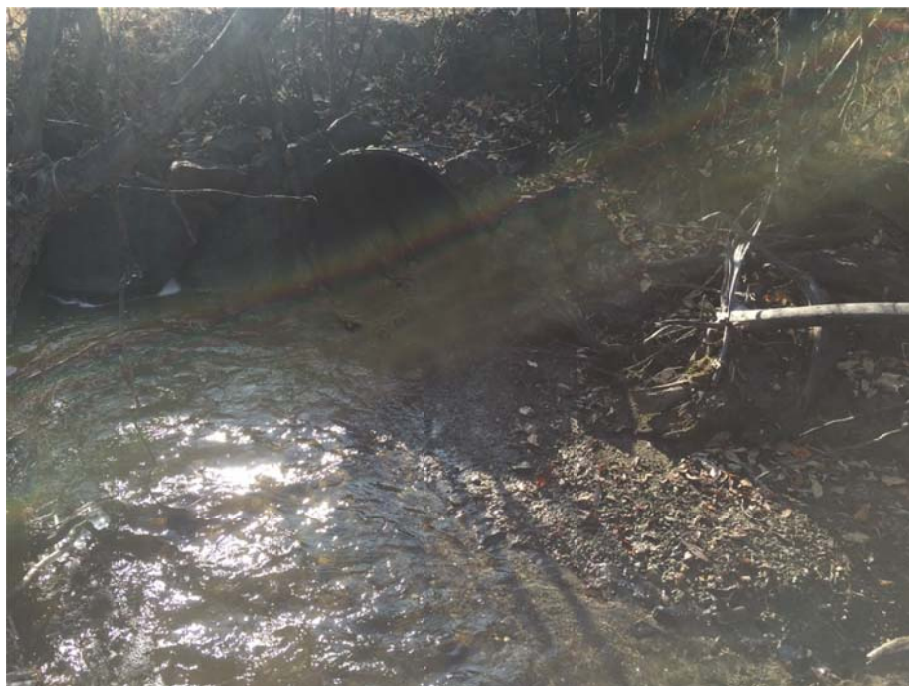
Task 2 was completed. Both culverts had minor debris which was removed.

Photo 1 – Culvert near gate following debris removal

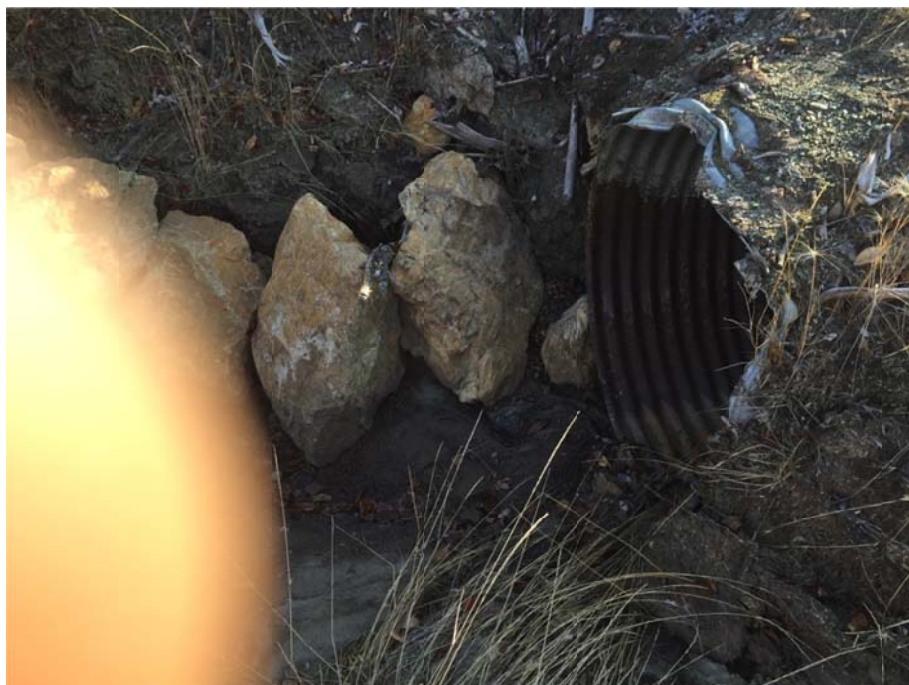
Photo 2 – Culvert near the gate following debris removal

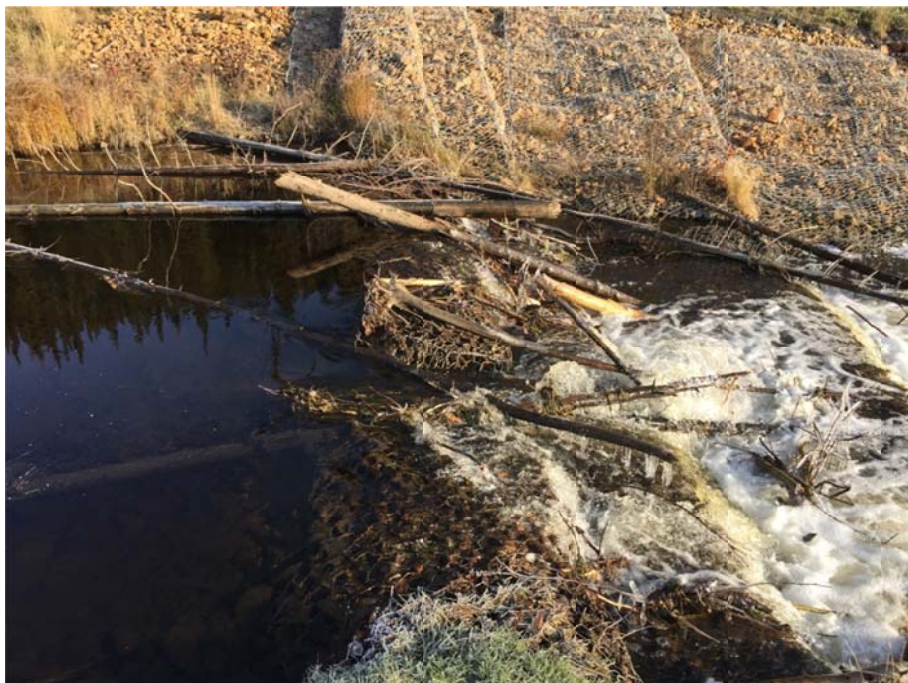
Photo 3 – DS1 prior to debris removal

Task 3 was completed per the terms of the contract. All debris was removed by hand with caution to prevent damage to the gabion baskets.

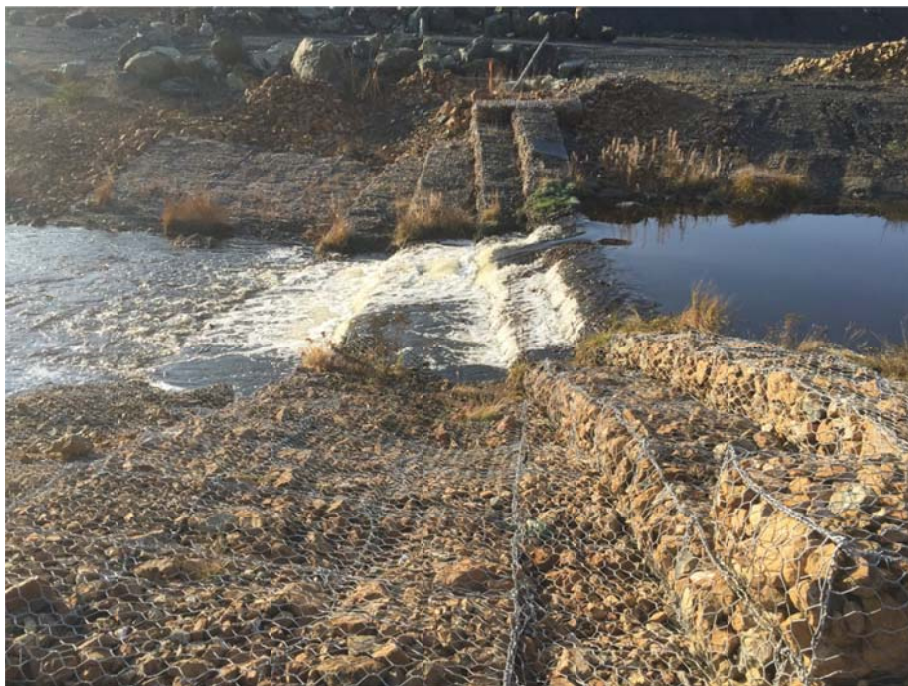
Photo 4 – DS1 after debris removal

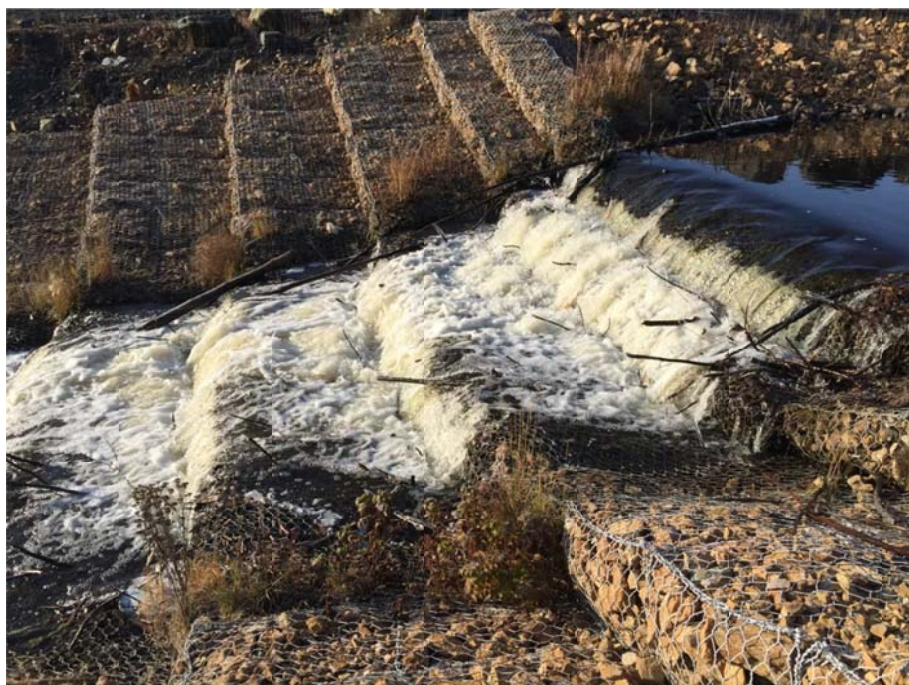
Photo 5 – DS2 prior to debris removal

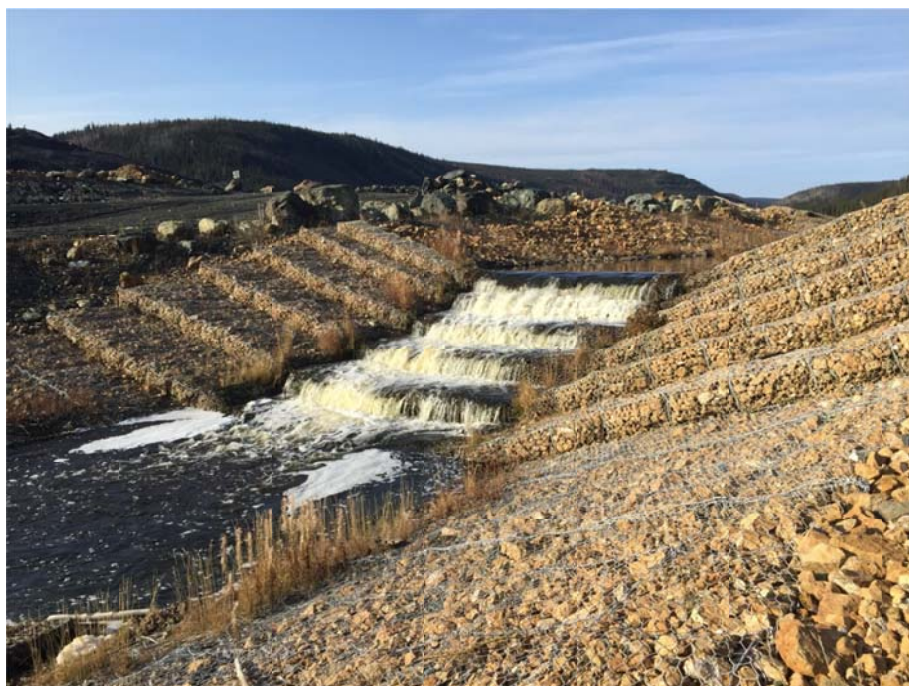
Photo 6 – DS2 following debris removal

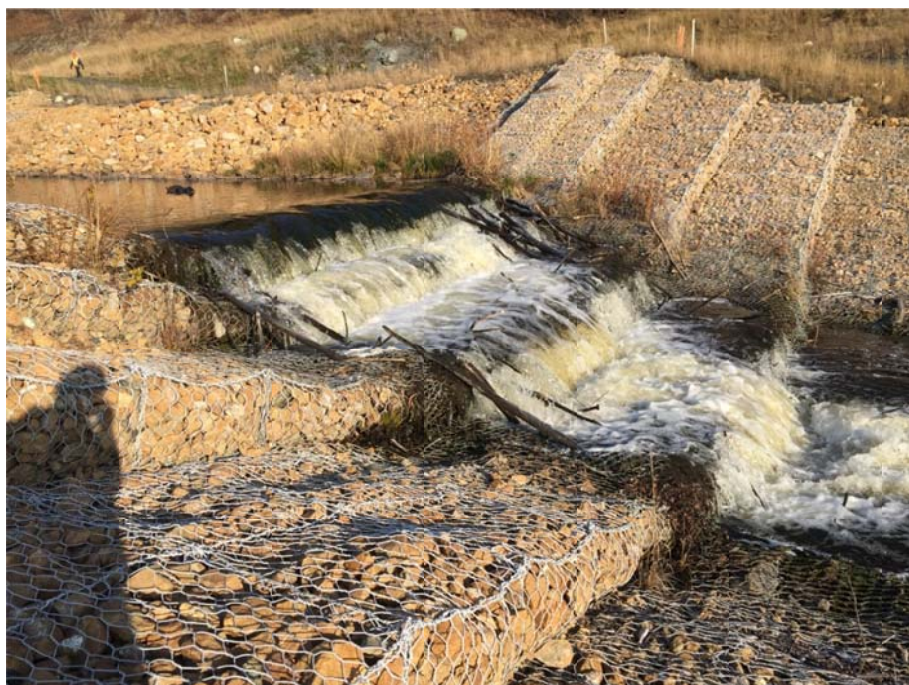
Photo 7 – DS3 prior to debris removal

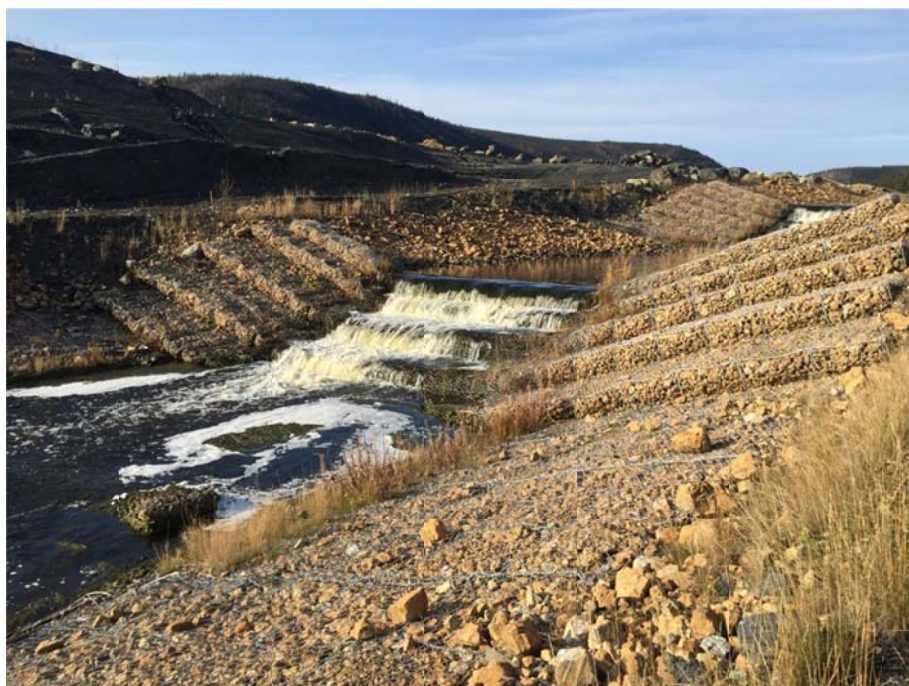
Photo 8 – DS3 following debris removal

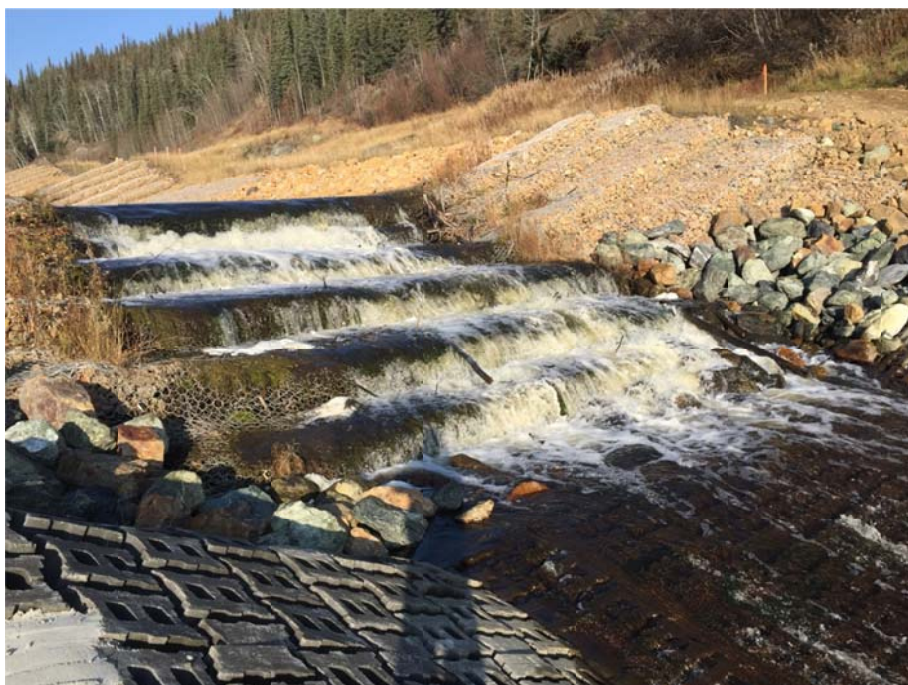
Photo 9 – DS4 prior to debris removal

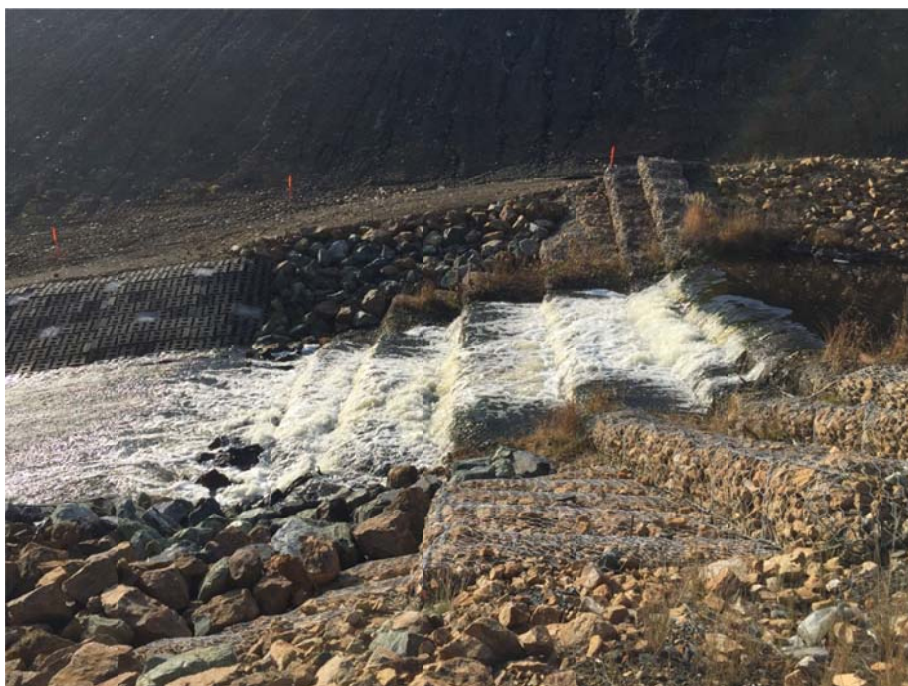
Photo 10 – DS4 following debris removal
