## **KENO HILL SILVER DISTRICT**

## **CLOSURE ISSUES REPORT**

MARCH 2009

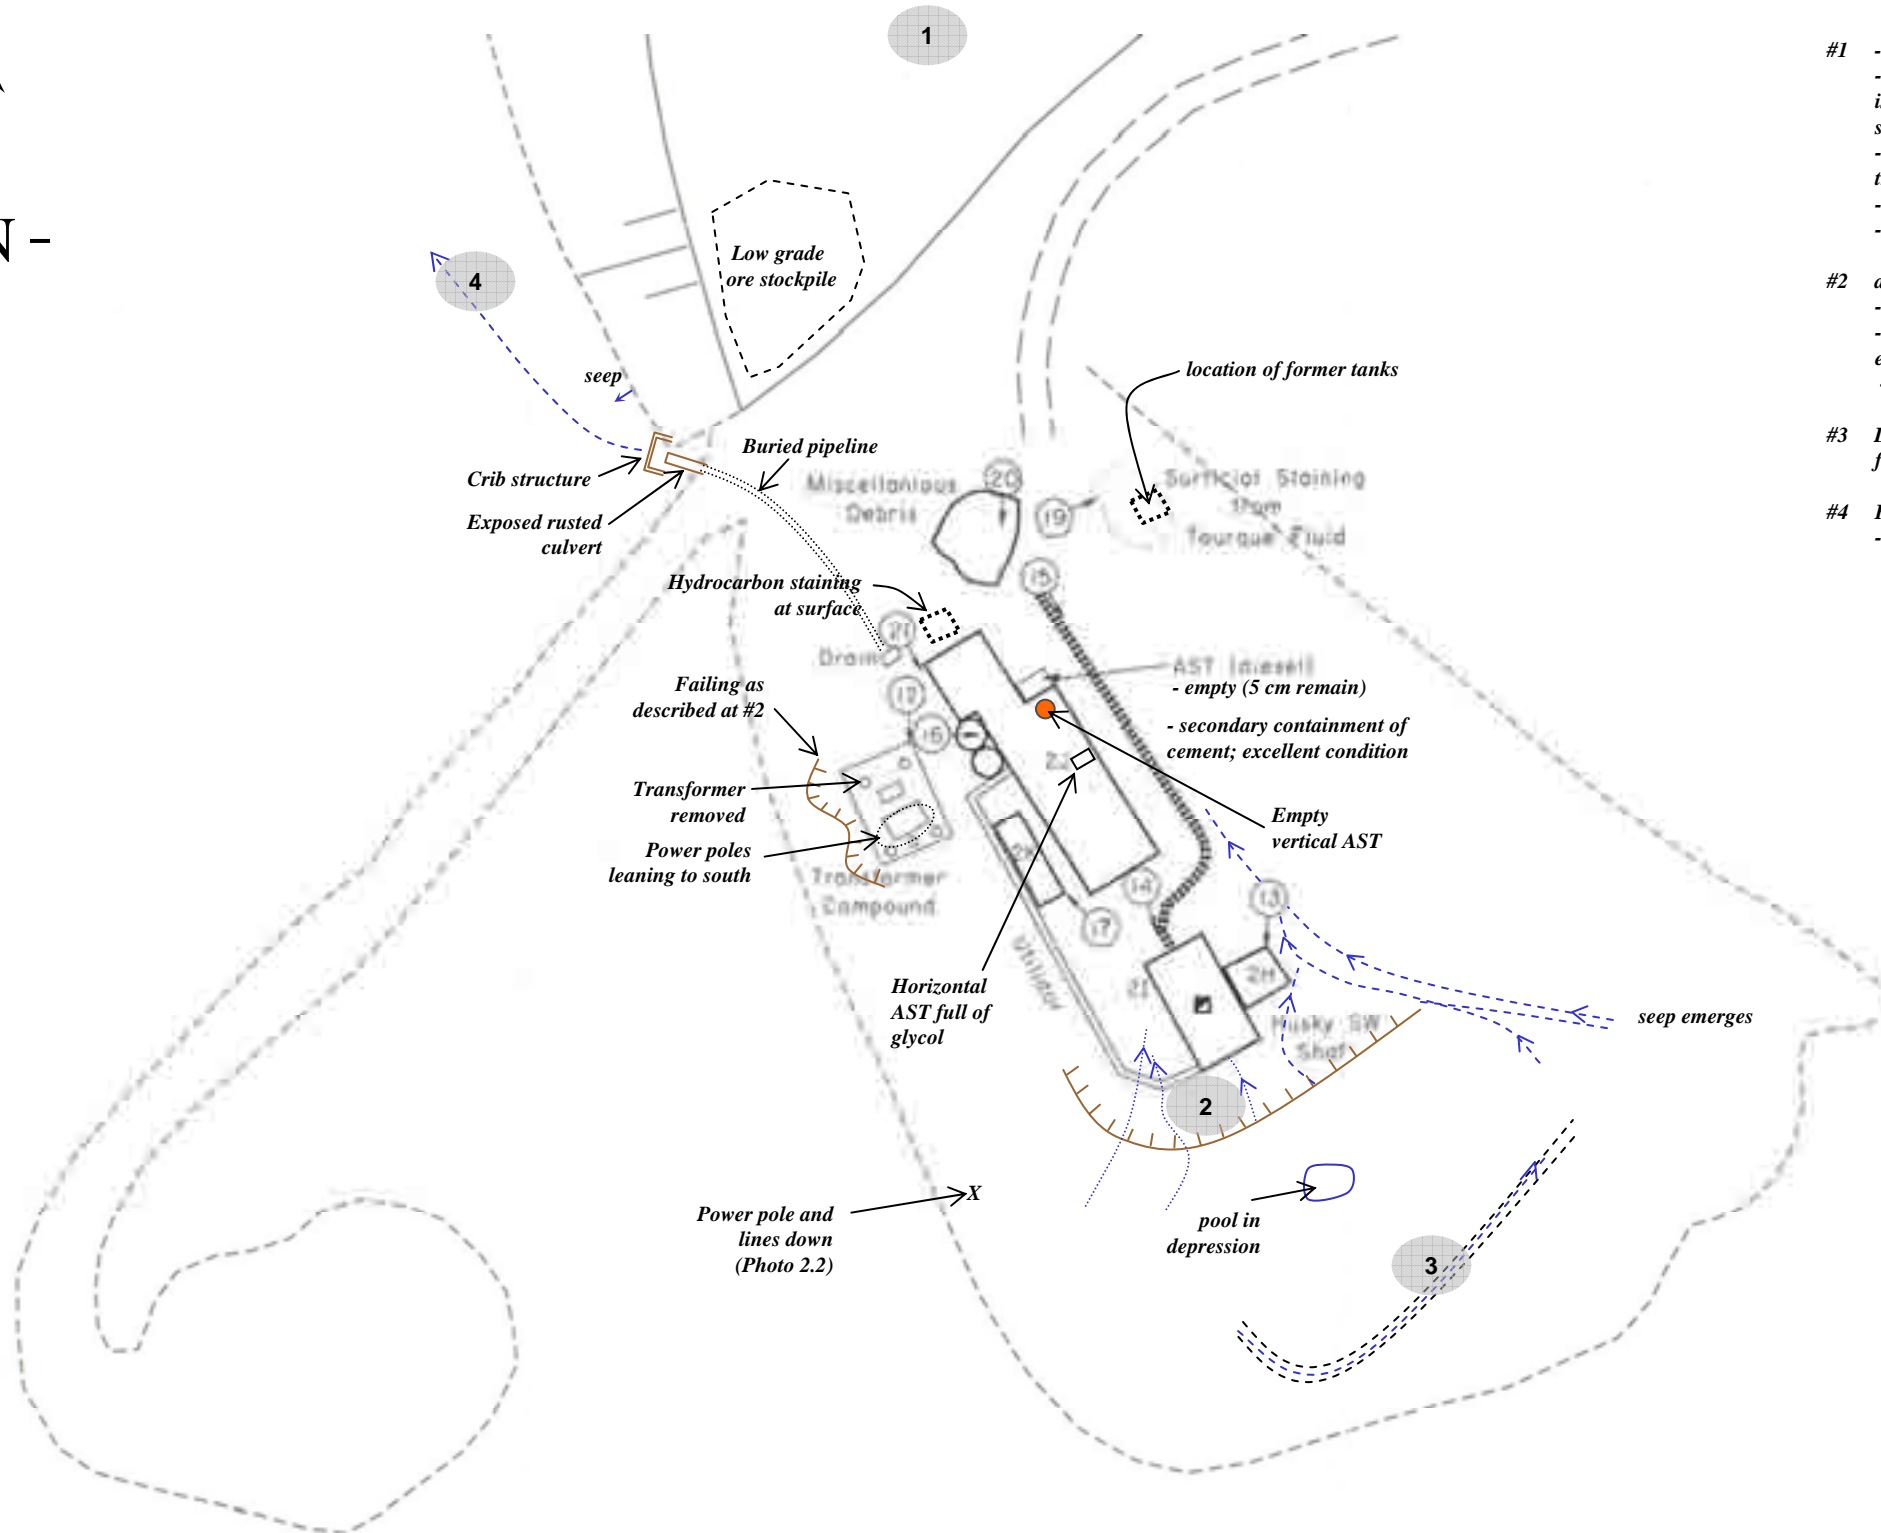
- #1 - waste dump has tension cracks up to 15 cm wide  
- in lowest bench, material contains rounded clasts (overburden?), but colour is greenish brown to greenish gray, with pale yellow to orange dark brown stains on clasts  
- Tension cracks (12 m back from crest) parallels dump crest (Photo 2.3), then curves to intersect dump crest at NE end  
- central part of zone of cracking has subsided by ~0.5 m  
- could be permafrost in dump foundation
- #2 actively failing till bank  
- seepage forms rivulets across entire face  
- slumped material is very soft, saturated; encroaching on headframe structure (Photo 2.1)  
- slope is ~2V:15H
- #3 Dozer trail with water seeping into it. Flow observed towards northwest, but flow diffuses into broad area of willows and grass
- #4 Flow visually estimated at 1 l/s  
-Orange staining and precipitation along flow path

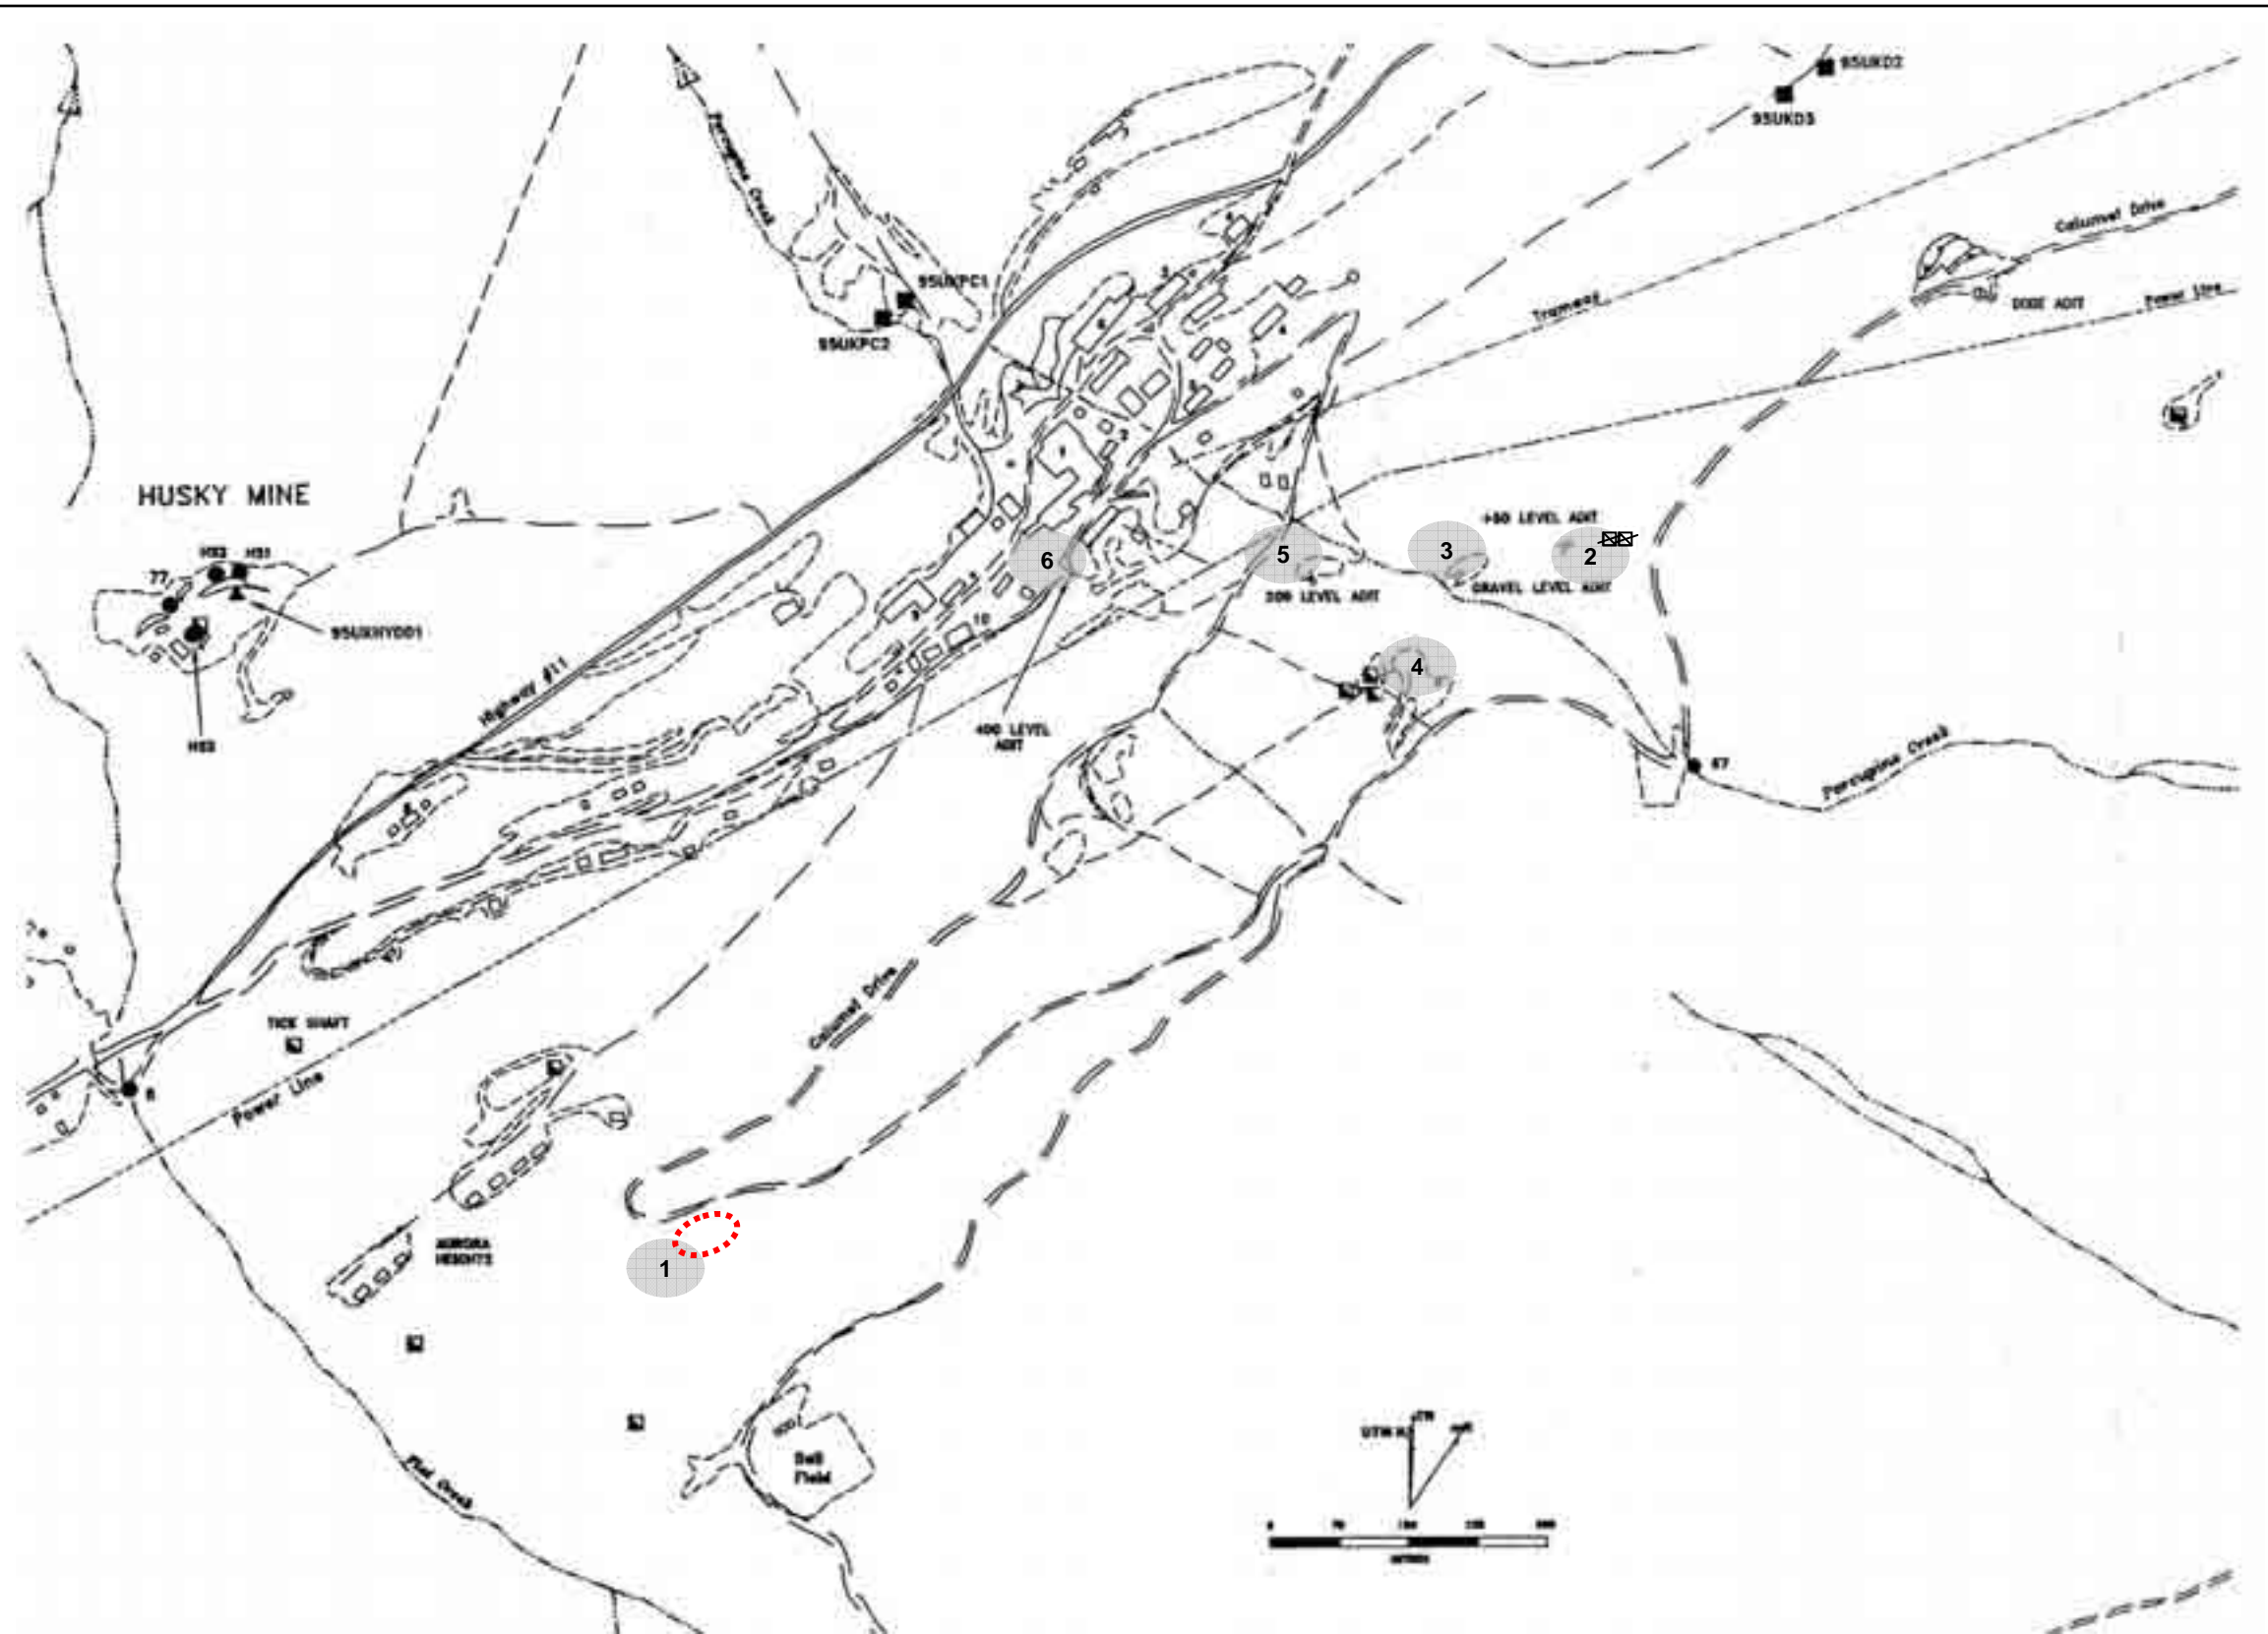
- #1 - Subsidence through to Elsa underground workings
- #2 - +50 adit confirmed collapsed; minor debris in the form of piping, rails, barrels, sheet roofing noted in front of collapsed adit.

- #4 - Only one shaft was located in this area. “Shed” noted in PWGSC (2000) was collapsed, and further investigation revealed that the debris was situated over an unstable shaft that appeared to be open. Ground subsidence was observed immediately adjacent to the shaft house debris on all sides. Access to the site is somewhat difficult due to dense alder growth, but the immediate vicinity is cleared and the collapsed shaft house presents an intrigue risk.

- #5 - 200 level adit confirmed gated and secure; timber portal supports remained intact. Timber loadout structure beginning to deteriorate; this structure is visible from Calumet Drive, and has ore cars sitting on rails that are also visible. The loadout structure and ore cars present an intrigue risk.

- Minor rusty brown staining observed on waste rock surface of working area between adit and loadout.
- #6 - 400 level adit confirmed gated and secure; portal support remained intact. Adit was partially full of ice at time of inspection; observed drainage was clear and colourless, with small flow volume (visual estimate up to 5 L/min) and no staining along flow path.

- Most of the waste rock brought to surface from the Elsa Mine has been used for construction rock within the area of the townsite. Although this waste rock was not assessed in detail, orange staining along isolated seepage flowpaths and secondary salts beneath some overhangs suggest that the Elsa waste rock is a potential source of metals and acidity.
- Timber support structures throughout the townsite are deteriorating, with minor failures of retaining structures observed in 2005 and 2006.

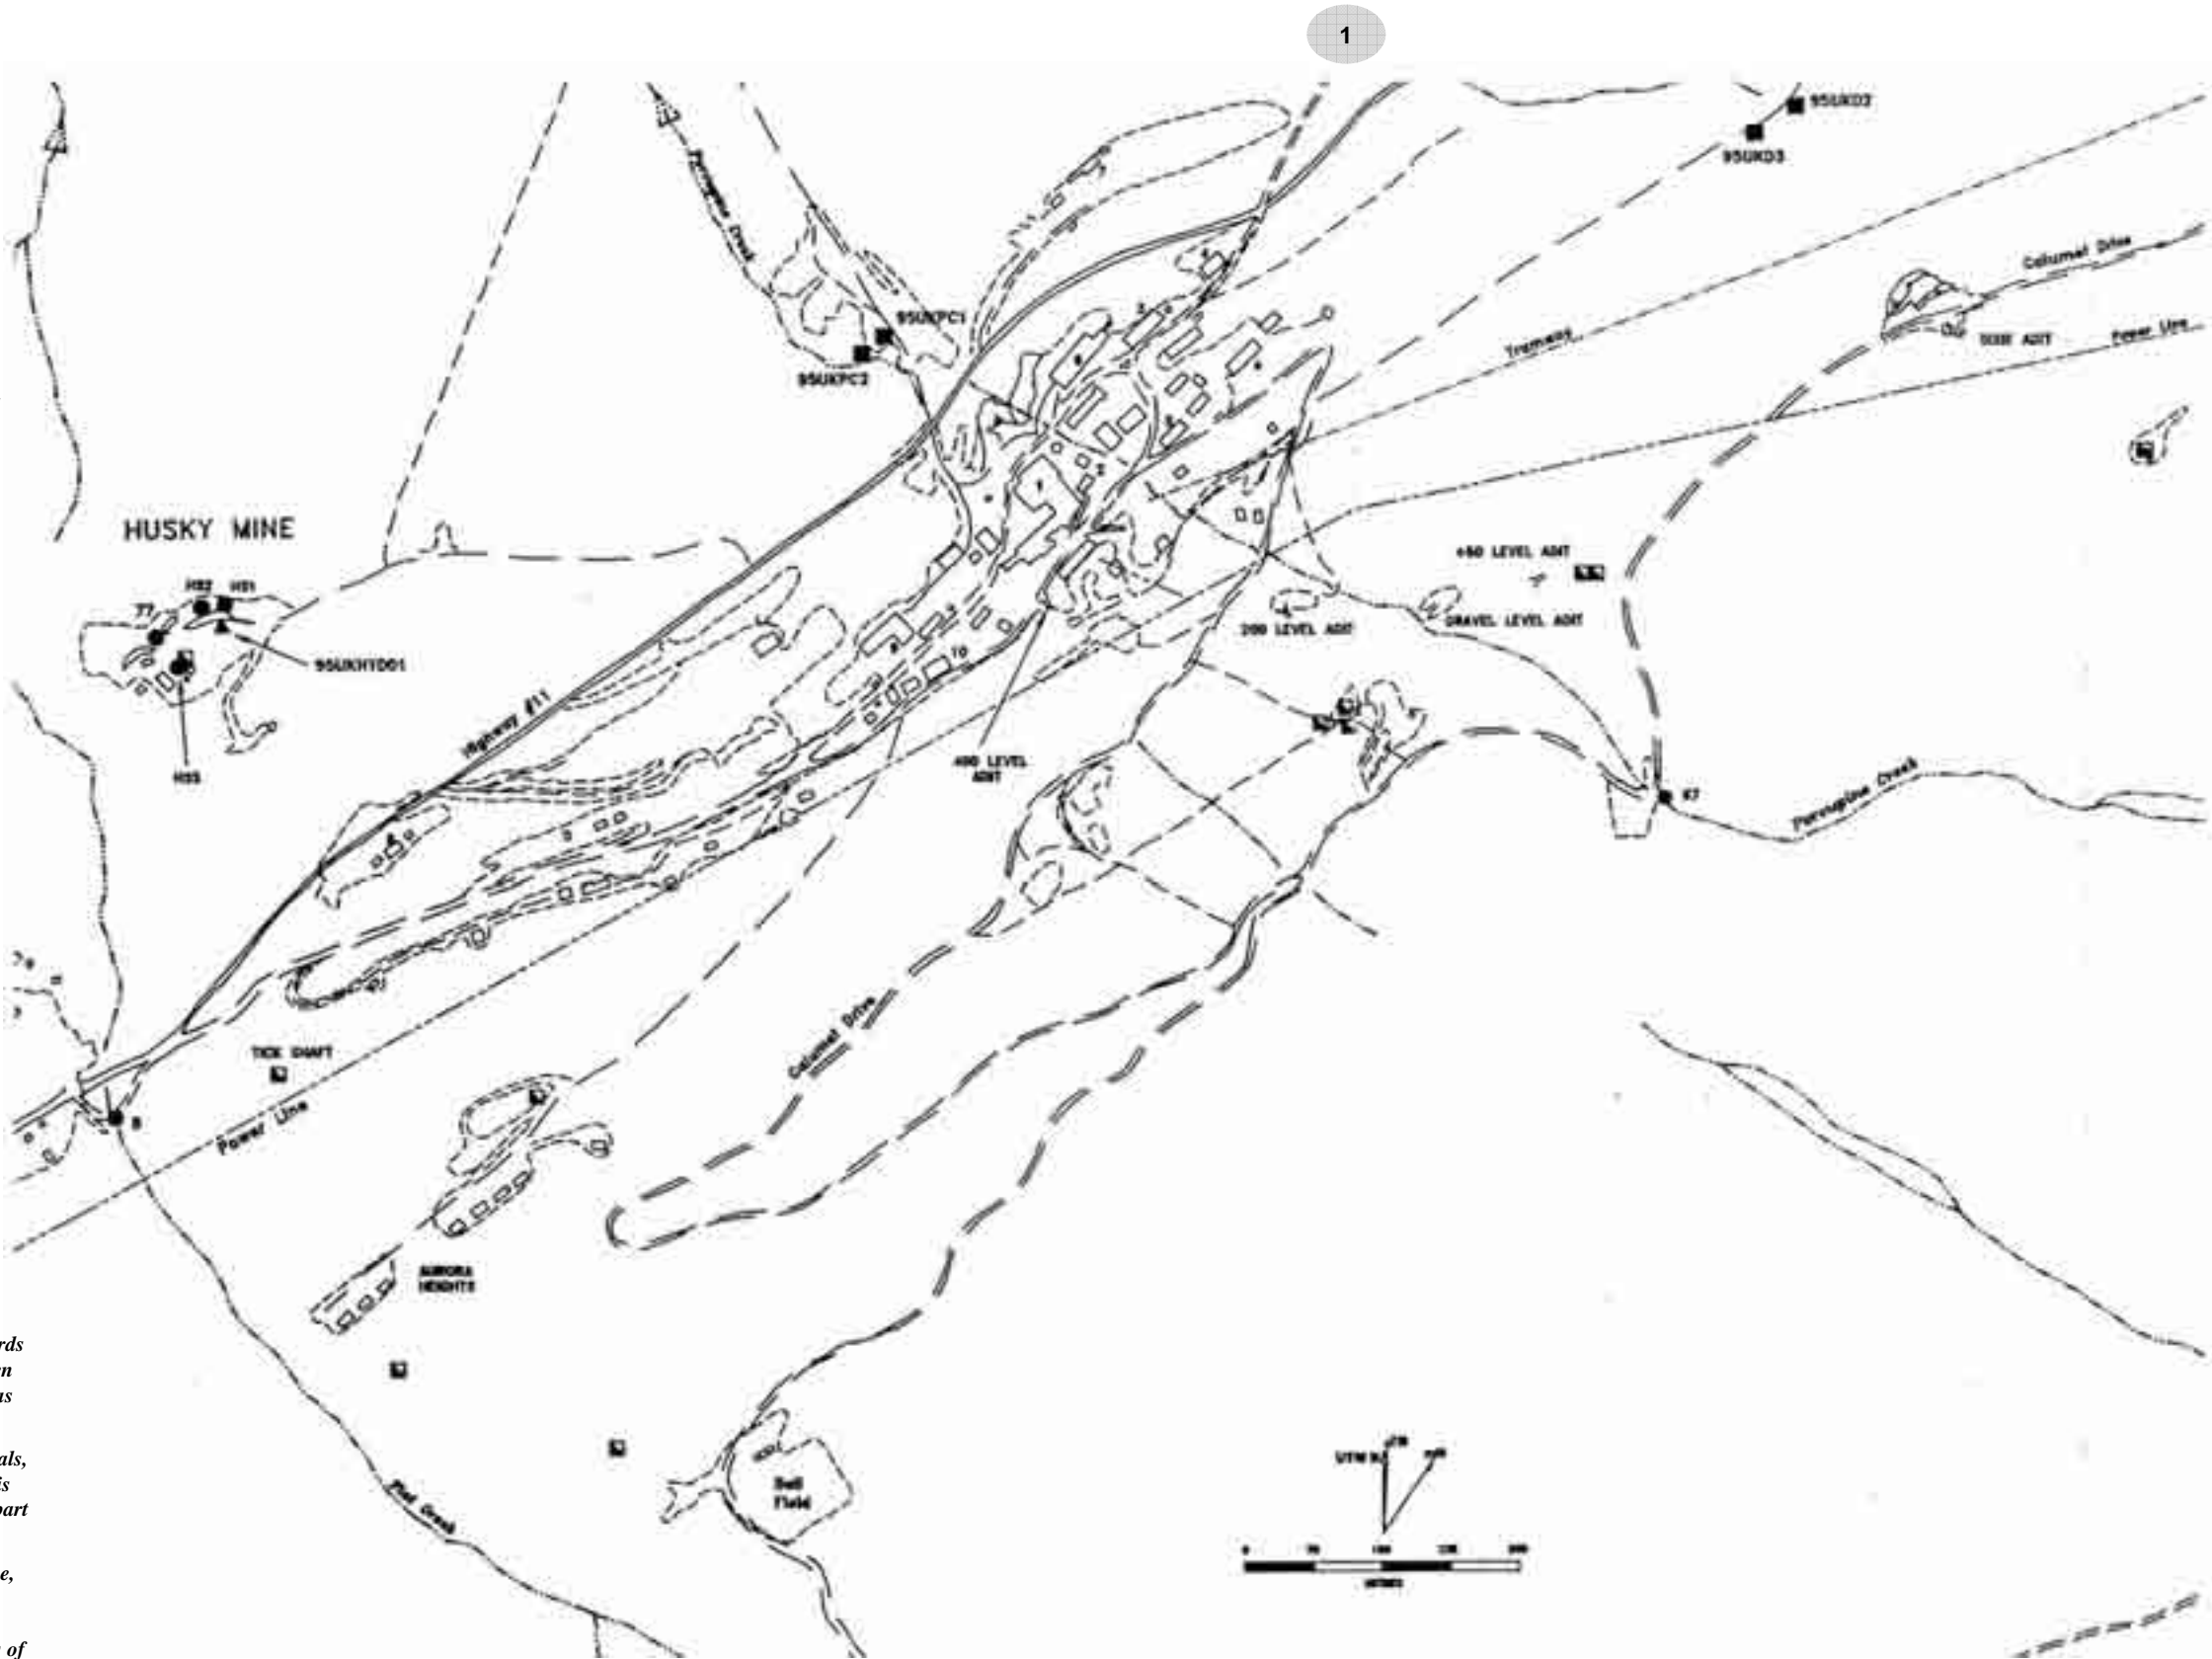
#1 - The Elsa Dump is located the position indicated. Seven other solid waste disposal sites are noted in PWGSC (2000).  
- Existing contaminants of concern, and concentrations of those contaminants, at the Elsa Dump and at other solid waste dumps reported in PWGSC (2000) are poorly understood at this time. In addition to municipal solid waste, it is possible that industrial chemical wastes, derived from mine and mill operations, are disposed at this site.  
- As is typical for solid waste dumps, there is no record of the types and quantities of waste disposed at this location. Although PWGSC (2000) provides an estimate of dump composition, actual dump composition may be different than reported.  
- No characterization of groundwater or surface water downgradient of the Elsa Dump has been carried out, and the presence and quality of landfill leachate remains uncertain.

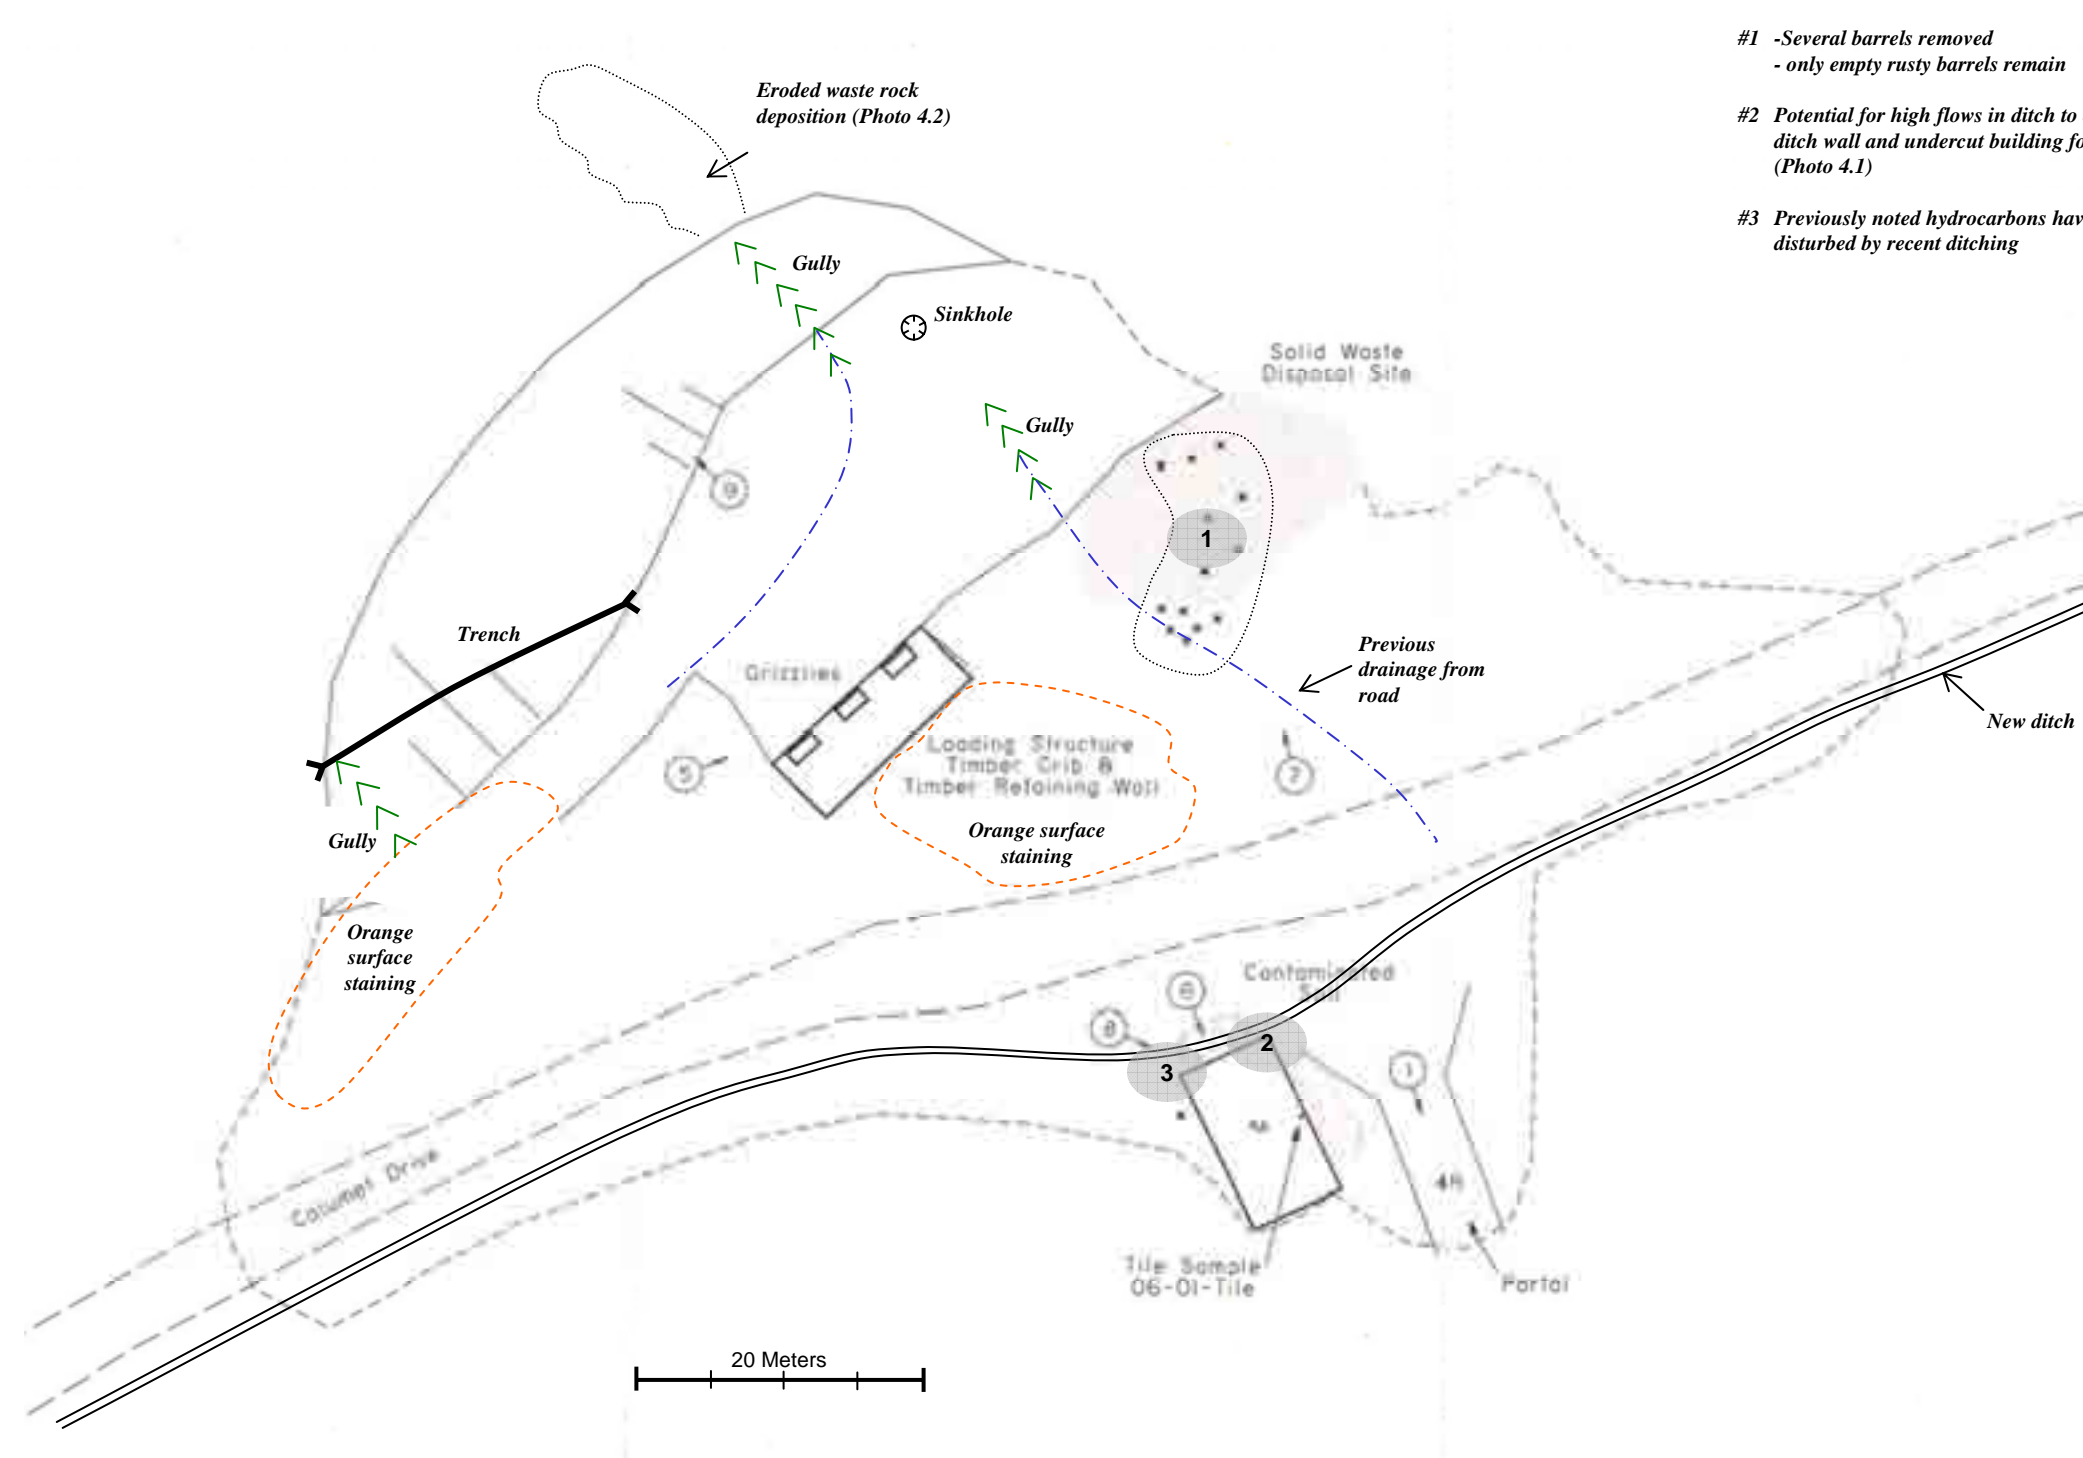
- #1 -Several barrels removed  
- only empty rusty barrels remain
- #2 Potential for high flows in ditch to erode  
ditch wall and undercut building foundation  
(Photo 4.1)
- #3 Previously noted hydrocarbons have been  
disturbed by recent ditching

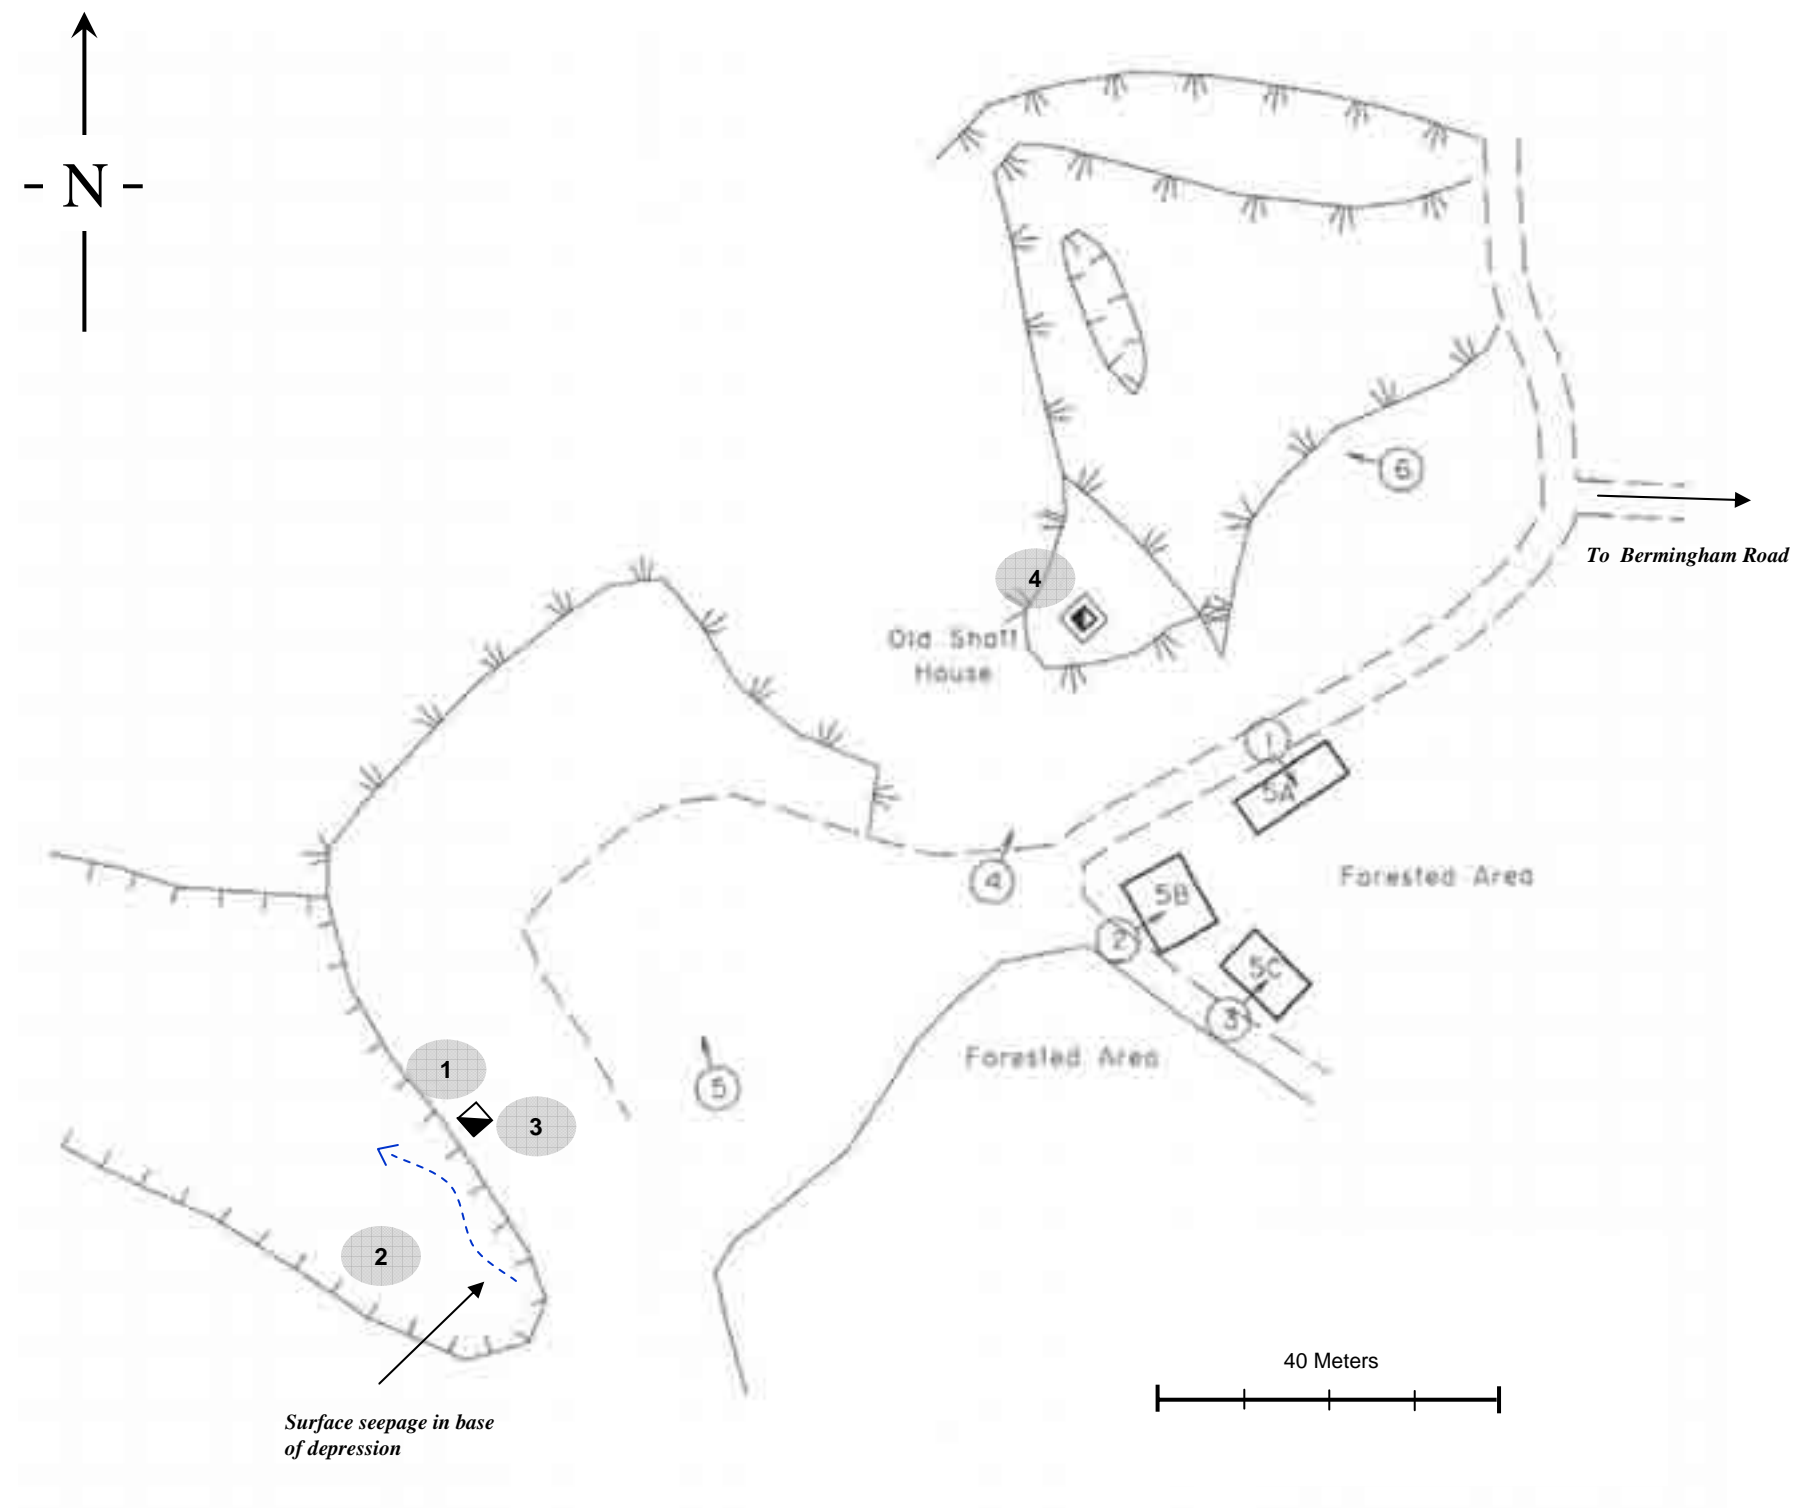
- #1** - Shaft #1 is open at surface, with no barrier to access. Timber cribbing is in good condition, and drift to southeast is clearly visible from top of shaft (Photo 1) and appears to be open. This feature represents a high intrigue risk.

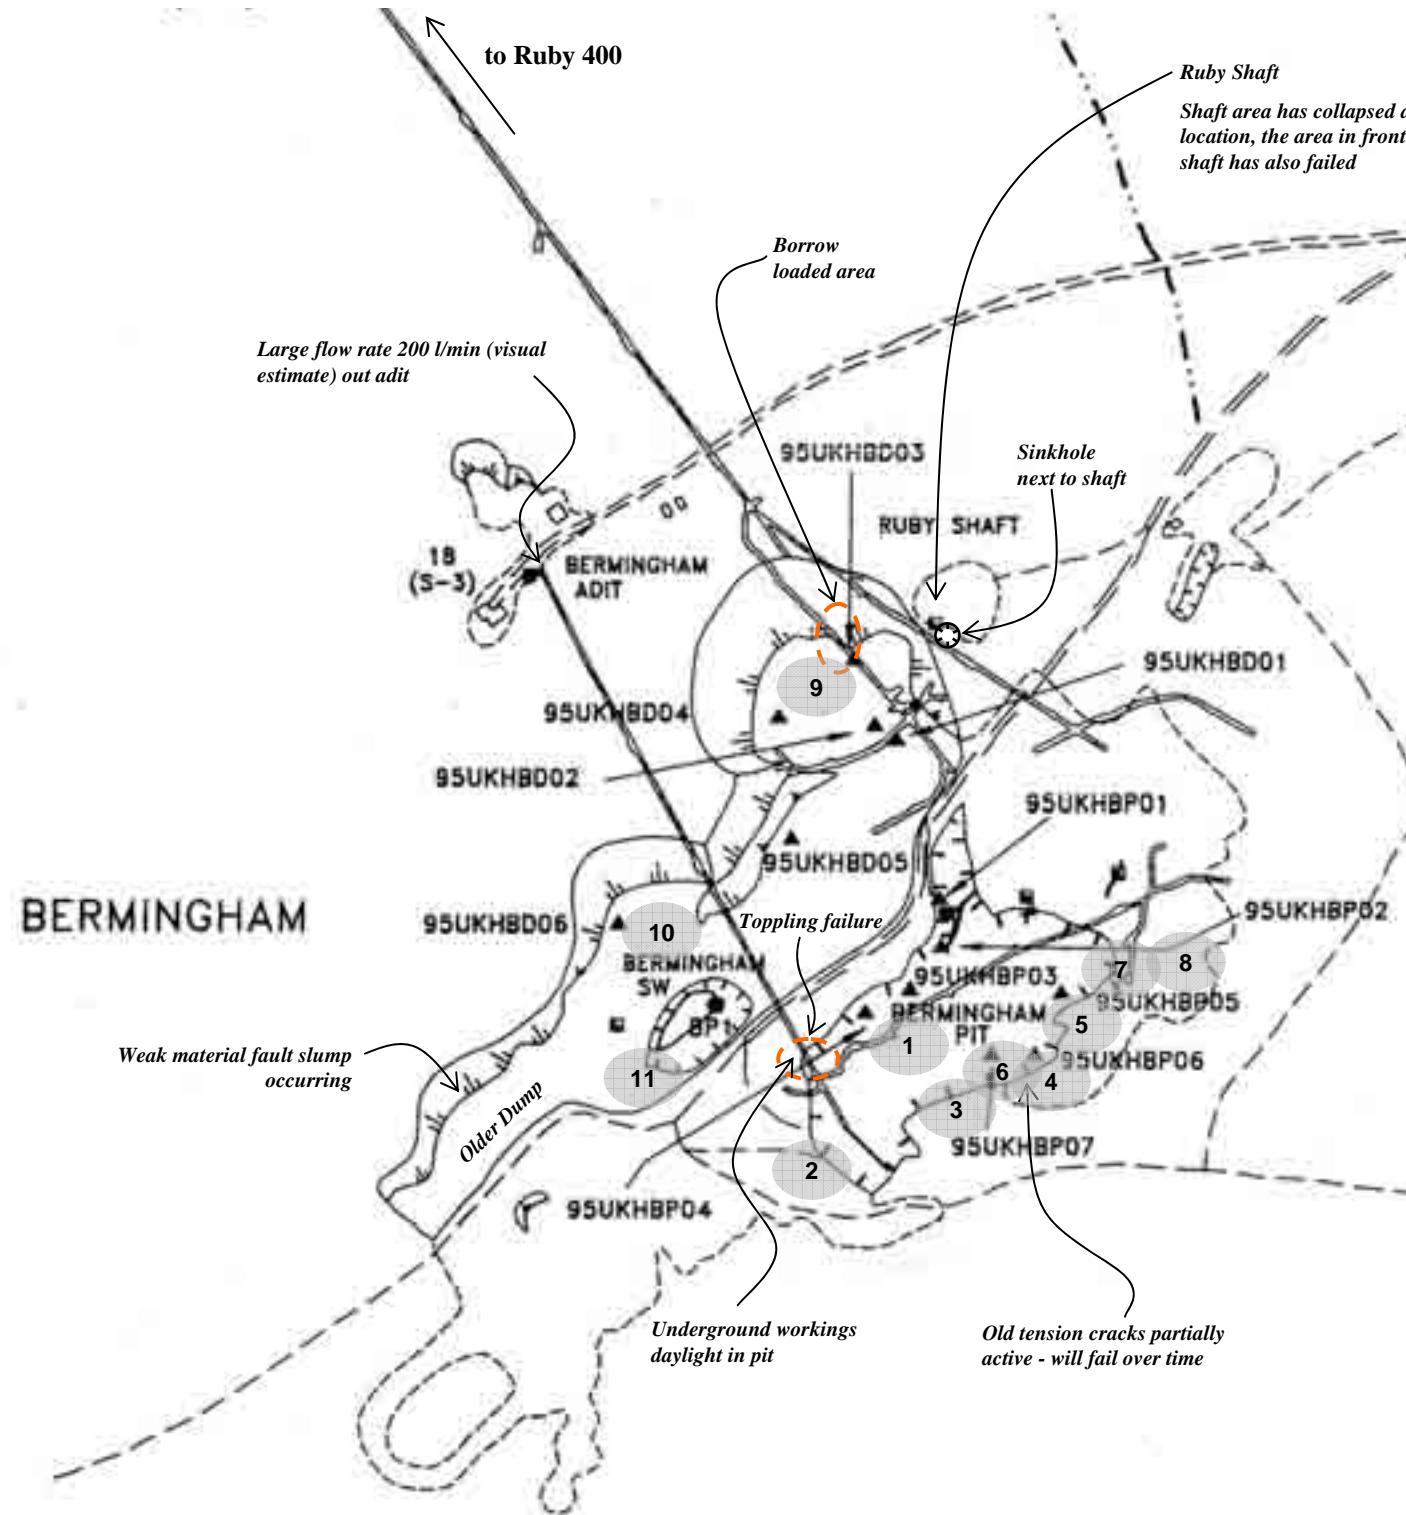
<b>KENO HILL SILVER DISTRICT</b>		
<b>CLOSURE ISSUES</b>		
<b>FIGURE 25 - BERMINGHAM &amp; RUBY</b>		
SITE PLAN		
DATE: 3/10/2009		
DRAWN BY: RS		SCALE: 1:4,852
FILE: Untitled.mxd

- #1** No water was noted in the bottom of the pit.
- Pre-split blasting techniques were used. The faces look good in the southeast corner, but less so in other areas of the pit.*

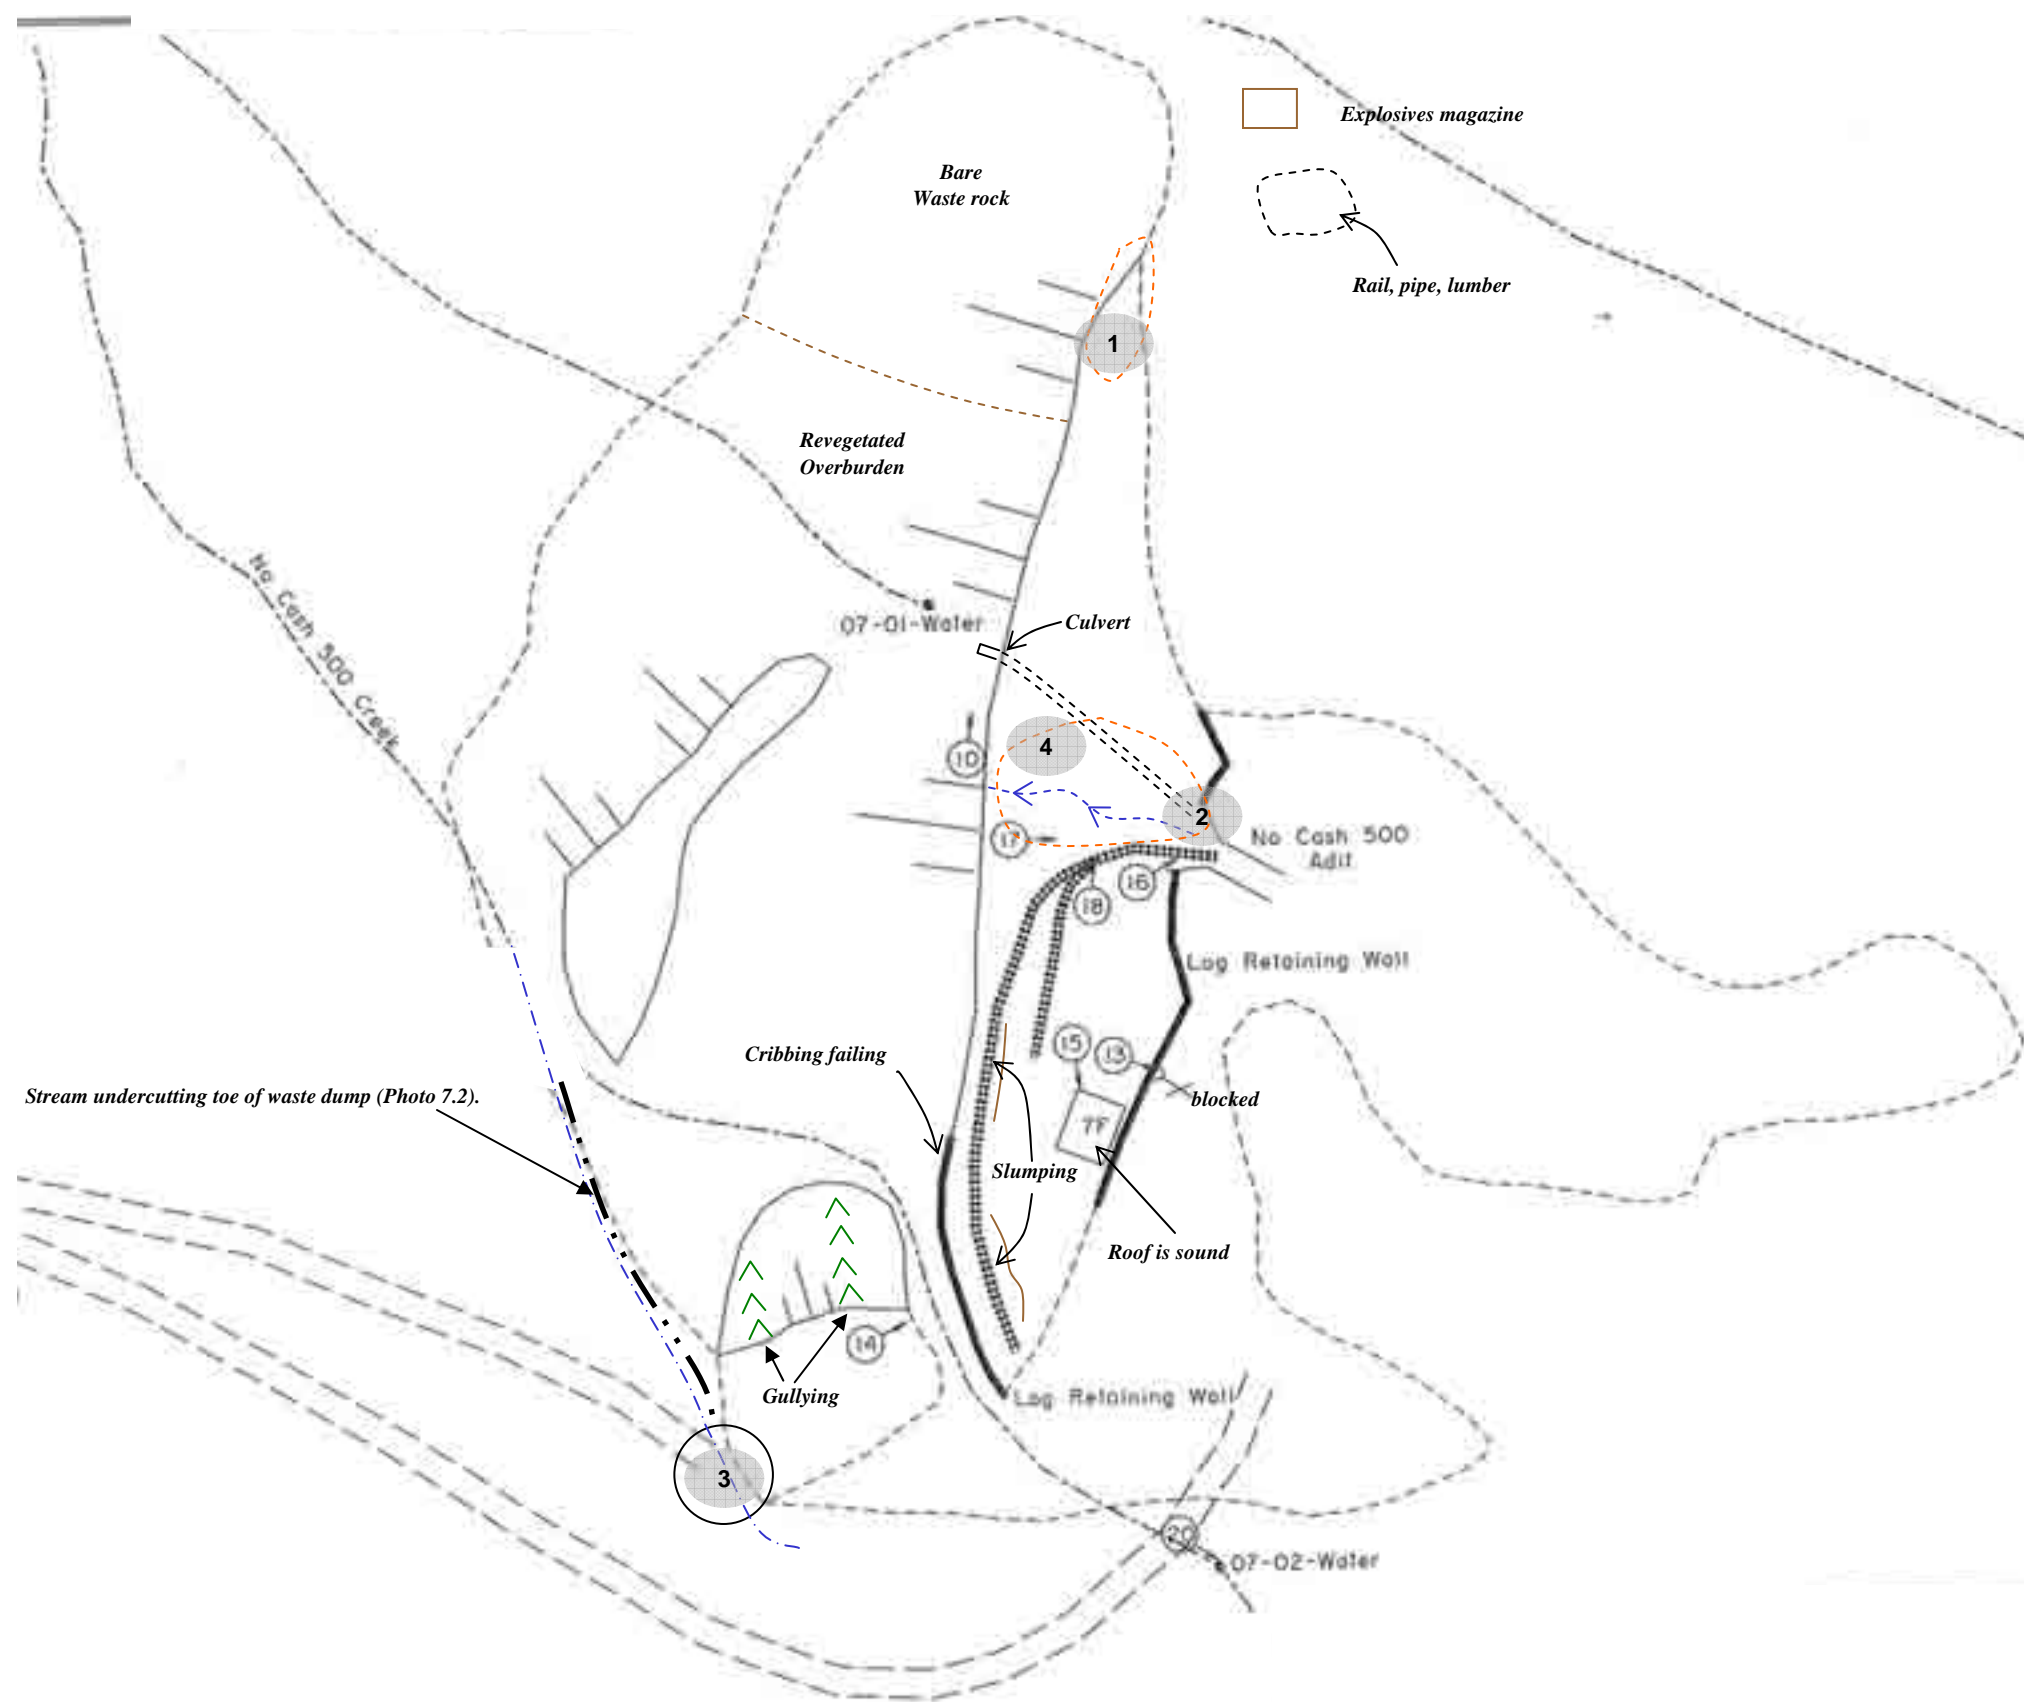
- #1 - Pale yellowish and orangey dark brown staining isolated clasts  
- Flow path (dry) marked by pale yellow stain
- #2 - Blockage inside of adit is causing part of flow to direct away from culvert and flow over crest of dump
- #3 - Square timber culvert is partially collapsed, and adjacent mine waste has been partially eroded, leading to reduced lateral support (Photo 7.1).
- #4 - Area of orange staining on dump surface along current and former flowpaths of adit discharge
