## **KENO HILL SILVER DISTRICT**

## **CLOSURE ISSUES REPORT**

MARCH 2009

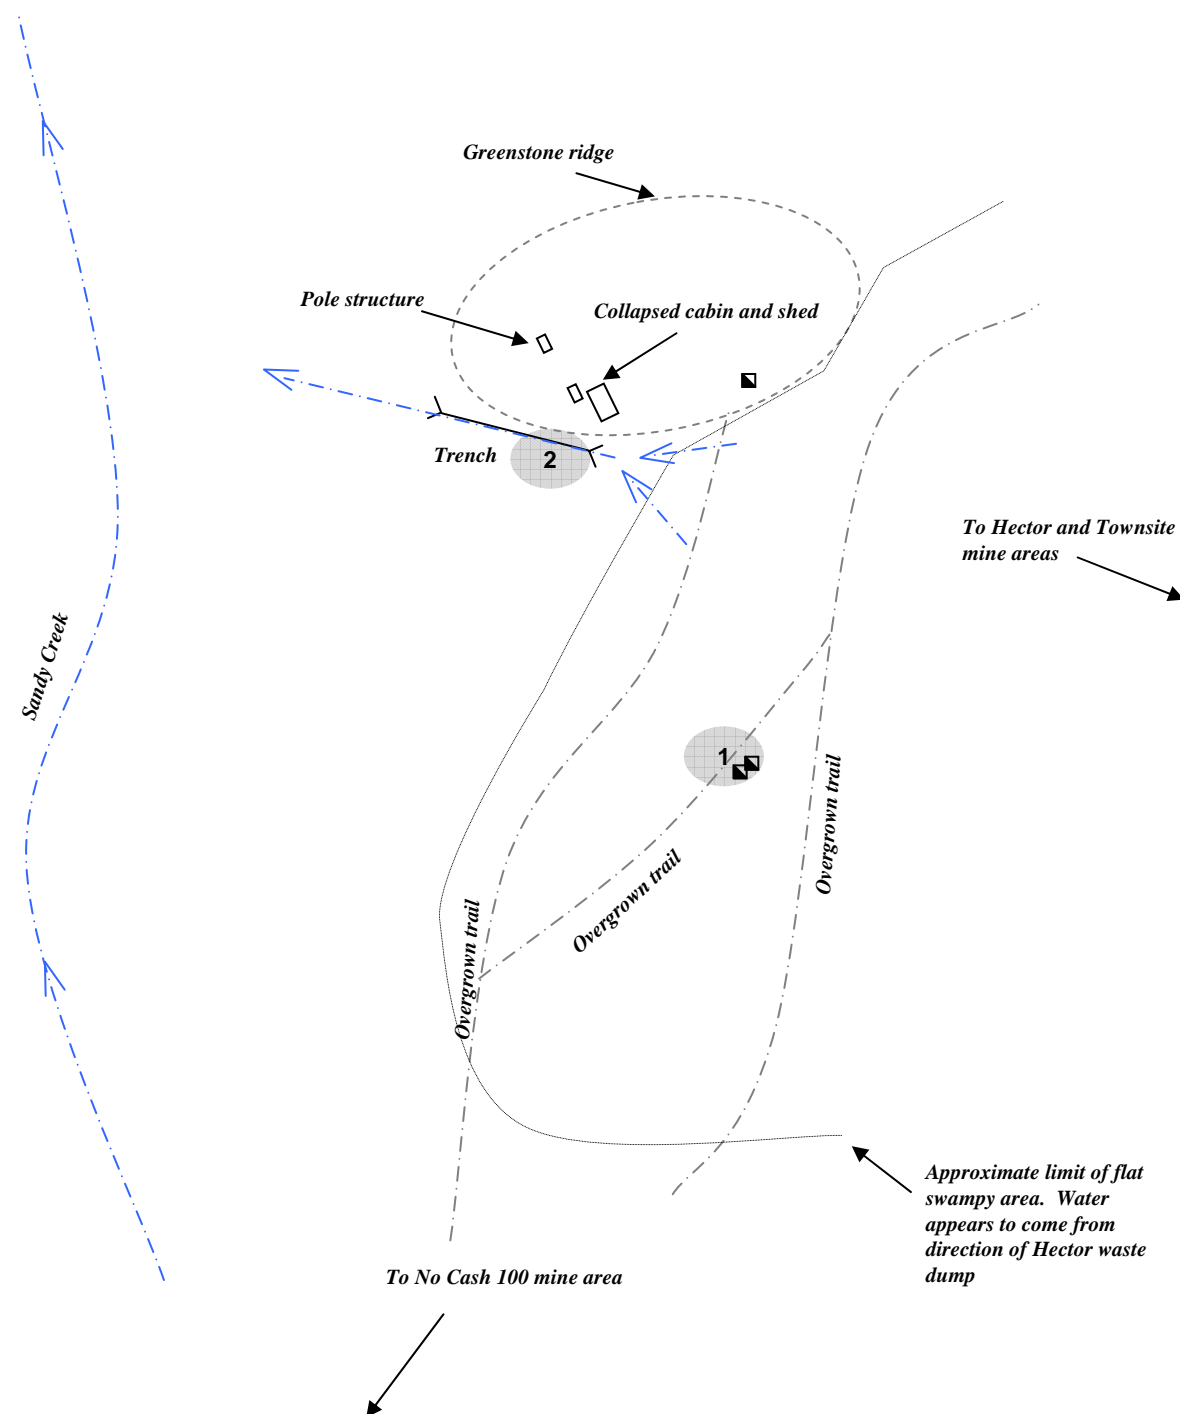
- #1 - Two 3 m x 3 m openings in muskeg, 1.5 m deep, with exposed mineral soil on margins. Waste rock pile adjacent to SW shaft approximately 0.5 m high x 5 m x 8m; composed of dark grey quartzite and minor quartzite breccia with siderite veining, with minor orange to dark rusty brown staining.
- Little vegetation growing on waste pile- 10% coverage.
  - Size of openings may be due to be regressive thawing of permafrost. Standing water (0.3 m) present in both holes, and bottoms felt solid when probed with a stick.
- #2 - Trench contains greenstone rubble, with water flowing through the rubble. Appears to collect water from flat swampy area to southeast and channel the water towards Sandy Creek.
- Trench is overgrown with willows and is difficult to identify.

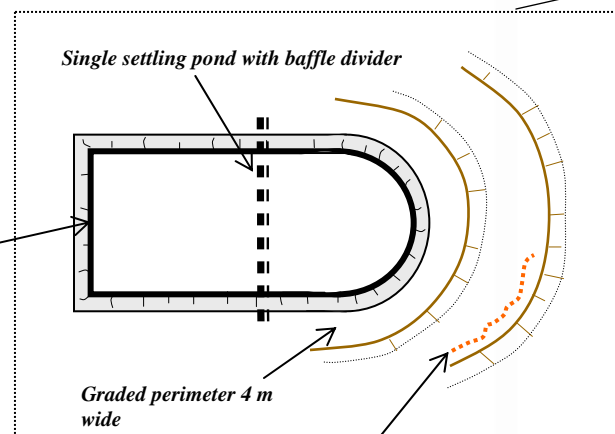
Exposed PVC liner around perimeter (Photo 1a, 1b)

Tension cracks (Photo 2)

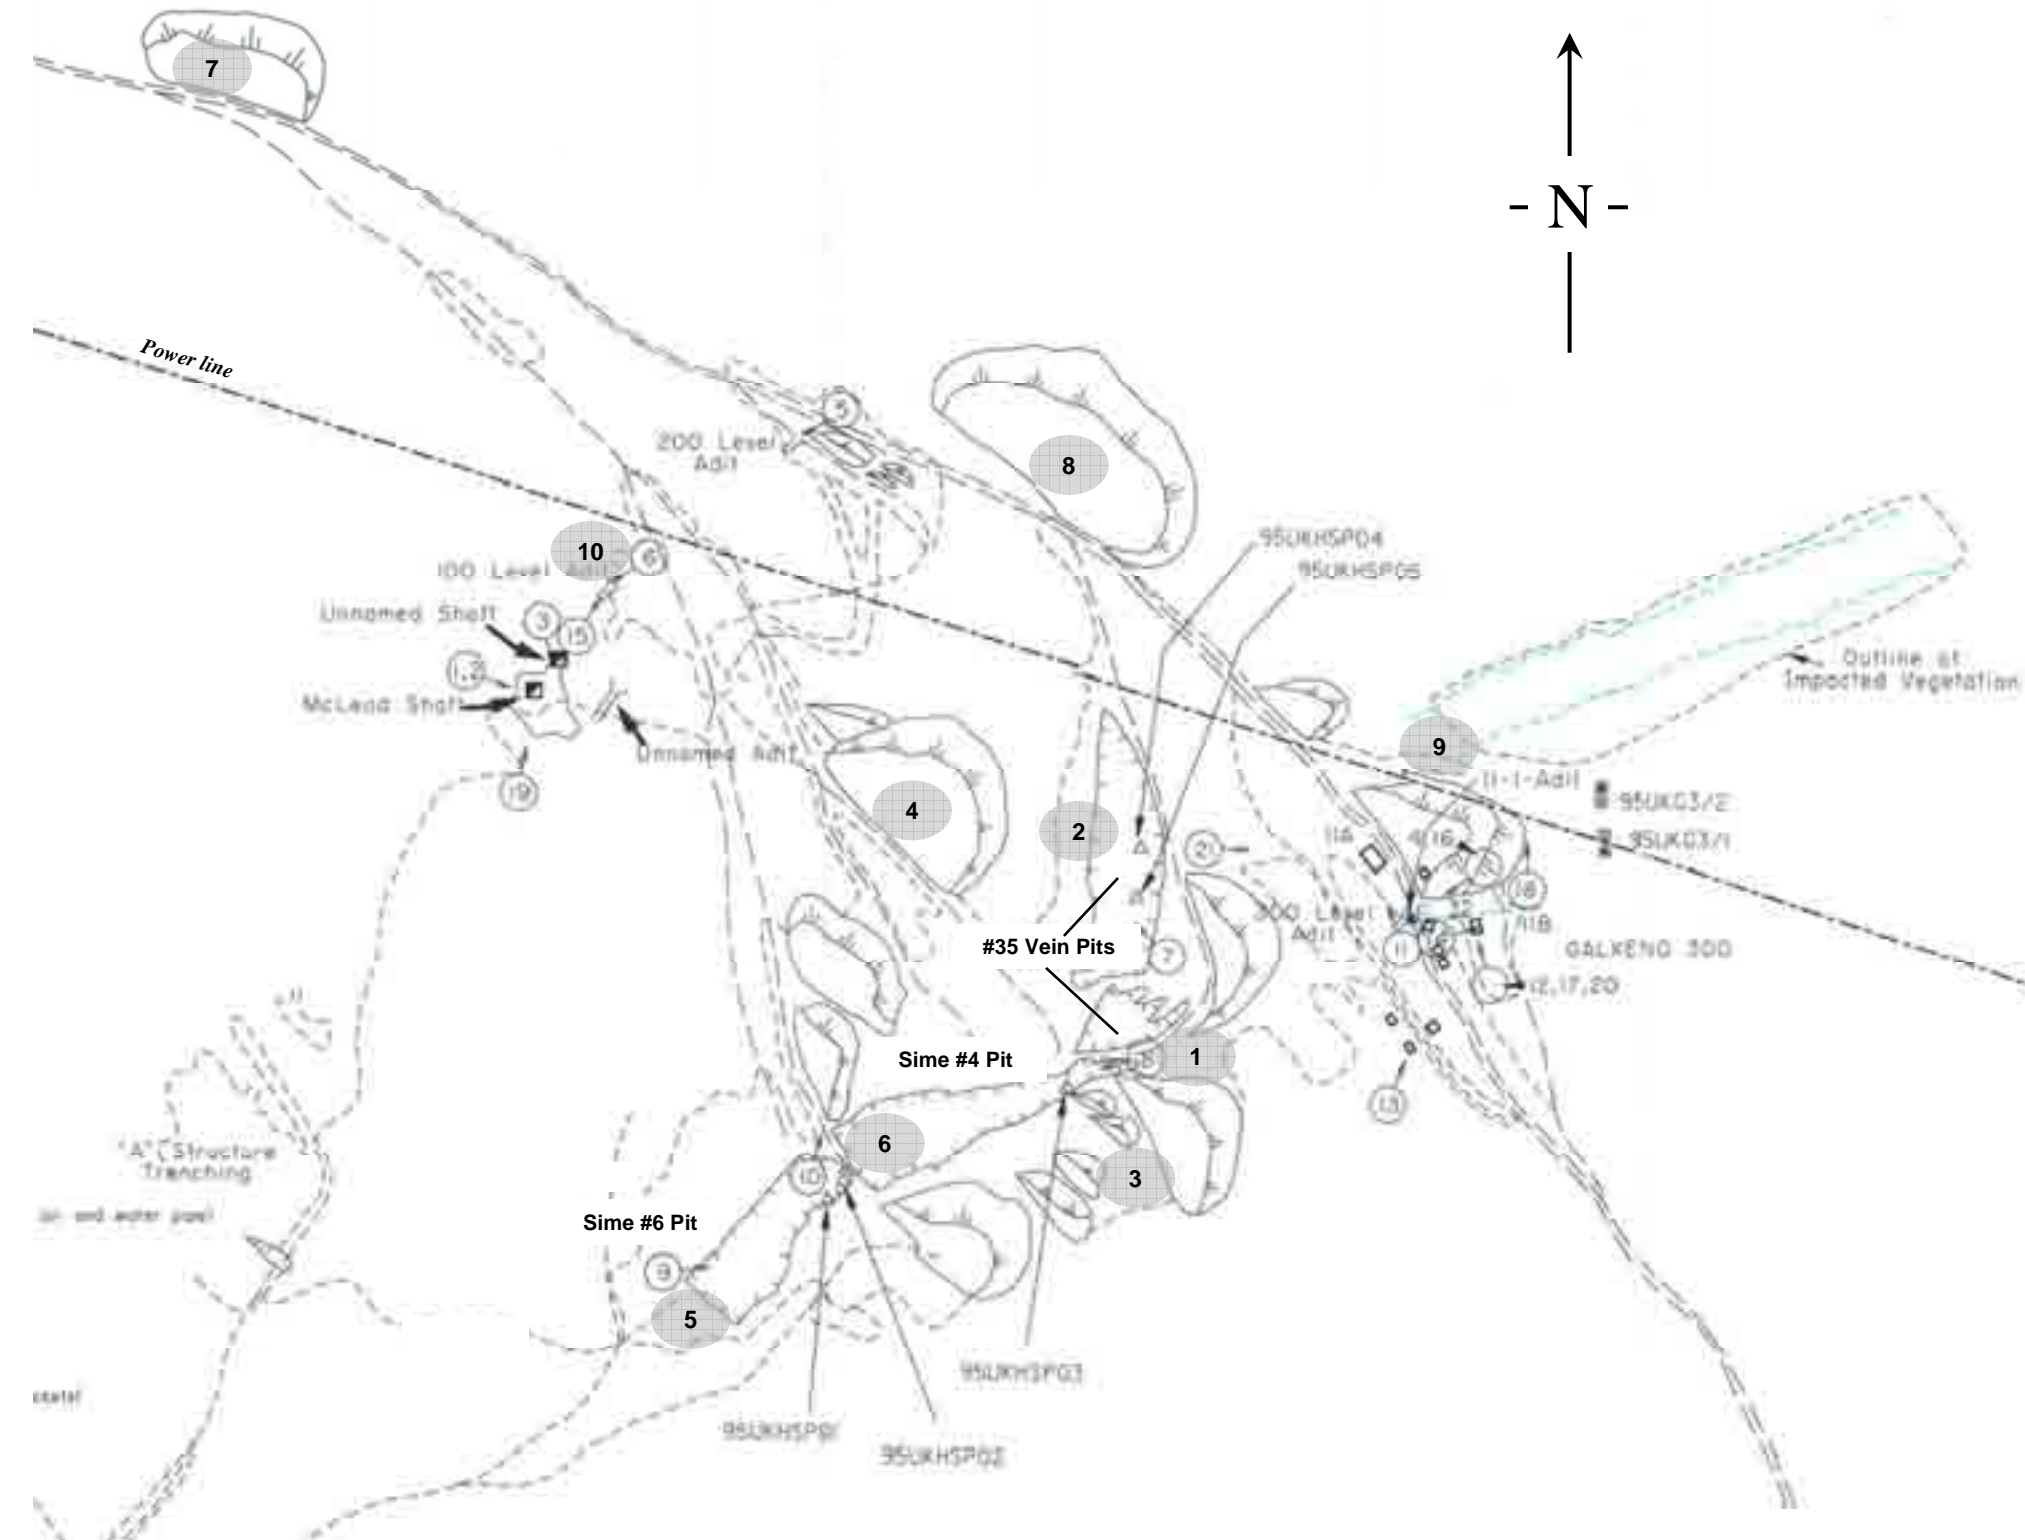
- #1** - Subsidence/Sinkhole, no timber was noted within the hole. This is a previously-unidentified hole, with 2 – 3m of fill over the area
- #2** - The #35 Vein pits are stable with no tension cracks observed around the pit perimeter.

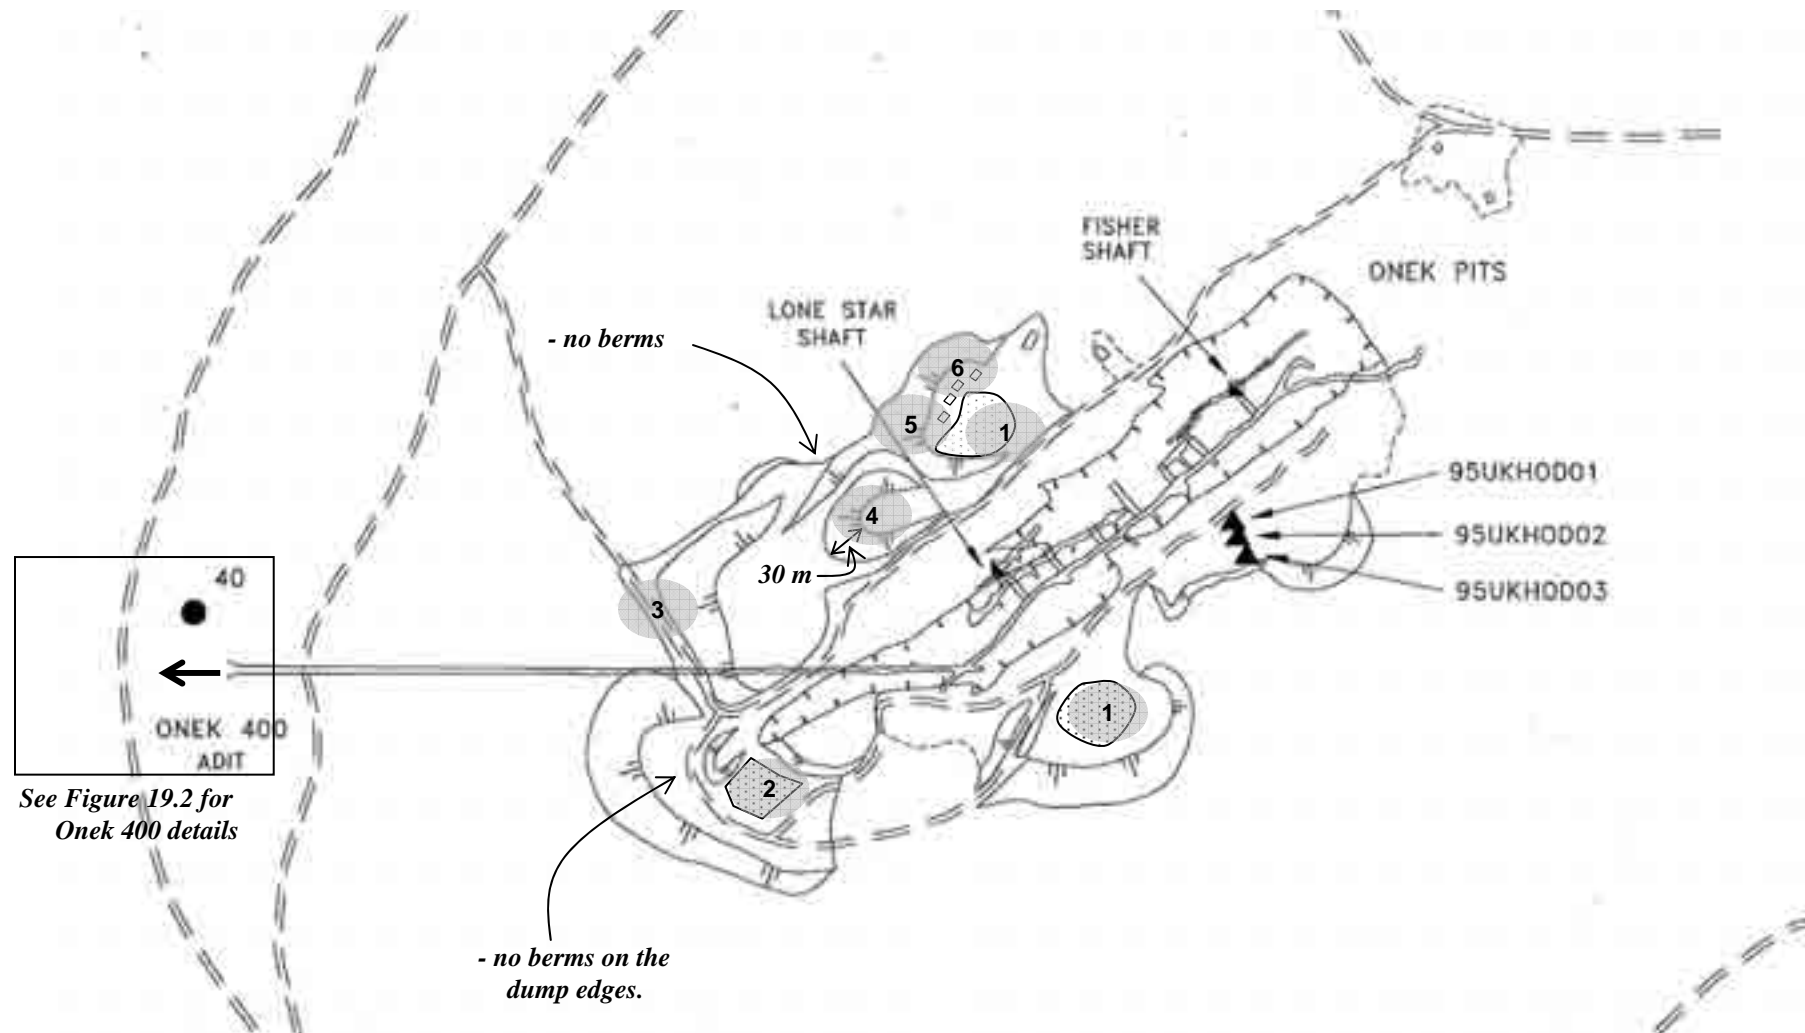
- #1** - Free dumps and traffic surfaces of oxidized dark orangey brown to black ore
- #2** - Free dumps of oxidized dark orangey brown to black ore  
- Approximately 40 dump loads, each 2 m x 4.5 m x 4.5 m
- #3** - North & west areas have berms  
- South area – high, no berms and very steep
- #4** - East slope berm – 30 m wide  
- Berms smaller
- #5** - No berms along the crest of the waste dumps
- #6** - Minor hydrocarbon staining near buildings. Buildings in poor repair. One lead/ acid battery noted.

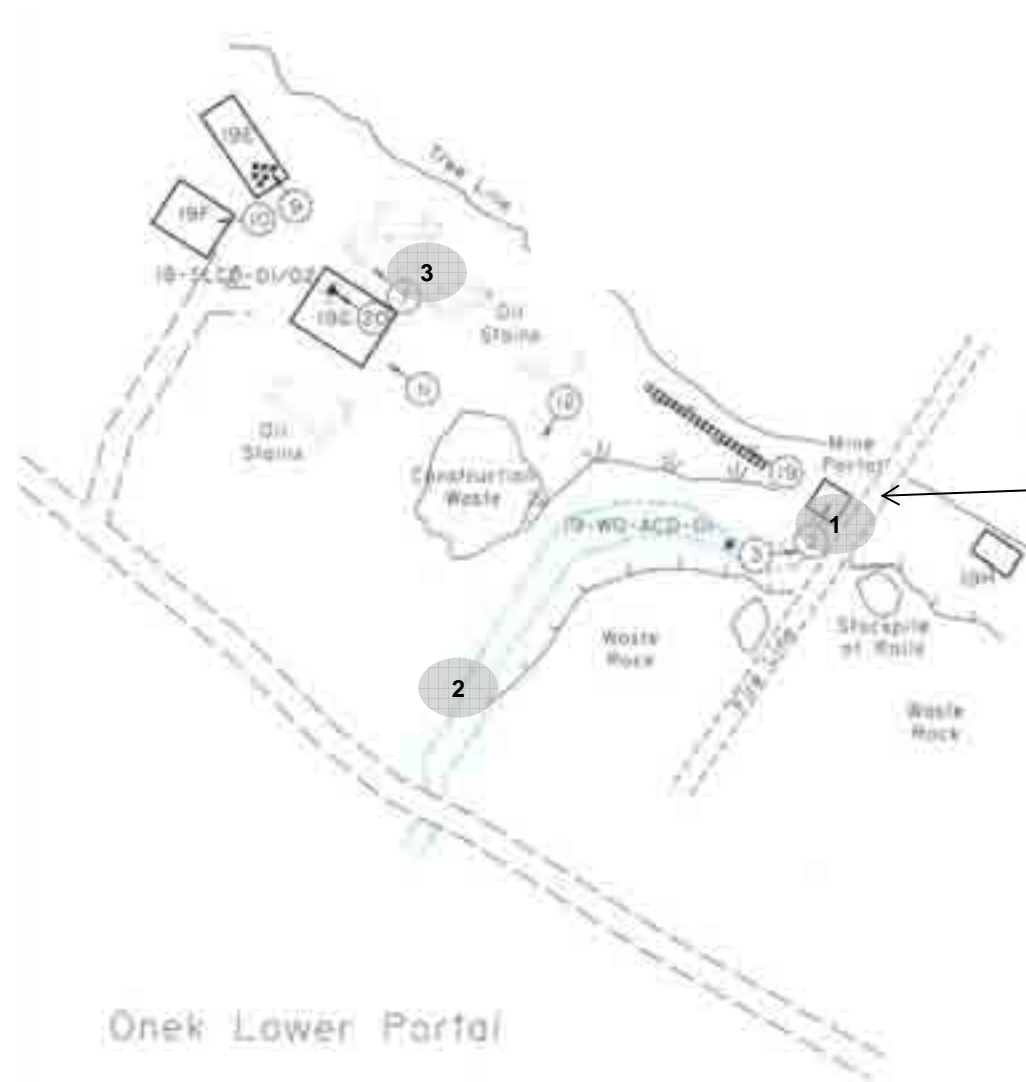
Collapsed rock extends about 5 m above portal

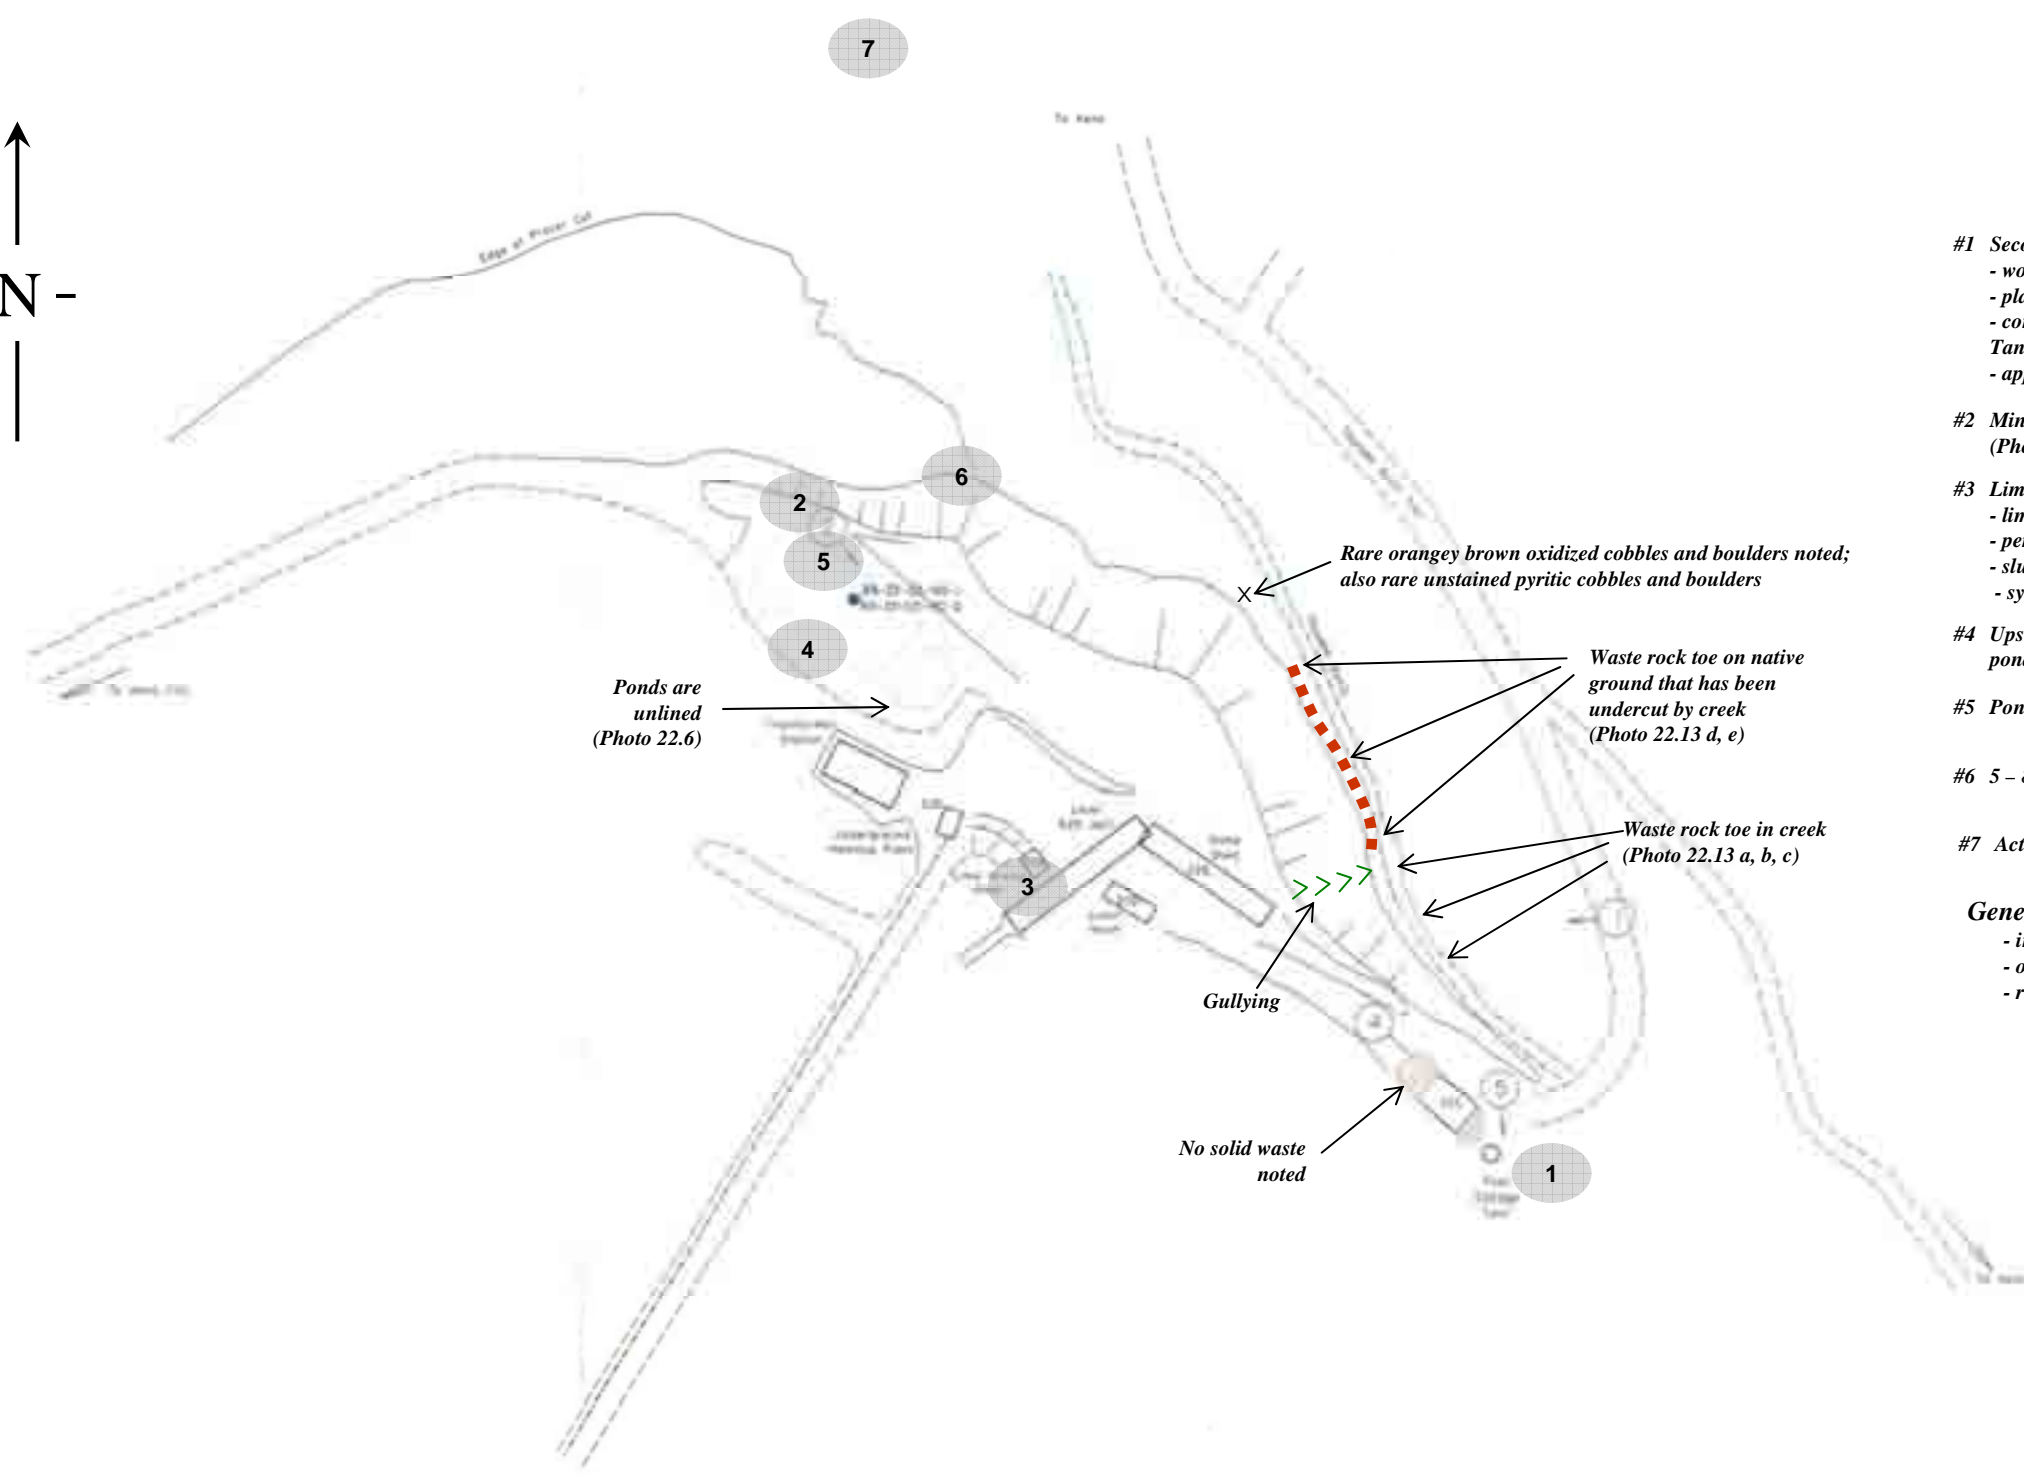
- #1 Secondary Containment
  - wood lumber crib lined with black plastic
  - plastic is compromised on west side, i.e. a spill would not be contained
  - containment has ponded water and algae inside to depth of 5 cm

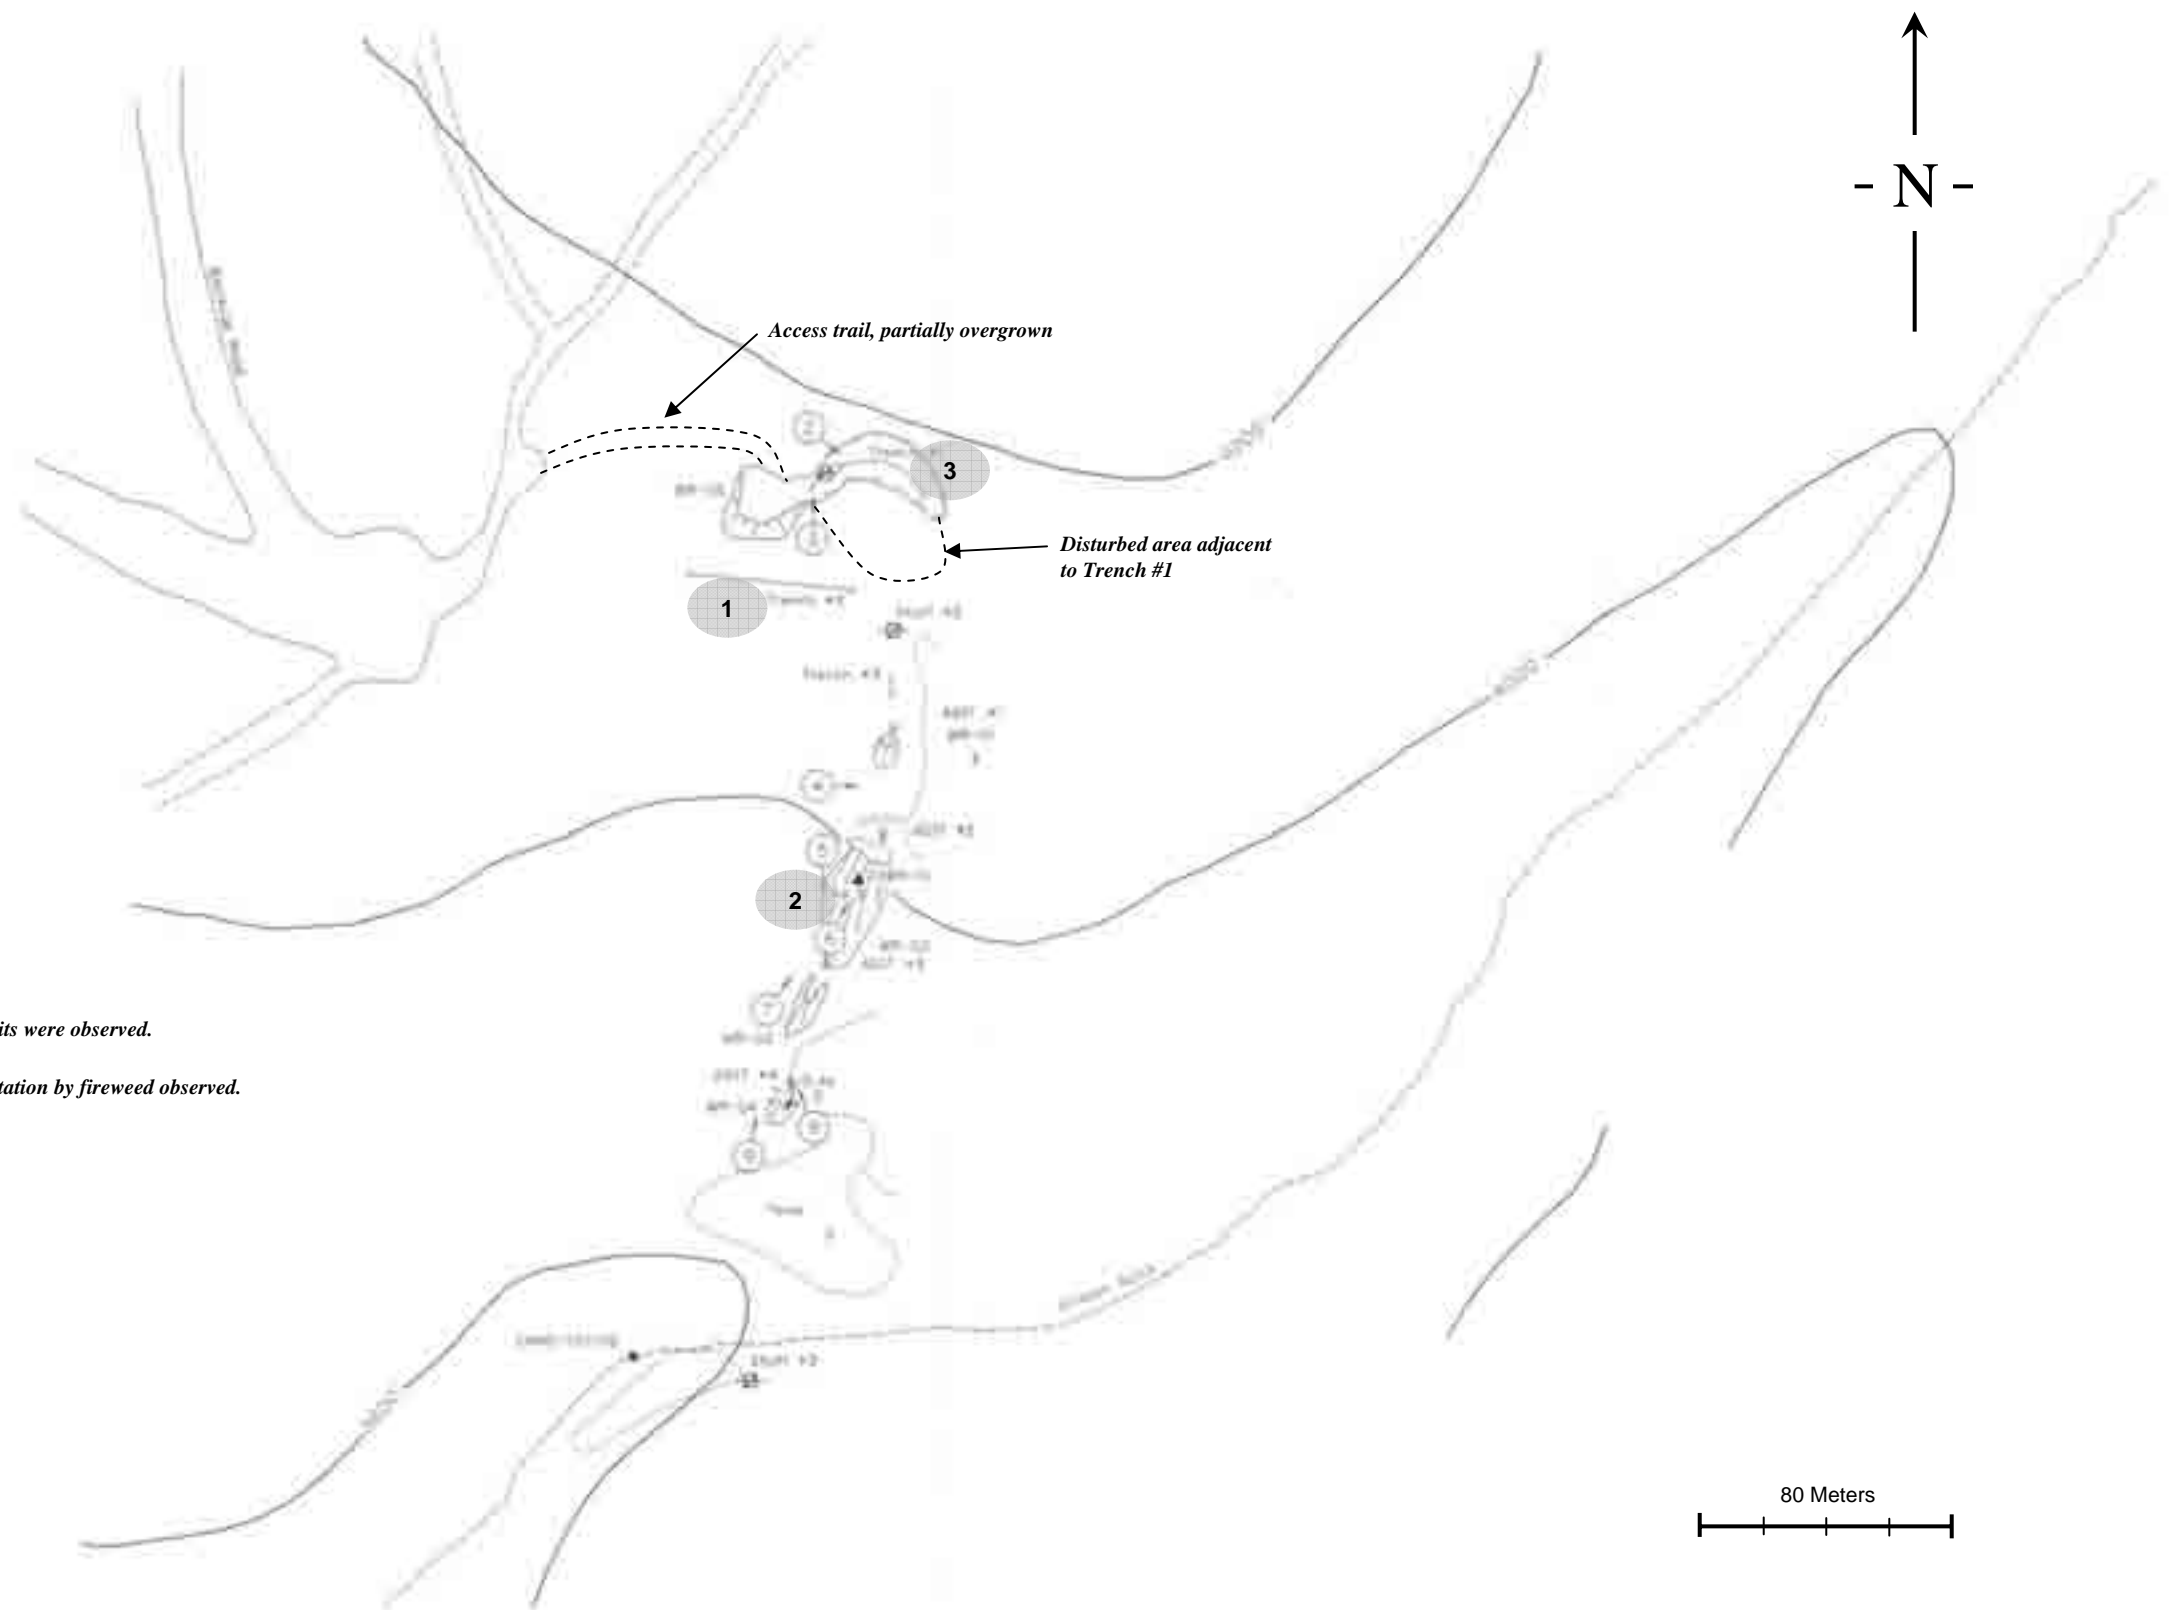
- #1 - Trench #2 appears to channel surface runoff, but no erosion or sediment deposits were observed.
- #2 - Slope of waste rock pile WR-02 is ravelling, but otherwise stable. Minor revegetation by fireweed observed.
- #3 - Minor quartz and quartz-siderite veining observed in trench wall.

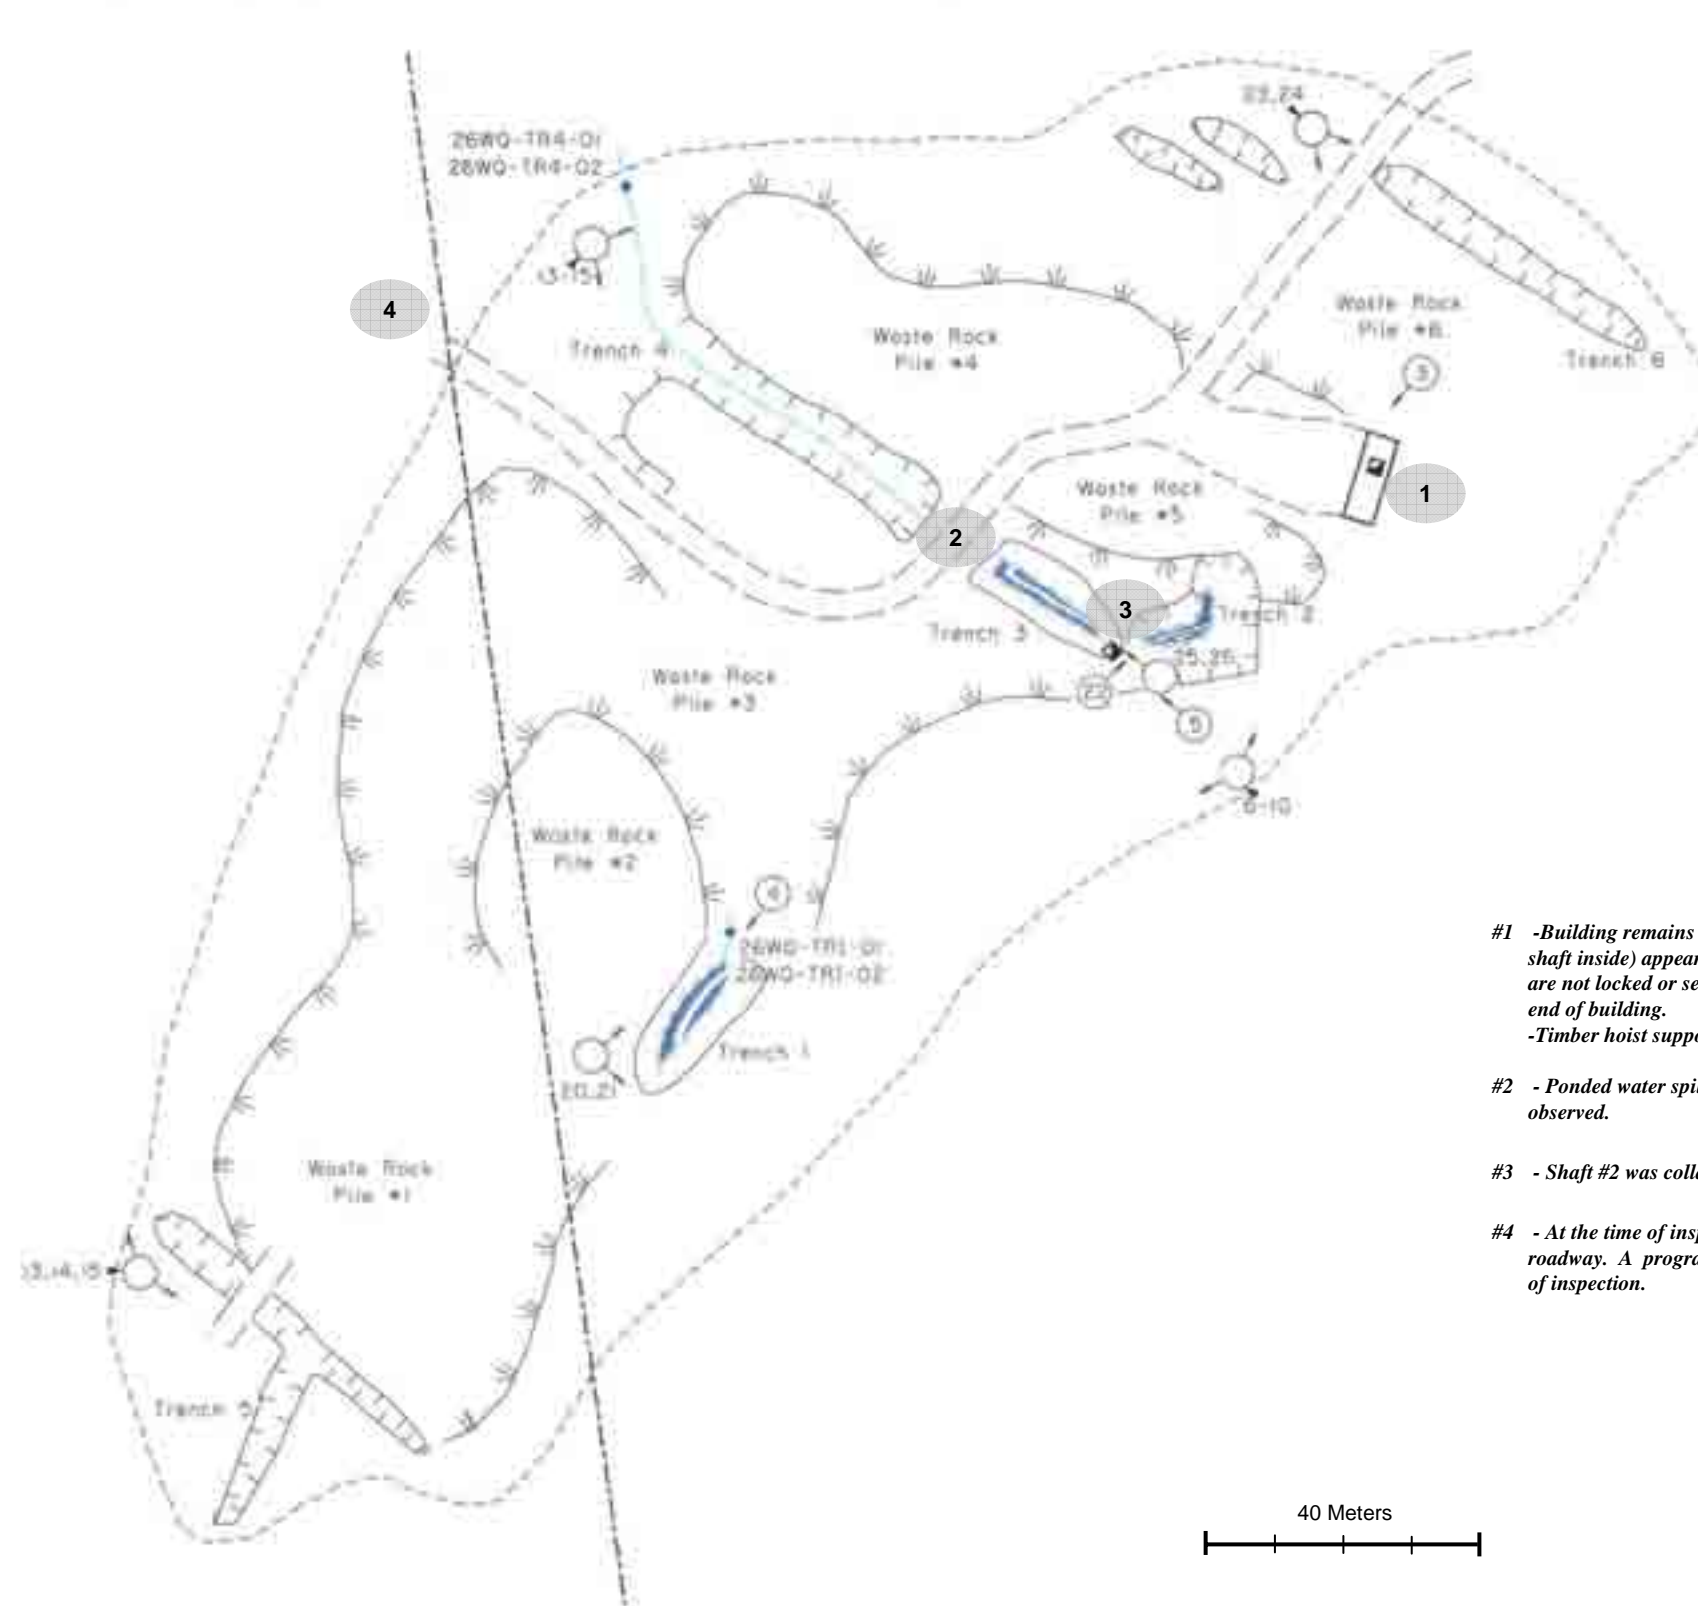
- #1 - Building remains in good condition and is easily accessible. Shaft #1 (inclined shaft inside) appears to be in excellent condition and is easily accessible- entry doors are not locked or sealed, and access is also possible through open ore chute at north end of building.  
-Timber hoist support structure inside is in good condition.
- #2 - Ponded water spilling over roadway in August 2006. No erosion of roadway observed.
- #3 - Shaft #2 was collapsed and inaccessible.
- #4 - At the time of inspection (August 2006), the powerline was down across the roadway. A program of wire clean-up was underway, but wire remained at the time of inspection.

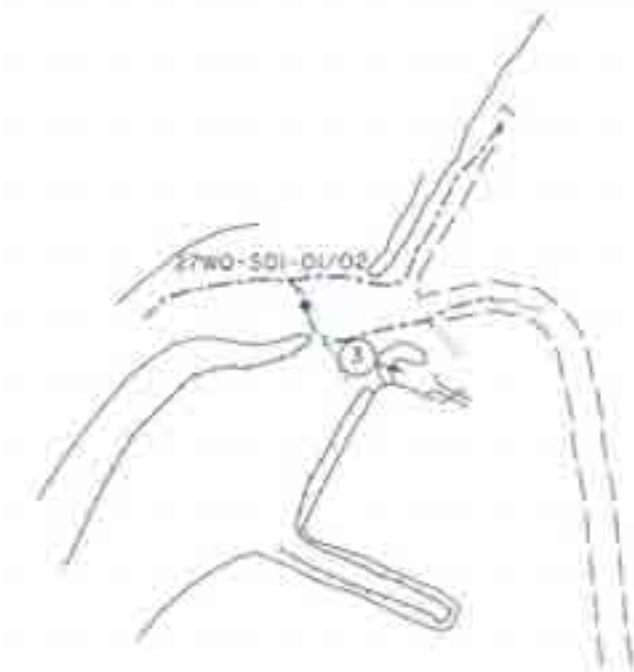
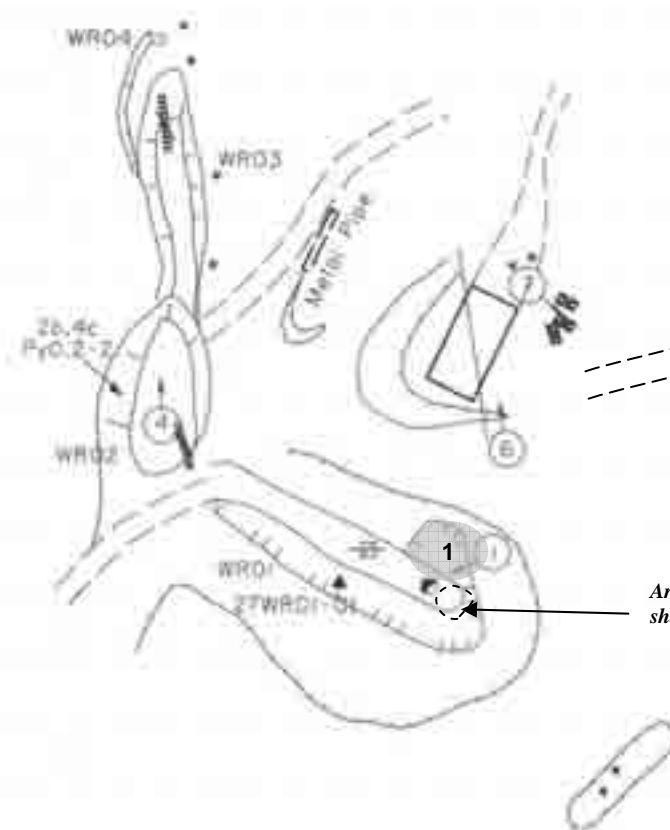
- #1 - Hanging wall to shaft has collapsed, and there appears to be an open void. Risk of inadvertent access was low at the time of inspection; however, wood structure that formed a roof over the opening was observed to be actively deteriorating, and may lead to the development of an open hole in the future. May be exacerbated by continued failure of hanging wall. Intrigue risk is high and access could be gained with intent. (Photos 1 and 2).
- Area of subsidence immediately west of shaft structure is overgrown with willows (Photo 3).
  - Manway was secured at time of inspection by planking nailed over entry, as noted in PWGSC (2000).

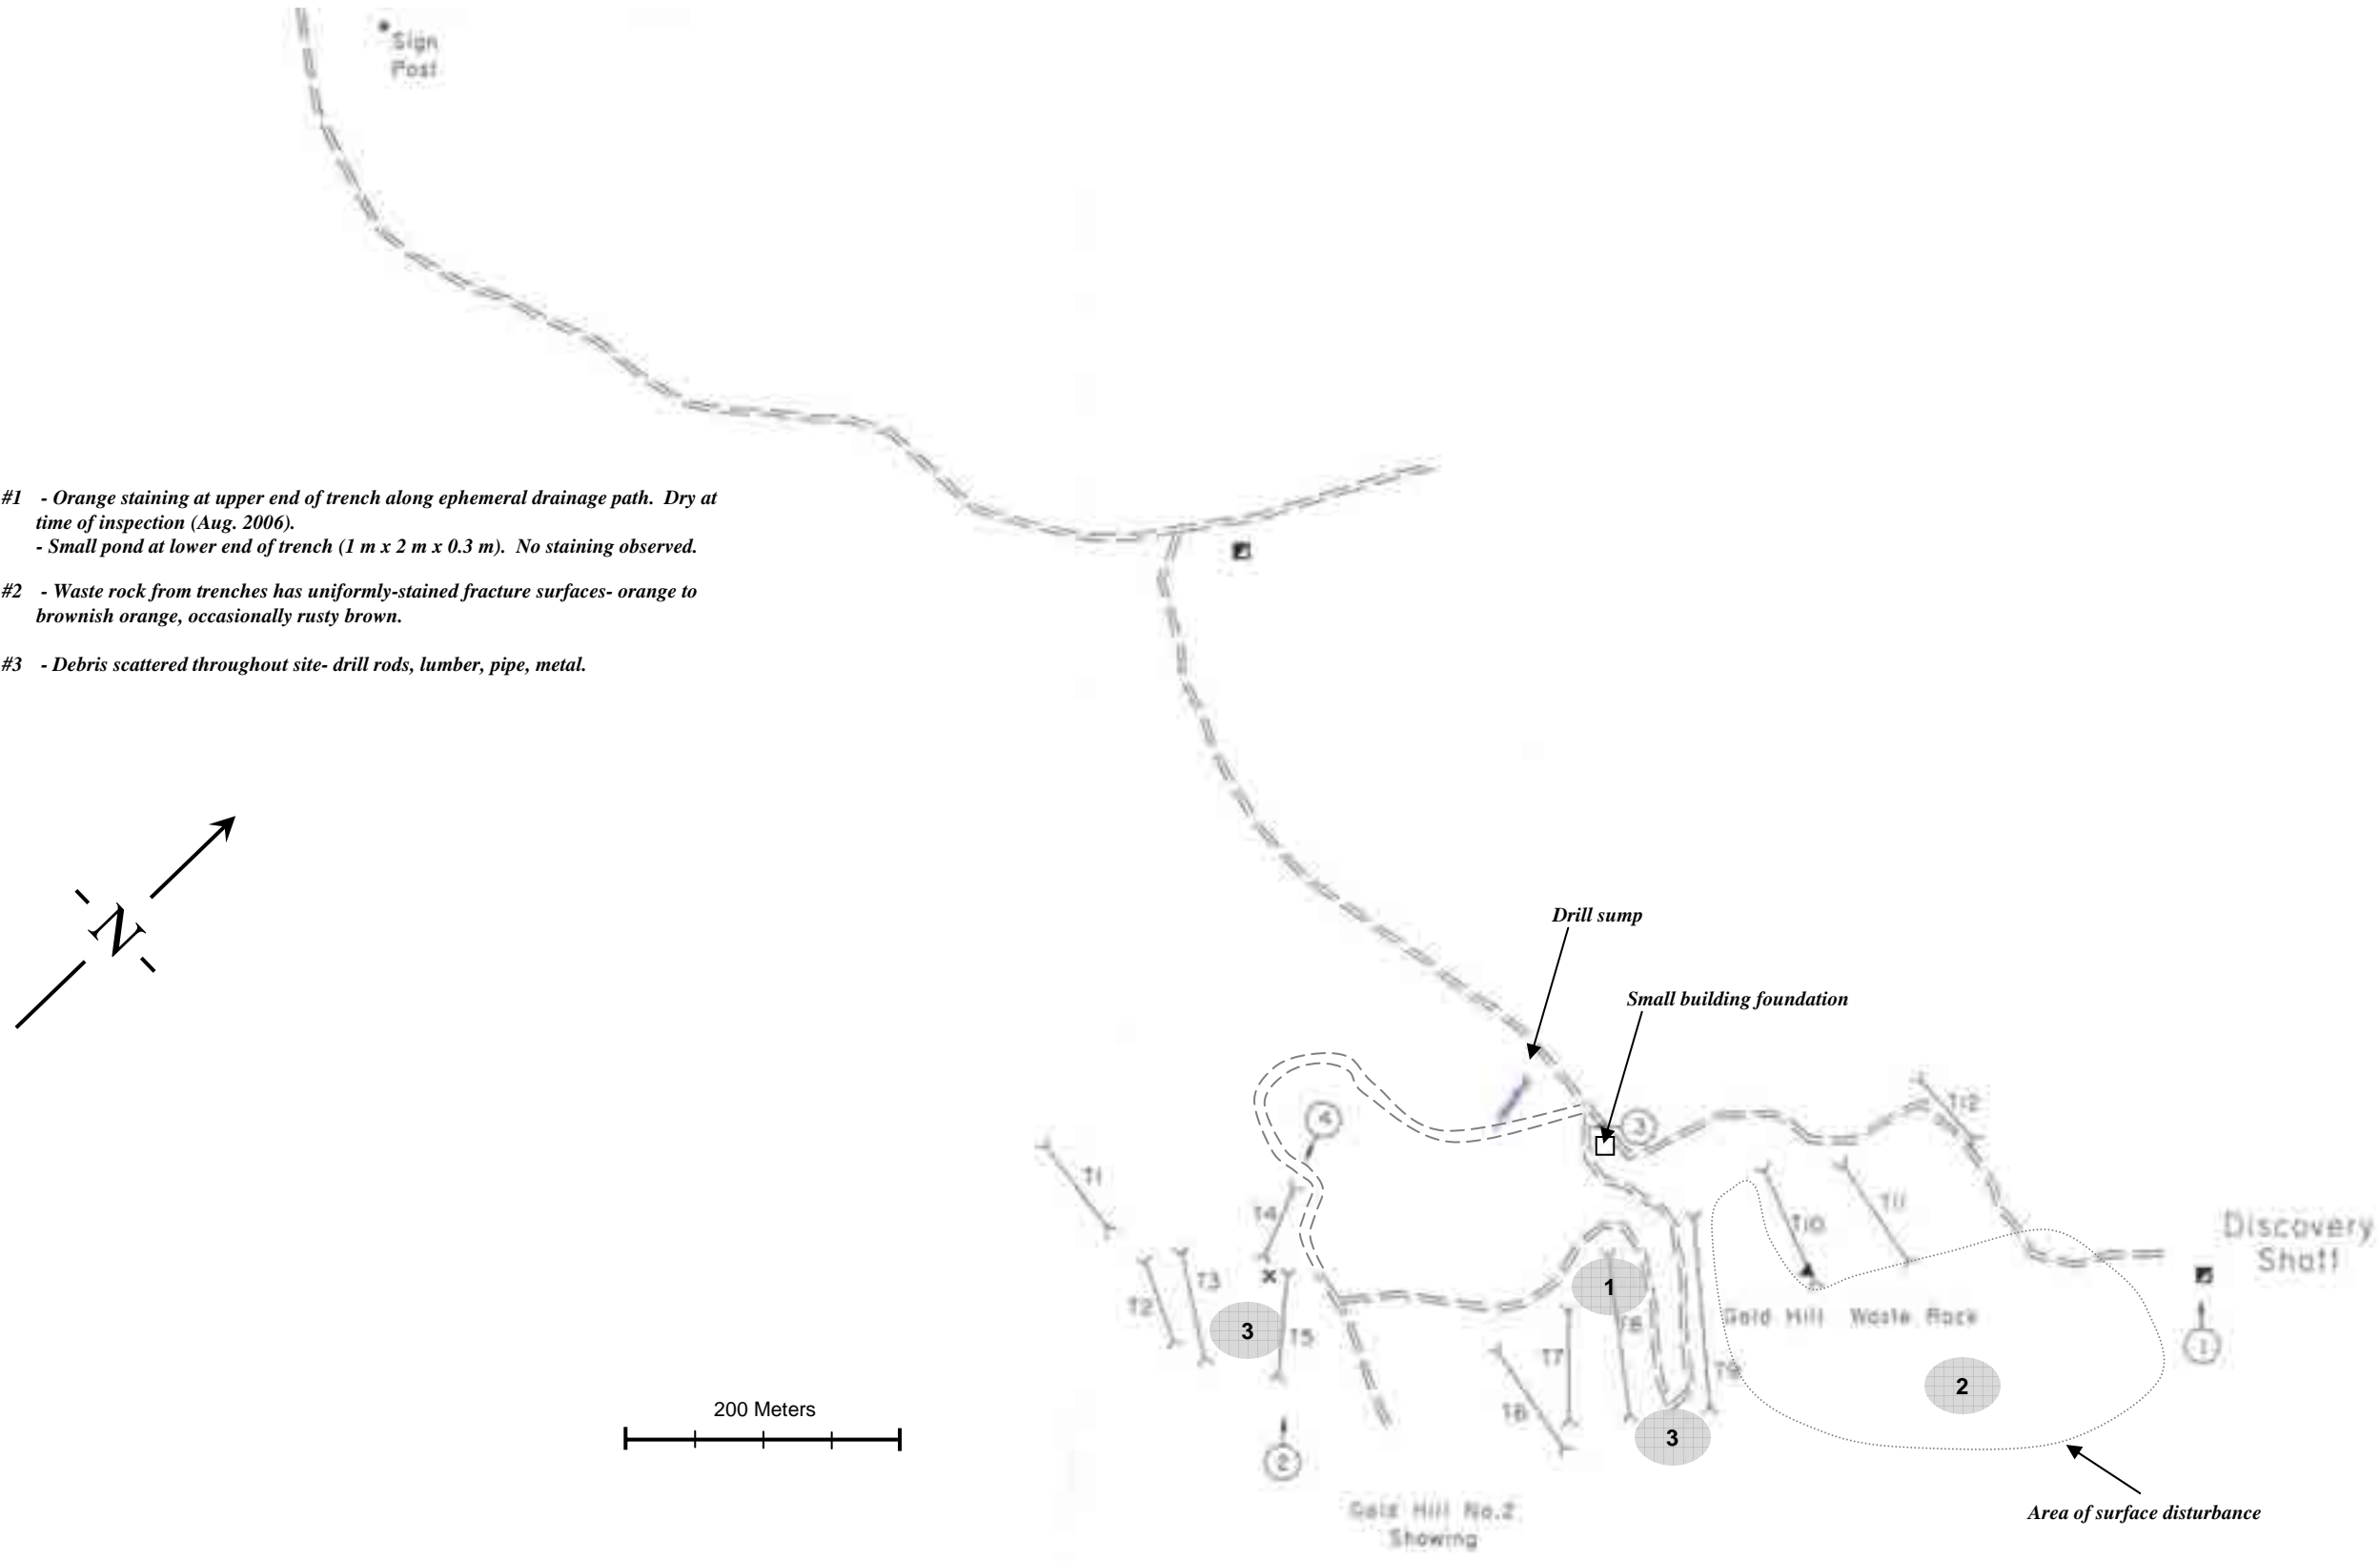
- #1 - Orange staining at upper end of trench along ephemeral drainage path. Dry at time of inspection (Aug. 2006).  
- Small pond at lower end of trench (1 m x 2 m x 0.3 m). No staining observed.
- #2 - Waste rock from trenches has uniformly-stained fracture surfaces- orange to brownish orange, occasionally rusty brown.
- #3 - Debris scattered throughout site- drill rods, lumber, pipe, metal.
