## **KENO HILL SILVER DISTRICT**

## **CLOSURE ISSUES REPORT**

MARCH 2009

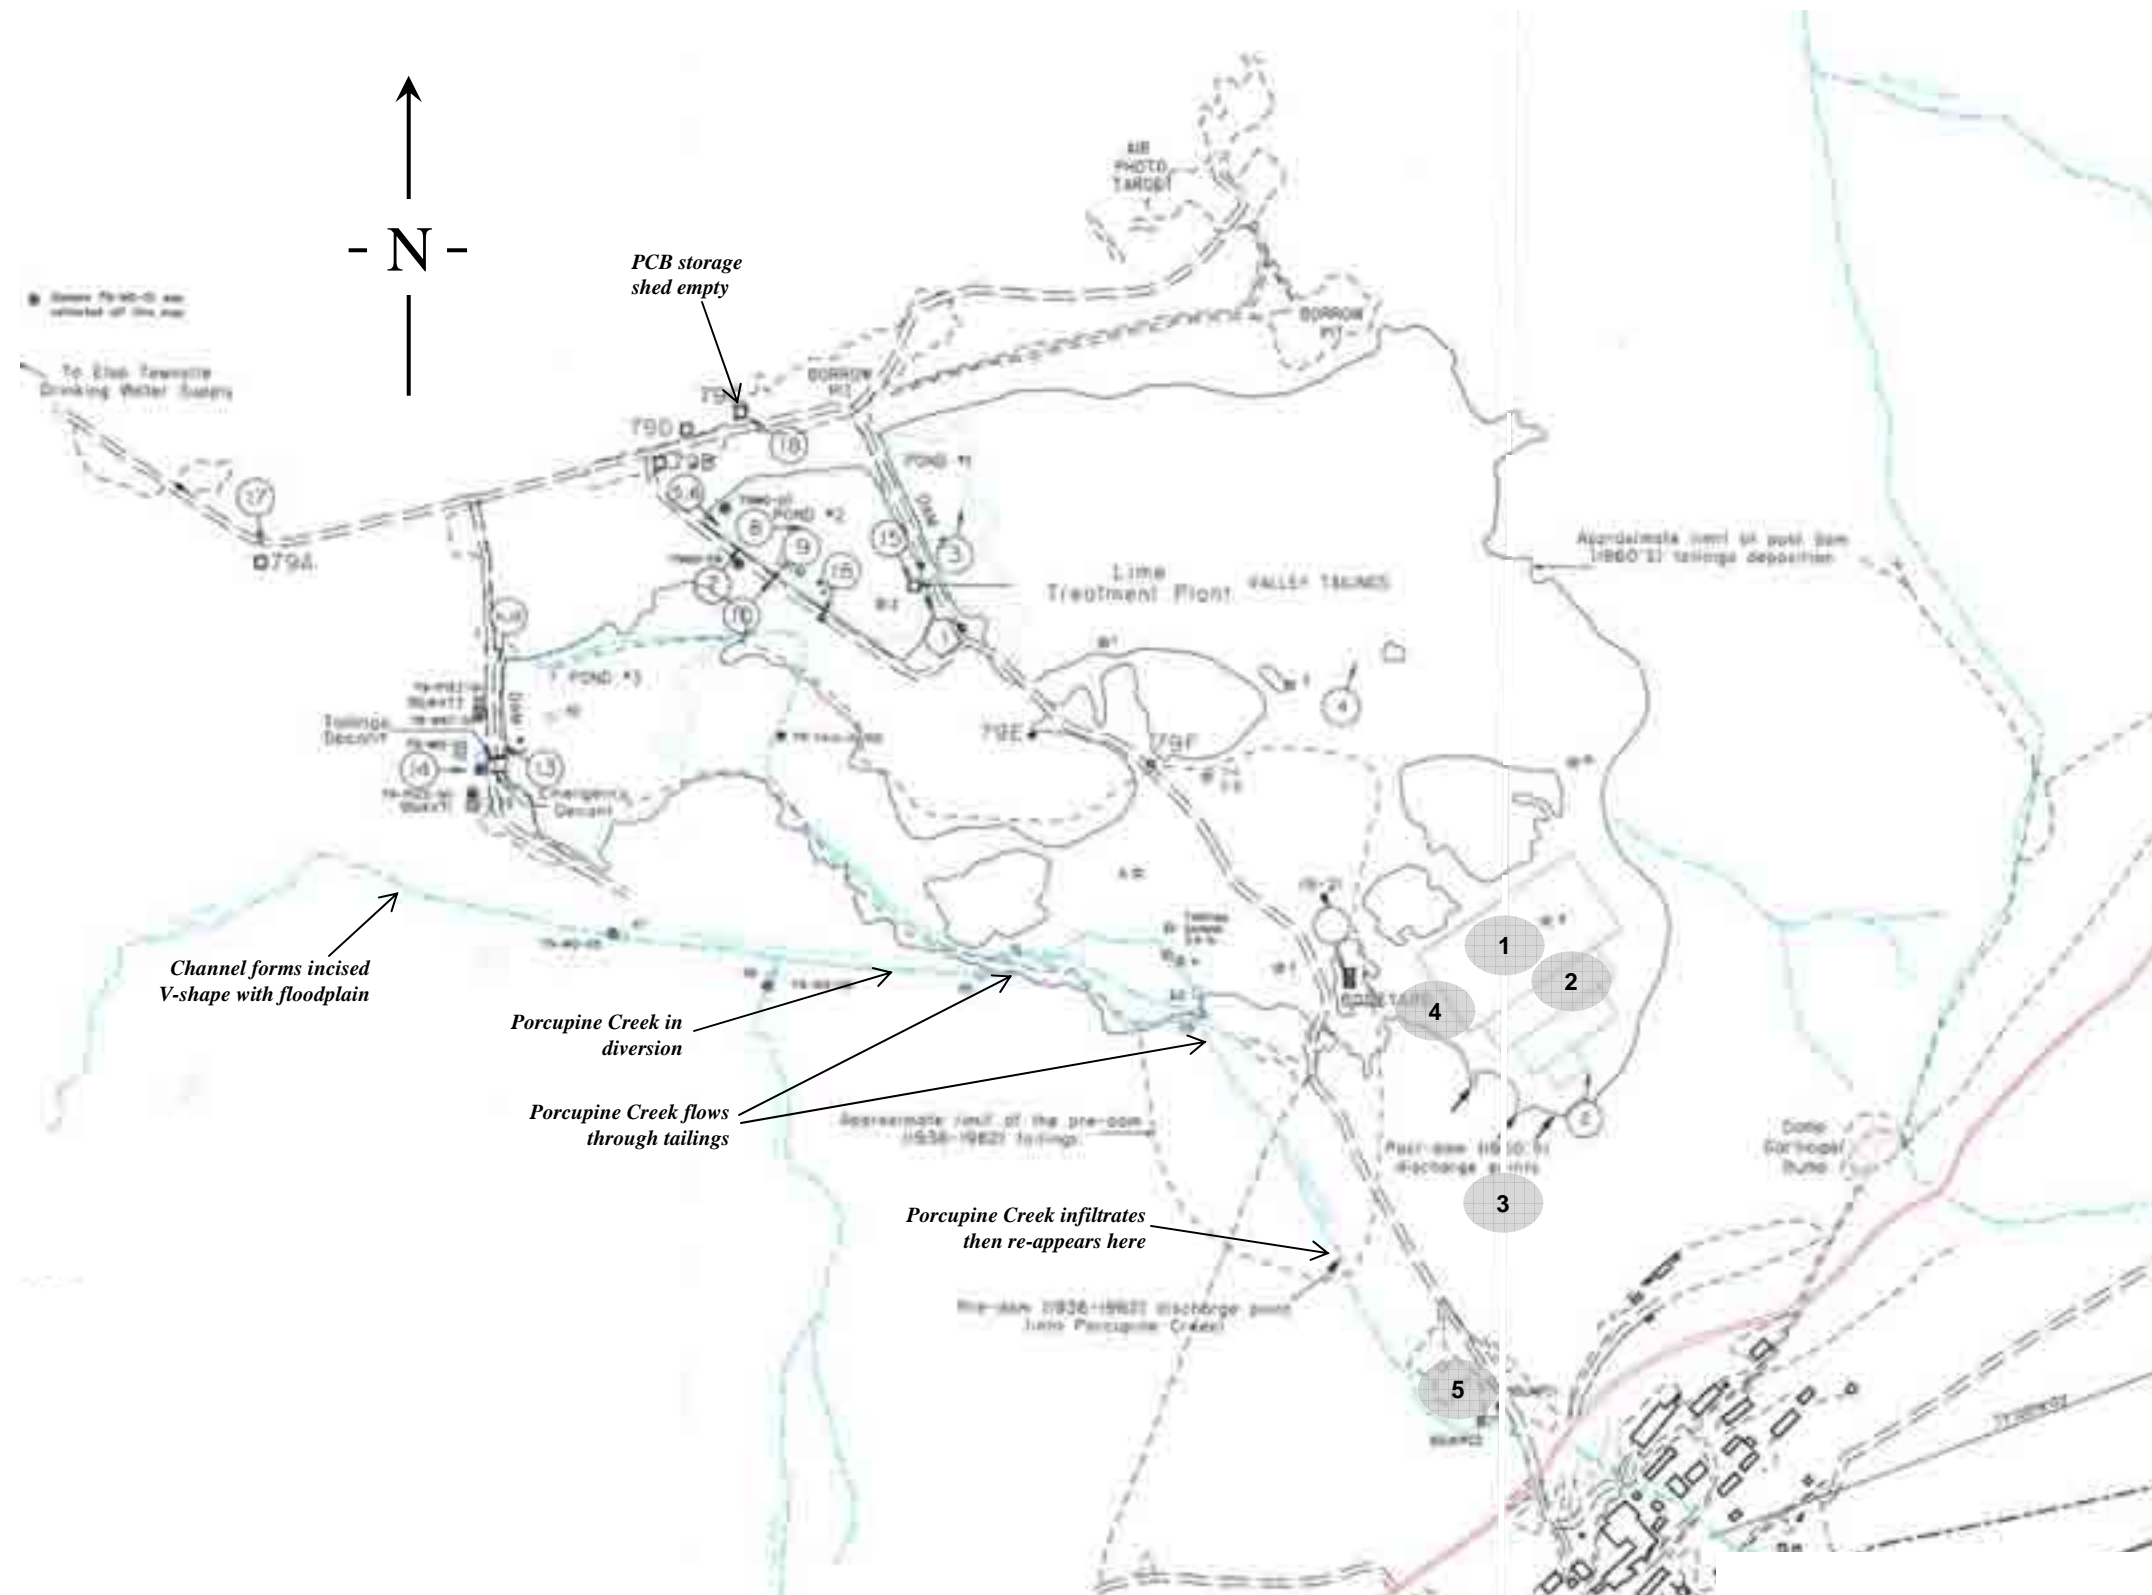
- #1 Approx. location of sludge disposal cells (Photo 79.1)  
Tension cracks in berm at the NE corner.
- #2 Tailings extensively re-graded in this area (Photos 79.2, 79.3).
- #3 Vegetation kills above former tailings discharge points
- #4 Diversion ditch in tailings. No flow observed (Photo 79.4)  
Oxidized tailings in upper 20 cm (Photos 79.5, 79.6)
- #5 Tailings present much further upslope than indicated on PWGSC 2000 maps

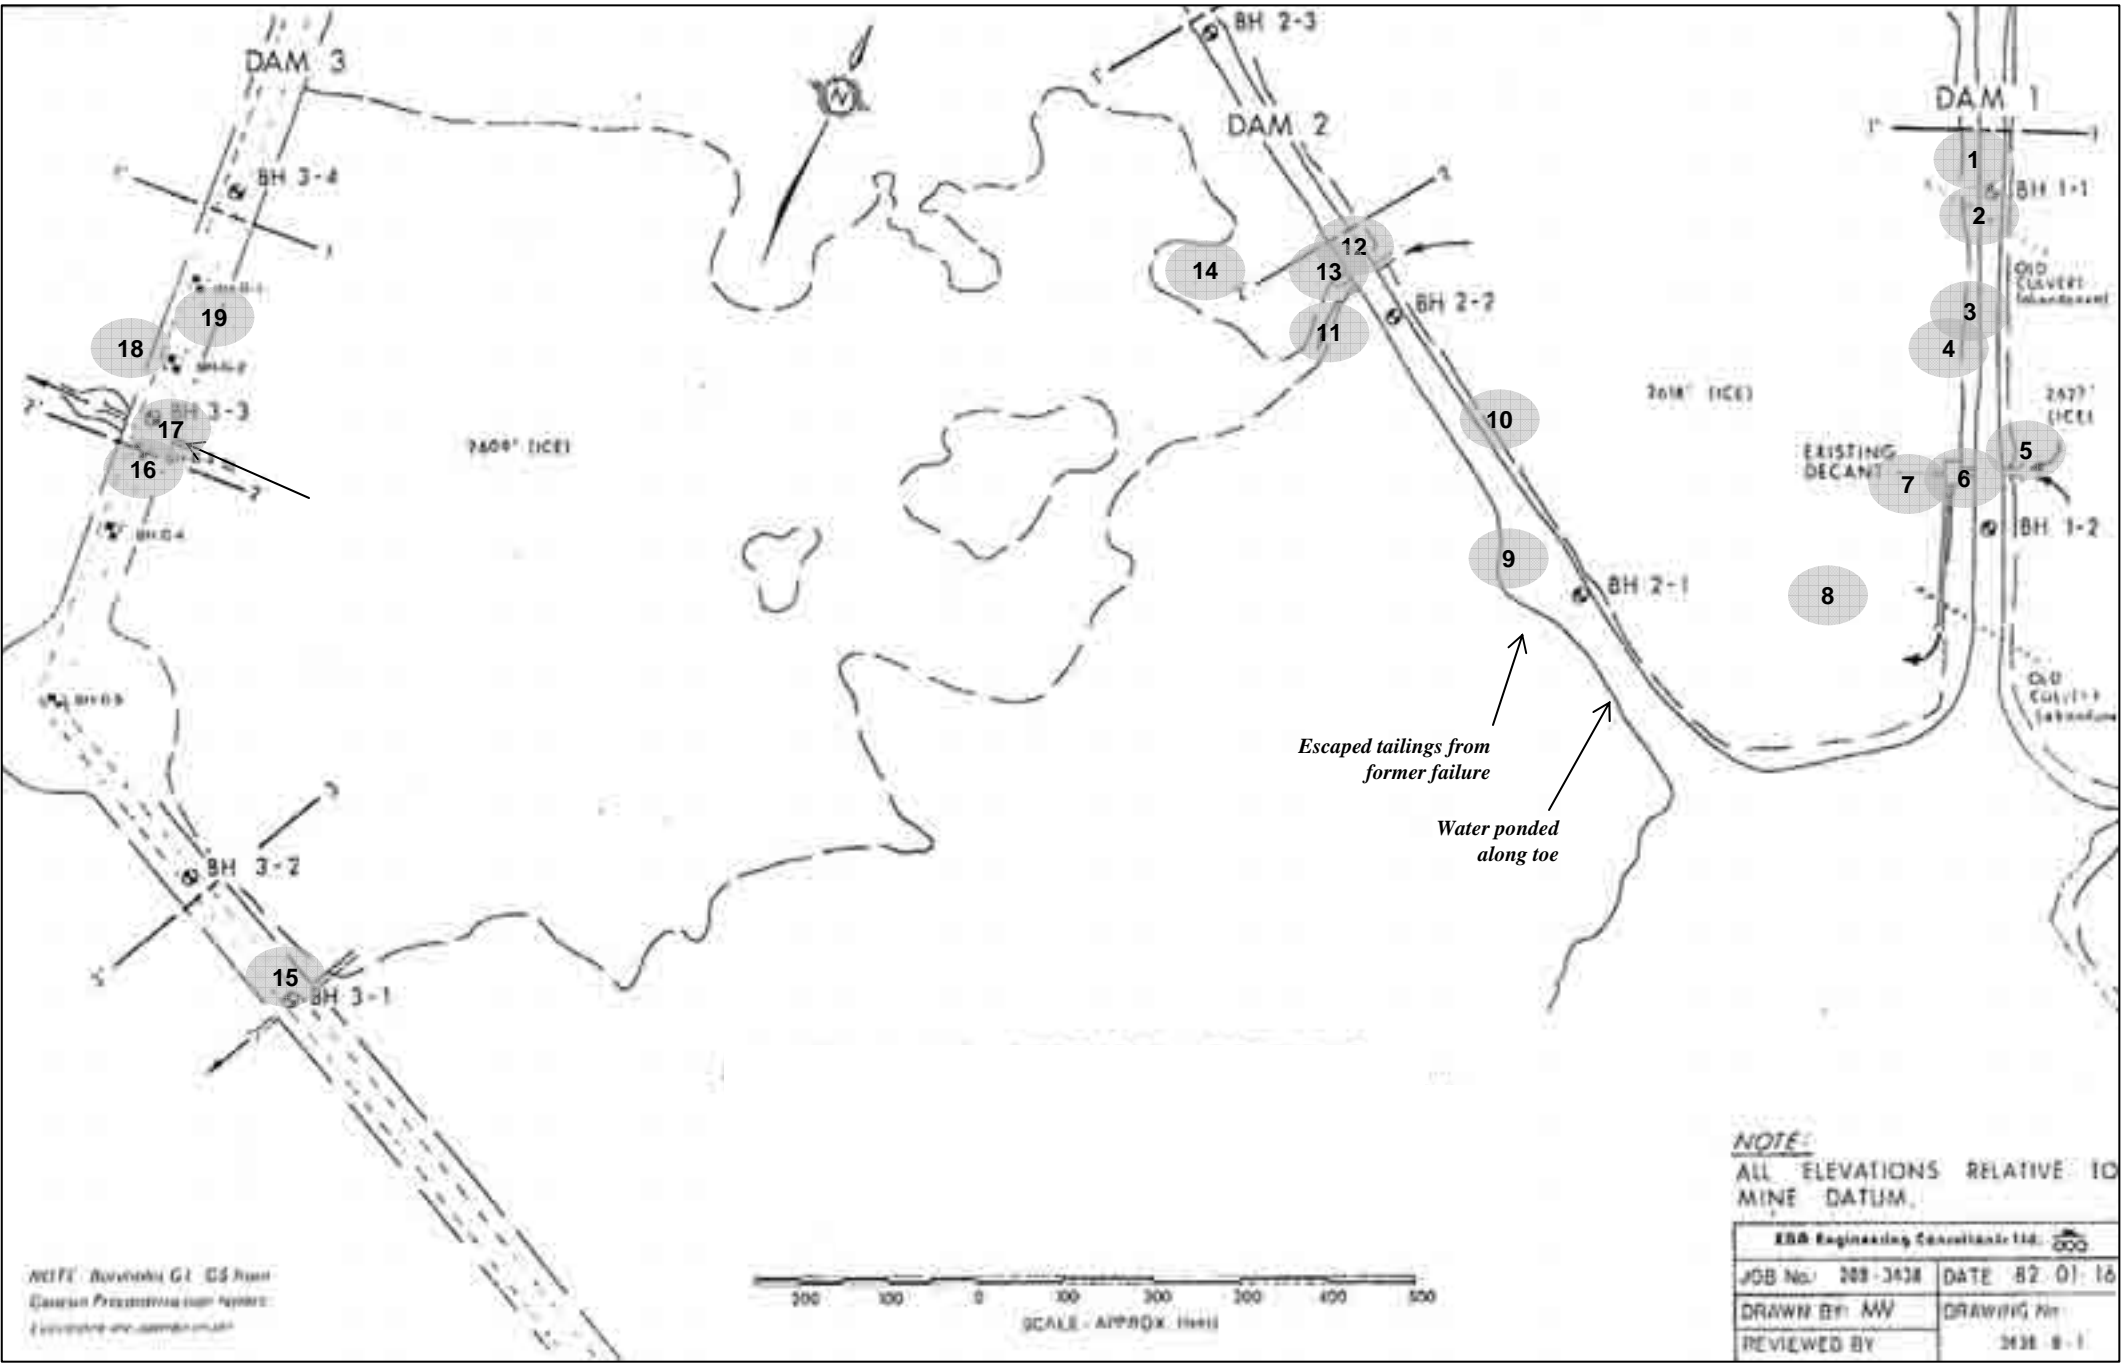
- #1 Dam 1 recently re-surfaced (Photos 79.7, 79.8)
- #2 Upstream crest shows tension cracks
  - 10 m long at north end
  - 20 m long mid-span
  - 10 m long in south third

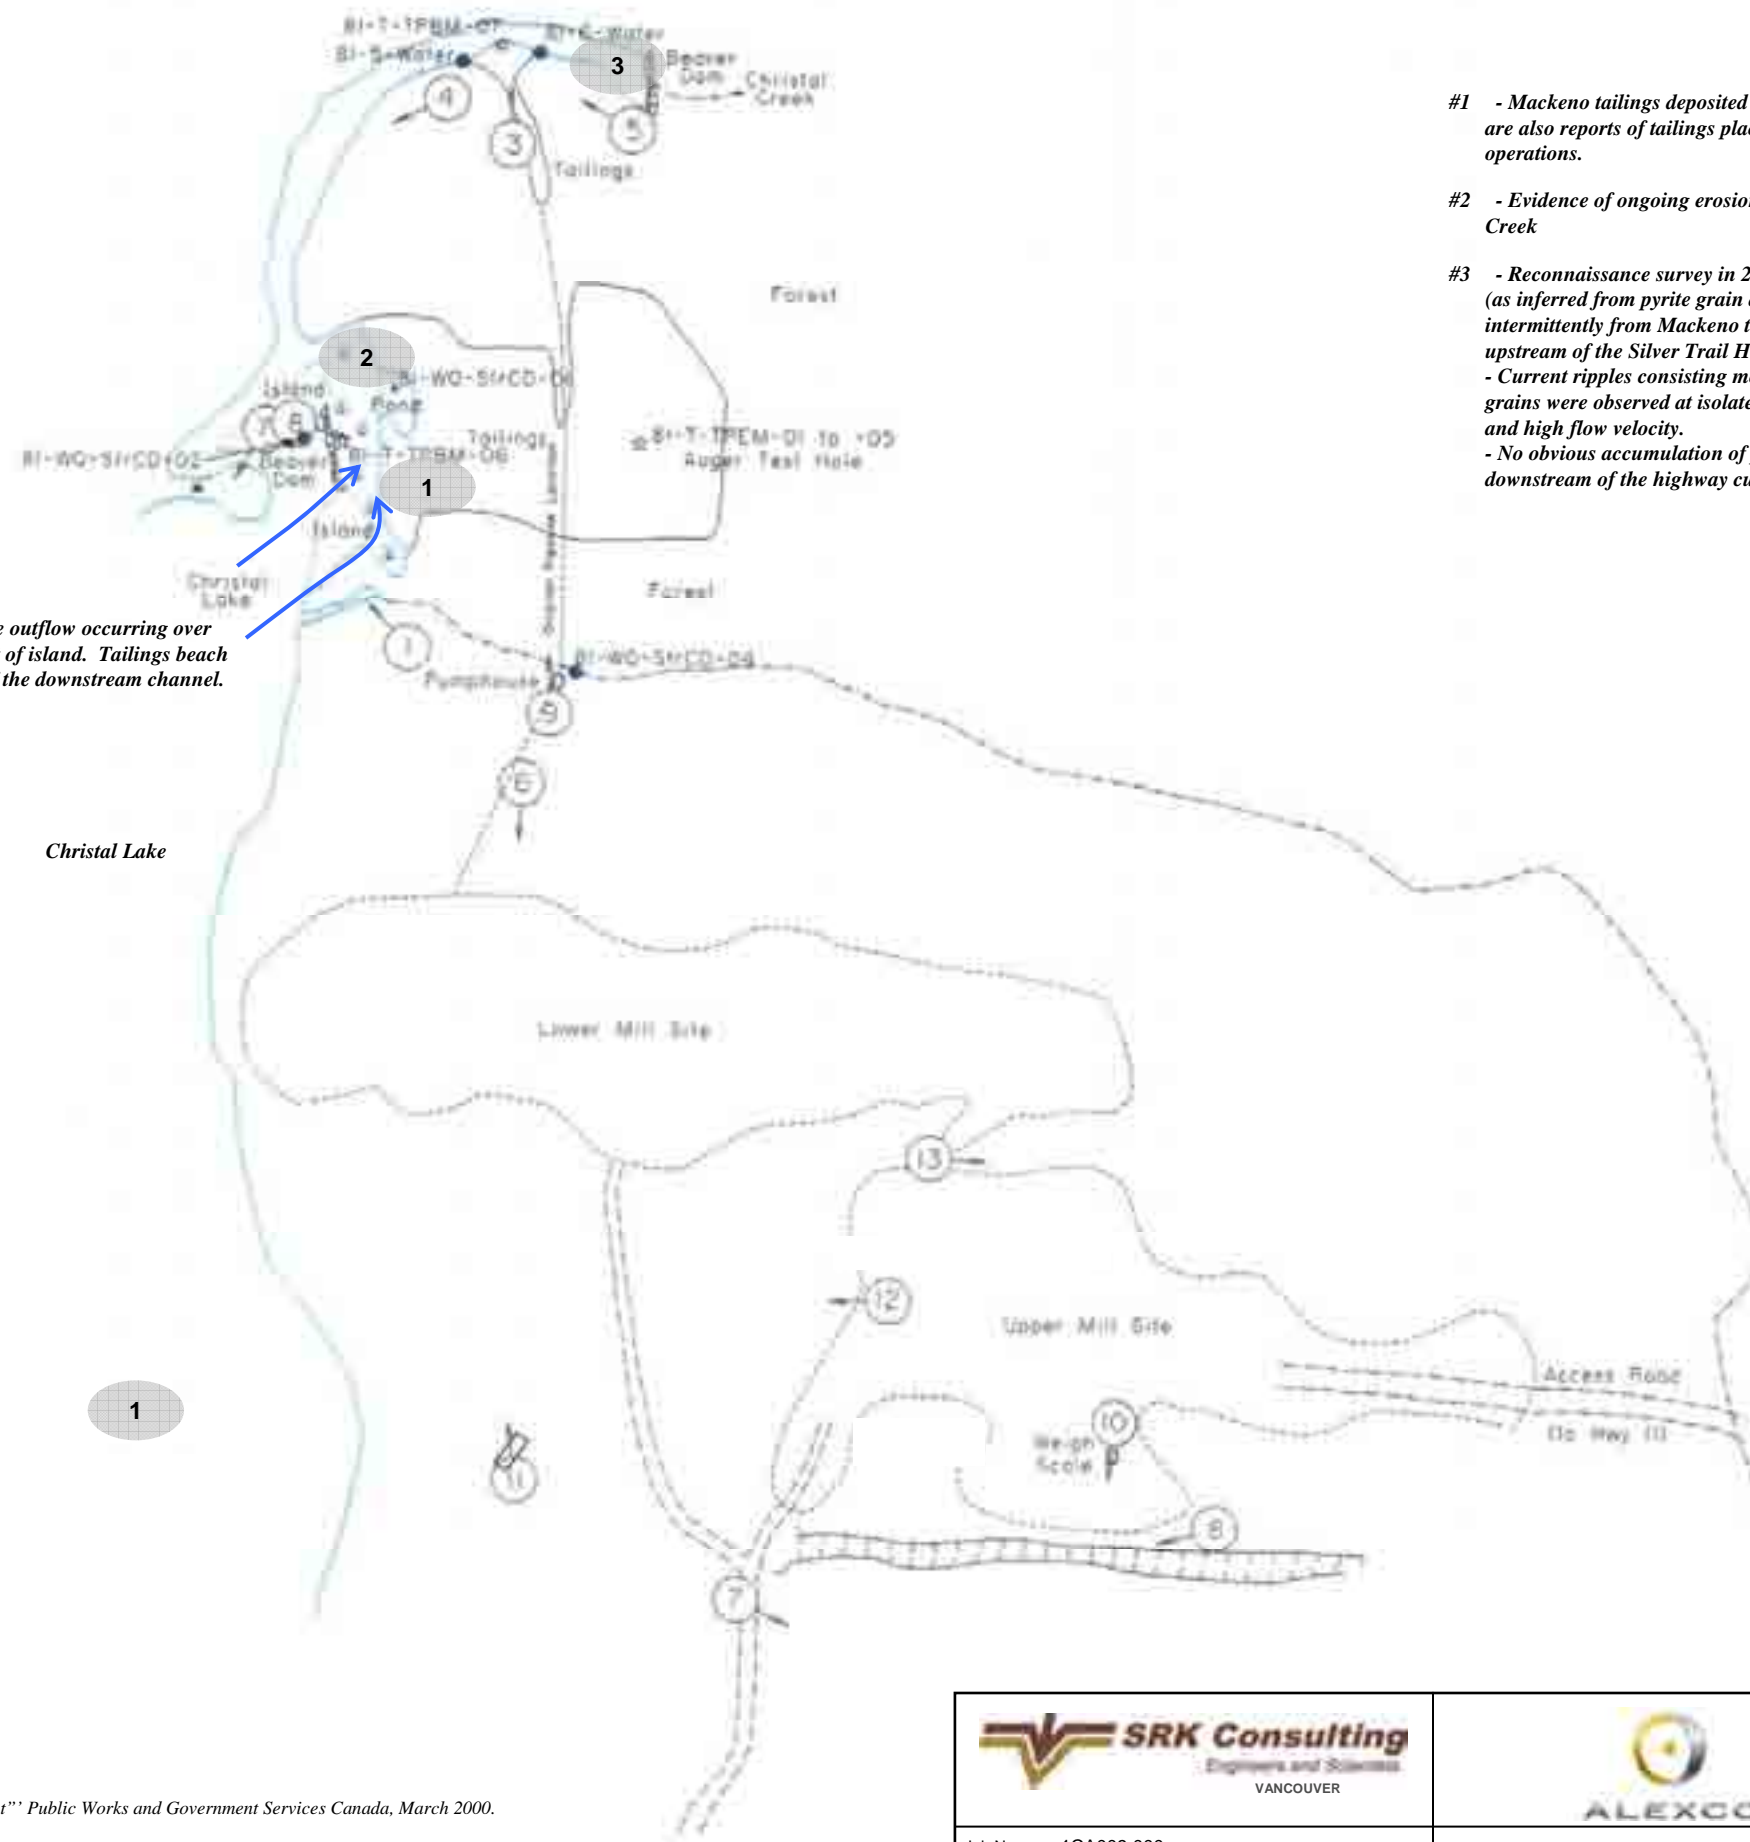
- #1 - Mackeno tailings deposited in lower Christal Lake. There are also reports of tailings placed on the lake ice during winter operations.
- #2 - Evidence of ongoing erosion of tailings beach into Christal Creek
- #3 - Reconnaissance survey in 2006 identified tailings deposits (as inferred from pyrite grain abundance) in active stream bed intermittently from Mackeno tailings down to pool 20 m upstream of the Silver Trail Highway culvert.
  - Current ripples consisting mostly of fine to medium pyrite grains were observed at isolated locations with shallow depth and high flow velocity.
  - No obvious accumulation of pyrite grains was identified downstream of the highway culvert.
