**Construction Report  
Mount Nansen Seepage Control Dyke  
and Spillway Upgrading  
Department of Indian Affairs & Northern Development  
Whitehorse, Yukon**

**Project No. 0201-00-14618**

**March 2003**

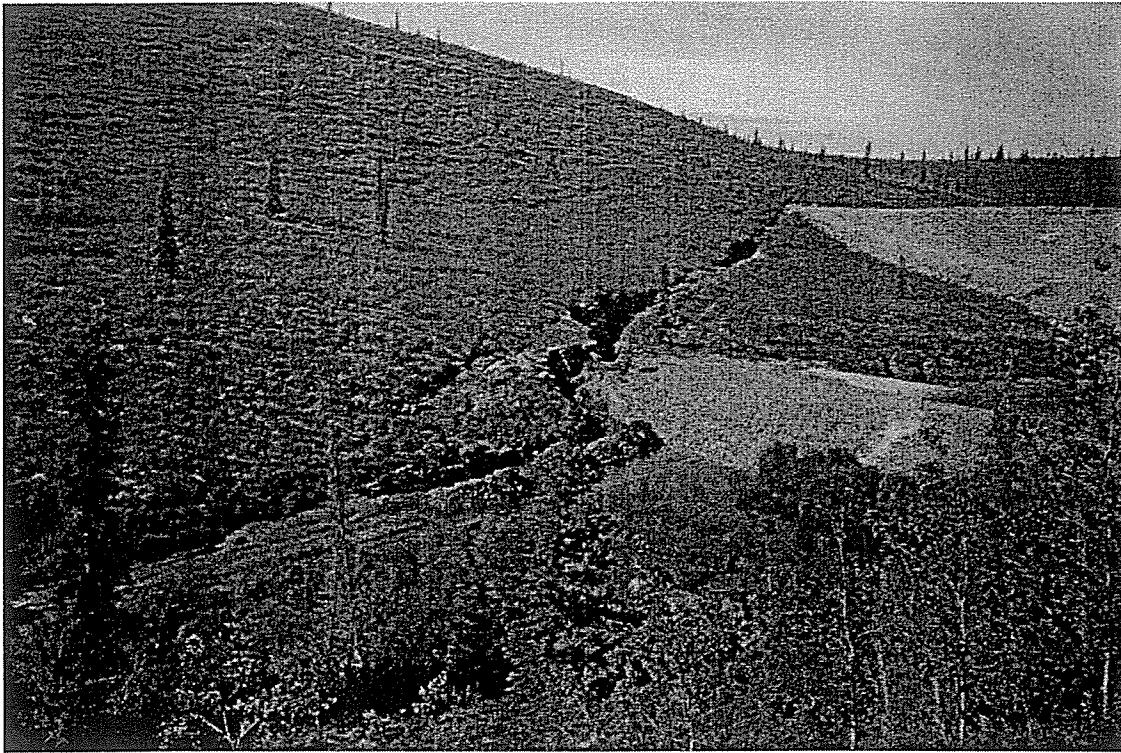
- *Erosion Channel Repair.* The erosion channel appeared to have developed from disturbance and removal of the natural vegetation cover during past construction activities. The reconstructed channel was designed to stabilize the erosion channel and protect it and the seepage collection dyke from further erosion. The channel was infilled with compacted Zone 1 sand fill, Zone 2 gravel fill, non-woven geotextile and riprap, as shown on the Contract Drawings (Appendix C). Specifications for the Zone 1 sand fill and Zone 2 gravel fill are described in the Contract Specifications (Appendix B). A small swale was incorporated in the design so that runoff water from the south slope of the Dome Creek valley would continue to flow around the south abutment of the seepage collection dyke.

Photo 1: South Abutment and erosion channel (October 2000)

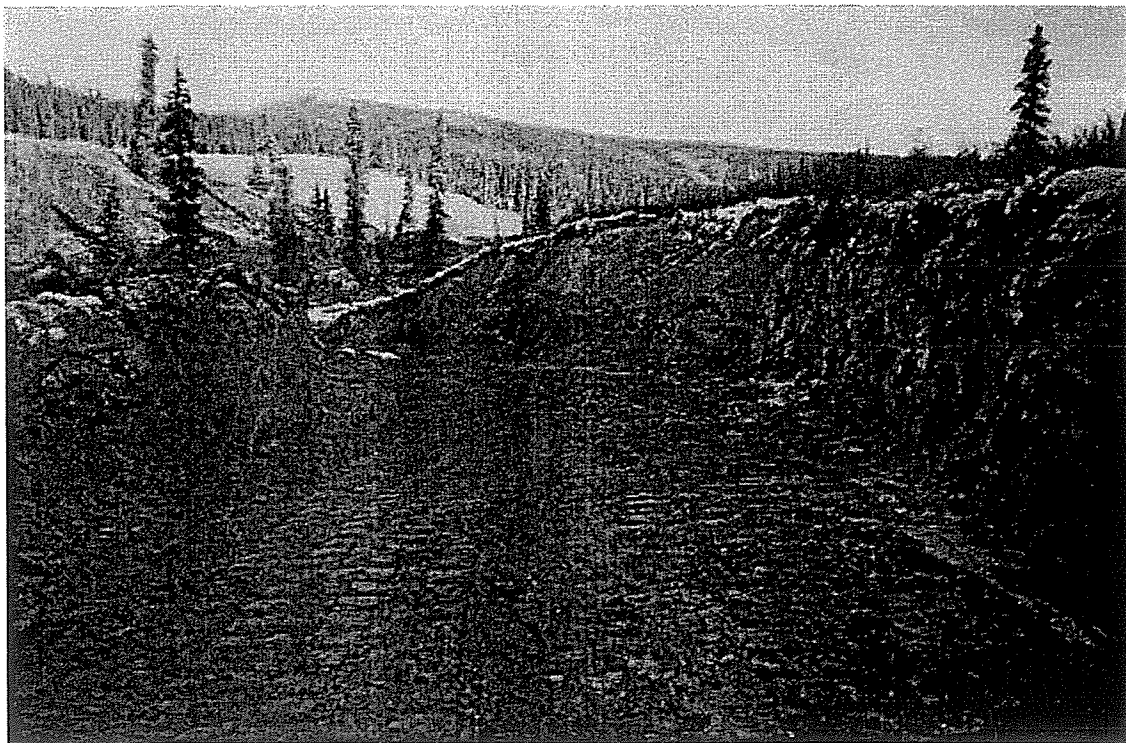
Photo 2: Excavated erosion channel at Sta. 0+75 (October 2000)

All loose, wet, and slumped organic and inorganic materials from the erosion channel base and sidewalls were excavated and removed from the channel. Zone 1 sand fill was then placed and compacted to achieve the desired grade. All compaction testing completed on this material met or exceeded the specified requirements; results of compaction testing are presented in Appendix E. A non-woven geotextile was placed on

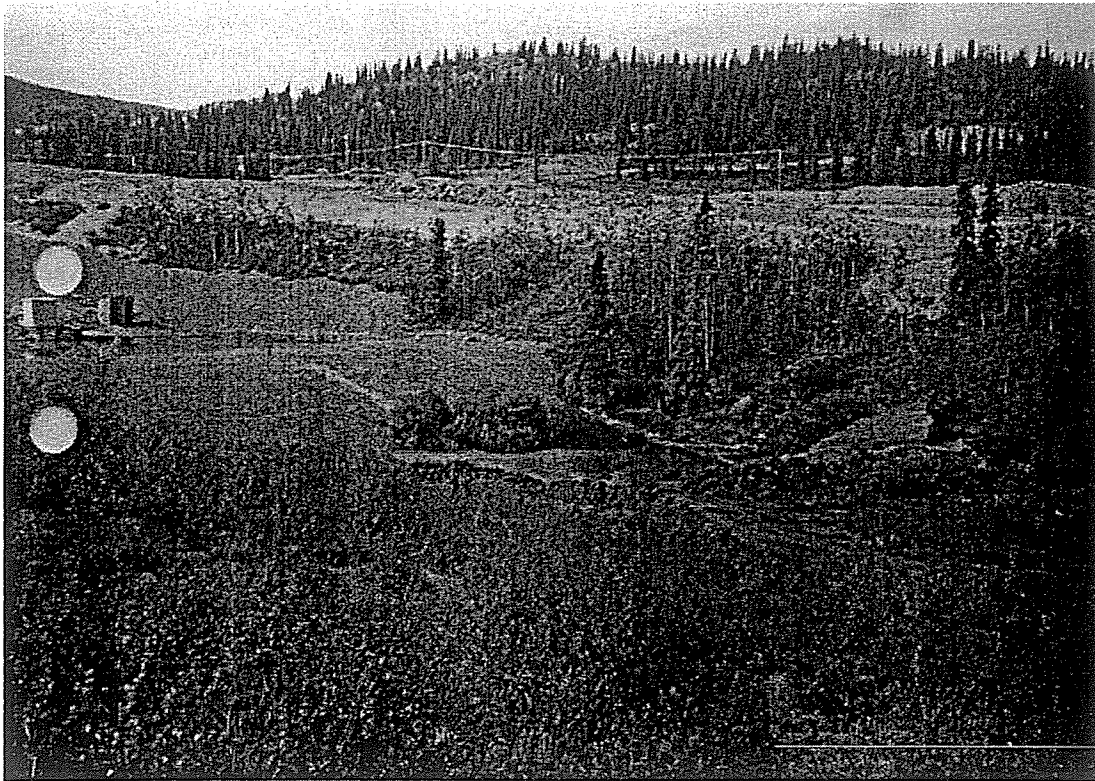
Photo 8: North Abutment of existing seepage control dyke (August 2000)

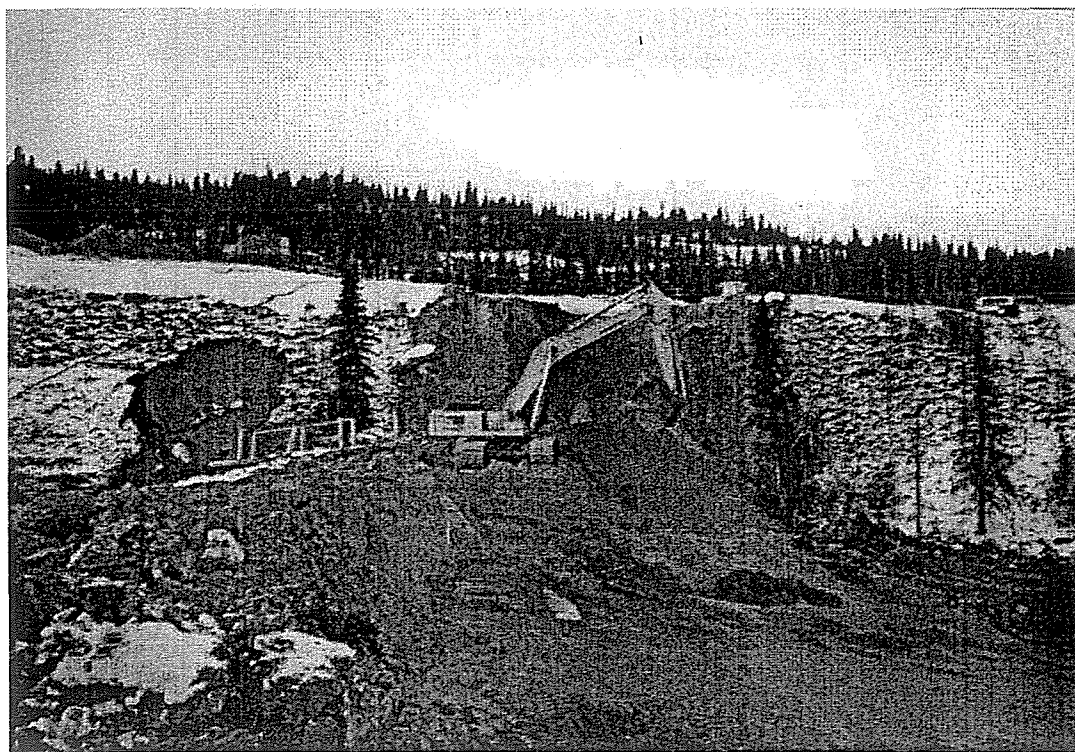
During excavation of the key trench, it was discovered that the thickness of the active layer at the north abutment was much greater than estimated. At the direction of DIAND, construction ceased on the dyke while a series of probe holes were completed to determine the elevation of the permafrost table along the key trench alignment. The elevation of the permafrost table was found to be approximately 1124 m between Stations 0+076 and 0+095, climbing to approximately 1136 m by Station 0+100, and levelling off from this station northwards. The actual permafrost table was up to 12 m deeper than originally assumed. Furthermore, the actual slope of the permafrost table at the north abutment was much steeper, 2.4V:1H, between Stations. 0+095 and 0+100. The deeper active layer may have been a result of permafrost degradation caused by the transfer of convective heat from groundwater flow through the north abutment.

Photo 12: Searching for permafrost within North Abutment

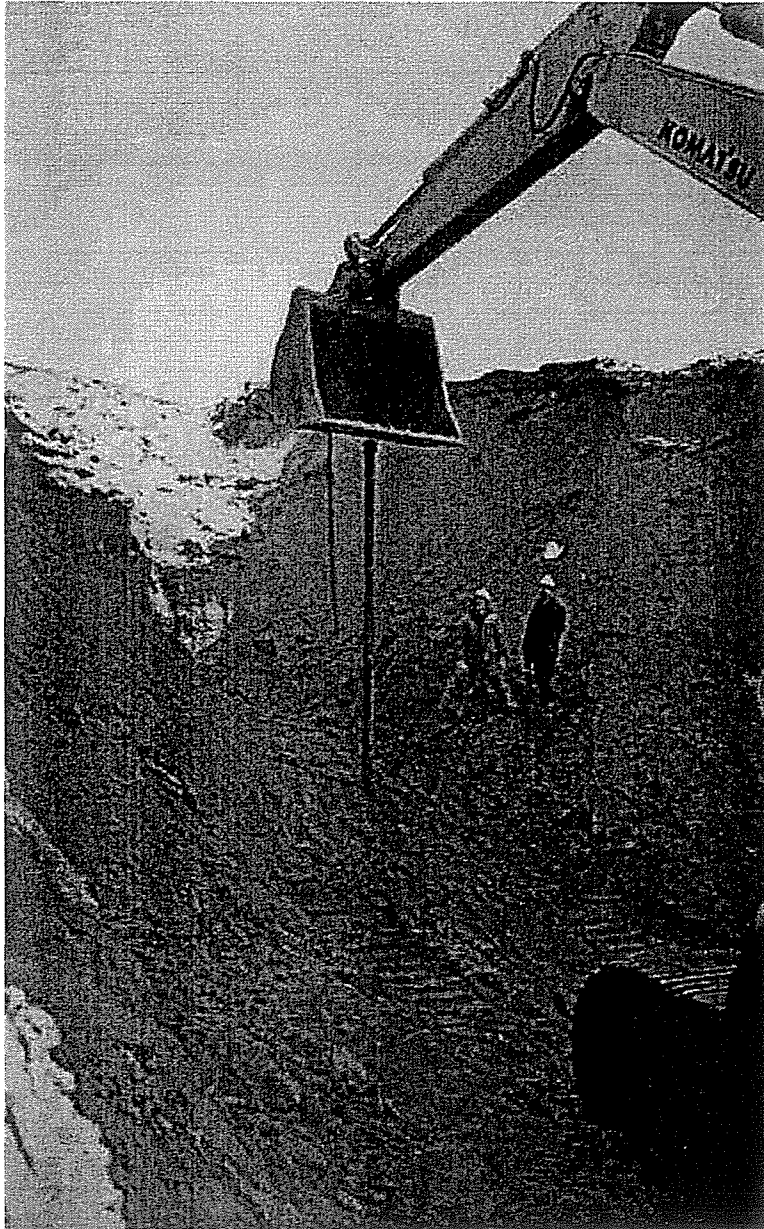
Photo 14: Probing for depth within North Abutment with a 50 mm pipe

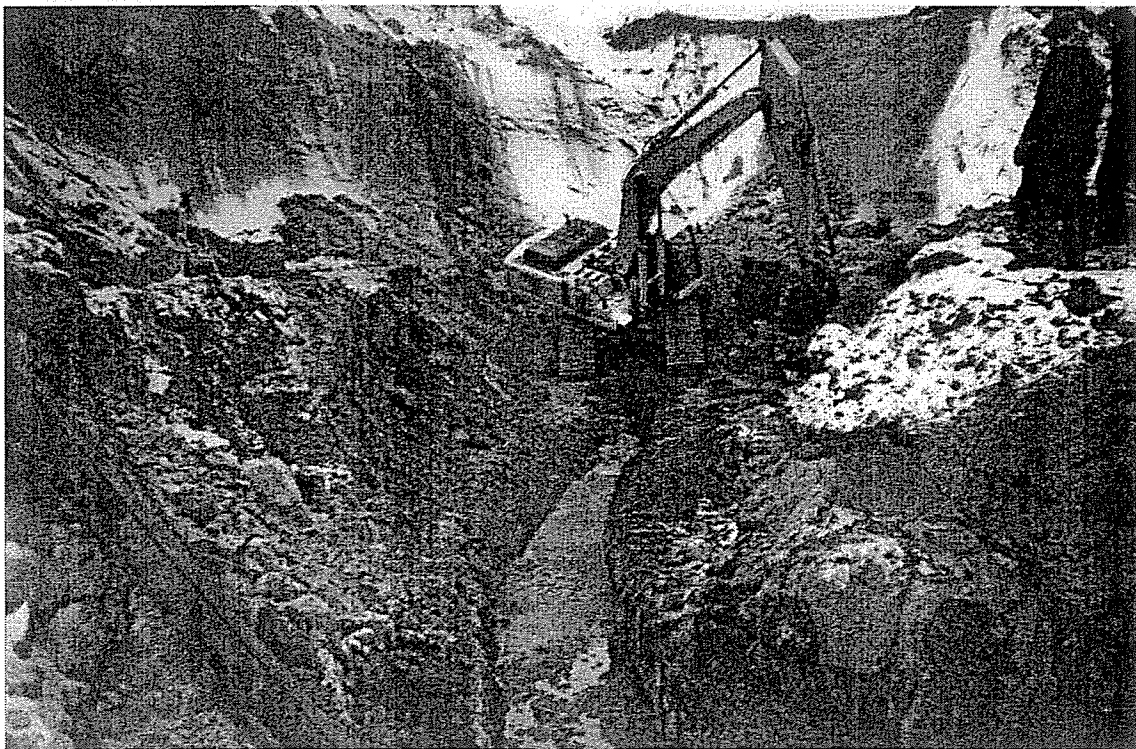
Dewatering of seepage water in the north abutment area required significant effort. Several options to control the seepage flows were evaluated. The sump configuration that was eventually used consisted of a geotextile "sock", wrapped around pipe and gravel, and buried in a drainage trench that was excavated into the permafrost. The drainage trench was located upstream of the key trench.

Photo 17: Construction of drainage trench in the North Abutment

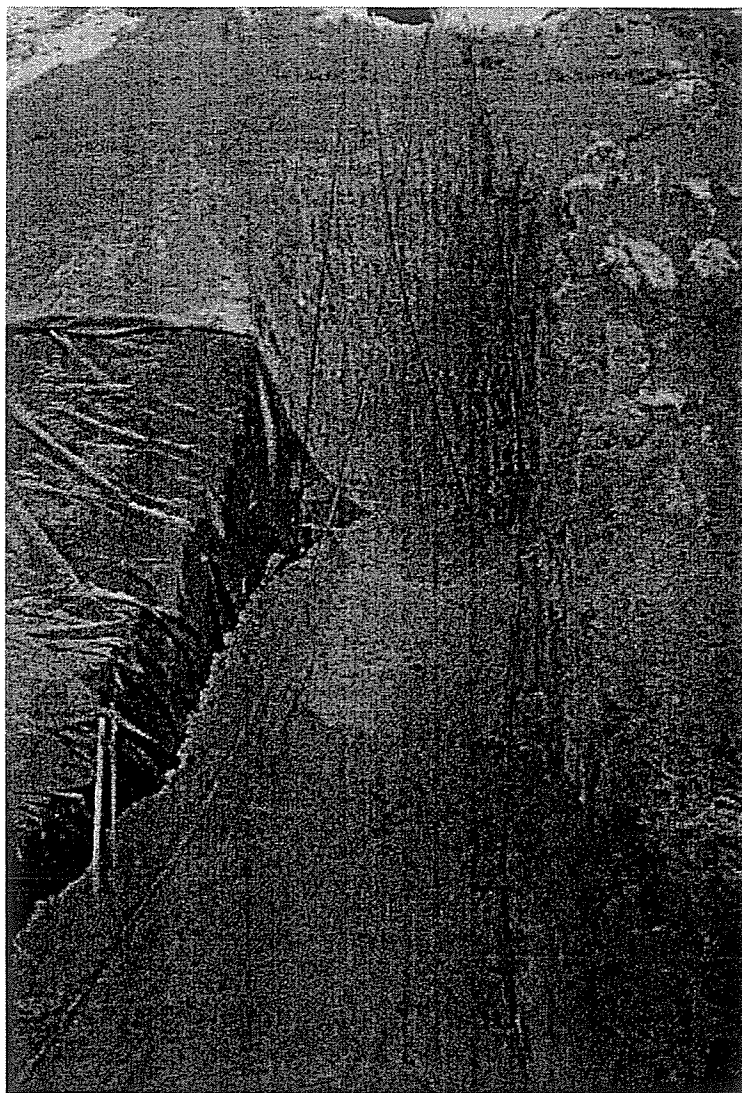
Photo 38: View of north end of cutoff trench with both loops and liner in place

The horizontal thermosyphons were installed between November 6 and 8, 2000 by Arctic Foundations of Canada Inc. The as-built thermosyphon configuration accounted for the new geometry of the key trench along the north abutment.

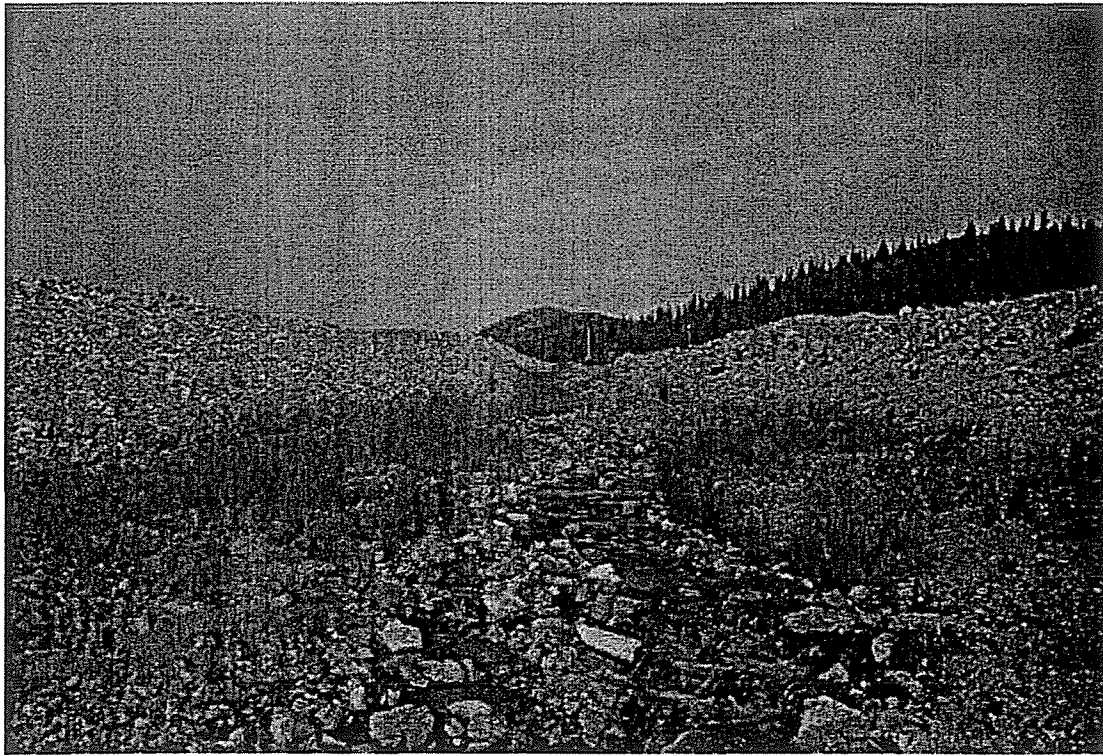
Photo 53: Typical spillway conditions (August 2000)

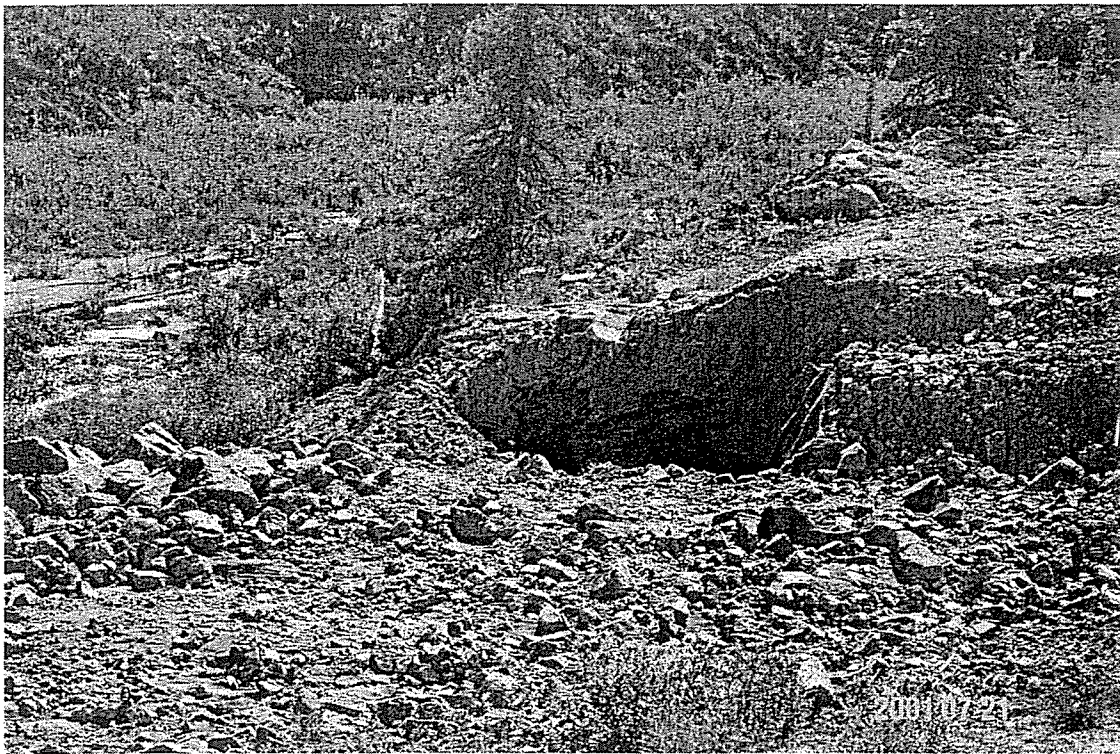
In July 2001, reconstruction of the spillway resumed. Prior to resuming construction, a scour and piping failure developed on the south side of the spillway channel near its discharge point. The cause of the failure was not determined but was suspected to be the

result of permafrost thaw initiated by the fall 2000 reconstruction of the seepage collection dyke. During July and August 2001, the failed section was rebuilt, additional riprap was placed in the spillway channel, and the drop structures were completed, excluding Drop Structure #1. This drop structure, located at the spillway discharge point, was not installed due to concerns about icing.

Photo 61: Scour and piping failure near spillway discharge

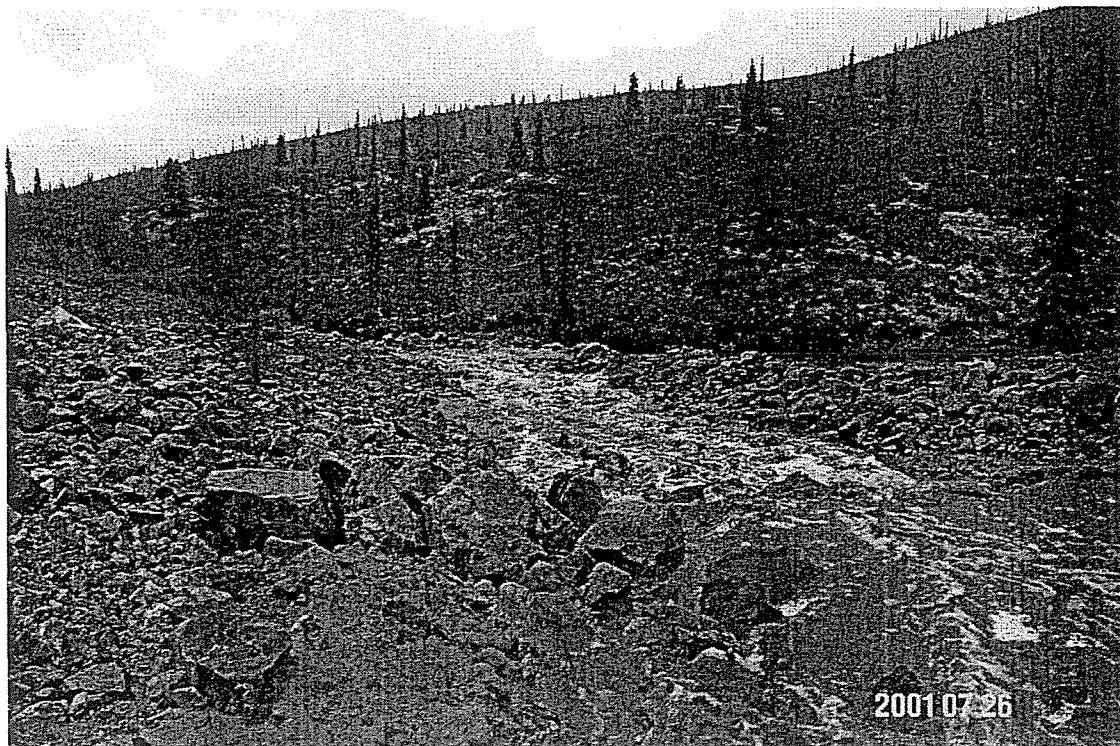
Photo 62: Rerouted channel as temporary remediation for failure

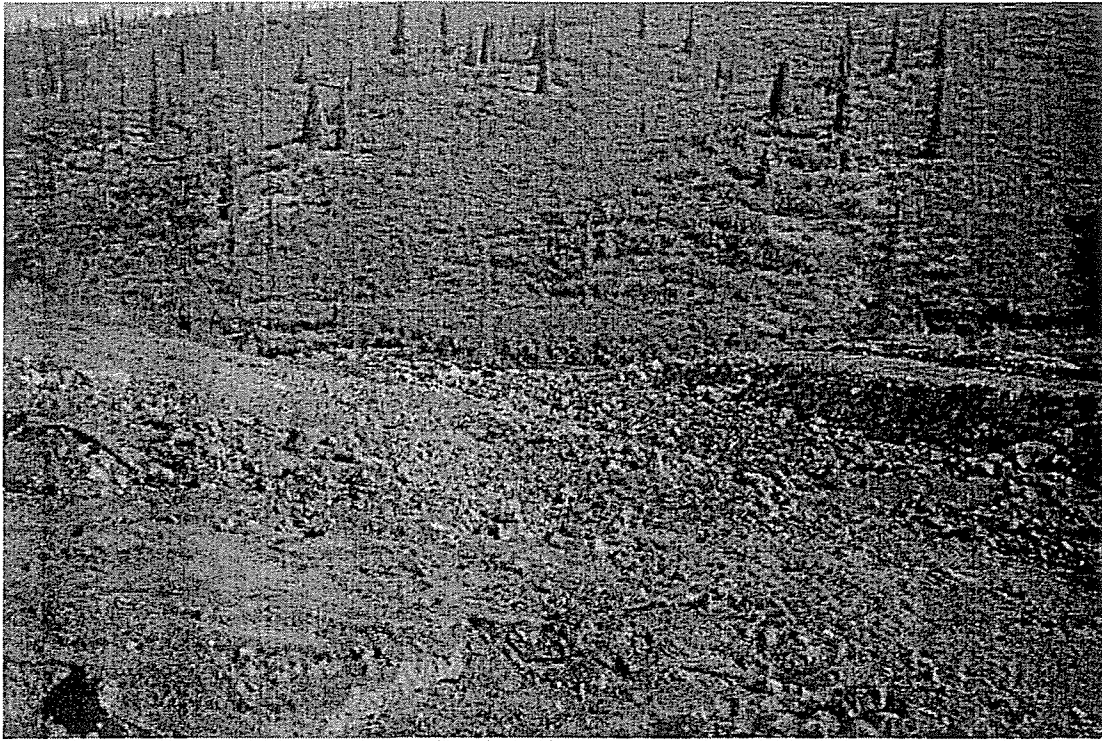
Because of limited onsite availability of riprap material, the placed thickness of riprap was half of the recommended thickness and the riprap covered only 50 to 80 percent of the channel bottom, whereas 100 percent coverage was recommended.

Photo 65: As built lower spillway (August 2001)

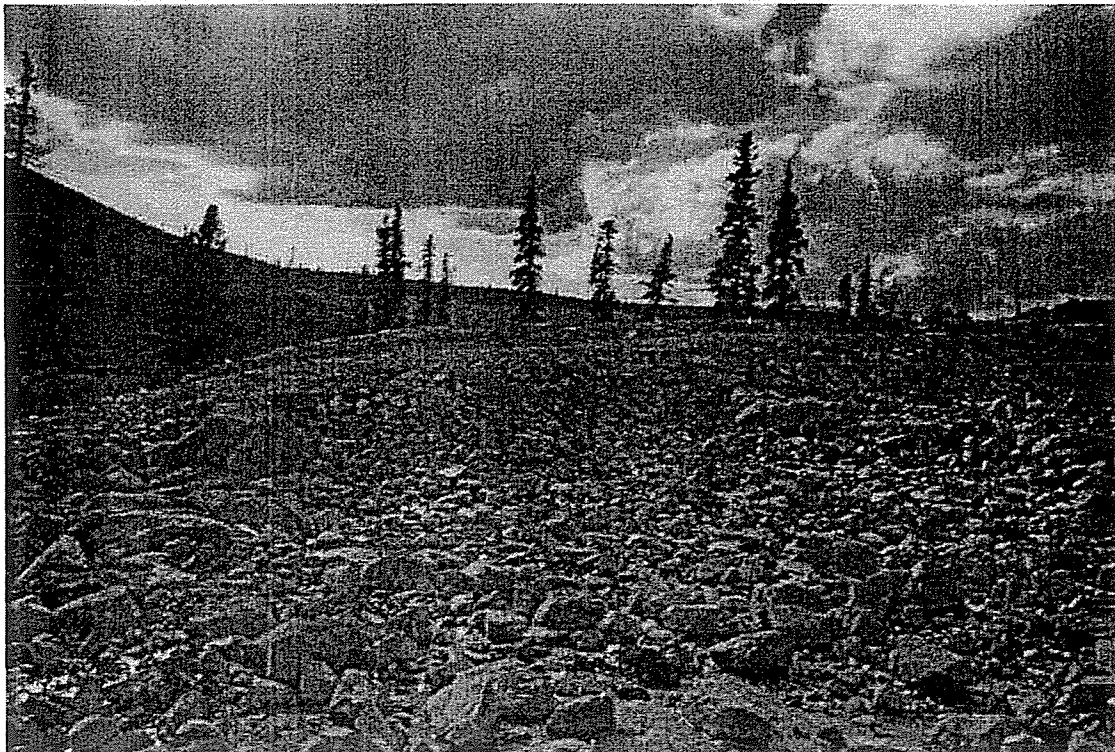
Photo 66: Repaired lower spillway (August 2001)
