Memo to: H.Copland, F. Patch Government of Yukon Type II Mines

From: B. Thrall, R. McIntyre, Alexco Resource Corp.

Date: November 9, 2006

Subject: *Contract for Service for Site Investigation and Improvements United Keno Hill Mine site: Special Projects Update Memo*

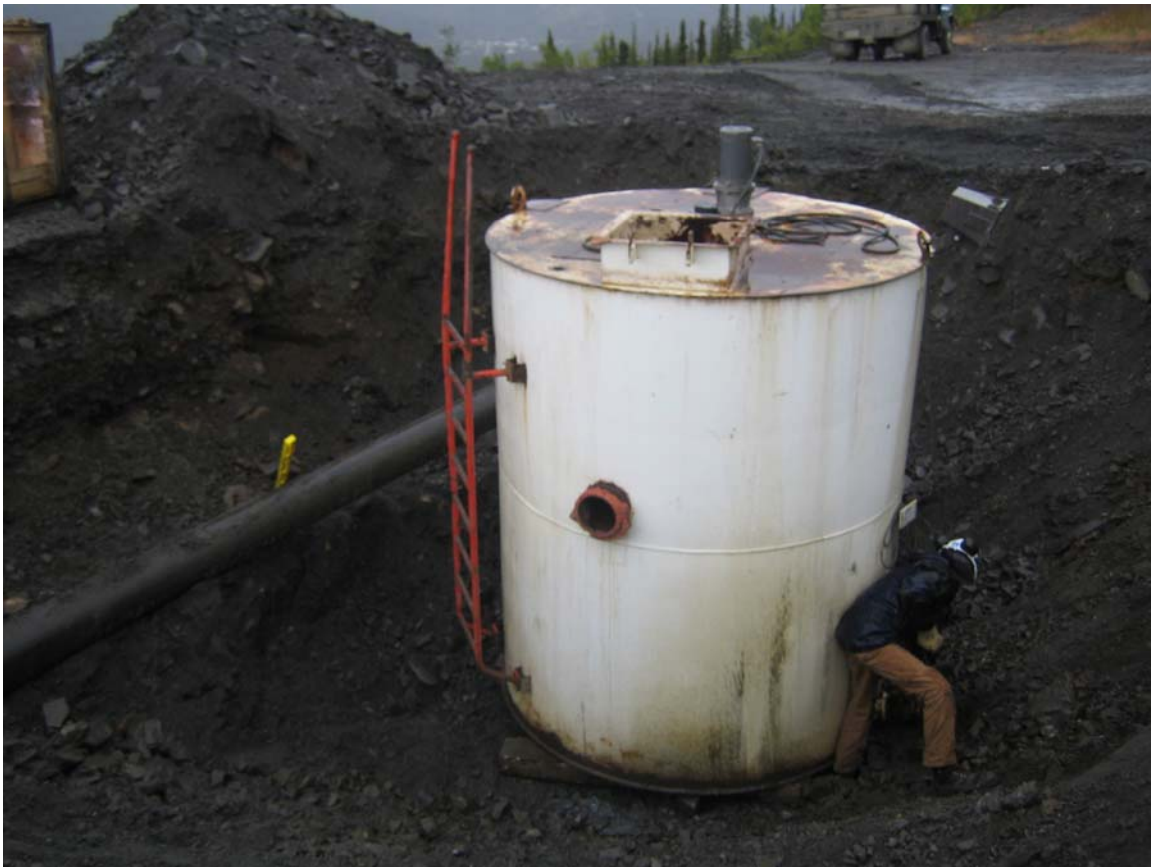
Photo 1: View of new Galkeno 300 mix tank.

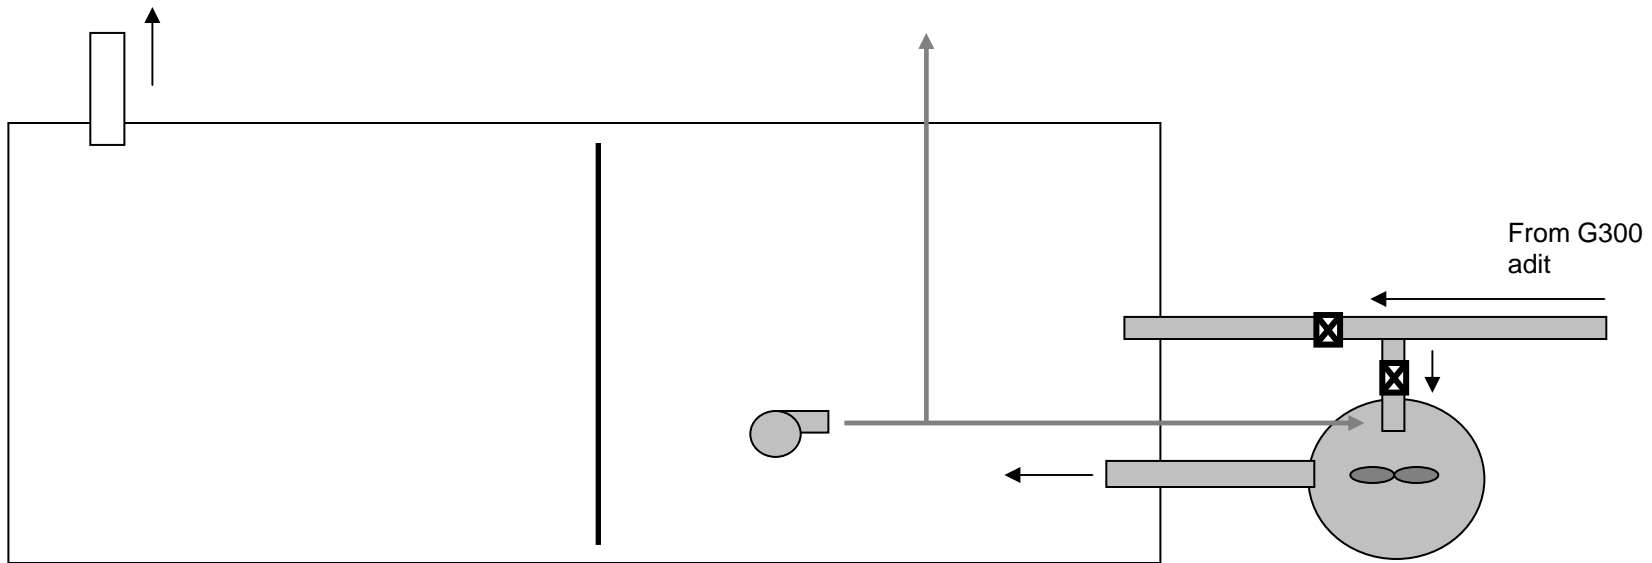
Figure 1: Schematic of Galkeno 300 water treatment improvements.

1. Sludge pump on floats approximately 12" above the bottom of pond, can be moved around to effectively recycle sludge
2. Tank buried to reduce elevation and allow adit water to directly flow into tank
3. Valves installed to bypass the mix tank if necessary
4. Piping sized to handle 300 gpm (8" line)
5. Solution enters the mix tank at the bottom and exits out the side
6. All existing systems left intact and operational and can be activated immediately if necessary
7. Sludge pump recycle piped to allow desludging directly into tanker on a routine basis

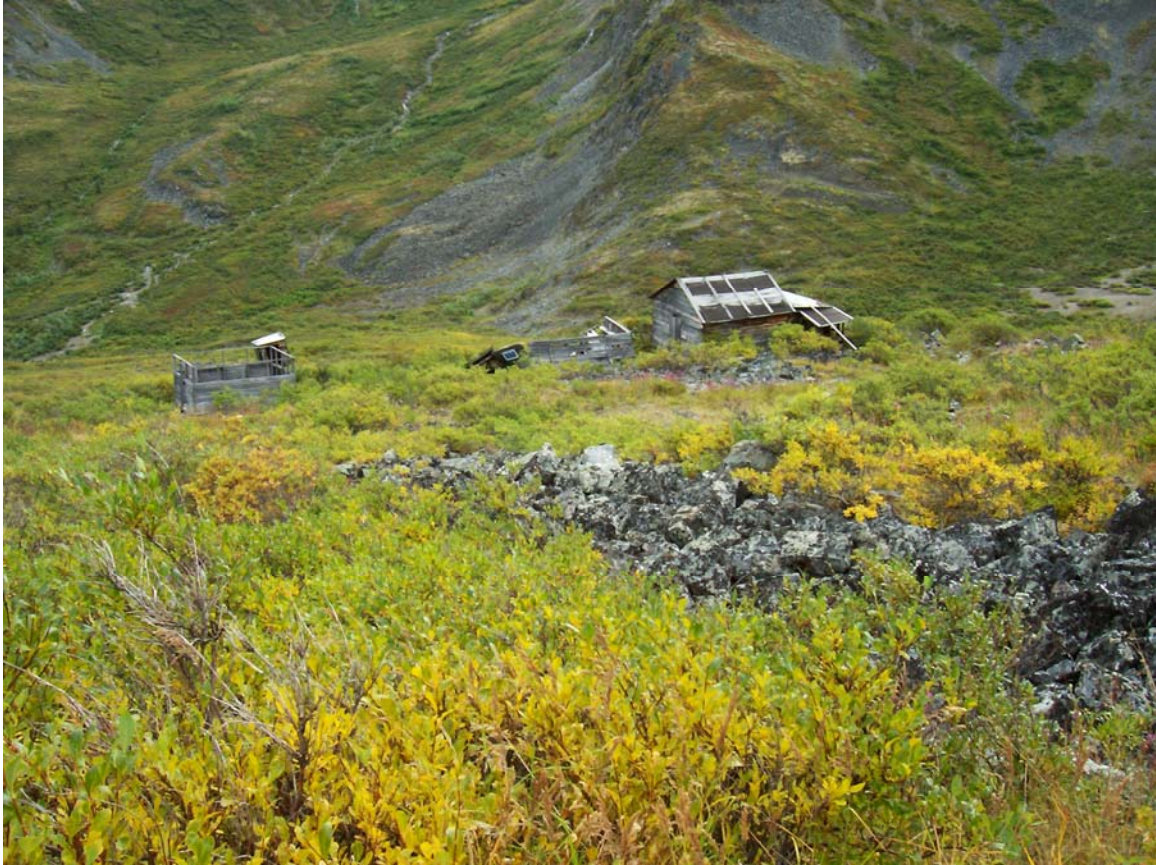
Photo 2: Assortment of buildings at Gambler site.

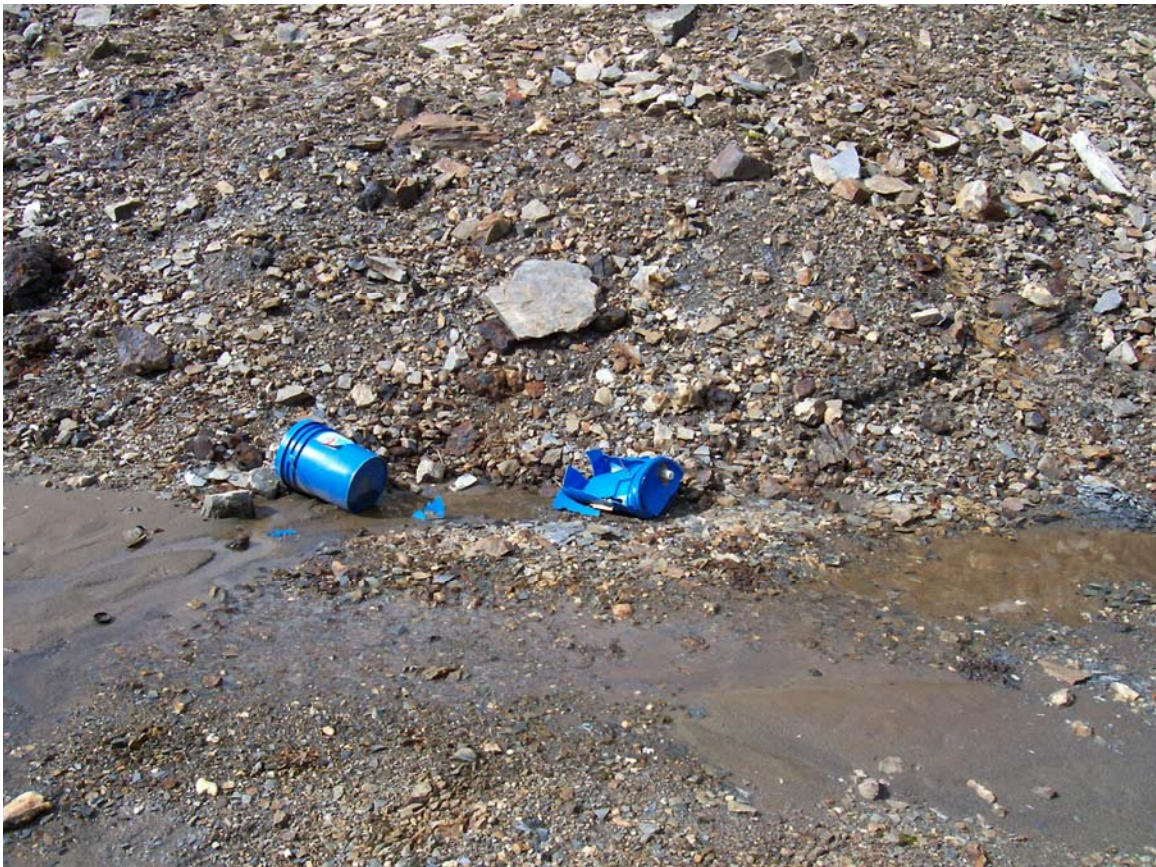
Photo 5: Evidence of hydrocarbon contamination at Caribou (Segsworth) site (later research determined that this site was not on UKHM claim package).

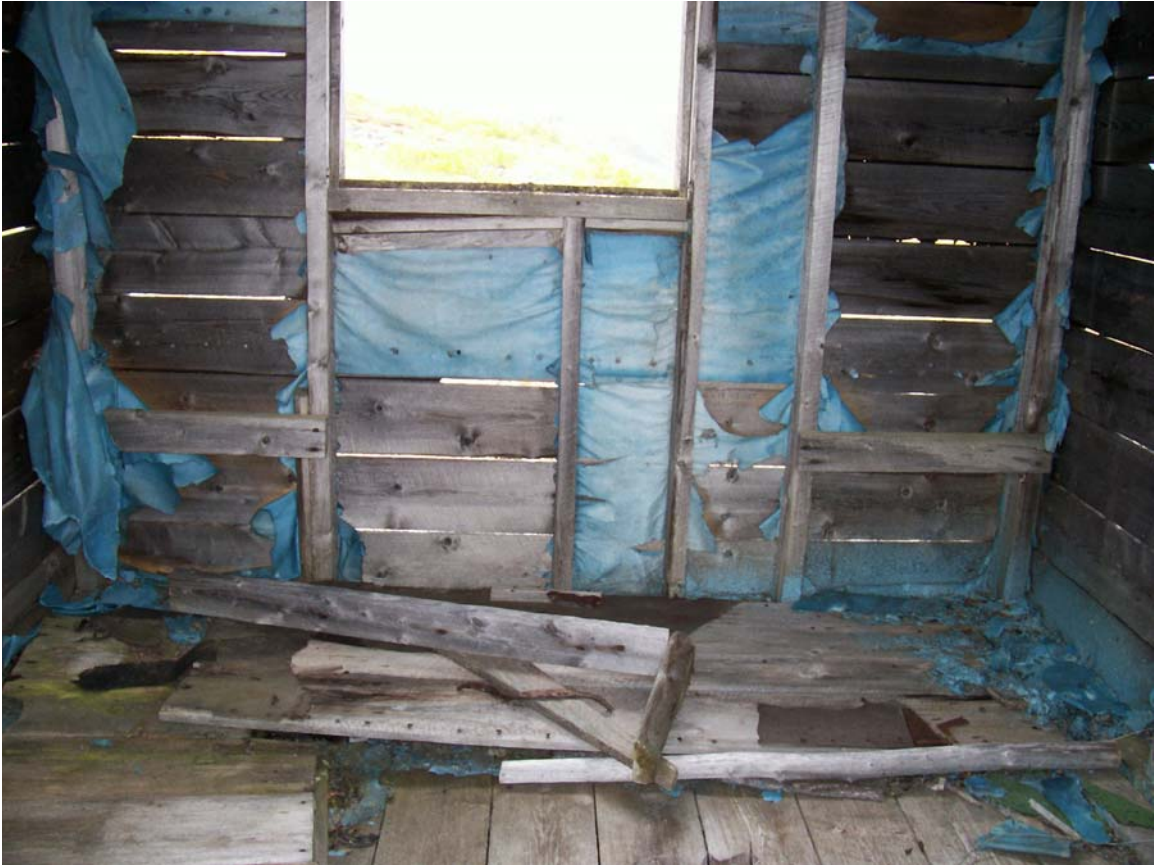
Photo 6: Possible building contamination at Main Fault & Nabob site.

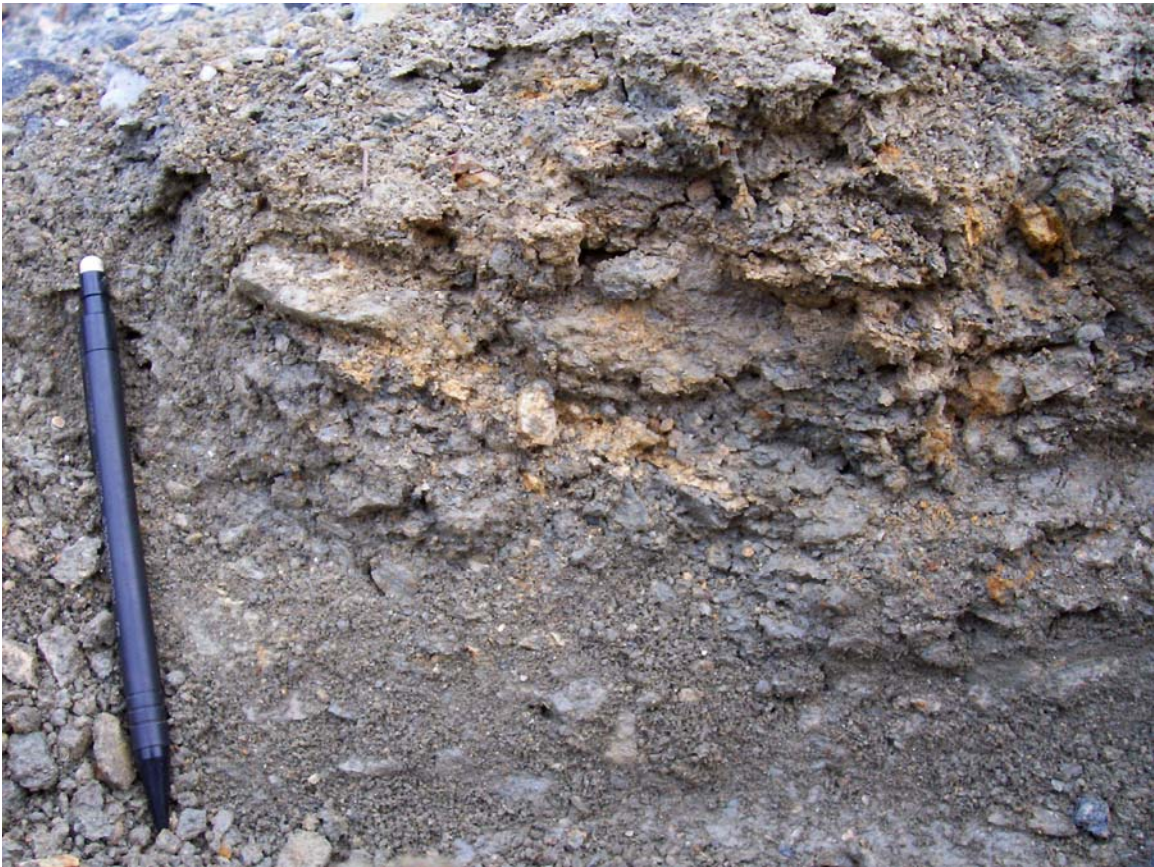
Photo 8: Detail view of waste rock pile at Eagle site.

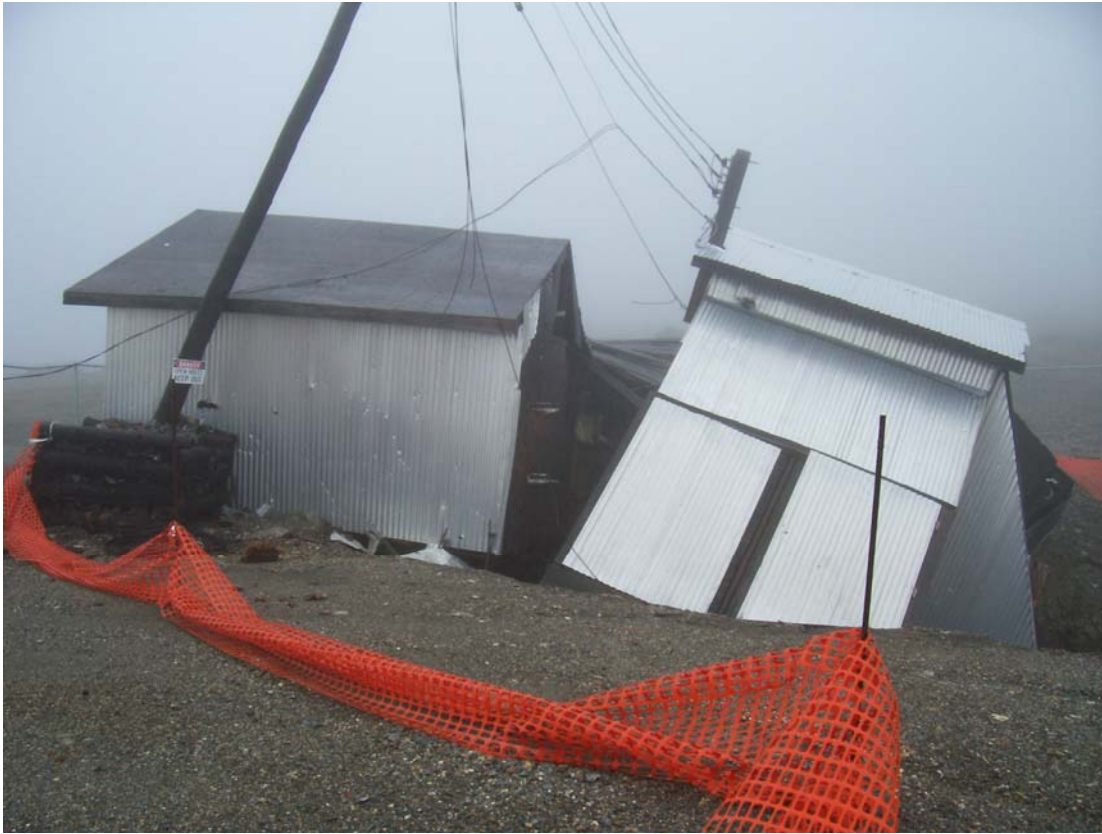
Upon removal of the building, it was evident that the vent raise was collapsed with overburden material. A 325 excavator was used to assess if the vent raise was bridged with material. The excavator dug approximately 20 feet into the material and it continued to be competent and not bridged. The hole was then filled with local borrow material as per SRK specs. The top of the filled hole was capped with growth media and mounded to promote water runoff. The building material was burned and the remaining metal debris was loaded and transported to Elsa. A burn permit was secured prior to burning the remnant building.

Photo 9: View of Shamrock J building partially collapsed over open vent raise.

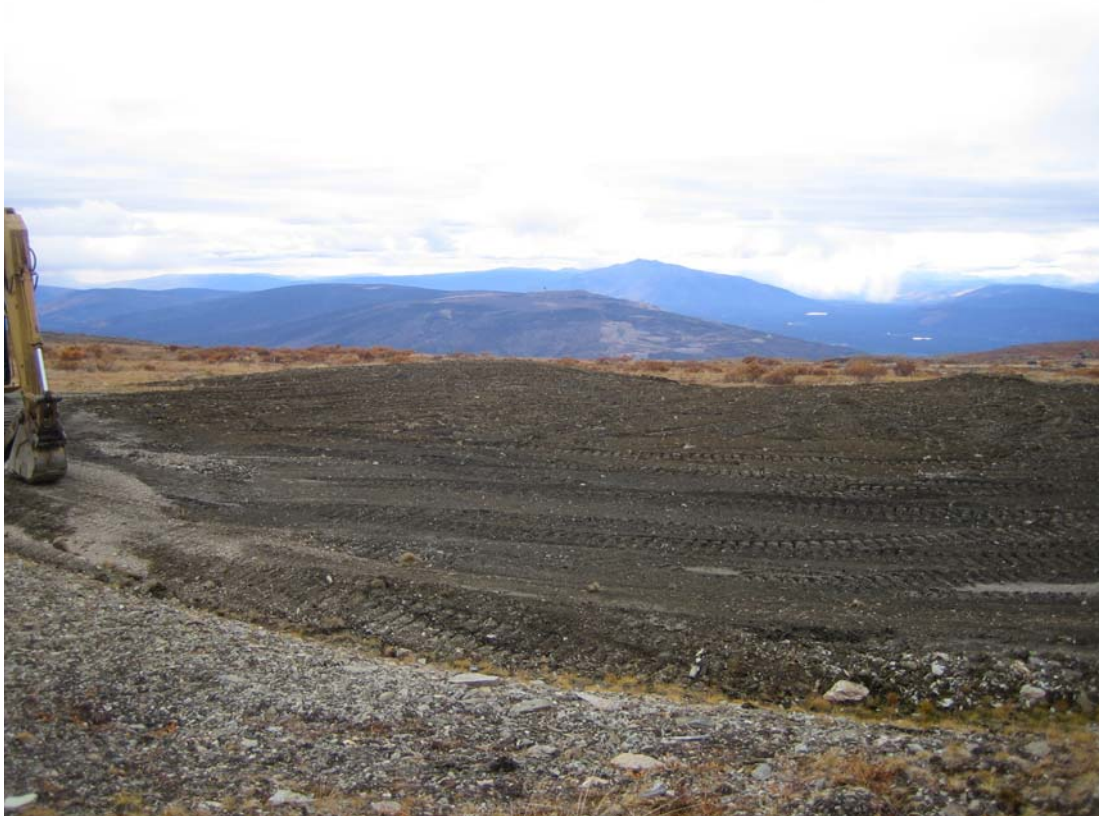
Photo 10: Photo 8: View of Shamrock J vent shaft filled and mounded with building removed.
