**Dam Safety Assessment
Mount Nansen Tailings Facility near Carmacks, YT**

Project No: 0201-00-14618

May 2002

**EBA ENGINEERING CONSULTANTS LTD.
Whitehorse, Yukon**

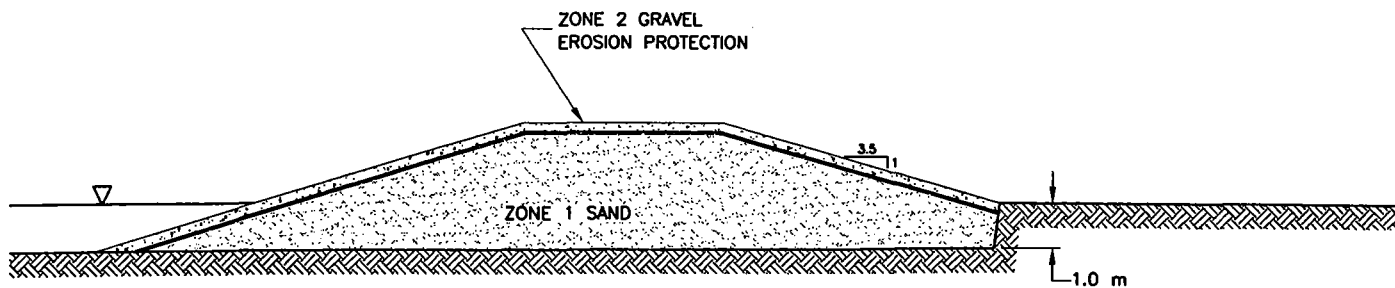
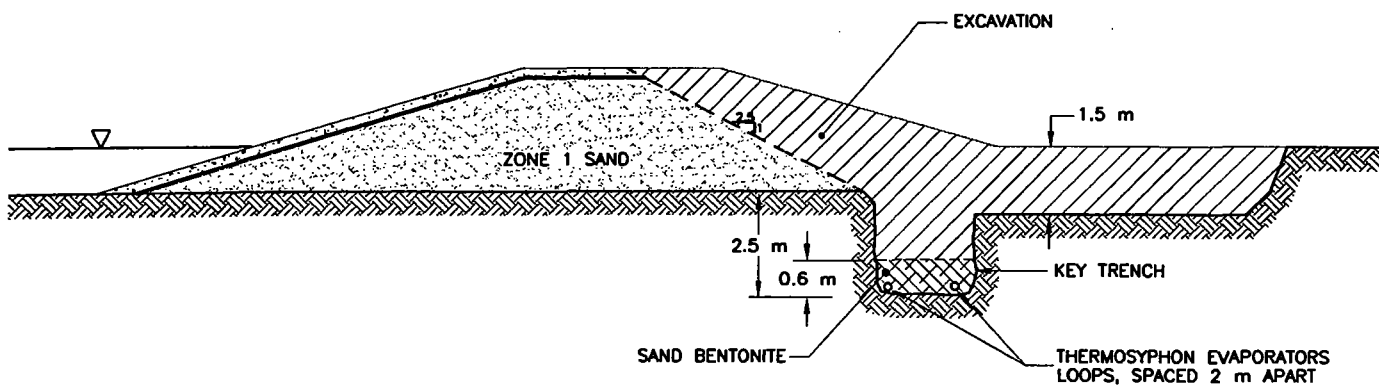
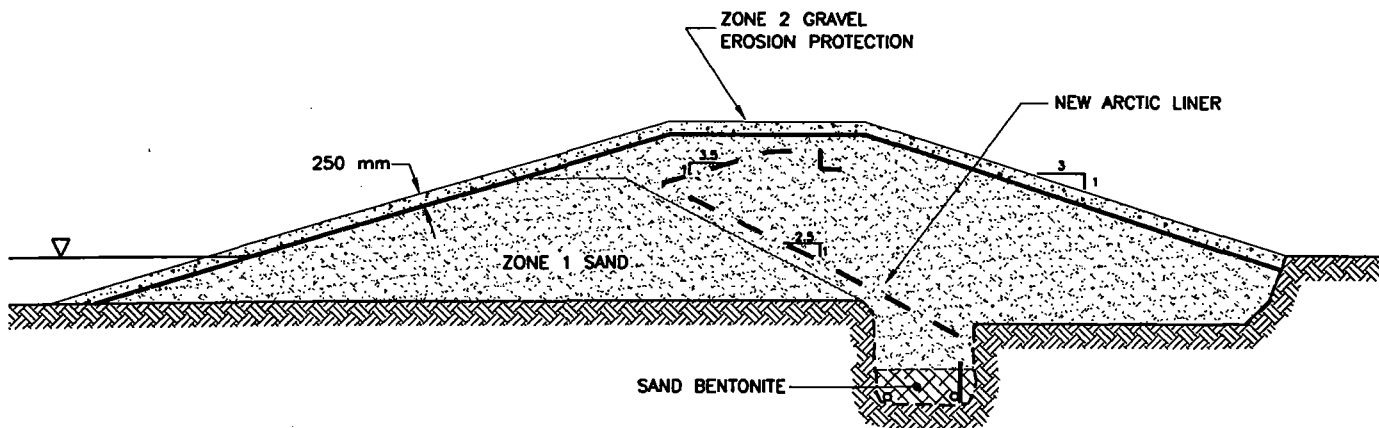
FIGURE 5

EXISTING DAM

REMEDIATION PLAN STEP 1

REMEDIATION PLAN STEP 2

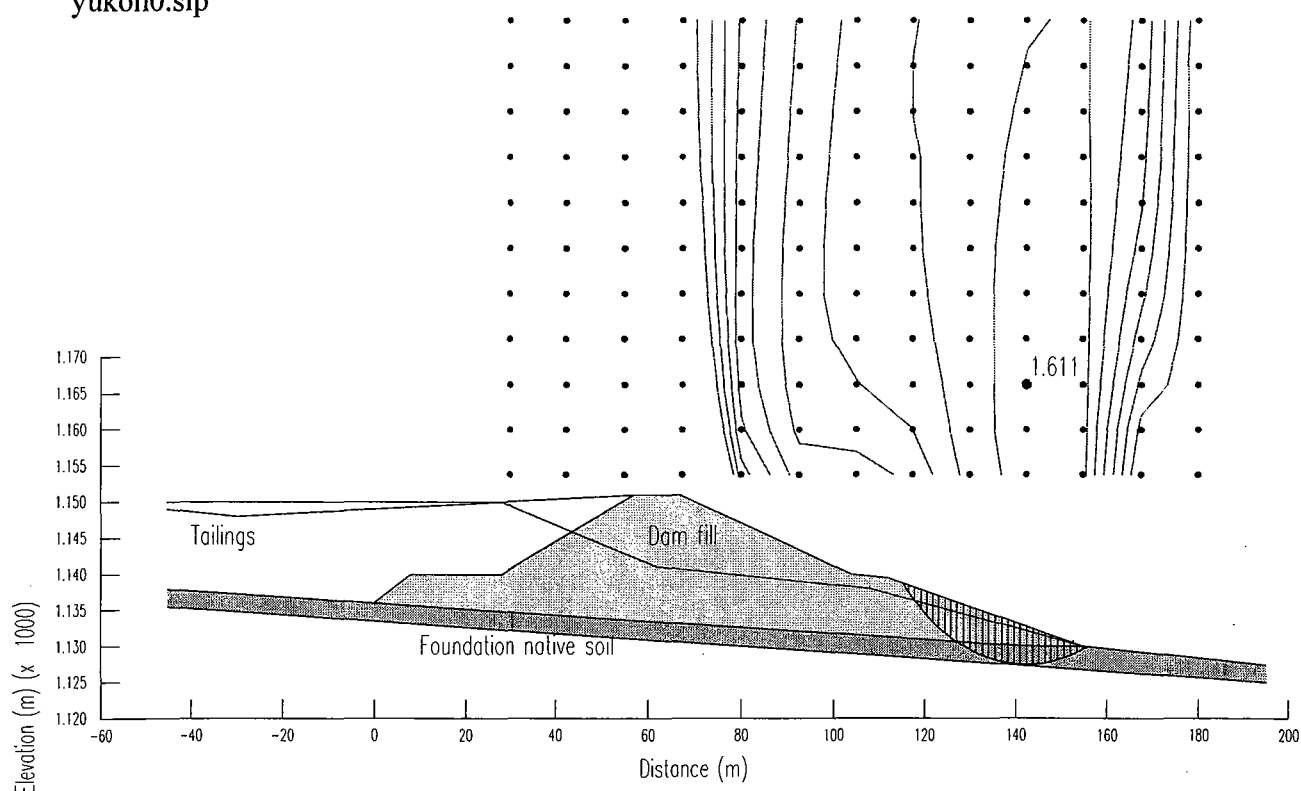
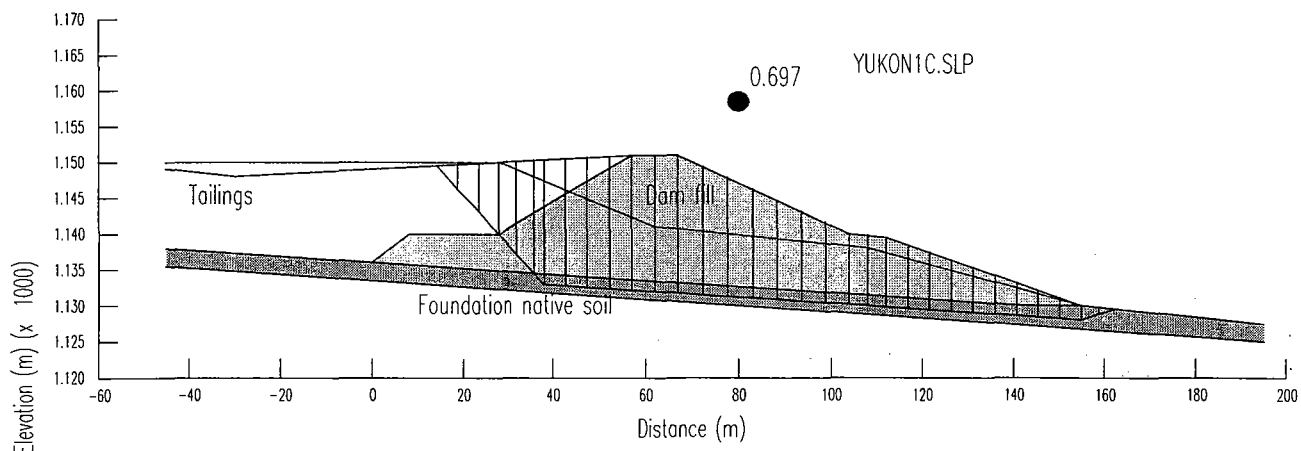
EBA Engineering Consultants Ltd.				PROJECT MT. NANSEN DAM SAFETY ASSESSMENT	
CLIENT DIAND				TITLE RESULTS OF SLOPE STABILITY ANALYSIS	
DATE	APRIL 2002	DWN.	JSB	CHKD.	CRH
FILE NO.	0201-00-14618	DRWG.	FIGURE 10

(a) Static Condition
yukon0.slp

(b) Post Liquefaction Static Condition
