Engineering Analysis of Vangorda Pit Wall Stability

Project Reference Number:
SRK 1CD003.15

April 2003

STEFFEN ROBERTSON AND KIRSTEN (CANADA) INC.

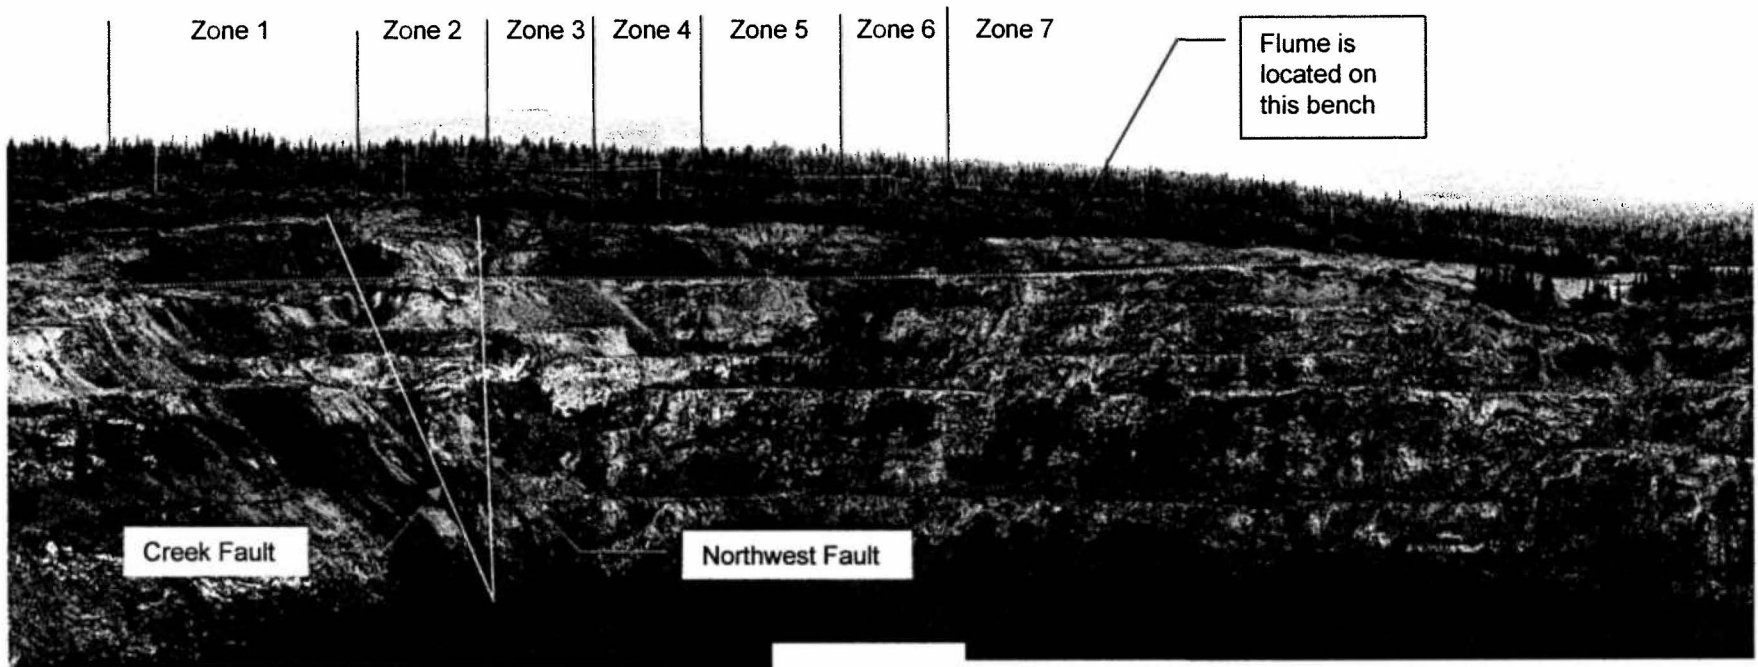
FIGURE 1
View of Vangorda pit northwest face
showing zoning of upper bench
and location of faults

Our inspection did not reveal any signs of recent movement at the location of the Northwest Fault. The flume was leaking at the location of the fault owing to a dislocation of some of the corrugated iron sections. The cause of the dislocation was not readily apparent, but may have been caused by frost heave or rolling rock damage.

The stability of the bench face was assessed by dividing it into a number of geotechnical zones, as shown in Figure 1. Each zone has similar geotechnical properties and is described in Table 1. Photographs showing the flume and the bench conditions in each zone are presented in Appendix A, Figures A1 to A6.

flume. It should be noted that the rockfall that occurred in June 1999 is located in Zone 3 (Figure 1). This area has since been partially remediated (see Appendix A, Figure A3).

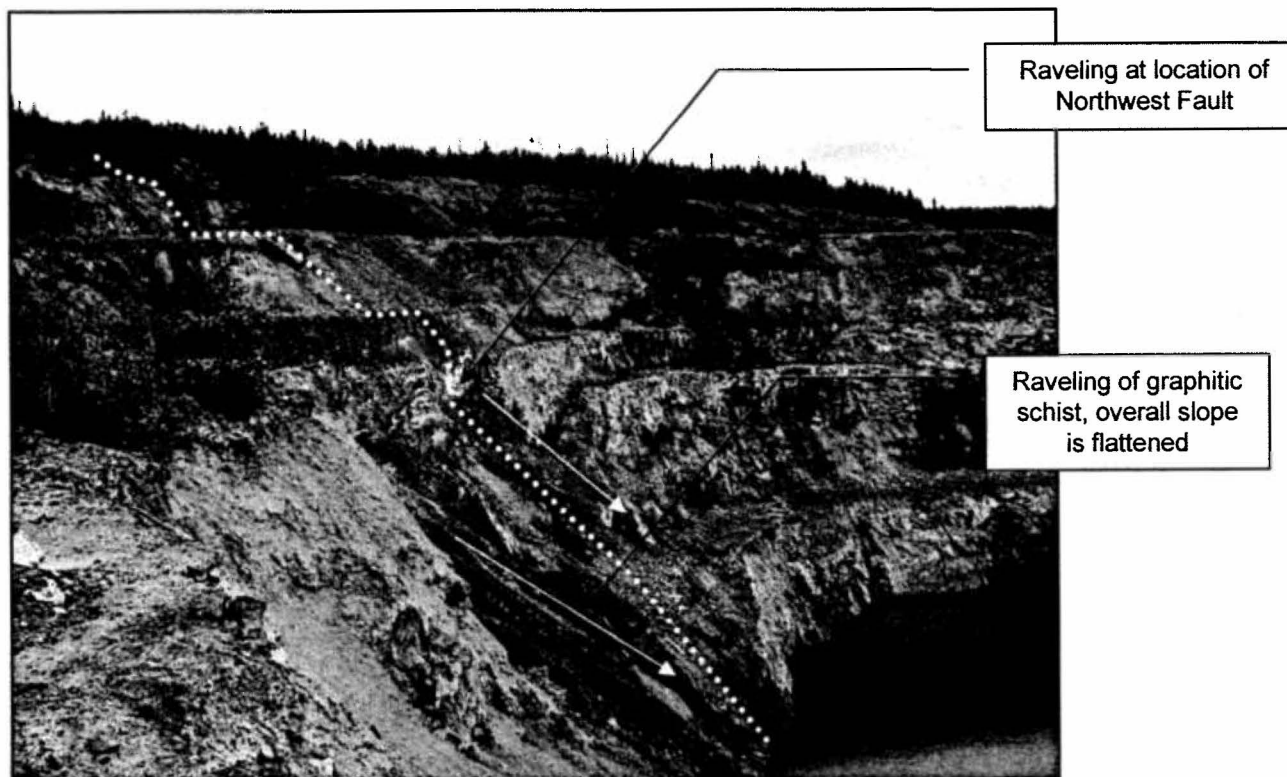
FIGURE 2
Raveling of northwest wall of Vangorda pit

There were some indications of seepage from the pit walls, but the general impression was not of a saturated pit. Sloughing and raveling of the weaker graphitic schist appears to have occurred over the past number of years and has affected the individual pit benches. Sloughing along the Northwest Fault line was also observed. Figure 2 shows the northwest wall of the pit and points out these features. In the longer term (more than 50 years), sloughing is expected to continue and may ultimately work its way back to the location of the flume.

Raveling of benches has resulted in flattening of overall slope. In the long term (50 years +), progressive raveling is likely to encroach on the flume.

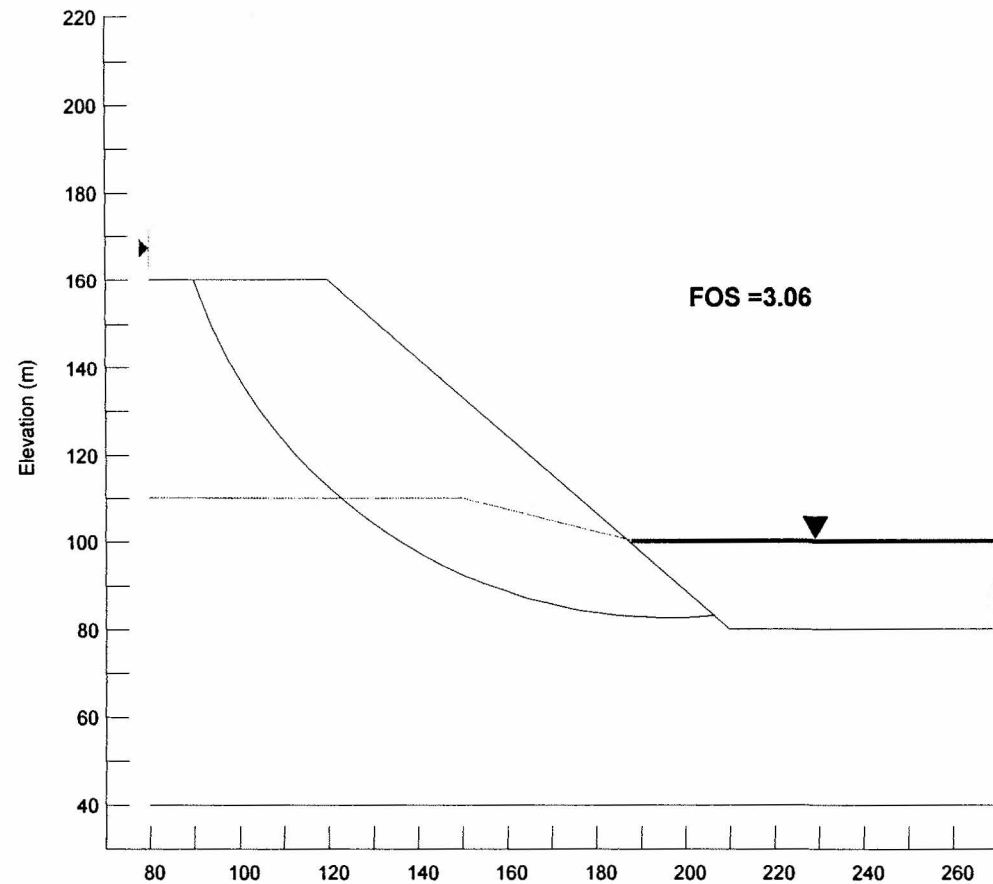
FIGURE 6

The Slope/W results for circular failure of the Vangorda northwest wall are summarized in Table 5. Figure 6 shows the profile as analyzed using the Slope/W program.

Condition	Safety Factor	Failure Probability
Current (static load, low water table)	3.06	0.23%
High water table	2.48	1.60%
Reduced strength	2.45	0.73%
Pit flooded	3.40	0.65%
Seismic load (MCE)	2.76	0.29%

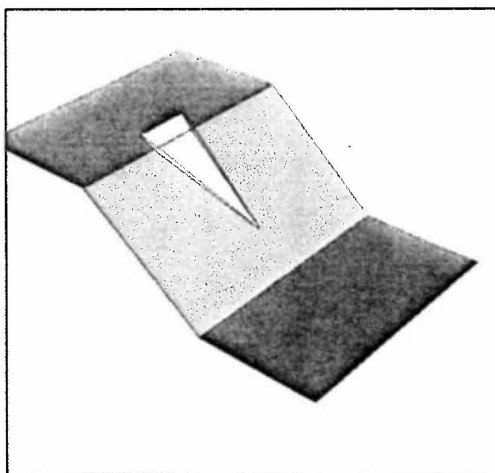
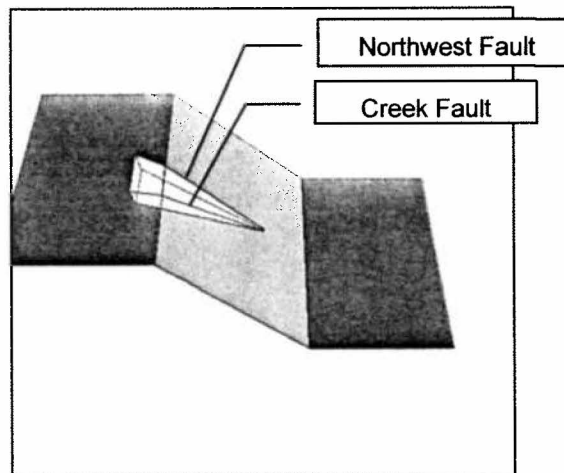
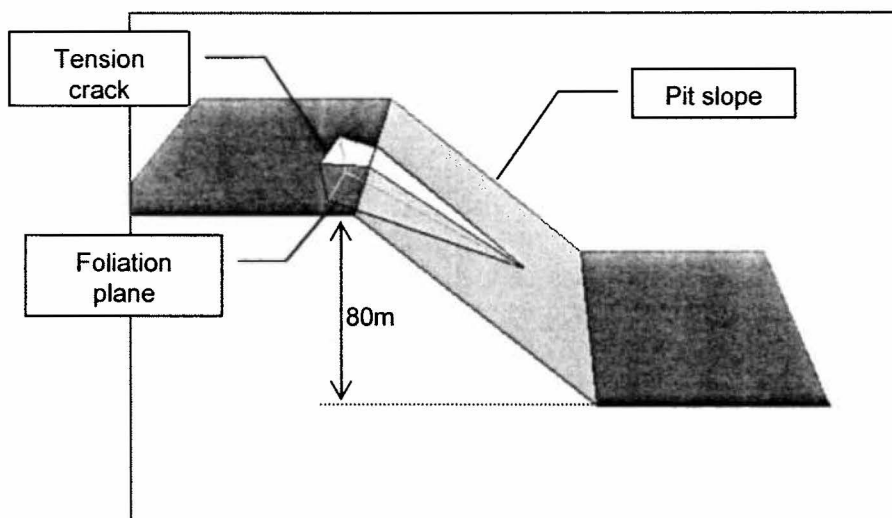
The Northwest Fault and the Creek Fault were assessed for the potential to form a large-scale wedge, but it was concluded that the resultant wedge cannot fail due to its geometry relative to the pit wall.

Stability of potential wedge formed by Northwest Fault and Creek Fault – with foliation as sliding plane.
Analysis shows that failure is not kinematically possible – the wedge is tapered towards the free face of the slope and cannot move outwards.

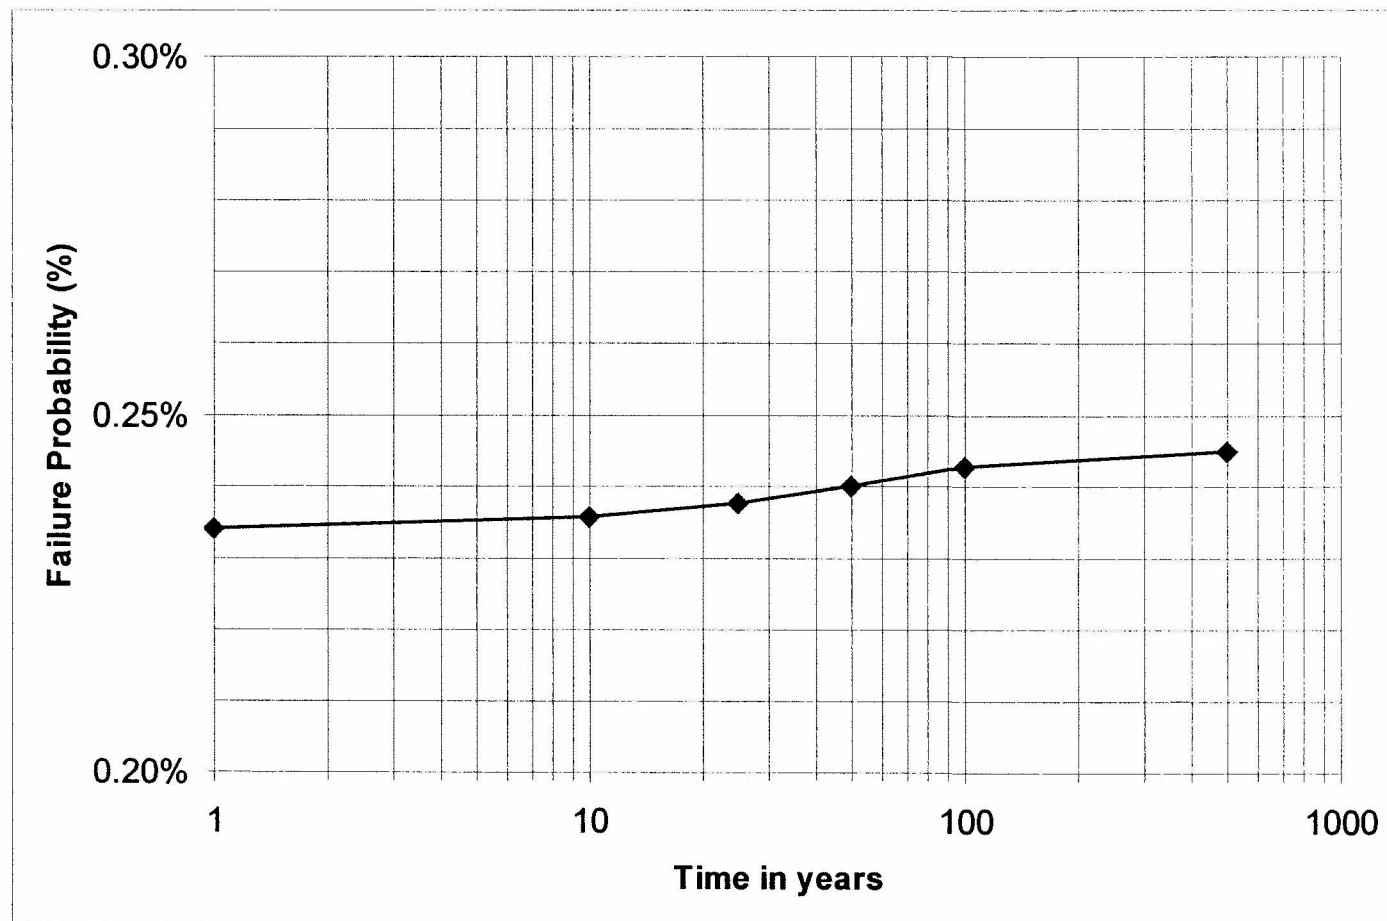
FIGURE 10
Effect of seismicity on failure probability
over time

The results are summarized in Figure 10, which indicates how the probability of failure of the slope increases with time owing to the increasing risk of seismicity. For comparison, the static failure probability of the slope is 0.23% (or 1:435) and if a time period of 500 years is considered, the probability increases to 0.245% (or 1:408). This increase is considered to be negligible and the seismic hazard is, therefore, insignificant to the stability of the pit walls over the longer term.

An assessment of the long-term seismic effects on pit stability was carried out and it was found that seismicity will have a negligible effect on the overall probability of a pit wall failure, even if a 500 year period is considered. The results showed that the probability of failure of the pit owing to seismicity over the next 500 years is 0.245% compared to 0.23% for the current static conditions.

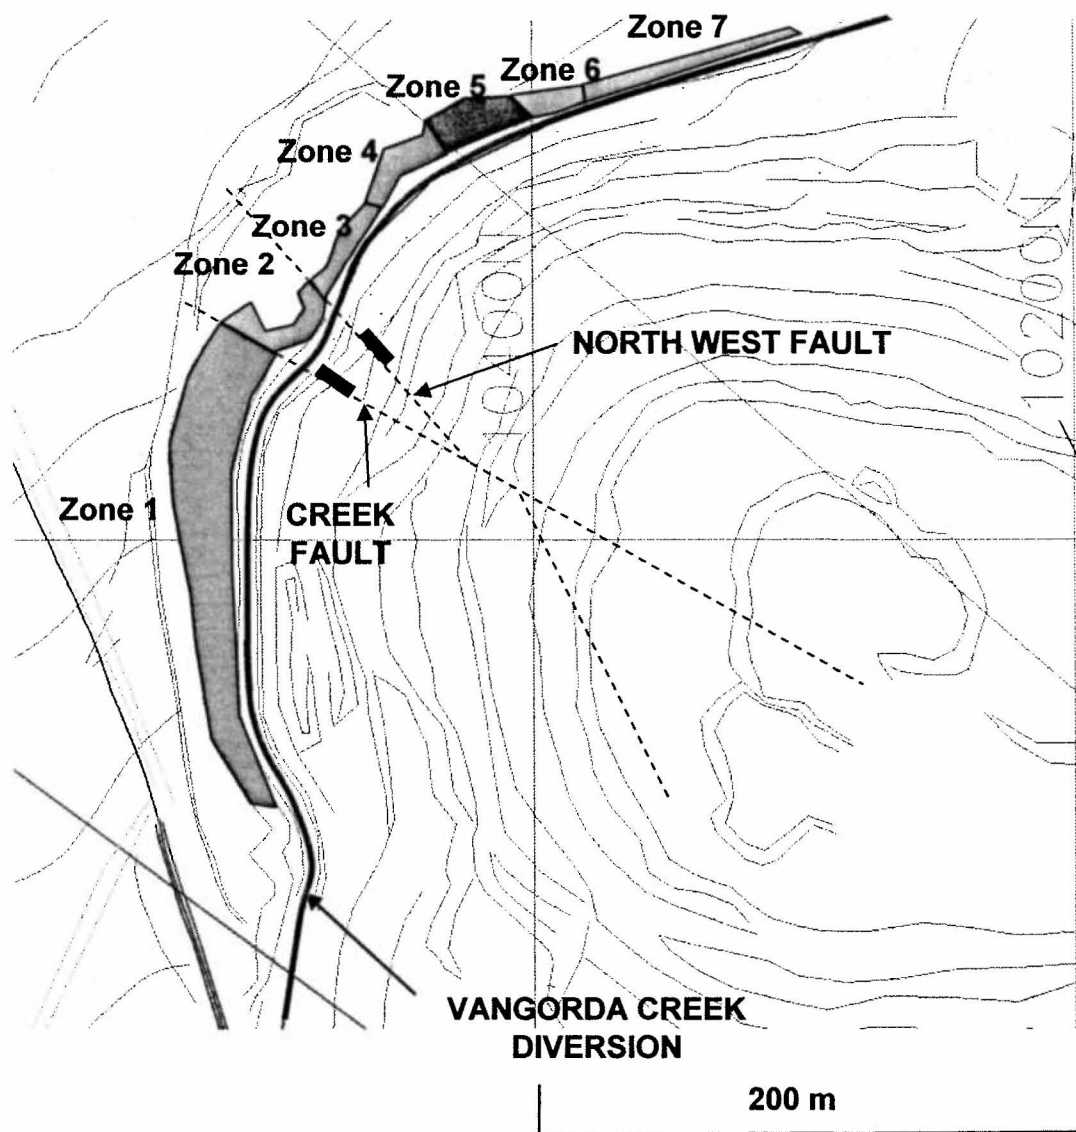
FIGURE 11
Rockfall Hazard Rating for the different
zones of the upper bench

It can be seen from the results that only Zone 5 has a “high hazard” rating and Zones 3 and 6 have “moderate hazard” ratings. The hazard ratings confirm our assessment of the likelihood of rockfalls impacting the flume, presented in Table 1. Zones with high and moderate ratings will require remedial works to ensure the flume functions in the long term. Areas with a “low hazard” rating are judged to be stable and will require no further action. Remedial actions that may be considered are flattening of the slope angles, removal of unstable rocks and creation of a catchment area adjacent to the

Zone	Likely failure mode	Rating	Rockfall Hazard
Zone 1	Raveling, sloughing	123	Low Hazard
Zone 2	Rock falls	75	Low Hazard
Zone 3	Plane failure on foliation	222	Moderate Hazard
Zone 4	Rock falls	63	Low Hazard
Zone 5	Rolling rocks and erosion	315	High Hazard
Zone 6	Raveling and sloughing	168	Moderate Hazard
Zone 7	Raveling	96	Low Hazard

Remedial work would include slope flattening, removal of loose boulders and creation of catchment space adjacent to the flume.

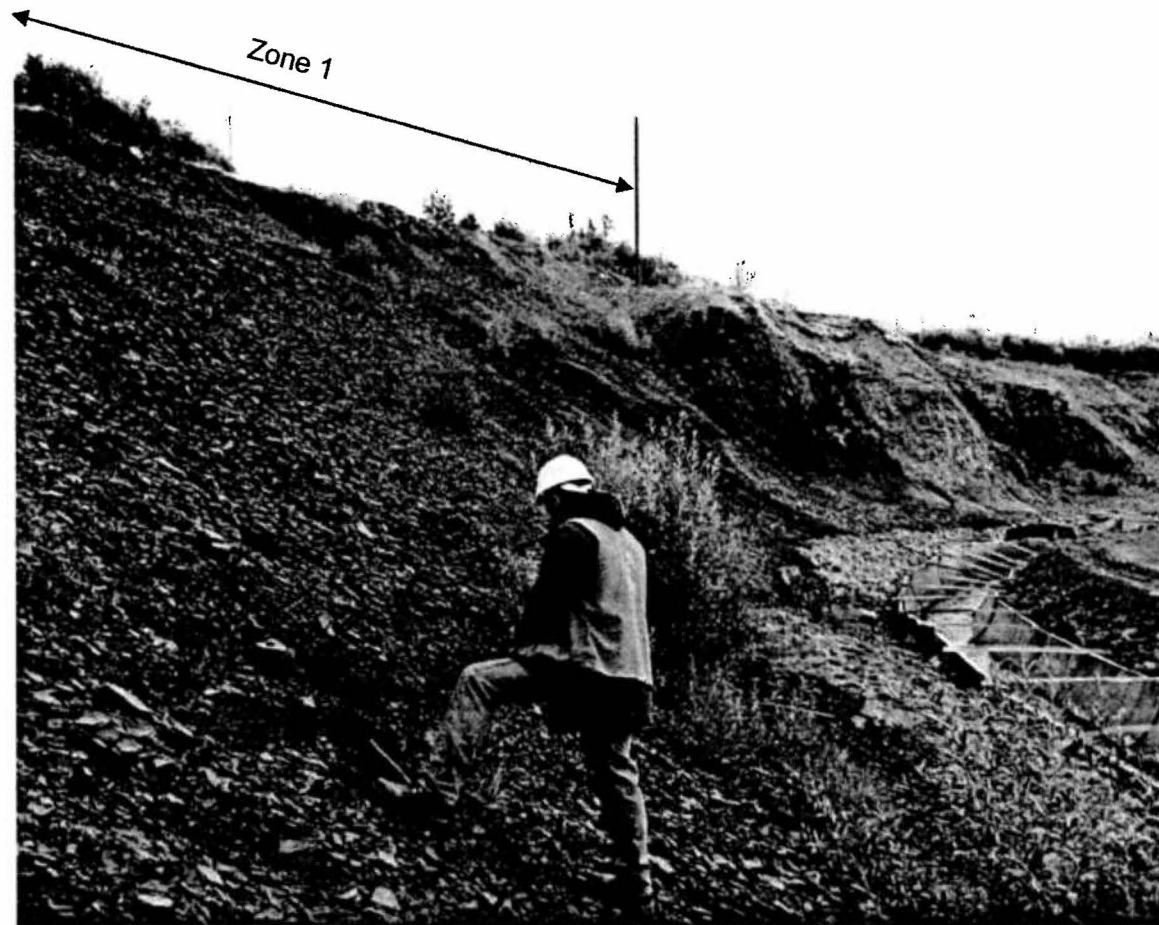
FIGURE A1
Zone 1

Zone 1: Schist – slopes at 40 degrees. Surface ravelling but no signs of recent instability. Low risk of failure affecting the flume.

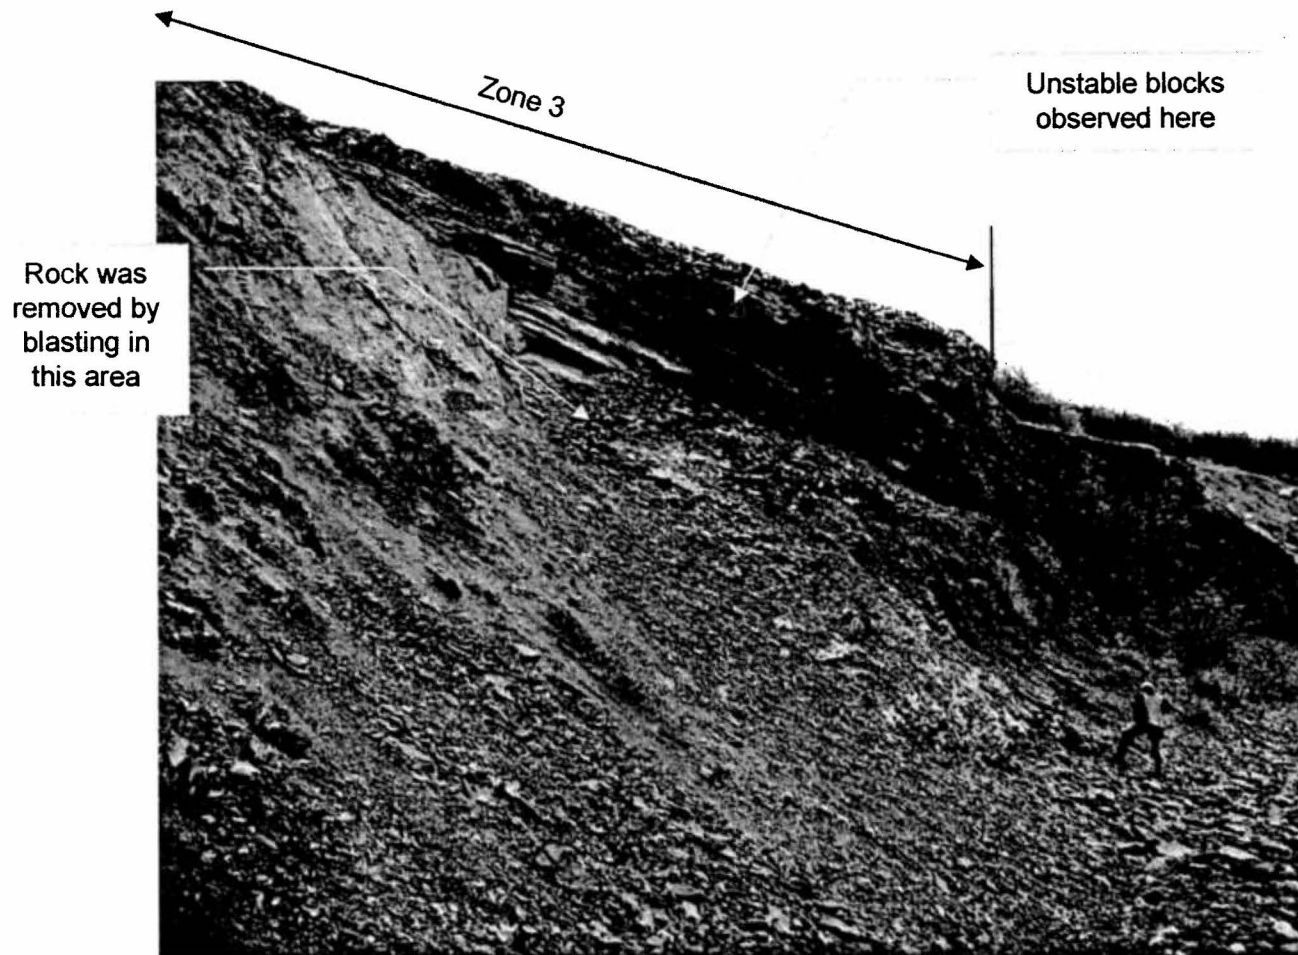
Zone 3: Pelitic schist with strongly developed foliation planes dipping at 35 degrees, forming failure surfaces. Active seepage. Moderate risk of failure affecting the flume.

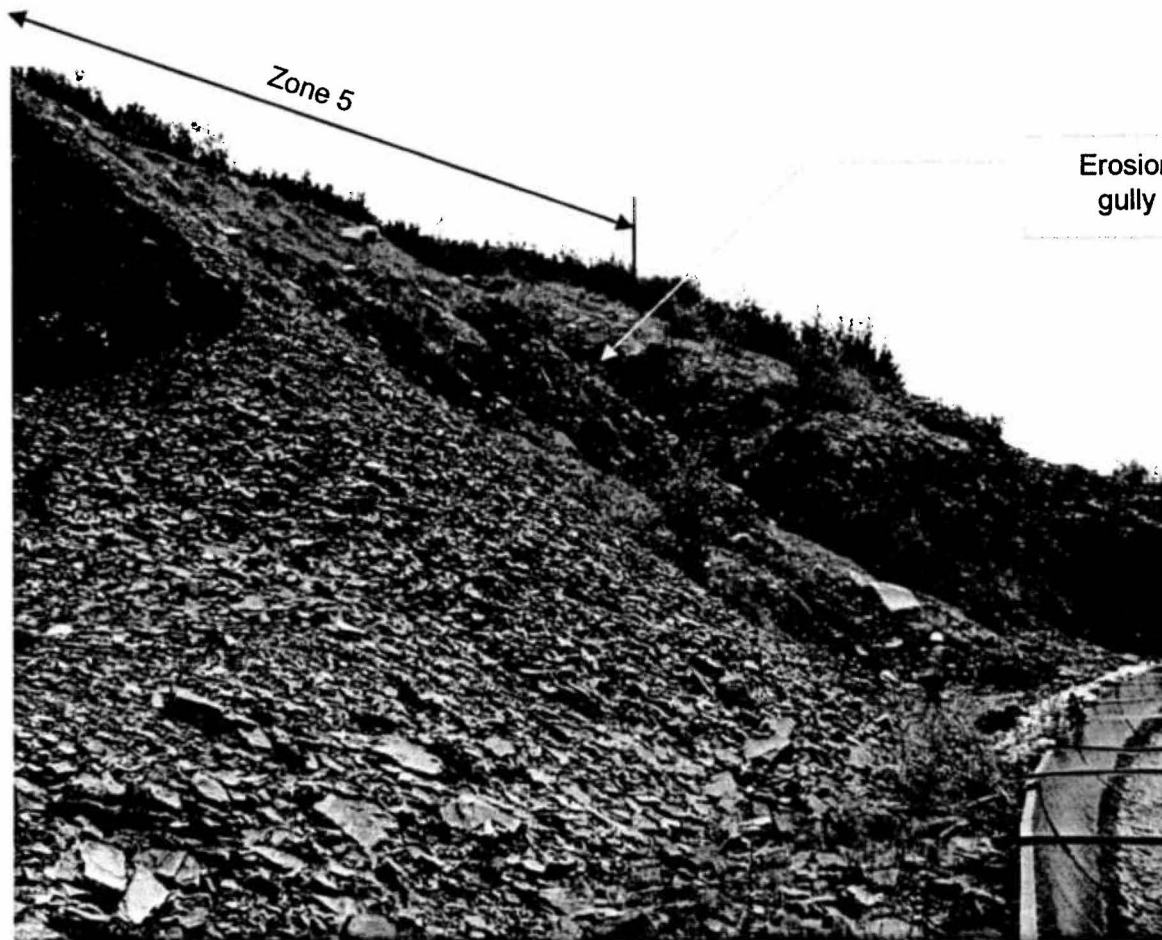
Zone 5: Talus-soil slope, saturated, containing boulders up to 2m. Erosion and saturated debris flows. Considerable erosion over last two years noted by BGC. Slope at 40 degrees. High risk of further soil slumps and rolling boulders affecting the flume.
