**DELOITTE & TOUCHE INC.**  
**EVALUATION OF SHORT TERM  
MANAGEMENT OPTIONS**

**VANGORDA DIVERSION FLUME  
FARO MINE, YUKON**

PROJECT NO.: 0257-002-03  
DATE: SEPTEMBER 6, 2000

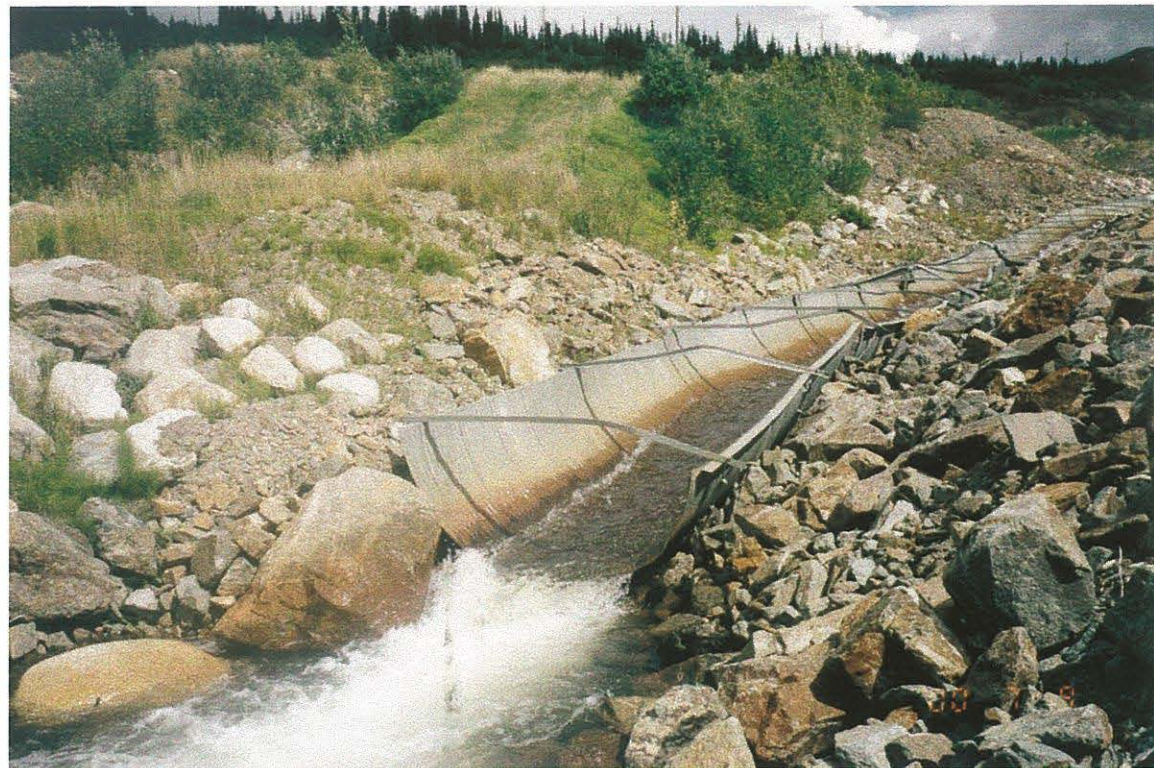
DISCHARGE END OF THE FLUME (SECTION #1).

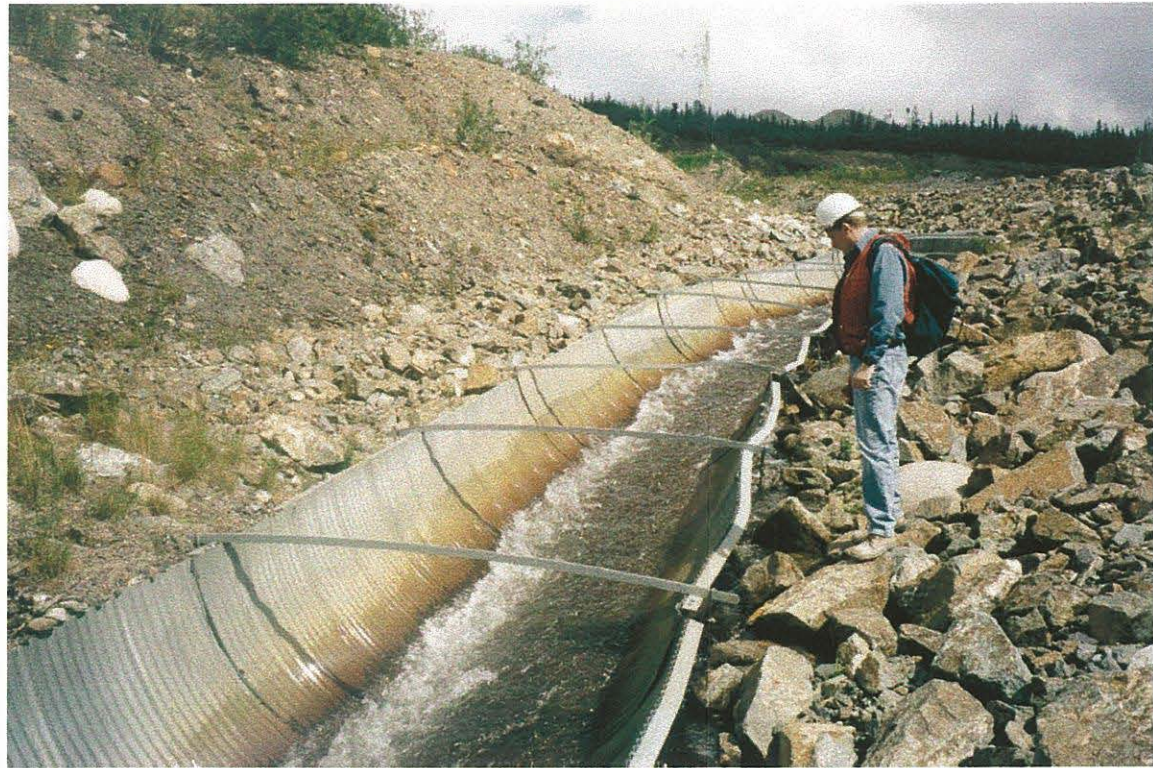
VIEW OF SOME FLOW ON THE OUTSIDE OF SECTION #8.

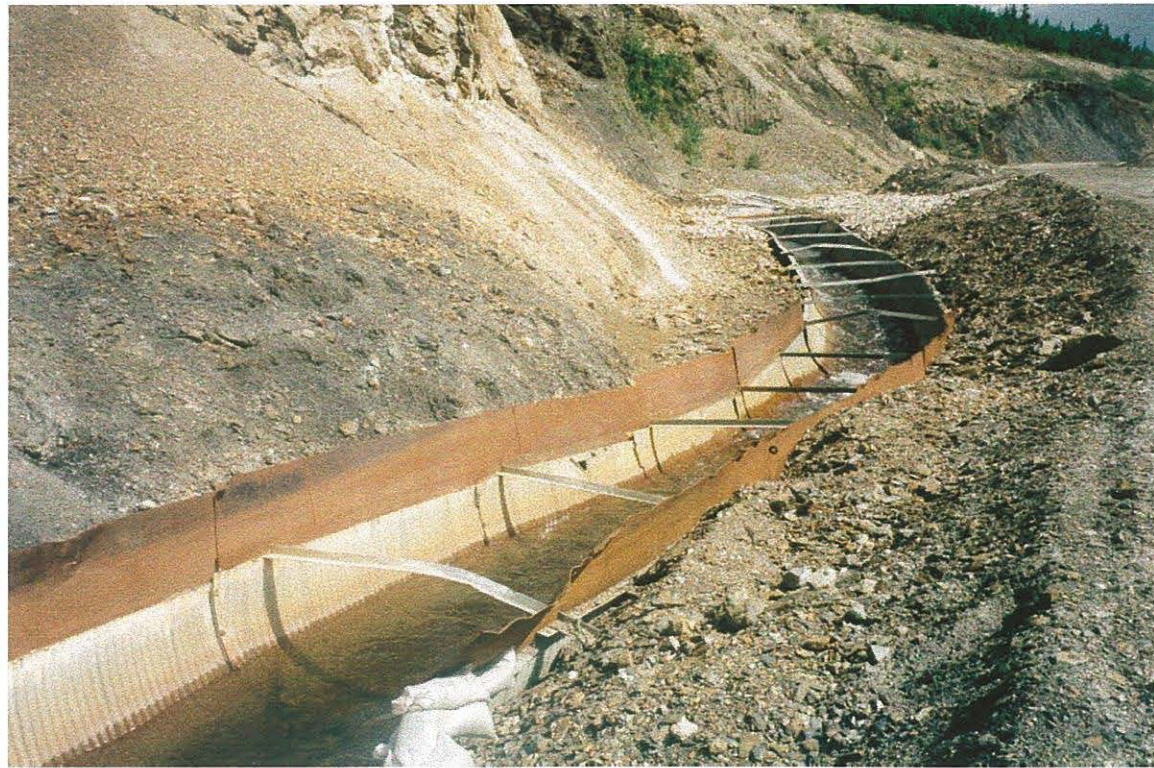
VIEW OF THE METAL SIDE WALLS BEGINNING AT SECTION #48.

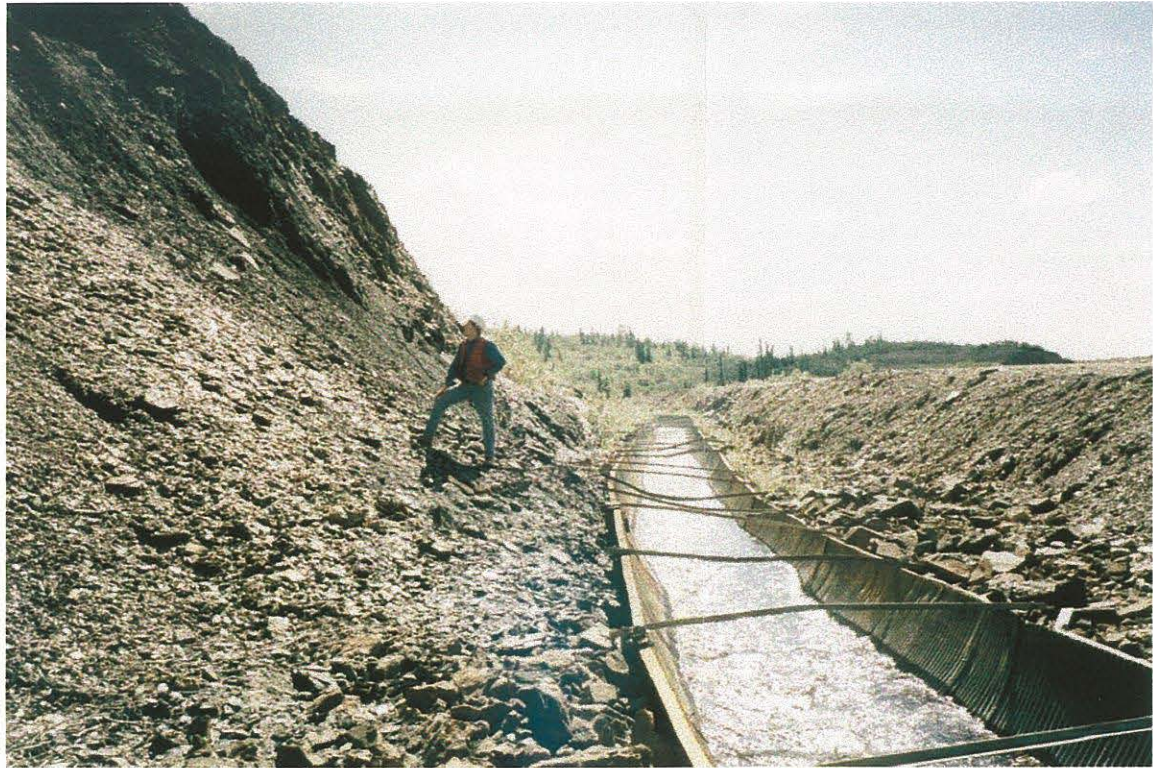
VIEW OF THE TALUS SLOPE CREATED BY WEATHERED PHYLLITE.

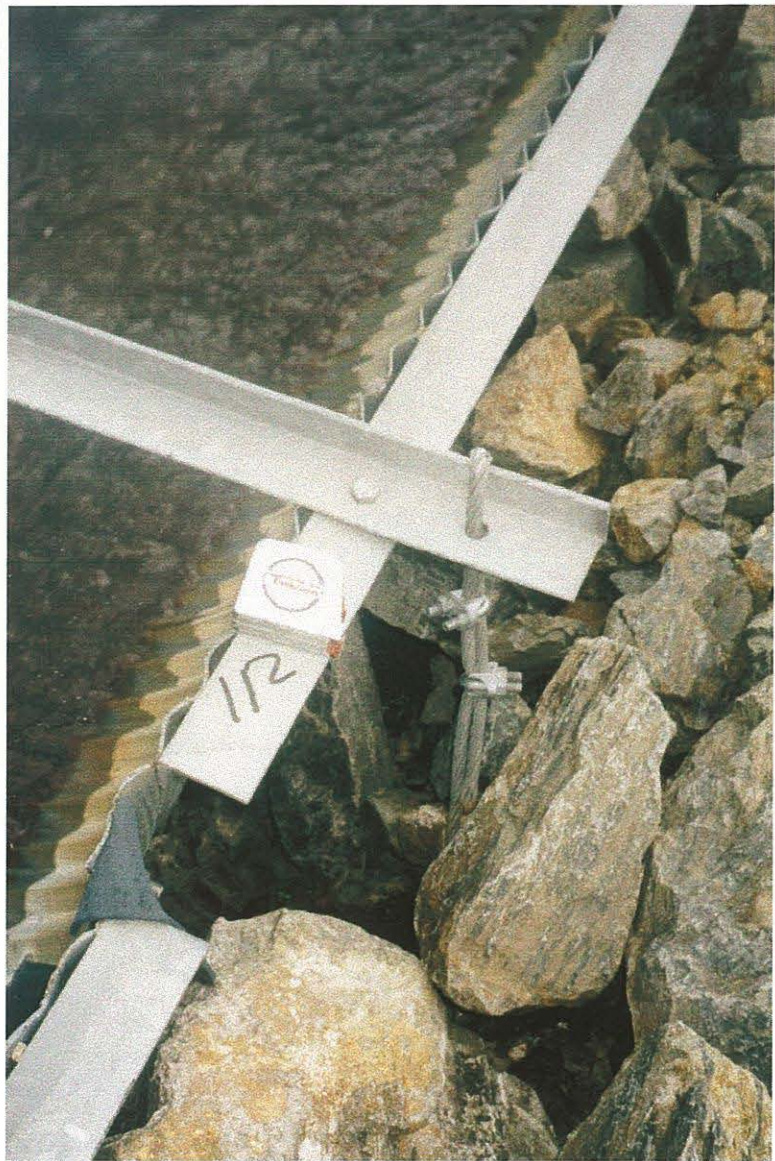
VIEW OF THE TIE-DOWN DETAIL AT SECTION #112.

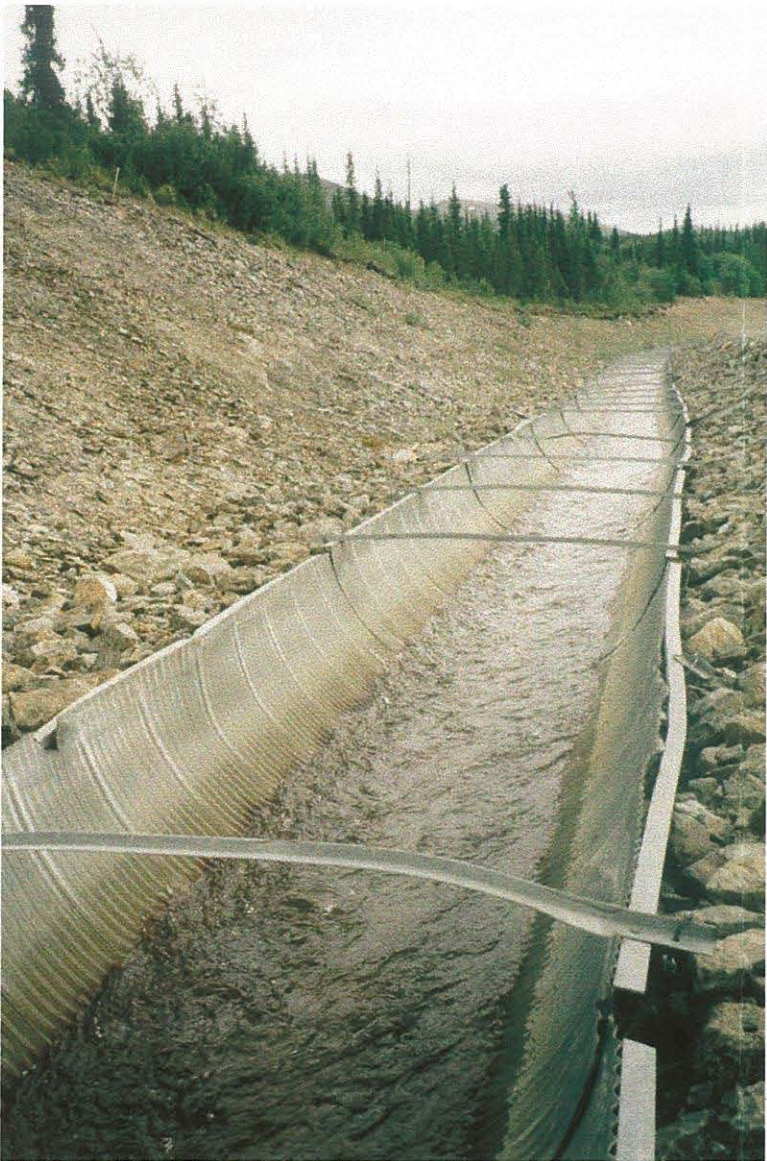
VIEW OF THE FLUME FROM SECTION #107.

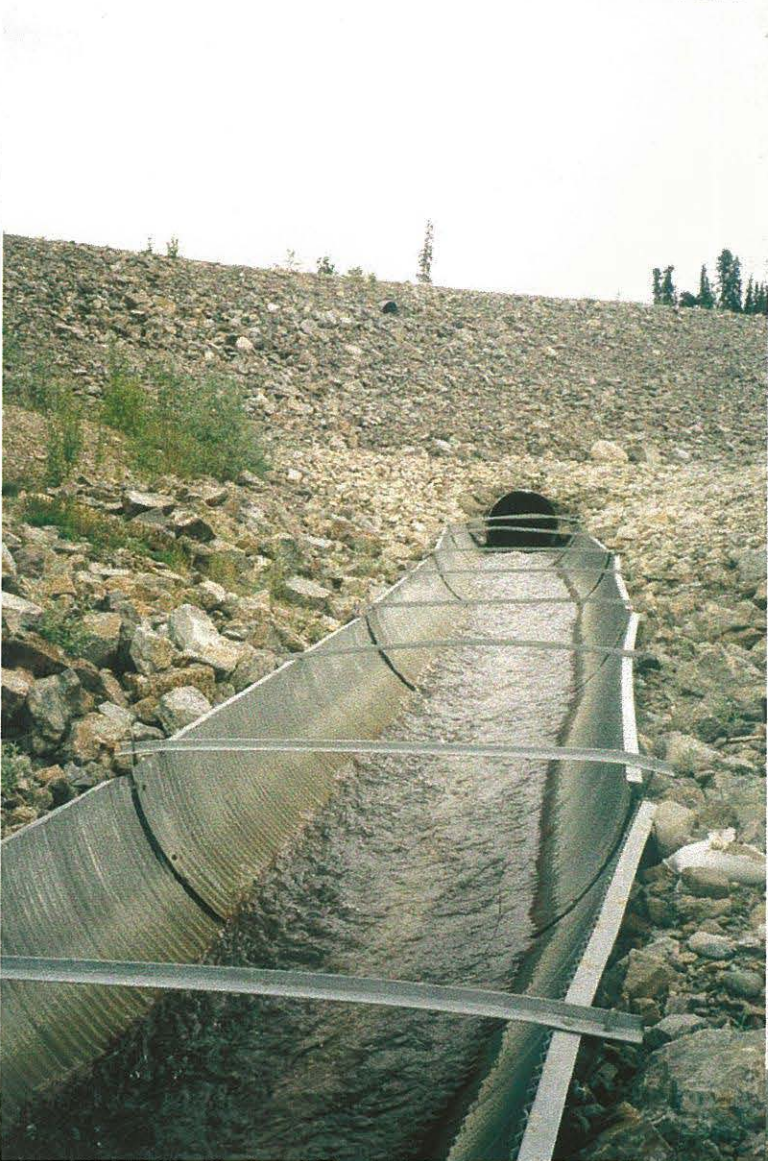
VIEW FROM SECTION #148 UP TOWARDS THE DIVERSION DAM.

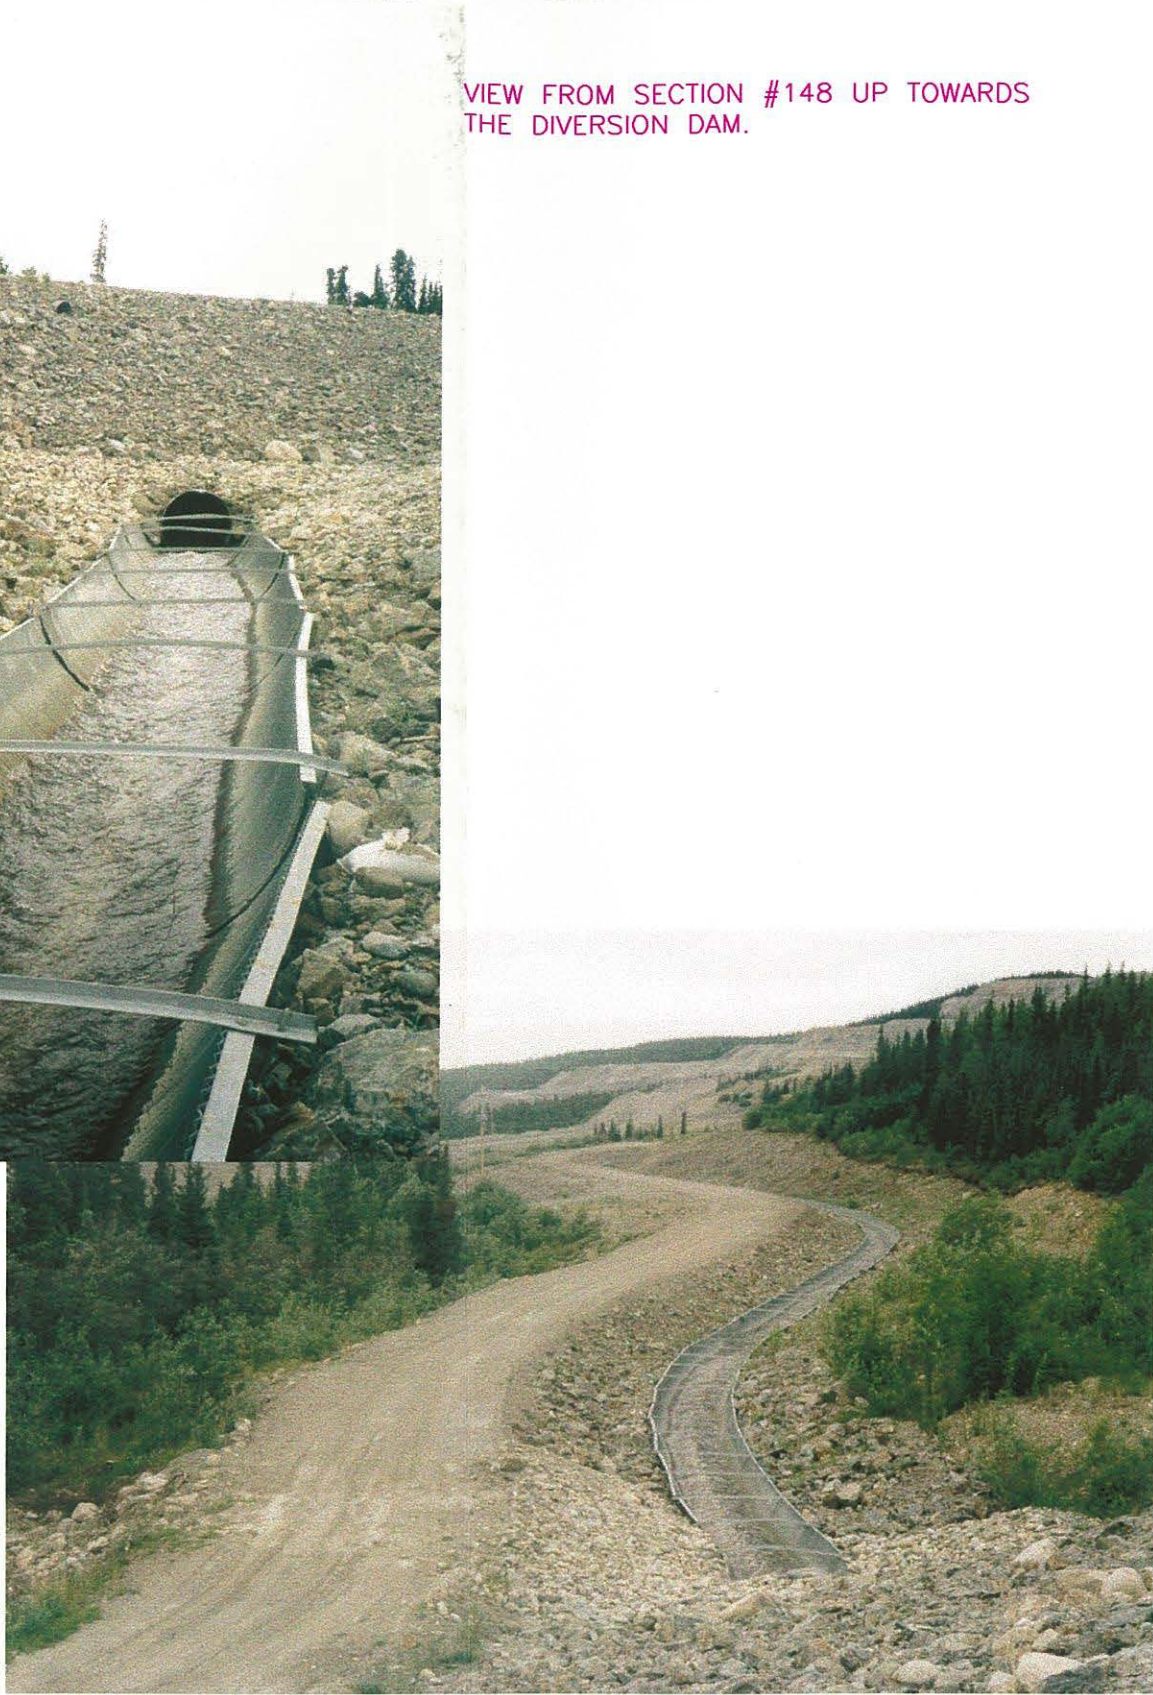
VIEW LOOKING DOWNSTREAM ALONG THE FLUME FROM THE DIVERSION DAM.

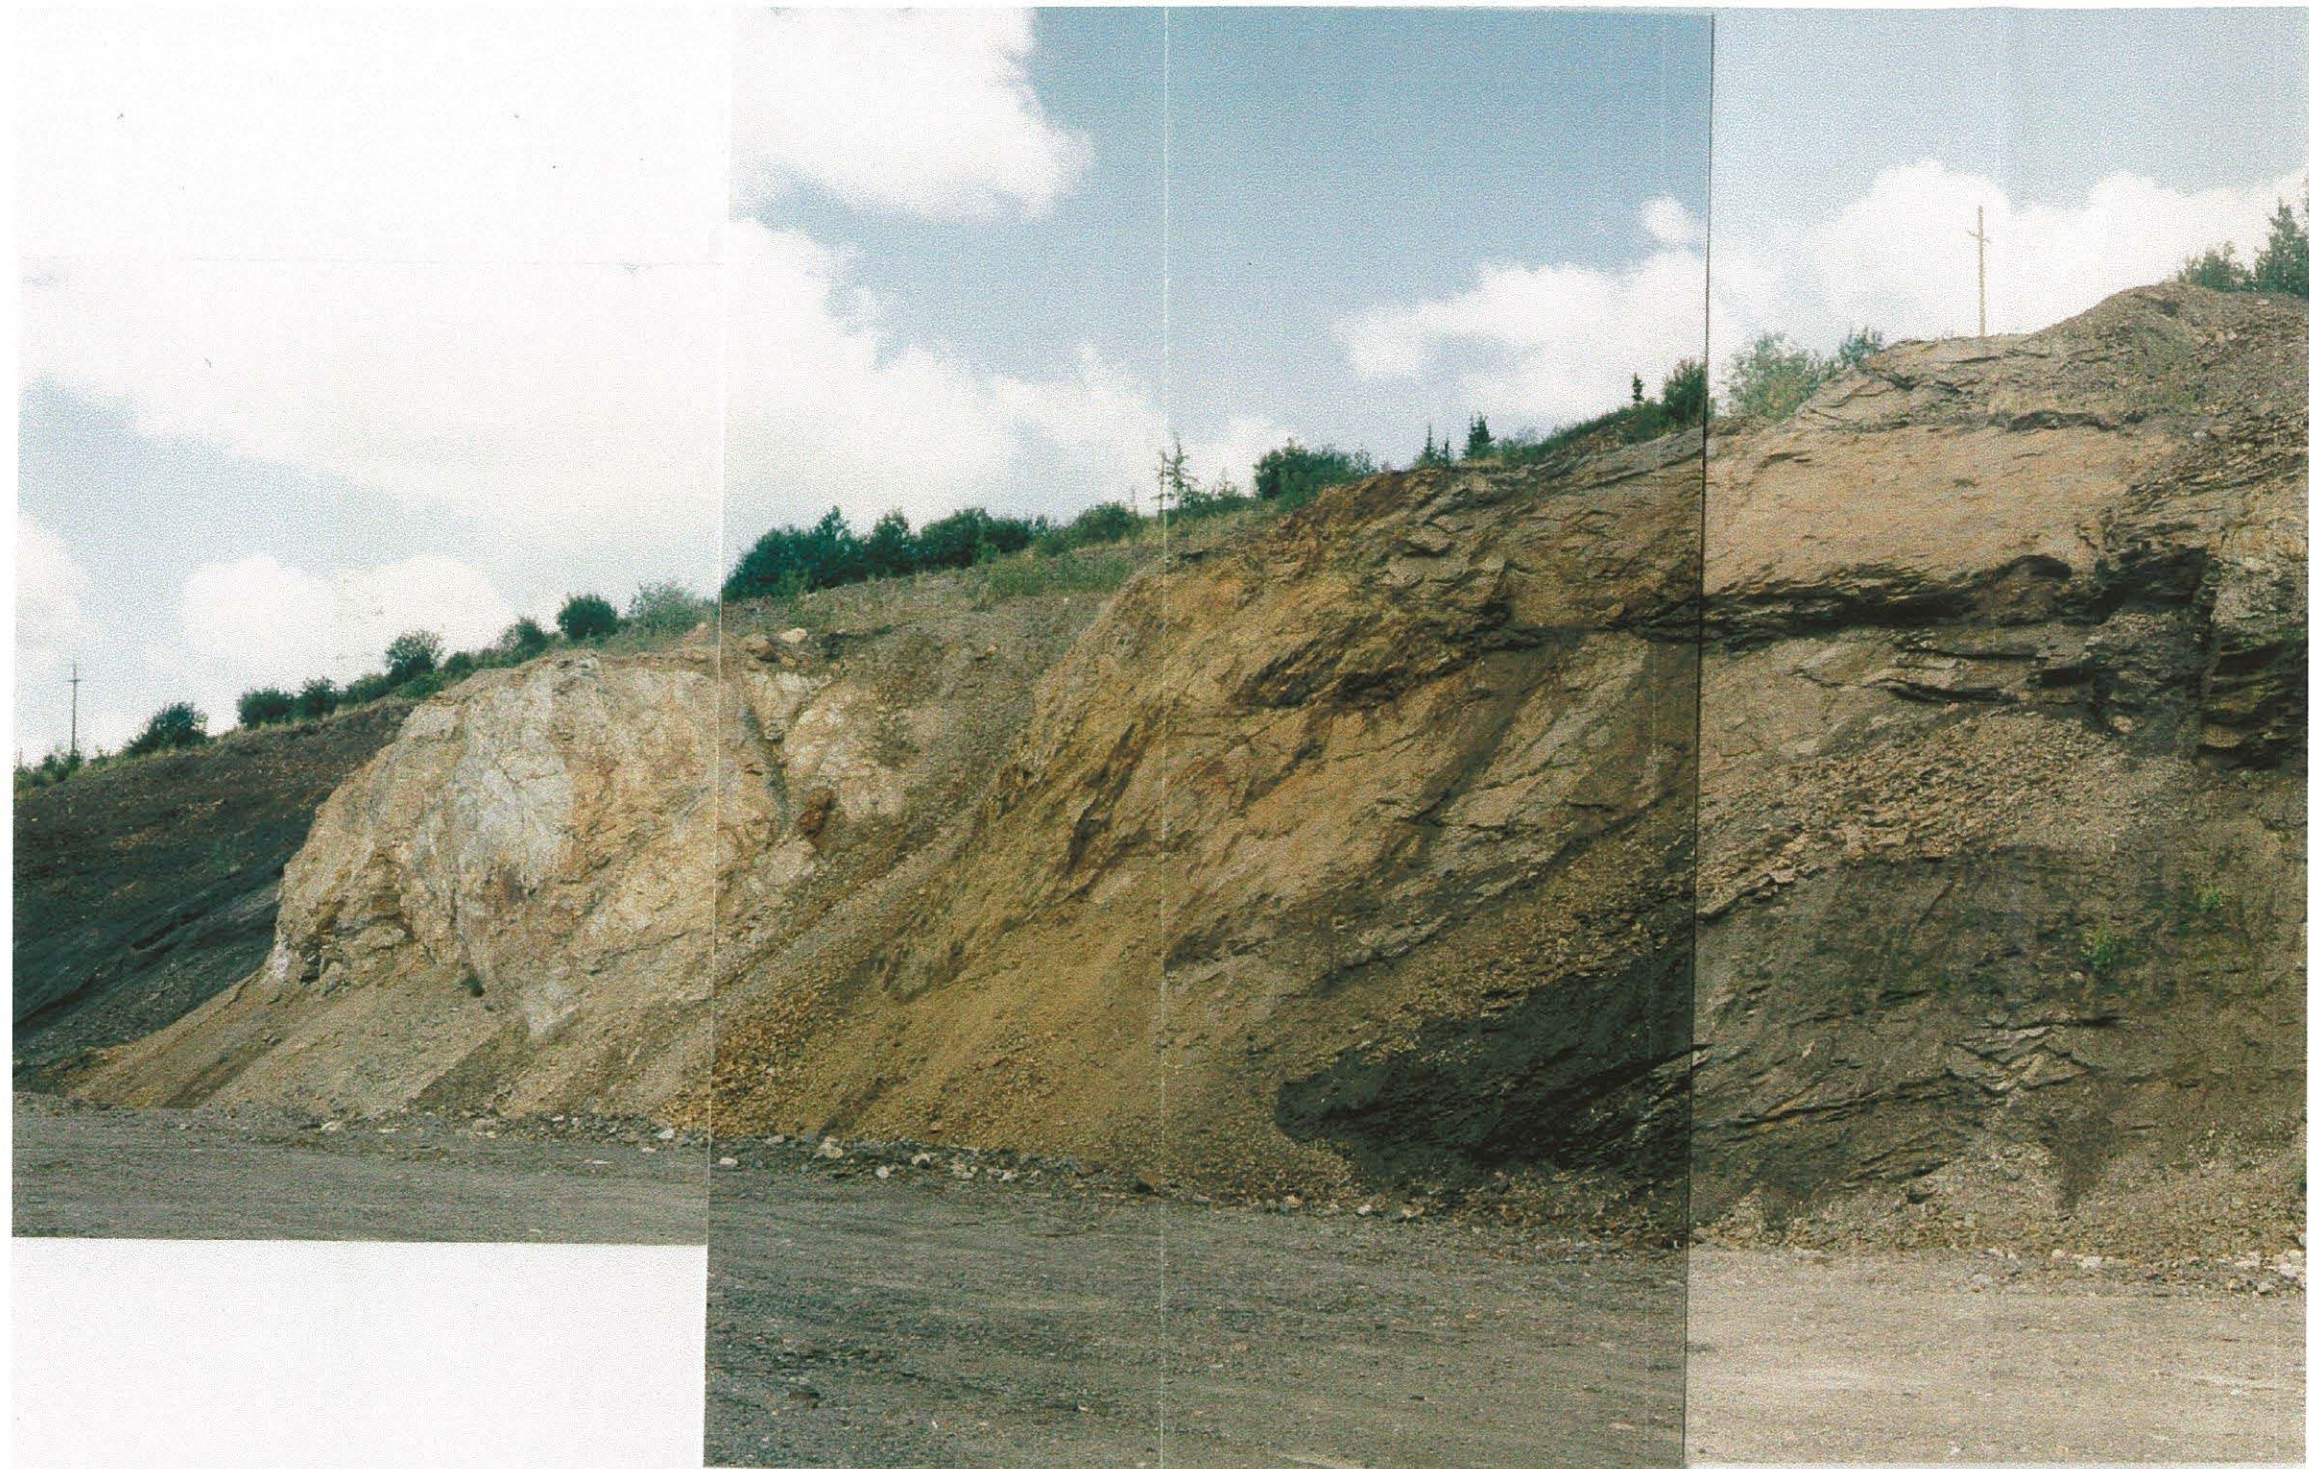
Zone 1 is the first rock slope encountered moving upstream from the plunge pool, and includes the area which generated a large rockfall in 1999. Photographs of Zone 1 are shown in Figure 7. Zone 1 is approximately 95 m in length and extends from flume Section #46 to Section #62. The slope is approximately 10 to 12 m high and is composed of a graphitic phyllite with well developed foliation planes and joint sets. Some seepage was noted immediately in the area of the detachment zone of the 1999 rockfall and also to the east of that area.

↑ AREA OF 1999 ROCKFALL ↓

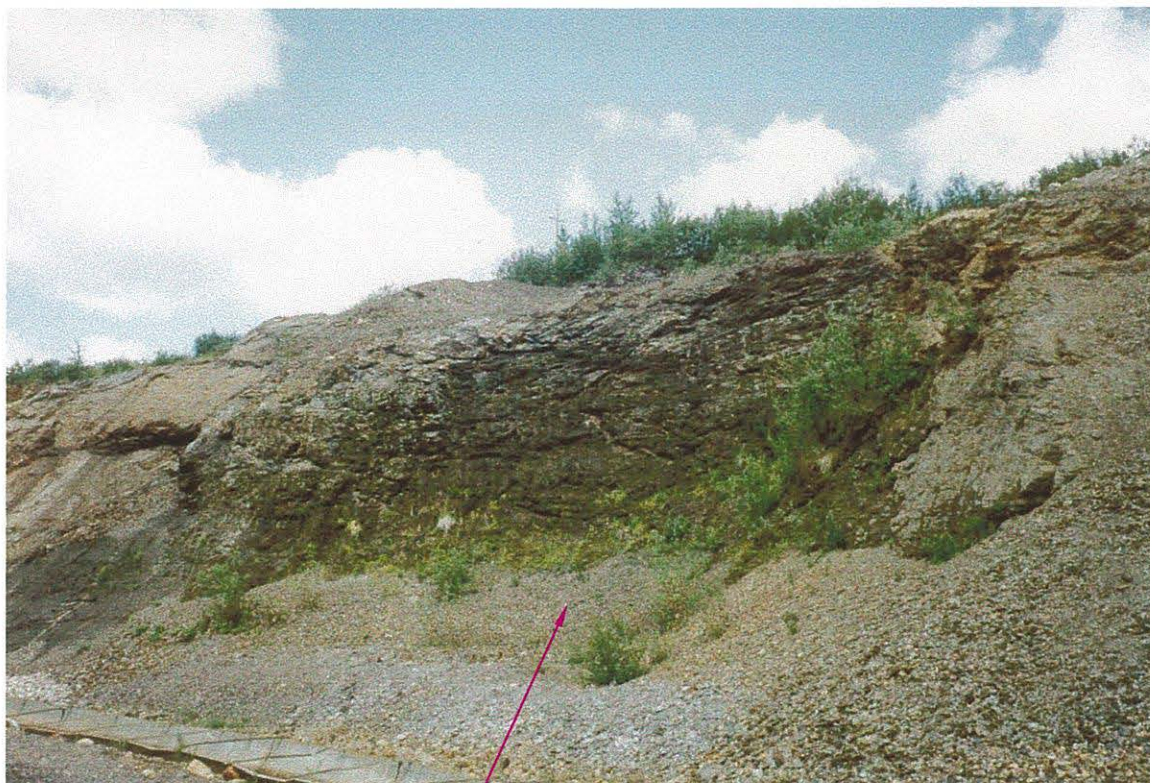
NOTE: NATURAL CATCHMENT  
AREA FORMED AT THE  
BASE OF THE SLOPE

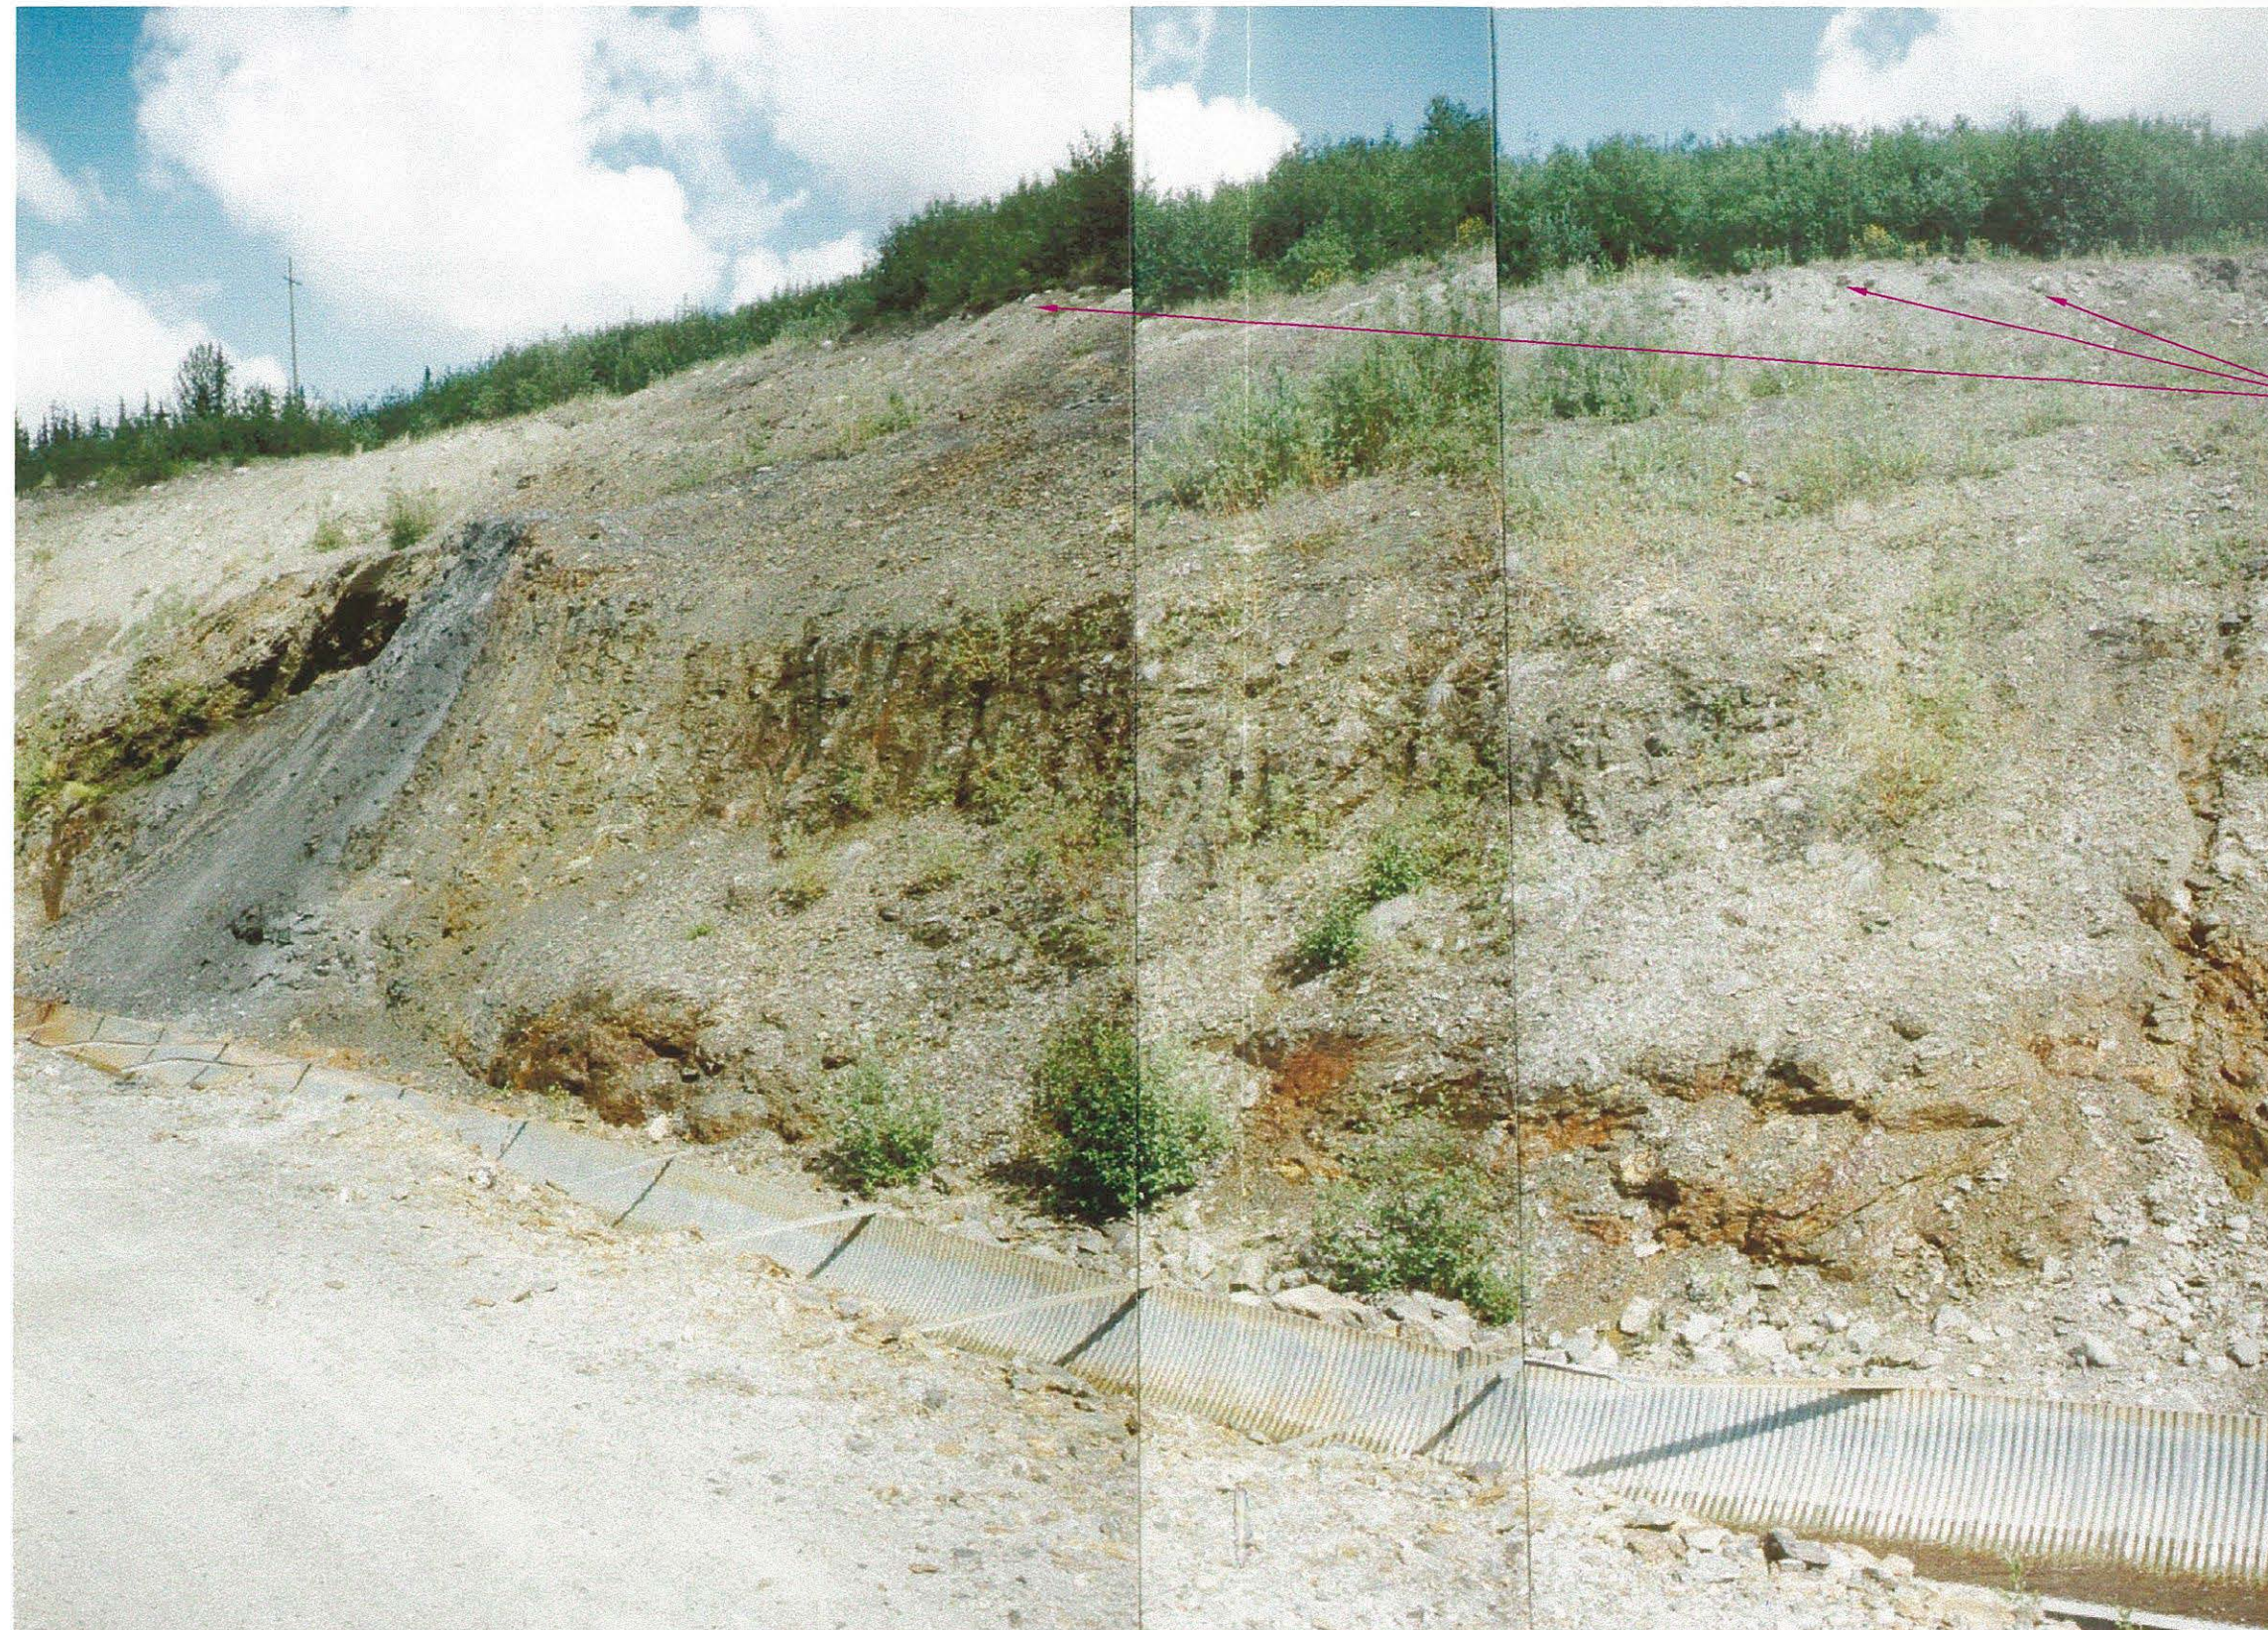
NOTE: ROUNDED  
BOULDERS AT TOP  
OF THE SLOPE.

The boulders that are imbedded within the sandy till at the top of the slope will continue to be undermined by erosion and could reach the flume in individual rockfall events. The boulders could damage the flume walls or cross-braces, but are not likely to block the passage of water. Therefore, the owner could accept the risk of this potential damage (and resultant repair work and cost) or the following work could be undertaken.

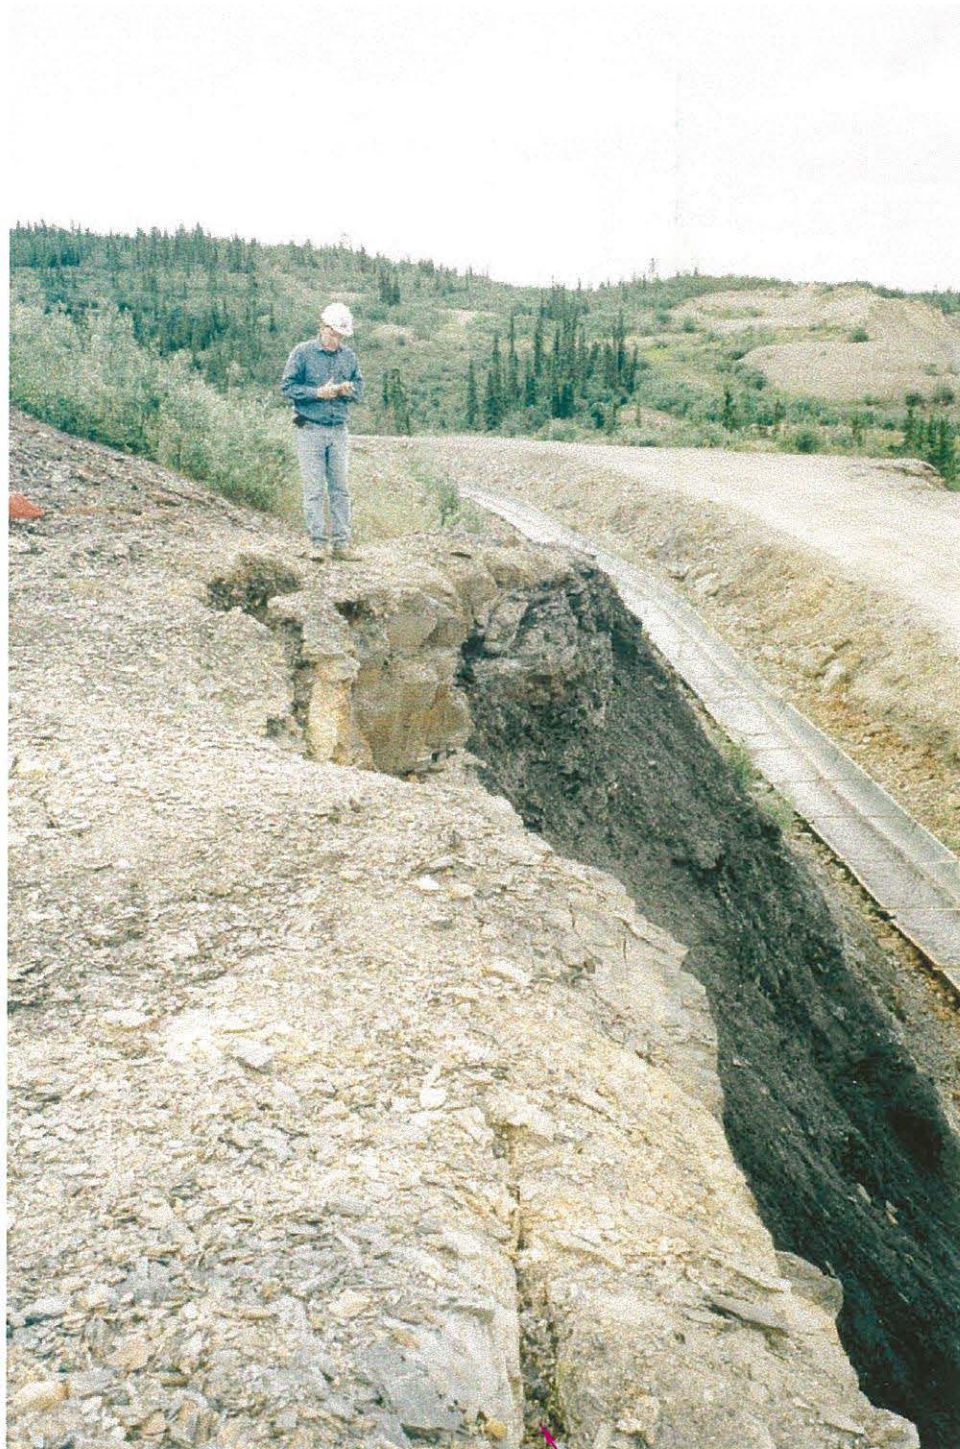
NOTE: TENSION CRACK FORMED IN UPPER MORE COMPETENT MATERIAL

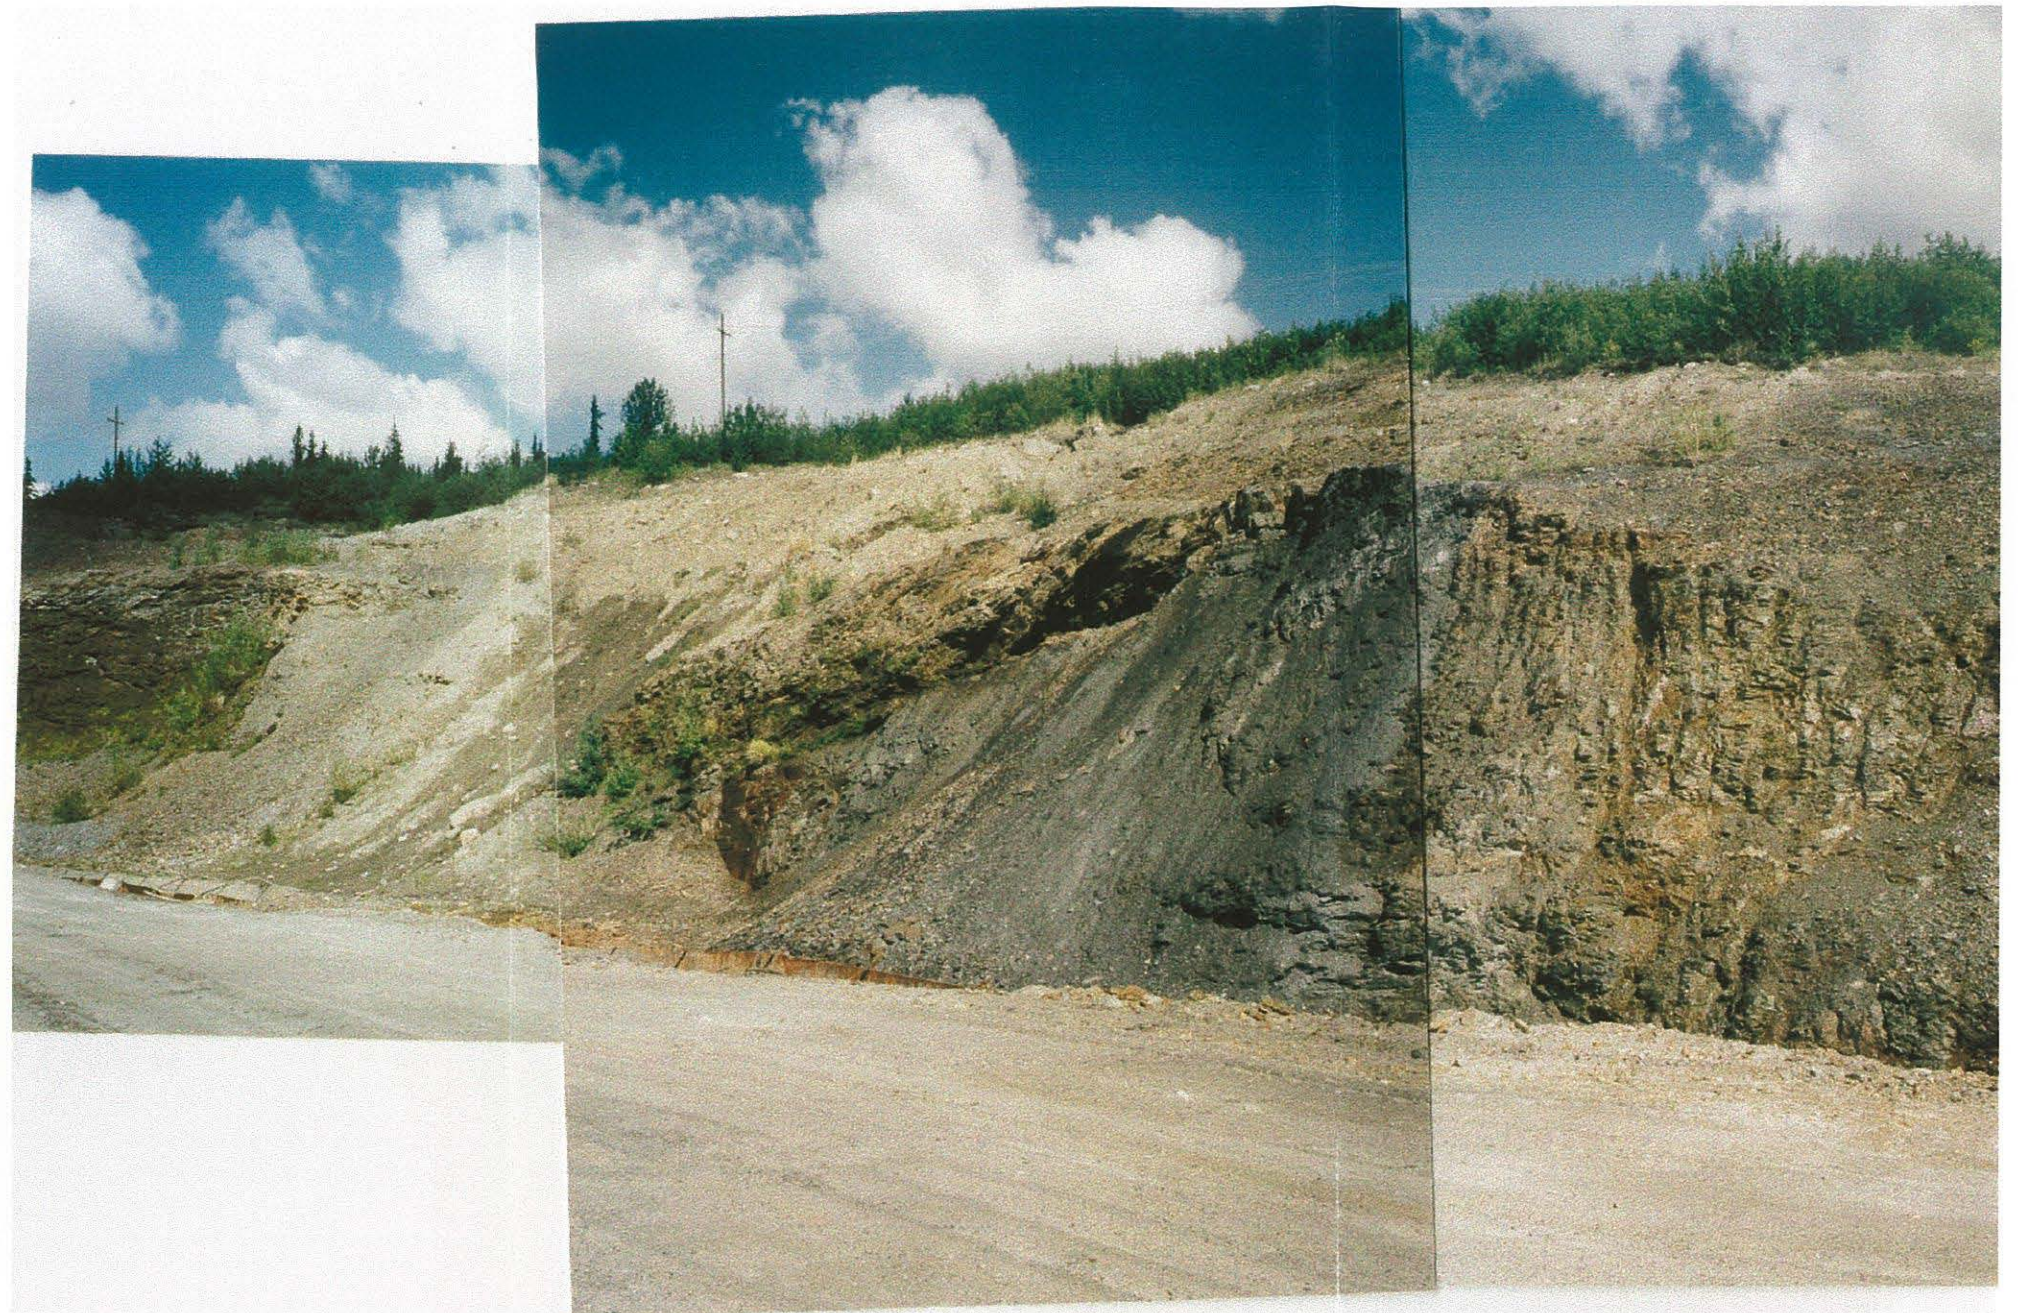
Zone 4 is composed of a dark gray to black carbonaceous phyllite with a talus fan at the base. The talus fan development is encroaching on the flume. Zone 4 is approximately 25 m in length and extends from Section #73 to Section #77. A band of more competent rock, approximately 2 m in thickness, is visible at the top of the slope. The raveling process, forming the talus slope, is undercutting the more competent rock and several tension cracks are visible 1 to 2 m from the crest edge. A panorama of the slope and a view of the tension cracks are shown in Figure 10. Some seepage was observed at the toe of the slope.

ZONE 4 – POTENTIAL ROCKFALL SOURCE AREA.  
 – BAND OF COMPETENT ROCK BEING UNDERCUT BY DEBRIS.  
 – DEBRIS CONE ENCROACHING ON DIVERSION FLUME.

The talus slope that is encroaching on the flume in Zone 4 is not expected to damage or block the flume. The undercut band of competent rock at the top of the slope may release rock of sufficient size to damage the flume, although blockage of the channel is not expected. Impact from rockfall is expected to be relatively low energy, as the talus slope will ensure the rocks are rolling and not bouncing as they move down the slope. Again, the owner could accept the potential risk or the following work could be undertaken.

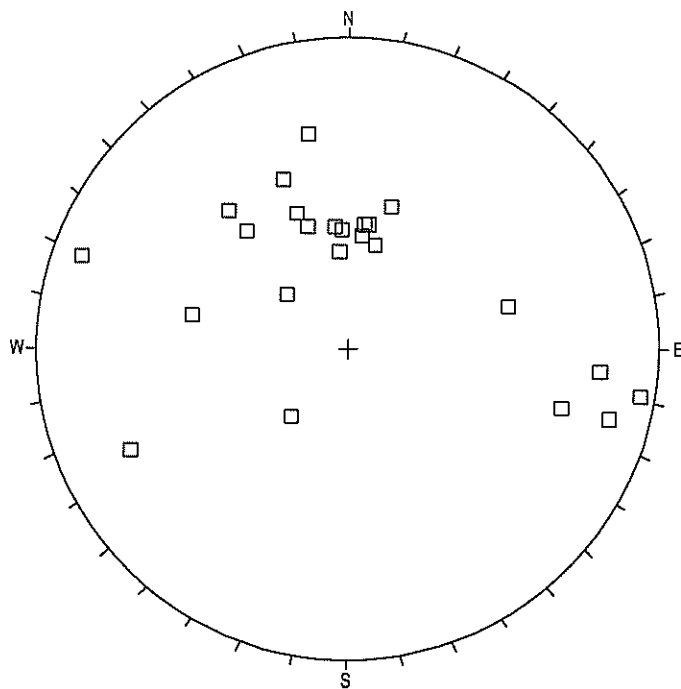
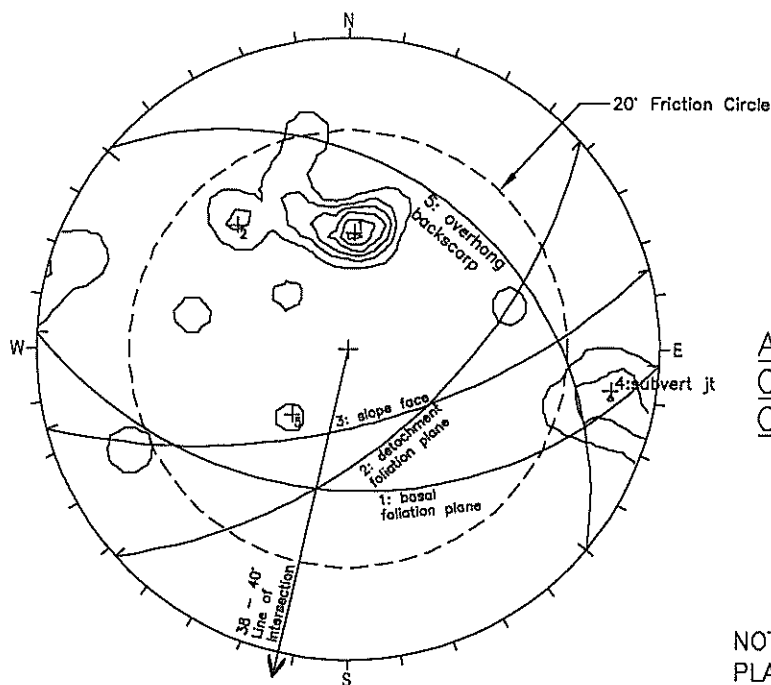
The discontinuity measurements from Zone 1 were plotted and contoured and are shown in Figure 11. The average orientation of the poles to joint sets and their corresponding planes that were interpreted to have caused the 1999 failure are labeled in Figure 11. As can be seen in this figure, the basal foliation plane and the release foliation plane, form a kinematically admissible potential failure mechanism. As the two foliation planes are similar in orientation they form a very open wedge, and thus sliding occurs predominantly along one plane as opposed to along the line of intersection. In this case the sliding is along the basal foliation plane, which is in agreement with the failure mechanism interpreted in the field. A simplified stability assessment compares the line of intersection of a potential wedge failure to the slope configuration and frictional resistance. The friction angle along the foliation planes was estimated to be 20° to 25° based on their smooth form and graphitic nature. As the line of intersection is shallower than the slope face, and thus able to daylight on the slope, and steeper than the angle of friction, the wedge will be unstable unless cohesion is acting along the joint.
