**DELOITTE & TOUCHE INC.**  
**EVALUATION OF SHORT TERM  
MANAGEMENT OPTIONS**

**VANGORDA DIVERSION FLUME  
FARO MINE, YUKON**

PROJECT NO.: 0257-002-03  
DATE: SEPTEMBER 6, 2000

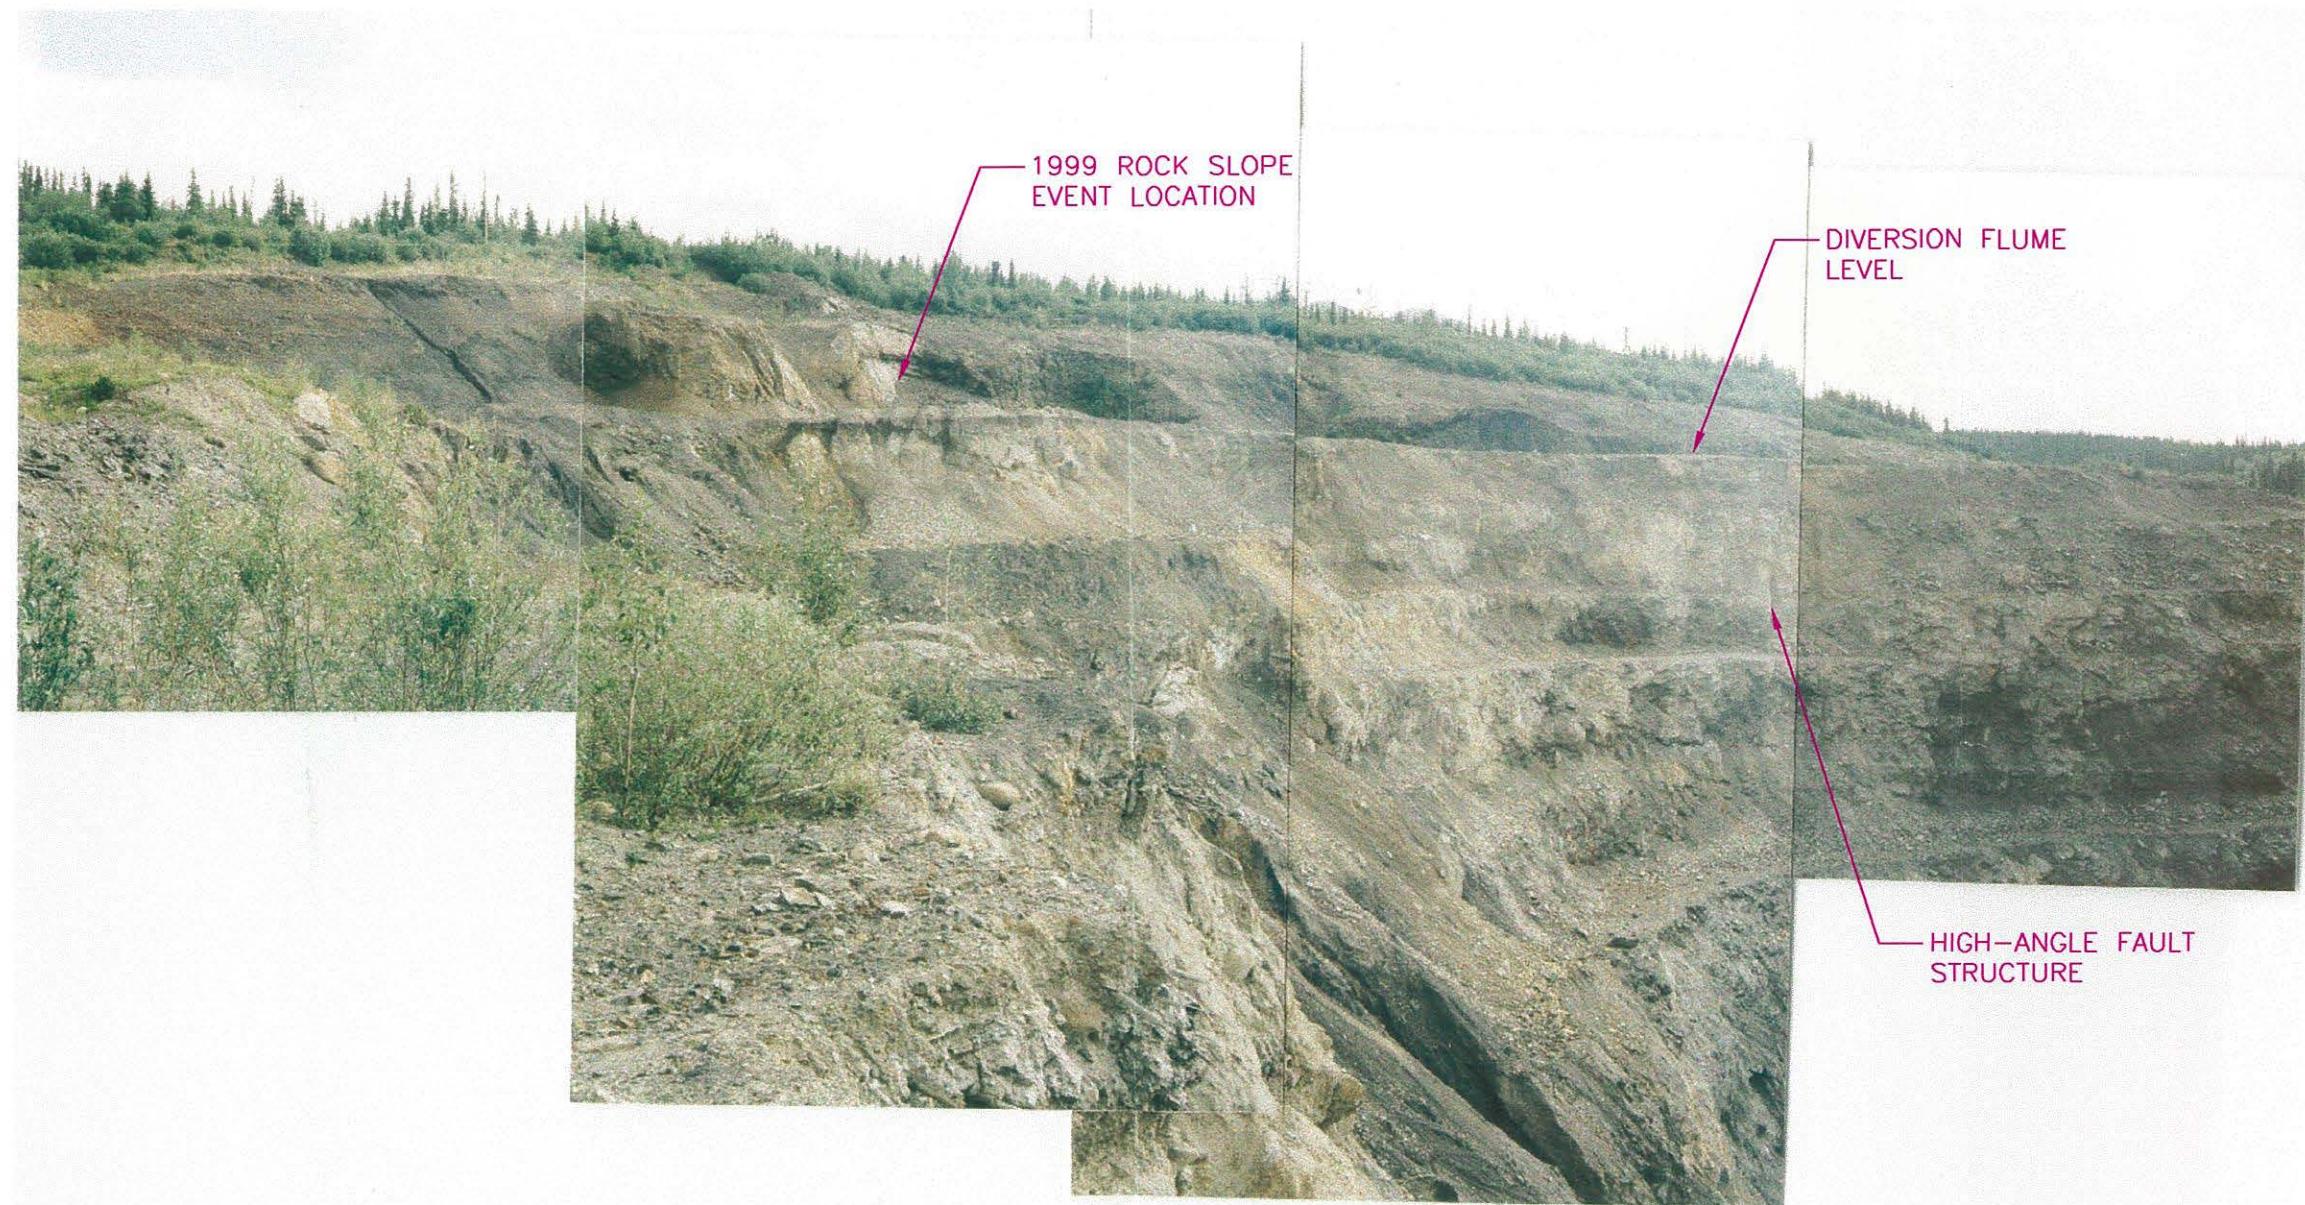
At present, the pit slope is experiencing widespread raveling and many of the catch benches have been filled with debris. A panorama of the slope is shown in Figure 12. Other than the bench scale failures, no evidence of large-scale distress such as cracking at the crest, or bulging of the slope was noted. On-site personnel have not noted any signs of large-scale slope deformation or reported any unusual maintenance requirements for the access road located between the flume and the pit, generally located on the lower benches.

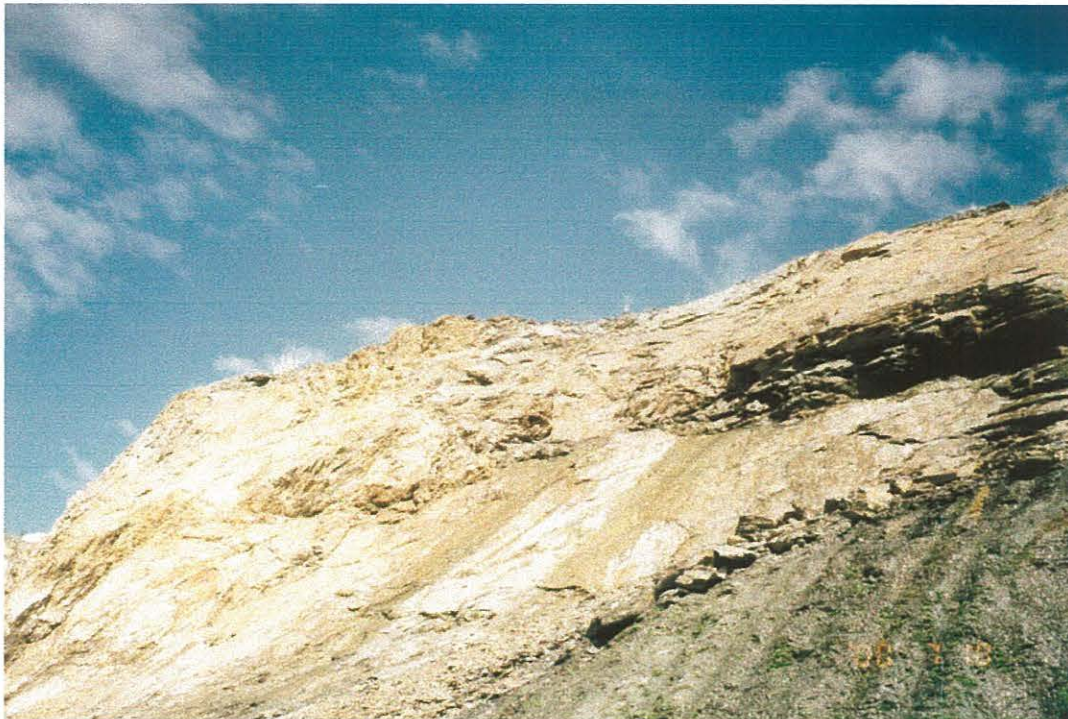
It is interpreted that the 1999 rockfall occurred as a wedge failure along the basal foliation plane, joint set 1, and the detachment foliation plane, joint set 2. The orientation of the foliation planes and slope face are shown in Figure 11. The wedge formed by joint sets 1 and 2 did not fail as an intact block, but rather was truncated along a joint dipping back into the slope, joint set 5. It appears that sliding took place predominantly along the basal foliation plane, and this plane appears to be continuous up to the top of the slope. The upstream side of the 1999 wedge failure released along steeply dipping joints that trend into the slope, joint set 4. Photographs of the 1999 rockfall source area are shown in Figure 13. In the lower photograph in Figure 13 the person is standing on the basal foliation plane and pointing to the intersection with the detachment foliation plane. The repeating joints forming the backscarp of the failure can be seen at the top of this photo, and the joints forming the side release can be seen to the far right of the photo.

LOCATION OF 1999 INSTABILITY

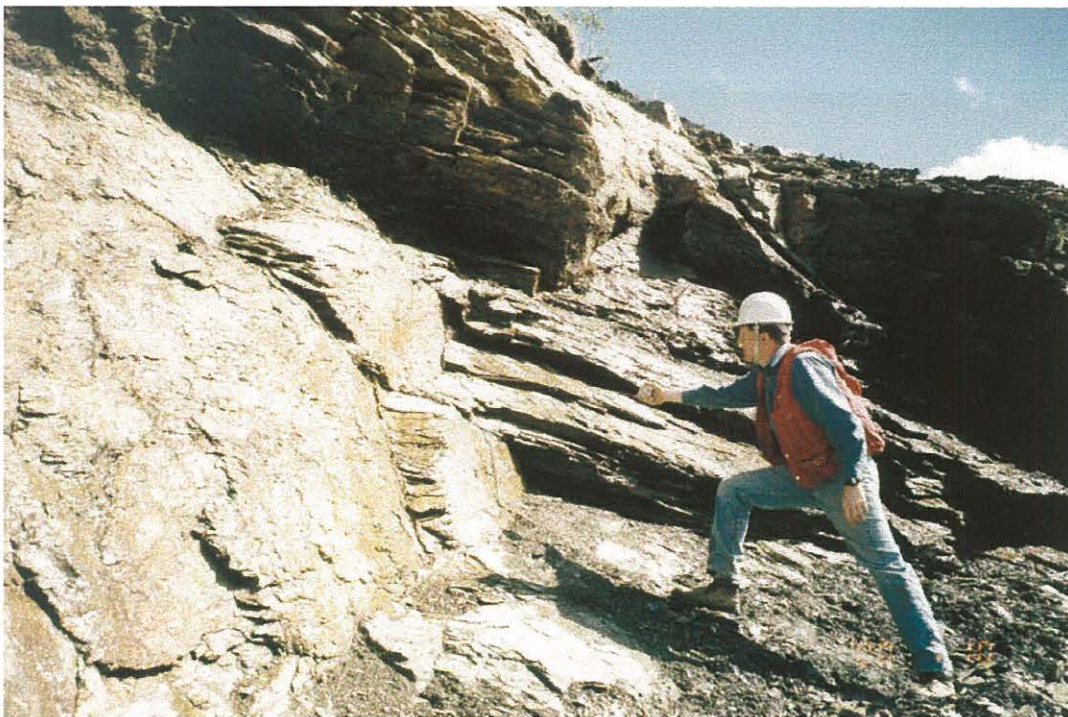
CLOSE UP OF DISCONTINUITIES BOUNDING 1999 INSTABILITY
