DELOITTE & TOUCHE INC.
**EVALUATION OF SHORT TERM
MANAGEMENT OPTIONS**

**VANGORDA DIVERSION FLUME
FARO MINE, YUKON**

PROJECT NO.: 0257-002-03
DATE: NOVEMBER 20, 2000

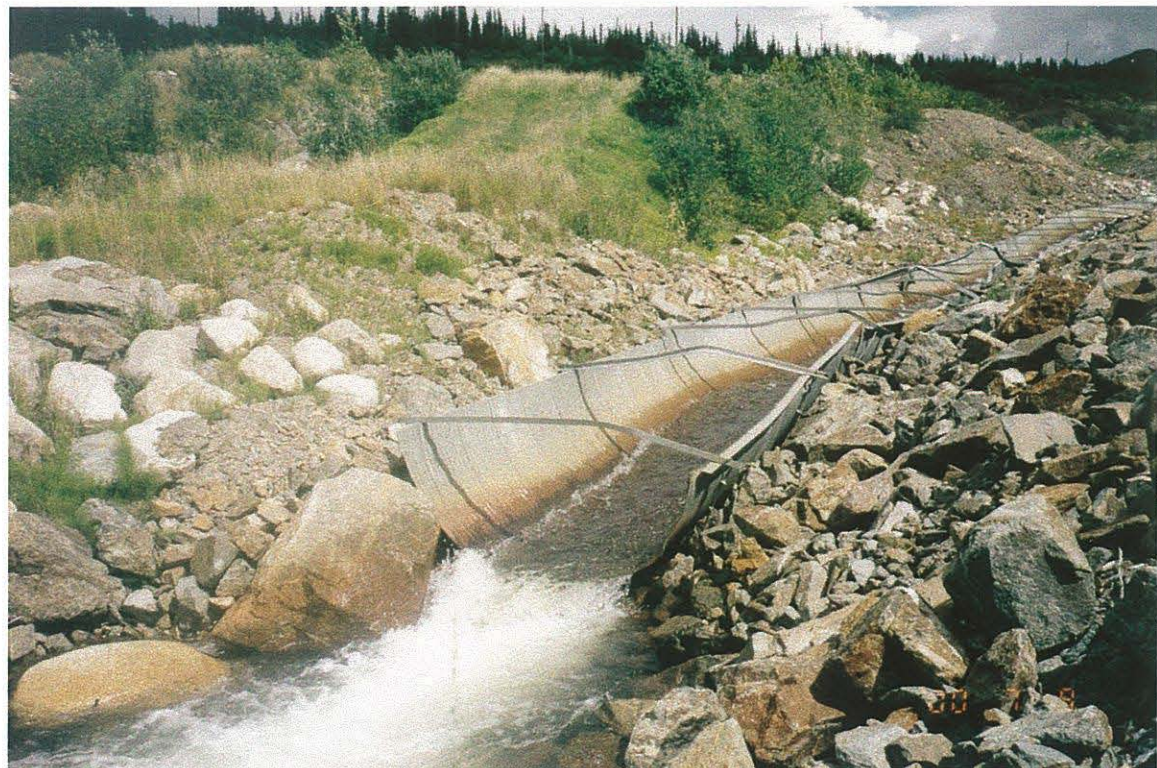
DISCHARGE END OF THE FLUME (SECTION #1).

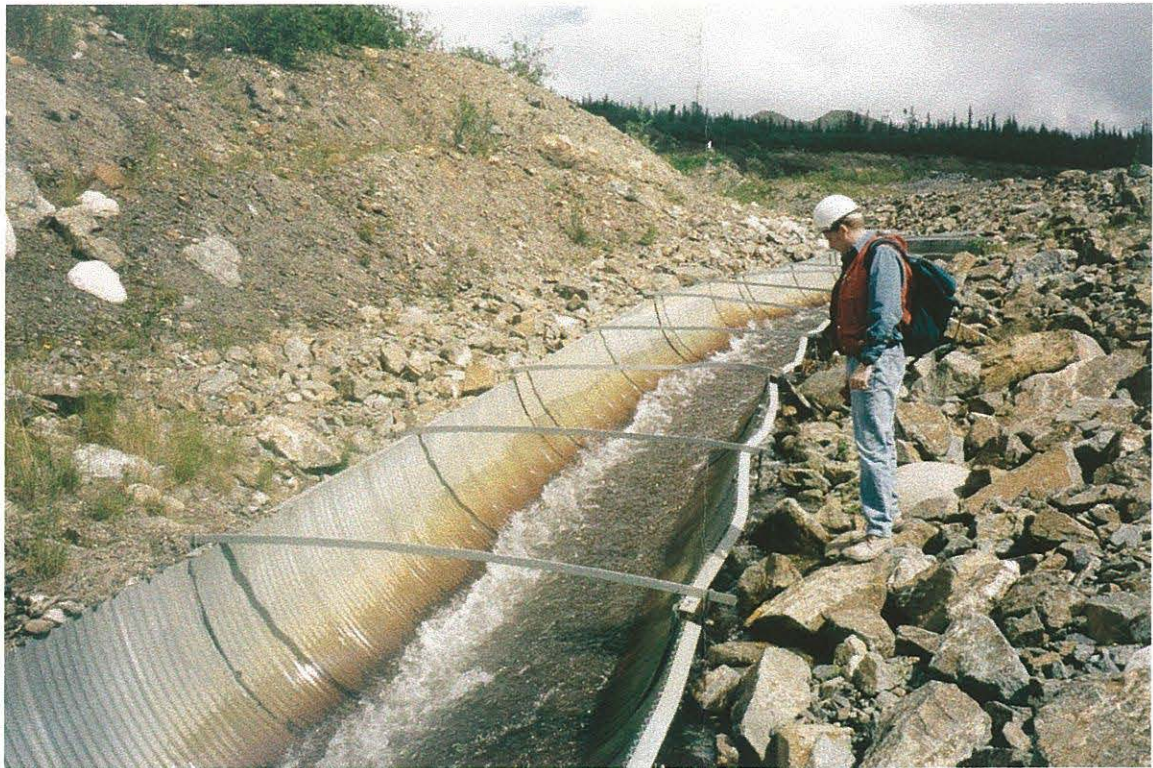
VIEW OF SOME FLOW ON THE OUTSIDE OF SECTION #8.

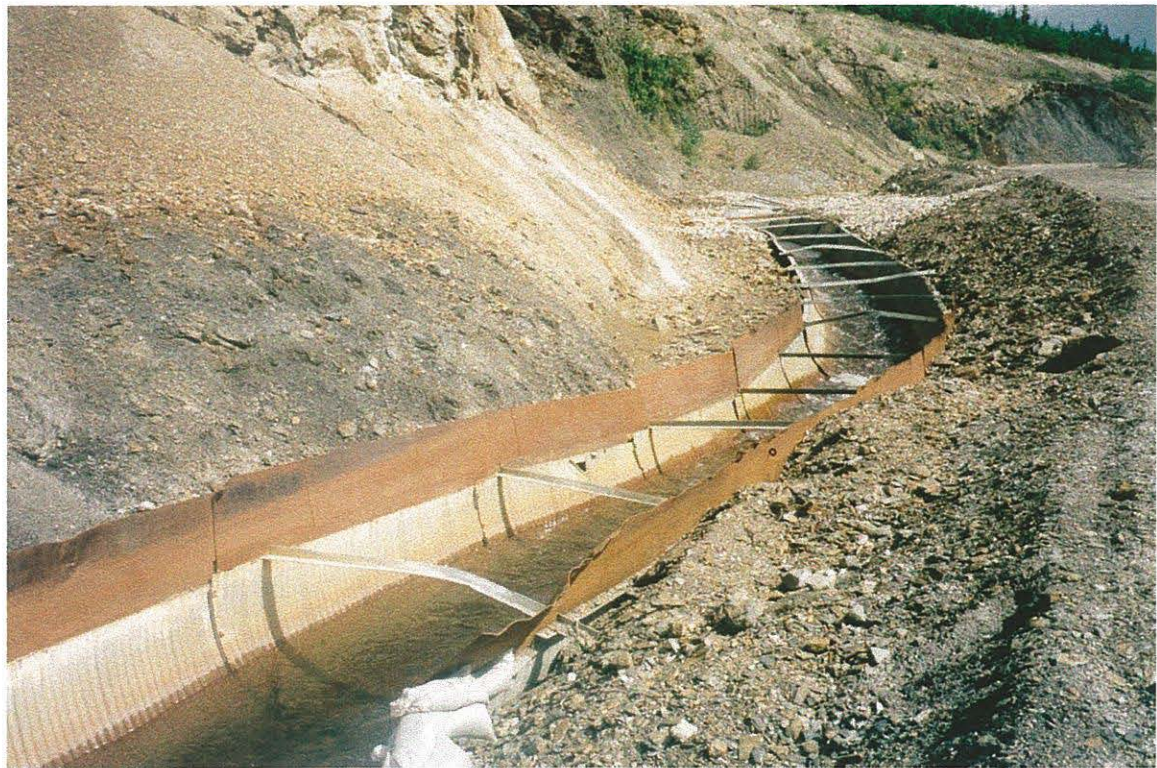
VIEW OF THE METAL SIDE WALLS BEGINNING AT SECTION #48.

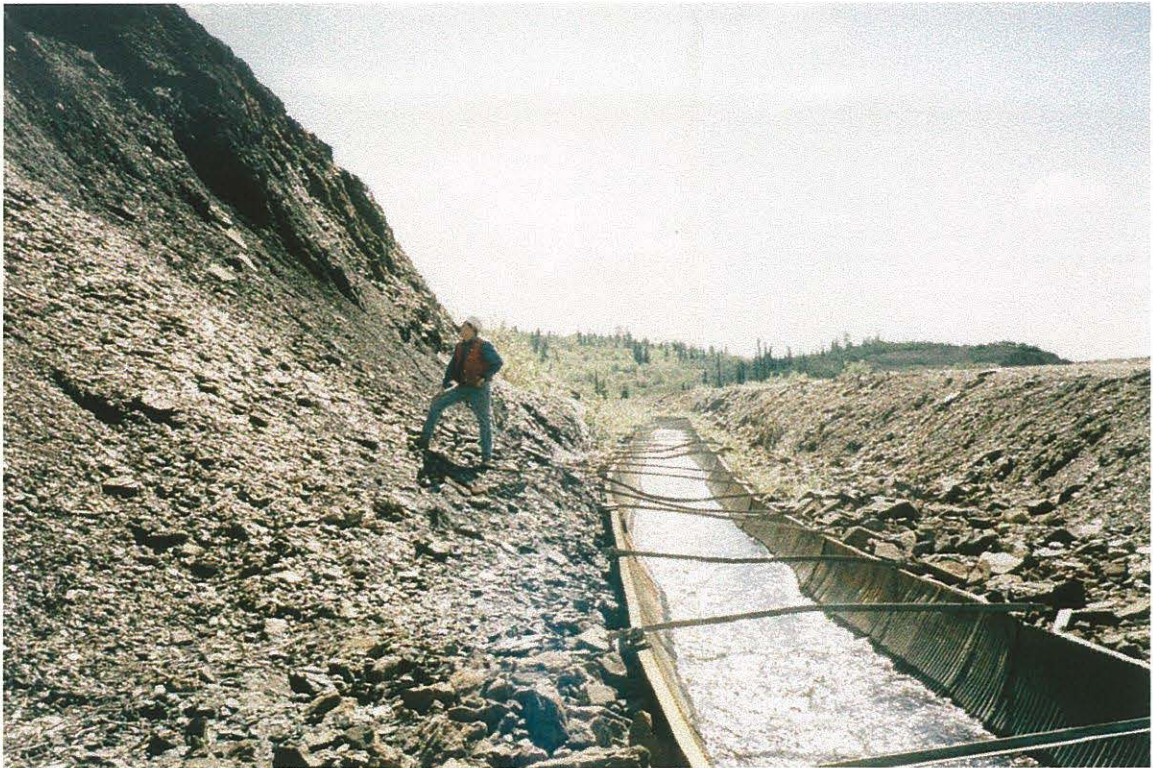
VIEW OF THE TALUS SLOPE CREATED BY WEATHERED PHYLLITE.

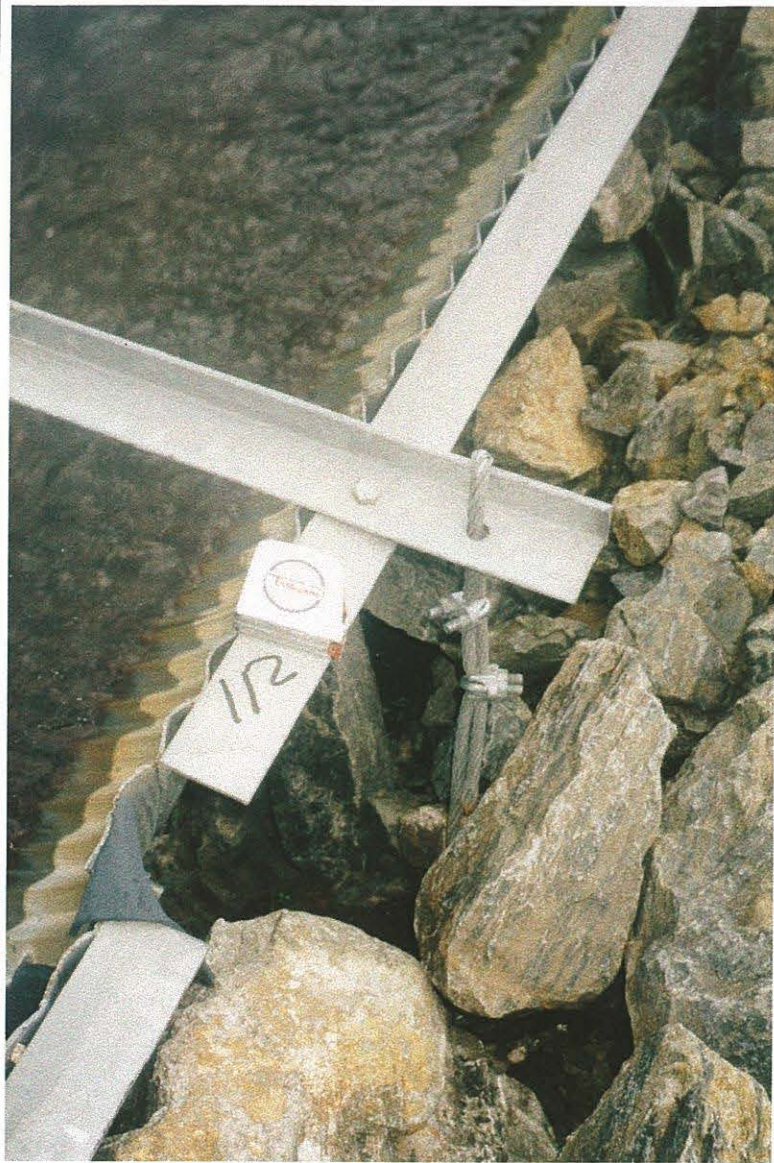
VIEW OF THE TIE-DOWN DETAIL AT SECTION #112.

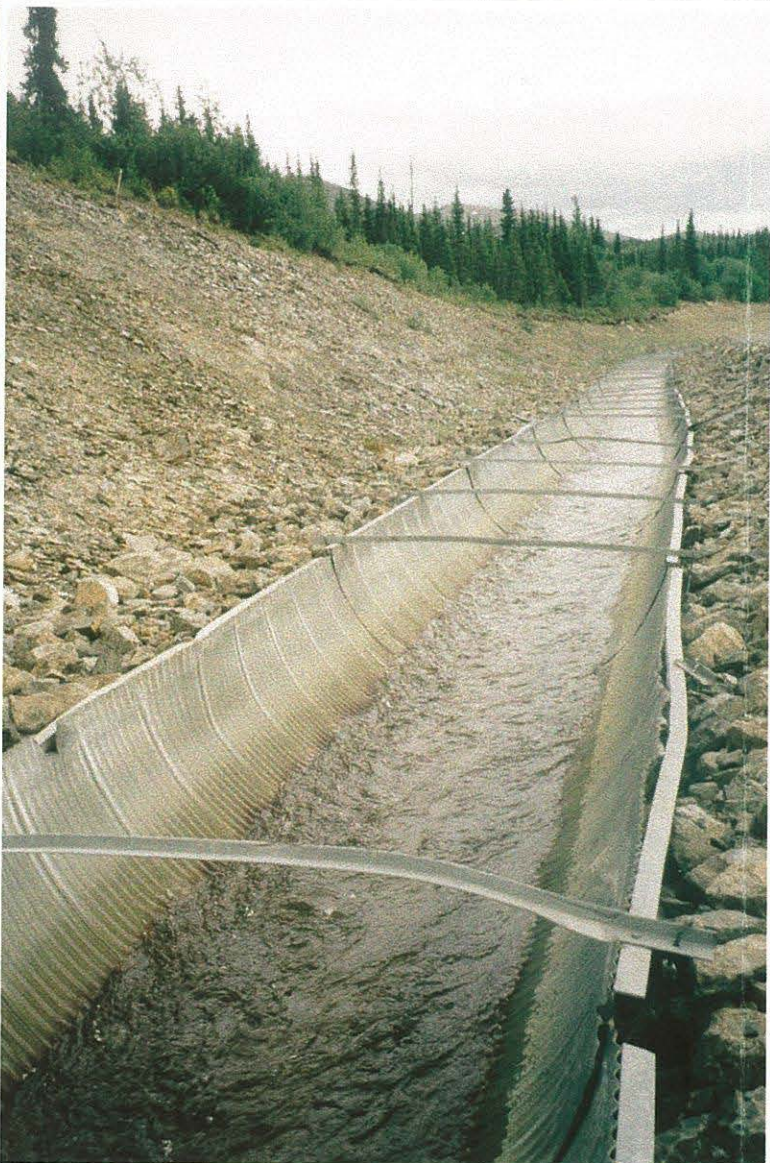
VIEW OF THE FLUME FROM SECTION #107.

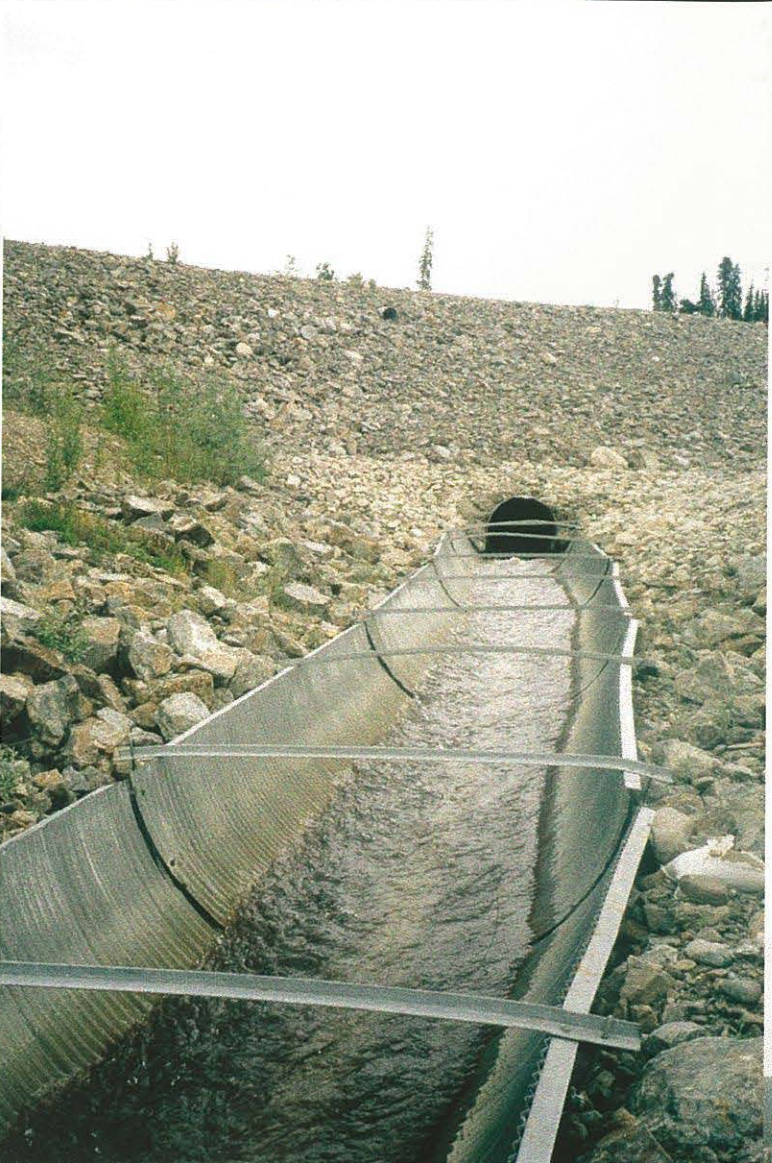
VIEW FROM SECTION #148 UP TOWARDS THE DIVERSION DAM.

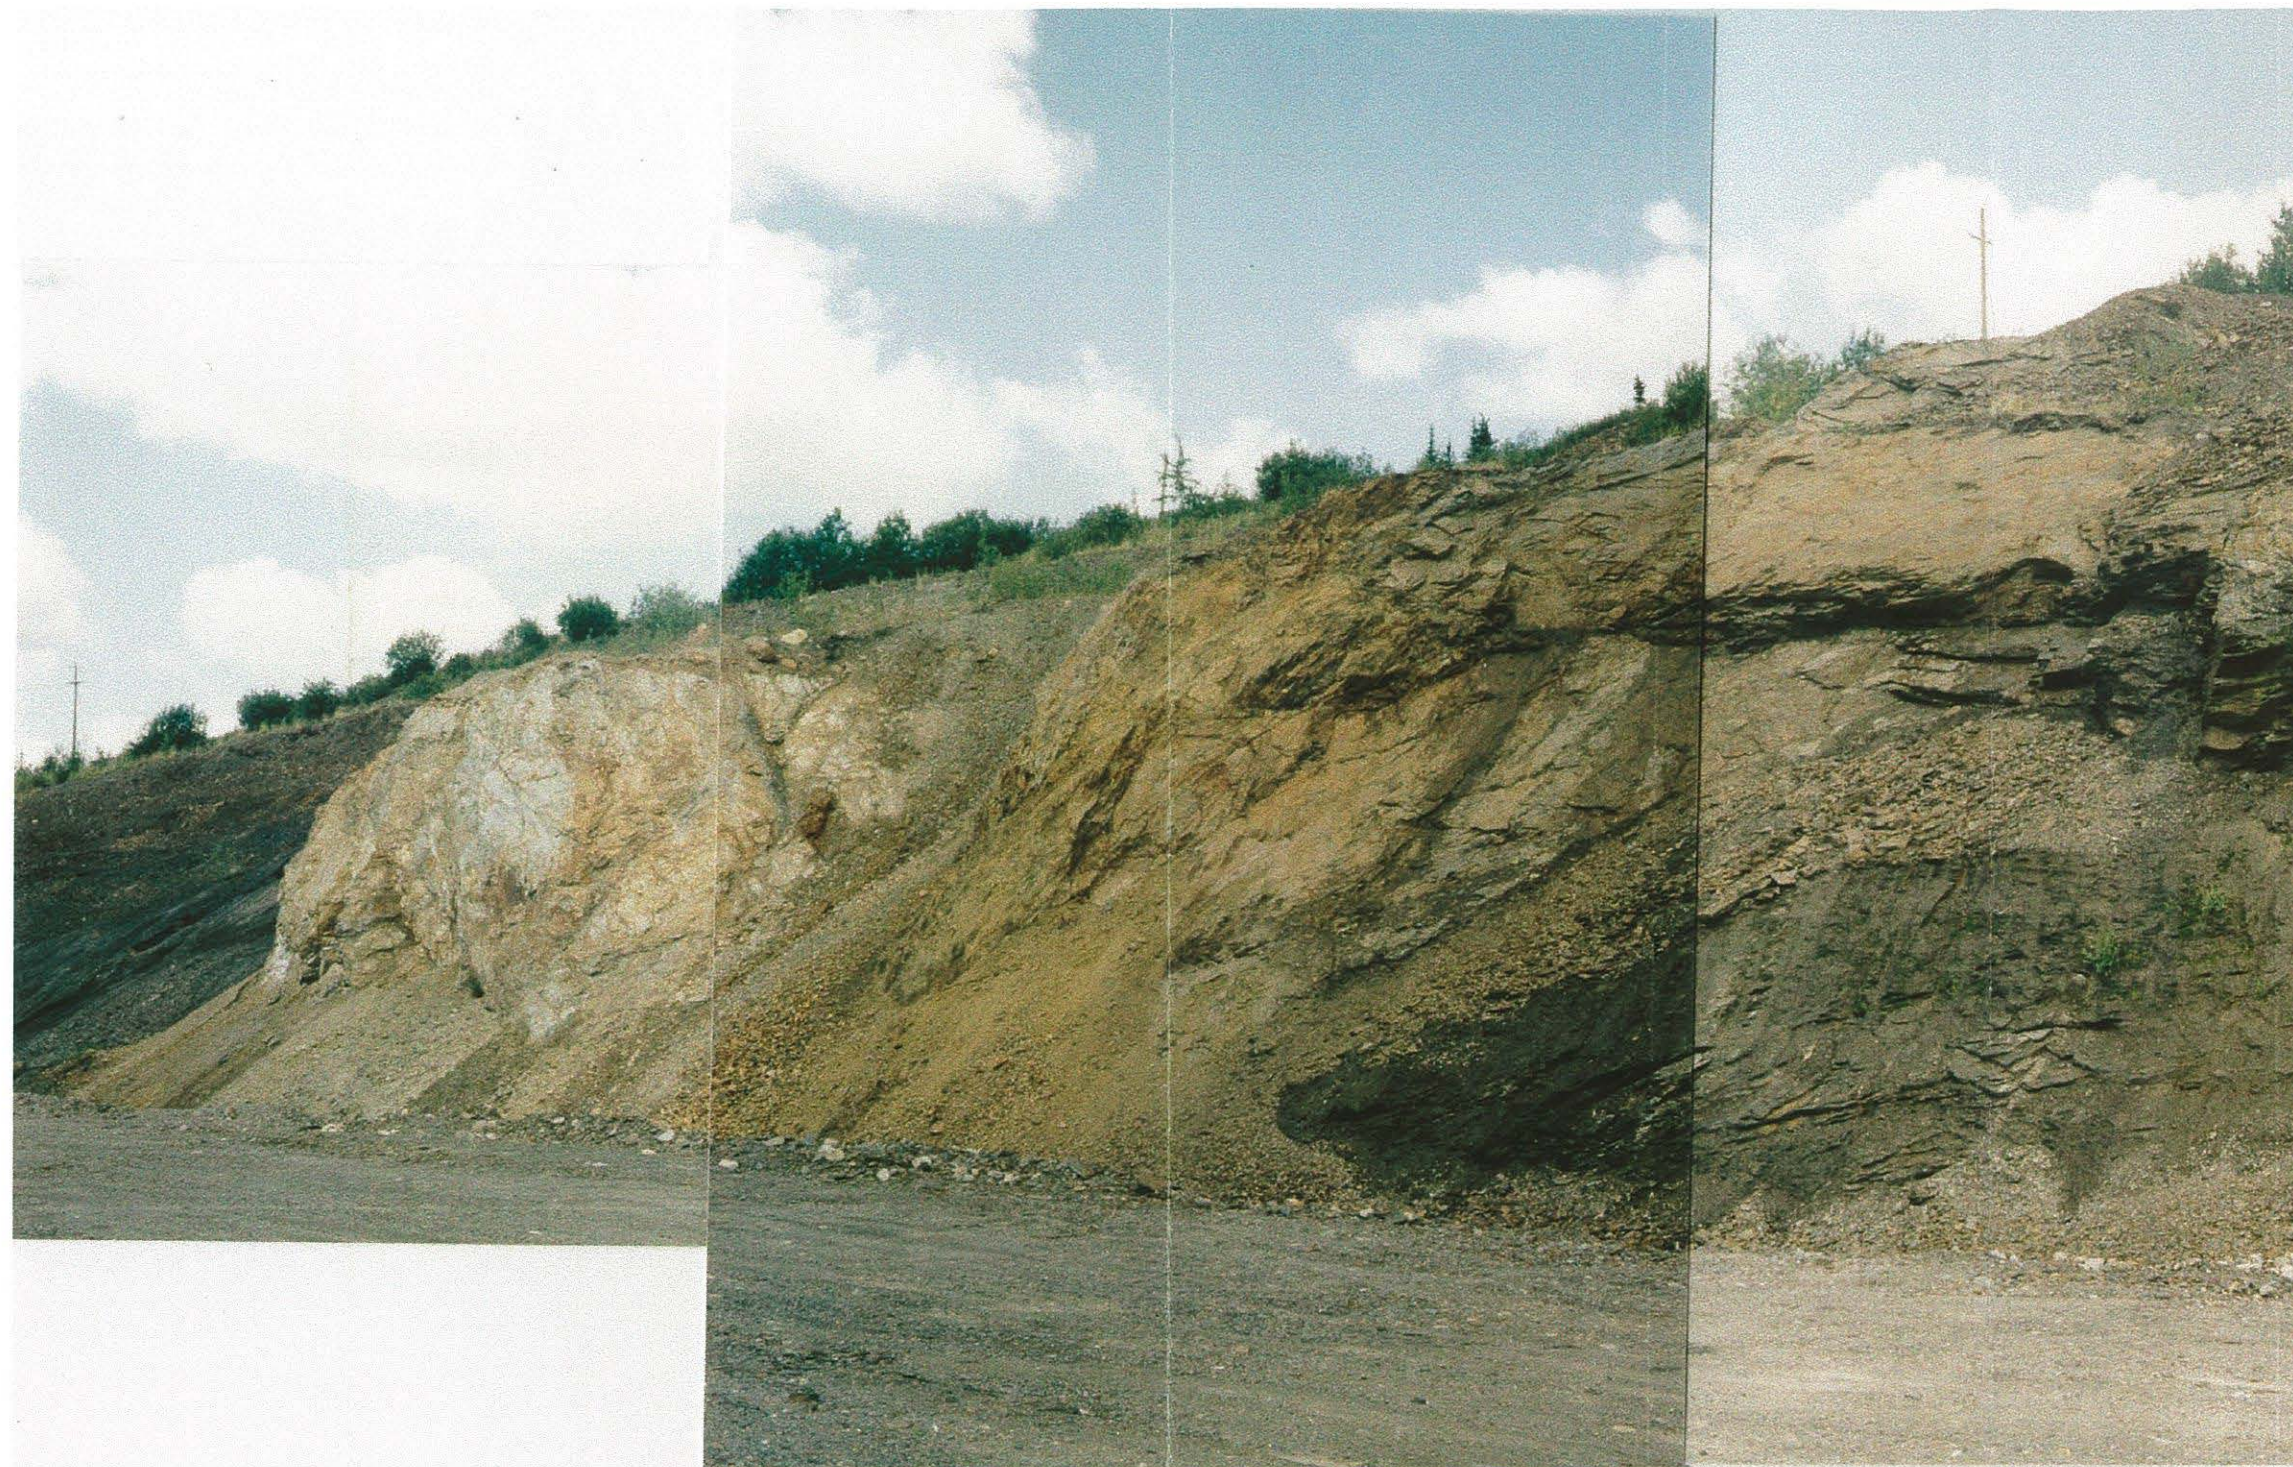
The first rock slope encountered, moving upstream from the plunge pool has been designated Zone 1, this zone includes the area which generated a large rockfall in 1999. Photographs of Zone 1 are shown in Figure 7. Zone 1 is approximately 95 m in length and extends from flume Section #46 to Section #62. The slope is approximately 10 to 12 m high and is composed of a graphitic phyllite with well developed foliation planes and joint sets. Some seepage was noted in the area of the detachment zone of the 1999 rockfall and also to the east of that area.

↑ AREA OF 1999 ROCKFALL ↑

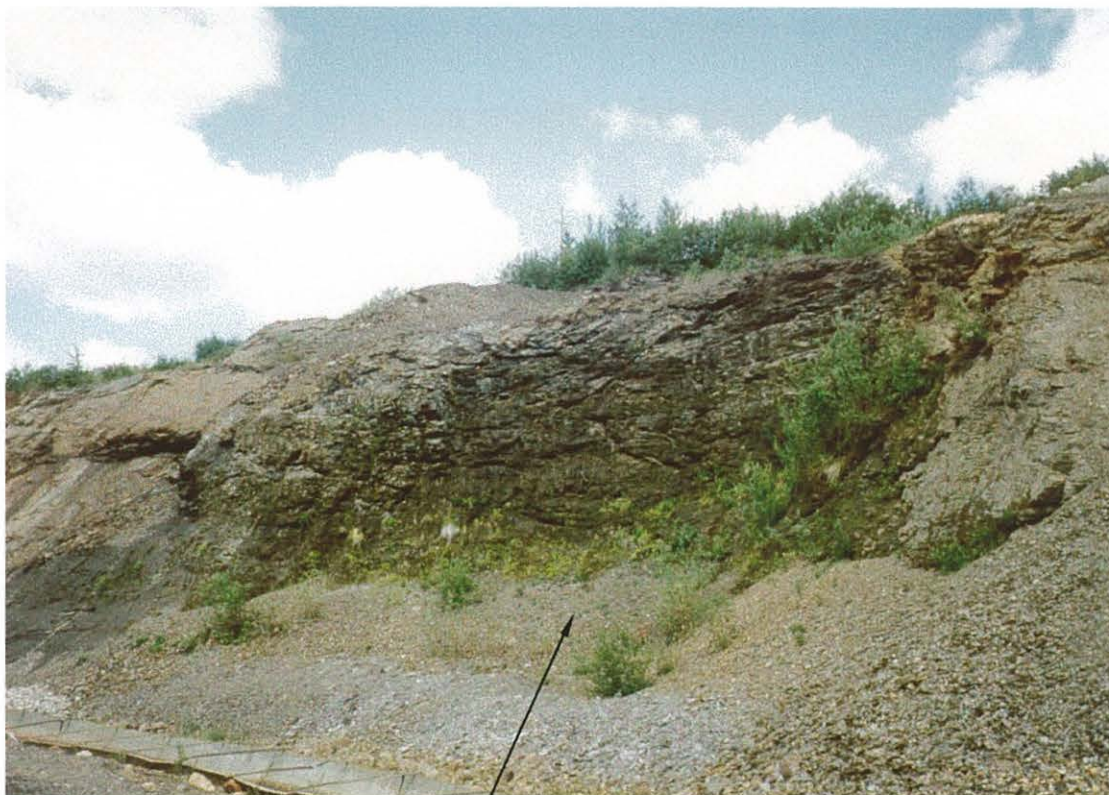
NOTE: NATURAL CATCHMENT
AREA FORMED AT THE
BASE OF THE SLOPE

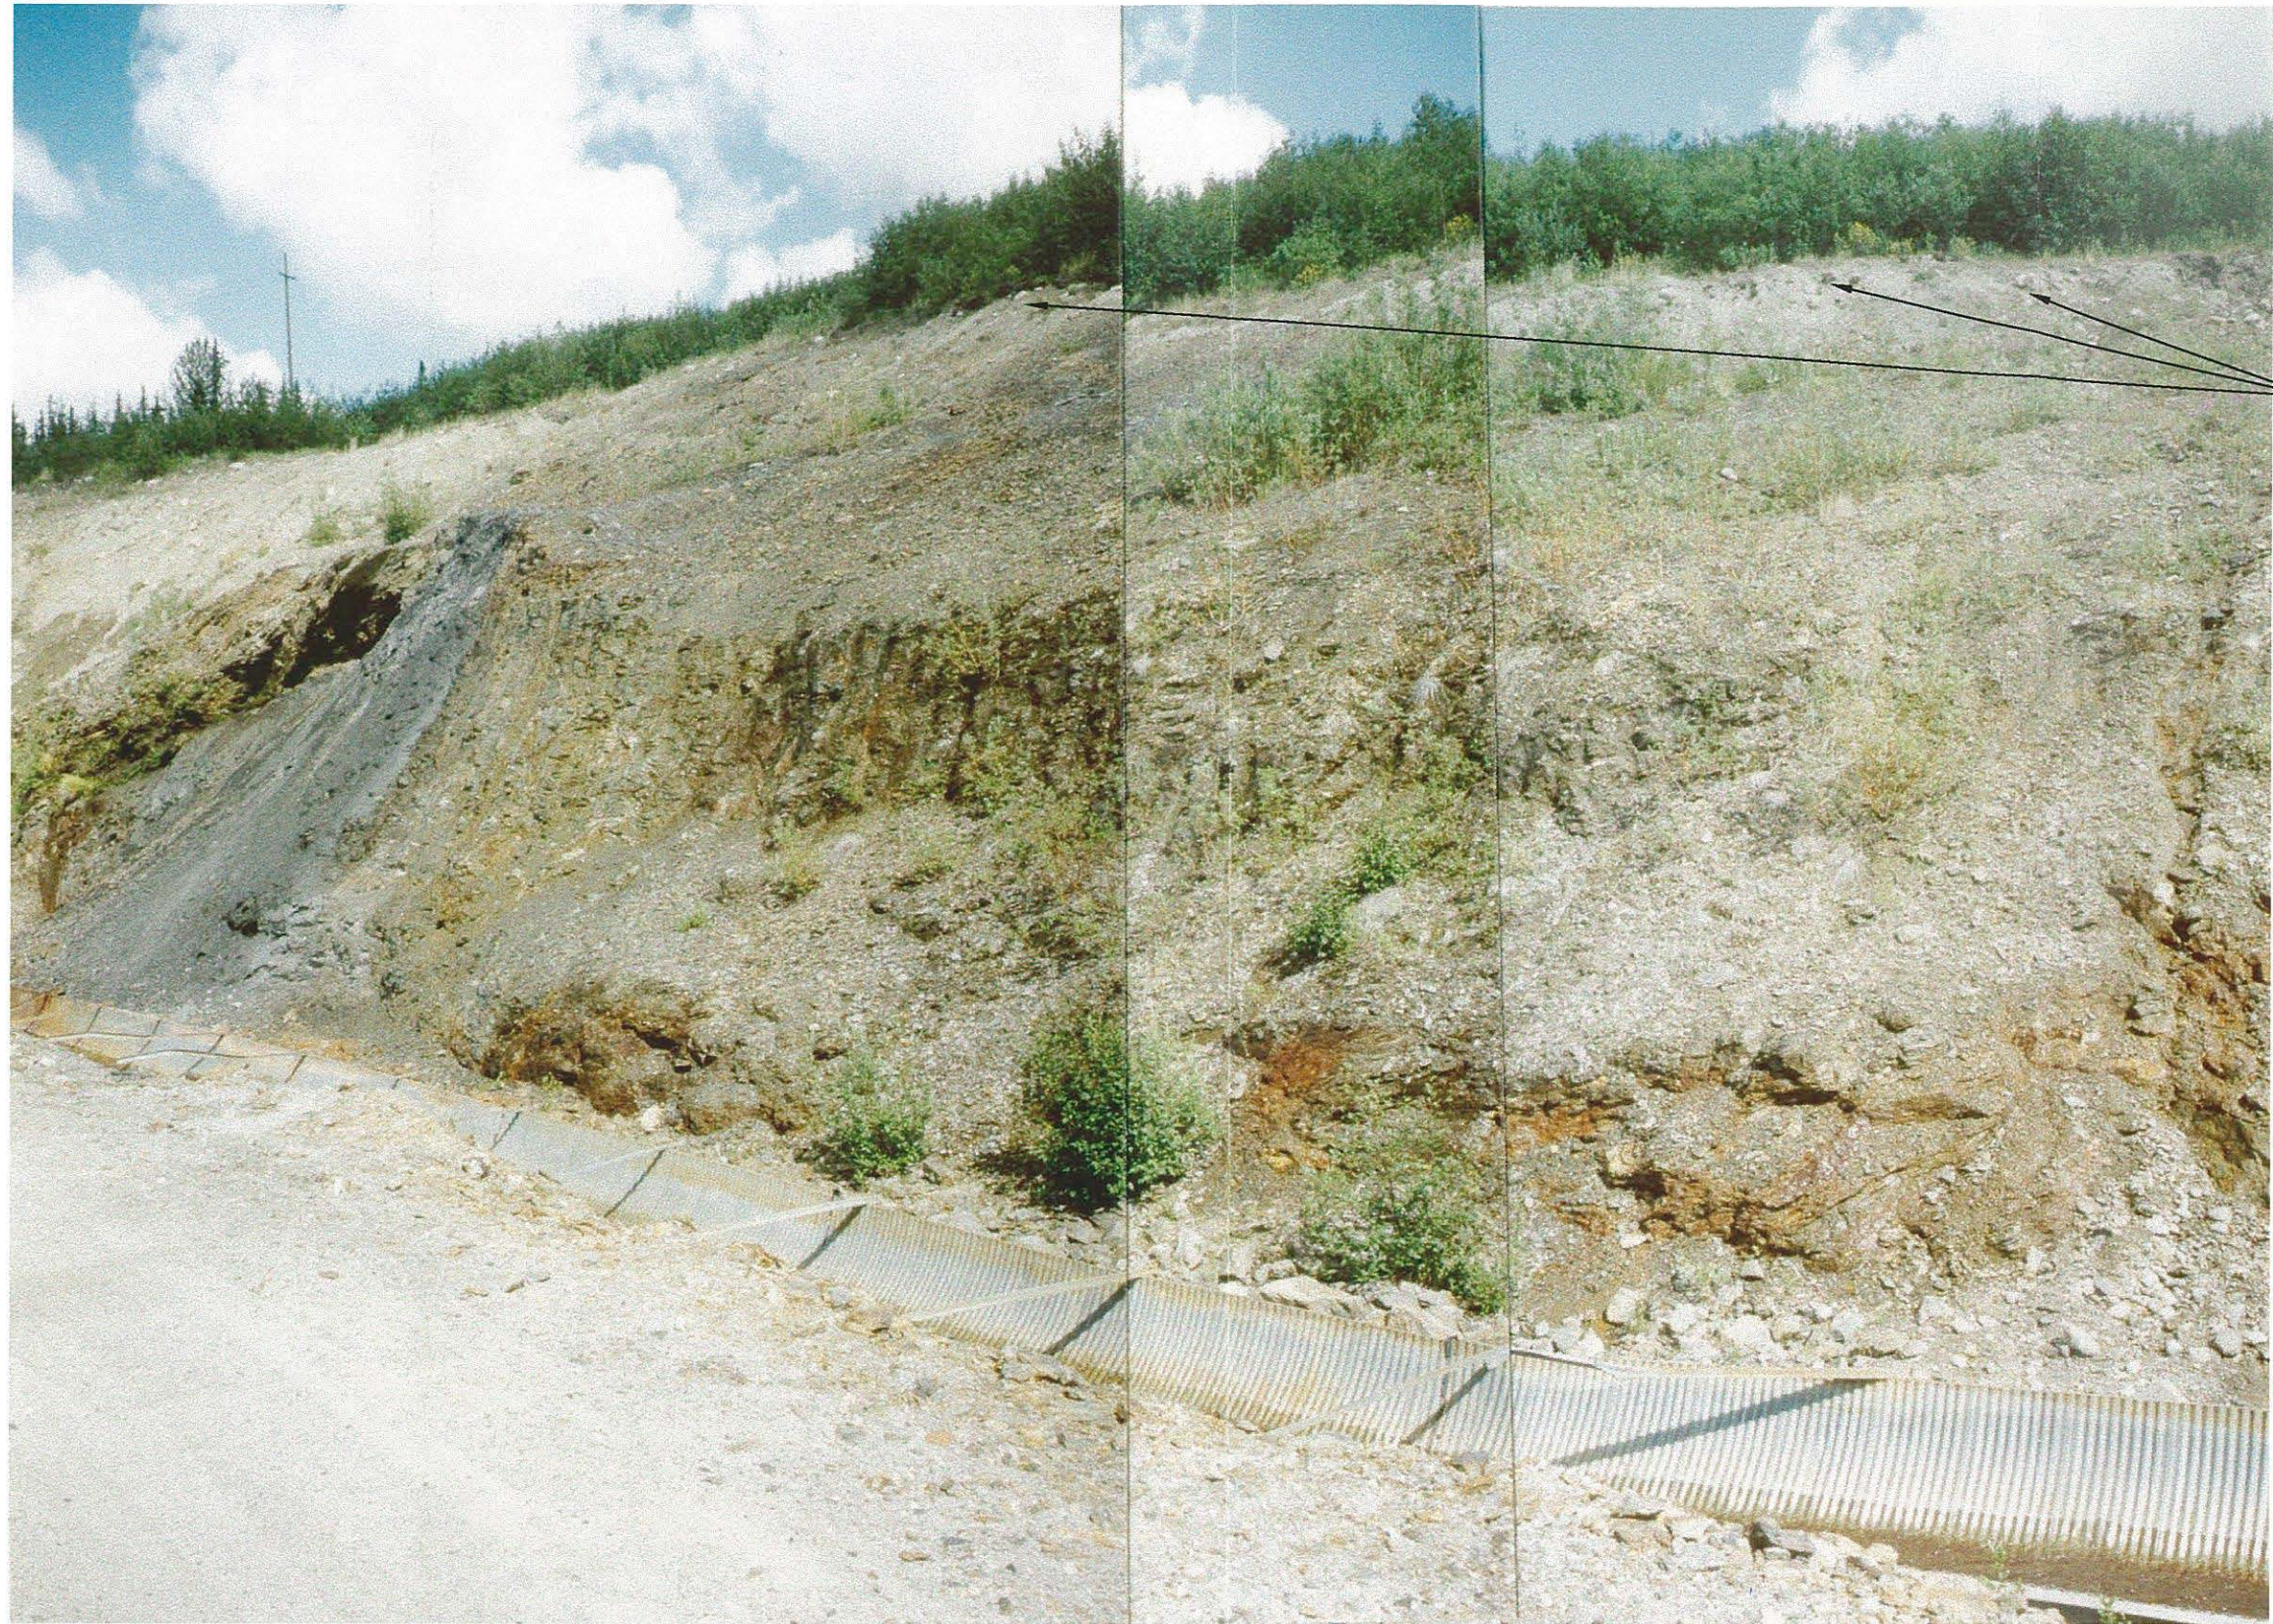
NOTE: ROUNDED
BOULDERS AT TOP
OF THE SLOPE.

The boulders that are imbedded within the sandy till at the top of the slope will continue to be undermined by erosion and could reach the flume in individual rockfall events. The boulders could damage the flume walls or cross-braces, but are not likely to block the passage of water. Therefore, the owner could accept the risk of this potential damage (and resultant repair work and cost), or the following remedial work could be undertaken.

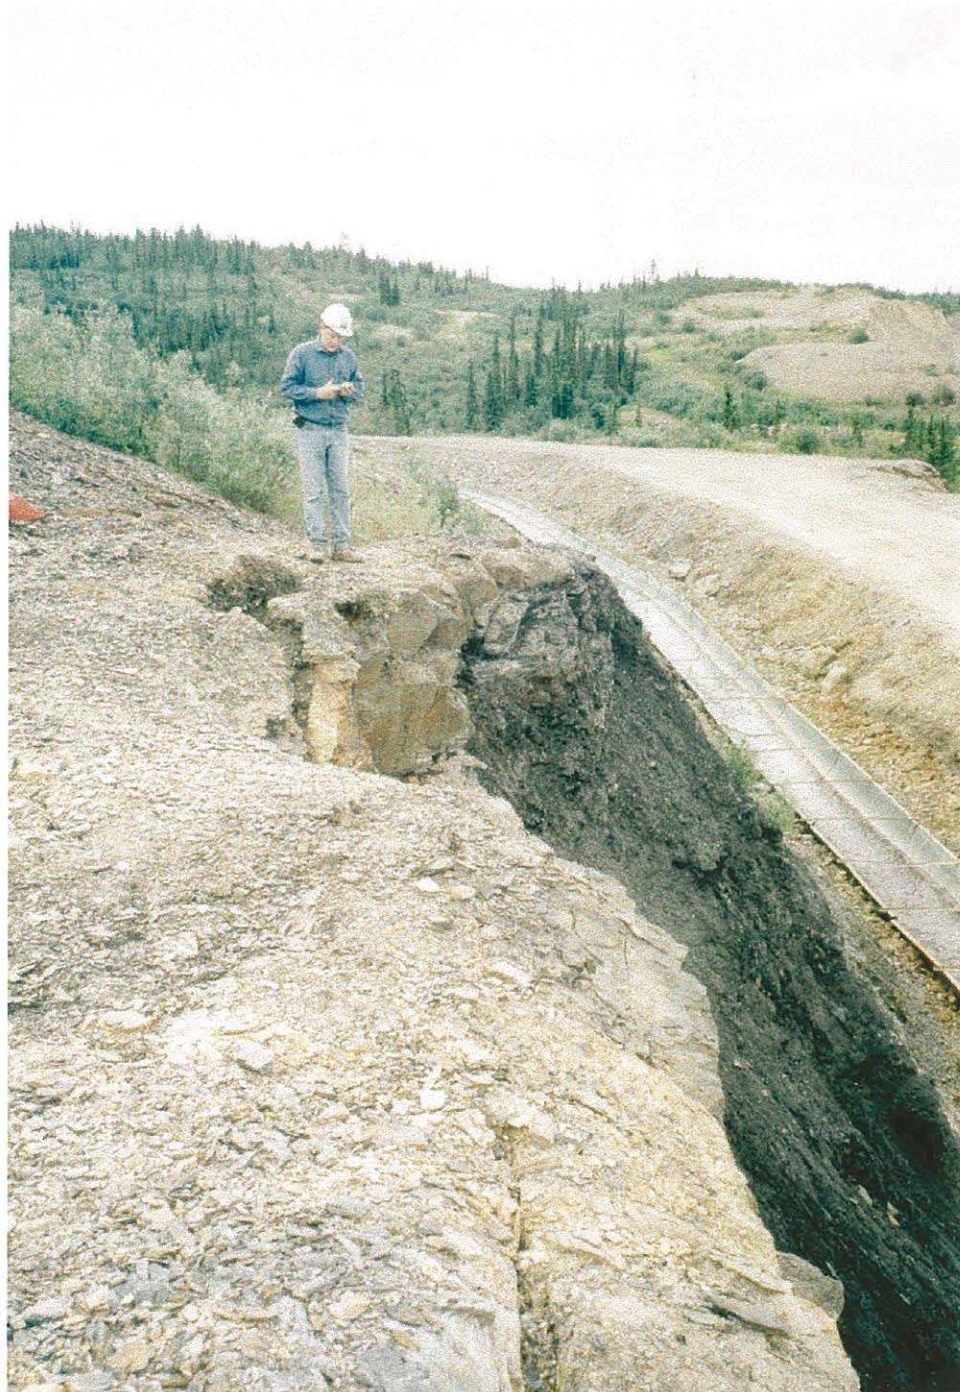
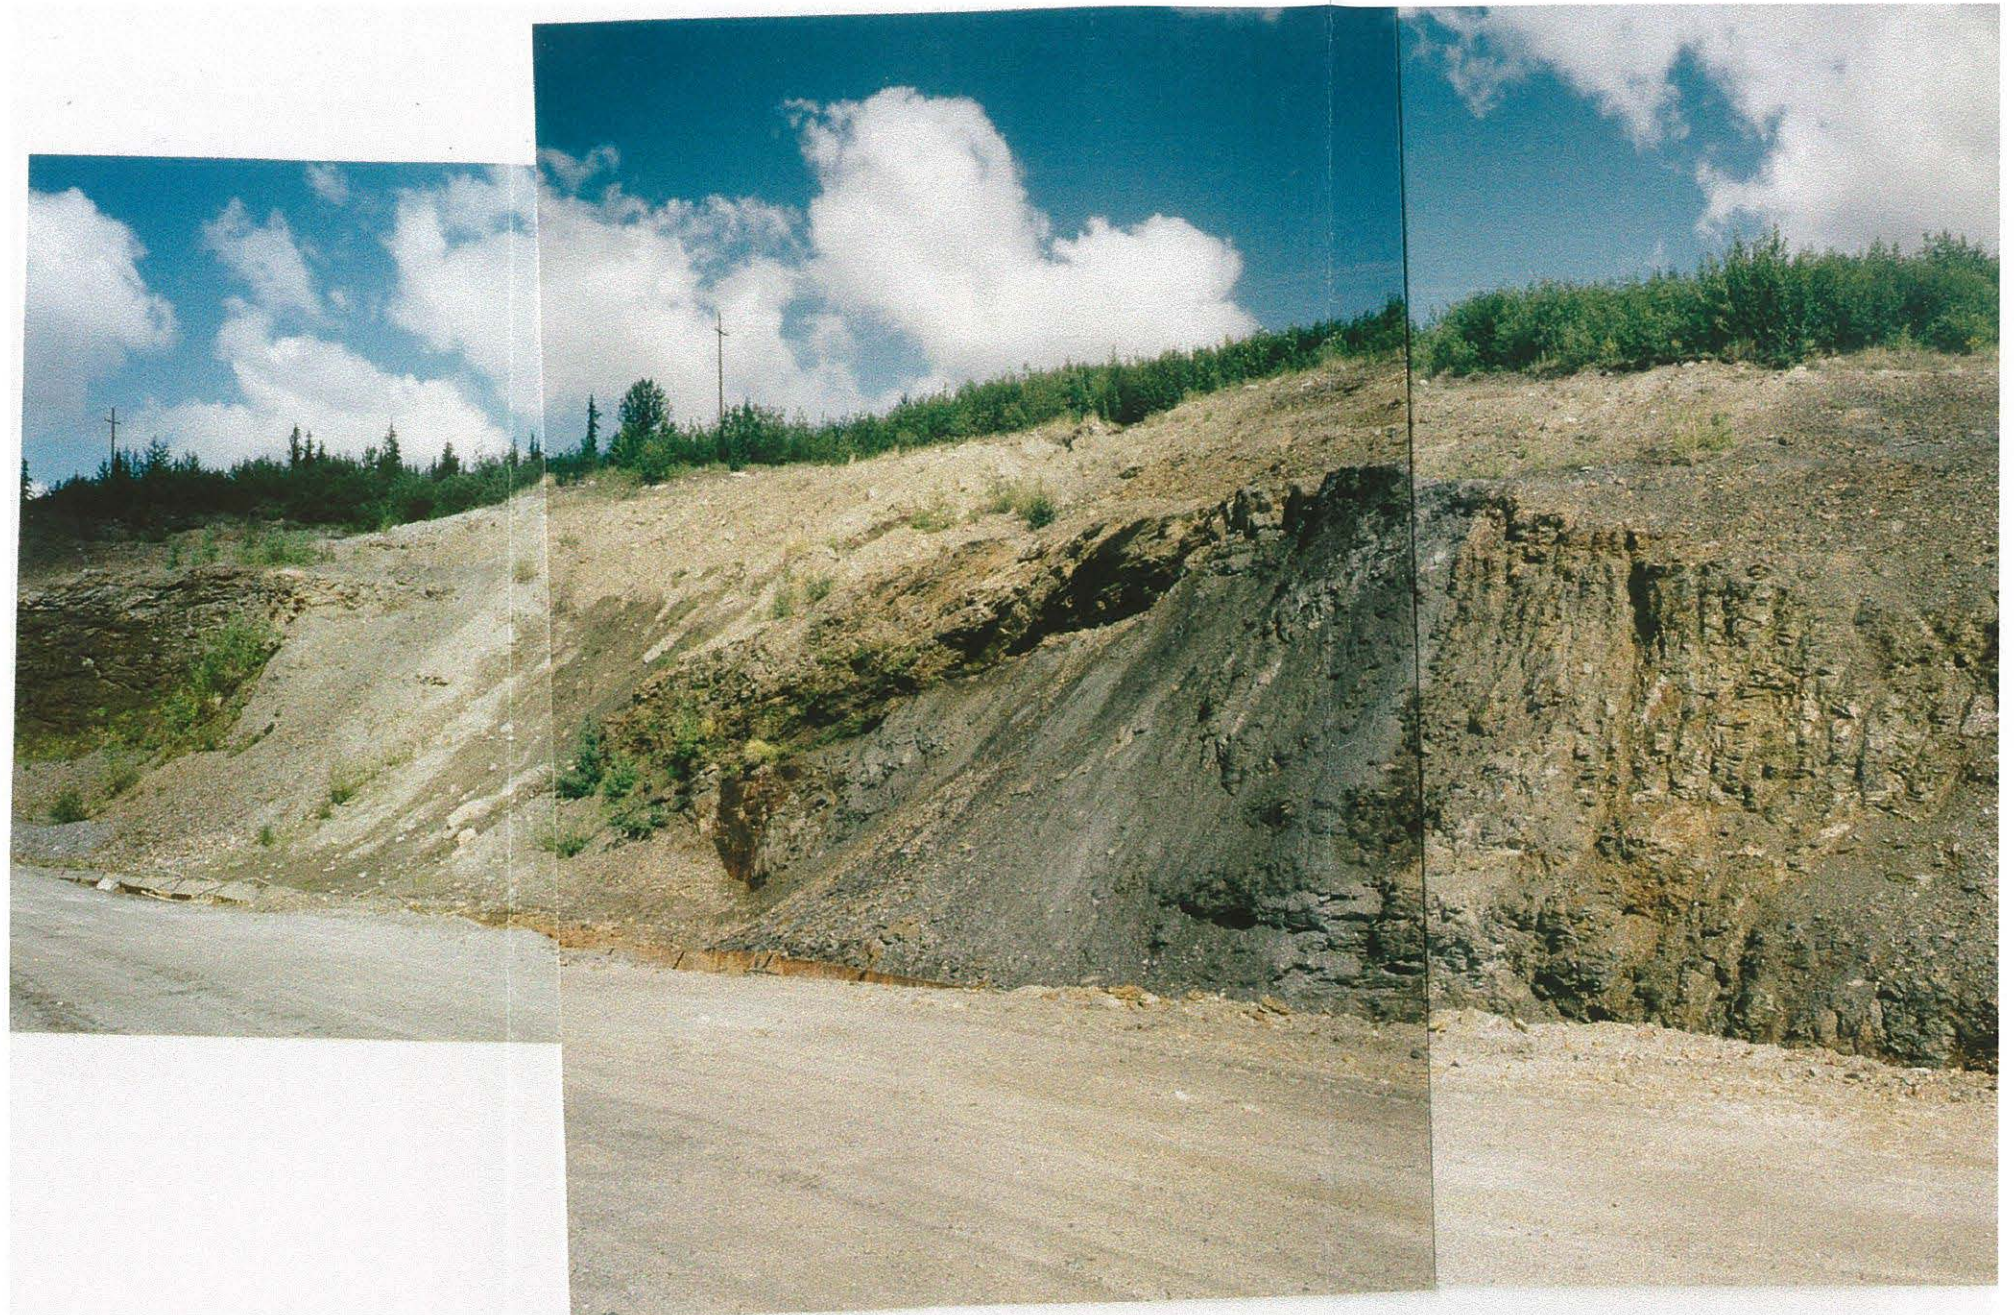
Zone 4 is composed of a dark gray to black carbonaceous phyllite with a talus fan at the base. The talus fan development is encroaching on the flume. Zone 4 is approximately 25 m in length and extends from Section #73 to Section #77. A band of more competent rock, approximately 2 m in thickness, is visible at the top of the slope. The raveling process, forming the talus slope, is undercutting the more competent rock and several tension cracks are visible 1 to 2 m from the crest edge. A panorama of the slope and a view of the tension cracks are shown in Figure 10. Some seepage was observed at the toe of the slope.

NOTE: TENSION CRACK
FORMED IN UPPER MORE
COMPETENT MATERIAL

ZONE 4 – POTENTIAL ROCKFALL SOURCE AREA.
– BAND OF COMPETENT ROCK BEING UNDERCUT BY DEBRIS.
– DEBRIS CONE ENCROACHING ON DIVERSION FLUME.

The talus slope that is encroaching on the flume in Zone 4 is not expected to damage or block the flume. The undercut band of competent rock at the top of the slope may release rock of sufficient size to damage the flume, although blockage of the channel is not expected. Impact from rockfall is expected to be relatively low energy, as the talus slope will ensure the rocks are rolling and not bouncing as they move down the slope. Again, the owner could accept the potential risk or the following remedial work could be undertaken.

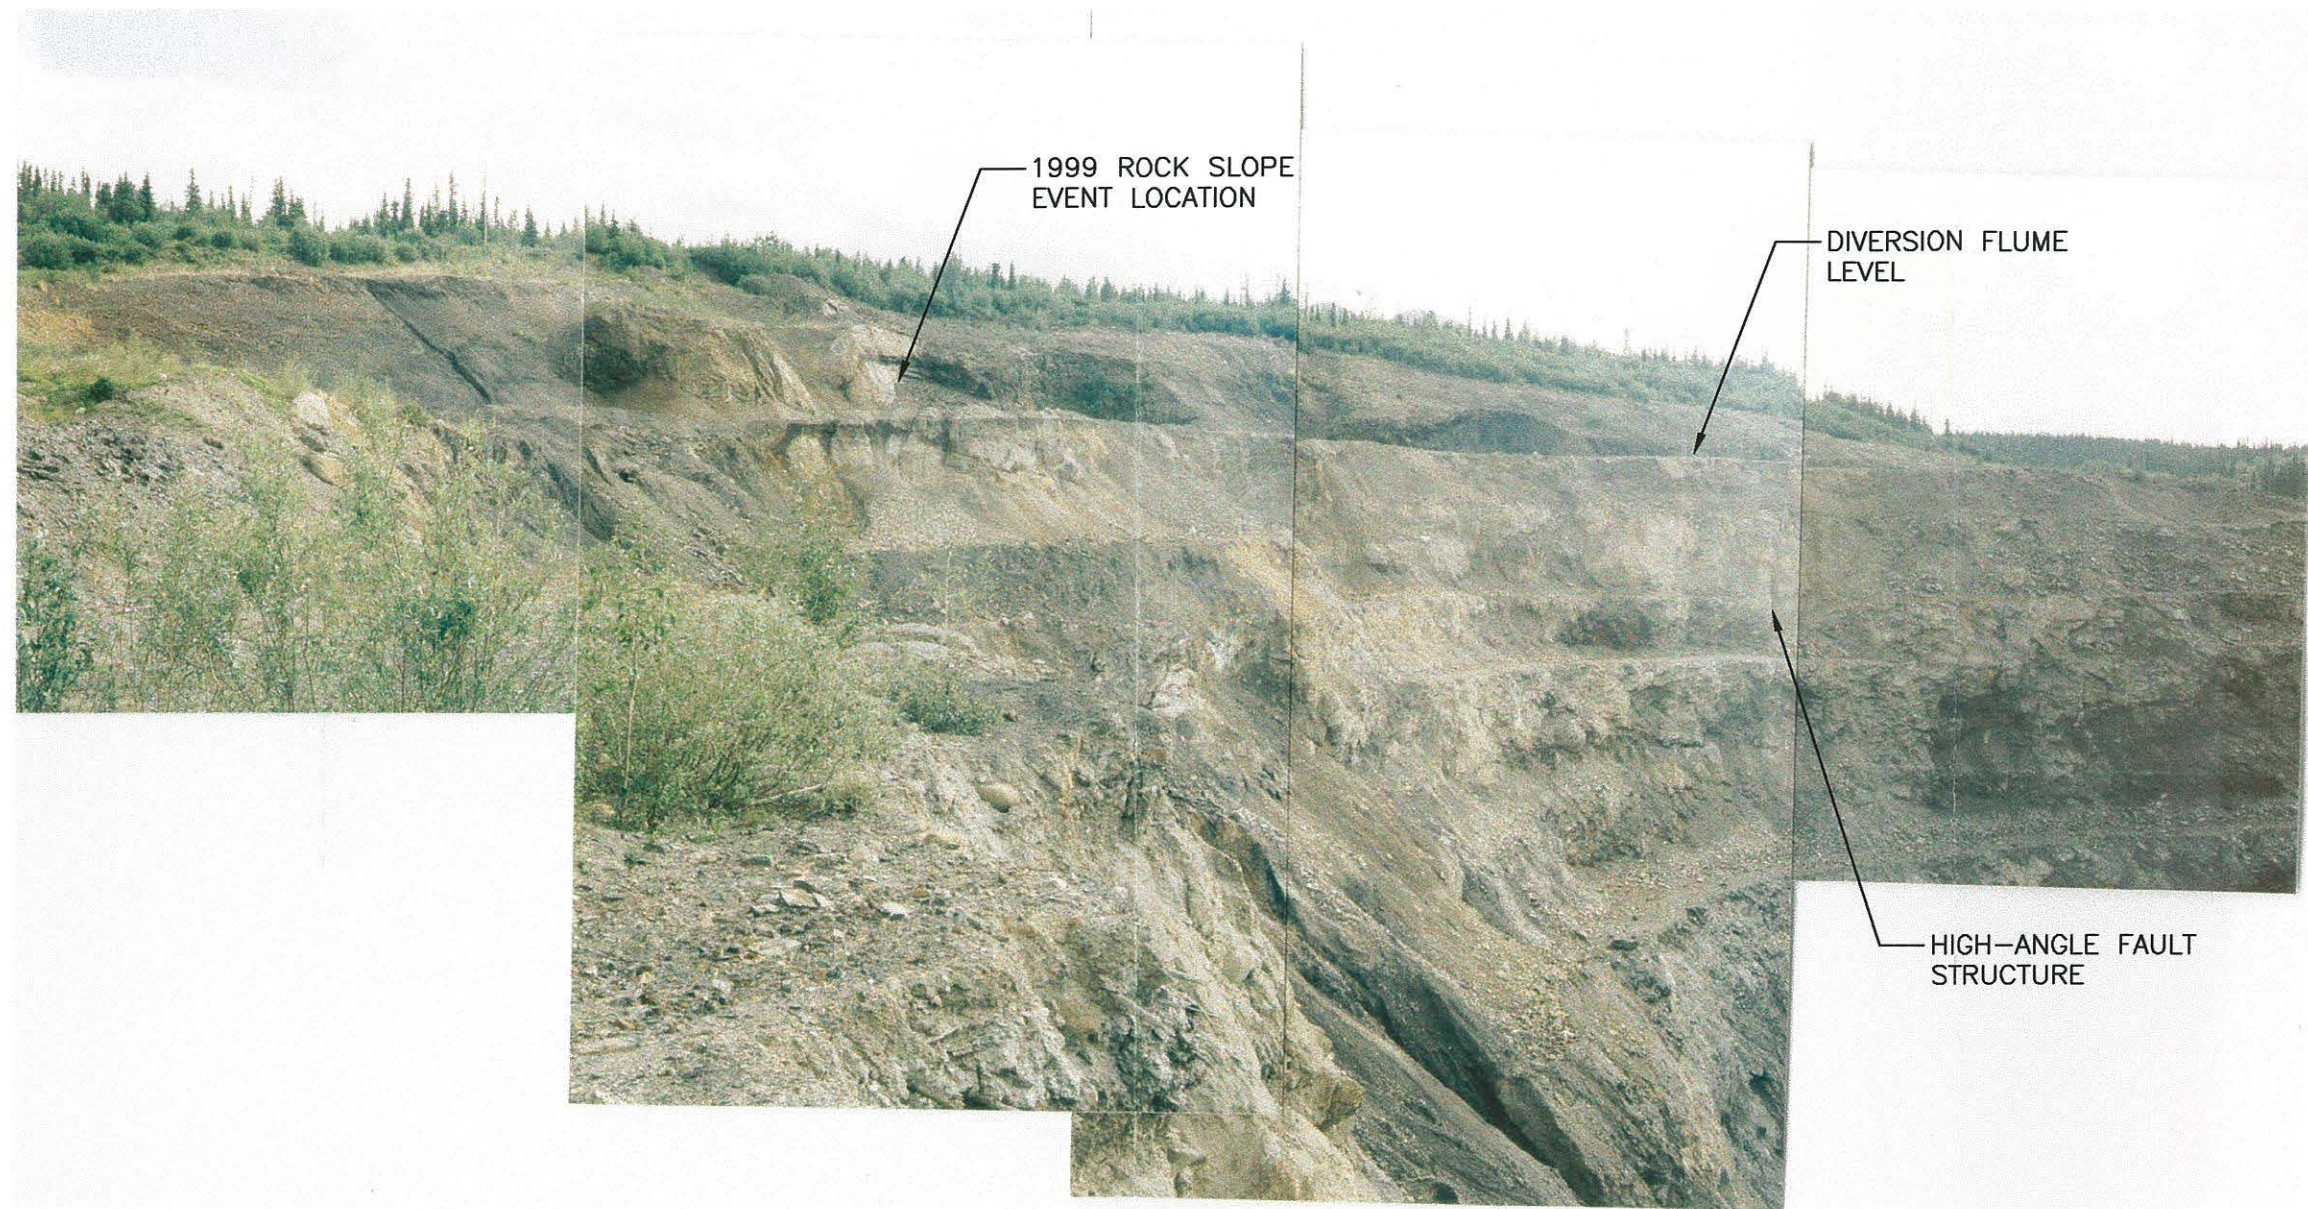
At present, the pit slope is experiencing widespread raveling and many of the catch benches have been filled with debris. A panorama of the slope is shown in Figure 12. Other than the bench scale failures, no evidence of large-scale distress such as cracking at the crest, or bulging of the slope was noted. On-site personnel have not noted any signs of large-scale slope deformation or reported any unusual maintenance requirements for the access road located between the flume and the pit.

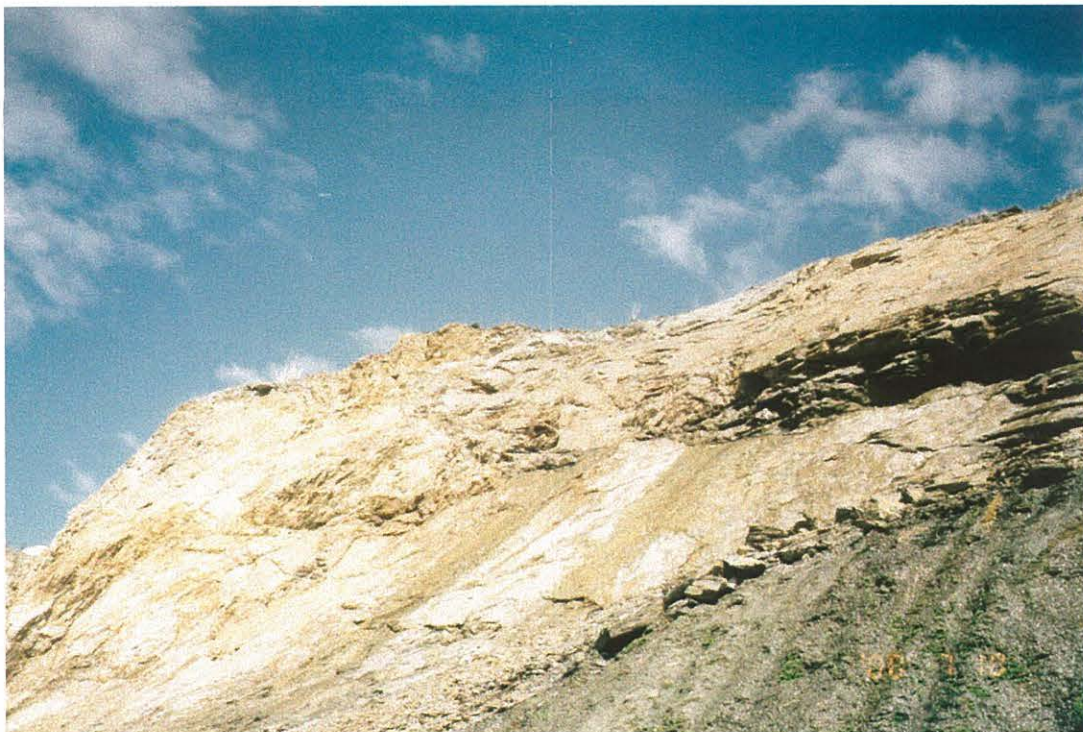
It is interpreted that the 1999 rockfall occurred as a wedge failure along the basal foliation plane, joint set 1, and the detachment foliation plane, joint set 2. The orientation of the foliation planes and slope face are shown in Figure 11. The wedge formed by joint sets 1 and 2 did not fail as an intact block, but rather was truncated along a joint dipping back into the slope, joint set 5. It appears that sliding took place predominantly along the basal foliation plane, and this plane appears to be continuous up to the top of the slope. The upstream side of the 1999 wedge failure released along steeply dipping joints that trend into the slope, joint set 4. Photographs of the 1999 rockfall source area are shown in Figure 13. In the lower photograph in Figure 13 the person is standing on the basal foliation plane and pointing to the intersection with the detachment foliation plane. The repeating joints forming the backscarp of the failure can be seen at the top of this photo, and the joints forming the side release can be seen to the far right of the photo.

LOCATION OF 1999 INSTABILITY
