DELOITTE & TOUCHE INC.
**EVALUATION OF SHORT TERM
MANAGEMENT OPTIONS**

**VANGORDA DIVERSION FLUME
FARO MINE, YUKON**

PROJECT NO.: 0257-002-03
DATE: NOVEMBER 20, 2000

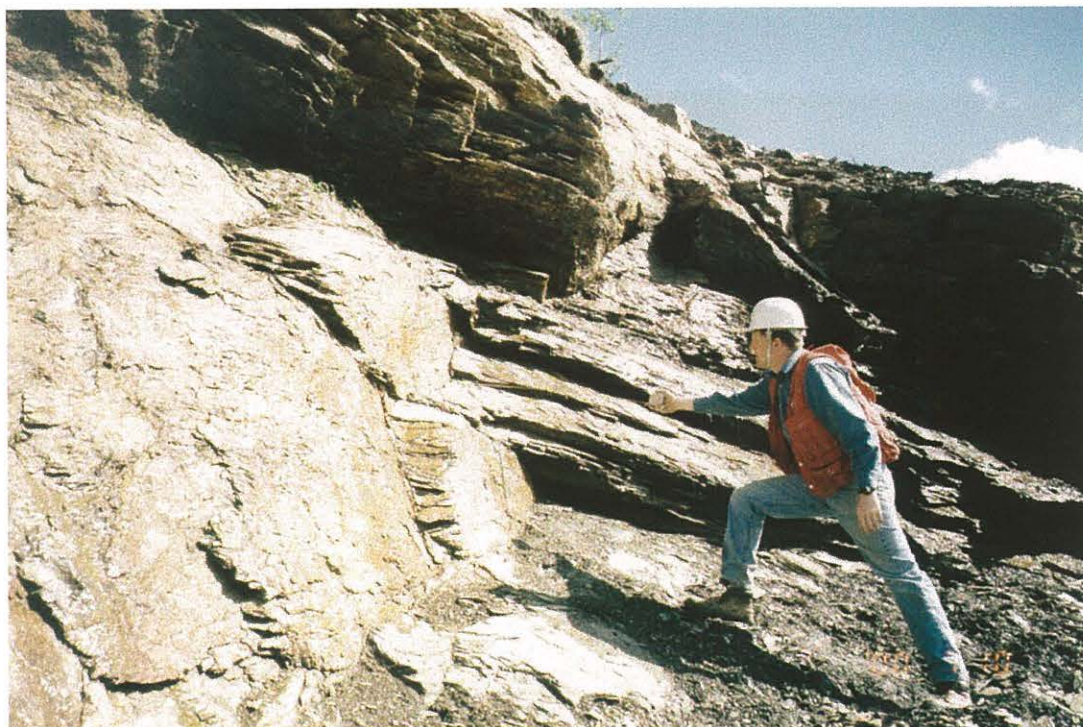
CLOSE UP OF DISCONTINUITIES BOUNDING 1999 INSTABILITY
