MN  
R 199

**EVALUATION OF THE  
MOUNT NANSEN MINE  
SURFACE PLANT, WATER SYSTEM AND MILL FACILITIES  
CARMACKS, YUKON TERRITORY**

**PROJECT NO. 1338-100**

**NOVEMBER, 1984**

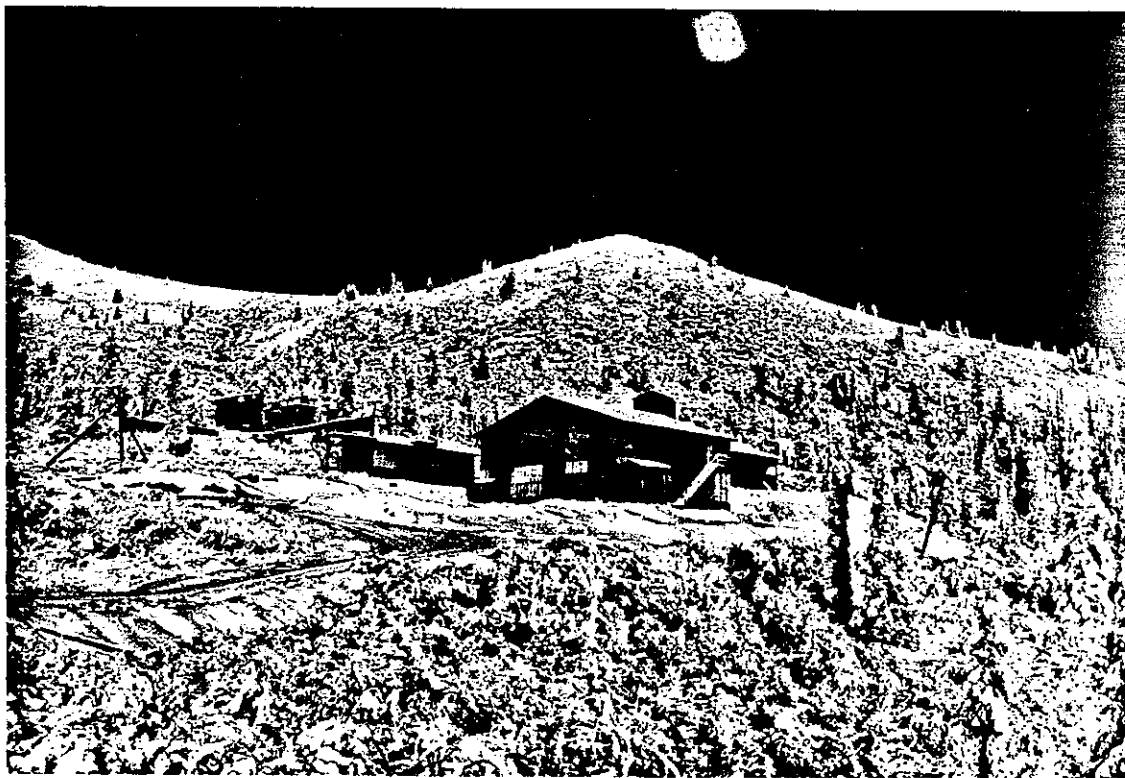
*OFFICE BUILDING*

Item	Description	Estimated Value	Comments
1.1.	Concrete foundations	30,000	Heating plant included.
1.1.1	Insulated building frame and partitions	38,400	Part of insulation, side paneling, floor decking missing (stripped).
1.1.3	Roofing	2,400	Roofing past guarantee period.
1.1.4	Finishes	10,000	Interior needs finishing and fixtures, windows and doors missing, exterior stairs to be repaired.
1.1.5	Services	10,000	Heating and lighting needs overhaul and replacement.

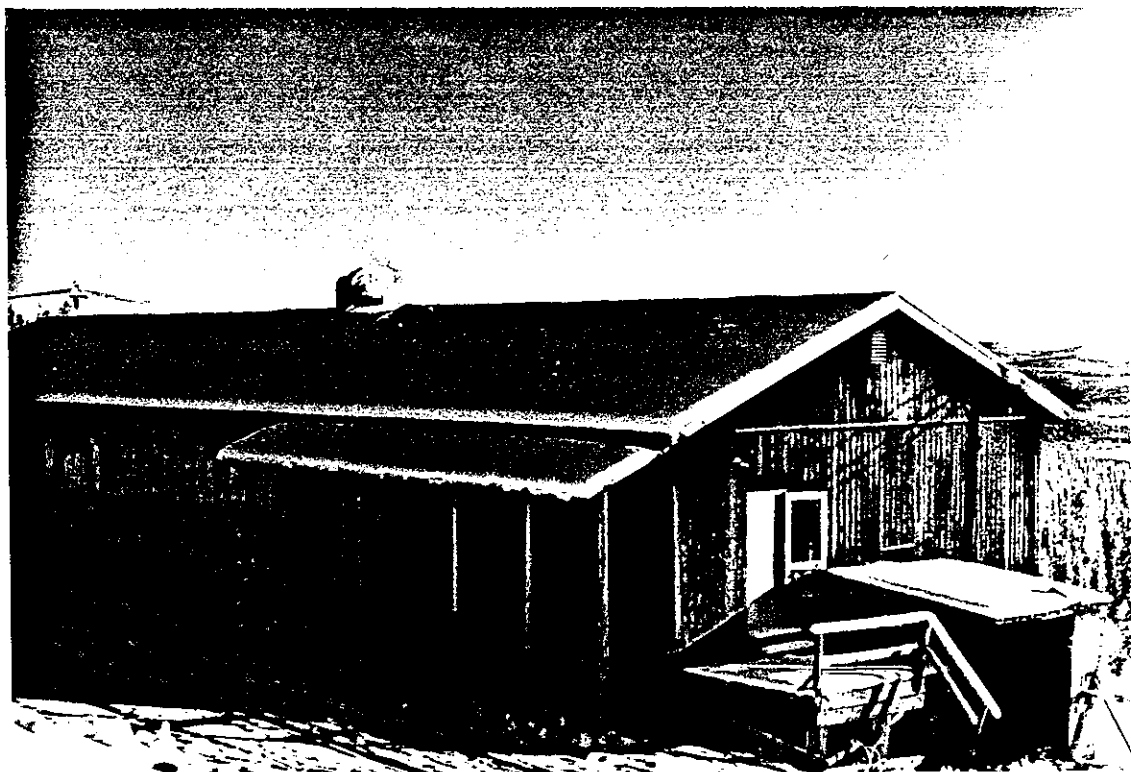
*COOKHOUSE*

<b>Item</b>	<b>Description</b>	<b>Estimated Value</b>	<b>Comments</b>
1.2.1	Concrete foundations	-	The whole bulding is stripped.
1.2.2	Insulated bulding, shell and partitions	24,000	Finishes and fixtures very minimal.
1.2.3	Roofing	1,800	Services have to be overhauled.
1.2.4	Finishes	3,600	This bulding is in the office complex area (up on the hill).
1.2.5	Services	9,000

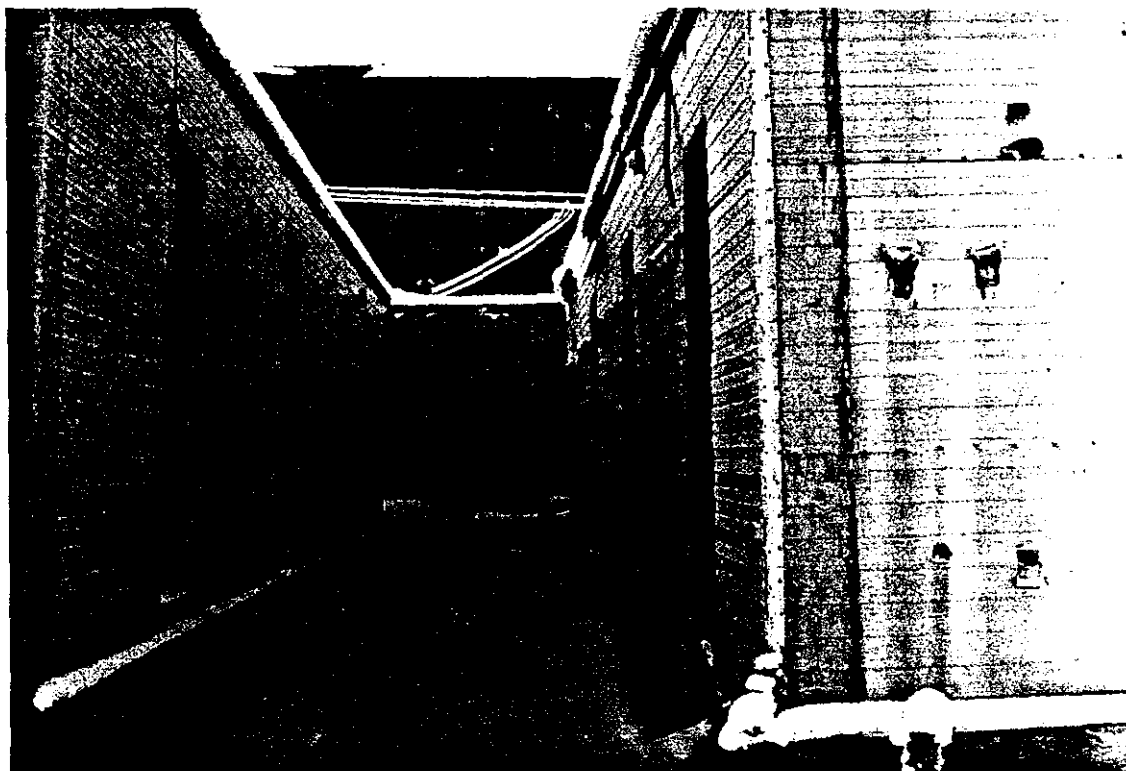
ASSAY OFFICE

<b>Item</b>	<b>Description</b>	<b>Estimated Value</b>	<b>Comments</b>
1.4.1	Concrete	9,000	This building is badly stripped. All services and finishes missing.
1.4.2	Building	9,000	
1.4.3	Finishes and services	-	
1.4.4	Equipment and supplies	-	No value.

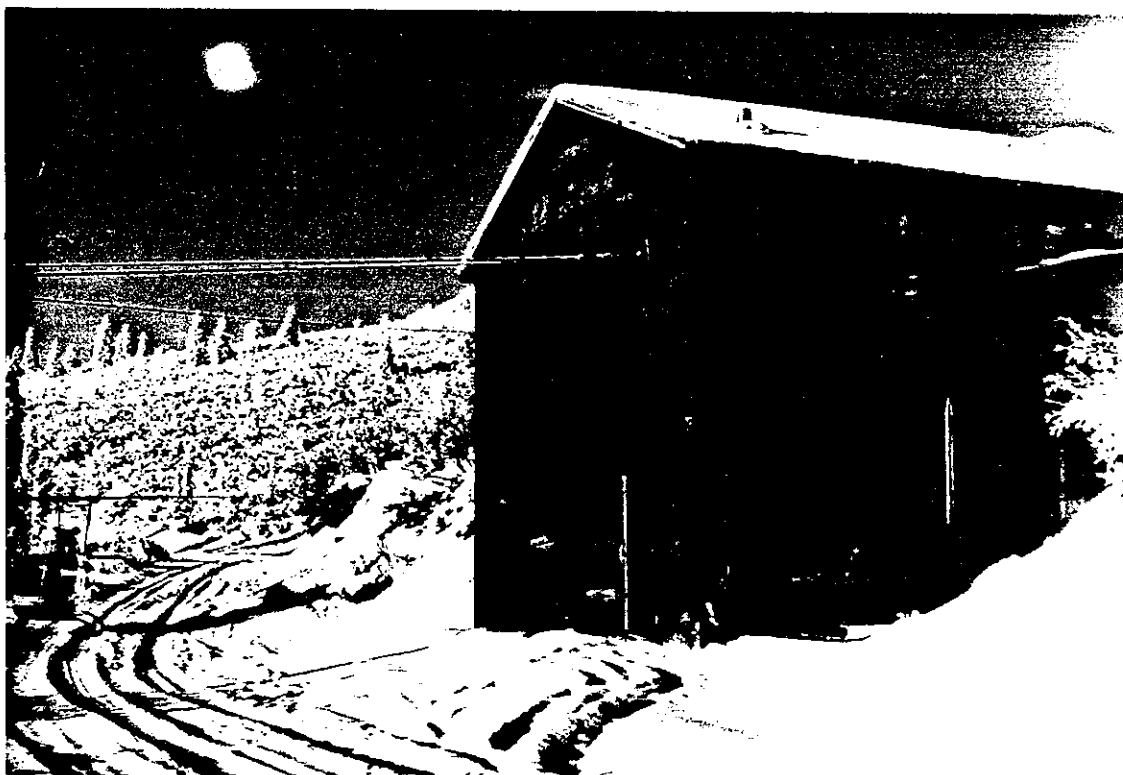
*TANKHOUSE*

Item	Description	Estimated Value	Comments
2.1.1	Concrete	13,800	Unfinished building, usable tank.
2.1.2	Building	14,900	
2.1.3	Tank	42,900	Wood stave tank in usable condition.
2.1.4	Roofing	1,000	
2.1.5	Finishes	-

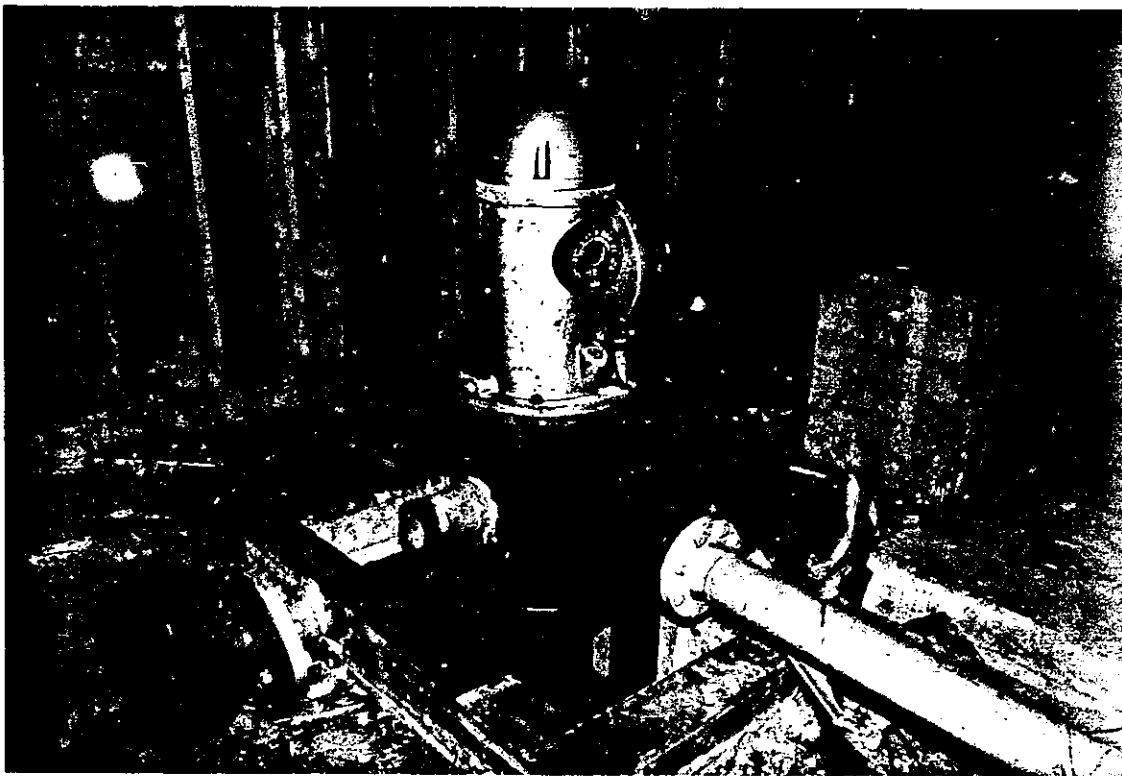
*FRESH WATER PUMPHOUSE  
PUMPS*

Item	Description	Estimated Value	Comments
2.3.1	Concrete	11,000	Unfinished bulding
2.3.2	Building	10,000	
2.3.3	Roofing	750	
2.3.4	Pumps (2) Lane size 8, type URHC and RT angle drive, no motor, and dismantled  Lane size 8, type DRHC, no motor, dismantled.	3,000	No switchgear or wiring. No motors. Would need extension work to rehabilitate, scrap value.

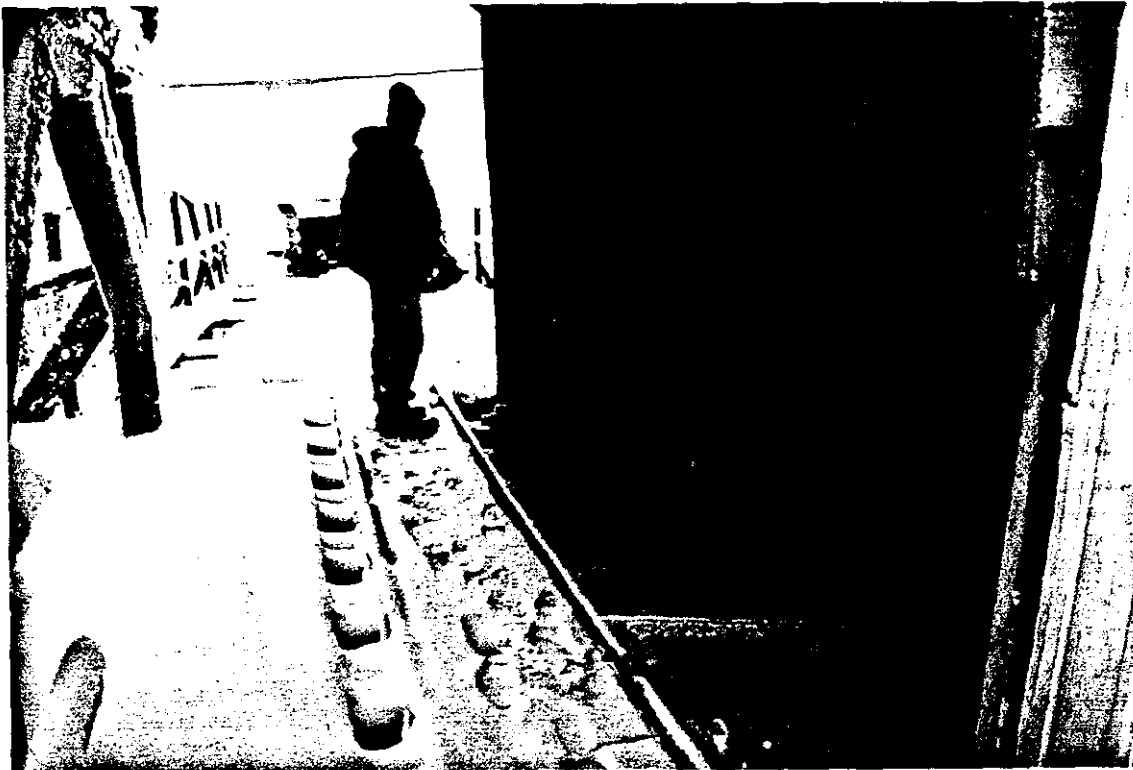
*DUMP POCKET*

Item	Description	Estimated Value	Comments
3.1.1	Coarse ore dump pocket building	29,000	Needs much repair.
3.1.2	Coarse ore conveyor (gallery, supports and tables)	221,000	Minimum repair needed.

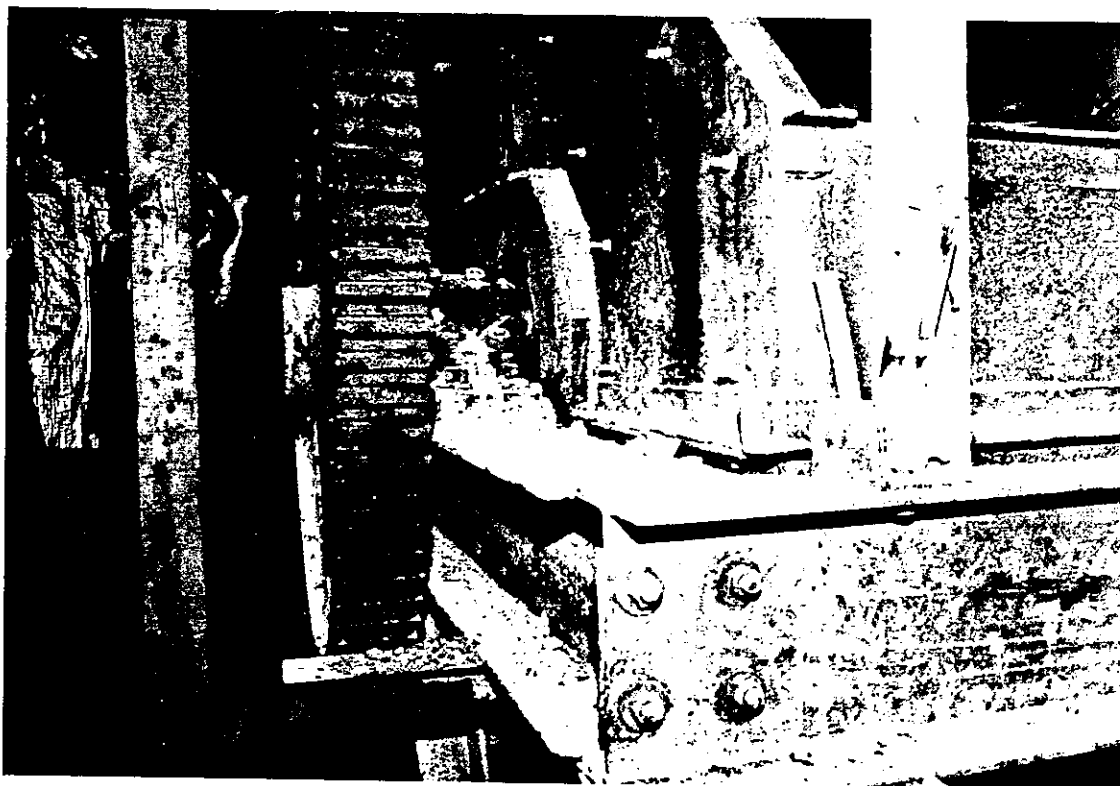
*APRON FEEDER UNDER DUMP POCKET*

3.1.5	Fine ore conveyors (galleries, supports, tower, tables, etc.)	60,000	Minimum repair required
3.1.6	Apron feeder, 30" wide x 8'-0" centres gear driven.	4,000	Partially dismantled. Second hand unit badly worn with rubber conveyor belt installed to cover worn pans. No motor.

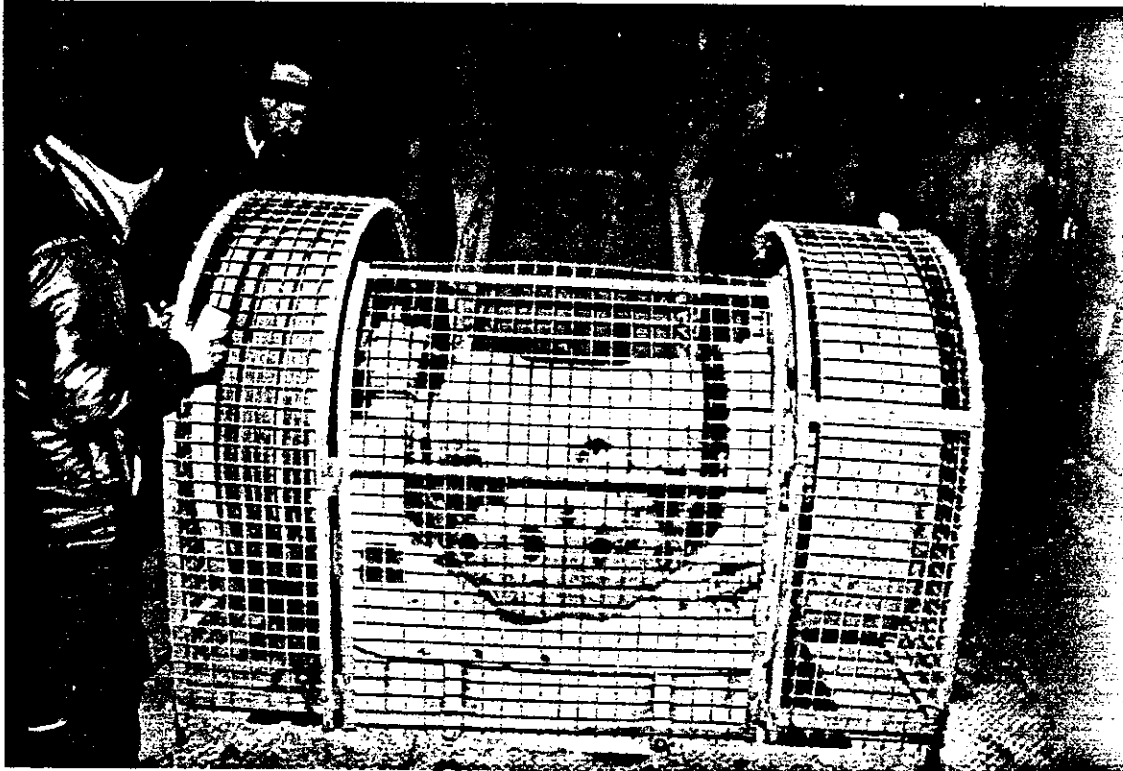
10x30 JAW CRUSHER

Item	Description	Value	Comments
3.1.10	Jaw crusher, 10 x 30, Telsmith	37,000	Probably new in 1967, appears in good shape including motor. There is a new eccentric drive shaft on the floor by the crusher.

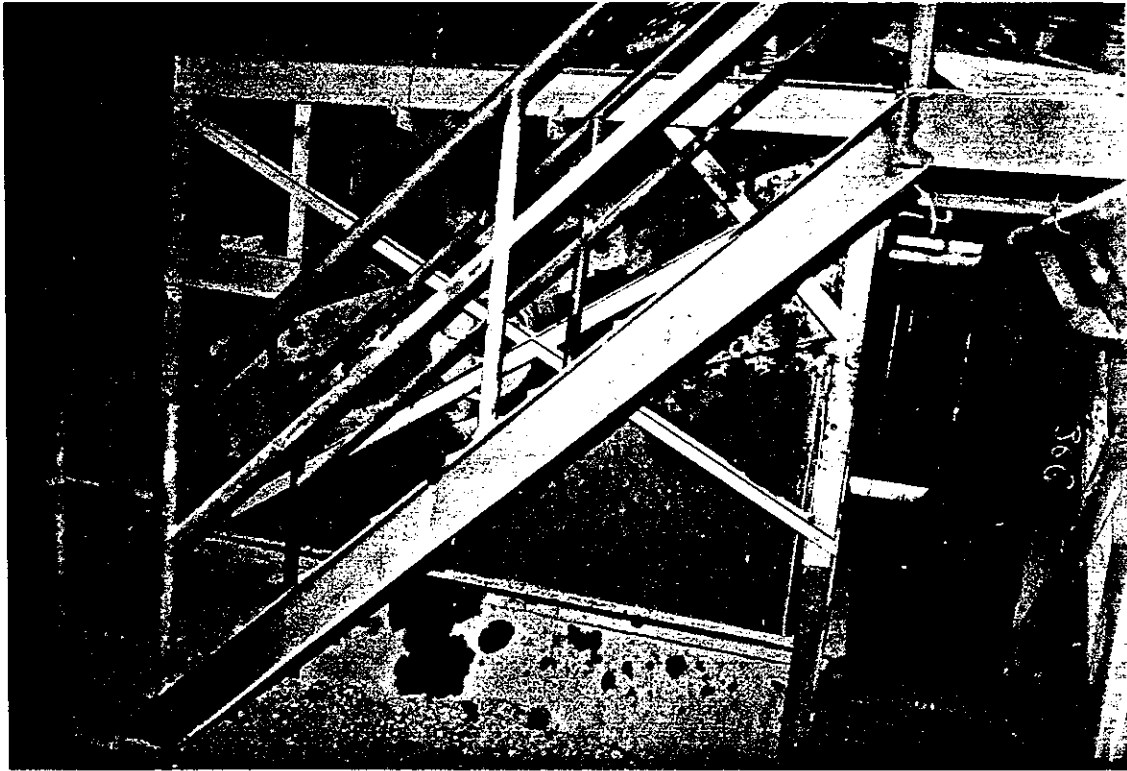
4x8 DILLON SCREEN

3.1.13	30" conveyor, 50' x 15' rise (#4 conveyor)	16,000	Good condition
3.1.14	4 x 10 Dillon screen, 2 deck top 1" opening, bottom 3/8" opening.	8,000	Appears to be in good shape.

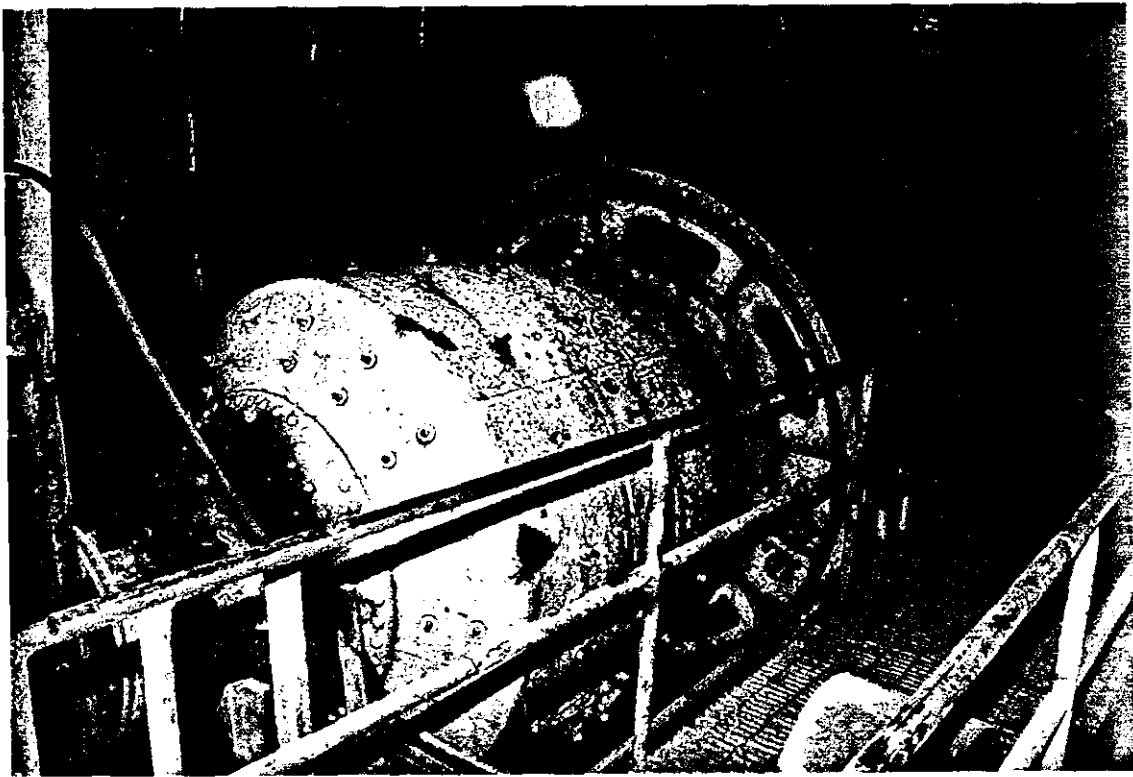
NO. 2 CIRCUIT  
7'x7' HARDINGE BALL MILL

Item	Description	Estimated Value	Comments
3.2.12	7 x 7 Hardinge ball mill (#2 circuit)	62,000	In operating condition with discharge trommel, indirect drive through gear-box and high speed motor, approx. 200 hp.

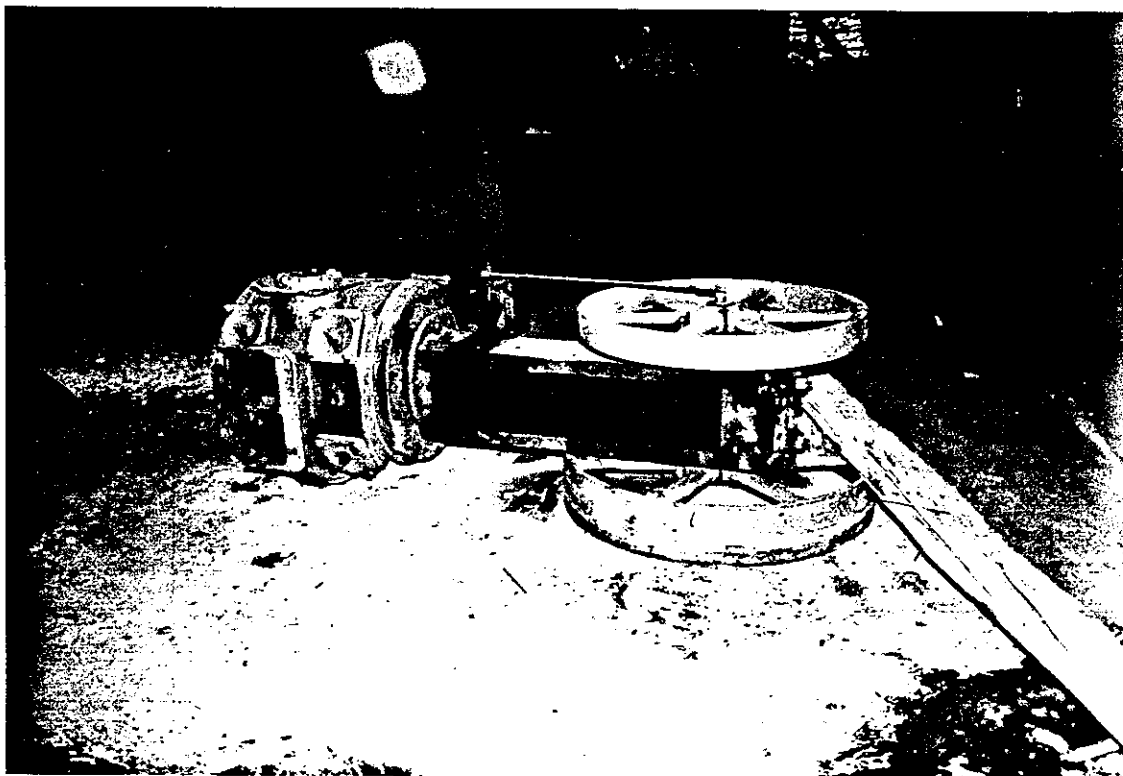
VACUUM PUMP

3.2.17	Conditioner tank agitator, 6 x 6 (#2 circuit)	2,300	
3.2.18	(2) thickener tank agitators, 12'-0" dia. x 8	11,000	
3.2.19	4'-0" dia. x 4 disc filter, c/w vacuum receiver, vacuum pump and discharge hopper	6,000	Disc filter needs extensive work (rotary valve missing). Scrap value only. Original vacuum pump appears to be worn out but a replacement in apparently reasonable condition is on basement floor. No motors.

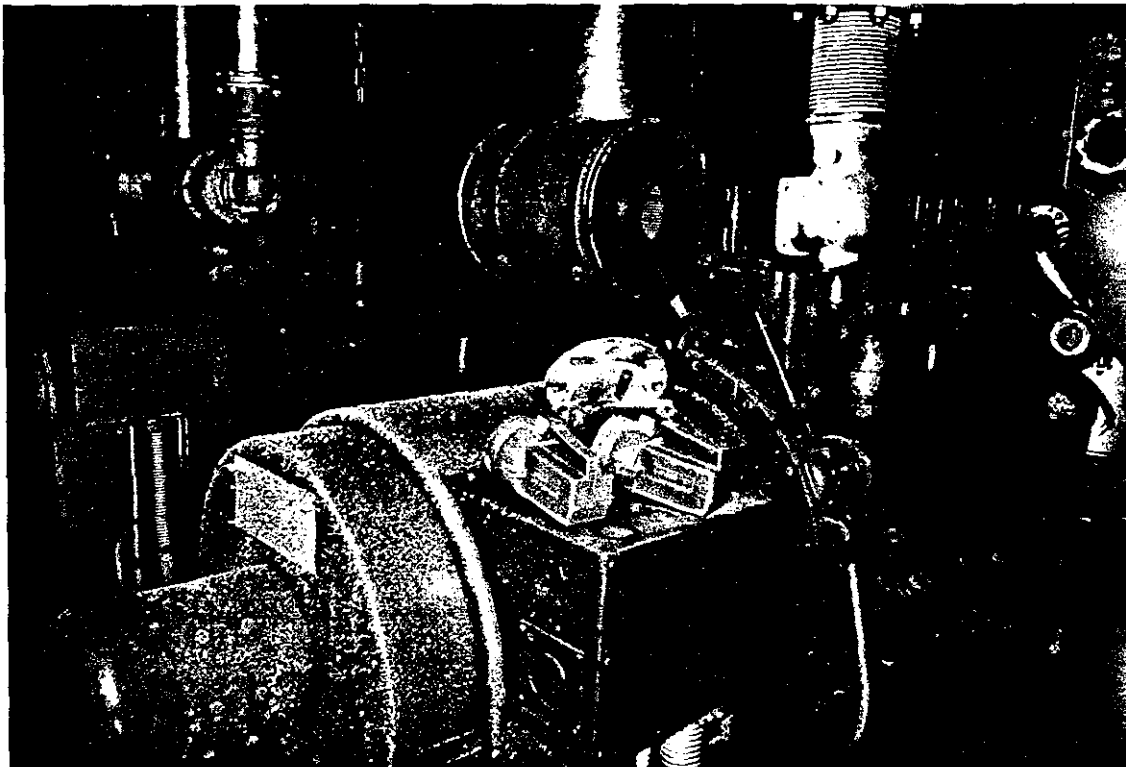
*GENERATORS*

3.3.3	Cladding	15,000	
3.3.4	(3) Diesel generators Tamper syn. gen. 250 kW, 440 volt, Model B6413G - 2 MVDAEM, 312 KVA Engine - Waukesha, F190, 5 DSIU/7x8/1-4 governed at 1200 rpm	90,000	All three have cylinder heads off. M. Phillips says local residents who worked at the mine say that these heads require constant attention. Exhaust complete with waste heat boilers for heating.

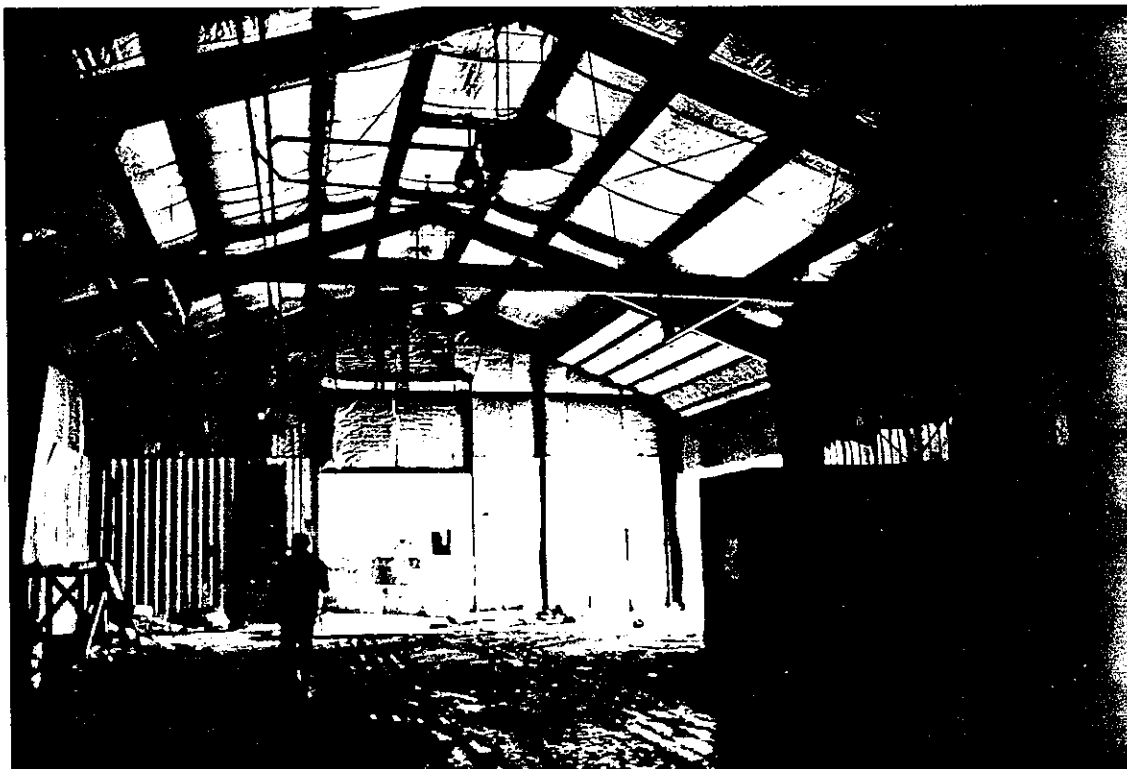
GARAGE

<b>Item</b>	<b>Description</b>	<b>Estimated Value</b>	<b>Comments</b>
3.5.1	Concrete	18,000	Floor needs repair.
3.5.2	Building	45,000	Includes overhead crane components.
3.5.3	Cladding	15,000	Doors need repair.
3.5.4	Overhead crane	1,000	Only crane beam left (someone has removed the crane mechanism).
3.5.5	Heaters and piping	2,500
