Re: Evaluation of the Vangorda Creek Diversion to Dixon Creek DRAFT (2005-06, Task 20h)

Subject: Assessment of Geology and Terrain Stability
Upper Vangorda Creek Diversion Option 3, Anvil Mine Site, near Faro, YT

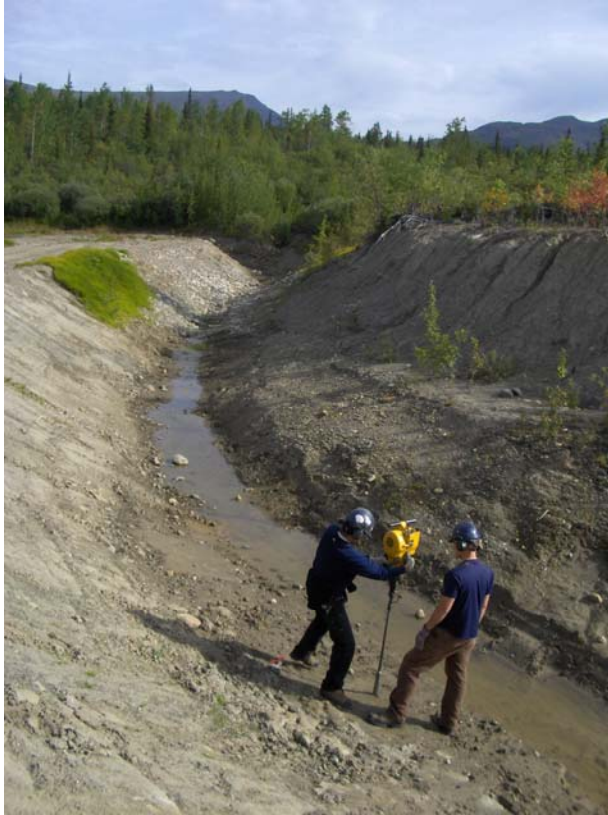
Photo 1: View of the existing seepage collection ditch above the Vangorda Pit. Site of one of the drill holes

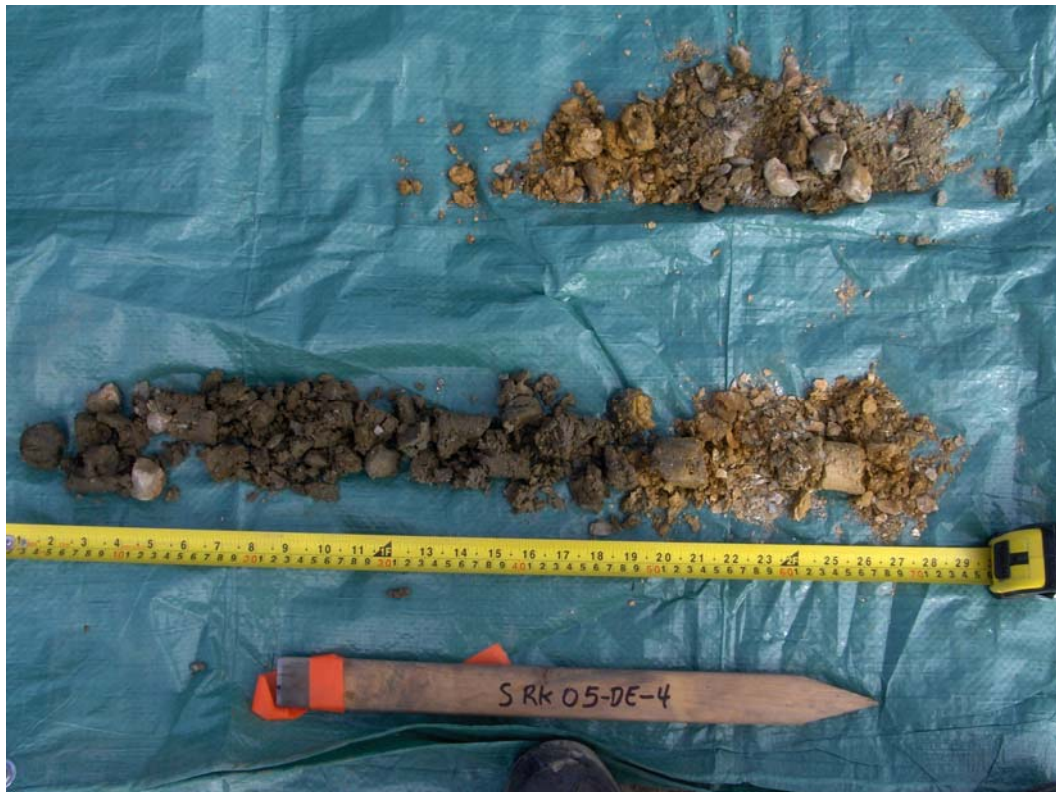
Photo 2: View of the soil sample at Test Pit SRK 05-DC-04

GPS (NAD27) readings		Location description Inside ditch, about 3m below road level.		
E	N			
594,705	6,902,977			
Interval (m)				
From	To	Soil type	Soil description	Notes
0.0	0.5	Sandy-clayey silt	Sandy-clayey silt (fine to coarse sand), with fine to coarse, sub-angular to sub-rounded gravel, gray, loose, damp.	Till. Sampled.
0.5	1.0	Bedrock	Weathered bedrock (schist).	Refusal at 1.0 mbgl.

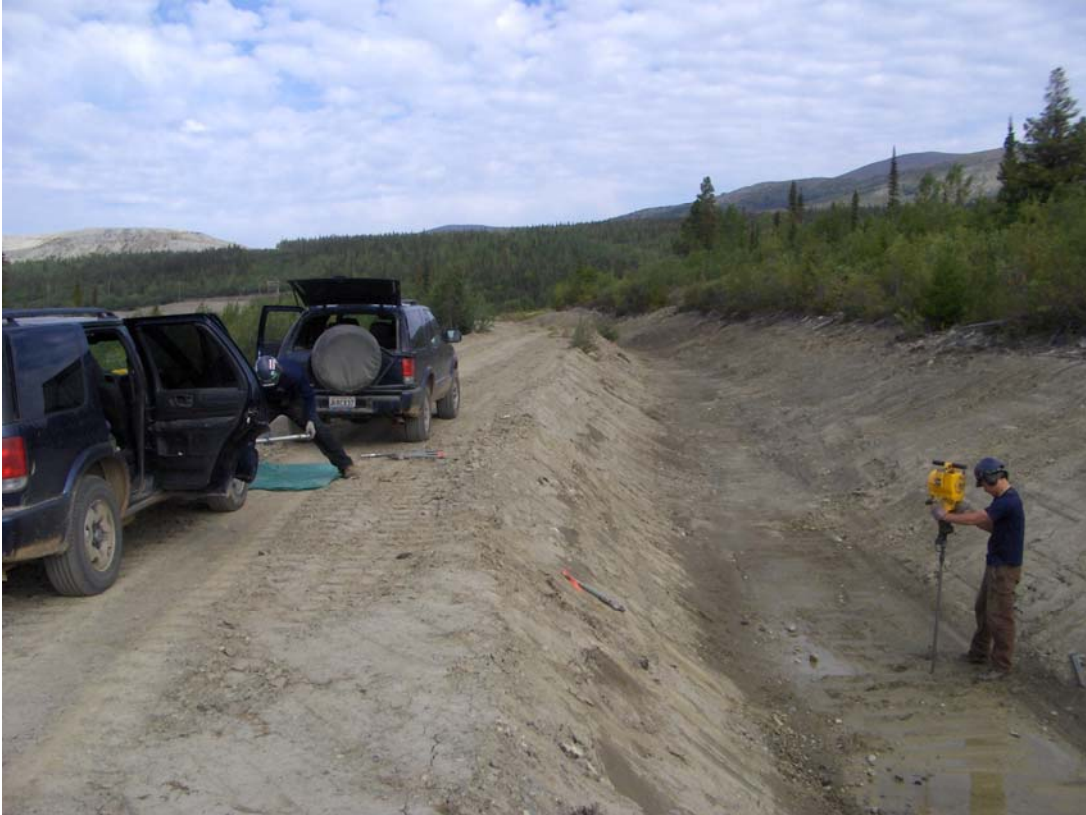
Photo 3: View along existing Seepage collection ditch

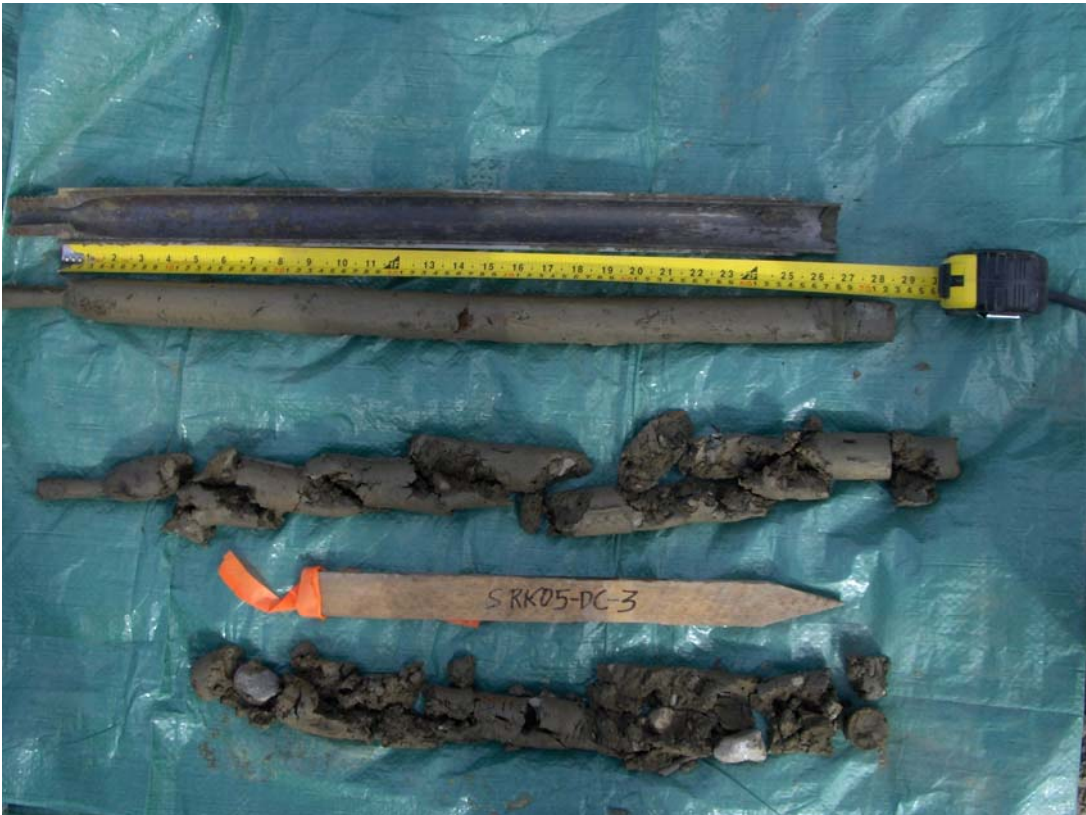
Photo 4: Soil Sample at SRK-DC-03

GPS (NAD27) readings				
E	N			
594,523	6,903,122			
Interval (m)				
From	To	Soil type	Soil description	Notes
0.0	5.3	Sandy-clayey silt	Sandy-clayey silt (fine to coarse sand), with fine to coarse, sub-angular to sub-rounded gravel, gray, stiff, damp, with low plasticity (thread diam~3mm).	Till gets harder and slightly more plastic with depth. Sample collected.
