July 12, 2006
Project Number 1CD003.080

Re: Evaluation of the Vangorda Creek Diversion to Dixon Creek (2005-06, Task 20h)

Subject: Assessment of Geology and Terrain Stability
Upper Vangorda Creek Diversion Option 3, Anvil Mine Site, near Faro, YT

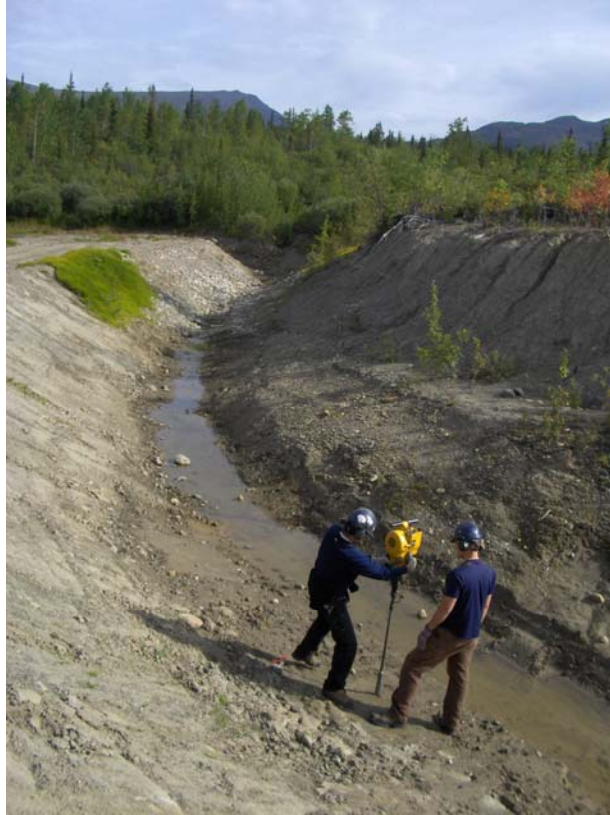
Photo 1: View of the existing seepage collection ditch above the Vangorda Pit. Site of one of the five drill holes completed by Rocky Mountain Soil Sampling Inc.

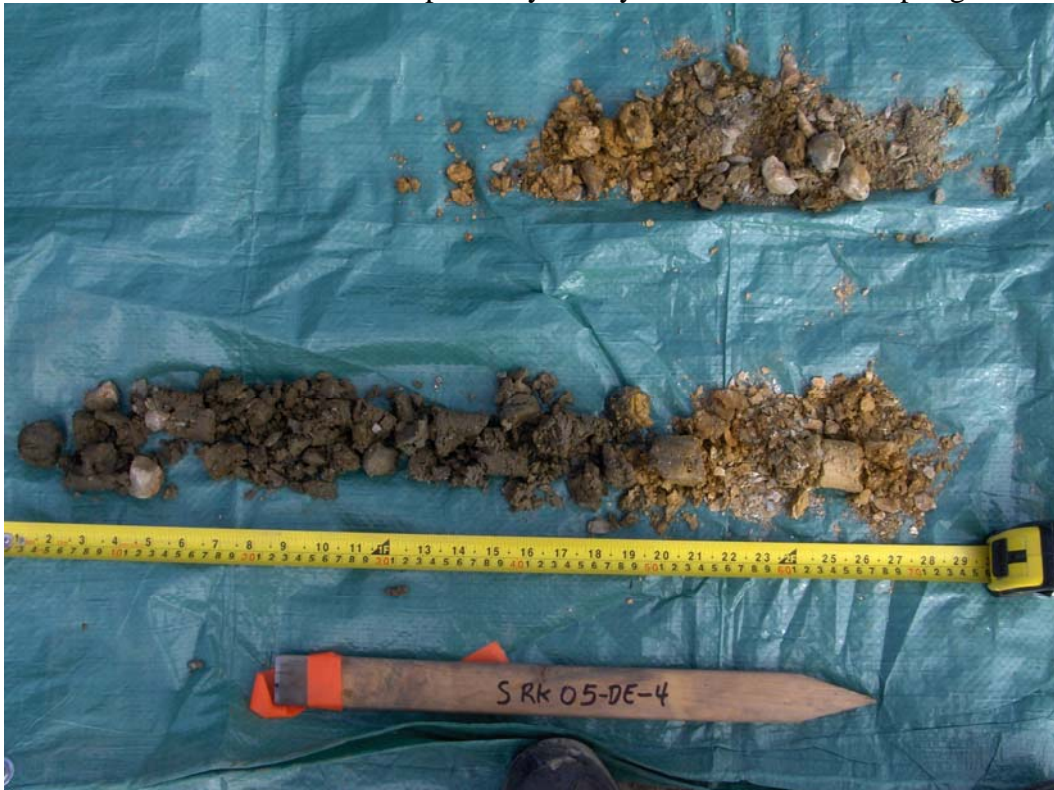
Photo 2: View of a soil sample from Drill Hole SRK05-DC-04

GPS (NAD27) readings		Drill hole completed on August 12, 2005 by Rocky Mountain Soil Sampling Inc. Logged by SRK (M. Prado)		
E	N			
594,705	6,902,977			
Interval (m)		Location description: Inside ditch, about 3m below road level		
From	To	Soil type	Soil description	Notes
0.0	0.5	Sandy-clayey silt	Sandy-clayey silt (fine to coarse sand), with fine to coarse, sub-angular to sub-rounded gravel, gray, loose, damp.	Till. Sampled.
0.5	1.0	Bedrock	Weathered bedrock (schist).	Refusal at 1.0 mbgl.

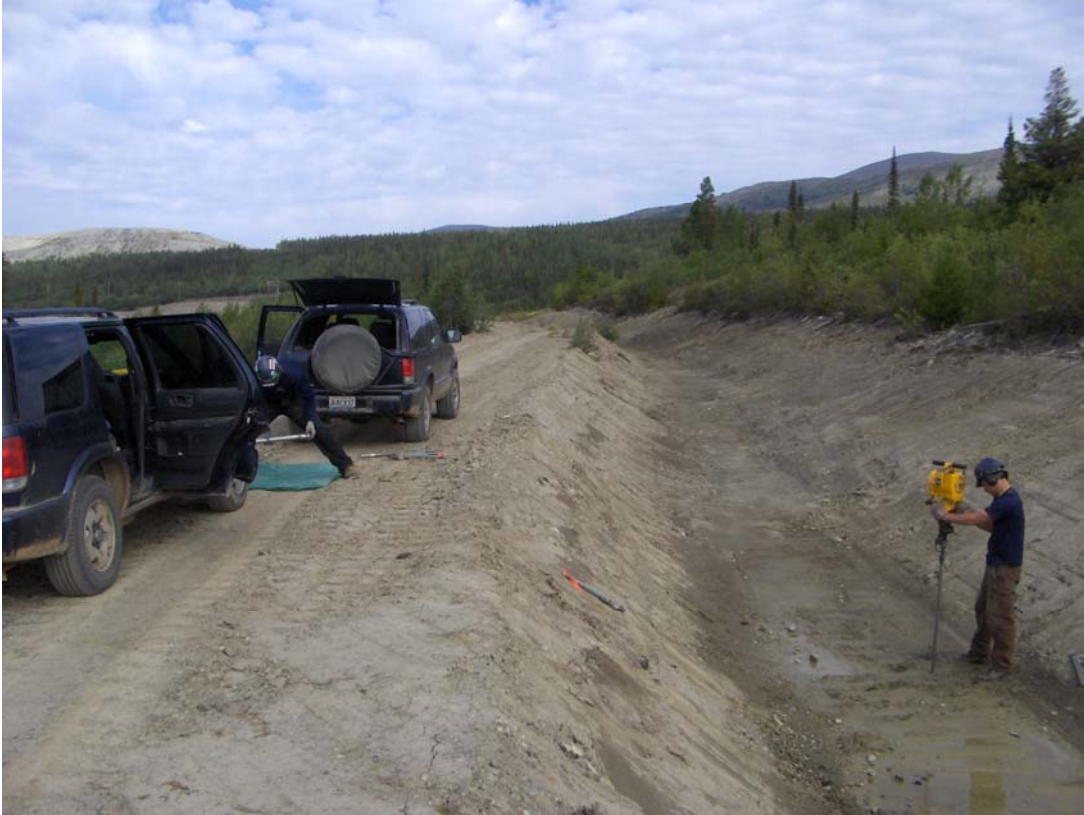
Photo 3: View along existing seepage collection ditch

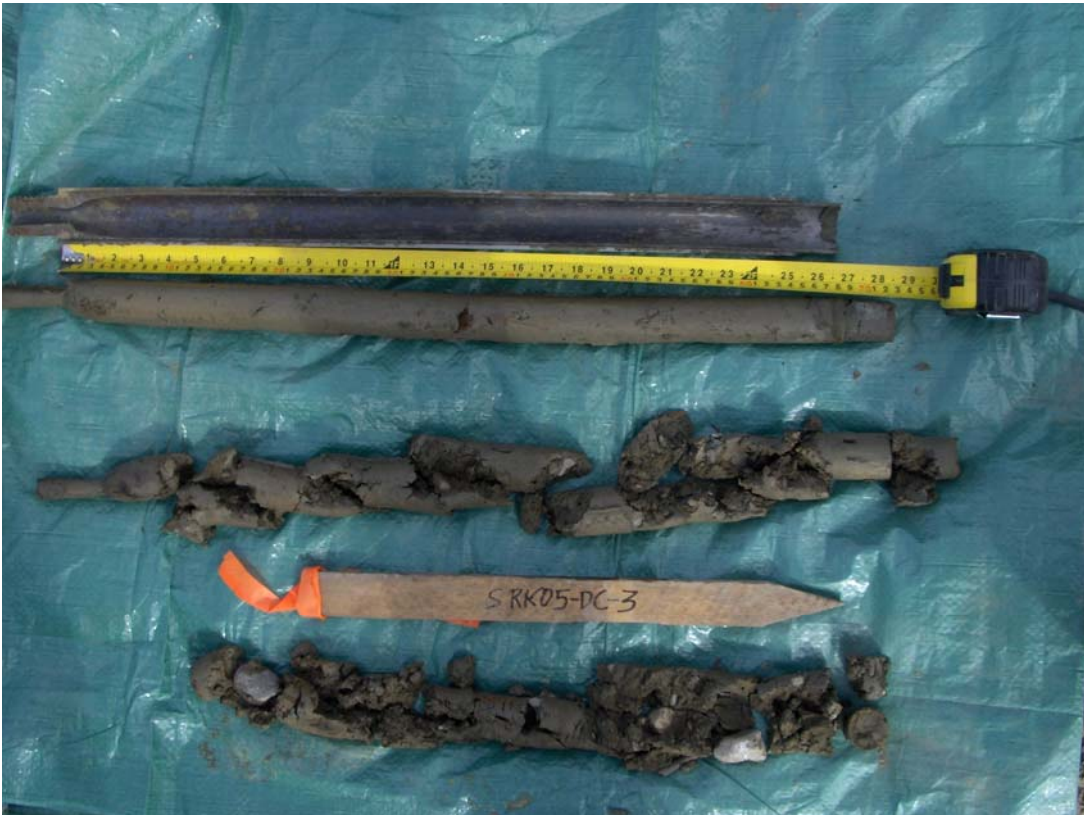
Photo 4: Soil sample from Drill Hole SRK05-DC-03

GPS (NAD27) readings		Drill hole completed on August 12, 2005 by Rocky Mountain Soil Sampling Inc. Logged by SRK (M. Prado)		
E	N			
594,523	6,903,122			
Interval (m)				
From	To	Soil type	Soil description	Notes
0.0	5.3	Sandy-clayey silt	Sandy-clayey silt (fine to coarse sand), with fine to coarse, sub-angular to sub-rounded gravel, gray, stiff, damp, with low plasticity (thread diam~3mm).	Till gets harder and slightly more plastic with depth. Sample collected.

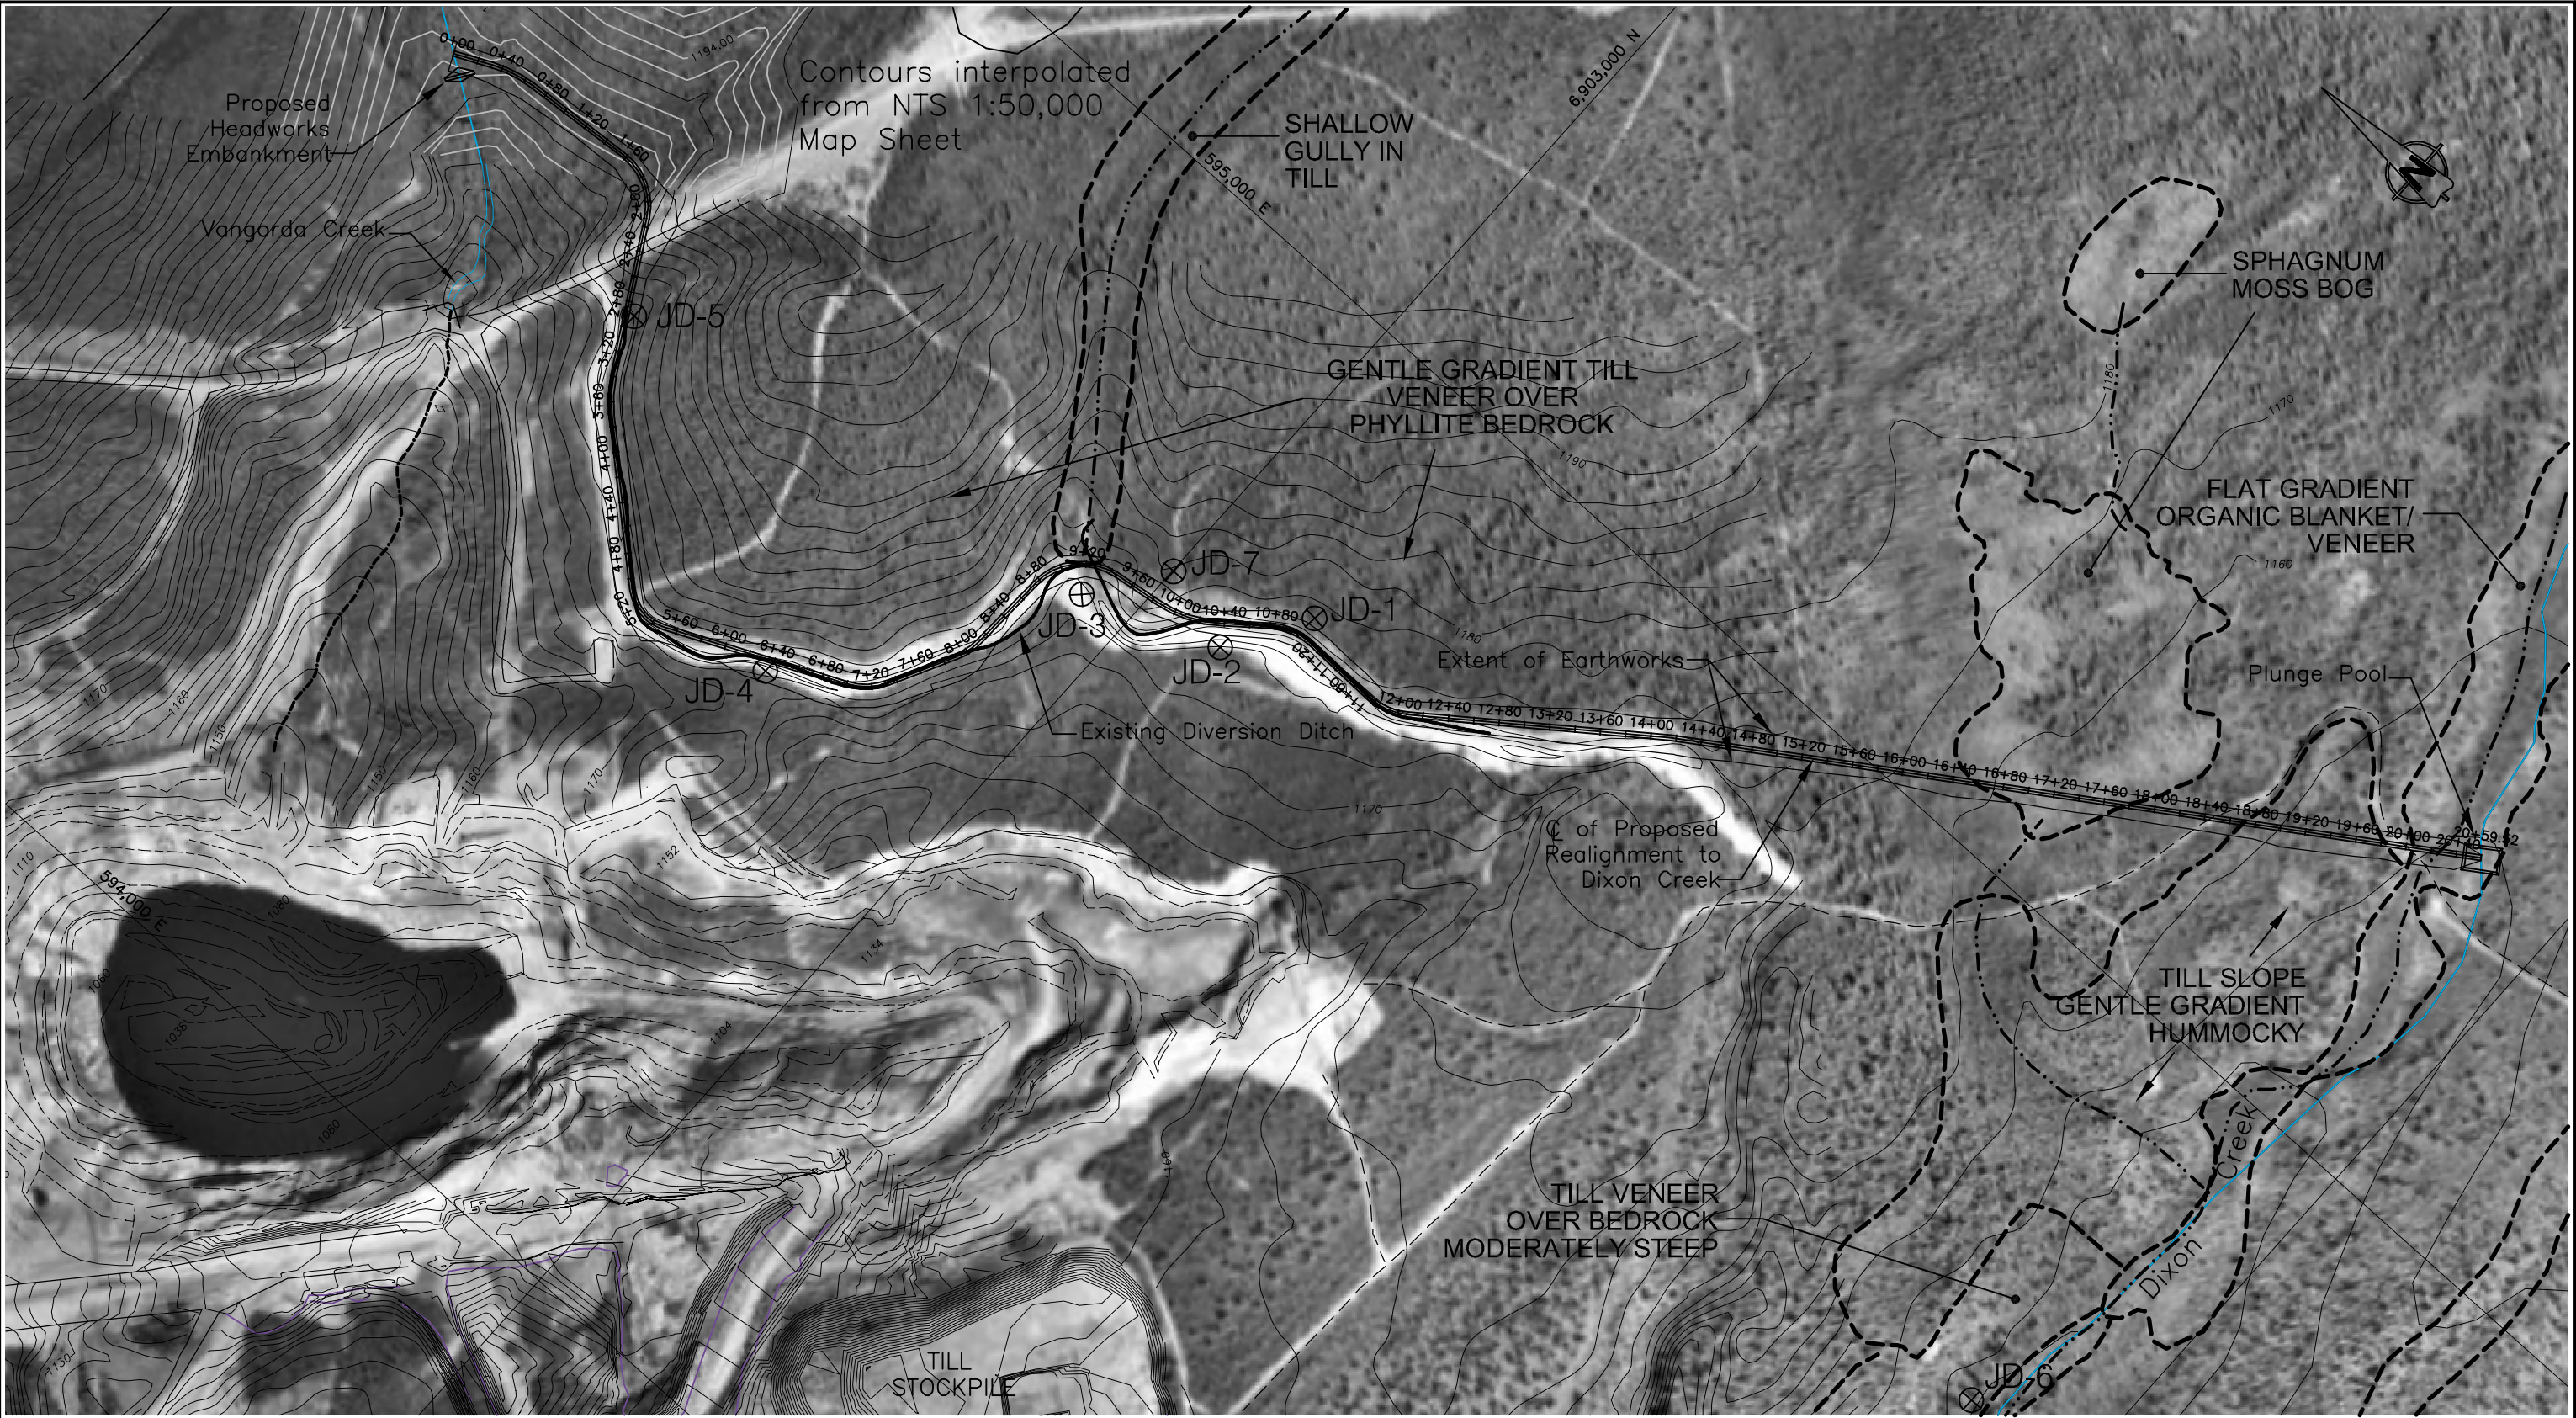
DRWG. FIGURE 2

A section prepared from a survey completed subsequent to the assessment indicates that the grade up to Station 3+40 is -1.8% to the southeast, a flat grade between actual station 3+40 and 9+10, a -5% grade to the southeast between 9+10 and 9+30 and a flat grade between 9+30 and 12+20. The proposed route of the Option 3 alignment southeast of approximate Station 14+20 (Figure 2) was not surveyed.

Station 14+00 m (Figure 2) is the approximate southeastern extent where the present interception ditch is aligned with the Option 3 diversion route. From this point the proposed alignment traverses gentle gradient forested terrain. At about Station 16+40 m (Figure 2), a 3 m high phyllite outcrop forms the northern edge of a 200 m wide flat, open, poorly-drained blueberry/willow/sphagnum moss bog with standing water in shallow depressions. A gentle to flat gradient, moderately to imperfectly drained spruce/aspen/willow forest forms a 60 m wide “island” within the bog.

Most of the proposed alignment crosses gentle, relatively consistent gradient terrain and there were no topographic features that would preclude construction of a diversion channel. However, in some sections of the proposed alignment the grade is greater than 5% and the flow would likely have to be confined within a structure to control potential erosion. The stream would also have to be confined within a structure where it crosses the area of bog that was identified during the field assessment (Figure 2).

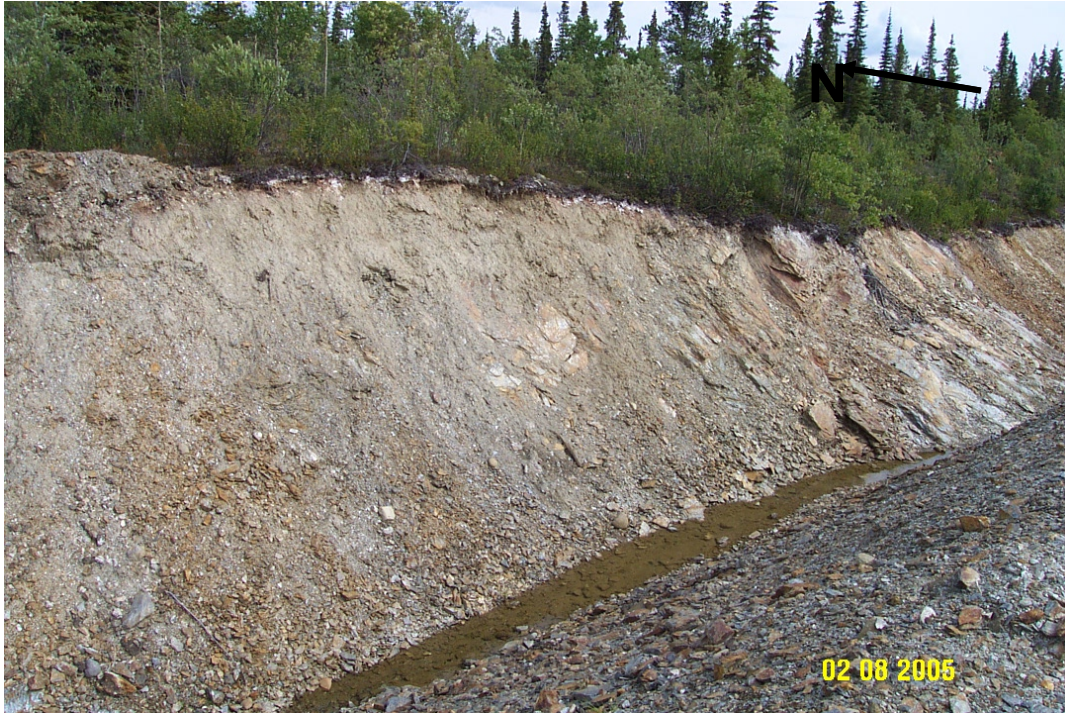
Bedrock exposed at the interception ditch (Station JD-1, Figure 2) is orange, rusty weathering, fissile phyllite (Photograph 1). This lithology was also exposed at an outcrop near Station 15+90 m (approximate location) and probably correlates with the Vangorda Creek Formation, which is mapped in the area. This unit was also exposed at an outcrop on steep valley side slopes of Dixon Creek near the road crossing, downstream of the proposed diversion plunge pool (Figure 2).

Field observations of soil texture suggest that the till and weathered bedrock substrate are permeable and unconsolidated. Near-surface bedrock is fissile, deeply weathered and incompetent. In sections where the proposed Vangorda Creek Diversion channel gradients exceed very shallow to flat grades, the probability of erosion is high and liners or other structures would likely be required to prevent scouring and infiltration.

Photograph 1: Station JD1. Interception Ditch is approximately 4 m deep into rusty weathering, steeply dipping ($\sim 45^\circ$ SW) fissile phyllite.

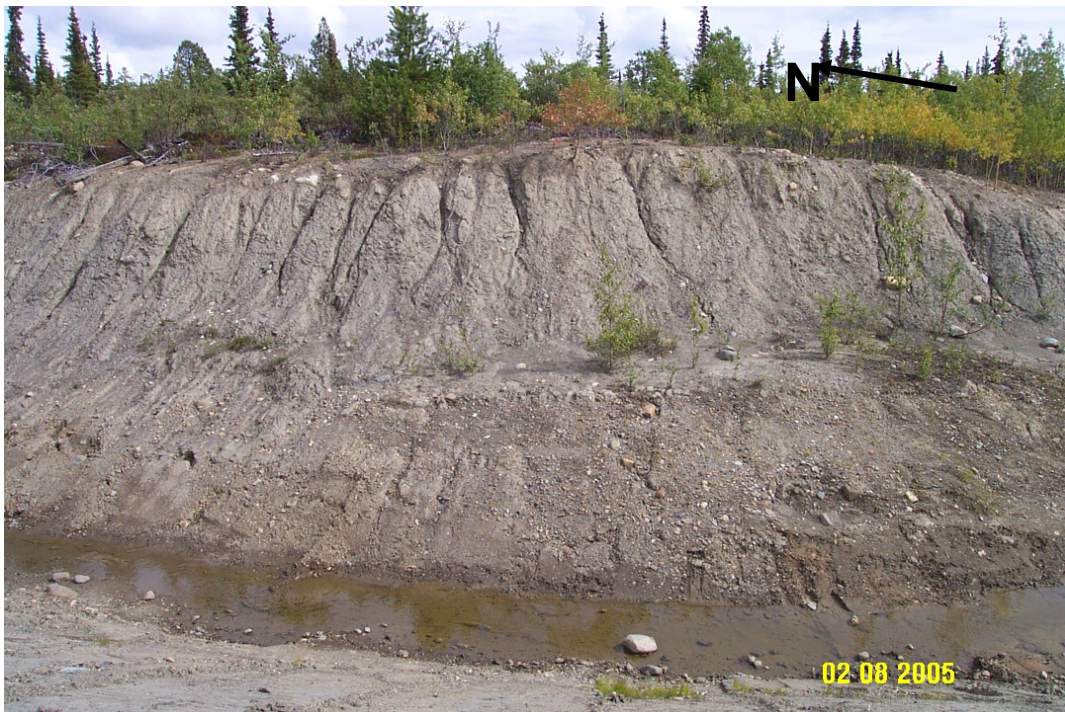
Photograph 2: Station JD7. Interception Ditch is approximately 3 m deep into till blanket overlying weathered phyllite.

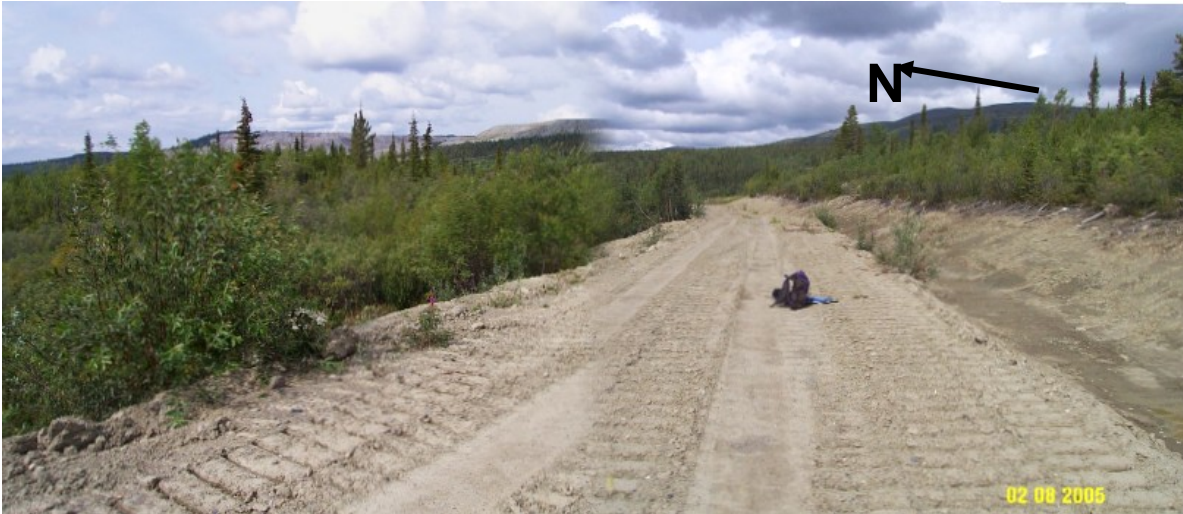
Photograph 3: Station JD4. Berm constructed on downslope side of shallow Interception Ditch is about 1 m deep into till blanket.

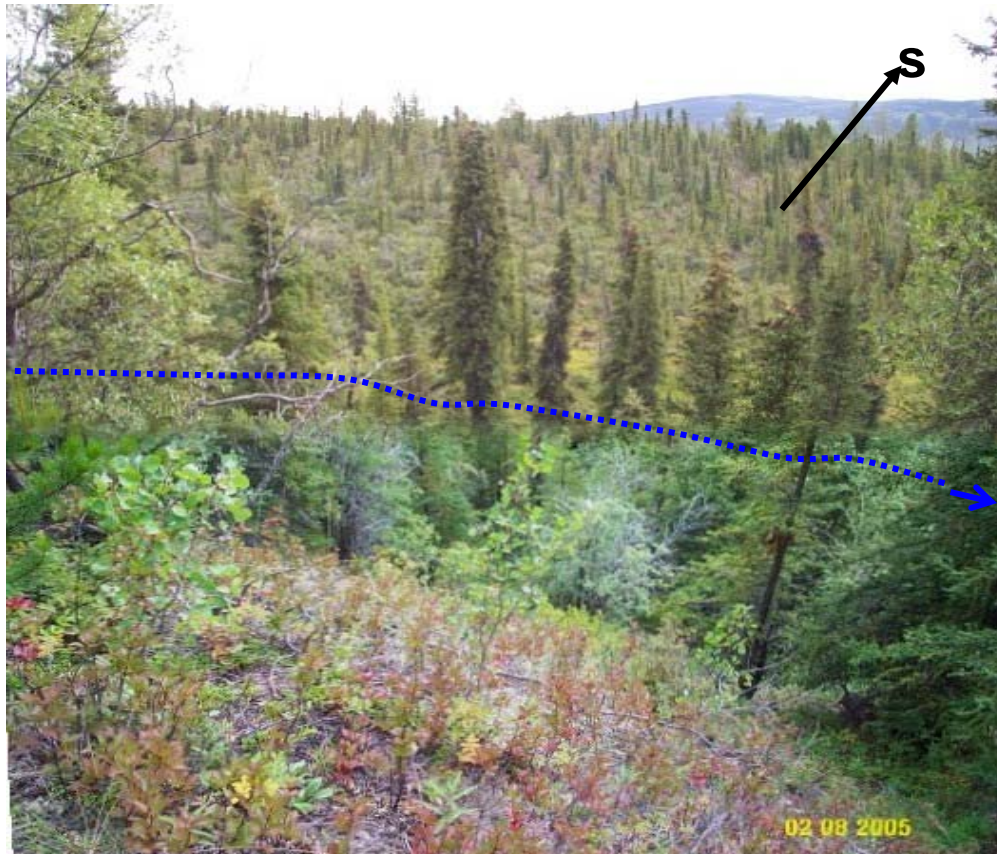
The vegetation setting is spruce-aspen-willow-alpine birch-Labrador tea forest with some pine (Photograph 4). An area of spruce-sphagnum moss bog was crossed between the existing interception ditch and Dixon Creek (Figure 2). The floor of the Dixon Creek valley at the point of entry of the proposed Vangorda diversion channel is a wide, open bog/fen (Photograph 4).

The channel of Dixon Creek is discontinuous and flow is mostly sub-surface to a point about 700 m downstream of the proposed diversion channel (JD-6, Figure 2). At this point it joins a small tributary from the south to form a continuous channel, intermittently braided, up to 1 m wide and 0.25 m deep. The channel gradient here is about 5% where it is confined on the north bank by steep (70% gradient) valley side slopes of silty sand till with some gravel to gravelly, overlying shale bedrock (Road River Group?). The stream channel gradient appears to increase slightly downstream. The channel was not traversed downstream of this point.

Likely the most significant limiting factor with the proposed Option 3 diversion of Vangorda Creek is the incompatibility of Vangorda Creek flows with the existing Dixon Creek valley and stream channel.

Photograph 4: View southeast from vicinity of Station 20+00 to Dixon Creek Valley. Blue broken line shows estimated location of sub-surface watercourse. There is no continuous open stream channel at this location.

diversion of the full flow of Vangorda Creek would require extensive and major engineering works to mitigate. To further pursue this option, additional studies are recommended to assess environmental implications and the feasibility of construction of many kilometres of artificial channel or other containment structures.
