# NORTHERN AFFAIRS PROGRAM

## FARO AND VANGORDA PLATEAU MINES

**REPORT  
ON  
1999 INSPECTION**

Prepared by:  
GEO-ENGINEERING (M.S.T.) LTD.  
Calgary, Alberta

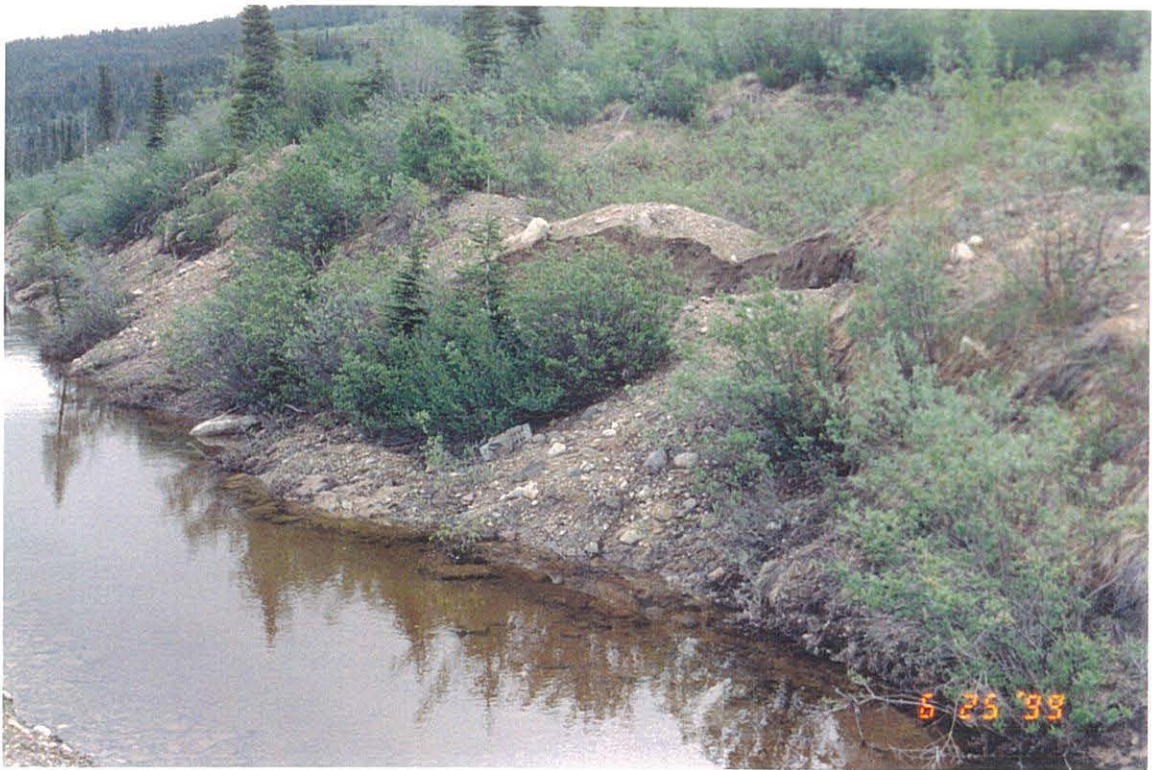
Photo 1: North Fork Rose Creek diversion channel. View of a slump developing in the upslope cut in the upstream section of this diversion

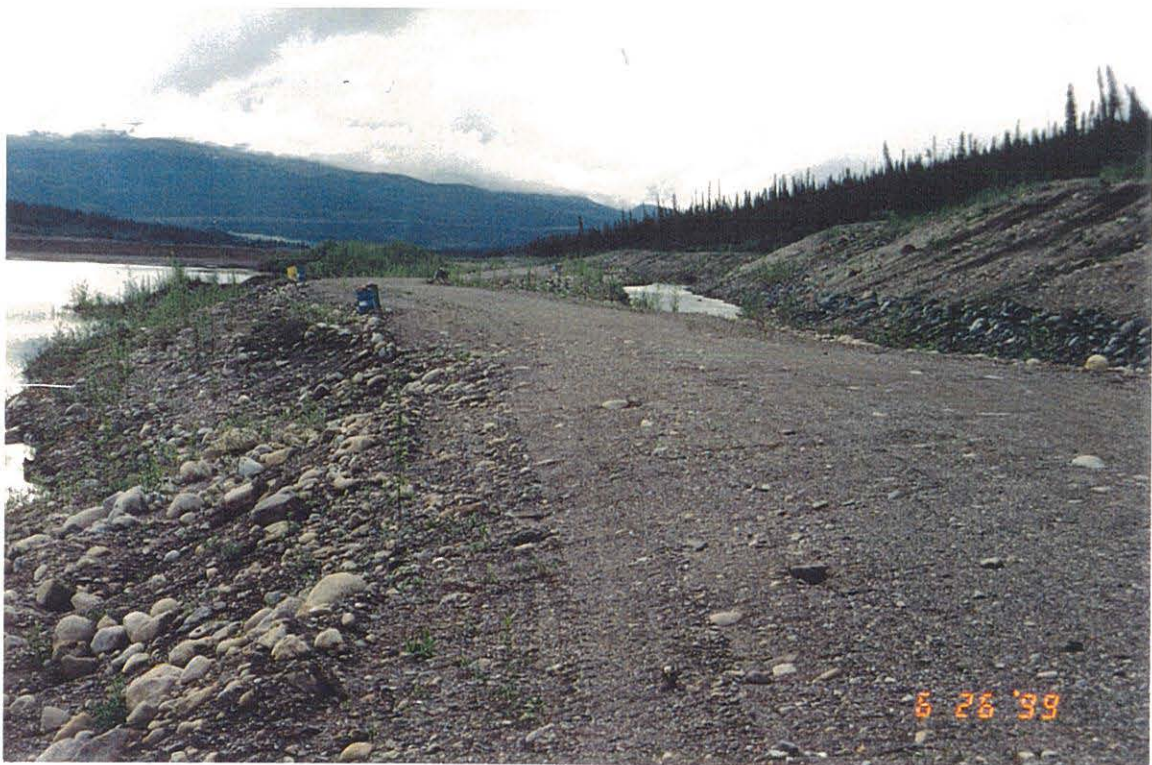
Major dyke deformations were noted between Stations 2+100 and 2+250 (Photo 2). Another, somewhat smaller, crest deformation exists between Station 1+500 and 1+600 and at Station 1+800 and 1+870. Heavy seepage from the diversion canal, similar to that in previous years, was observed at Station 1+300.

Monitoring of thermistors between Stations 2+100 and 2+250 indicates that permafrost conditions persist below 5 m to 8 m depths. It appears that elsewhere warming thawed frozen ground to or below the bottom of installed thermistors. Old fissures and cracks were effaced by previous crest grading and no new cracks were observed during this year's inspection.

Photo 2: Depression and sloping crest of the Rose Creek diversion dyke between Station 2+100 and 2+250.

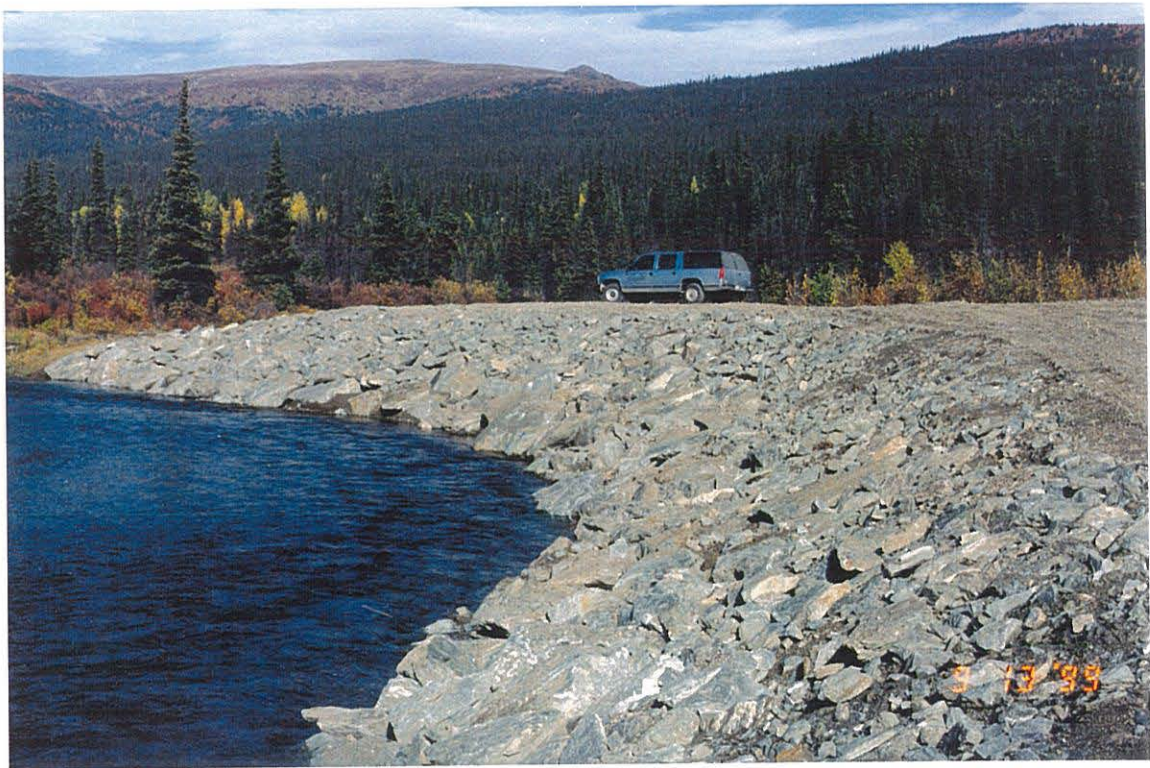
While the overall function of the canal drop section (system of rock weirs) is good, deterioration of some of the weirs continues. It is evident that the diversion canal requires periodic maintenance. The creek bank downstream from the weir section was rip-rapped (Photo 3).

Photo 3: Rose Creek diversion. View of the recently constructed rip-rap bank downstream from the weir section.

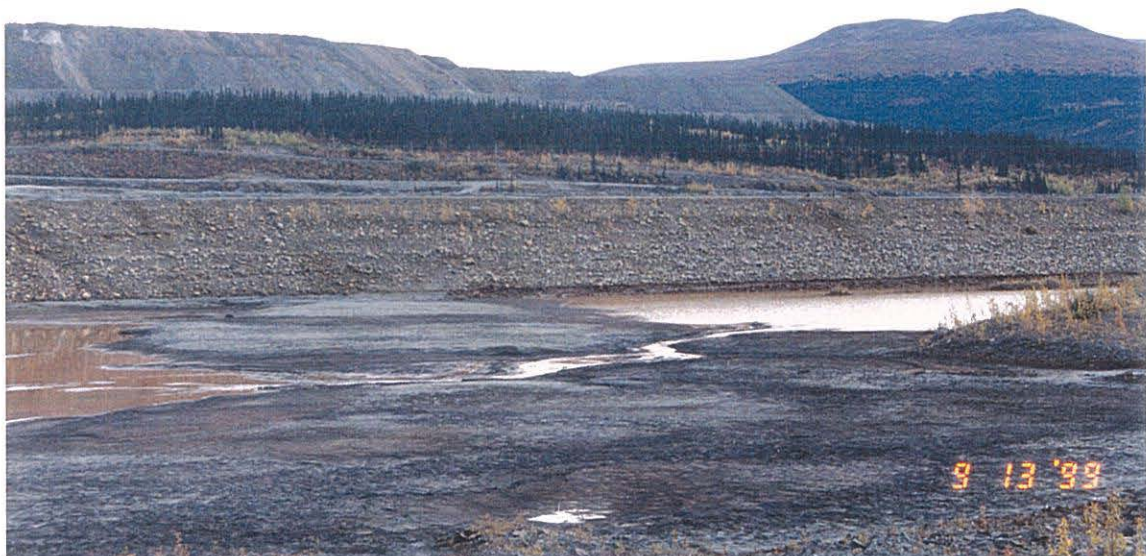
Seepage from the Rose Creek diversion, at its upstream end, continues to be heavy and contributes to ponding of water in the channel at the creek channel emergency spillway (Photo 4). Additional seepage from the diversion channel occurs at several locations further downstream. The water level in the pond (at the Intermediate Dam) was estimated to be about 0.75 to 1.0 m below the dam crest. In June 1999, the spillway was blocked by an about 0.5 m high earth dyke. This dyke was removed and the spillway rip-rap restored in September 1999.

Photo 4: Looking at the Second Tailings Pond dyke. Note ponded seepage from the Rose Creek diversion.

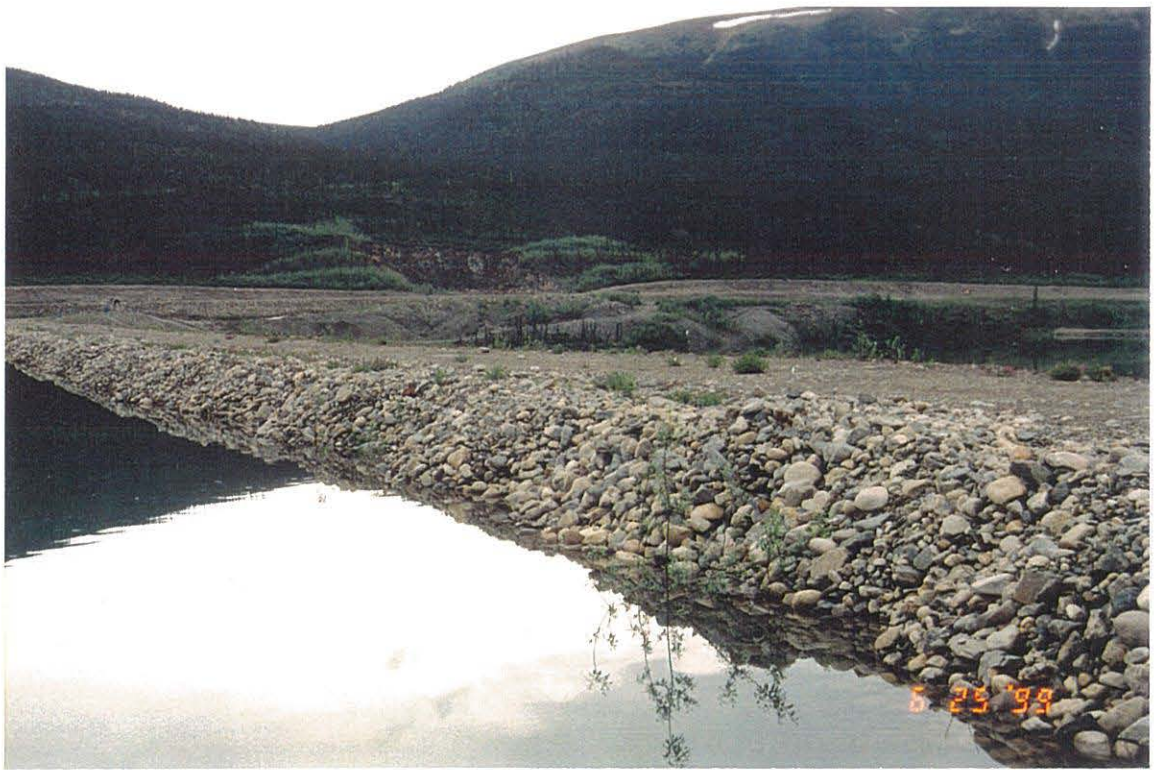
Rip-rap, placed on the upstream face of the Intermediate Dam a couple of years ago, controls erosion despite its relatively small size (Photo 5). Cracks in the dam crest were first observed in 1996 and 1997. The cracks were more common in 1998, at some locations, up to 2 m back from the upstream edge of the crest. However, no new cracks were observed in 1999.

Photo 5: View of rip-rap protection of the upstream face of the Intermediate Dam.

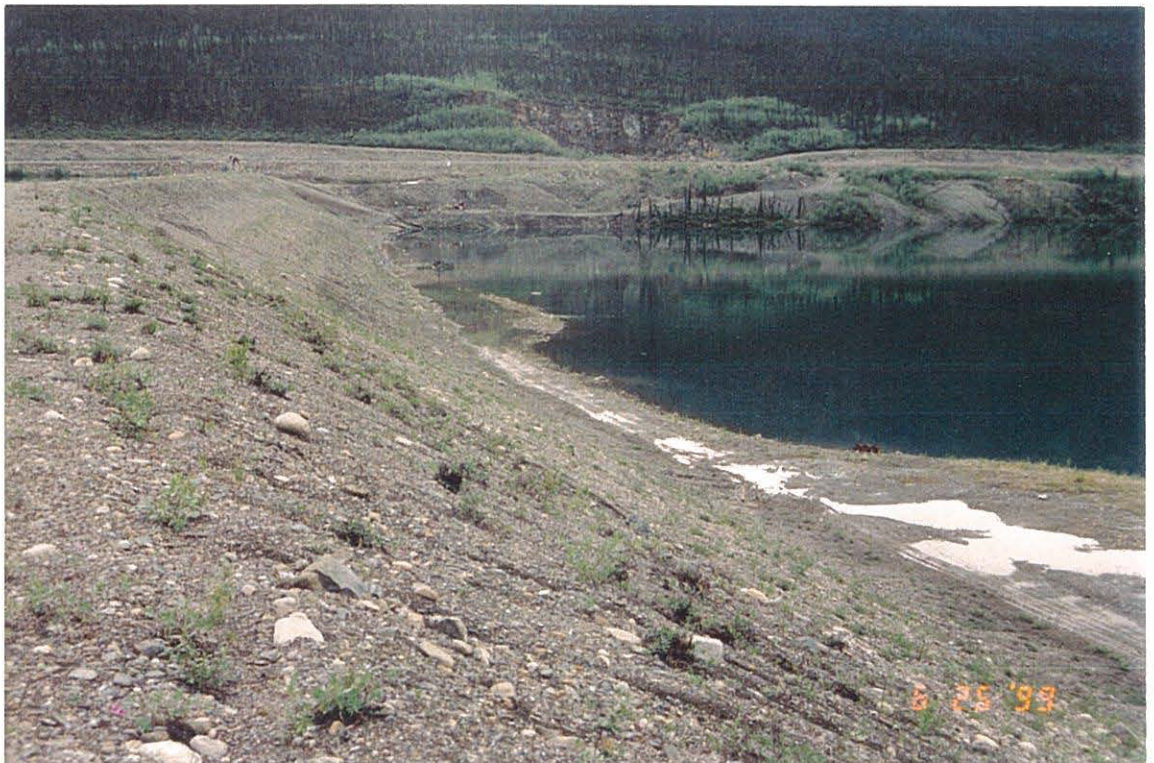
The downstream face of the dam is rilled but dry and appears to be stable. The south abutment drain at the downstream bench level functions well; however, there is also some seepage discharging from the dam toe (Photo 6).

Photo 6: Intermediate Dam, downstream face.

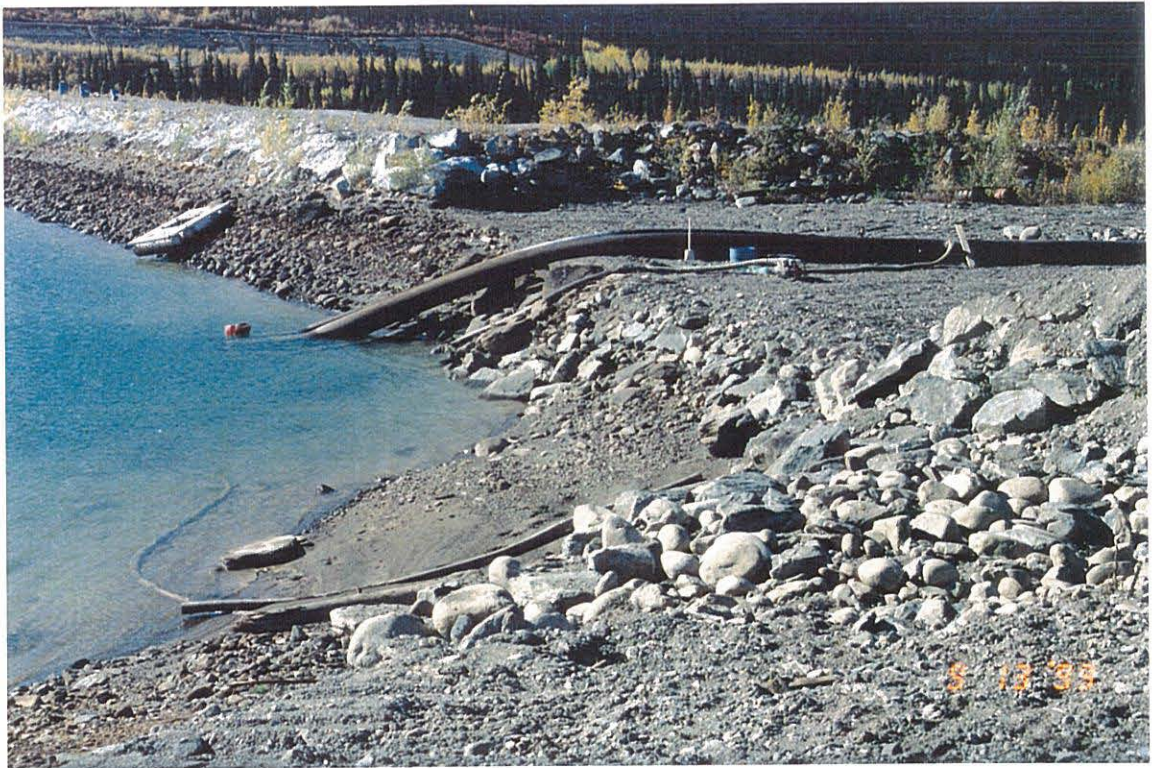
No significant deformations were evident on the Cross Valley dam slopes. The available thermistor data indicates that the permafrost in the valley bottom thawed to the instrumented depths. The water level in the polishing pond was lowered for a fourth year to some 3.5 m below the crest of the dam (Photo 7), prior to the onset of winter, while the

Photo 7: Lowering water level in the polishing pond by syphon.

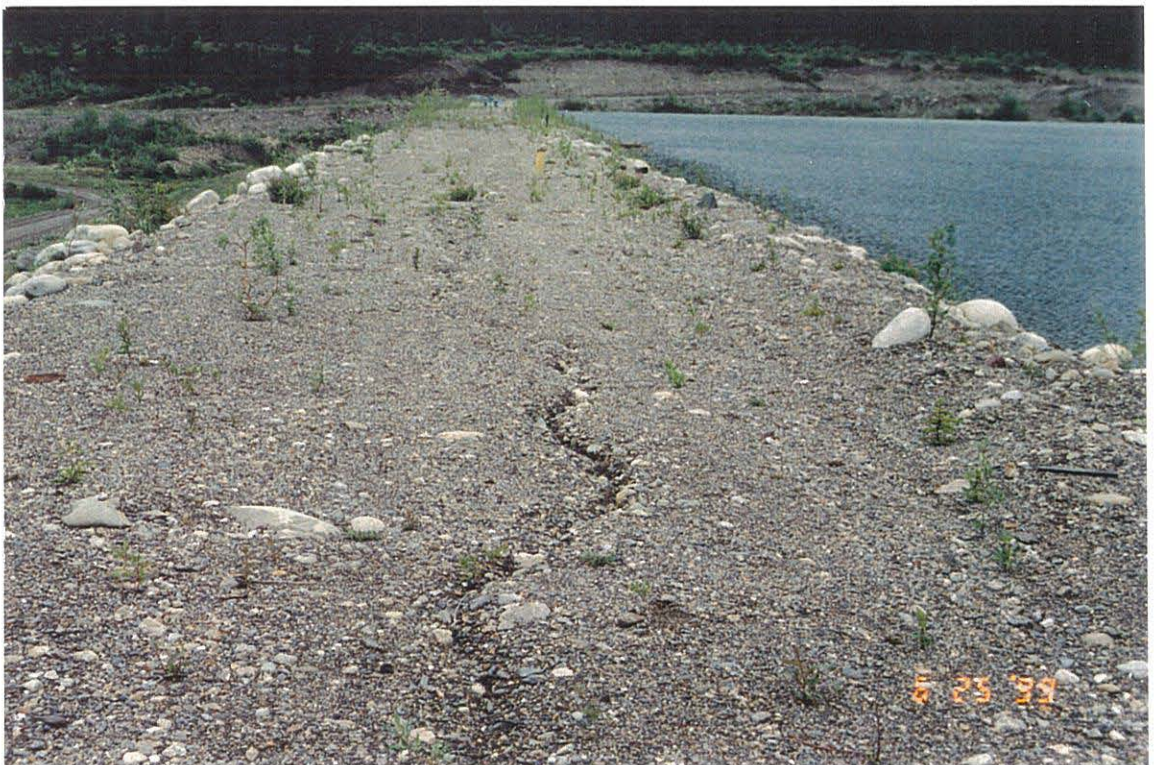
While fissures in the dam crest are evident, no fresh cracks were noticed since the 1997 site visit (Photo 8). It appears that the lowering of the water level has been beneficial since the core is not saturated to the depth of seasonal frost (determined to be about 3.5 m on the dam crest) thus minimizing the adverse affects of the freeze-thaw process.

Photo 8: Partially healed crack in the crest of the Cross Valley Dam.

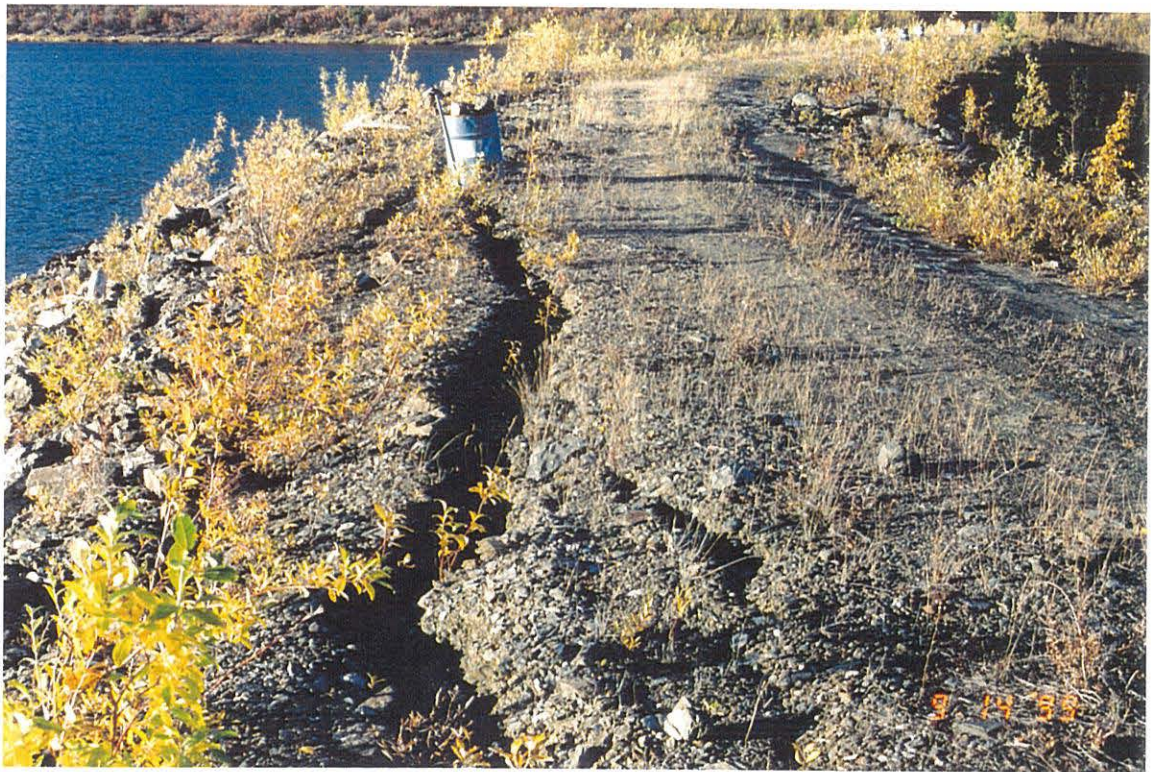
Fissures and cracks in the dam crest were fresh and appeared to be larger and wider than in 1998 (Photo 9). The main crack, which is 35 to 150 mm wide and up to 200 mm deep, parallels the upstream side of the dam crest at a distance of some 1 to 2 m (Photo 10). Smaller cracks, about 5 to 30 mm wide, are discontinuous and occur locally on either side of the main crack. Some secondary cracks reach locally to the centreline of the dam crest.

Photo 9: Primary and secondary cracks in the crest of the Fresh Water Dam, near the north abutment.

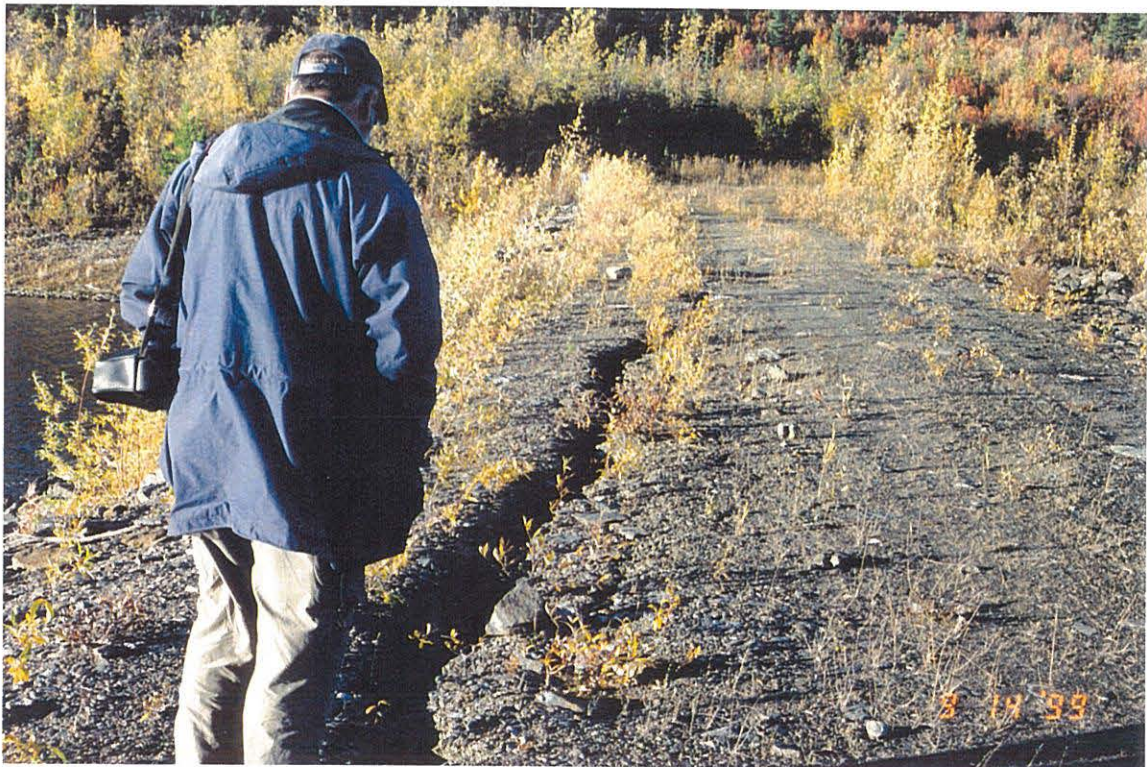
Photo 10: Fresh Water Dam crest, main crack at the approach to the south abutment.

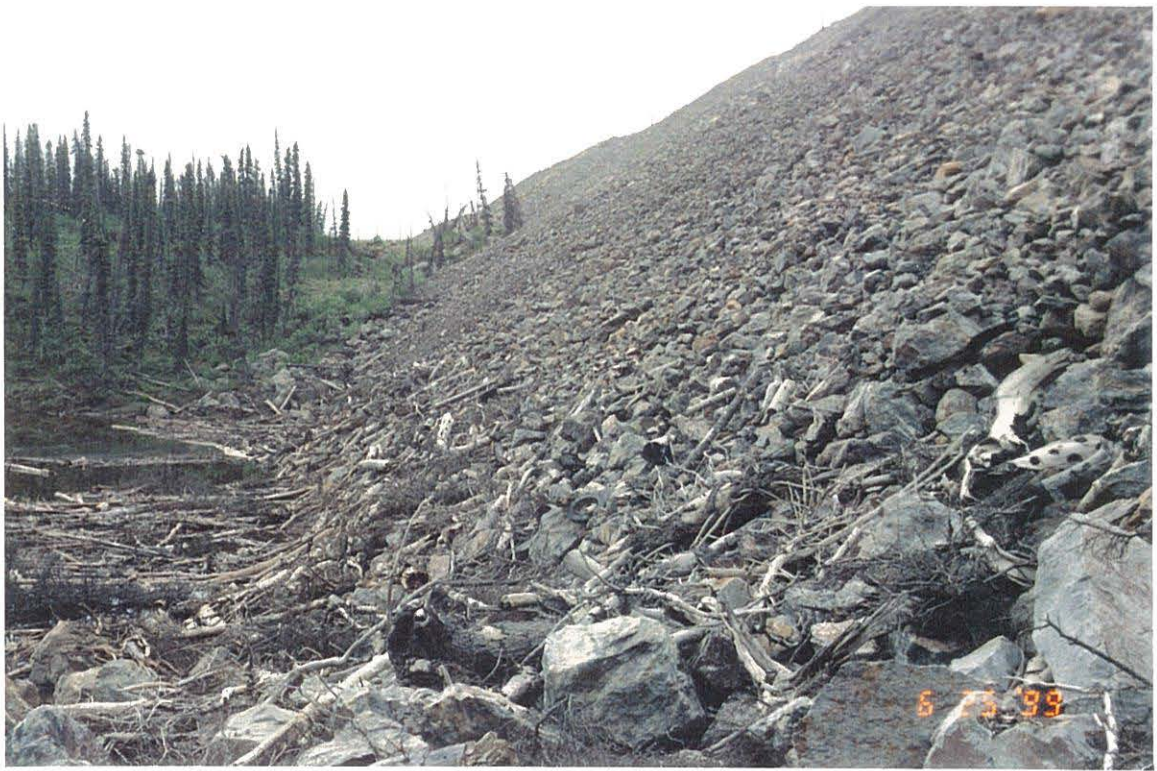
The upstream side of the North Fork Rose Creek rock drain shows signs of slow, but continuing deformations. The rocks at the surface are generally loose and the embankment slope, at and below the high water level mark, exceeds a 50 degree gradient. However, reference lines established in 1996 were found and they do not confirm any significant slope surface deformations. Despite the deposition of additional debris (Photo 11) on the upstream face, no significant changes were observed at the downstream discharge area. The flow in the creek, at the time of the site visit, appeared to be similar to that observed during previous site visits.

Photo 11: Vangorda causeway, view of the upstream slope of the rock fill and deposited driftwood.

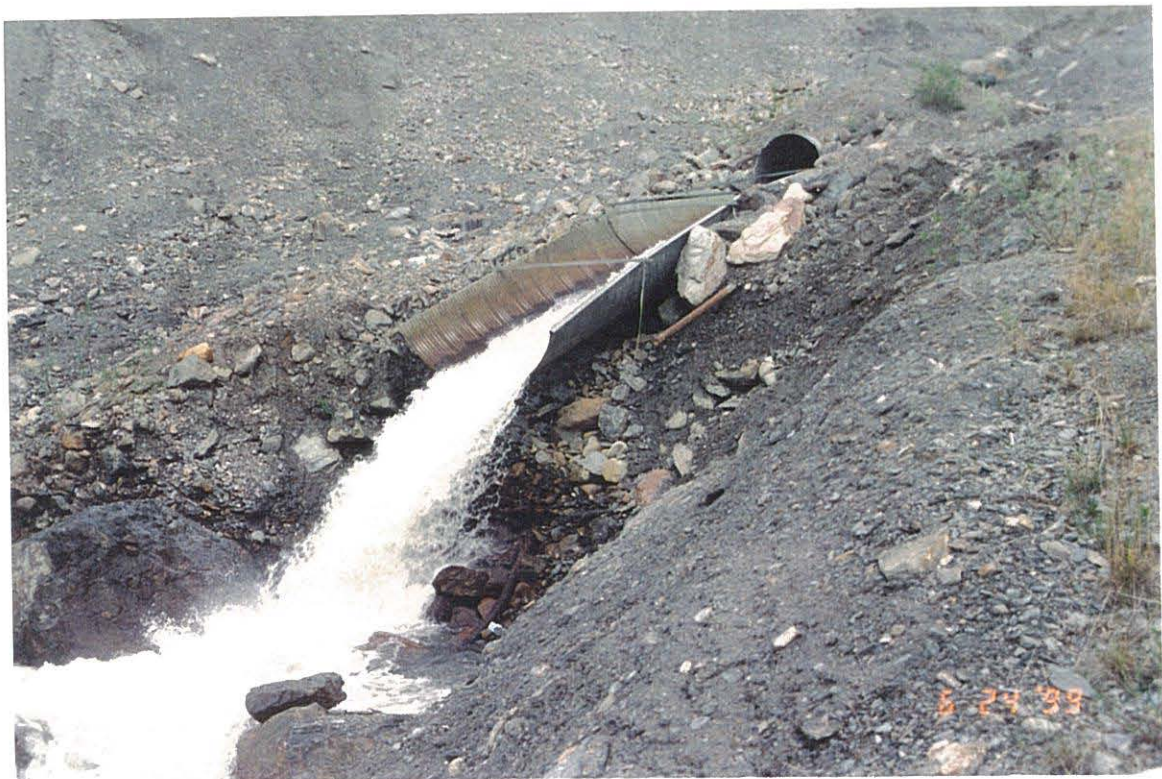
The Vangorda Creek crossing was also checked at this time. The embankment at this crossing is approximately 25 m high and the creek is conveyed through a culvert (possible capacity of 1 in 20 year flood) and the flow is discharged over a corrugated steel flume, composed of two sections. The last flume section continues retrogressive erosion in the plunge pool (Photo 12).

Photo 12: Vangorda Creek diversion. View of the discharge flume downslope from causeway.

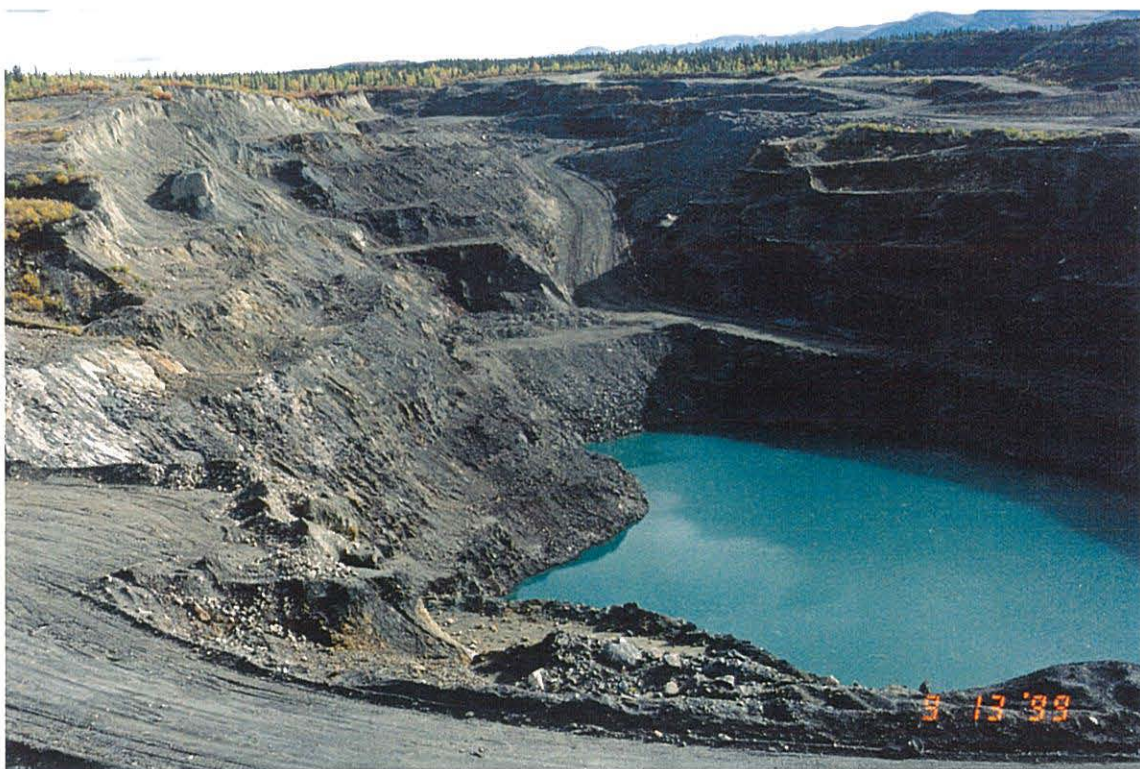
The Vangorda Mine infrastructure comprises an open-pit mine (gradually flooding - Photo 13), the Vangorda Creek Diversion (progressively deteriorating), and the Vangorda Waste Rock Dump with an acid drainage collection connected to Little Creek Pond (Figure 2 in Appendix B). Because of the lack of power, the water treatment plant was not operating in 1999.

Photo 13: Vangorda open pit, looking southeast.

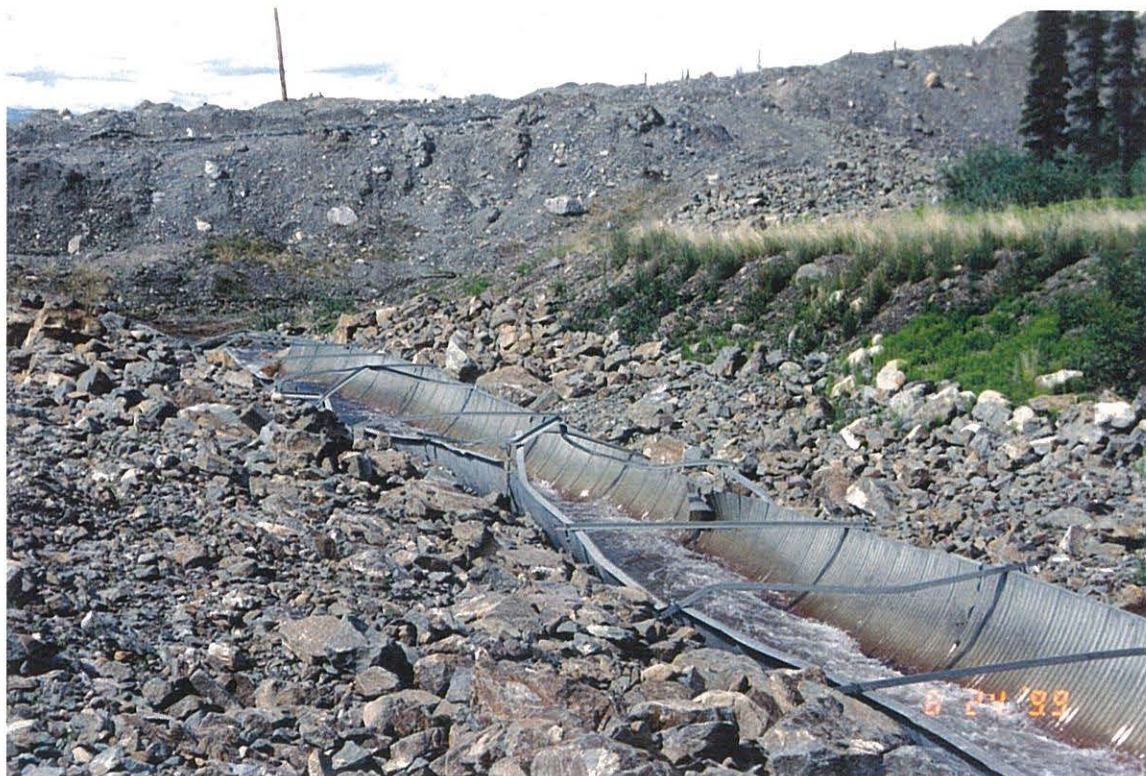
m high), with a culvert and trash rack but without an emergency spillway. The diversion itself consist of an 0.5 km long, 2,400 mm diameter half-culvert set on a pit bench carved into the north side of the open-pit wall. The culvert and channel have been designed to accommodate the 1 in 20 year flow, estimated to be in the range of  $5.2 \text{ m}^3/\text{s}$ . The culvert-lined channel does not have a constant gradient and locally rocks are deposited on its bottom. Consequently, the actual flow capacity may be less than the design one. Because of bends and occasional blockages (specifically icing), spills have been experienced and erosion problems have occurred along the downstream portion of the flume. At points of overtopping, the culvert bedding has been locally washed away, resulting in culvert misalignment. Removal of debris and ice from the channel often causes damage to the channel (Photo 14).

Photo 14: Vangorda Creek flume. Cleaning of the channel causes its misalignment and damages this structures.

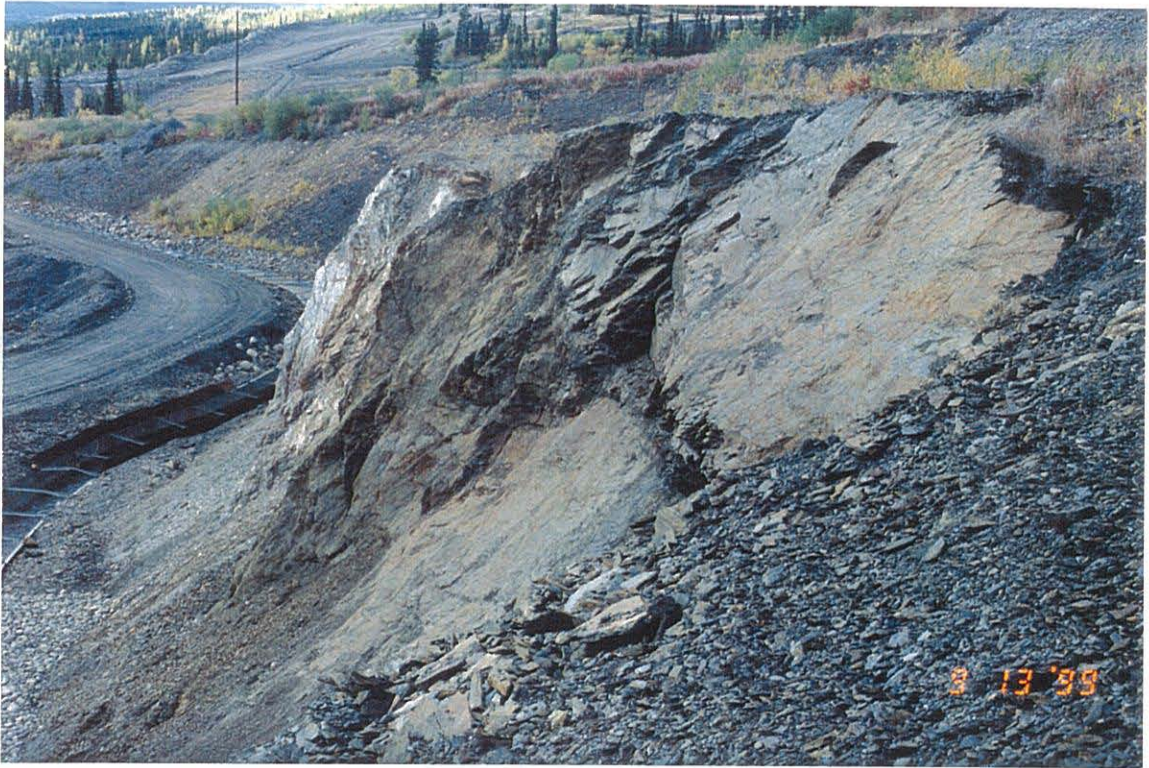
A failure (rock fall) of a section of the rock wall above the Vangorda Creek diversion flume occurred in June 1999 (Photo 15), which resulted in a blockage of the diversion channel. The rock debris filled approximately 25 metres of the length of the flume and several half culvert flume sections were crushed. The damaged sections were subsequently replaced and the flow was diverted into the pit during that time. A total of seven sections of culvert were replaced, representing a 30 m section of the flume.

Photo 15: View of the Vangorda Creek diversion cut wall in the segment which failed in June 1999.

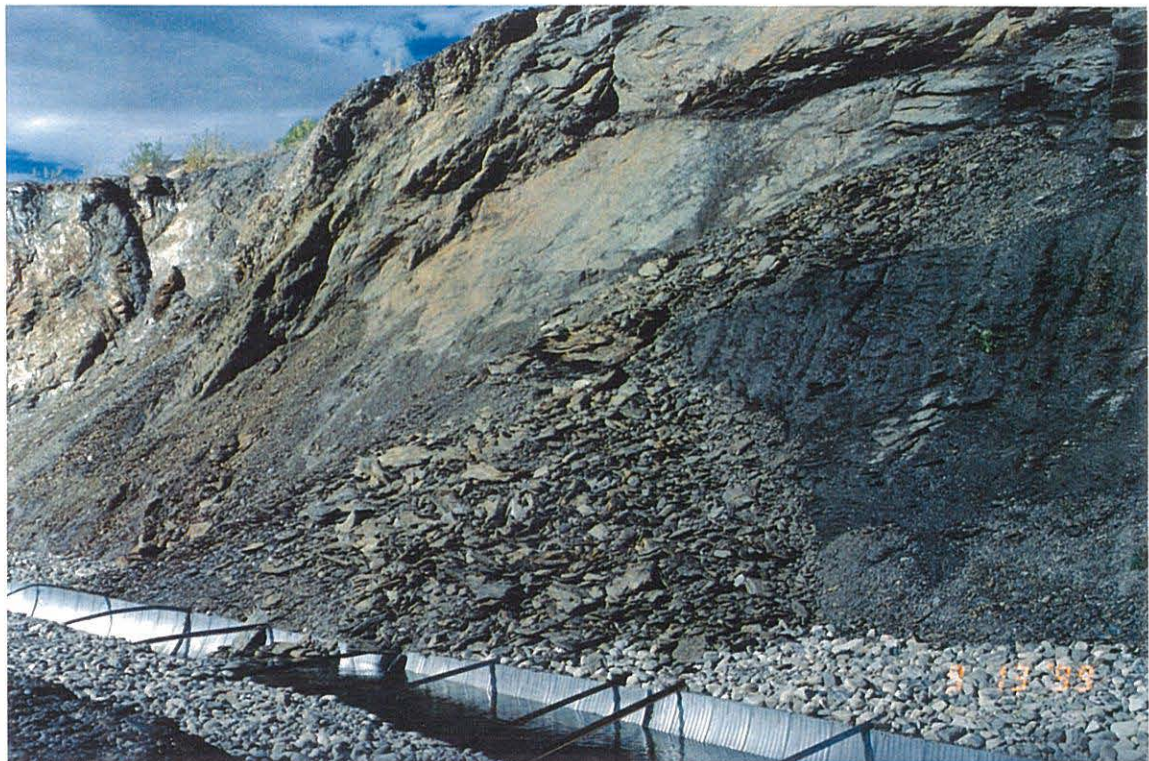
Another rock fall (smaller than the June one – Photo 16) involving an estimated 10 to 15  $\text{m}^3$  of rock, occurred on September 12, 1999 and partially blocked the flume. However, most of the rock fall was retained on a ledge between the channel and the rock wall toe. There are steep rock faces resting on the joints dipping towards the diversion channel.

Photo 16: View of a minor rock fall which occurred in the same area on September 12, 1999.

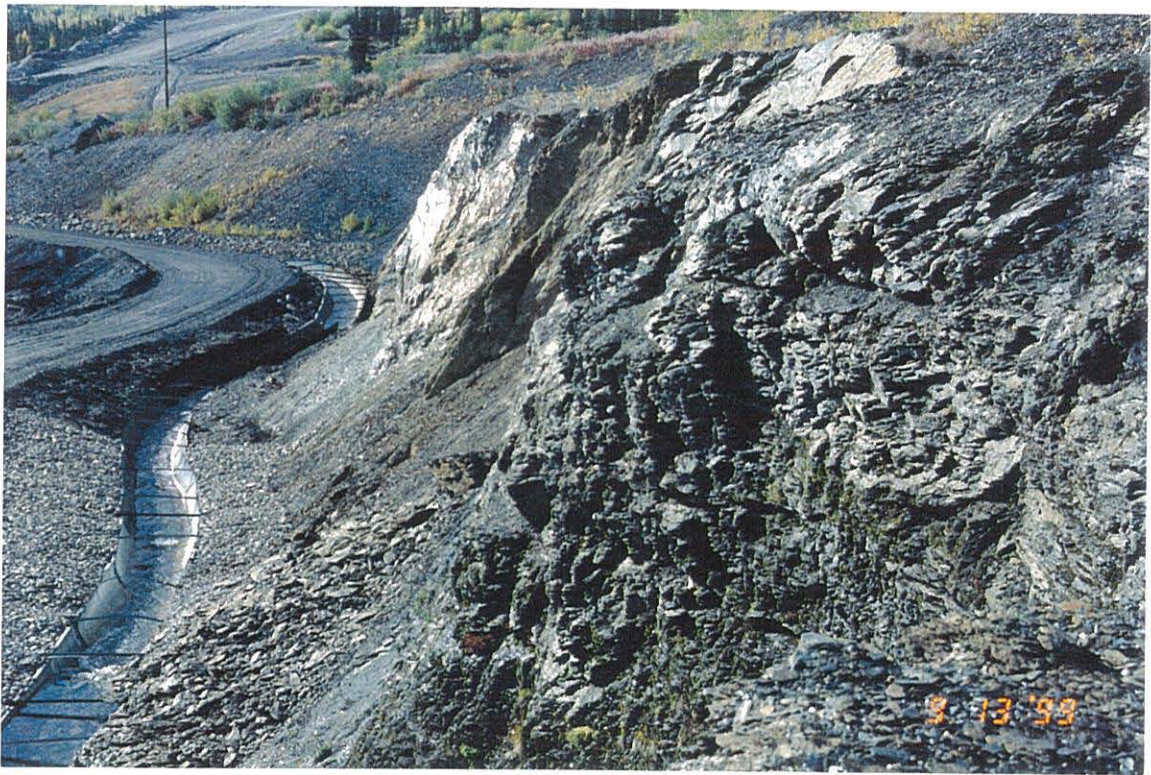
The wall segments, downstream and upstream from the failed slope segment (Photos 17 and 18), may fall in the future. Possible mitigative measures would entail the following:

Photo 17: Looking downstream over the June-September 1999 rock fall area. Note step escarpment resting on adversely dipping joint.

- Removal of potentially unstable rock blocks and scaling of the rock wall. This would require a bench cut along the crest of the rock wall and temporary protection of the diversion channel.
- Clean-up of the ledge between the channel rim and the toe of the rock wall and construction of a retention barrier along the channel. The barrier may be constructed using gabions or concrete New Jersey road barriers. This option may be combined with placement of an anchored wire mesh, intended to direct small rock blocks into the rock retention area.

Removal of potentially unstable rock blocks represents better protection of the diversion channel, resulting in less water discharge into the open pit.

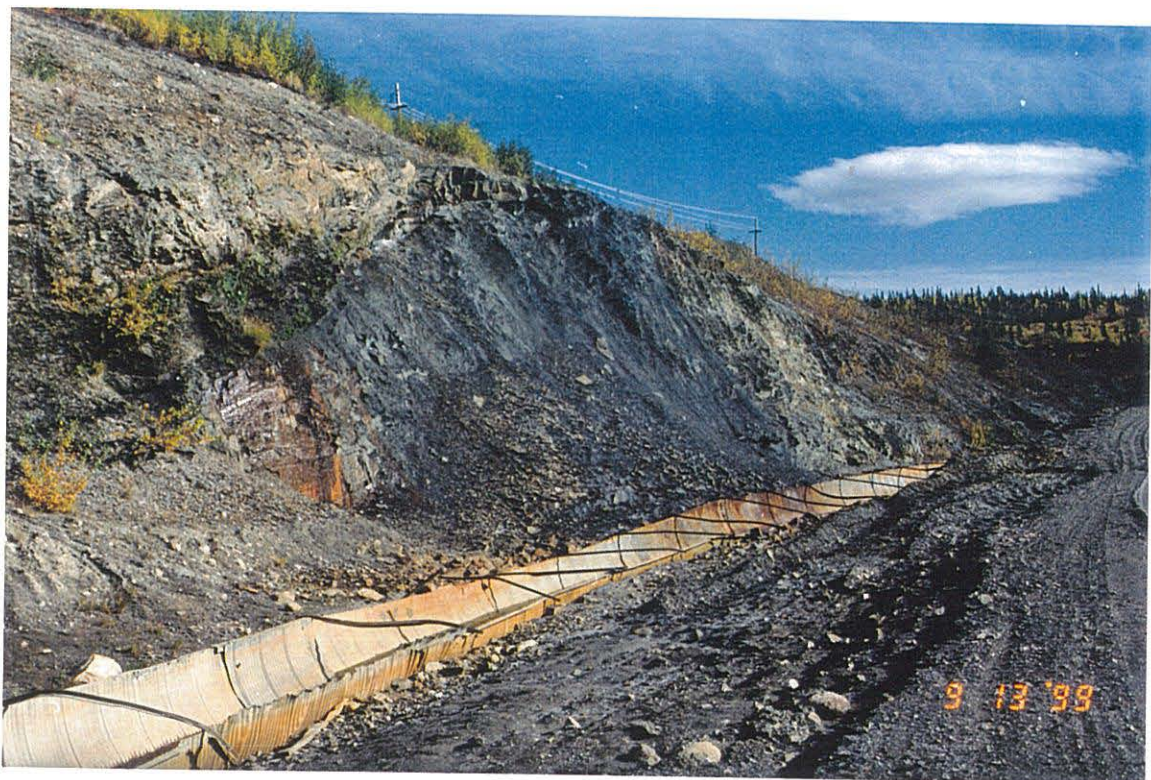
Photo 18: View of the potentially unstable area upstream from the 1999 rock fall.

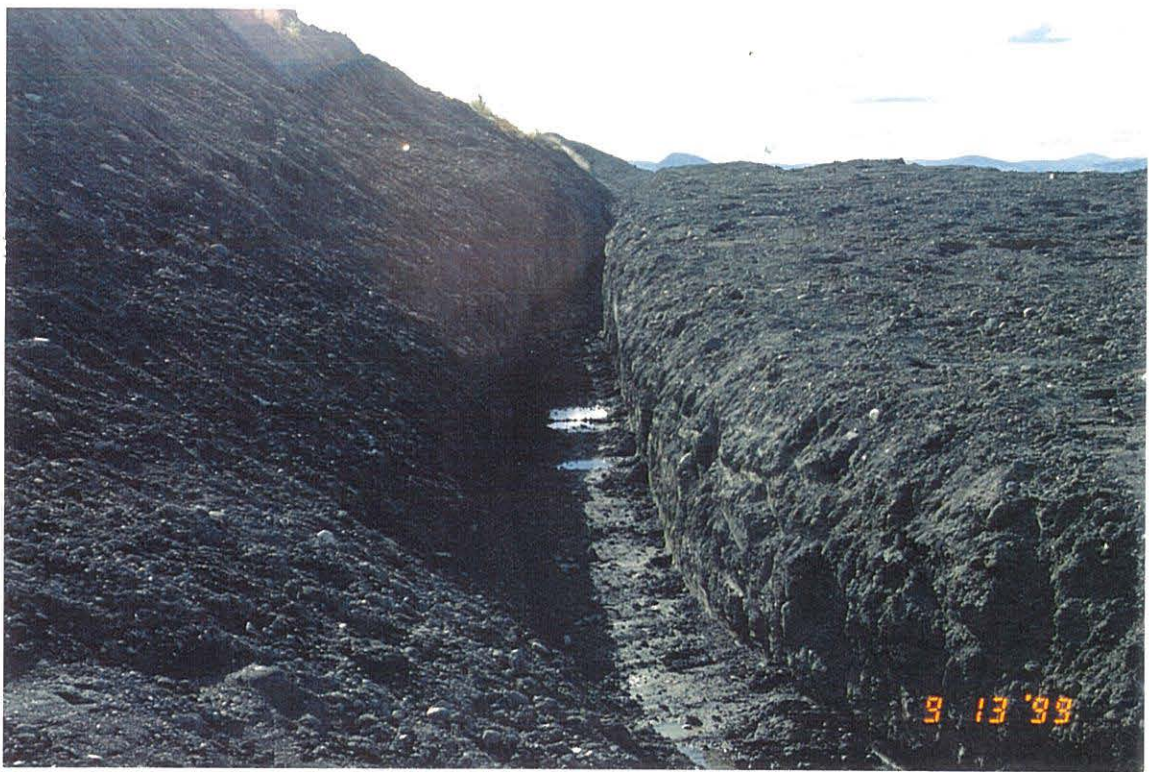
There is a depression behind the top of the second till berm on the northeast side of the dump, upslope from the Drain Nos. 5 and 6. Surface runoff was ponded in this depression, reportedly causing concern about the till berm stability. In an attempt to drain this area, a drainage ditch, up to 2.5 m deep and about 1.5 m wide (Photo 19), was excavated along the toe of the second till berm. The second berm face was steepened to about 40 degrees slope and excess material dumped over the face of the first berm, destabilizing this slope as well. This work, in the writer's opinion, substantially decreased the stability of both berms. It would be prudent to drain the depression straight down over both till berms via a sand-gravel-rock rip-rapped channel, backfill the ditch and re-grade the till berm slopes.

Photo 19: View of the drainage ditch, undercutting the toe of the second till berm on the Vangorda rock dump.

The Vangorda Waste Rock Dump drainage ditch represents a hazard to the stability of the till berms in this area. It is recommended that this drain be backfilled and a new drain constructed, if deemed necessary.

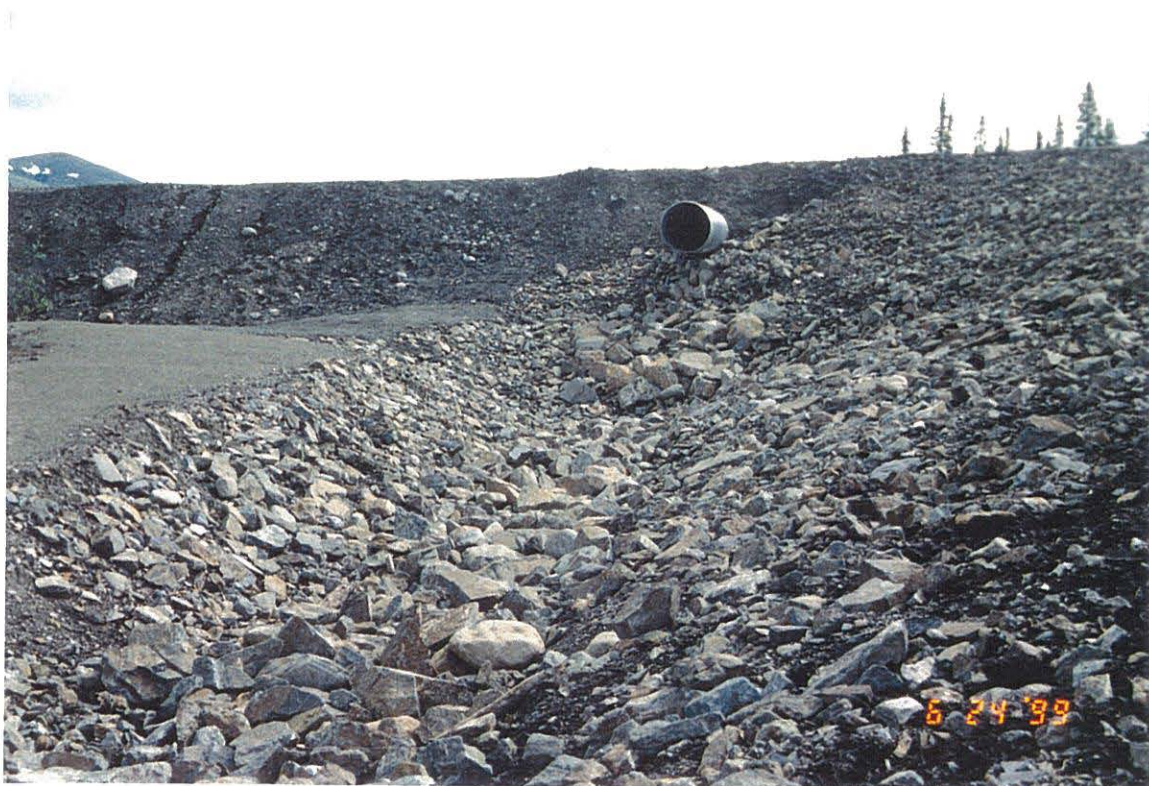
No significant deformations were observed on the Little Creek dam. Relatively extensive erosion rills on the downstream dam slope continue to expand and cut deeper into the dam slope. The emergency spillway, comprised of a culvert with a rock apron at its discharge end, was finally constructed (Photo 20). The outlet channel requires placement of additional rip-rap.

Photo 20: Little Creek Dam; view of the culvert spillway and discharge channel.

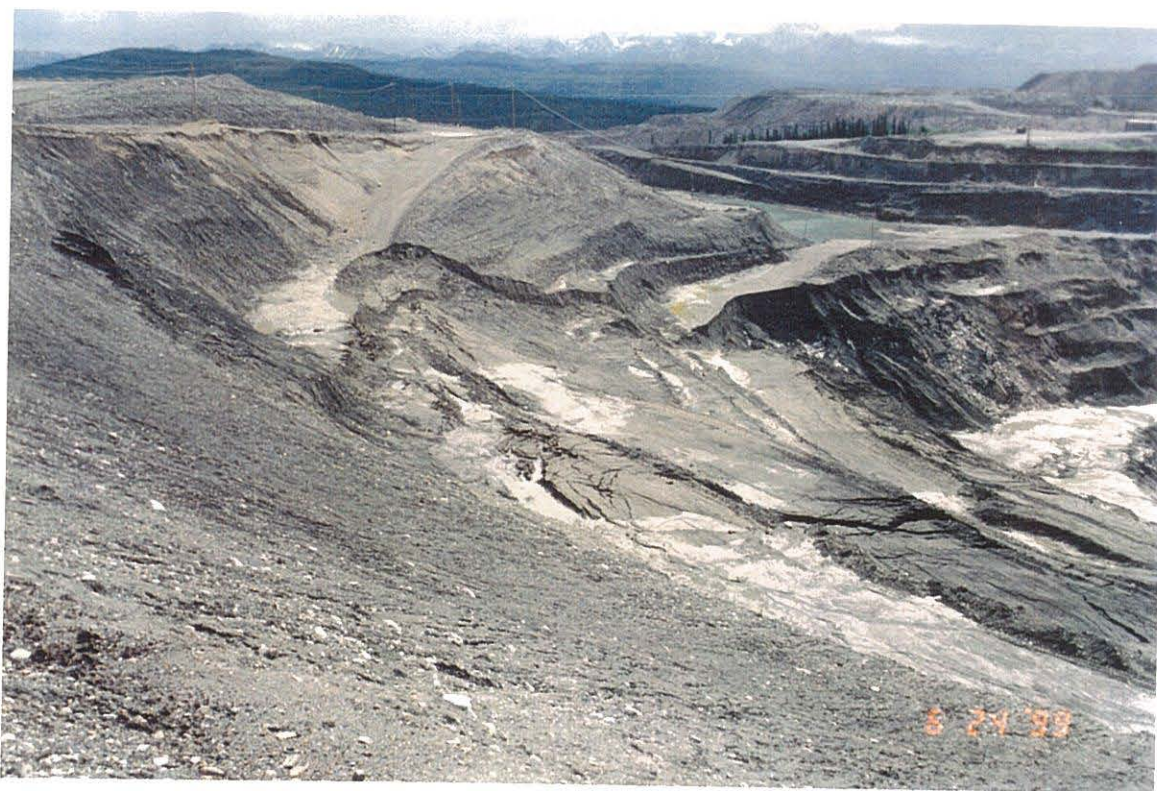
A major failure occurred in the eastern segment of the pit in 1997 (Photo 20), possibly because pumping of perimeter wells was discontinued during a temporary halt of operations in the winter of 1996/1997. Anvil Range decided to construct a so-called Slot Cut access into the pit and excavate the slide debris, chiefly comprised of clay till. The excavated material was dumped into the rock waste dump.

It was noted, during this site visit, that the pit slide continues to be active, several mud flows were developed and the slide retrogressed behind the original pit rim and sideways into previously stable rock slopes.

Photo 21: Grum pit, view of its eastern segment affected by a major slide. So-called slot cut pond surface runoff which, in turn, contributes to the instability of the adjacent pit wall.

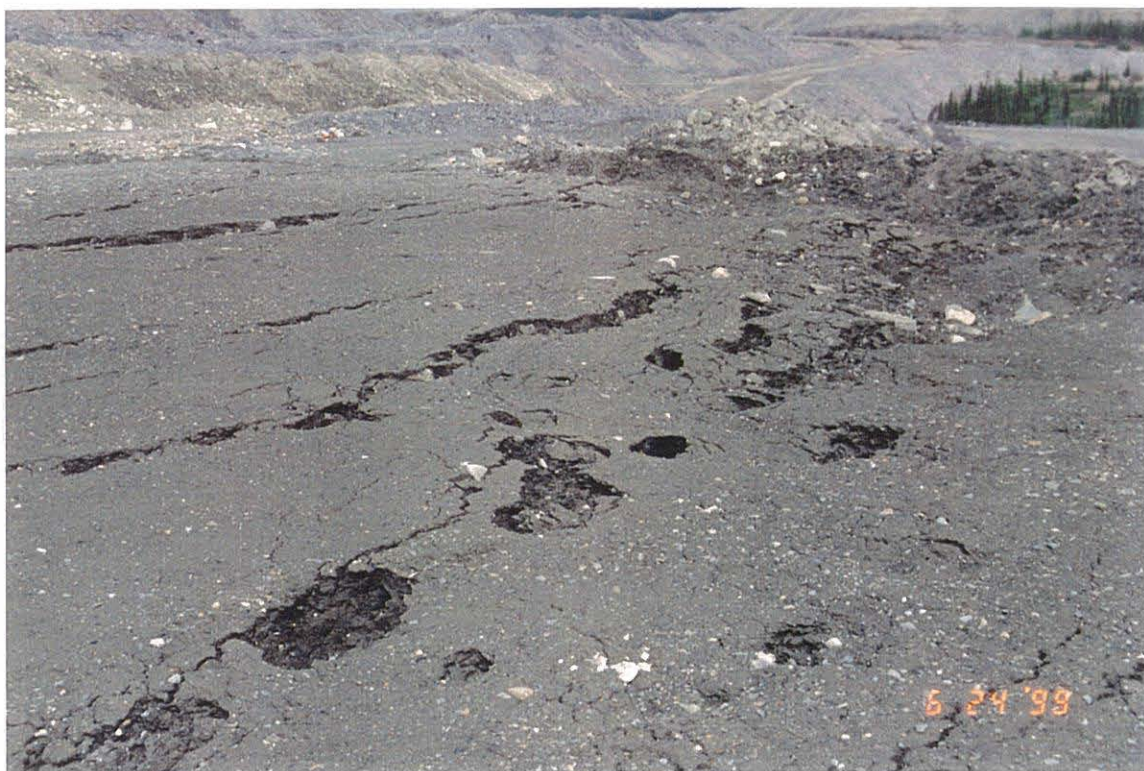
More widespread cracks and other signs of ongoing deformations were observed on all dump levels and slopes, except the top dump segment which is only 10 to 15 m high. Instabilities involve all types of waste materials (Photo 23 and 24).

Photo 23: Second level of the Grum waste dump comprised, in this segment, chiefly of till.
