# NORTHERN AFFAIRS PROGRAM

## FARO AND VANGORDA PLATEAU MINES

**REPORT  
ON  
1999 INSPECTION**

Prepared by:  
GEO-ENGINEERING (M.S.T.) LTD.  
Calgary, Alberta

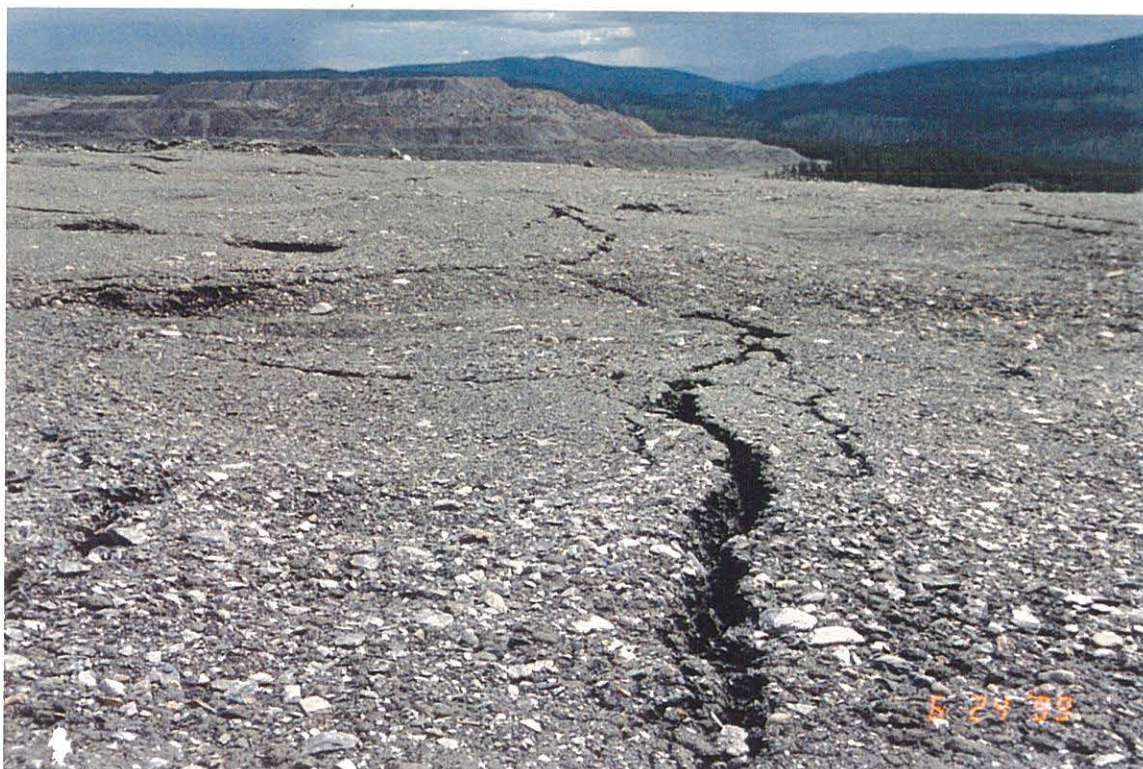
More widespread cracks and other signs of ongoing deformations were observed on all dump levels and slopes, except the top dump segment which is only 10 to 15 m high. Instabilities involve all types of waste materials (Photo 23 and 24).

Photo 24: Fourth level of the Grum waste dump, comprised predominantly of phyllite.
