DRAFT REPORT
Faro Fresh Water Supply Dam
Evaluation of Reclamation Approaches

Prepared for
Deloitte and Touche Inc.

Prepared by:
Gartner Lee Limited

GLL 20-933

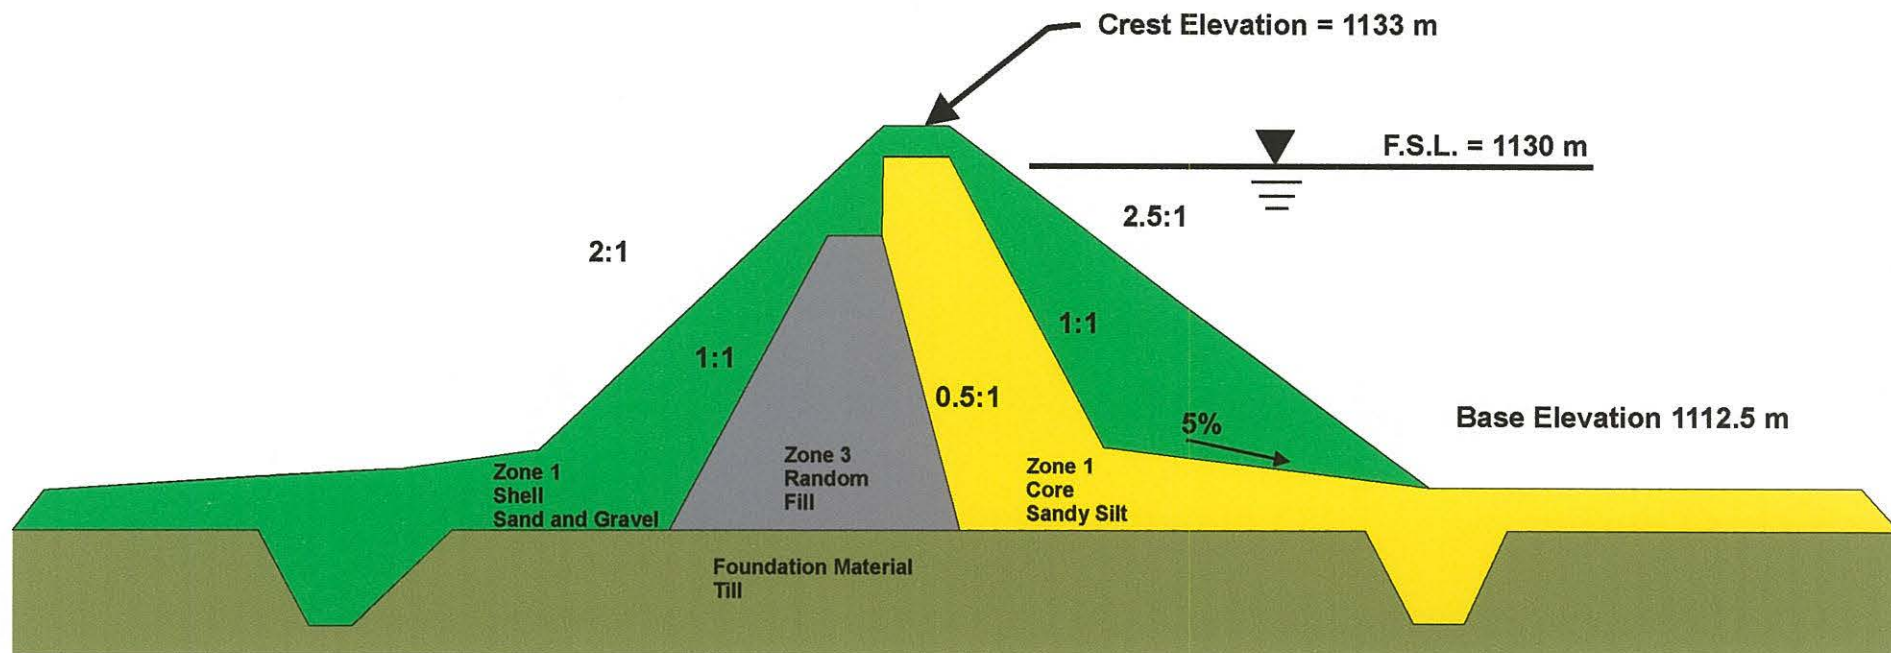
Figure 7 provides a view of the model geometry for the stability analysis. For the designers case, Table 5 outlines the results obtained by searching for the minimum factor of safety, using both of the analytical methods noted previously:

Stability of the downstream toe is always the most critical case for steady state seepage conditions, in agreement with the results of Table 5. The critical case is a block failure on the downstream toe, which reaches back through the random fill zone and foundation till. As noted earlier, the designers of this dam would have likely been designing for a static assessment value of 1.5, which has been achieved using the parameters assumed. These results, therefore, validate the assumptions made.

As can also be seen from Table 5, the factors of safety are insensitive (1.5% variation) for the downstream side and slightly sensitive (9.5%) for the upstream side. Since testing results from Golder (1980) validate the values for the likely set of parameters, these values are assumed for all further stability analyses.

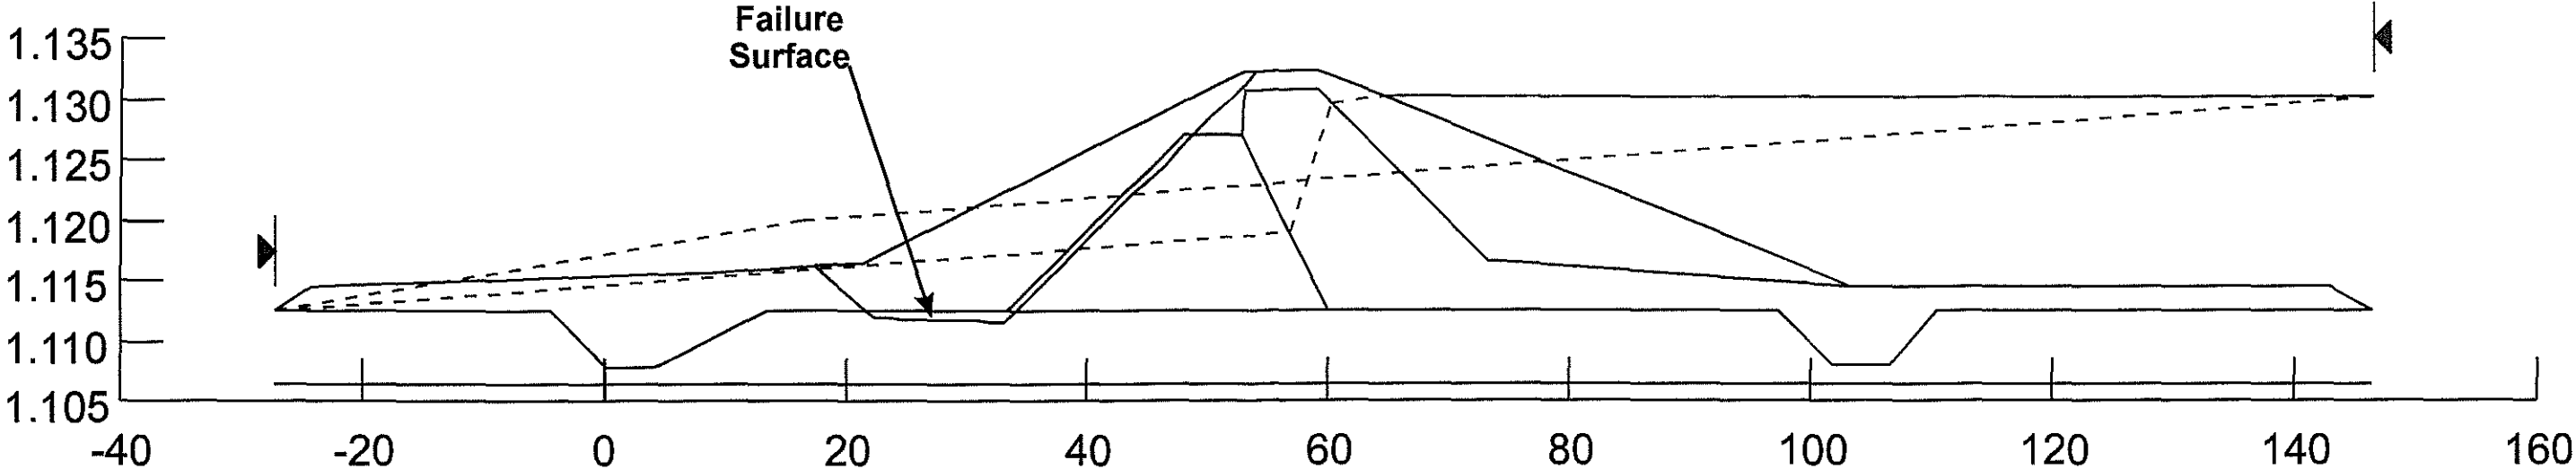
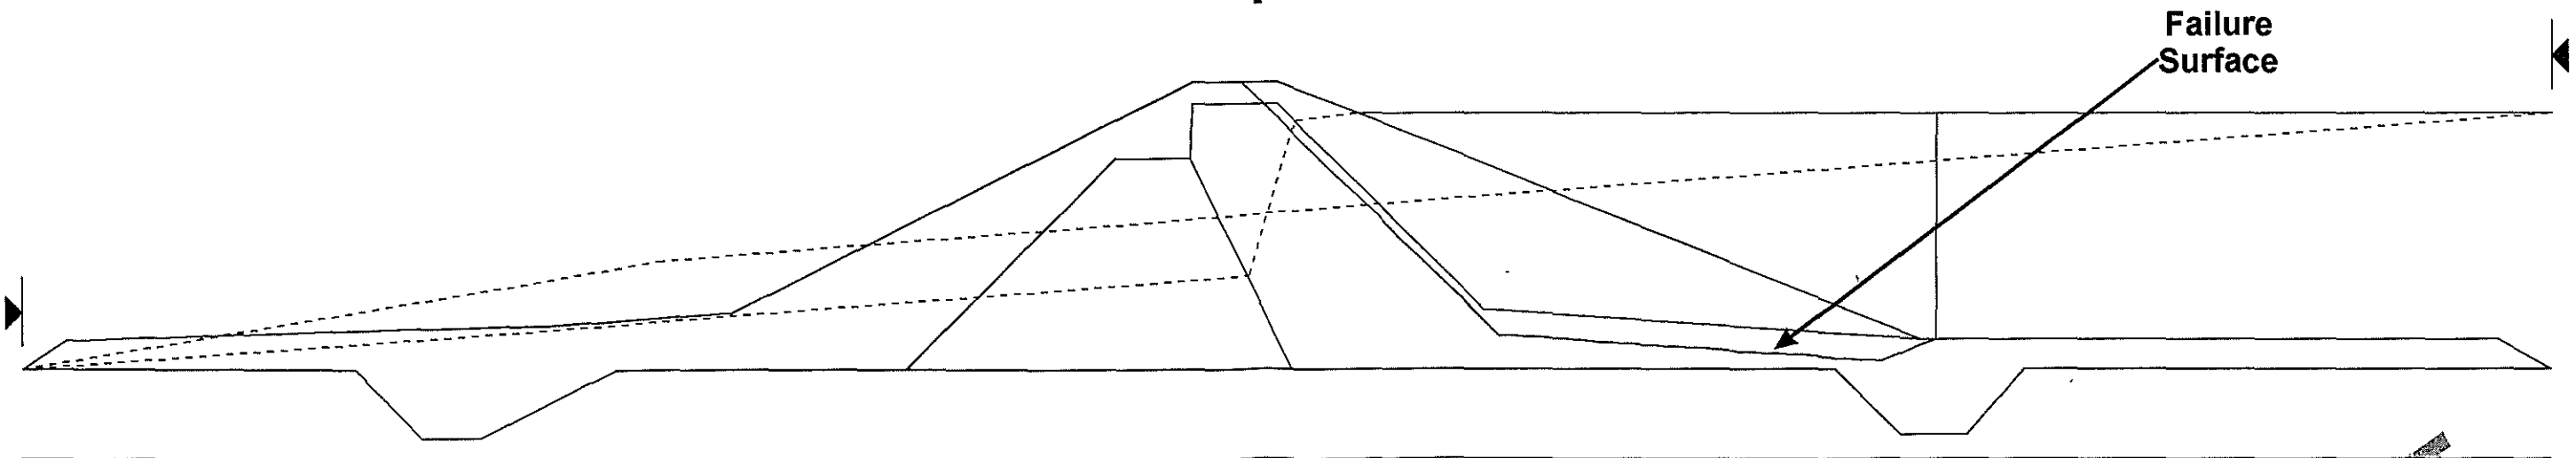
PROJECT			Faro Fresh Water Supply Dam Evaluation of Reclamation Approaches		
TITLE			Specified Failure Surfaces for Breached Conditions		
PROJECT No.		0168-007-01 GLL: 20-933		FIGURE No.	Figure 9
				REV.	0.

Table 7 provides a summary of the factors of safety obtained from the analyses. These values were for the Janbu method only (previously demonstrated to be the critical method) and for a fully-specified failure block as illustrated on Figure 9.

Table 7 indicates that the safety factor on the downstream toe increases as the reservoir level decreases, as would be expected. The total increase in the factor of safety for the static condition amounts to 45% if the entire reservoir was removed.

A minimal lowering of the reservoir was assessed with the intent of reducing the risk of failure of the dam by dropping the maximum water level in the reservoir by 3 metres, to an elevation of 1127 m (above mean sea level). At this elevation, it is not possible to make the current geometry of dam meet the accepted dam design guidelines.

A substantial lowering of the reservoir was assessed with the intent of reducing the risk of failure of the dam and preserving or improving the existing fish habitat by dropping the maximum water level by 6 metres, to an elevation of 1124 m (above mean sea level). Again, it is not possible to meet design guidelines with the current dam configuration; the upstream side is critical in terms of both static and seismic analysis.

Since this case is beneficial for fisheries habitat (as described elsewhere in this report), the stability of the dam was assessed with the placement of a 15 m wide rockfill berm on the upstream side of the dam. This berm was assumed to go from the water level at 1124 m down to the bottom grade. With this berm installed, the upstream side factor of safety increases to 1.67 for static conditions, 1.23 for 0.07g and 1.0 for 0.13g, which would just be marginal. Hence, it is likely that decreasing the water level and constructing a rockfill berm on the upstream side can be designed to meet required guidelines.

A case of complete breach of the dam, leaving no water in the reservoir, was analyzed with the intent of eliminating the risk of failure of the dam by dropping the water level by 17.5 metres to original ground at elevation 1112.5 m (above mean sea level). As previously noted, this option meets safety guidelines after the breaching is undertaken.
