CURRAGH RESOURCES INC.

FARO MINE

1988 ANNUAL REPORT
TO THE
YUKON TERRITORY WATER BOARD

APRIL 1989

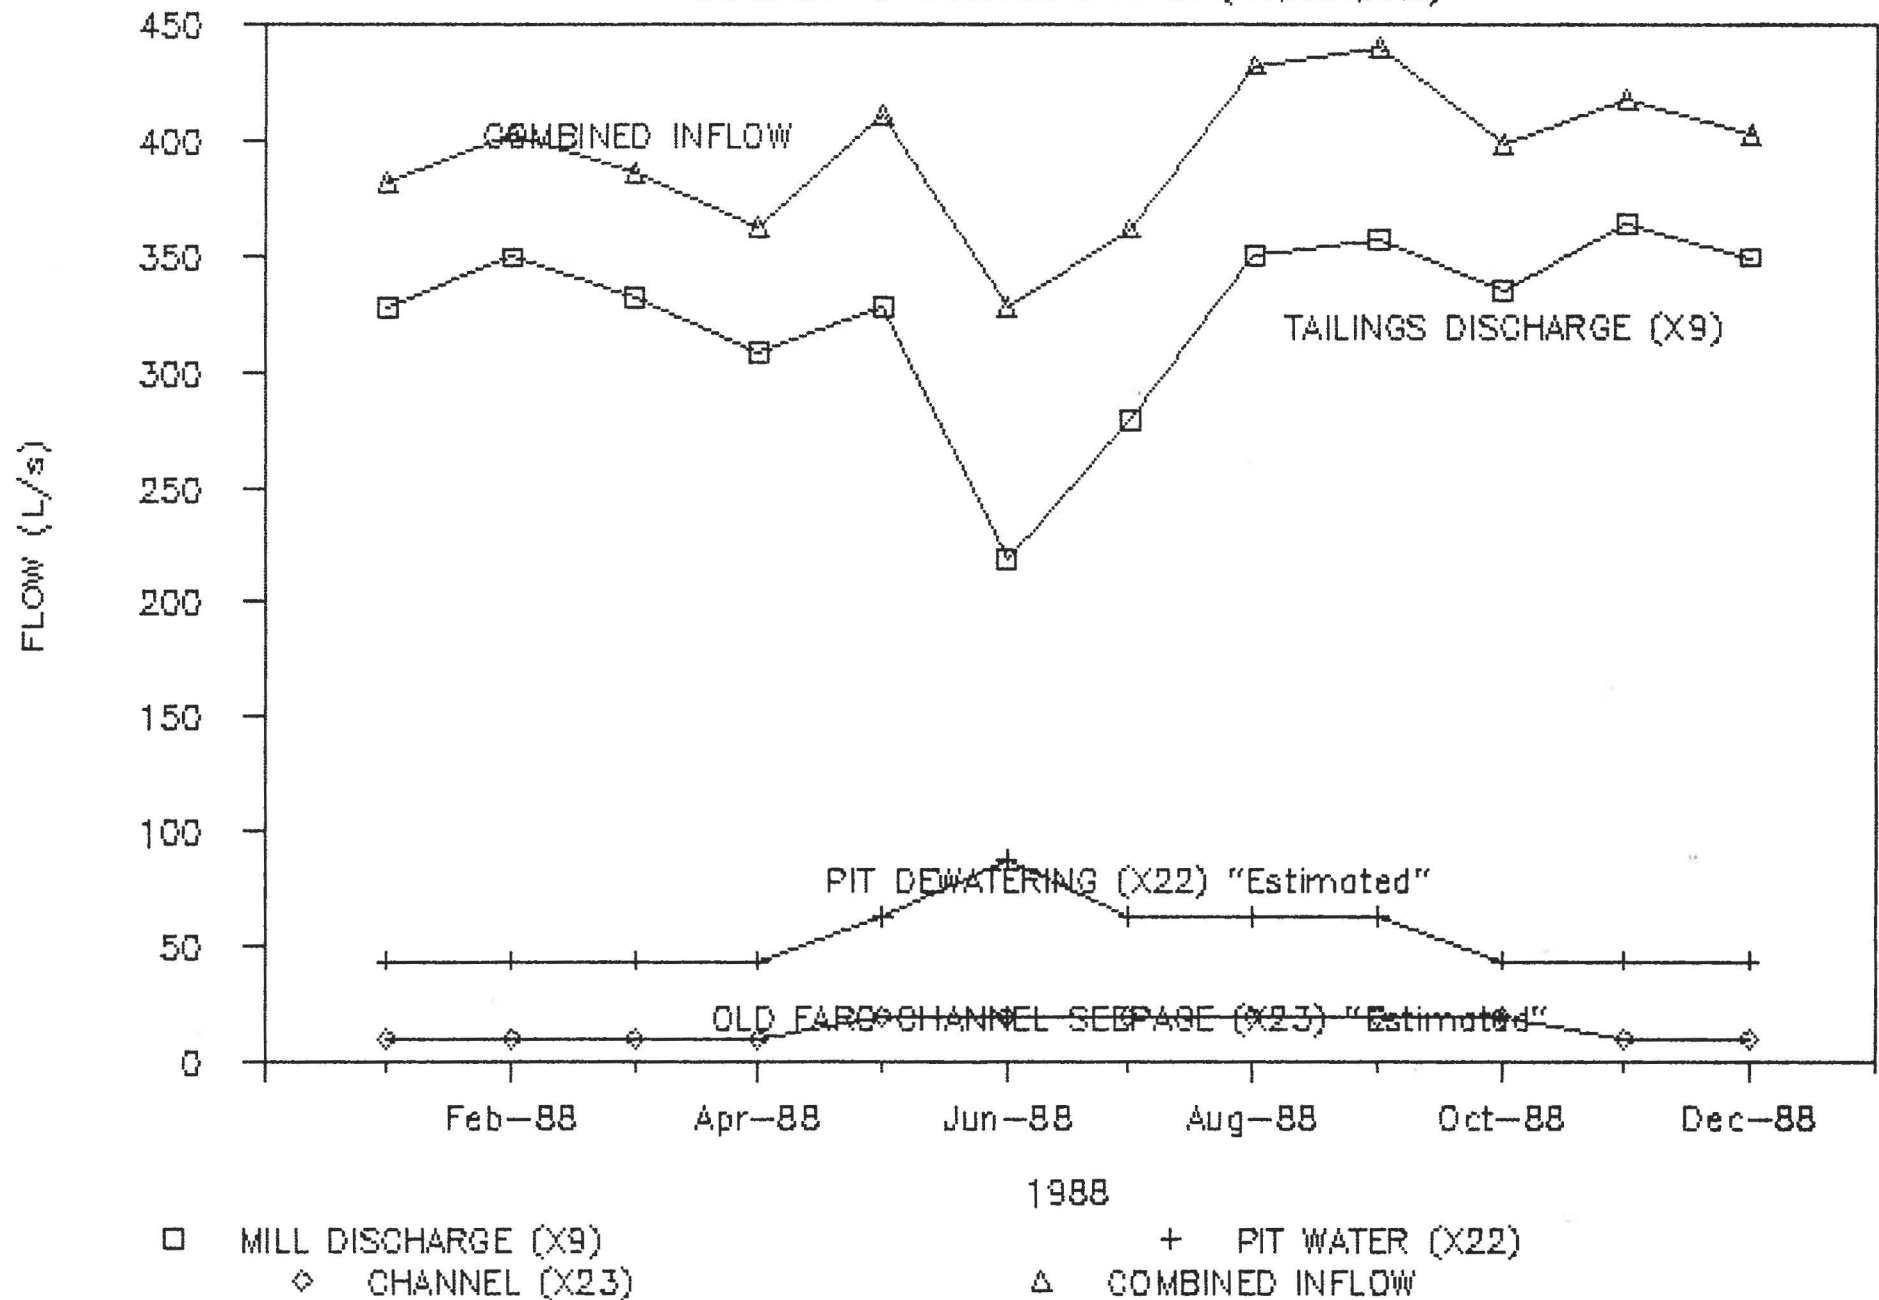
FIGURE 2

The tailings impoundment area has three major inflow sources; the Faro concentrator discharge (X9), the open pit dewatering discharge (X22), and the waste rock dump seepage discharge which collects in the old Faro Creek channel (X23). The average 1988 monthly discharge rates from these sources, and the combined tailings impoundment inflow rate are shown on Figure 2. The 1988 yearly average total inflow to the tailings area was 394 L/s (6246 USGM).

Inflow readings and estimates indicate that the greatest proportion of water flow to the system is from the tailings pipeline (X9). This flow is fairly constant, except during periods of concentrator shutdown.

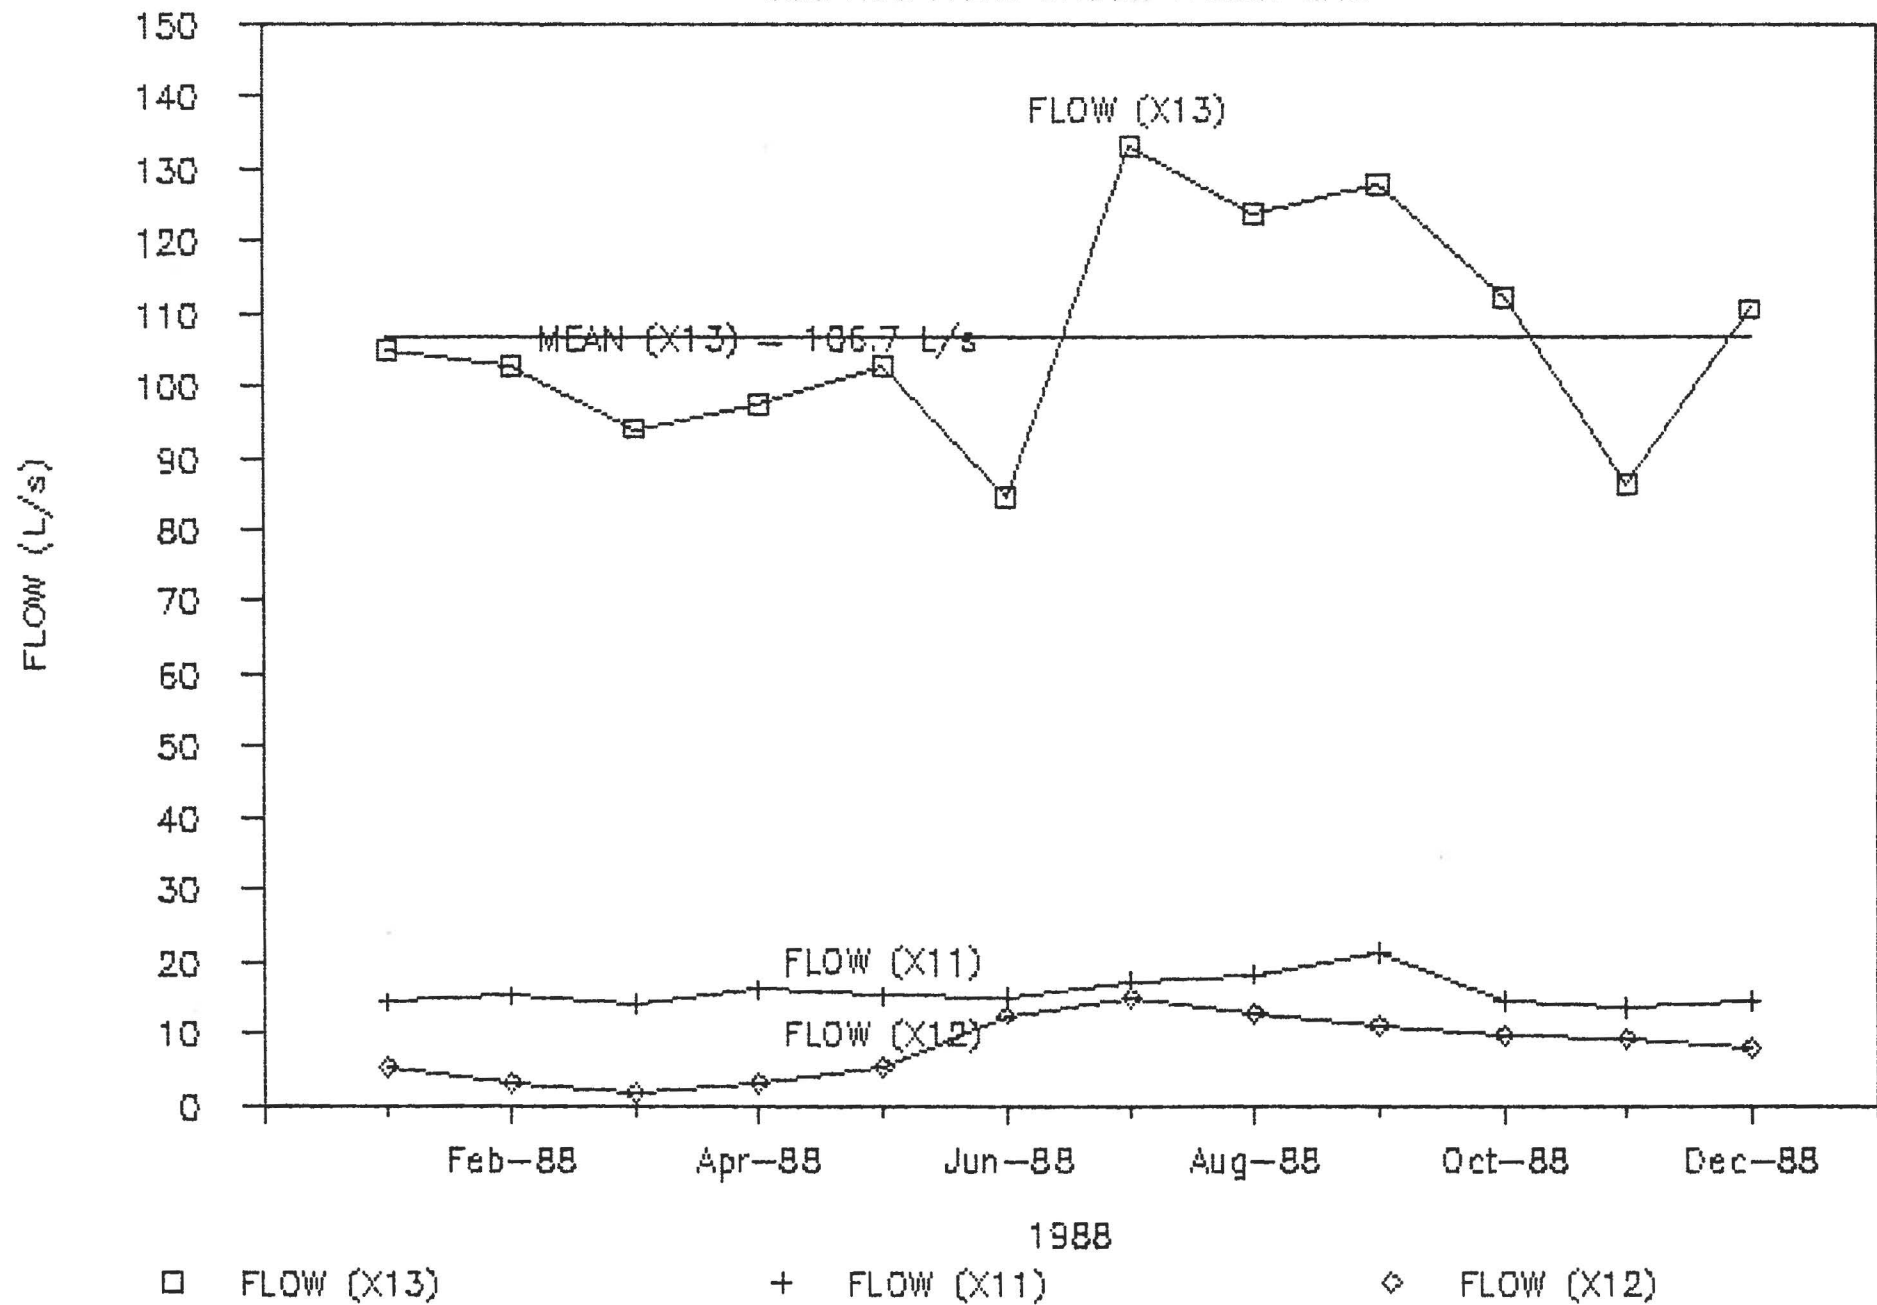
FIGURE 3

Effluent water is discharged from the Tailings impoundment area through the decant structure of the Cross Valley Dam (X5). Water also discharges as groundwater seepage through the Cross Valley Dam. Flows of decant water (X5) were not recorded on a regular basis. However, weekly flow readings were taken at the weirs located at sites X11, X12, and X13. Weirs located at sites X11 and X12 record discharge seepage from the north and south abutments, respectively, of the Cross Valley Dam. The weir at site X13 records the total seepage through the Cross Valley Dam. Monthly averages of these seepage flows are shown on Figure 3. The 1988 yearly average seepage flow was 107 L/s (1696 USGM).

Seepage discharge readings are also fairly constant; however there are higher rates during summer months. Abutment seepage (X11 and X12) comprise only a small proportion of the total seepage flow (X13) through the dam. Decant discharge (X5) although not measured, can be expected to parallel inflow discharge if adjustments are made for precipitation events and spring snow and ice melt. The estimated 1988 minimum yearly average flow through the Cross Valley Dam decant, therefore was 287 L/s (4550 USGM).

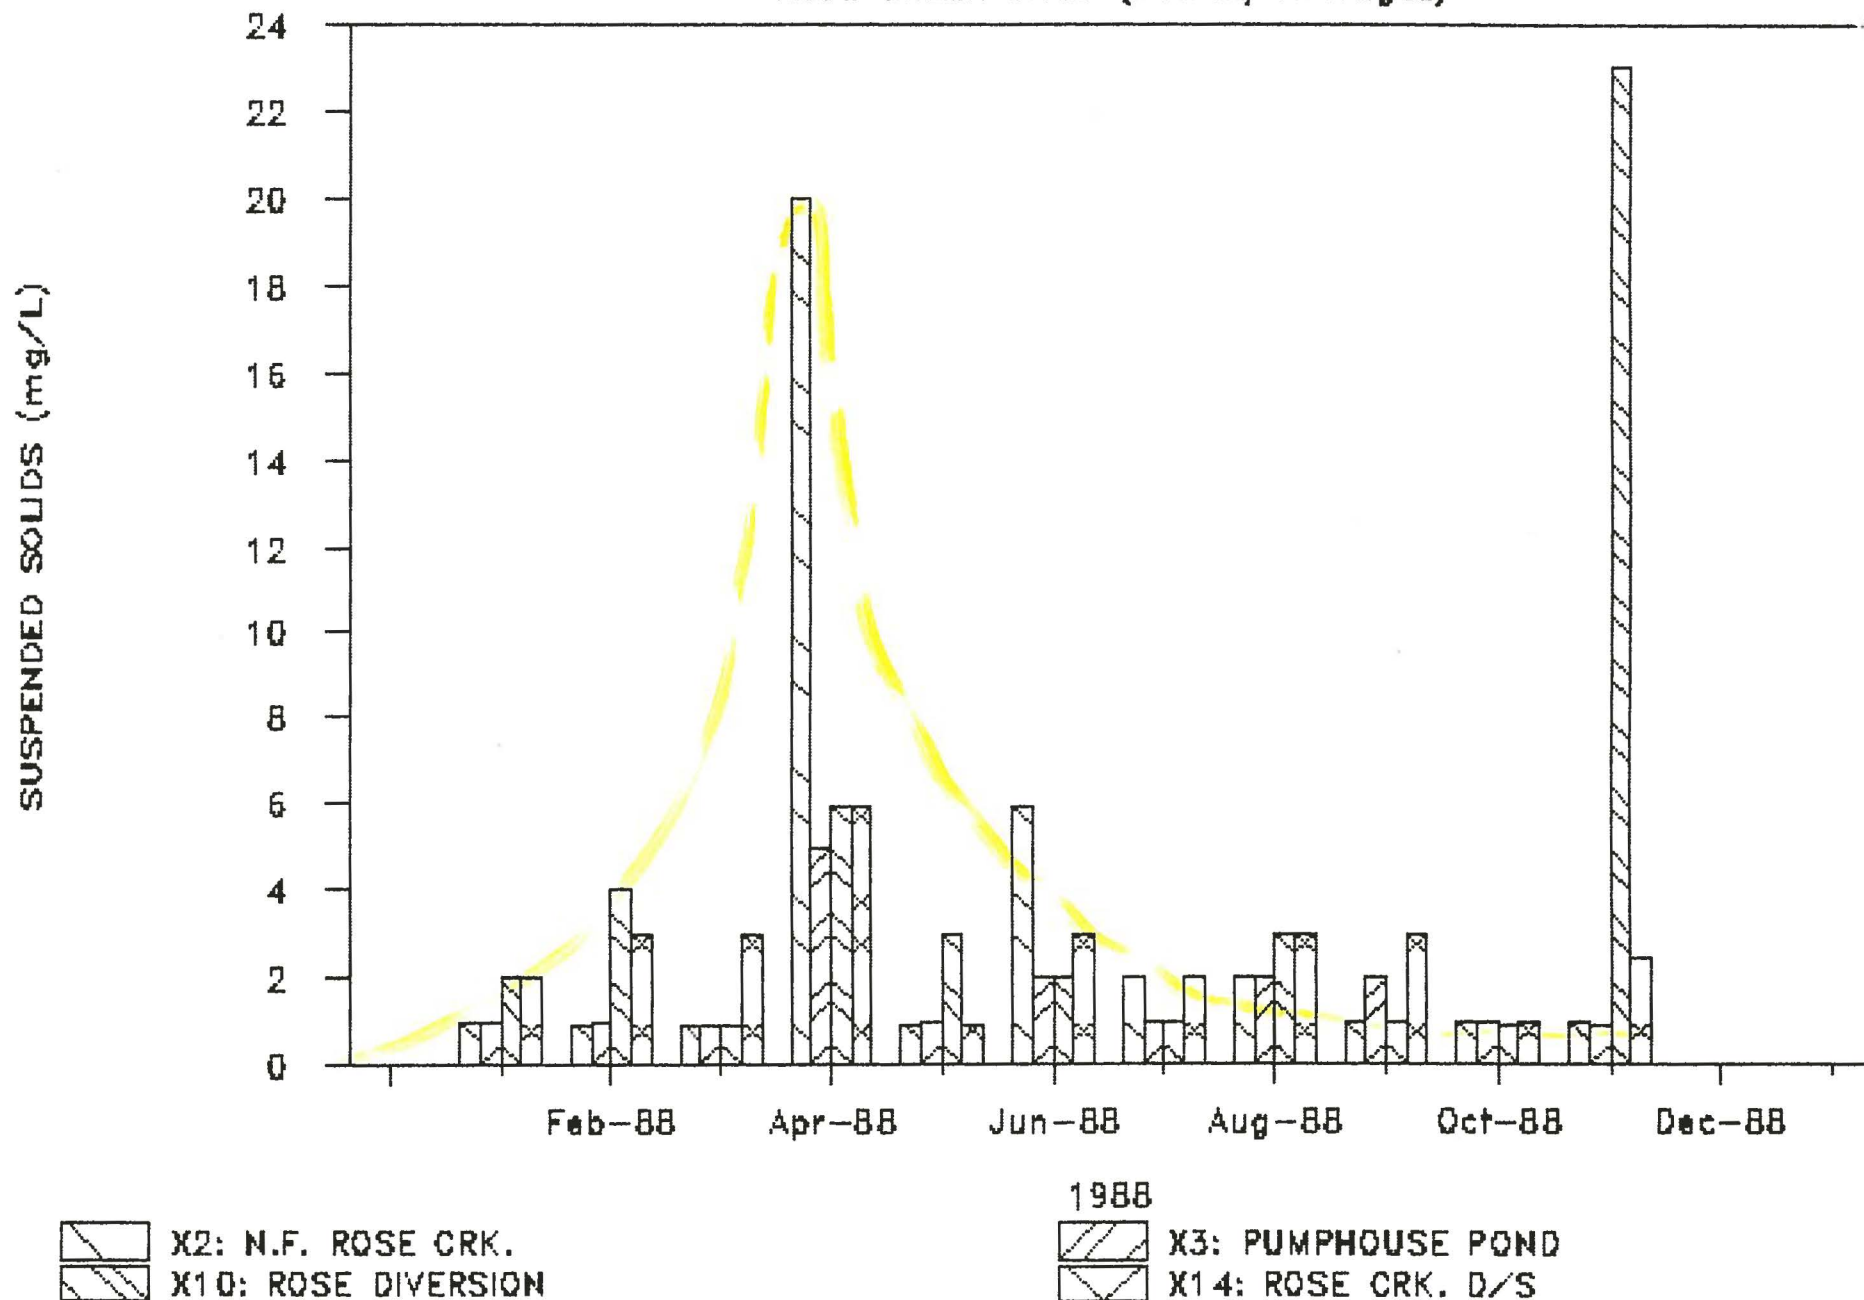
FIGURE 4 : SUSPENDED SOLIDS

The average monthly suspended solids levels at various Rose Creek sites are shown in Figure 4. As illustrated, elevated levels of suspended solids occurred in Rose Creek upstream and downstream of the minesite during freshet. The creek was clear at all other times, with the exception of Rose Creek diversion (X10) during November. Increased suspended solids levels at this time are attributable to canal maintenance work.

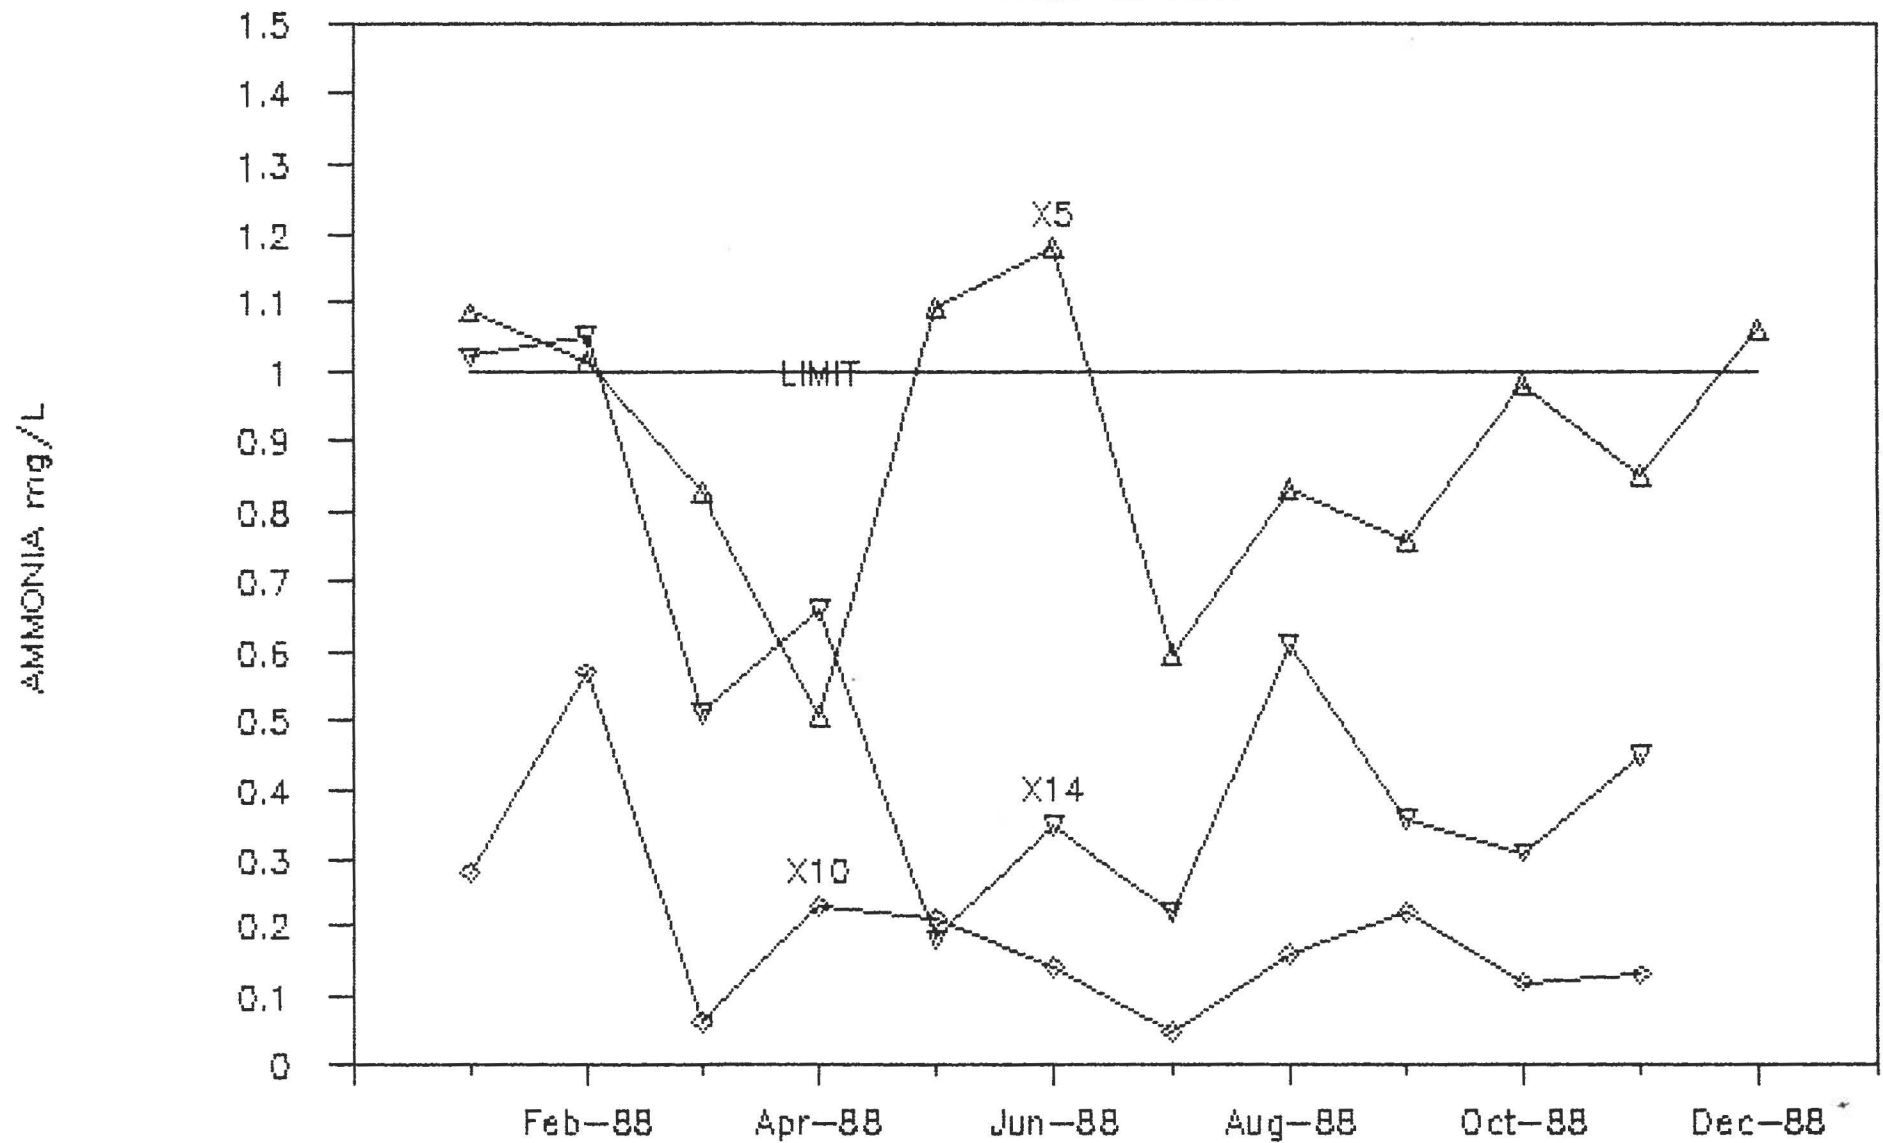
FIGURE 5 : AMMONIA

The average monthly ammonia concentrations of the decant discharge (X5), the Rose Creek diversion background water (X10) and Rose Creek water below the mine site (X14) are illustrated on Figure 5.

The Cross Valley dam decant (X5) reflects the ammonia inputs from the pit water and pit ore into the tailings system. As illustrated in Figure 5 the ammonia concentrations being discharged in the Cross Valley dam decant water were erratic, showing no seasonal trend.

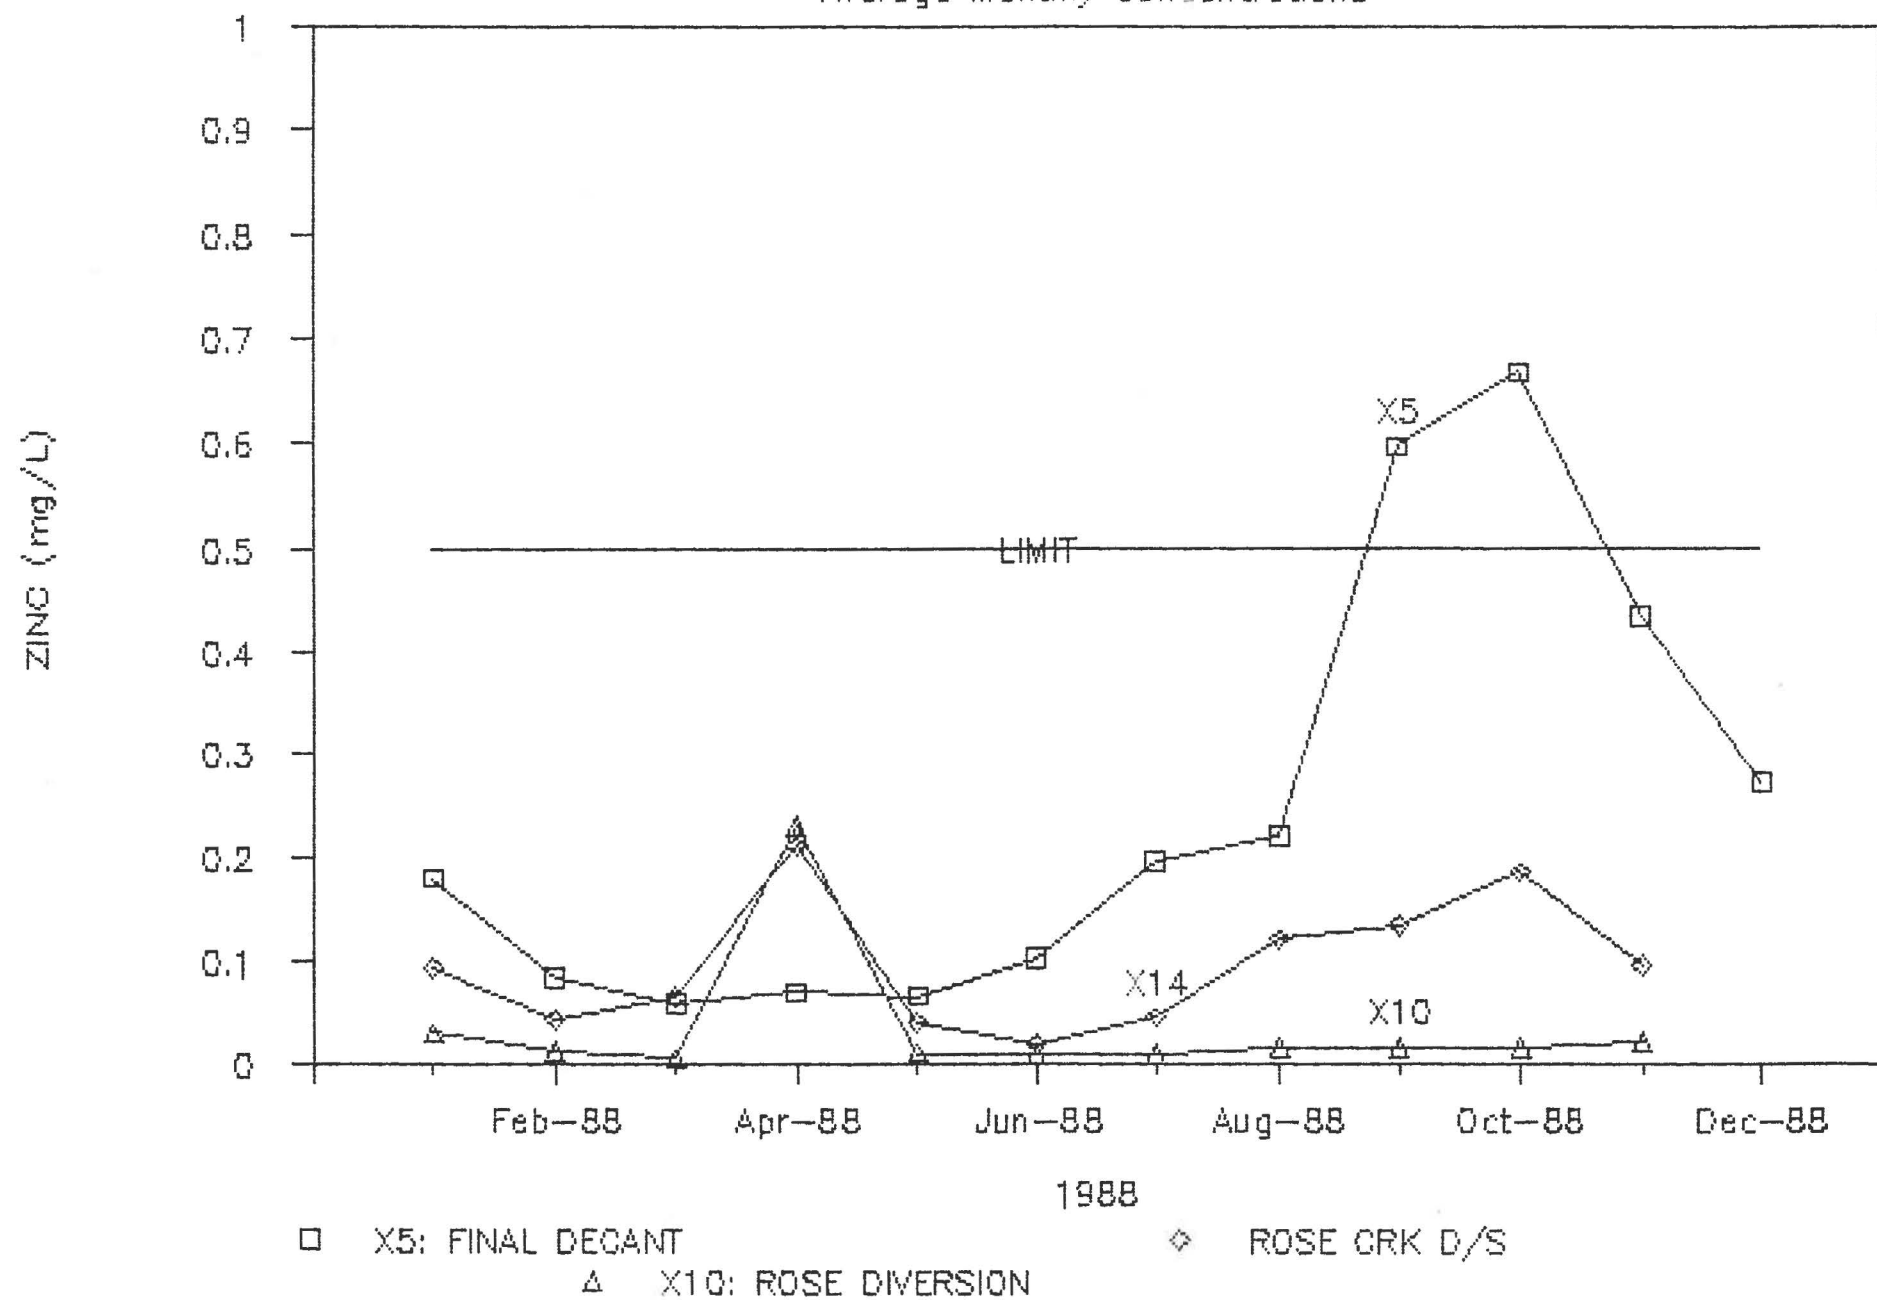
FIGURE 6 : ZINC

The average monthly zinc concentration of the final decant (X5), the Rose Creek diversion water (X10) and Rose Creek water downstream of the minesite (X14), are shown on Figure 6. Zinc averages for well water discharge (PW4), North Fork Rose Creek water (X2) and pumphouse pond water (X3) are shown on Figure 7.

Zinc concentrations in Rose Creek downstream of the minesite (X14) ranged from 0.02 to 0.21 mg/L and during 1988, averaged 0.097 mg/L. These zinc levels in receiving water and illustrated in Figure 6, are not considered toxic; however, zinc toxicity to fish may begin at concentrations of 0.07 mg/L (Anon. 1987).

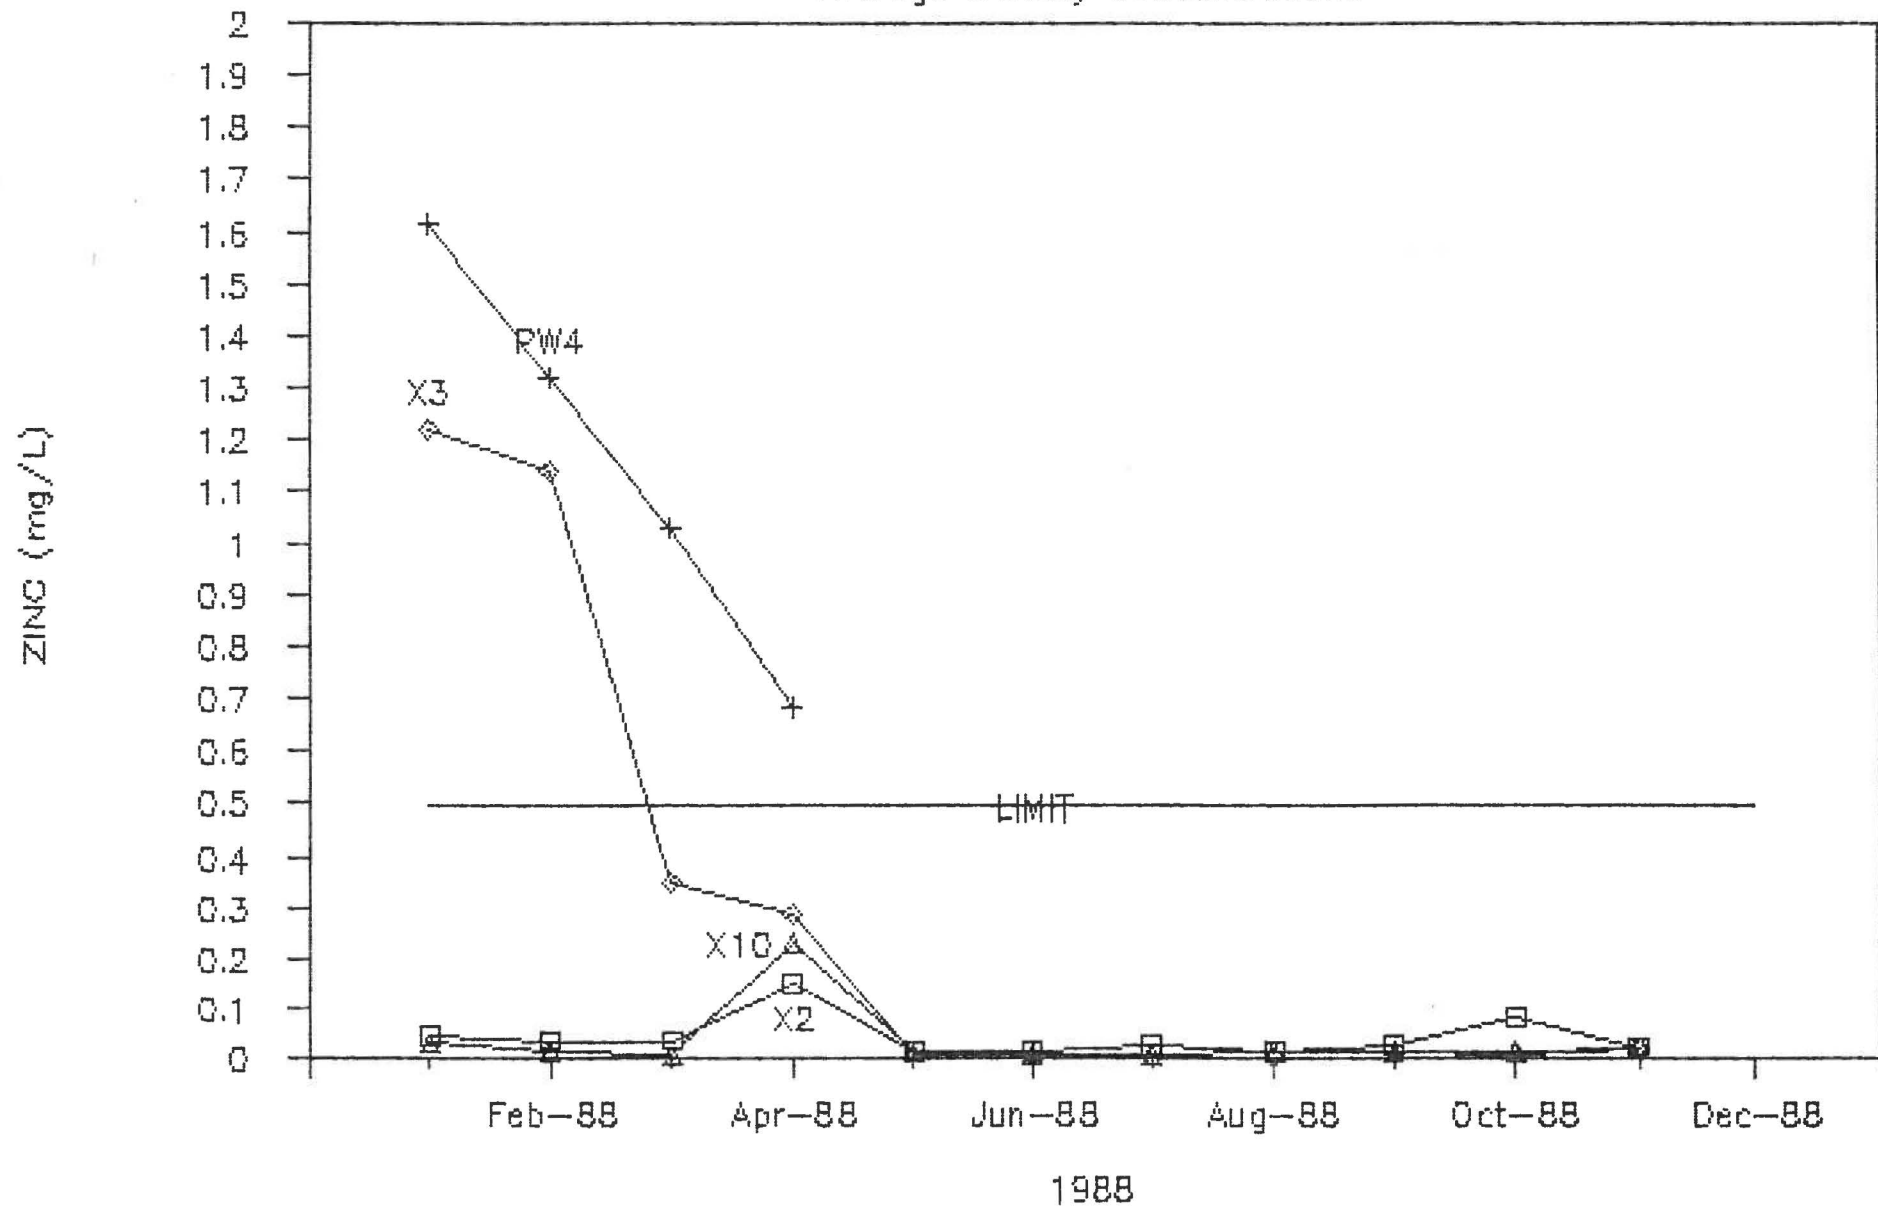
FIGURE 7 : ZINC

Zinc concentrations in the pumphouse pond water (X3) increased during the well pumping period. The yearly average was 0.277 mg/L, but a maximum concentration of 1.220 mg/L was recorded in January when pumping was occurring.

Zinc concentrations in the pumphouse pond (X3), as previously noted, were elevated during the January to April period of well operation. During most of this period water discharge does not occur from the pumphouse pond. Thus, downstream, at both the Rose Creek diversion (X10) and Rose Creek below the minesite (X14), increased zinc concentrations were not evident until April. The year maximum of 0.230 mg/L zinc at X10 and 0.210 mg/L zinc at X14 were recorded in April and these peaks are not exclusively a reflection of zinc loading from the well water discharge since Rose Creek at X2, above the pumphouse pond, also shows an increase in April Figure 7. This loading does not appear to be significant.

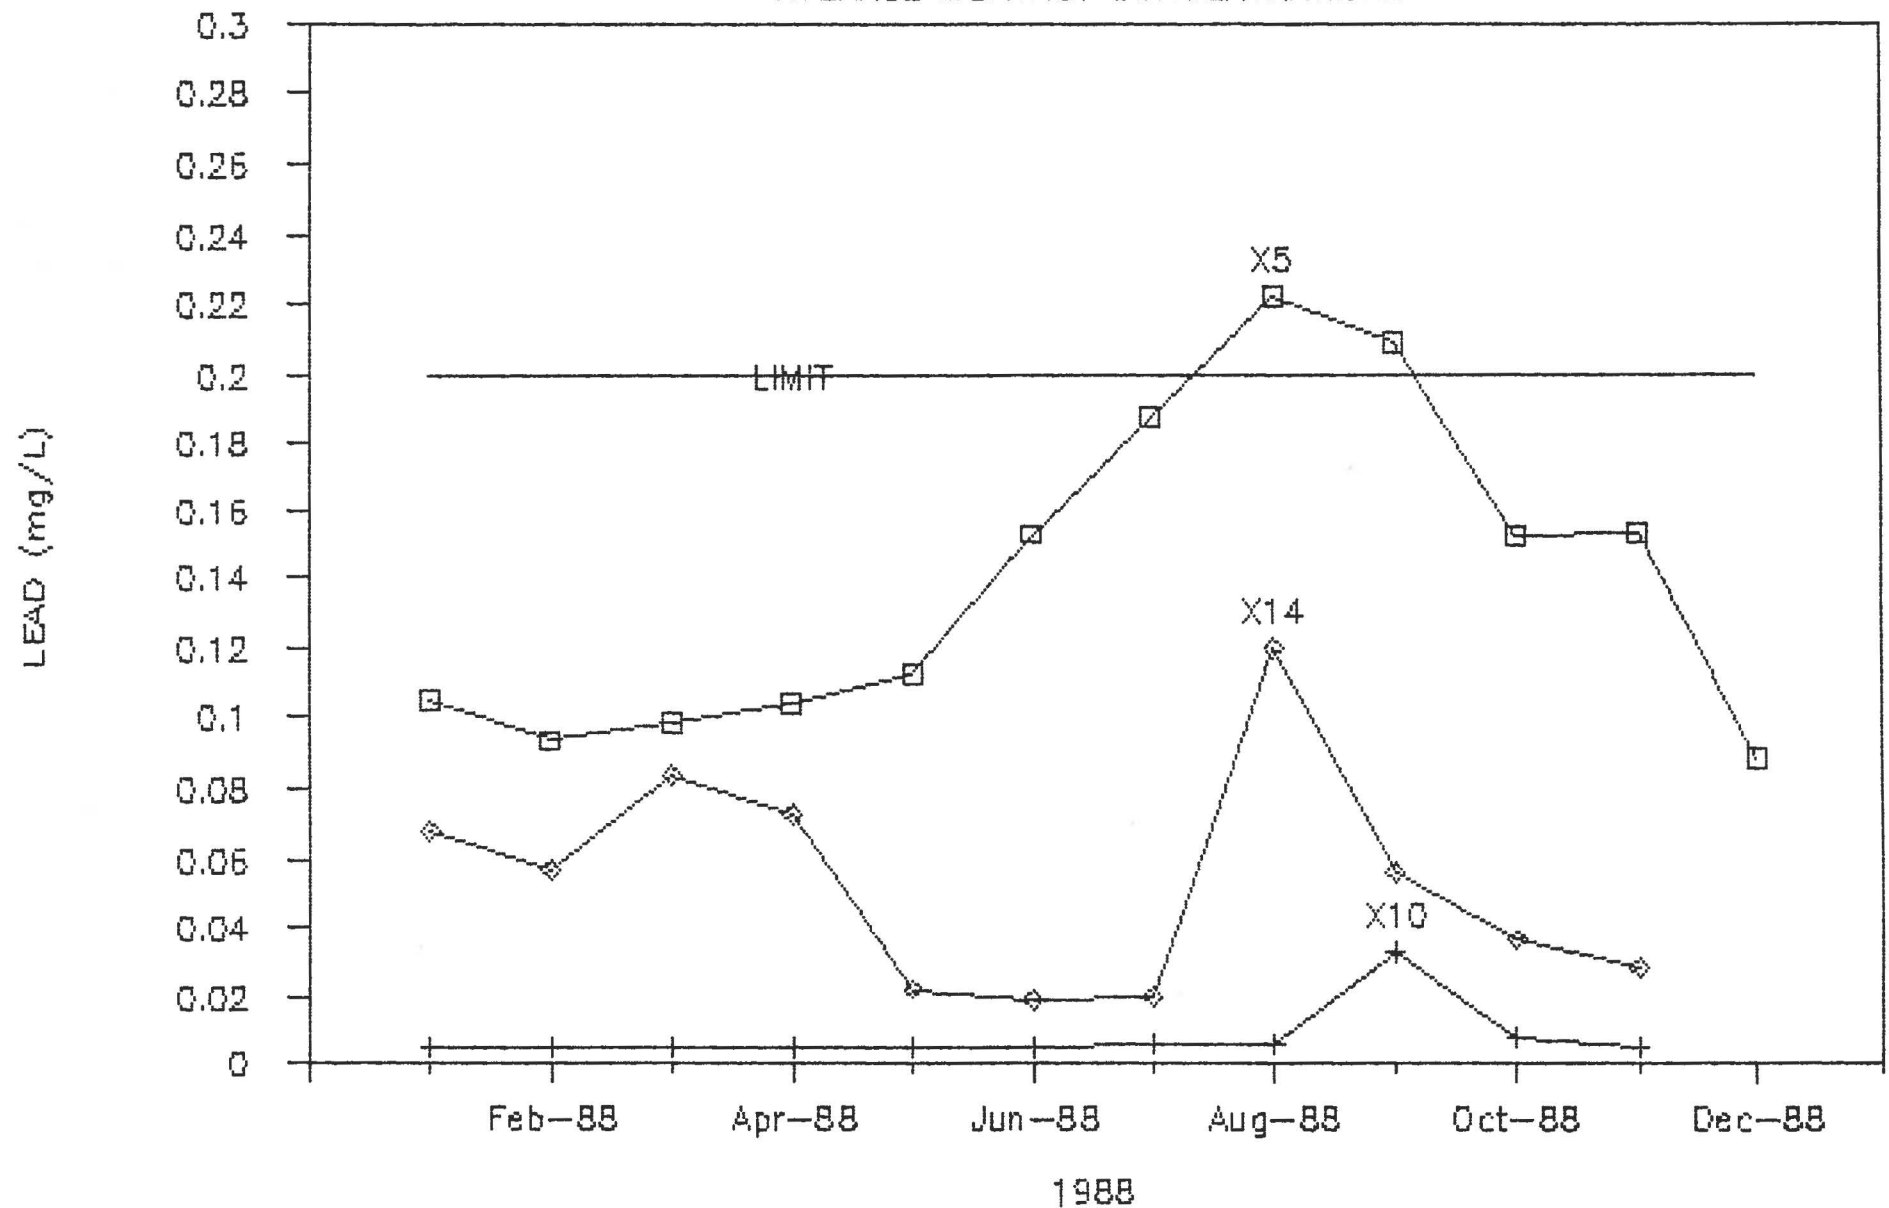
FIGURE 8 : LEAD

The 1988 monthly lead concentrations of the Cross Valley decant (X5), the Rose Creek background water (X10), and the Rose Creek water below the mine site (X14) are shown on Figure 8.

Rose Creek downstream of the mine (X14) had an average 1988 lead concentration of 0.053 mg/L and a range of 0.005 to 0.120 mg/L. As shown in Figure 8, lead levels in the Rose Creek receiving waters were fairly constant. The peak of 0.120 mg/L was recorded in August. Background lead levels are illustrated with lead levels in Rose Creek diversion water (X10). Lead levels, in conjunction with 1988 bioassay results, did not appear to produce chronic toxicity in Rose Creek.

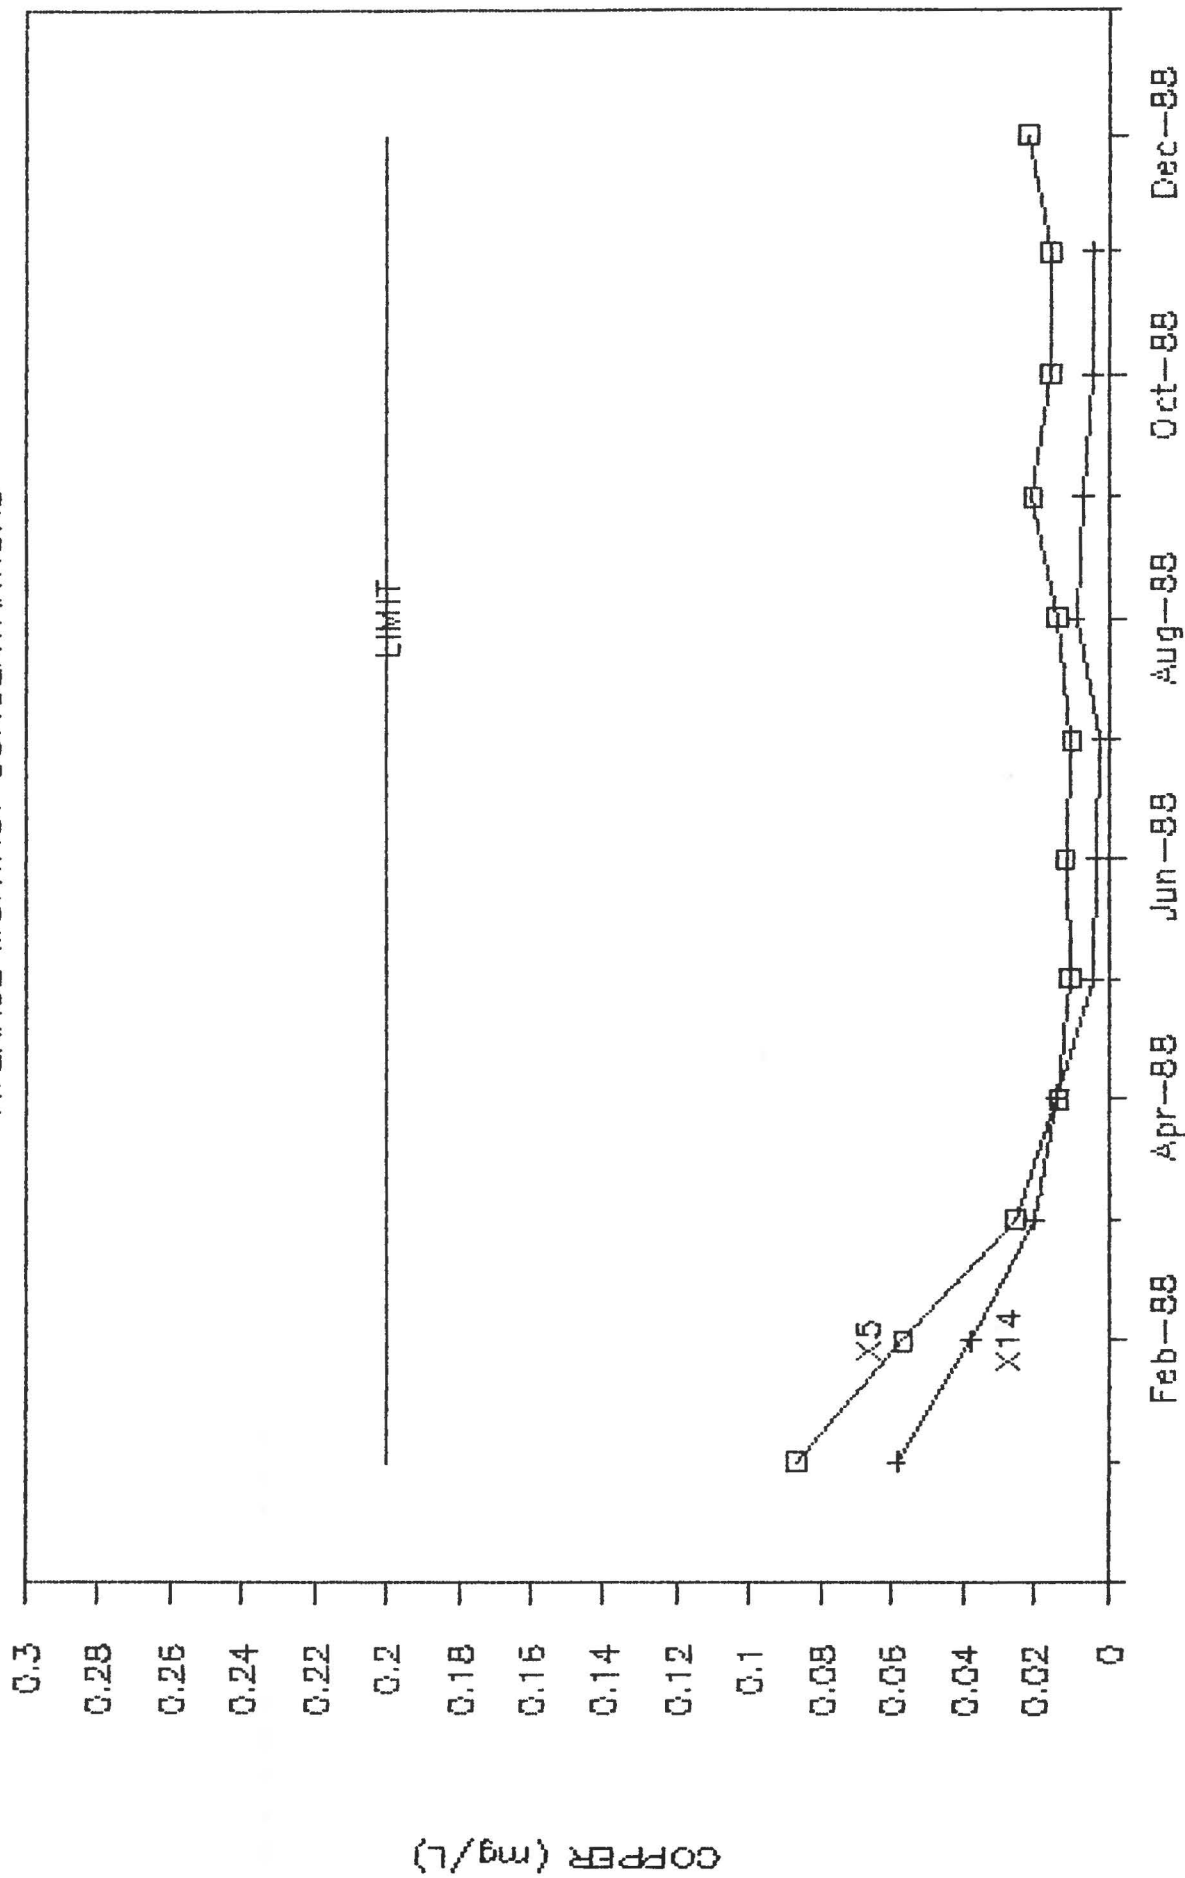
FIGURE 9 : COPPER

Copper levels were well below the effluent standard of 0.20 mg/L. The yearly copper concentration average in the Cross Valley Dam decant was 0.025 mg/L with a range of 0.008 to 0.110 mg/L. Monthly averages for the decant (X5) and Rose Creek below the mine site (X14) are shown on Figure 9.

The 1988 average copper concentration in Rose Creek water below the mine site was 0.015 mg/L. These levels were below the 0.07 mg/L copper concentration considered toxic to juvenile fish (Anon. 1987).

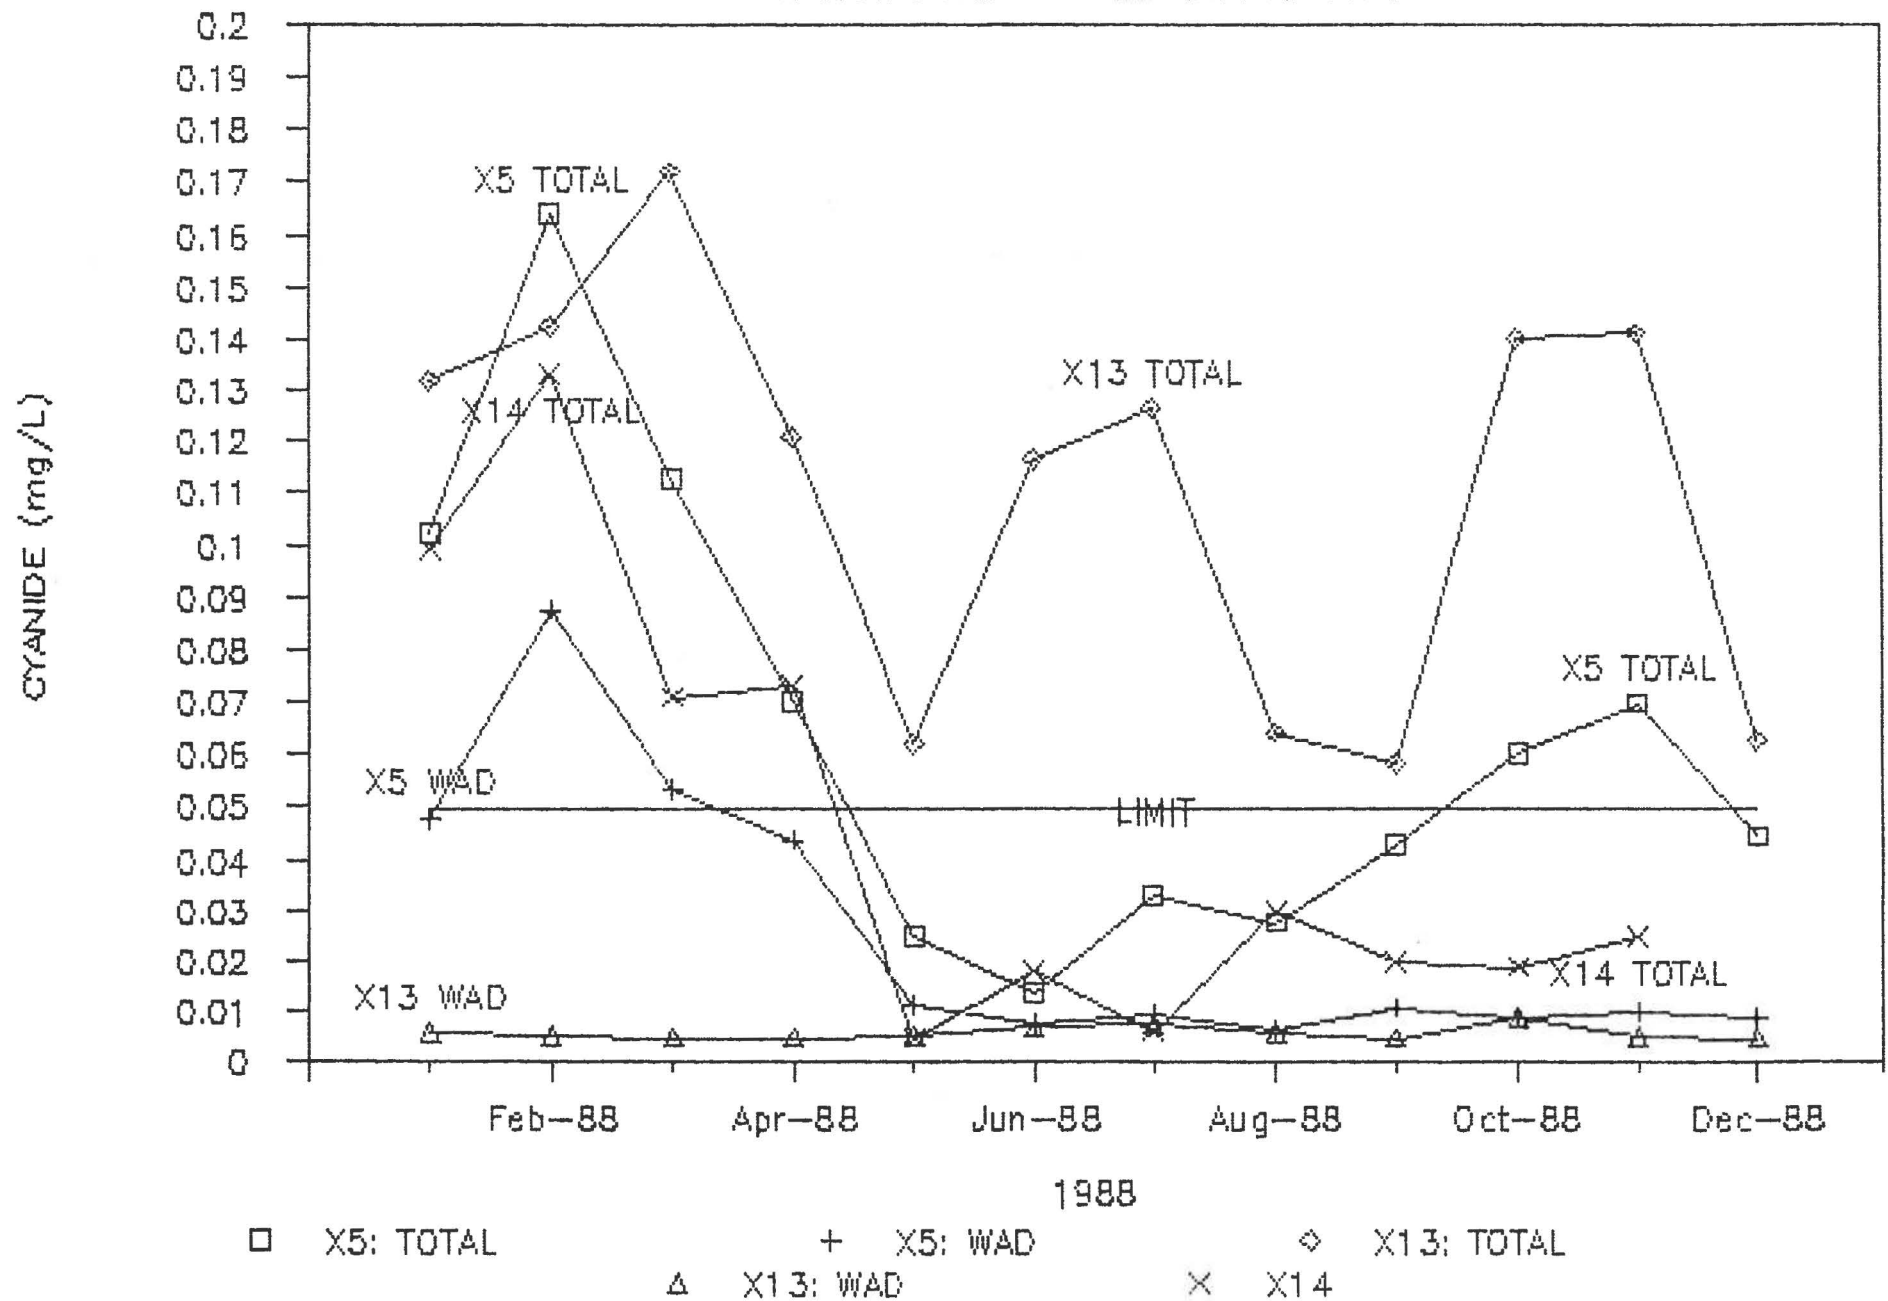
FIGURE 10 : CYANIDE

Total and weak acid dissociable (WAD) monthly average cyanide concentrations are shown for the Cross Valley decant (X5), the Cross Valley dam seepage (X13), the Rose Creek diversion water (X10), and the receiving water of Rose Creek below the mine site (X14) on Figure 10.

From January to April, 1988 cyanide concentrations in effluent discharge (X5 and X13) exceeded the effluent discharge standard of 0.05 mg/L. The lower cyanide consumption rates of ores being processed during this period, and a decrease in the natural cyanide degradation rate during the winter are considered the primary causes. Cyanide concentrations also increased in October for the same reasons.

In December, 1988 a cyanide spill occurred in the reagent building of Curragh Resources' concentrator. Cyanide effluent levels were reduced during this period through treatment using hydrogen peroxide. Peroxide addition is continuing, on a as required basis, to control
