DATE 6 January 2017**REFERENCE No.** 1410944-013-TM-Rev1-2016**TO** Ms. Carrie Gillis
Faro Mine Remediation Project**FROM** Ryan Preston and Al Chance**EMAIL** Ryan_Preston@golder.com;
Al_Chance@golder.com**FARO MINE REMEDIATION PROJECT PIT SLOPE MONITORING PLAN**

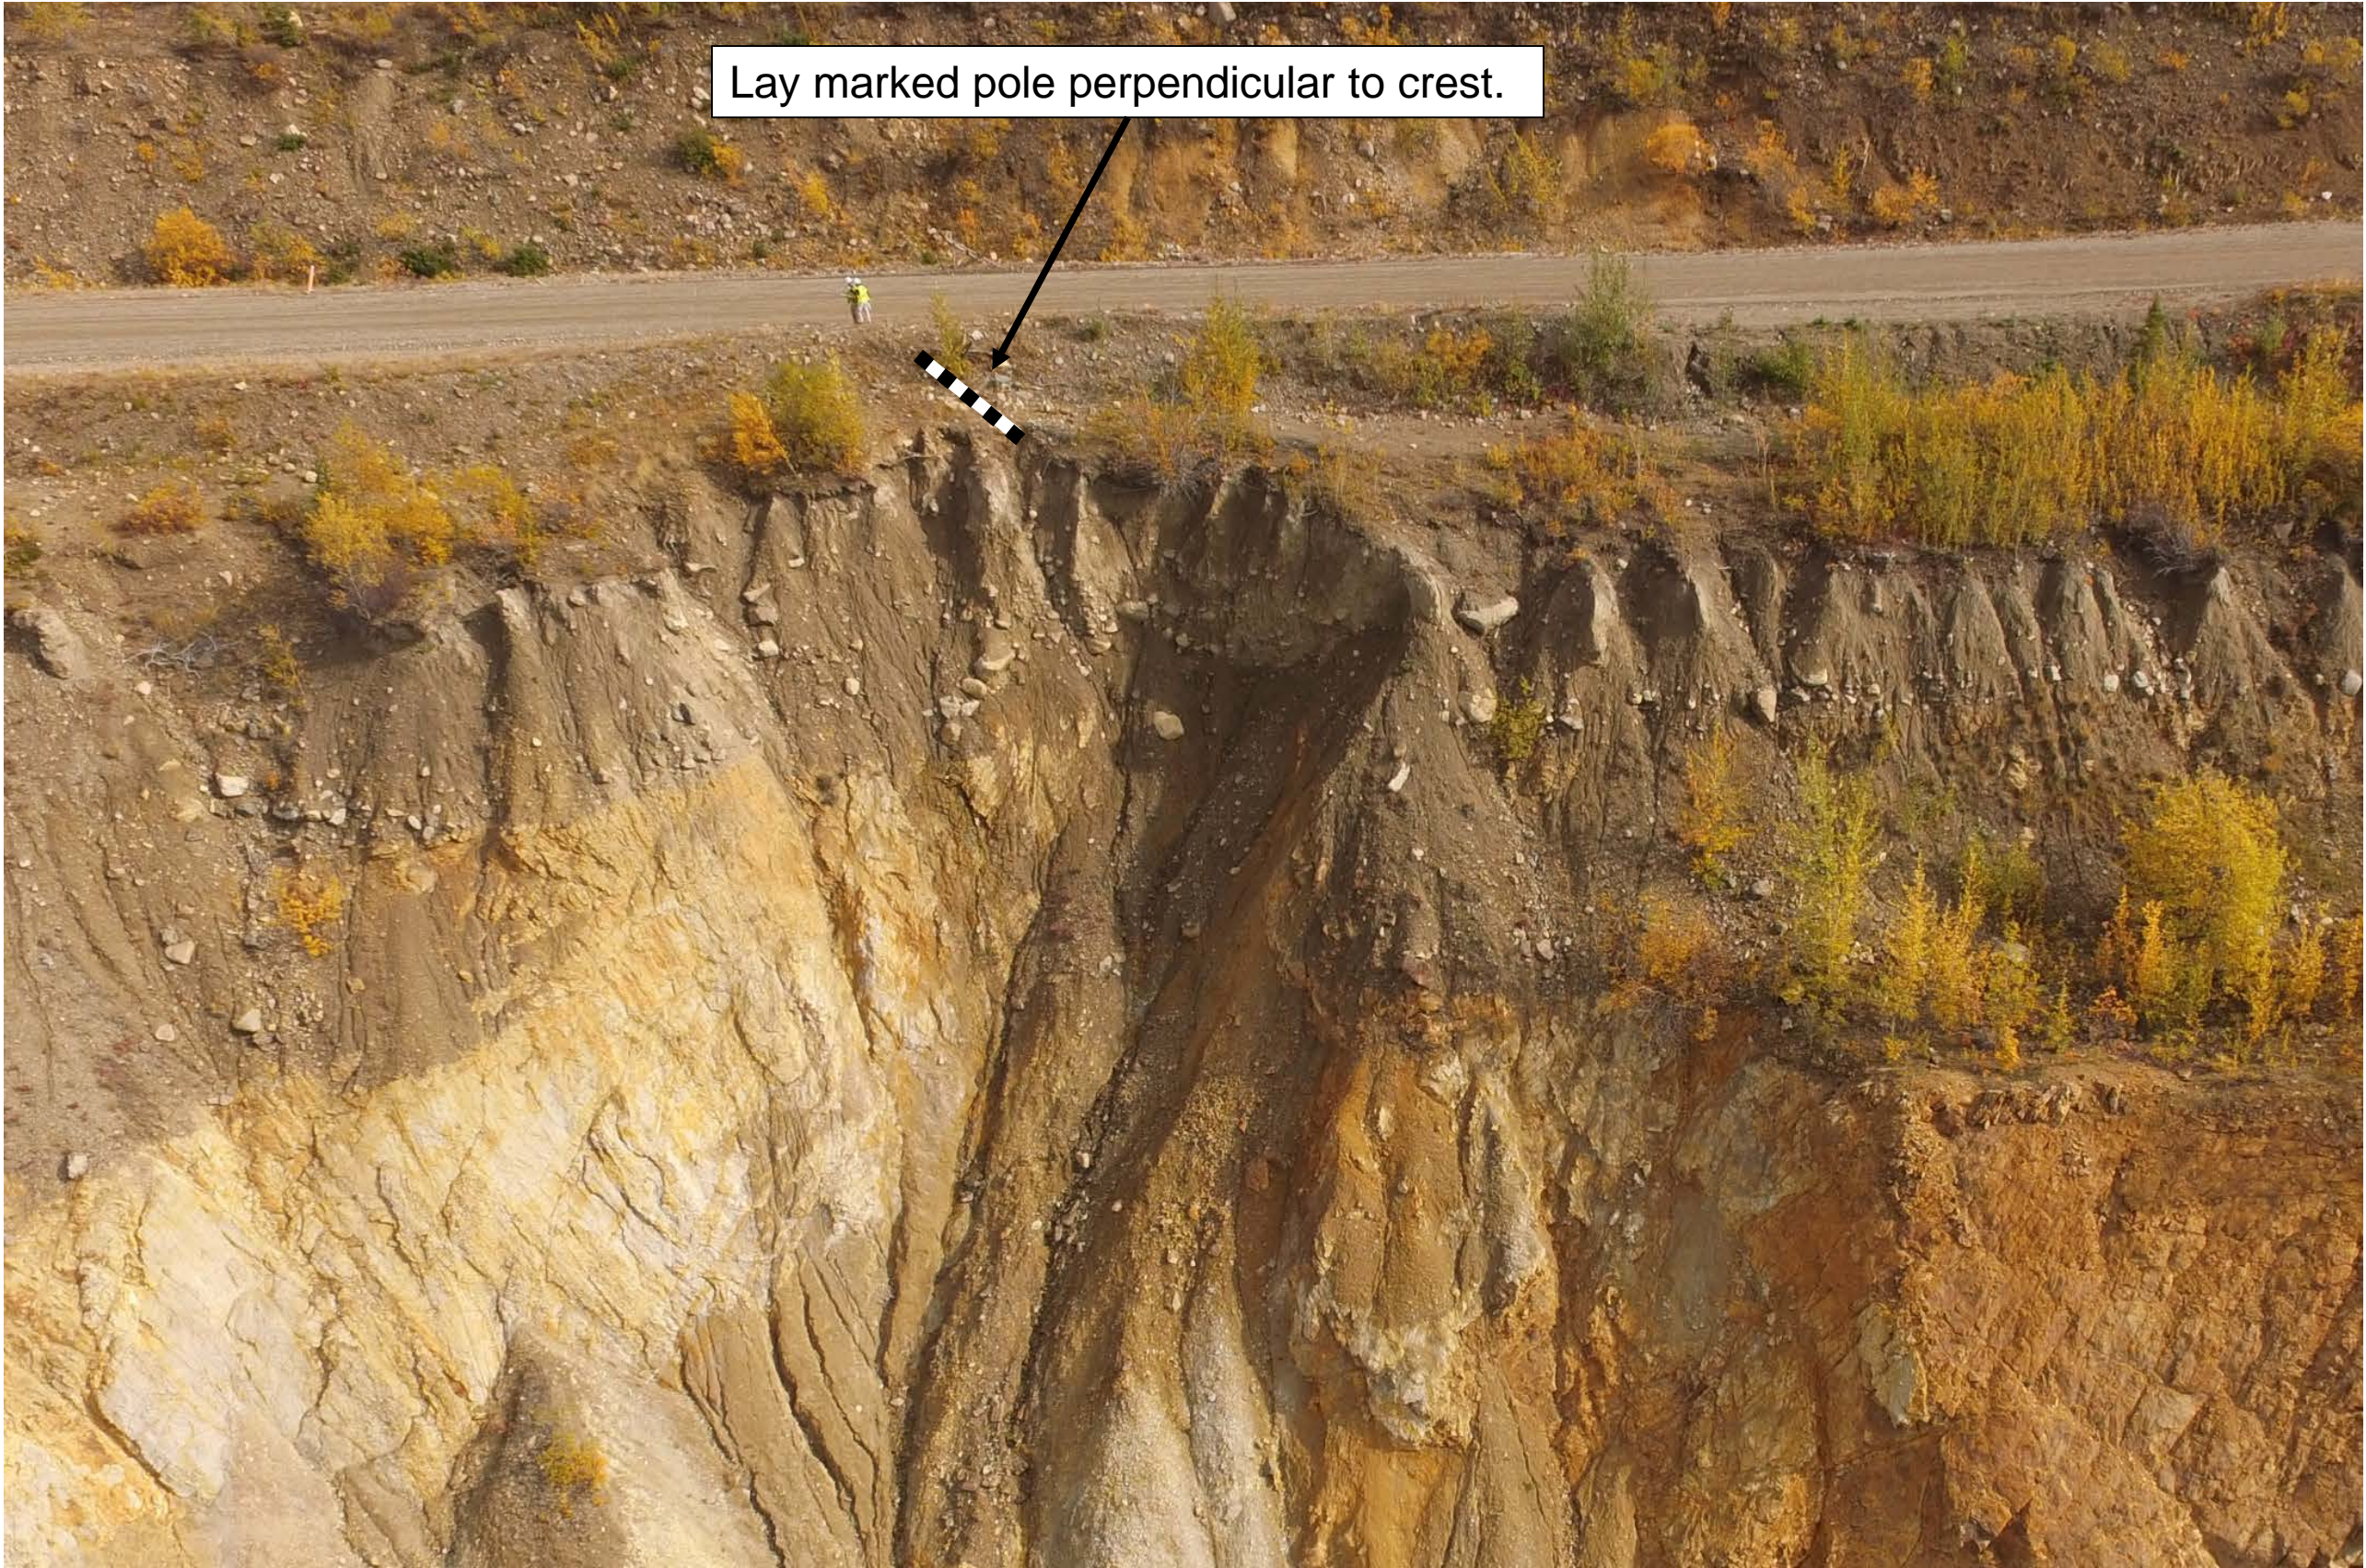
B		26/SEP/16	FIGURE		RP	RP	AVC	AVC
REV	DATE		DESCRIPTION		DRW	DES	CHK	Rvw
PROJECT		FARO MINE REMEDIATION PROJECT FARO, YT PIT SLOPE MONITORING PLAN		1410944/2015				
CONSULTANT		Golder Associates		FIGURE No. 4

There is a critical portion of the Faro pit crest that is exhibiting crest regression adjacent to the Faro Creek Diversion Channel (FCDC) (Figure 4). It is desirable to be able to accurately measure the crest regression in this area. In order to increase the accuracy of the photogrammetry monitoring in this area, a large, long object which will be visible from across the pit (i.e. section of thick pipe or a telephone pole), marked in 20 cm increments could be lain behind the area of maximum crest regression in the Faro pit, perpendicular to the slope, such that approximately 1 m of the pole extends over the crest, beyond the regression (Figure 4). This will serve as a scalar reference during photograph comparison and, when combined with the high resolution photos (approximately 3 cm ground coverage per pixel), will allow for remote measurement of the regression. Large objects such as telephone poles and HDPE pipes are advantageous because they are visible from across the pit and can be placed using an excavator or similar large equipment to manipulate the far end of the pole/pipe while maintaining clearance from the pit crest. If this is considered unfeasible or unsafe, the crest regression in this area can be estimated using the photogrammetry system only. However, the addition of the marked large object provides a known reference to confirm the displacements indicated by photogrammetry. Having this reference point will improve the accuracy of crest regression estimates at this critical location.

CRITICAL CREST REGRESSION AREA WITH
SCHEMATIC LAYOUT FOR TELEPHONE POLE

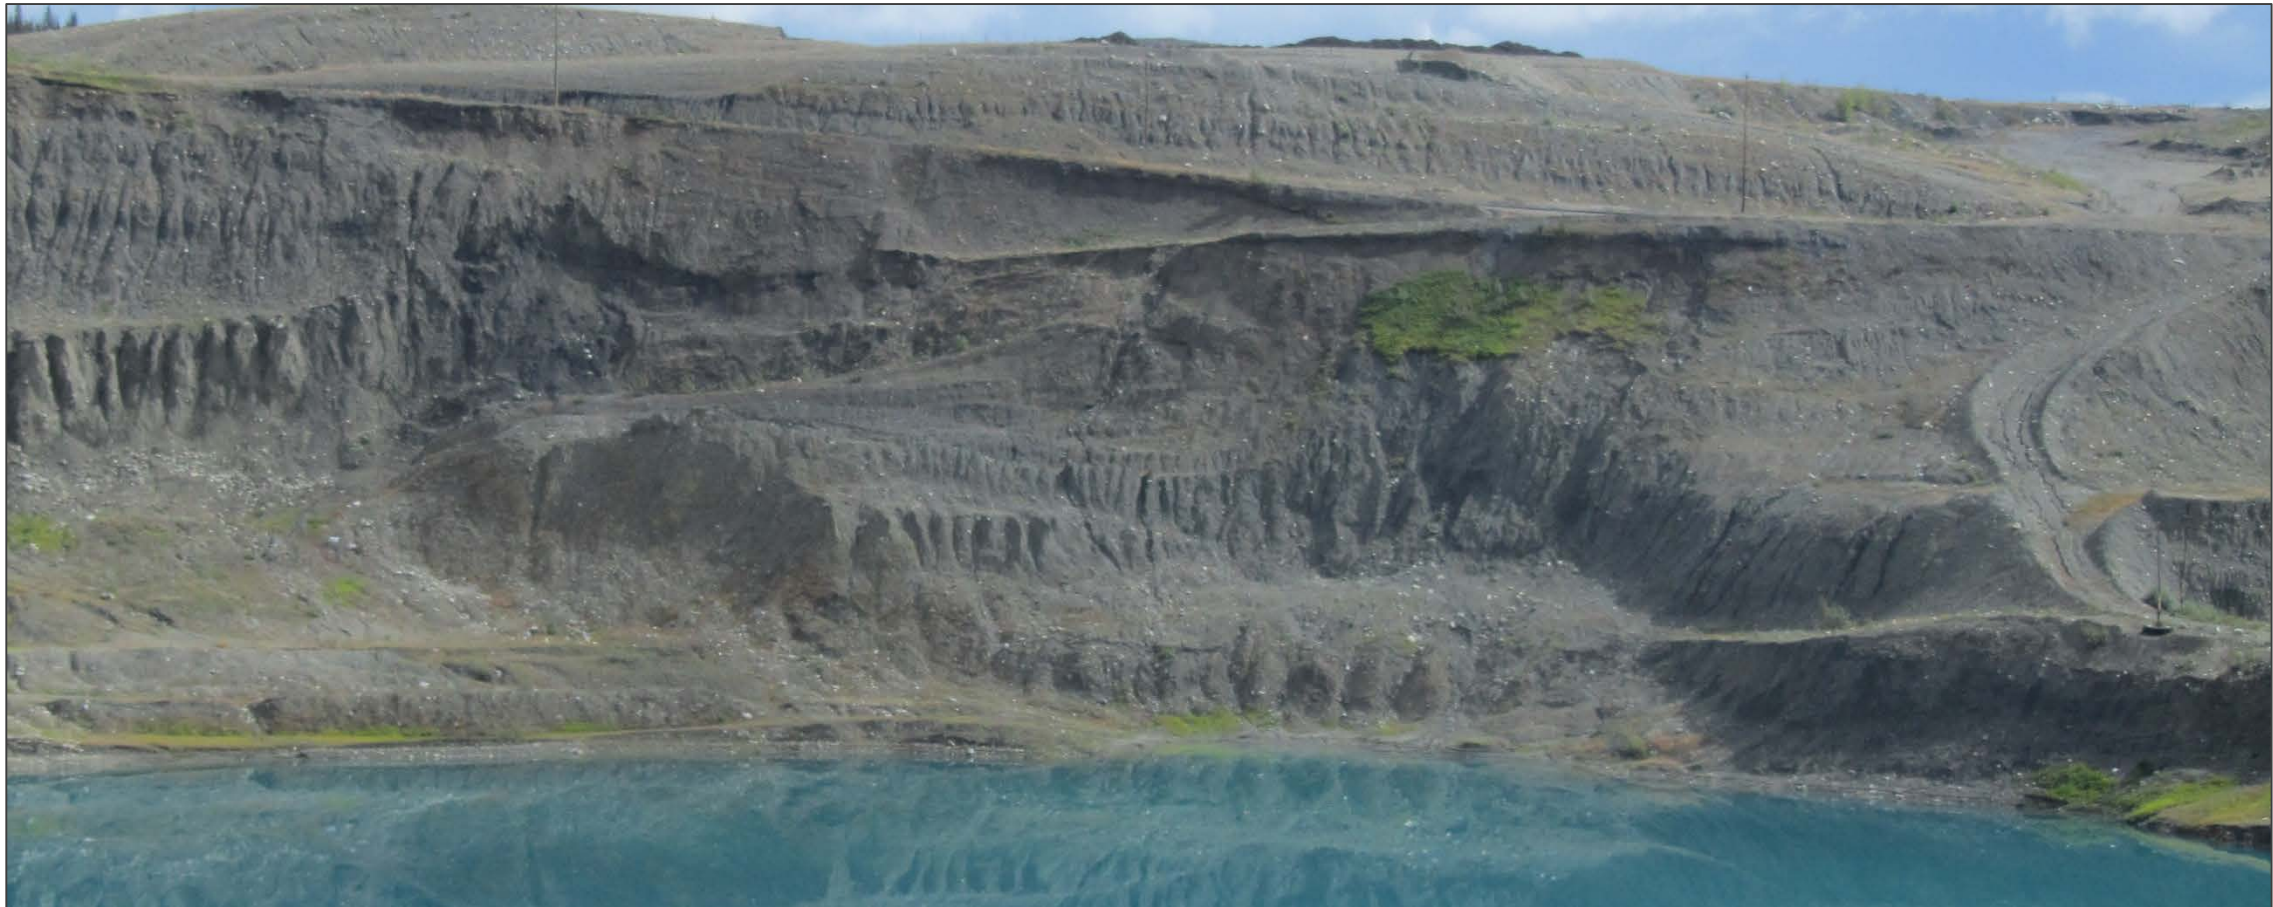
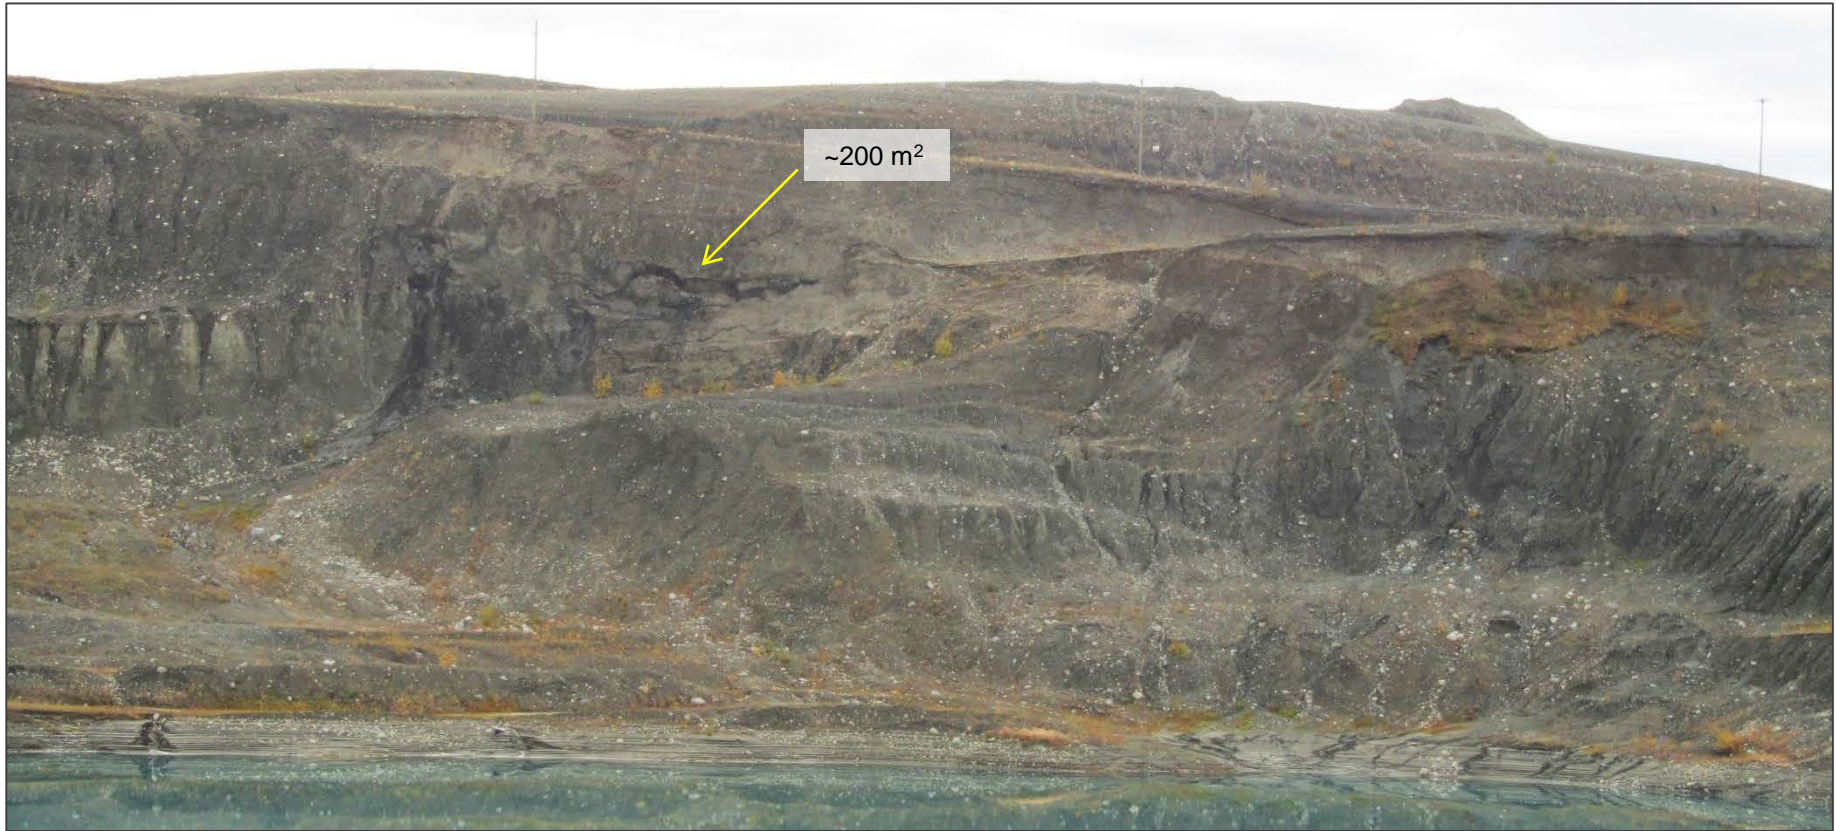
2014 PHOTOGRAPH OF INSTABILITY ZONE, VIEW LOOKING EAST

2015 PHOTOGRAPH OF INSTABILITY ZONE, VIEW LOOKING EAST

CLIENT		FIGURE		RP	RP	AVC	AVC
REV	DATE	DESCRIPTION		DRW	DES	CHK	RVW
PROJECT		FARO MINE REMEDIATION PROJECT		1410944/2015			
		FARO, YT					
		PIT SLOPE MONITORING PLAN					
CONSULTANT		TITLE					
		EXAMPLE OF SLOUGHING – GRUM PIT					
				FIGURE No.			
				5

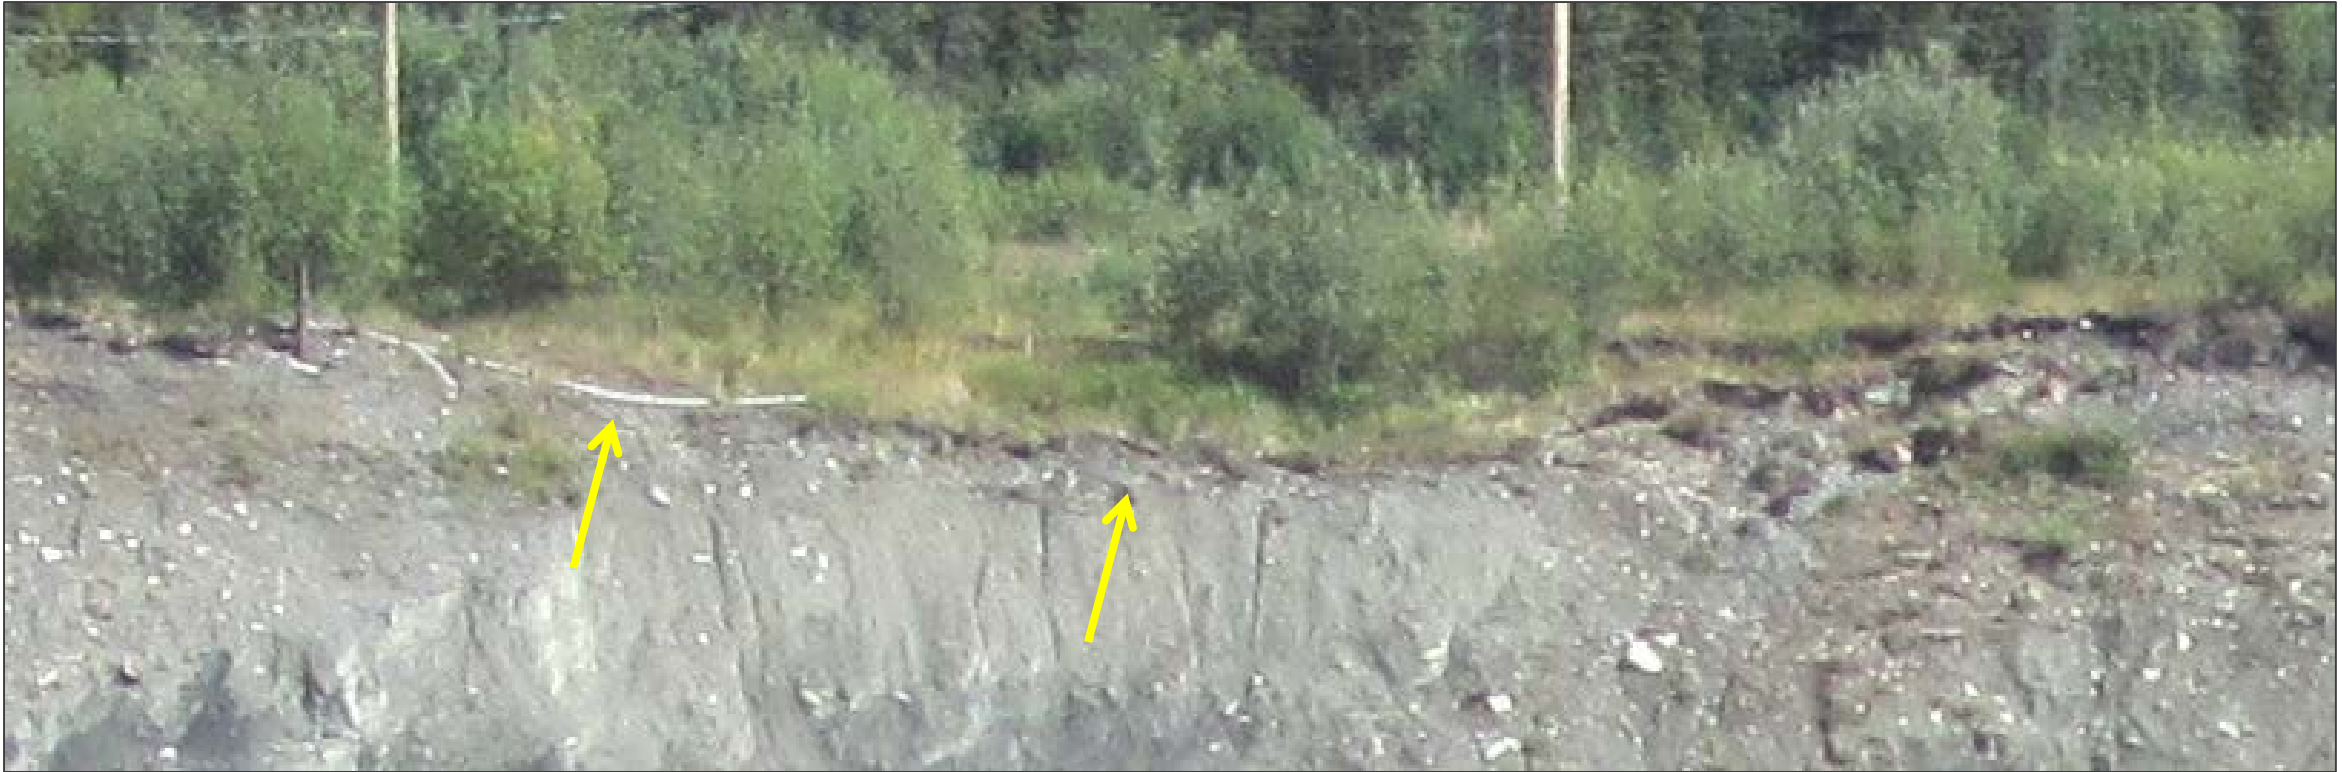
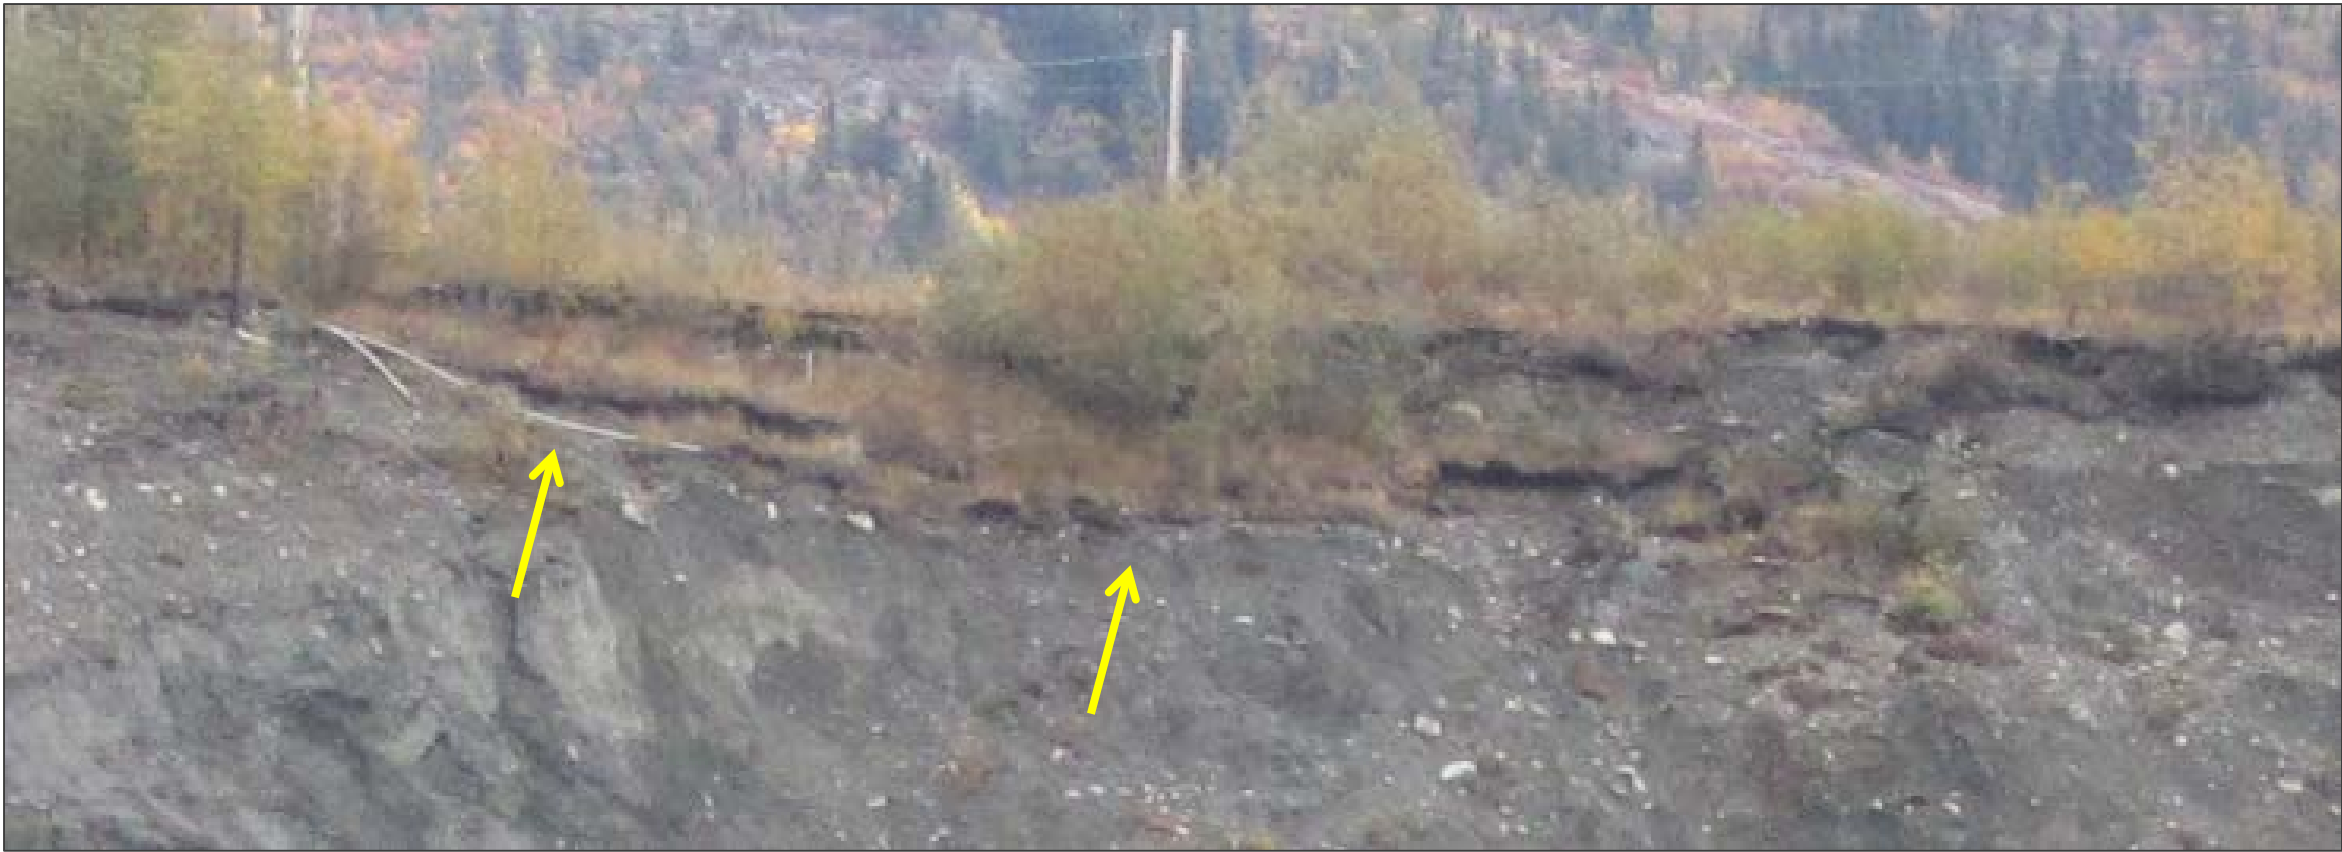
2014 PHOTOGRAPH OF
CREST OF EAST WALL,
BACKSCARP OF
INSTABILITY ZONE,
VIEW LOOKING EAST

2015 PHOTOGRAPH
OF CREST OF EAST
WALL, BACKSCARP
OF INSTABILITY ZONE,
VIEW LOOKING EAST

CLIENT		FIGURE		RP	RP	AVC	AVC
REV	DATE	DESCRIPTION		DRW	DES	CHK	RVW
PROJECT		FARO MINE REMEDIATION PROJECT		1410944/2015			
		FARO, YT					
		PIT SLOPE MONITORING PLAN					
CONSULTANT		TITLE					
		EXAMPLE OF SLUMPING – GRUM PIT					
				FIGURE No.			
				6

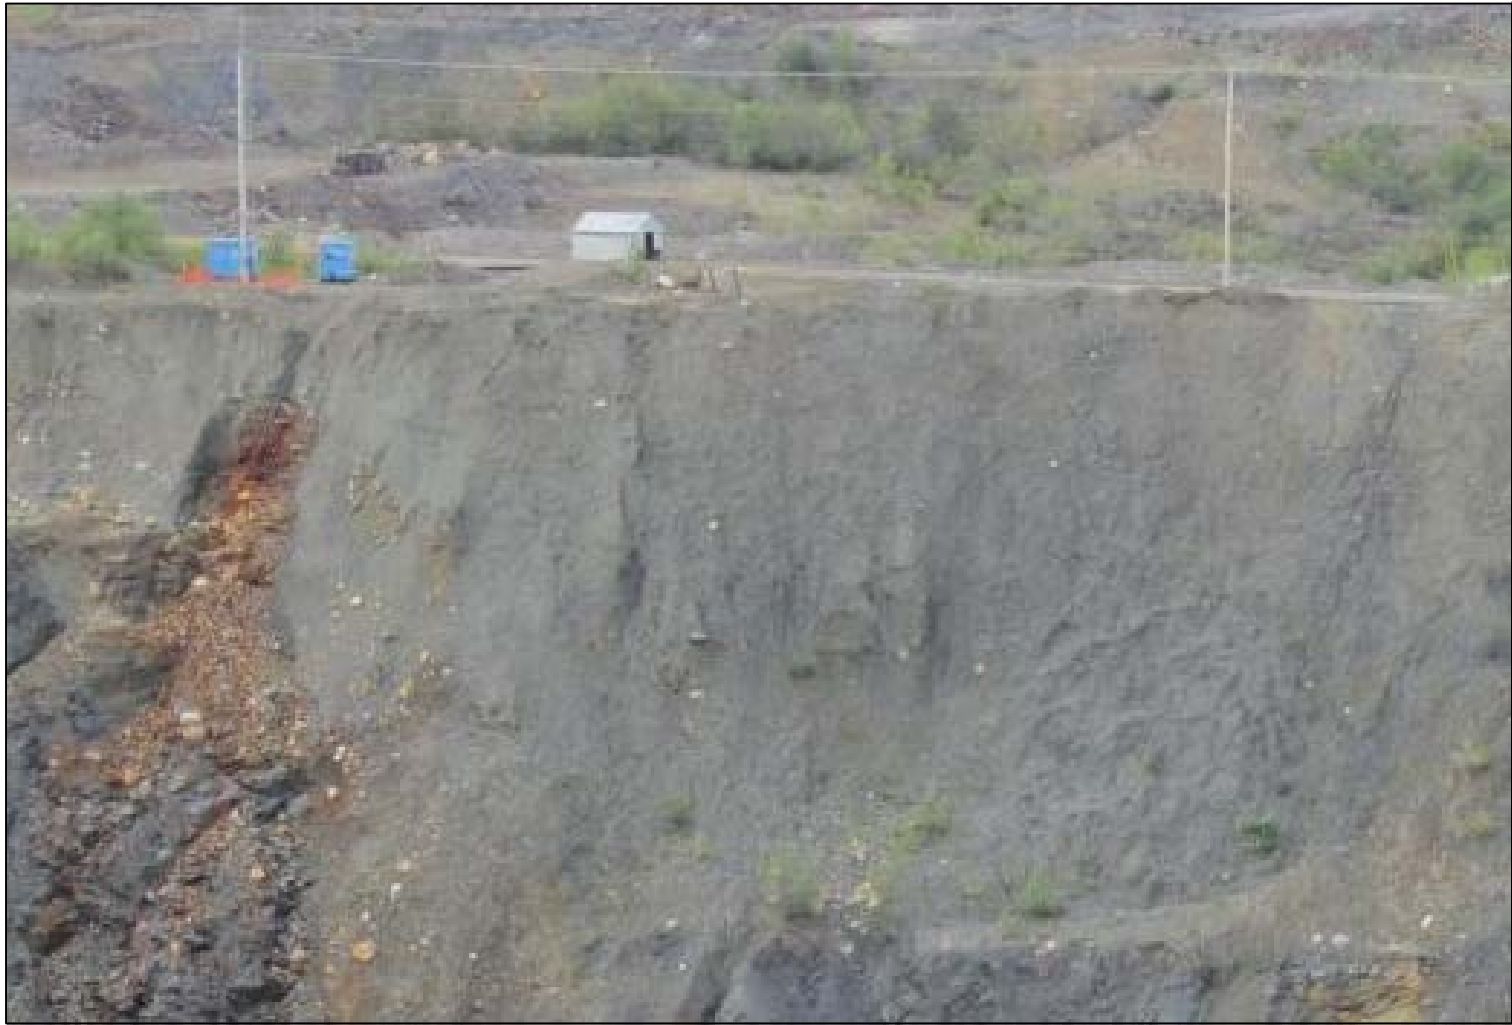
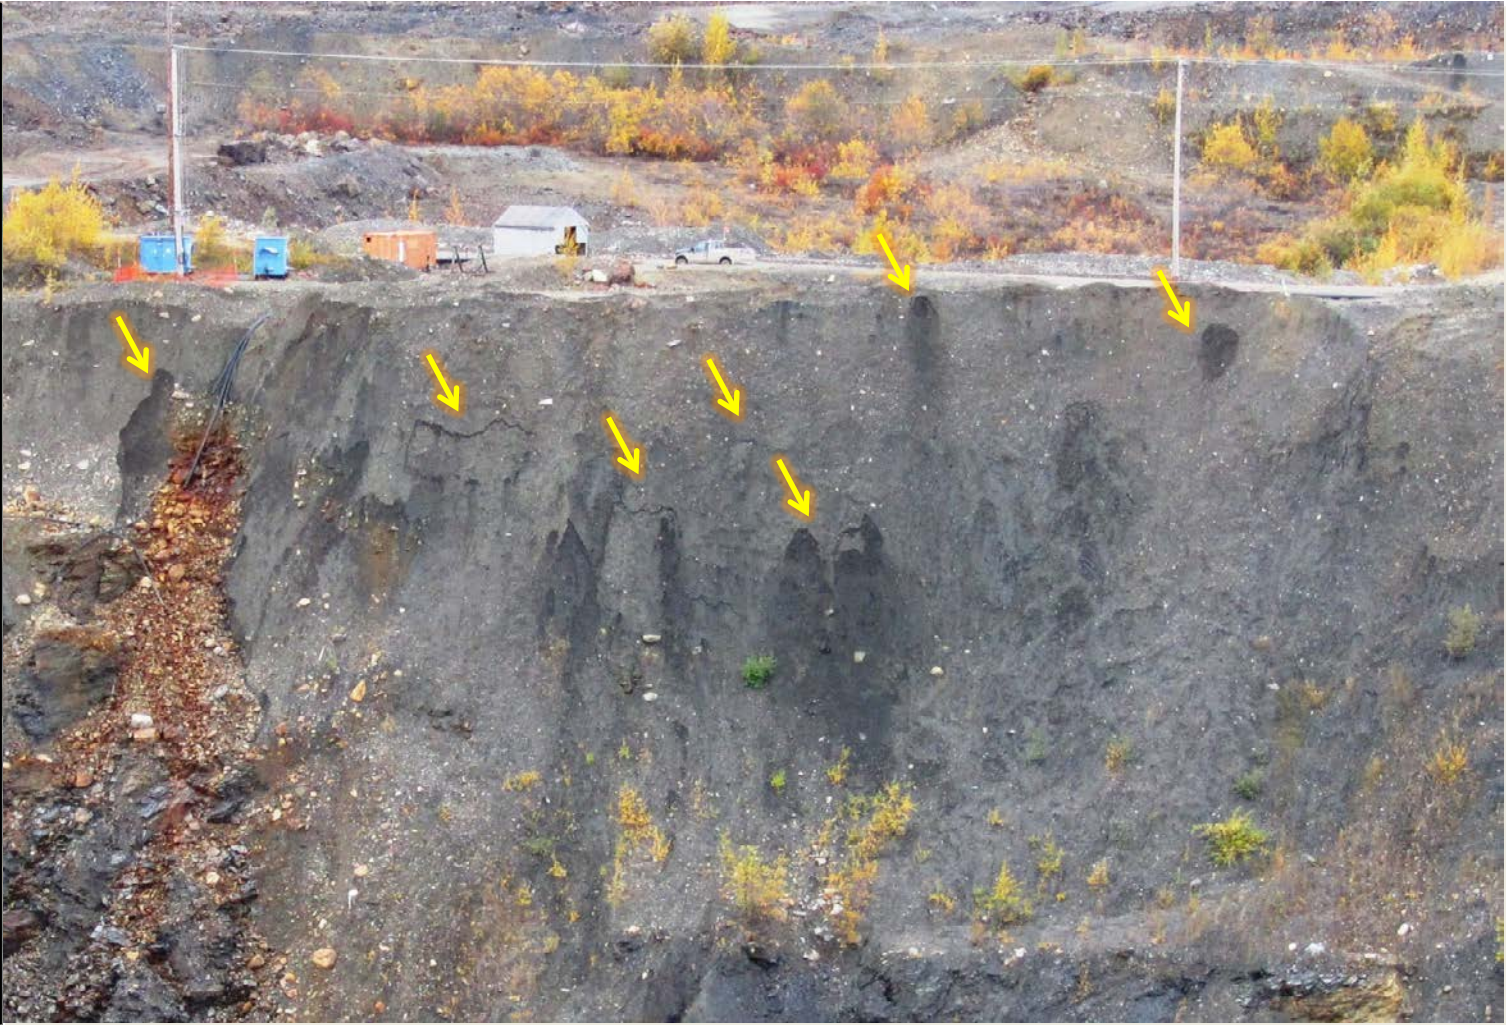
2014 - SOUTH SIDE OF UPPER WEST WALL, VIEW LOOKING WEST

2015 - SOUTH SIDE OF UPPER WEST WALL, VIEW LOOKING WEST
YELLOW ARROWS SLUMPED AREAS

CONSULTANT		TITLE							
		SEEPAGE INDUCED SLOUGHING IN UPPER PART OF VANGORDA WEST WALL							
								FIGURE No. 7

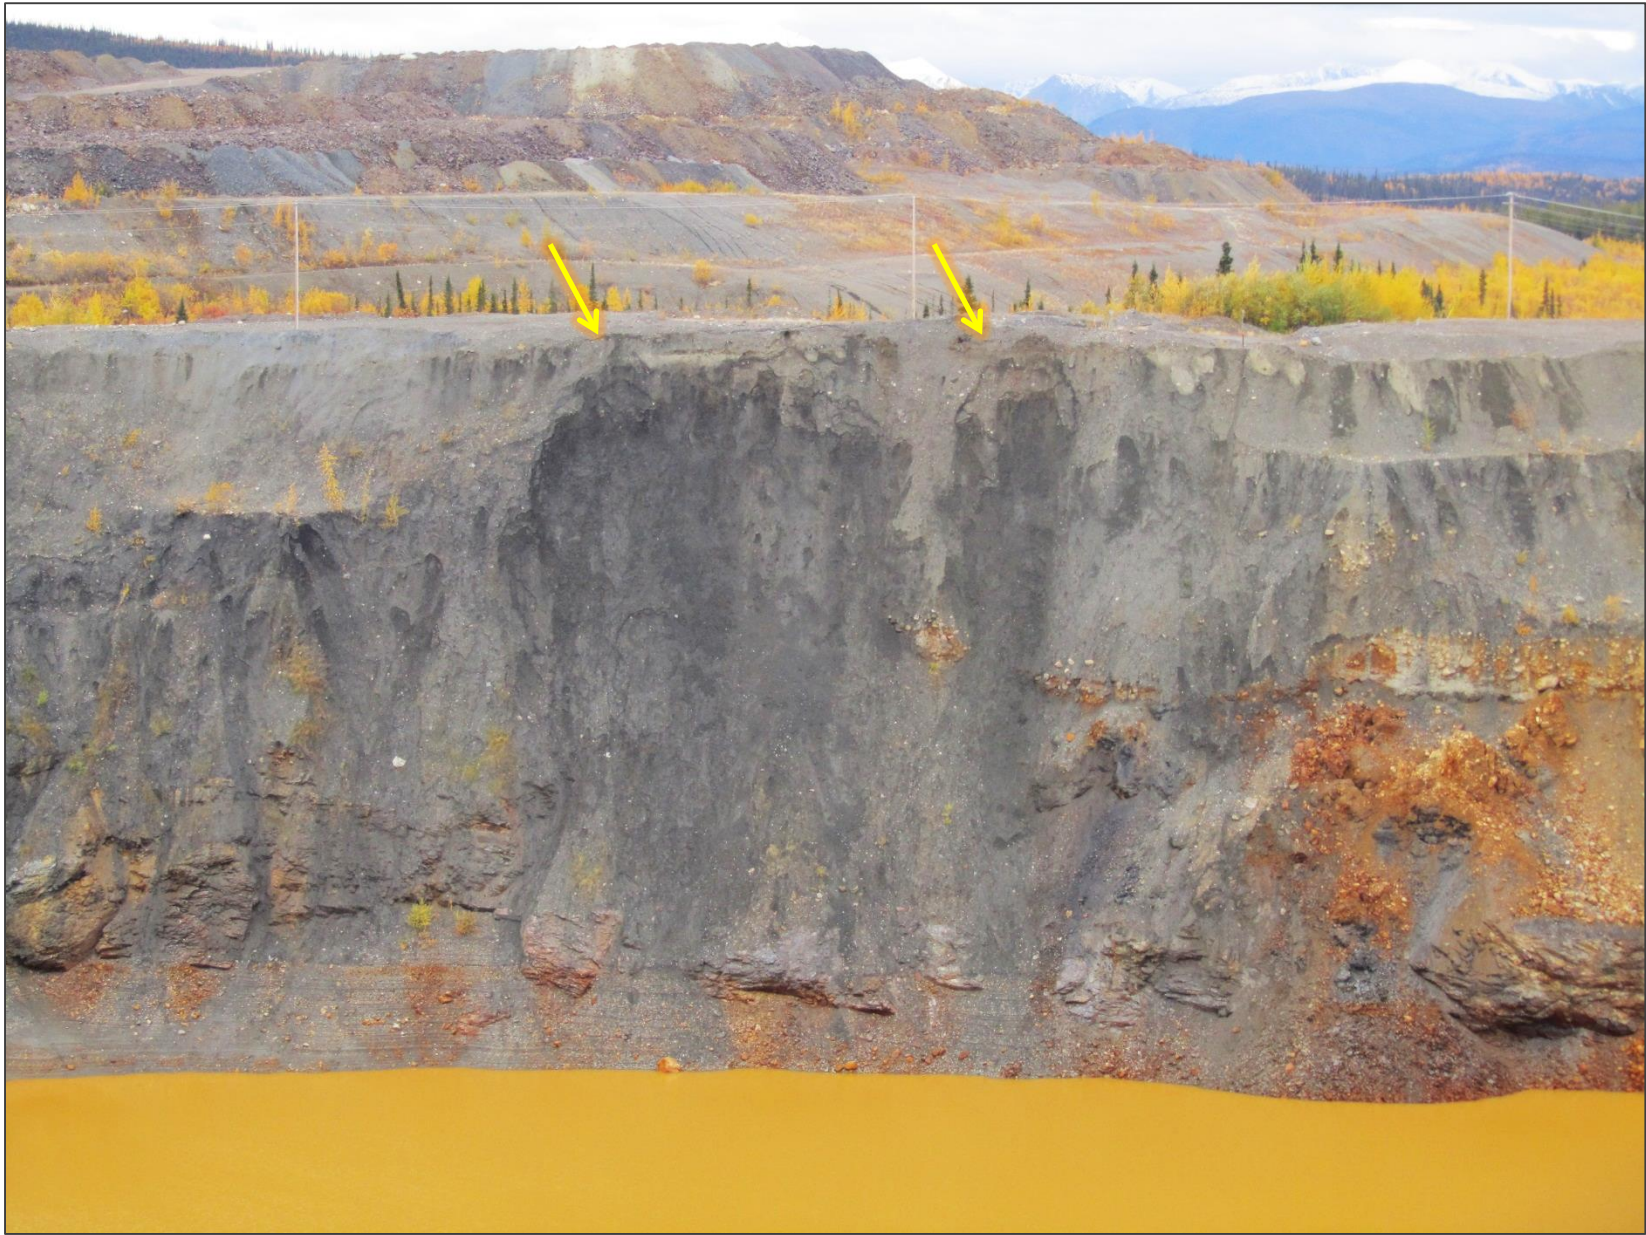
NORTH SIDE OF WEST WALL, VIEW LOOKING WEST
ARROWS INDICATE RECENTLY SLUMPED AREAS

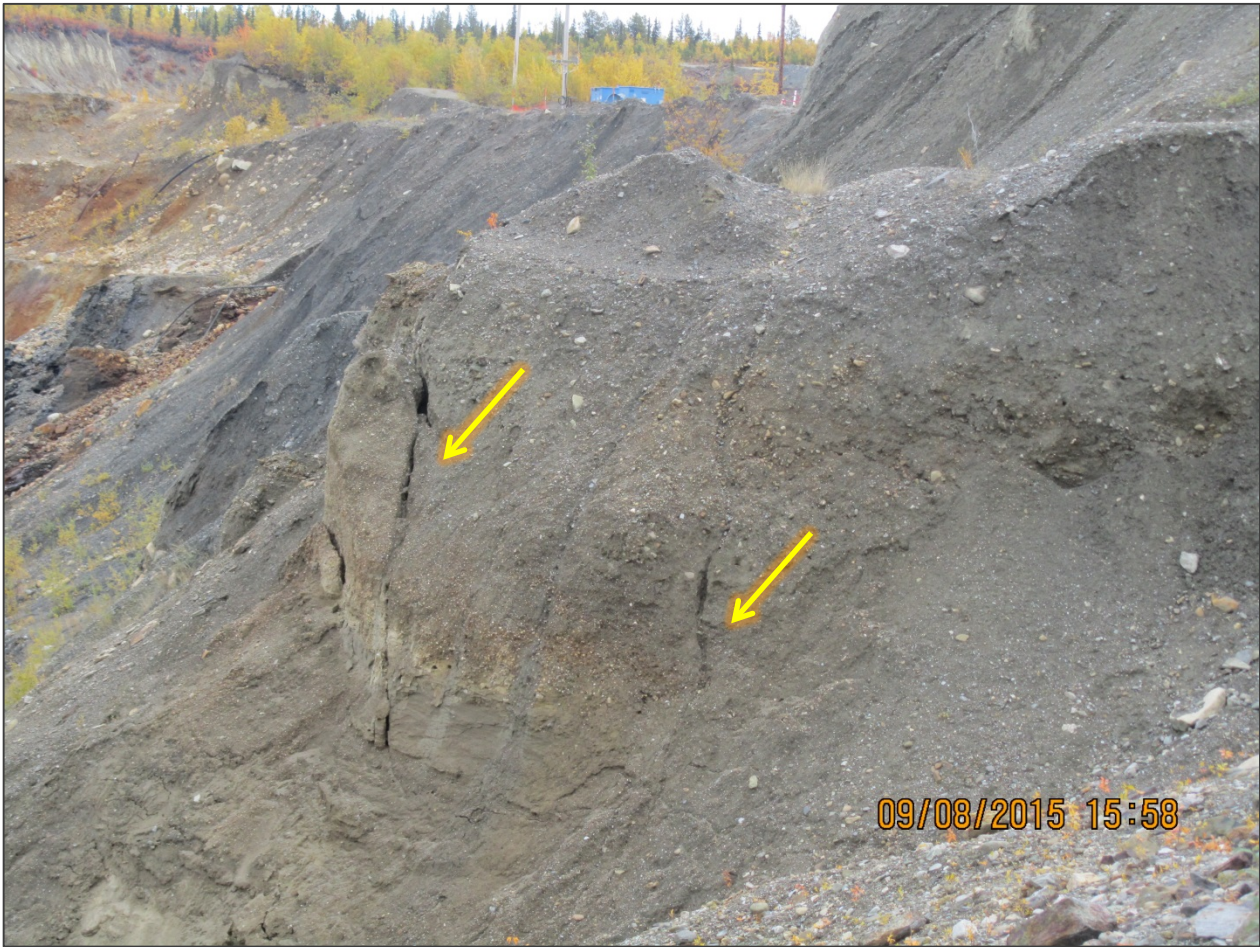
NORTH SIDE OF WEST WALL, VIEW LOOKING SOUTH FROM CREST
ARROWS INDICATE CRACKS

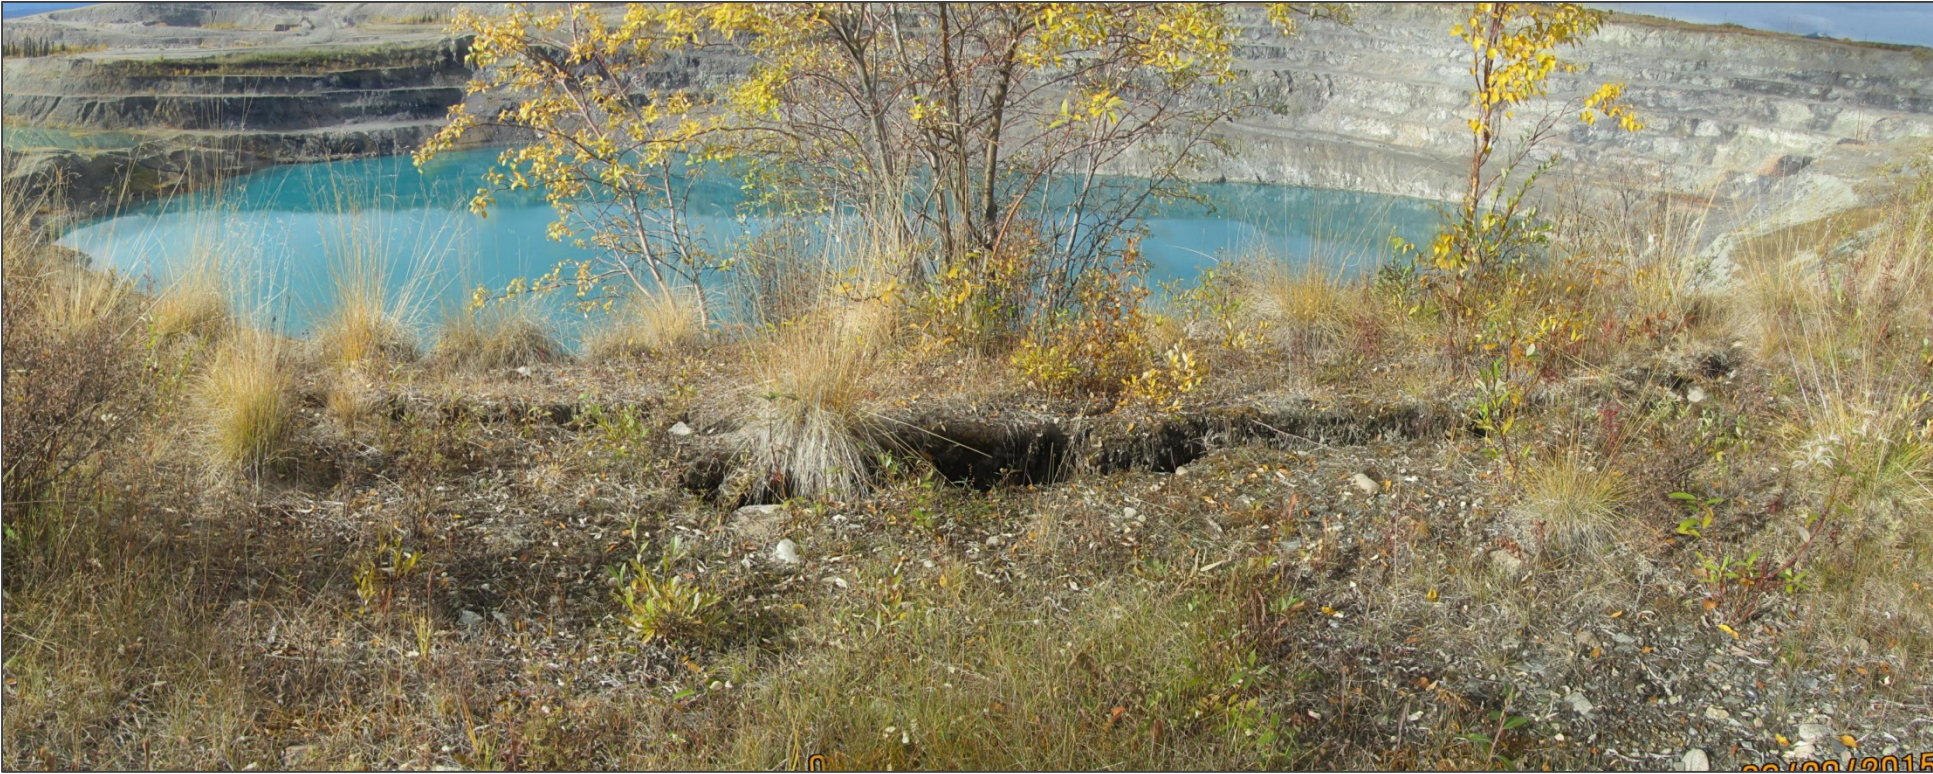
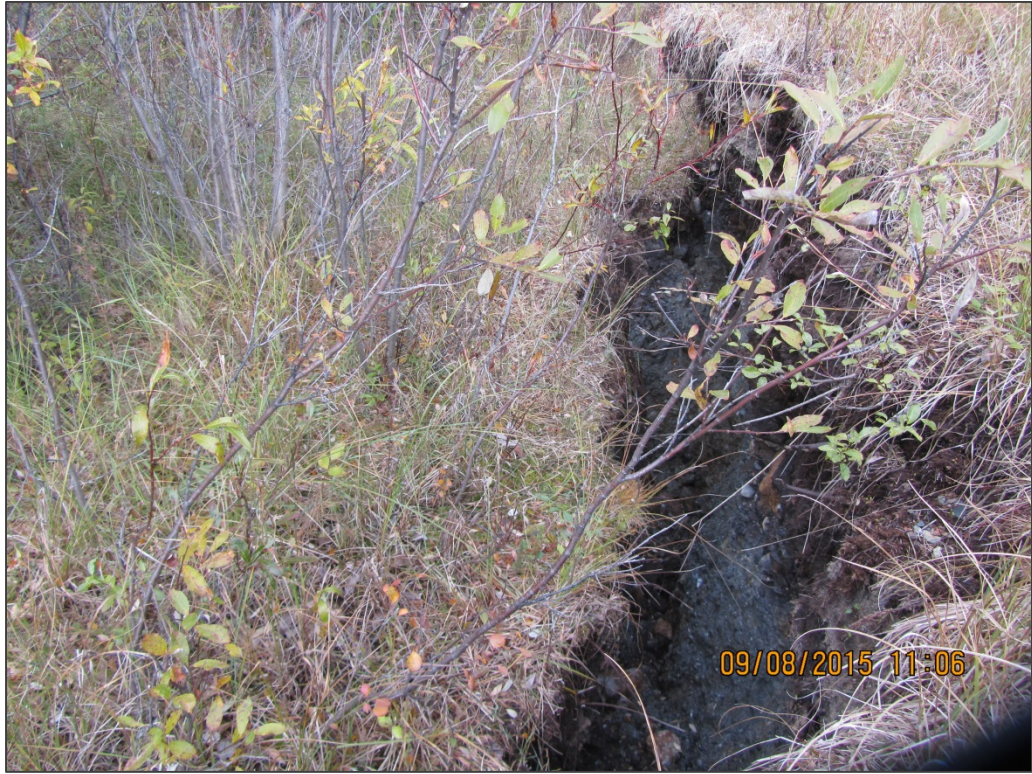
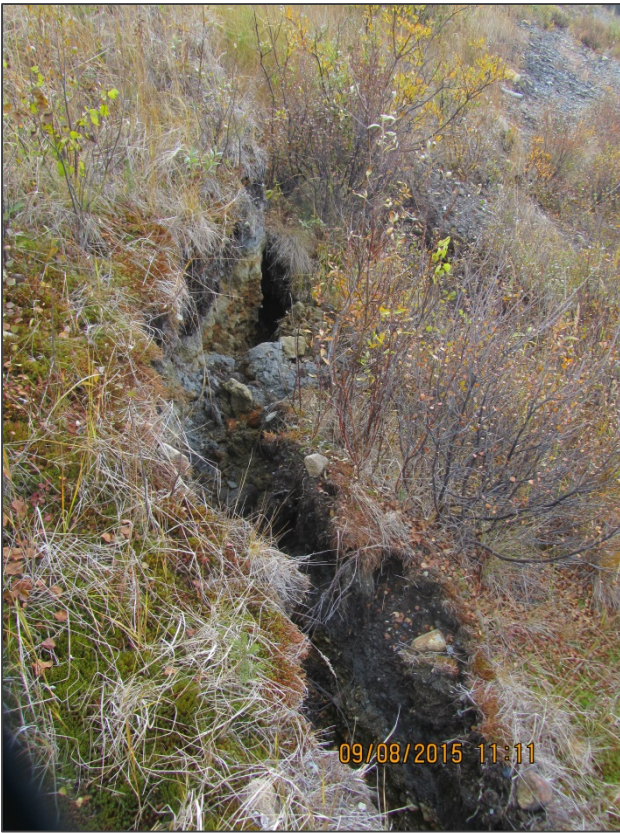
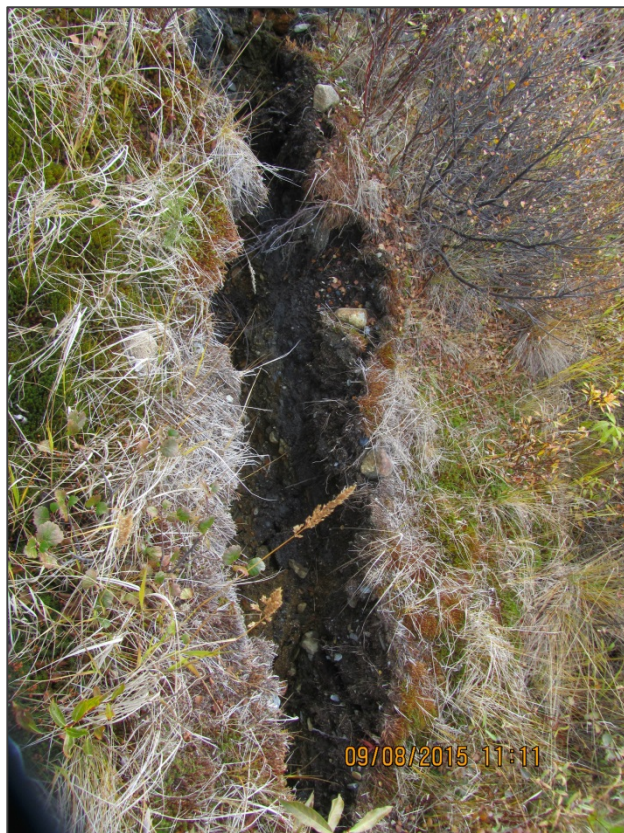
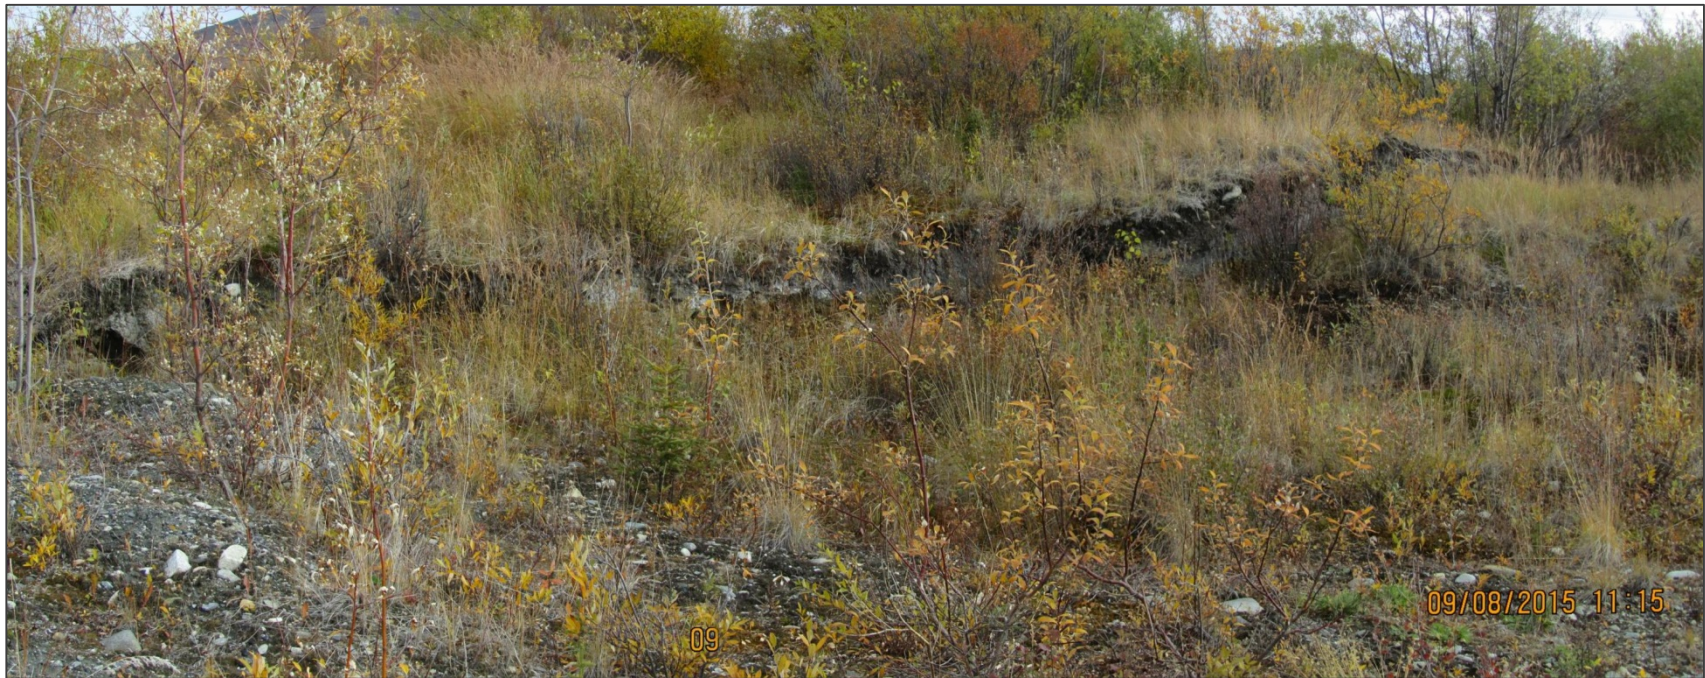
CRACKS CONTINUE TO THE NORTH OF NORTH ARRAY,
BEHIND THE CREST OF THE EAST WALL

CLIENT		FIGURE		RP	RP	AVC	AVC
REV	DATE	DESCRIPTION		DRW	DES	CHK	RWV
PROJECT		FARO MINE REMEDIATION PROJECT		1410944/2015			
		FARO, YT					
		PIT SLOPE MONITORING PLAN					
CONSULTANT		TITLE					
		CRACKS IN TILL BEHIND CREST OF EAST WALL – GRUM PIT					
				FIGURE No. 10
