## Memo

**To:** Cam Scott **Date:** Oct. 30, 08  
**cc:** **From:** Peter Mikes  
**Subject:** Faro SIS Site Visit – October 29, 2008 **Project #:** 1CY001.021.003

This memo summarizes the site visit completed on October 29, 2008 to investigate the constructability of the SIS located in the “S-Cluster” area near the North Fork Rock Drain at the Faro Mine site. Present at the site visit was Wayne from Arctic Backhoe Services, Peter Mikes and Dan from Deliotte & Touche who provided assistance with discussing sources of clean backfill material and access options around the site.

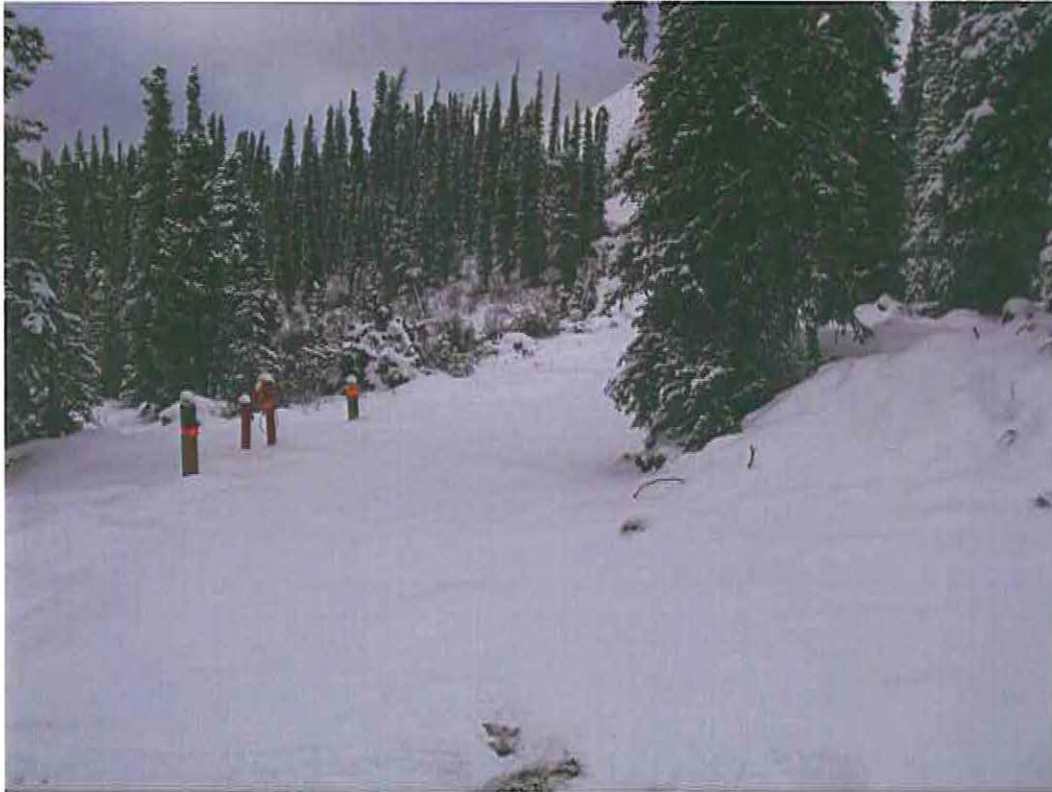
Photo 1: View of seepage infiltration trench area taken from the proposed sump location looking west.

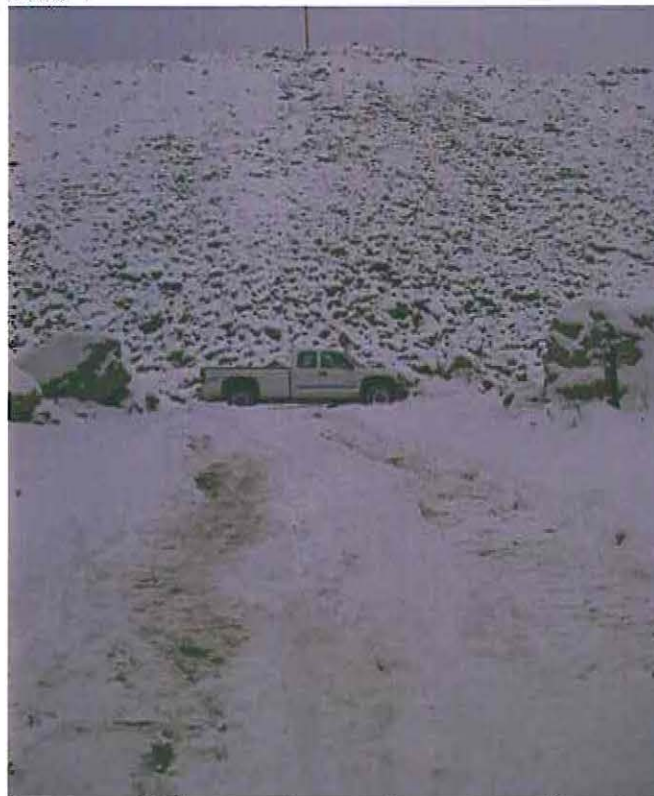
The notable exception for access is the last 50 m where the road turns south down a slope away from the toe of the waste rock dump. It is expected that a tandem would not be able to travel up this slope loaded. Road improvements would also have to be made in this area to allow a rock truck to travel up this slope.

Photo 2: View of access road down to the trench area taken from the sump location looking north.

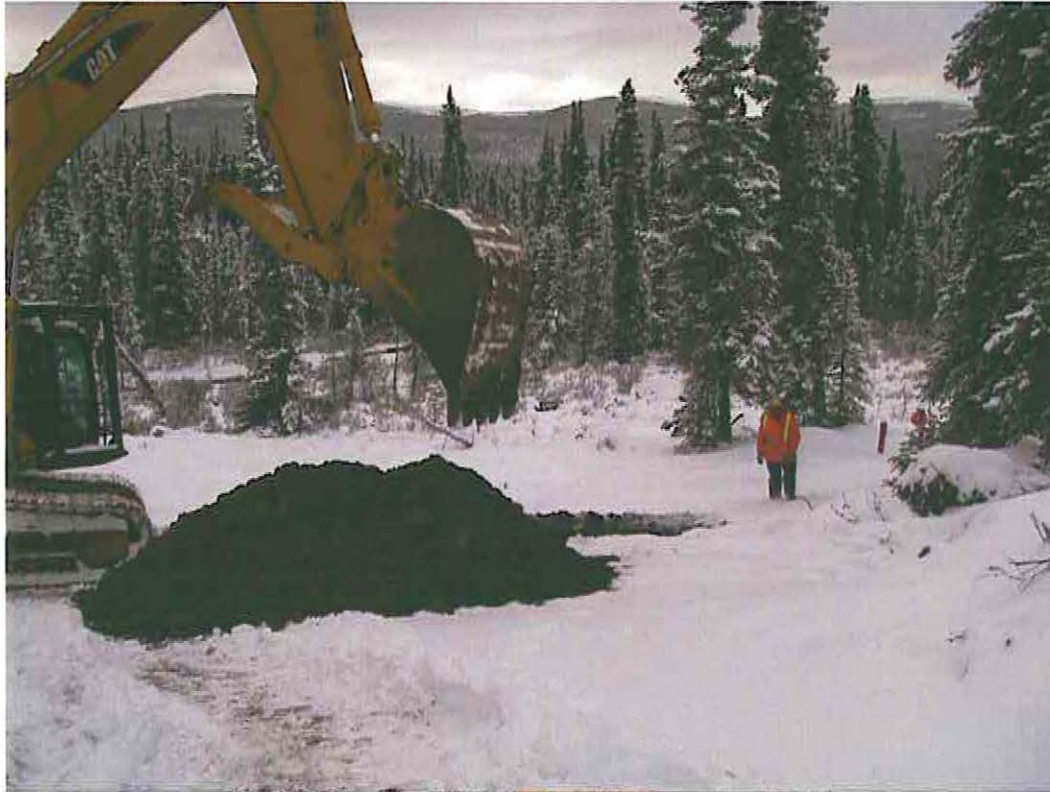
Photo 3: Start of excavation of the test pit taken from the access road looking south.

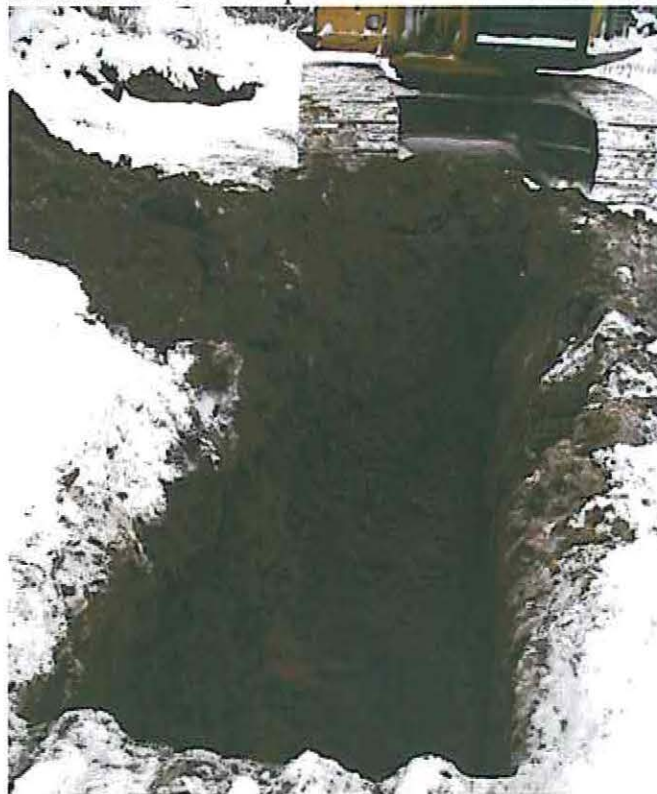
Upon reaching the gravel water began pouring into the hole and sloughing began to occur, primarily on the upgradient (north) side of the excavation (see attached photos). The pit wall in the lower silty sand layer was fairly competent.

Photo 4: Excavation of the test pit. Water began to pour into the excavation at a depth of 1.5m.

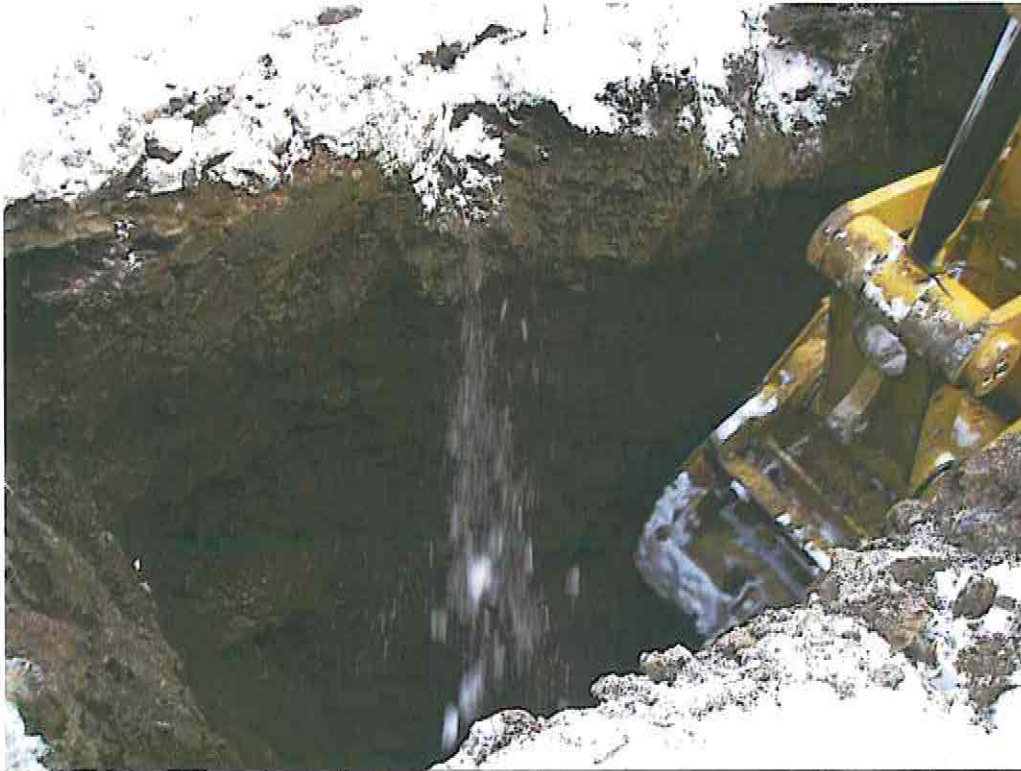
Photo 5: Excavation of test pit.

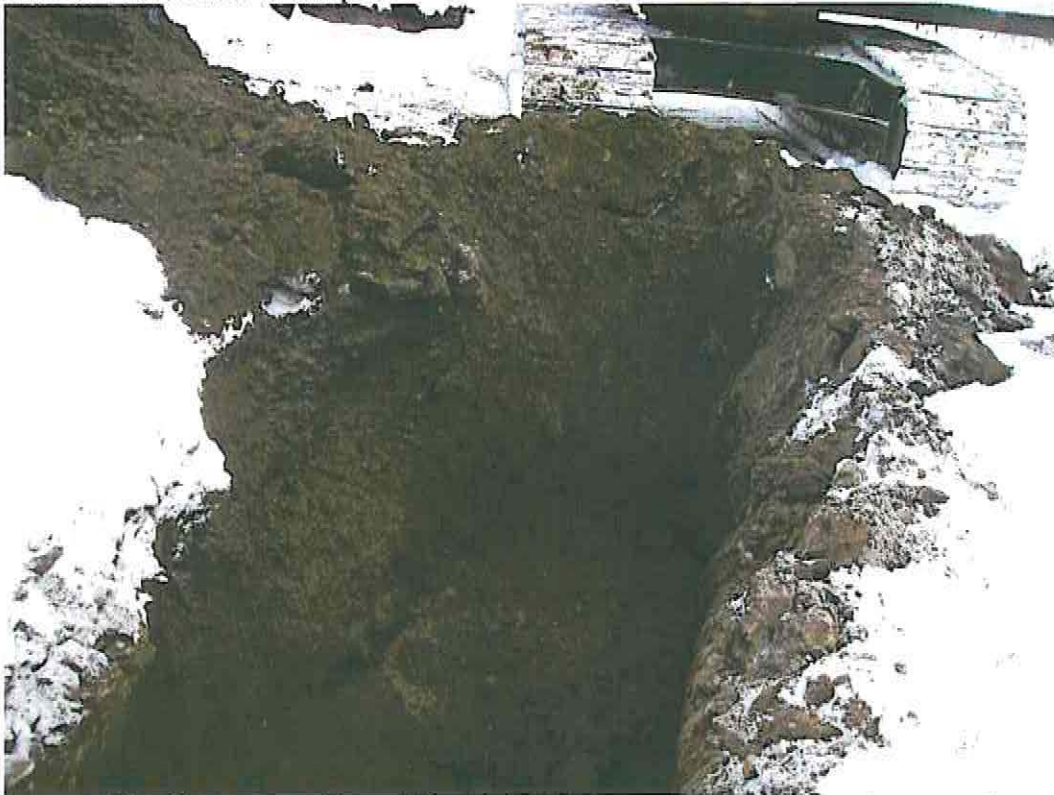
Photo 7: Significant sloughing of the pit began to occur primarily on the upgradient side of the test pit upon reaching the coarser sandy gravel layer.

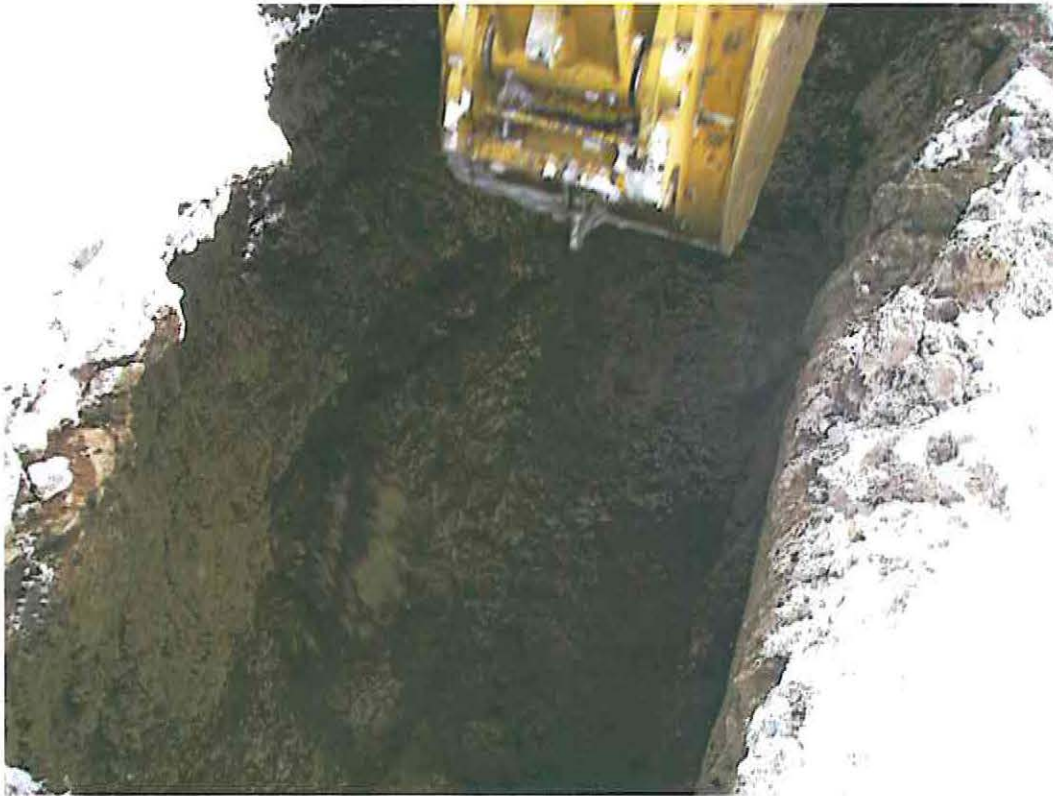
Photo 8: Excavation of the test pit with sloughing.

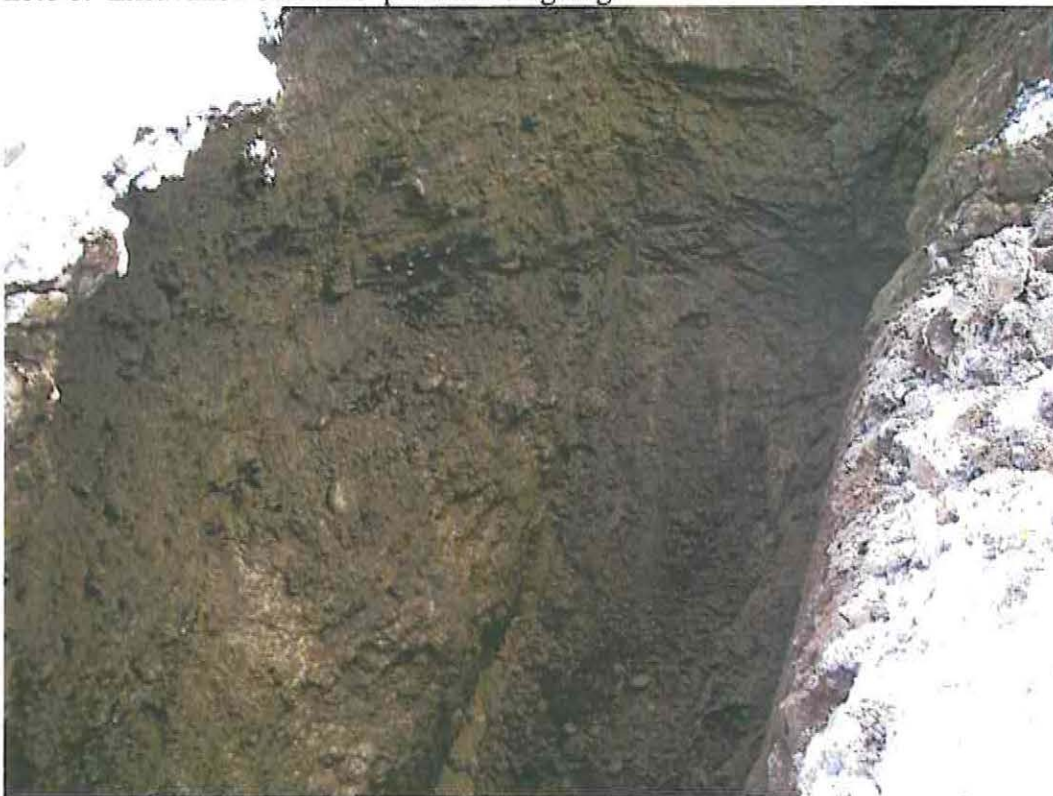
Photo 10: View of water seeping into the test pit.

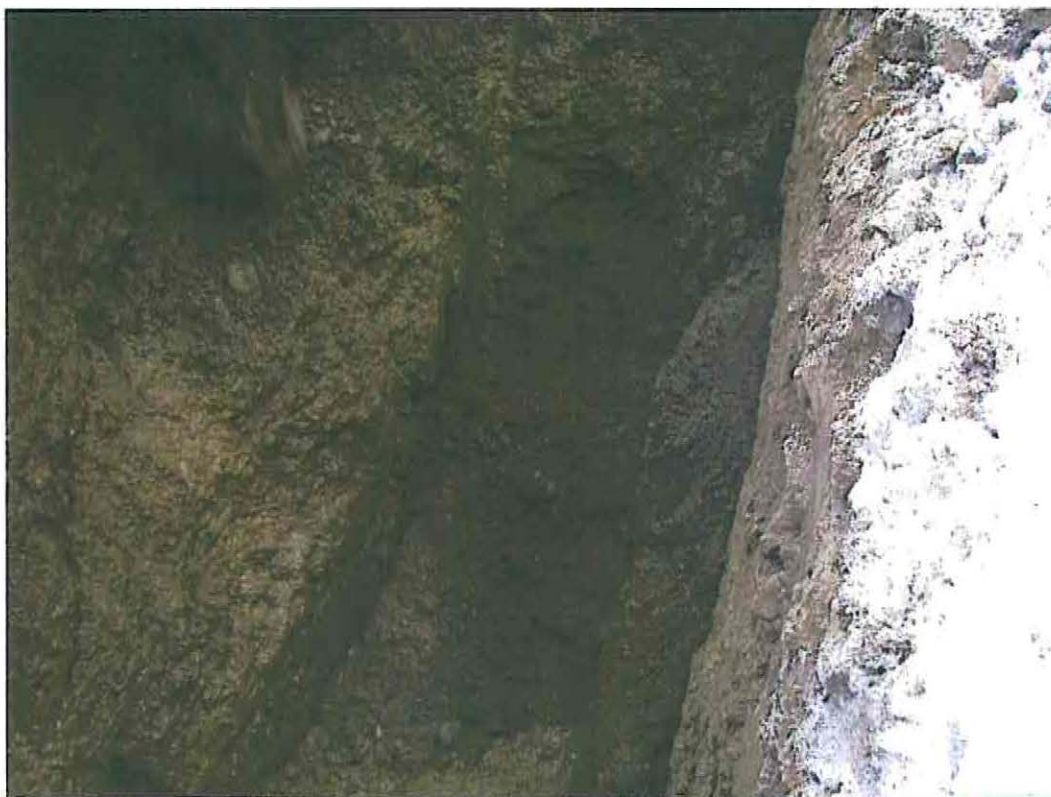
Photo 11: Excavation of test pit

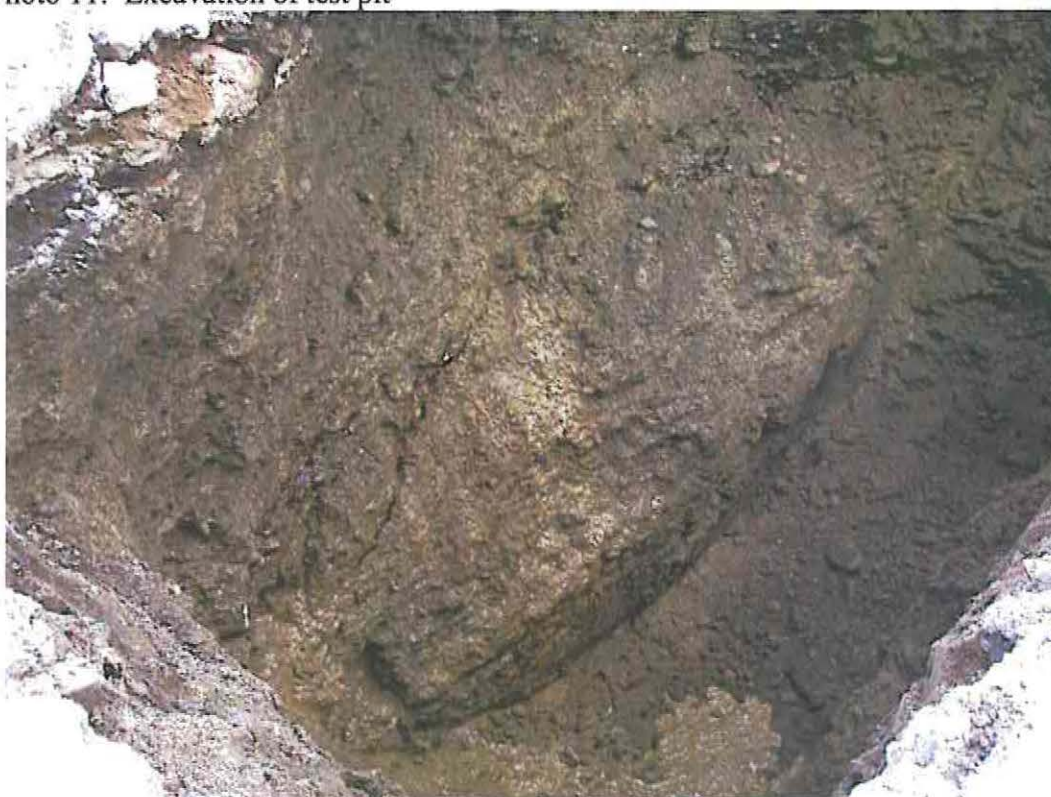
Photo 12: Excavation of test pit. The material below the gravel layer was relatively dry.

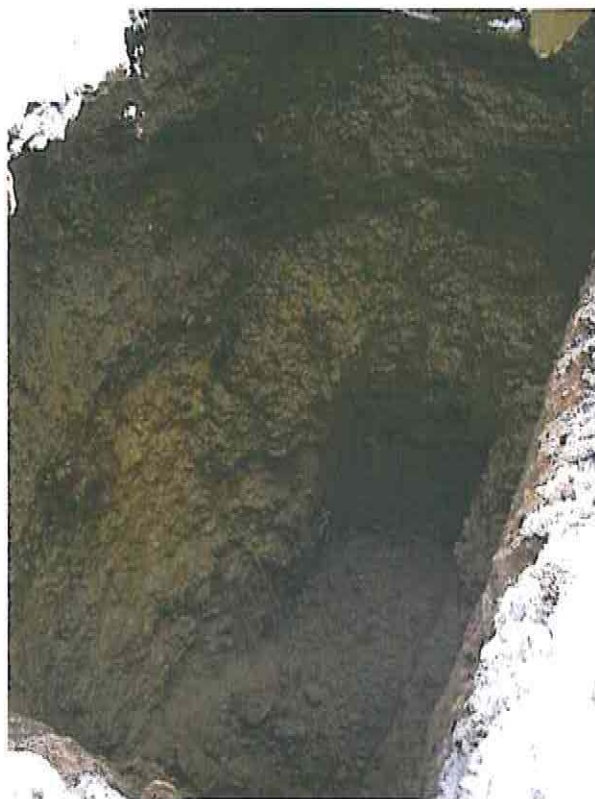
Photo 14: Excavation of test pit (end of hole)

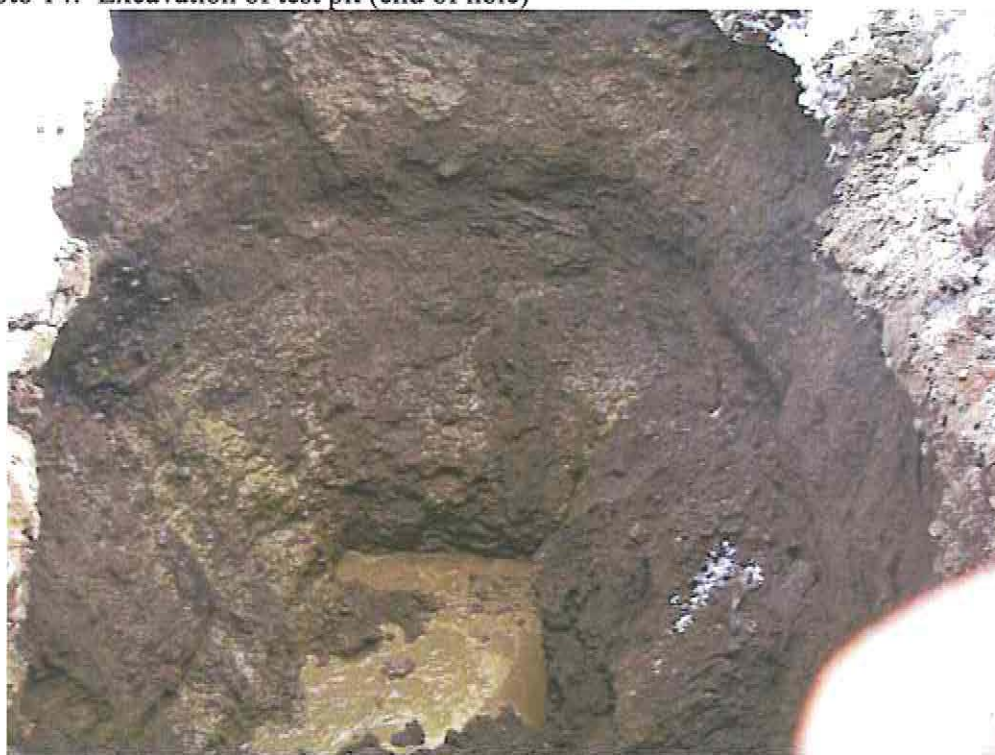
Photo 15: View of test pit after approximately 2 minutes after completion of hole.

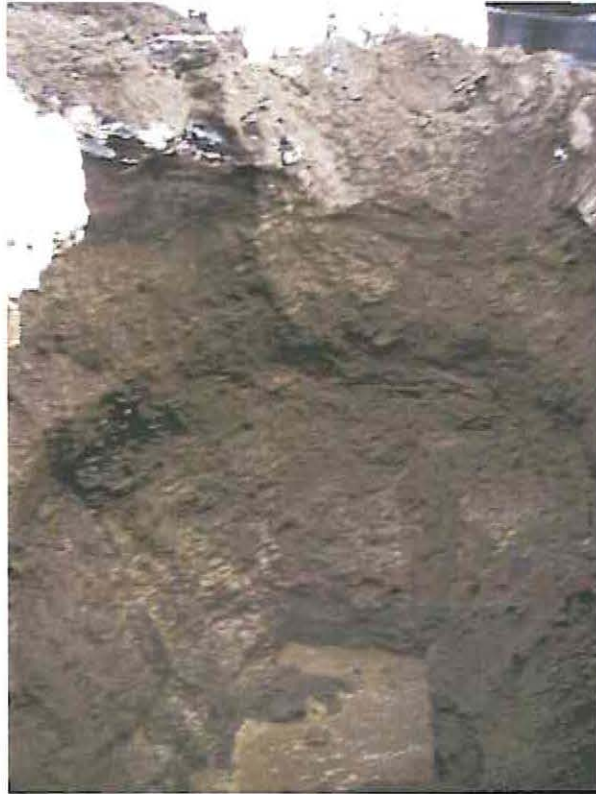
Photo 16: View of test pit after approximately 2 minutes after completion of hole.

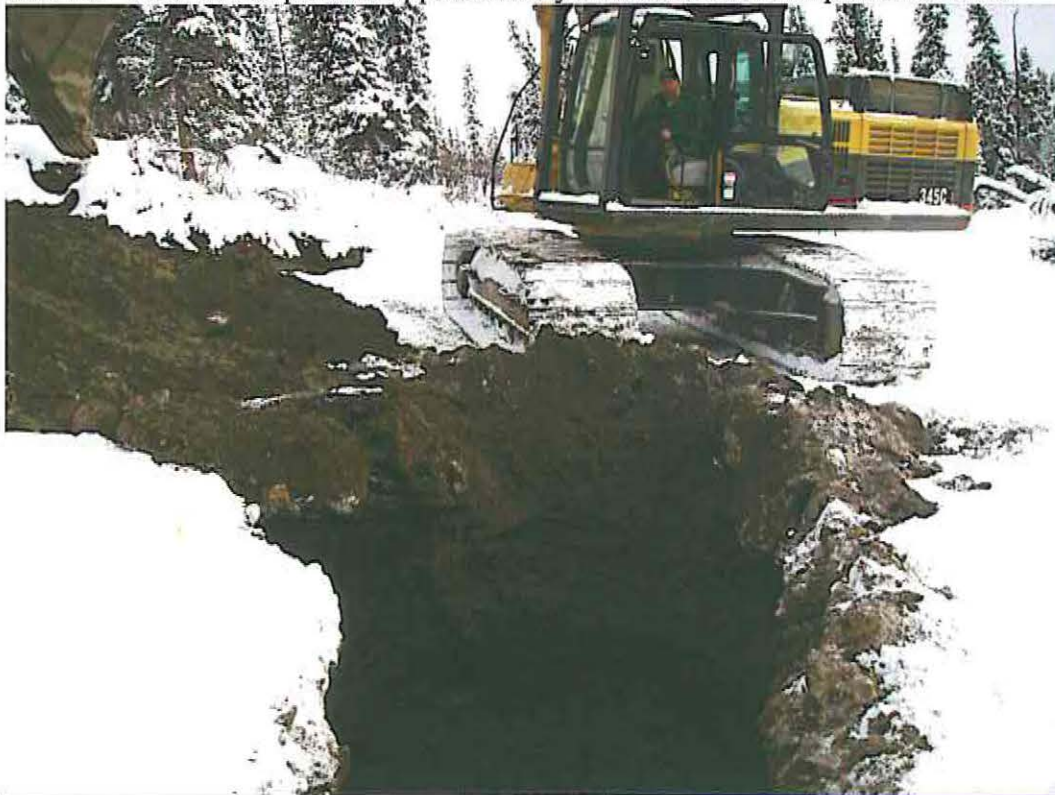
Photo 18: View of test pit after approximately 2 minutes after completion of hole.

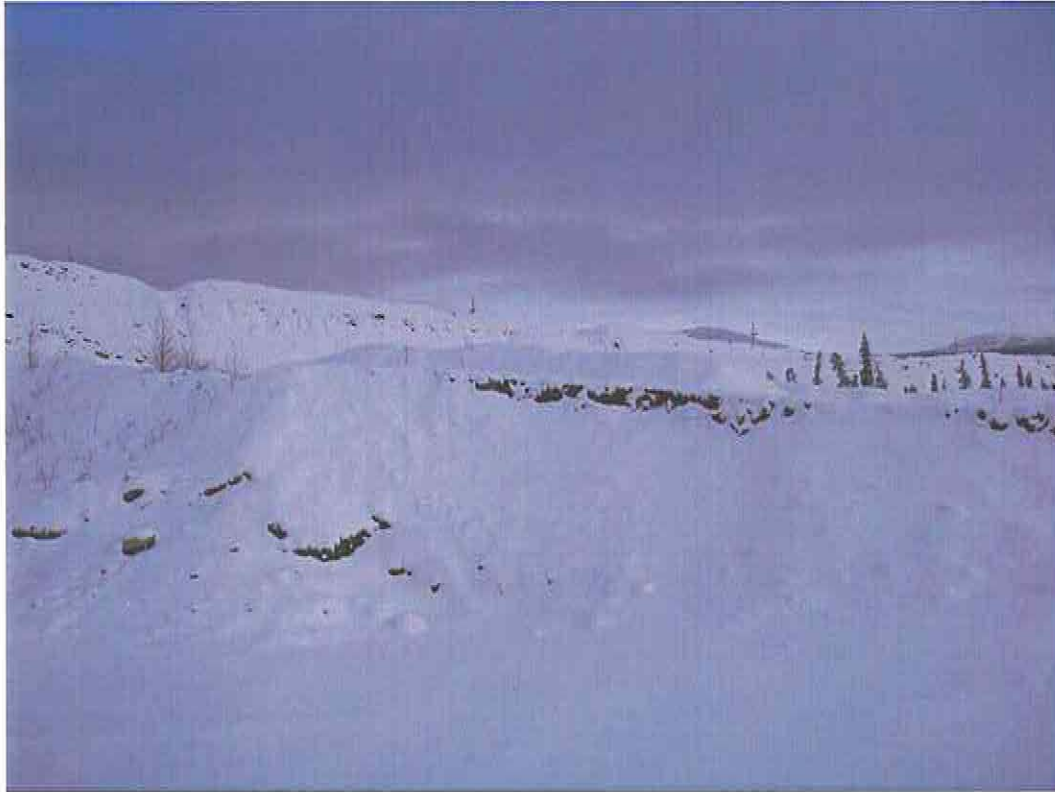
The material in the Haul Road Borrow Pit was investigated. It was noted by D&T that there was a stockpile of screened oversized material in one location of the pit. The volume is estimated at 100 to 150 m<sup>3</sup> of gravelly material that would be ideal as backfill material. This material is shown in photos 19 to 21. The pit run material was also looked at with the exposed areas of the pit appearing to contain a significant amount of gravels (Photos 22 and 23).

Photo 19: View of screened oversized reject stockpile in Haul Road Borrow Pit.

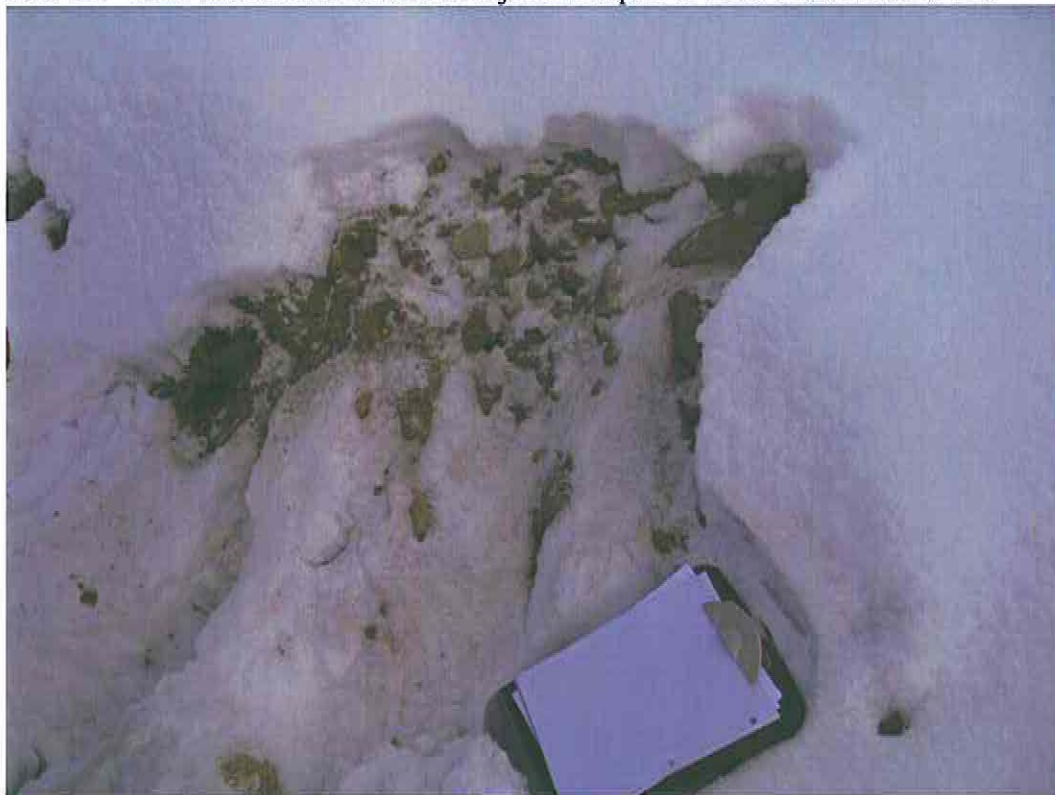
Photo 20: View of screened oversized reject stockpile in Haul Road Borrow Pit.

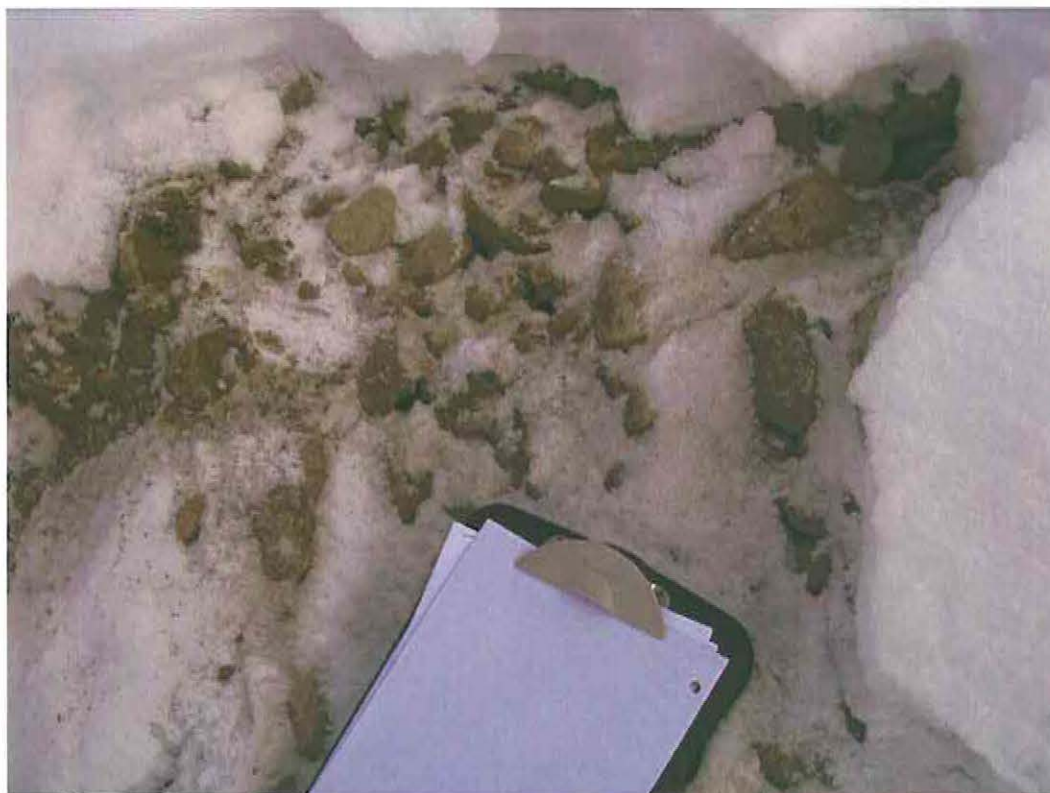
Photo 21: View of screened oversized reject stockpile in Haul Road Borrow Pit.

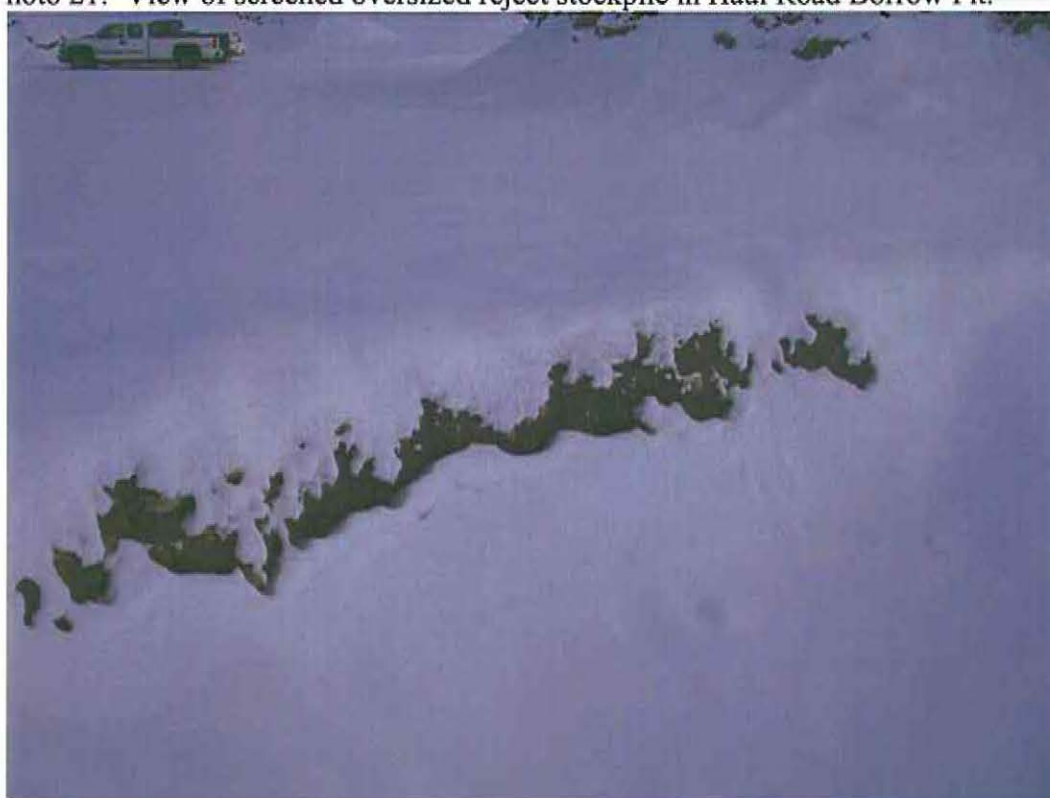
Photo 22: View of exposed pit run in the Haul Road Borrow Pit.

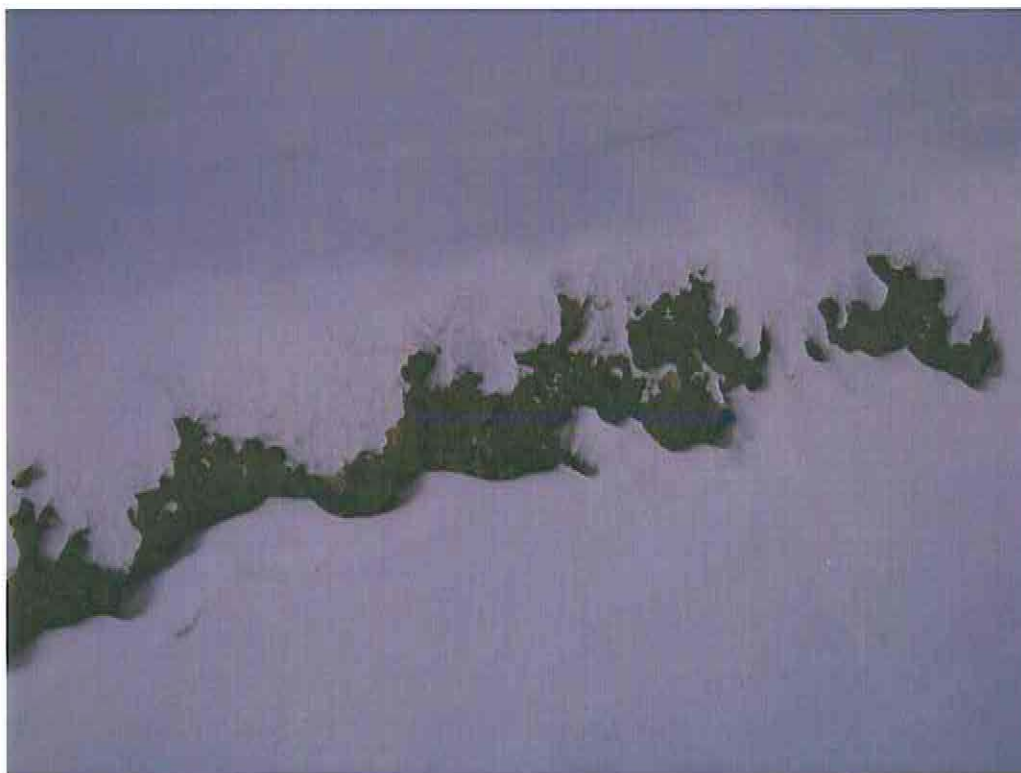
Photo 23: View of exposed pit run in the Haul Road Borrow Pit.
