**Robertson GeoConsultants Inc.**

**Memorandum**

**DATE:** July 17, 2006  
**TO:** Valerie Chort, Deloitte & Touche  
**CC:** Wes Treleaven, Deloitte & Touche  
**FROM:** Christoph Wels, Robertson GeoConsultants Inc.  
**RE:** **Final Inspection of Decommissioned "Leaky Wells", Rose Creek Tailings Facility**

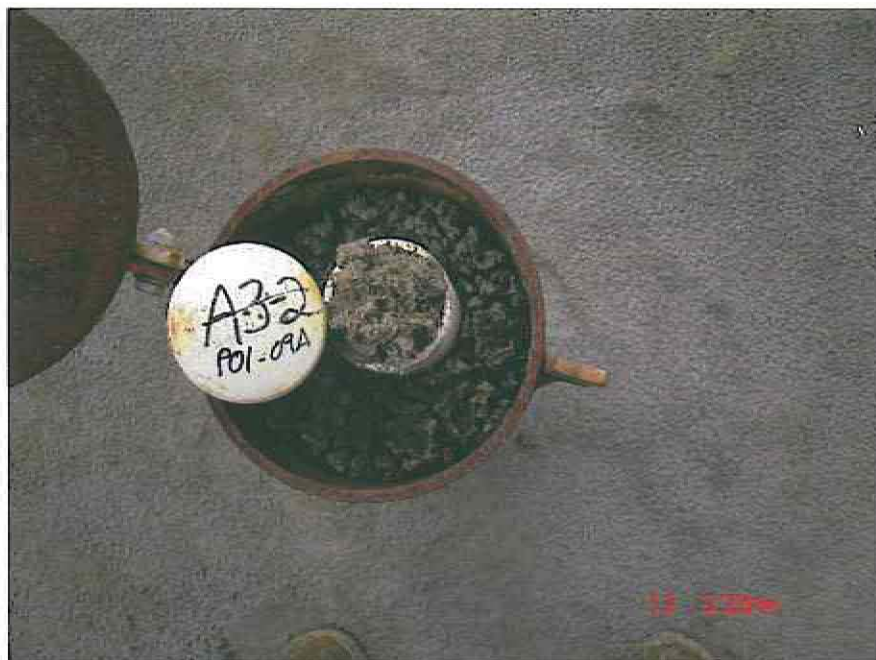
Photo 1 - bentonite seal at P01-09A

P01-09A photo 1

handwritten to top of casing  
putty like, outside of  
PVC dried up

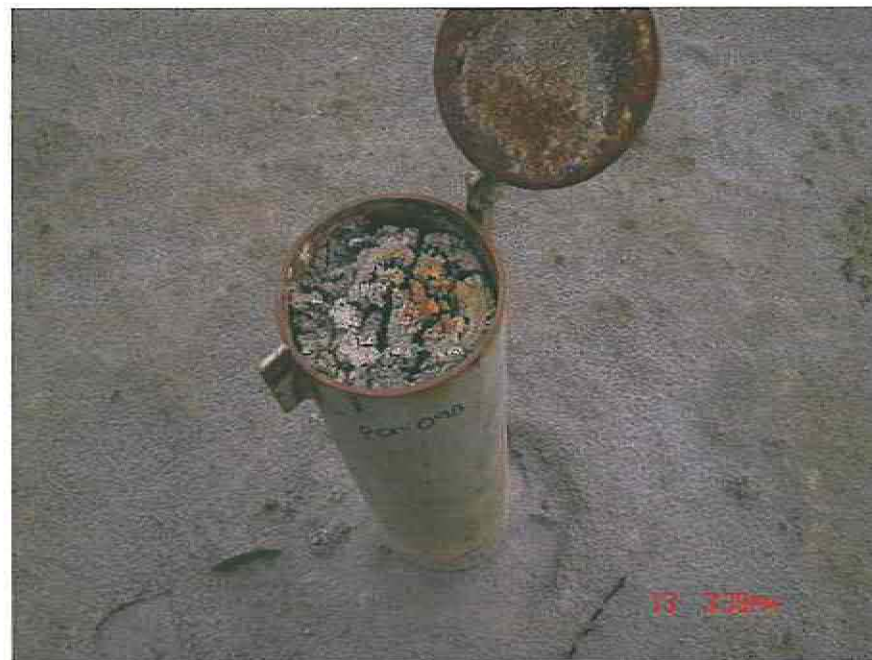
Photo 2 - bentonite seal at P01-09B

P01-09B dried at top of powder

casing  
putty like, inside PVC  
to top, no shrinkage

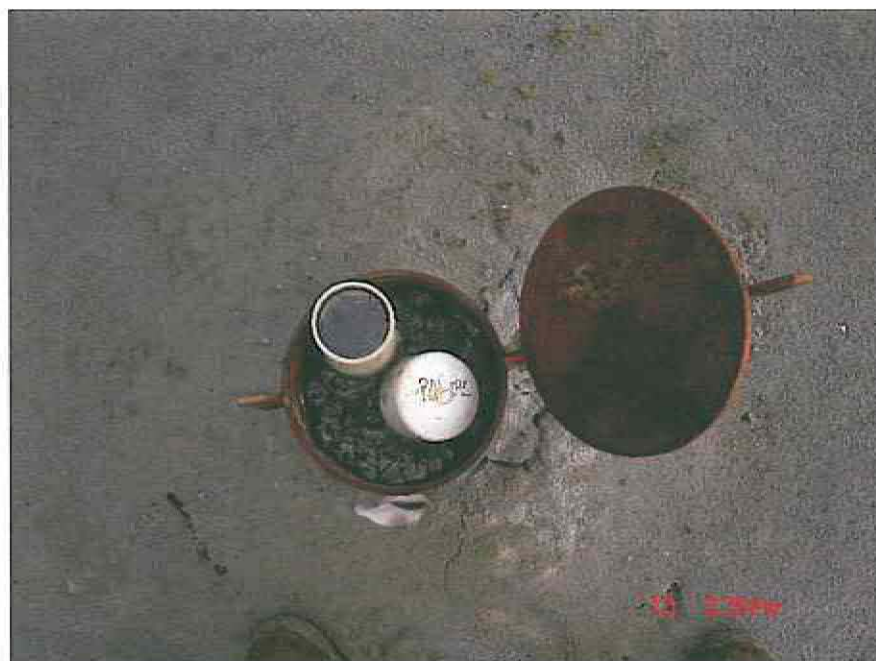
Photo 3 - bentonite seal at P01-09C/D

P01-09C putty-like ~ 7m to top  
09D " at top of PVC  
no sign of shrinkage/shrinkage

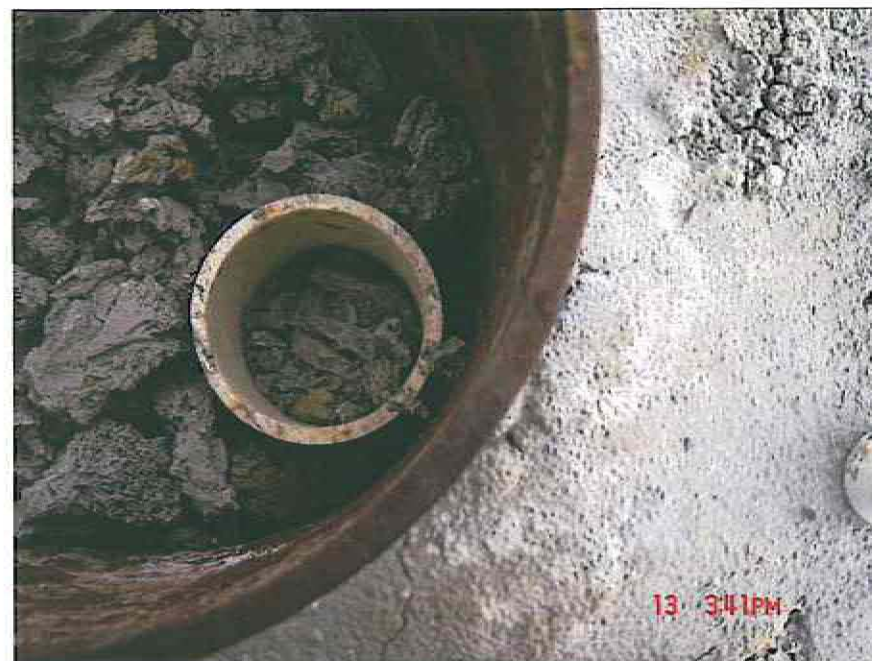
Photo 4 - putty-like seal at 7 cm bTOC at P01-09C

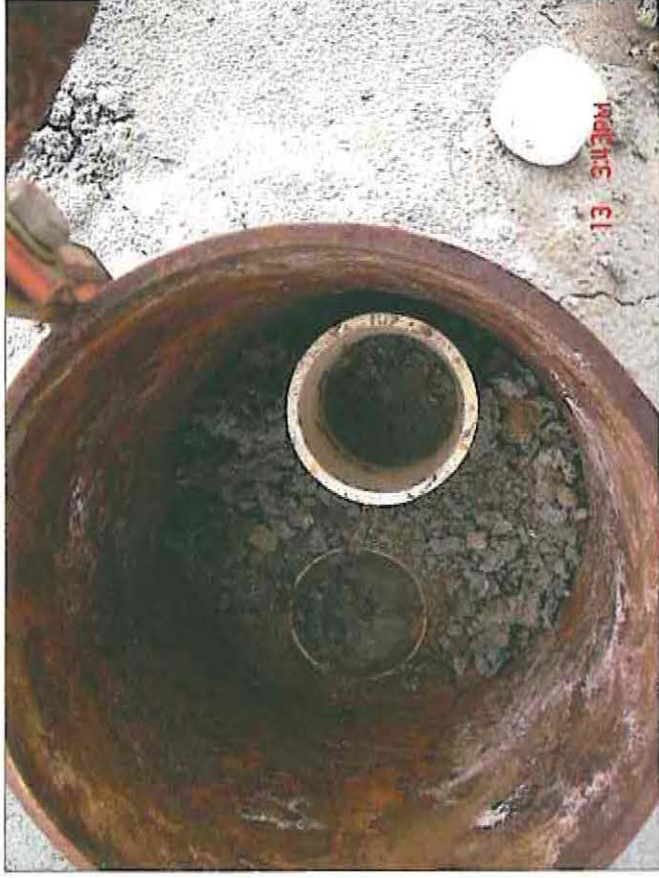
Photo 5 - putty-like seal at TOC at P01-09D

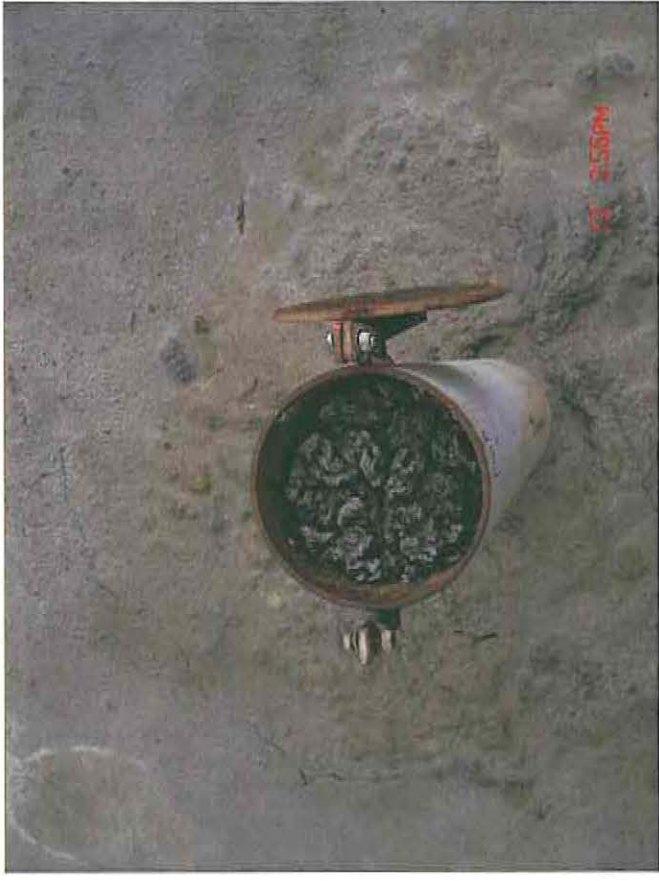
Photo 6 - bentonite seal at P01-08A

P01-08A dry, shrinkage at steel casing  
putty-like at top of  
PVC casing

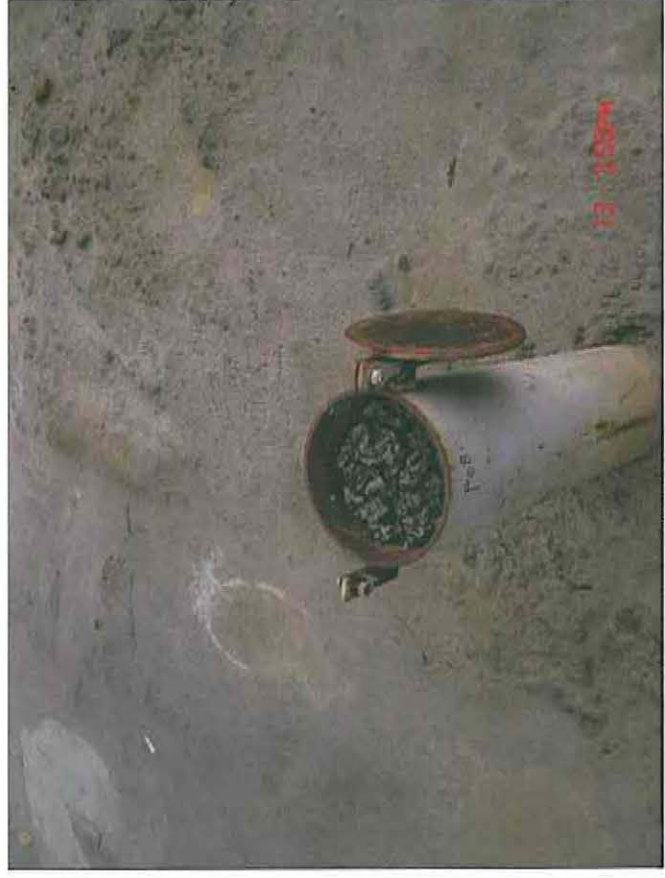
Photo 7 - bentonite seal at P01-08A

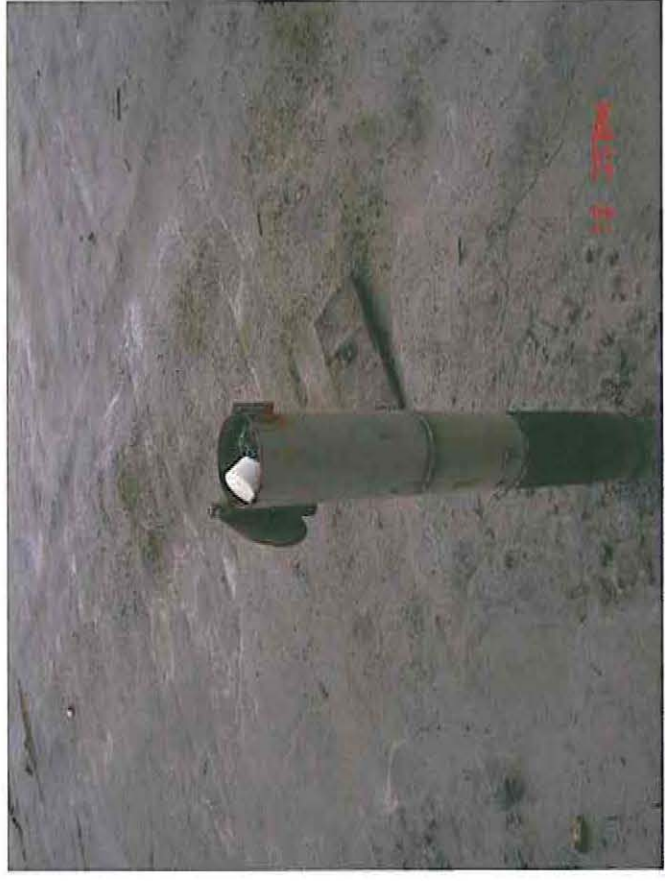
Photo 8 - bentonite seal at P01-08B

P01-08B a> above  
putty-like at ~ 6m to top

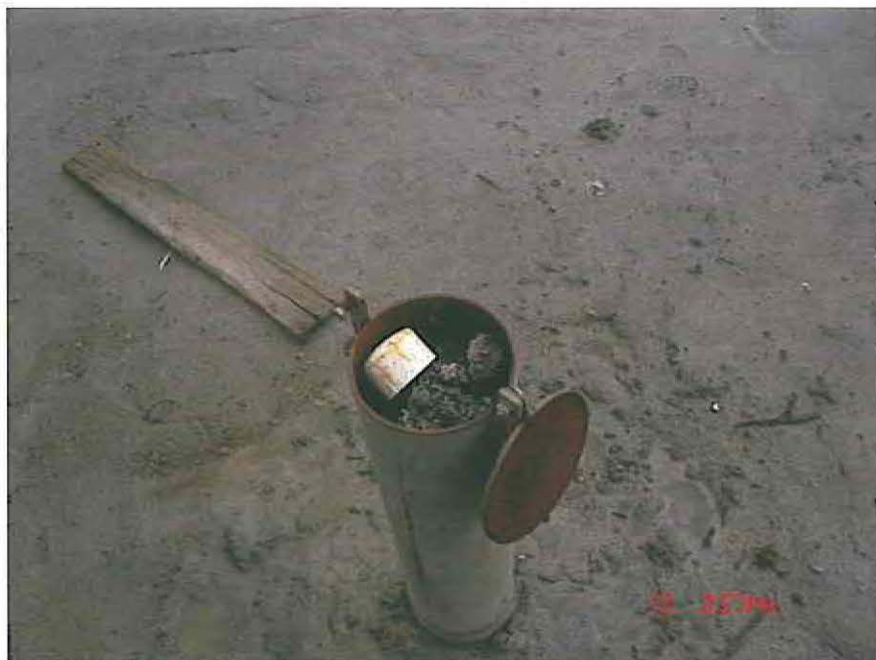
Photo 9 - bentonite seal at P01-08C

P01-08C dry at top  
putty-like at ~ 6m to top  
no loss/shrinkage (2 plates)

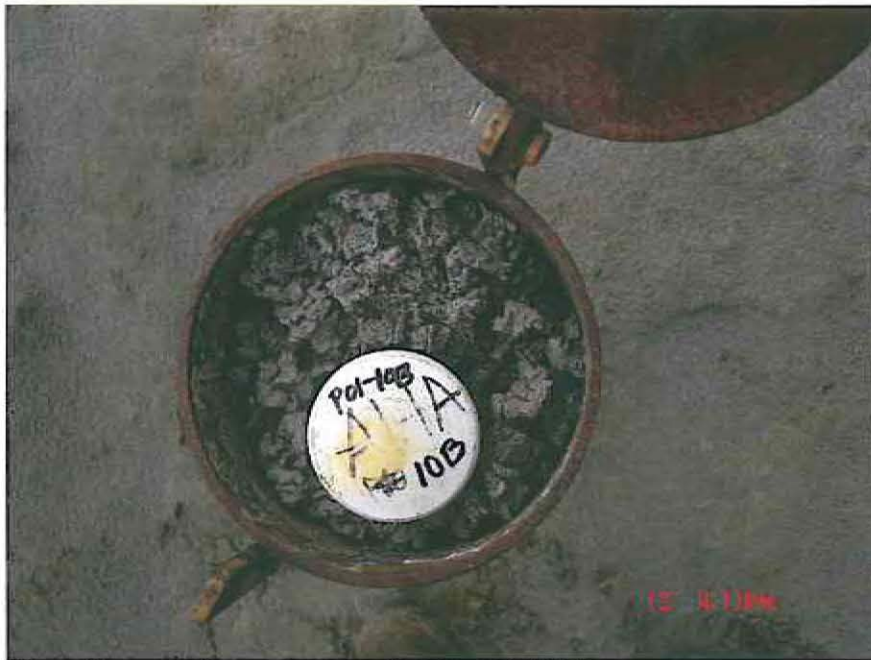
Photo 13 - putty-like seal at 7cm bTOC at P01-10A

putty-like at 7cm

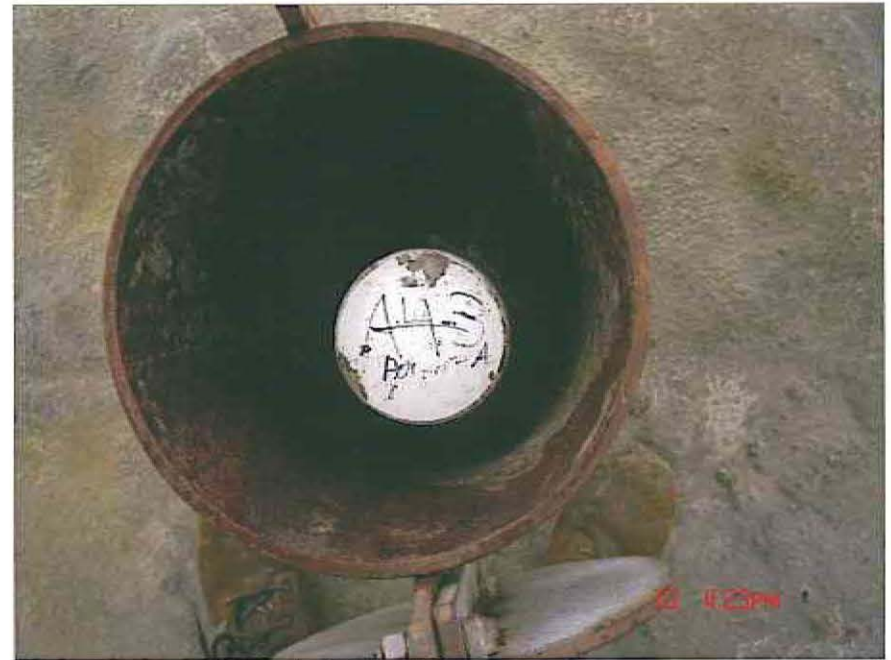
Photo 14 - bentonite seal at P01-10B

putty-like at 4cm

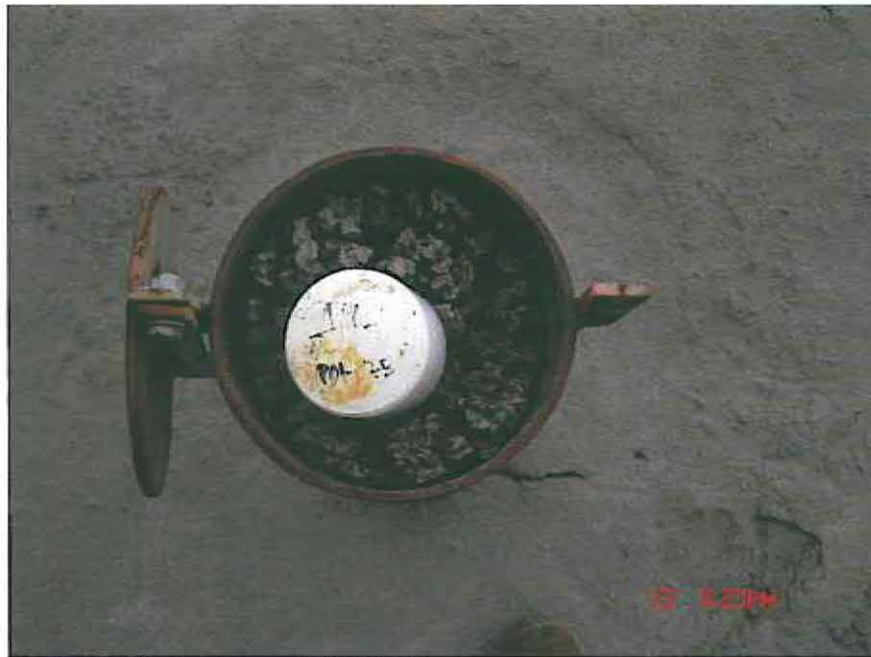
Photo 15 - bentonite seal at P01-07A

P01-07A putty-like to top of PVC casing

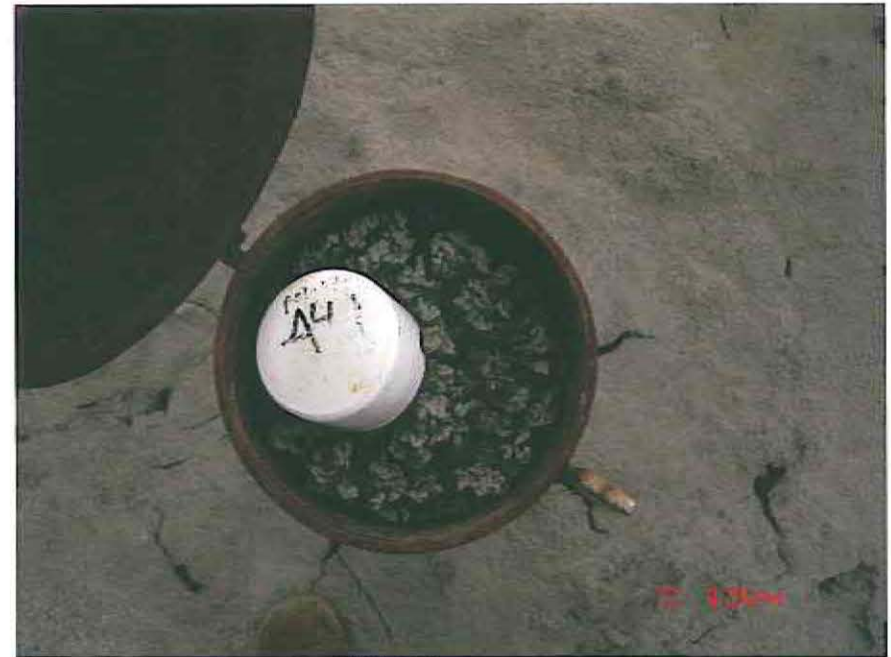
Photo 16 - bentonite seal at P01-07B

B " at 4.5m to top

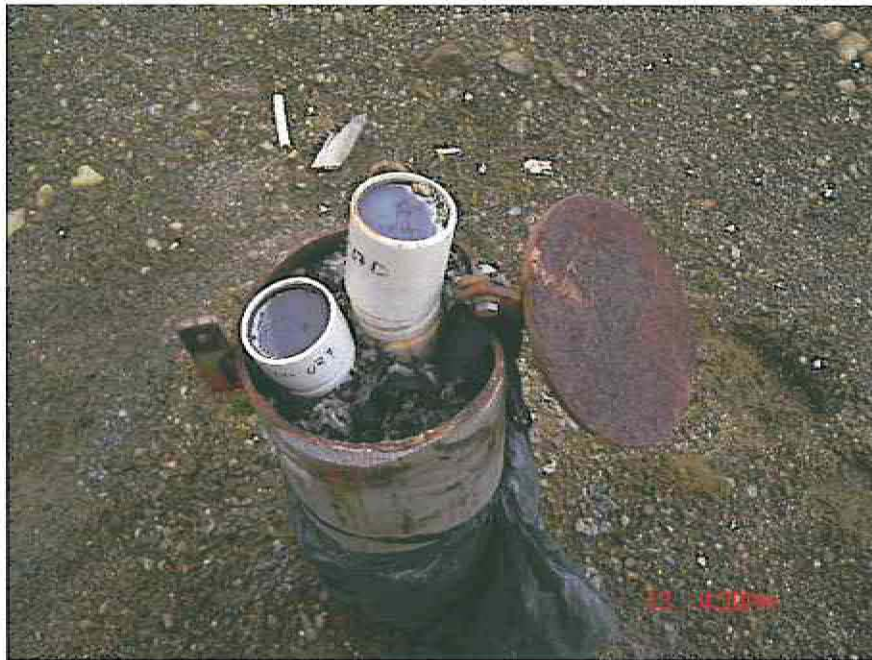
Photo 17 - bentonite seal at P01-07D/E

D/E both putty-like to top of PVC  
cleaned out to place top of well

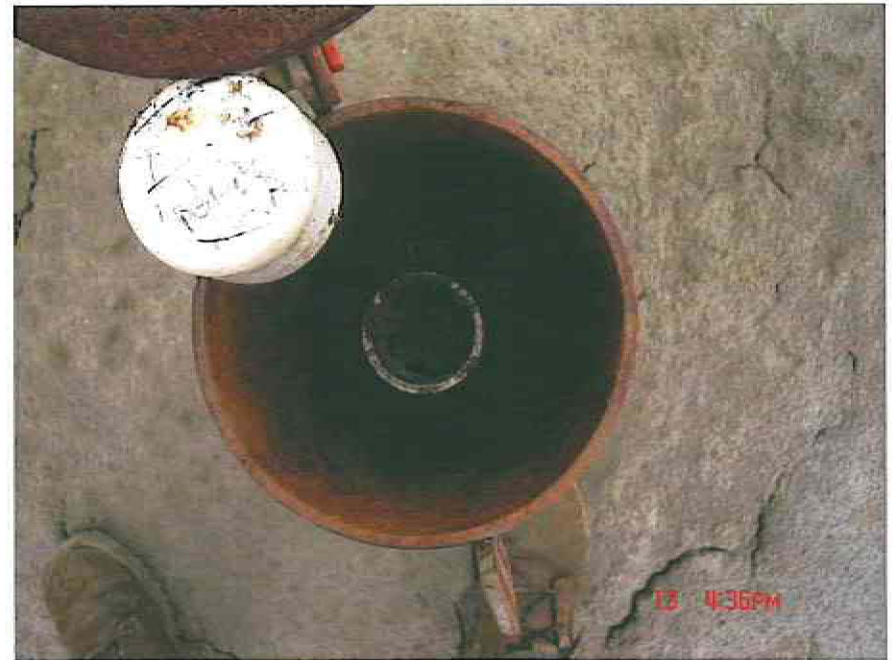
Photo 18 - bentonite seal at P01-06A

handwritten ~ 6cm to top of PVC casing  
slur putty-like just below  
dry surface

no change from last year

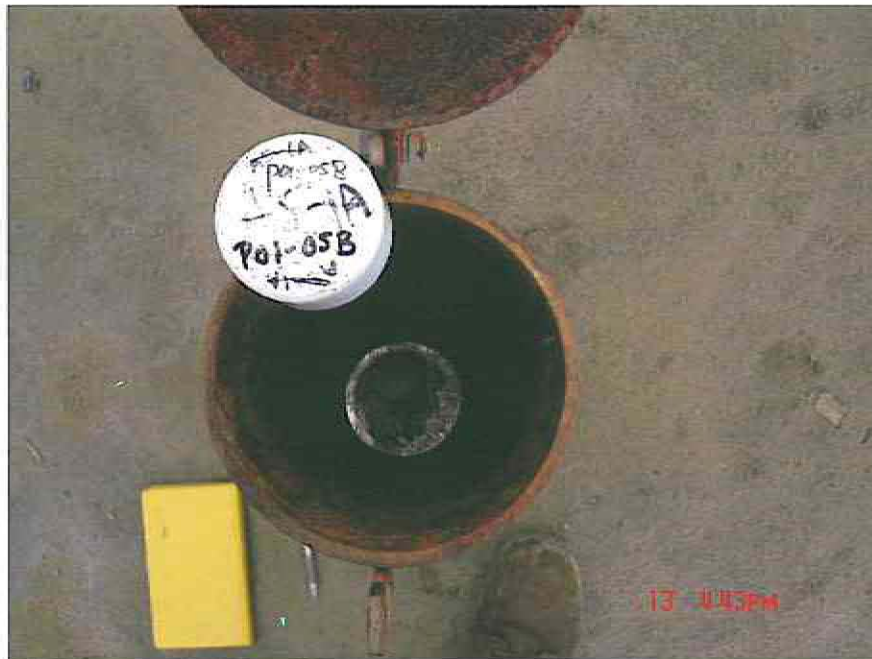
Photo 19 - bentonite seal at P01-05B

P01-05B putty-like at 5cm to top of PVC casing

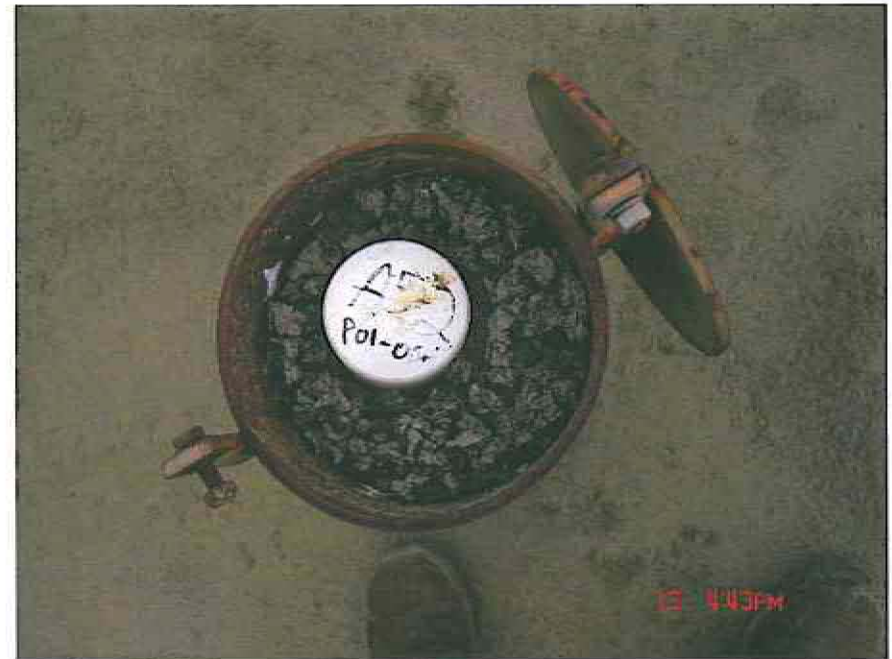
Photo 20 - bentonite seal at P01-05A

P01-05A " at top (wet)  
no change from last year
