**GOVERNMENT OF YUKON
FORMER CLINTON CREEK ASBESTOS MINE -
Long Term Performance Monitoring Program**

UMA Project No. 6029 007 00 (4.6.1.3)

August 2006

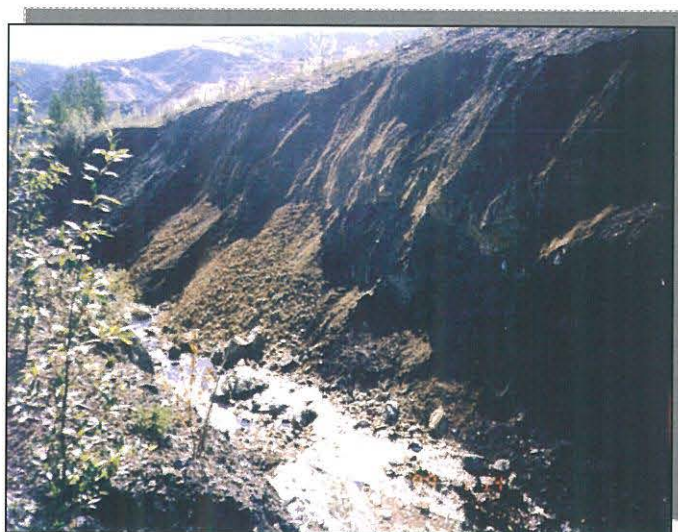
Figure 2-1 Waste Rock Slumping Into Creek Channel (View Downstream)

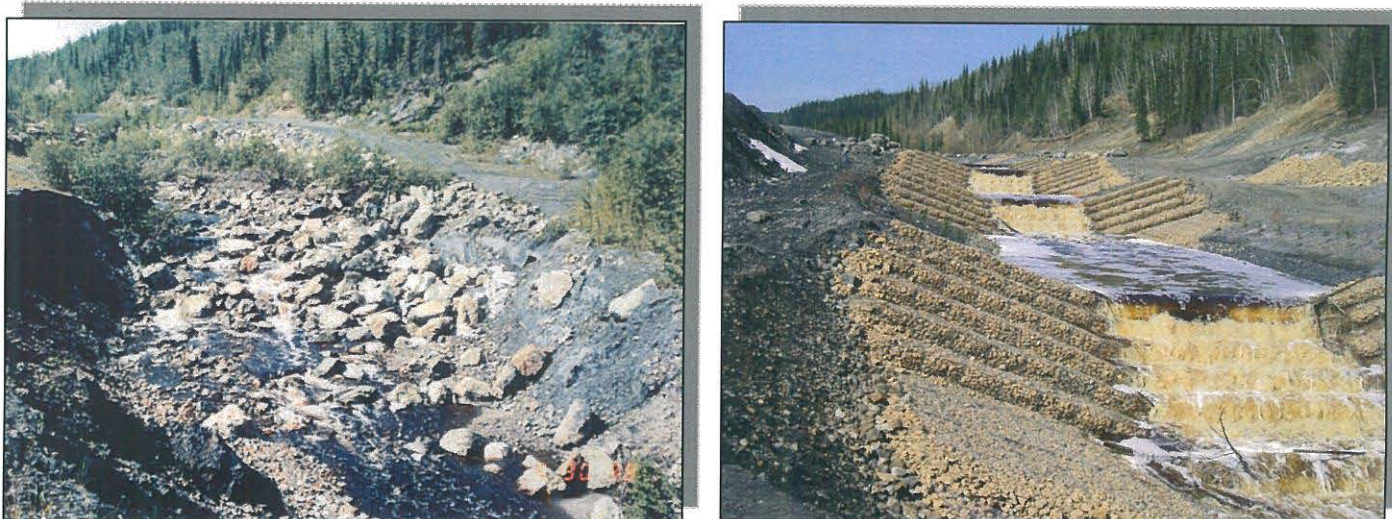
Following the spring freshet (spring run-off) of 2003, inspection of the Stage I stabilization works completed the previous year revealed some deformation of the first drop structure, loss of material from some of the baskets forming the floor of each step and the development of a scour hole in the channel bottom immediately downstream of the drop structure where there was no downstream structure to provide the design tailwater effect illustrated on Figure 2-2. The largest deformation was on the north side slope at the last row of baskets directly upstream of the scour hole. Deformation of the north flank of the structure farther upstream at the steps was believed to be from settlement of channel fill. The deformations of the structure did not significantly affect the overall hydraulic performance or capacity and the gabion structures were left as is. In 2003 during Stage II construction, several baskets of the first drop structure were opened and topped up with 100 mm or larger diameter gabion fill material to replace the finer material that had been dislodged from the baskets. The scour hole was also addressed during Stage II by installing an extra row of baskets at the downstream end of the drop structure. This extra row of baskets was added to the design details for all subsequent drop structures to minimize the potential for similar scouring to develop between construction stages or in the event that the tailwater effect from a downstream drop structure is reduced. The second structure was completed in 2003 and the last two structures were constructed in 2004 (Stage III). No scour hole developed at the downstream end of Drop structure 2 between Stage II and III. The completed channel stabilization works are shown in profile on Drawing 02. Photographs of the channel, before and after construction are shown on Figure 2-2.

Figure 2-2 Hudgeon Lake Outlet Before (1998) and After Construction of Gabion Drop Structures (2005)

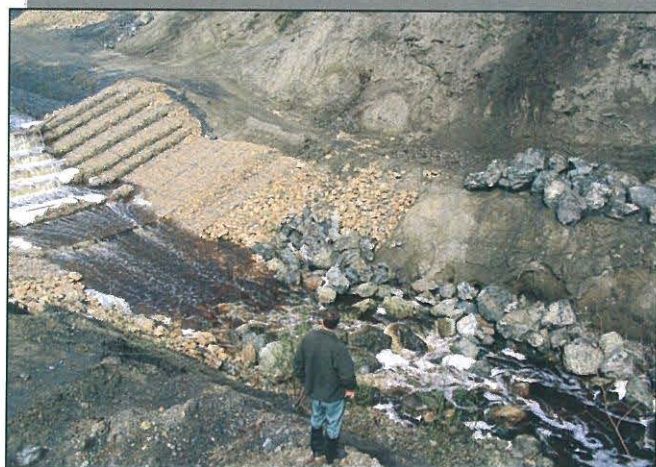
During Stage II construction, the location of the bedrock contact in the channel bottom was confirmed at Station 0+225 m. Based on this information and in consideration of the overall height of the waste rock pile above the channel bottom and lack of construction access on the north side of the channel, the last two drop structures were eliminated from the design and four structures were positioned along the channel with the last structure at Station 0+175 m or about 50 m upstream of where the bedrock contact was visible. The final position of the third and fourth structures was adjusted during construction to better suit the channel geometry and tie into boulders remaining from the original channel stabilization works (UMA 2002). A transition at the downstream end of the stabilized channel section was constructed to minimize the potential for undercutting of the last drop structure. This consisted of adding an additional full row and a partial row of baskets to the downstream end of the last drop structure (UMA 2005) and armouring the channel banks for about 20 m downstream of the last row of baskets (Figures 2-3 and 2-4 note: DS = downstream).

Figure 2-3 Channel Armouring DS of Drop Structure 4

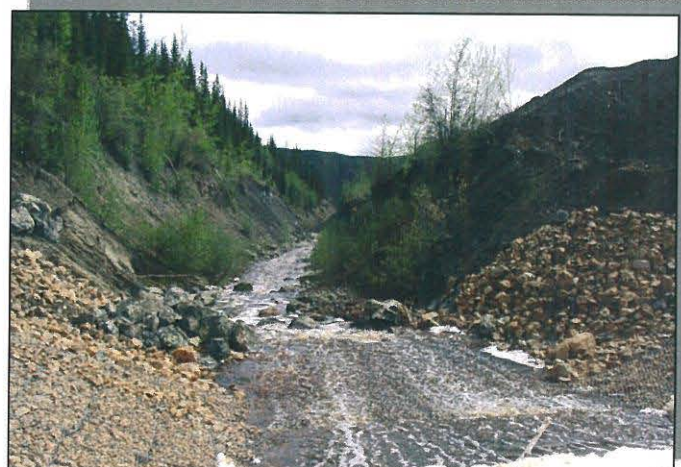
Figure 2-4 Creek Channel DS of Drop Structure 4

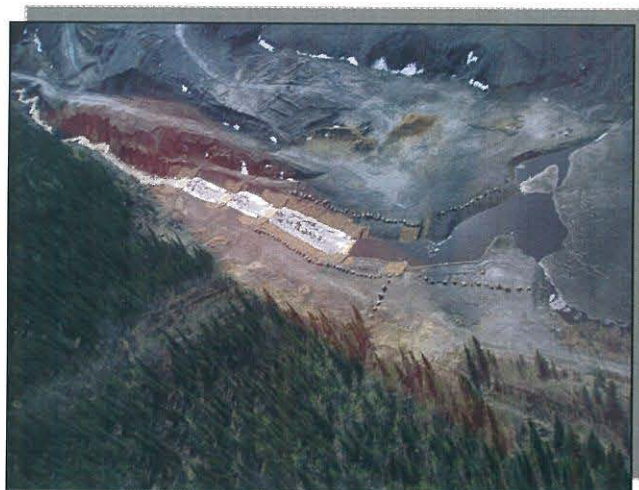
As presented in UMA's 2005 site inspection letter (Appendix A), post-construction inspections were carried out by the Government of Yukon (GY) and UMA in May 2005 and by GY staff in June 2005. The condition of the stabilized channel during spring freshet is shown on Figure 2-5. Although at the time of the May inspection water in the channel obscured the baskets forming the floors of the drop structures, the gabion structures appeared to be in good condition with only minor lateral deformation. During the June 2005 inspection, the water levels had dropped enough to reveal that some gabion fill had been washed out of the baskets forming the floor of Drop Structures 3 and 4 (Figure 2-6). It is our understanding that the baskets were opened and topped up in the summer of 2005 under the direction of GY staff (Appendix A).

Figure 2-5 Hudgeon Lake Outlet May 2005

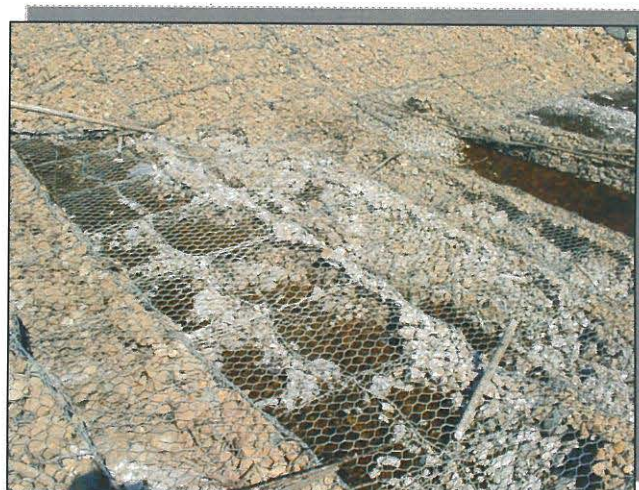
Figure 2-6 Loss of Gabion Fill June 2005

Some post-construction deformation of the gabion structures is expected as the channel fill below the drop structures adjusts. A non-woven geotextile was placed between the compacted fill and the gabion baskets to reduce the potential for erosion beneath the structures. The flexible nature of the gabion baskets will permit the drop structures to accommodate some adjustments without a significant loss of capacity or performance. By design, the fourth structure can accommodate some channel scouring / undercutting before the integrity of the structure is compromised. The first evidence of this will be erosion of the armouring followed by undercutting of bedding material below the last row of baskets. Should this occur, the last few rows of baskets will begin to rotate down into the channel bottom by hinging at their connection points. Left unattended, this situation would gradually worsen until the stability of the fourth structure is jeopardized.

Any gabion baskets affected by corrosion should be patched with the same wire mesh that the gabions are constructed of (i.e. PVC coated galvanized wire mesh) and stapled in place using the same stainless steel SPENAX rings used to assemble the gabions. Baskets that require additional gabion fill material should be opened and topped up with gabion fill that is no smaller than 100 mm in diameter and the lids re-attached with stainless steel SPENAX rings. This maintenance work should be completed before the end of the construction season. Gabion fill material left over from construction is stockpiled on site. The remaining gabion baskets and assembly supplies are stored at Gillespie Equipment Rentals in Dawson City, Yukon. (UMA 2005).

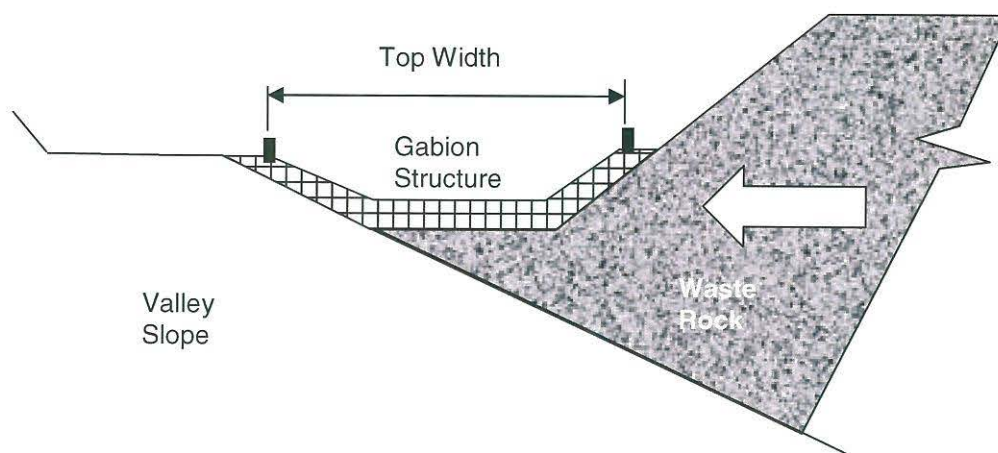
Figure 2-7 Channel Closure Monitoring Points

This is illustrated on Figure 2-7. Comparison of these measurements will determine if the channel closure is related to waste rock movement or independent deformation of the structure. This is important to understand so the long term performance of the stabilization works can be anticipated based on waste rock movement monitoring results. Of concern would be a reduction in hydraulic capacity of the drop structures from settlement or erosion of underlying channel fill and/or closure of the structure due to horizontal waste rock movements. If the capacity is reduced, then some flow events could overtop and by-pass the stabilized portion of the creek channel.

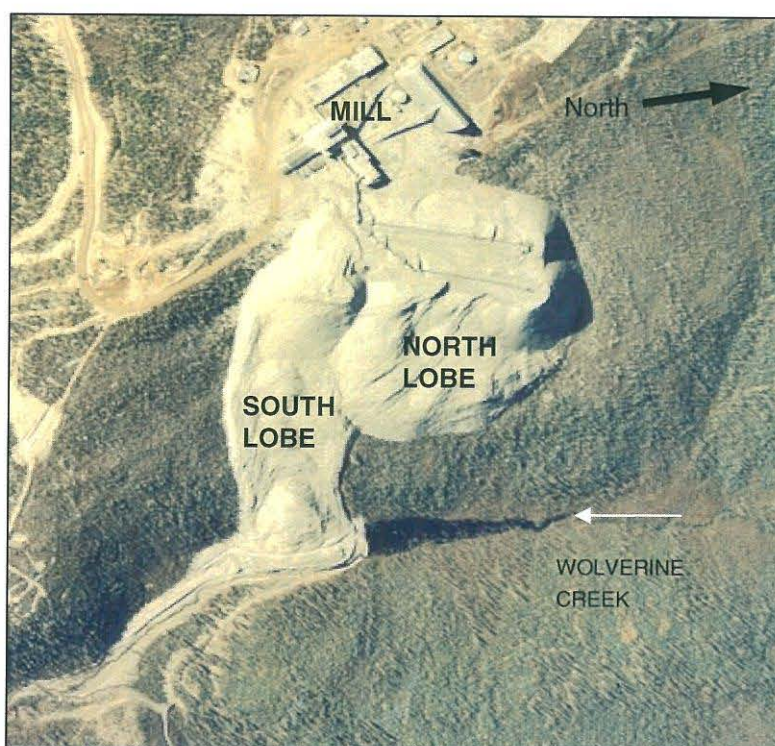
Figure 2-8

Between 1968 and 1974, tailings were deposited on the upper portion of the west slope of Wolverine Creek valley (referred to as the south lobe). In 1974, rapid downslope movement of the south lobe blocked natural flow in Wolverine Creek backing up approximately 9 m of water behind the landslide material (Figure 2-8). In the spring of 1974, a sudden breach of the channel blockage occurred resulting in flash flooding in the Wolverine Creek valley to the confluence with Clinton Creek where the flooding would have quickly attenuated. The eroded tailings were deposited several metres deep in the creek valley directly downstream of the south lobe. Although the majority of the tailings are believed to have been deposited upstream of the mine access road, some of the finer material including asbestos fibres would have entered the Clinton Creek channel and been deposited possibly as far downstream as the Forty Mile River.

Failed South Lobe
(1976)

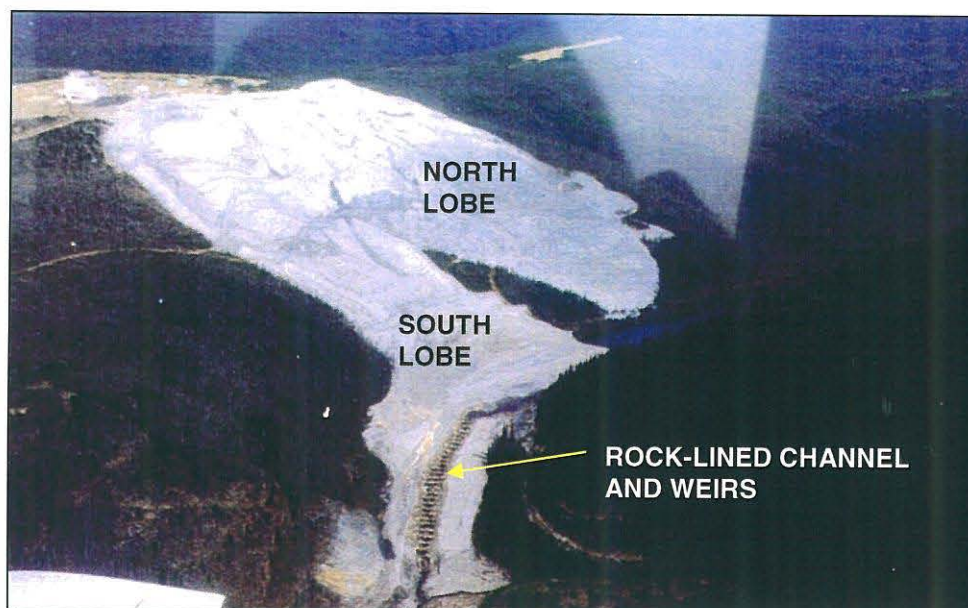
Figure 2-9 Rock-Lined Channel and Weirs (1982)

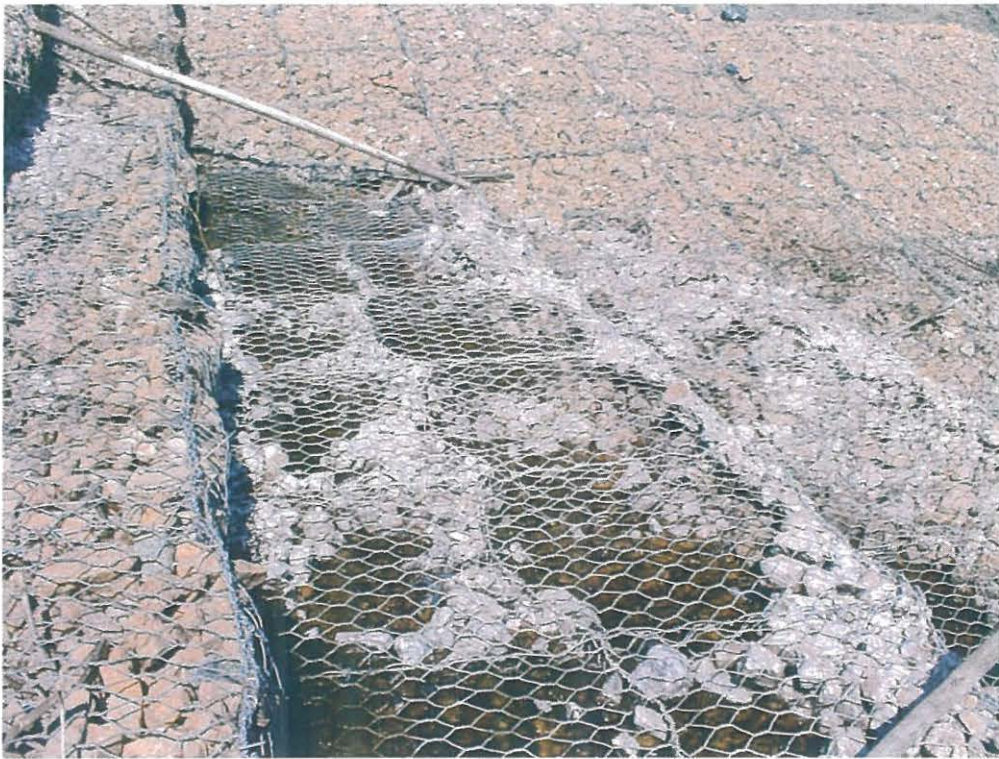
Photograph 1: Erosion of gabion fill from baskets following first spring freshet event

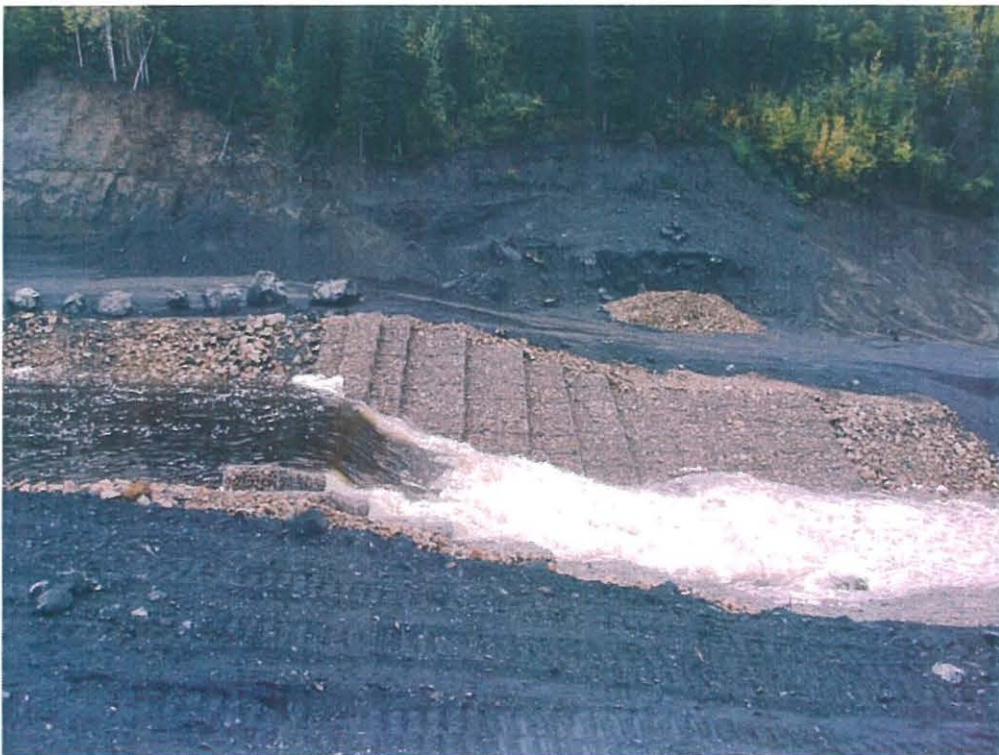
Photograph 2: Turbulence and energy dissipation on lower baskets of each tier.

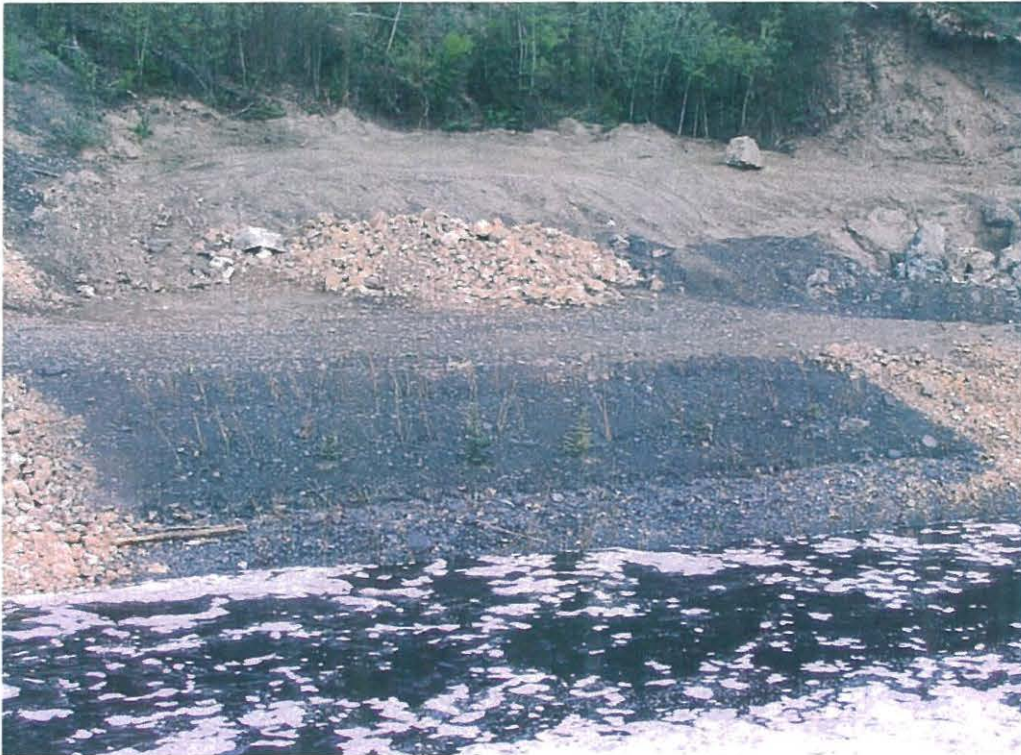
Photograph 3: High water line from spring freshet and vegetation planted on channel slopes.

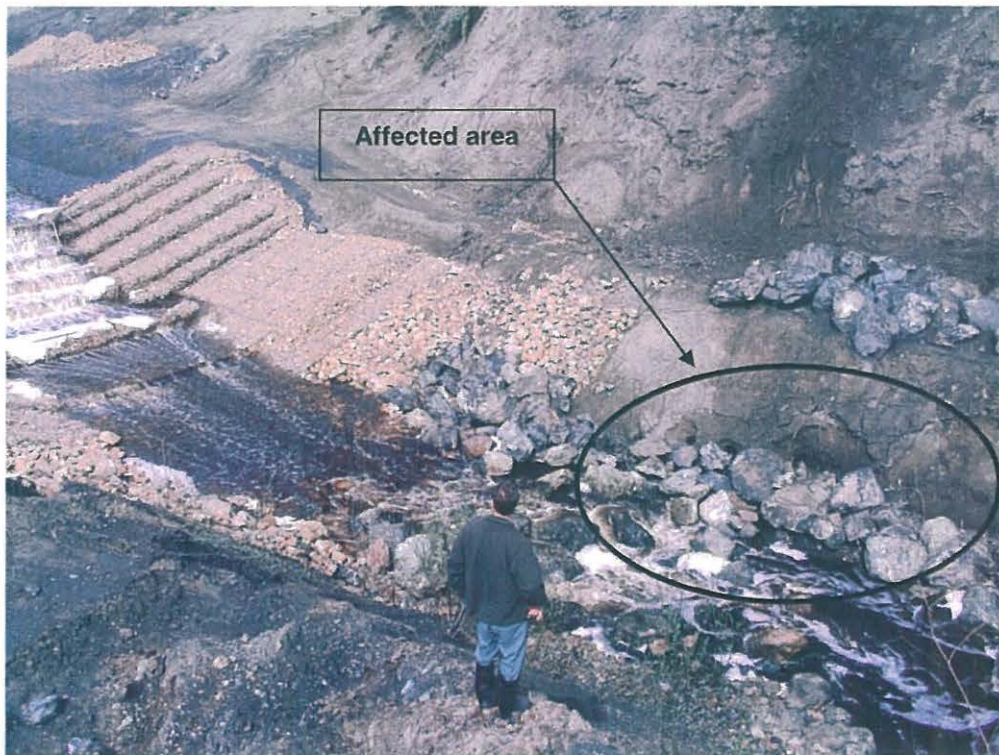
Photograph 4: Erosion on left hand side of the channel transition downstream of Drop Structure 4.

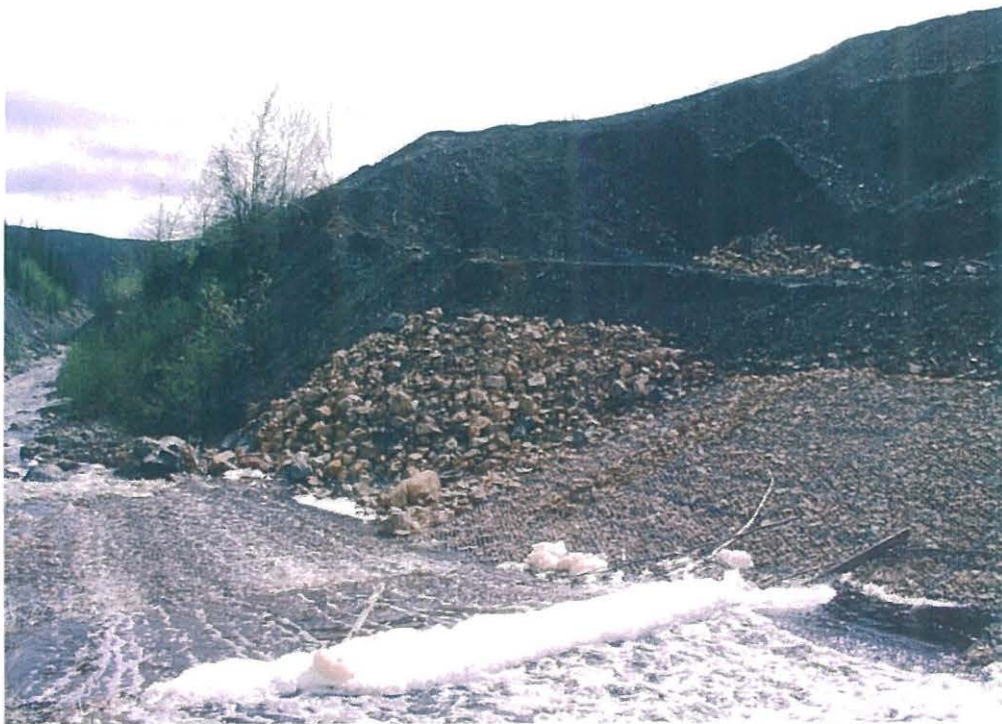
Photograph 5: Minimal erosion on right hand side of the channel transition downstream of Drop Structure 4.

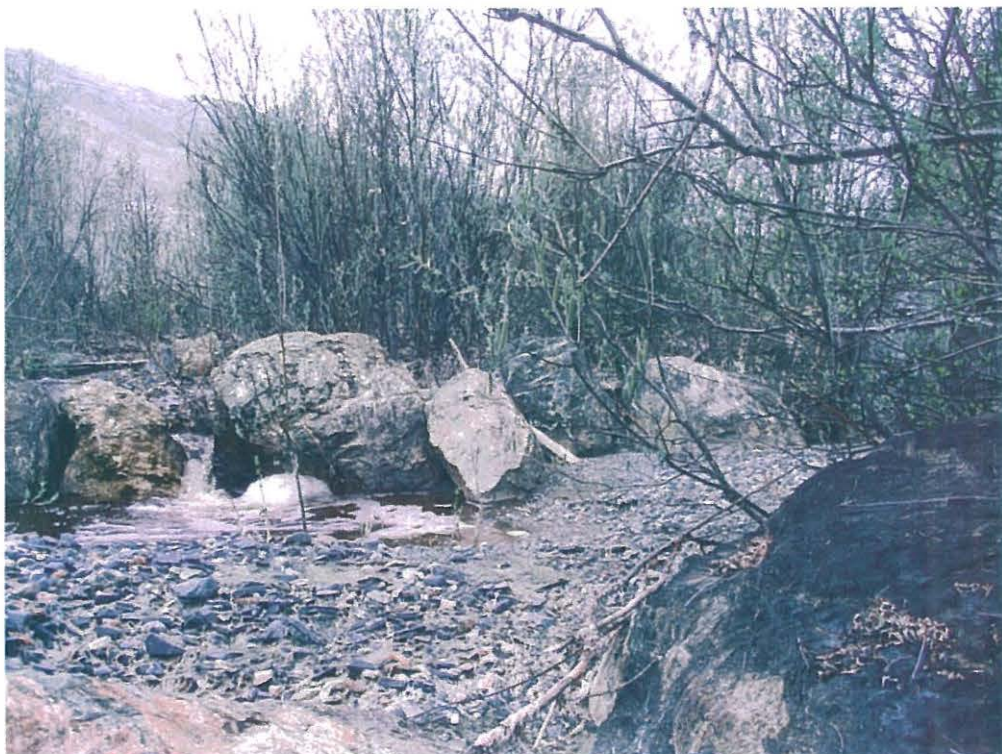
Photograph 6: Wolverine Creek - Rock lined channel: trees growing in channel and some sedimentation occurring.

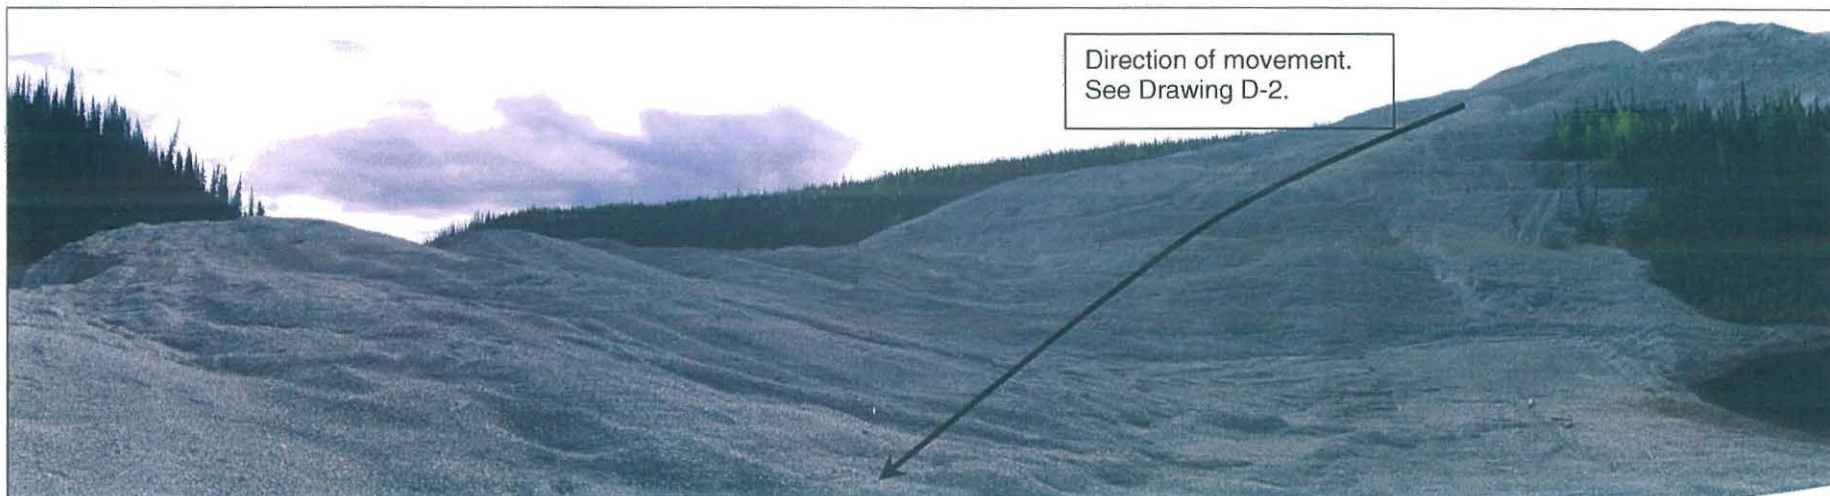
Photograph 7: South Lobe of tailings pile taken facing south from the north end of the lower slope near Wolverine Creek.
