Memorandum

Date: October 14, 2003

Re: **Galkeno 300 Flow Redirection Construction Memo**

The purpose of this memo is to report on the recently completed construction of Galkeno 300 flow redirection project. Ongoing monitoring and inspection is also described in this memo.

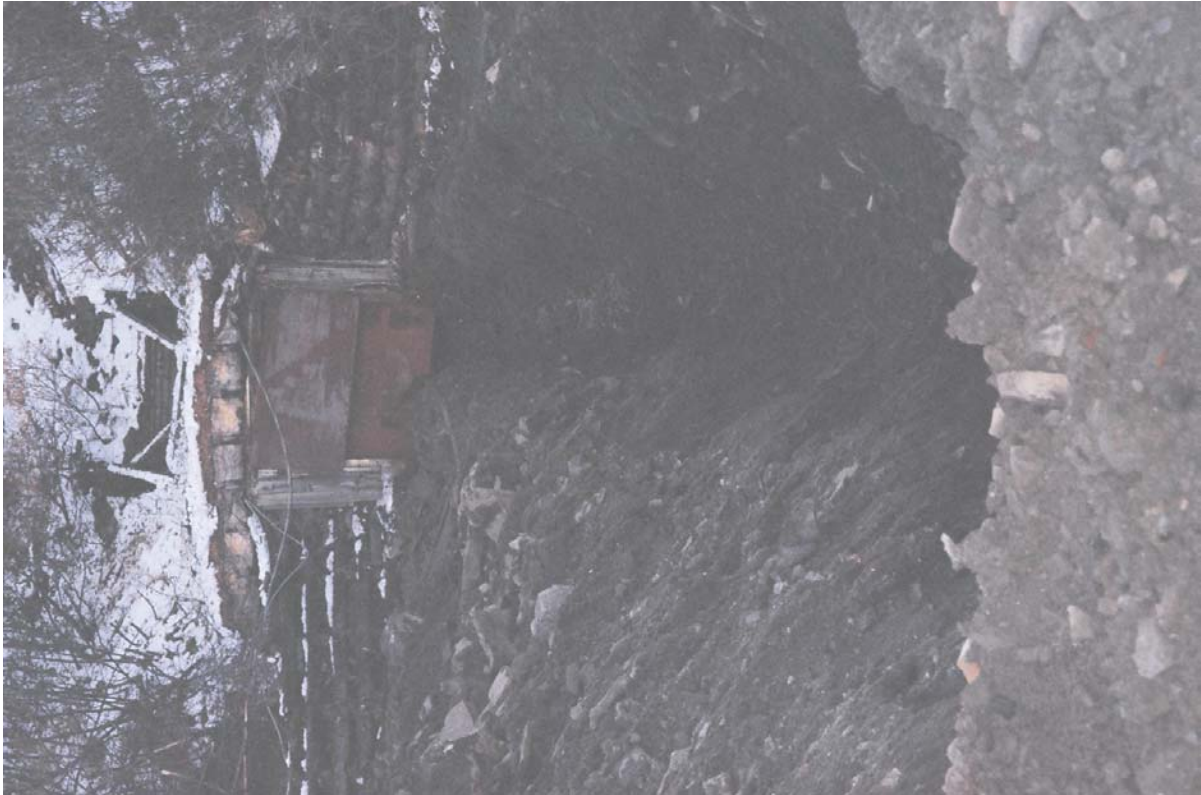
Plate 1: Galkeno 300 Adit – upper end of pipe install trench

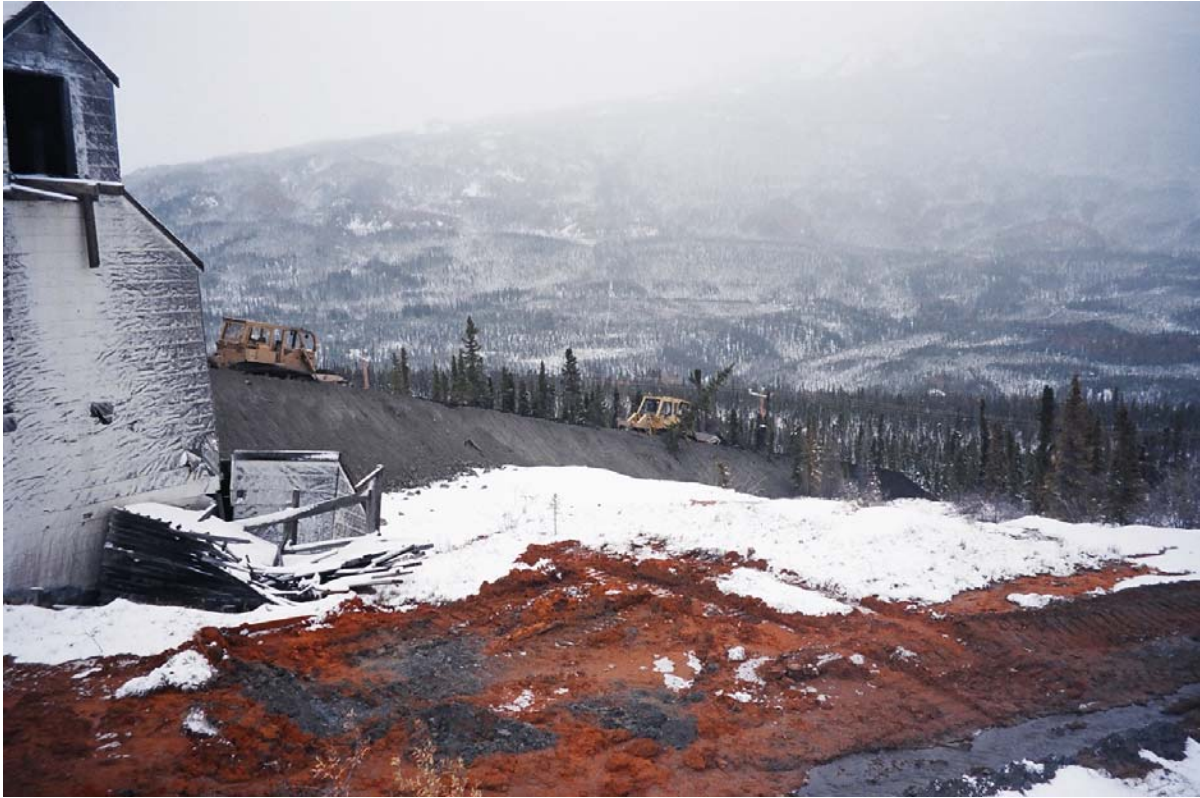
Plate 2: Construction of pipe “road”, looking towards power line past old Load out Facility, adit discharge staining in foreground

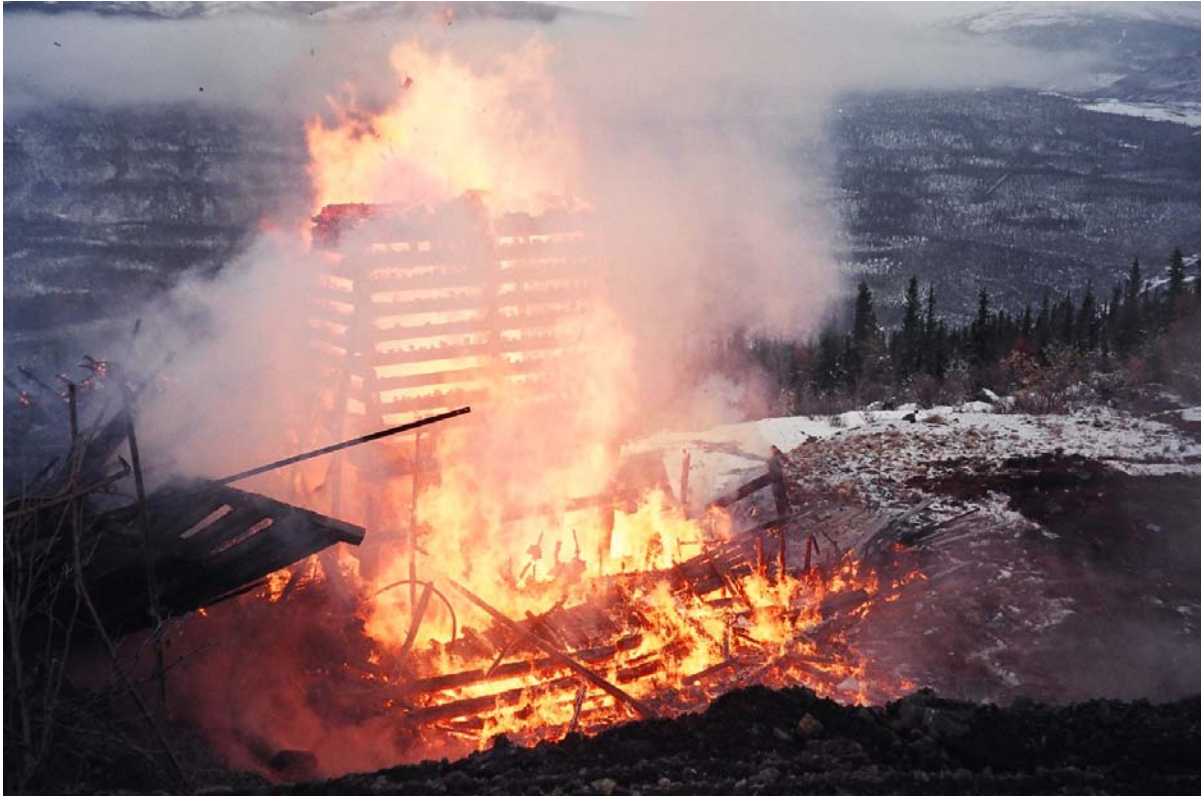
The bypass channel was excavated for a distance of approximately 15 metres, to the edge of the bank. From this point, redirected flow would occupy exactly the same path that it has taken since discharge from the adit began. The surrounding site was graded, and two old buildings that were deemed by Yukon Government to be safety hazards, were ordered burned. Please see photographs at the end of this memo, for some of the construction methods.

Plate 4: Removal of dangerous building (old load out facility) by burning

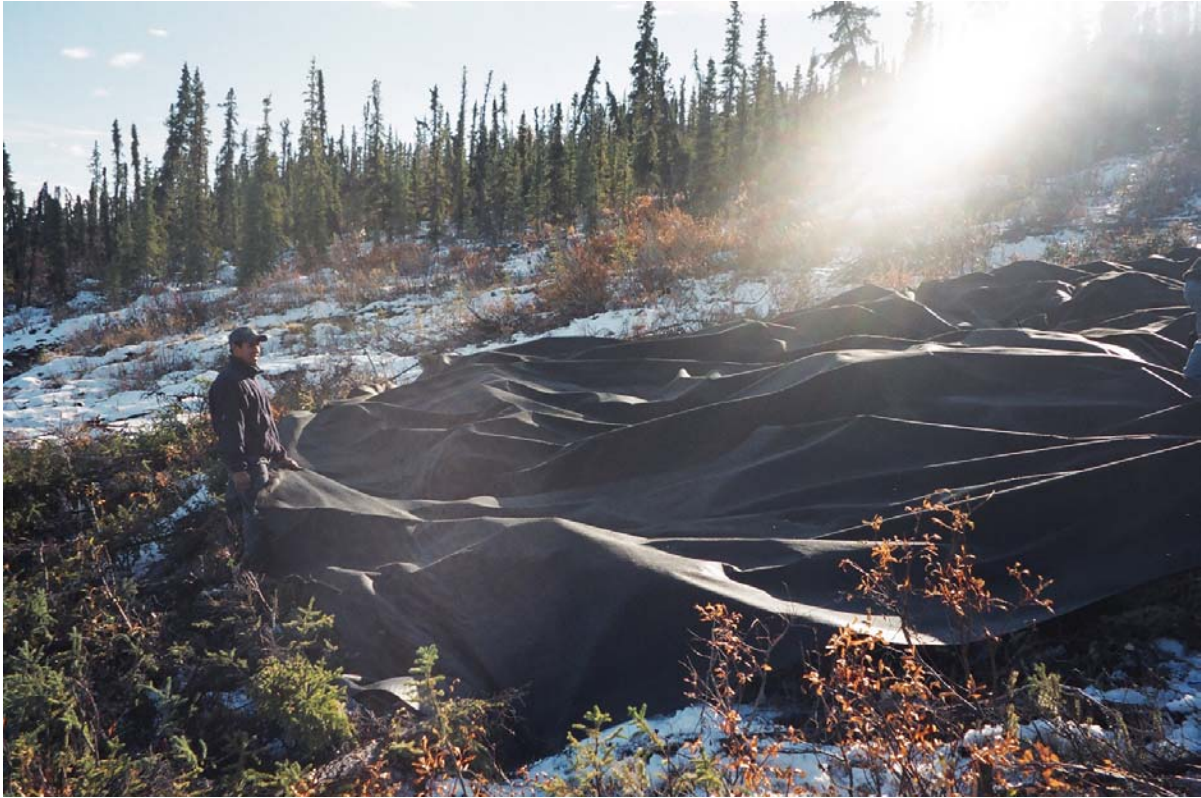
The terminus of the pipeline was embedded in an approximately 4 meter x 4 meter pad built of coarse (greater than 300 mm, some to 900 mm) riprap rock (mine waste from the Sime pits waste dumps), underlain by geotextile cloth, placed over original, undisturbed ground, as an energy dispersion mechanism. Plates # 5, 6, and 7 show the construction of this pad.

Plate 5: Installation of geotextile blanket over ground at pipe terminus location

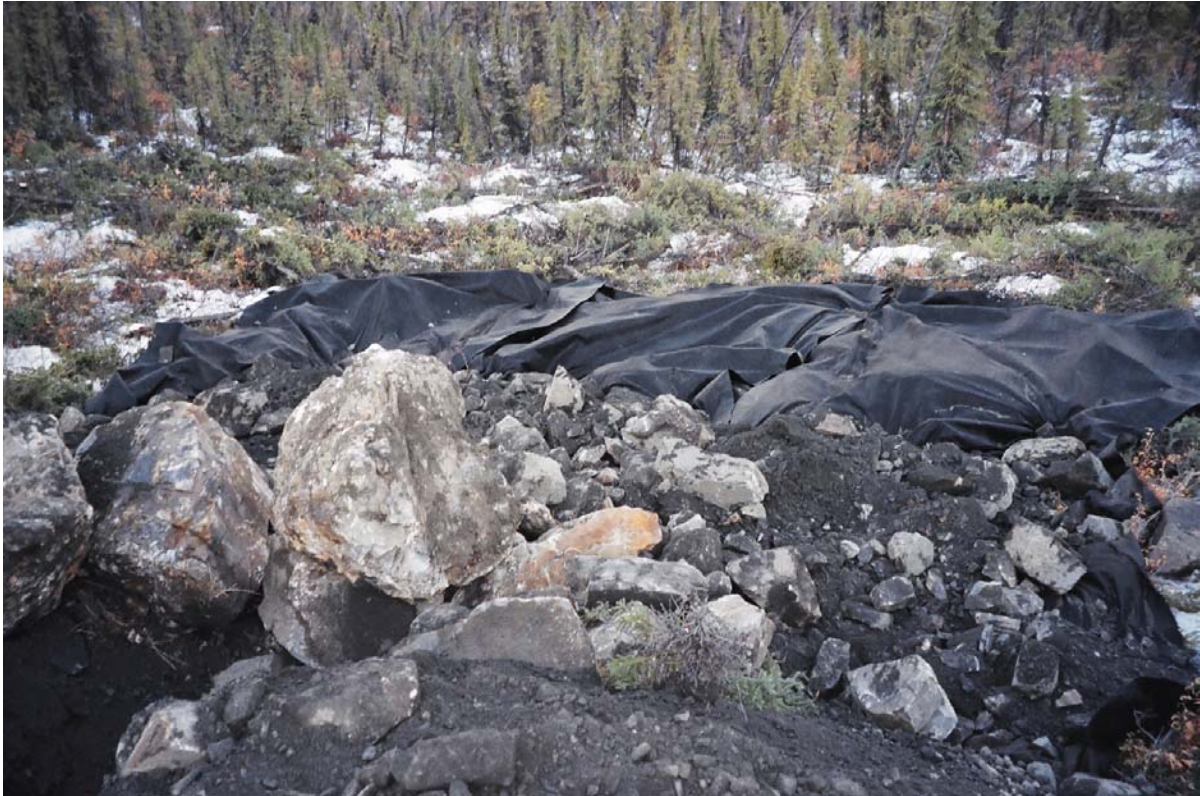
Plate 6: Showing placement of riprap on top of geotextile at pipe terminus, for energy dissipation.

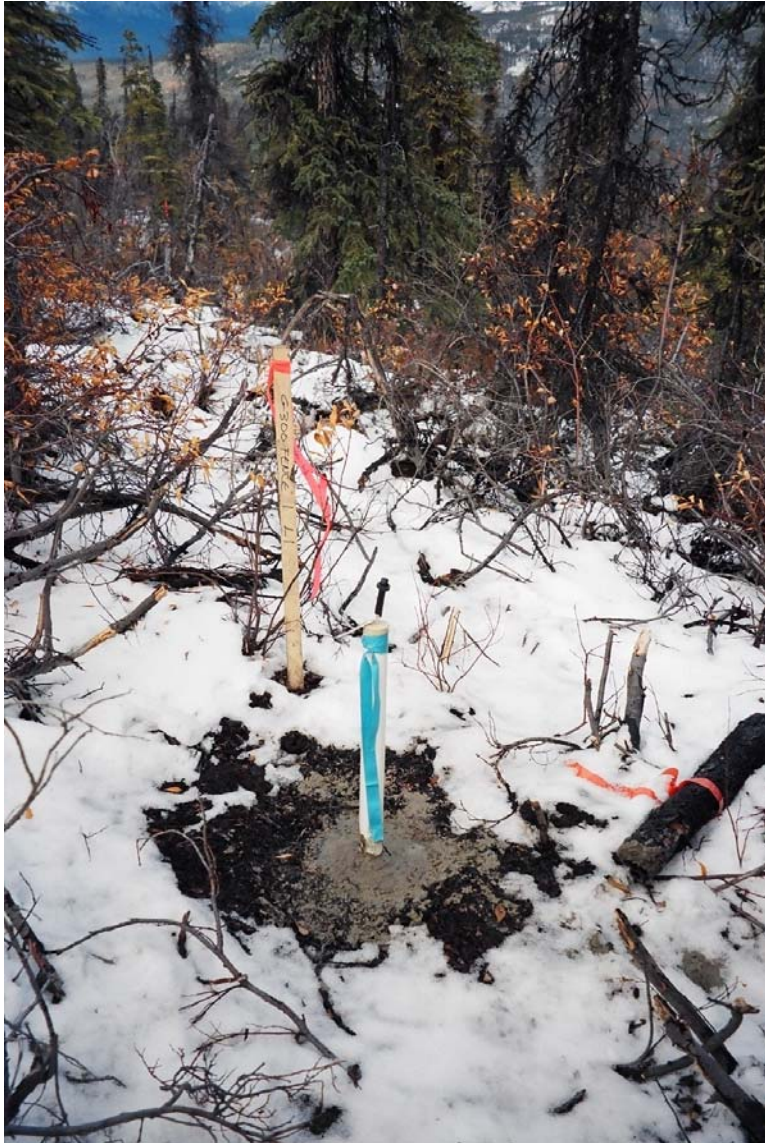
At fence 1, approximately 60 meters from the discharge, three lysimeters were installed that enable the sampling of the soil pore water. In between the lysimeters, two drive-point piezometers were installed, which allow the sampling of ground water. In addition to the water sampling at Fence 1, soil samples were taken at each of the lysimeter locations. Once the flow has been established on the ground, surface water samples will be taken where there is evidence of flow.

Plate 8: Typical Lysimeter installation

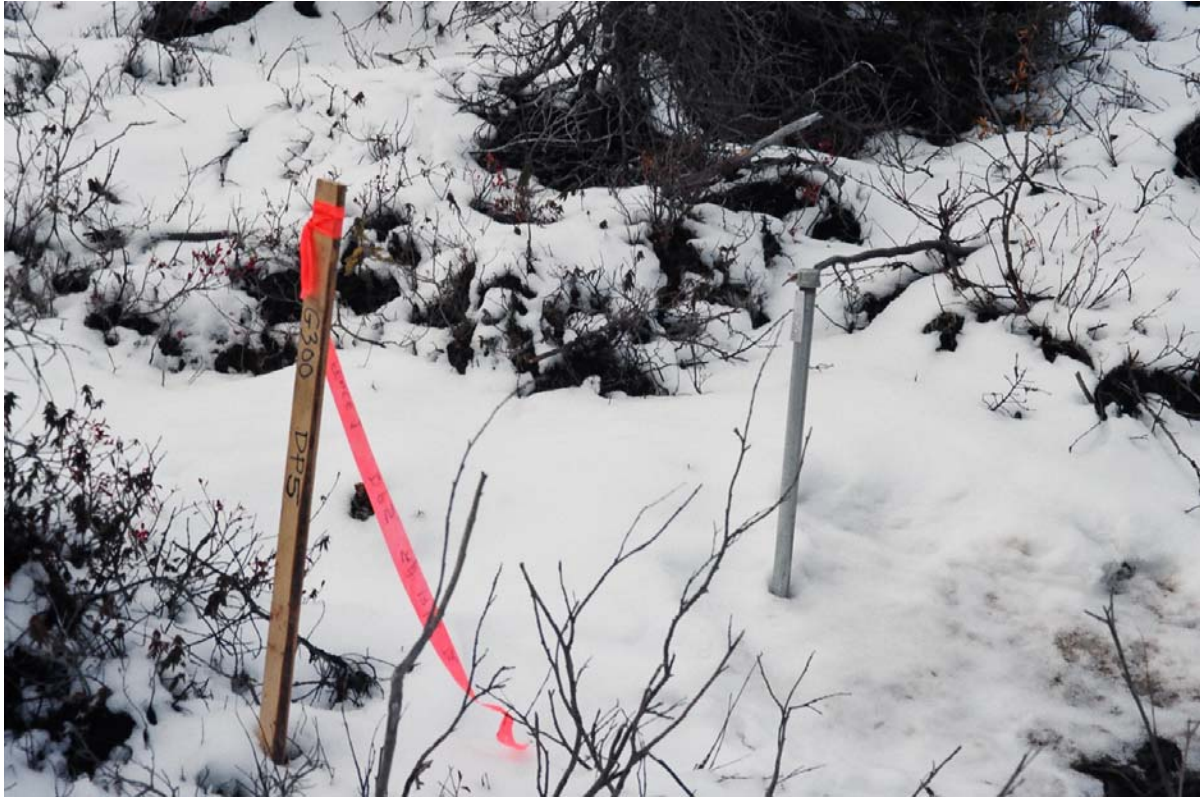
Plate 9: Typical Drive point Installation at Galkeno 300

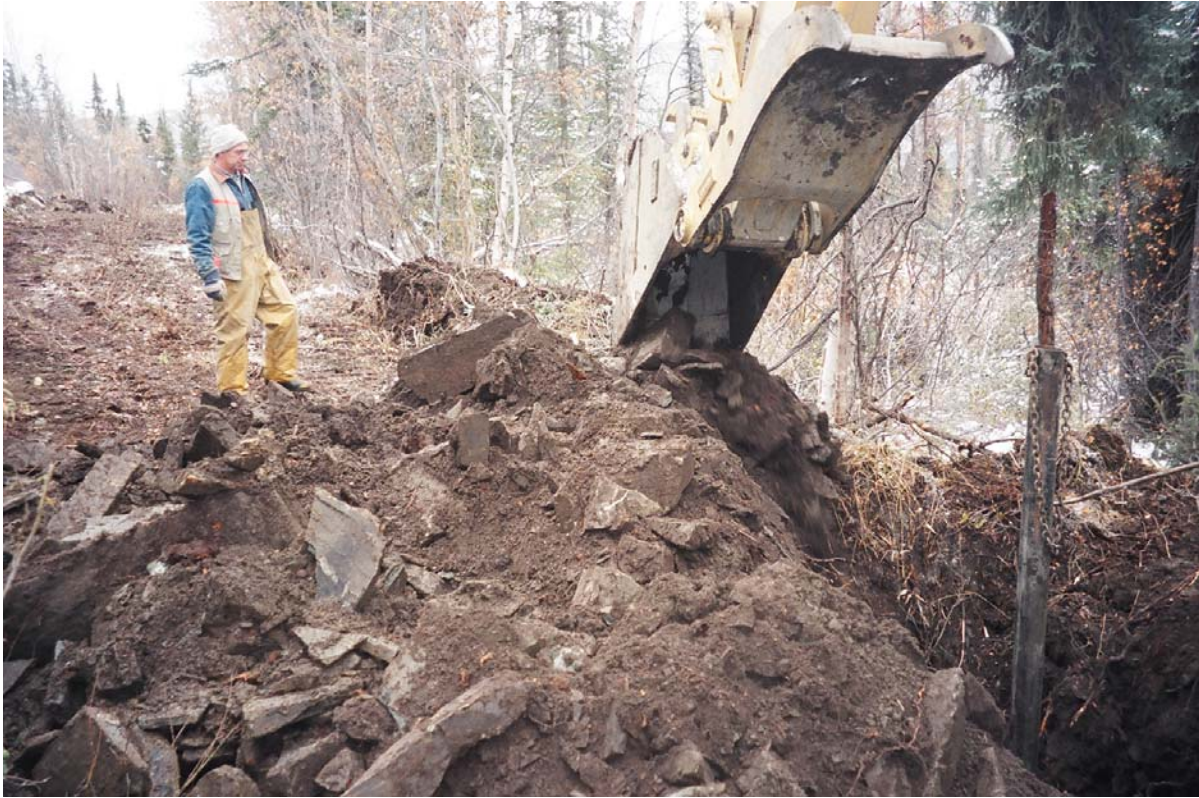
Fence three sample points are all located on the old haul road roughly 600-650 meters from the discharge. 7 standpipe piezometers were installed monitoring ground water quality. Surface water samples will be taken along the haul road once there is evidence of flow.

Plate 10: Typical Piezometer installation on old haul road below Galkeno 300; note use of steel protection pipe for installation in coarse rocky ground
