Geotechnical Evaluation Grum Sulphide Cell Cover Erosion Control Measures Faro Mine Complex, Yukon - 2011

Prepared For: Boreal Engineering Ltd.

Date : June 6, 2011

File No: 100-002-11

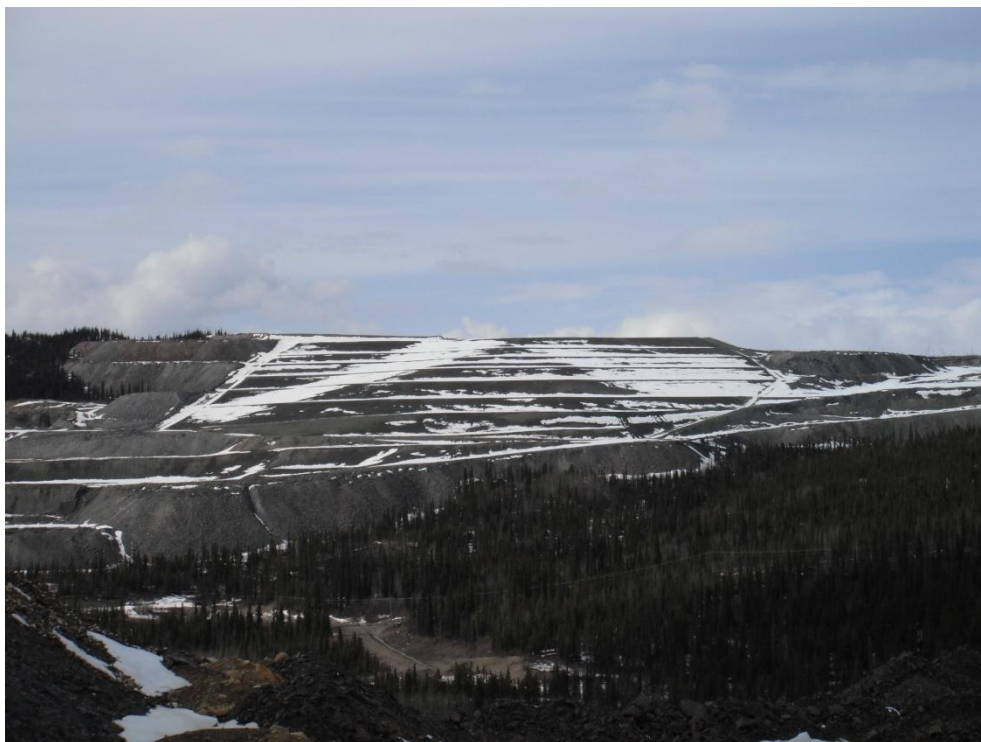
1 - May 10, 2011 – Site Conditions as viewed from the Van Gorda Tailings piles

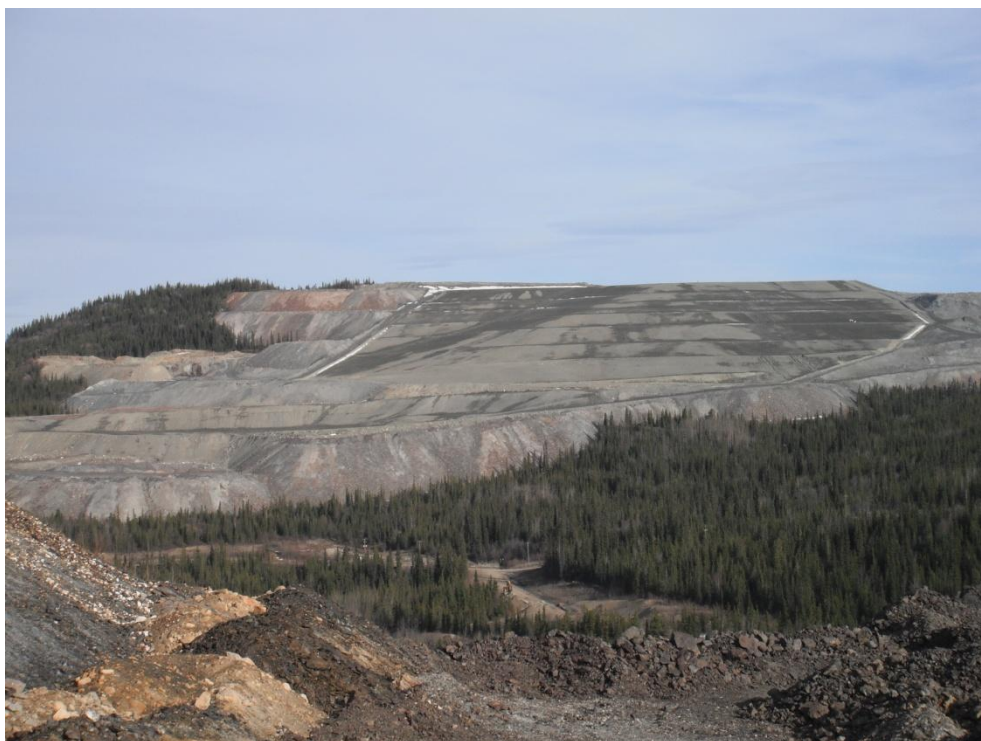
2 - May 20, 2011 – Cell conditions.

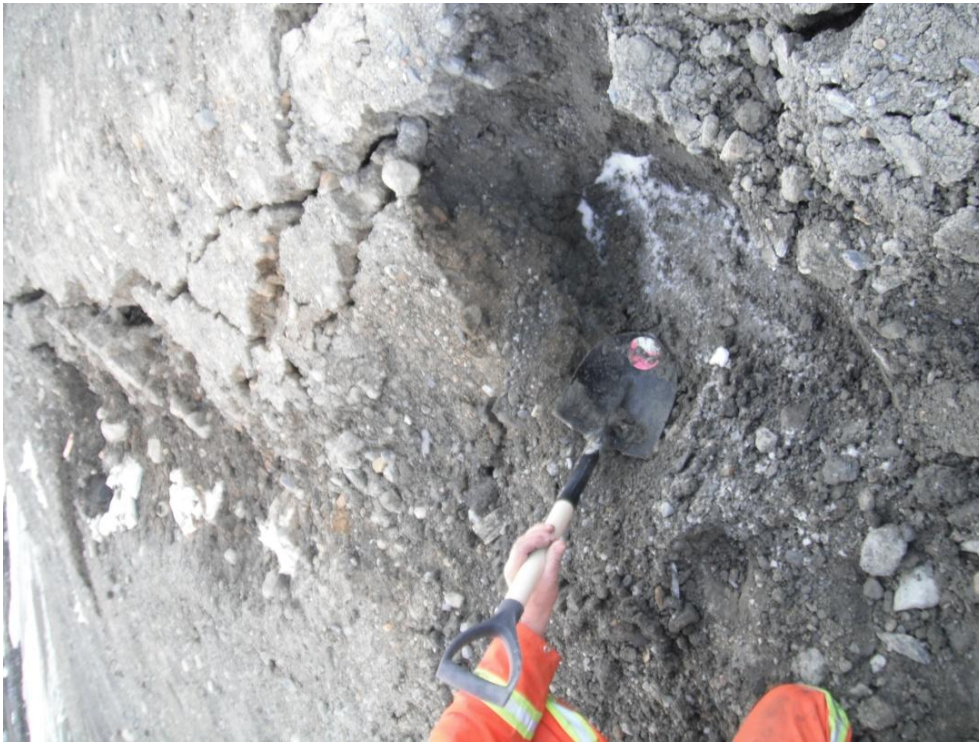
Several test-pits were hand excavated near the crest of the toe berm immediately above the as-built liner depth on May 10, 2011. While the liner was not encountered during the exploratory work, sand-bags (which were known to weigh down the liner during installation) were encountered along with buried snow and ice. The presence of deleterious (snow & ice) materials entrained within the backfilled materials was cause for concern. Thaw of the deleterious (snow/ice and frozen) material was likely the cause of zones of subsidence (which were observed as (approximately 1 by 4 meter) linear features oriented parallel to the crests of several benches) and general loss of local design continuity.

3 - May10, 2011 – Toe Berm conditions near liner elevation. Note buried snow.

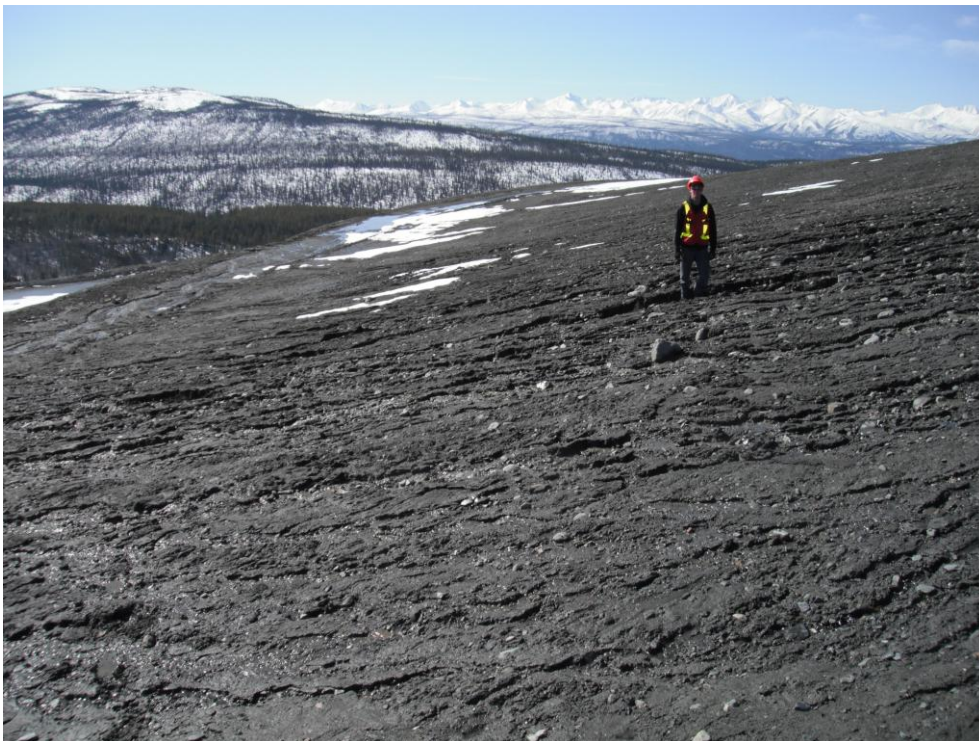
4 - May 16, 2011 – Erosion rills on cell cover below east side of bench 5.

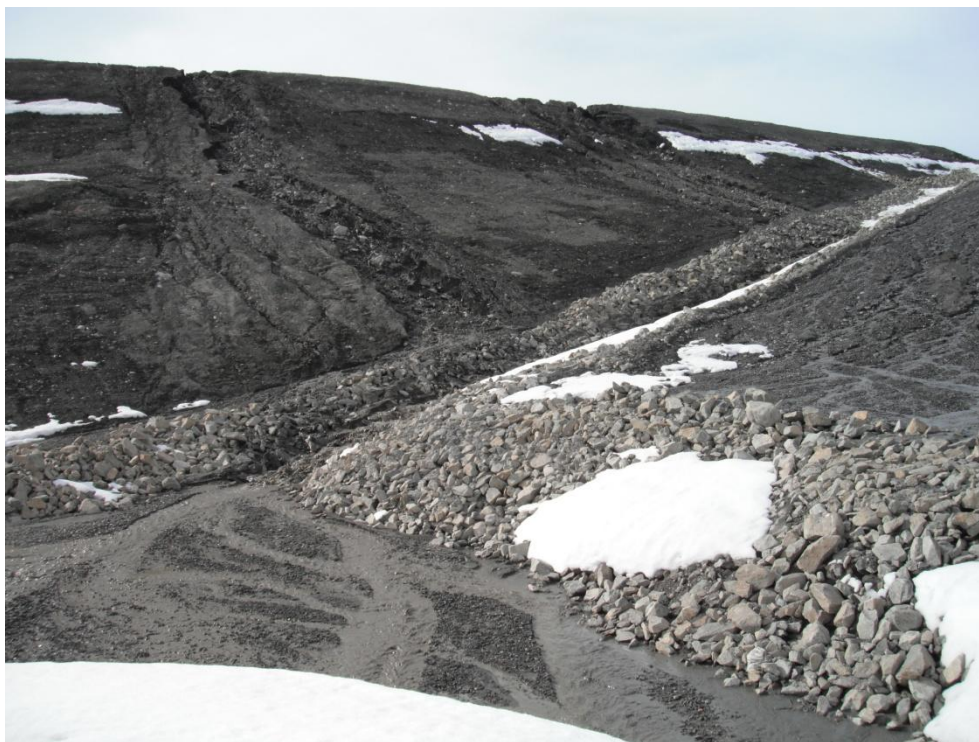
relative to the peak toe berm height in either direction. The presence of this low area essentially concentrated all the surface waters on the east side of the cell onto the face of the toe berm. This flow resulted in the formation of the erosion gully's. While onsite, the gully's were noted to incise approximately 2 meters in from the crest of the toe berm bench and create chasms which measured in the order of 2 meters deep.

5 - May 16, 2011 – Toe Berm conditions. Note sediment and erosion gullies.

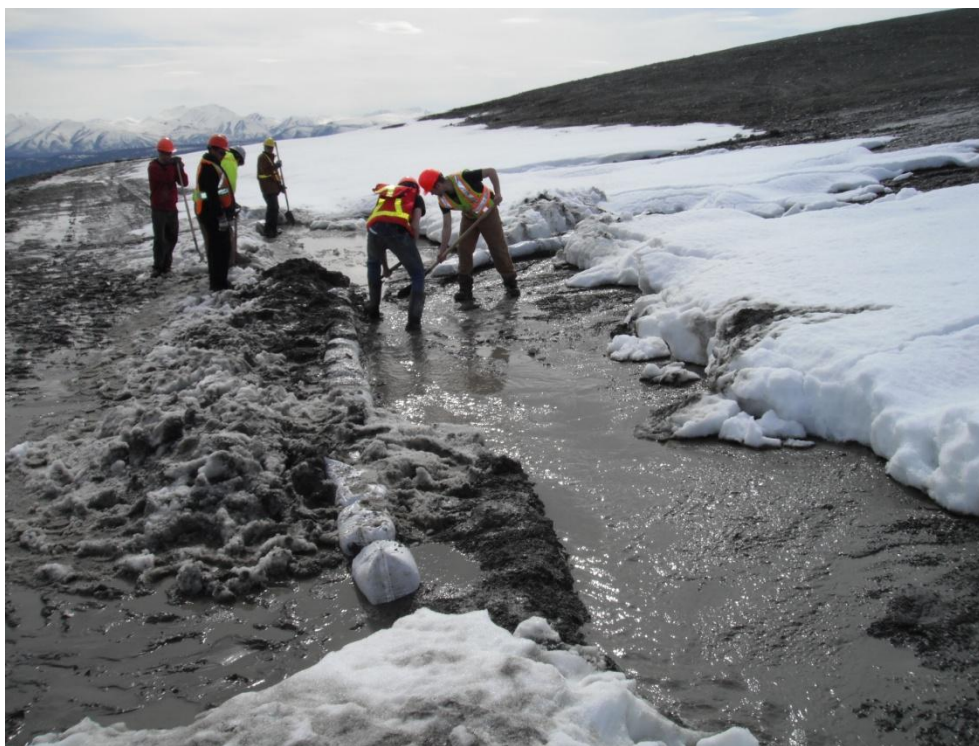
6 - May 16, 2011 – Bench 5 ~ Station 0 + 080 Sand-bagging to redirect overflow.

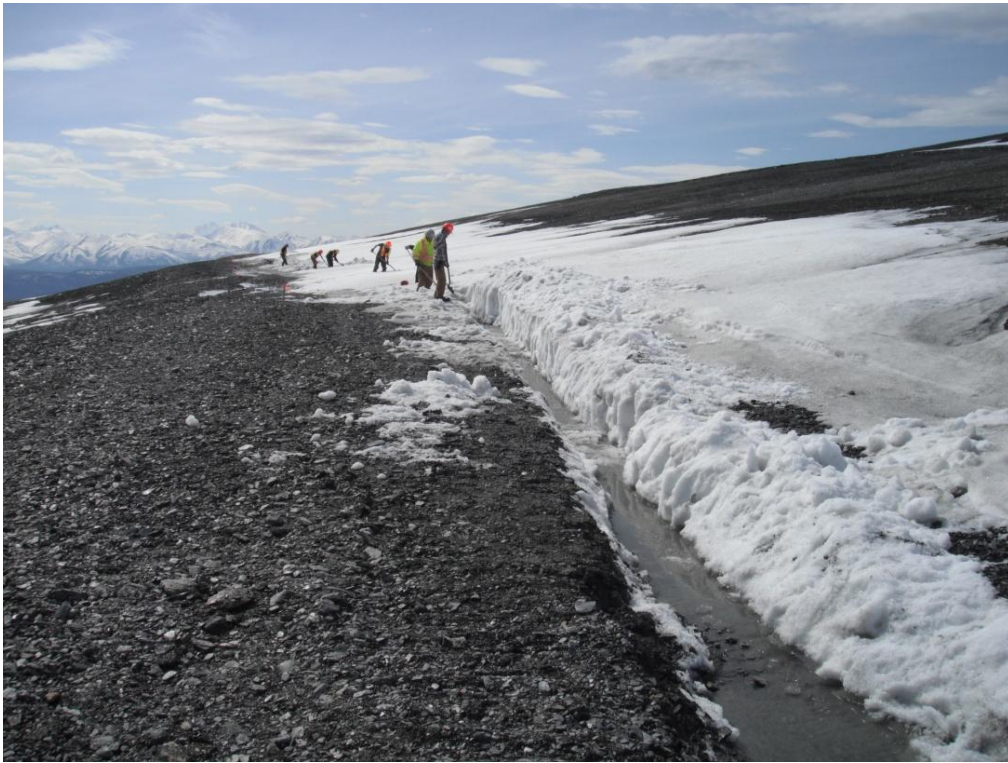
7 May 17, 2011 – Hand excavation of east side of Bench 4 ditch.

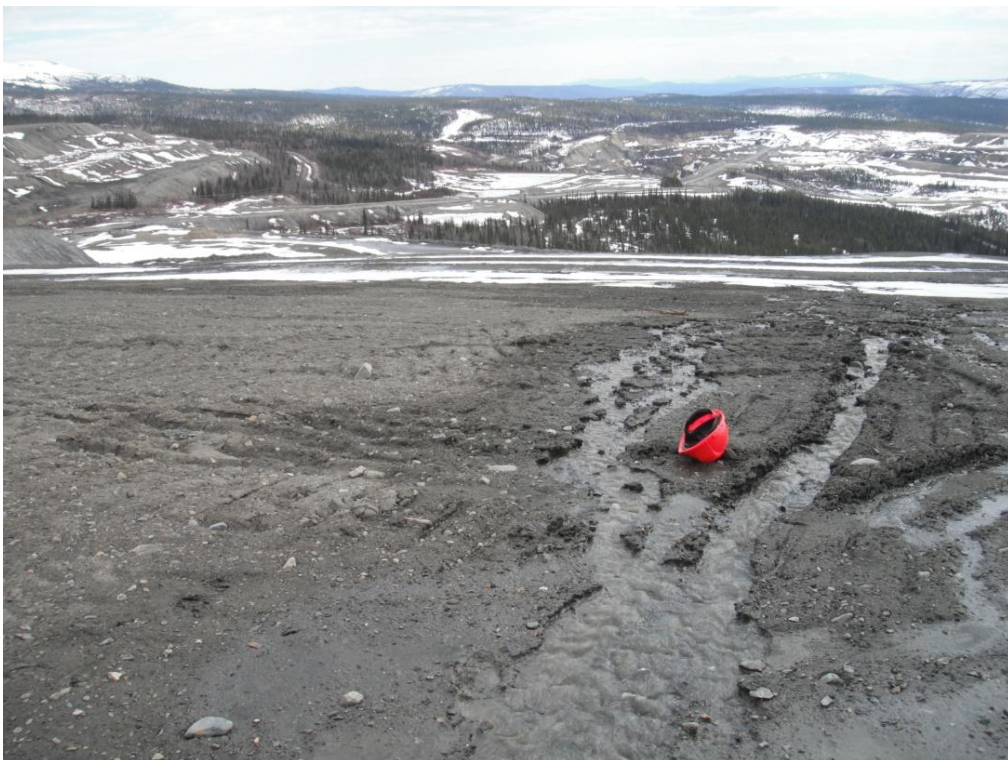
8 - May 17, 2011 – Up-slope (beyond elev. 1300) conditions.

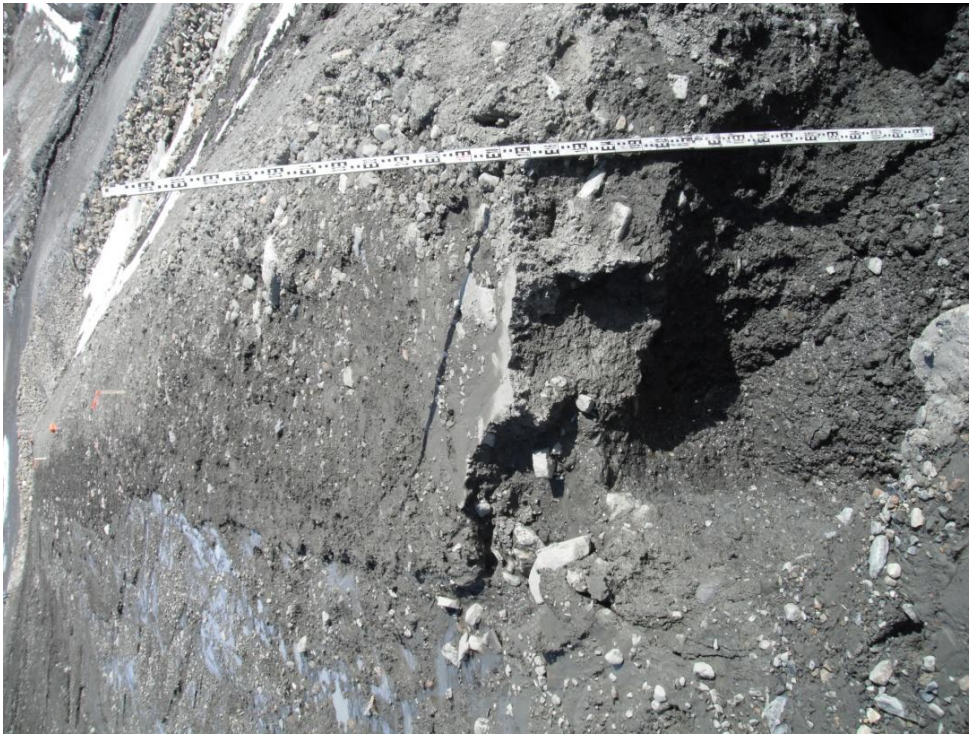
9 - May 17, 2011 – Erosion gully at Toe Berm Crest ~ Station 0 + 080.

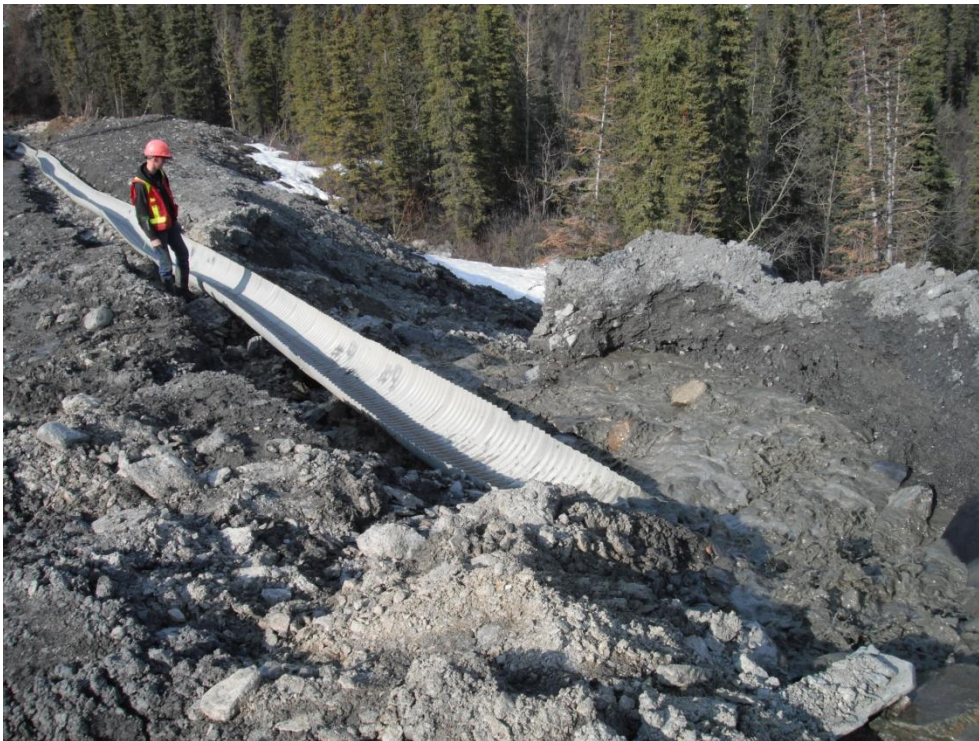
Upon inspection of the 600 mm half culvert outflow flue, the noted conditions were considered poor. Specifically, undermining of the outflow flue was occurring. The undermining appeared to have been ongoing for some time and was in our opinion likely due to a combination of;

Undermining of the outflow flue appeared to be ongoing since our initial investigation of May 10 & 11. The erosion gully (which formed on the eastern side of the adjacent slope descending to the Grum Creek area), was noted to have increased in size. While this increased the sediment load of the surface waters discharging from the cell cap, the oversized composition of the slope material resulted in (what appeared to be) essentially self-armoring slope conditions. The geotechnical durability and long-term environmental ramifications of the conditions should be assessed by qualified personnel.

10 - May 18, 2011 – Outflow flue conditions.

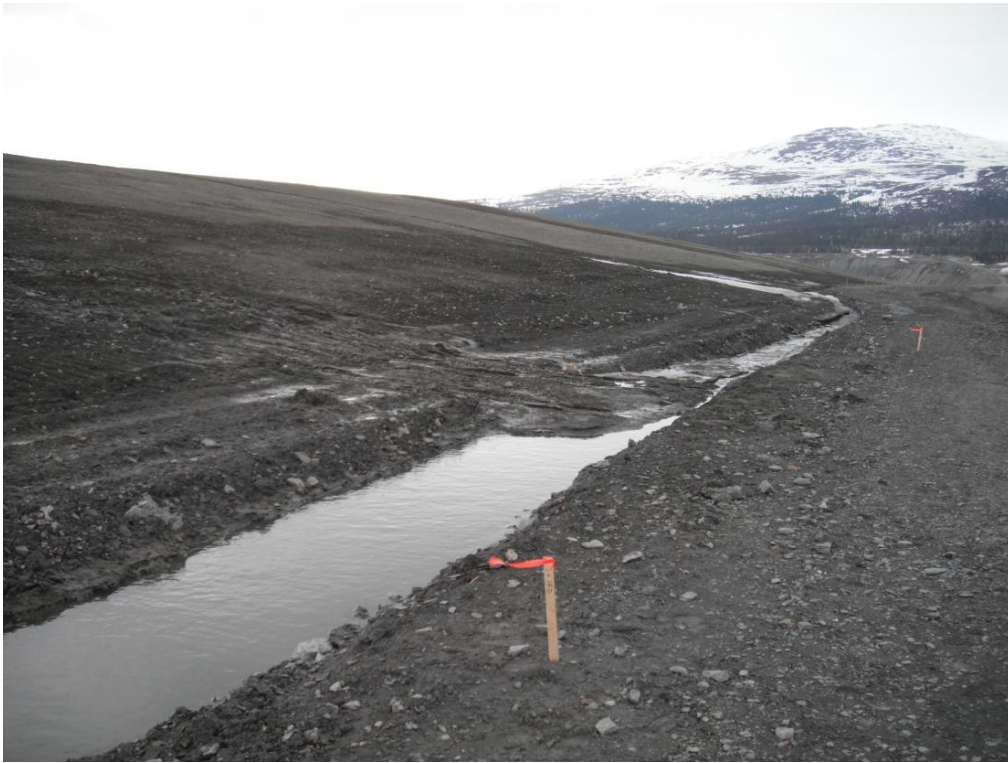
11 - May 19, 2011 – Sedimentation of bench ditch. Bench 1 + 180 facing east.

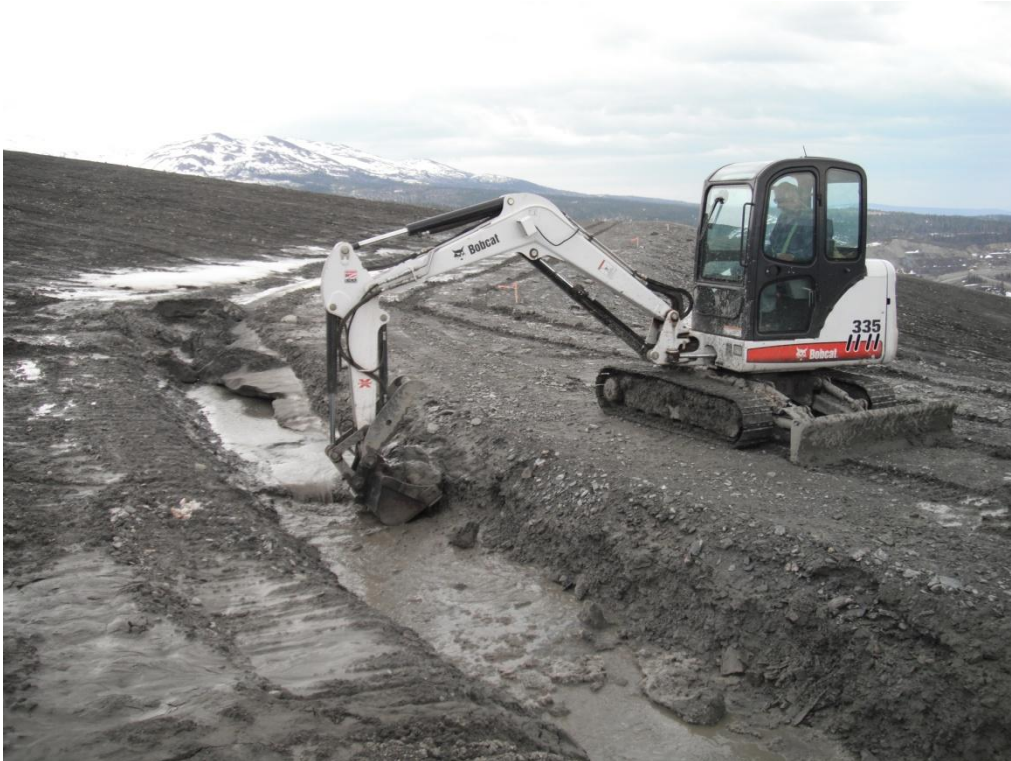
12 - May 19, 2011 – Excavating ditch sediment from Bench 4 ditch.

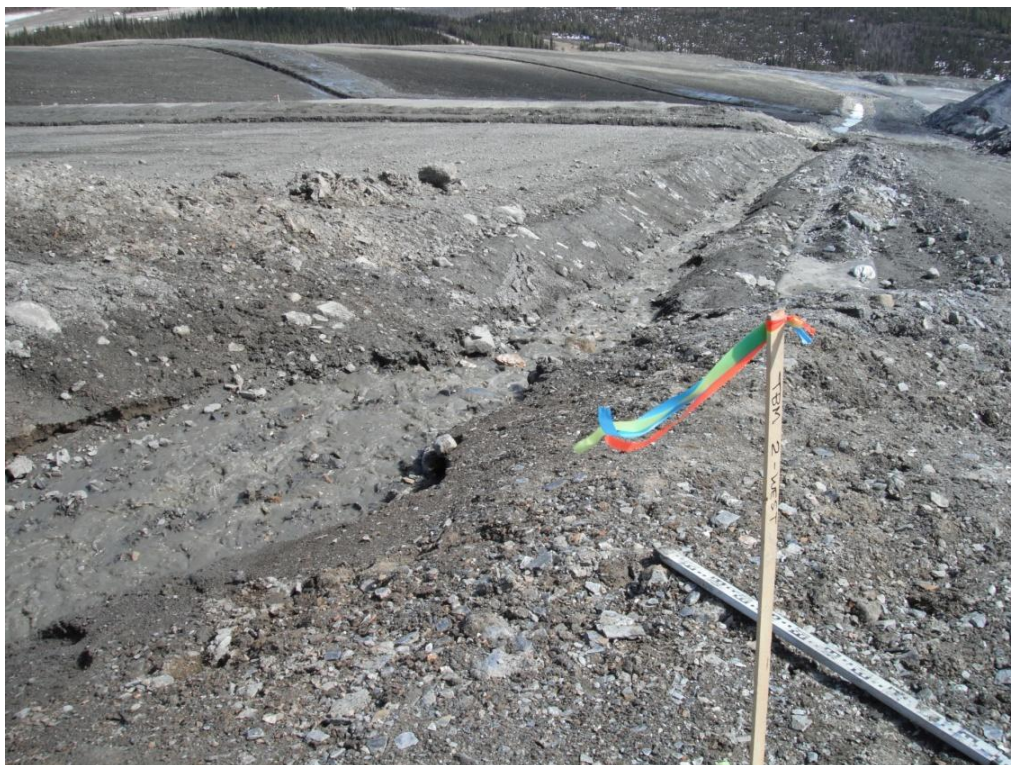
13 - May 21, 2011 – Bench 2 west side facing down slope. Note incising of ditch.

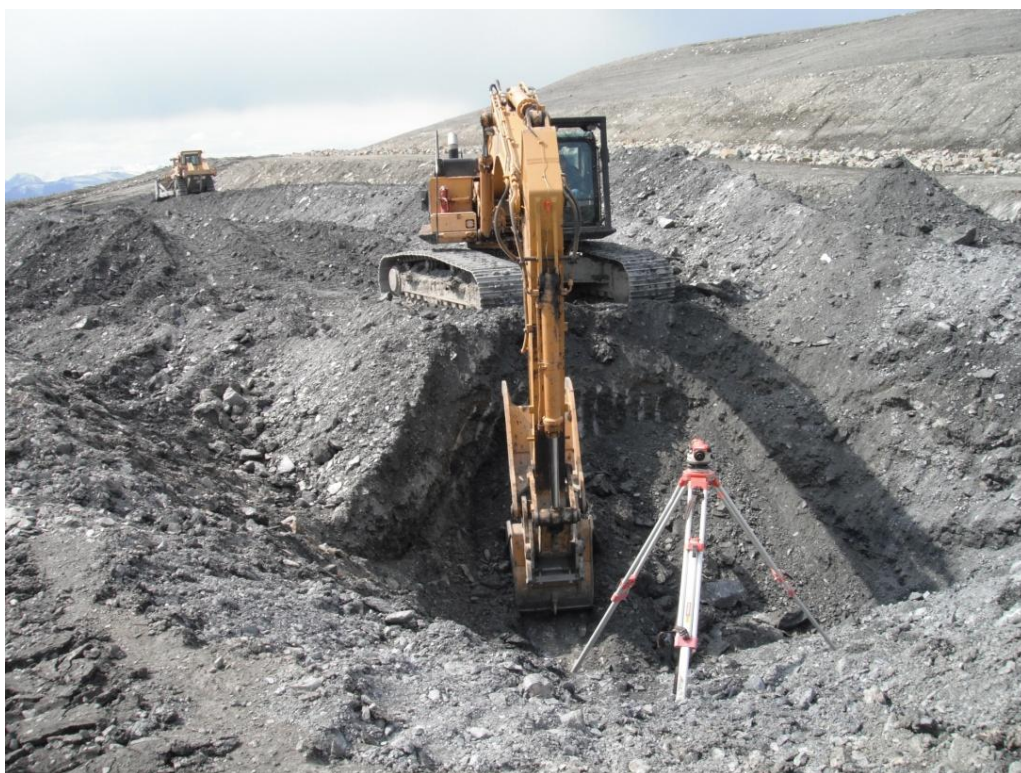
14 - May 21, 2011 – Excavation of emergency storm water management pond.
