# Hazardous Material Supplementary Investigation Faro Mine Remediation Project

PREPARED FOR: Government of Yukon  
PREPARED BY: CH2M HILL Canada Limited  
DATE: December 17, 2013  
PROJECT NUMBER: 472645.09.W1

This technical memorandum summarizes observations noted during a supplementary investigation of hazardous materials (HAZMAT) from various locations at the Faro Mine Complex (FMC) on Wednesday, October 2, 2013. Please refer to the location plans in Attachment A for the hazardous material storage locations.

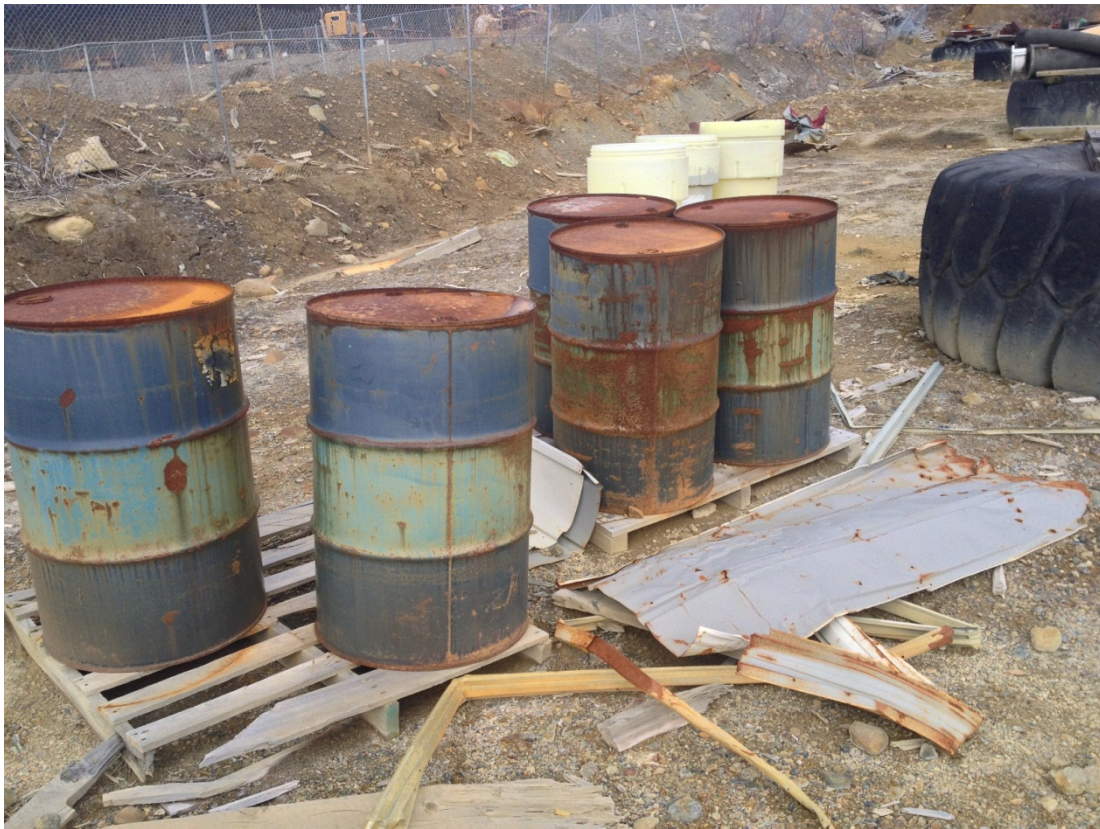
PHOTOGRAPH 1  
**Methanol Drums in Active Storage Yard**

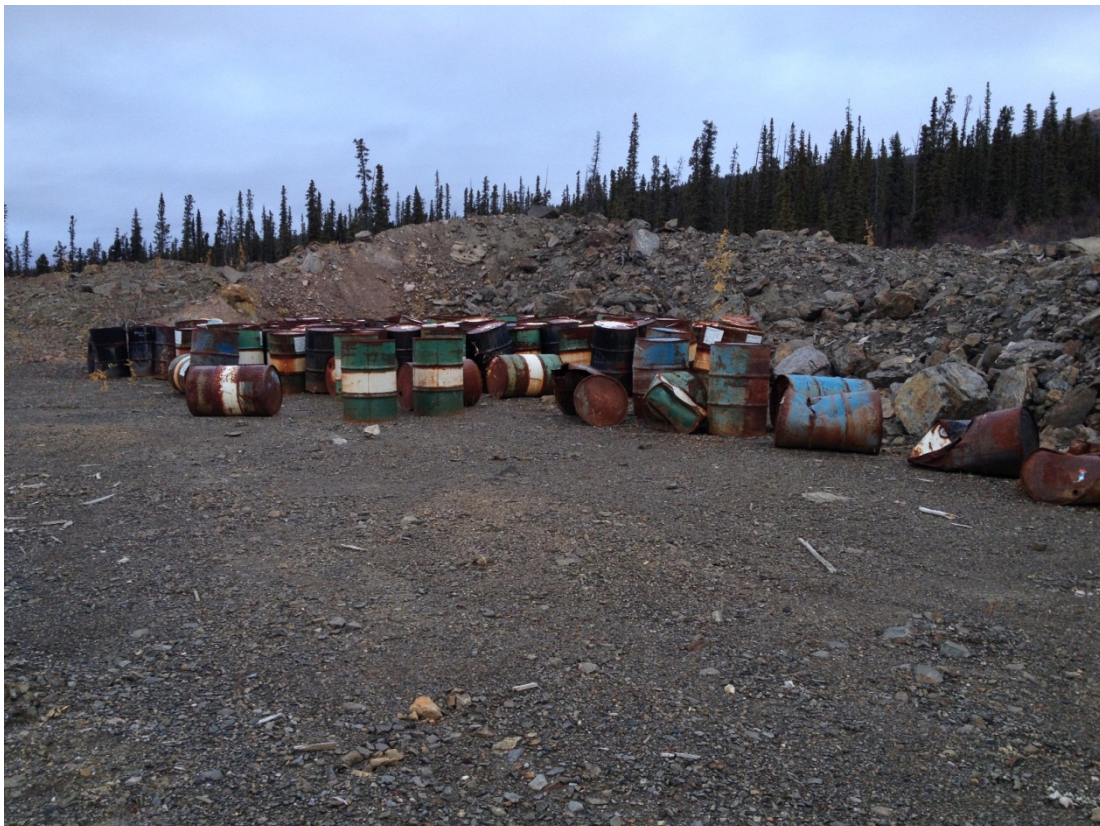
Location	Expected Contents	Estimated Quantity	General Properties	Conditions Observed	Recommended Interim Risk Mitigation Measures
North Drum Dump	MIBC and Water <sup>a</sup> pH of contents varies between 2.80 and 5.40 <sup>a</sup>	~100 – 205-L drums (mostly steel, some plastic)	MIBC is regulated as a Dangerous Good under The Transportation of Dangerous Goods Regulation (SOR/2012-245) in Schedule 1 as a Class 3 flammable liquid (PIN UN2053).  Waste materials containing MIBC in appreciable concentrations are expected to exhibit similar properties; as such, should be deemed Special Waste under the Yukon Environment Act Special Waste Regulations (O.I.C. 1995/047).  MIBC is moderately volatile and moderately soluble in water.  MIBC is highly mobile in soil, but is not expected to adsorb to sediments or particulate matter in water. It has a predicted half life of 10.6 days in a model pond environment.	Drums are placed in direct contact with waste rock.  Drum labels are not clearly visible.  Drums contain varying levels of material.  Some drums are open (bungs missing).  Some drums are displaying significant deformation because the contained product has frozen.  The ground surface is visibly stained in some areas.	Include location and warning to avoid storage area in facility orientation information.  Place snow fencing around the open face of the barrel storage area to mitigate unauthorized access.  Post signs indicating a hazardous waste storage area, at the entrance to the barrel storage area.  Inspect the area on a biweekly basis and immediately after rainfall events until final disposal occurs.

PHOTOGRAPH 2  
**Methyl Isobutyl Carbinol (MIBC) Drums**

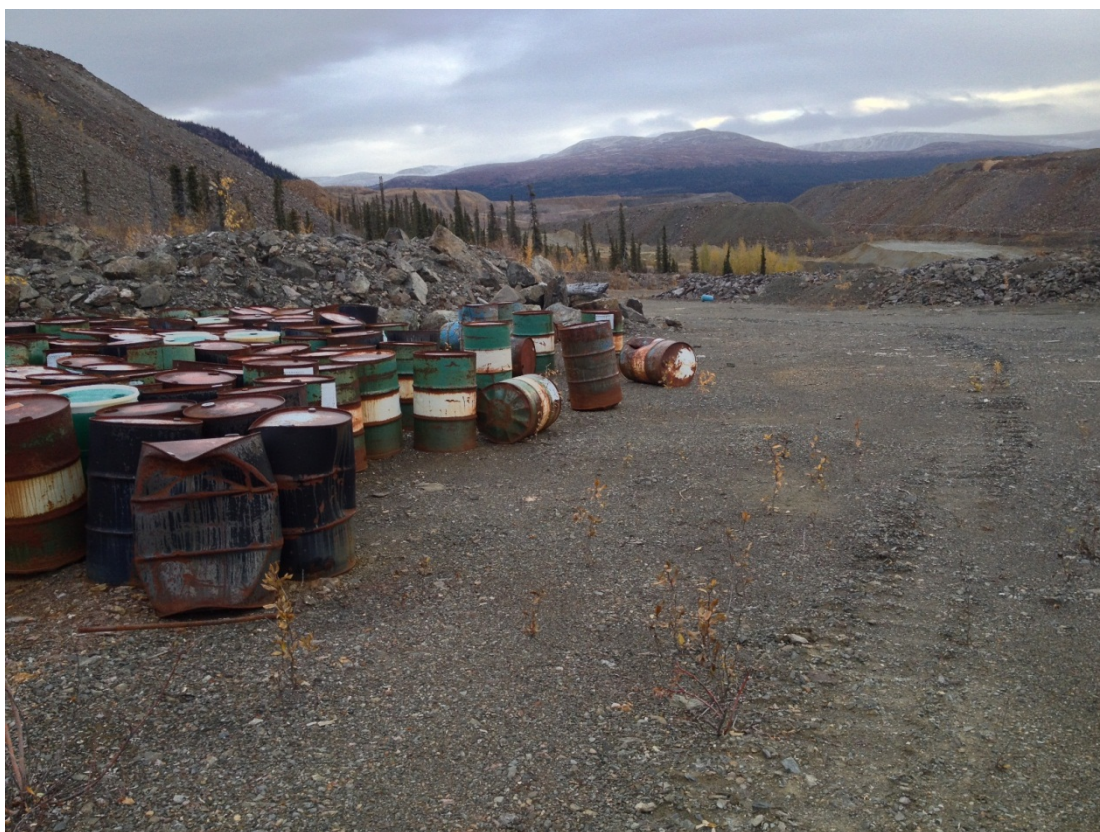
PHOTOGRAPH 3  
**MIBC Drums Damaged by Previous Freeze/Thaw Events**

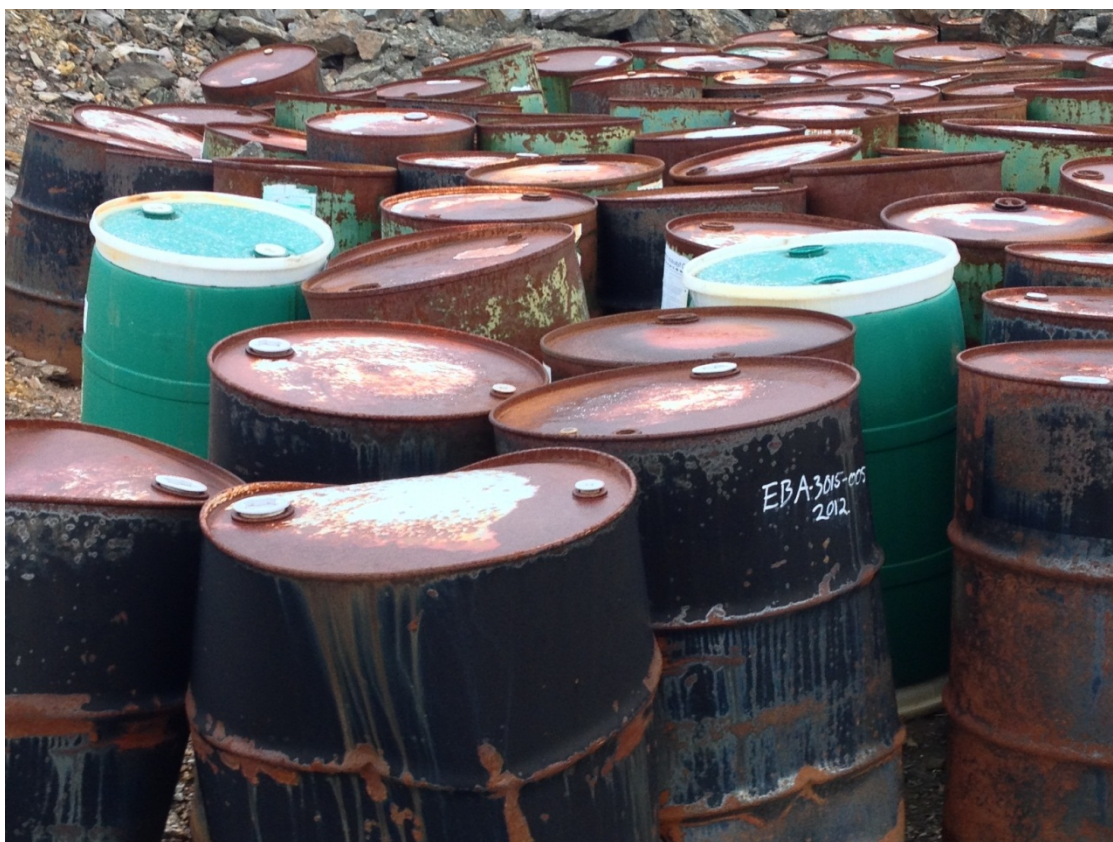
PHOTOGRAPH 4  
**MIBC Drums (without Bungs)**

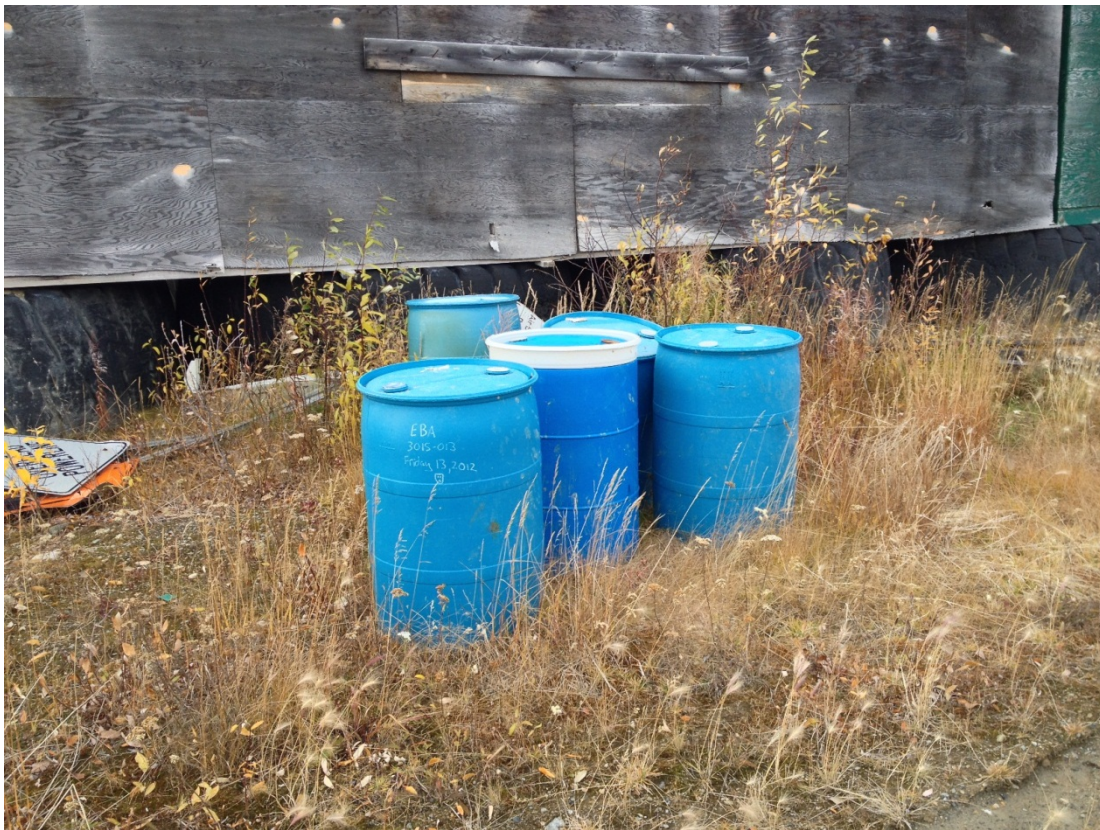
Location	Expected Contents	Estimated Quantity	General Properties	Conditions Observed	Recommended Interim Risk Mitigation Measures
Vangorda Drum Storage	Low pH hydrocarbon <sup>a</sup>	4 – 205-L plastic drums	General properties unknown. May be flammable.  Hydrocarbons are regulated as Special Waste under the Yukon Environment Act Special Waste Regulations (O.I.C. 1995/047).	Drums are placed in direct contact with ground.  Drums are not labelled.	Include location and warning to avoid storage area in facility orientation information.  Place snow fencing around area.  Post signs indicating a hazardous waste storage area, at the entrance to the barrel storage area.  Inspect the area on a biweekly basis and immediately after rainfall events until final disposal occurs.  Investigate requirement for a Special Waste Permit for onsite management options of the residuals and deteriorated containers.

PHOTOGRAPH 5  
**Vangorda Drums**

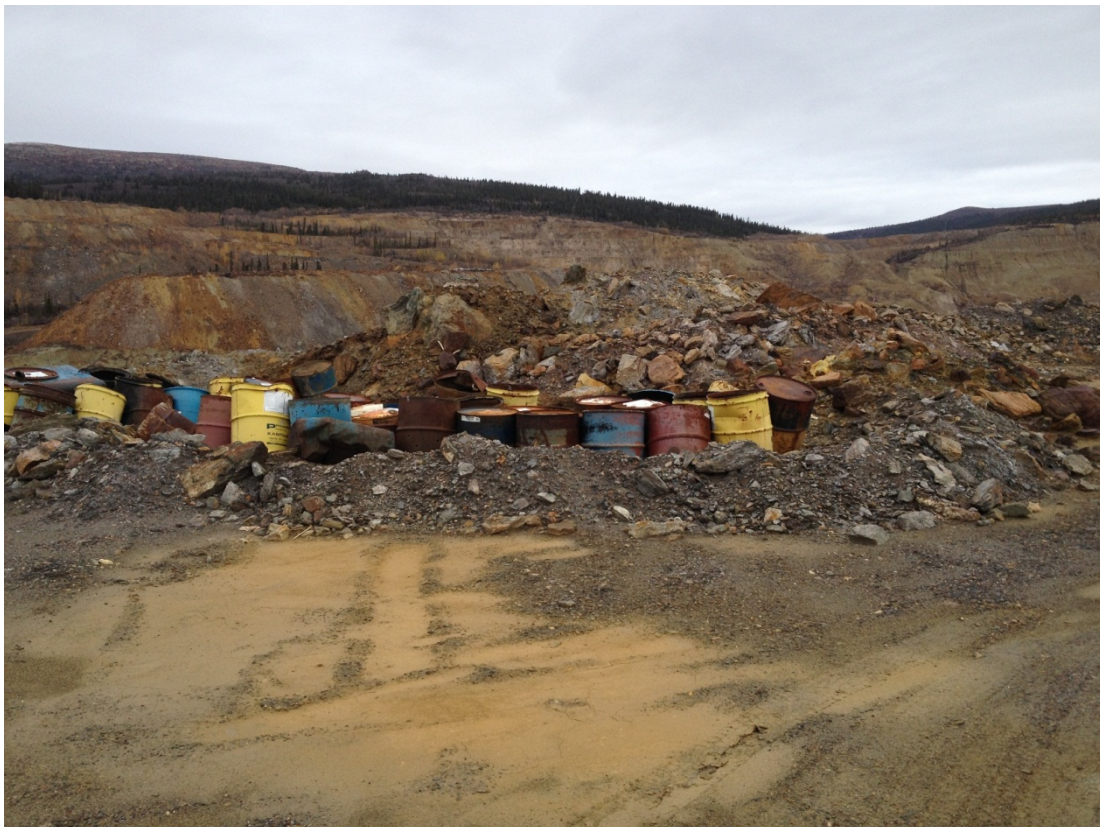
PHOTOGRAPH 6  
**Waste Oil Drums**

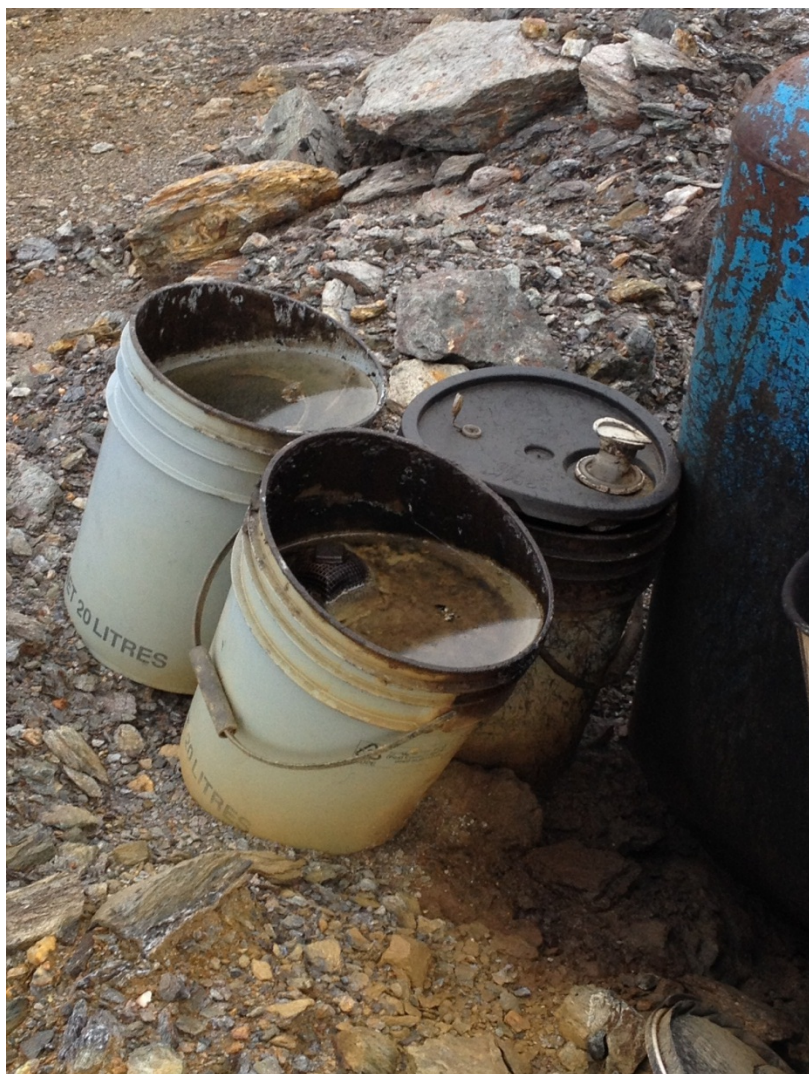
**PHOTOGRAPH 7**  
**Waste Oil Containers**

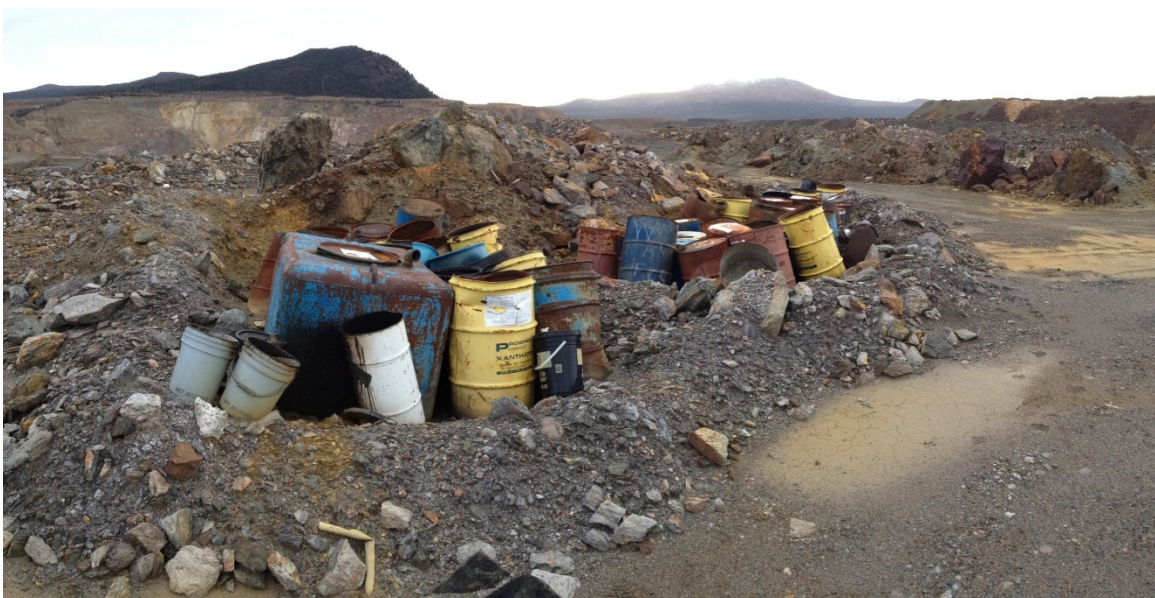
**PHOTOGRAPH 8**  
**Waste Oil Containers**

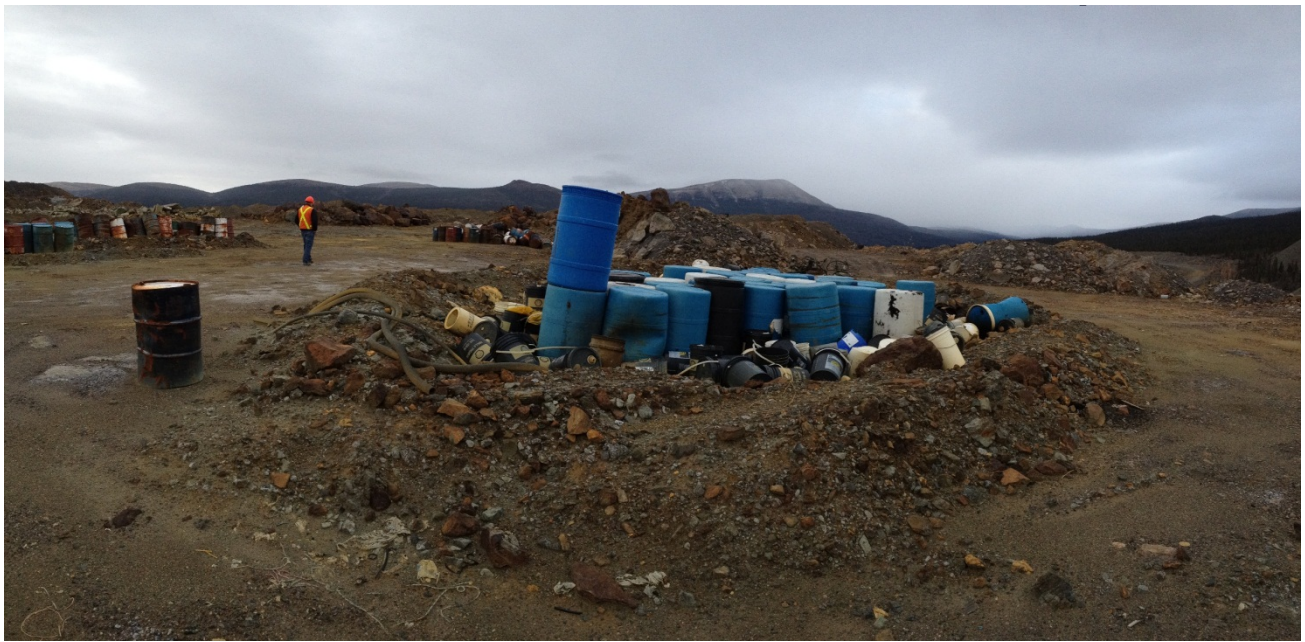
PHOTOGRAPH 9  
**Waste Oil Containers**

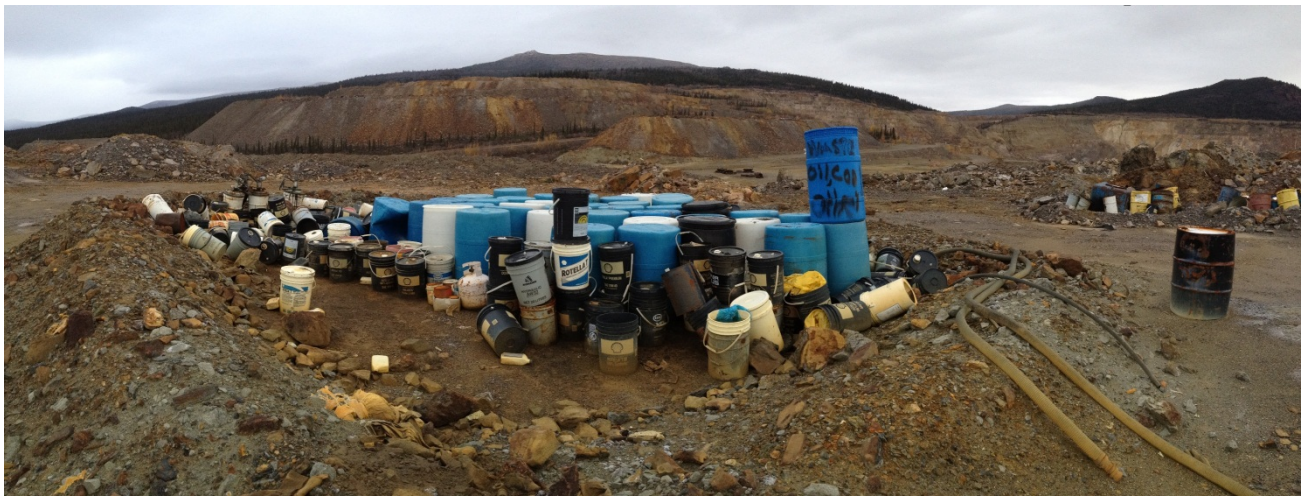
PHOTOGRAPH 10  
**Waste Oil Containers**

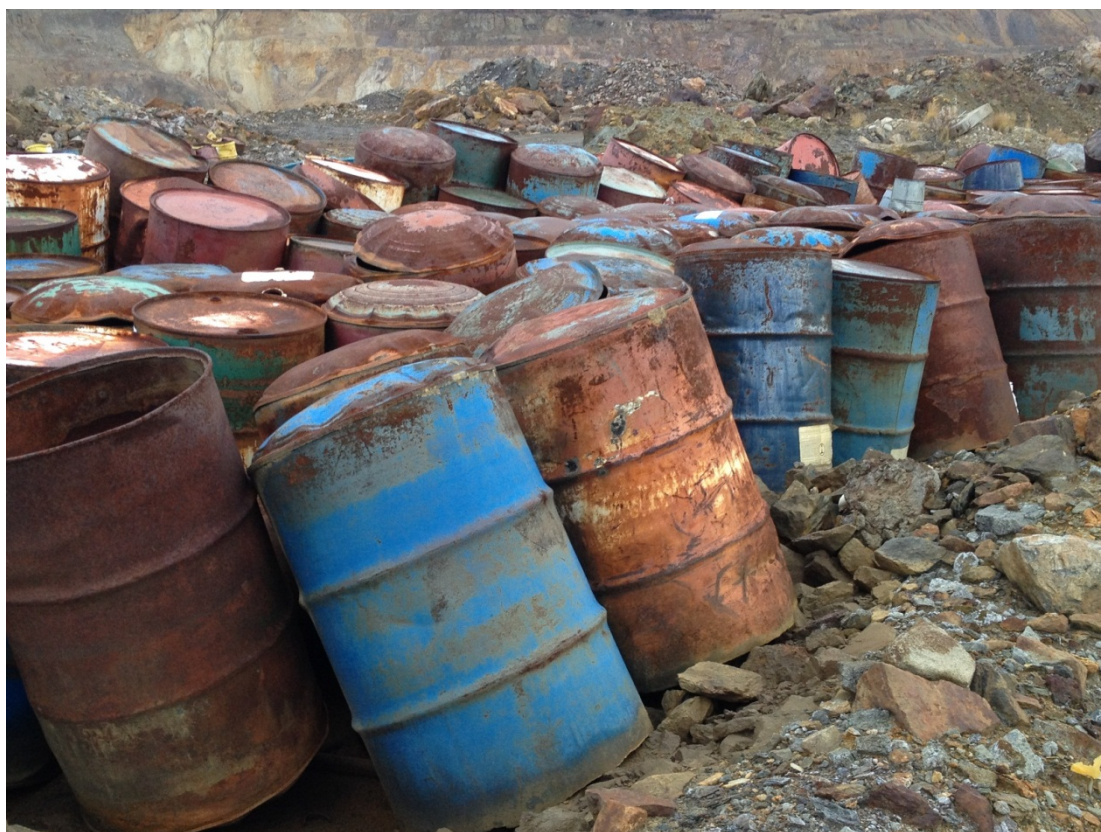
PHOTOGRAPH 11  
**Waste Oil Drums**

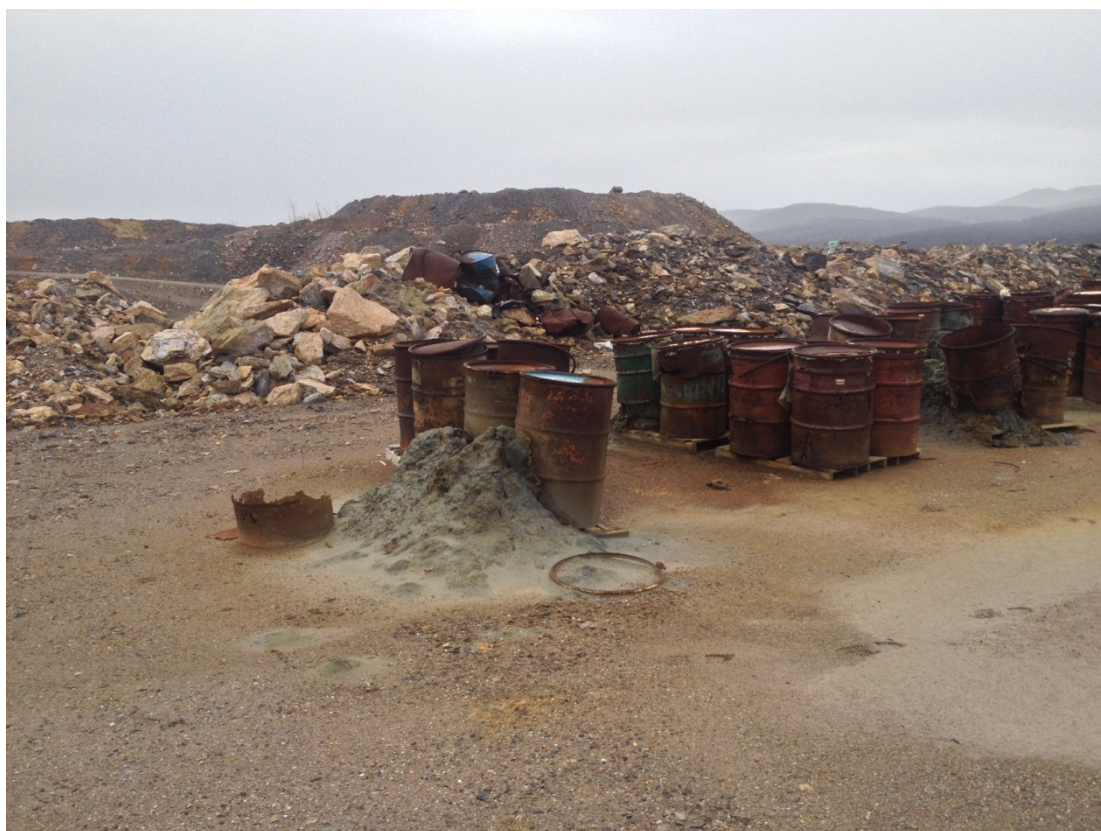
Northwest Drum Dump	Degraded Sodium Isopropyl Xanthate <sup>b</sup> pH of contents is 2.33 <sup>a</sup>	~ 40 - 205-L metal drums (all showing extensive corrosion)	Xanthates are regulated as a Dangerous Good under The Transportation of Dangerous Goods Regulation (SOR/2012-245) in Schedule 1 as a Class 4.2 spontaneously combustible solid (PIN UN3342). Given the properties observed, this will likely be deemed a Special Waste under the Yukon Environment Act Special Waste Regulations (O.I.C. 1995/047). Xanthates are generally stable when kept cool and dry. Exposure to heat causes decomposition, resulting in disulphide vapours. MSDS indicates Xanthate pH to be 13 +/- 1. The corrosion observed is not consistent with the pH reported by EBA. Carbon disulphide may react with water vapour to form acid gases, which may explain the low pH of the solids and corrosion observed. Carbon disulphide is generally considered incompatible with air, metals (including rust), and oxidants. Recommended storage conditions include: airtight drums, storage in shade during summer, and spraying the drums with water to prevent pressure from developing.	Drums placed on pallets are exhibiting varying degrees of corrosive decomposition. Drum labels are not clearly visible. Drums contain varying levels of material; some has been released because of drum wall failures. Some drums display perforated sides. The ground surface is visibly stained downgradient from the drums. The area below these drums (waste rock) was used for chemical drum disposal during the operating life of the FMC <sup>b</sup> .	Include location and warning to avoid storage area in facility orientation information. Place snow fencing across the open access way. Post signs indicating a hazardous waste storage area, at the entrance to the barrel storage area. Inspect the area on a biweekly basis and immediately after rainfall events until final disposal occurs. Investigate requirement for a Special Waste Permit for onsite management options of the residuals and deteriorated containers.

PHOTOGRAPH 12  
**Xanthate Drums**

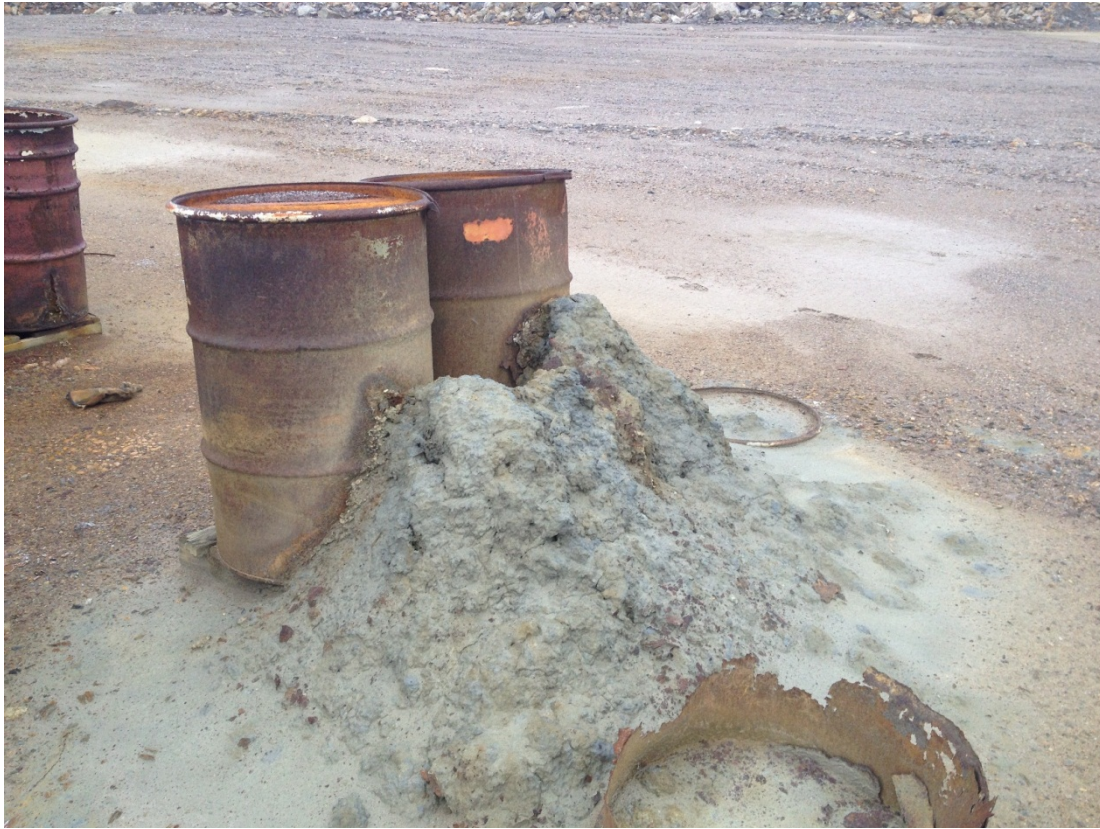
**PHOTOGRAPH 13**  
**Xanthate Drums**

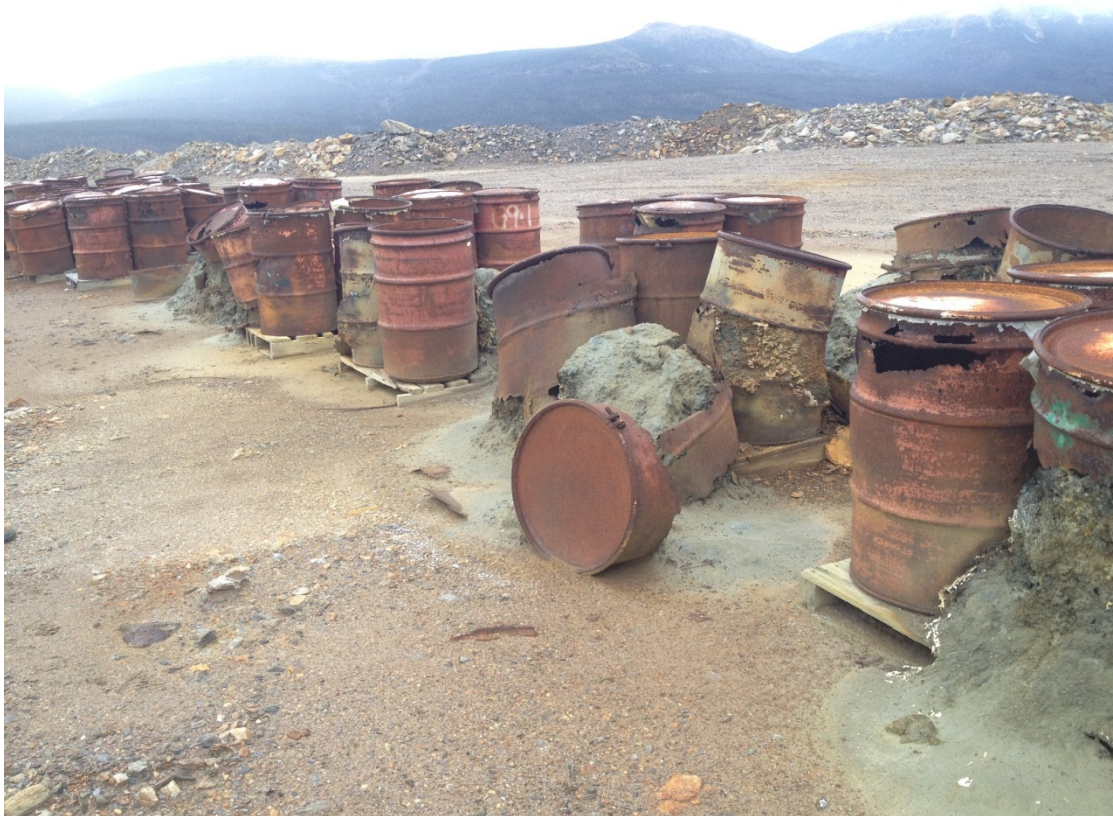
**PHOTOGRAPH 14**  
**Xanthate Drums**
