INSPECTIONS OF
CLINTON MINE
OPERATIONS

JUNE 10-11, 1974

W. B. BOWIE
ASSISTANT RESOURCE
MANAGEMENT OFFICER
DAWSON CITY

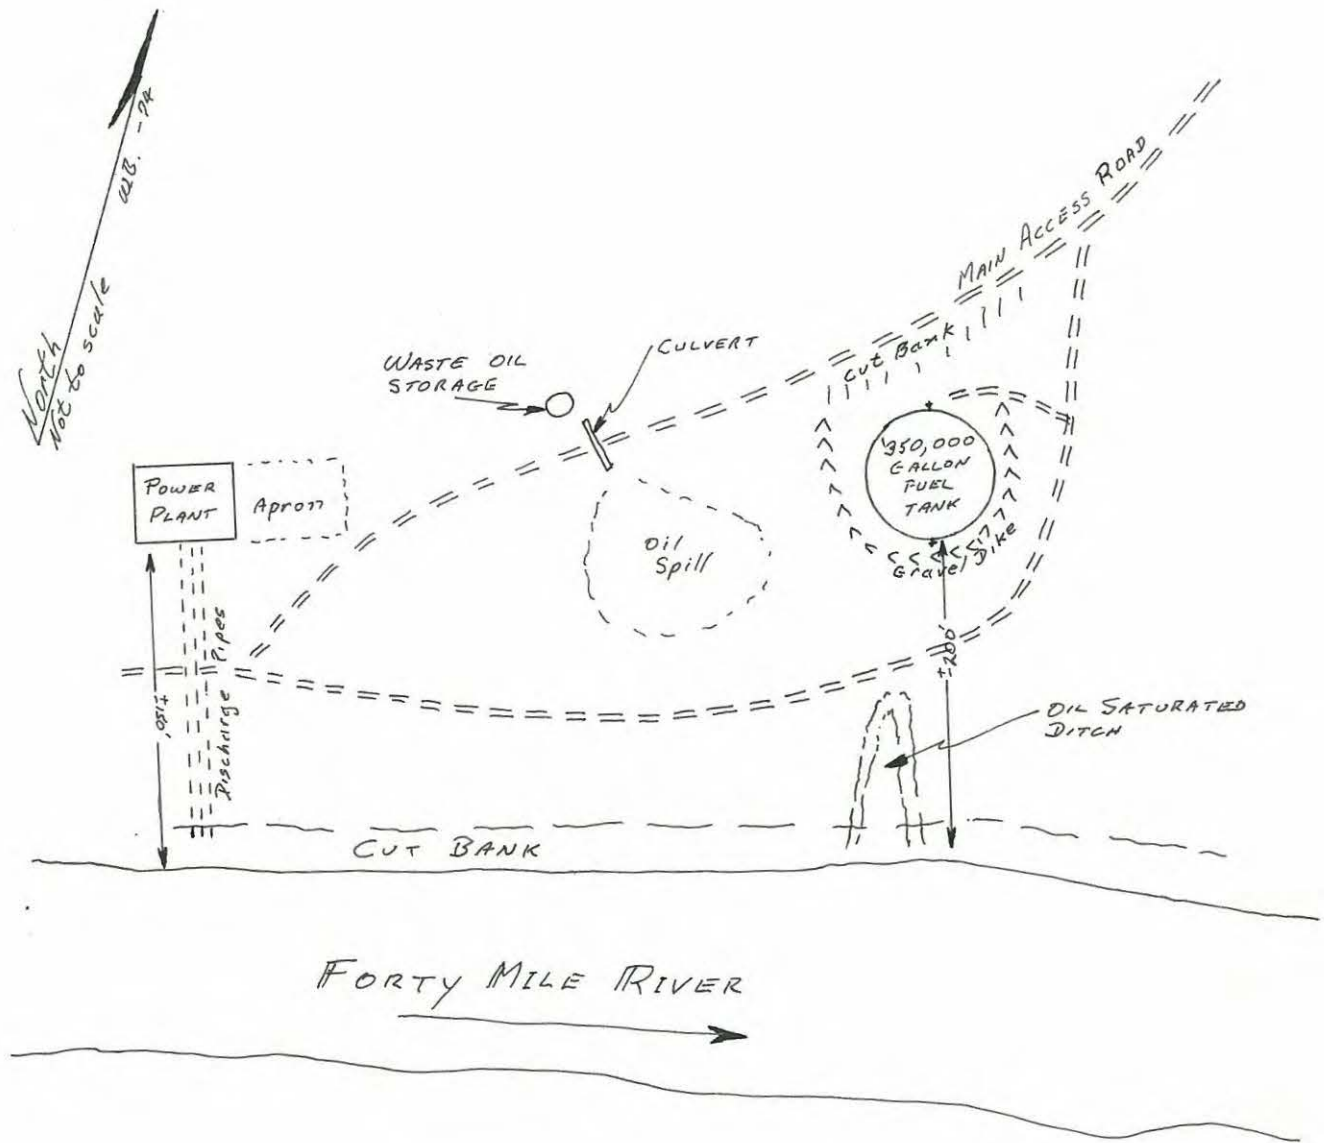
FIGURE 1

Oily Water Separation: Dirty oil from the power plant is flushed to an underground storage tank (Figure 1, Photo 1). When this tank is full, the oil and water mixture is run through the oily water separator which removes the water and discharges it into the river. Problems arise when the separator encounters pure oil which

SKETCH OF POWER PLANT SITE

3. Drainage Ditch: A ditch located between the access road to the oil tank and the Forty Mile River (figure 1 & Photo 4) is completely saturated with oil. A very minor amount of water was running in the ditch at time of inspection but would likely increase during run-off from a rain shower. The oil present in the ditch may be from ground saturation or from dumping of waste.

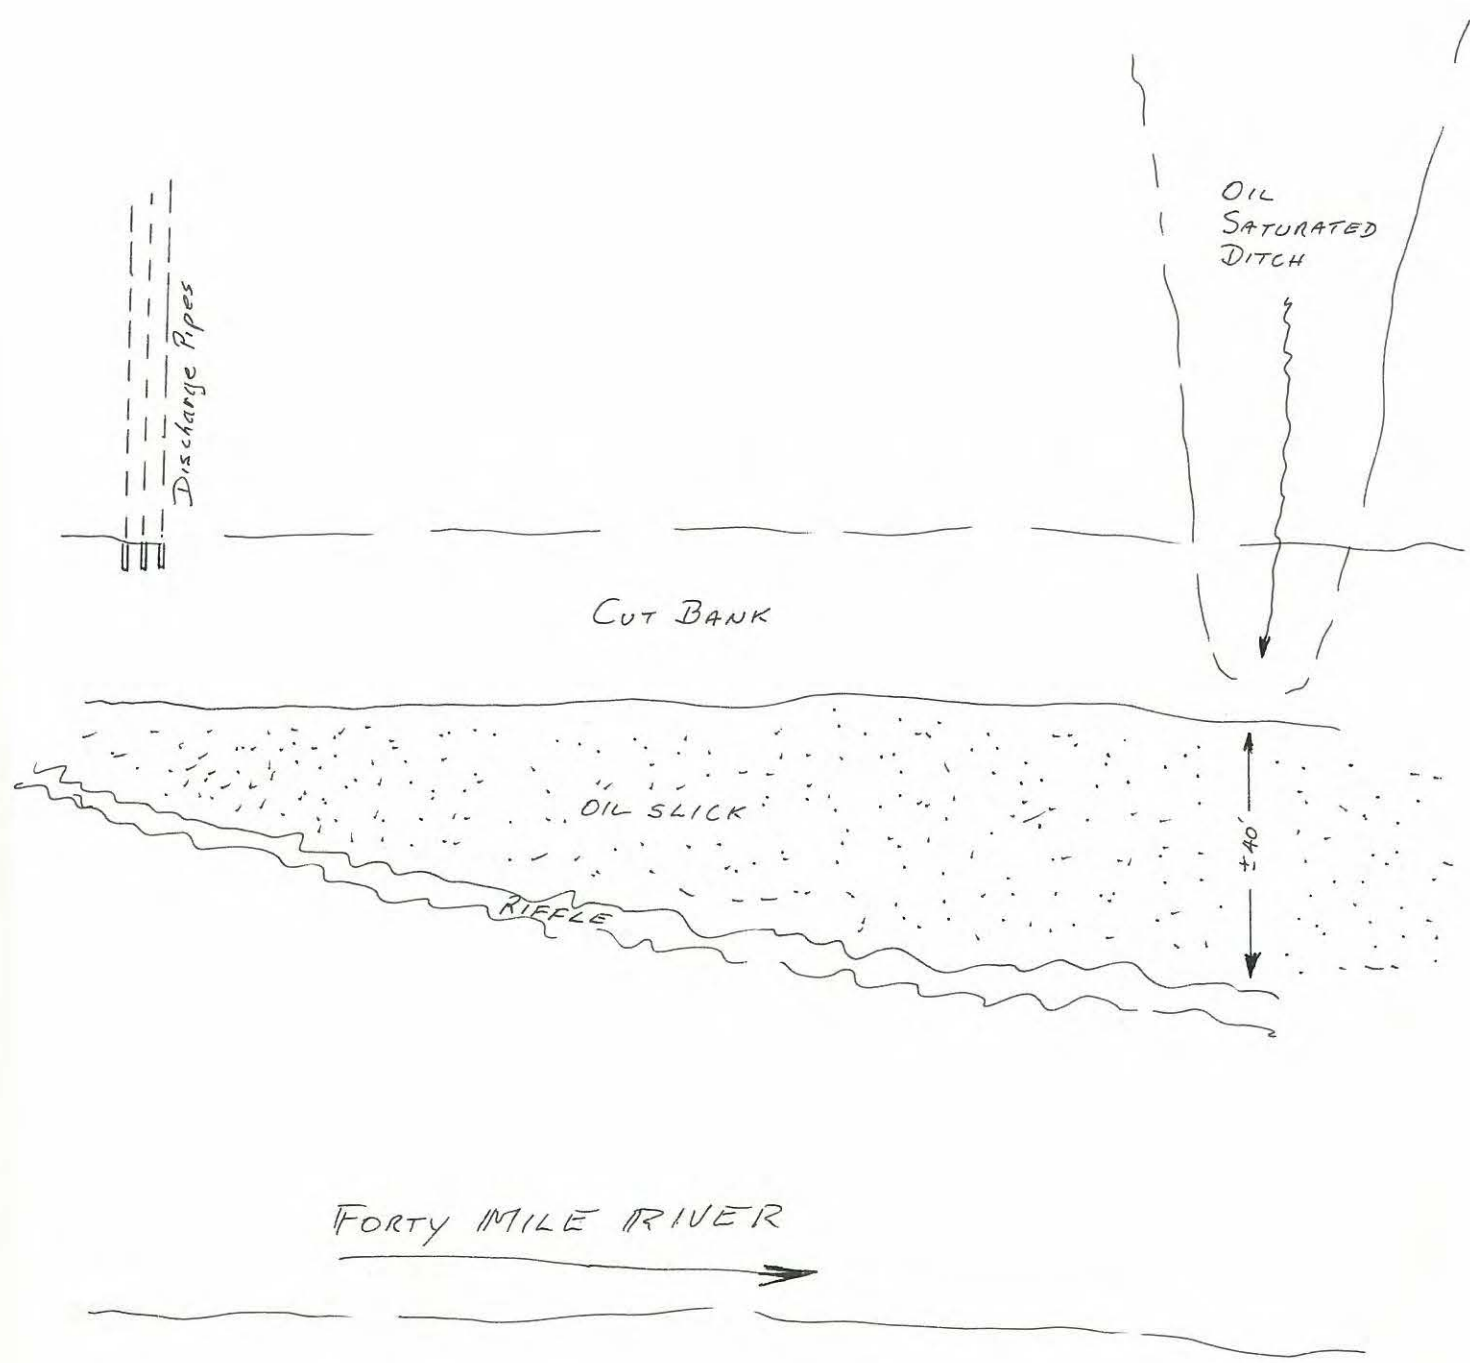
FIGURE II

Investigation of the power plant location revealed that an oil slick was present on the Forty Mile River. The slick originated in the vicinity of the power plant. Although the slick was constant, it was quite small and thin. The slick reached a maximum width of + 40'(figure 2) before dissipating in the river water several hundred feet downstream.

There appeared to be three possible sources for the slick. I suspect the slick is caused by a combination of at least two of these possible sources. (See Figure 2)

SKETCH OF OIL SLICK

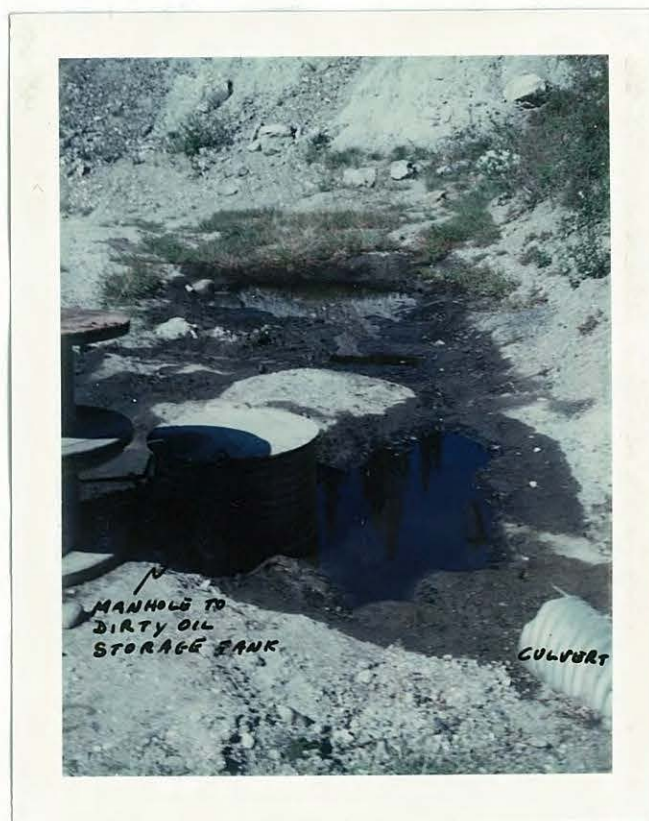
PHOTOGRAPH 1

MANHOLE TO WASTE OIL STORAGE TANK

Note indications of spilled oil on surface and proximity to culvert which would permit free passage of the oil with runoff water.

(a) The dirty oil tank contains about 500 gallons when full. The system is not sealed hence when the tank is overfull the fluid fills the manhole to the tank (photo-1) and seeps into the surrounding ground. Photos 1 & 2 show evidence of considerable overflow from this tank. The culvert shown (photo 1 & 2) allows free passage for this overflow to run on the surface towards the river.

It may be necessary to redesign the oily water separator system to eliminate the possibility of accidental discharge of oil into the Forty Mile River. Also, there is the possibility of leakage from the storage tank for this system. It may be necessary to excavate the tank and connecting pipe to check for leakage. Allowing this tank to overfill may be the cause of much of the ground saturation with oil. At the time of inspection the tank was overfull and the fluid was up almost to the top of the manhole culvert.

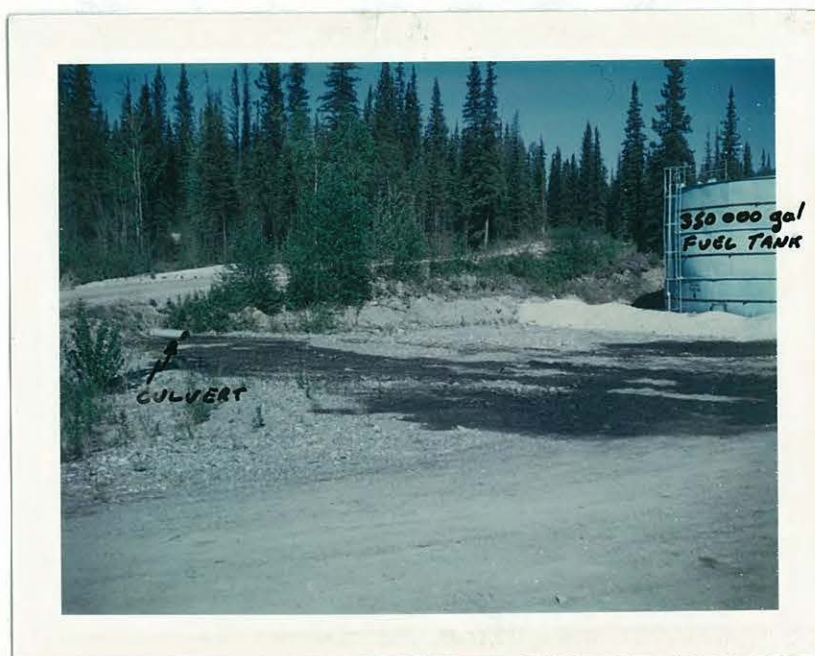
PHOTOGRAPH 2

2. Ground Saturation With Oil: There are several indications at the power plant site of oil spills and discharges onto the ground. It is quite possible that over the years the ground has become saturated with oil and that this oil is now seeping into the river. When observing the present oil slick on the river, oil globules seemed to be rising from below the surface and spreading to cause or contribute to the slick. There appears to be two principal sources of this ground contamination with oil. (a) Overflow from the oily water separator storage tank (photos 1&2) and (b) oil spills from the 350,000 gal diesel fuel tank (photos 2 & 3).

OIL ON SURFACE NEAR POWER PLANT

Culvert at centre left of photo is the same culvert shown in Photo 1. Note the large amounts of oil which appear to have washed out from this culvert. The diesel storage tank and dike are visible to the extreme right.

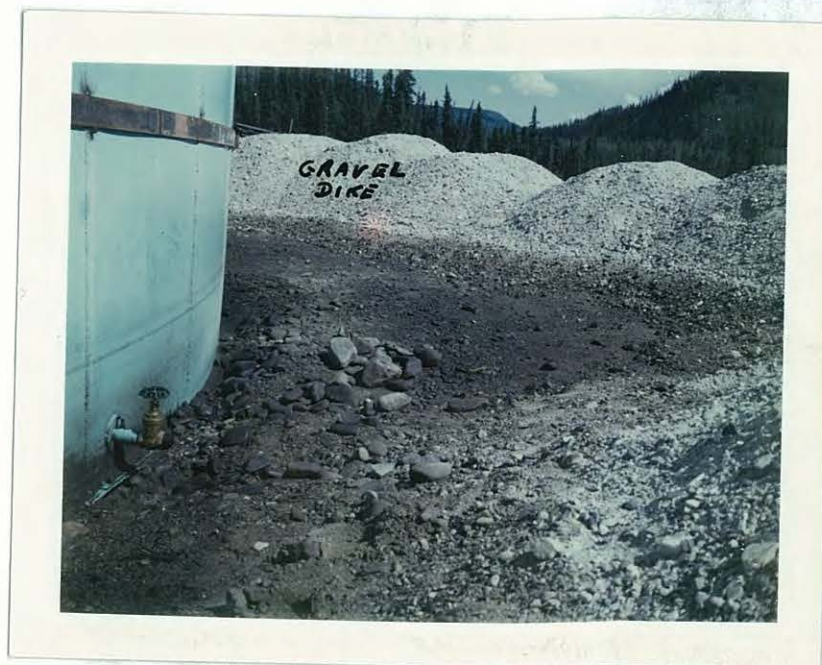
PHOTOGRAPH 3

350,000 GALLON FUEL TANK AND SURROUNDING DIKE

Note indications of large amounts of fuel spilled within the dike.
The valve shown on the tank cracked in May 1974 causing a spill
estimated at 400 gallons.

(b) The 350,000 gal fuel tank is enclosed by a gravel dike. However, there is no membrane in the dike or under the tank to prevent seepage of spilled oil. There is an opening in the dyke at the rear of the tank to allow truck access to the fuel valve. There are indications within the dike of substantial fuel spills (photo 3).

In May 1974 a spill occurred at this tank. Mine officials estimate 400 gallons were spilled within the dike. Of this amount, 200 gallons were recovered and pumped back into the tank. A crack in the valve shown in photo 3 was responsible for this spill.

impervious membrane in the dike and ground adjacent to the 350,000 gallon tank would aid considerably in containing future spills.

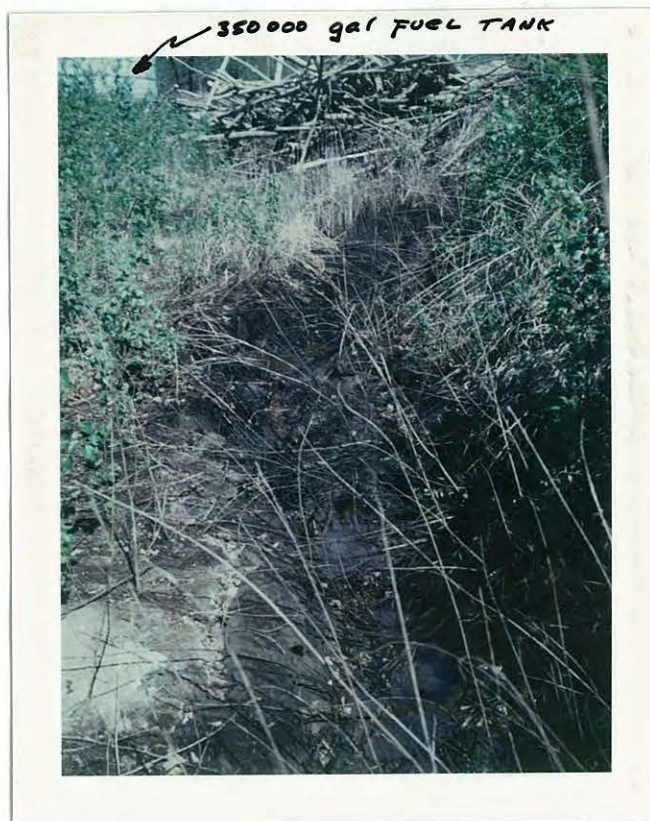
PHOTOGRAPH 4

OIL SATURATED DITCH

The dark area through the centre of the photo is completely saturated with oil. Oily puddles are visible in the bottom of the ditch. This oil will flush into the river with runoff water. The 350,000 gallon oil tank is visible at the upper left corner of the photo.

At the time of inspection it was recommended that a dike be placed accross the lower end of the ditch shown in photo 7 (see figure 4). A pipe and valve at the bottom of the dike would allow water to drain and the oil could be skimmed or burned off the surface. It was also recommended that a series of test holes be dug parallel to the river bank to determine if oil seepage through the ground could be contained by a ditch parallel to the river bank.

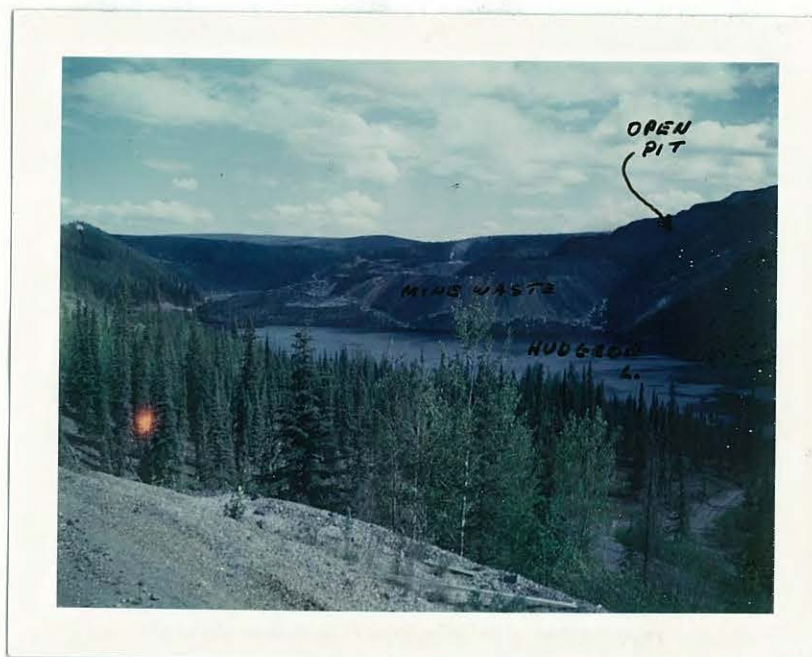
PHOTOGRAPH 5

EAST END OF HUDGEON LAKE

The mine waste pile is visible in the background. Water flows over the waste at the toe of the pile.

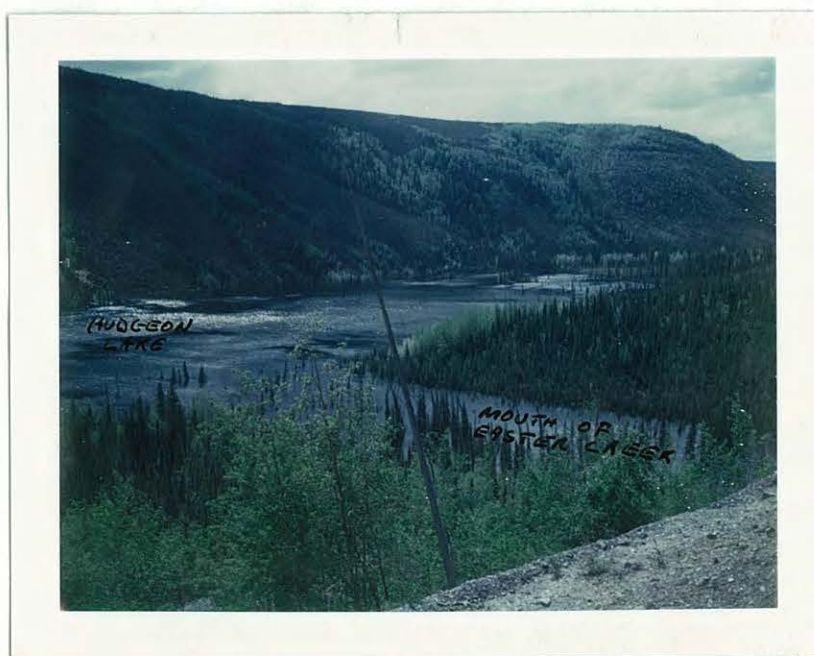
PHOTOGRAPH 6

WEST END HUDGEON LAKE

Note the areas of timber flooded by the lake. Partially covered trees are easily visible.

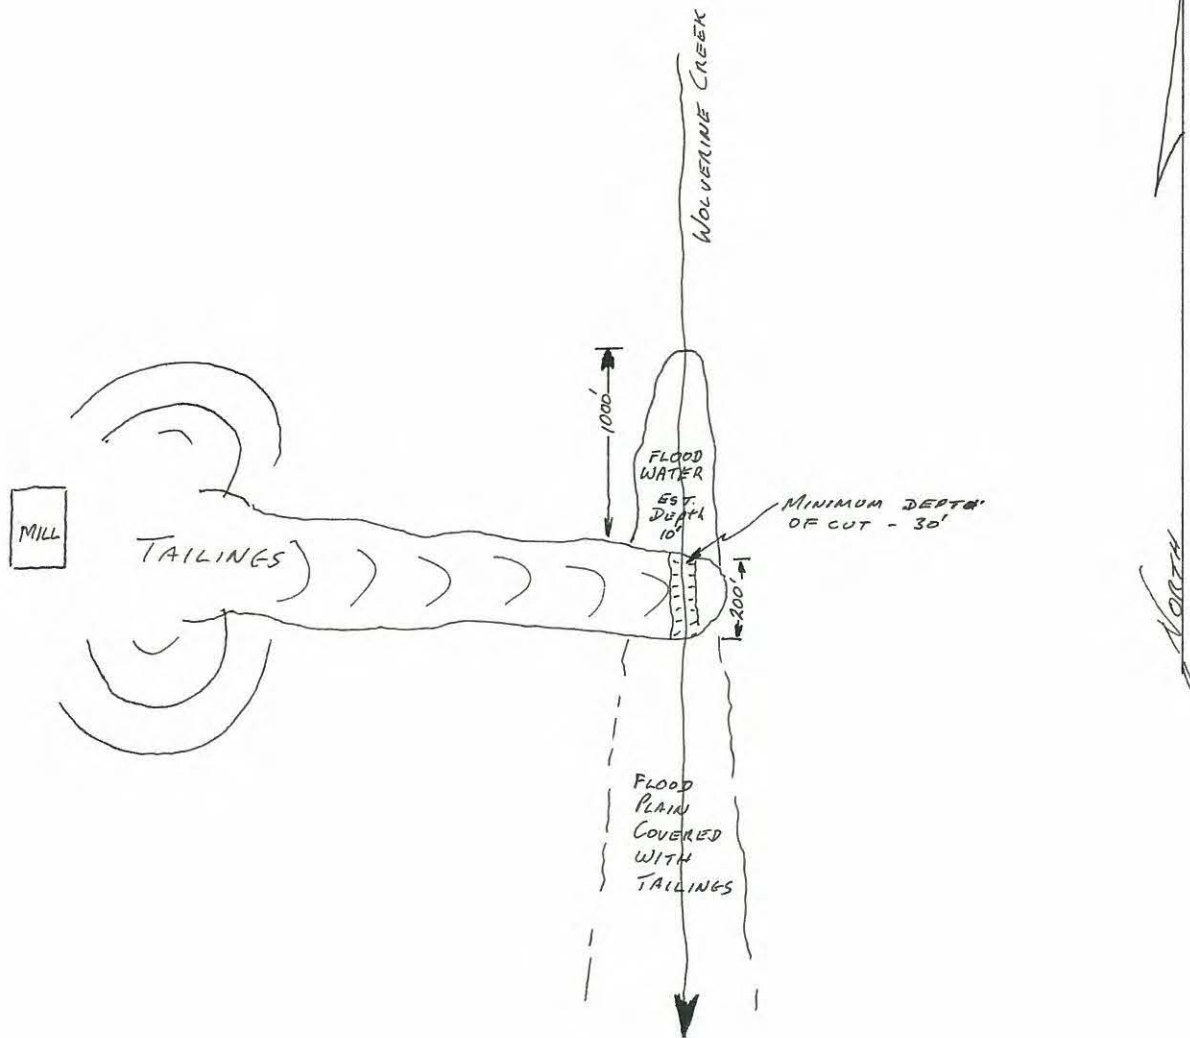
FIGURE III

Tailings from the mill have slumped into Wolverine Creek blocking the normal flow. (See fig. 3 & photo 7). This spring about a 30' head of water backed up behind these tailings and washed out causing a flash flood down Wolverine Creek to the mouth of Clinton Creek. Tailings were washed down Wolverine Creek to Clinton Creek and deposited across the valley floor (Photo 7). Asbestos dust was carried down to the Forty Mile River and deposited across the Clinton Creek valley floor where it flooded. (Photo 8 & 9). A considerable amount of this dust is still evident in the water at the mouth of Wolverine Creek. (Photo 9)

Due to the unstable condition of this tailings pile this flooding is likely to be an annual occurrence unless alternate passage is provided for the creek flow. Continued flooding will result in flood killed timber behind the tailings, possible washout of the access road and powerline to the mine, depositing of tailings over several acres of valley bottom, and washing of asbestos dust into the Forty Mile River.

SKETCH OF MILL TAILINGS - WOLVERINE CREEK

3. Mill Tailings: Alternate means for the free passage of Wolverine Creek must be provided. If this is not done future floods

may occur with far more disastrous results than the flood which occurred this year. The tailings from the mill are not stable and will undoubtedly continue to slump and block the valley. Free passage for the water could be provided by a ditch up the east side of the valley above the tailings or by a large culvert through the tailings. A culvert would, however, likely be impractical due to freezing. Routing of the water around the tailings would also have a beneficial effect on water quality.

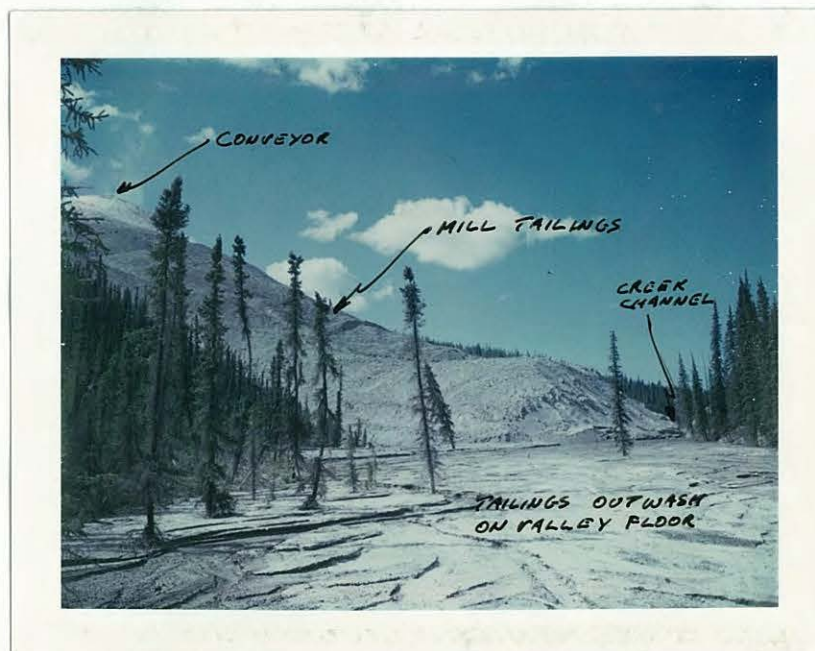
PHOTOGRAPH 7

MILL TAILINGS IN WOLVERINE CREEK

Tailings in the foreground were washed across the valley floor by the flash flood. The cut washed through the tailings exceeds 30 feet in depth. Uprooted trees are present for several hundred feet down the valley.

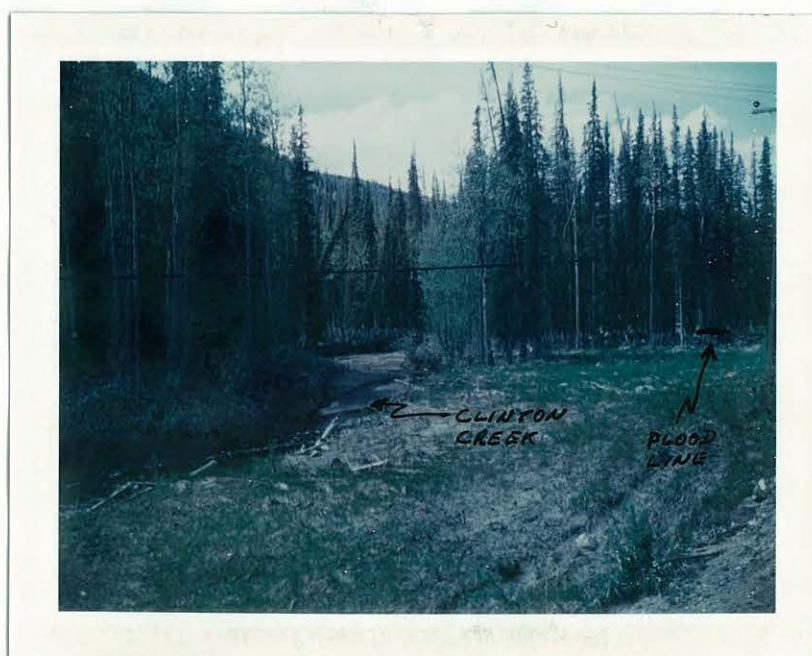
PHOTOGRAPH 8

FLOODED AREA ON CLINTON CREEK

This photo was taken about 2 miles downstream from the mouth of Wolverine Creek. The flood-line is visible in the trees and the ground is covered by dust washed down from the tailings. Rate of flow shown in the creek is about normal.

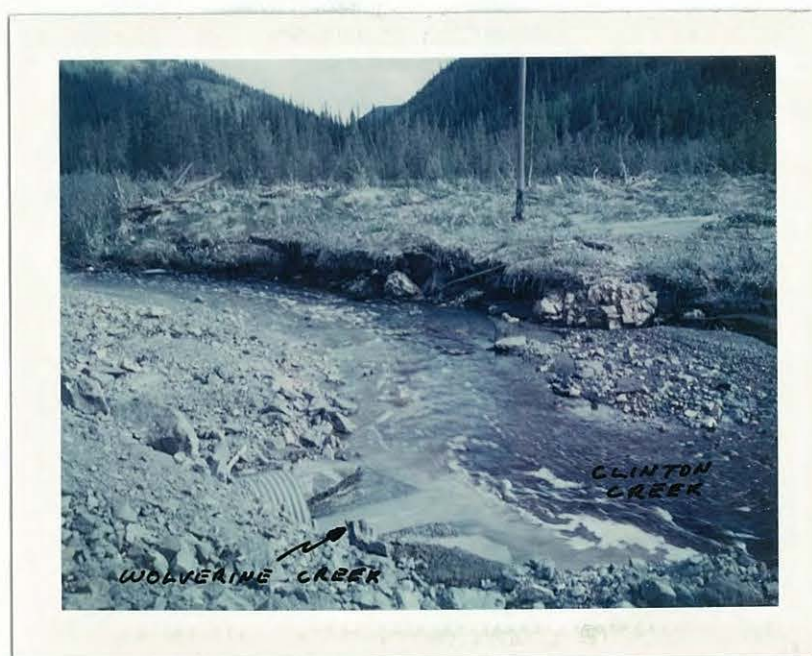
PHOTOGRAPH 9

MOUTH OF WOLVERINE CREEK

Note the difference in water color. The milky water in Wolverine Creek has run through the mill tailings. The flat in the centre of the photo is covered with dust and sludge washed down from the mill tailings.

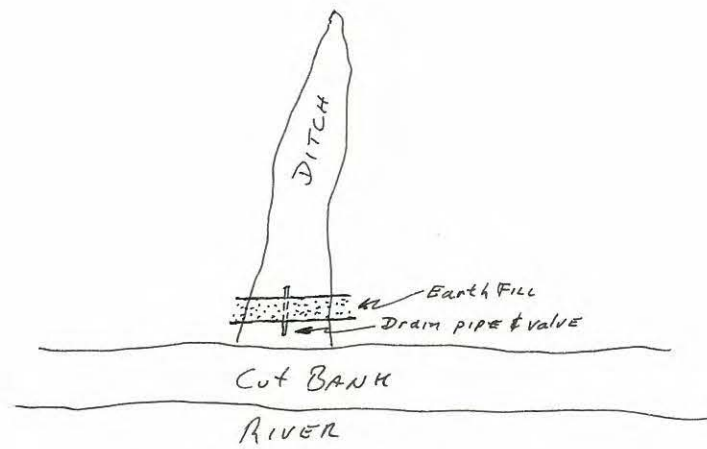
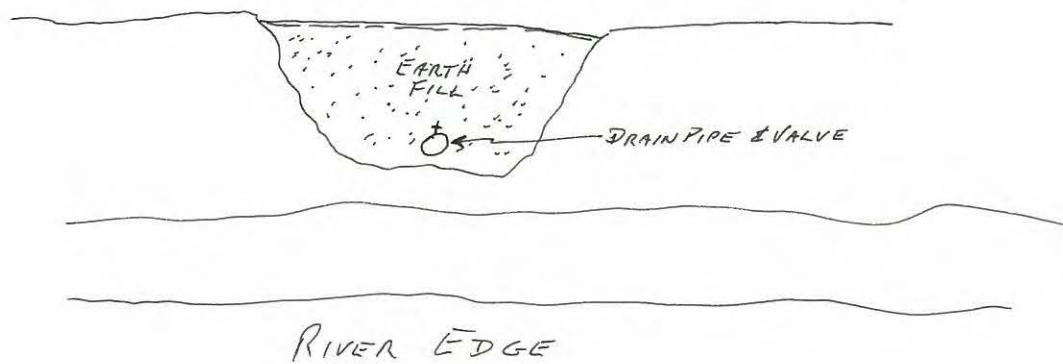
FIGURE IV

PROPOSED DIKE ACROSS OIL FILLED DITCH
