BRODIE
CONSULTING

MEMORANDUM

SUBJECT: Intermediate Dam Rip Rap
DRAFT PENDING FURTHER FIELD ASSESSMENT

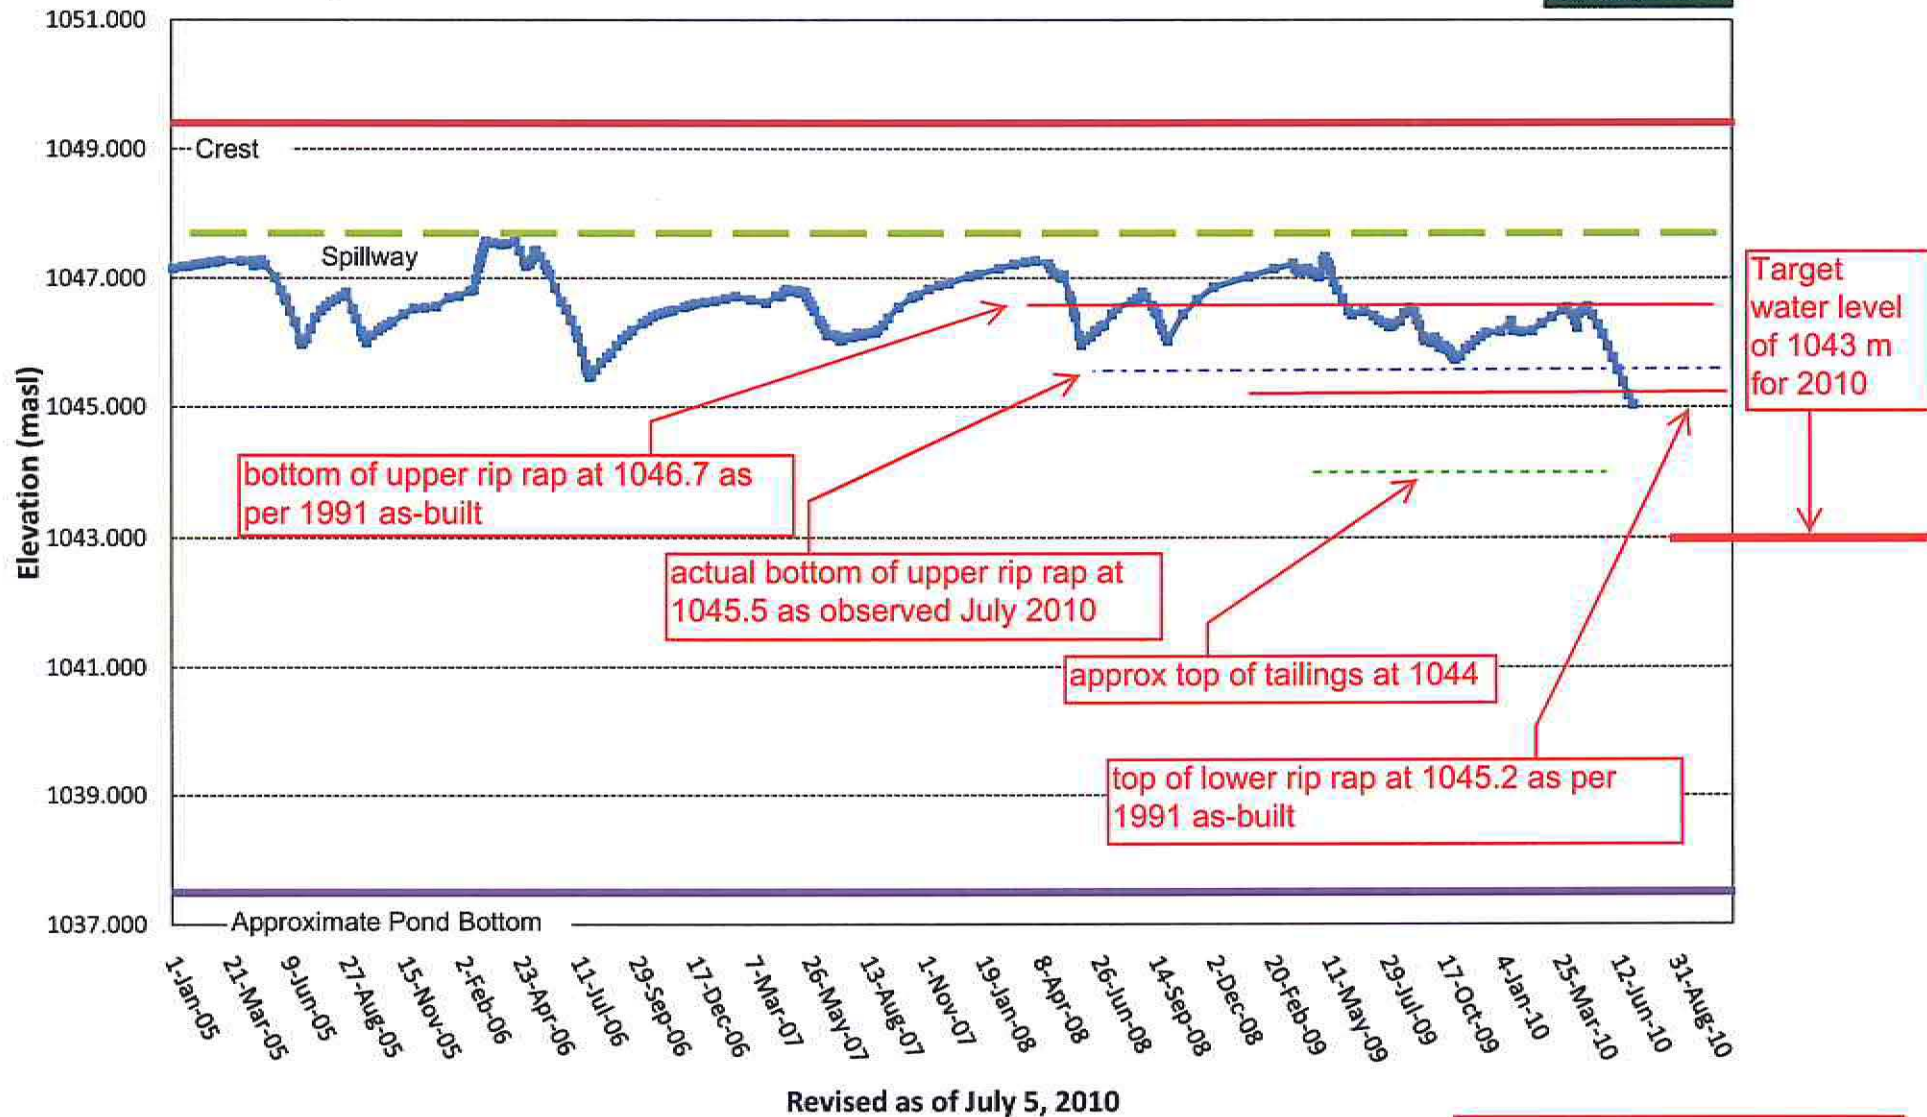
Intermediate Pond Water Elevations

In order to reduce the risks associated with site water management, it has been decided that the Intermediate pond is to be operated at a level which is lower than historic levels. The current target is 1043 +/- m elevation. See Figure 1. We may be only able to approach but not meet this target in 2010 due to limits on the maximum drawdown rate to ensure stability of the upstream slope of the dam.

Figure 1, attached, shows the historic water level trends since 2005 with key elevations annotated. Figure 2 shows the Int. Dam in cross-section with similar annotation.

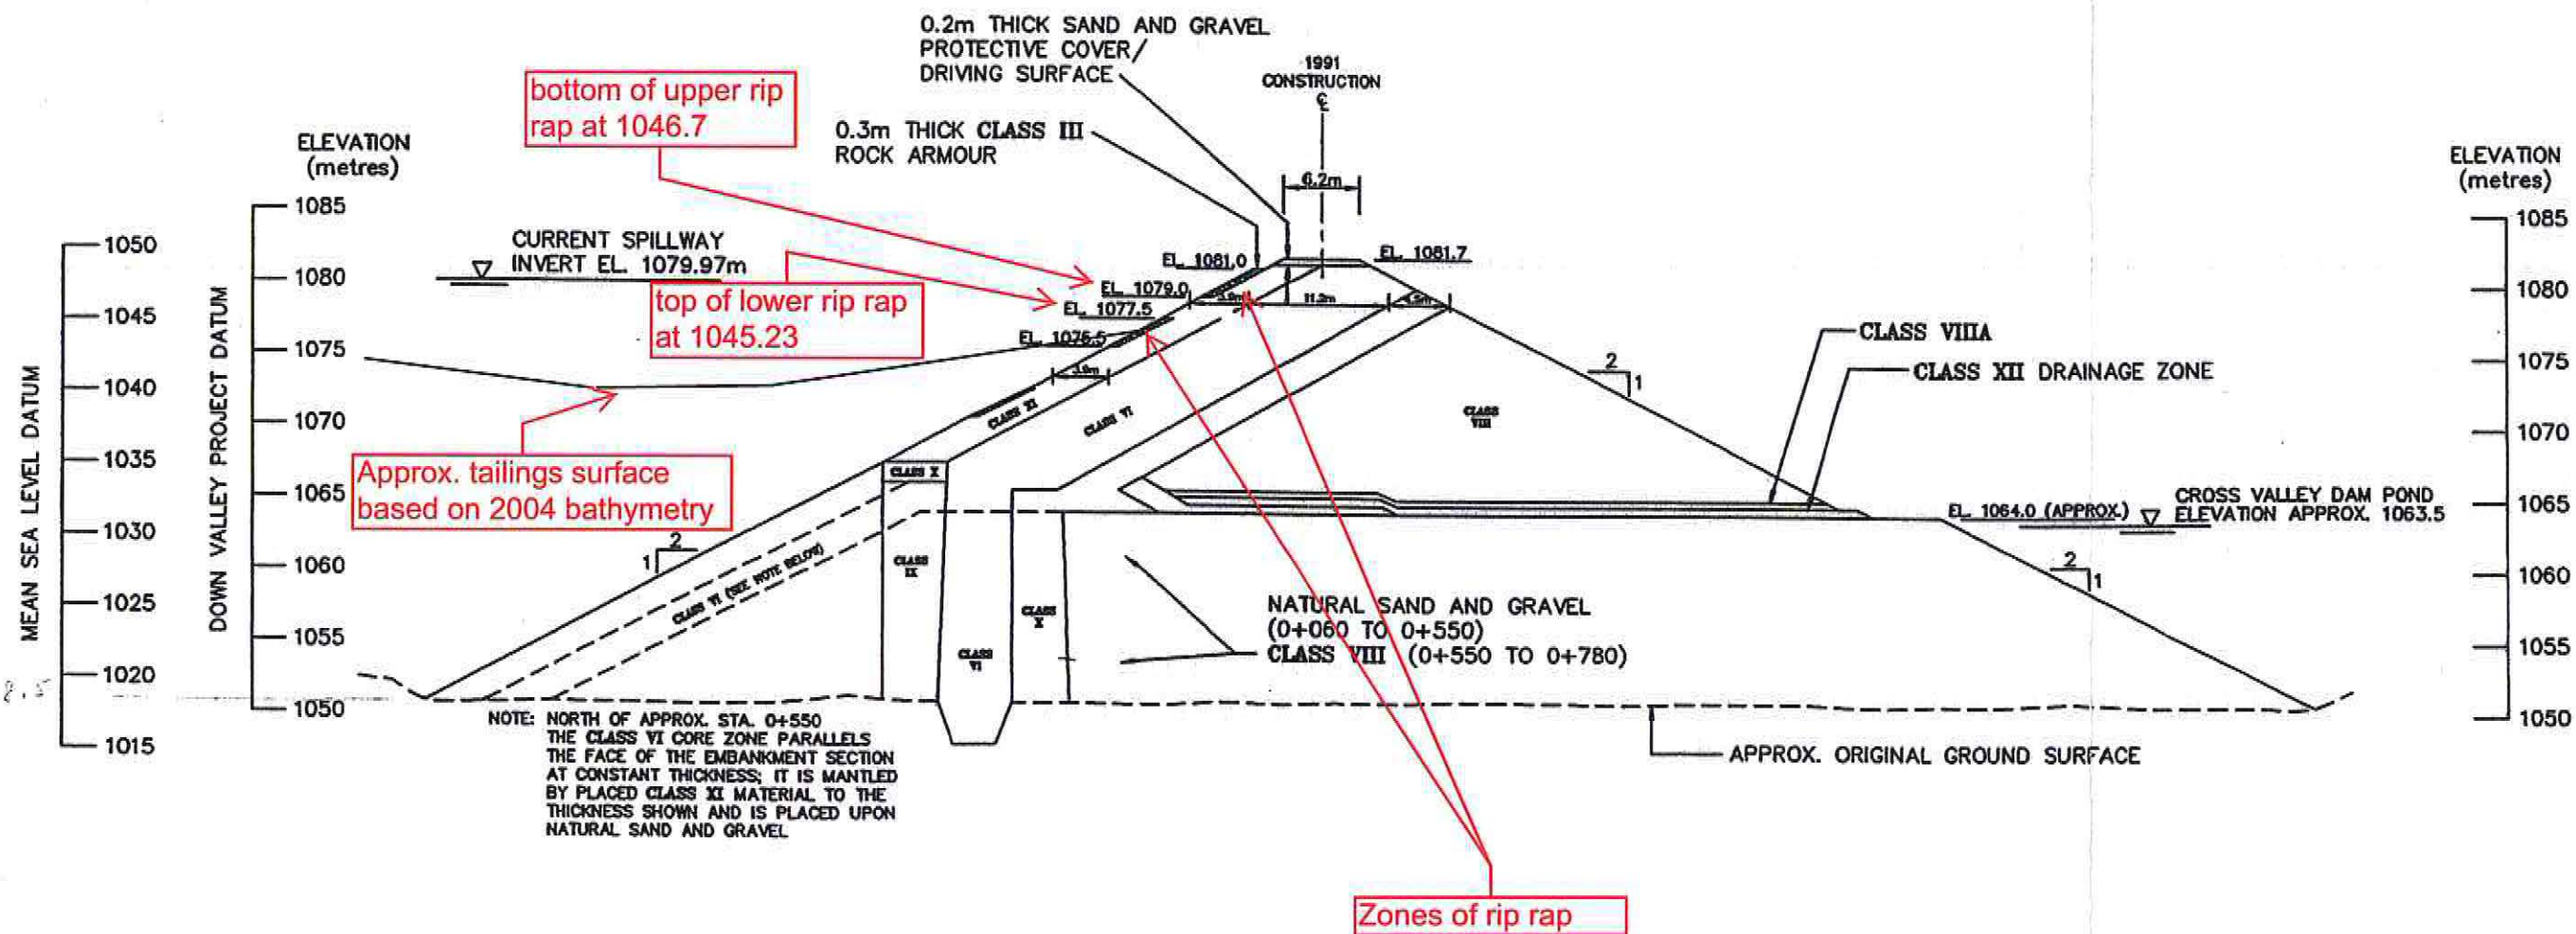
Figure 2
Int. Dam Rip Rap Assessment
BCL July 2010

The historic lower limit for operation of the pond was based upon not exposing the interval on the up-stream face of the dam which does not have rip rap, and it was anticipated that lowering the pond water level in 2010 would expose this interval. The top of this interval has recently been found to be at 1045.5 +/- m elevation. This is different from what is indicated in the available records (see Figure 2). However, BGC 2009 Annual Geotechnical Evaluation and Instrumentation Review page 18 notes:

At this time we are unable to locate any as-built information concerning the location and scope of those repairs. The existing rip rap surface is very steep and loose, which suggests that the 2007 repair consisted of placing a layer of new rip rap over the dam face to blanket the interval without rip rap. This was done down to the limit which could be reached with the available equipment.

Option 1 seems like an excessive amount of work to address a small (0.5 m) gap in the rip rap at point which is well below the crest of the dam and would be a deficiency only until the closure plan is implemented. The extent of the gap in the rip rap must be confirmed. Assuming actual conditions/dimensions on the dam are found to be as described herein, then Option 1 seems less preferable than Option 2.

Option 2, by default appears to be the best option, although it should be noted that this is a departure from best management practice for a dam. It is only acceptable if:

- monitoring of the face of the dam is carried out as described, and,
- water level control is carried out to the extent practical, and,
- the situation is temporary (implementation of closure measures will be conducted), and,
- return to Option 1 is taken if monitoring indicates that the integrity of the dam is at risk.
