Government of Yukon  
Energy Mines and Resources  
Assessment and Abandoned Mines

**Miscellaneous Repairs at the Clinton Creek Site**

November 8, 2014

Erik Nyland, P.Eng.

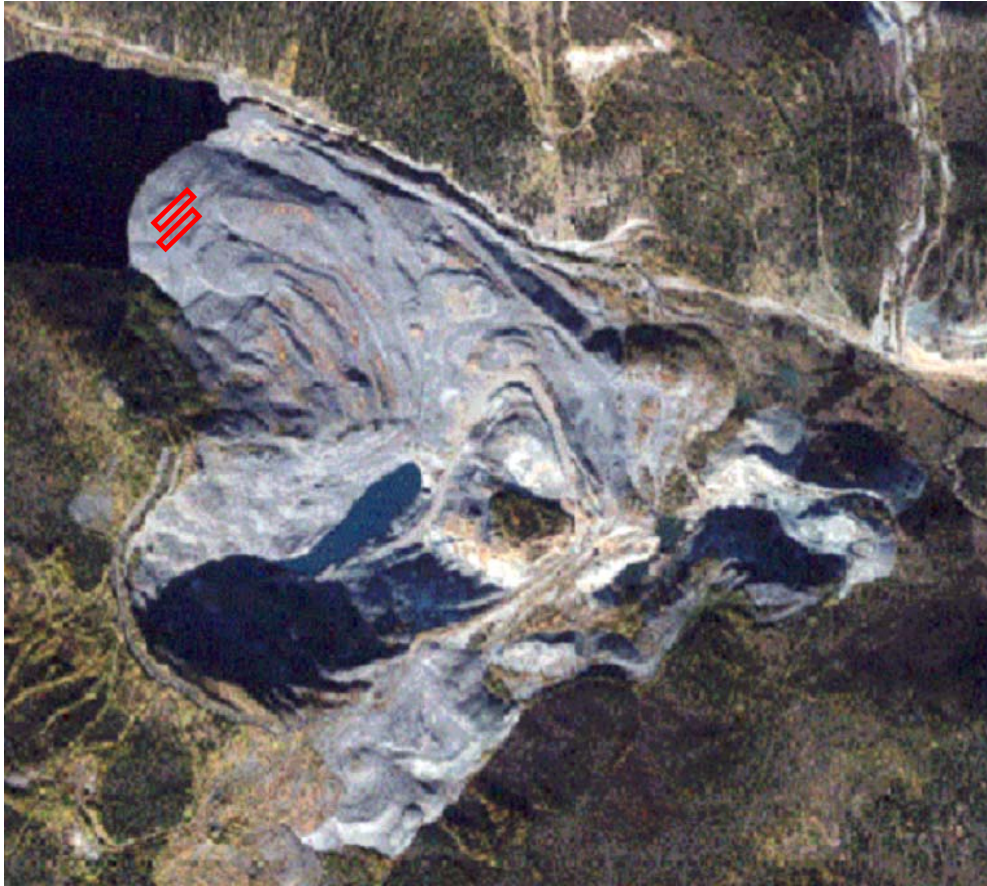
Both log-booms were transported and placed on the south side of Clinton Creek at a sufficient distance / elevation from the lake so as to avoid any potential movement as a result of flash flooding within the area. It was determined (with a reading on the staff gauge at Hudgeon Lake to be 1 ¼ inches below 0 mark) that the lowest elevation at which the log-booms sit is at 1.5 m above water, permitting adequate leeway for water to rise without disrupting their placement.

Figure 1. Aerial view showing the approximate location of the log-booms near Hudgeon Lake.

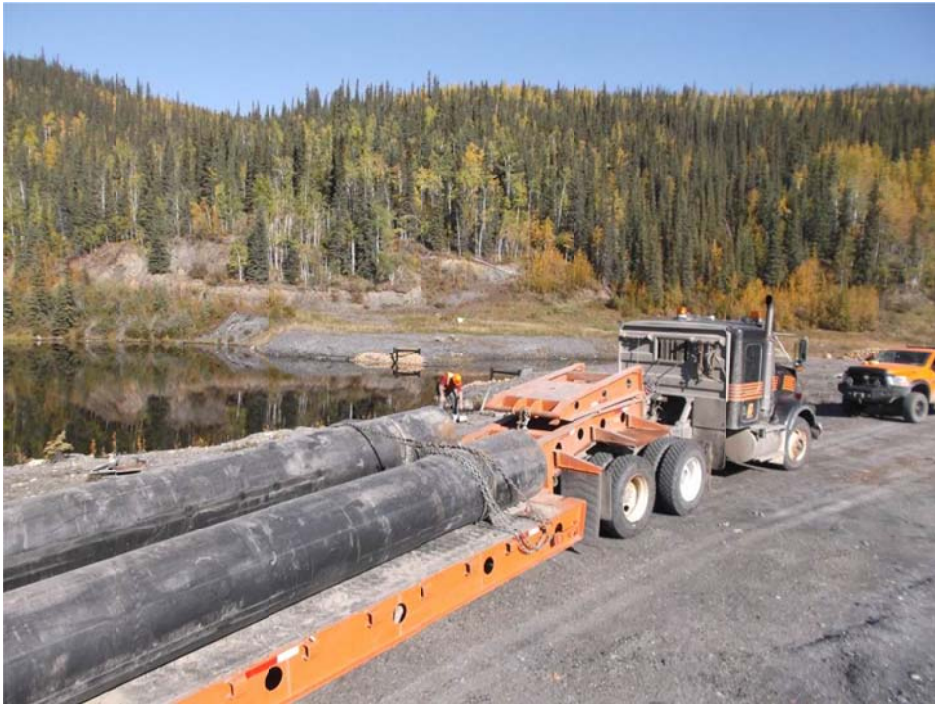
Photo 1. Transportation of log-booms to Hudgeon Lake Outlet.

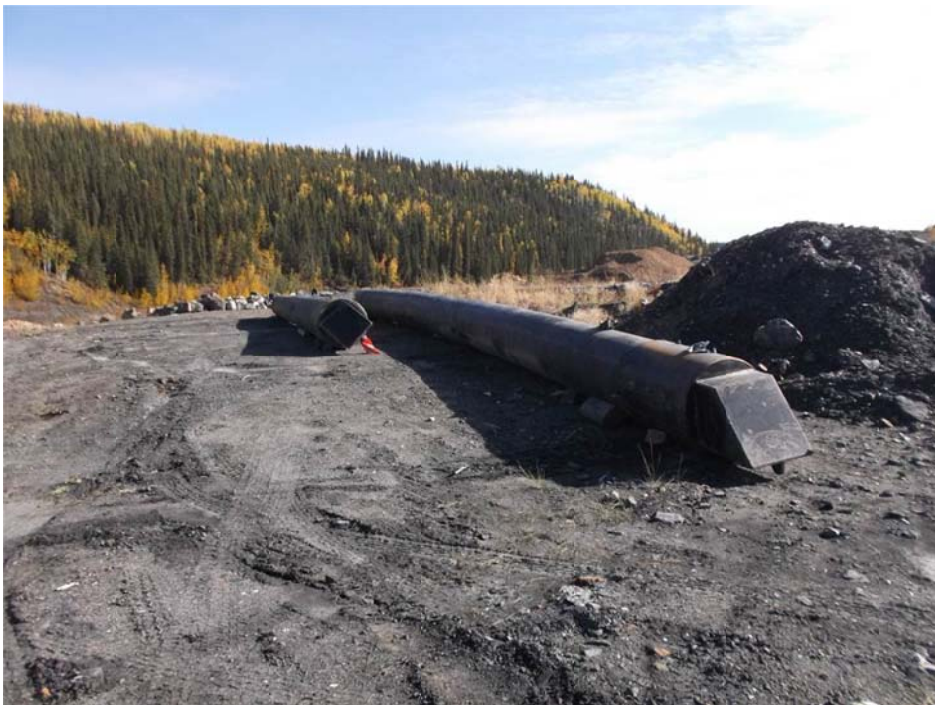
Photo 2. Placement of the log-booms at a sufficient elevation above Hudgeon Lake water level.

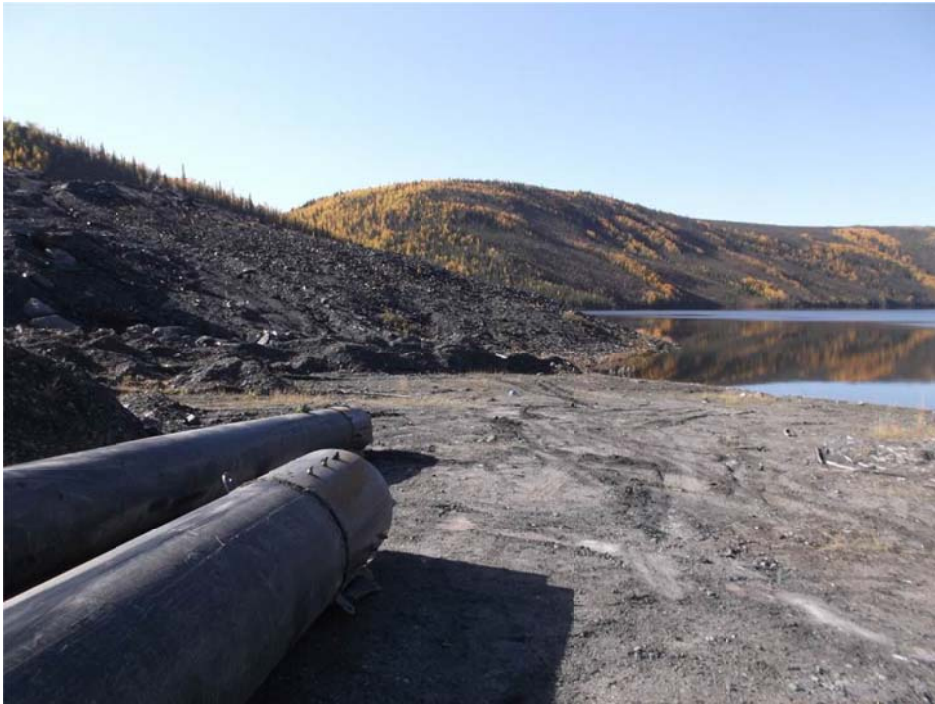
Photo 3. Placement of the log-booms at a sufficient elevation above Hudgeon Lake water level.

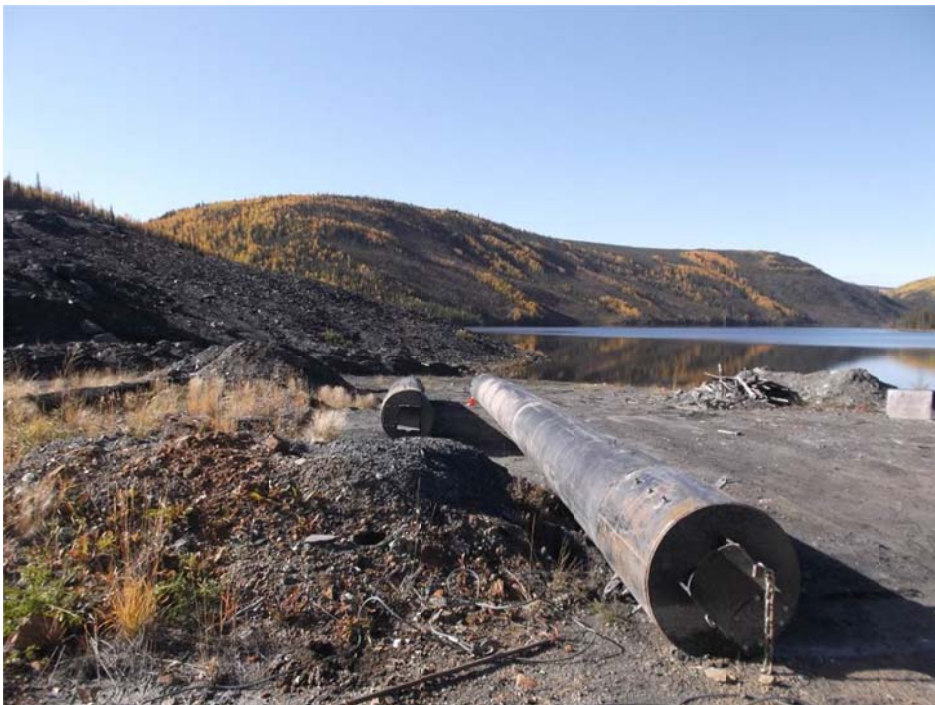
Photo 4. Placement of the log-booms at Hudgeon Lake Outlet.

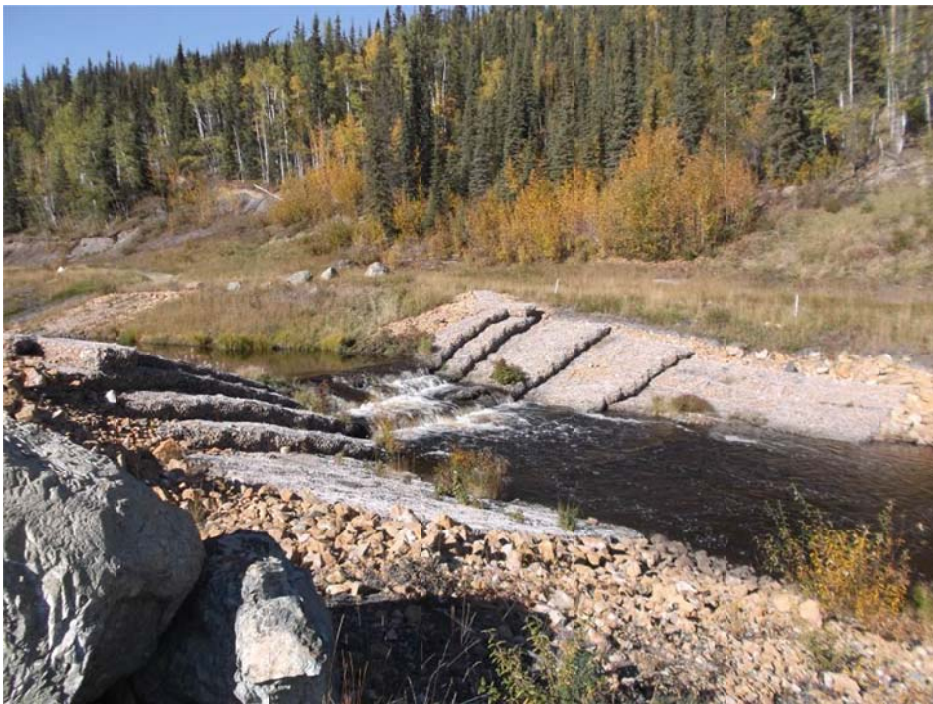
Following the transportation of the log-booms, Luca Poloni (AAM) and Gavin Nyland (Boreal Engineering) were able to safely remove most wood debris from drop structure 1-3 by hand and with the help of an ATV and winch. All wood debris removed from the structures was safely placed on high ground to prevent re-entrance of wood debris following potential of a flash flood.

Photo 5. Drop Structure 1 following removal of wood debris from gabion baskets.

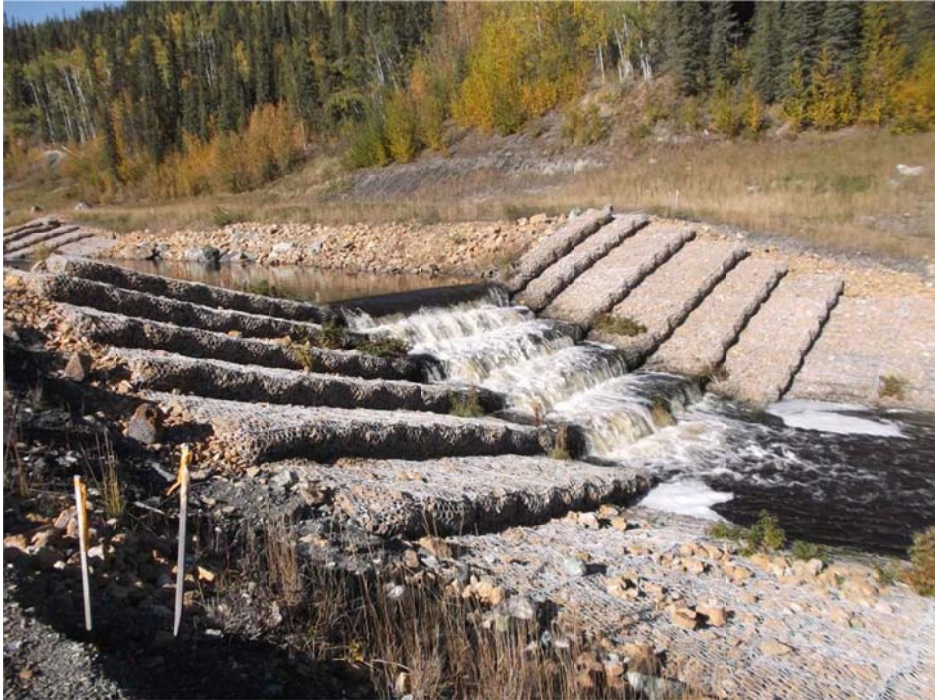
Photo 6. Drop Structure 2 following removal of wood debris from gabion baskets.

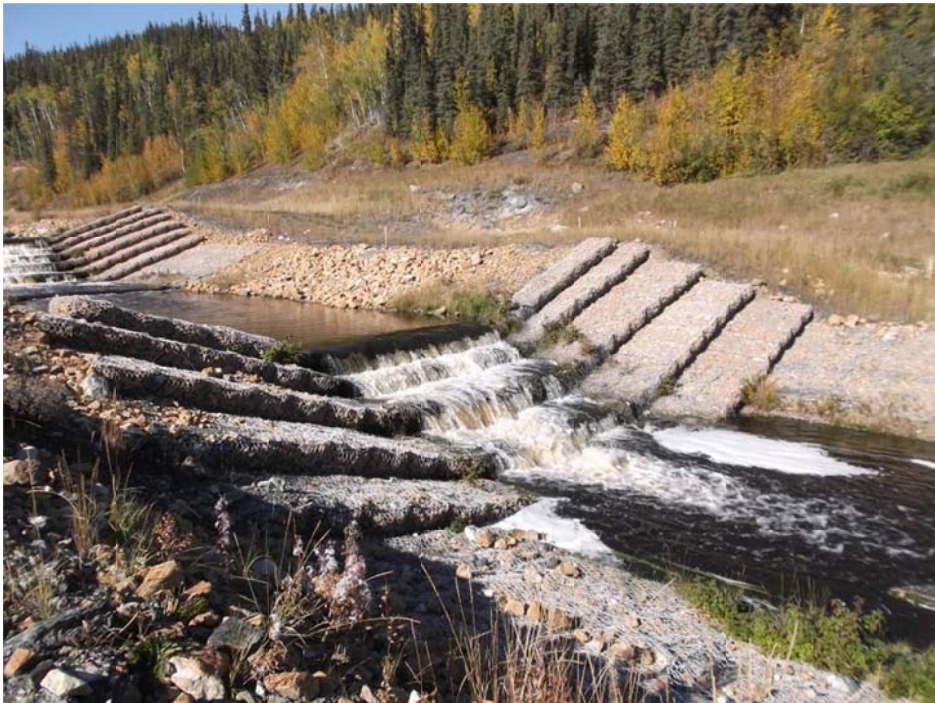
Photo 7. Drop Structure 3 following removal of wood debris from gabion baskets.

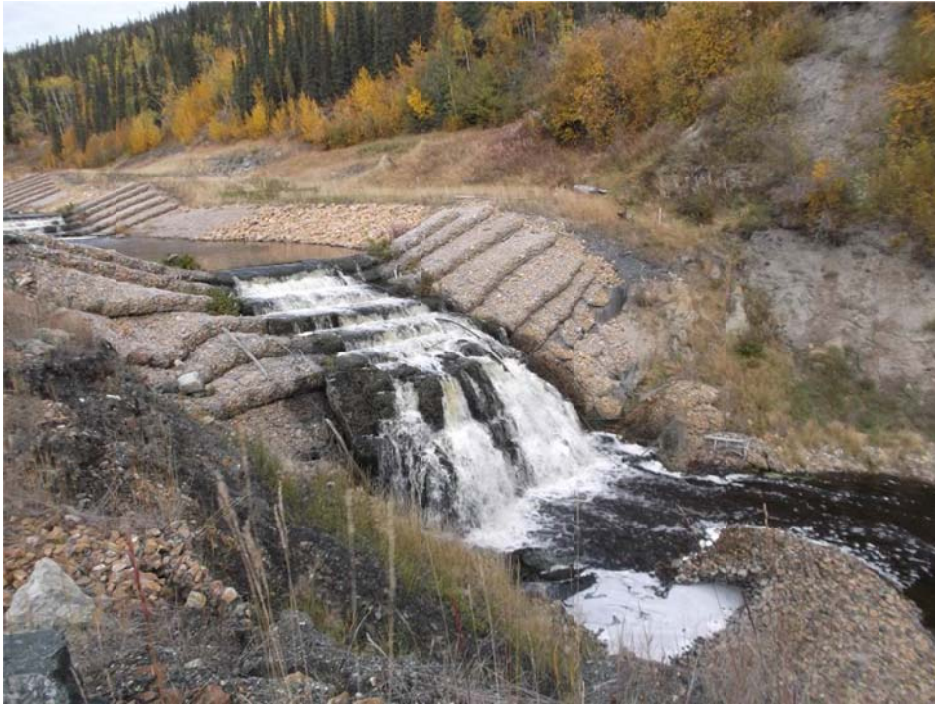
It is important to note that all wood debris within drop structure 4 was untouched due to unsafe working conditions within the area. Furthermore, removal of wood debris from structures 1-3 occurred only where safe accessibility to the debris was permitted.

Photo 8. Current condition of Drop Structure 4, showing significant buildup of wood debris.

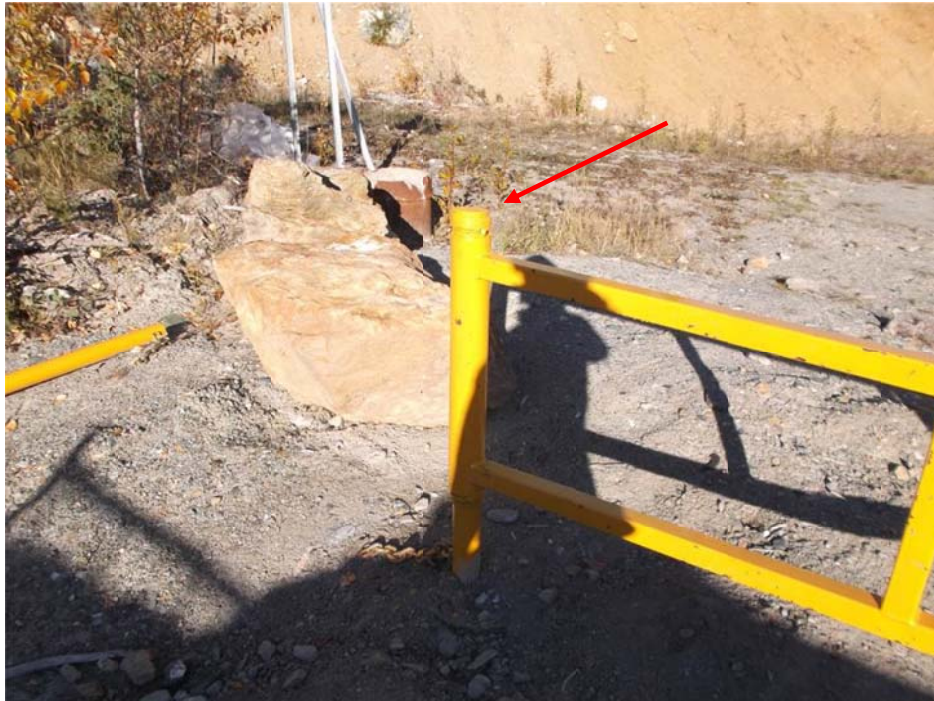
Photo 9. The red arrow above shows the welded metal cap that prevents the gate from being lifted off its resting post.

Firstly, a metal cap plate was welded at the end of the gate where it swings open/closed on a stationary post. Previous to this, trespassers would just lift the gate off the swivel post and would immediately gain access to the site.

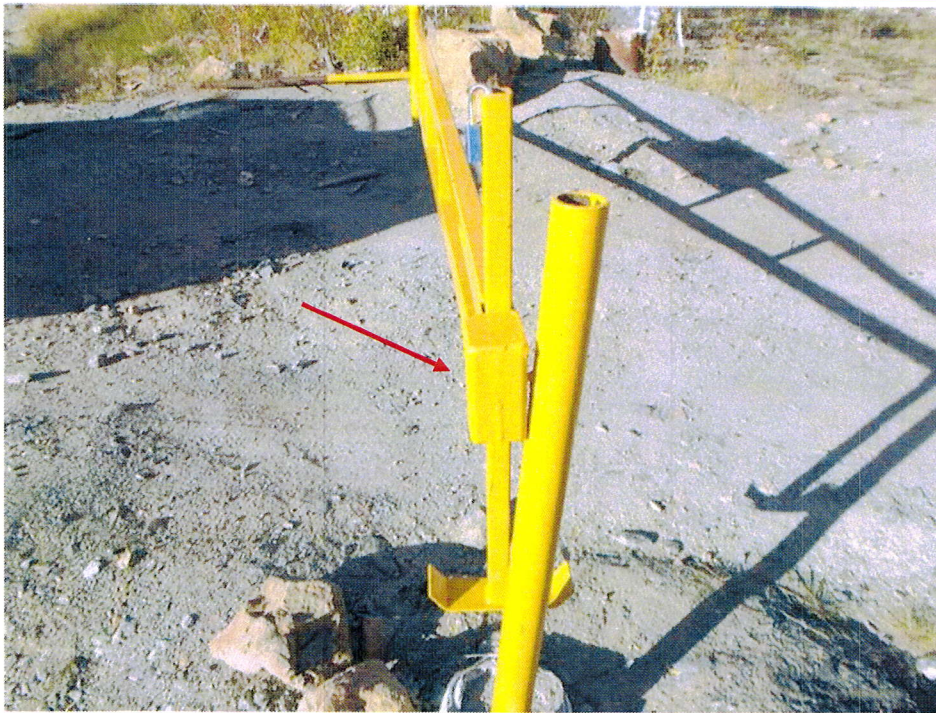
Photo 10. The red arrow above shows the welded metal box that prevents the lock from being cut with the use of lock cutters.

Secondly, a metal casing (or box) was fabricated and welded around the lock pad itself in order to prevent trespassers from using lock cutters.
