TECHNICAL MEMORANDUM

To: Bill Slater and Fred Green **Date:** 20 Sept 2016
Cc: Patricia Randell, Erik Pit, Emilie Hamm, Chris Dixon,
Jason Berkers, and Paul LePage **Project #:** A399-1
From: Alan Martin and Justin Stockwell (Lorax Environmental Services Ltd.)
Subject: Mount Nansen – 2016 Water Quality Update – **FINAL**

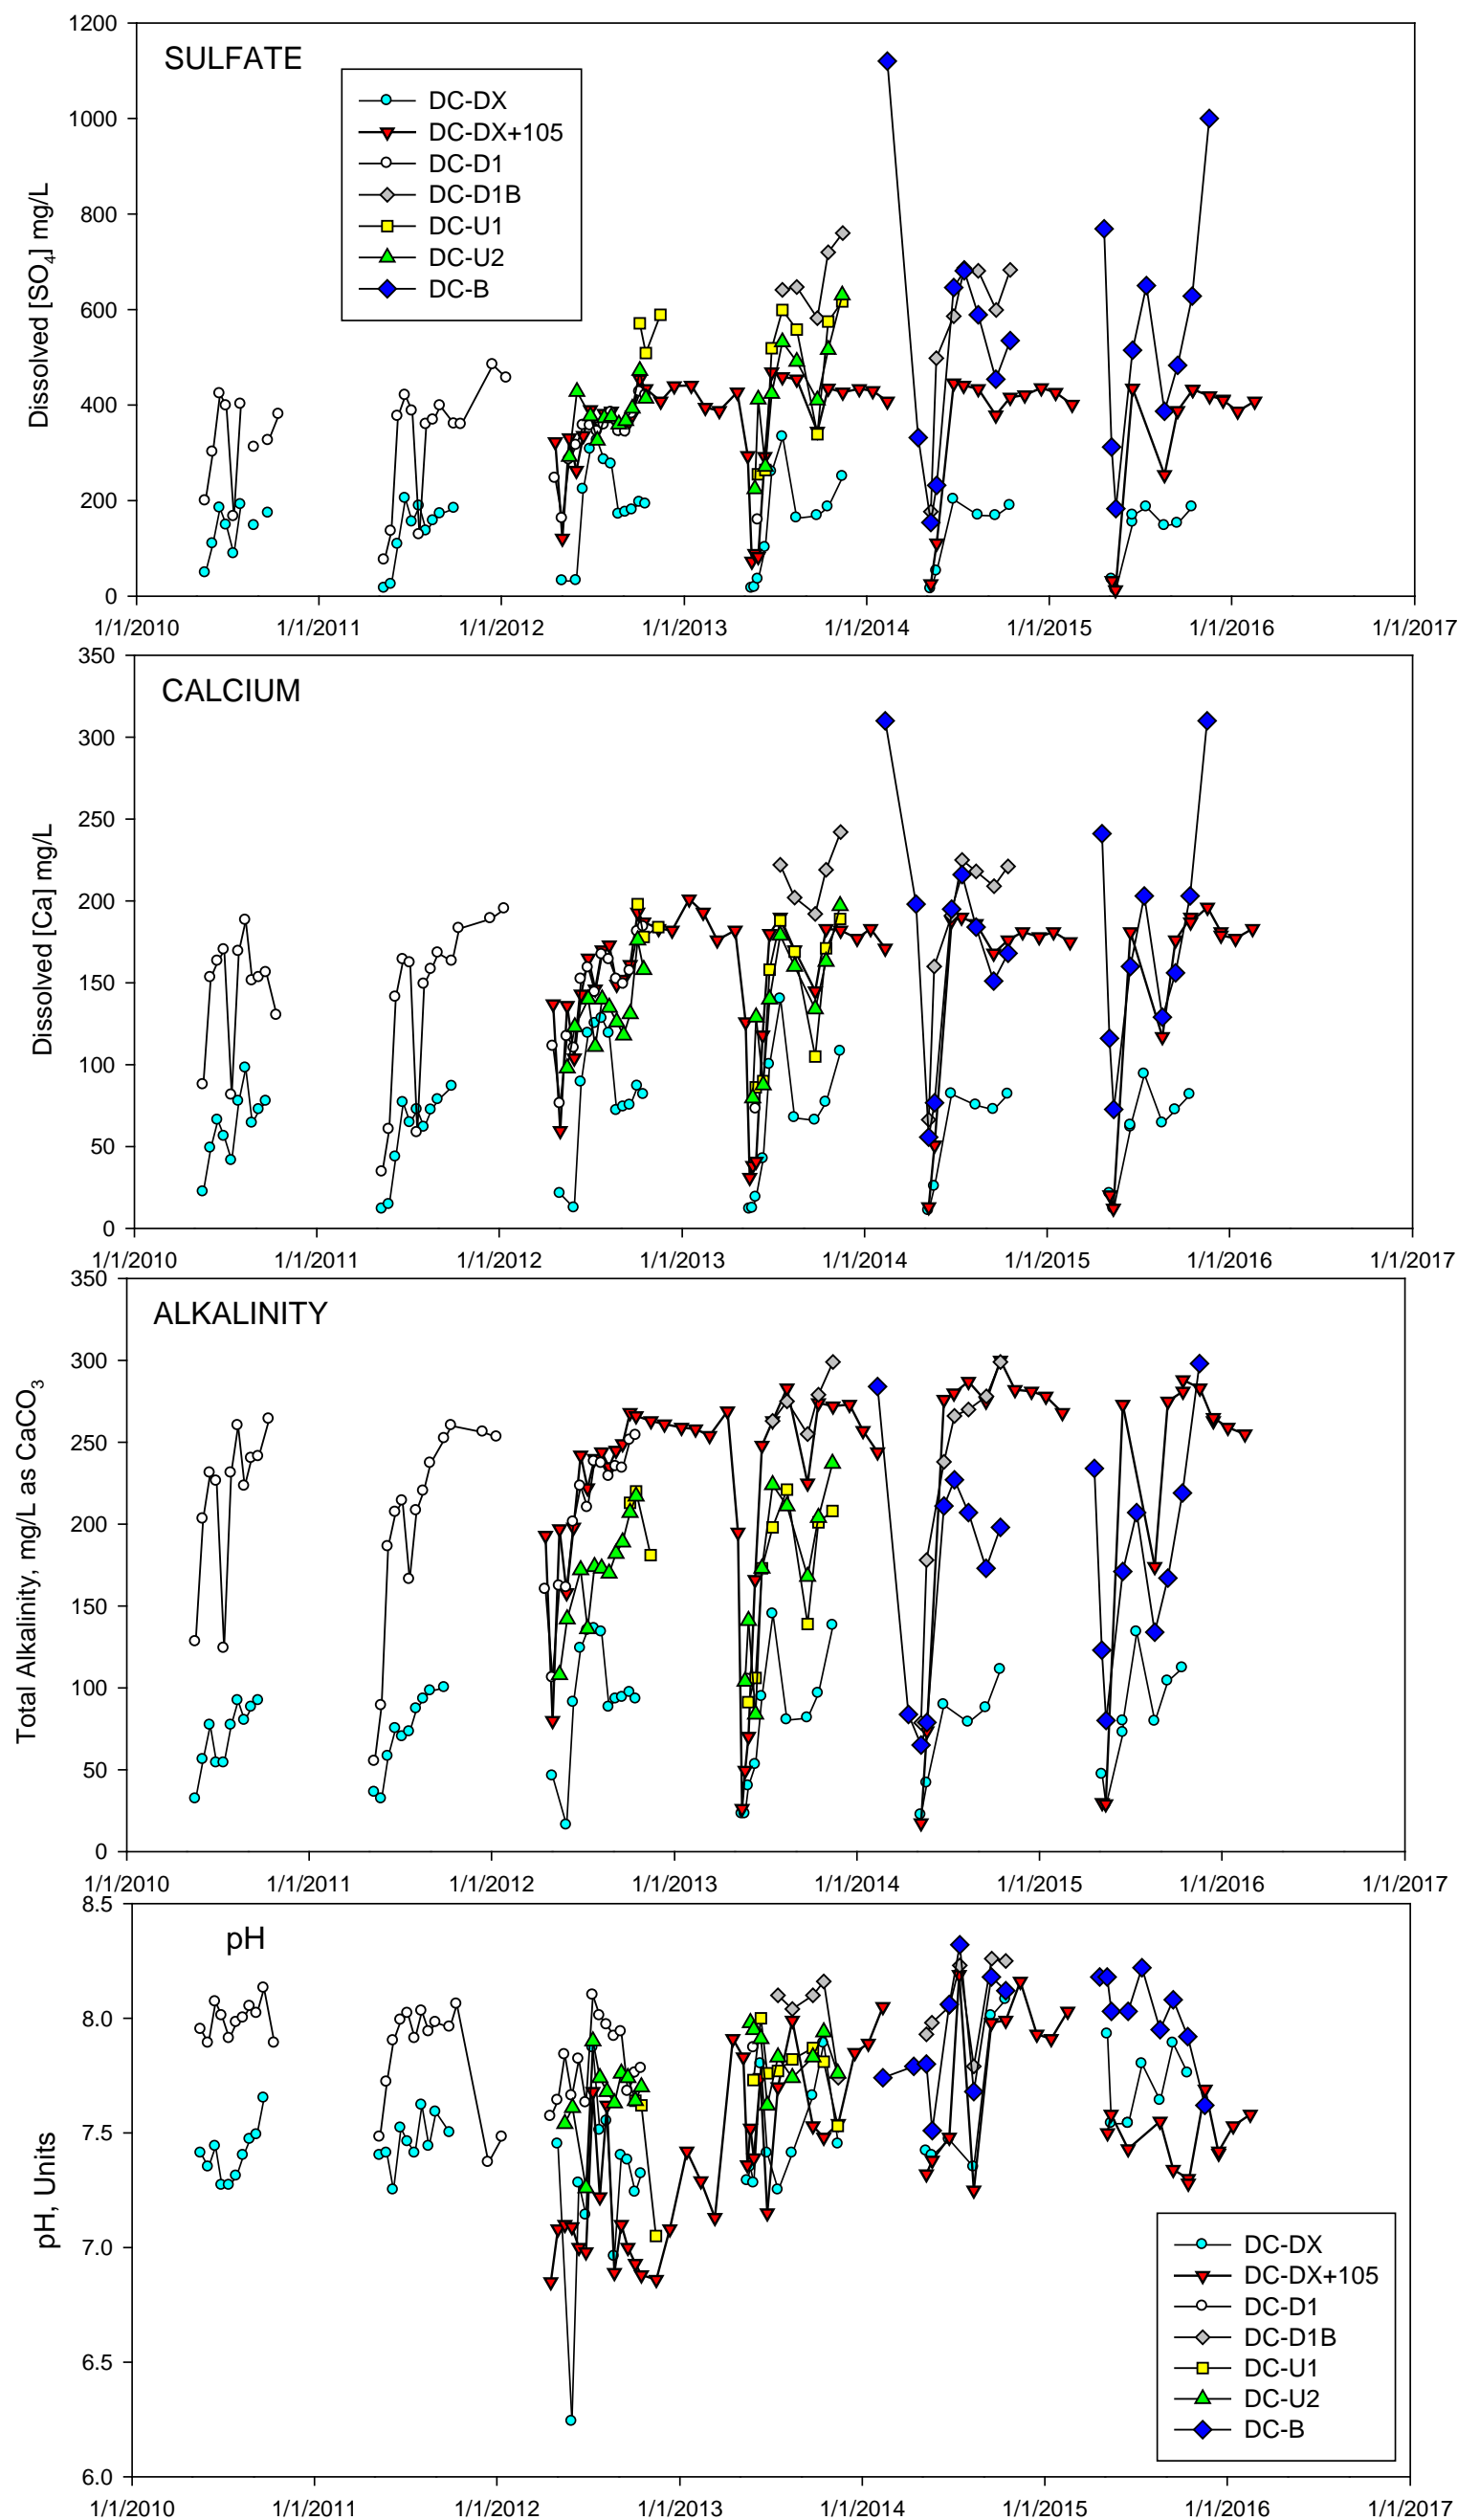
At the upstream control location (DC-DX), time series profiles for major ions (Figure 3) and trace elements (Figure 5) show generally stable seasonal cycles, with pronounced minima observed during freshet. In contrast, the data for dissolved Mn and Fe at DC-DX show episodic spikes in concentration that are not observed for other parameters.

Downstream of DC-DX+105 at DC-D1b, major ions (e.g., SO₄ and Ca) show generally higher concentrations, reflecting additional mine-related inputs upstream of this location (Figure 3). These major ion signatures show evidence of further increases at DC-B, possibly indicating the influence of waste rock drainages. In contrast to the major ion parameters, concentrations of As, Cd and Zn show progressive decreases in concentration from upstream (DC-DX+105) to downstream (DC-B). The data for dissolved Cd and Zn, for example, show strong parallels,

Figure 3: Time series profiles for major ions and pH for surface water stations in Upper Dome Creek (2009-2015 data).

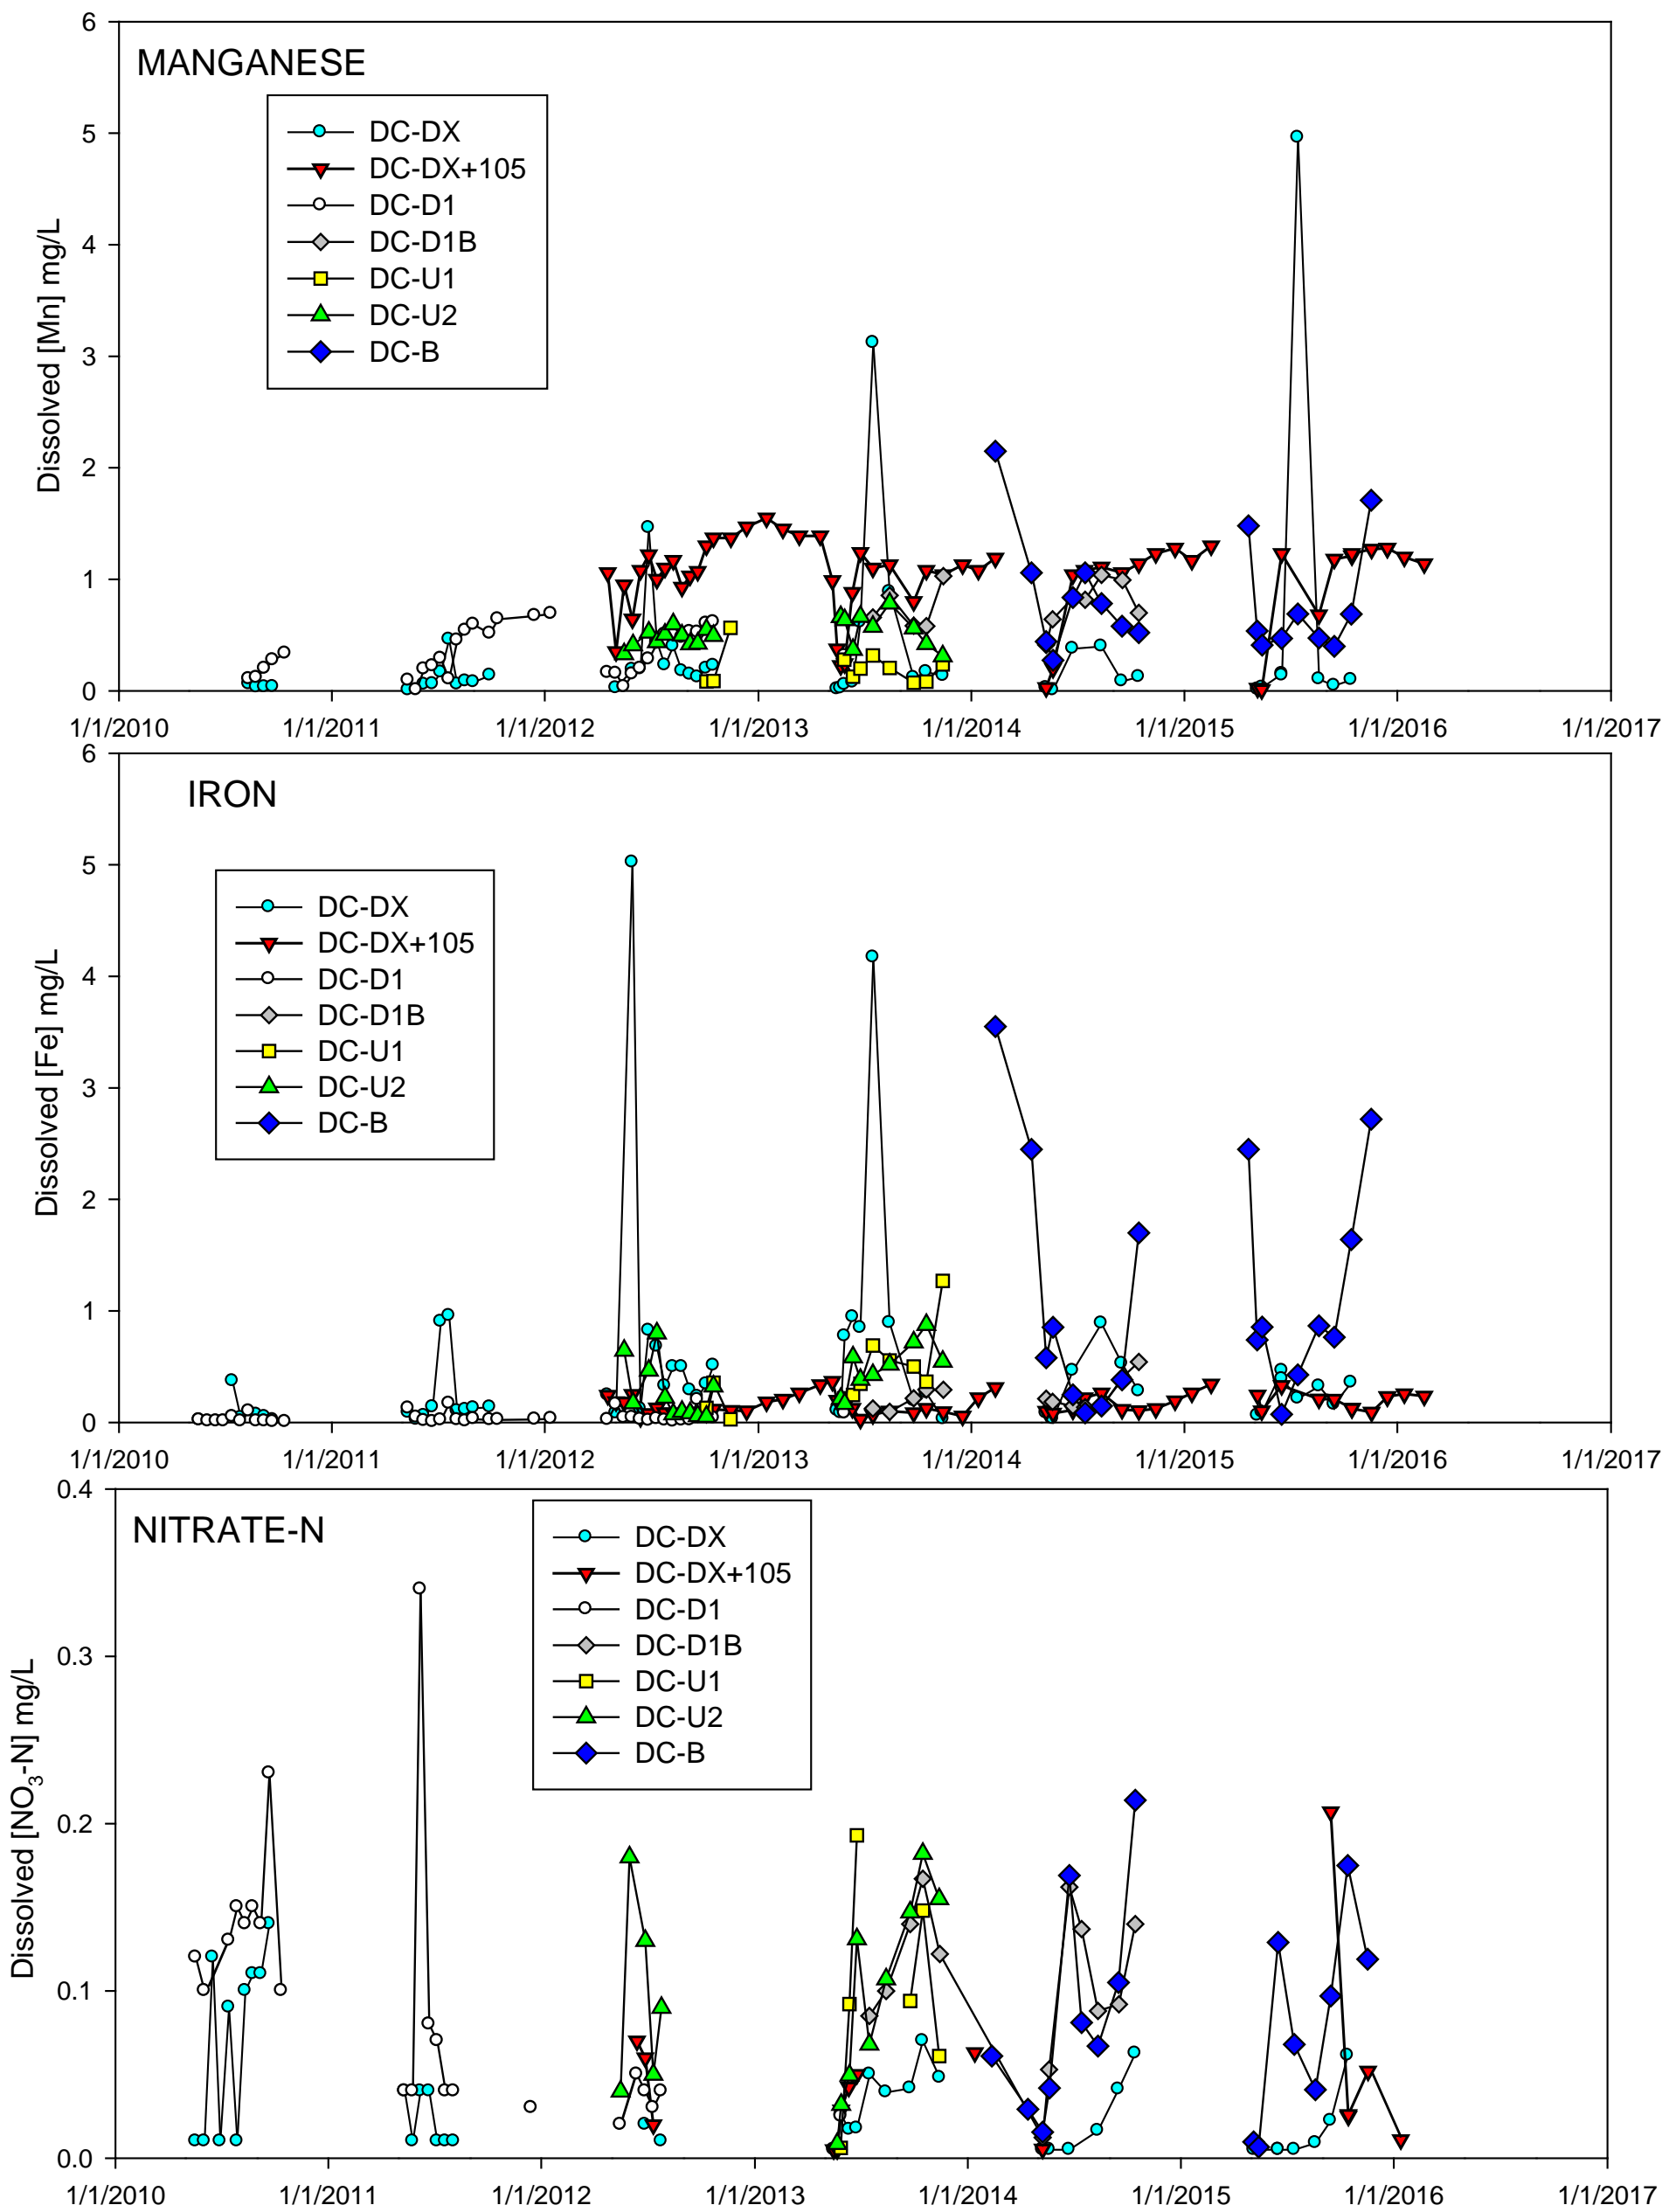
With respect to redox-related parameters, dissolved Fe and Mn show the highest values at DC-B. Dissolved Fe and Mn are not stable in neutral, aerated waters. Given the circum-neutral pH conditions, the elevated levels of Fe and Mn are predicted to reflect the input of suboxic (reduced) waters to the creek system (Figure 4).

Figure 4: Time series profiles for redox-related parameters for surface water stations in Upper Dome Creek (2009-2015 data).

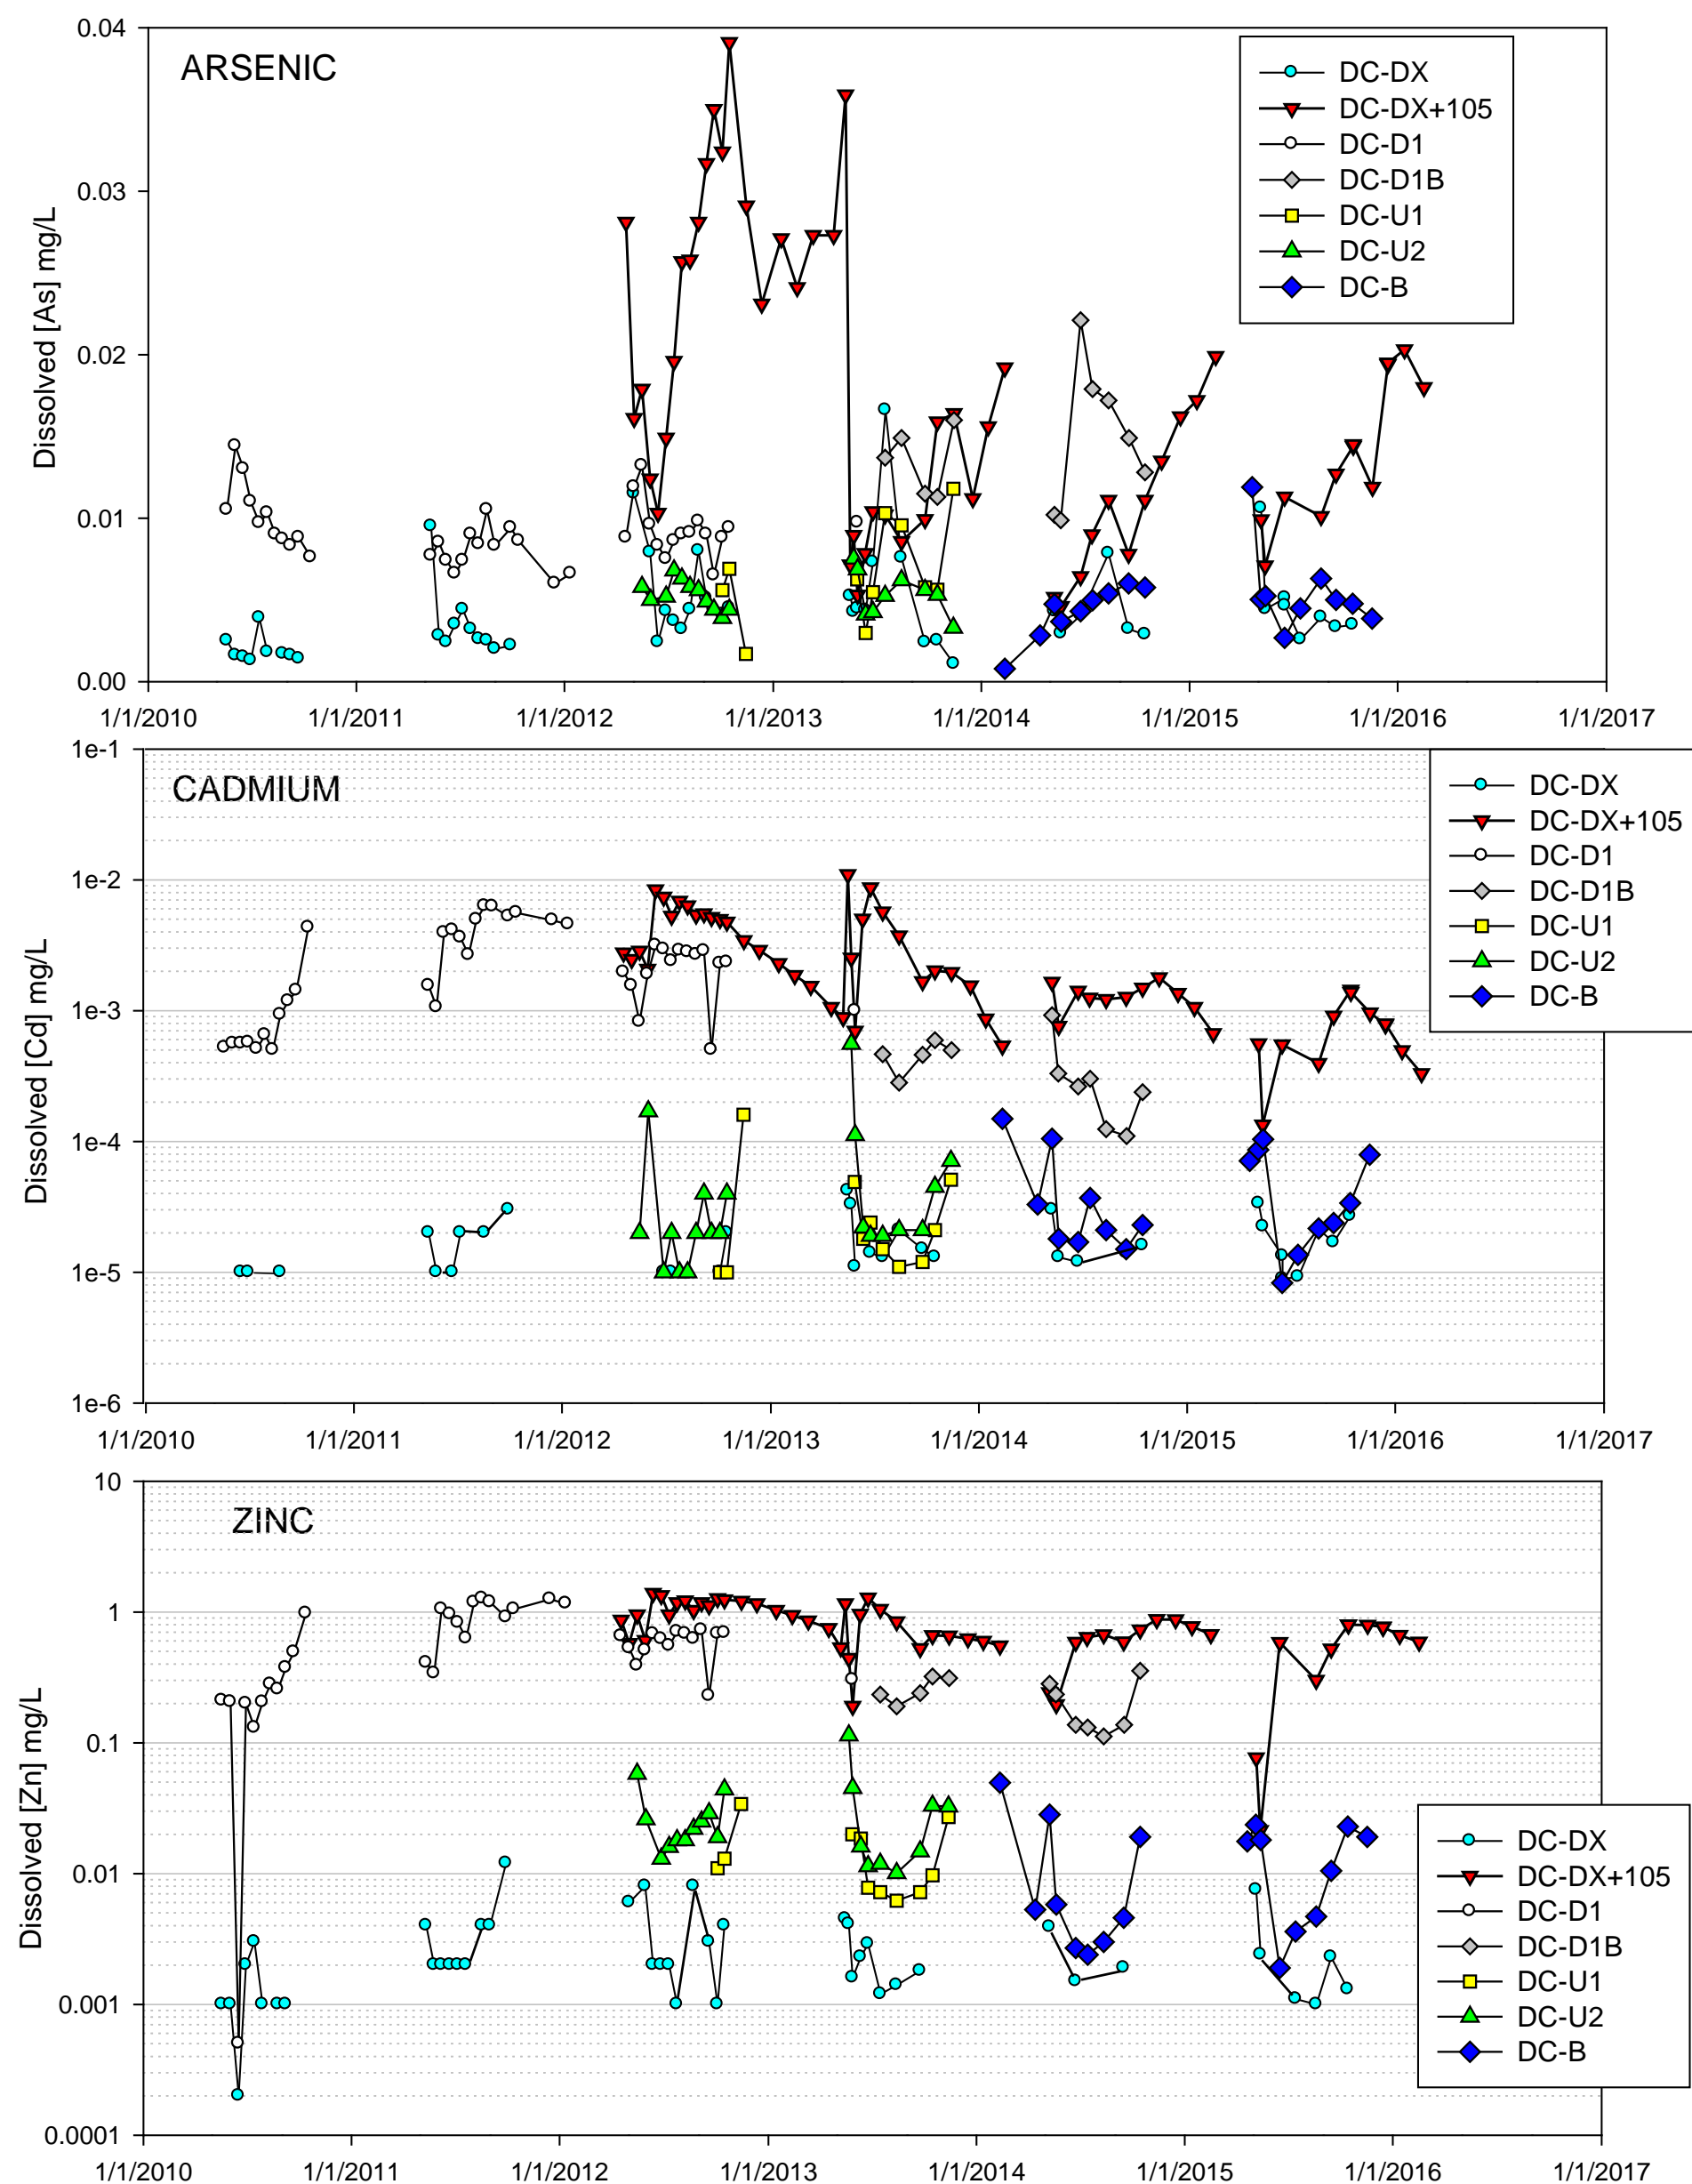
In terms of temporal trends, values for SO₄, Ca and alkalinity at DC-DX+105 have remained relatively constant since 2012. In contrast, the time series profiles for As, Cd and Zn show evidence of decreasing values. Dissolved As, for example, shows a dramatic drop in concentration in 2013, while Cd and Zn show more gradual and congruent declines over the period of record (Figure 5).

illustrating that similar processes govern their remobilization and attenuation within Upper Dome Creek (Figure 5). For both parameters, the highest values are observed at DC-DX+105, with progressively lower values occurring with distance downstream to minima at DC-B. Dilution may play a role in the observed decrease as flows increase by roughly a factor of 10 between the two sites, however other mine signatures (e.g., SO₄ and Ca) show increasing trends with distance downstream (Figure 3). Based on these combined observations, the decrease in Cd and Zn between DC-DX+105 and DC-B is interpreted to reflect the attenuation processes along the creek system flowpath and is consistent with the data and interpretations provided in Lorax (2010) and SLR (2015b). The exact nature of the attenuation processes has not been defined, but likely include to some degree, adsorption/co-precipitation with Fe/Mn oxides, and possibly adsorption to organic substrates.

The magnitude of attenuation in Lower Dome Creek is significant, with values for As, Cd, and Zn at DC-B being very similar to background ranges observed at DC-DX (Figure 5). The concentrations measured at DC-B are also lower than values measured in the Tailings Seepage Pond and downstream at DC-U and DC-R, indicating that Upper Dome Creek contributes negligibly to the Cd and Zn signatures in Lower Dome Creek.

Figure 5: Time series profiles for dissolved As, Cd and Zn for surface water stations in Upper Dome Creek (2009-2015 data). Note log scales on Y axes for Cd and Zn.

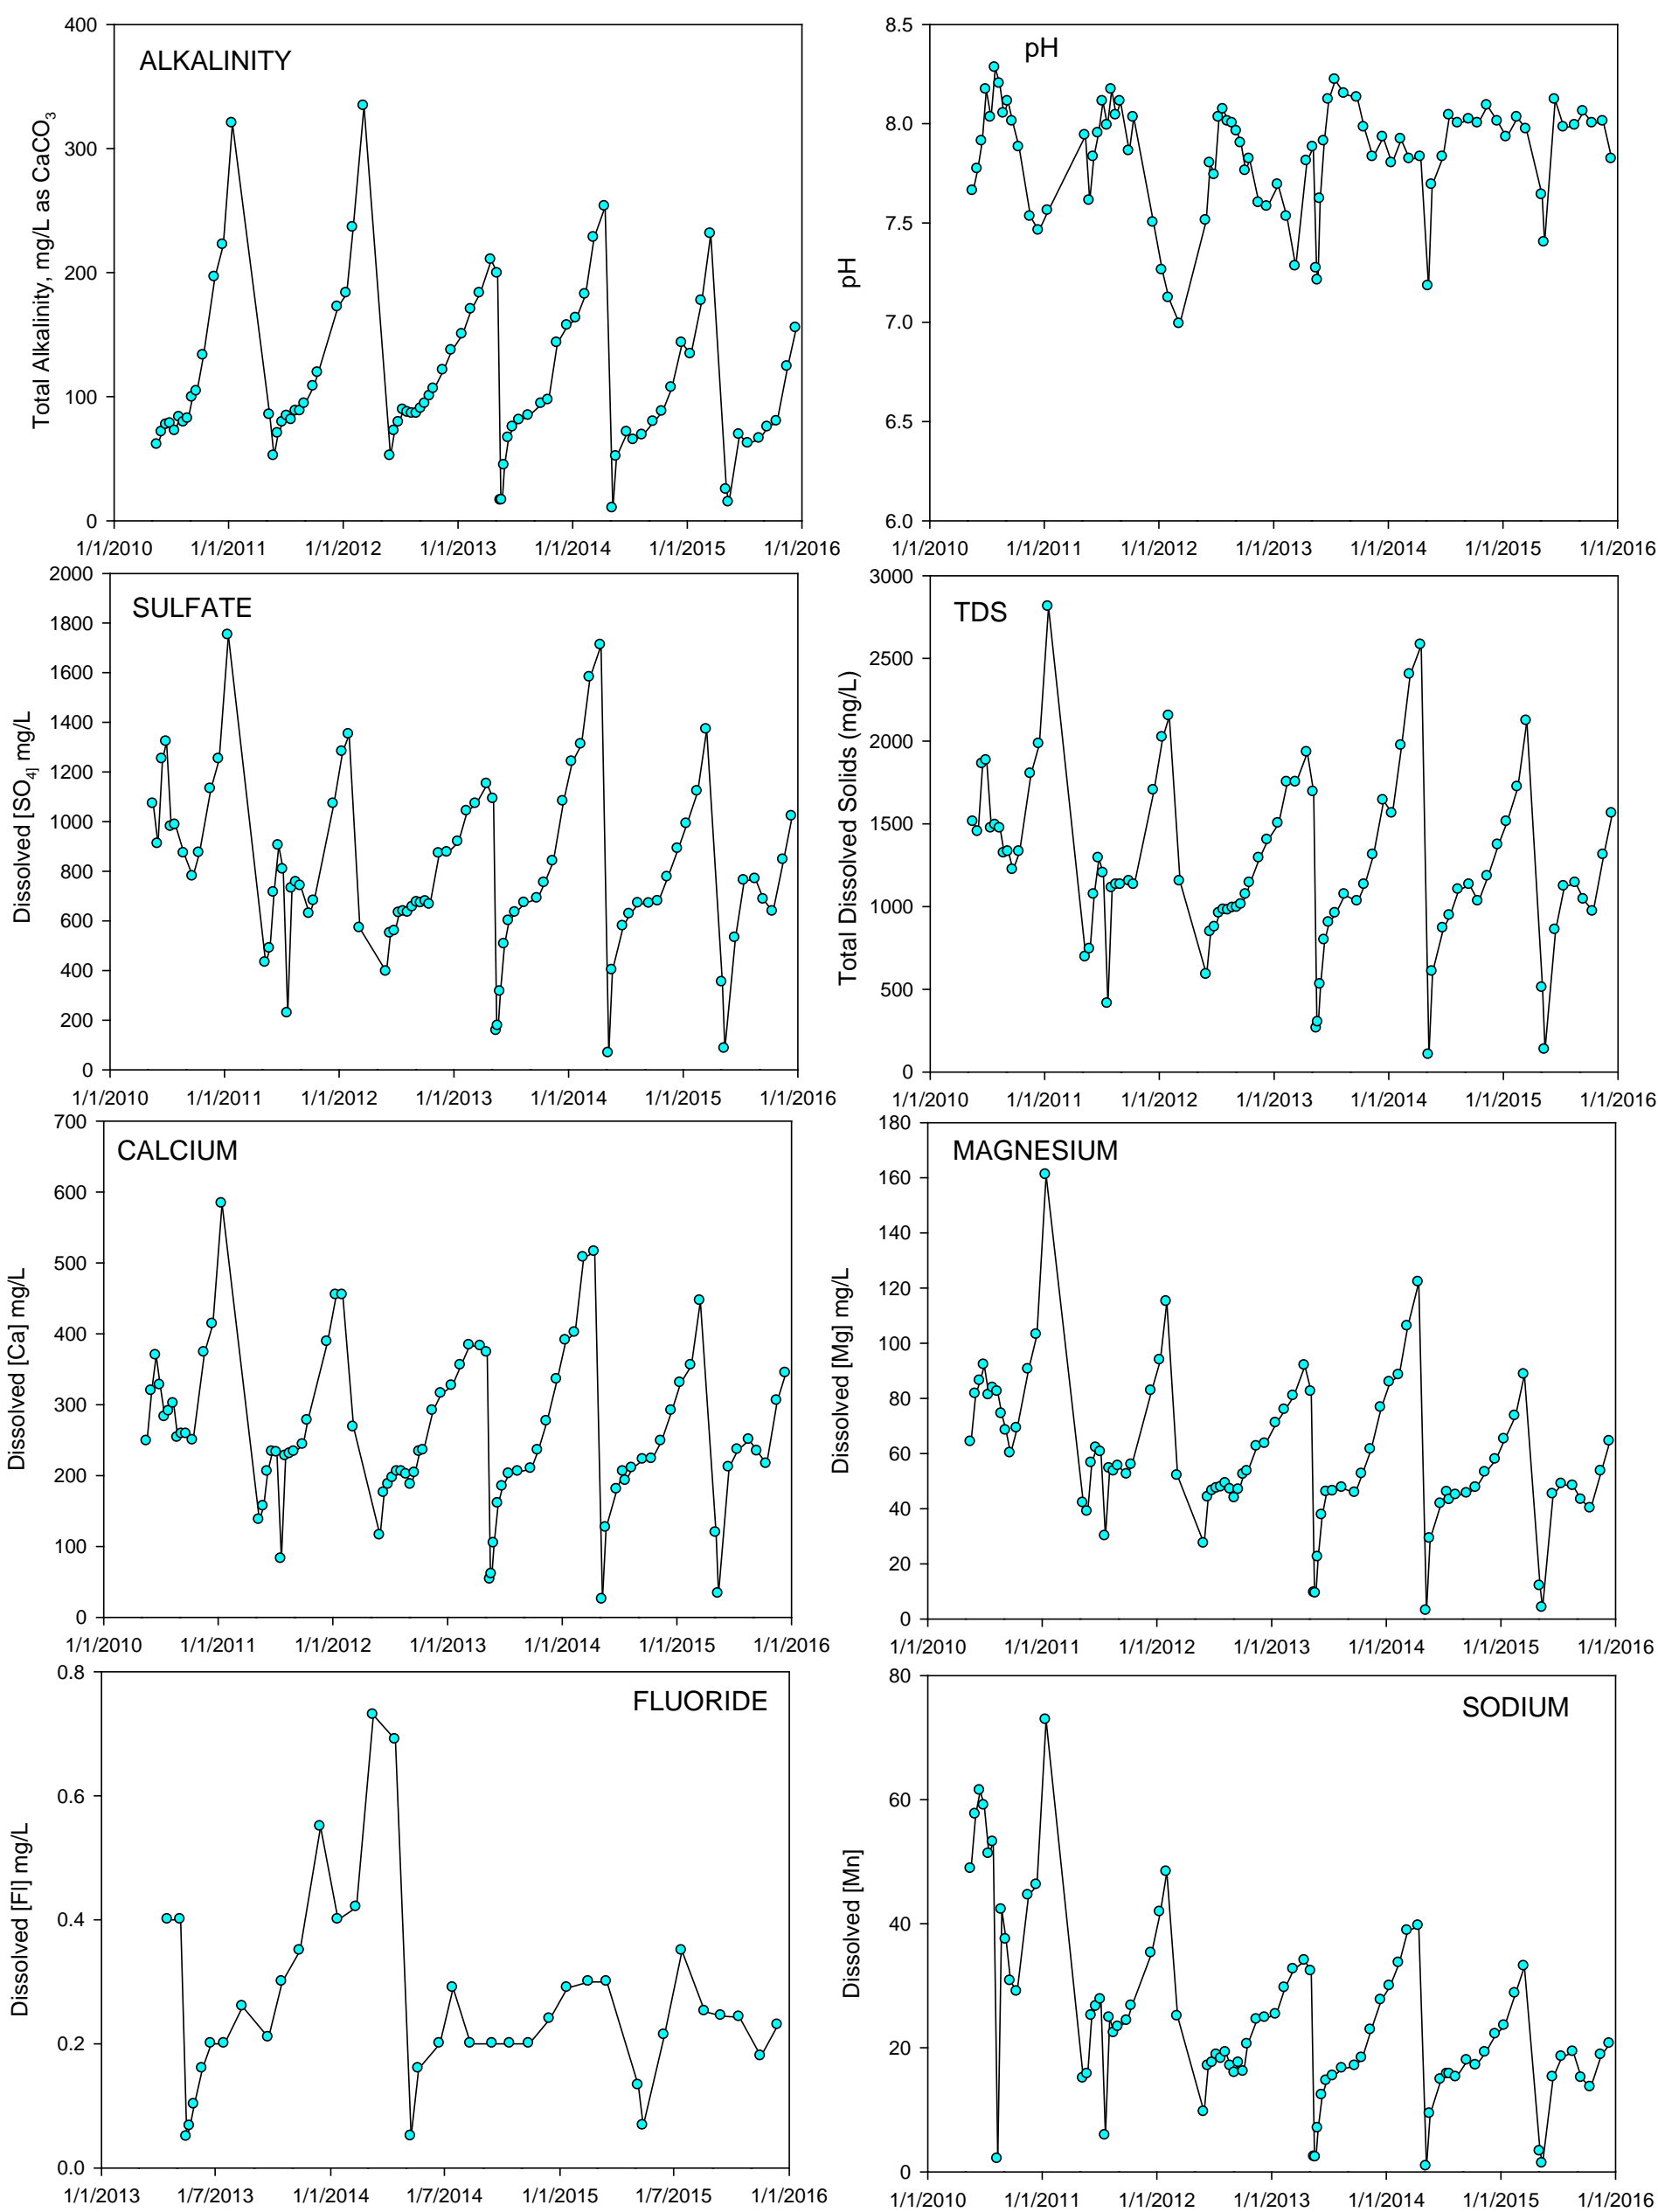
Major ion concentrations in the Tailings Pond show a consistent seasonal pattern of minima during freshet (typically May), and increasing over the summer/fall/winter to maxima in the late winter period (April) (Figure 6). Superimposed on this seasonal cycle is a trend of decreasing major ion values since 2010, with both the annual minima and maxima generally showing lower values over time. Tailings pond pH values have remained stable (most values 7.2<pH<8.2). With respect to redox-related parameters, data for dissolved Fe, Mn, nitrite (NO₂-N) and ammonia (NH₃-N) show variable values, with no discernible inter-annual trends (Figure 7). In contrast, nitrate (NO₃-N) has shown a trend of declining concentrations since 2010, with all values in 2015 being <0.2 mg/L.

Alkalinity and pH in the Seepage Pond show variable, though stable conditions (Figure 12). Sodium shows a progressive decline in concentration in the Seepage Pond since 2010 (Figure 12). Sodium is positively correlated with SCN, suggesting the Na decrease reflects the progressive flushing of residual cyanide mill reagents (added as NaCN). This trend is consistent with generally decreasing Na values in the Tailings Pond (Figure 6).

Figure 6: Time series profiles for major ions, TDS and pH for the Tailings Pond.

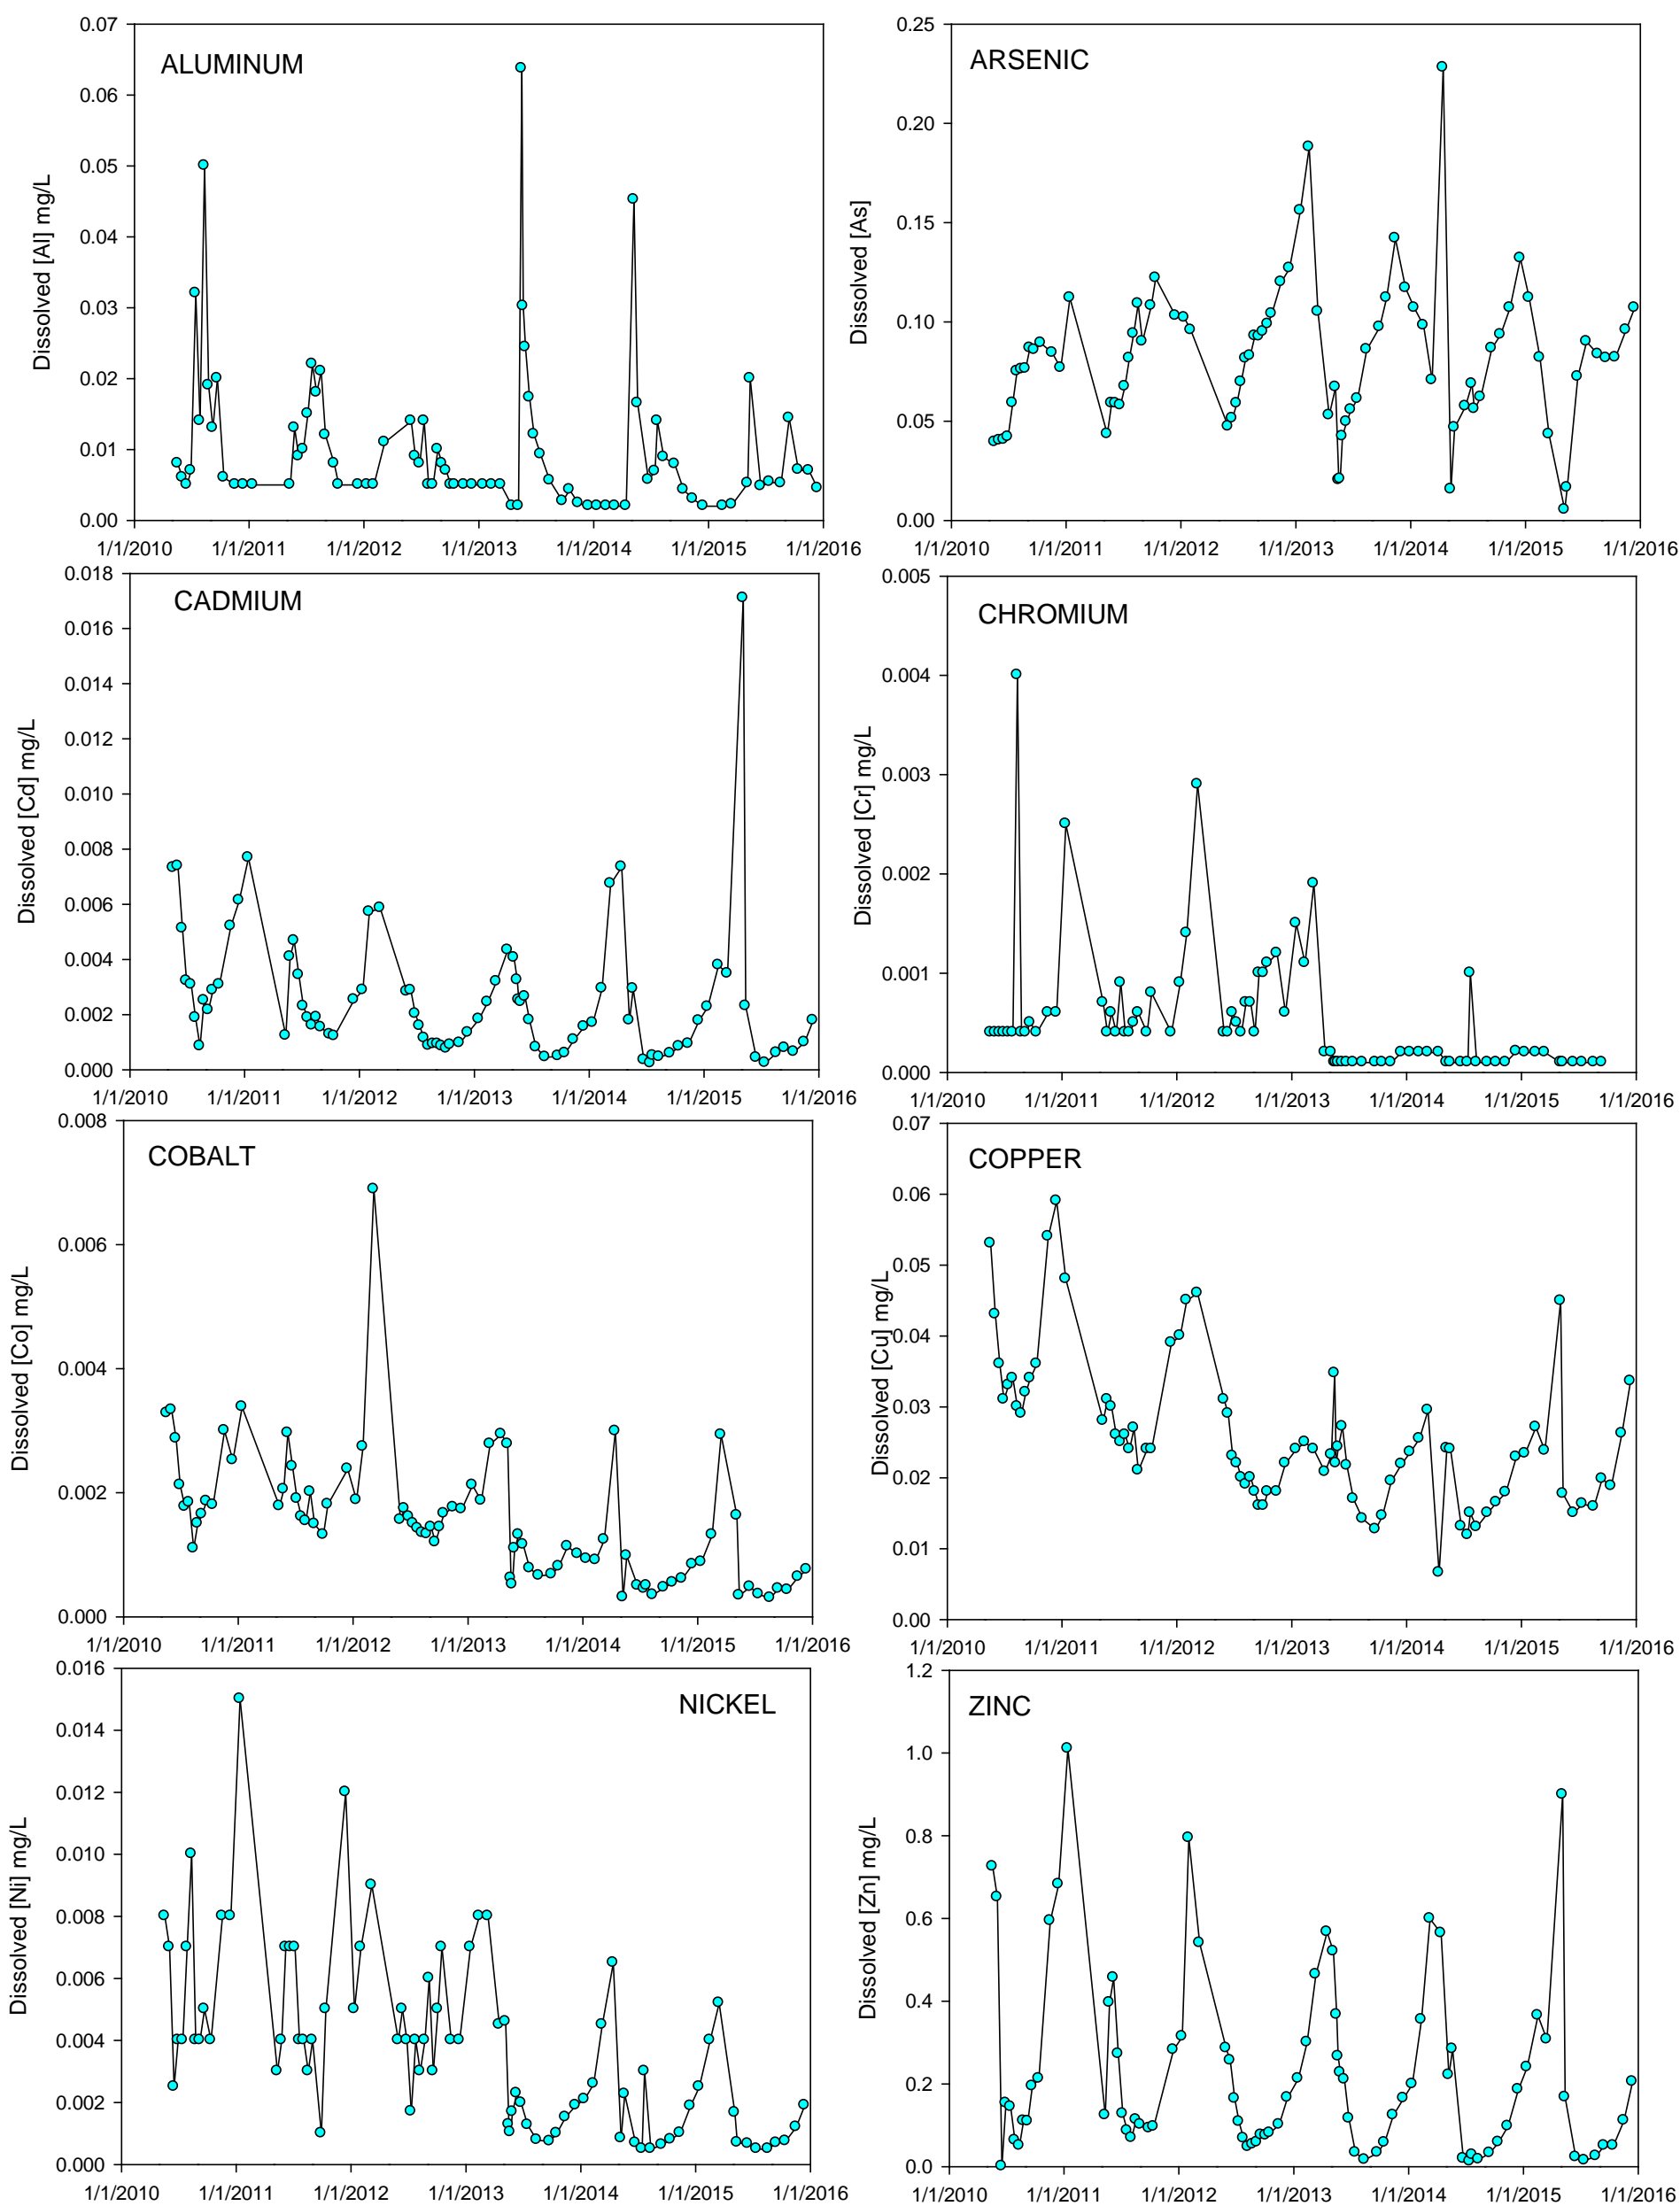
Trace element data for the Tailings Pond show mixed trends (Figure 8). Dissolved Co, Cu and Ni, for example, show generally decreasing concentrations since 2010. In contrast, As, Cd, and Zn do

not show any definitive inter-annual trends, with the exception of decreasing annual minima since 2010 (Figure 8). Chromium shows a pronounced decline in concentration beginning on April 17, 2013. This date coincides with decreases for other trace elements (Pb and Se) and NO₂-N, as well as a transition to higher detection limits for chloride, thiocyanate and cyanate. These observed changes may reflect a systemic analytical change (e.g., laboratory, instrument or methodology change) and are assumed to not be related to changes in the natural environment.

Figure 8: Time series profiles for trace elements for the Tailings Pond.
