TECHNICAL MEMORANDUM

To: Bill Slater and Fred Green **Date:** 20 Sept 2016
Cc: Patricia Randell, Erik Pit, Emilie Hamm, Chris Dixon,
Jason Berkers, and Paul LePage **Project #:** A399-1
From: Alan Martin and Justin Stockwell (Lorax Environmental Services Ltd.)
Subject: Mount Nansen – 2016 Water Quality Update – **FINAL**

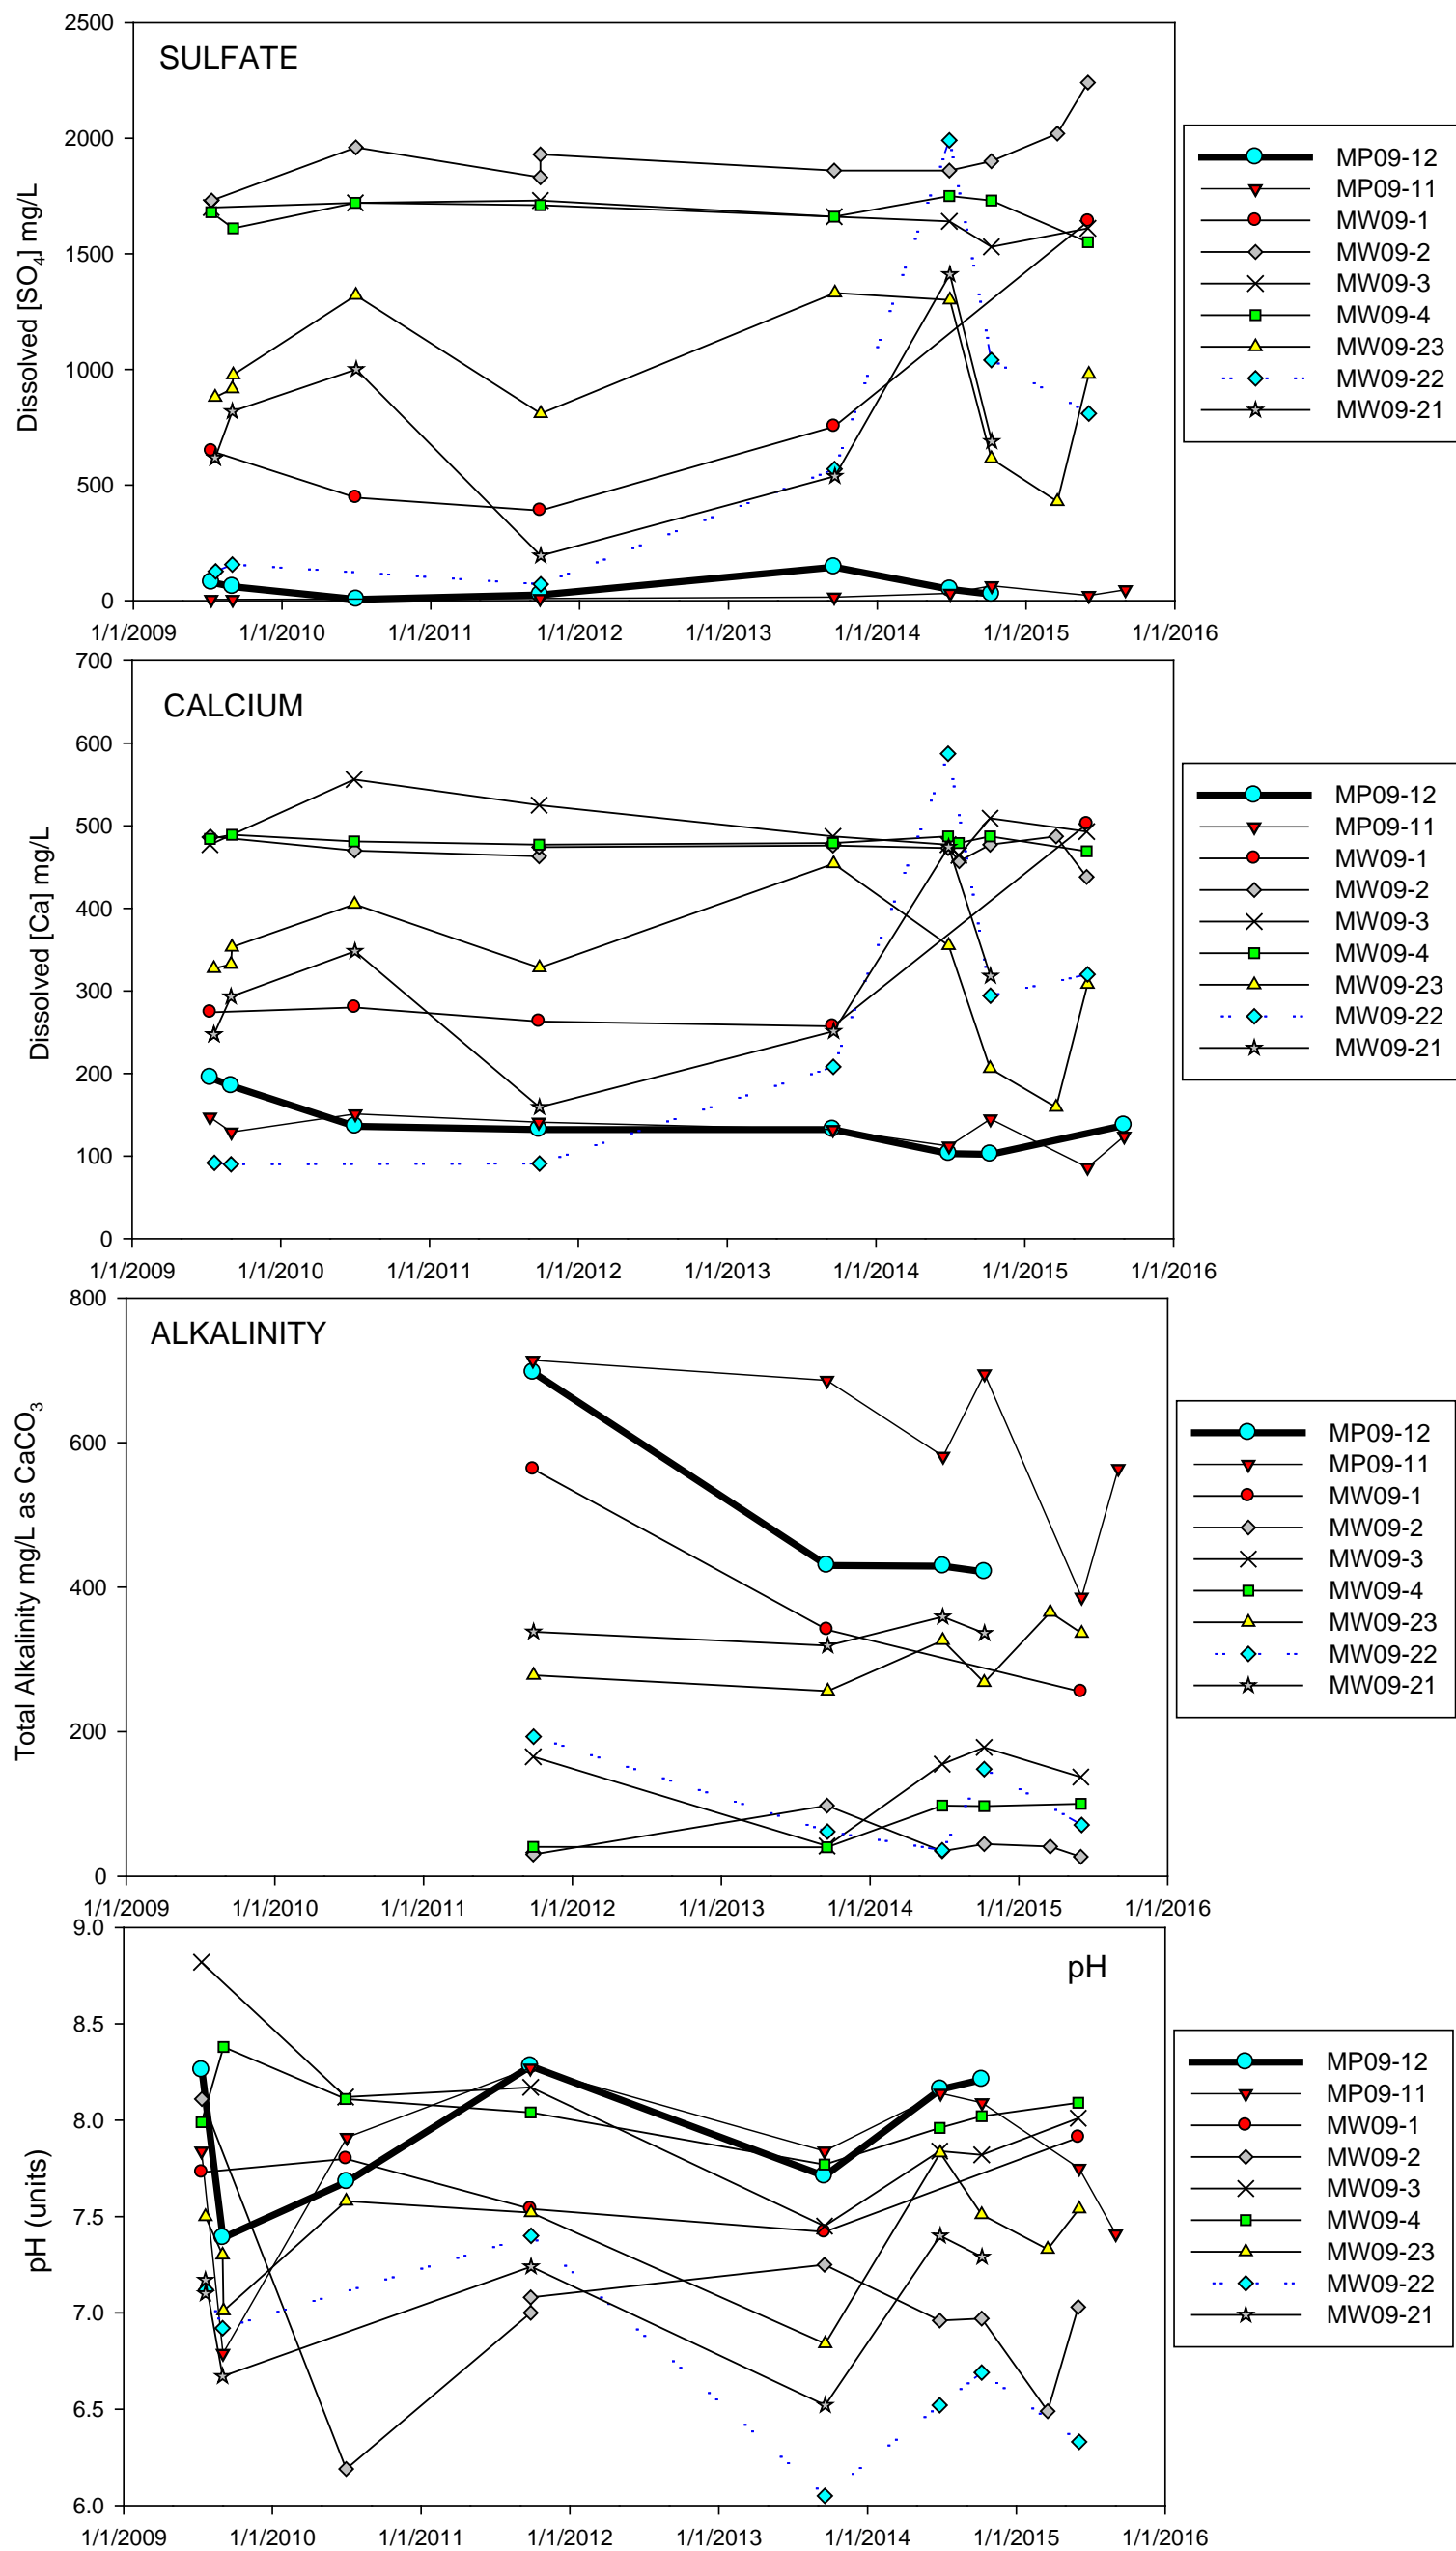
Water quality data for groundwater wells in the tailings facility are shown for major ions and pH (Figure 9), trace elements (Figure 10) and redox-related parameters (Figure 11). In general, major ions show seasonal and spatial variability. Data from piezometer MP09-12 are generally interpreted to be representative of background conditions and are shown in bold for comparison to other locations. With respect to major ions, SO₄ shows significant temporal variability with some evidence of increasing concentrations at MW09-1, MW09-2, and MW09-22. Data from MW09-1 should be viewed with caution, however, as the well head is reportedly cracked at surface (Hemmera, 2016) and likely has been contaminated by near-surface tailings and/or pond water. Possible SO₄ increases are evident at MW09-22, which shows a trend towards higher values in 2014 and 2015 (809 to 1990 mg/L) in comparison to values in 2009 and 2011 (70 to 156 mg/L).

Figure 9: Time series profiles for major ions and pH for Tailings Management Area groundwater wells.

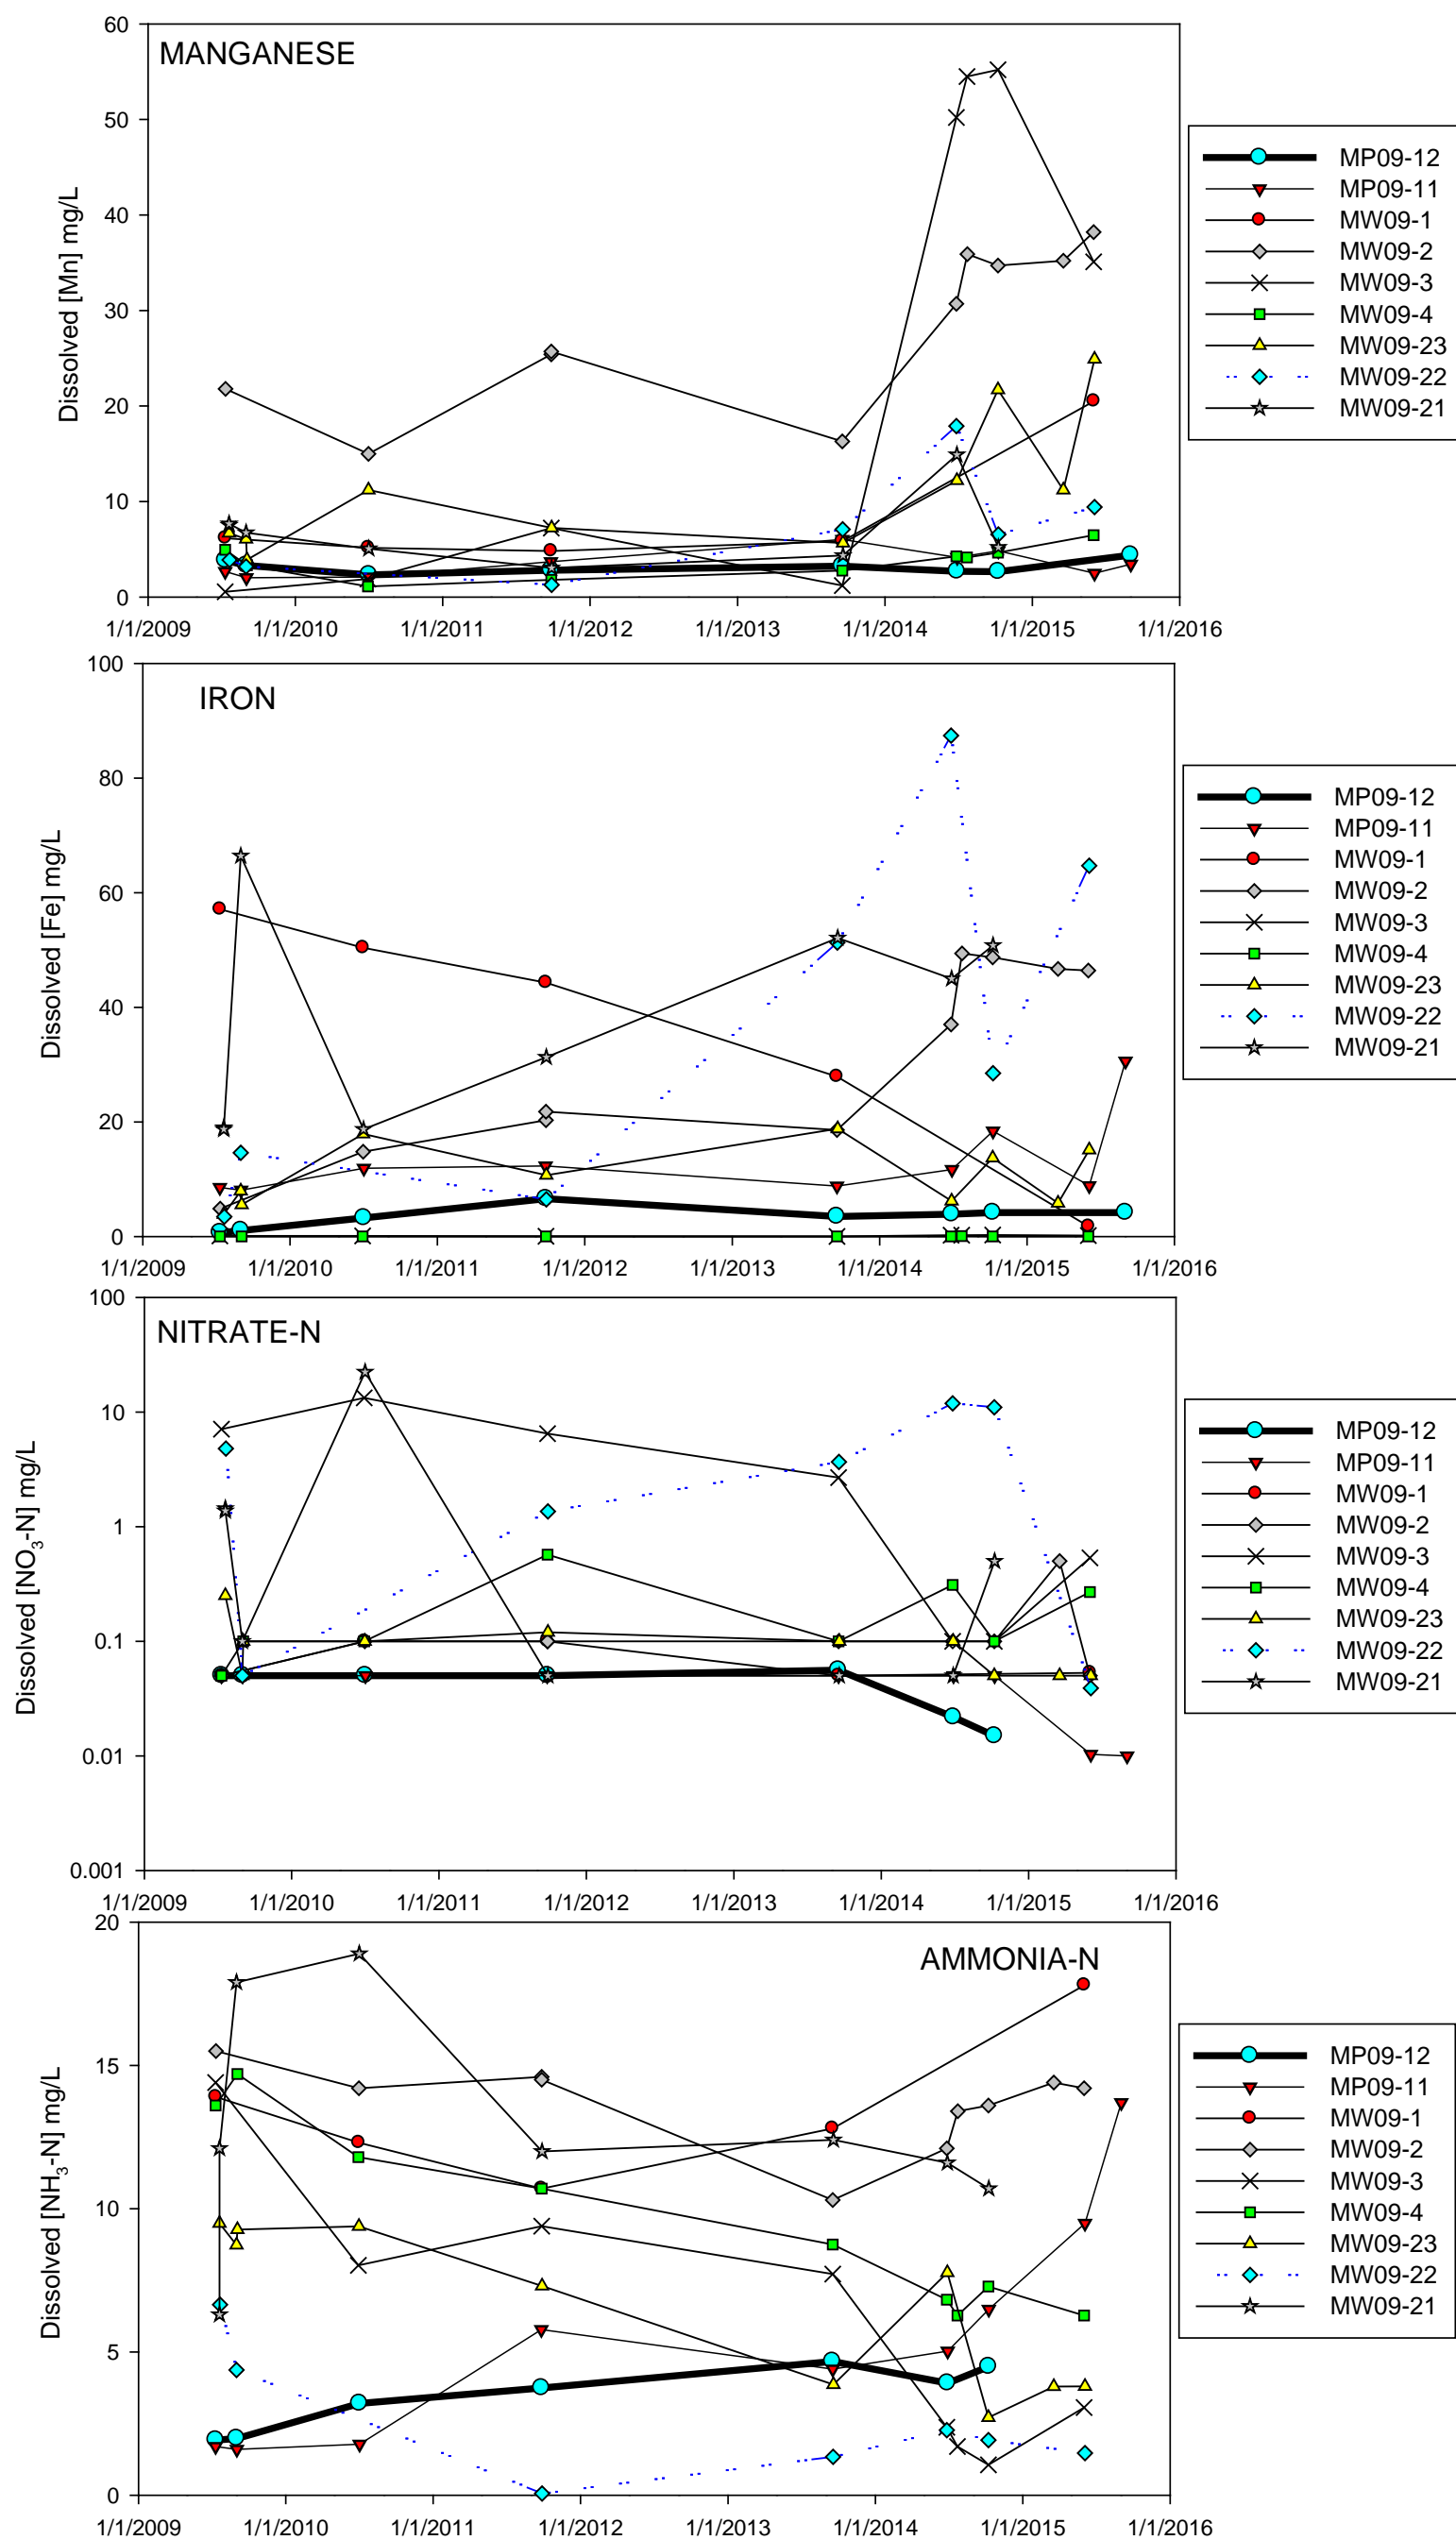
Inspection of redox-related parameters shows evidence for increasing Mn values in most wells since 2013, including MW09-1, MW09-2, MW09-3, MW09-21, MW09-22 and MW09-23 (Figure 11). Of these wells, MW09-2, MW09-21 and MW09-22 also show increases in dissolved Fe concentration in recent years. These observations may indicate a trend towards more reducing conditions in tailings porewaters, as supported by data for the Seepage Pond (discussed below).

Figure 11: Time series profiles of redox-related parameters for Tailings Management Area groundwater wells.

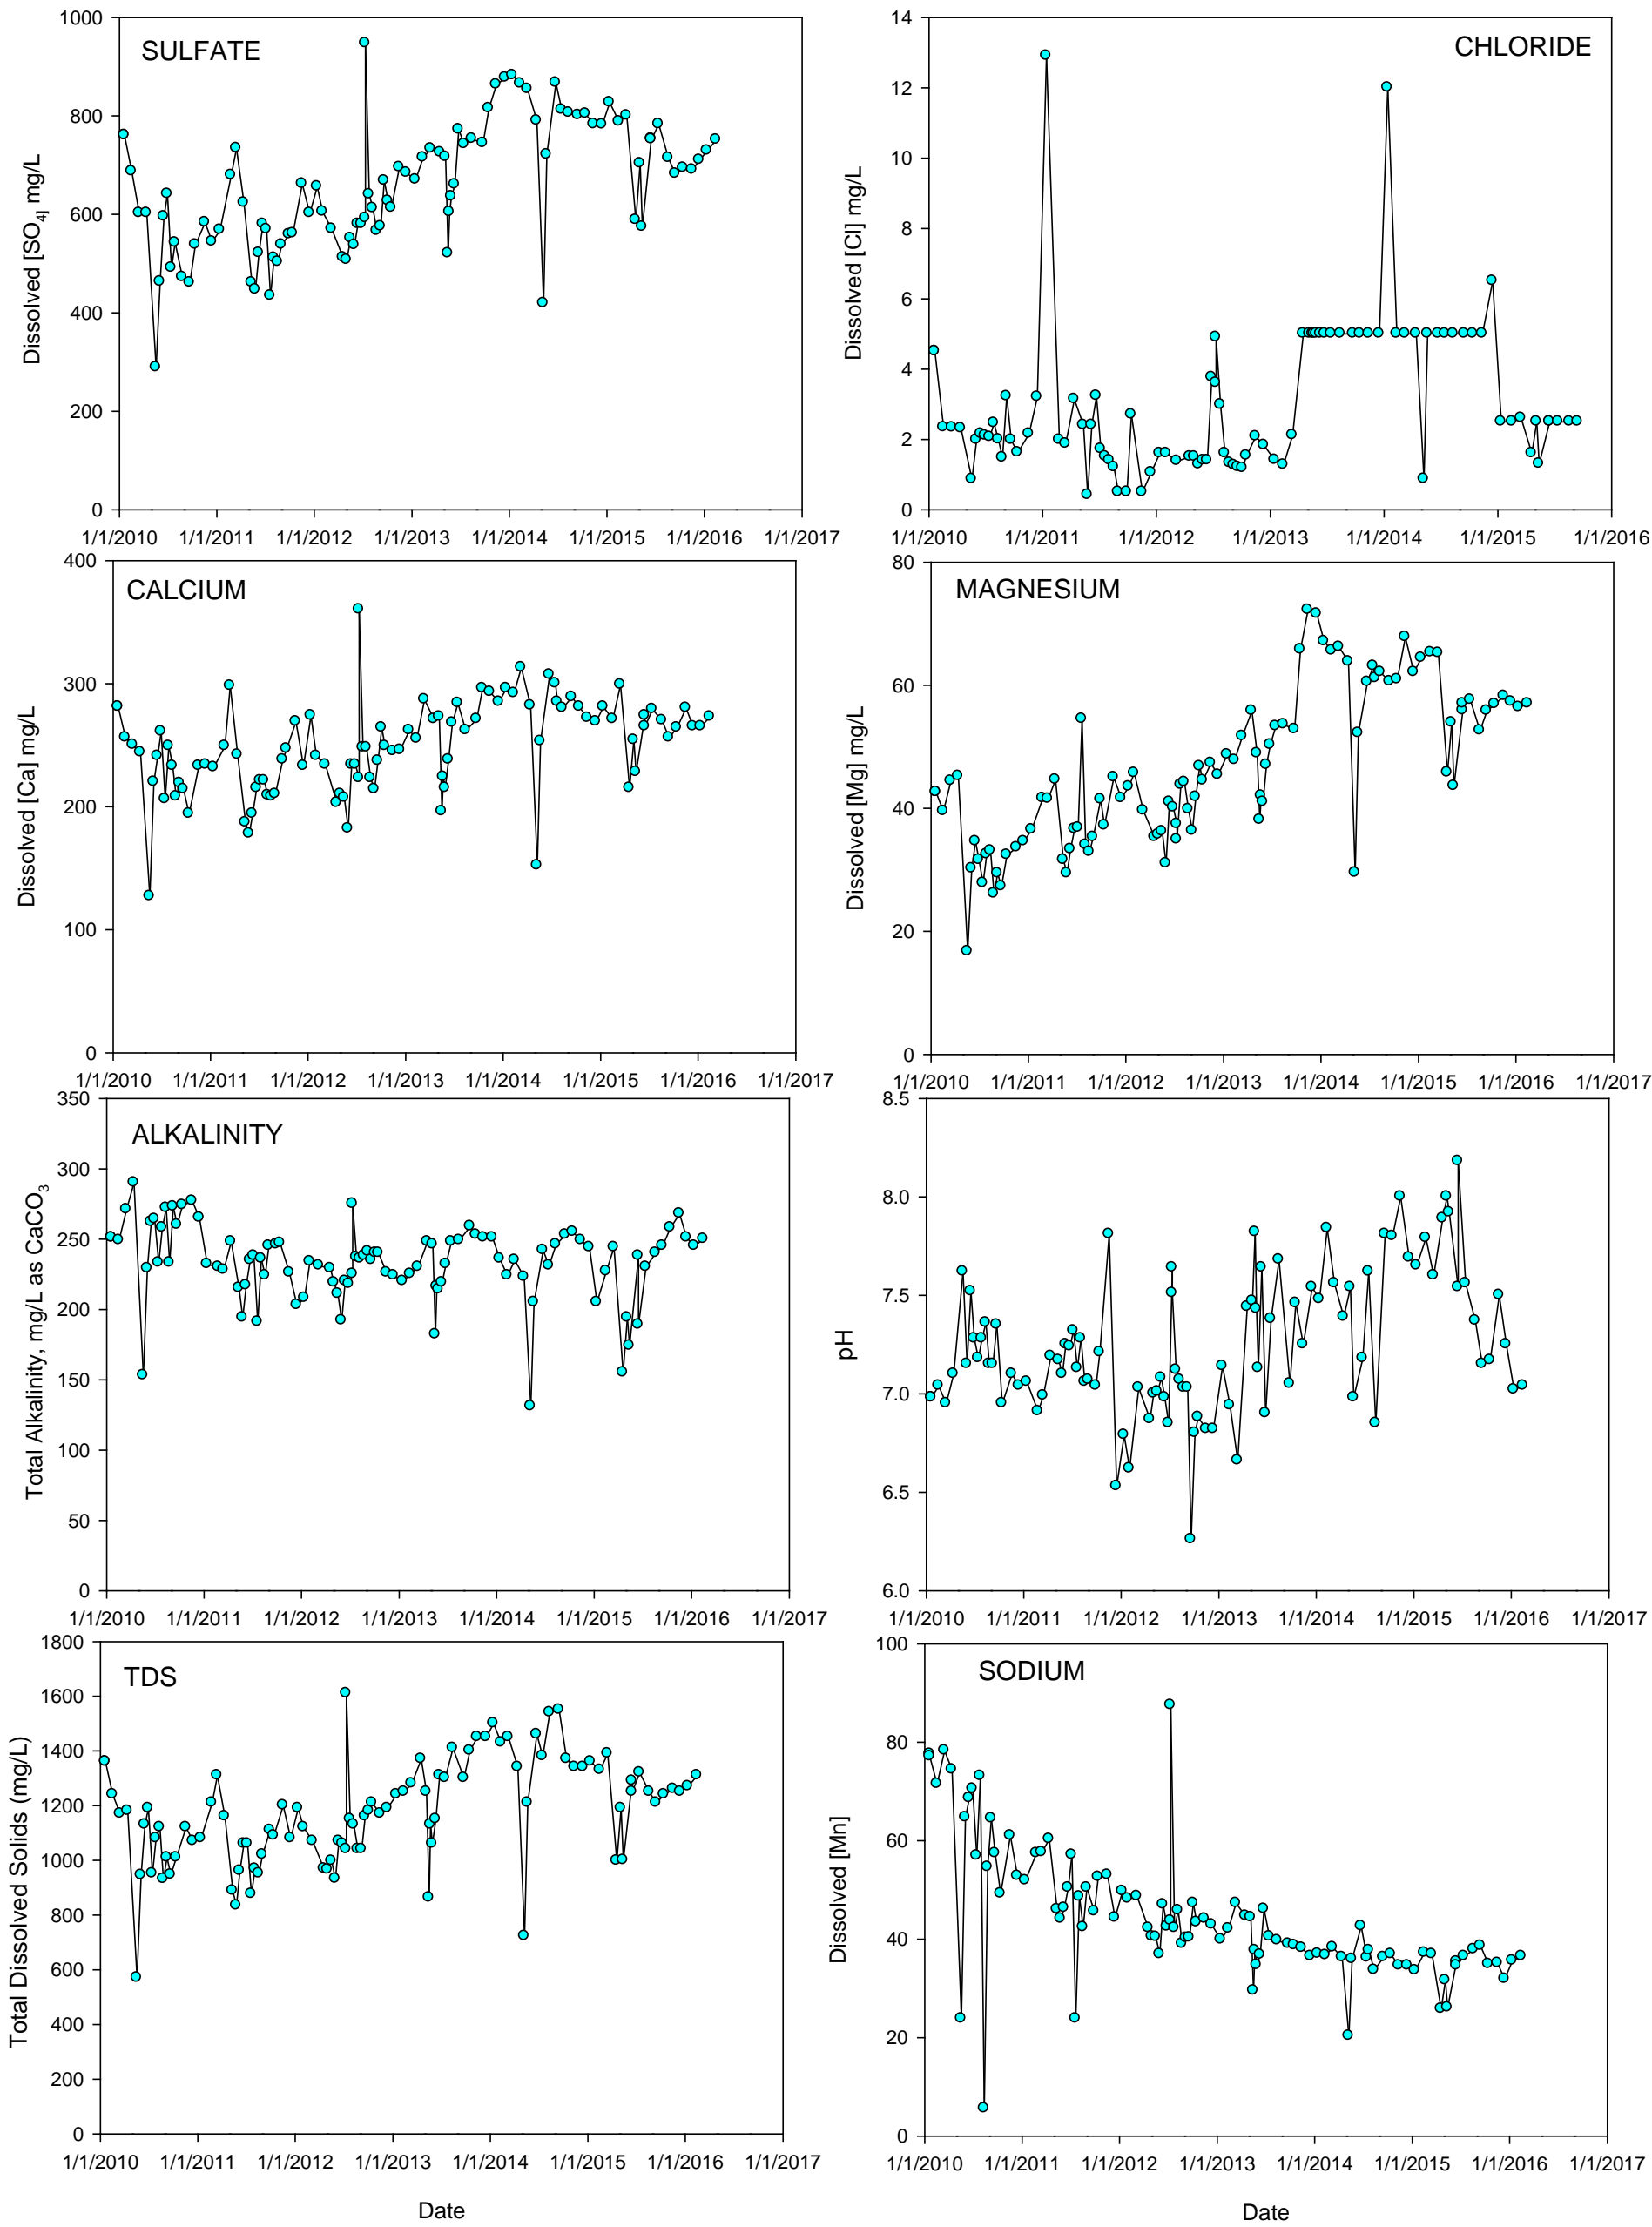
Time series profiles of major ions for the Tailings Seepage Pond show trends of increasing concentration for TDS, SO₄ and Ca from 2011 to maxima in 2014, with values decreasing over the last half of 2014 and 2015 (Figure 12). These trends are not mirrored in the Tailings Pond, which typically shows trends of decreasing concentration for most salinity proxies (Figure 6). These observations suggest the trends in TDS, SO₄ and Ca in the Seepage Pond reflect processes within the tailings mass. This is supported by increasing values for SO₄ and Ca in some monitoring wells since 2010, including MW09-1, MW09-21 and MW09-22. As outlined above, increasing values for SO₄ and Ca may indicate the early stages of enhanced sulfide mineral oxidation.

Alkalinity and pH in the Seepage Pond show variable, though stable conditions (Figure 12). Sodium shows a progressive decline in concentration in the Seepage Pond since 2010 (Figure 12). Sodium is positively correlated with SCN, suggesting the Na decrease reflects the progressive flushing of residual cyanide mill reagents (added as NaCN). This trend is consistent with generally decreasing Na values in the Tailings Pond (Figure 6).

Figure 12: Time series profiles for major ions and pH for the Seepage Pond (2010-February 2016 data).

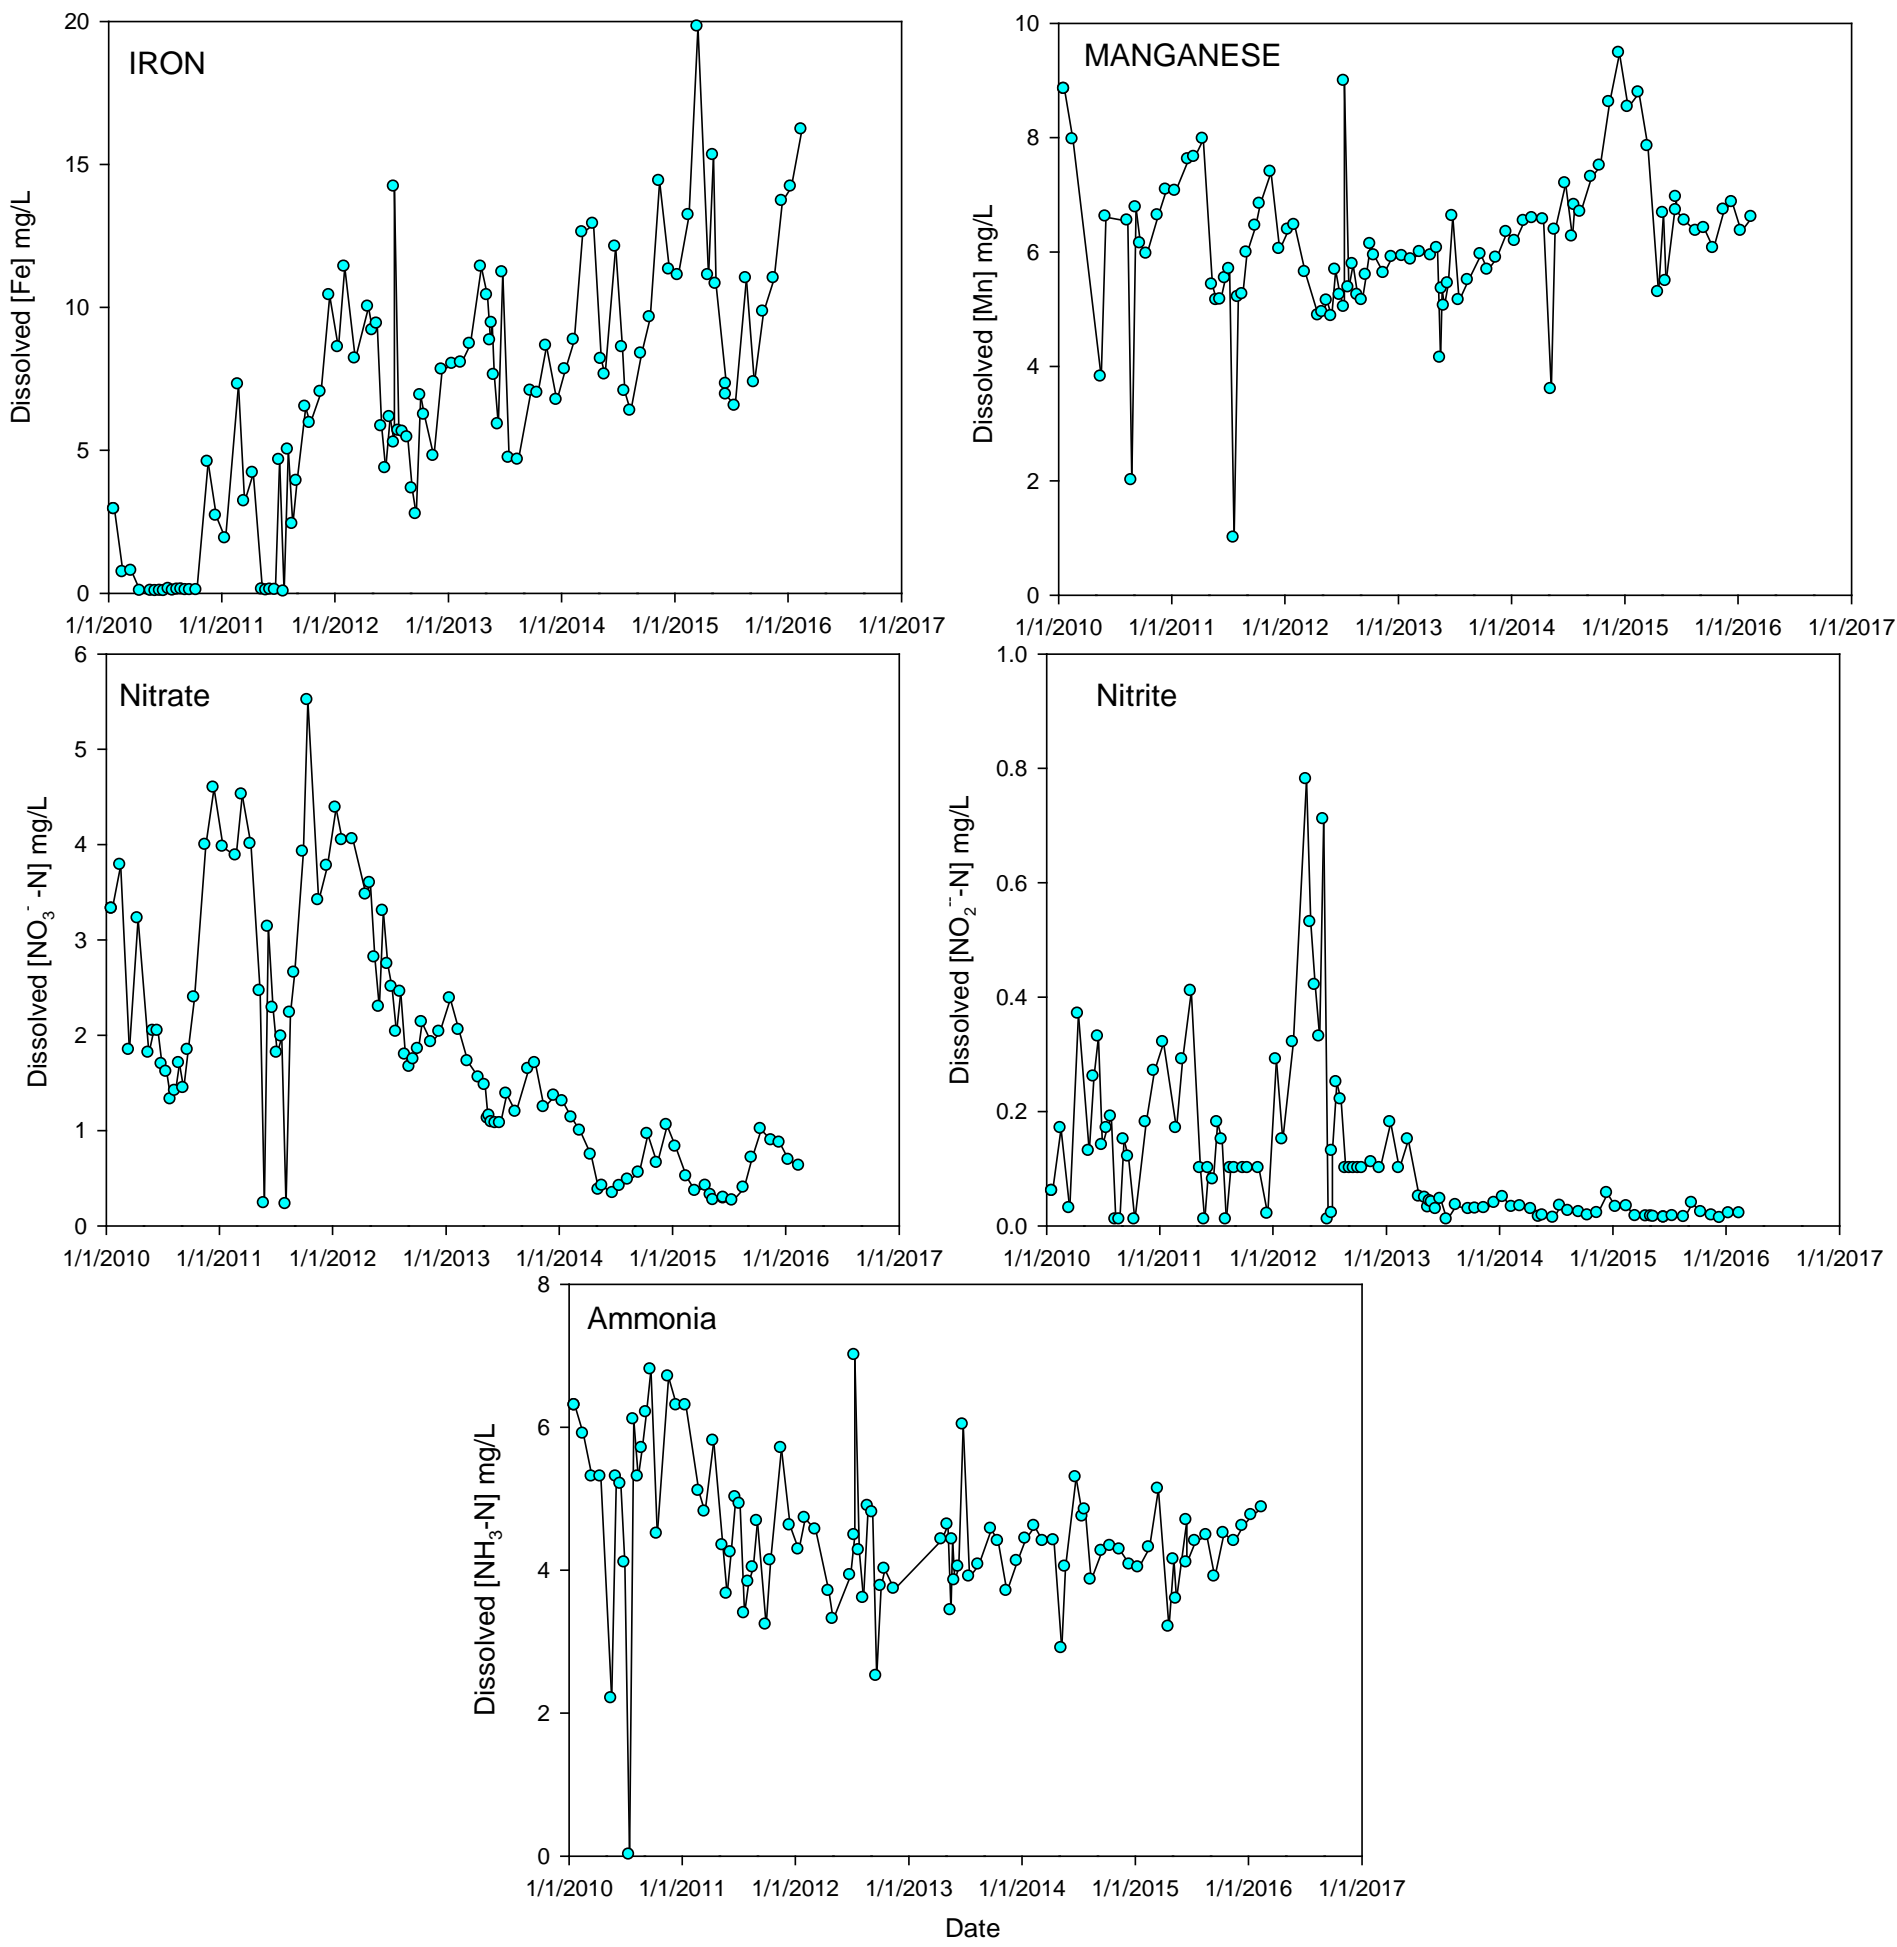
The onset to more vigorous Mn(IV) and Fe(III) reduction may result from decreased availability of NO₃-N, which has shown a pronounced decrease in concentration since 2011 (maximum of 5.5 mg/L) to 2015 values ≤ 1 mg/L (Figure 13). In reduction-oxidation (redox) reactions in tailings porewaters, NO₃ will serve as a preferential electron acceptor over Mn(IV) and Fe(III) as dictated by thermodynamics. Specifically, redox conditions in saturated tailings are governed by a series of microbially-mediated redox reactions in which reduced carbon compounds (e.g., dissolved organic carbon - DOC) serve as electron donors to various oxidants that serve as terminal electron acceptors. The reaction sequence proceeds in an order which is determined by the net free energy yield, with aerobic oxidation (oxygen reduction) being the most favourable. In the absence of oxygen, nitrate presents the next most favourable reaction. Following nitrate reduction (denitrification), the redox sequence proceeds via Mn(IV)-oxide reduction, Fe(III)-oxyhydroxide reduction, sulfate reduction, and methanogenesis (CO₂ reduction) (Froelich et al., 1979).

Figure 13: Time series profiles for redox-related parameters for the Seepage Pond (2010-February 2016 data).

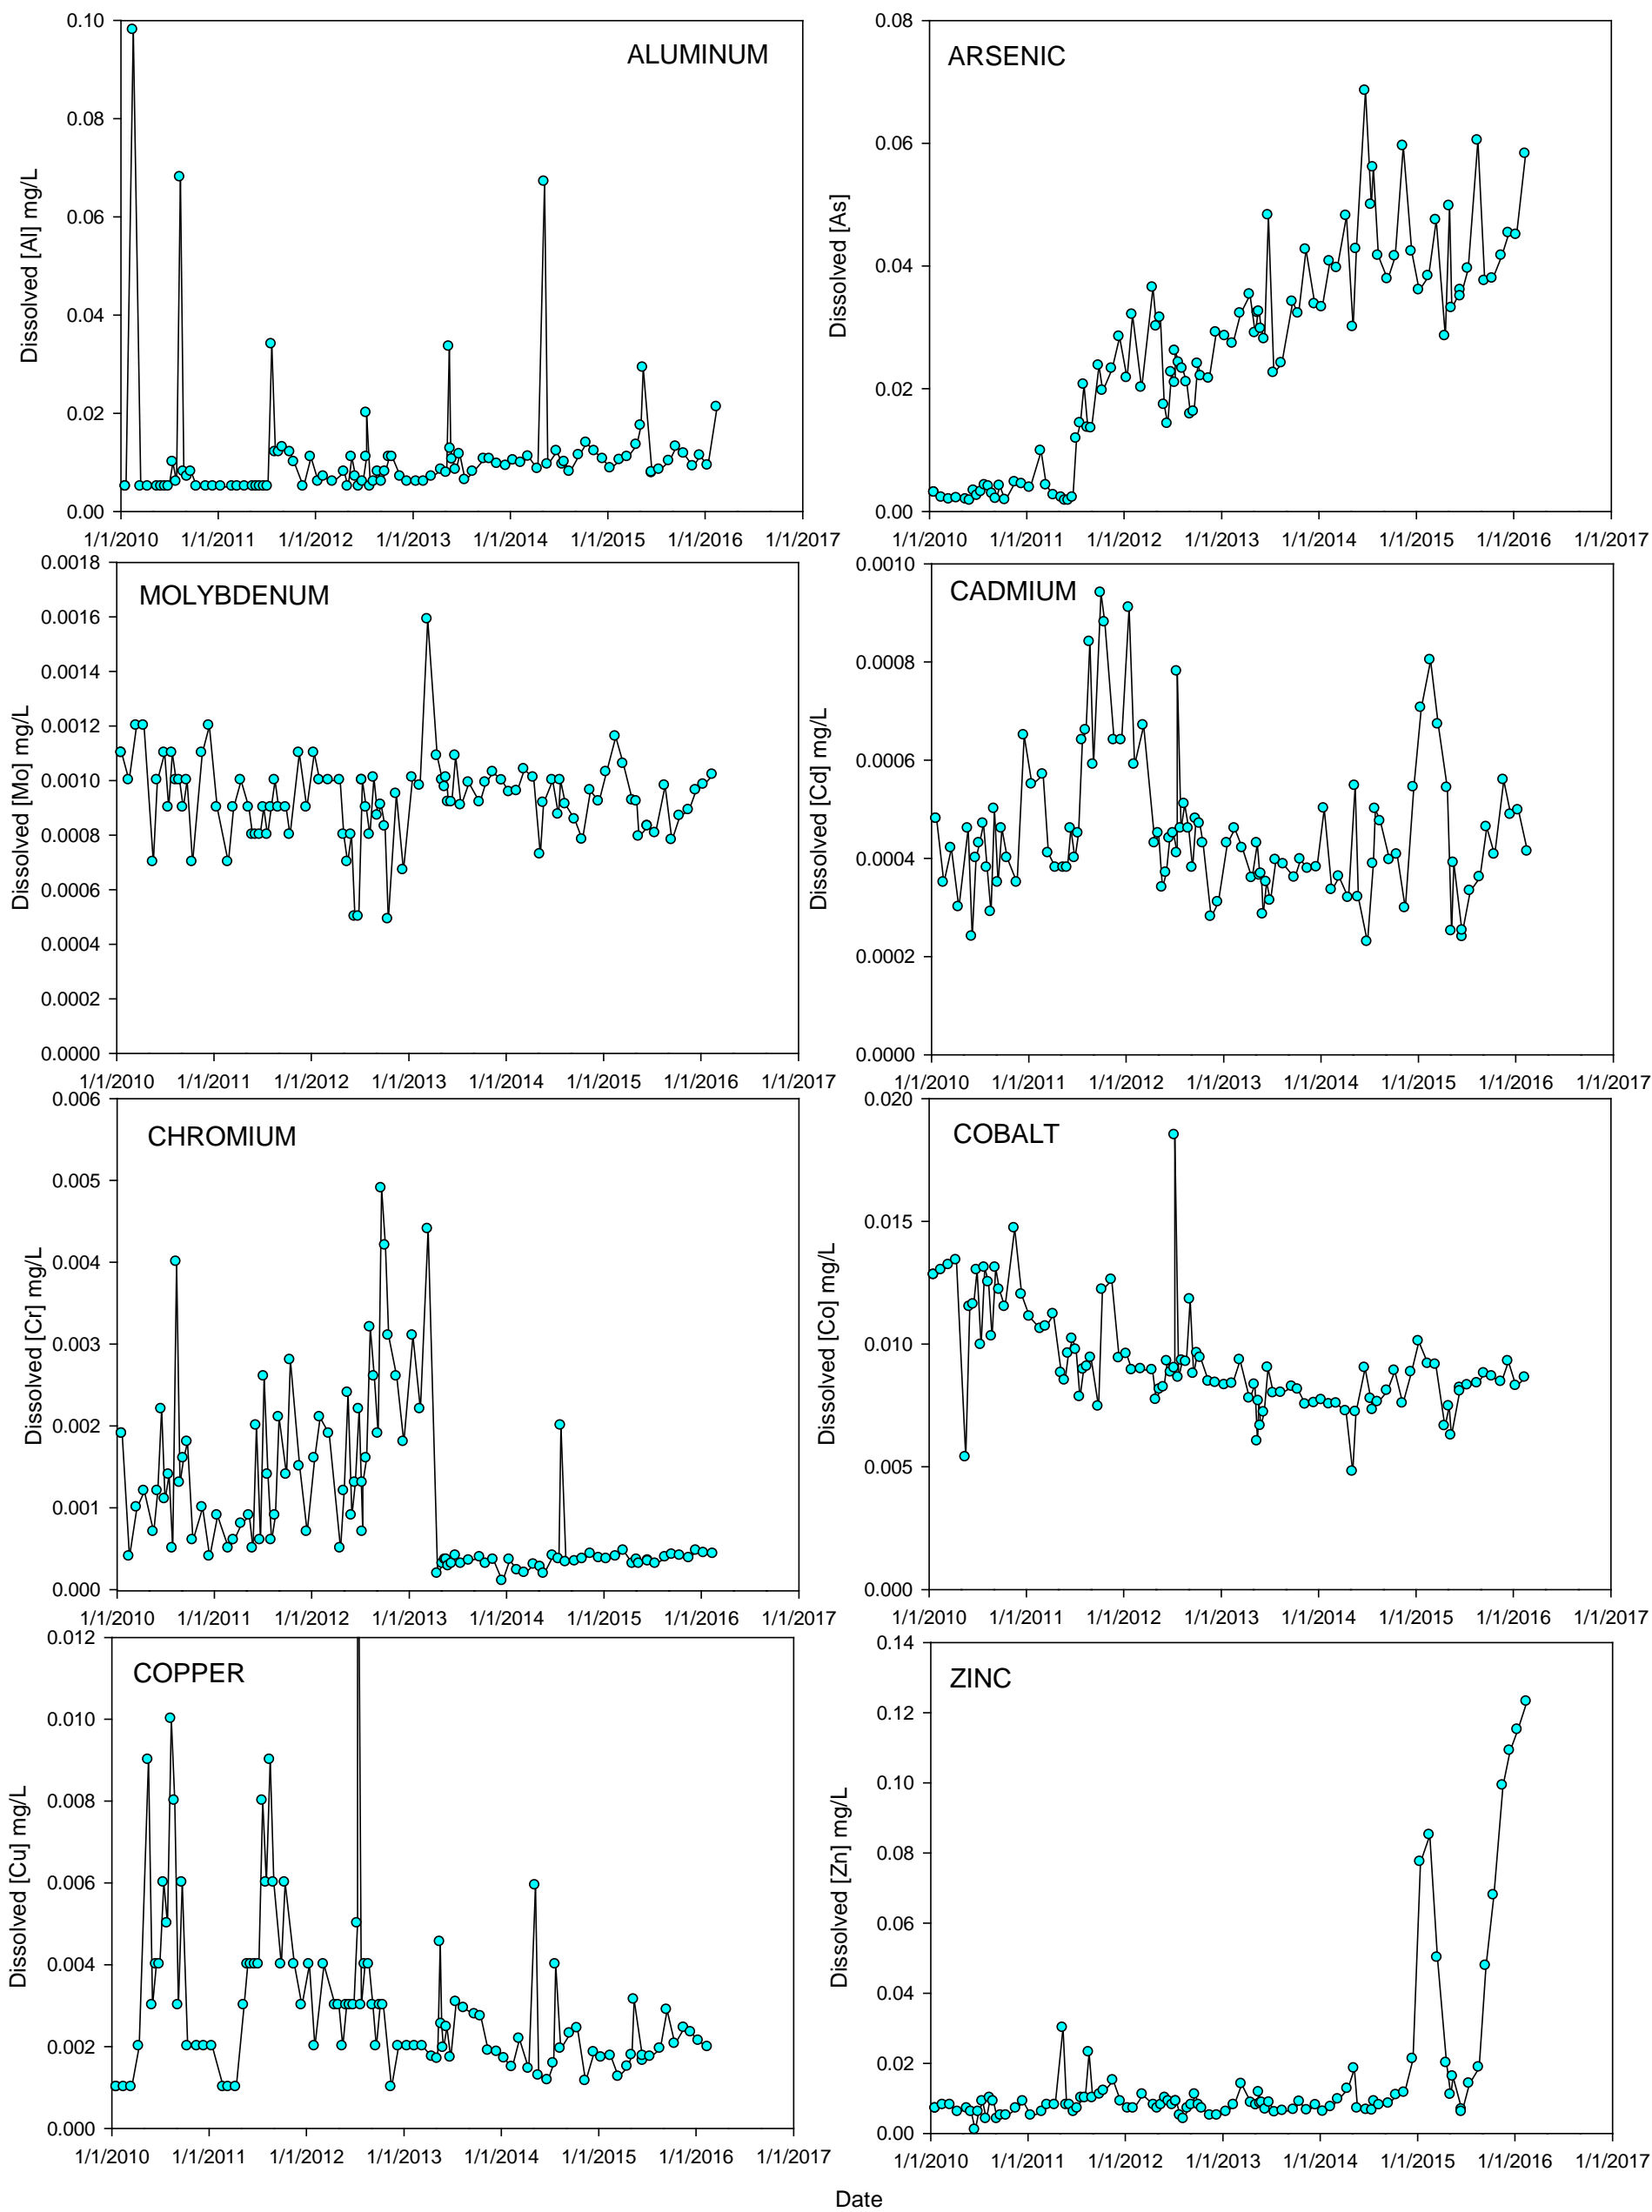
The transition towards more suboxic conditions within the tailings area is further supported by the data for dissolved As (Figure 14) which show an increase very similar to that of Fe. Indeed, the two parameters are strongly correlated ($r^2 = 0.73$). Arsenic shows a strong affinity to Fe oxides, and the congruent nature of their concentration profiles strongly suggest that As is being remobilized via the reductive dissolution of As-bearing Fe-oxyhydroxides.

Figure 14: Time series profiles for trace elements for the Seepage Pond (2010-February 2016 data).
