TECHNICAL MEMORANDUM

To: Bill Slater and Fred Green **Date:** 20 Sept 2016
Cc: Patricia Randell, Erik Pit, Emilie Hamm, Chris Dixon,
Jason Berkers, and Paul LePage **Project #:** A399-1
From: Alan Martin and Justin Stockwell (Lorax Environmental Services Ltd.)
Subject: Mount Nansen – 2016 Water Quality Update – **FINAL**

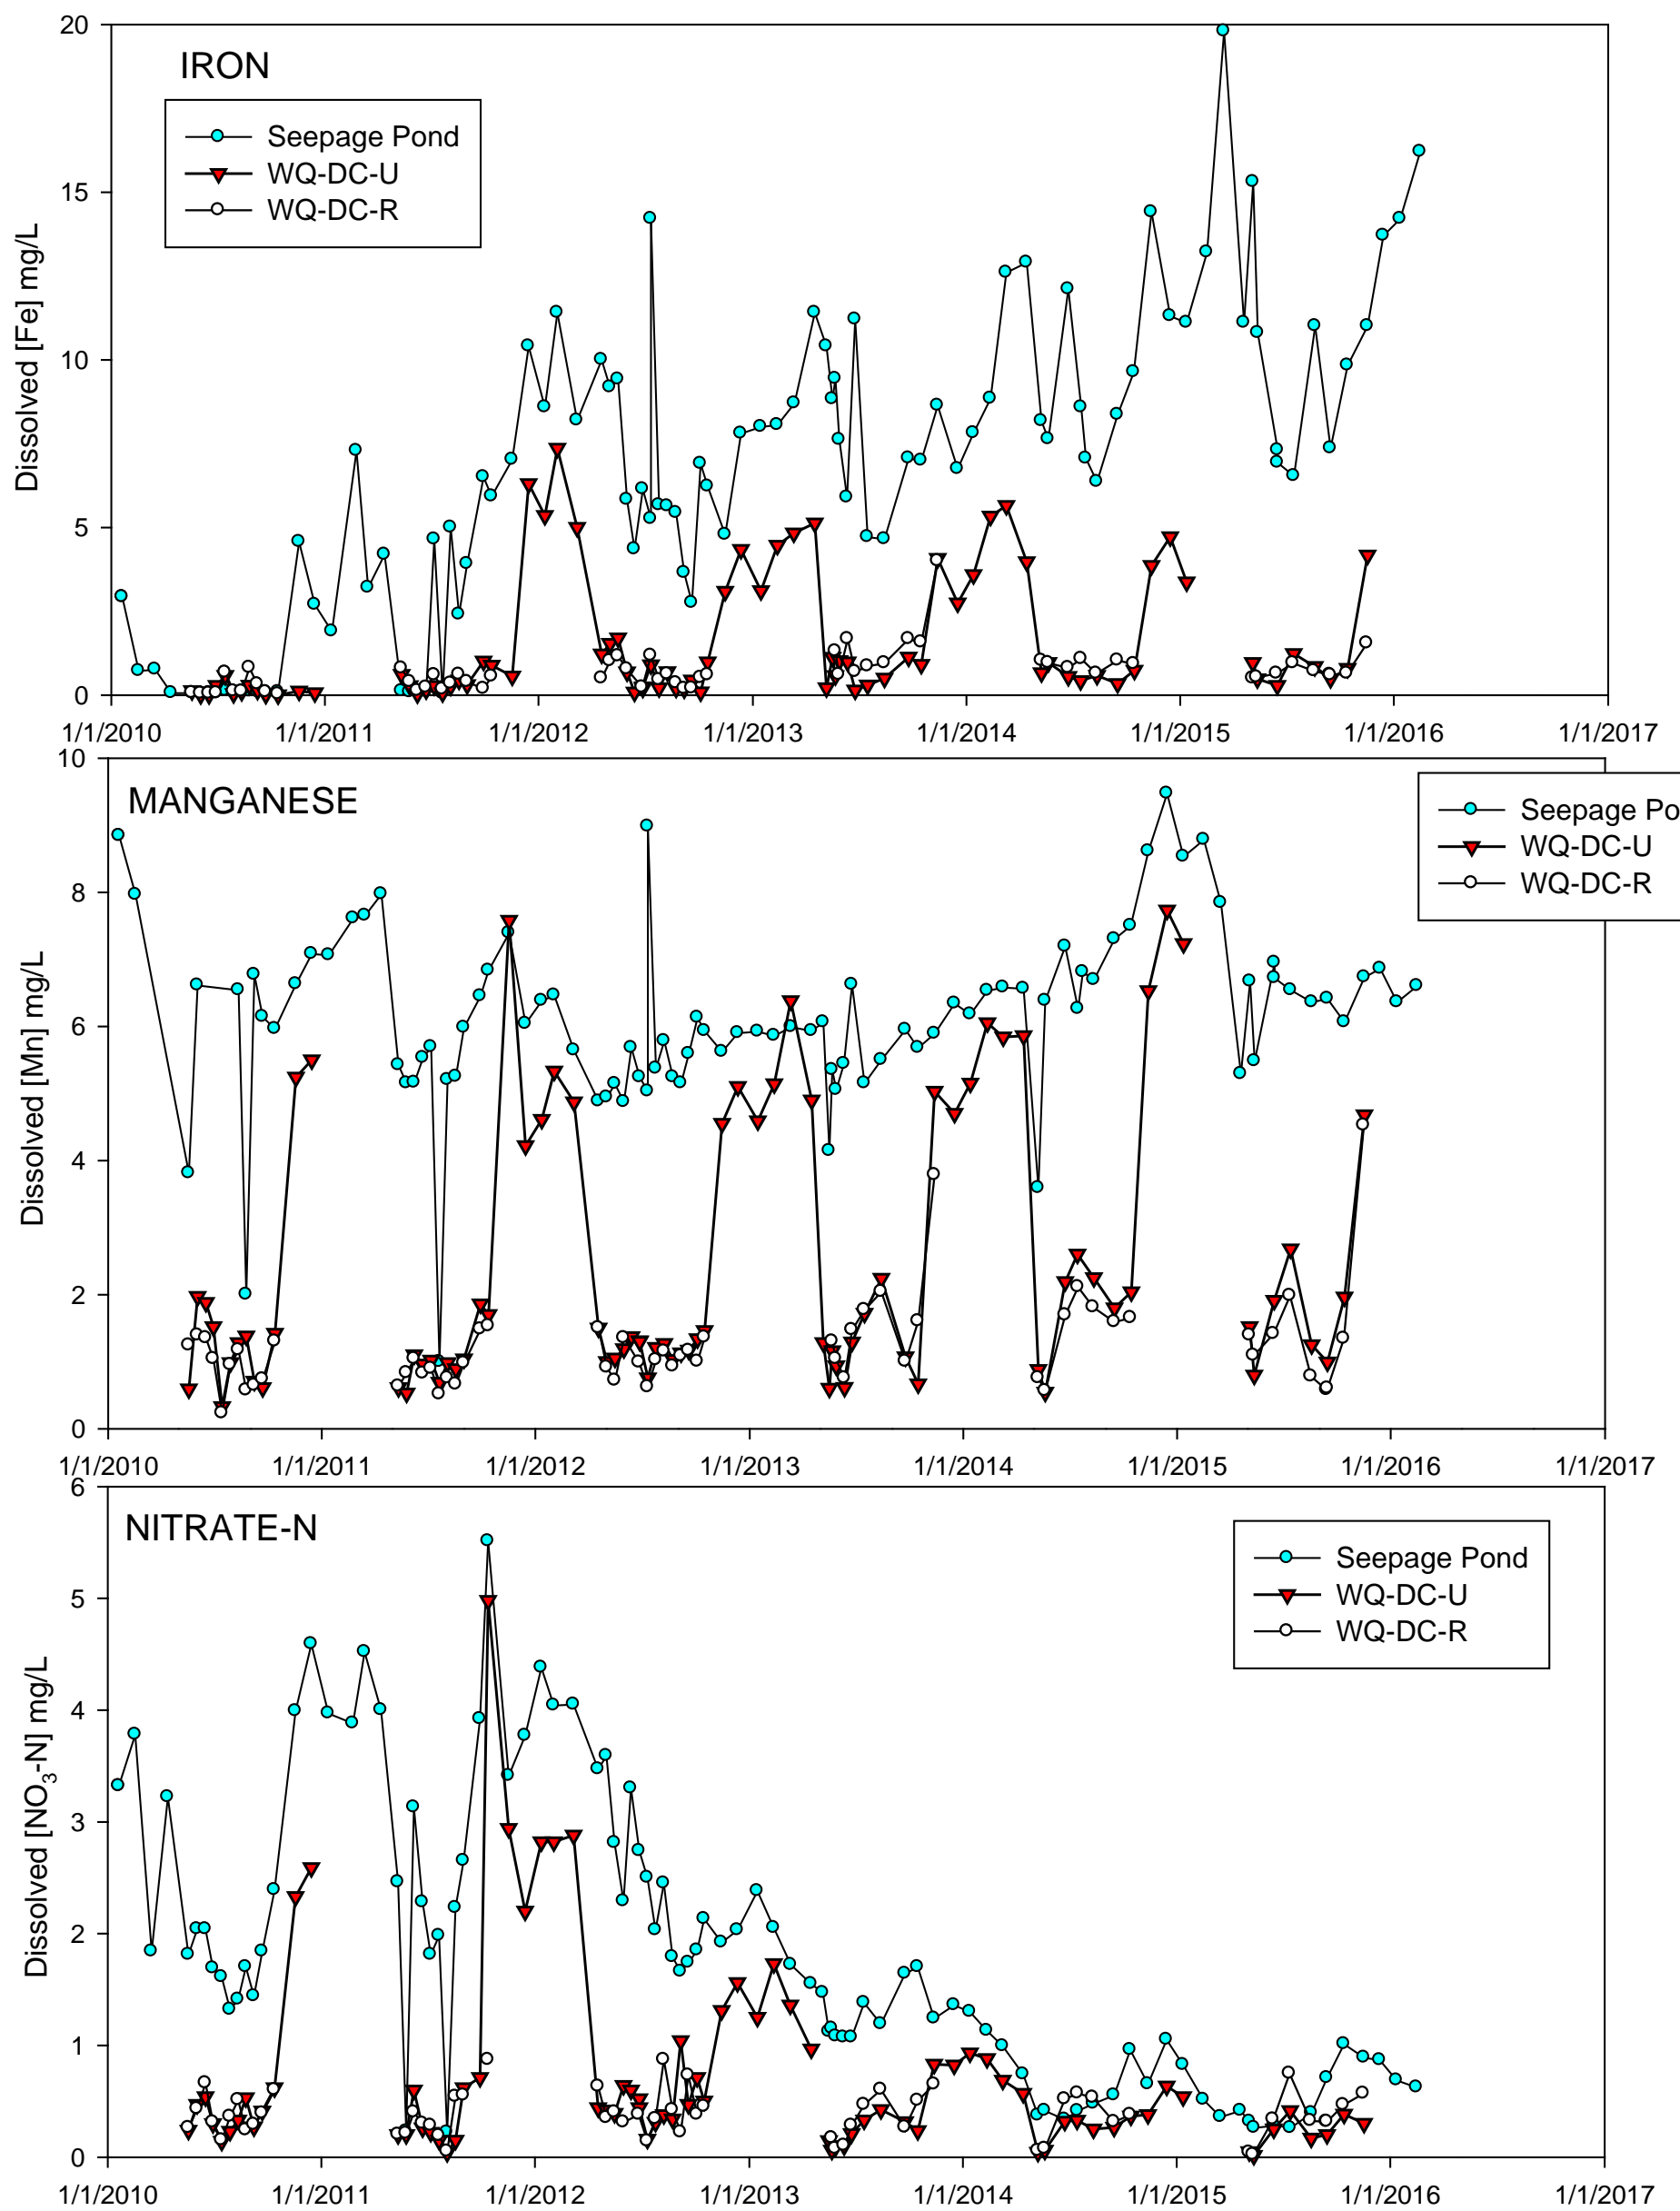
As outlined in Section 2.2, several parameters show recent increases in concentration in the Seepage Pond (SO₄, Fe, Mn, Zn, Cd), while NO₃-N concentrations have been decreasing. The increase in SO₄ concentration observed between 2012 and 2014 is evident in lower Dome Creek at both DC-U and DC-R (Figure 15). With respect to redox-sensitive parameters, the dissolved Mn peak in the Seepage Pond in 2014 is congruent with peak values at DC-U (Figure 16). However, evidence for increasing trends in Mn concentrations over time is not apparent further downstream at DC-R. Comparison of Mn data between DC-U and DC-R suggest a slight effect of dilution downstream similar to SO₄. In contrast, the relative effect of dilution on Fe is markedly different as Fe concentrations show seasonal increase between DC-U and DC-R. Further, the progressive rise in dissolved Fe concentrations in the Seepage Pond since 2010 is not evident at

DC-U nor DC-R (Figure 16), suggesting that Fe is not behaving conservatively downstream of the Seepage Pond.

With respect to trace elements, the elevated values observed for As, Cd, and Zn in the Seepage Pond in recent years are not clearly manifested in lower Dome Creek (Figure 17), suggesting commensurate attenuation of these elements with Mn and Fe. Comparison of downstream trends at DC-U and DC-R is somewhat hindered by the less frequent sampling collection at these sites. This is particularly evident for location DC-R, which has been sampled less frequently in the winter due to glaciation. The progressive decrease in $\text{NO}_3\text{-N}$ values since 2011 is evident in lower Dome Creek at both DC-U and DC-R (Figure 16).

Figure 16: Time series profiles for redox-related parameters for Seepage Pond and Lower Dome Creek (2010-2015 data).

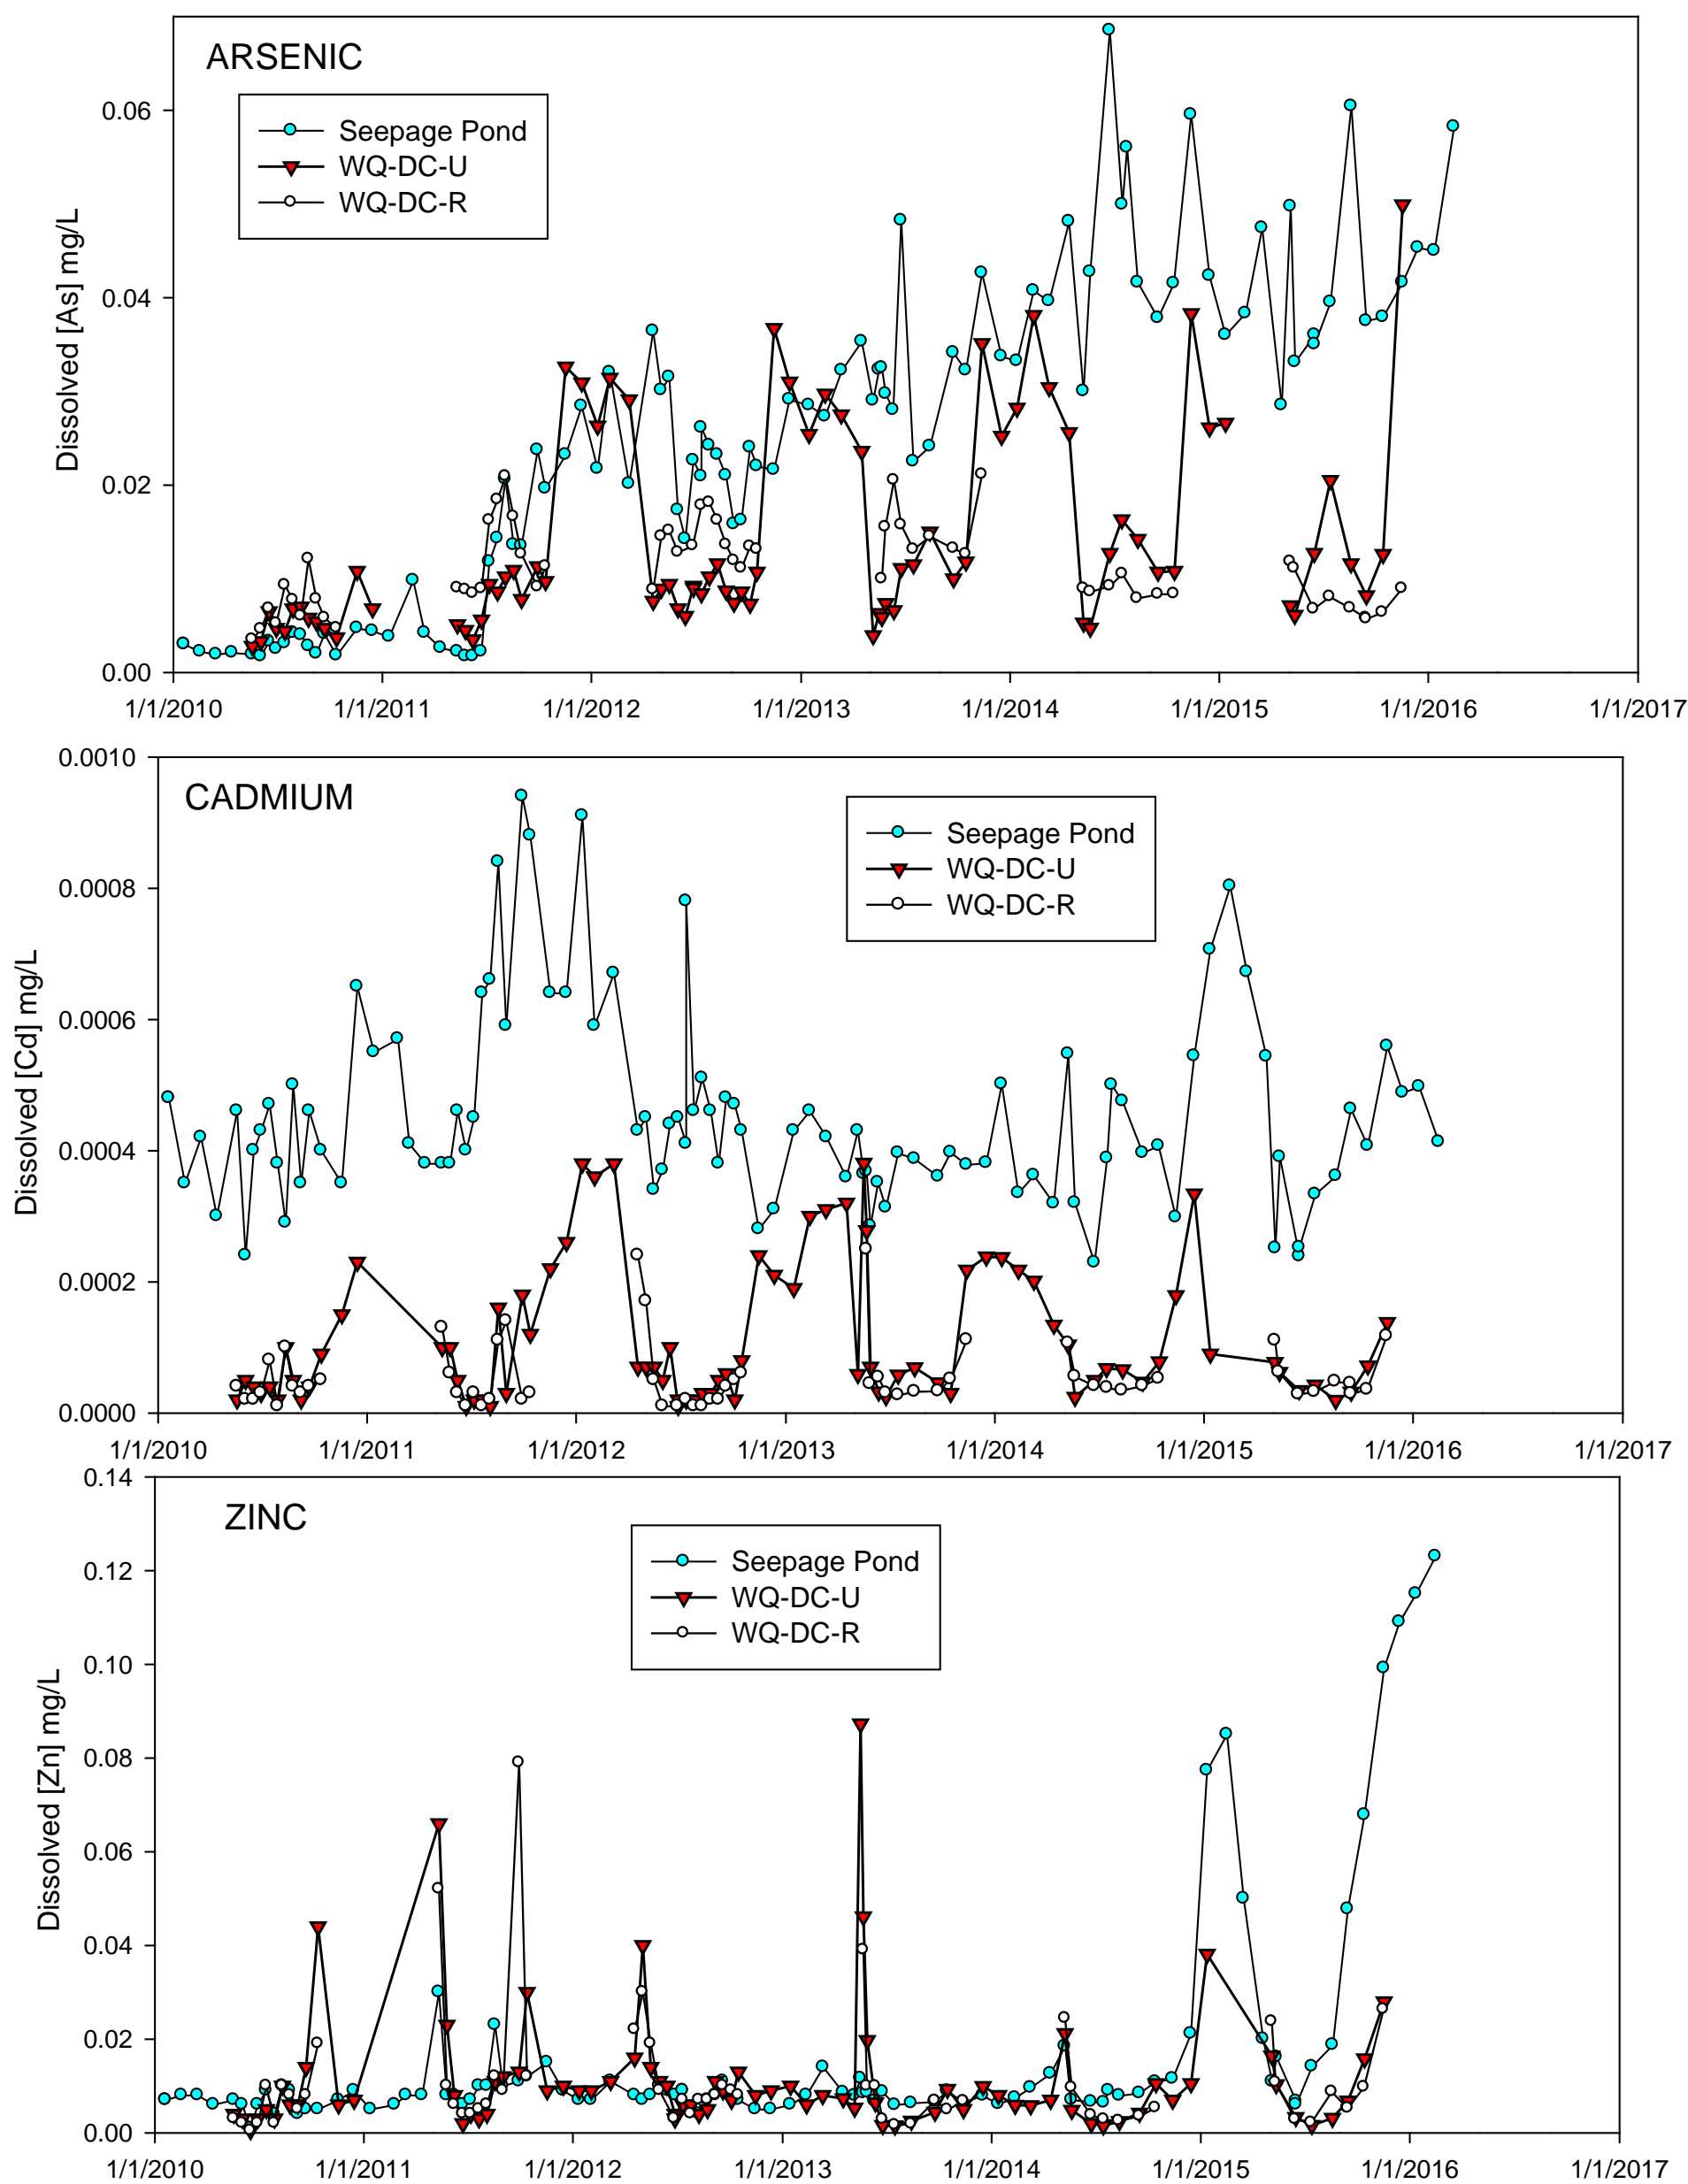
Figure 17: Time series profiles for dissolved As, Cd and Zn for Seepage Pond and Lower Dome Creek (2010-2015 data).

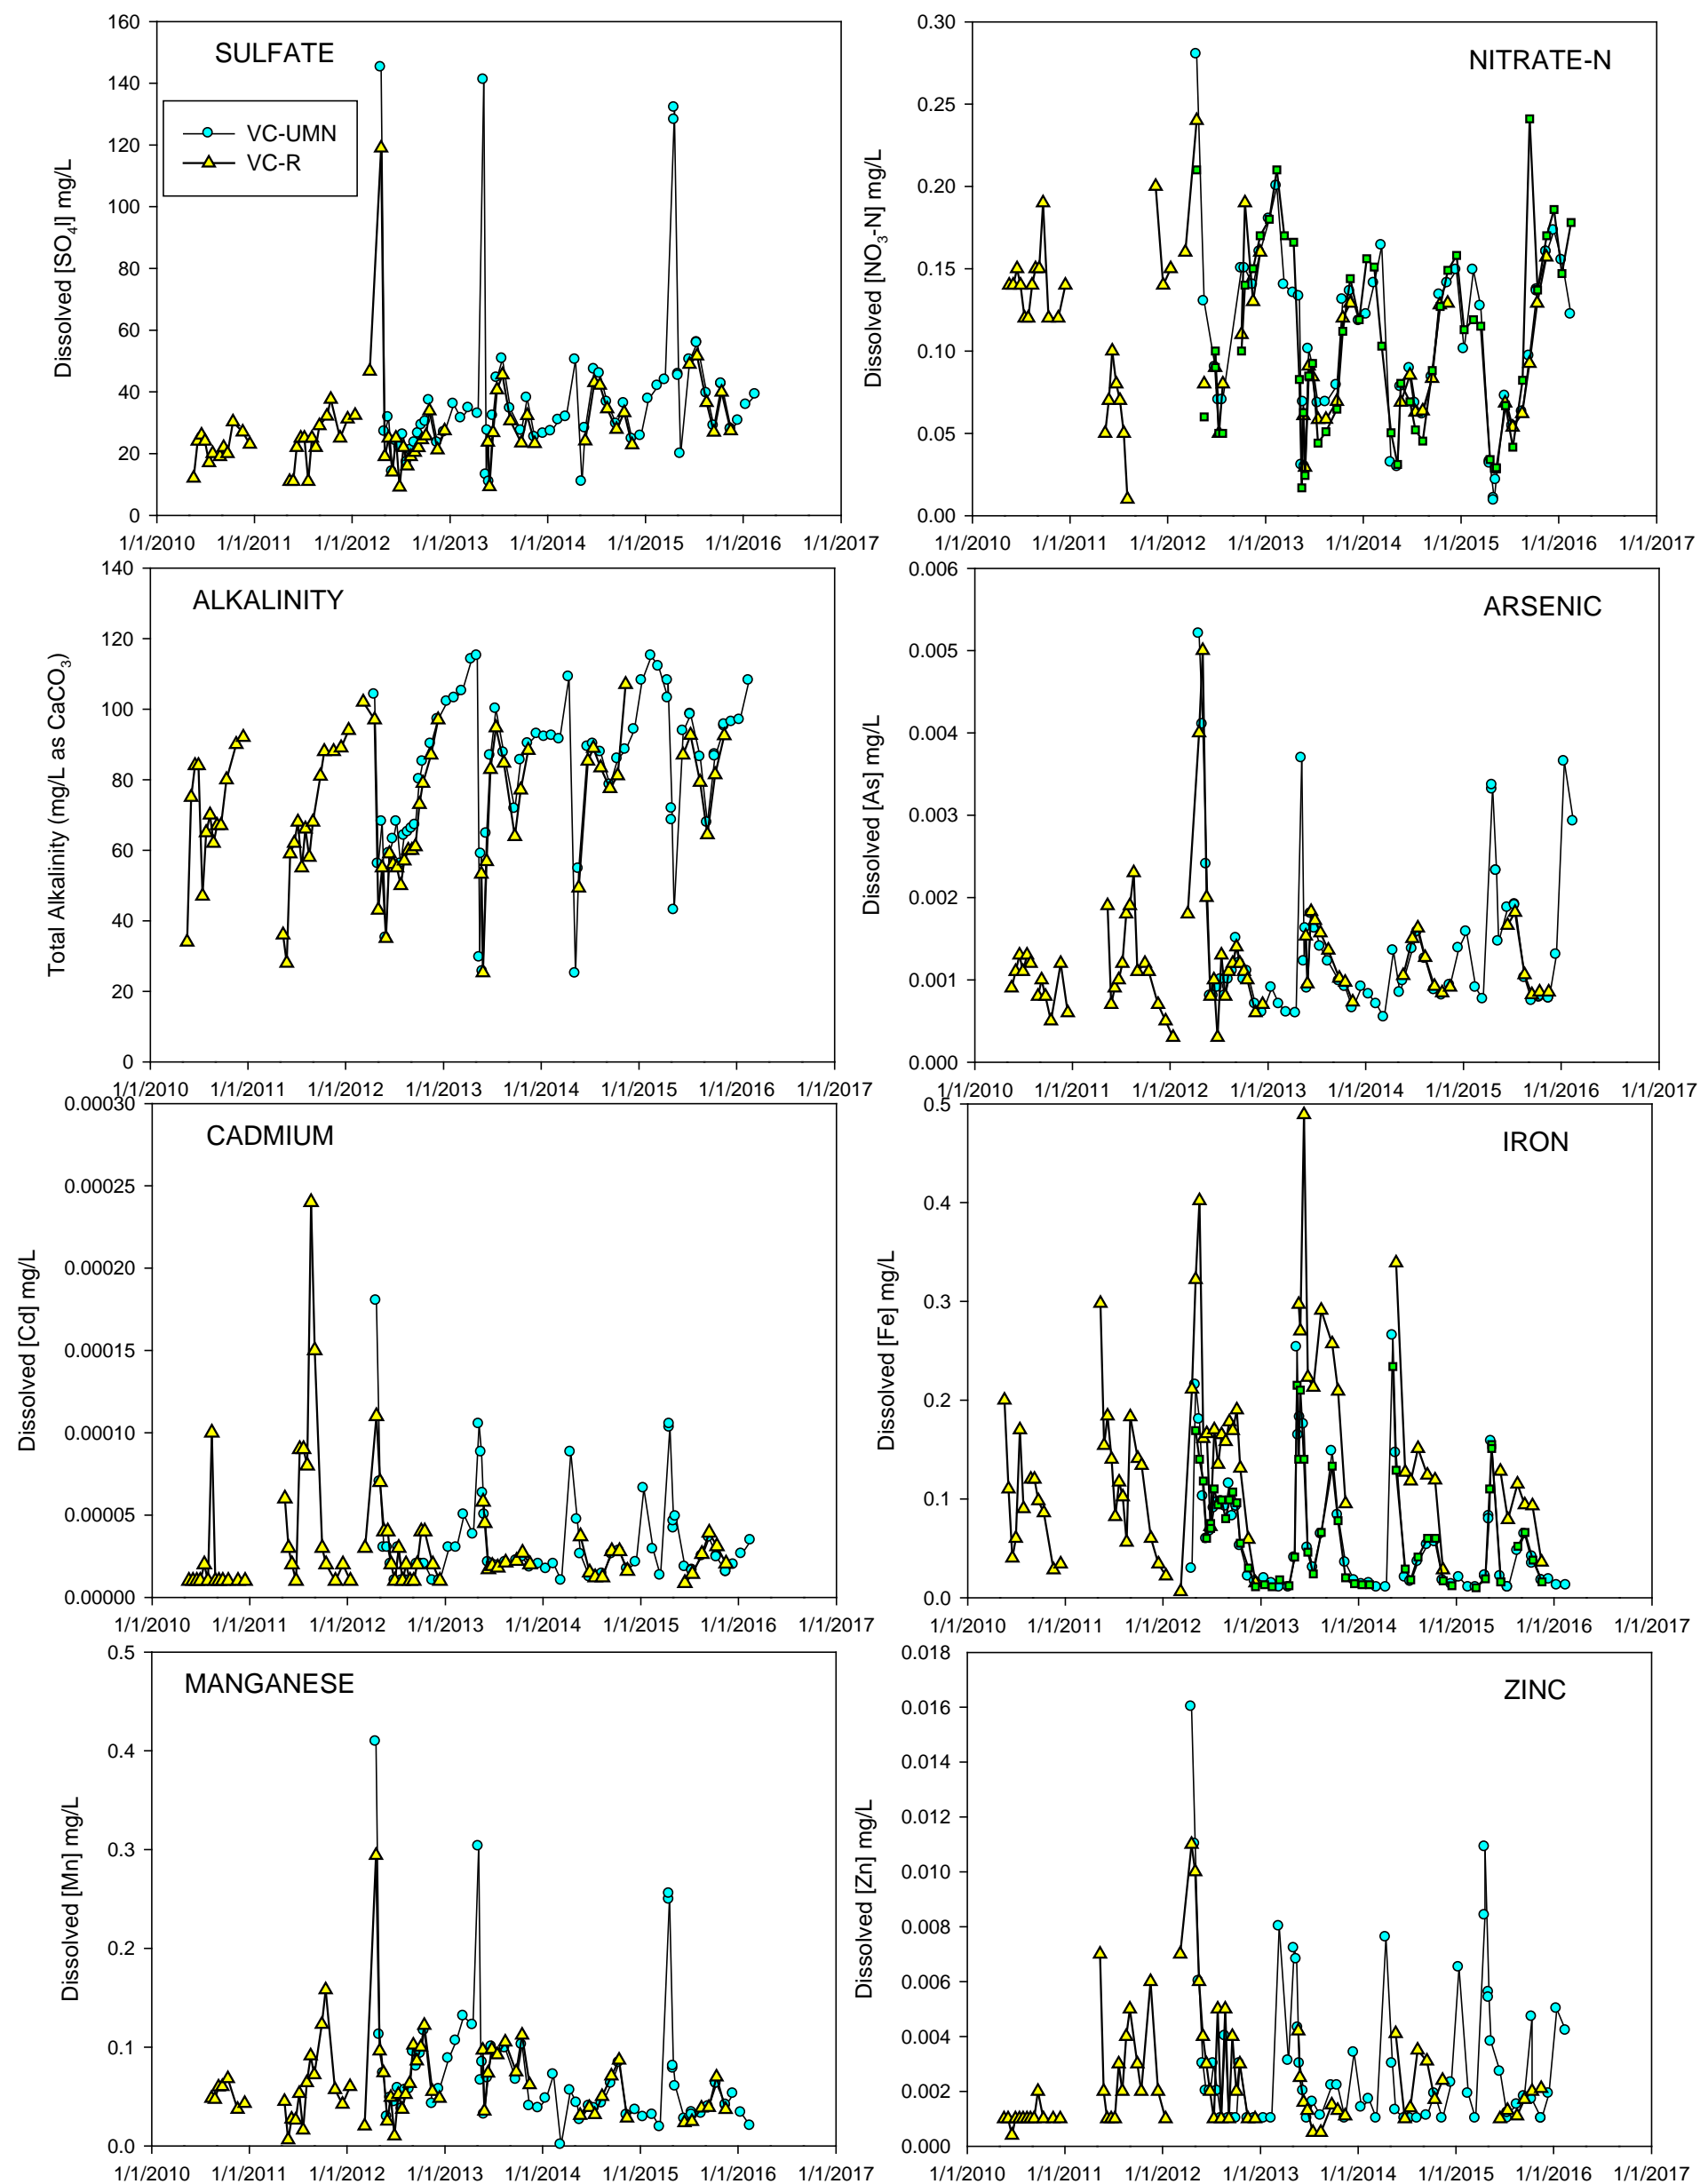
Time series profiles for VC-UMN and VC-R show a high level of congruency, illustrating the minimal influence of Minnesota Creek on water quality in Victoria Creek (Figure 18). Downstream of the Dome Creek confluence, mine-related signatures are evident in Victoria Creek with respect to SO₄, Fe, Mn, As, Cd and Zn (Figure 18), as illustrated by the data for VC-UMN and VC-R in comparison to upstream values (VC-U).

In terms of temporal trends, increases in SO₄ since 2010 have been evident at both VC-UMN and VC-R (Figure 18). At VC-R, the mean annual SO₄ concentration increased from 22 mg/L in 2010 to 39 mg/L in 2015. Inspection of the SO₄ data for Victoria Creek upstream of the Dome Creek confluence (VC-U and VC-DBC) also shows evidence of increasing values (Figure 19). However, the magnitude of SO₄ values at VC-U and VC-DBC is not sufficient to account for the increases downstream of Dome Creek, suggesting that the recent increases in SO₄ concentration at VC-UMN and VC-R can be linked to the higher values observed since 2010 in the Seepage Pond and Lower Dome Creek (i.e., tailings-related source).

Figure 18: Time series profiles for dissolved sulfate, nitrate-N, alkalinity and various trace elements (As, Cd, Fe, Mn and Zn) for Victoria Creek downstream of Dome Creek confluence, both upstream (VC-UMN) and downstream (VC-R) of Minnesota Creek. Data compared to control site VC-U.

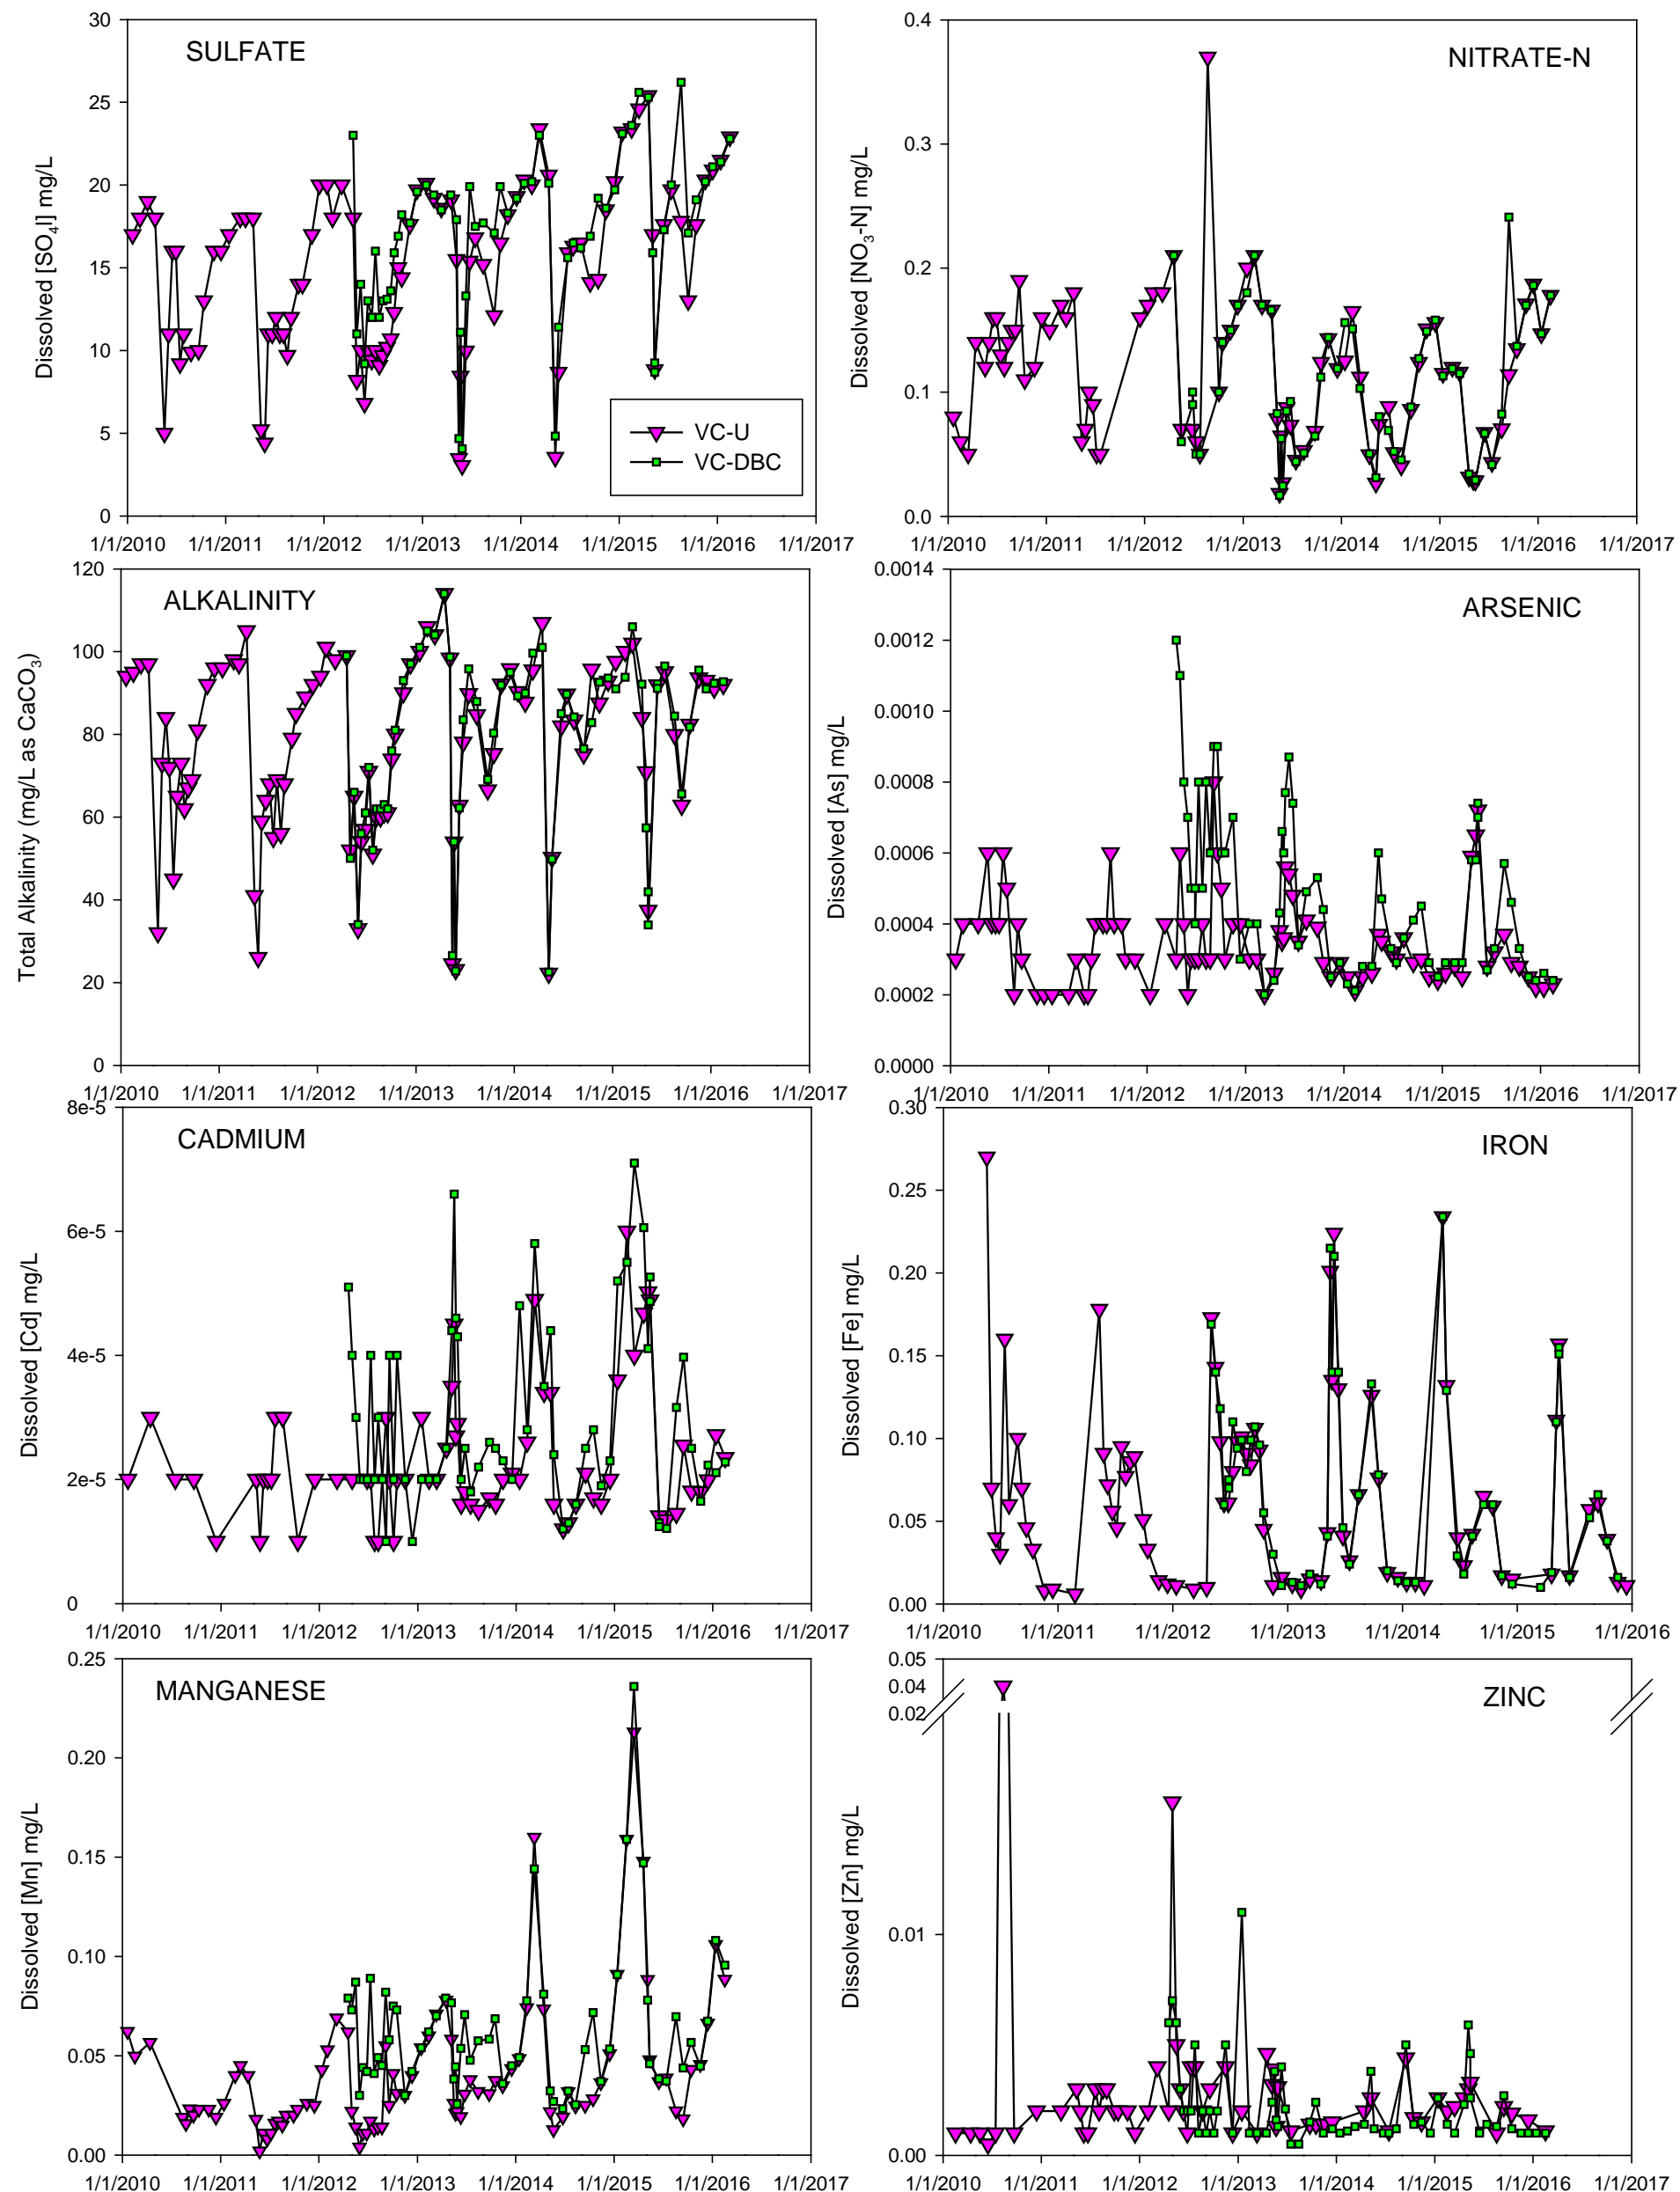
For other parameters of interest (e.g., As, Cd, Fe, Mn and Zn), the water quality data for Victoria Creek downstream of Dome Creek (VC-UMN and VC-R) do not reveal any temporal trends, with the possible exception of dissolved Cd, which shows evidence of decreasing values since 2010 (Figure 18). This perceived decrease cannot be attributed to changes upstream, since data for both VC-U and VC-DBC show higher Cd values in recent years (Figure 19).

Figure 19: Time series profiles for dissolved sulfate, nitrate-N, alkalinity and various trace elements (As, Cd, Fe, Mn and Zn) for Victoria Creek upstream of Dome Creek confluence, both upstream (VC-U) and downstream (VC-DBC) of Back Creek.
