**Mount Nansen Summary Data Report
Department of Indian Affairs & Northern Development
Whitehorse, Yukon**

Project No. 0201-00-14618

September 2002

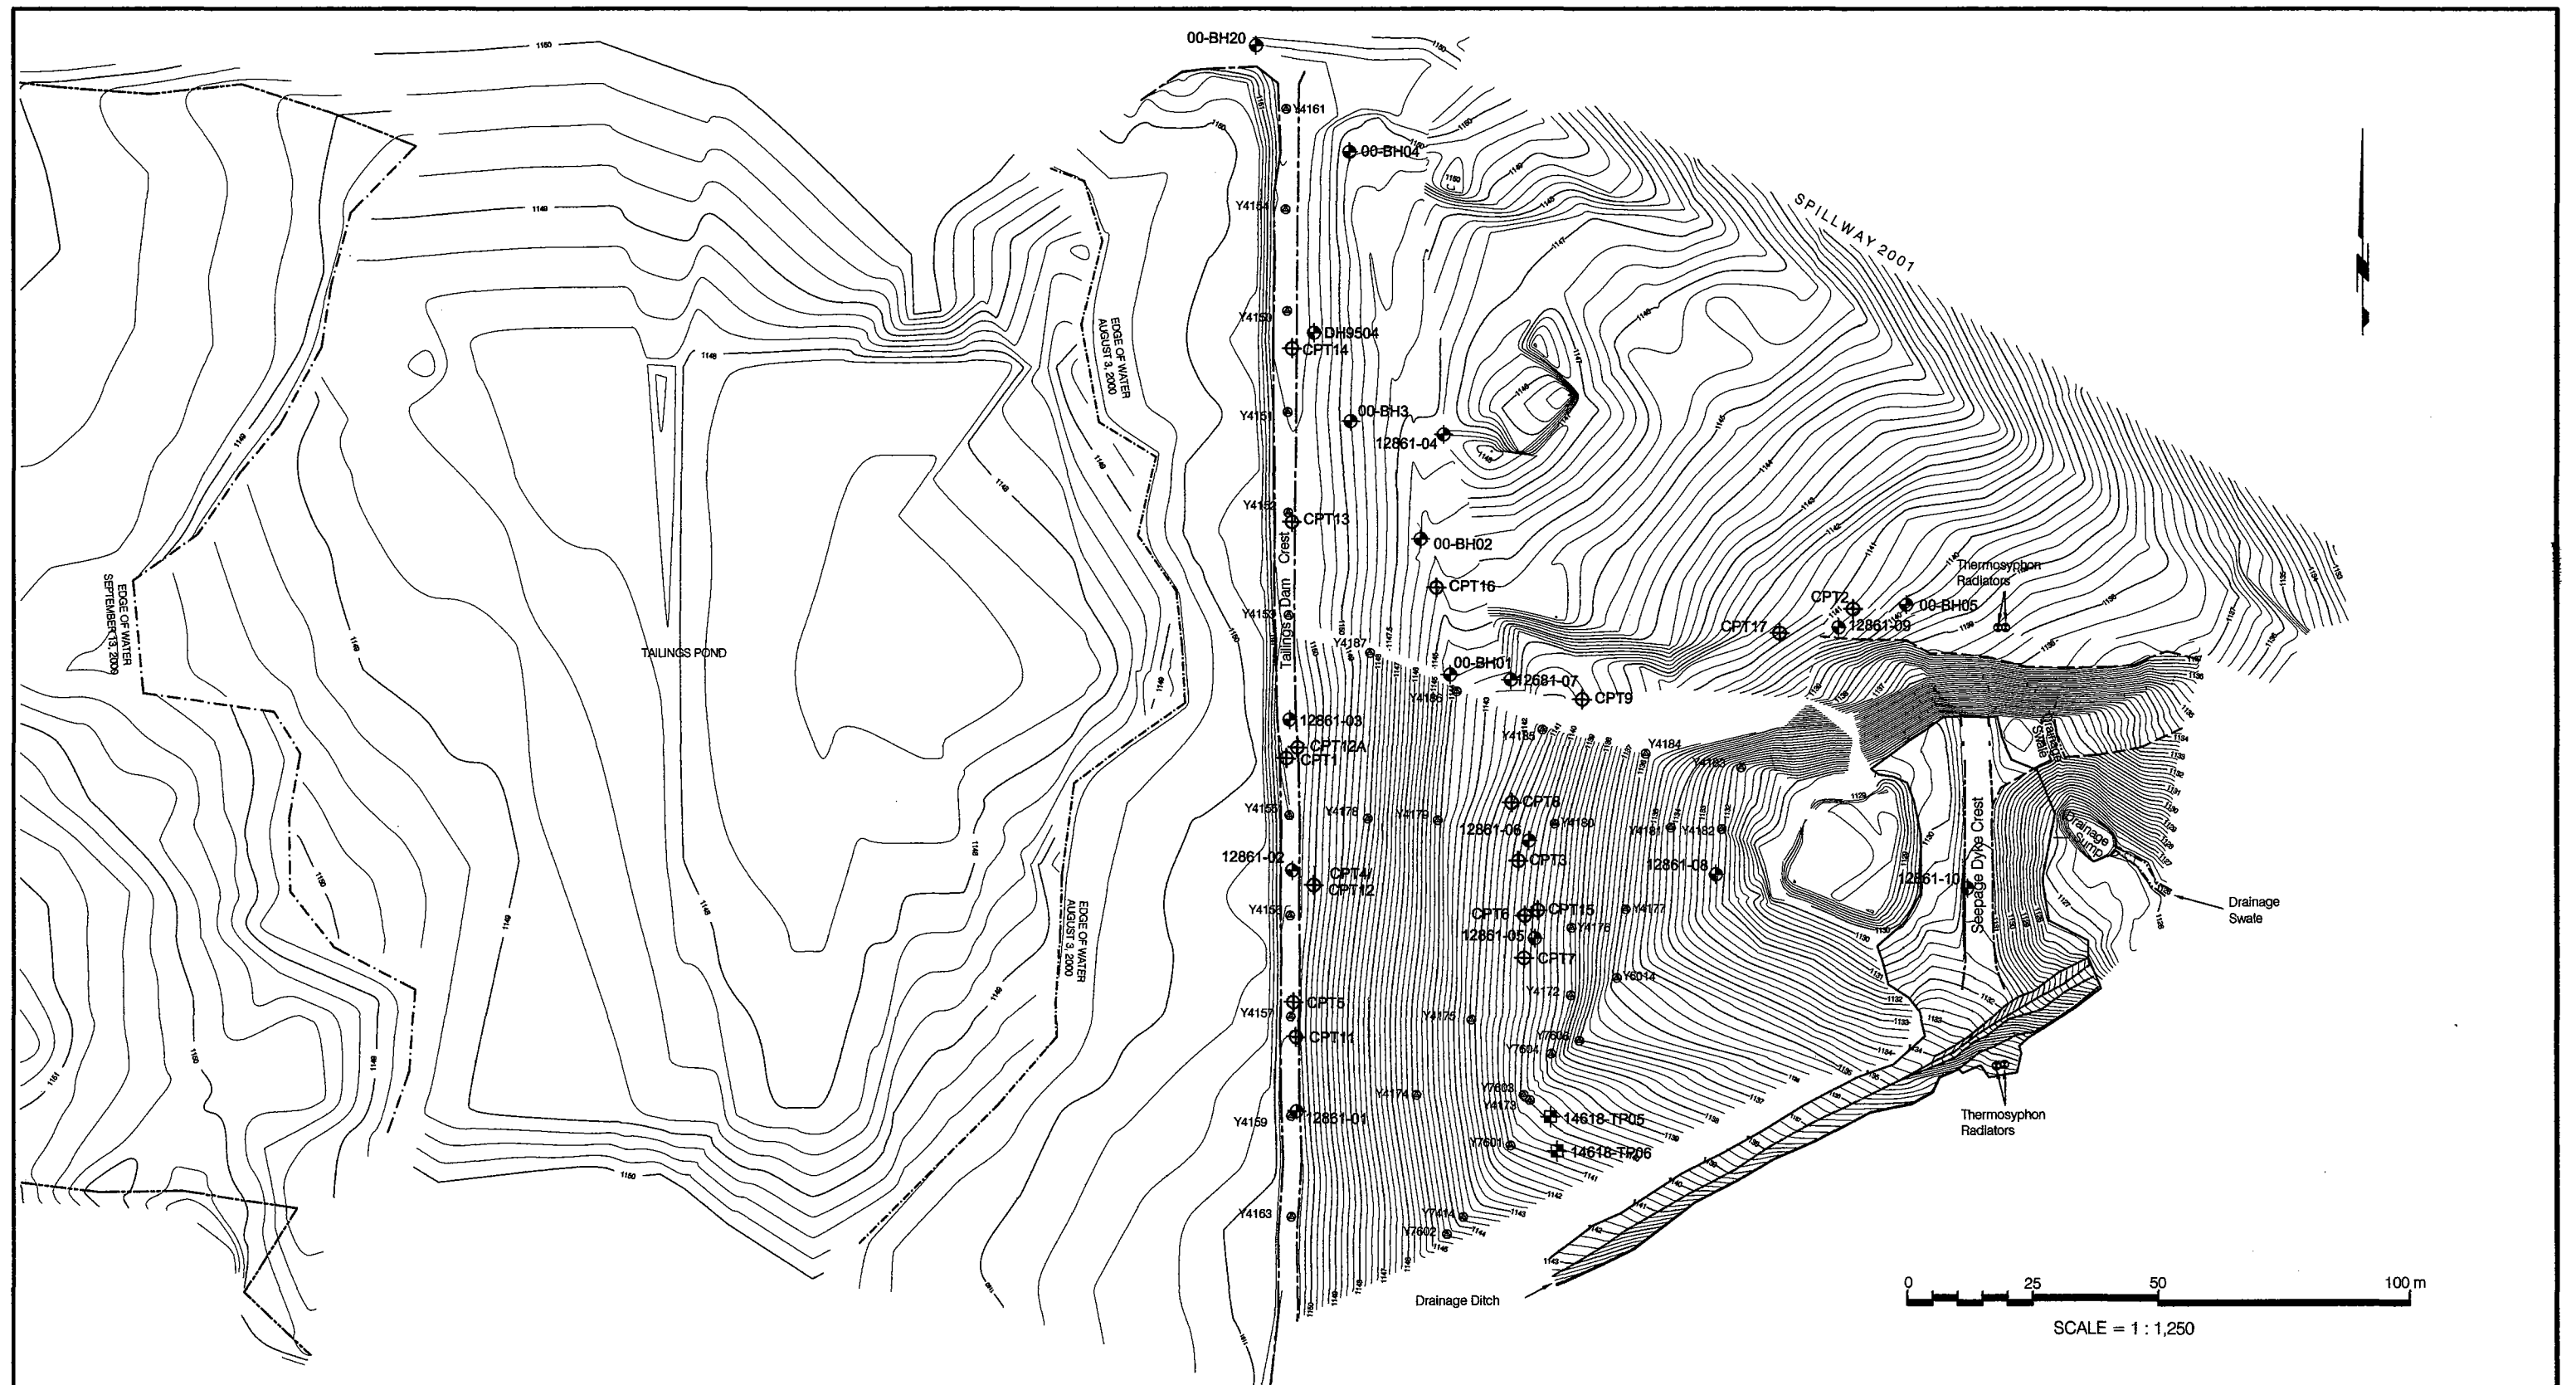
EBA Engineering Consultants Ltd.				PROJECT		MT. NANSEN DAM SAFETY ASSESSMENT	
CLIENT				TITLE		SITE PLAN SHOWING TESTHOLE LOCATIONS	
DIAND				FILE NO.	0201-00-14618	DRWG.	FIGURE 2
DATE	SEPTEMBER 2002	DWN.	JSB	CHKD.	JRT

Using the YES site surveys and the bathometry a single existing surface model was developed by YES. The developed as-built surface model is shown in Figure 2. Comparison of the existing surface model to the original ground surface model allowed for the calculation of the quantity of tailings within the impoundment limits. This volume was found to be 280 000 m³

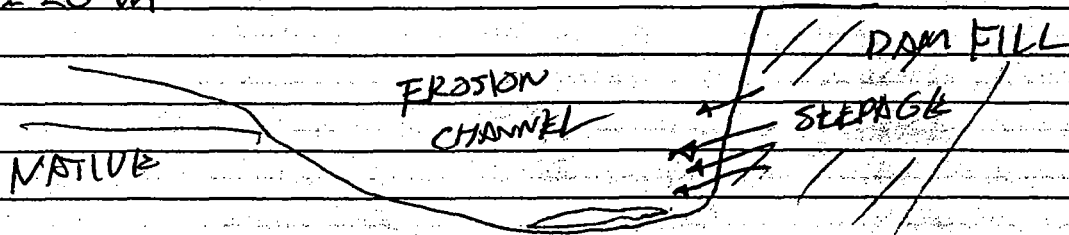
- SEEPAGE FROM SOUTH ABUTMENT EROSION CHANNEL IS STILL PRESENT; SOME SEEPAGE APPEARS TO BE COMING OUT OF EMBANKMENT FILL INTO THIS CHANNEL, JUST ABOVE END OF TOE BERM FOR ≈ 20 m

- INSTRUMENTATION SUITE PREVIOUSLY LOCATION IN O/S TOE BERM HAS BEEN WIPED OUT
