**MT. NANSEN GOLD MINE**

**1998 EFFLUENT QUALITY ANALYSIS REPORT**

*Prepared By:*  
Vista Engineering  
502 Olgilvie St.  
Whitehorse, YT  
Y1A 2S7

**290-08**  
**July 15, 1998**

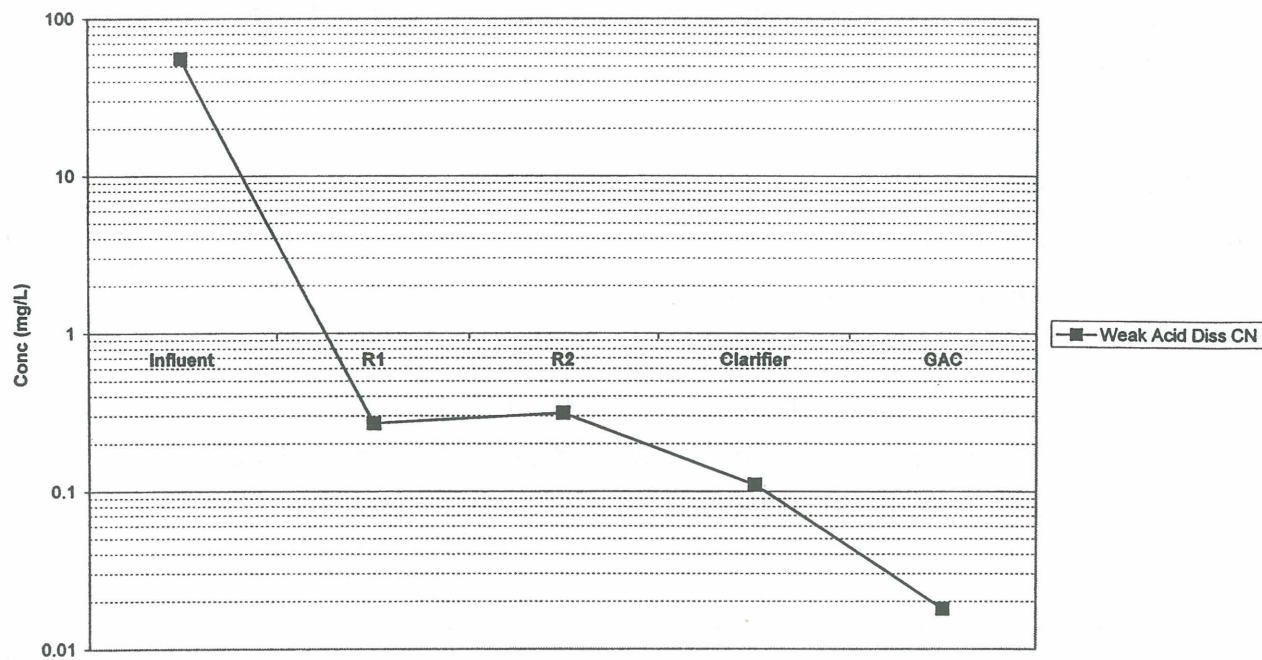
Figure 6.3

The data indicates that the majority of cyanide removal occurs at the first reactor with final polishing provided by the activated carbon columns.

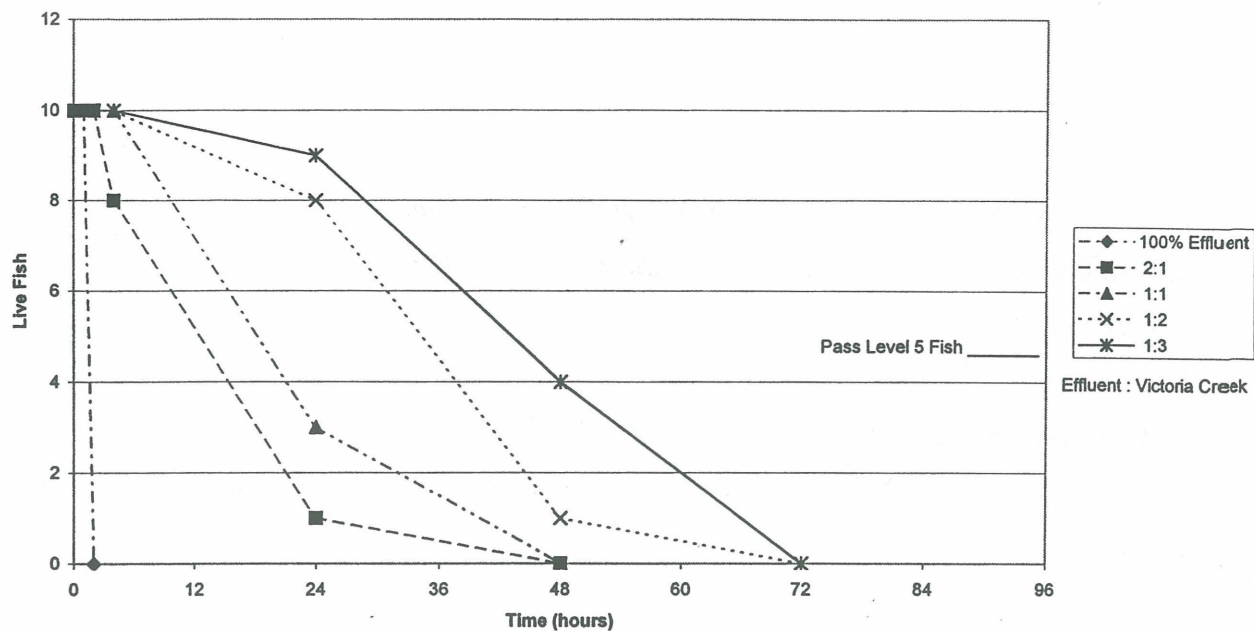
Figure 6.4

A reduction in toxicity was noted after the carbon columns had operated for approximately 24 hours. This can be attributed to the development of steady state conditions in the tanks after they had been filled with carbon.
